**KENSINGTON AVENUE PRIMARY  
SCHOOL, KENSINGTON AVENUE,  
LONDON BOROUGH OF NEWHAM, E12  
6NN**

**HISTORIC BUILDING ASSESSMENT**

**June 2013**

*In May 2013 Compass Archaeology was commissioned to produce a historic building assessment of Kensington Avenue Primary School on behalf of Newham Borough Council. The assessment has been produced in support of a planning application for the redevelopment of the school, including the expansion of the second-floor and other alterations.*

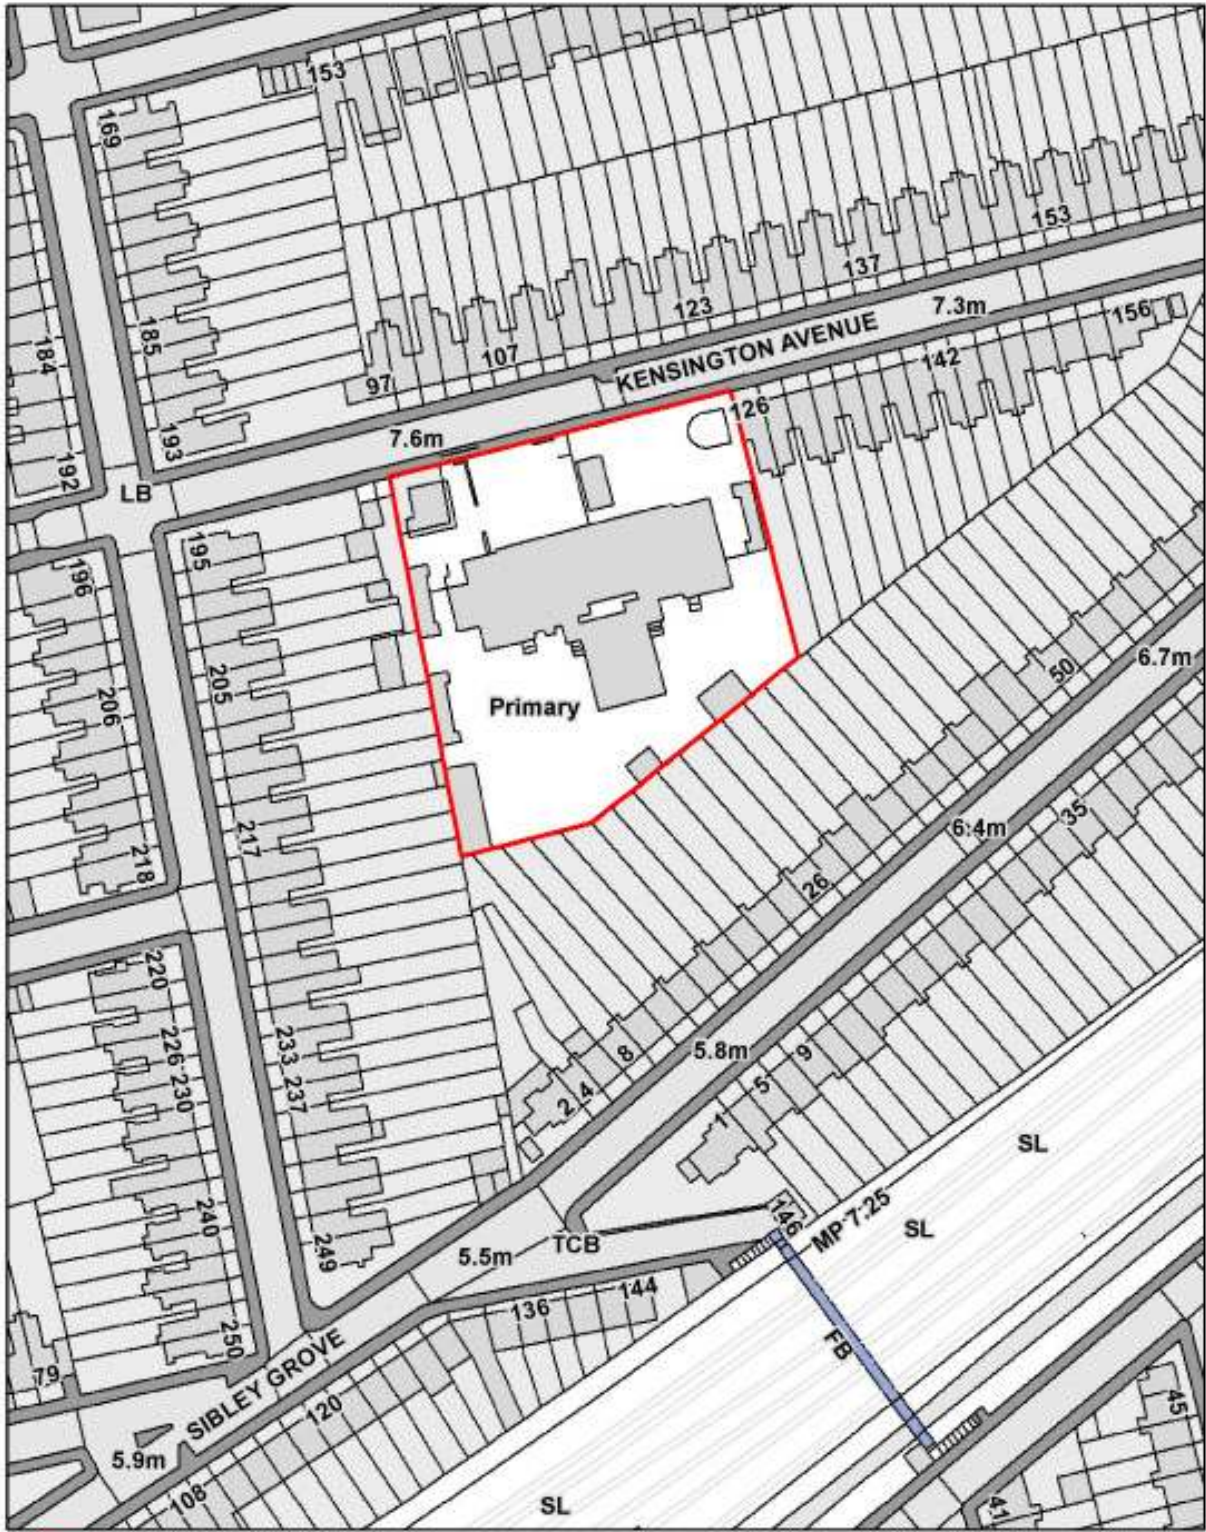
Fig.2: Current site plan

TITLE: LOCATION PLAN KENSINGTON AVENUE PRIMARY SCHOOL, KENSINGTON AVENUE E12 6NN

Scale 1 : 1250

- 1.2** The building is positioned on the southern side of Kensington Avenue, just to the east of the junction with Browning Road, and some 450m to the north-east of East Ham tube station (Fig.1: site centre TQ 42701 84596). The building to be redeveloped is positioned in the centre of the school land (Fig.2).

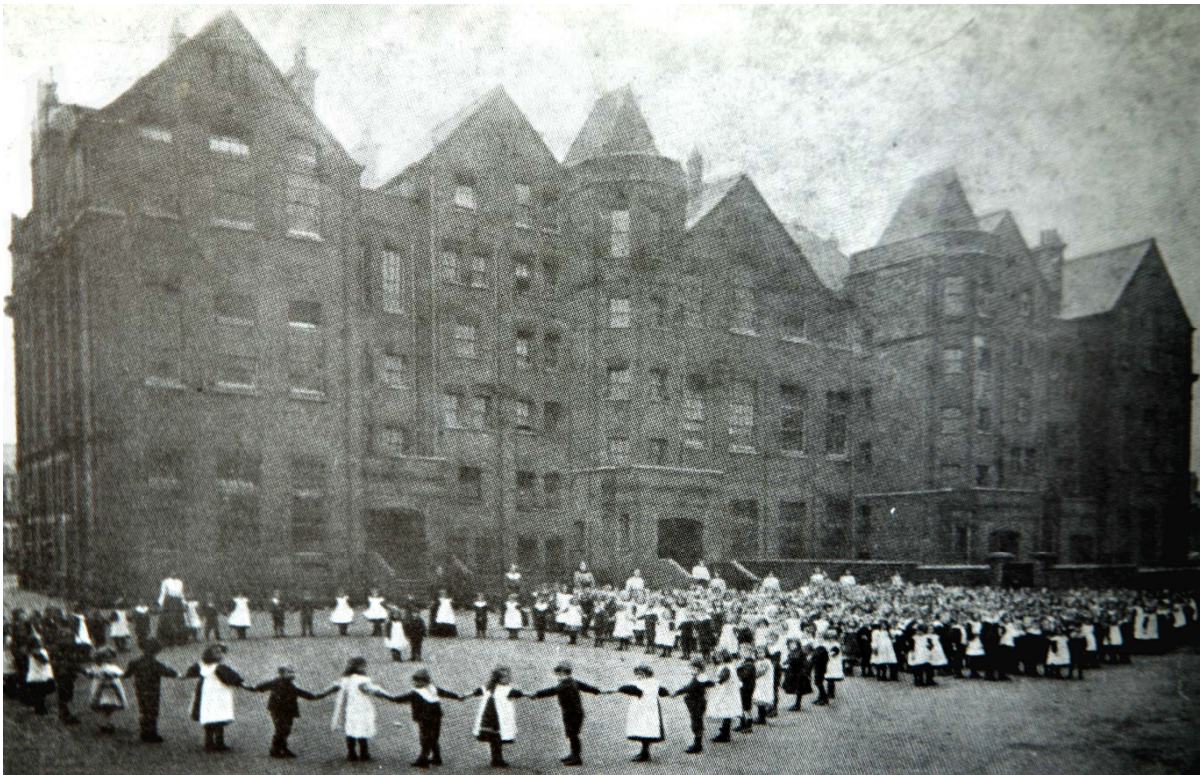
Fig.7: *Photo of the southern side of Kensington Avenue Primary School, early 1900s*

3.3 This photograph, from the early 1900s, shows the rear (southern) part of Kensington Avenue Primary School (fig.7). The school building is substantial, consisting of three main floors, plus five gables forming the southern side of the roof, and gables at each end. Four sets of stairs leading up into the ground-floor of the building are shown. Either side of the centre of the school are projecting 'turrets', with six sets of windows / floors, and with a smaller gabled roof on top of them – these contained the inner flights of stairs, and are still present today. Leading off each of these 'turrets' are sections with six sets of windows and floors – these equate to the mezzanine levels found today.

The main difference between this photograph and the school today is the loss of the third floor (second storey) – at either end the entire upper floor and roof has been lost and is now an open roof terrace, and the central section has lost its gabled roof. The 'turrets' and adjacent areas of mezzanine floors survive to their full height, with their roofs. It should be noted that the northern side of the building has entirely lost its upper storey and roof (this cannot be seen on this photo).

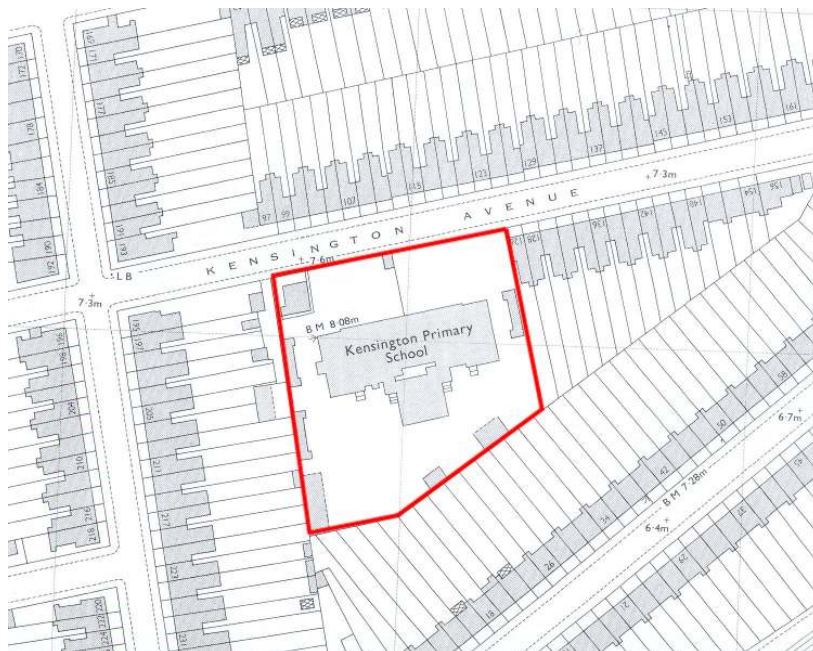
Fig.11: 1971 OS Map

**3.8** The 1971 OS Map (fig.11) shows, crucially, the single-storey southern extension (housing the Sports / Dining Hall) which exists today. This is the major change depicted on this map, and which renders the building in broadly the same form as it is today. The small western projection is still depicted, indicating that the main entrance to the school was still through here at this date, and that the western extension was constructed after the 1970s.

There is also a change in the exterior building to the south of the main block, which is now a small square structure rather than the more complicated elongated structure shown on the earlier maps, alongside the destruction of the other exterior building to the south of the main block. The only difference between the exterior buildings shown on this map and those found today is the lack of the small rectangular block in the northern part of the site.

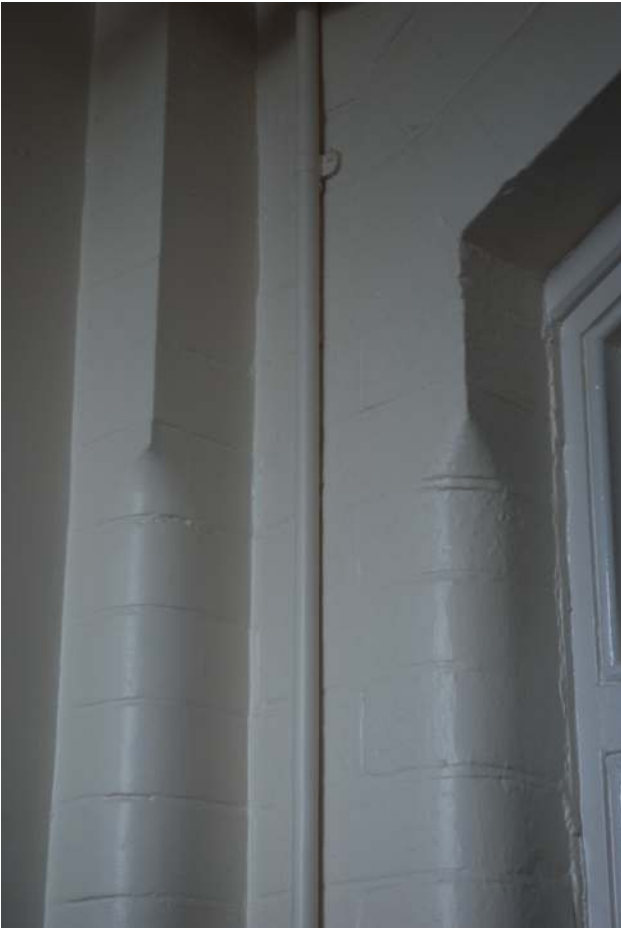
*Fig.20: The rounded (bullnosed) corners of brickwork in one of the corners in room 3*

The southern walls of all of these rooms are original, plus the eastern part of the northern wall, the eastern and western walls of the building, and the wall dividing room 4 from rooms 5+6 (green on fig.18). These walls all have certain decorative features, including a string course running around the walls just below window height (originally exposed and glazed), visible coursing of brickwork, glazed lower section of brickwork, and rounded (bullnosed) corners to the buttresses, doorways, etc.

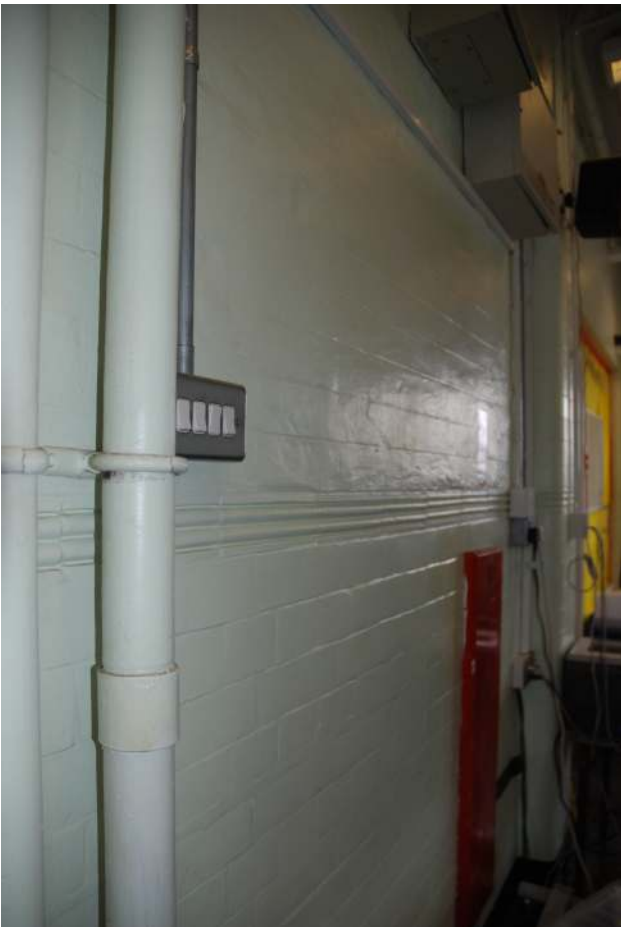
*Fig.21: The string course running along one of the original walls in room 4, but seen throughout the school*

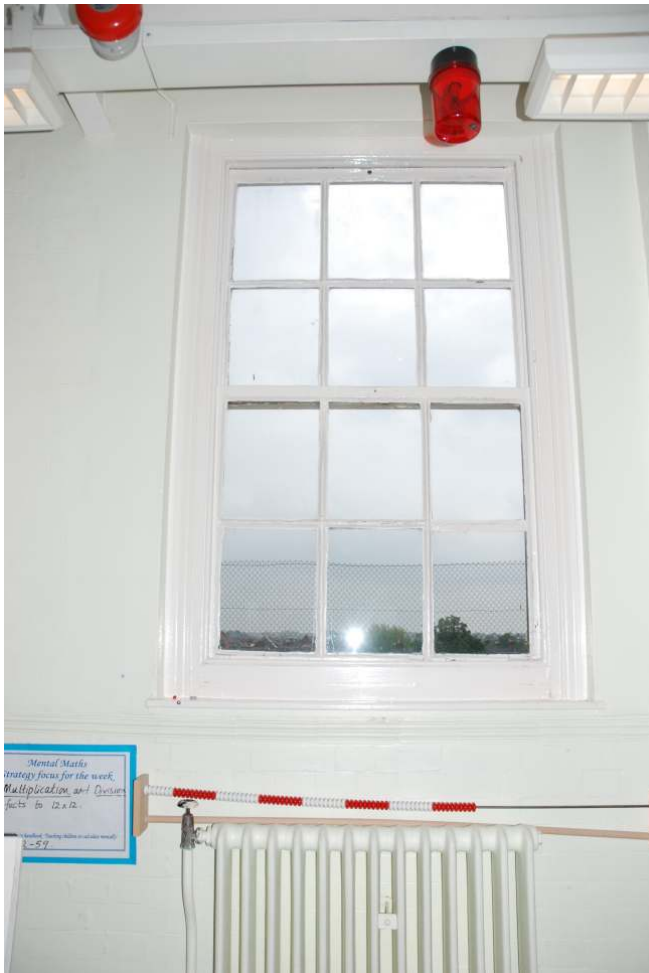
*Fig.22: One of the original window openings in the northern wall of room 3*

The window openings in the surviving original northern wall are set in a masonry reveal, with a wooden sill, and are 3 panes wide (although many of the windows themselves are later replacements). The door in the eastern part of the northern wall of room 3 is set within the original opening – a tall rounded opening stretching up to ceiling height, with a window probably set above it. The original opening between rooms 4 and 6 can also be observed – this was clearly a tall wide opening, with the present door being a later insertion. The doorway opening, plus original surrounding glass panel, at the eastern end of room 3 leading to the stairs is also original, however that at the western end of room 6 is not. A small high-level blocked-up opening can also be visible in room 3 – the nature of this has not been identified, although it enabled access into mezzanine level 3B. The positions of radiators can also be identified on the floors, marked out in concrete.

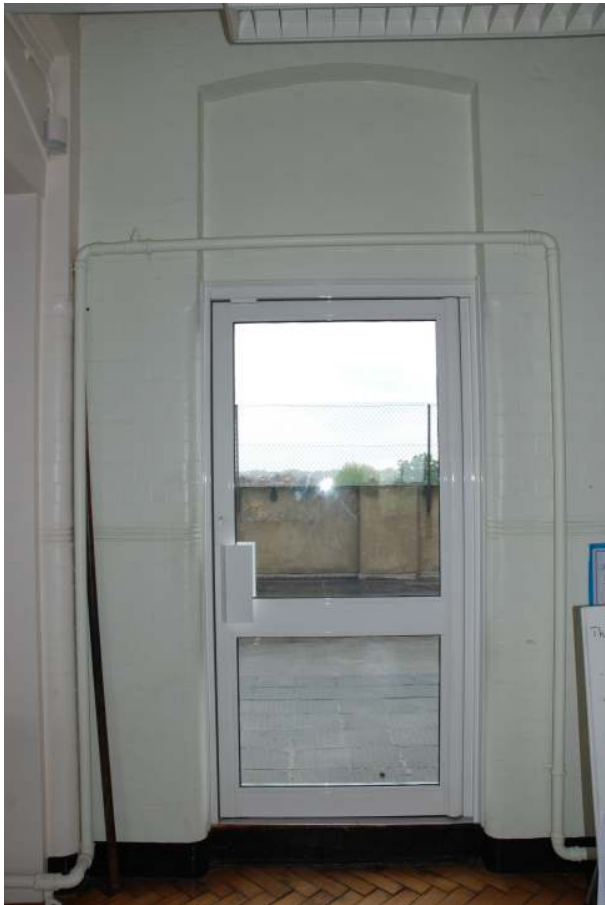
Fig.23: *The modern door in the original doorway opening in the northern wall of room 3*

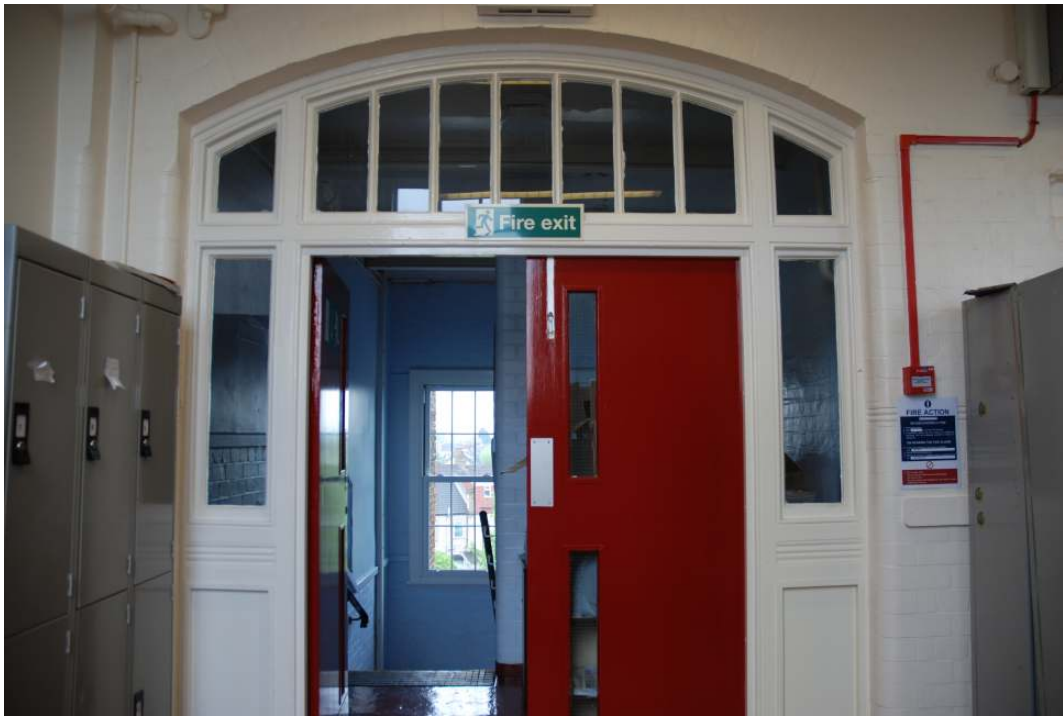
Fig.25: Original doorway and glass panelling in the eastern part of room 3, leading to the stairs

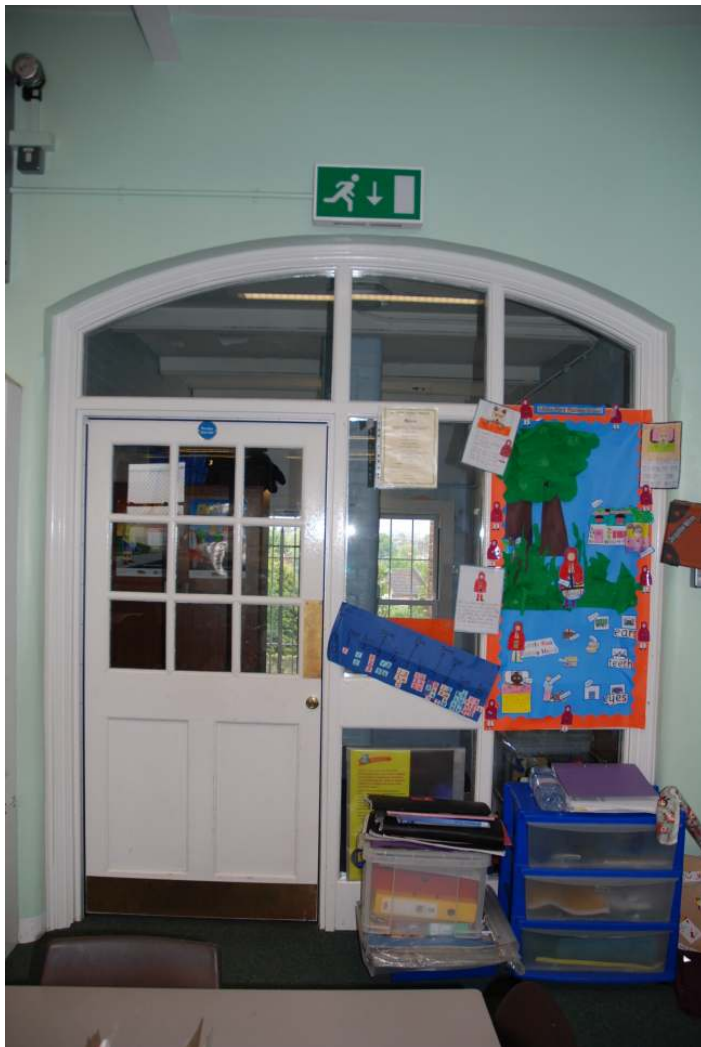
Fig.26: Later doorway and glass panelling in the south-western corner of room 6

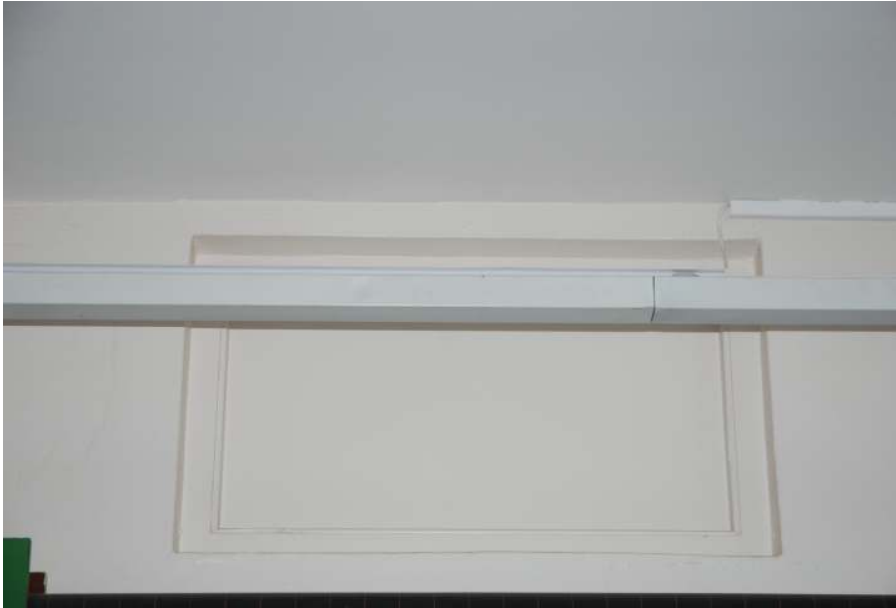
*Fig.27: Small high-level blocked-up opening on southern side of room 3*

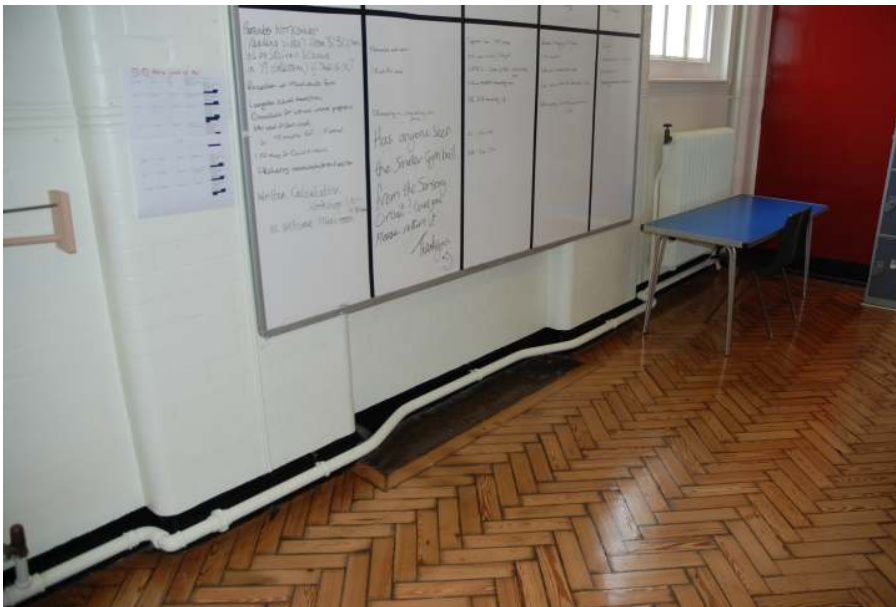
*Fig.28: Original position of one of the radiators in room 3*

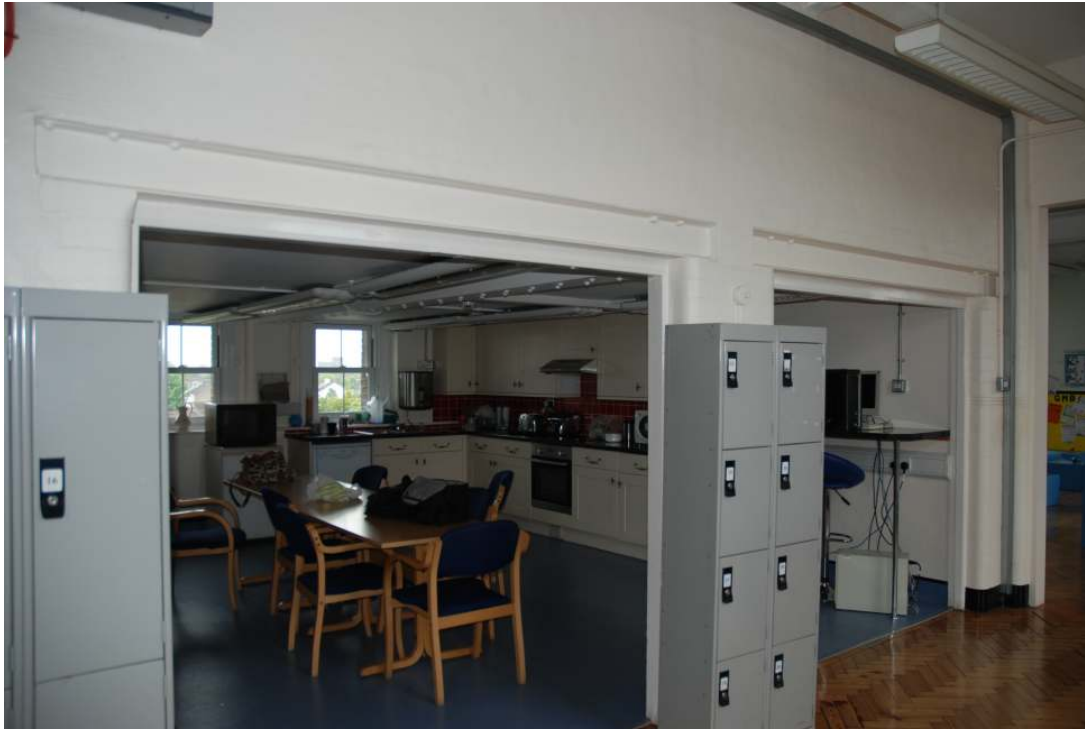
*Fig.29: Room 2, looking south-west, through openings that would originally have held a pair of double doors*

The two smaller lower-ceiling rooms (rooms 2 and 5) are also original, and contain a number of original features. These are positioned directly beneath the mezzanine floors, explaining their lower ceiling-levels. Original features in these rooms include the riveted metal beams in the ceilings, plus the supports for chimneys in the overlying rooms. Room 2 appears to have originally had a pair of double doors on its northern wall, and room 5 a single door.

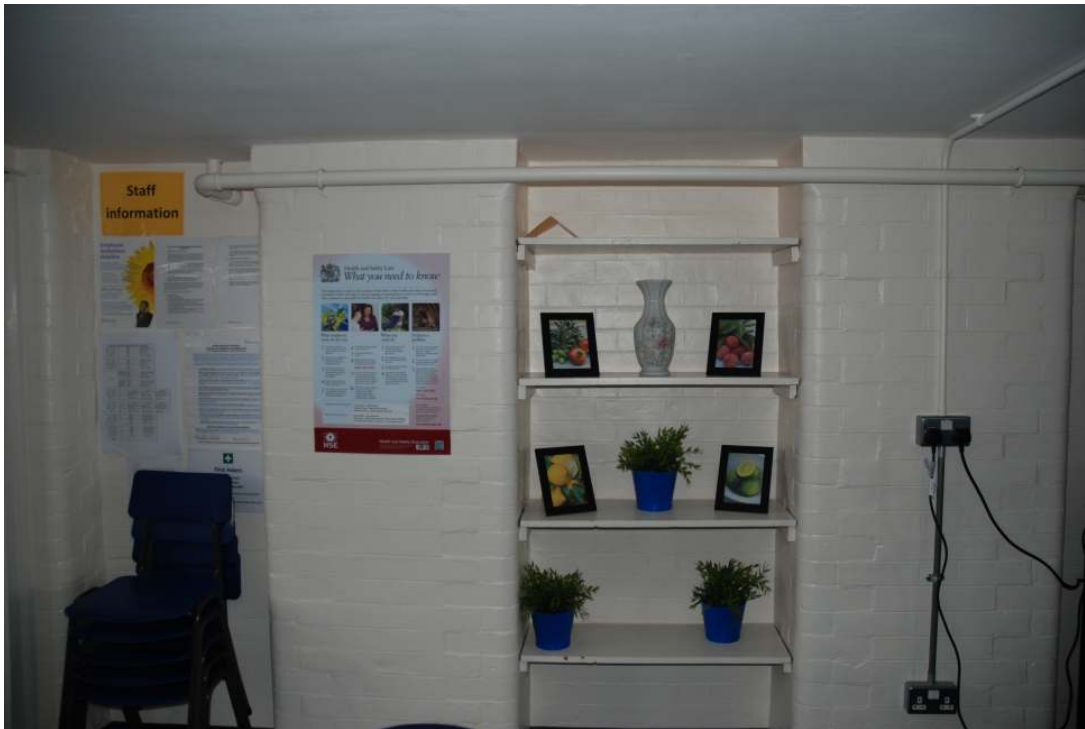
*Fig.30: The chimney supports on the eastern side of room 2, for fireplace in overlying mezzanine level*

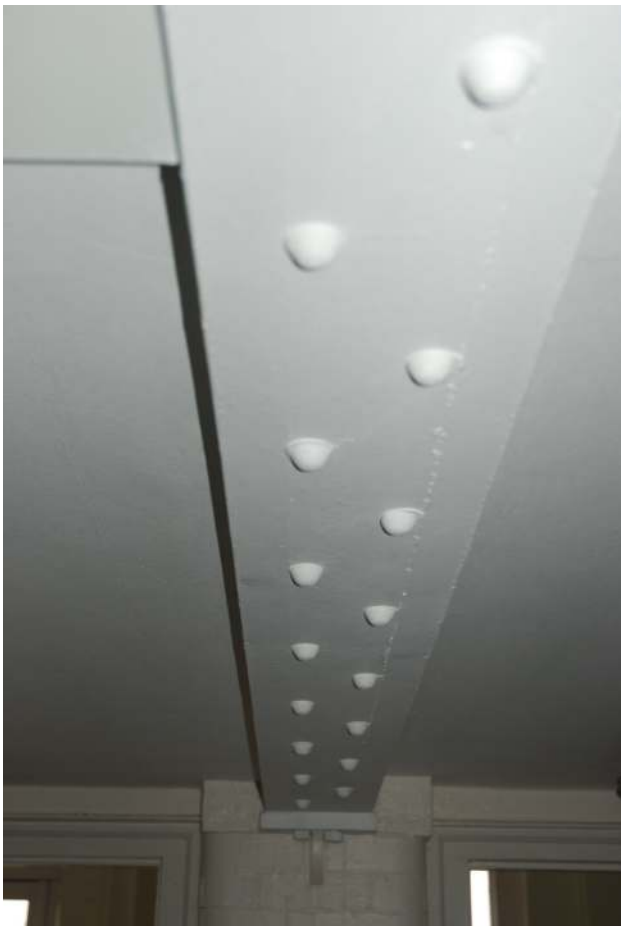
Fig.32: One of the riveted metal beams in rooms 2 and 5

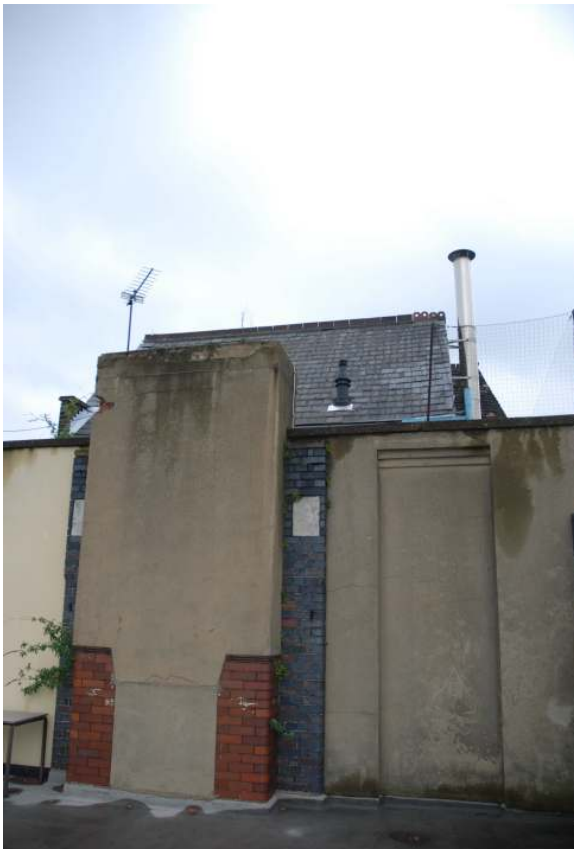
*Fig.33: The chimney on the western side of the building*

Certain other original features can be seen from the exterior roof-terrace area of this floor. This includes the blocked fireplaces / chimneys on both the eastern and western sides of the building, and the engineering brick abutments surrounding the entirety of the roof-terrace.

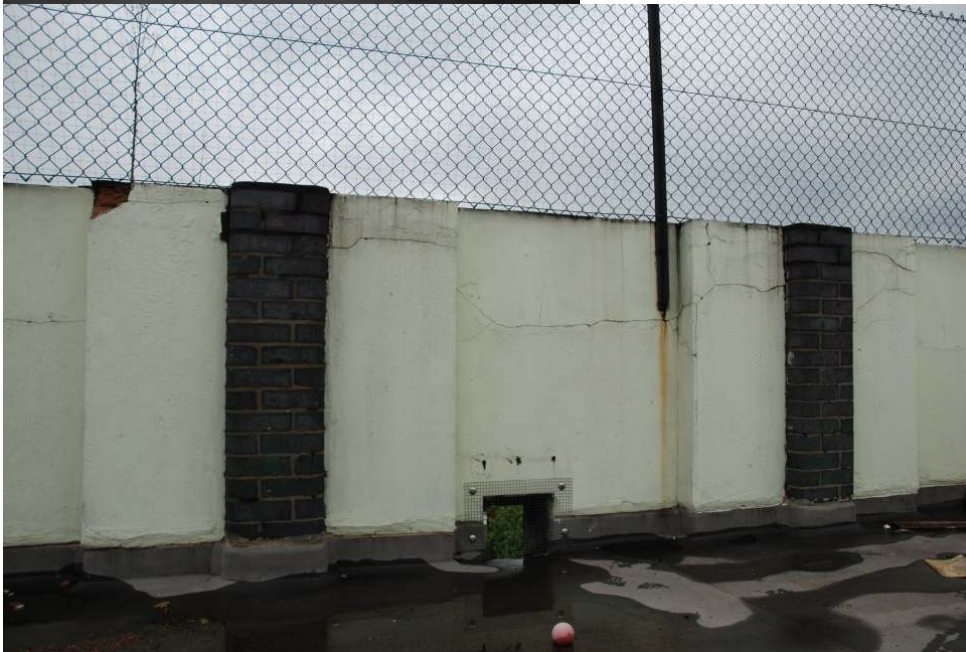
*Fig.34: Some of the engineering brick abutments on the perimeter of the building*

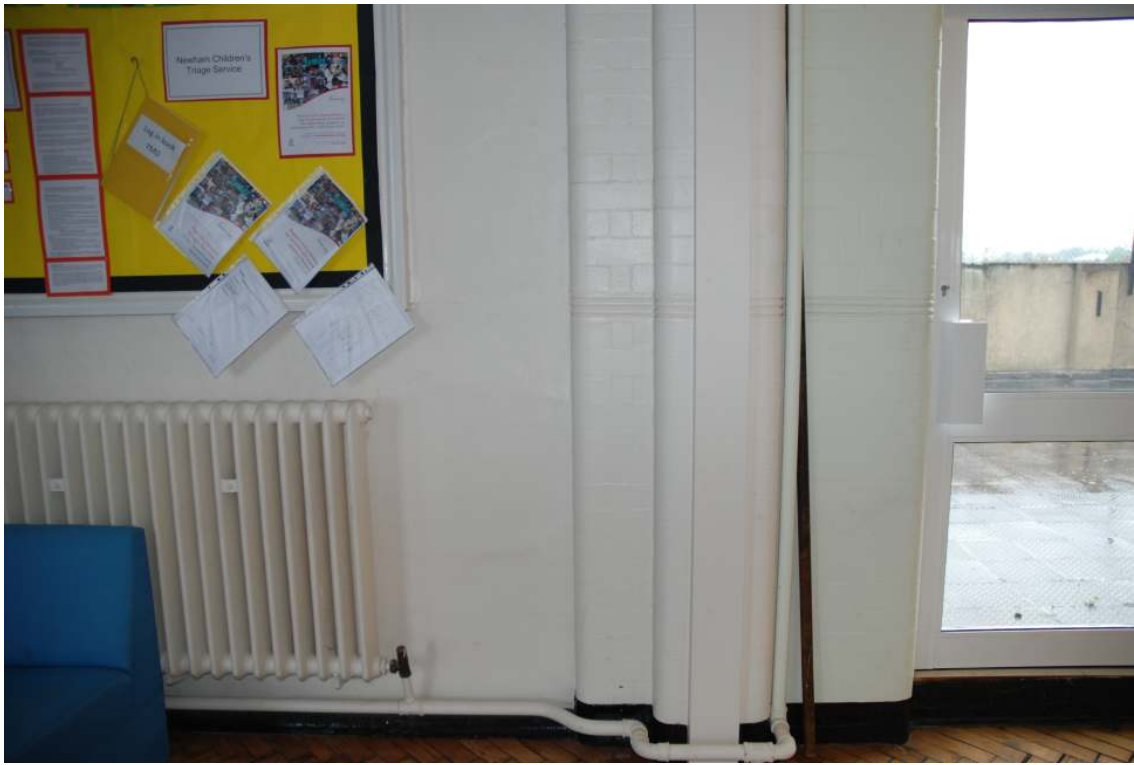
*Fig.35: The join between the original and new parts of the northern wall of room 3 – the original (eastern) part has a string course and visible brick coursing; the later (western) part lacks these*

The main evidence for this phase of rebuilding is the northern wall along the majority of the building. This is with the exception of the far eastern part of the wall, which is original (based on the differences on the interior face of the wall, as the original eastern part has string courses, brick coursing visible, rounded corners to buttresses, etc, whereas the western part of the wall lacks these – see fig.35). Clearly this part of the wall survived World War II, and there was originally a wall along this line. The new wall is slightly thinner than the original wall (*c*100mm thinner). The windows in this new wall are different from the original ones, being set in a wooden frame, having no sill, and being 4 panes wide, and there are no door openings in the new part of this wall. The exterior of the entirety of this wall (both the original and later parts) has been rendered over. This is with the exception of the far western part, which has since become incorporated into the larger extension to the north, with only a beam at the upper levels along this line surviving (see discussion below, 5.2.3).

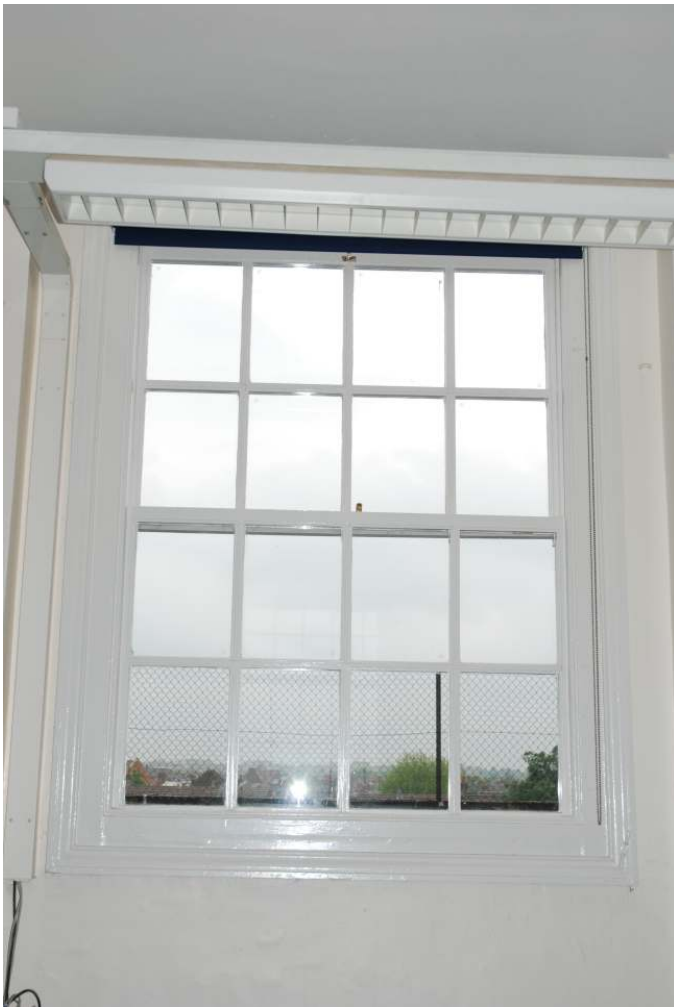
*Fig.36: One of the later windows in the northern wall of room 3*

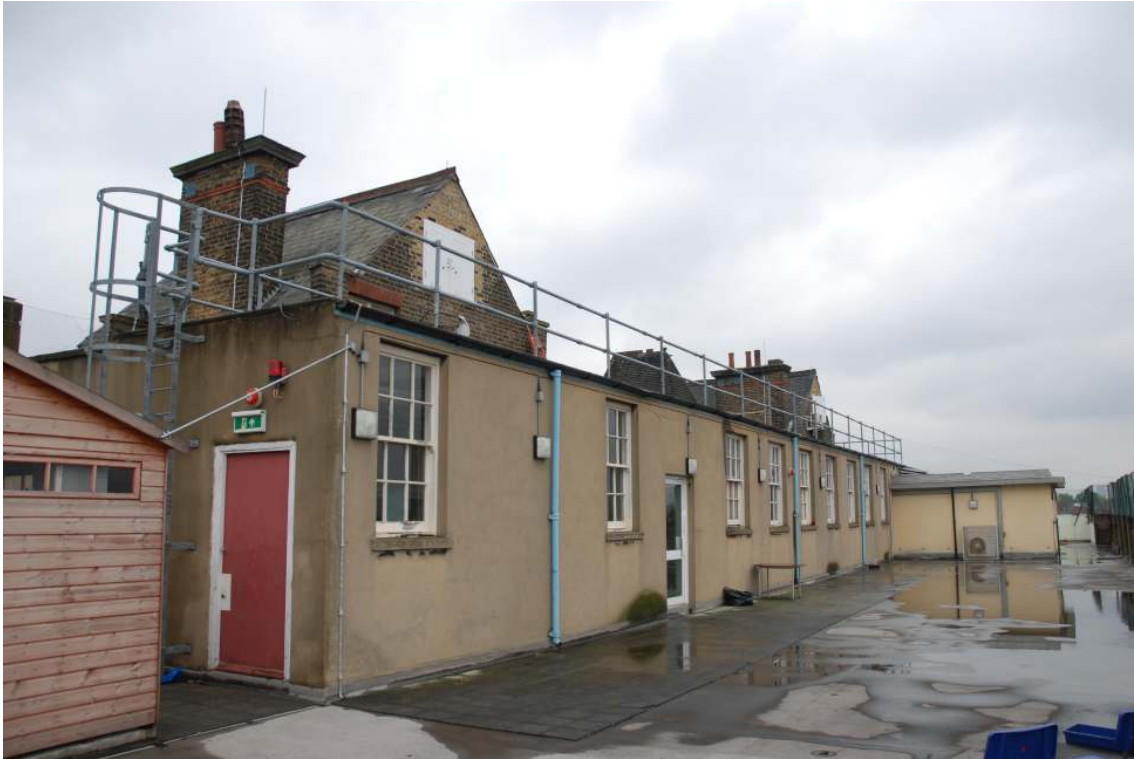
*Fig.37: The northern exterior face of room 3 (in foreground) and room 4 (in background), rendered over*

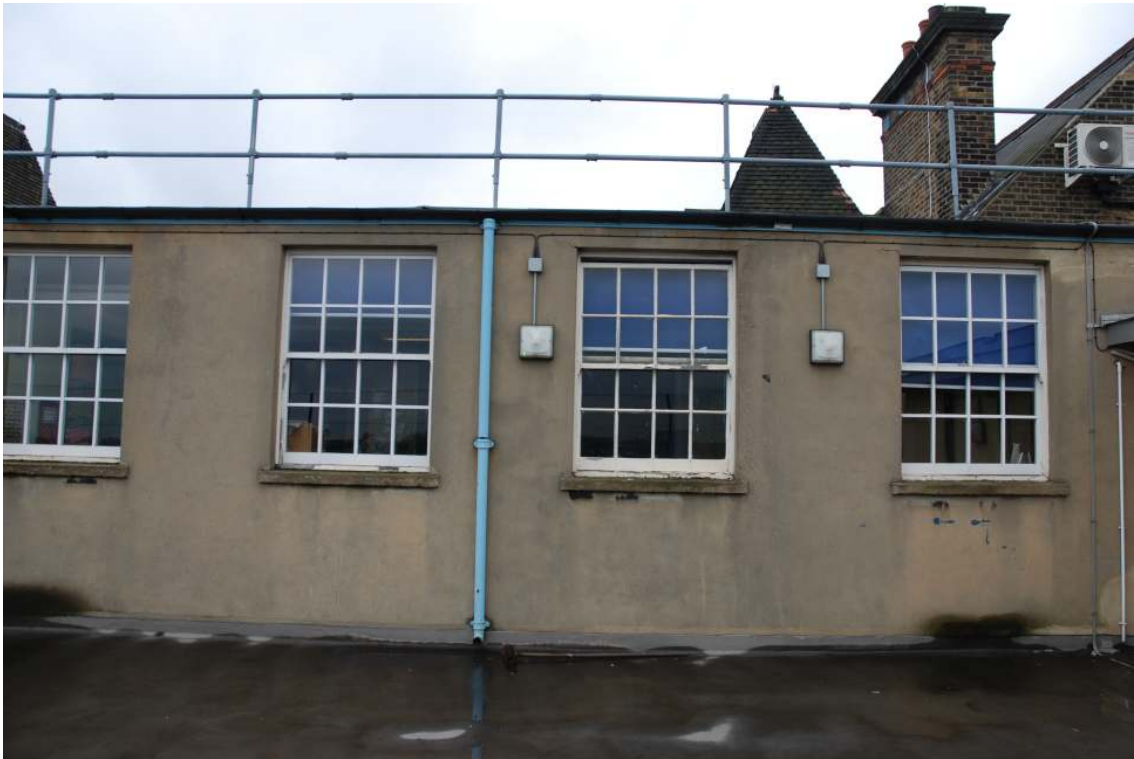
*Fig.38: Close-up of the new northern wall of room 4, exterior face, showing rendering and wider 4-pane windows*

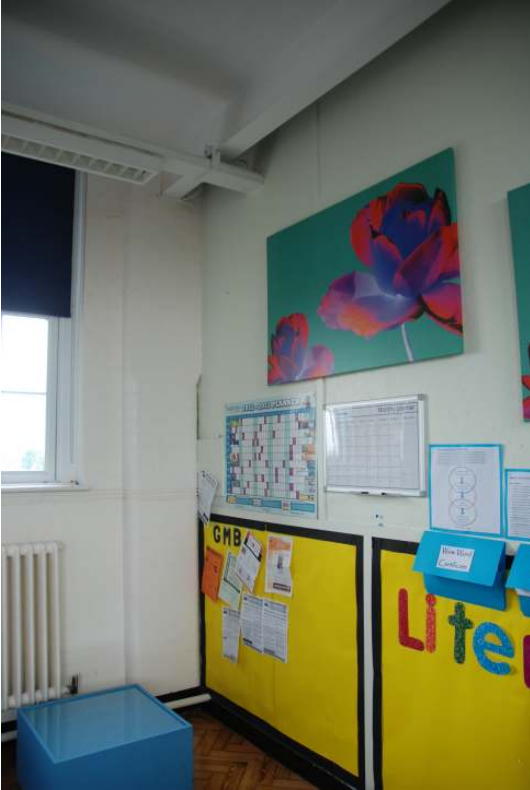
The interior of the classrooms on this floor have been partly modified alongside the changes made after the destruction of World War II. In particular, a wall has been inserted between rooms 3 and 4 (a wooden-framed chipboard insertion). The ceilings in the western half of room 3 and in room 4 have been replaced, presumably during the rebuilding after WWII.

Fig.39: *The later chipboard wall between rooms 3 and 4*

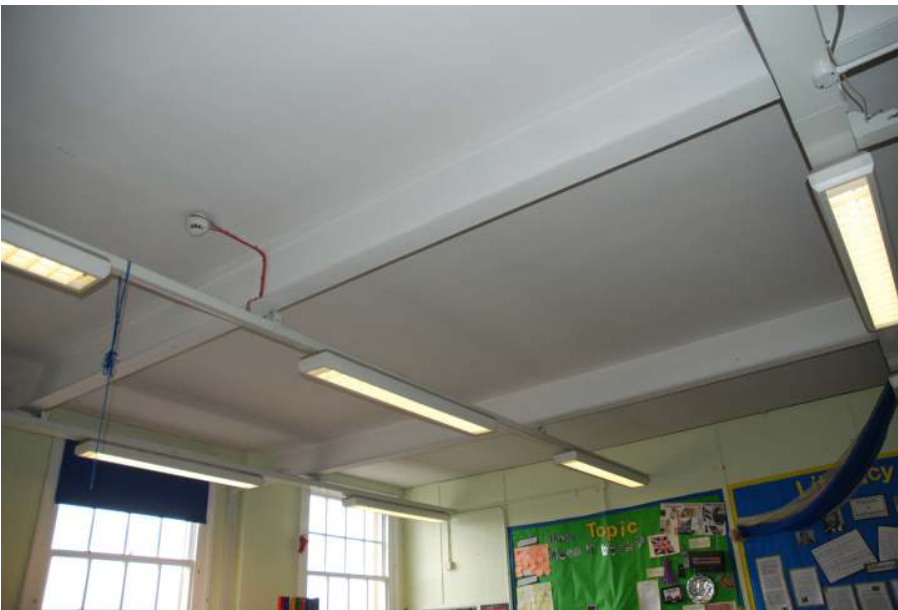
Fig.40: *The later ceiling in room 4*

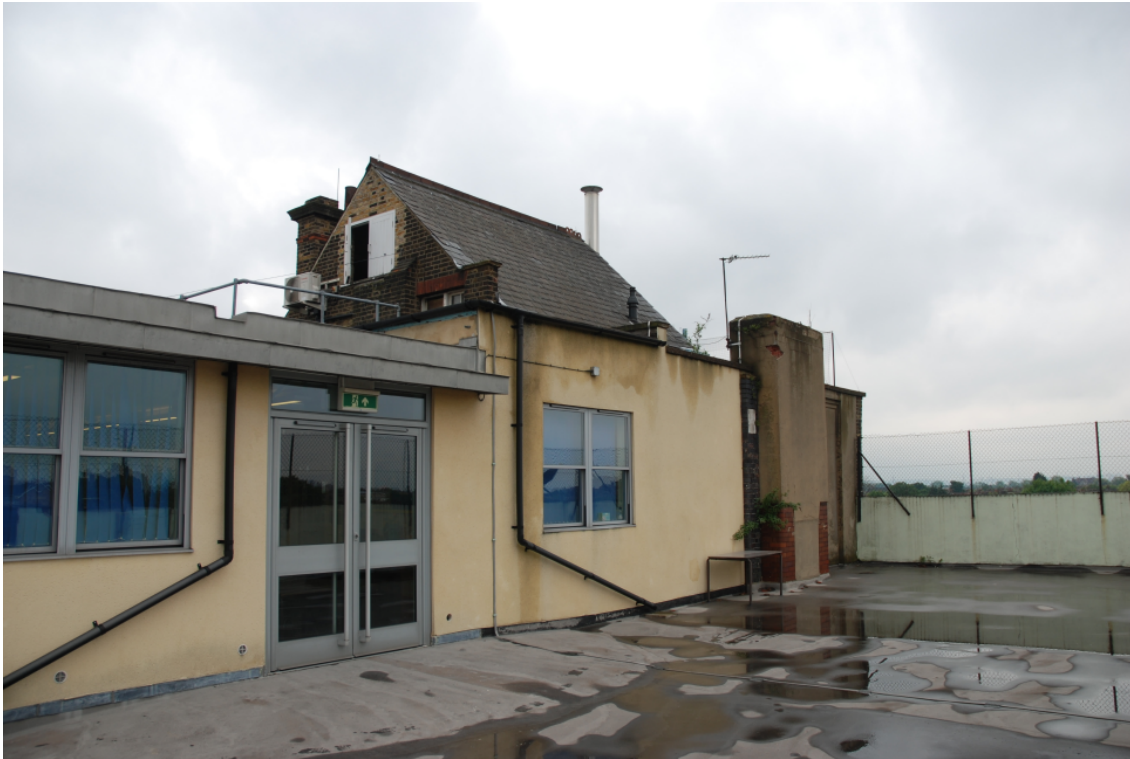
The eastern and western ends of this floor were also modified after WWII, as the rooms which once existed here were presumably destroyed by bombing. The ends of the building were rationalised, to end beside the stairs, with the eastern and western parts being left as open roof-terraces. The southern parts of these walls were original, as can be seen from the outside where the remnants of the chimney can be seen, so there was originally a wall on this line. However, these ends have been rendered over, in a similar way to the northern wall, and any rooms beyond them demolished.

*Fig.41: The western end of the second-floor buildings, and adjacent roof terrace*

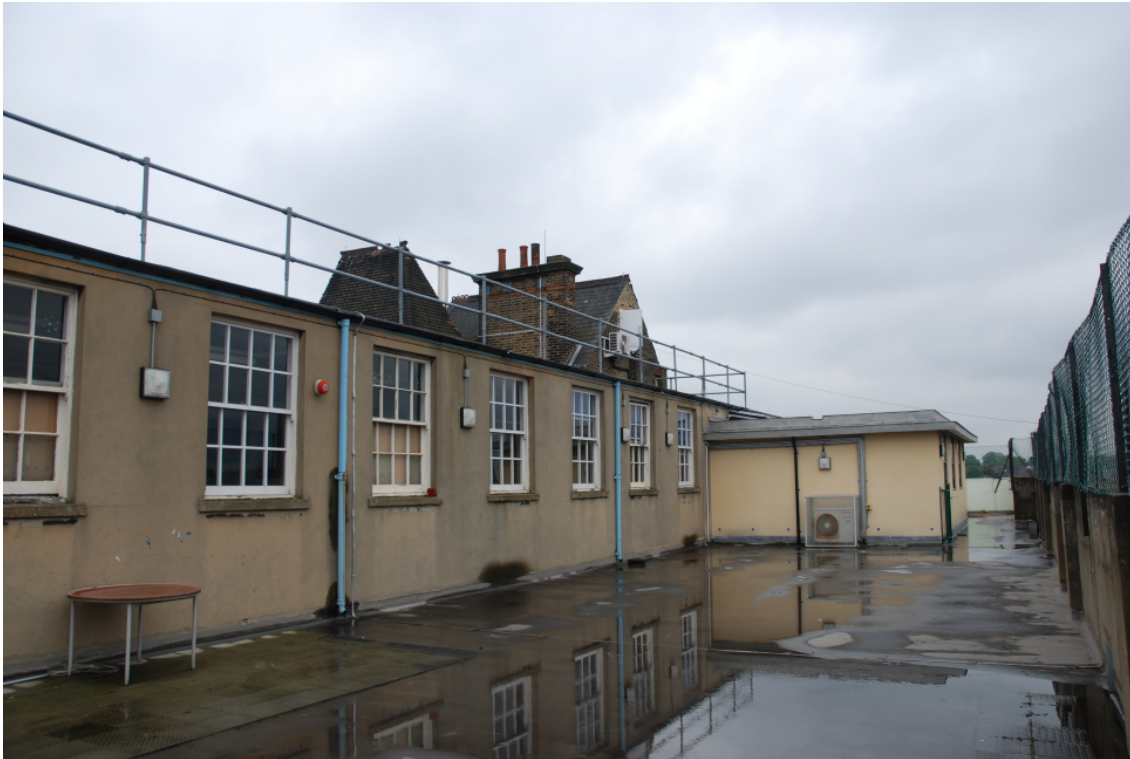
The latest change to the second-floor is the construction of the northern part of room 6. This is obvious from the outside, as this part has a lower roof than that to the south, and this roof is of metal construction. The position of the earlier door on the western face can be seen just to the south of the present door. The difference in ceiling heights between this later extension and the earlier part of the room is also visible on the inside, with a large beam separating these two parts (along the line of the earlier northern wall). The extension contains modern fixtures and fittings (windows, doors, etc). It is believed that this extension was constructed in the last ten years or so.

Fig.42: *The modern extension, looking south-west*

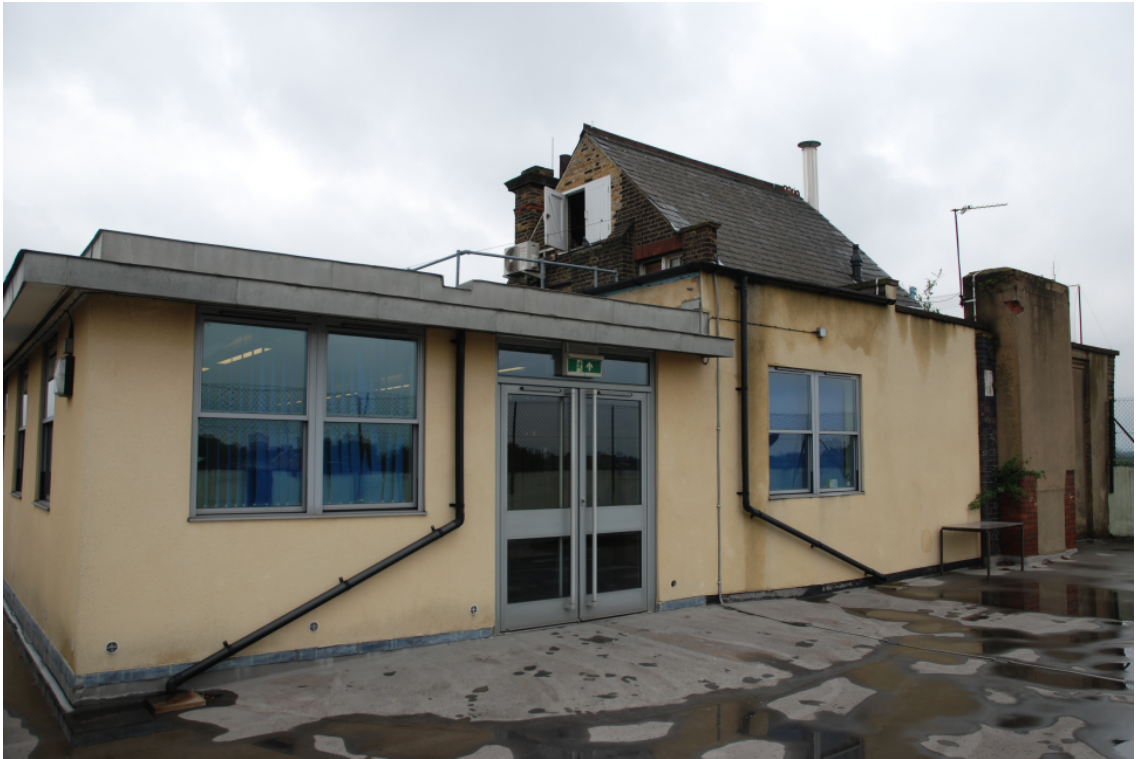
*Fig.43: The modern extension, with the lower ceiling height, looking south-east. The earlier door is visible to the right of the present door*

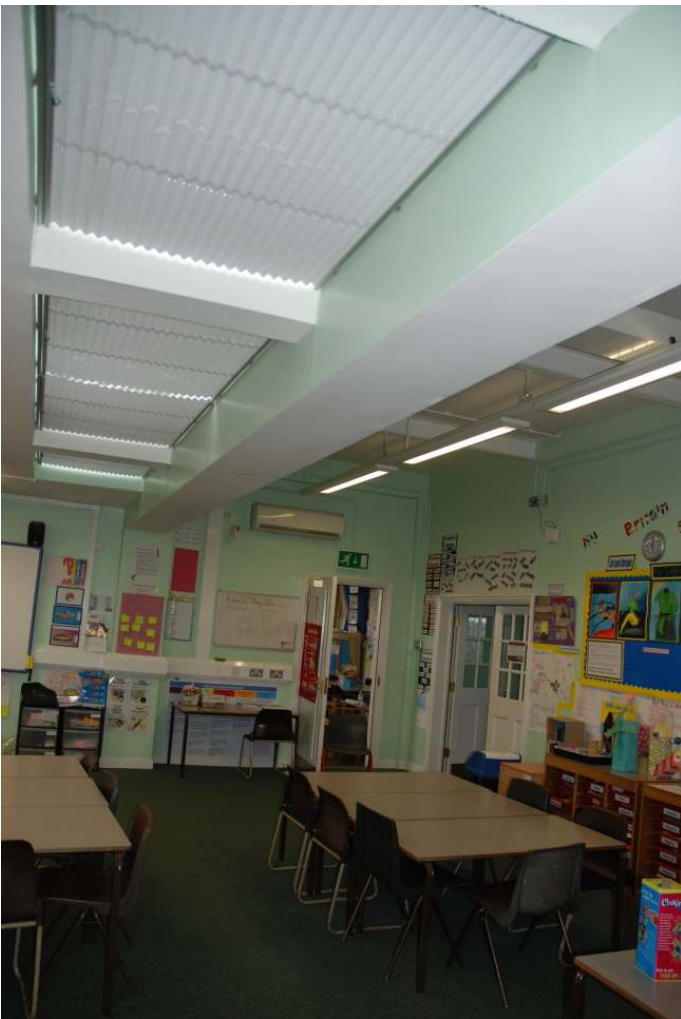
*Fig.44: The interior of room 6, looking south-east (from within the area of the modern extension), showing the beam running across and separating the modern extension from the older higher-ceiling part*

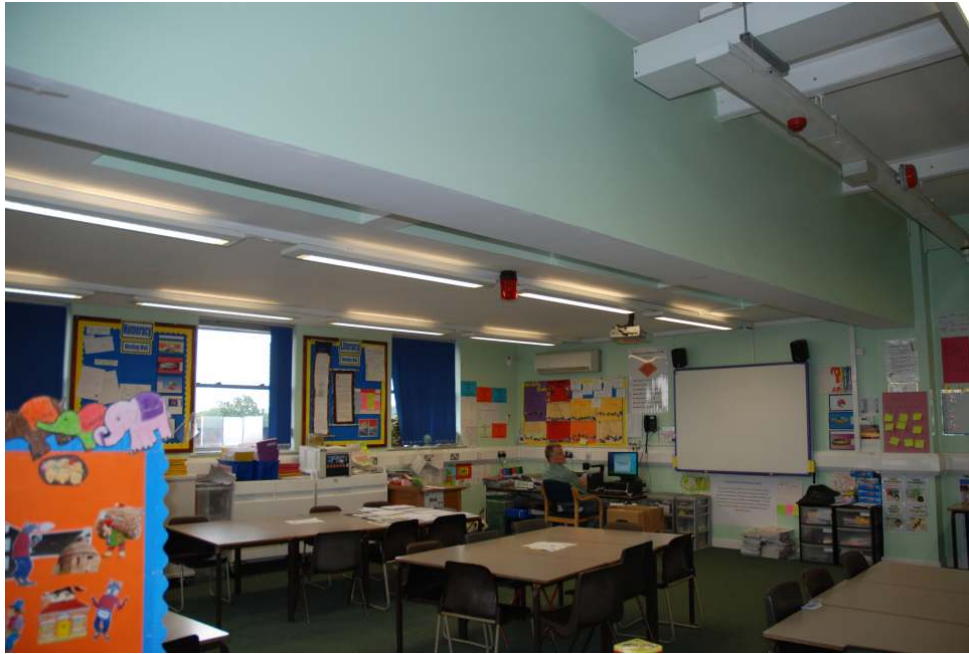
*Fig.45: Room 6, looking north-east (towards the modern extension), showing the beam running across and separating the modern extension from the older part*
