**KENSINGTON AVENUE PRIMARY  
SCHOOL, KENSINGTON AVENUE,  
LONDON BOROUGH OF NEWHAM, E12  
6NN**

**HISTORIC BUILDING ASSESSMENT**

**June 2013**

*In May 2013 Compass Archaeology was commissioned to produce a historic building assessment of Kensington Avenue Primary School on behalf of Newham Borough Council. The assessment has been produced in support of a planning application for the redevelopment of the school, including the expansion of the second-floor and other alterations.*

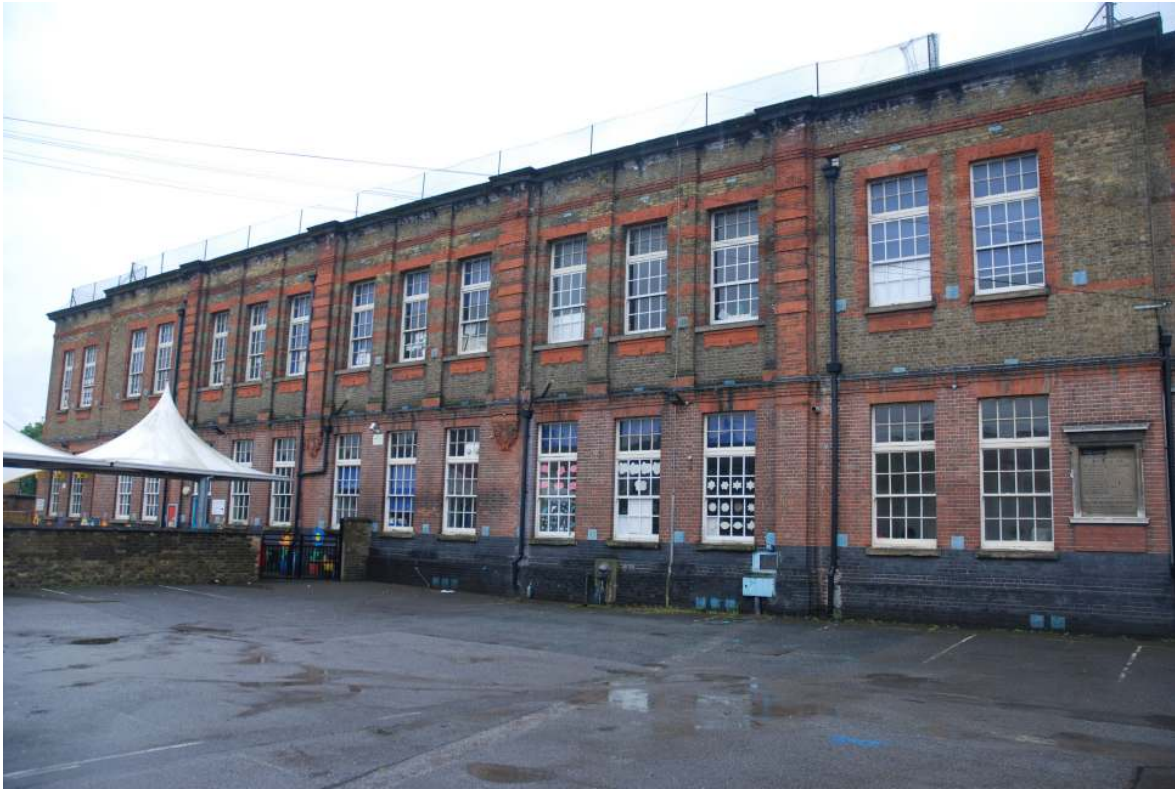
*Fig.46: The northern elevation, showing the flat roof*

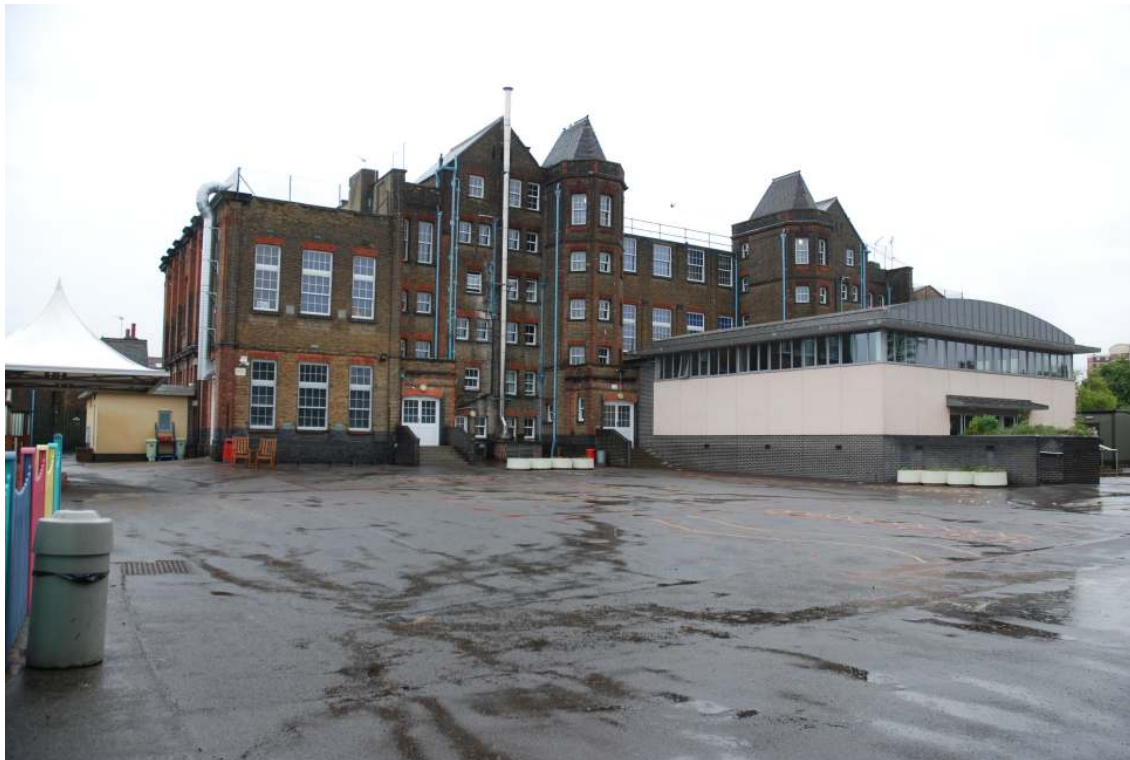
*Fig.47: The southern elevation, showing the existing gables towards the centre of the building*

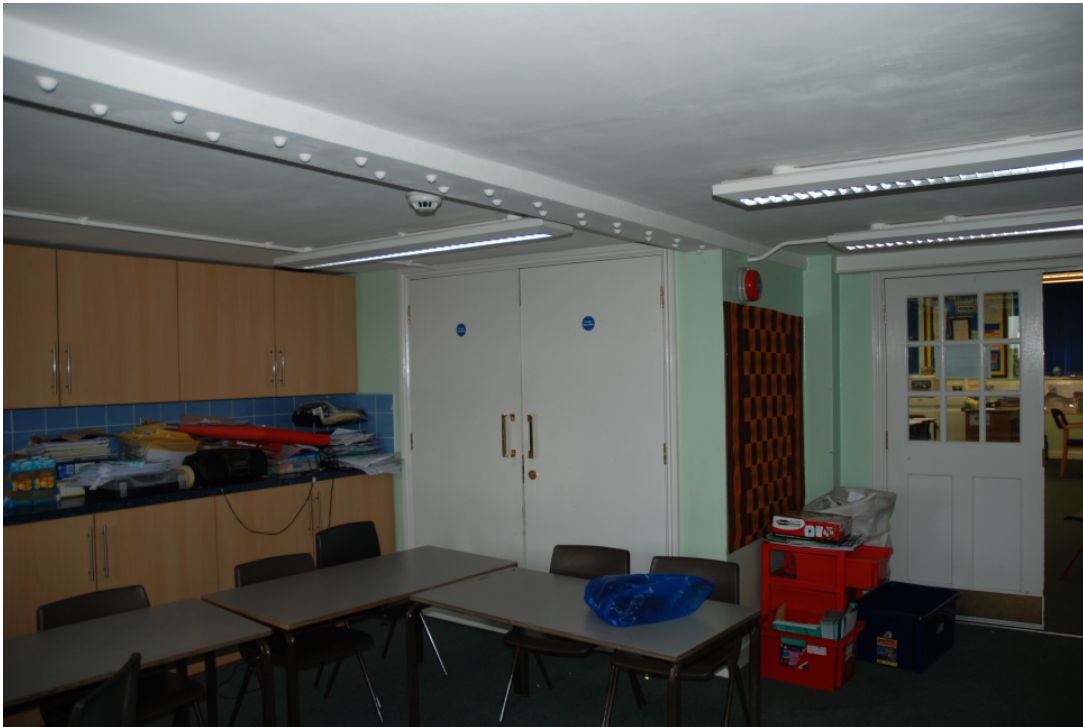
The dumb waiter is believed to be original to the construction of the building. It has now fallen out of use, however the void in which it once operated remains, and the area of this can be seen at each level. Furthermore, the panelling outlining the area of the dumb waiter can be seen on both the ground and first floors.

Fig.48: *The cupboard containing the dumb-waiter void on the second-floor, in the north-west corner of room 5*

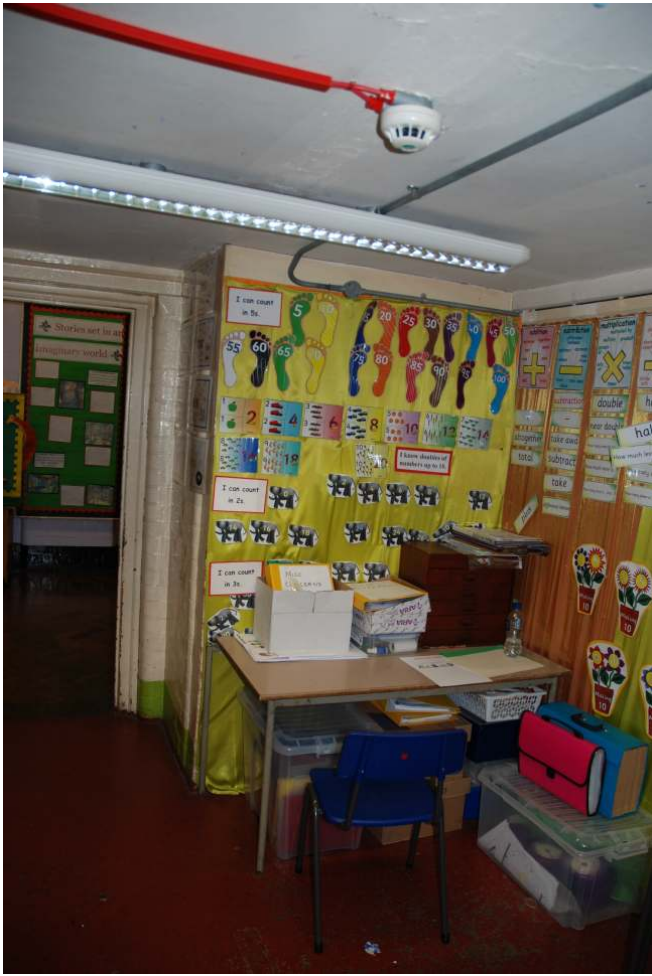
Fig.49: *The area of the dumb-waiter on the first-floor, on eastern side of the doorway in room 10*

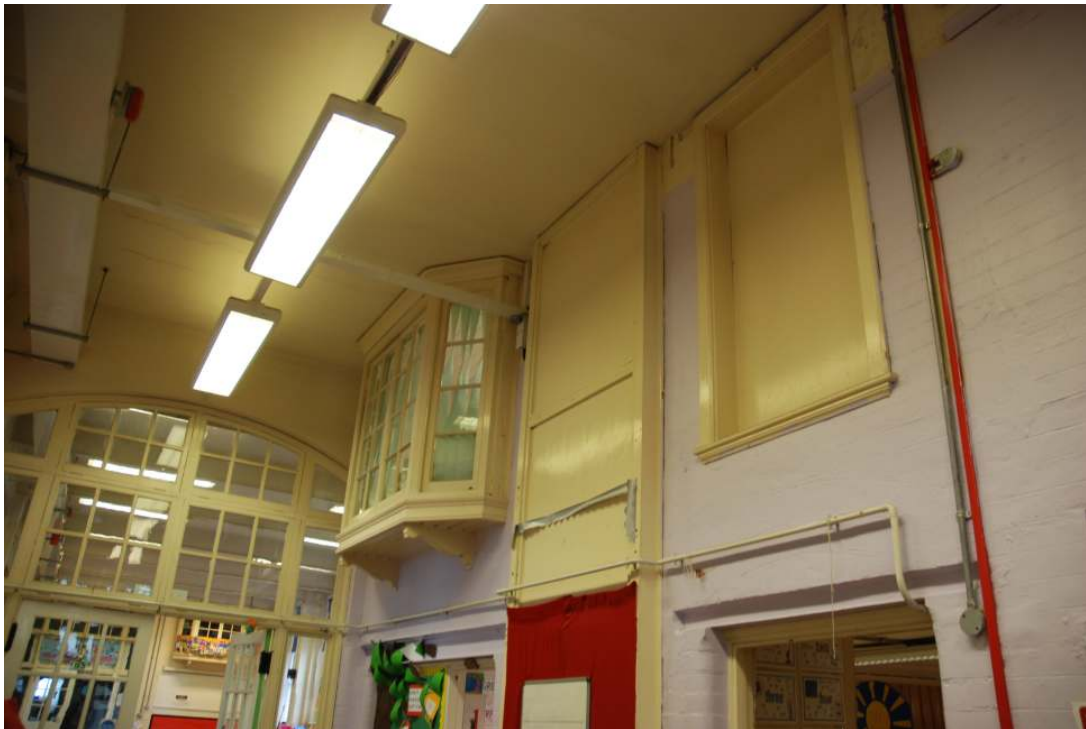
Fig.50: *The panelling showing the area of the dumb waiter on the first-floor, viewed from the central lobby, looking south-east*

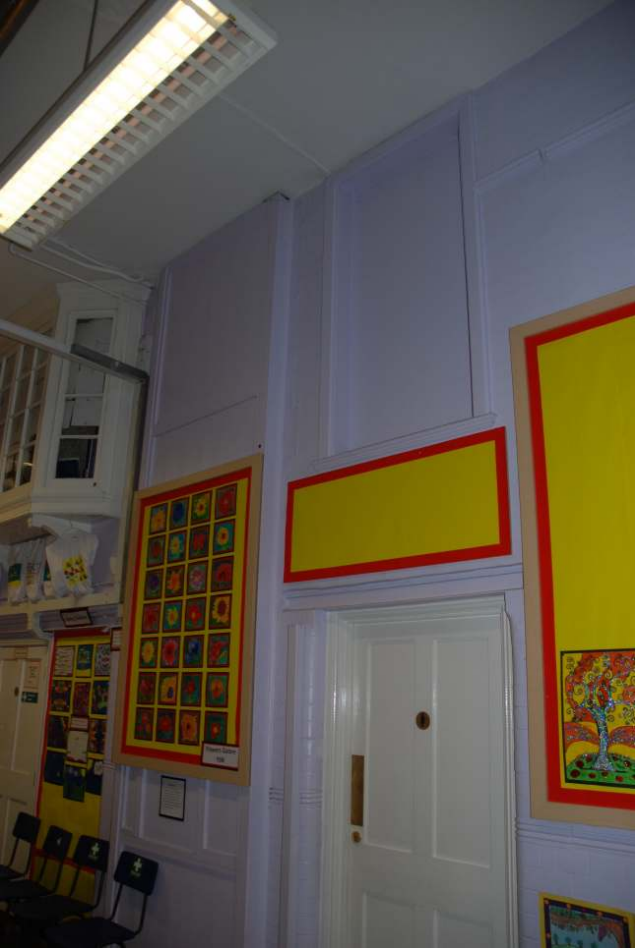
*Fig.51: The panelling showing the area of the dumb-waiter on the ground-floor, between the door on the right of frame and high-level internal window to left*

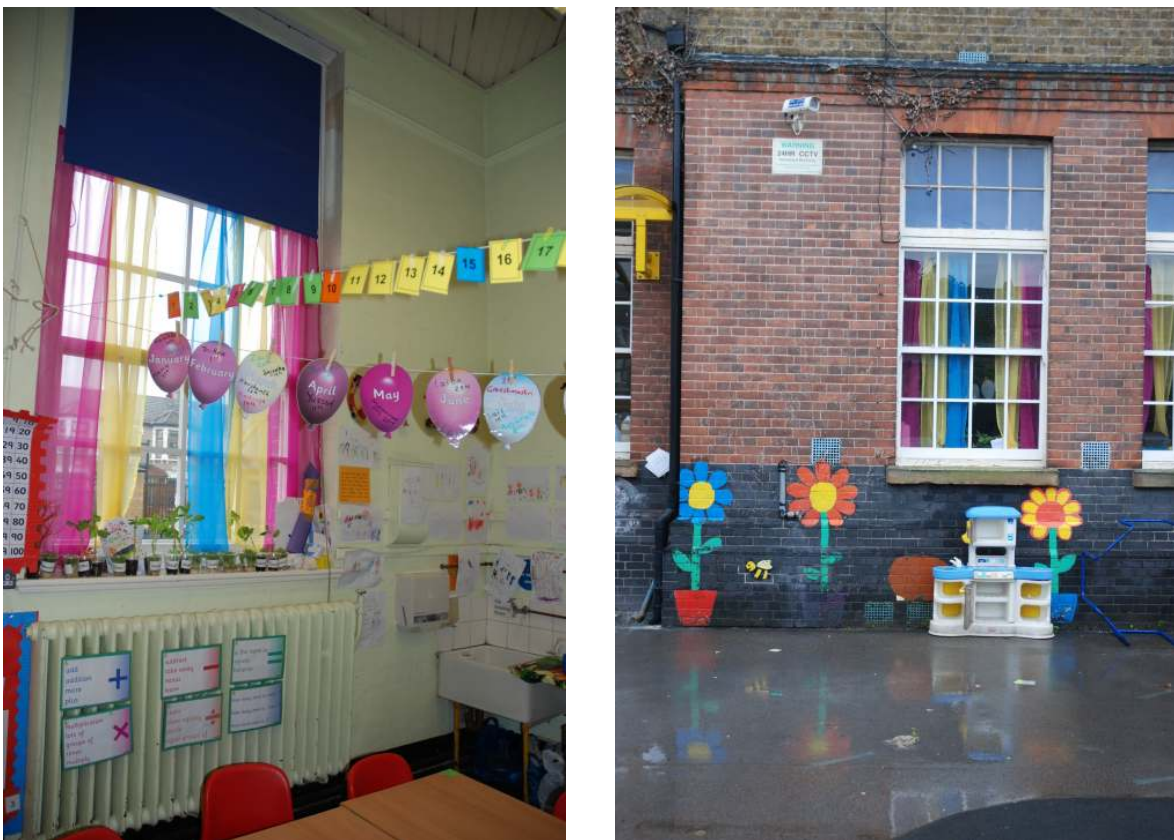
The exact size and positioning of this door is undecided, however it appears to fall in an area of broadly open wall / brickwork, with the only original feature in this area being a ventilation box (seen in a number of different places around the school). It may also fall within the area of a window. Although the insertion of this door could arguably diminish the regular feel of the building frontage, the door could be inserted in such a way as to fit with this. For example, the current door, to the west of this, has an overlying window-light (fig.53) – a similar thing could be done for the new door.

Fig.52: The location of the proposed door into room 12 – interior and exterior

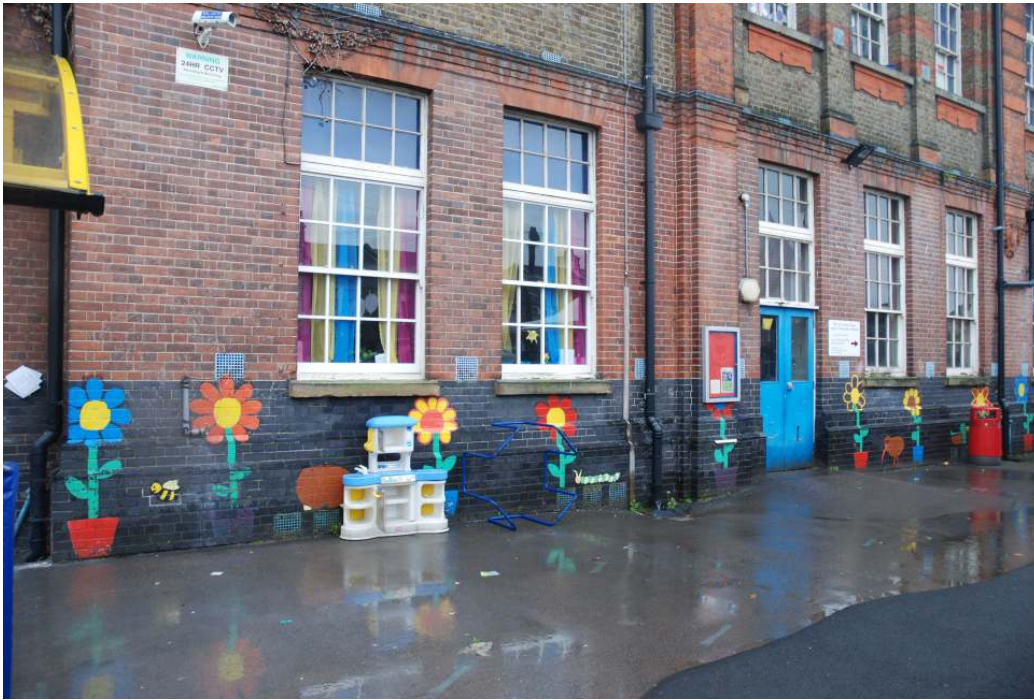
*Fig.53: Part of the northern frontage of the building, showing the area of the proposed new door (left of image), and the existing door with overlying window light (right of image)*

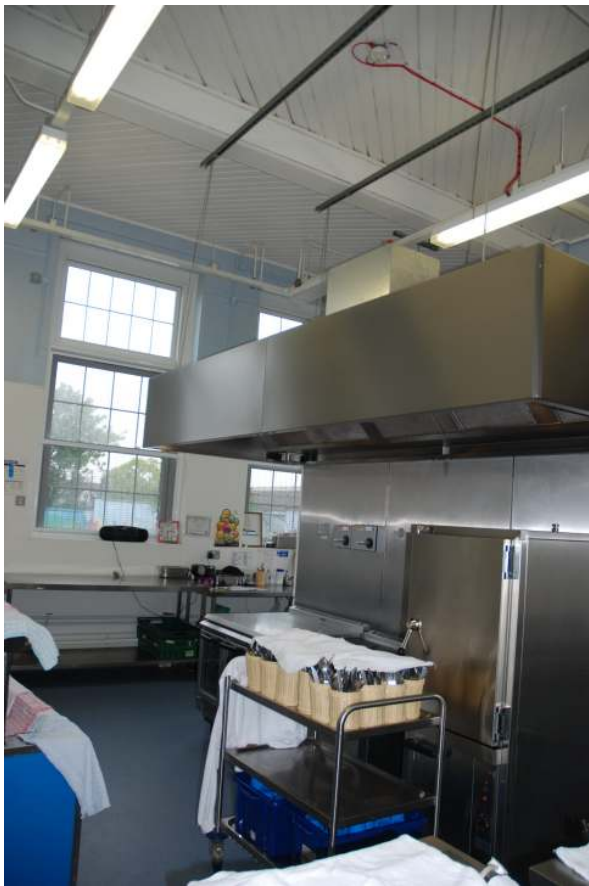
*Fig.54: Room 15, looking south-west, and showing the original windows*

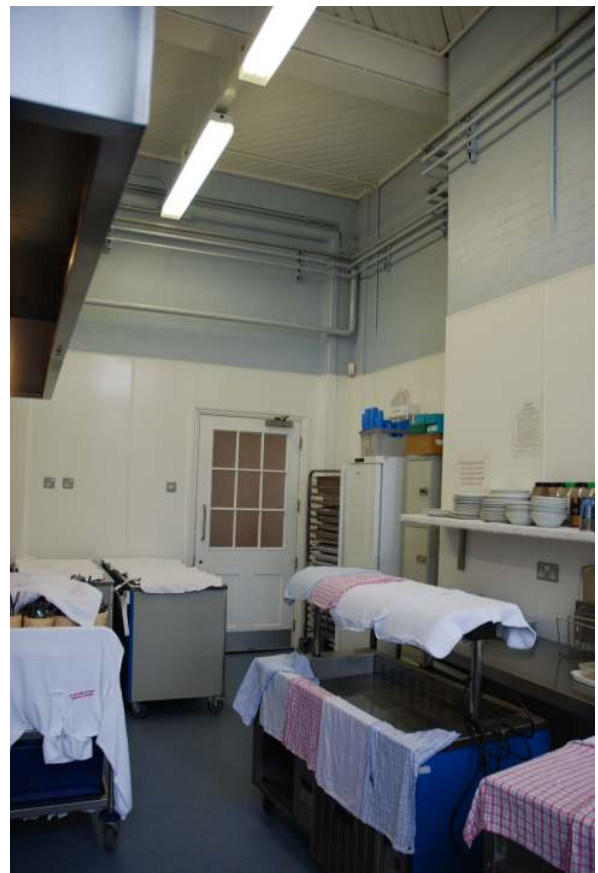
*Fig.55: Room 15, looking north-east, and showing the door in*

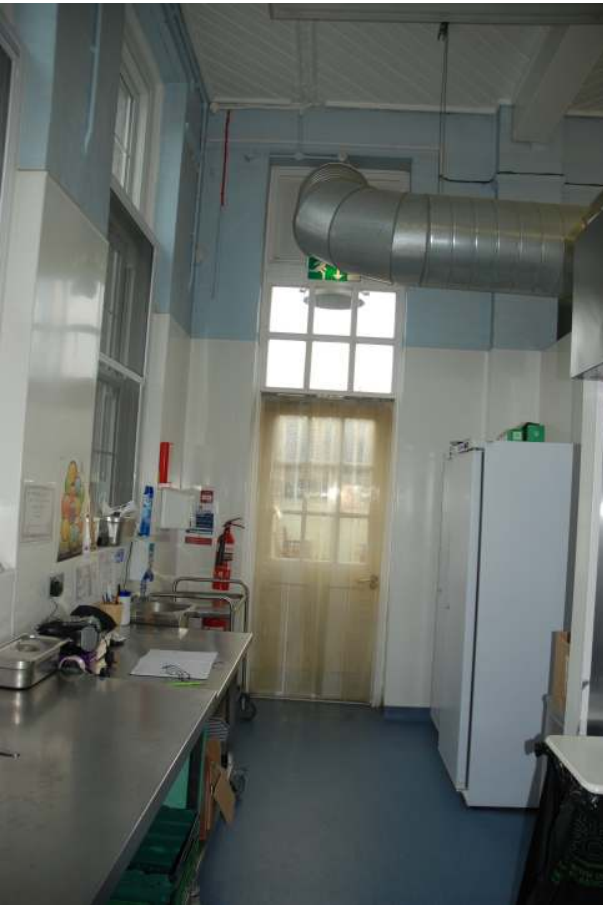
Fig.56: *The door to the exterior in room 15, with the original lower part of the overlight*

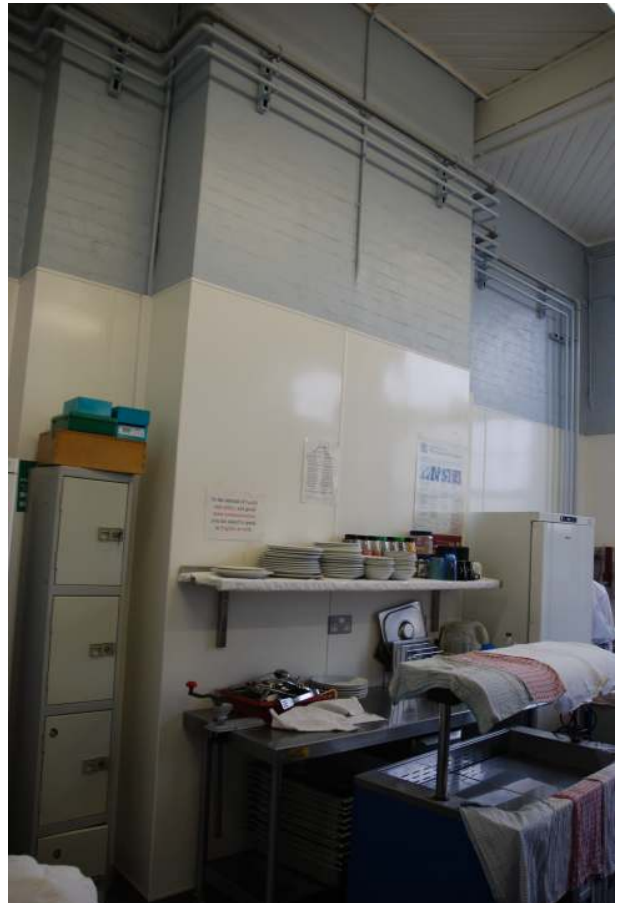
Fig.57: *The blocked-up fireplace in the eastern wall of room 15*

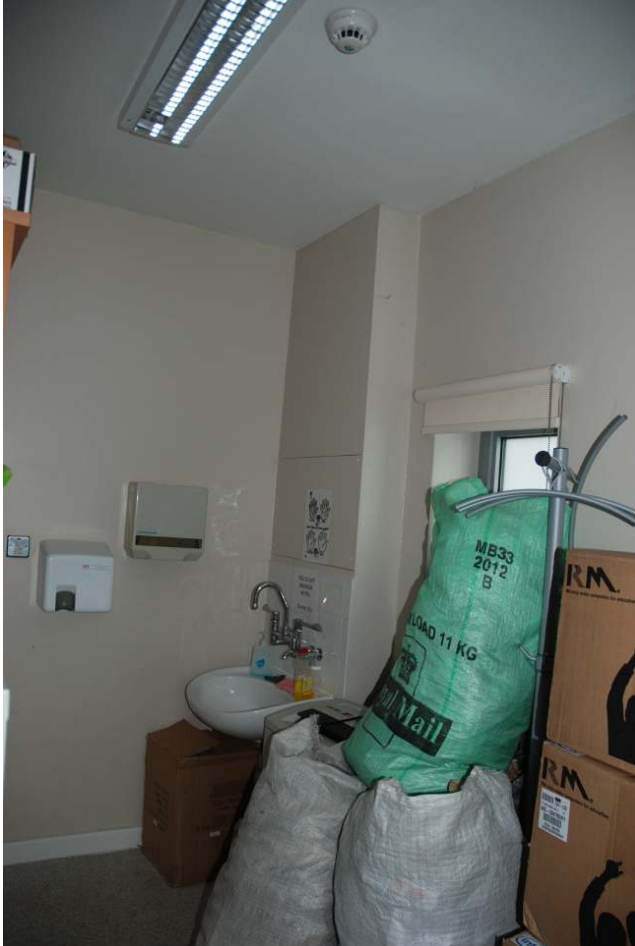
However, room 16, the store cupboard, is not part of the original school building, but instead forms the southern part of the single-storey western extension, constructed after 1971 (based on cartographic evidence). The difference between this part of the building and the main school building is obvious from the exterior, as the later extension has a flat roof, is painted in yellow, and has different windows. The interior of this store cupboard therefore has no features of historic interest.

Fig.58: *The interior of room 16*

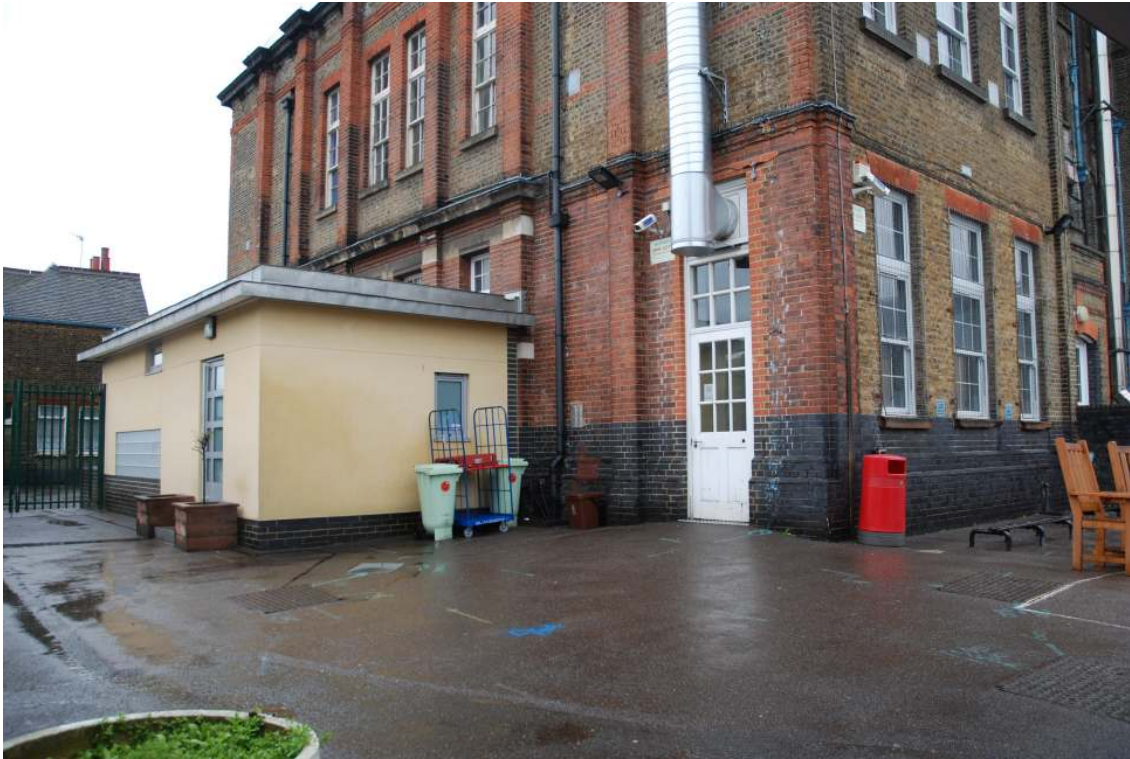
*Fig.59: The area of the proposed extension between rooms 15 and 16, looking north-east, and showing the original school building and later single-storey extension*

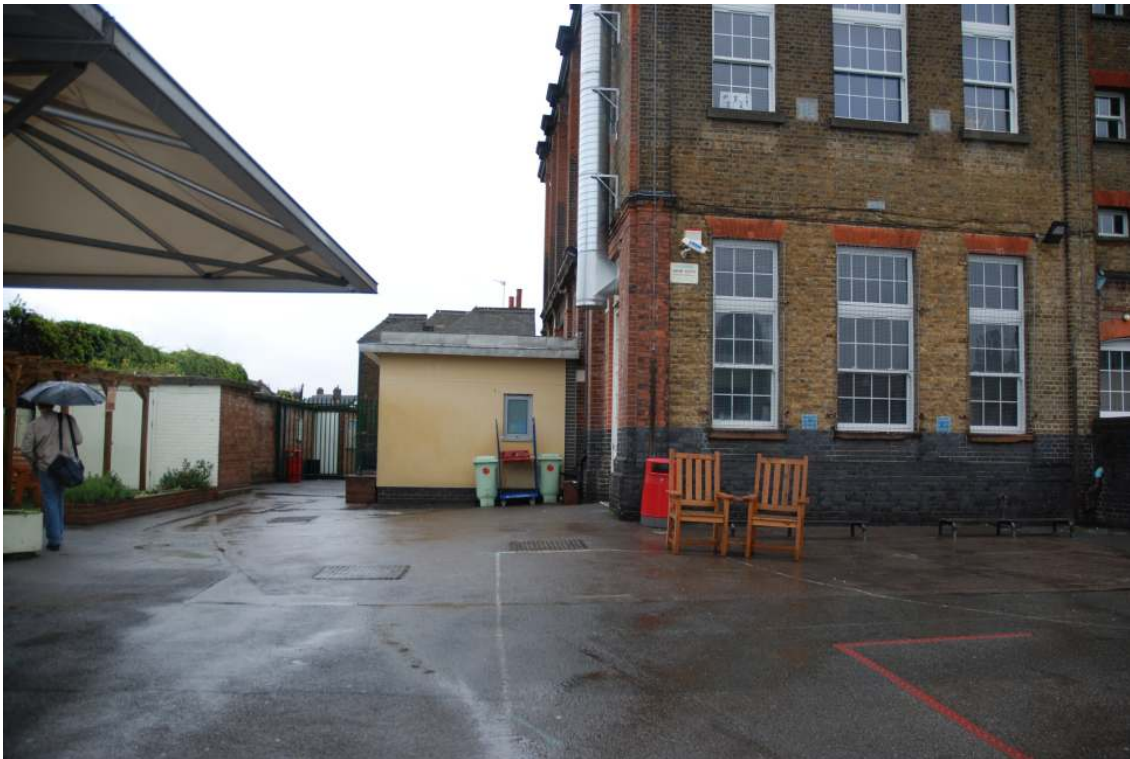
*Fig.60: The area of the proposed extension between rooms 15 and 16, looking north*

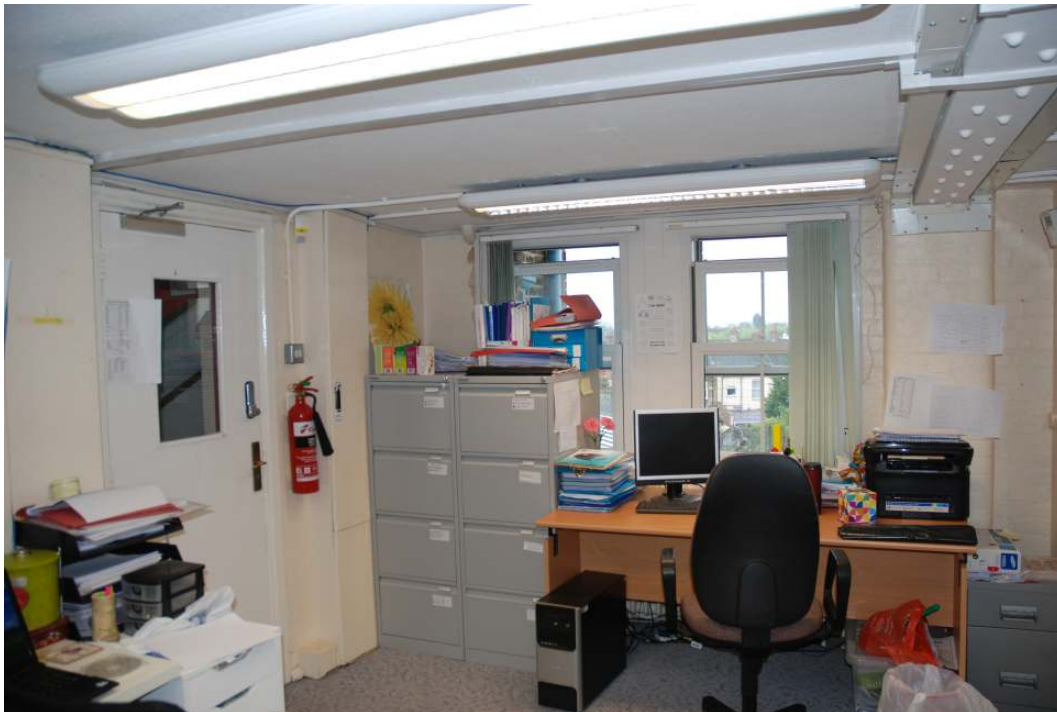
Fig.61: Mezzanine level 2A, looking south, showing the area of the proposed new lobby

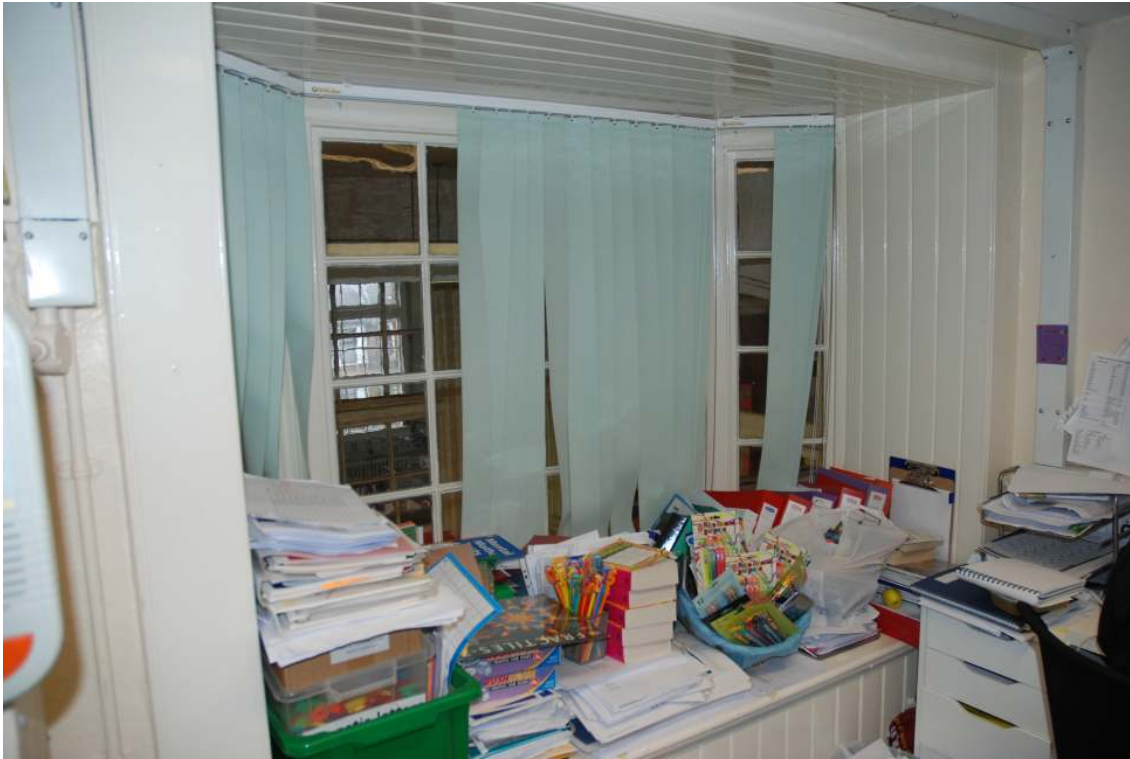
*Fig.62: Mezzanine level 2A, looking north, showing the internal bay window onto central lobby*

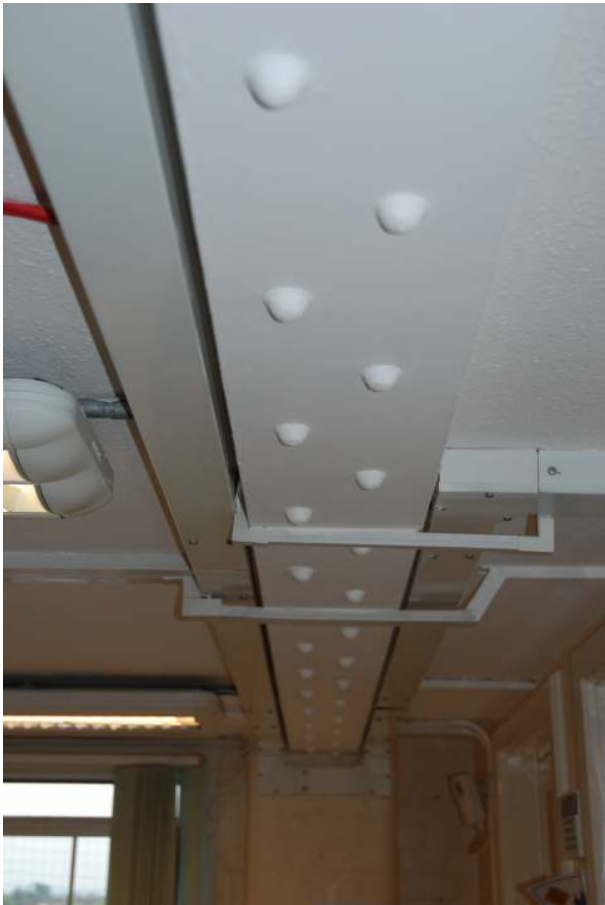
*Fig.63: The original riveted cross-beam, in mezzanine level 2A, but seen elsewhere across the building*

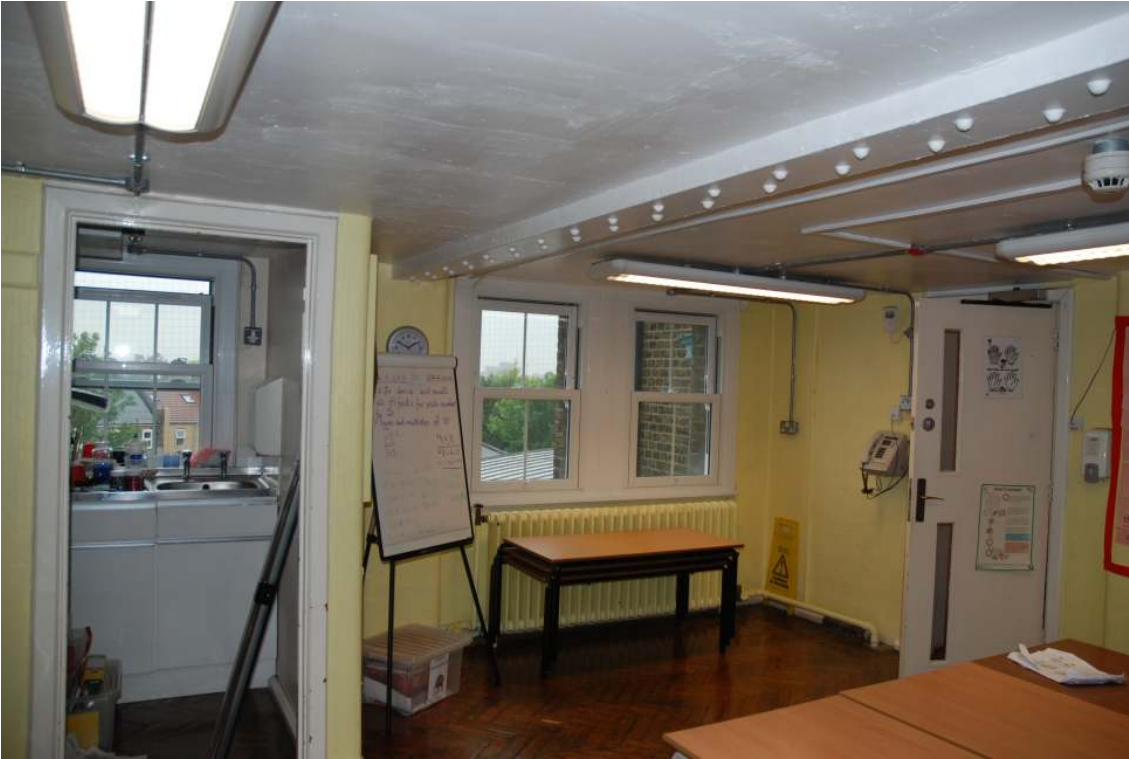
Fig.64: Mezzanine level 2B, looking south-west, showing the area of the proposed new lobby

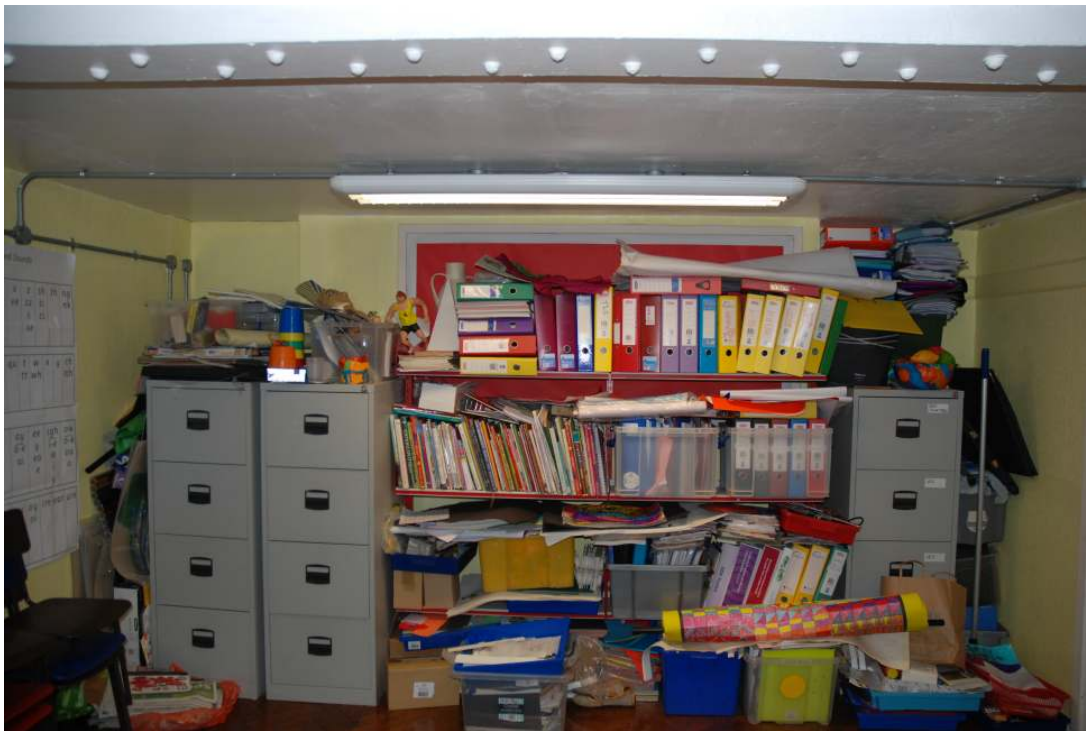
Fig.65: Mezzanine level 2B, looking east, showing the blocked fireplace wall and riveted cross-beam in foreground

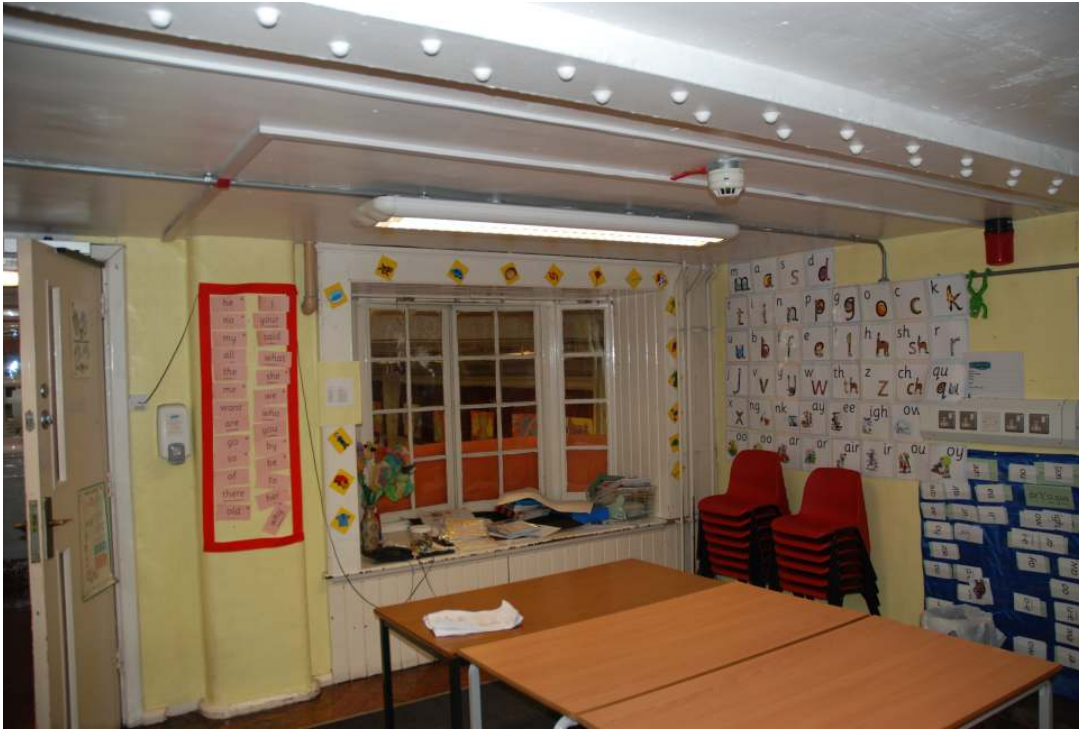
Fig.66: Mezzanine level 2B, looking west, showing the original internal bay window

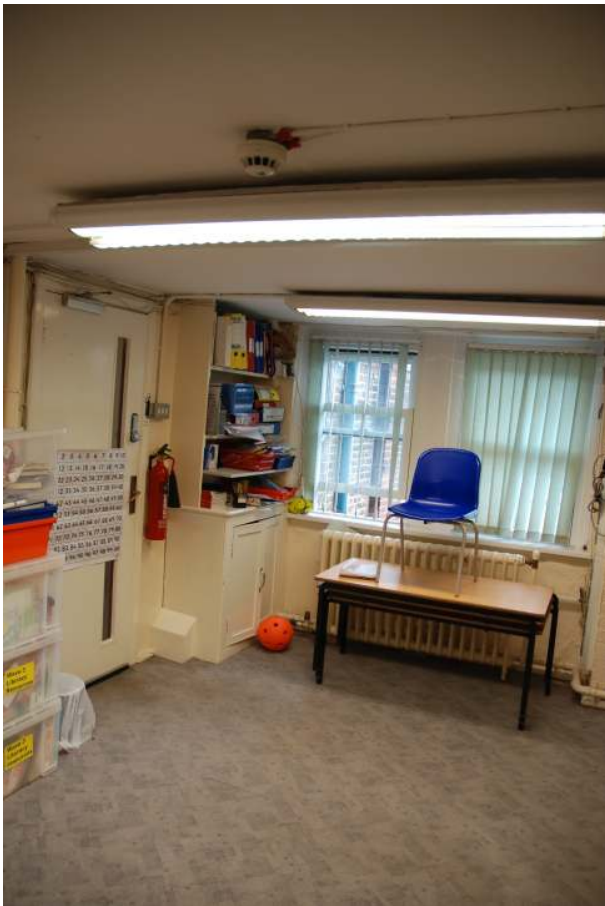
Fig.67: Mezzanine level 1A, looking south-east, showing the area of the proposed new lobby

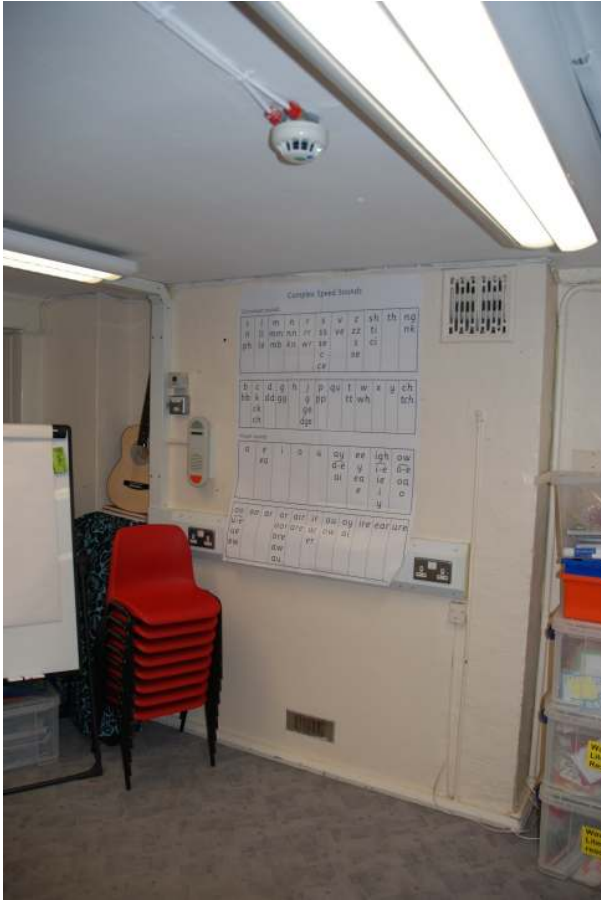
Fig.68: *The blocked fireplace on eastern wall of mezzanine level 1A*

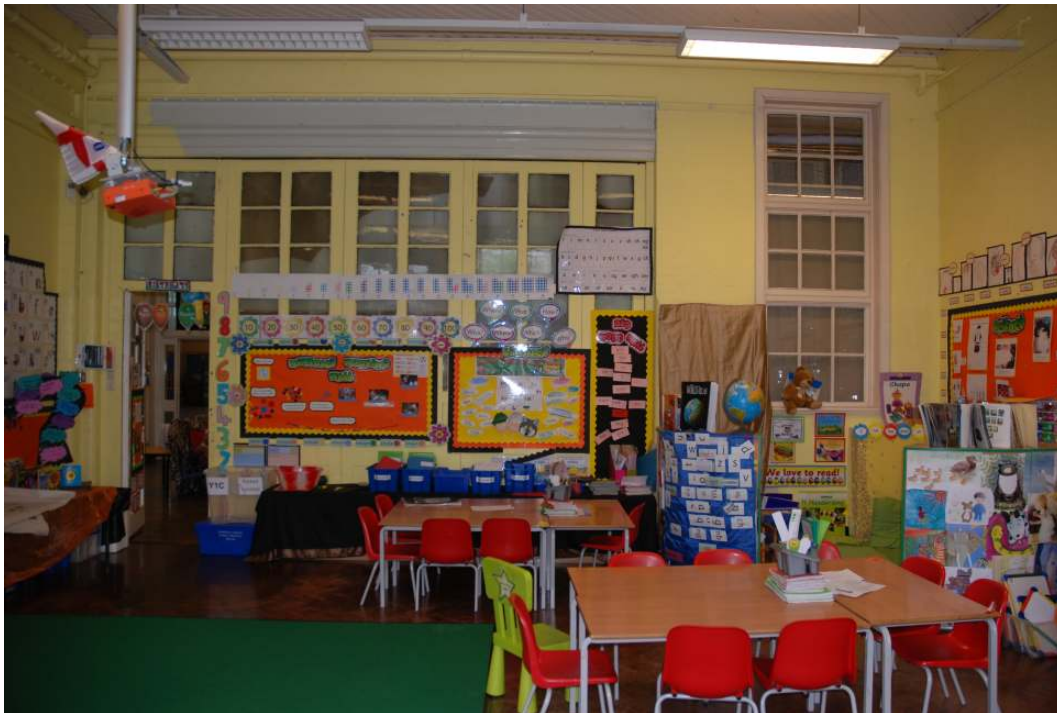
The doorway into room 13, and the windows positioned over and to the west of it, are original to the construction of the building, and were designed to allow light into the corridor.

*Fig.70: The southern wall of room 13, showing the original doorway, overhead light, and adjacent windows into hall / corridor*

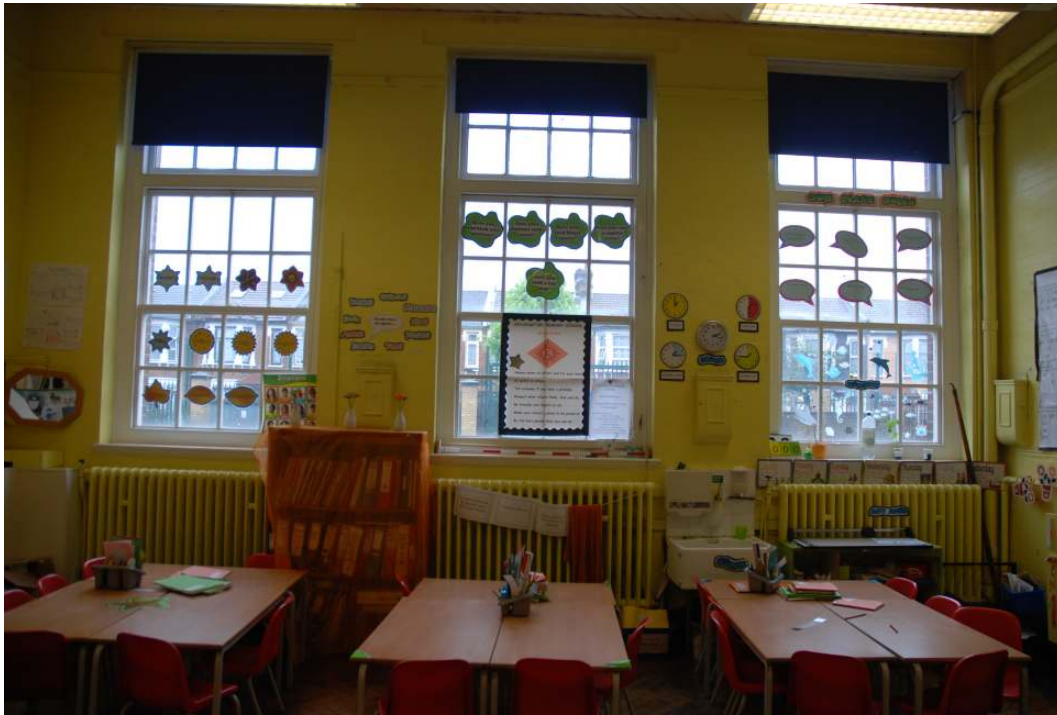
The three windows on the northern wall of room 13, plus the three ventilation boxes, are also original, and similar to those seen elsewhere in the school (see discussion of the ventilation boxes in section 5.8).

*Fig.71: The northern wall of room 13, showing the original windows and ventilation boxes (between windows and on adjacent eastern wall)*

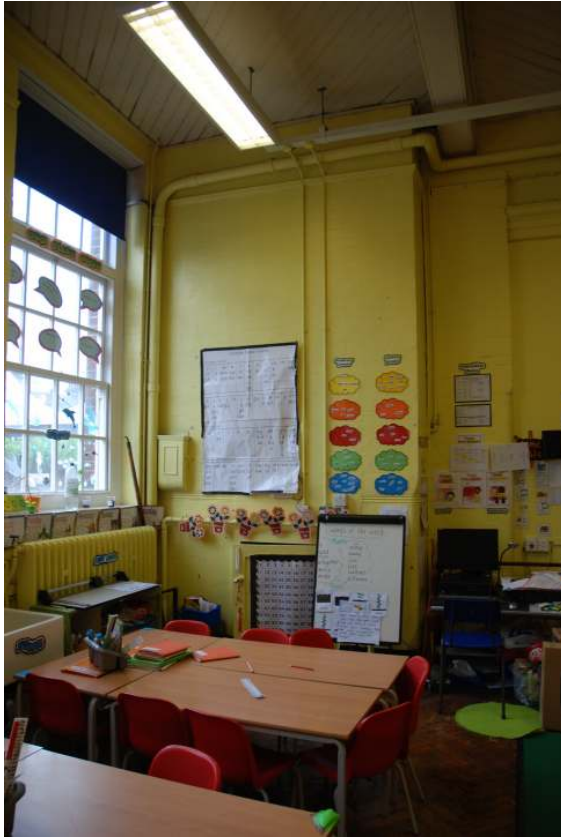
The original fireplace in this room was observed in the north-eastern corner of room 13, although it is now blocked-up and used as a cupboard, in a similar way to the other fireplaces in the school.

*Fig.73: The blocked-up fireplace in the north-eastern corner of room 13*

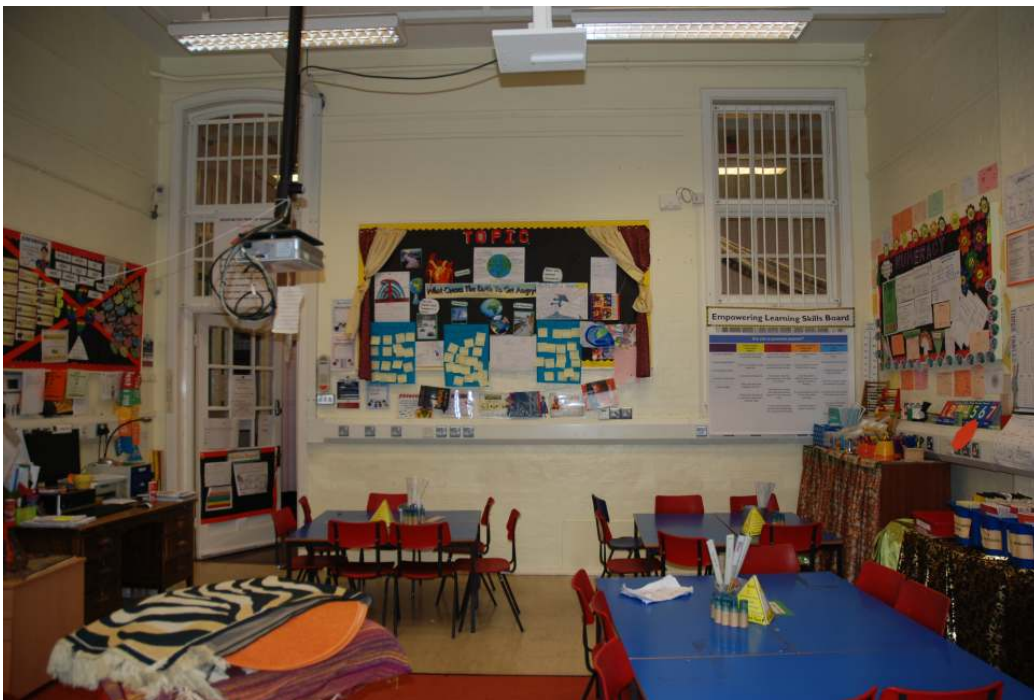
The door into the classroom, on the southern side of the room, is original, with the overlight above it. The light to the west of this, also on the southern wall, is also original to the construction of the building – designed to let light into the adjacent corridor.

*Fig.74: The southern wall of room 9, showing the original doorway, overlight, and internal window to the west*

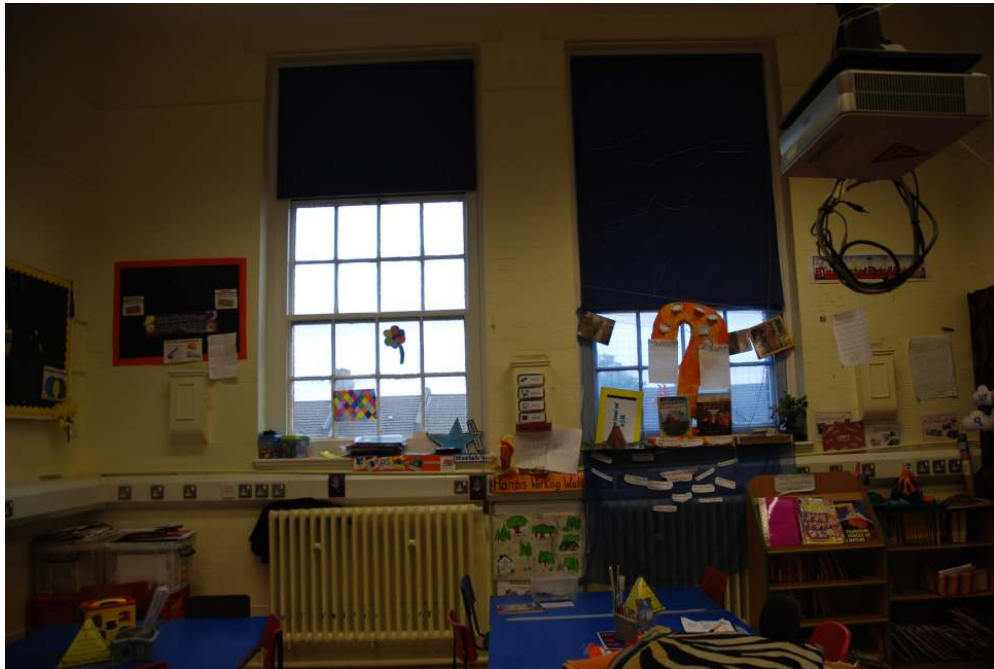
The window openings on the northern wall are also original, and are the same as those found elsewhere in the school.

*Fig.75: The northern wall of room 9, showing the original windows and three ventilation boxes*

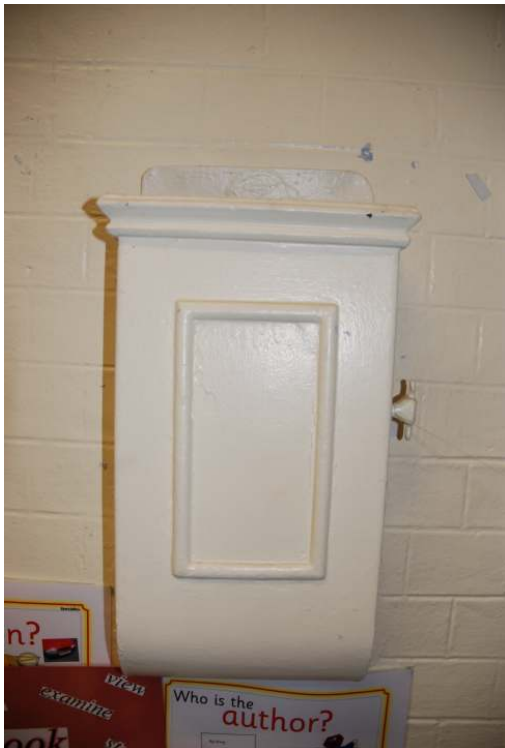
Three ventilation boxes were observed on the northern wall of room 9, and in other locations around the school. The handle which is used to open and shut them is interesting, as it is in the form of a hand clutching a baton (fig.76).

*Fig.76: One of the ventilation boxes on the northern wall of room 9*

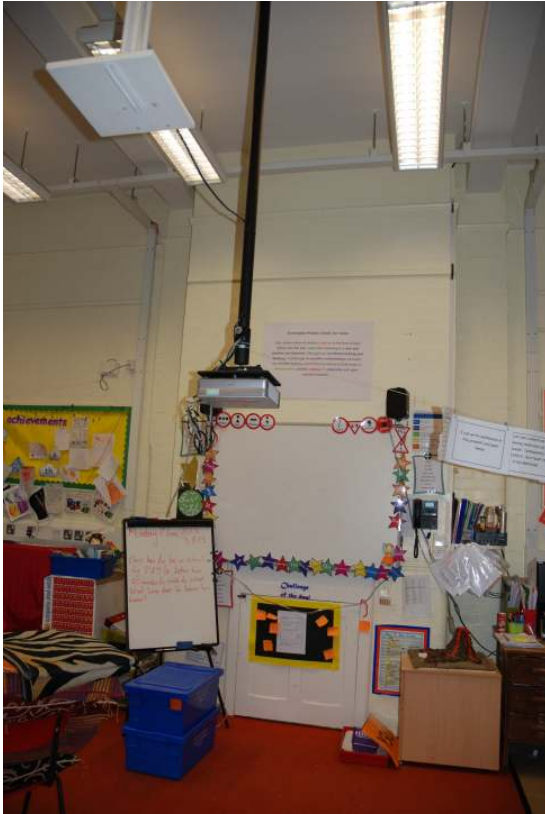
The original fireplace, in the eastern wall of the room, has been blocked up and is now in use as a cupboard, although its position can clearly be seen. This has been done to most of the other fireplaces in the school.

Fig.77: *The blocked fireplace in the eastern wall of room 9*
