**ST DUNSTAN IN THE EAST CHURCH, ST DUNSTAN'S HILL
CITY OF LONDON EC3R**

AN ARCHAEOLOGICAL WATCHING BRIEF

SITE CODE: DIE15

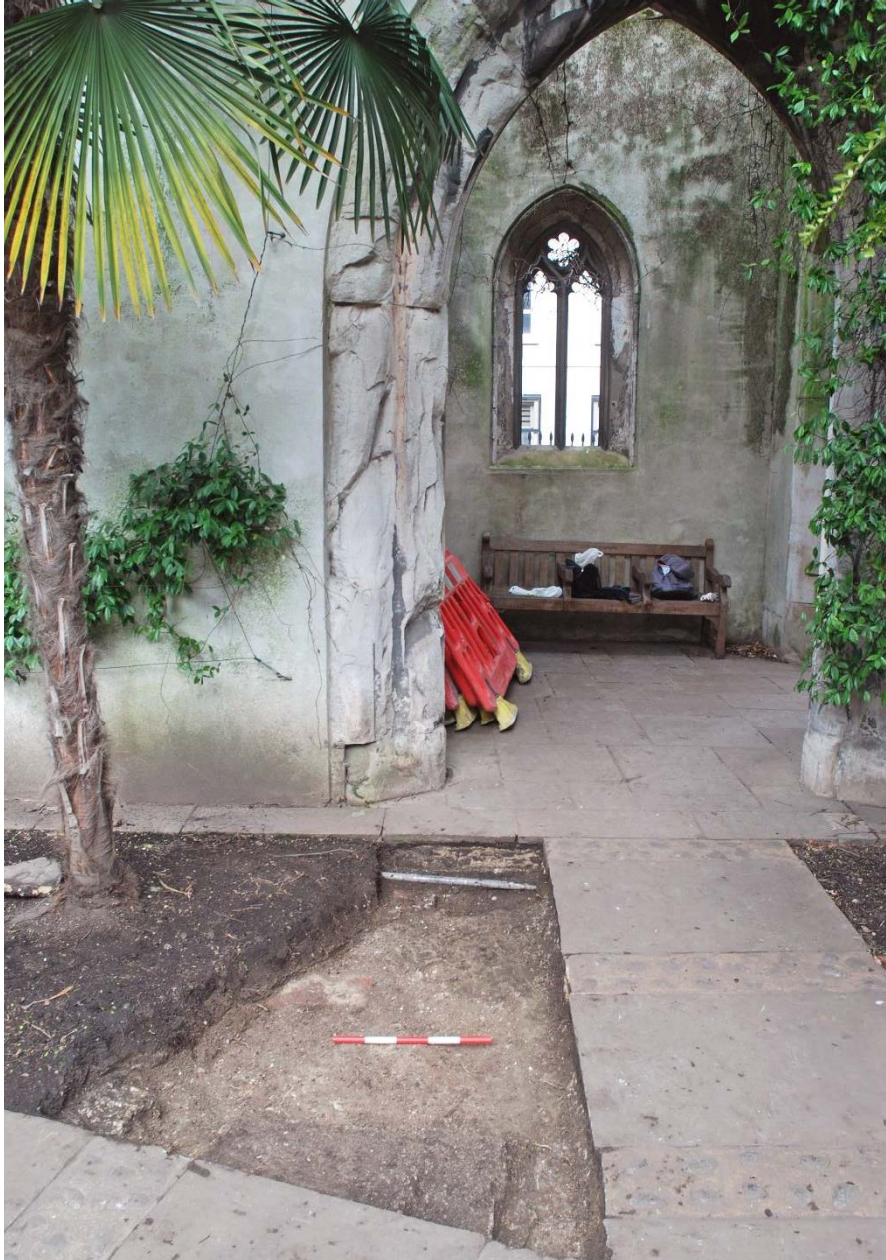
Fig.7: *General view of Trench 1 looking north towards the Church entrance (0.5m scale)*

Trench 1 was located just inside the northeast doorway, and measured up to *c* 2.4m by 1.5m in plan, the width tapering to just over 0.70m to the north. The present ground level was about 12.82m OD, and overall depth of excavation *c* 0.20m.

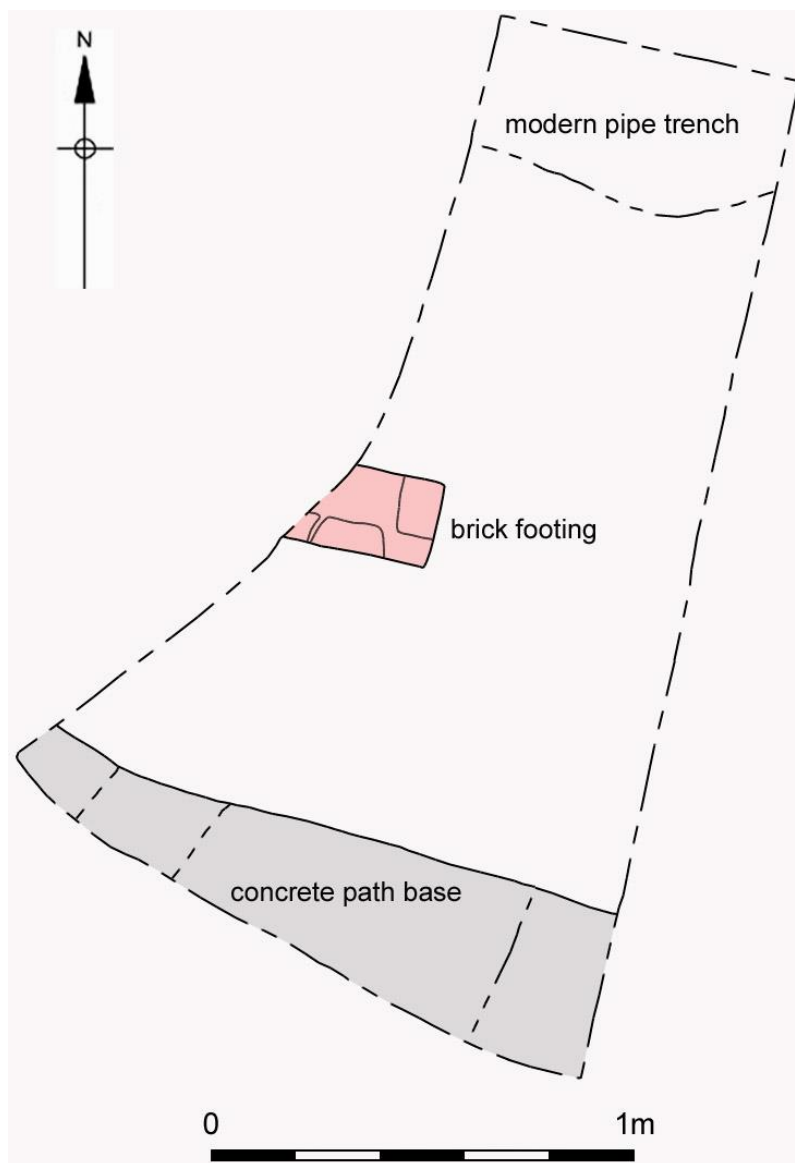
Fig.8: *Plan of Trench 1 showing the principal features*

The southern end of the trench was crossed by a strip of modern concrete *c* 0.15m to 0.40m wide (increasing to the east), and extending below the limit of excavation. The concrete also continued southward under the existing paved path, and evidently been laid down as part of the base for this. Deposits at the northern end of the trench were similarly cut away for some 0.3 to 0.4m by a modern pipe trench.

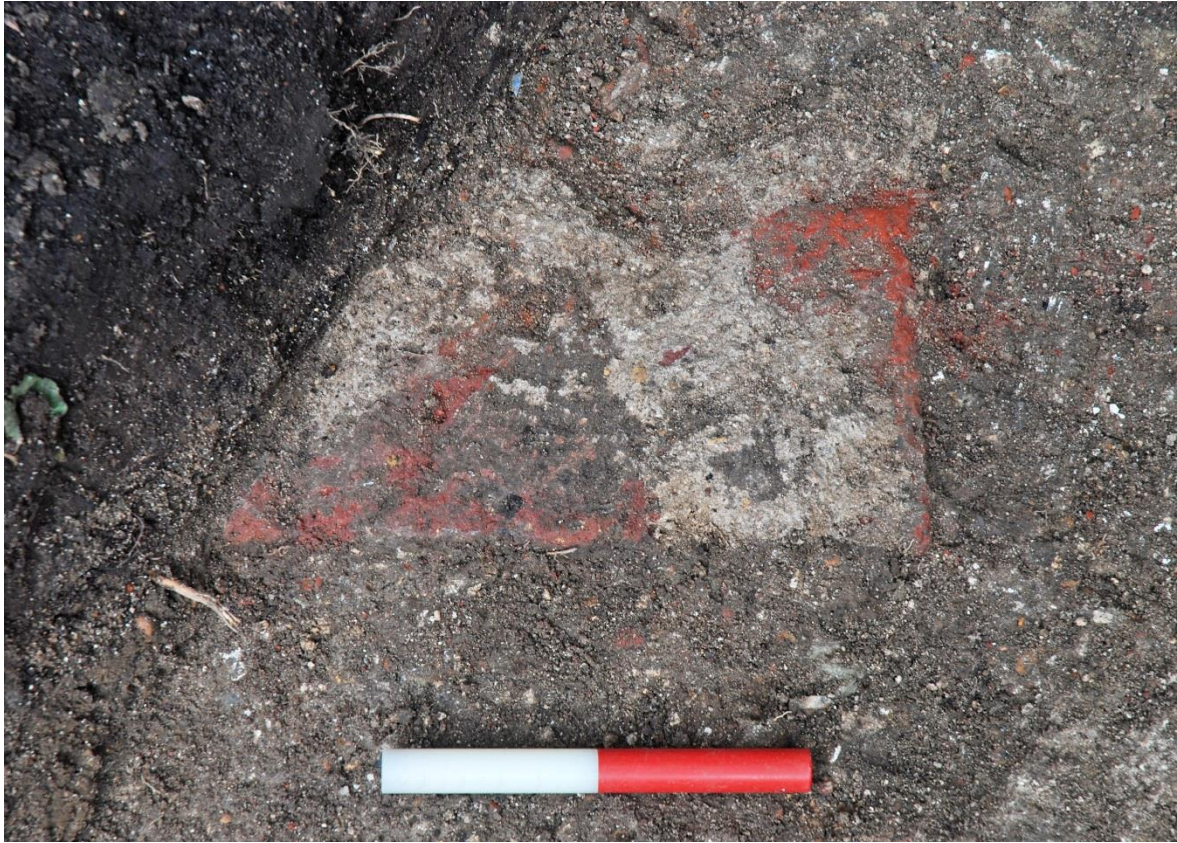
Fig.11: *Close-up view of the brick base on the western side of Trench 1 (0.2m scale)*

Additional support for this last point is provided by the existence of a small red brick base on the western side of the trench, running parallel with (and *c* 1.4m to the south of) the adjacent north wall of the Church (Fig.11). The surviving top of this feature was level with or just above the general light brown loose mortar/sand horizon.

The brickwork was also solidly mortared and at least two courses deep. It may well have been associated with the glazed wooden vestibule that once enclosed the northeastern entrance to the Church (*cf.* Fig.12), forming a foundation for the standing structure. The eastern end of the brick base would thus roughly coincide with the western side of the inner doorway, as visible in the photograph.

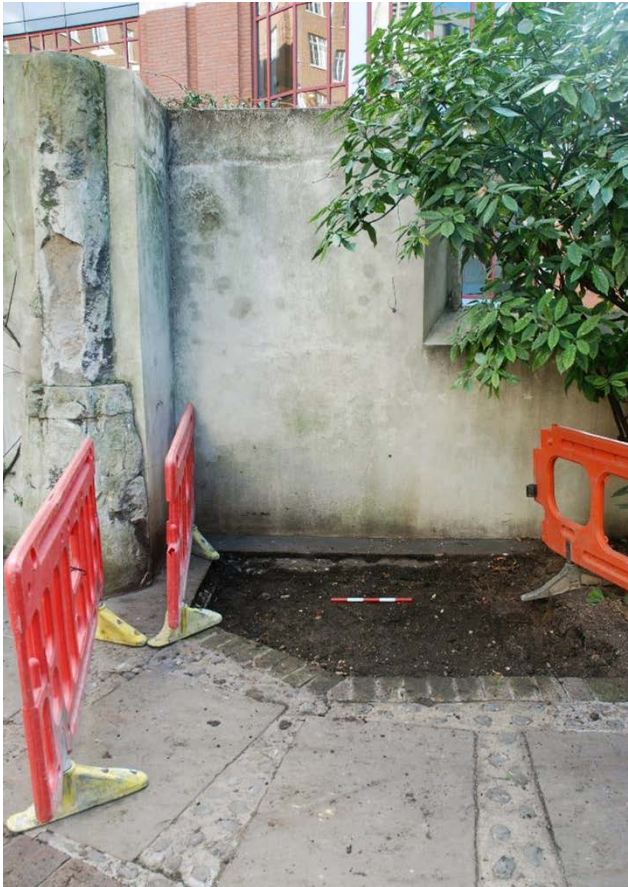
Fig.13: *General view of Trench 2, looking east (0.5m scale)*

No archaeological finds or features were revealed in Trench 2. The excavation exposed a slightly lighter and more mixed silty deposit with frequent fine gravel, presumably the lower part of the soil horizon imported onto the site during the creation of the public gardens. To the north and east the concrete base for adjacent surfacing extended some 0.15m into the trench

Trench 2 was located towards the southeast corner of the Church and adjacent to the east wall, and measured up to about 2.15m by 1.8m in plan (*cf.* Fig.6). The level on the path immediately to the west was about 12.80m OD, and the depth of excavation *c* 0.15m to 0.18m.

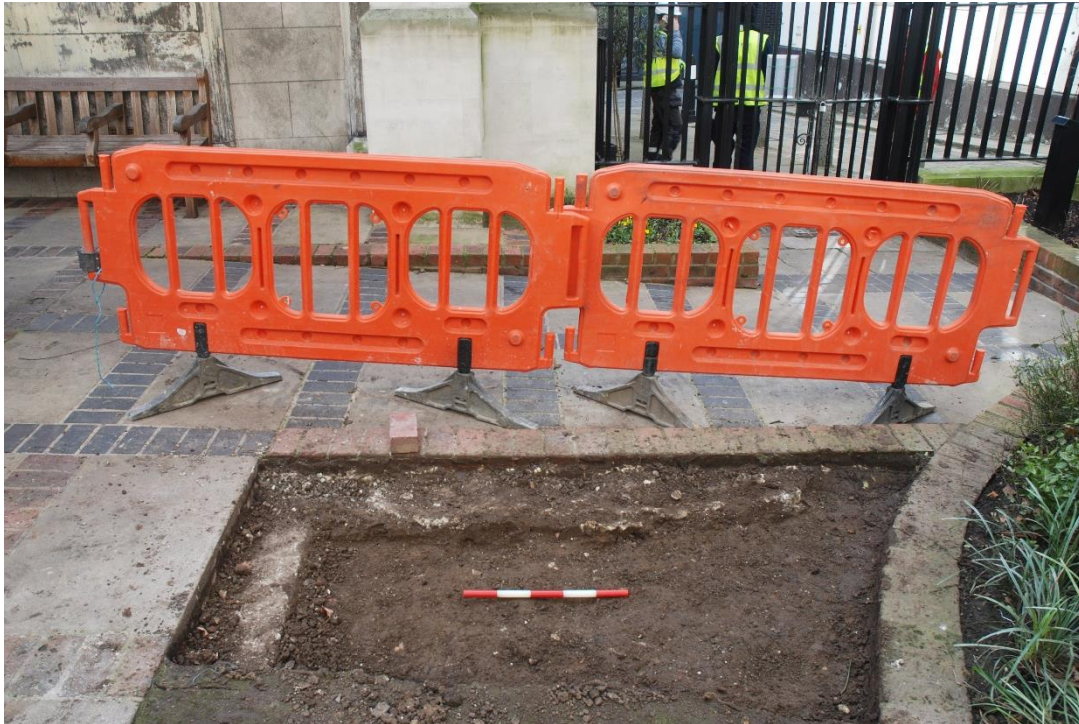
Fig.15 (above):
Trench 3, looking south towards the NE corner of the Church (0.5m scale)

There were no archaeological finds or features: removal of the topsoil exposed a slightly lighter and firmer deposit, most likely part of the Churchyard soil profile rather than imported made ground. To the south and east this was cut by the concrete base of the adjacent paths, which extended some 0.23 to 0.30m into the trench.

Trench 3 was located just outside and to the northwest of the Church, and measured up to *c* 1m by 2.4m in plan. The depth of excavation was about 0.12 to 0.15m.

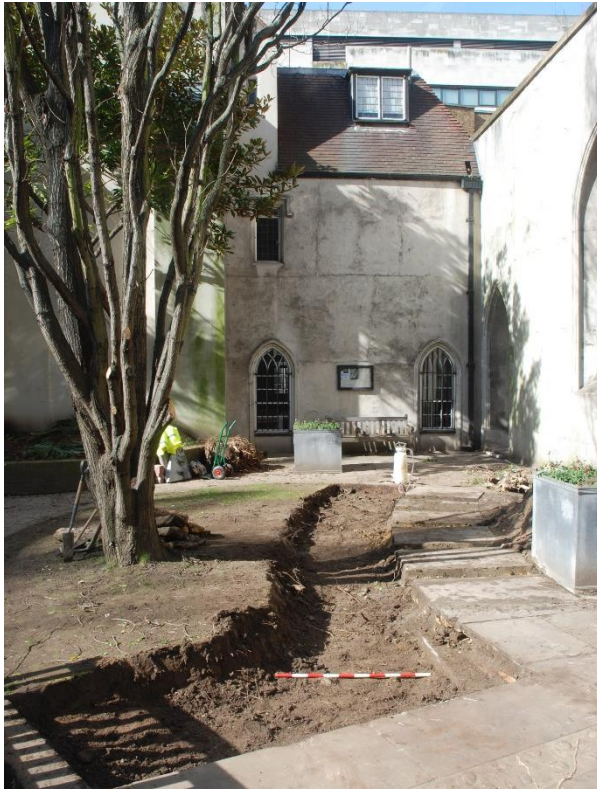
Fig.17: *Trench 4, general view looking west. (1.0m scale)*

As in the case of Trenches 2 and 3 no archaeological finds or features were revealed: the exposed deposit was slightly more mixed than the topsoil above, but presumably part of the same soil horizon and imported onto the site during the creation of the gardens.

Trench 4 was located within and on the north side of the former Church, measuring up to c 8.2m in length by c 1.1 to 1.25m wide (Fig.6). The present ground level at either end was about 12.80m OD, and depth of excavation 0.18 to 0.32m (shallower in the centre).

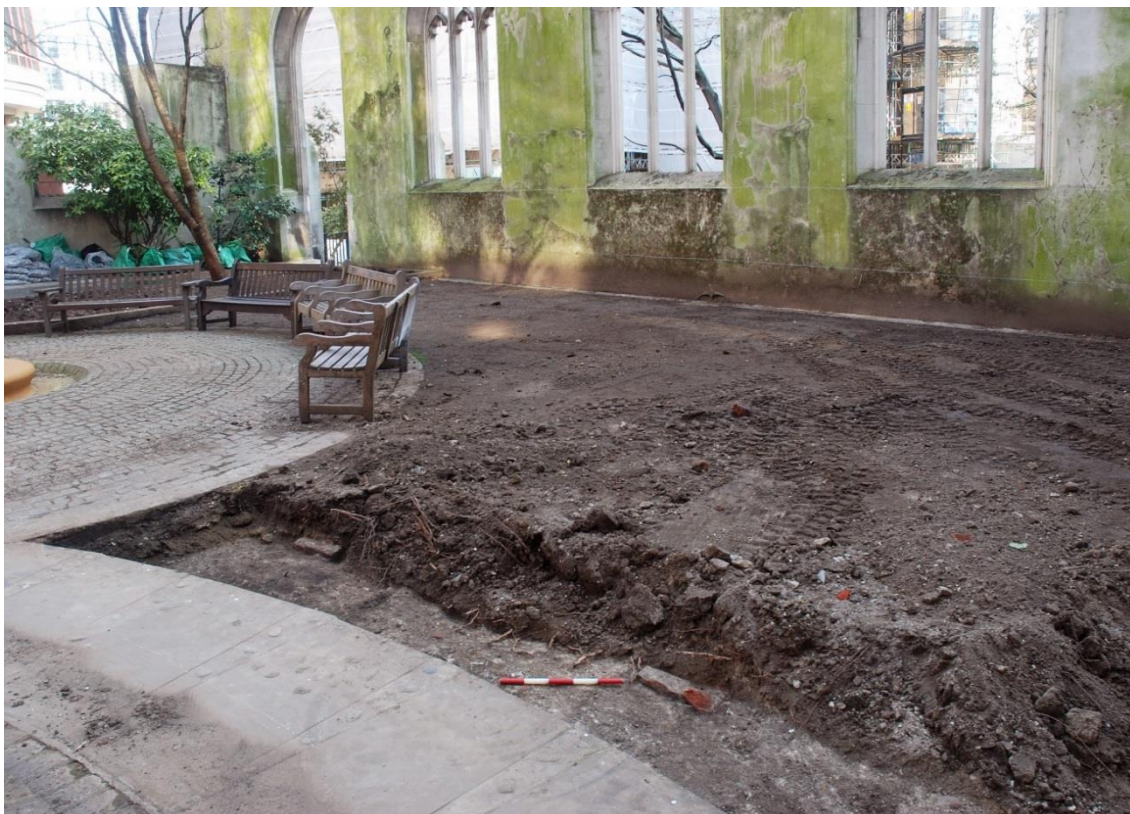
Fig.20 (above): *General view of Trench 5 looking southeast (0.5m scale)*

Trench 5 was excavated to a depth of between 0.25m and 0.35m, removing imported topsoil and some more mixed underlying material. The western end of the trench was more deeply disturbed, but over some 4.5m from the eastern end this revealed a compacted buried surface. The composition of this varied from light to dark grey, mixed loose mortar and silty sand with some pebbles, charcoal and small fragments of stone and ceramic building material.

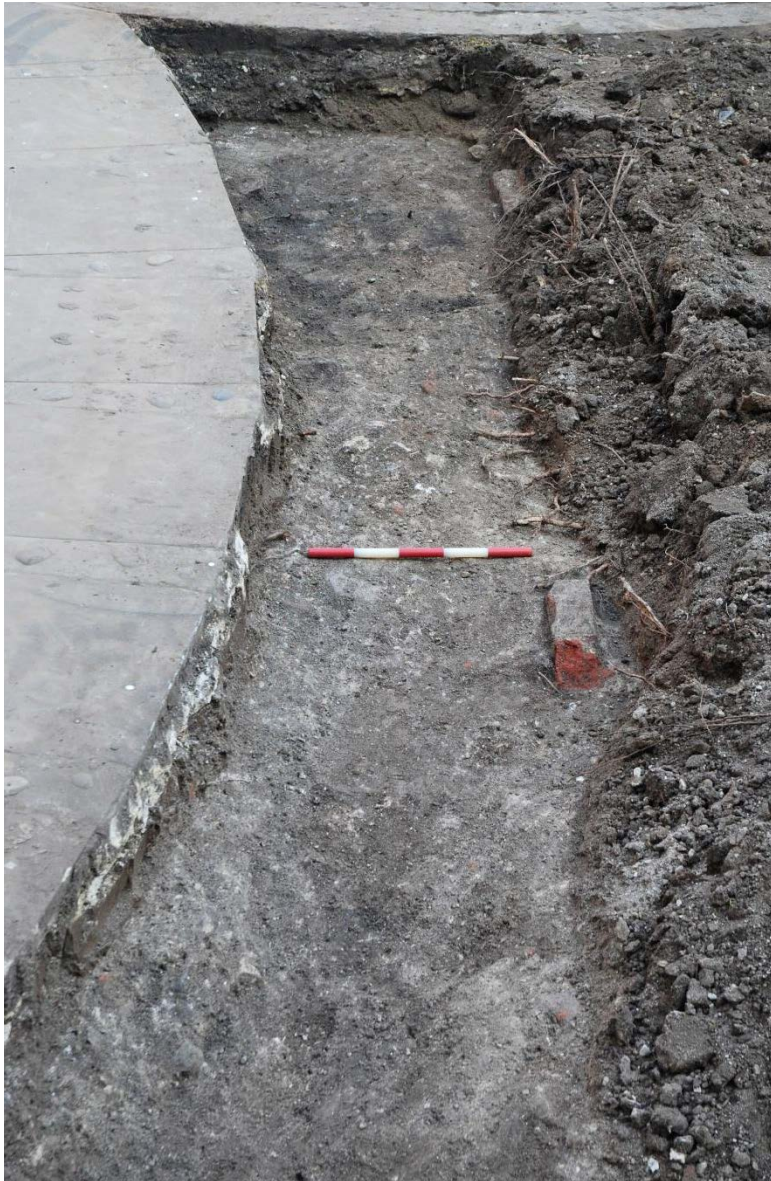
Fig.22: *View of Trench 5 looking east (0.5m scale)*

The compact surface and deposit exposed in Trench 5 was broadly similar to that in Trench 1, although here with some additional evidence for burning. As in Trench 1 this assumed to represent levelling/make-up for the former floor, and to have been truncated at this level after the destruction of the Church in 1941 – either by wartime clearance or possibly the later development of the public garden.

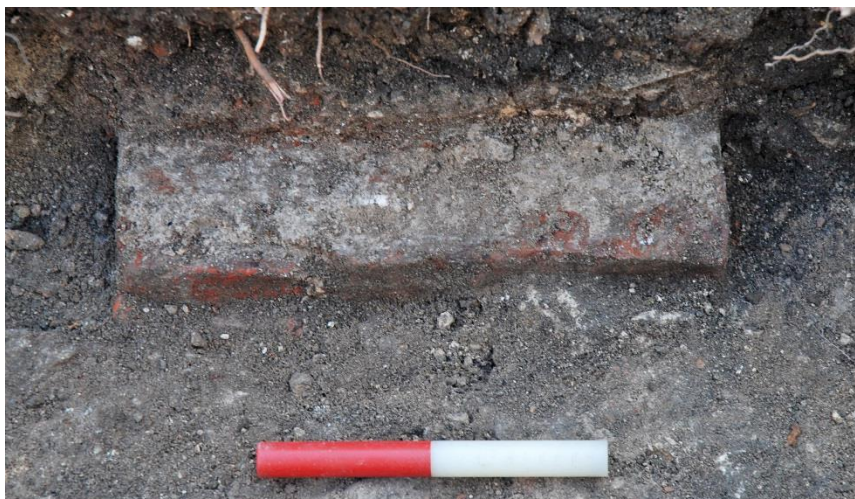
Fig.23: *Detail of the two brick bases on the southern side of Trench 5 – the eastern at the top, the western below (0.2m scale)*

The only features in Trench 5 were two red brick bases on the southern edge of excavation, set some 2.15m apart and both apparently running back into unexcavated ground – in the case of the western base for at least 0.2m (*cf.* Fig.23 overleaf). The bases were each about 0.35m wide, and were exposed at almost identical levels – 12.40m to 12.41m OD.

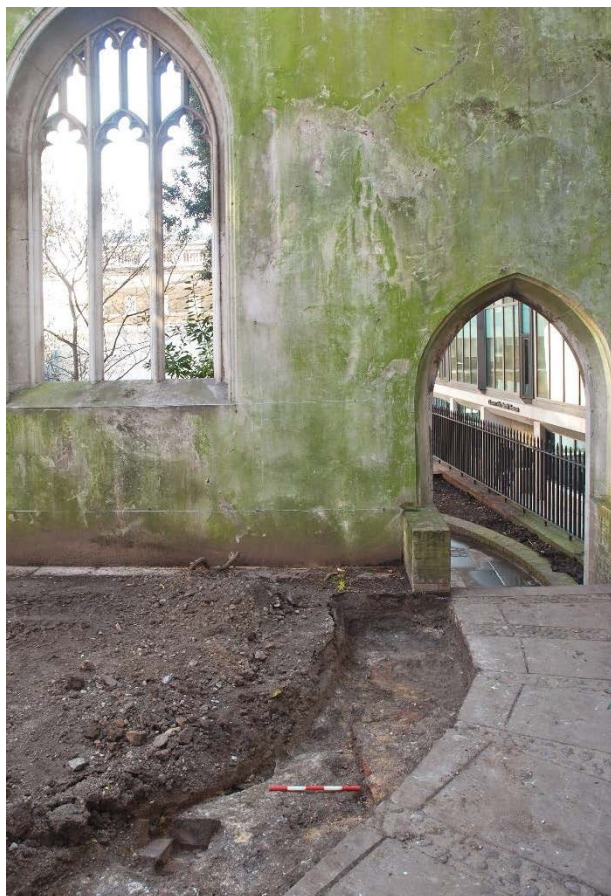
Fig.24: *General view of Trench 6, looking south*

Trench 6 was the by far the most productive part of the site, both in terms of finds and *in situ* features – the latter surrounded by a compacted deposit of light/mid brown or grey silty sand with crushed mortar and some charcoal. These remains were all recorded within the southern part of the trench, over a distance of less than 4m (Fig.27). As a whole the trench was excavated to a depth of between 0.20m and 0.30m: however, the northern and slightly larger section did not produce any features or *in situ* deposits, and appeared to have been disturbed to a greater depth following the destruction of the Church.

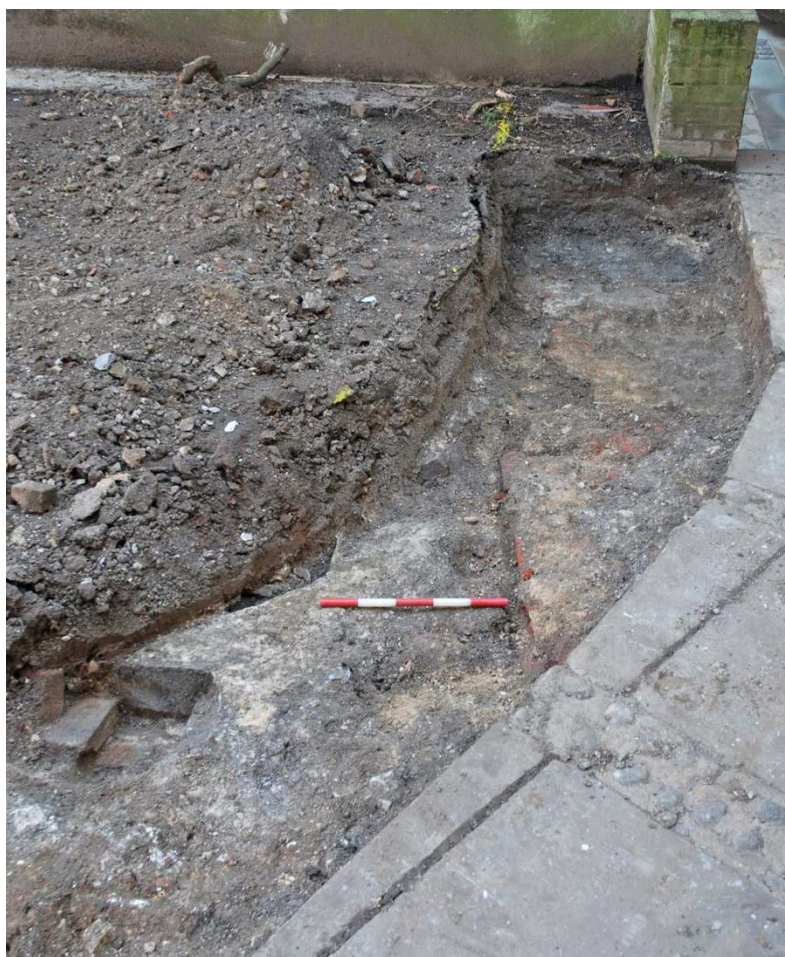
Fig.25: *Closer view of the above, the right hand end of the 0.5m scale next to the brick vault wall*

- The eastern end and southeast corner of an east-west aligned brick vault, the upper part of the roof broken away and the structure itself filled with compacted debris. The exposed external width was *c* 1.70m and the length 0.95m, the walls being *c* 0.23m (one stretcher) thick.

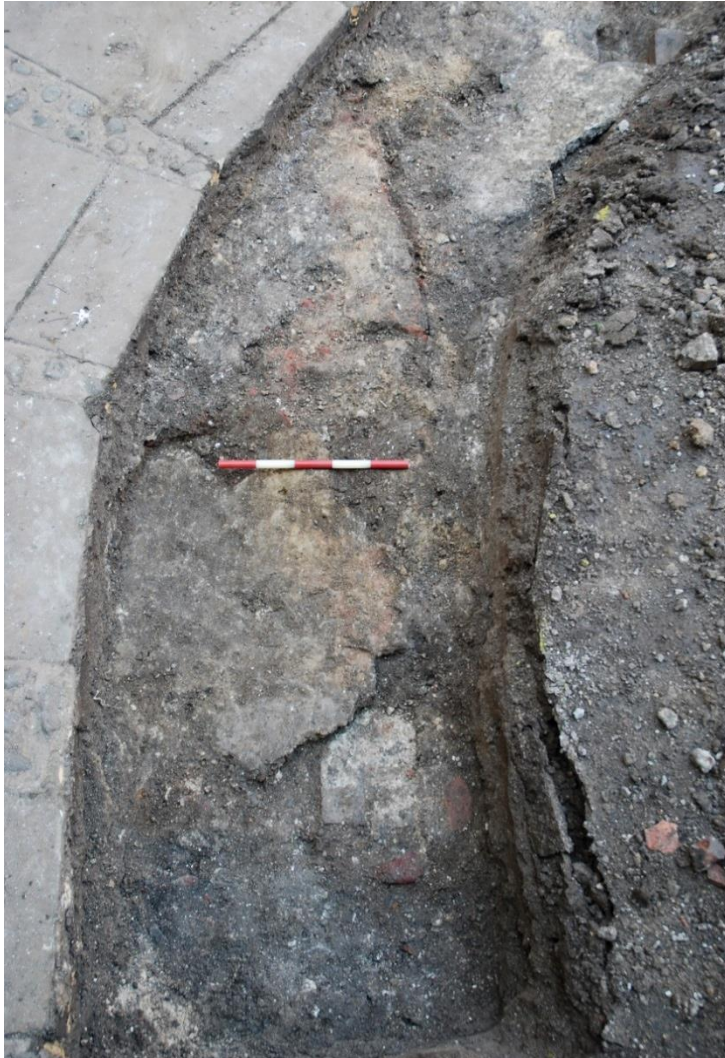
Fig.26: Overhead view of Trench 6, the 0.5m scale overlying the truncated arch of the vault roof

It is possible that the top of the vault was broken in and infilled following the wartime destruction. However, the nature and solidity of the fills suggests that this was an earlier event – potentially associated with the rebuild of the Church between 1817-21, and the vault itself therefore predating this event.

At least three separate features were defined within the southern part of Trench 6, as described below (& see also Figs.26 & 27 overleaf):

At least one brick-built vault, partially broken and backfilled, was recorded in Trench 6. As noted above, this may well relate to the 1660s-1817 Church, although no firm date was established. There were two or three other brick features in trenches 5 and 6 that may also be associated with the old Church.

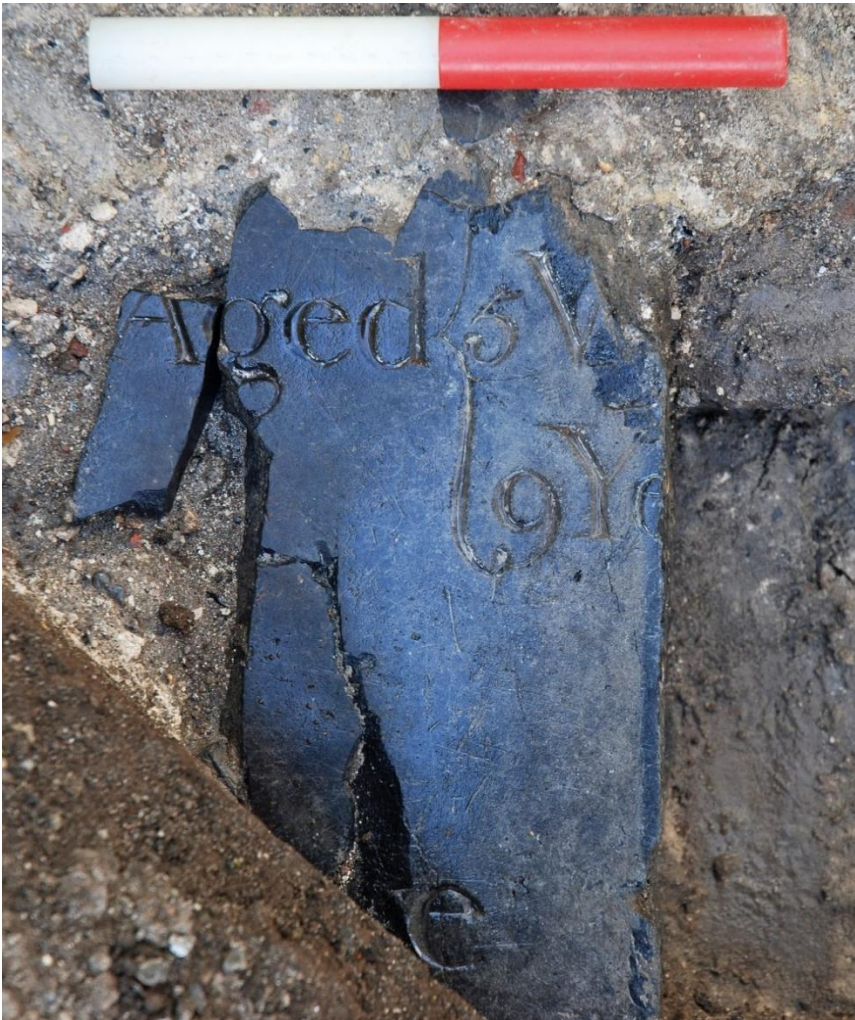
Fig.29: *The surface of the ledger stone fragment after further cleaning*

The mortared stonework to the south mainly comprised a fragment of a ledger stone, incised as follows (see also Fig.29):

.....
 Aged 5 W(eeks)
 9 Ye(ars)
e

It appears that this section of the inscription relates to at least two (& probably three) infant/child burials. The surviving slab was 140mm thick and was in a fine dark grey stone – either true marble or Ashford Black Marble (a fine-grained sedimentary/Carboniferous limestone found in Derbyshire). The date is unknown but most likely 18th century: the stone appears to have been reused within the floor base of the rebuilt early 19th century Church

1. Two pieces of worked stone were recovered during the on-site monitoring, both from the overburden in the area of Trench 6. A further fragment of ledger stone was left *in situ* within the trench and is described above (7.5.2; Fig.29).
2. A fragment of an inscribed tablet in dark grey ?marble, roughly broken on three sides and to the rear. This may have been set in one of the walls: the surviving finished side retained traces of mortar where the tablet had been secured.

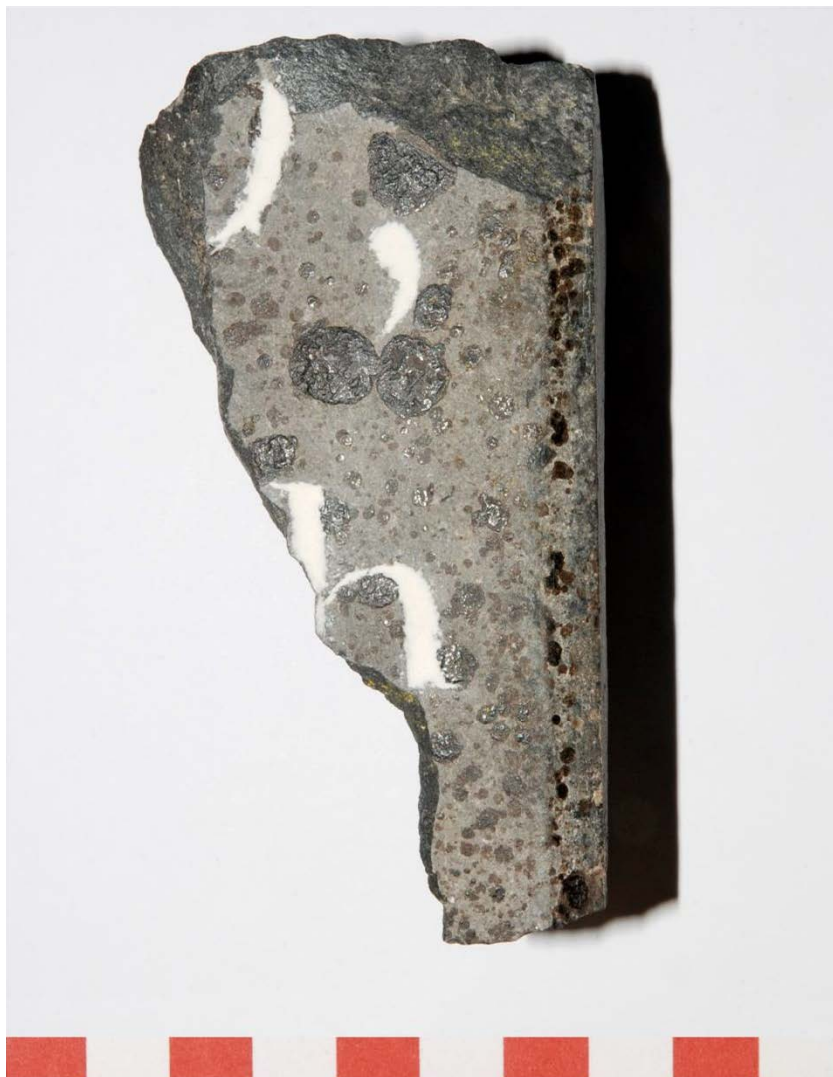
Fig.30: *Fragment of the right-hand side of a probable wall tablet, from Trench 6 (100mm scale; inscription highlighted by French chalk)*

The face (Fig.30) was chamfered on its surviving edge, so would have been slightly proud of the surrounding surface. It retained fragments of two letters – at the top a larger script (though possibly also upper case) followed by a comma, and below this a lower case and smaller ‘h’. The face was also spotted by encrustations that had clearly come from the fire which destroyed the Church in 1941.

Other individual finds from Trench 6 included two fragments of worked stone – an inscribed probable wall tablet in dark grey ?marble and part of a statuette in white marble (see Appendix I & Figs.30 & 31). There were also occasional metal items: a circular copper alloy and enamel lapel badge decorated with a cross pattée, plus a couple of iron nails and two pieces of melted lead (*cf.* Appendix II & Figs.32-34).

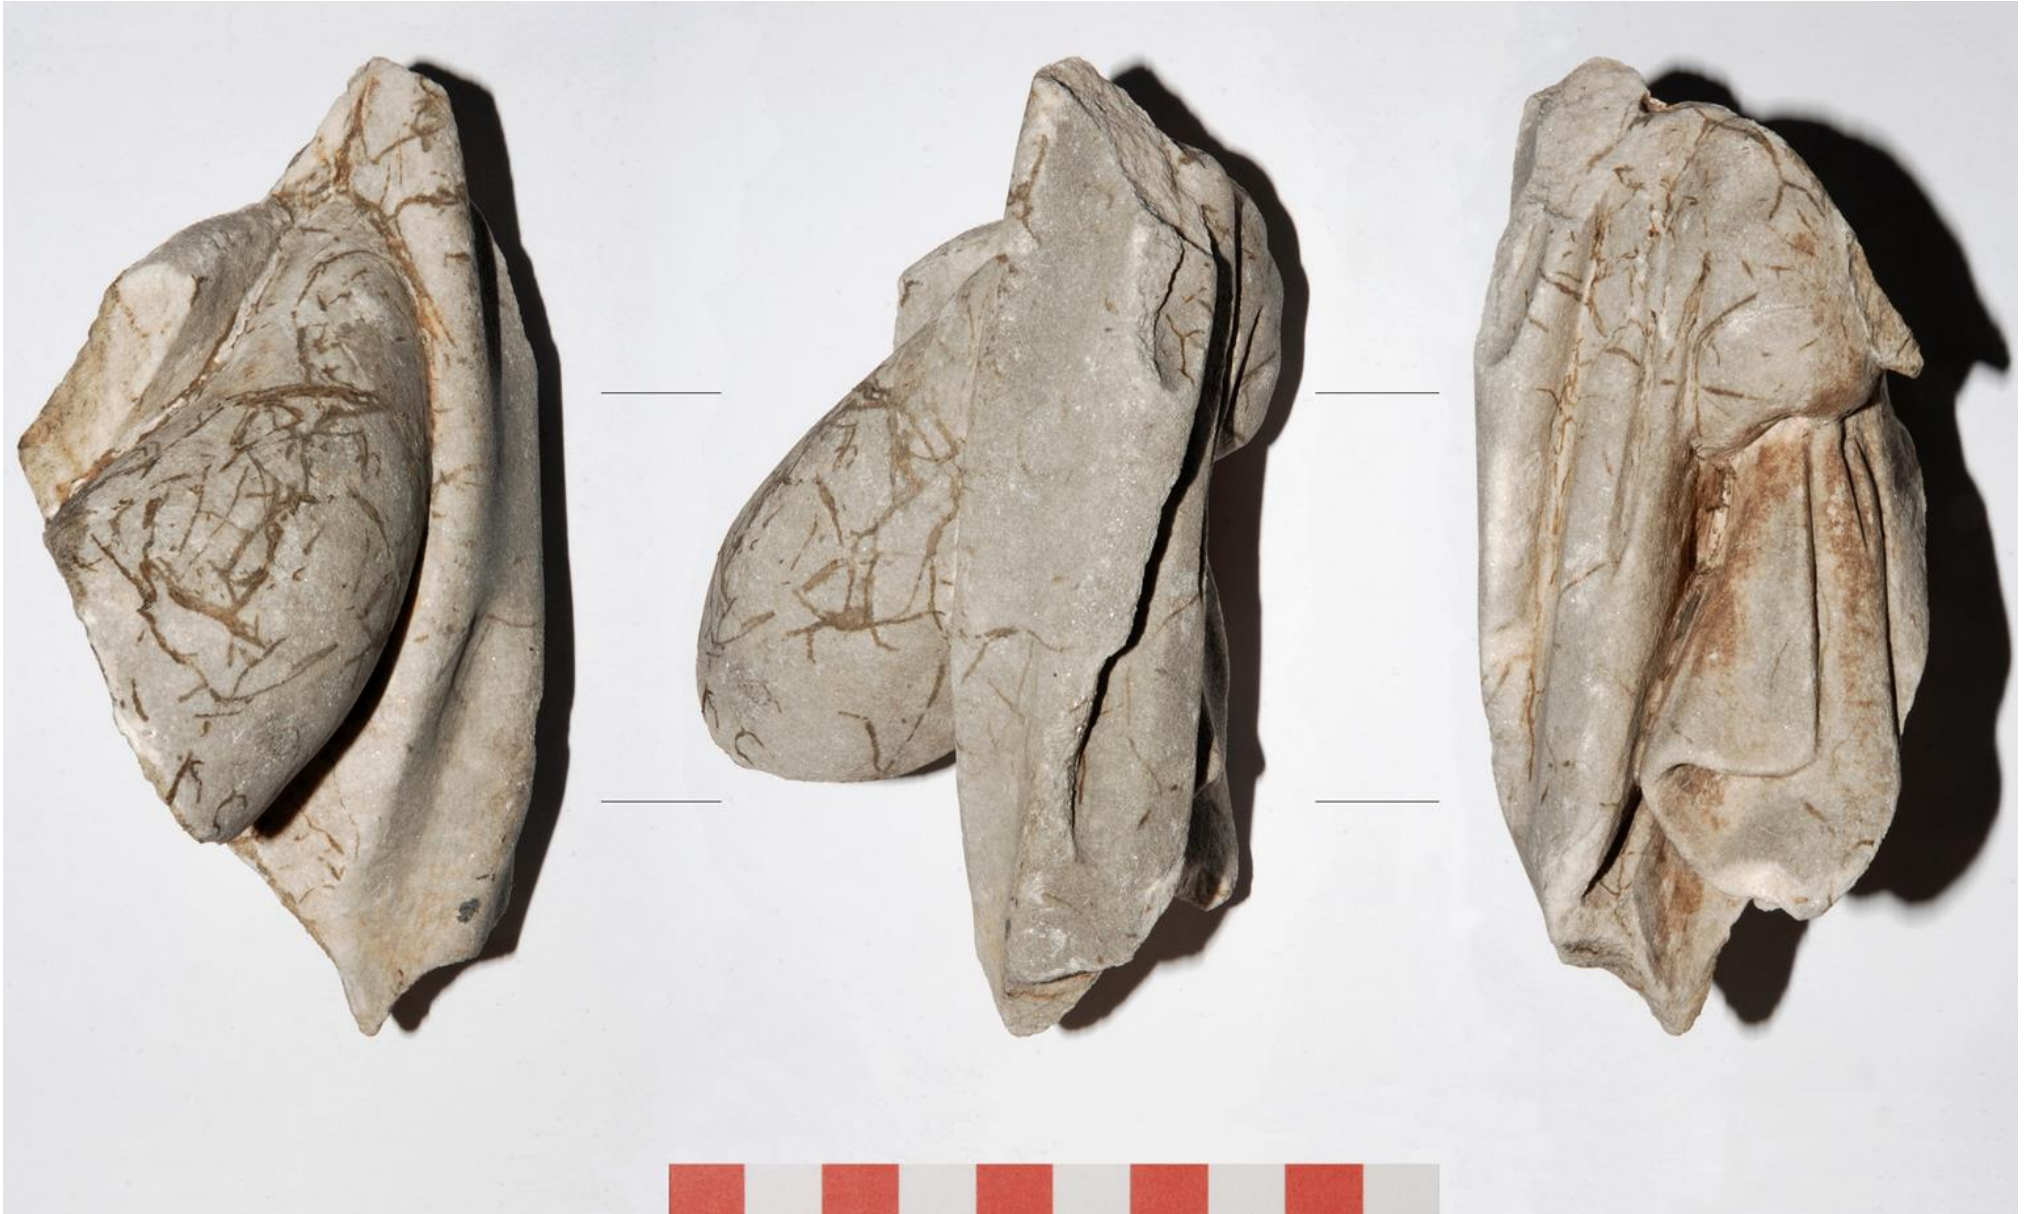
3. Part of a small statuette, in white marble though also showing superficial crazing/ discolouration – presumably produced by the wartime fire. The stone depicts the right forearm of a figure, raised at about 45° and with the wrist largely obscured by draped fabric/clothing (see Fig.31 overleaf).

Fig.31: Fragment of a small statue from Trench 6, side and front views depicting the right forearm of a figure with draped clothing or robe (100mm scale)

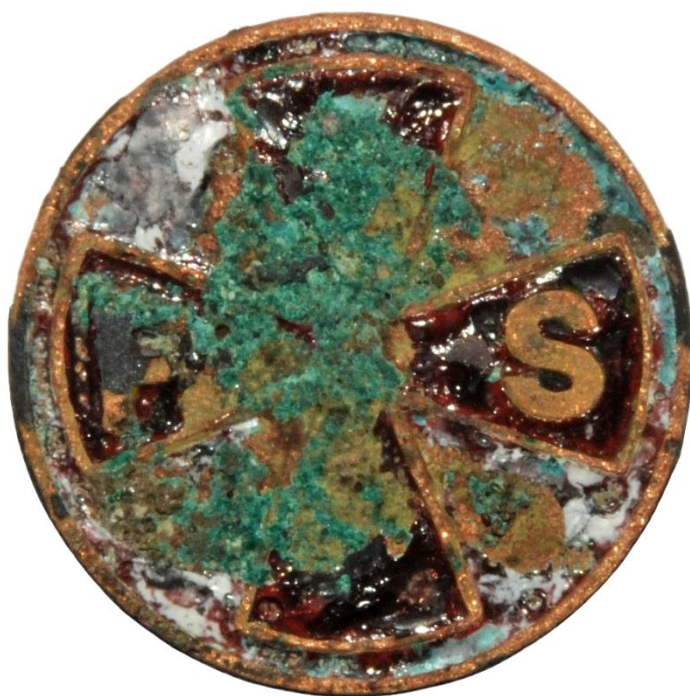
2. A small circular copper alloy lapel badge from Trench 6, of probable earlier 20th century date (Fig.32). The design consists of a cross pattée in low relief, at least two of the arms containing the letters **F** (or **H**) and **S**. The cross itself is highlighted in red enamel against a surrounding white enamel background – a pattern often referred to as the Templar cross.

Fig.32: Copper alloy badge with red cross pattée against a white background

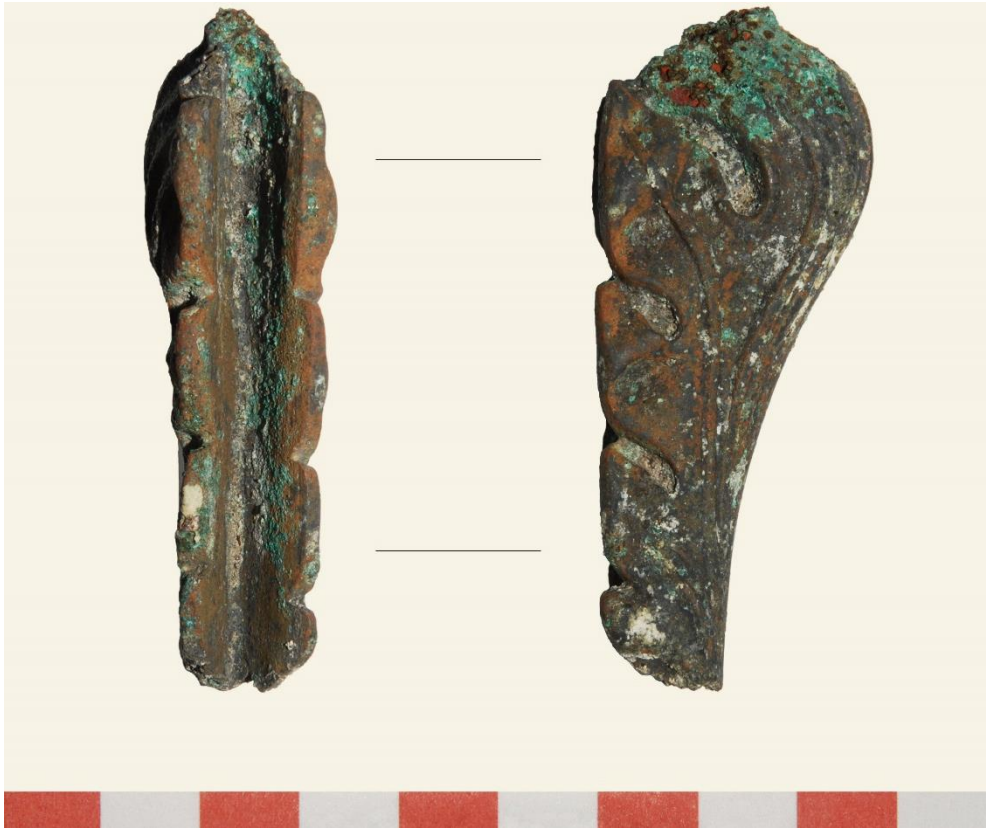
3. A decorative cast copper alloy fitting (Fig.33). Both ends are broken, but the rear is deeply grooved and the item appears to have been made as some form of decorative edging or attachment.

Fig.33: *Cast copper alloy fitting from Trench 6 (100mm scale)*

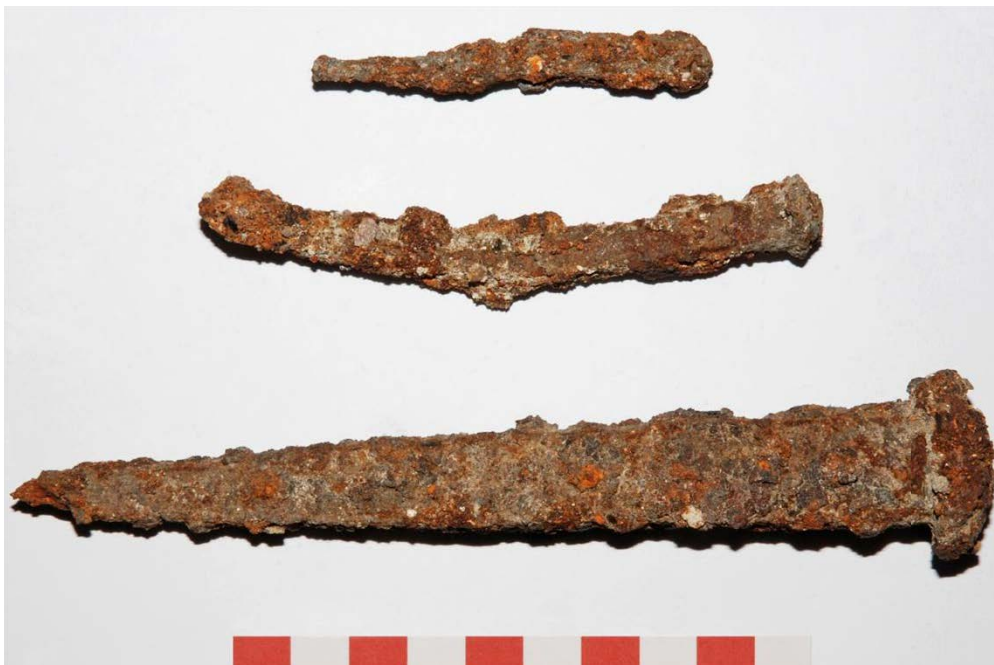
3. Iron nails (Fig.34). Three corroded nails, of varying sizes – the largest some 166mm in length and c 13 by 19mm in cross-section immediately below the head, and likely to have come from the roof.

Fig.34: *Nails from trenches 5 (at bottom) and 6*

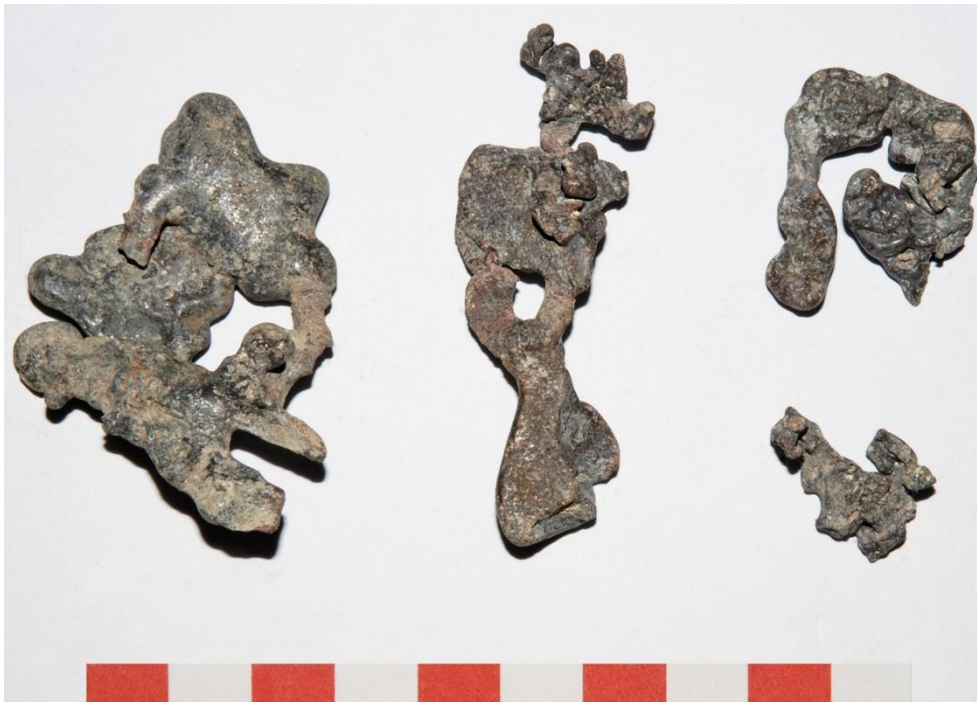
4. Melted fragments of lead (Fig.35 below). Four separate pieces were recovered, with a total weight 96gm, and are also likely to have originated in the roof.

Fig.35: *Fragments of melted lead from Trenches 5 & 6 (100mm scale)*
