Devon Historic Environment Record Entry

Parish: South Milton	NGR: SX69804289	Number:
Subject: Archaeological watching brief at All Saints Church, South Milton		
Ref: EA Project No. 5745		
Date: 26-29 November 2007		
Description: <p>A watching brief was undertaken by Exeter Archaeology at All Saints Church, South Milton during the installation of new toilets, a kitchen and associated drainage. The work was commissioned by Heighway Field Associates on behalf of the PCC. A brief for the archaeological work was produced by the Devon County Historic Environment Service.</p> <p>The font, south door, and possibly the nave, are 12th-century. The south transept was added in the 13th century, and the north aisle and tower were built in the 15th century. The porch was added later, possibly as late as the 17th century.¹</p> <p>The church is terraced into a south-facing slope. The north edge of the terrace is marked by a distinct bank around the north side and north-west corner of the building. The south edge of the terrace extends up to 4m beyond the retaining wall along the south side of the churchyard. Ground level is higher inside the wall where the graveyard soil has built up against it.

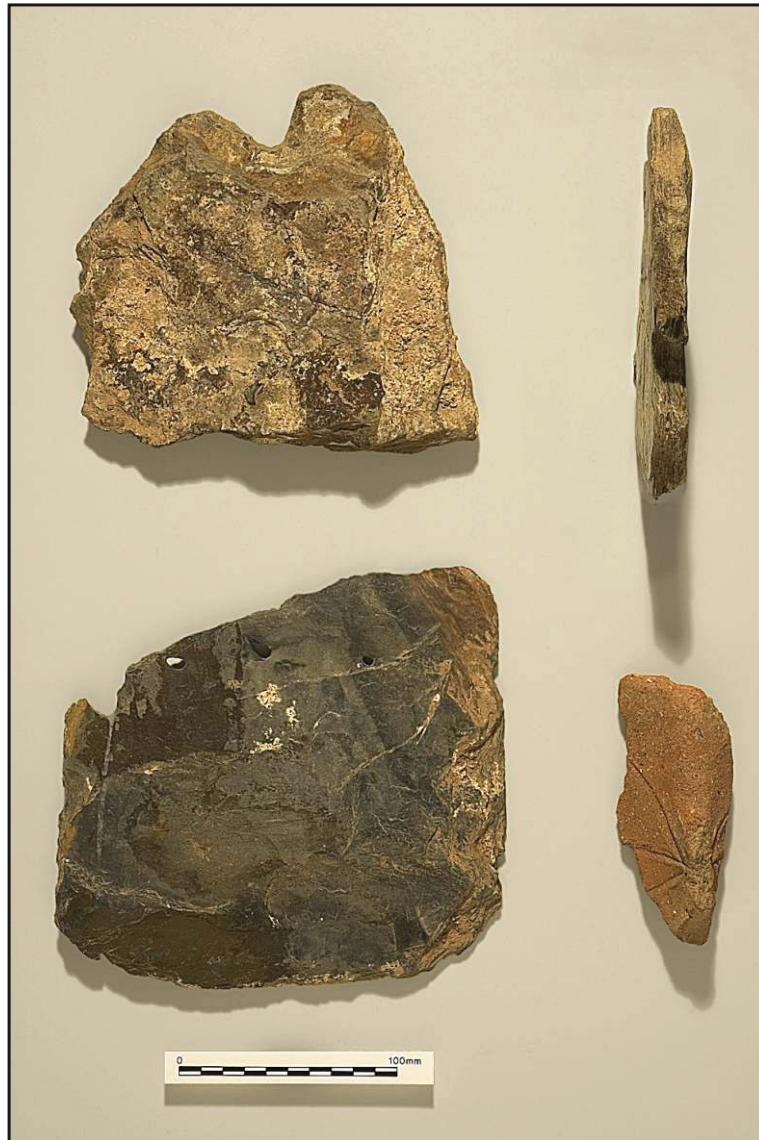
Plate 1 Medieval roof slates and ridge tile.

The levelling deposit (a) contained a high proportion of intact and broken medieval roof slates (Plate 1). Some of these were thick (13-21mm) and heavy and are more probably 12th- or 13th-century in date. Others were thinner (7-12mm) and lighter and could be 14th- or 15th-century, or later, in date. Some still contained peg or nail holes, some had lime mortar adhering to them. Part of a 14th- or 15th-century clay ridge tile in a granite-derived fabric also came from this layer. It was unglazed, with incised decoration, and was made locally in the South Hams.
