**ARCHAEOLOGICAL RECORDING
DURING BUILDING WORK
AT ST NICHOLAS PRIORY, EXETER, IN 2007**

Exeter Archaeology Report No. 07.91

Project 5980

November 2007

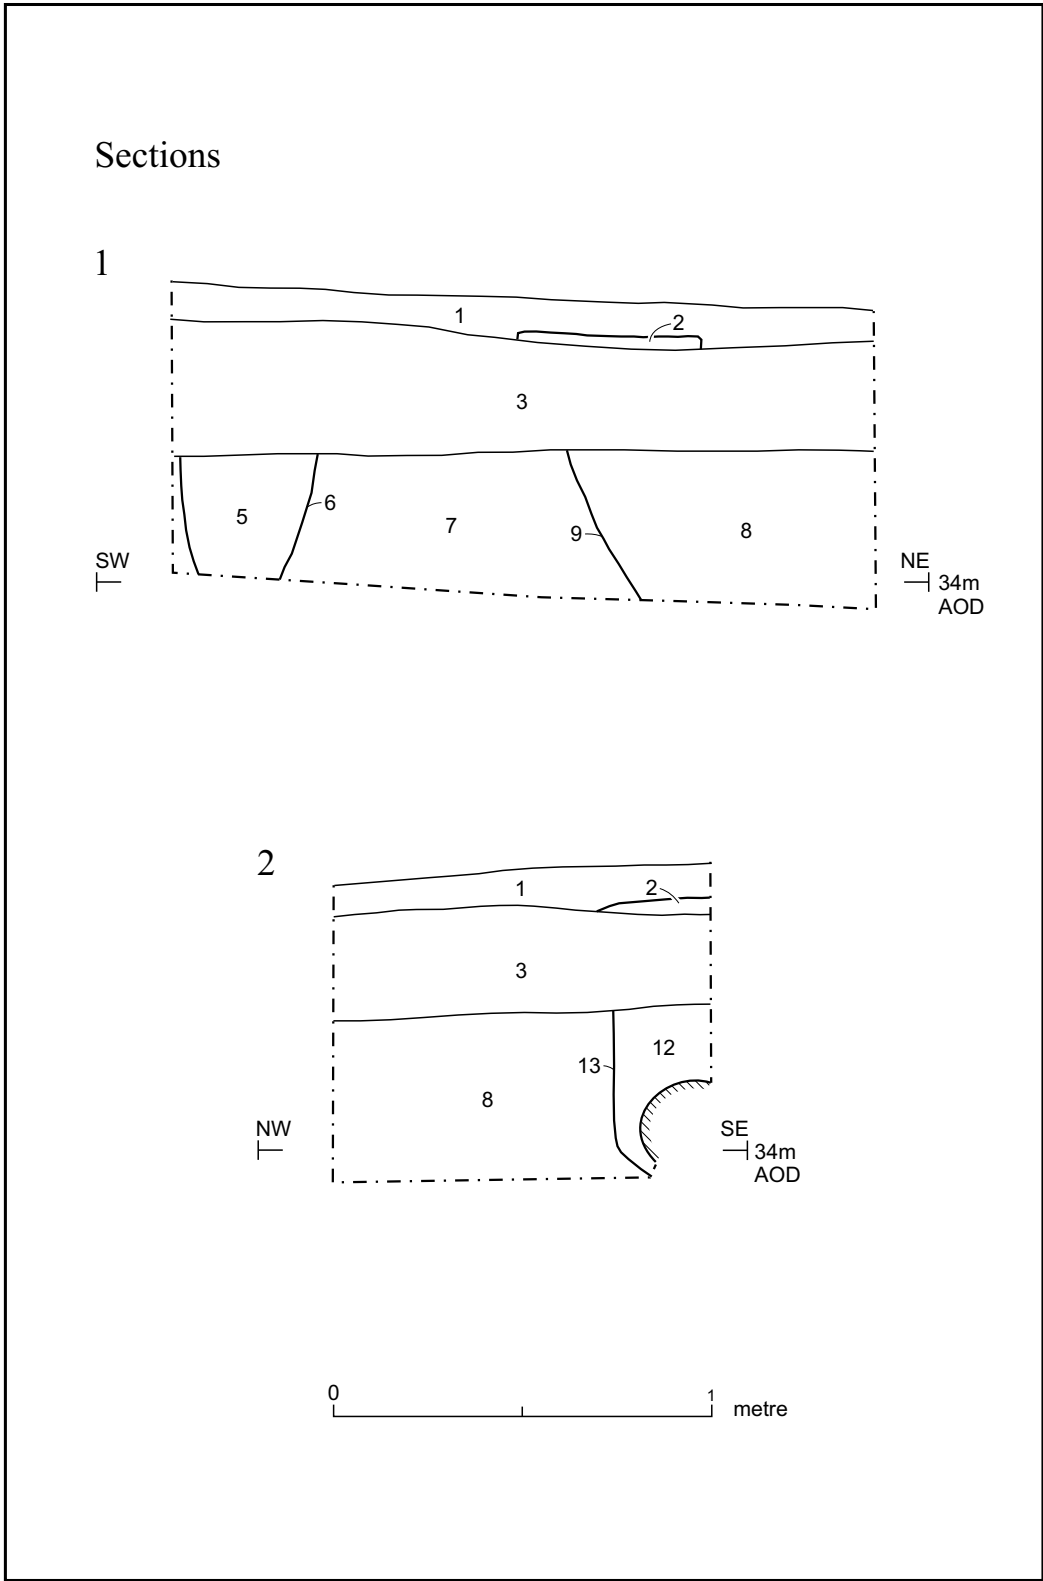
Fig. 3 Evaluation trench sections. Scale 1:20.

The evaluation trench was located in the northern part of the footprint of the new toilet block (see plans, figs 1–3). The trench measured 2.4m in length (east to west), a maximum of 1.0m in width and was excavated to a depth of 0.78m. Ground level was at 34.72m AOD. Below the *c.*0.15m deep modern gravel surface and makeup was a thin deposit of mortar (layer 2) that appeared to be the remains of a surface (see sections 1 and 2, fig. 3). Beneath was a *c.* 0.4m deep deposit of dark grey-brown sandy clay (layer 3) that extended across the trench. Finds retrieved from this deposit indicated that it dates from the 20th century. This makeup/levelling layer sealed all the deposits below. In the western end of the trench was a small brick ‘barrel’ culvert (context 4) that was aligned north-west to south-east. This feature is likely to date from the late 19th century. A service trench containing a ceramic drainpipe occupied the southern part of the trench. Several intercutting features were recorded within the remainder of the trench. All of the fills contained varying quantities of brick, slate and mortar. Layer 7 in the centre of the trench, was later found to be the fill of a pipe trench; it is likely to date, at the earliest, from the 19th century. Cut 6 and fill 5 appeared to represent a small pit. Cut 9 and fill 8, in the eastern part of the trench, may represent the robbing and subsequent backfilling of a wall aligned north–south.
