ARCHAEOLOGICAL EXCAVATION AT THE GUARDHOUSE, FORT NO. 3, BERRY HEAD, BRIXHAM, DEVON

prepared for Torbay Coast and Countryside Trust

Exeter Archaeology

Report No. 09.88

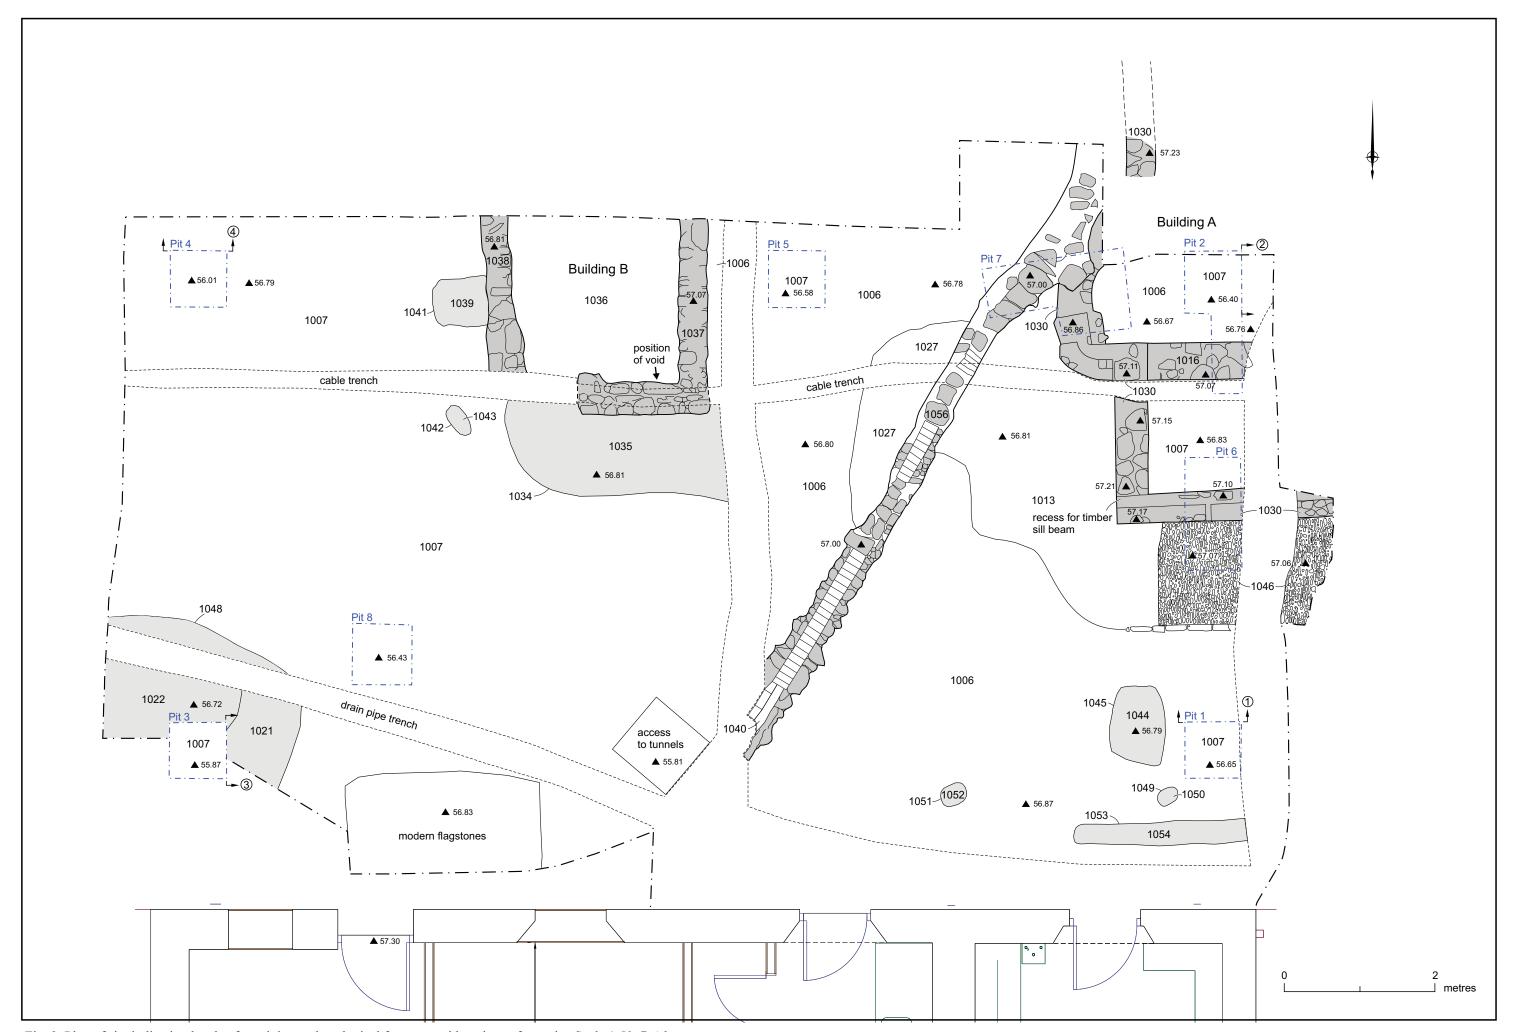
Fig. 2 Plan of site indicating levels of surviving archaeological features and locations of test pits. Scale 1:50 @ A3.

4.1 **Test pit evaluation** (Plan fig. 2, sections fig. 3)

4.2 The excavation (fig. 2)

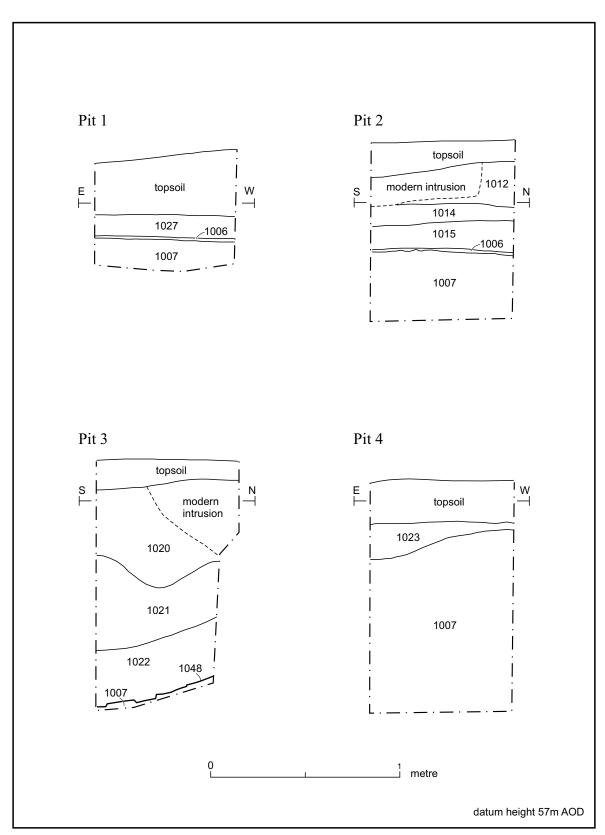
Fig. 3 Pits 1-4: sections. Scale 1:20 @ A4.

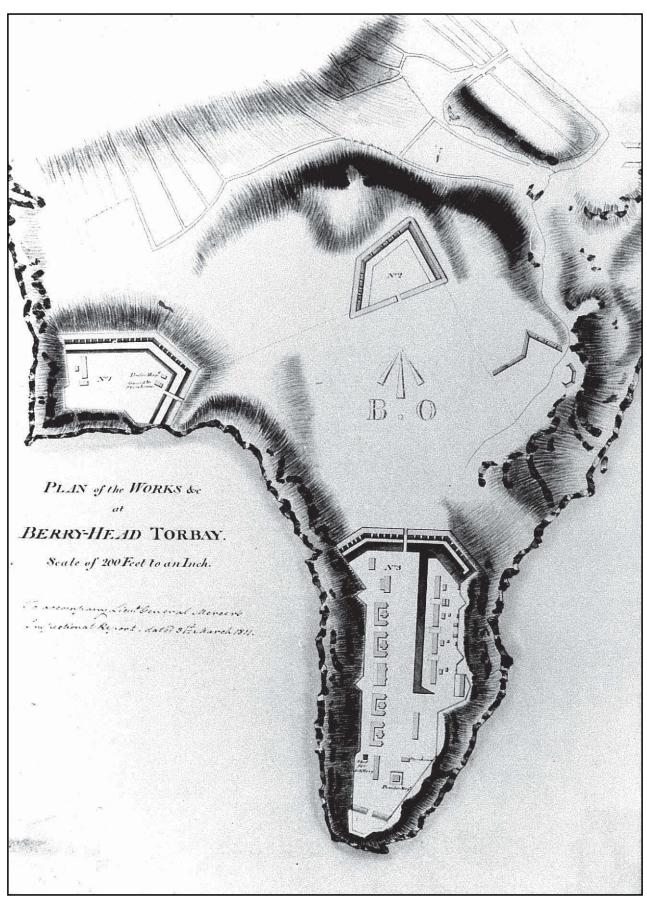
Fig. 4 Plan accompanying Lieut. General Mercer's report of 1811 (PRO ref: MPH 233/11).

building corresponds well with that of a building represented on a plan of the fort dated 1811 (fig. 4), however its function remains ambiguous. A plan produced by T.S. Blenkin in 1931 (fig. 5) labelled the building as 'Hospital (old)', but this interpretation is not corroborated by evidence from elsewhere⁵.

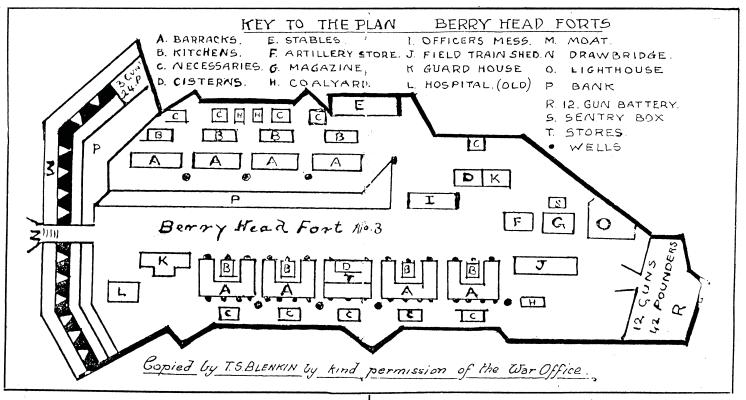
Fig. 5 T.S. Blenkin's 1931 plan of Fort 3 (Source Blenkin 1931, p 6-7).

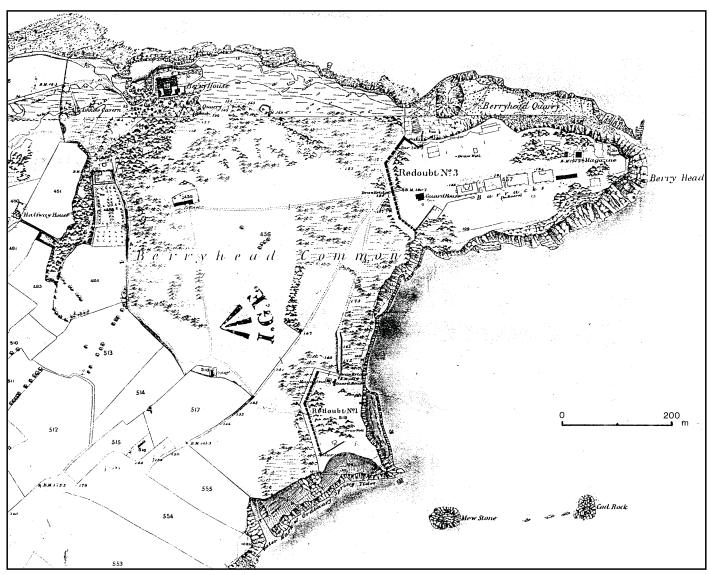
Fig. 6 War Office copy of the 1st edition (1865) OS 1:2500 map (PRO ref: WO78/589).

Little can be said about the function of Building B, which, unlike Building A was not visible from the surface prior to excavation. It appears to be indicated on the 1st edition OS map of 1865 (fig. 6) as a tiny square to the south of the Guardhouse. An apparent void below its north wall may suggest that it links with the tunnel system. It is possible that it represents the remains of a privy building. The tunnels were not exposed during the excavation, although it was observed that they are buried within what appears to be the primary levelling and makeup of the site, suggesting that they are also an original feature of the fort layout⁶

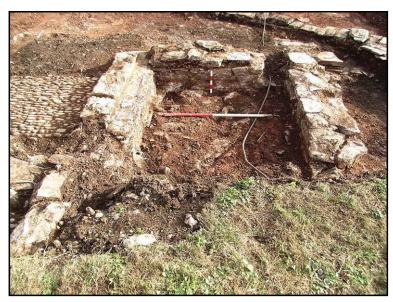
Pl. 3 Detail of building A. Looking east.

Building A (plates 2 & 3)

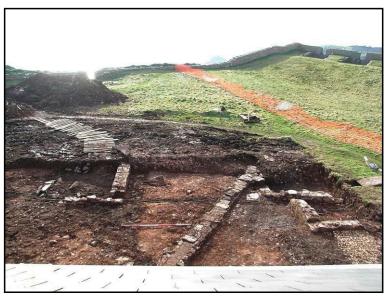
Pl. 2 Overview of south-west corner of site showing buildings A (right) B (left). Looking south.

Building B (plates 2 & 4)

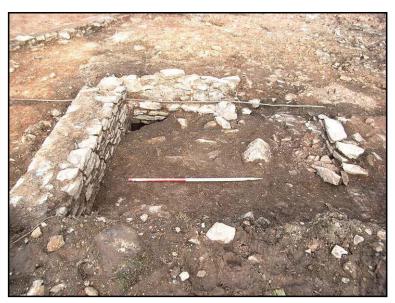
Pl. 4 Detail of building B. Looking north.
