**ARCHAEOLOGICAL INVESTIGATIONS AT
STANMER HOUSE, STANMER PARK, EAST SUSSEX**

**A POST-EXCAVATION ASSESSMENT AND
UPDATED PROJECT DESIGN REPORT**

**ASE Project No: 4699
Site Code:SER11**

**ASE Report No: 2012102
OASIS ID: archaeol6124550**

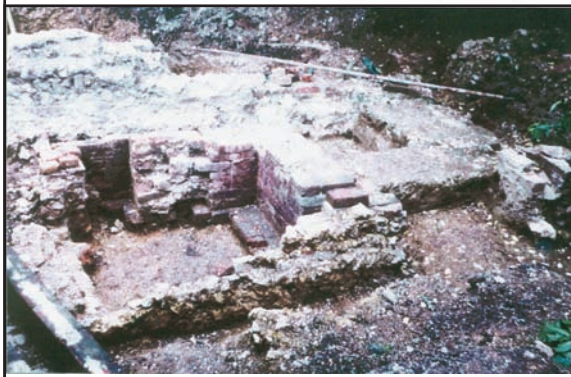
22.2: BHAS excavation looking north

- 1.4.3 This description appears to be describing the structures depicted in a copy of a BHAS excavation plan obtained by Neil Griffin in 2004 (Fig 22). It is even possible that a photograph also obtained at the same time, might depict the same structure (Fig 22.2). Unfortunately the BHAS plan was not tied into the national grid, and the location of these structures remains unknown. However, a possible location has been proposed based upon features identified in both the 2004 evaluation and the current phase of fieldwork and is depicted on Fig. 2.
