**FORMER HARPERBURY HOSPITAL,
HARPER LANE, RADLETT, HERTFORDSHIRE**

**HISTORIC BUILDINGS RECORD
(HISTORIC ENGLAND LEVELS 2 & 3)**

**Site Code: FHH17
Project No. 160560
Report No. 2017303
OASIS ID: archaeol6-305660**

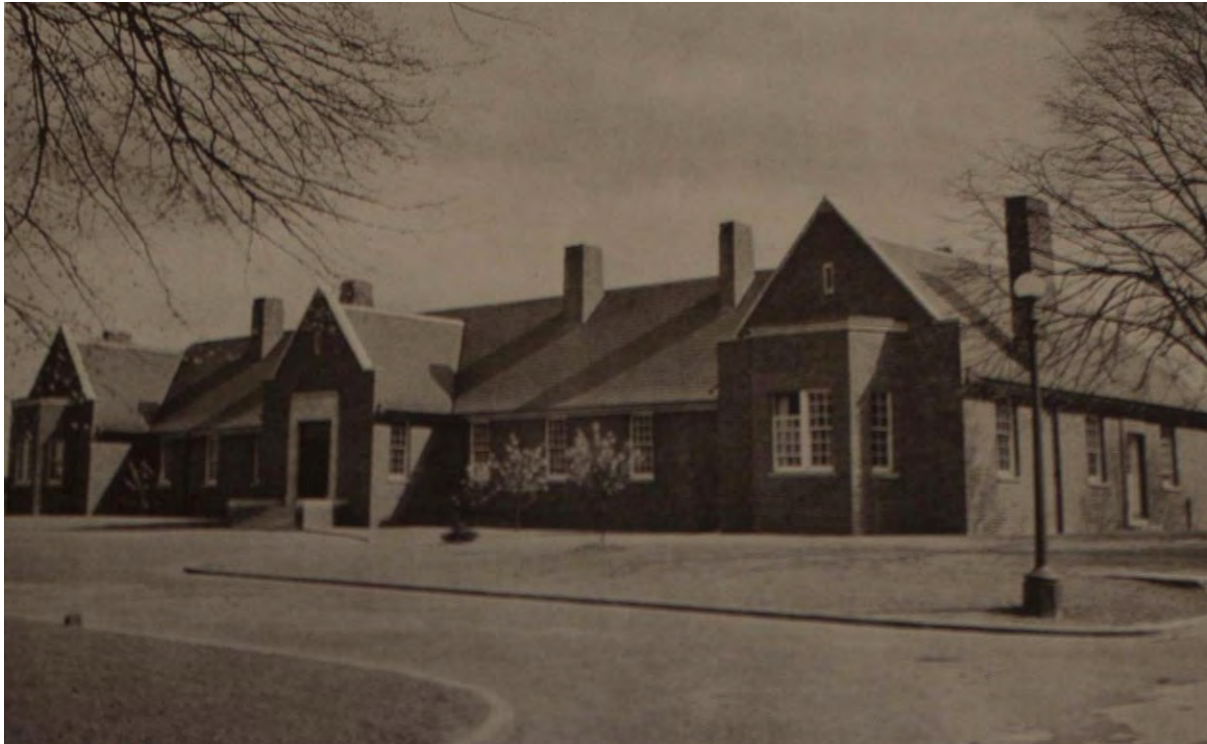
Plate 1 Building 1, entrance/administrative block, 1936, facing south-east (LMA ref. MCC/CI/GP/CER/121)

7.1.7 Historic plans suggest that the eastern half of the kitchen was built first, with the remainder of the building conceived from the outset and provision made for its later construction (Fig. 9). The building had been completed by the time the hospital officially opened in 1936 (Plate 1; LMA ref. MCC/CI/GP/CER/121).

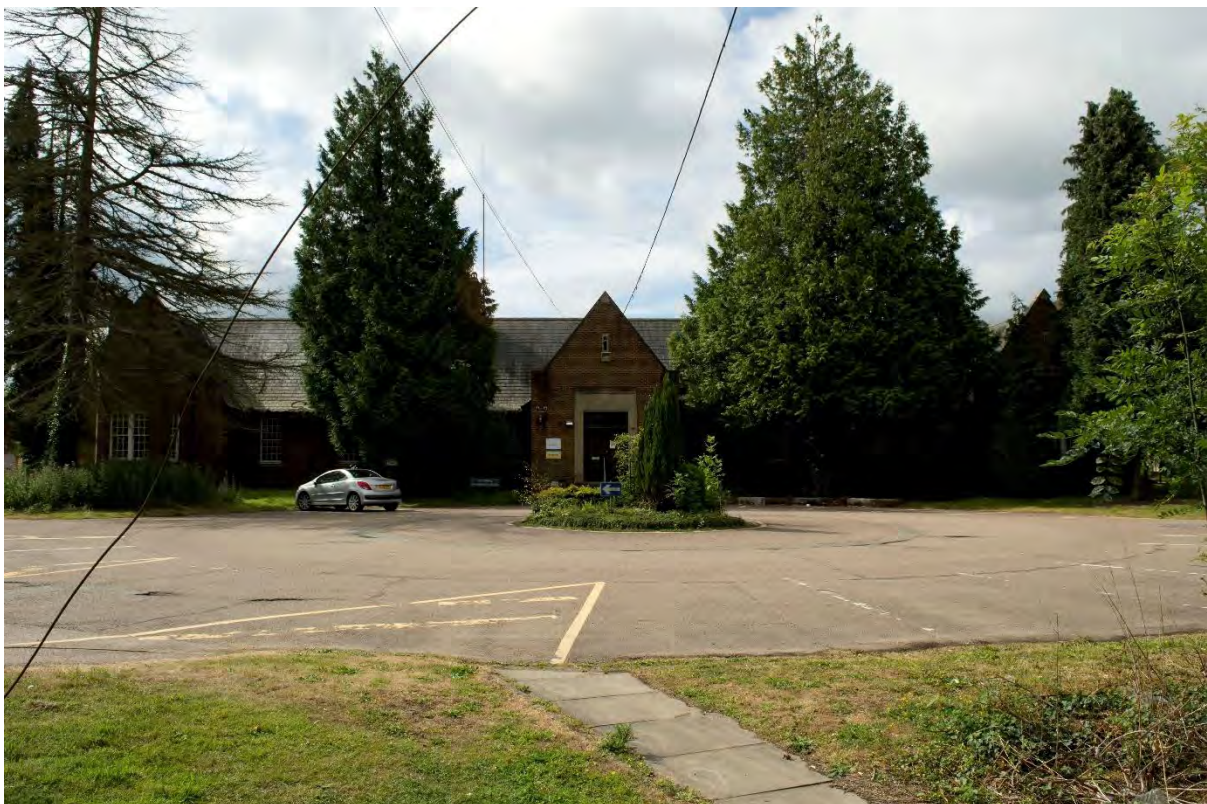
Plate 2 Building 1, principal (north) elevation of the entrance/administrative block (FHH17-0443)

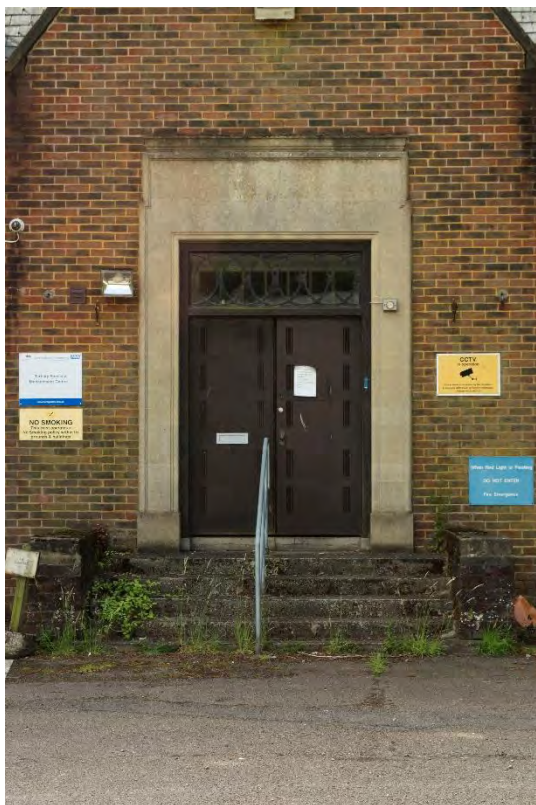
Plate 3 Building 1, detail of principal entrance (FHH17-447)

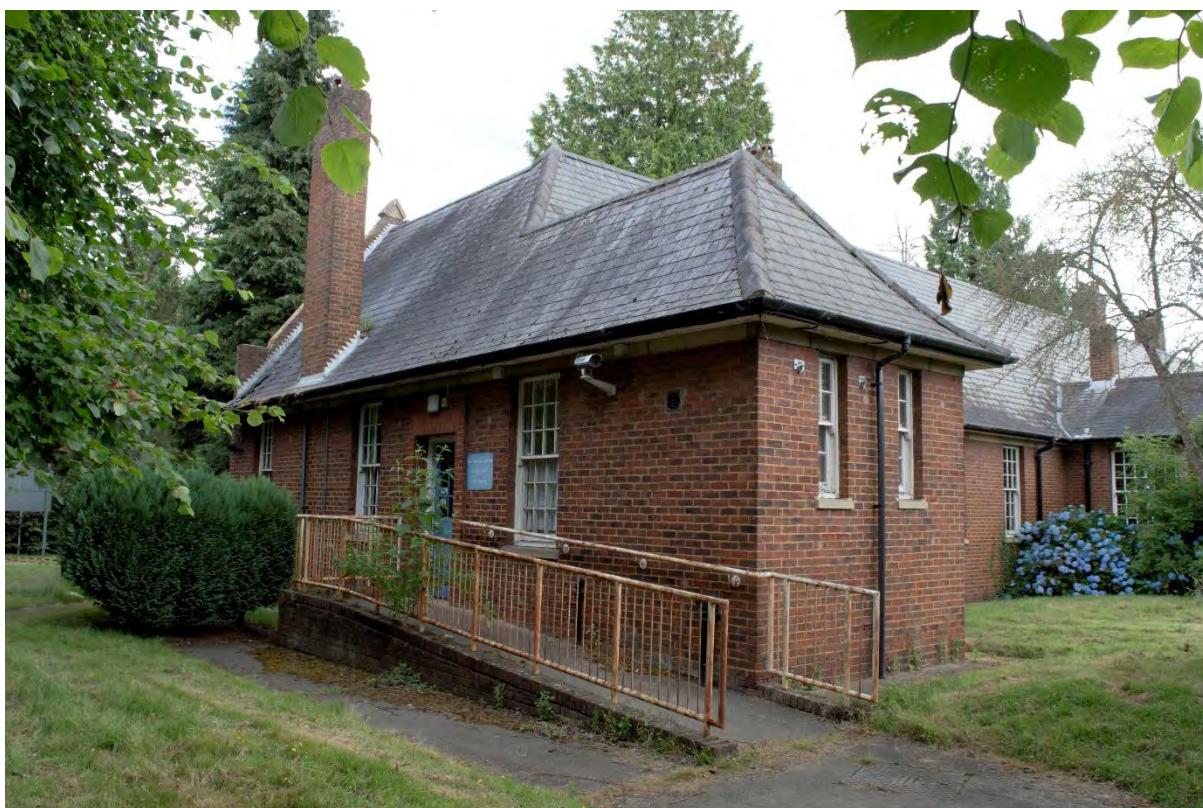
Plate 4 Building 1, entrance/administrative block, facing north-east (FHH17-474)

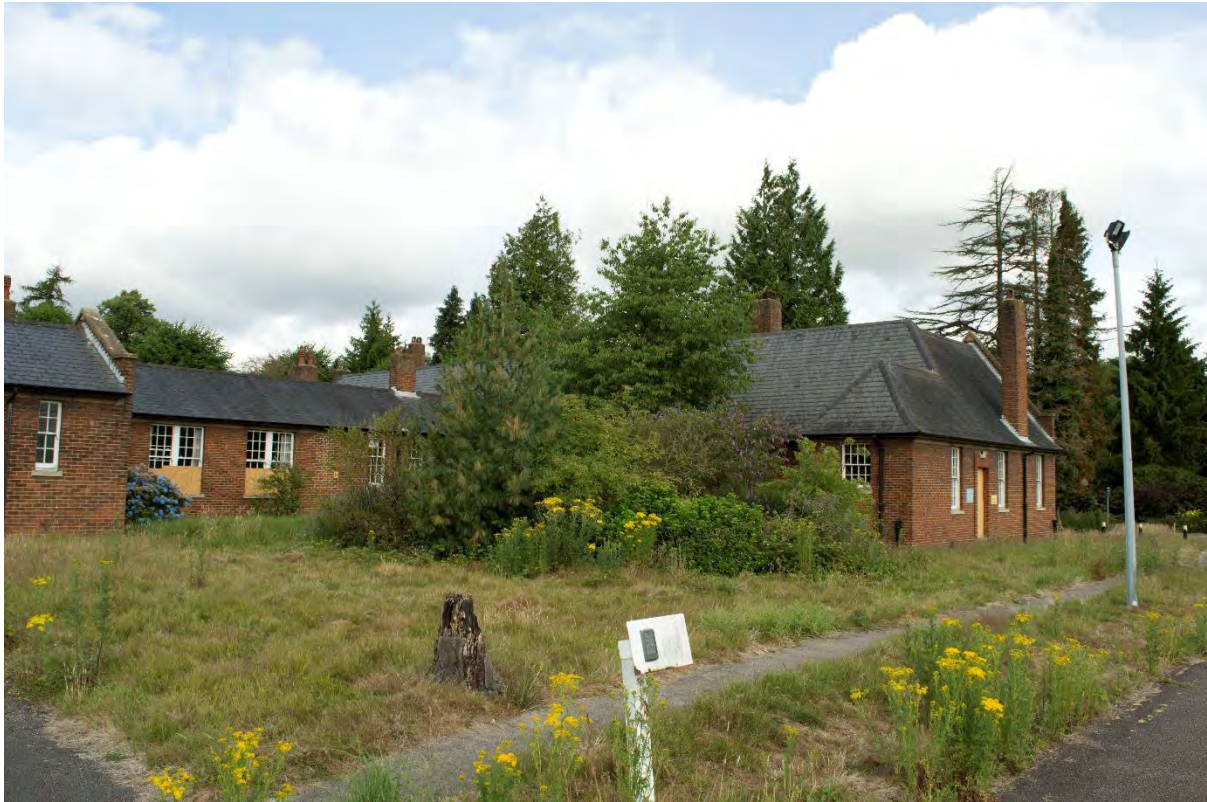
Plate 5 Building 1, entrance/administrative block, facing north-west (FHH17-0451)

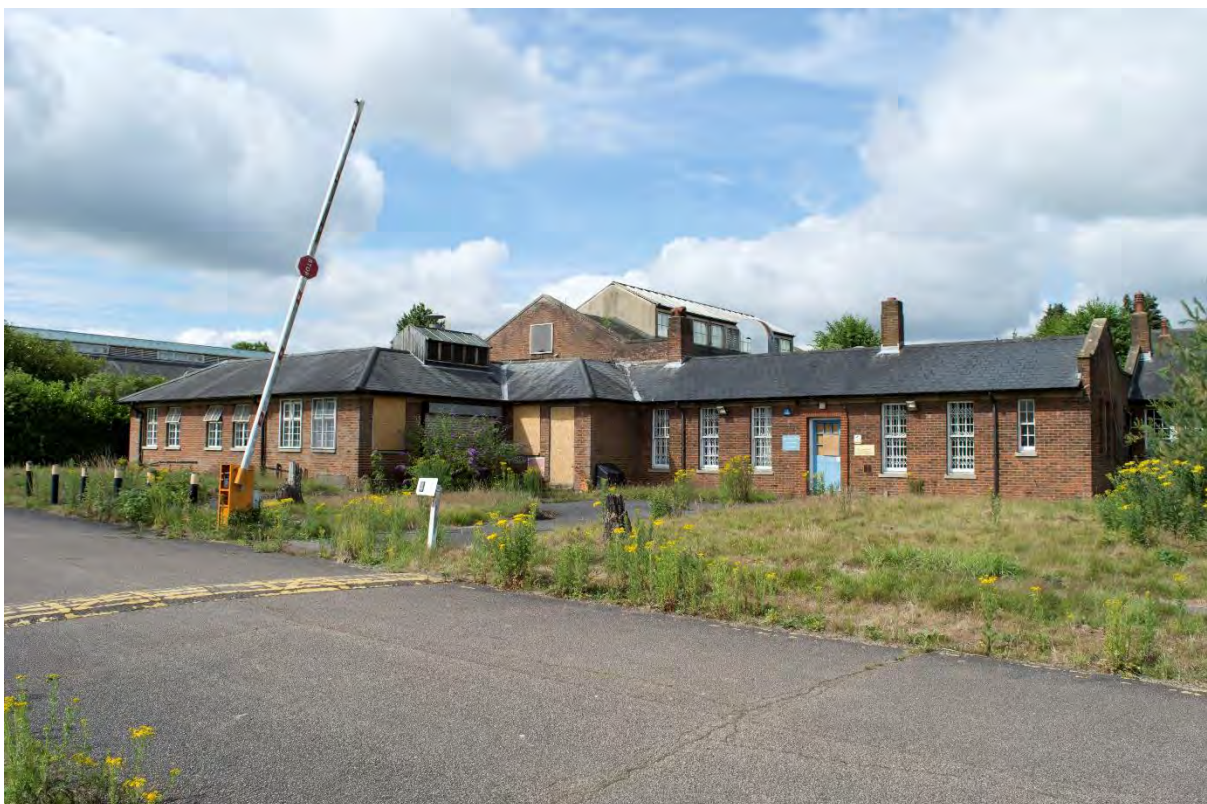
Plate 6 Building 1, dispensary and kitchen blocks, facing south-west (FHH17-456)

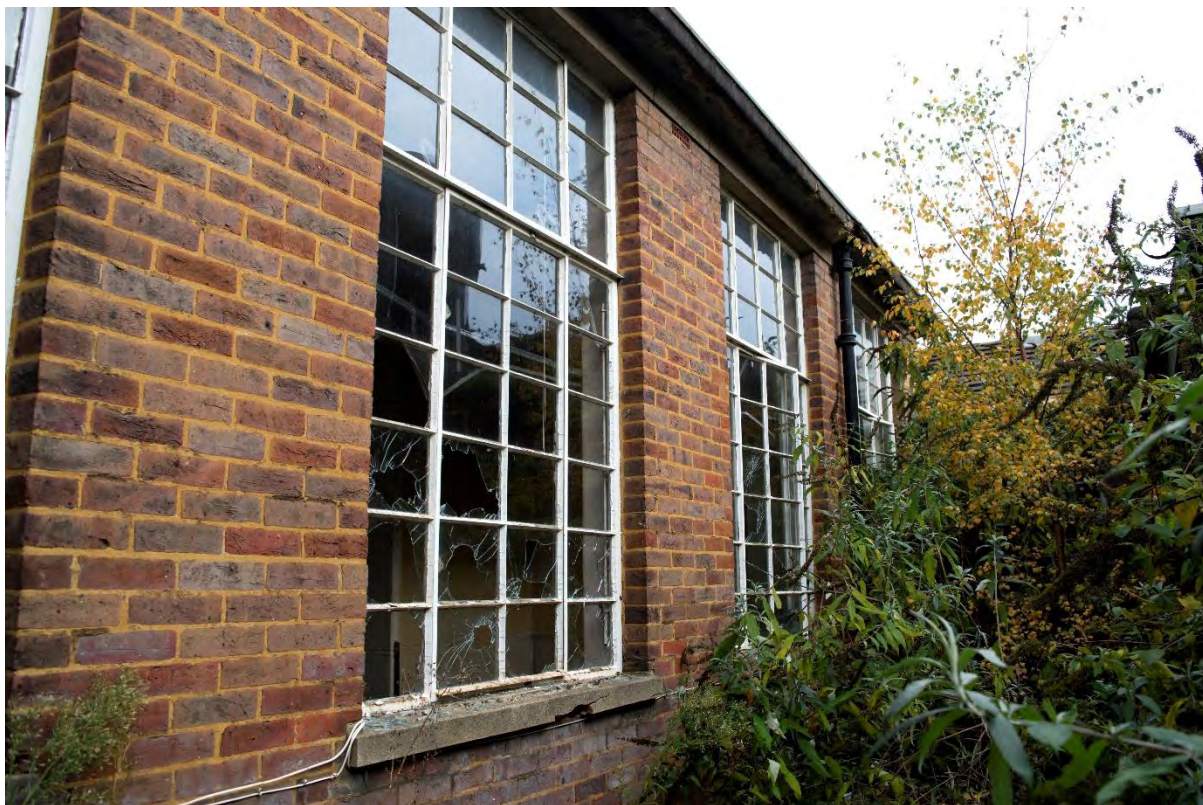
Plate 7 Building 1, south elevation of dispensary, overlooking a courtyard, facing east-north-east (FHH17-987)

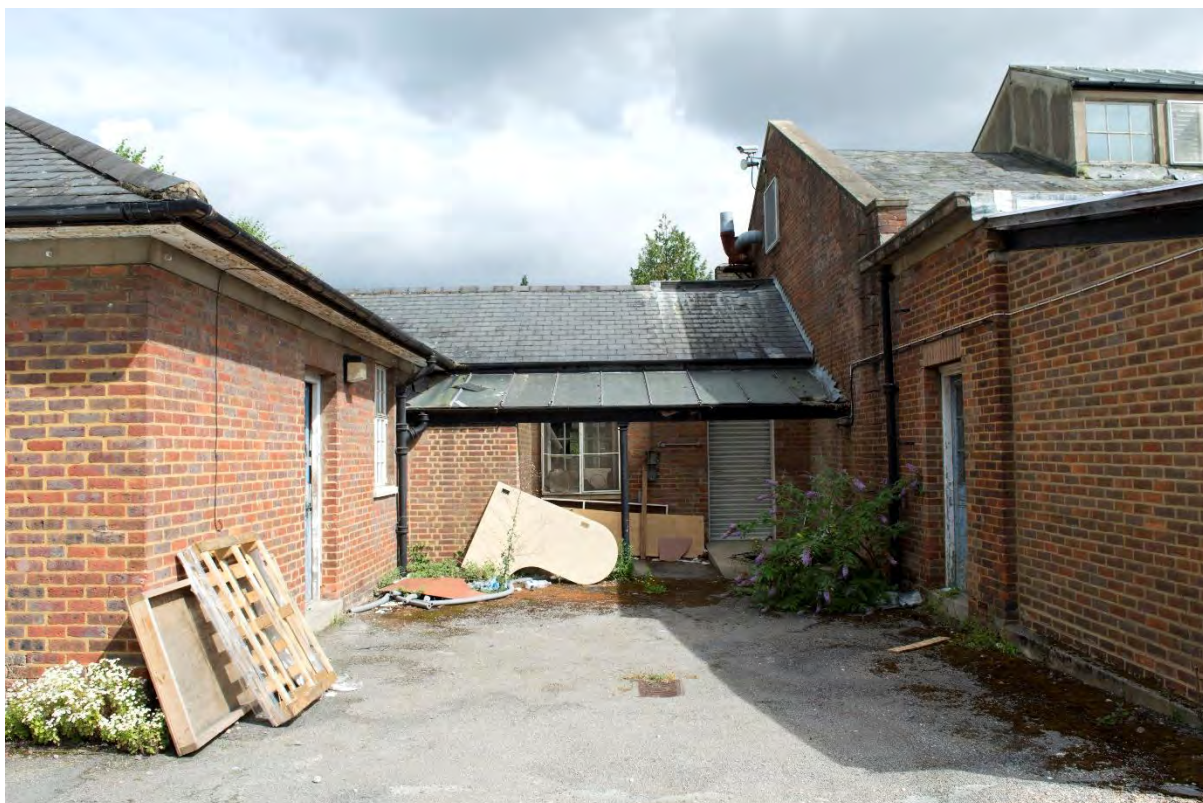
Plate 8 Building 1, central kitchen, covered walkway on south side of west flanking range, facing north (FHH17-466)

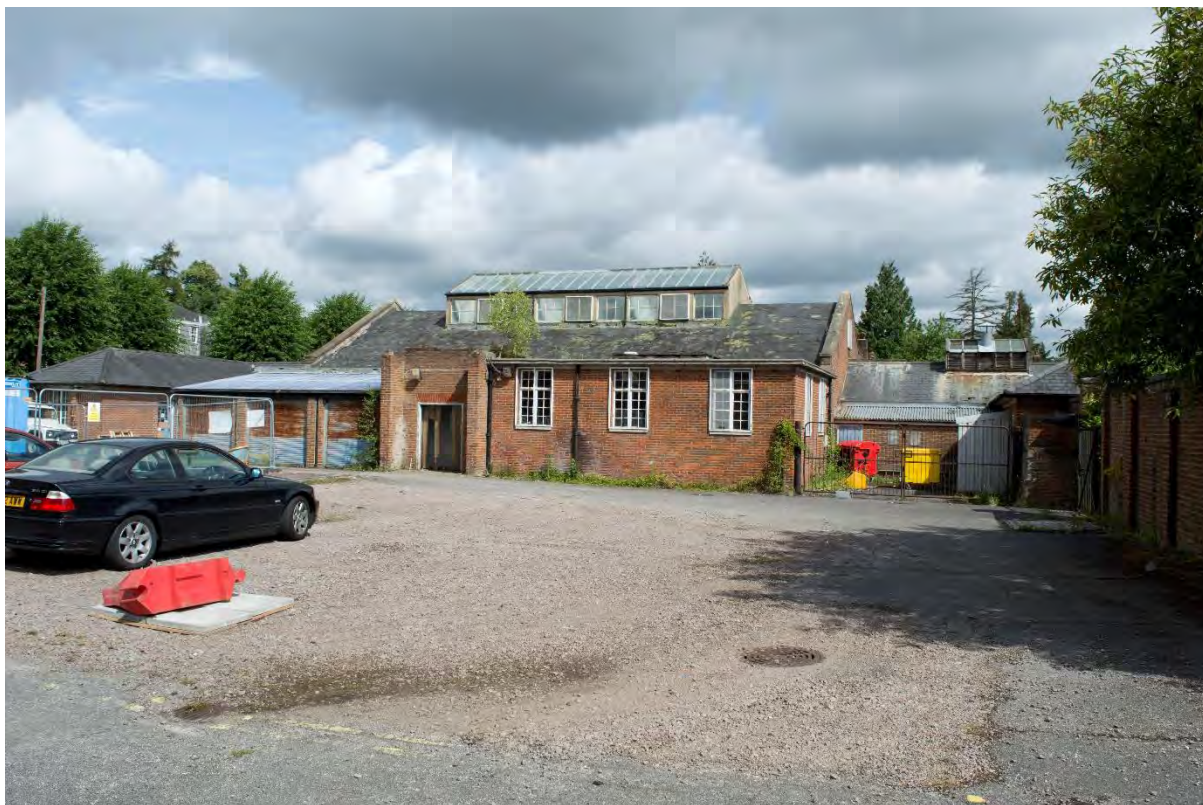
Plate 9 Building 1, central kitchen, facing north-north-west (FHH17-460)

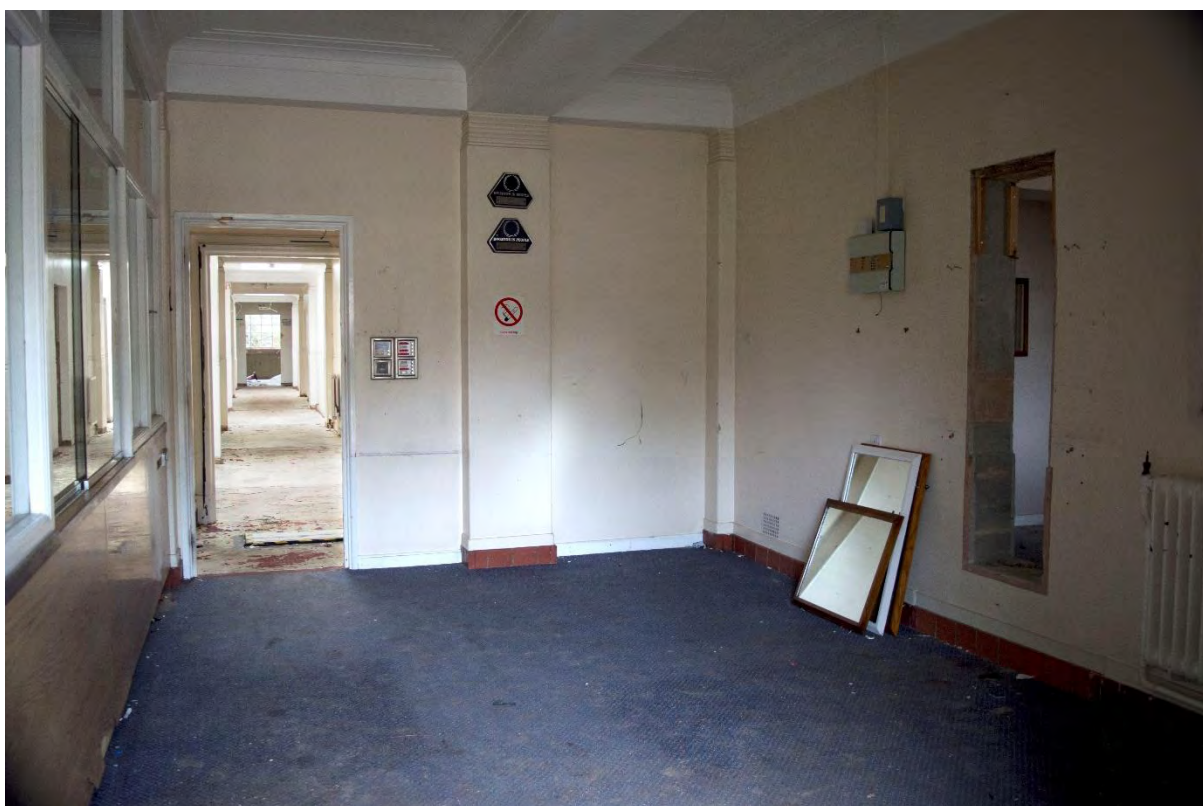
Plate 10 Building 1, entrance/administrative block, main entrance hallway, facing south (FHH17-0994)

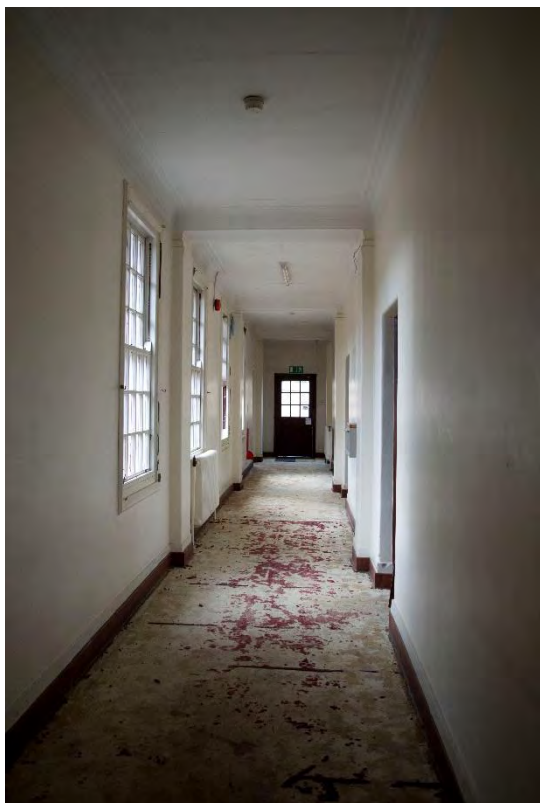
Plate 11 Building 1, entrance/administrative block, west hallway, facing west
(FHH17-1022)

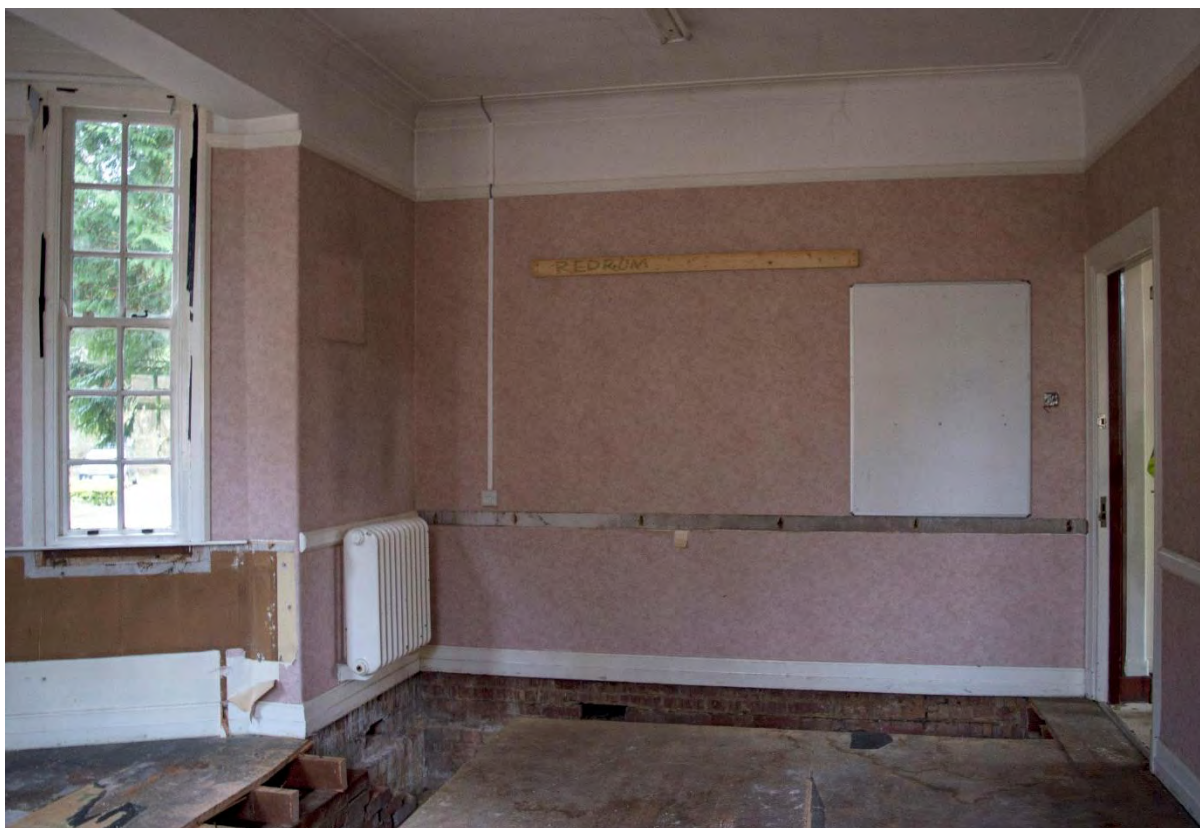
Plate 12 Building 1, entrance/administrative block, typical room in north range
(FHH17-1035)

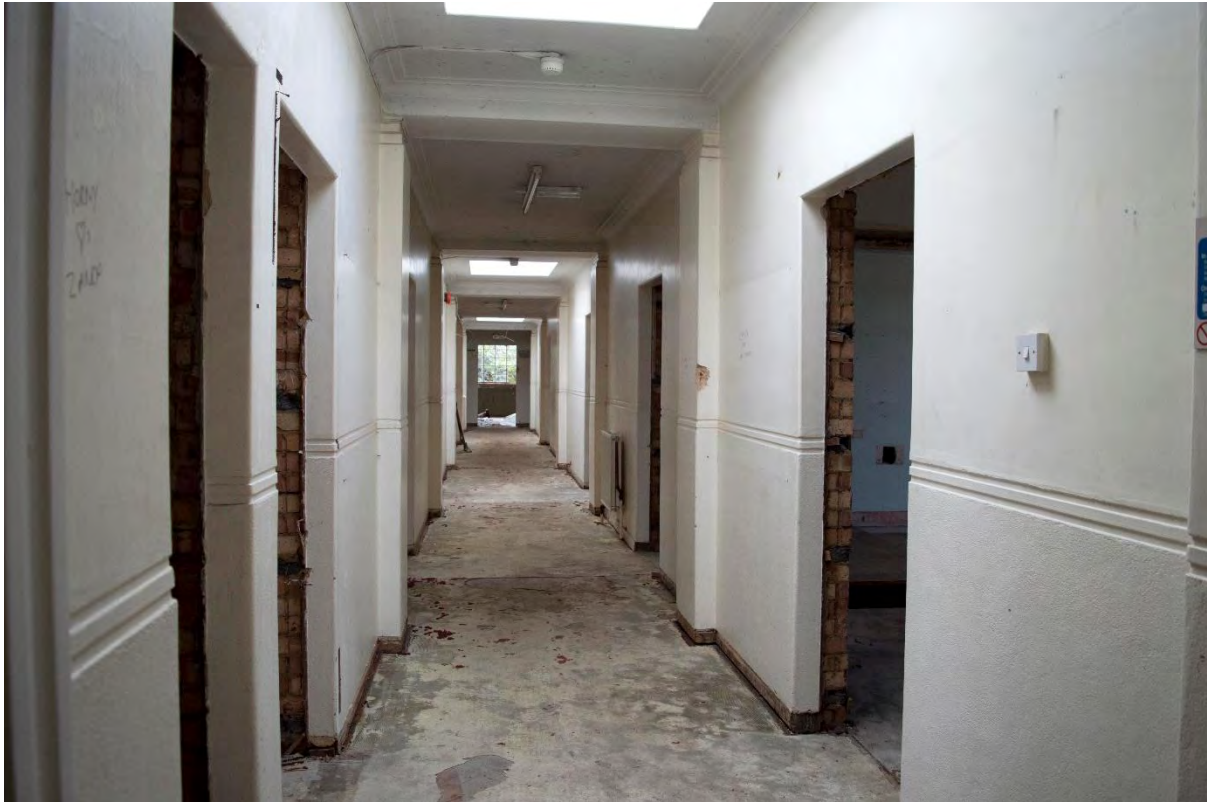
Plate 13 Building 1, entrance/administrative block, south corridor, facing south (FHH17-1047)

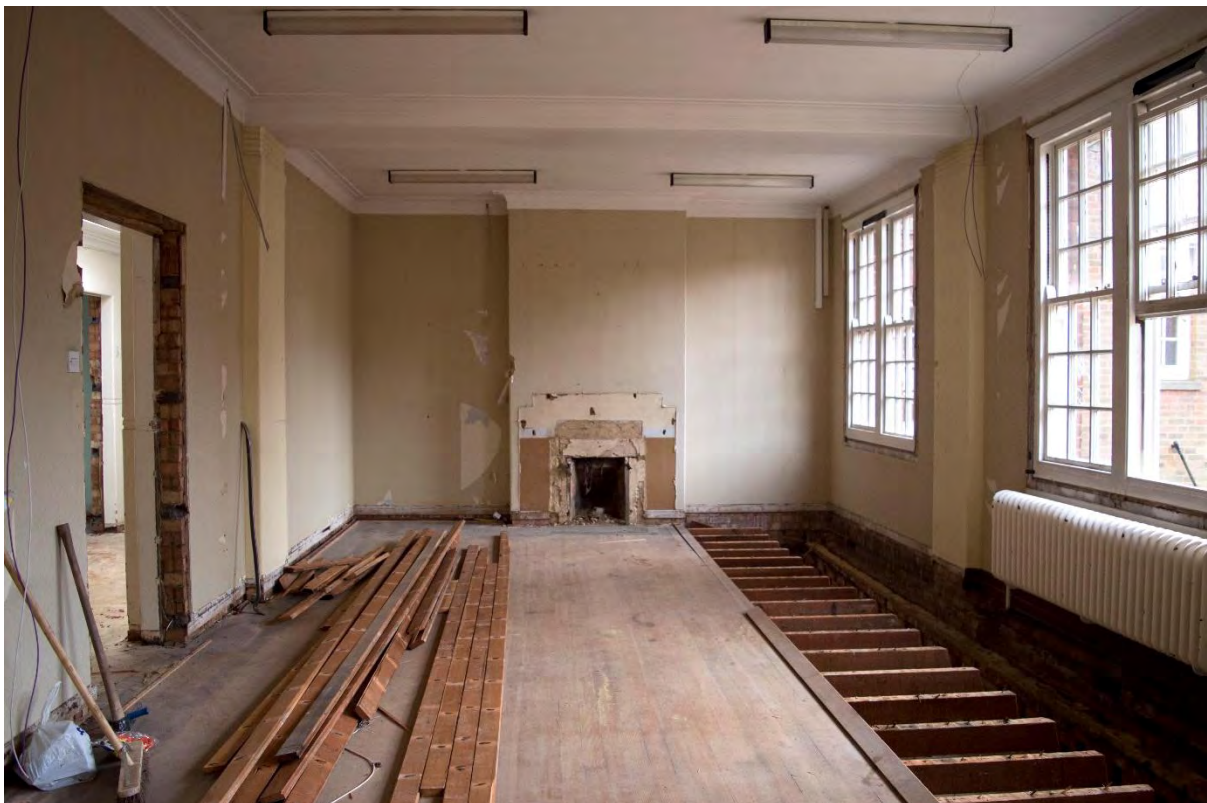
Plate 14 Building 1, entrance/administrative block, probable visiting room, facing south (FHH17-1073)

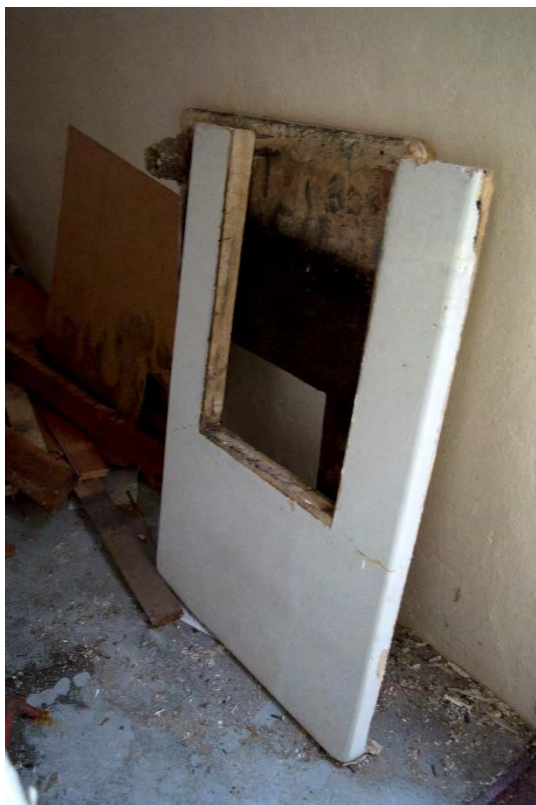
Plate 15 Building 1, entrance/administrative block, examples of concrete fireplace surrounds (FHH17-1057)

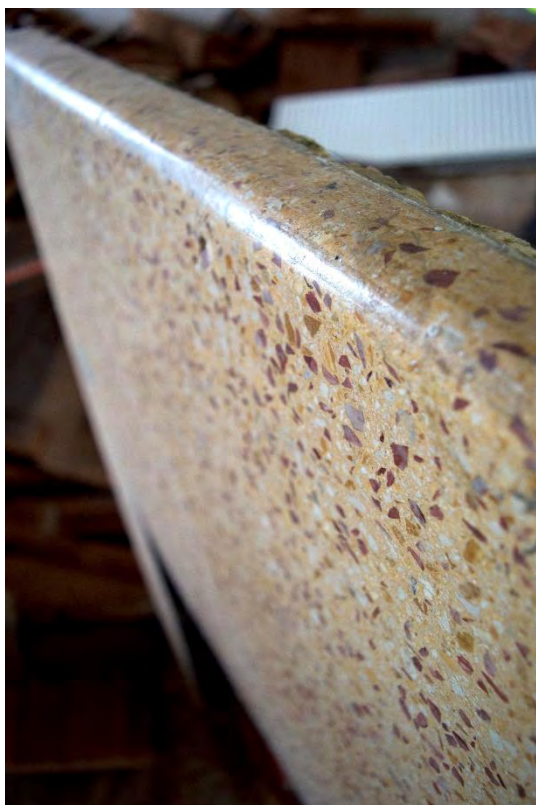
Plate 16 Building 1, entrance/administrative block, detail of polished concrete/terrazzo fire surround (FHH17-1067)

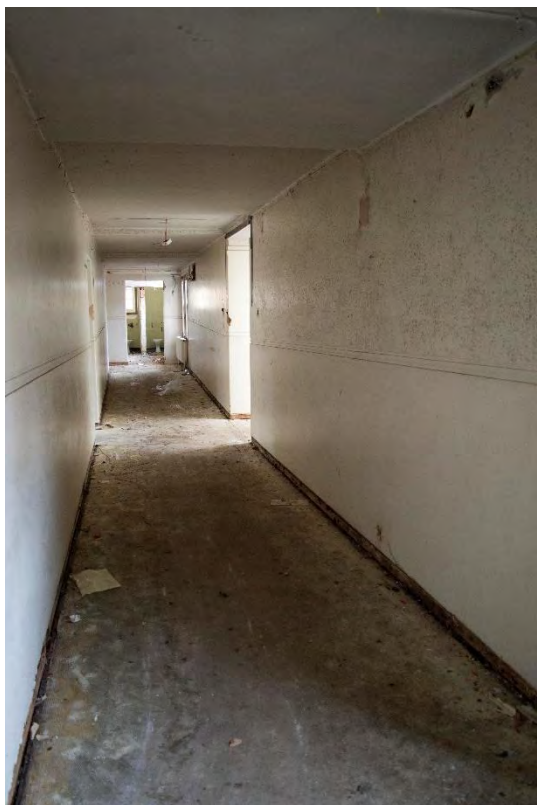
Plate 17 Building 1, dispensary block, corridor to north of dispensary, facing west (FHH17-1091)

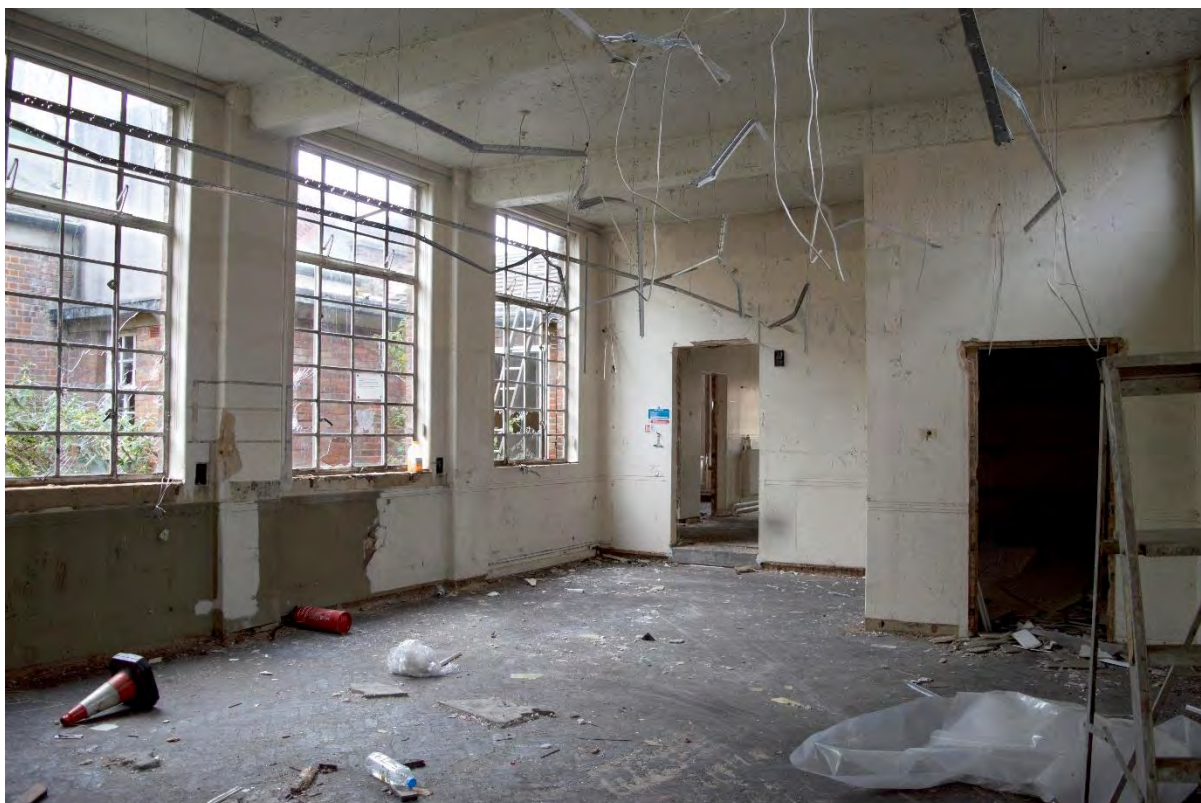
Plate 18 Building 1, dispensary, facing south-west (FHH17-1094)

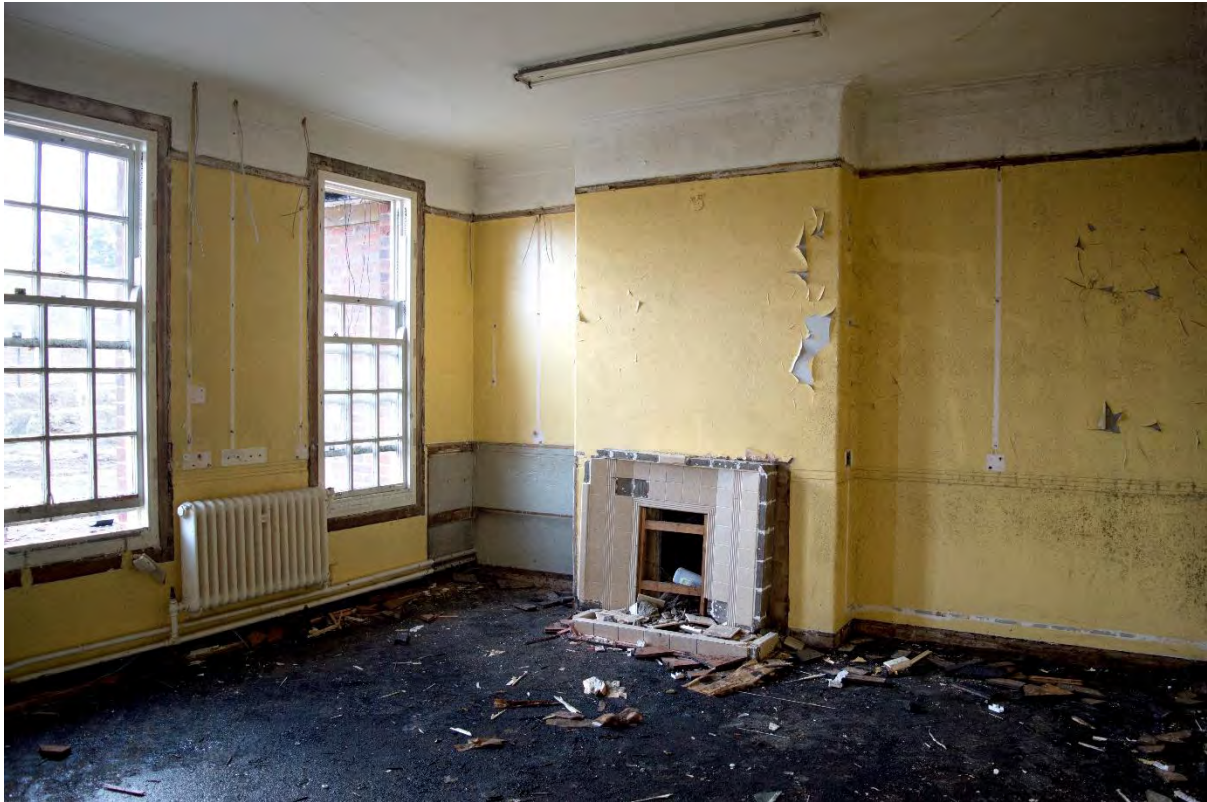
Plate 19 Building 1, dispensary block, south-east room, facing south-east (FHH17-1126)

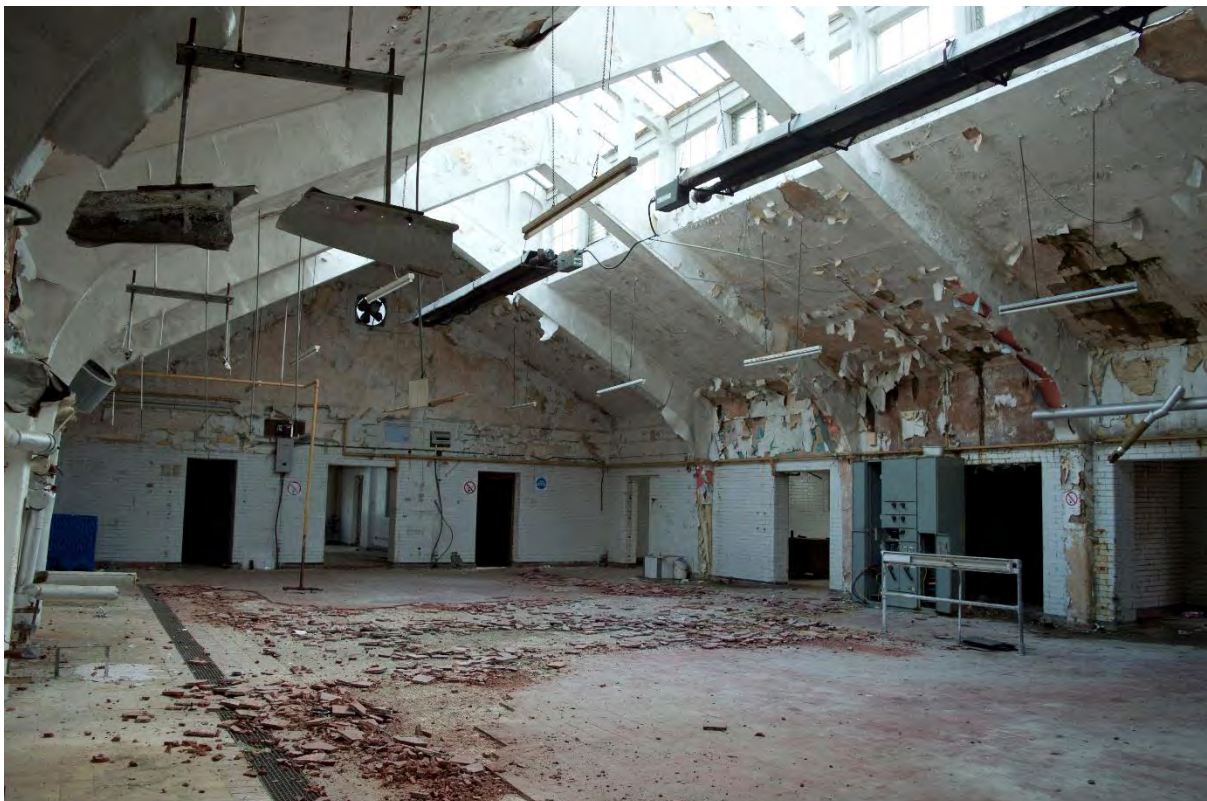
Plate 20 Building 1, central kitchen, facing south-east (FHH17-1164)

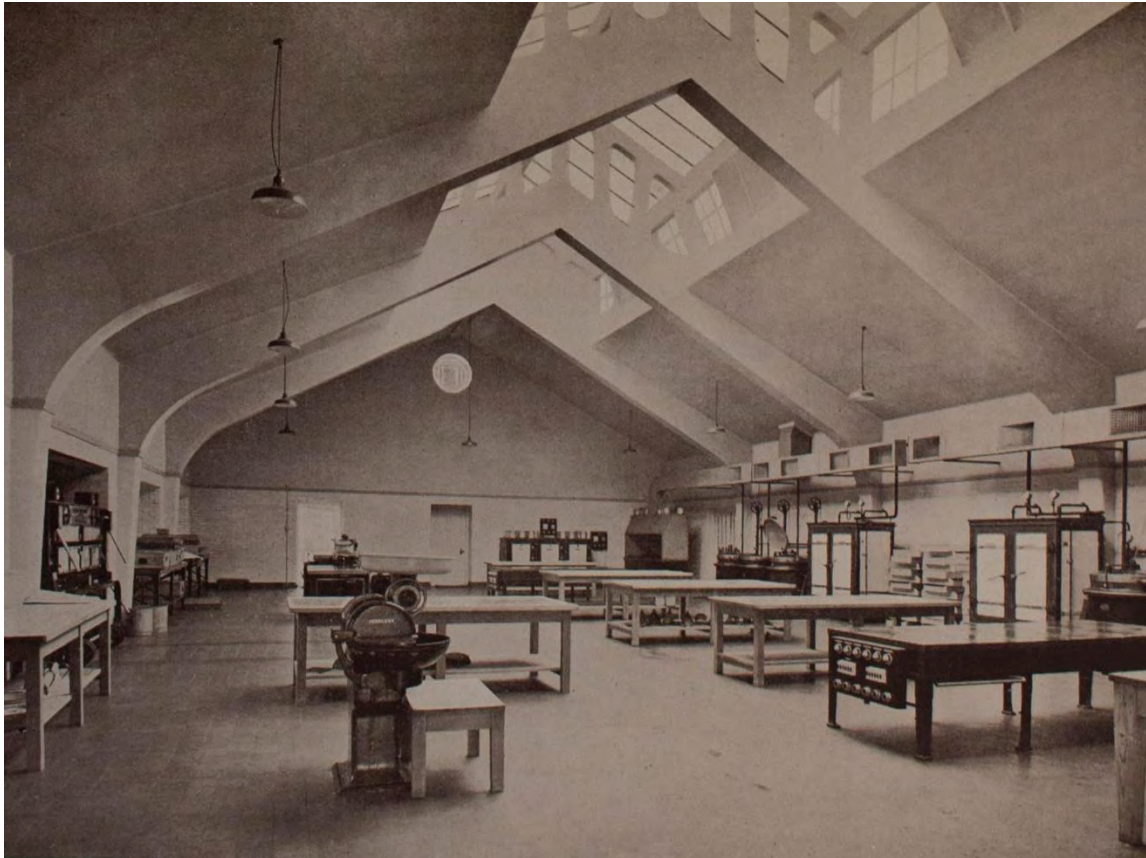
Plate 21 Building 1, central kitchen, 1936, facing north-west
(LMA ref. MCC/CI/GP/CER/121) 1696b

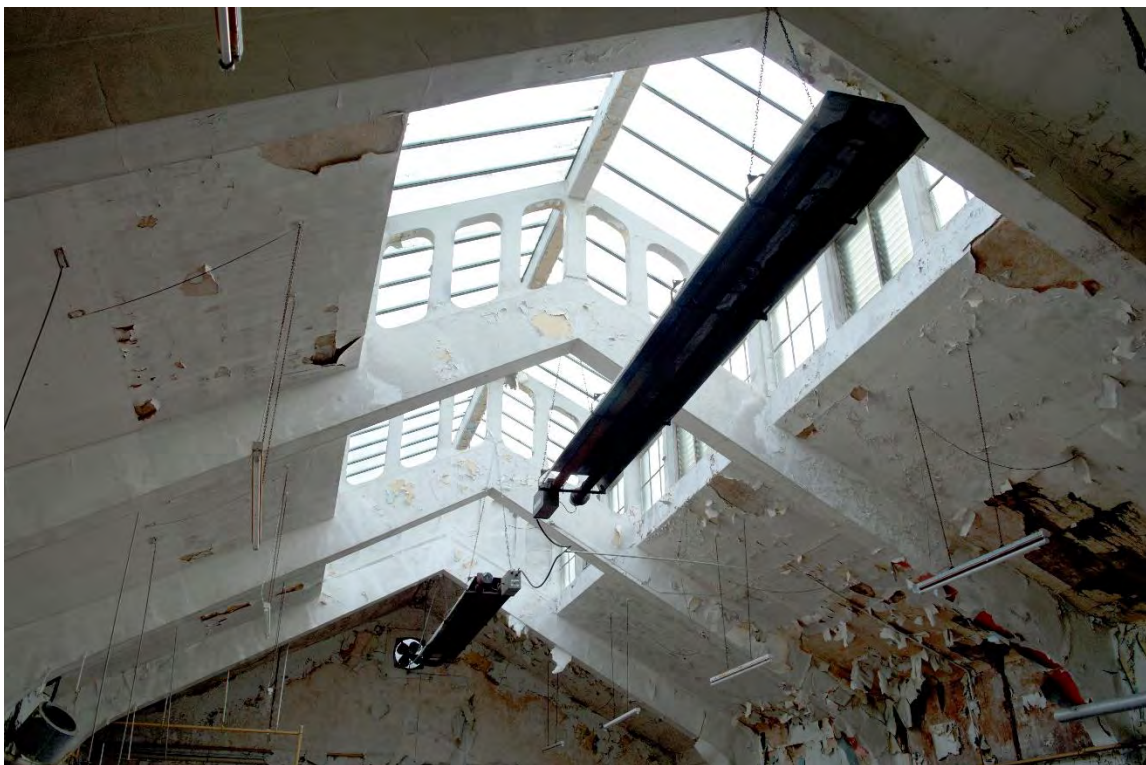
Plate 22 Building 1, central kitchen, detail of roof trusses and lantern light, facing south-east (FHH17-1165)

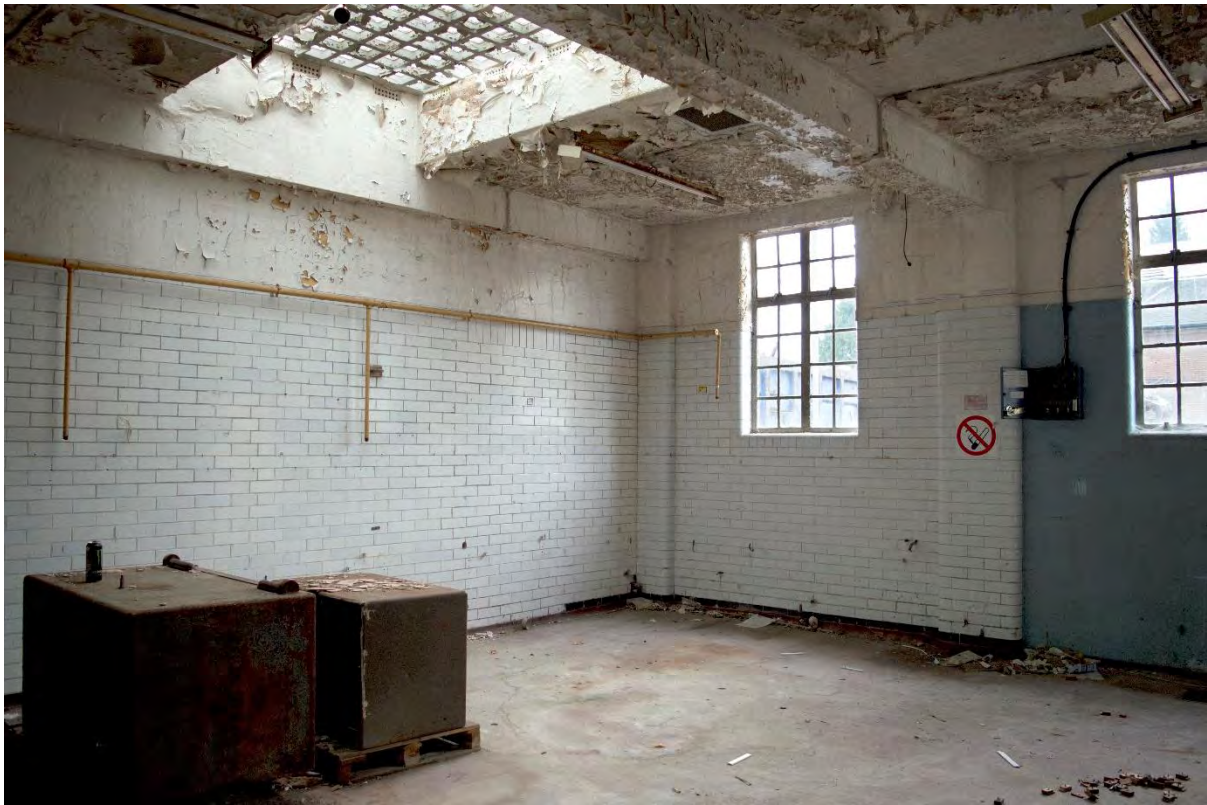
Plate 23 Building 1, central kitchen, scullery, facing south-east (FHH17-1153)

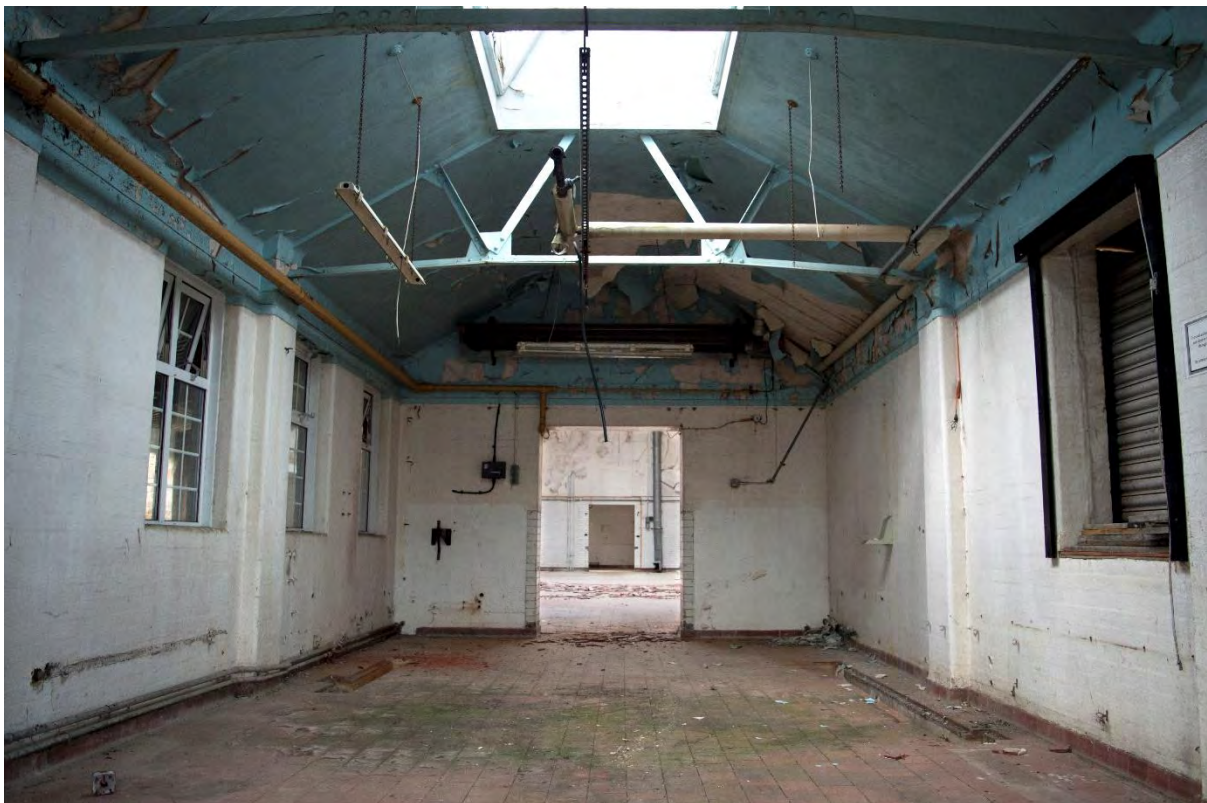
Plate 24 Building 1, central kitchen, vegetable scullery/pot wash east of main kitchen, facing west (FHH17-1143)

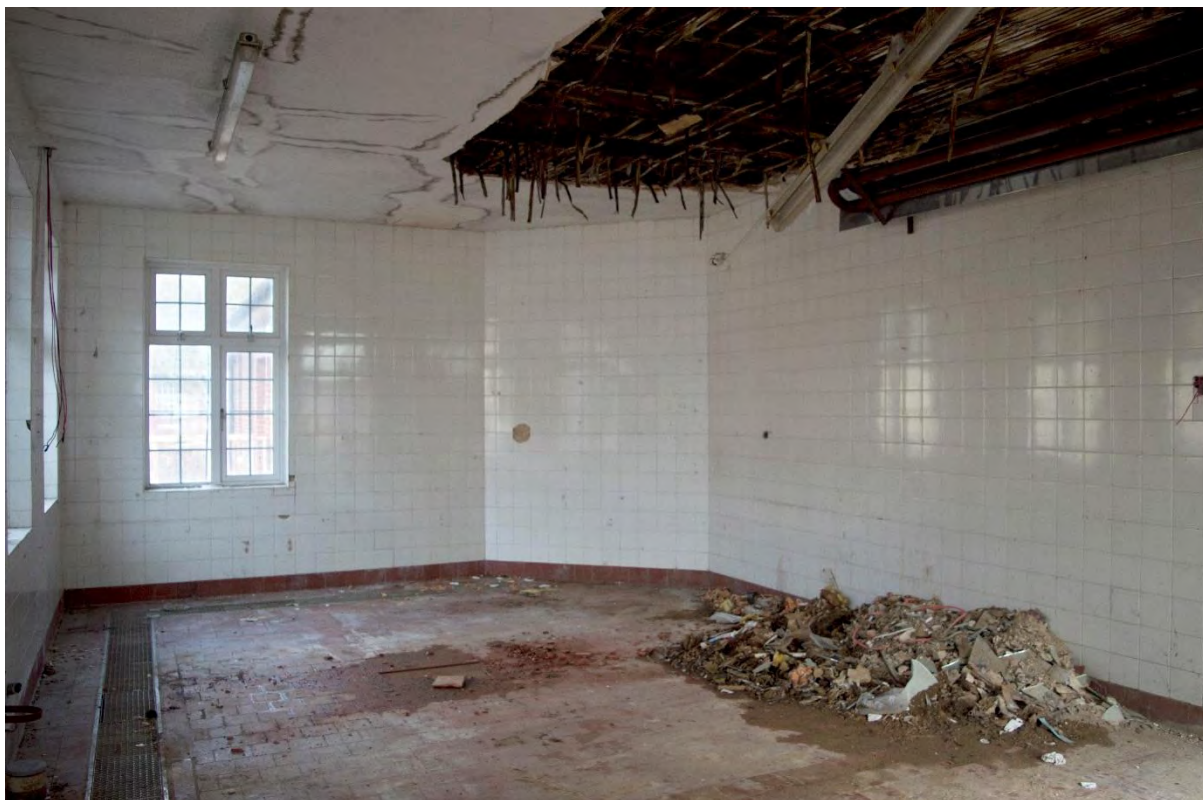
Plate 25 Building 1, central kitchen, food preparation area, possibly original servants' hall, facing north (FHH17-1166)

- 7.1.33 Immediately west of the main kitchen is a large room (possibly the original servants' hall – see section 7.1.31) which most recently served as a food preparation area. It has a quarry-tiled floor and skirting, and a chimney-breast to its north-east corner; its walls are faced with modern tiles (Plate 25). On its southern side is a doorway to a small covered way. West of the servants' hall/food preparation area are three rooms, the southern of which has a concrete floor, painted brick walls and a timber skirting. On its northern side a doorway leads to the central of the three rooms, which has painted glazed brick walls and a quarry-tiled floor and skirting. A doorway on its eastern side leads into a brick-built lobby, which occupies the western end of an original covered way. This, in turn, provides access to the northern of the rooms, which has a quarry-tiled floor and skirting, and plastered walls with an integral step-moulded dado. A doorway on its northern side, with half-glazed door of nine panes over two bead-moulded panels, provides access to the exterior. Evidence is visible for an inserted partition which once subdivided the room to create a passage from this doorway to the inserted lobby to the south.
