**FORMER HARPERBURY HOSPITAL,
HARPER LANE, RADLETT, HERTFORDSHIRE**

**HISTORIC BUILDINGS RECORD
(HISTORIC ENGLAND LEVELS 2 & 3)**

**Site Code: FHH17
Project No. 160560
Report No. 2017303
OASIS ID: archaeol6-305660**

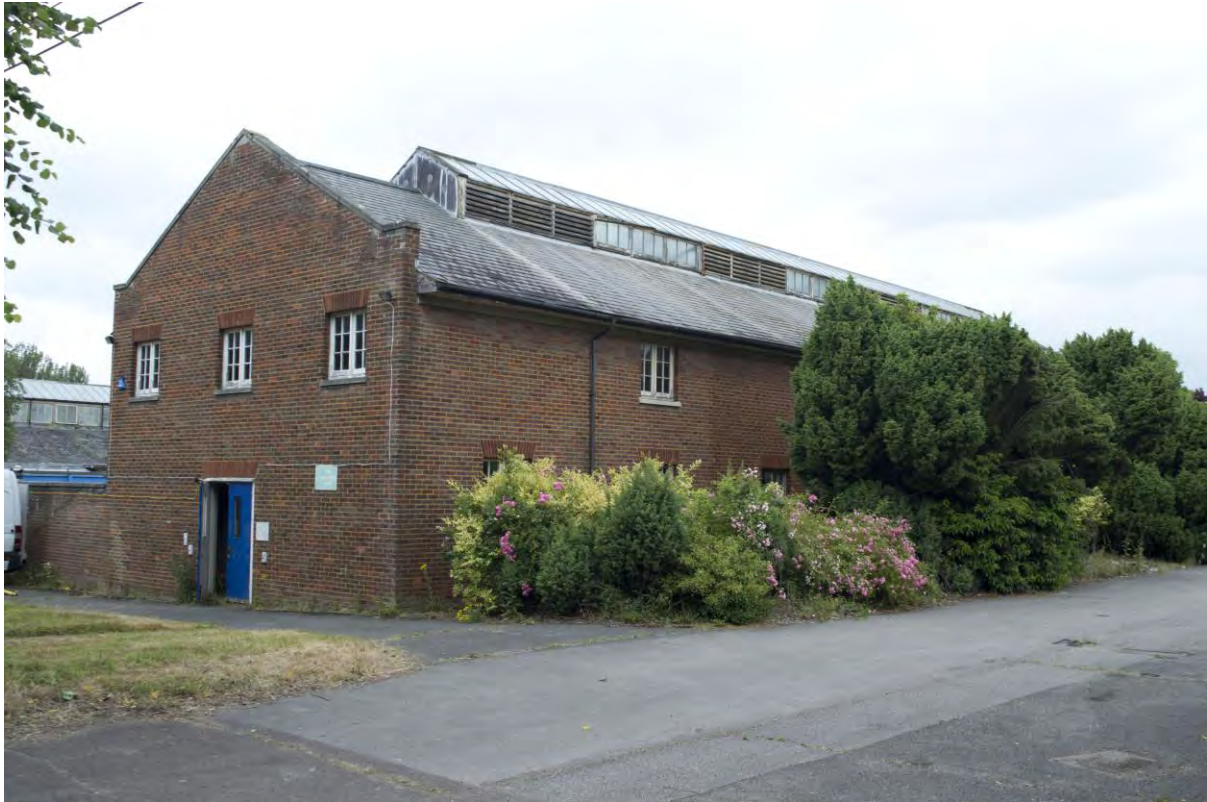
Plate 26 Building 3, main stores, south and west elevations, facing north-east (FHH17-0003)

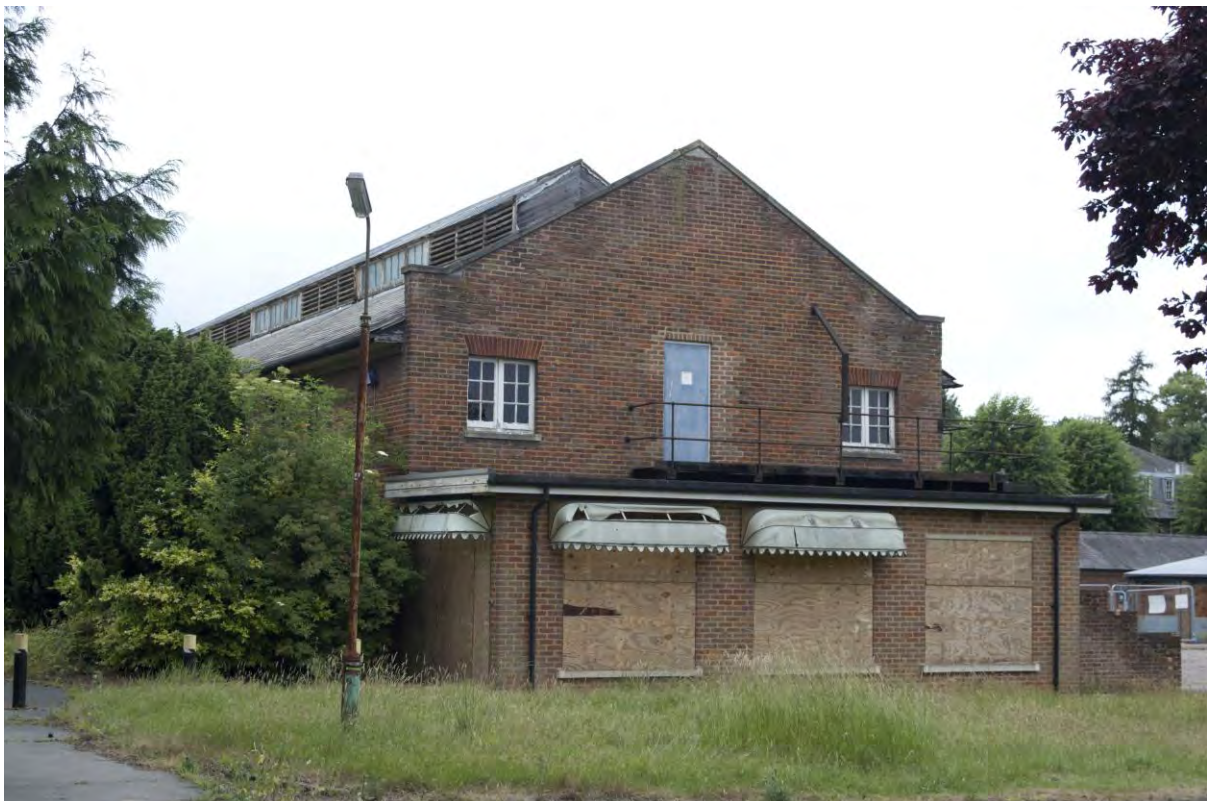
Plate 27 Building 3, main stores, east elevation (FHH17-0007)

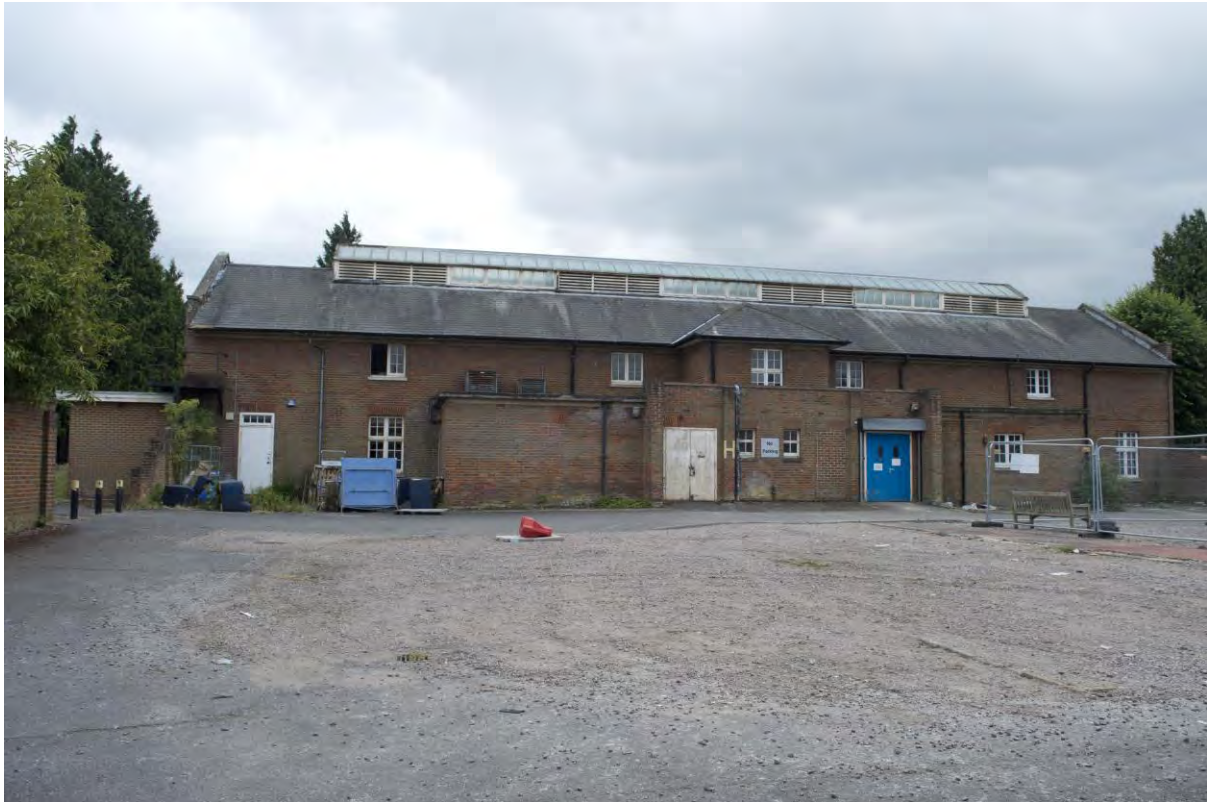
Plate 28 Building 3, main stores, north elevation (FHH17-0010)

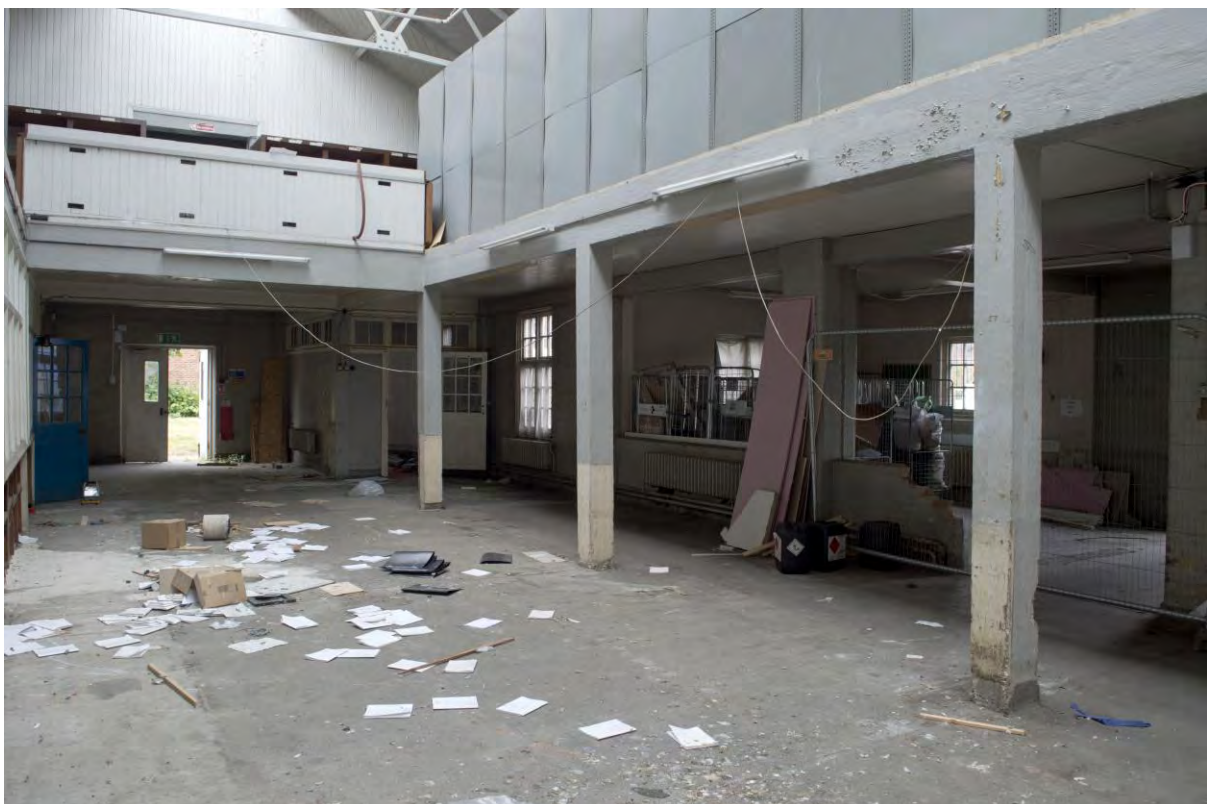
Plate 29 Building 3, main stores, interior, facing west (FHH17-0019)

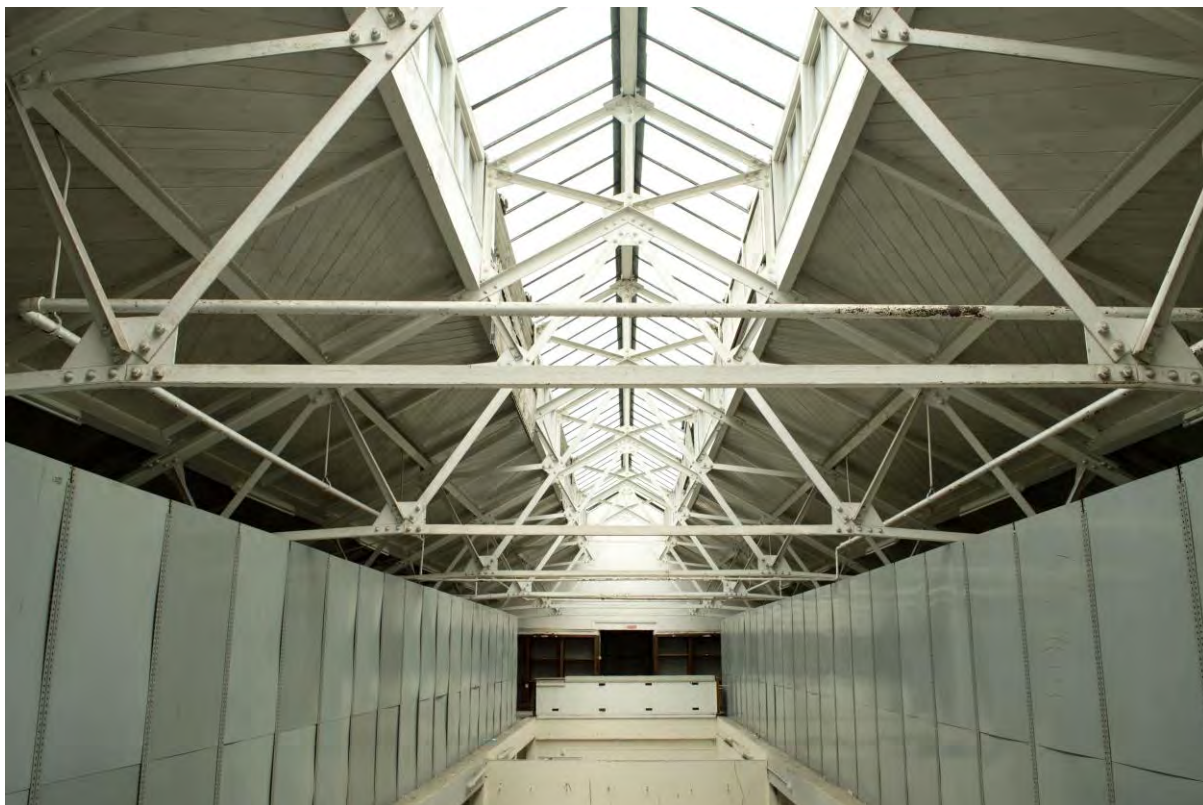
Plate 30 Building 3, main stores, roof, facing east (FHH17-0058)

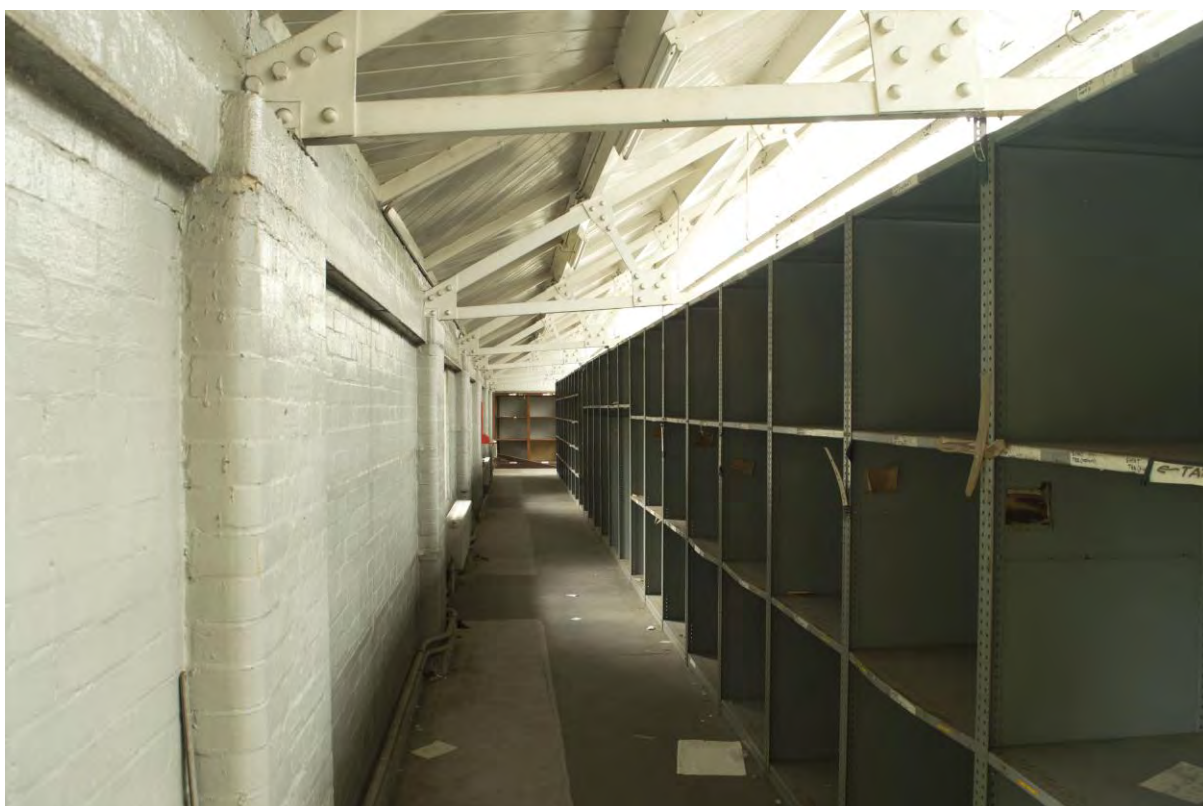
Plate 31: Building 3, main stores, roof truss resting on concrete wall-plate over brick pilaster-buttress, facing west (FHH17-0065)

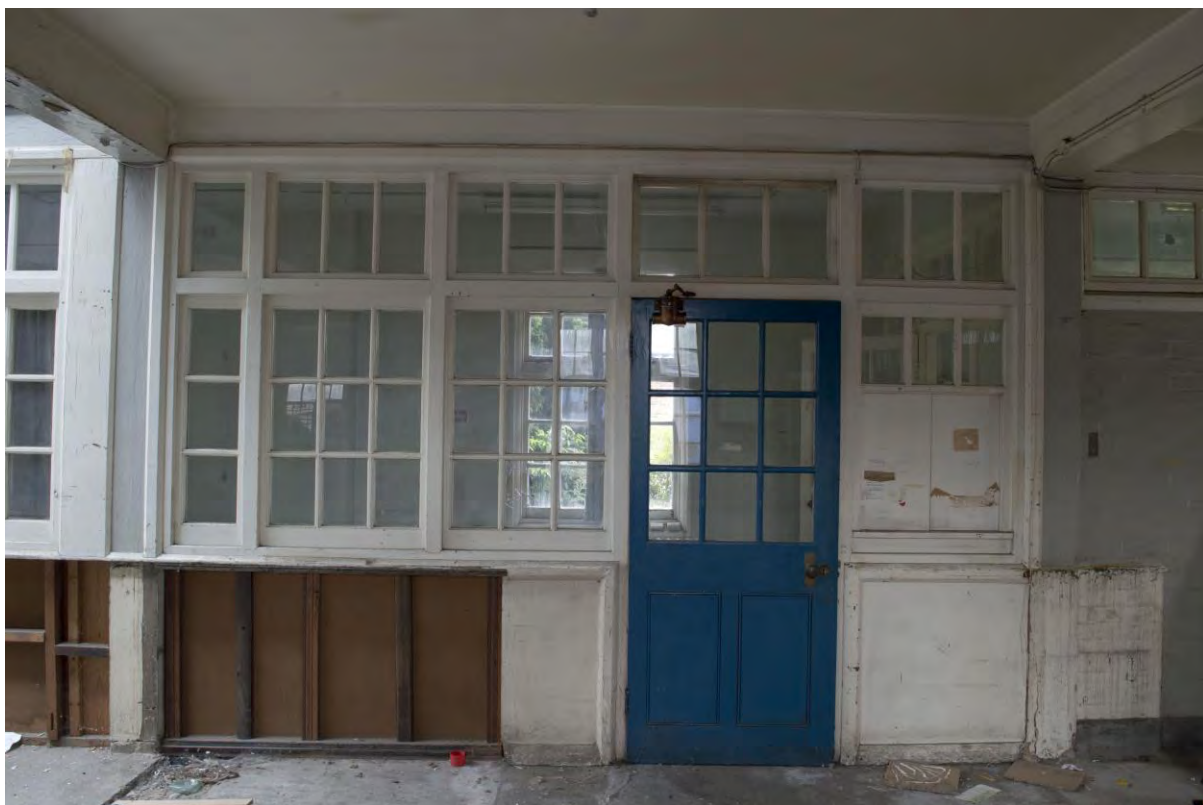
Plate 32: Building 3, main stores, ground floor partition, facing south (FHH17-0026)

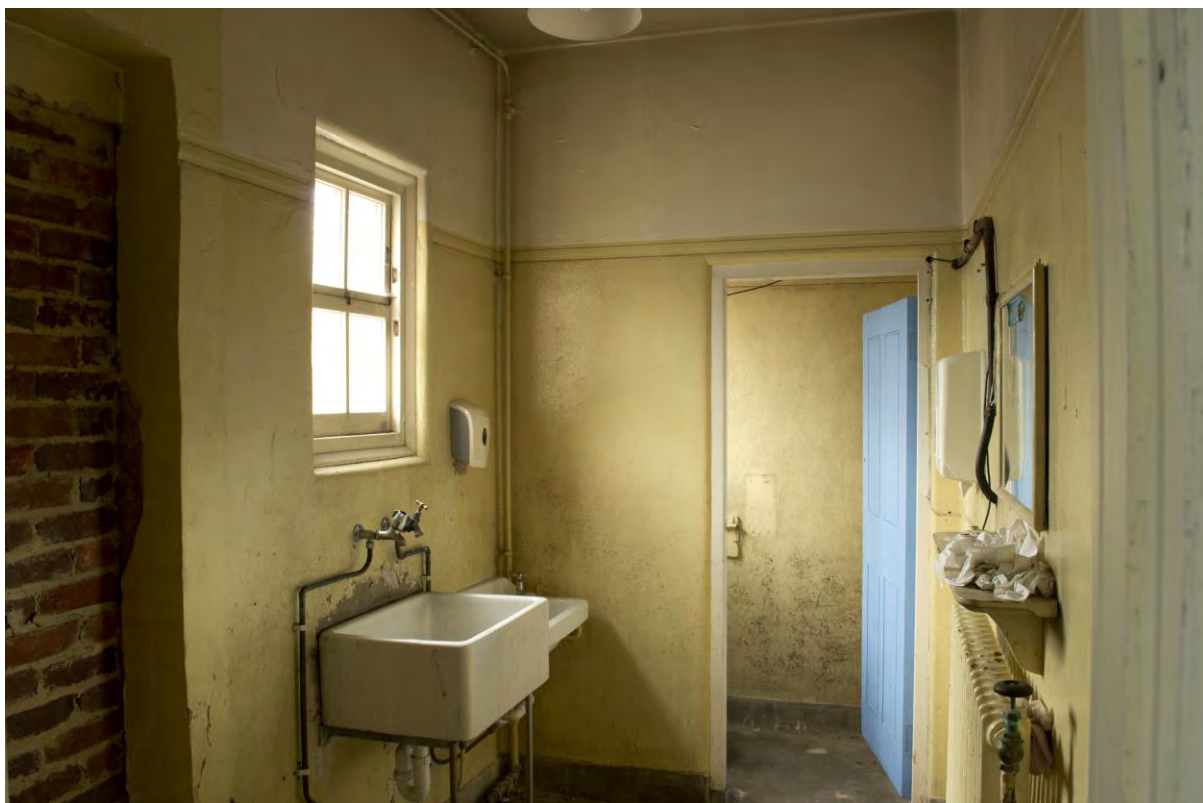
Plate 33: Building 3, main stores, WC, facing east (FHH17-0040)

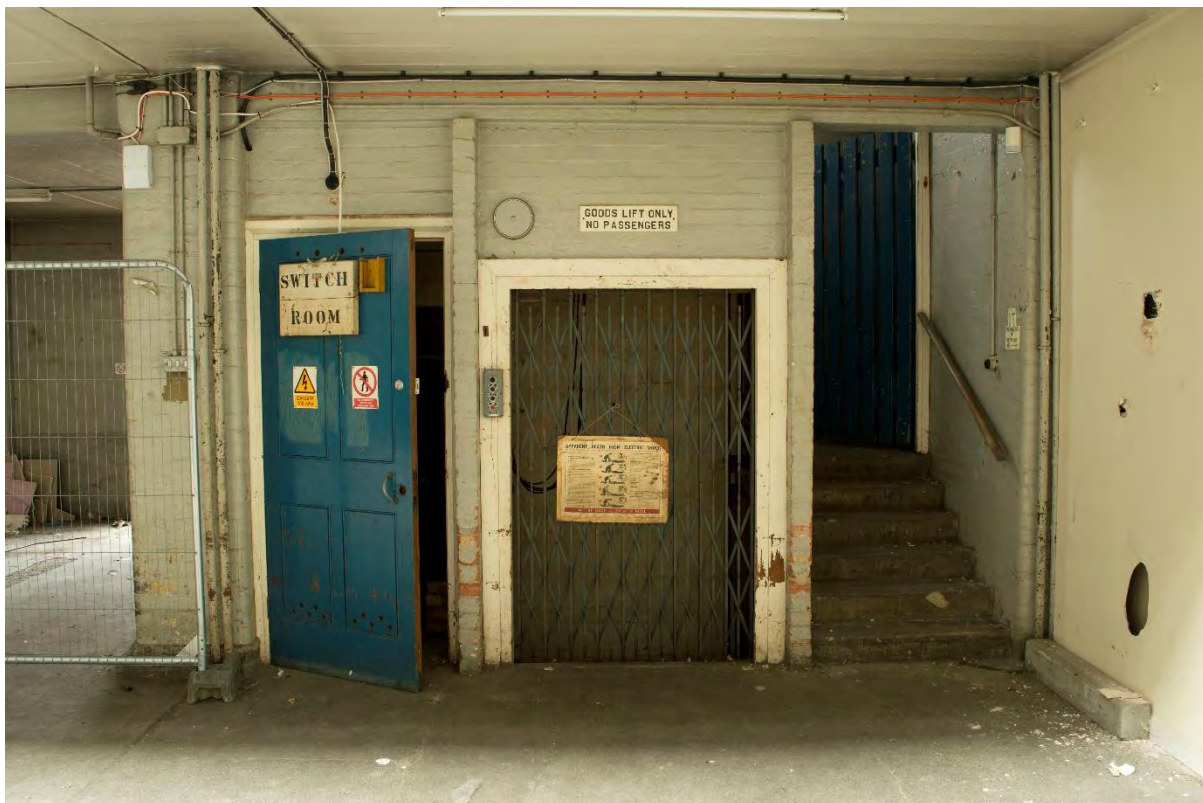
Plate 34: Building 3, main stores, stair and goods lift on north side (FHH17-0036)

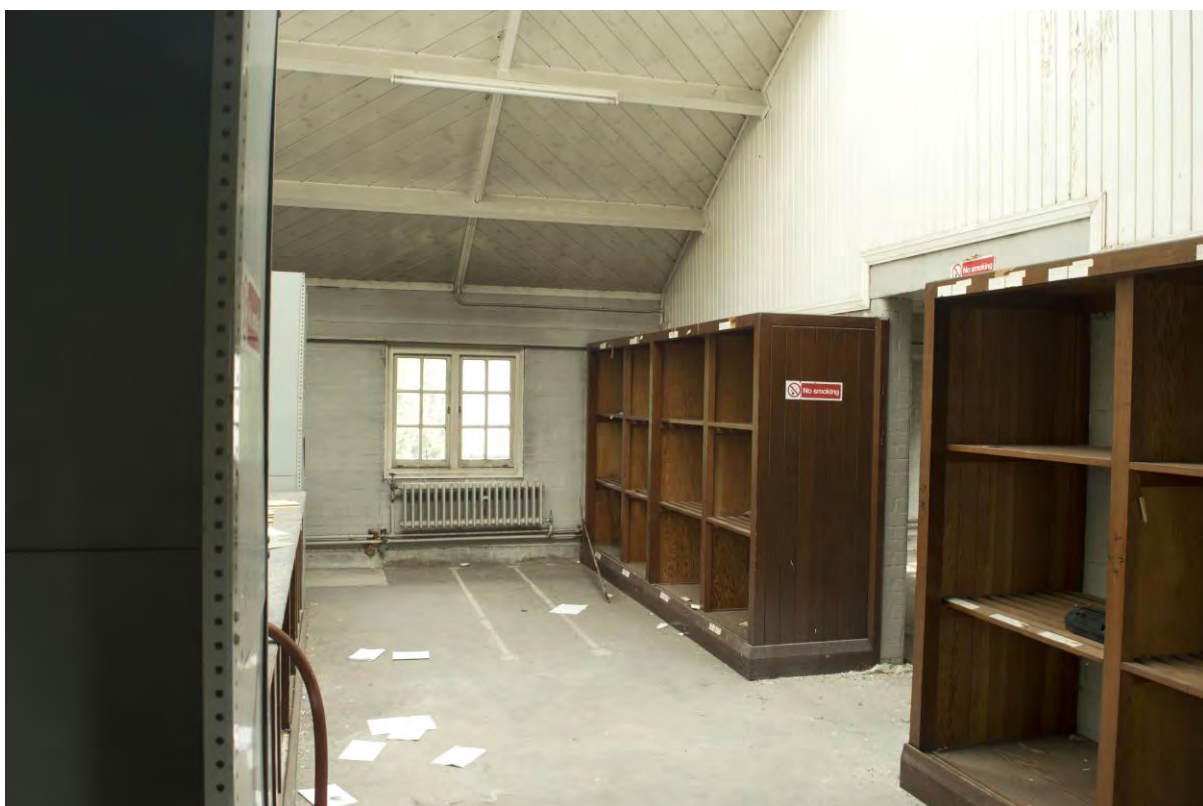
Plate 35: Building 3, main stores, wooden shelving on first floor, facing north (FHH17-0055)

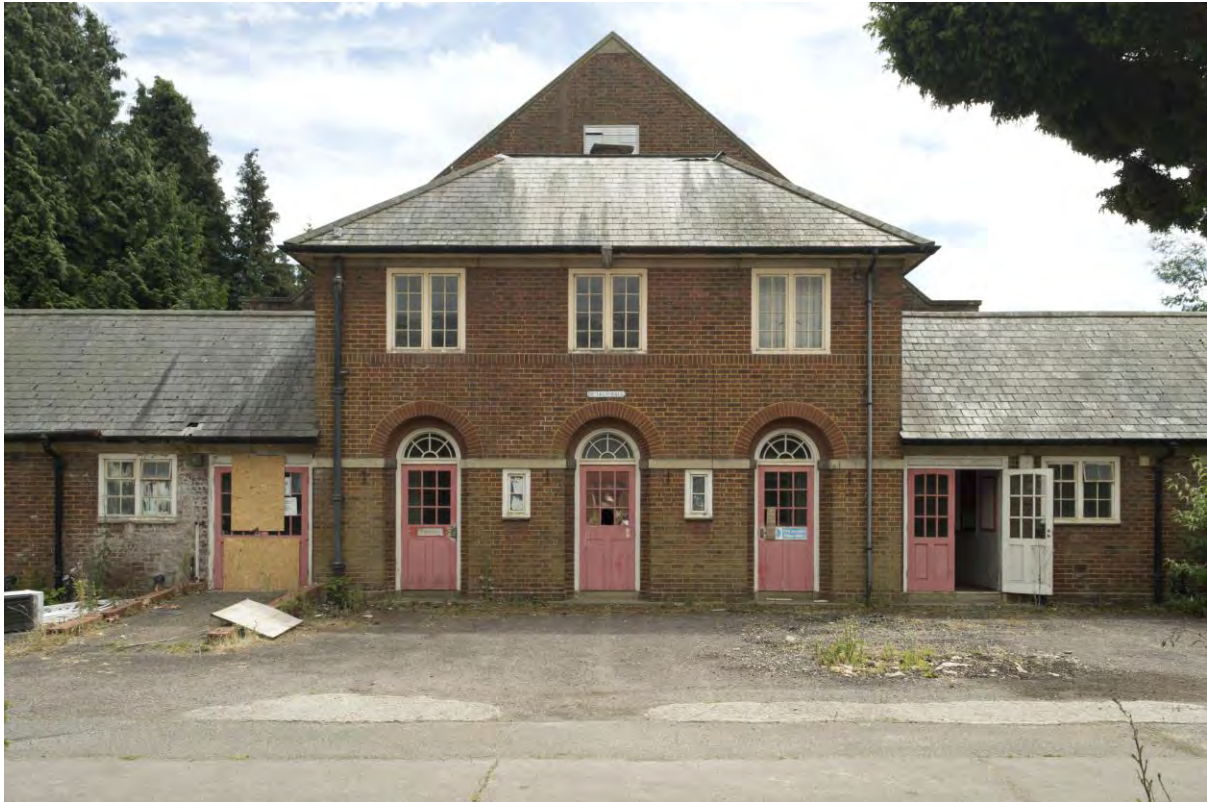
Plate 36 Building 4, recreation hall, north elevation (FHH17-0077)

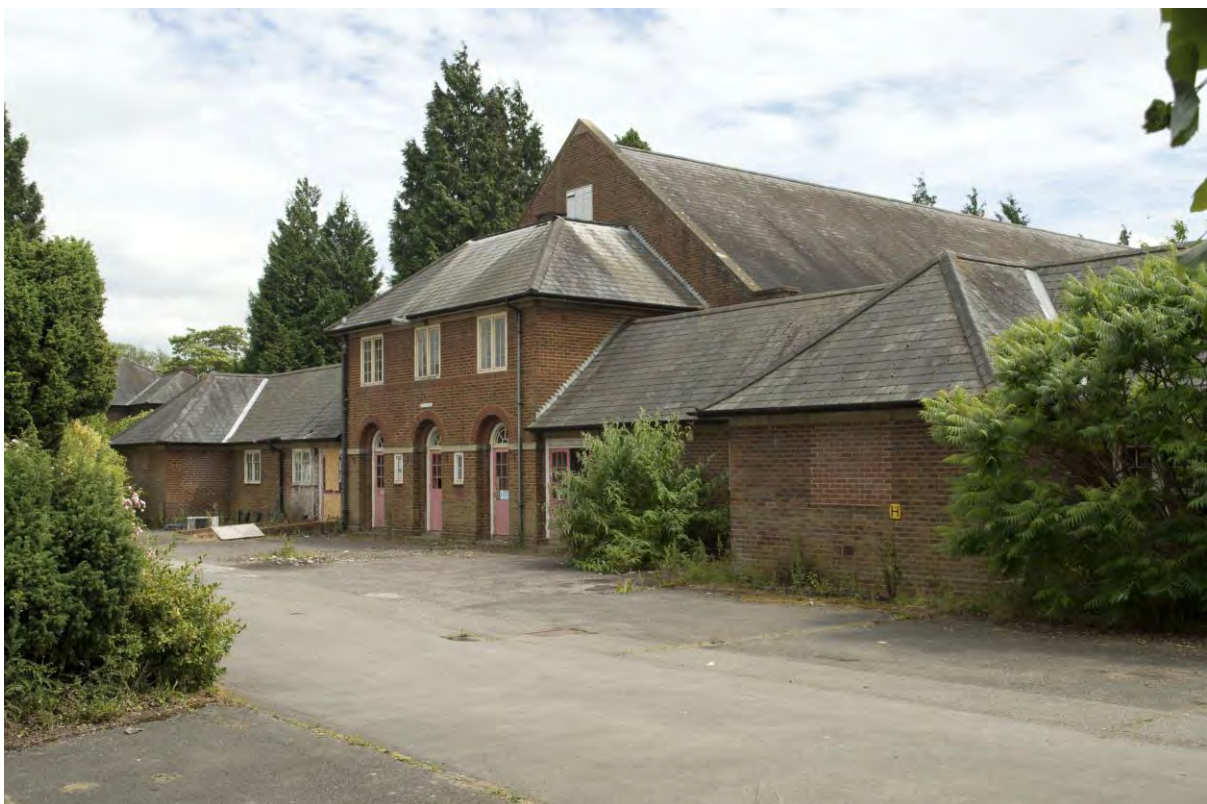
Plate 37 Building 4, recreation hall, north elevation, facing south-east (FHH17-0081)

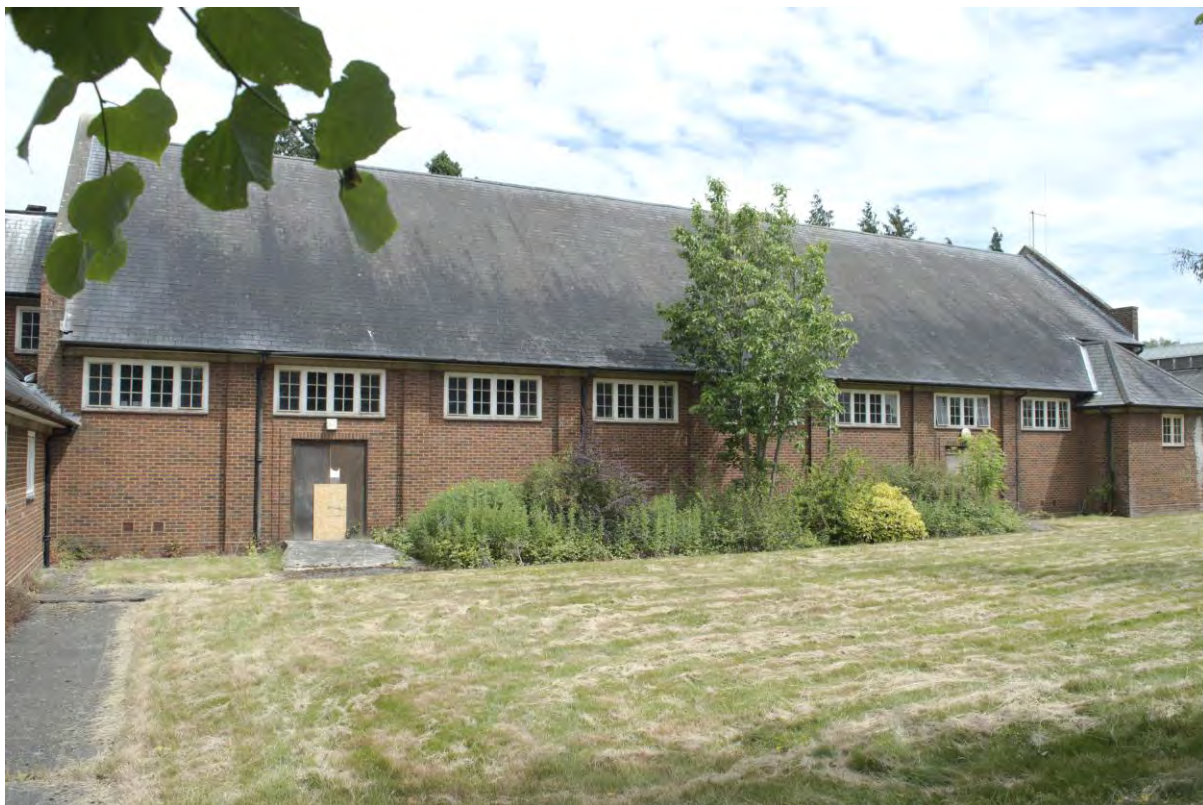
Plate 38 Building 4, recreation hall, west elevation (FHH17-0085)

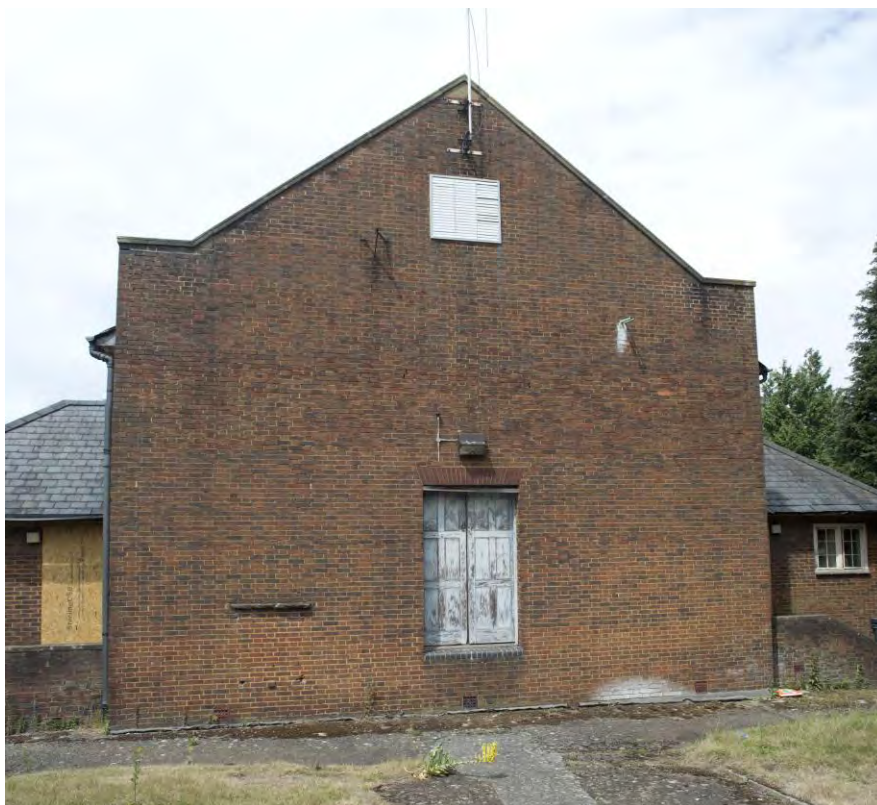
Plate 39 Building 4, recreation hall, south elevation (FHH17-0092/0093)

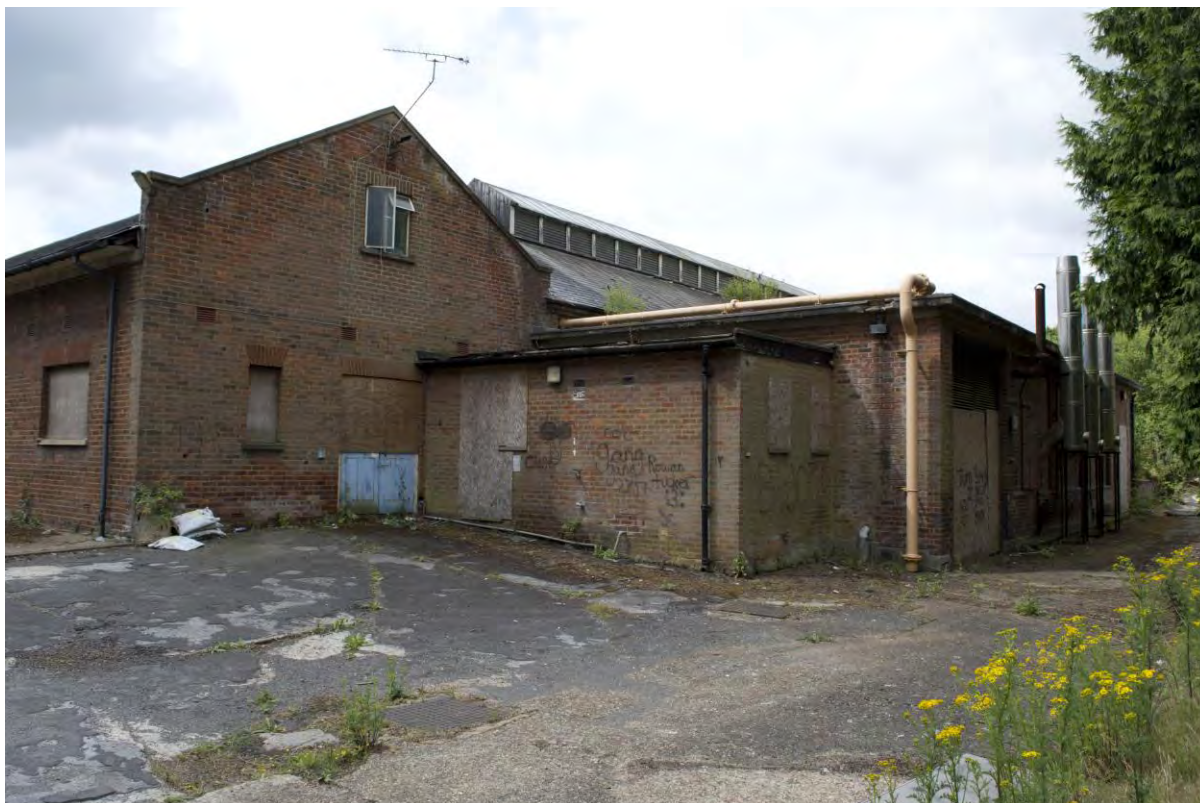
Plate 48 Building 5, boiler house and bakery, north-elevation, facing south-west
(FHH17-0479)

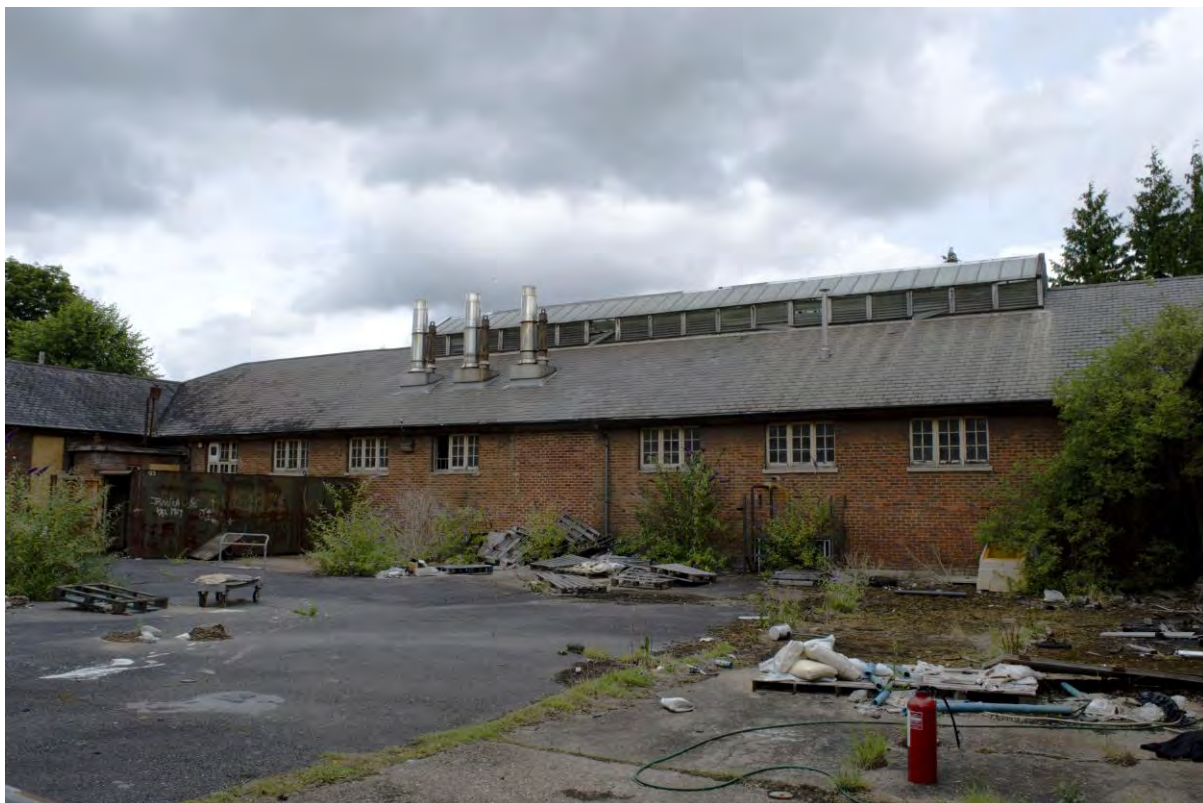
Plate 50 Building 5, boiler house, south elevation, facing north-north-west (FHH17-0496)

- 7.4.8 The south elevation of the main range, which overlooks the yard, comprises a series of regularly-spaced high-level timber windows, each comprising three six-pane casements (Plate 50). The westernmost window is slightly different, with a four-pane top-opening light above each of its casements. Central to the elevation is a wide full-height opening, which has been blocked in darker red stretcher-bonded brick. This marks the position of where the original boiler house chimney (since demolished) was attached to the range. The original plans show the chimney was a substantial brick structure which towered over the surrounding buildings (Fig. 19). Three modern steel flues now project above the southern roof slope.

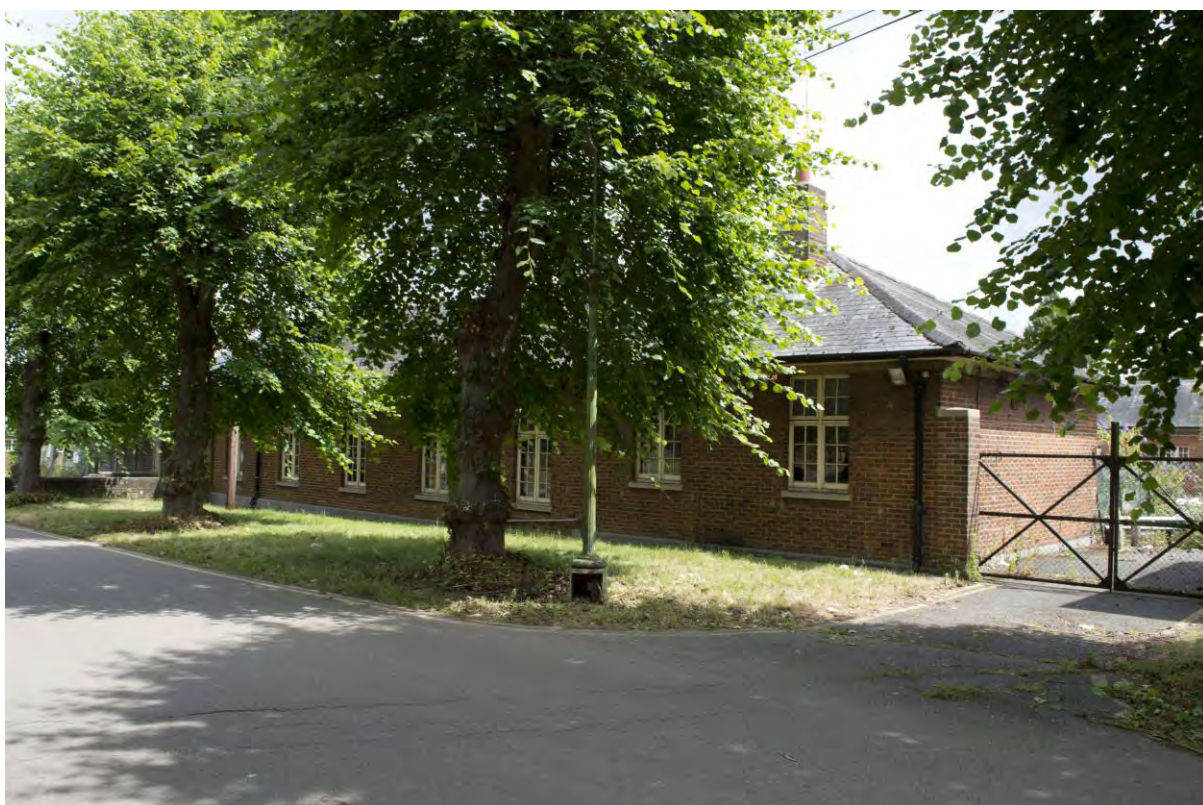
Plate 51 Building 5, workshop on west side of boiler house, west elevation, facing north-west (FHH17-0524)

- 7.4.10 The external side elevations of the flanking wings, facing Lime Way and Heath Way, are characterised by regularly-spaced, tall timber cross-type windows, comprising a pair of casements with top-opening lights above (Plates 51 & 52). The east range elevation also contains two single-width doorways, while the west has a wide, full-height doorway with roller shutter at its northern end, accessed by a ramp flanked by low brick walls. The yard elevations of both ranges are more irregular. That to the east range comprises two tall windows at its northern end, with two smaller windows to the south, flanking a blocked doorway containing a modern small steel window. That to the west range comprises a wide full-height opening with up-and-over metal door at the southern end, flanked to its north by a pedestrian doorway with modern flush door (Plate 53). North of this is a pair of tall windows, and at the northernmost end, adjoining the main range, is a small brick-built structure with flat concrete roof and a doorway and small window to its east elevation, which forms a lobby and WC.

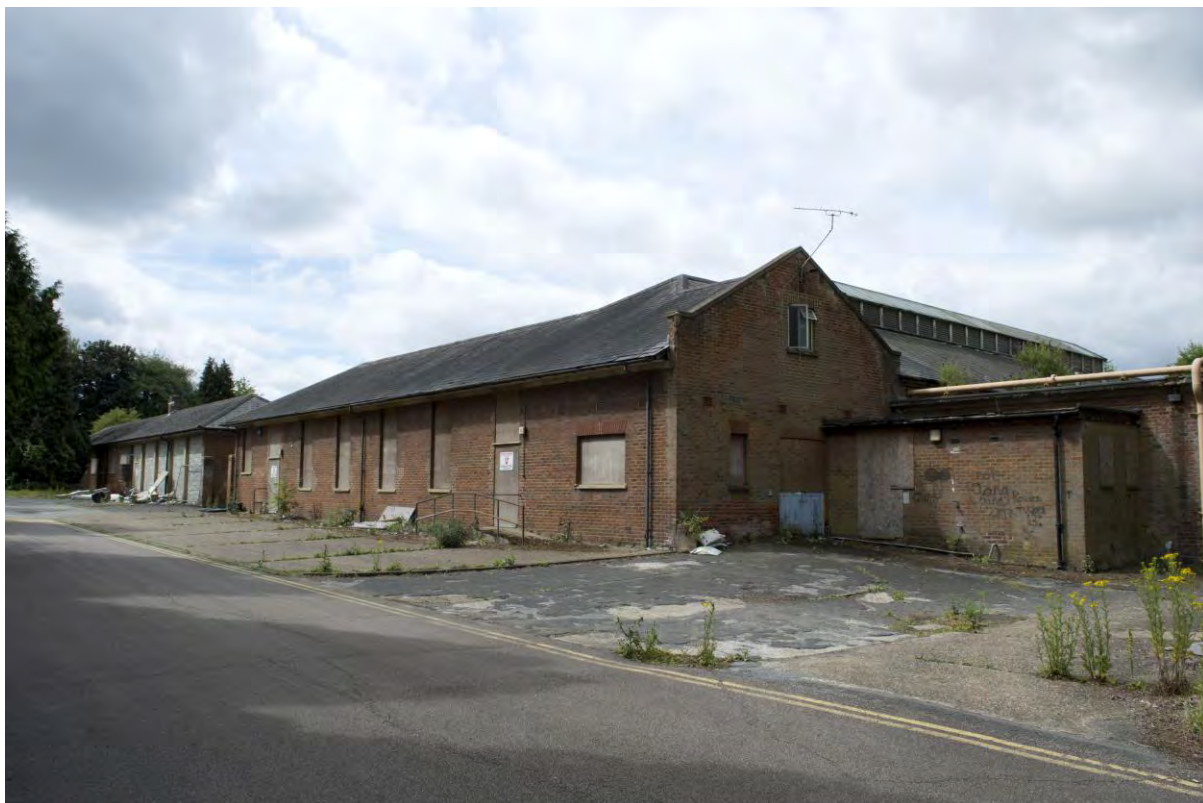
Plate 52 Building 5, bakery on east side of boiler house, east elevation, facing south-west (FHH17-0481)

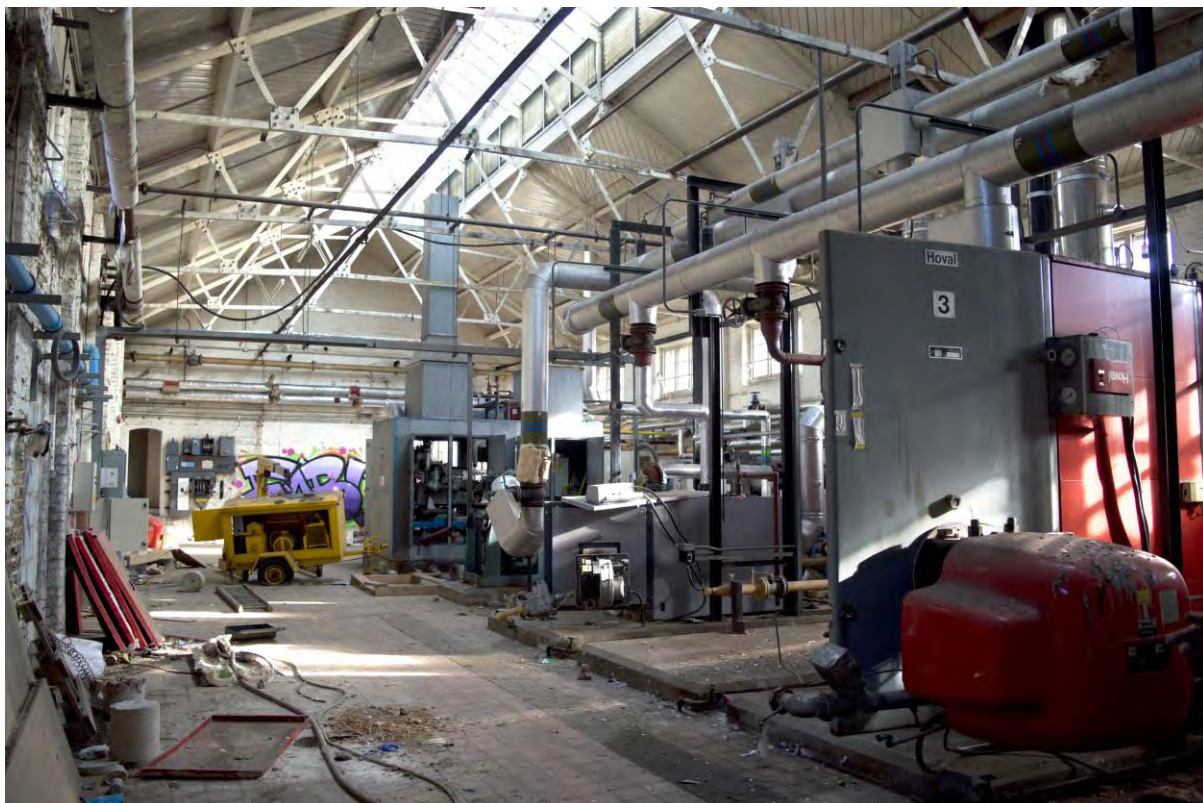
Plate 54 Building 5, boiler house, interior, facing south-east (FHH17-0910)

- 7.4.12 The main boiler house range comprises eight structural bays (Plate 54). It contains a series of modern generators, but originally housed seven boilers,
-

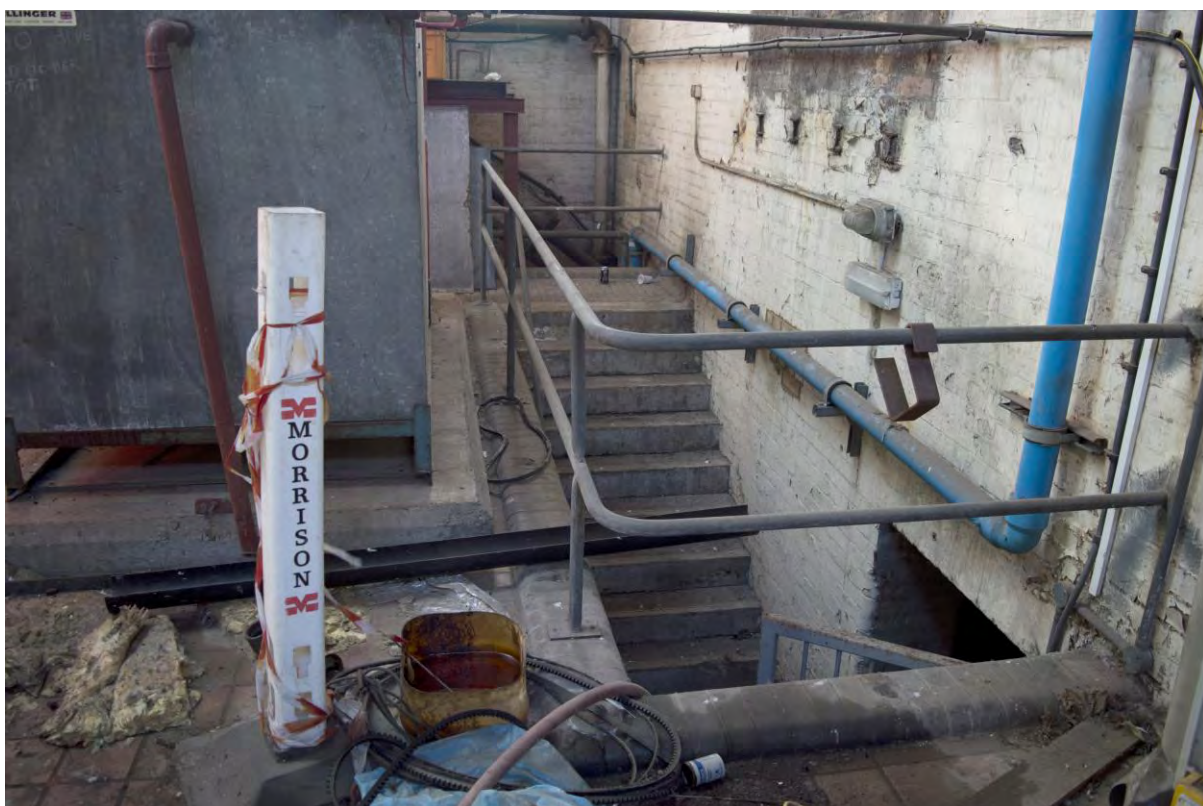
Plate 55 Building 5, boiler house, steps to basement pump room, facing south-west (FHH17-0909)

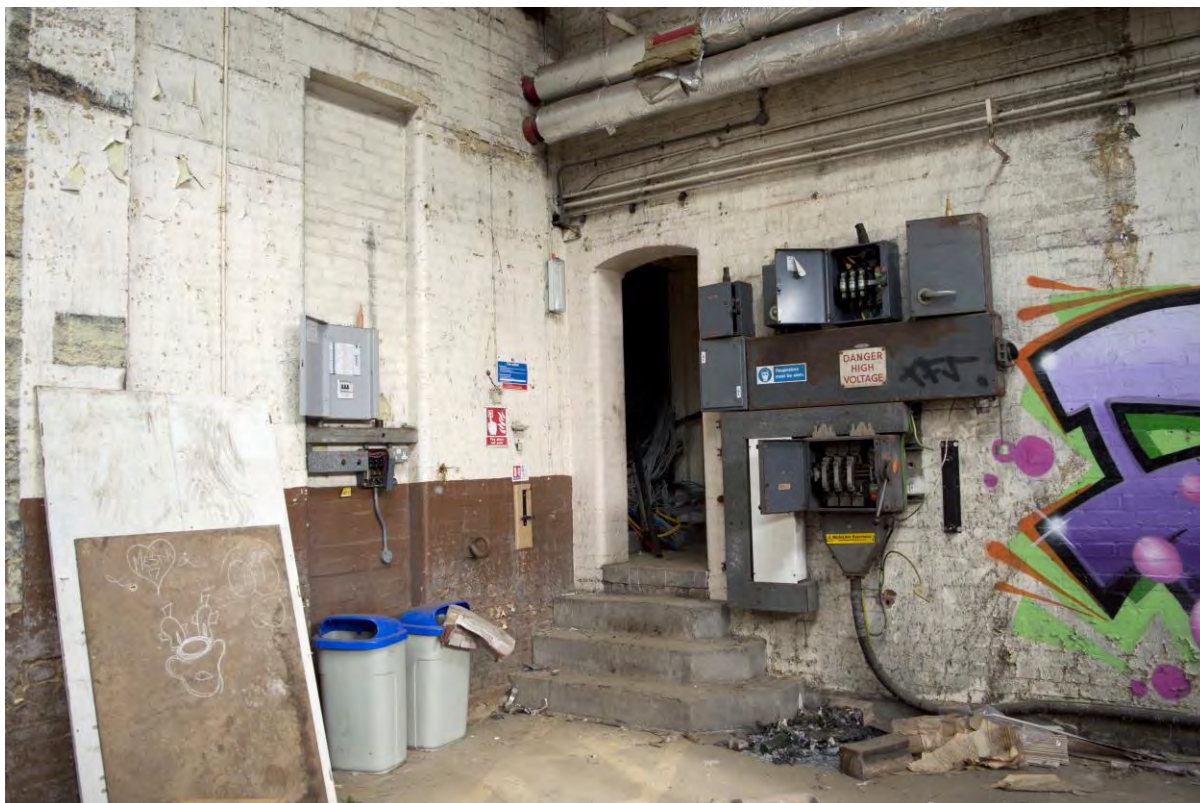
Plate 56 Building 5, boiler house, inserted steps and doorway to 1960s extension, facing north-west (FHH17-0894)

- 7.4.13 In the north-east corner a flight of concrete steps lead up to a small lobby which provides access to a small plain room with WCs beyond, which served as the 'stoker's changing room and toilet accommodation', added c.1967 (Plate 56). The steps and doorway are not shown on the original plans and are an alteration of the same date.

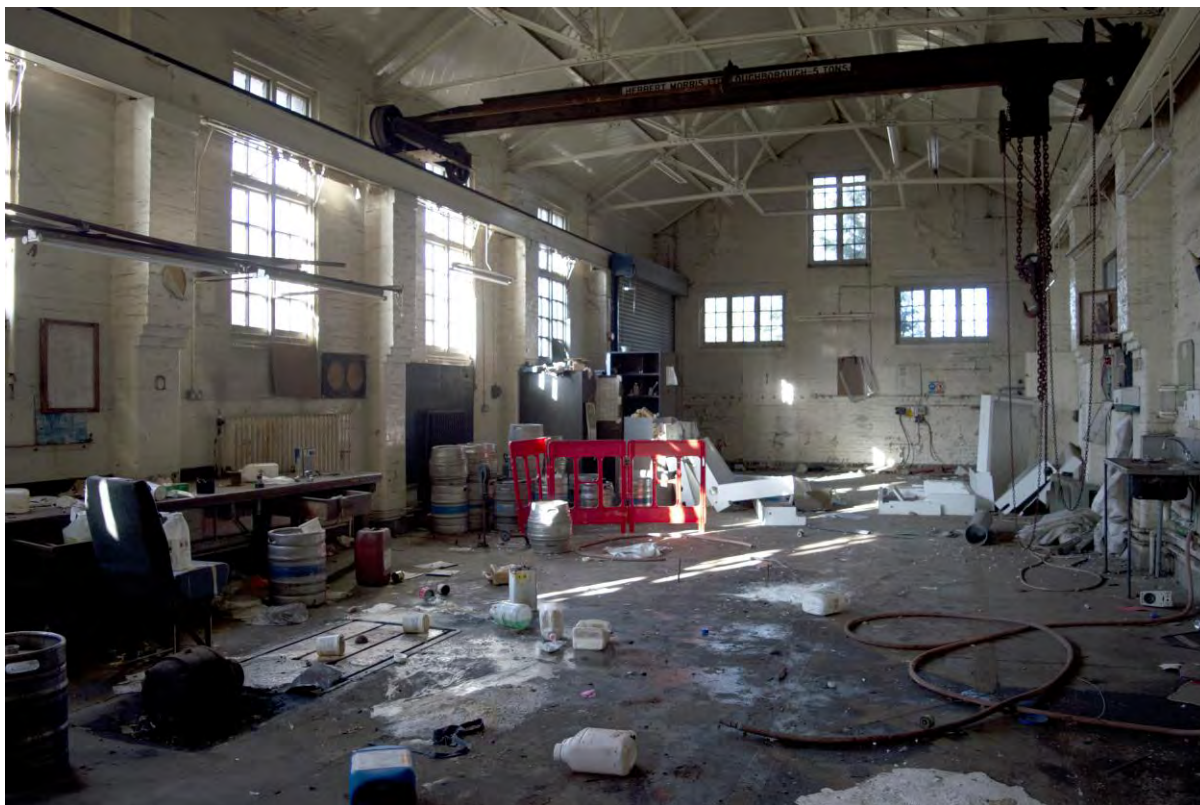
Plate 58 Building 5, workshop on west side of boiler house, facing north (FHH17-0923)

- 7.4.15 A full-height wide opening on the western side of the main boiler room, closed by a metal roller shutter, leads to the west range, which served as a workshop. The workshop is six bays in length and has painted brick walls, a concrete floor, and a metal truss roof matching that of the main boiler room, but without a lantern light (Plate 58). The roof is carried on brick pilaster buttresses which are bull-nosed up to half their height, above which they are corbelled and support two I-girders running along the east and west walls, for moveable
-

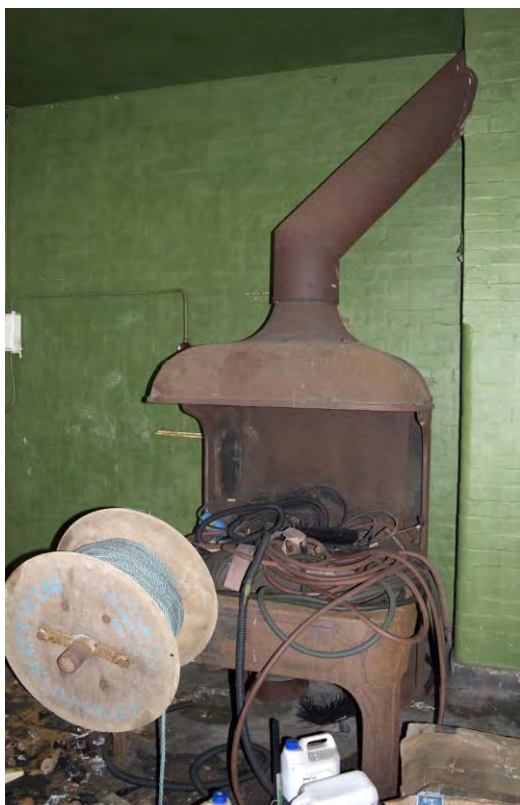
Plate 59 Building 5, workshop, blacksmith's forge, facing west (FHH17-0927)

- 7.4.16 South of the main workshop, a flight of concrete steps leads to an office, formerly a tool store, and a small store room. Beyond the office is a workshop/smithy with an up-and-over metal door on its eastern side. It contains a blacksmith's forge, embossed with 'C. Lindley & Co. Englefield Road London N1 Works Southgate Road London Hiddenend Works York' (Plate 59). This is likely to be an original survival: the room is identified on original plans as a smithy and C. Lindley & Co were based at Englefield Road until 1937 (Grace's Guide website).
