**FORMER HARPERBURY HOSPITAL,
HARPER LANE, RADLETT, HERTFORDSHIRE**

**HISTORIC BUILDINGS RECORD
(HISTORIC ENGLAND LEVELS 2 & 3)**

**Site Code: FHH17
Project No. 160560
Report No. 2017303
OASIS ID: archaeol6-305660**

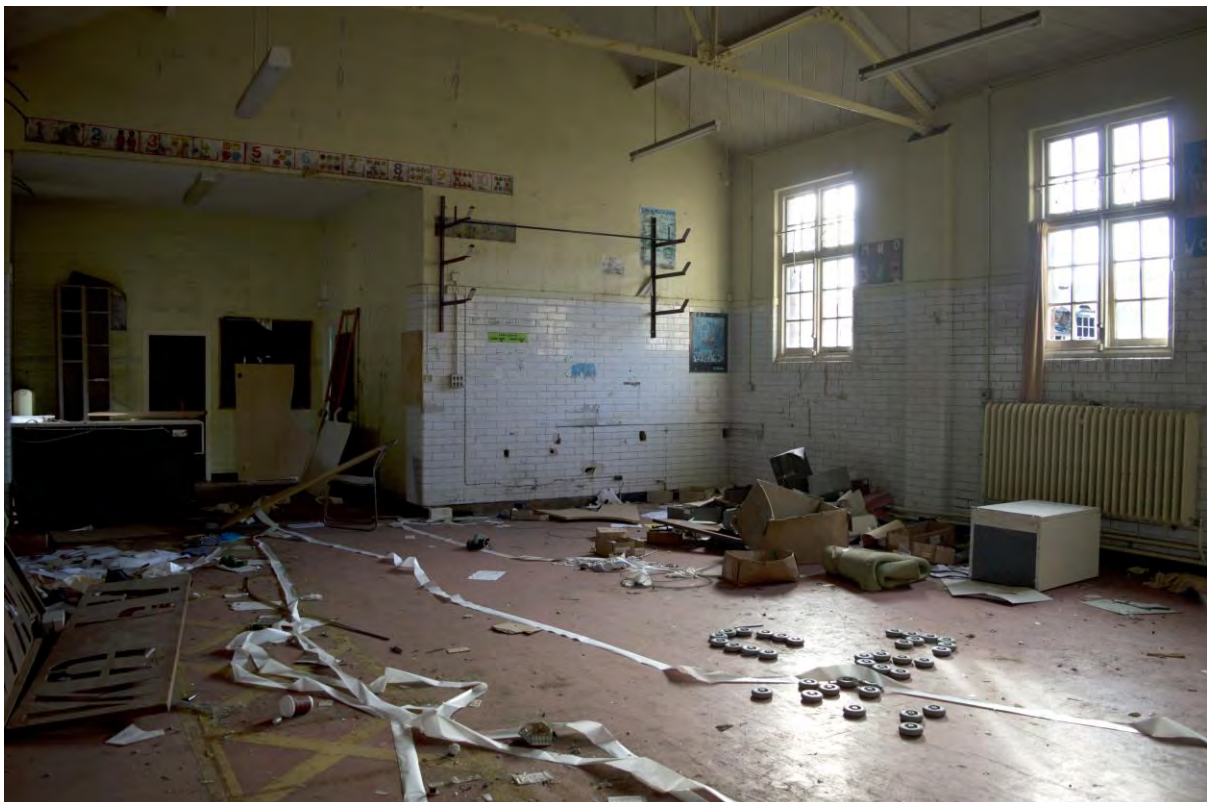
Plate 61 Building 5, bakery to east side of boiler house, facing south-east, showing the large recess which housed a drawplate oven (FHH17-0935)

- 7.4.19 The main bakery room has a concrete floor and walls of white glazed brick to half height, above which they are plastered (Plate 61). The roof is of the same type as that in the workshop to the west, and the trusses are carried on bull-nosed pilaster-buttresses. The room is lit by a series of large timber casements with top-opening lights to the east and west. At the southern end, where the oven was originally situated, the walls are of painted brick and the area has a flat concrete ceiling. The former scullery adjoining the oven area
-

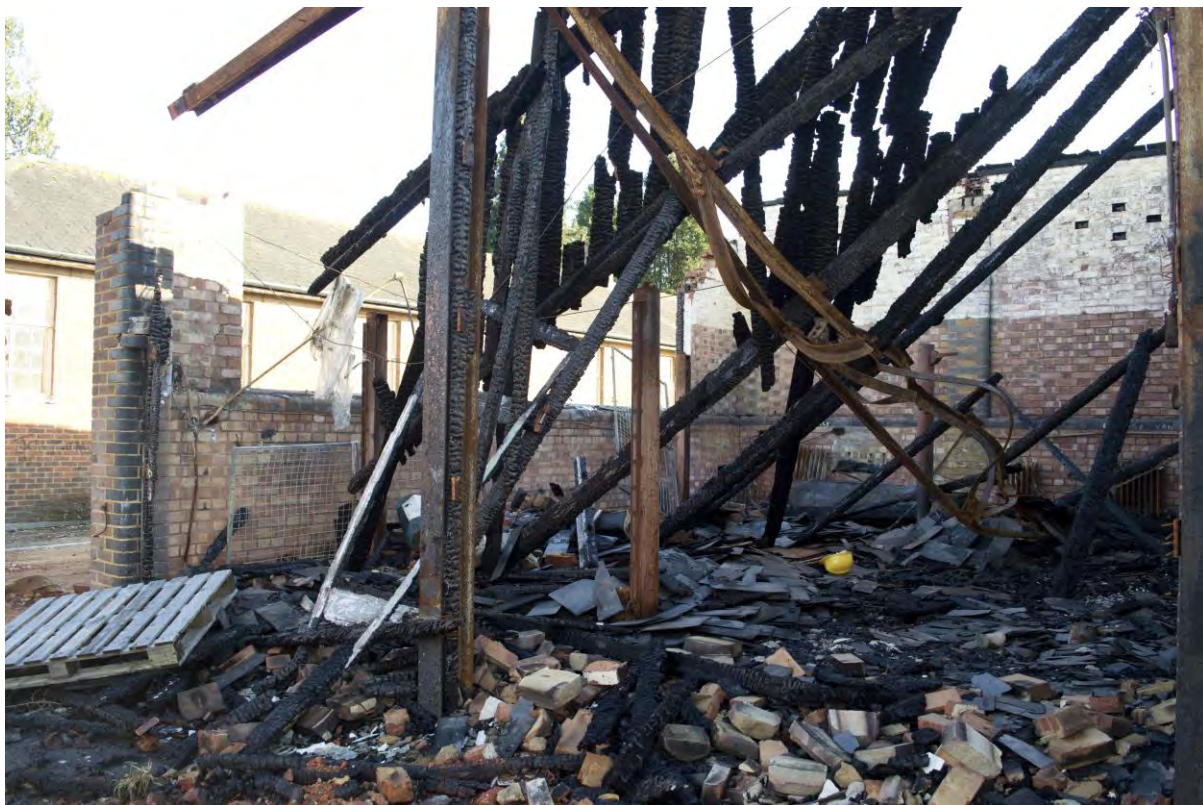
Plate 66 Building 6, fuel store, interior following 2017 fire, facing south-east (FHH17-0652)

- 7.4.23 The interior of the building was surveyed in November 2017; prior to this, but post-dating the survey of the exterior in June 2017, the building had been severely damaged by fire. What could be discerned of the interior was that the building is seven bays in length; its walls comprise exposed Fletton brickwork, variously painted and unpainted, with a plinth capped with bull-nosed blue engineering bricks (Plate 66). Gaps in the brickwork close to the eaves of the
-

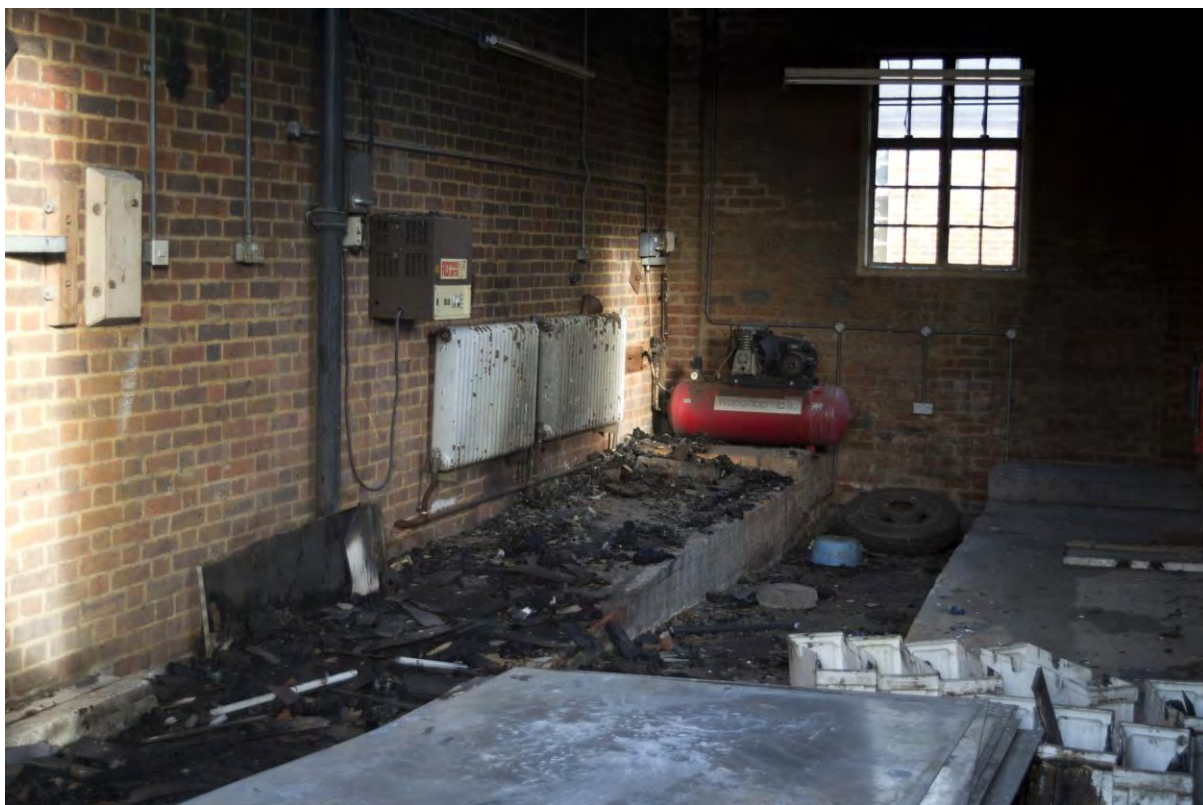
Plate 67 Building 6, fuel store, interior of addition to south, facing east (FHH17-0665)

- 7.4.24 The addition to the south served as a vehicle repair garage and contains a pair of concrete ramps forming an inspection pit (Plate 67).

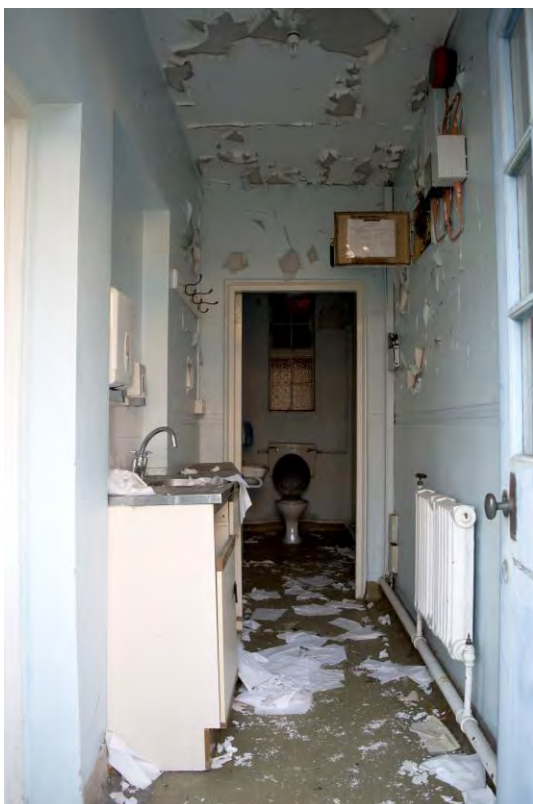
Plate 79 Building 9, workshop, lobby and WC to former clerk of works' office, facing west (FHH17-0685)

7.4.30 The centre of the range is occupied by two large rooms, which originally served as a mess room and the clerk of works' office and are now interconnecting. Both have concrete floors laid with parquet, plastered walls and ceiling, simple bevelled skirting and picture rails, and an integral step-moulded dado rail (Plate 78). The rooms were heated by back-to-back fireplaces; the southern room has a brick fire surround, while that to the northern room has a simple surround which probably had a polished concrete/terrazzo finish, as seen elsewhere. An arrangement of an entrance lobby and WC to the north of the former clerk of works' office has been retained: access to this office was originally self-contained (Plate 79).

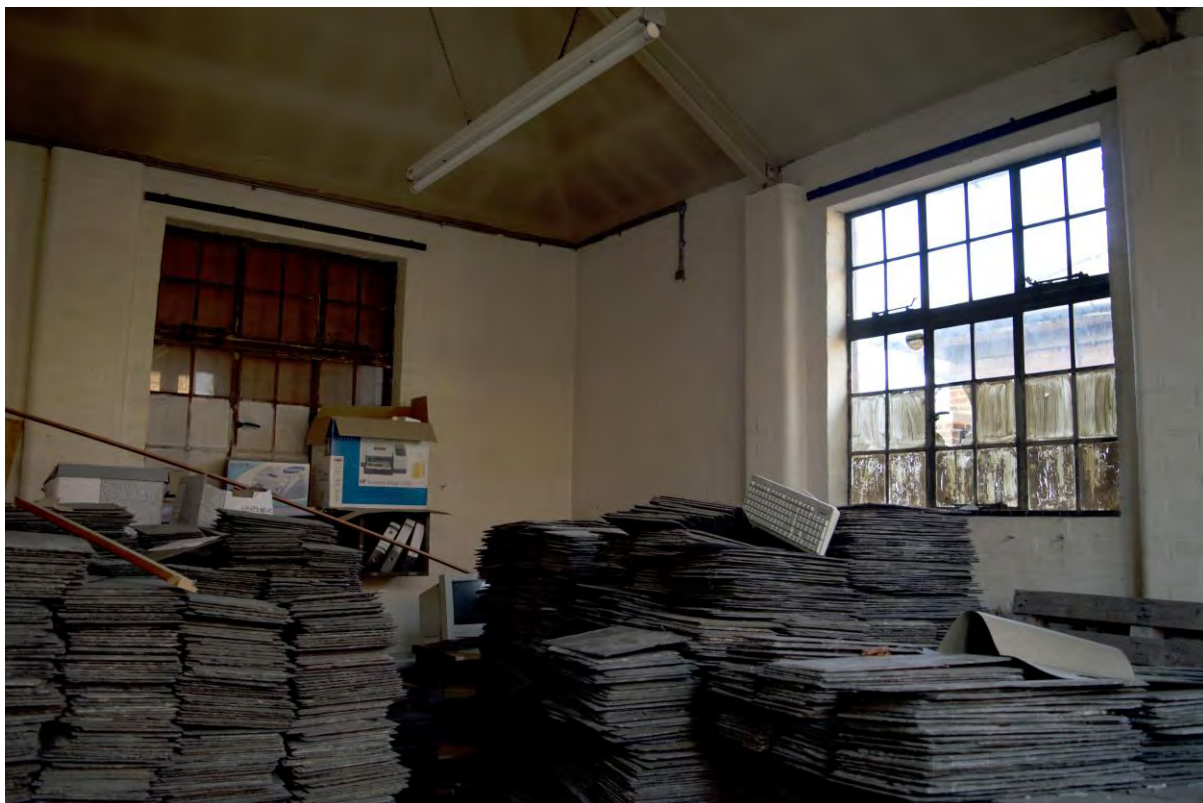
Plate 80 Building 9, workshop, former repair garage at north end of range, facing north-east (FHH17-0686)

7.4.31 The northernmost part of the range, which originally formed a repair garage, has a simple appearance with painted brick walls and exposed bolted hip rafters. It most recently served as a store for building materials (Plate 80).

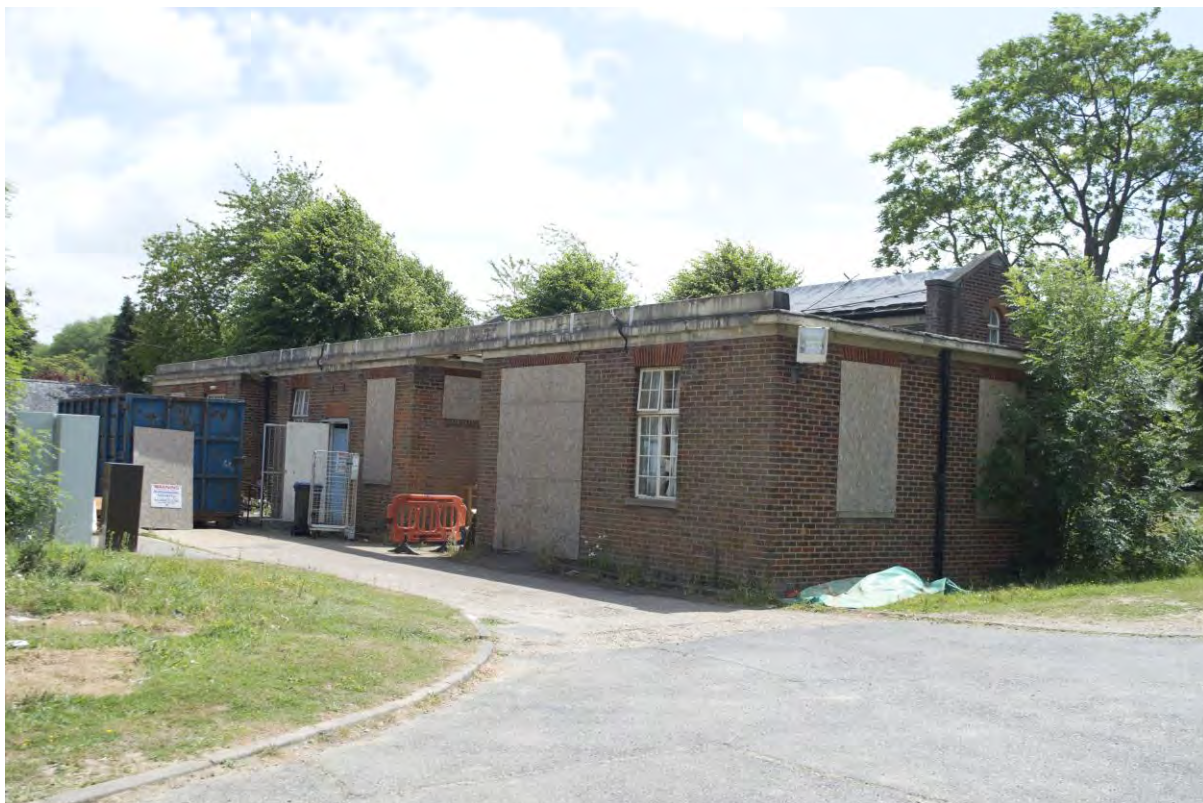
Plate 81 Building 10, staff laundry, facing south-east (FHH17-0182)

7.5.7 The former staff laundry is a single-storey building comprising an east – west range with three blocks of square footprint attached to the north, and connected to each other by a concrete bridging beam at the eaves (Plate 81). Each of the three blocks has an entrance to the building, the principal entrances being to the east and west blocks, and comprising half-glazed doors with a fourteen-pane overlight. The central block has a single-width doorway, with a door of four bead-moulded flush panels, accessing a plant room/electricity substation; it originally had two entrances to each of its return walls, serving a cloakroom, boiler room and lavatories. Only one of these remains to each side, the others having been blocked with matching brickwork. The windows to these blocks are predominantly two-light steel casements with multiple panes and top-opening lights.

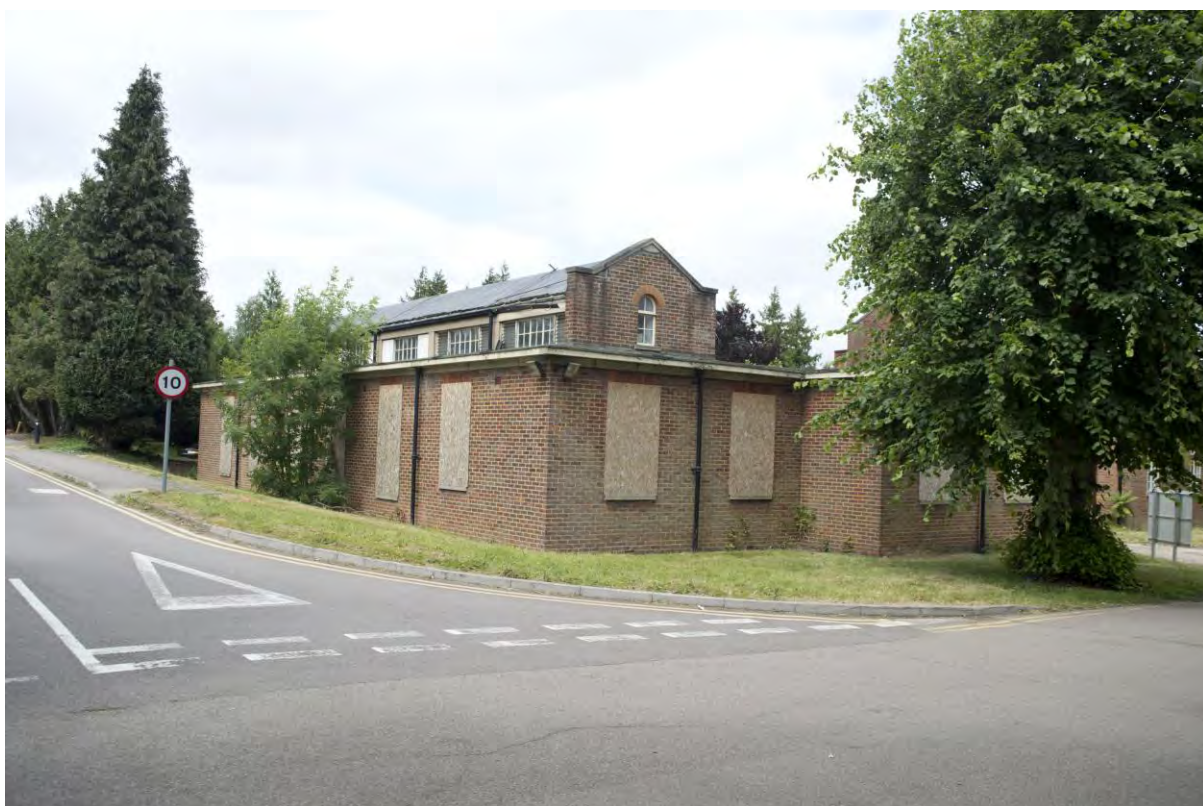
Plate 82 Building 10, staff laundry, facing north-west (FHH17-0172)

7.5.8 The main southern range has a simple appearance, with a regular arrangement of matching steel windows to its south, east and west elevations; some windows have been replaced with uPVC (Plate 82). It has a flat concrete roof, with a substantial roof lantern with brick gables to the east and west. Each gable has a parapet and kneelers, and a central round-arched steel

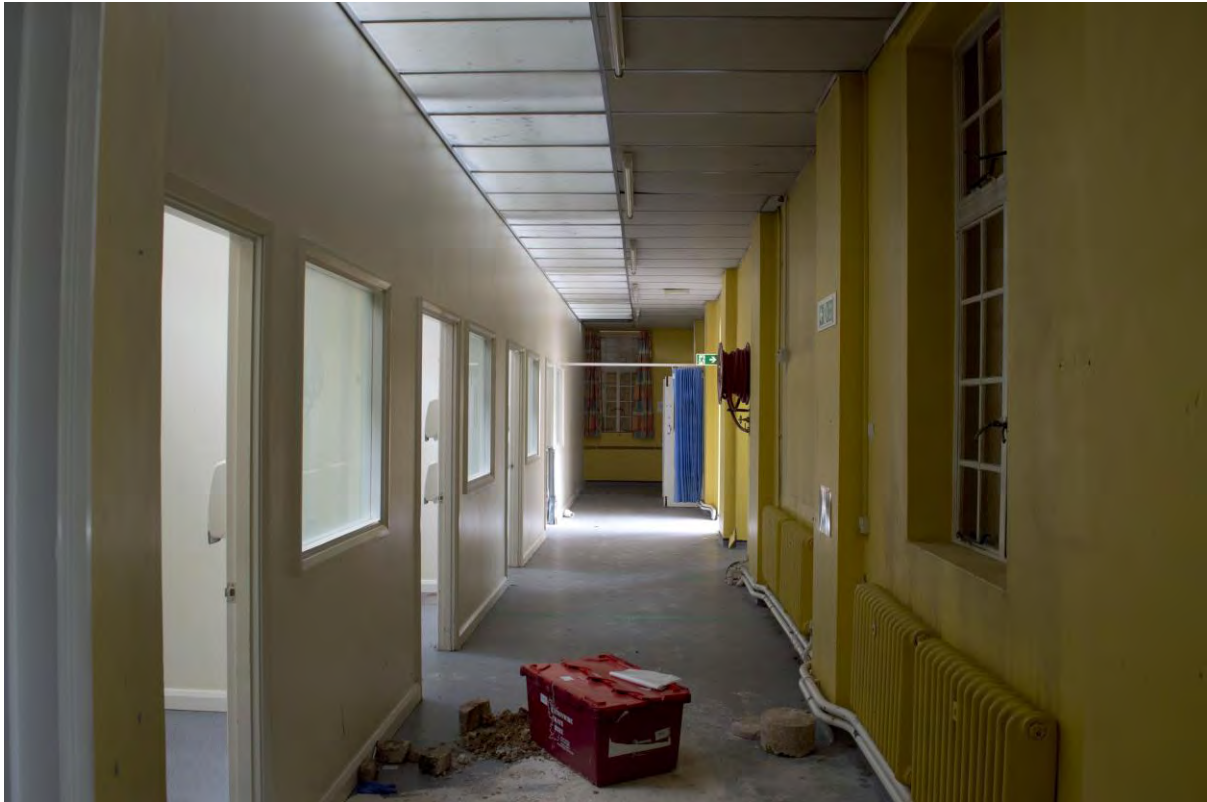
Plate 83 Building 10, staff laundry, interior of main range, facing west, showing inserted corridor and suspended ceiling (FHH17-0191)

- 7.5.9 The main range of the building was originally subdivided into two open-plan halves, with washing being carried out in the western half and ironing in the eastern half (Fig. 25). This has been subdivided with a series of modern stud partitions to provide a series of six rooms accessed by a wide corridor running along the northern side of the range (Plate 83). Regularly-spaced pilaster buttresses remain visible along the external walls, which have a plastered finish. A suspended ceiling has been inserted; above this, the roof lantern is framed with steel trusses clad with concrete (Plate 84).

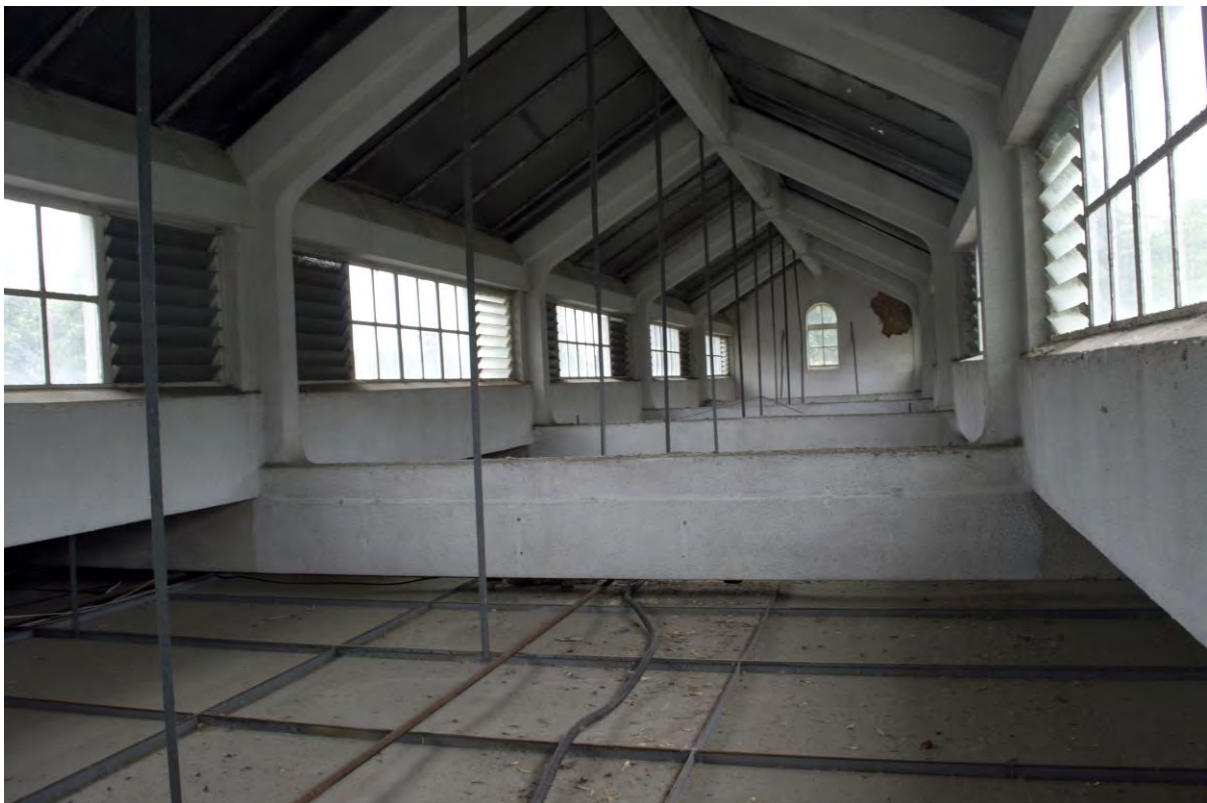
Plate 84 Building 10, staff laundry, roof of main range, facing east (FHH17-0212)

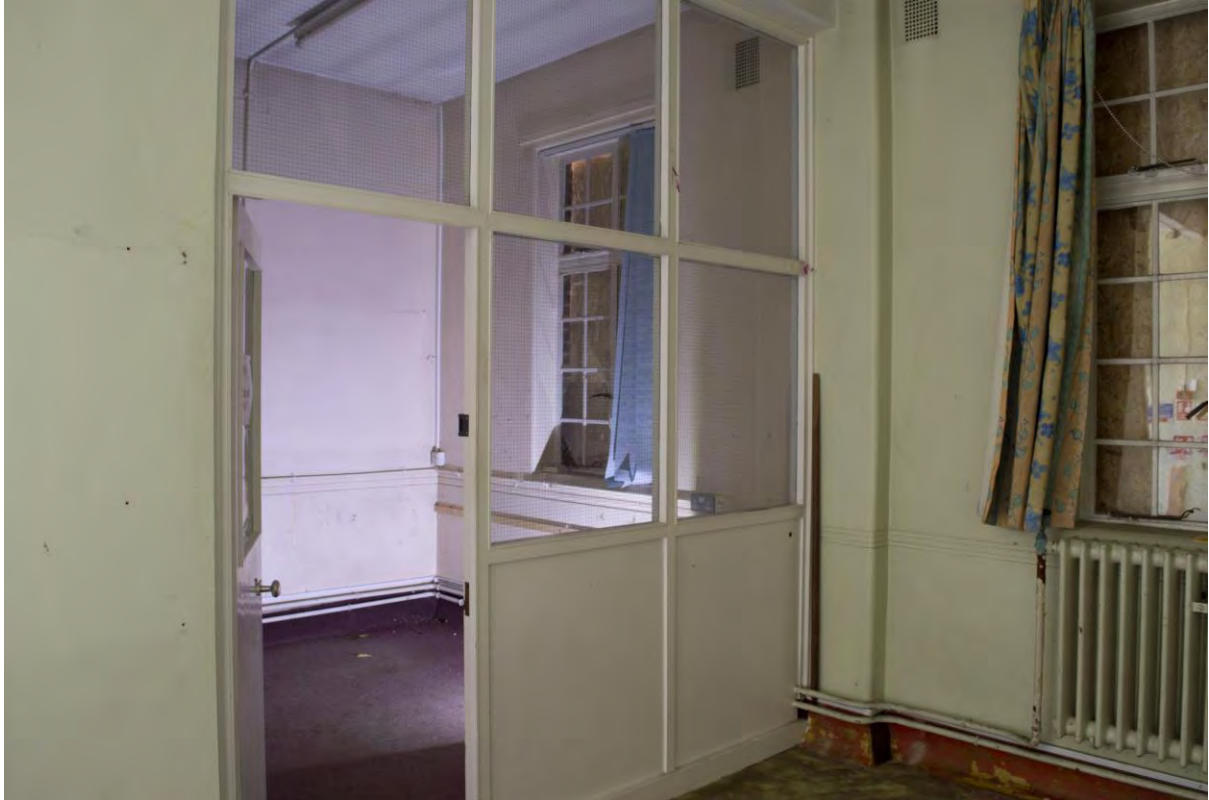
Plate 85 Building 10, staff laundry, modified interior of original laundry distribution room, facing north-east (FHH17-0189)

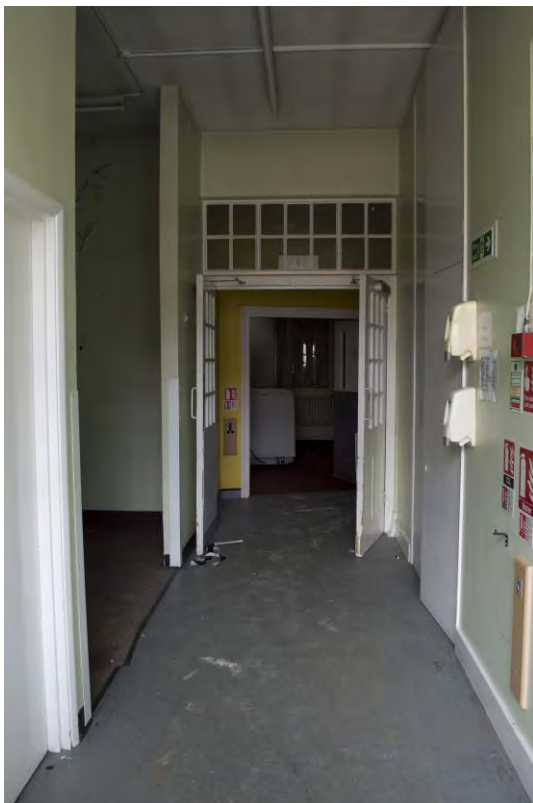
Plate 86 Building 10, staff laundry, original doors from laundry distribution room to main range, facing south (FHH17-0186)

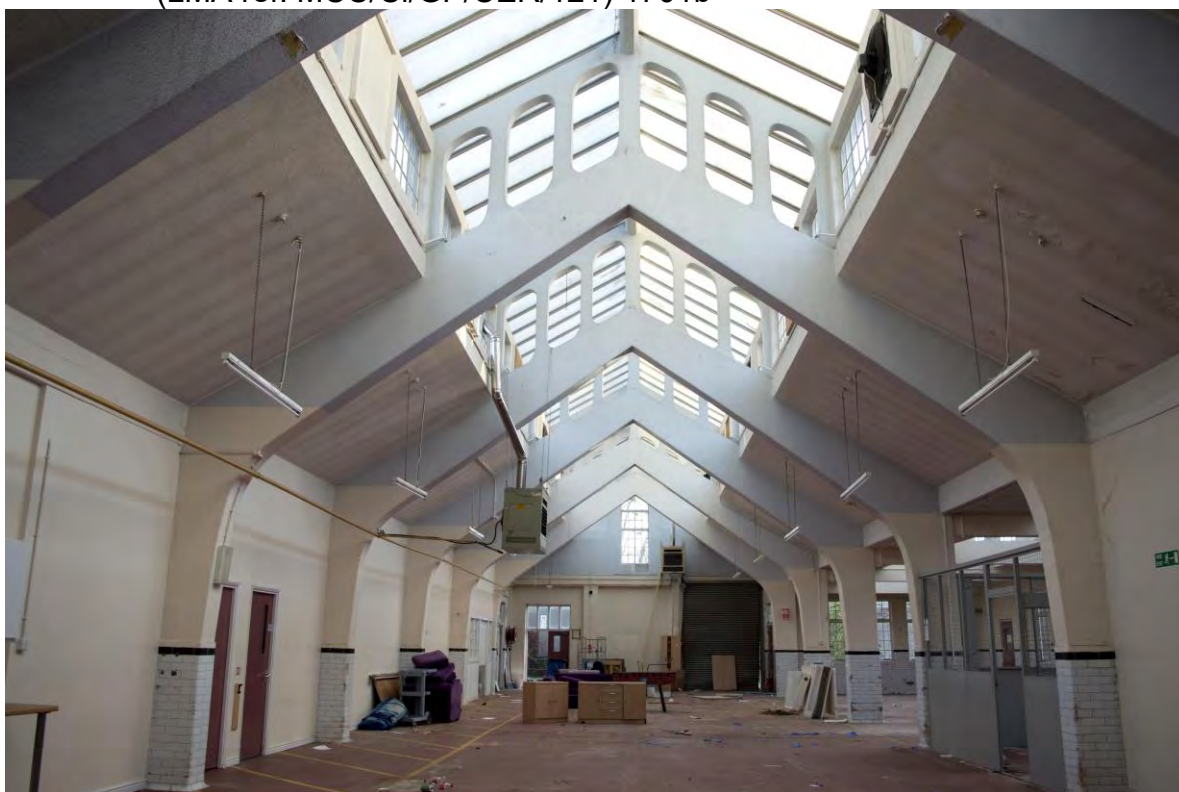
Plate 92 Building 11, general laundry, interior of main range, facing south (FHH17-0701)

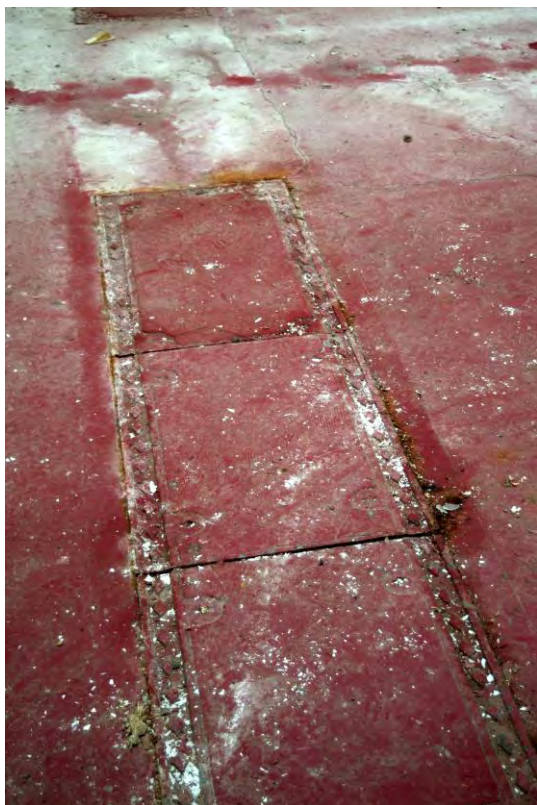
Plate 93 Building 11, general laundry, floor ducts in main range (FHH17-0704)

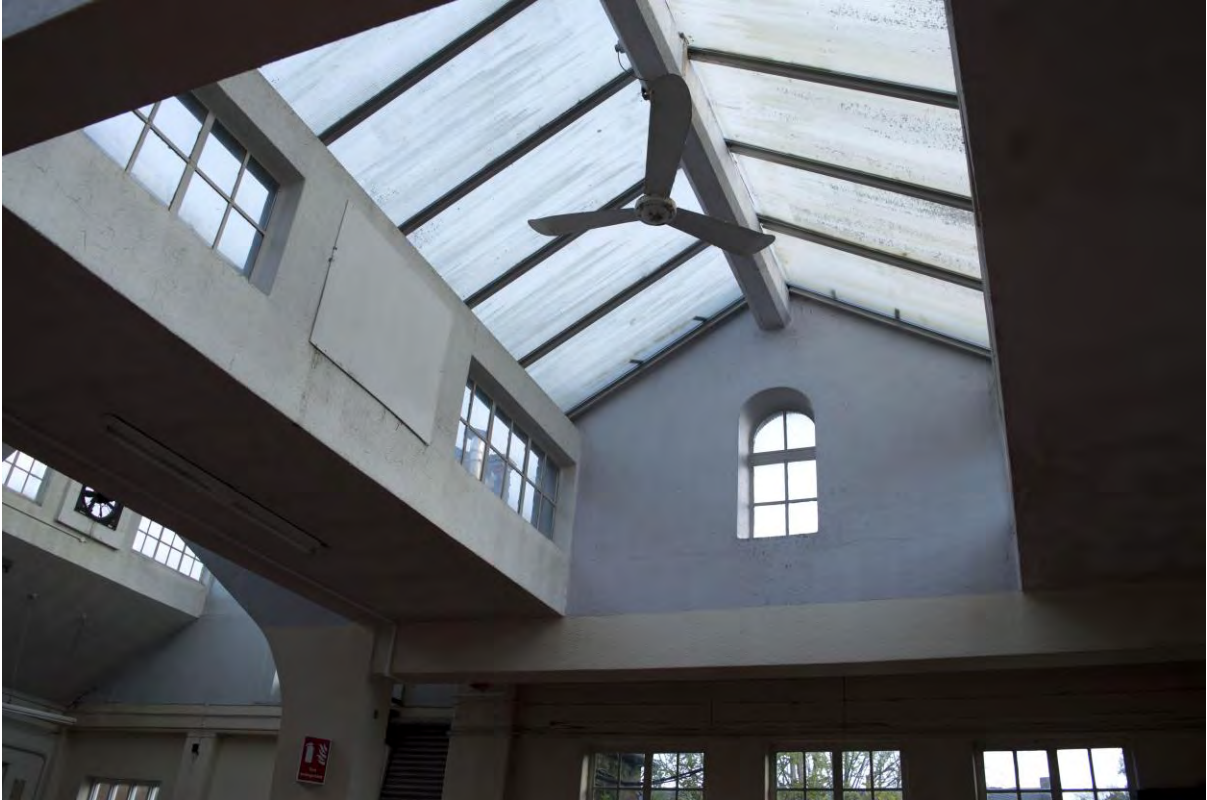
Plate 95 Building 11, general laundry, roof lantern above west flanking range, facing south (FHH17-0710)

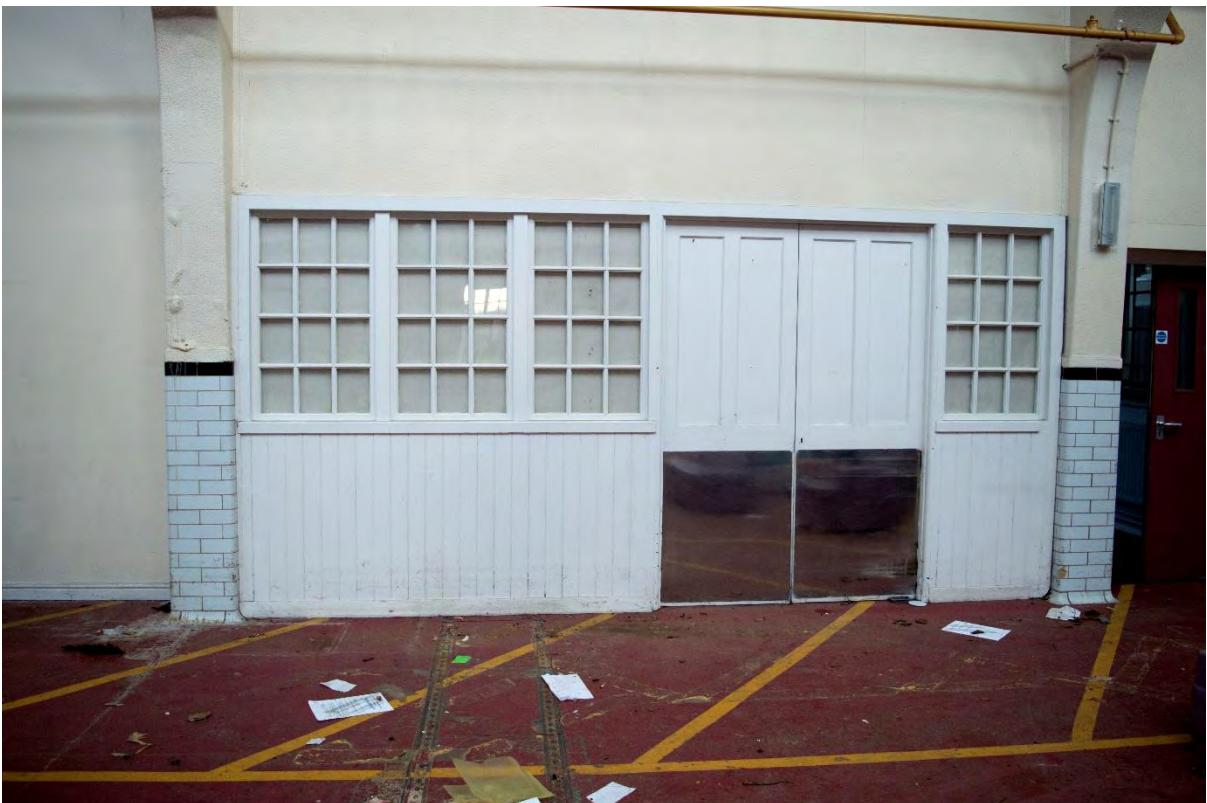
Plate 96 Building 11, general laundry, original partition on east side of main range, facing east (FHH17-0712)

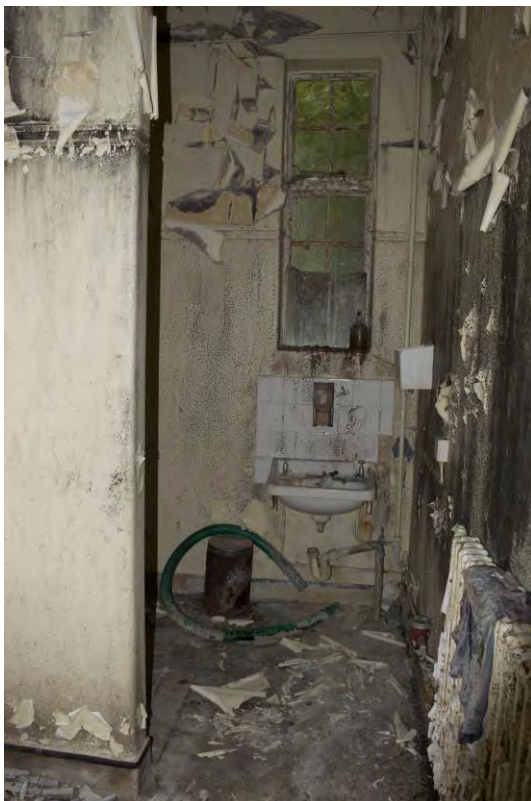
Plate 104 Building 12, disinfectant block, interior of WC/shower room at west end of building (FHH17-0237)

7.5.29 The separate room at the western end of the building contains a shower, WC, urinals and washbasin. Its walls are plastered with an integral step-moulding at two-thirds the height of the room and it has a quarry-tiled floor (Plate 104).

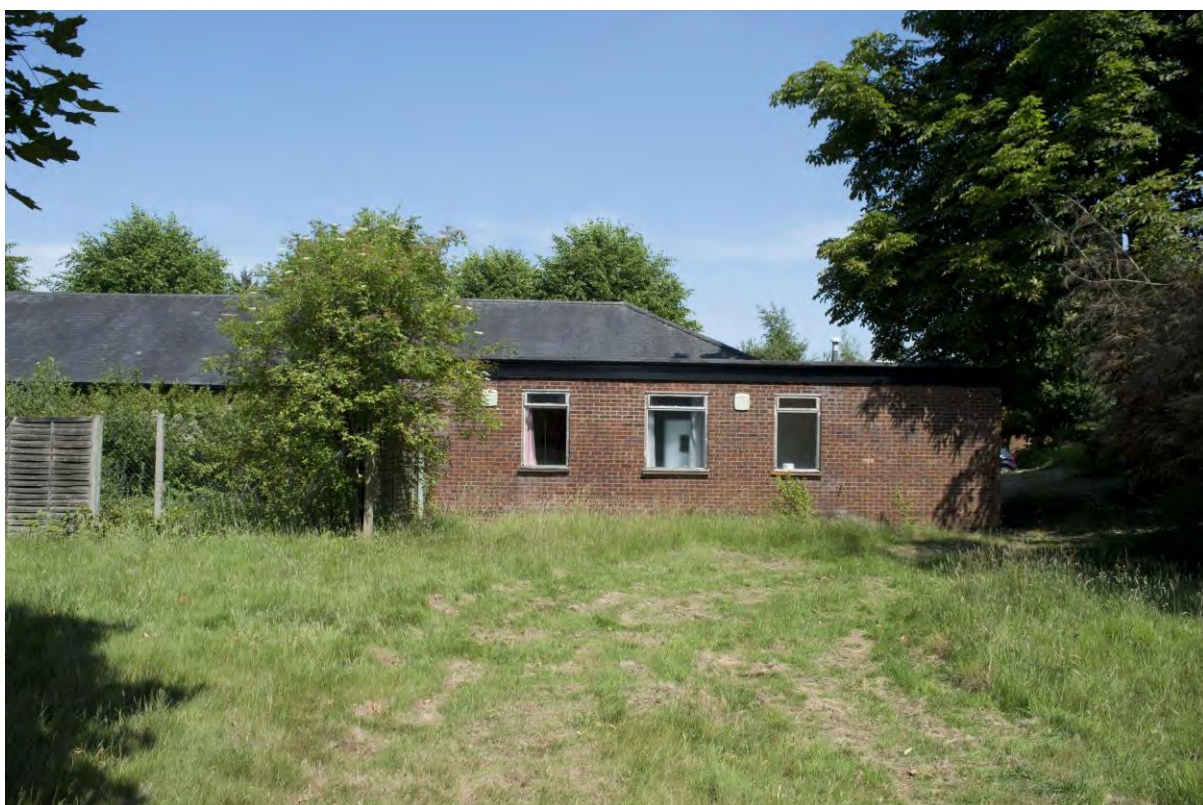
Plate 106 Building 13, fire training building, southern extension, facing east (FHH17-243)

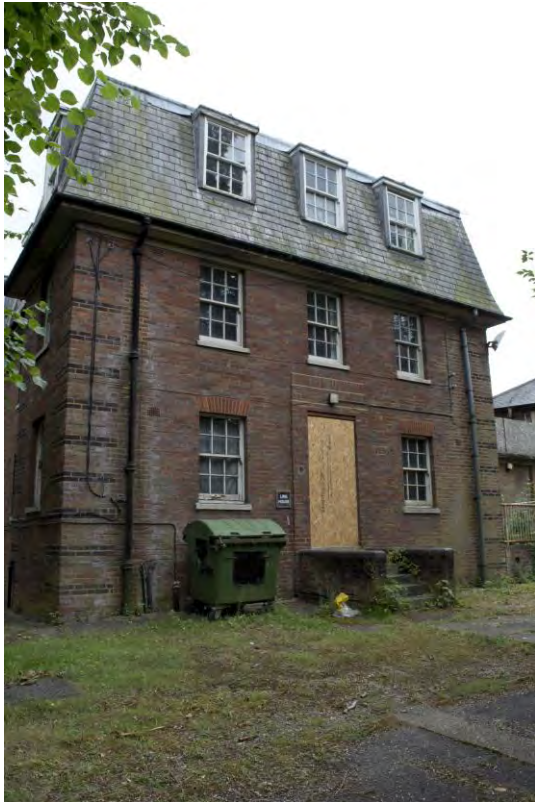
Plate 111 Building 28, nurses' home, north elevation (FHH17-0568)

- 7.7.11 The end elevations to the north and south are identical and echo the appearance of the central pavilion to the front elevation (Plate 111). They each have a regular arrangement of sashes of six-panes-over six around a central entrance. Here, the entrance is a single-width doorway with modern flush timber door, set in a simple projecting brick surround. The north entrance is approached by a set of concrete steps flanked by brick plinth walls with bull-nosed engineering brick coping, while the south entrance is on the flat and has a simple door canopy comprising a corrugated metal roof supported on two metal posts; it appears to be a later addition.

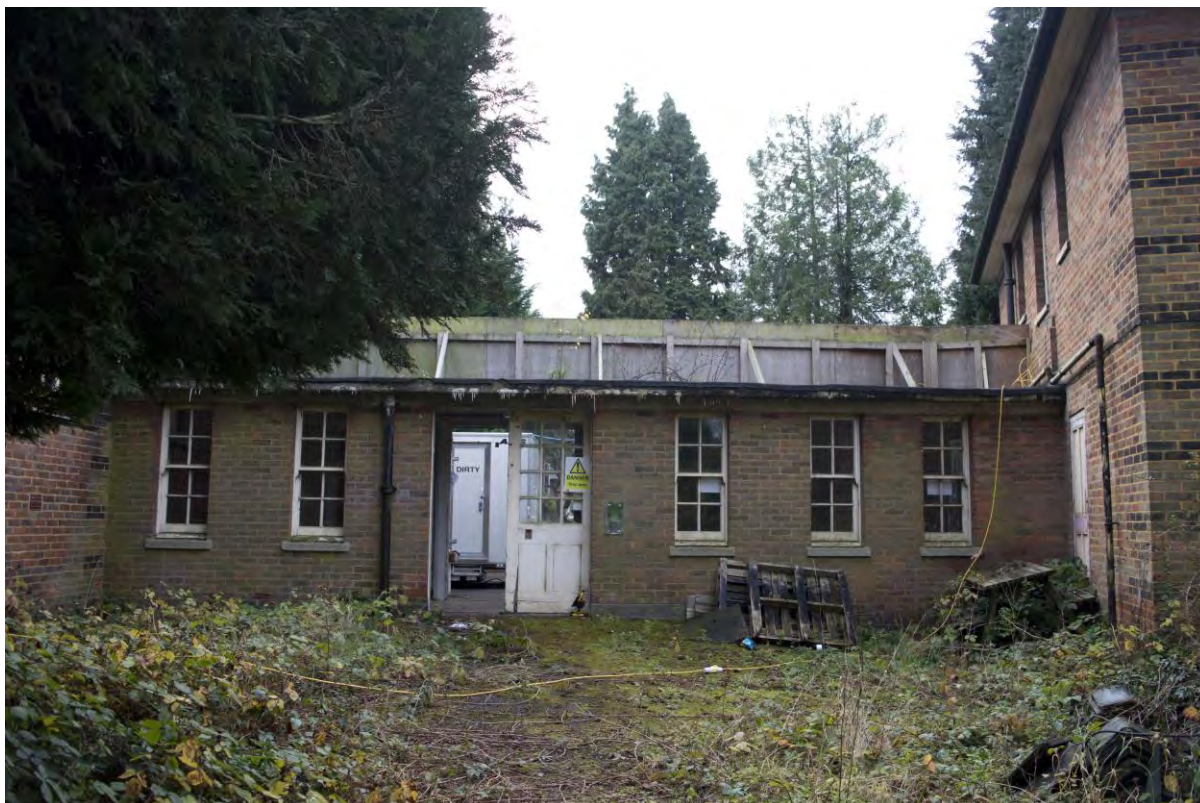
Plate 115 Building 28, nurses' home, corridor linking Buildings 28 and 25, facing south (FHH17-0733)

- 7.7.13 The range is connected to Buildings 25 and 27 via two single-storey brick-built corridors. The corridors have flat reinforced concrete roofs, overlaid with asphalt, and are canted at their western ends, where they meet the rear ranges. The northern corridor has a centrally-placed, single-width doorway with half-glazed door to both its north and south sides, flanked by sashes of four-panes-over-four: two to the east and three to the west of each doorway. The southern corridor has the same arrangement albeit it has double doorways to each side with a pair of half-glazed doors (Plate 115).

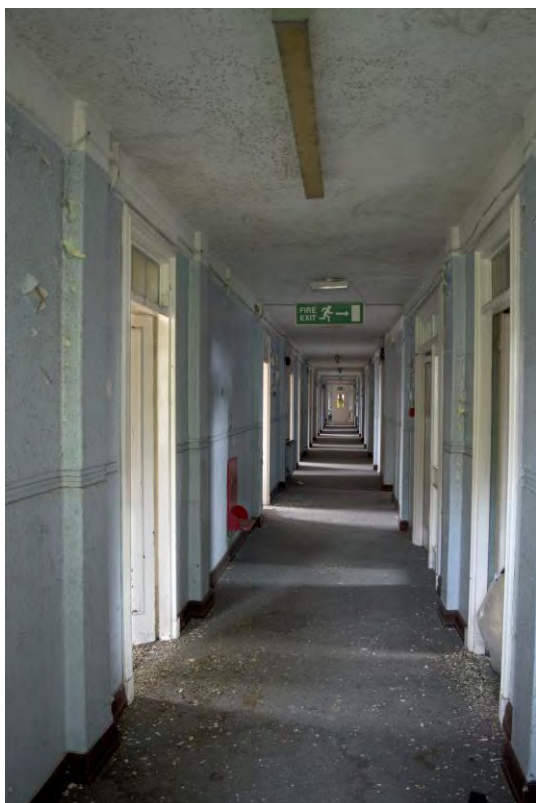
Plate 116 Building 28, nurses' home, first floor corridor, facing south (FHH17-0783)

- 7.7.15 The corridors have smooth-plastered walls and ceilings and concrete floors (Plate 116). The concrete frame of the building is visible in the form of concrete downstands in the position of a cornice, carried on regularly-spaced concrete pilaster-buttresses. Simple ornamentation is employed in the form of an integral step-moulded dado rail at half-height, in common with many of the other hospital buildings, and a shallow step-, ovolo- and cyma-moulded skirting. Doors are set in simple step- and cyma-moulded architraves; the doors themselves have an applied cyma-moulded panel to each side and a three-pane overlight.

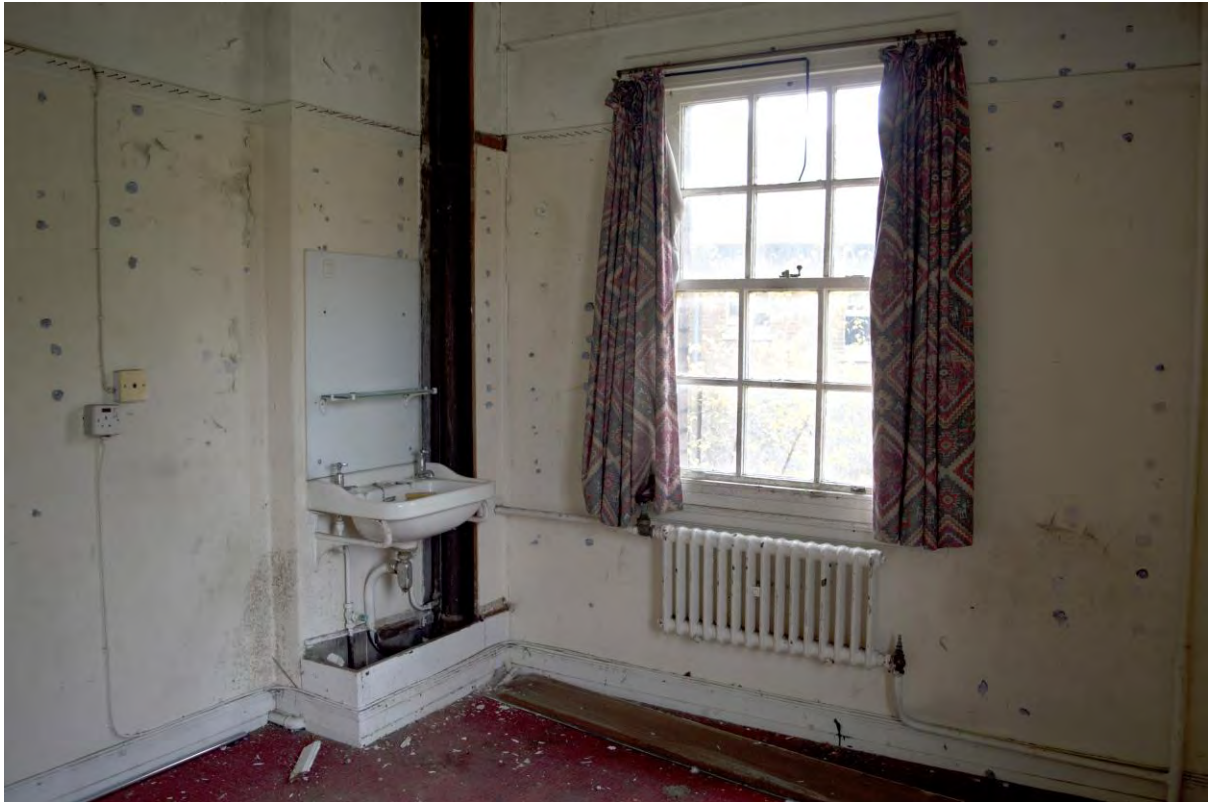
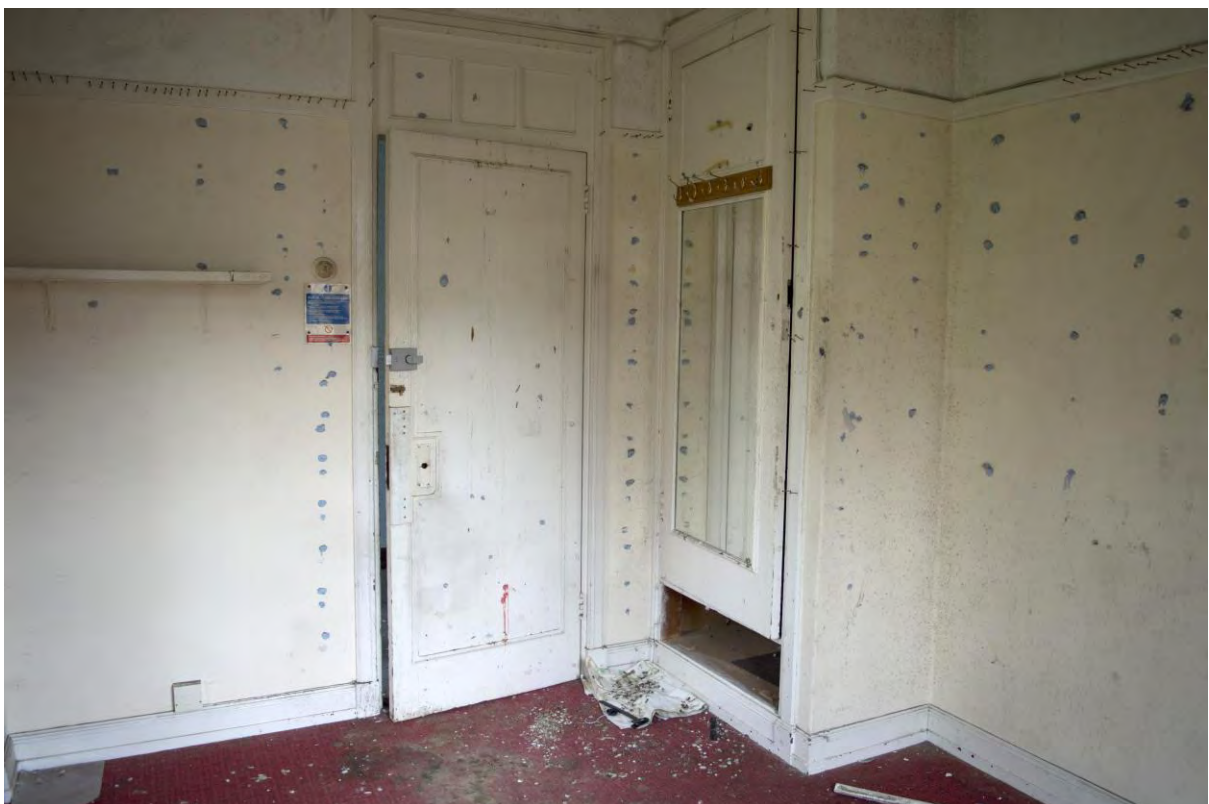
Plate 117 Building 28, nurses' home, typical bedroom, first floor (FHH17-0784)

Plate 118 Building 28, nurses' home, typical bedroom first floor (FHH17-0785)

- 7.7.16 The nurses' bedrooms each have smooth-plastered walls and ceilings, skirting to match that in the corridor, a wide picture rail, cyma-moulded at its base, and a floor of slender timber boards; at second floor level the floors are of parquet (Plates 117 & 118). Each bedroom was furnished with a built-in wardrobe, and every other partition between the rooms is constructed with recesses to house the wardrobes and a wash basin. The wardrobes each have a drawer at their base, and a door of two moulded panels, matching that to the room door; the lower panel contains a mirror. The bedrooms did not have fireplaces but were
-

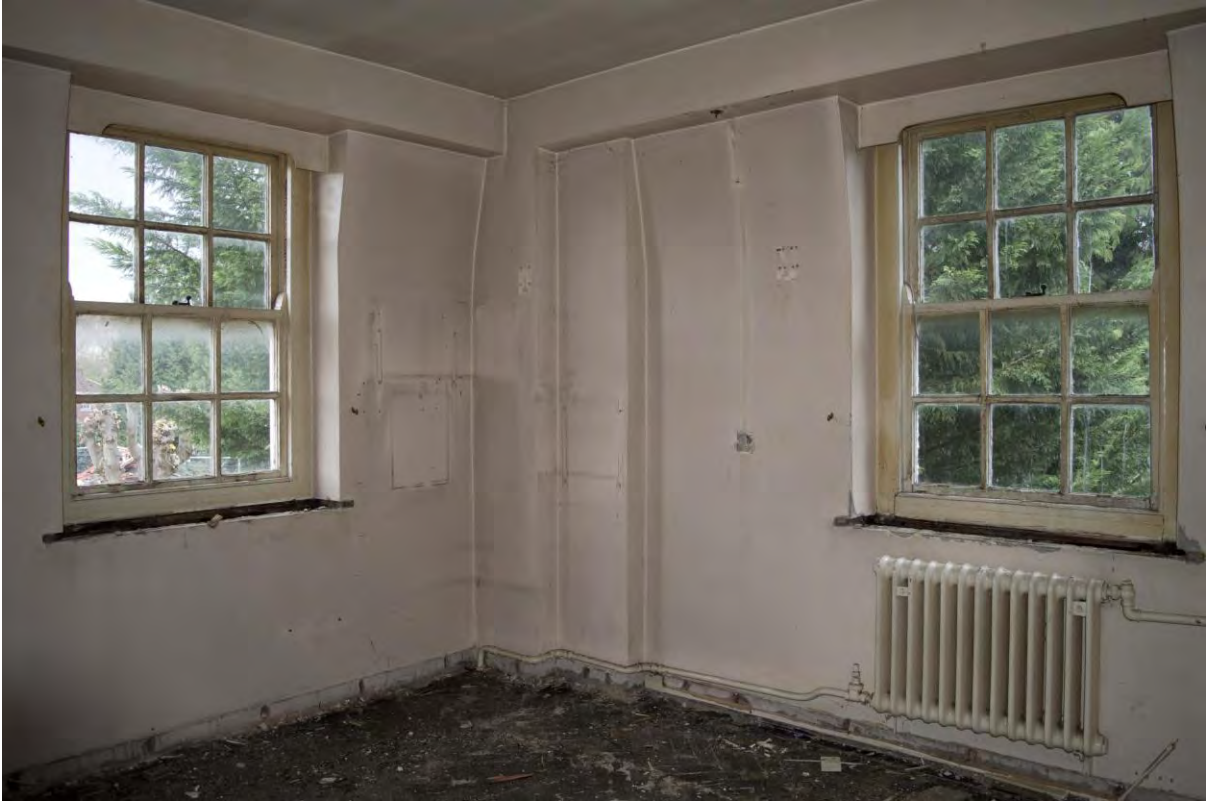
Plate 119 Building 28, nurses' home, larger bedroom at south end of range, second floor, facing south-east (FHH17-1392)

heated with cast iron radiators. Each has a high-level metal ventilation grille and was lit by a single window. The corner rooms to the north-east, north-west, south-east and south-west are slightly larger, and have two windows (Plate 119). At first and second floor level these rooms form part of a suite along with a sitting room and small bathroom, all accessed by their own lobby. These larger rooms and suites would have provided accommodation for more senior staff, as indicated on second floor plans from 1948 which identify sisters' rooms and officers' suites (Fig. 38).

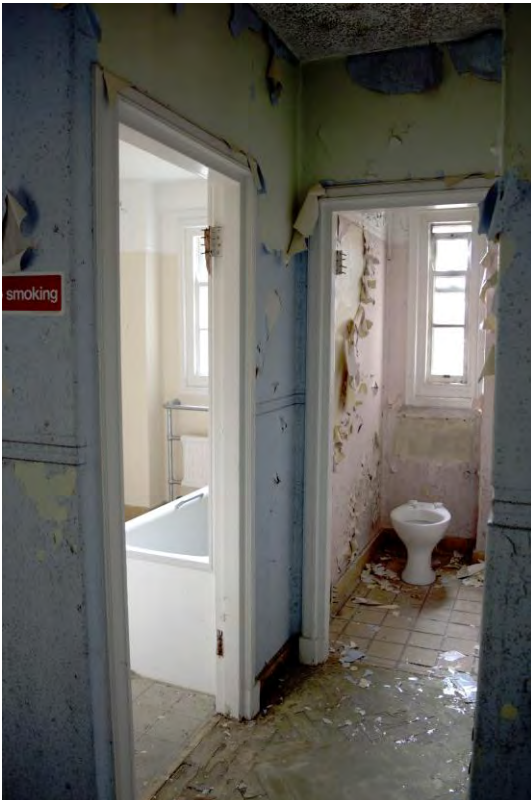
Plate 120 Building 28, nurses' home, typical bathroom arrangement, first floor (FHH17-0781)

- 7.7.17 The bathrooms and WCs all have concrete floors, laid with buff quarry tiles, a course of which forms a skirting around the perimeter of the rooms, and are ornamented with an integral step-moulded band at picture rail height (Plate 120). The linen stores adjoining the end staircases are plain, with concrete floors laid with parquet. One example retained slatted timber shelves (Plate 121).

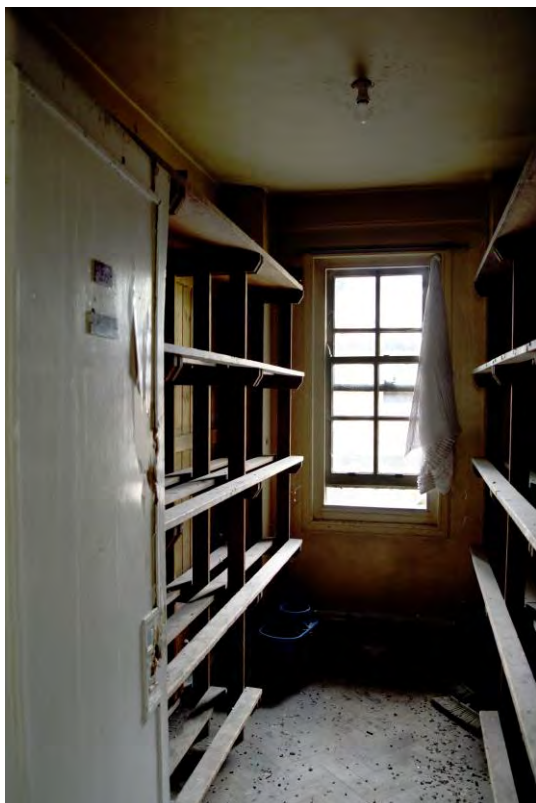
Plate 121 Building 28, nurses' home, first floor north linen store, facing west
(FHH17-0786)
