**FORMER HARPERBURY HOSPITAL,
HARPER LANE, RADLETT, HERTFORDSHIRE**

**HISTORIC BUILDINGS RECORD
(HISTORIC ENGLAND LEVELS 2 & 3)**

**Site Code: FHH17
Project No. 160560
Report No. 2017303
OASIS ID: archaeol6-305660**

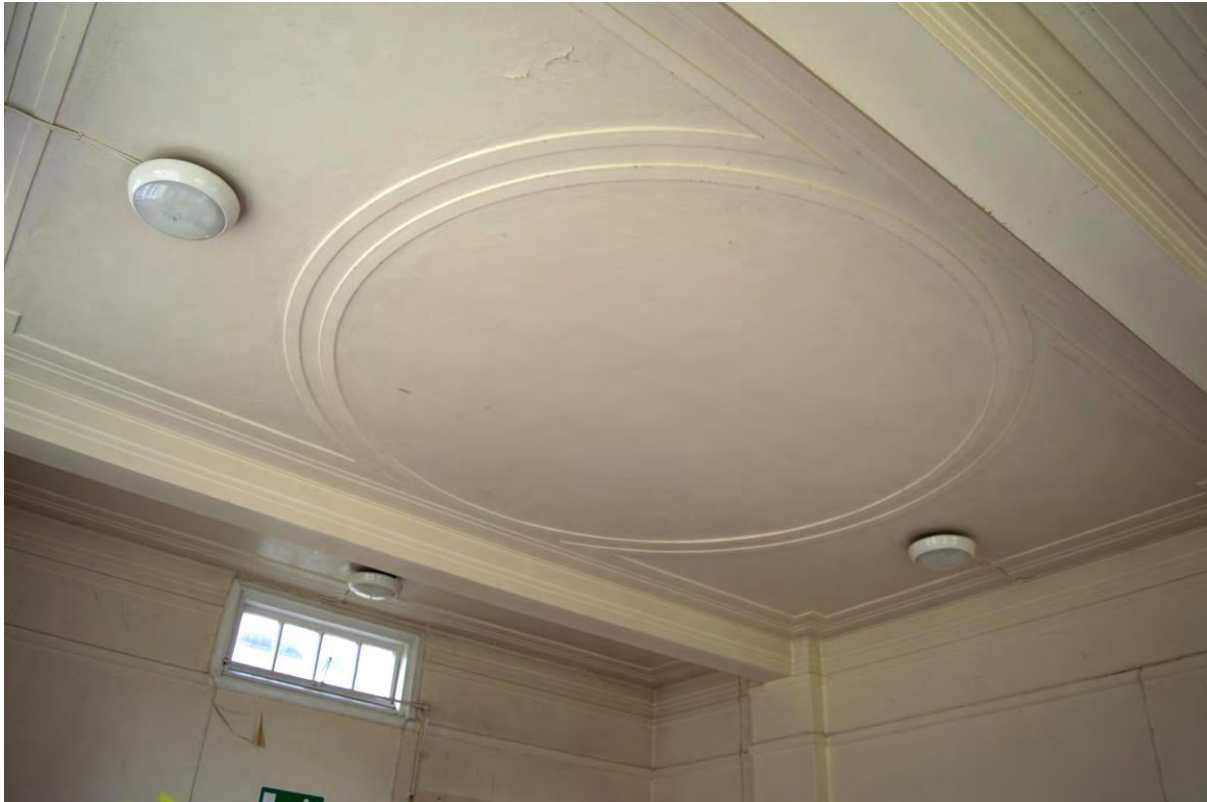
Plate 146 Building 26, nurses' home, detail of roof lantern in nurses' dining room (FHH17-1221)

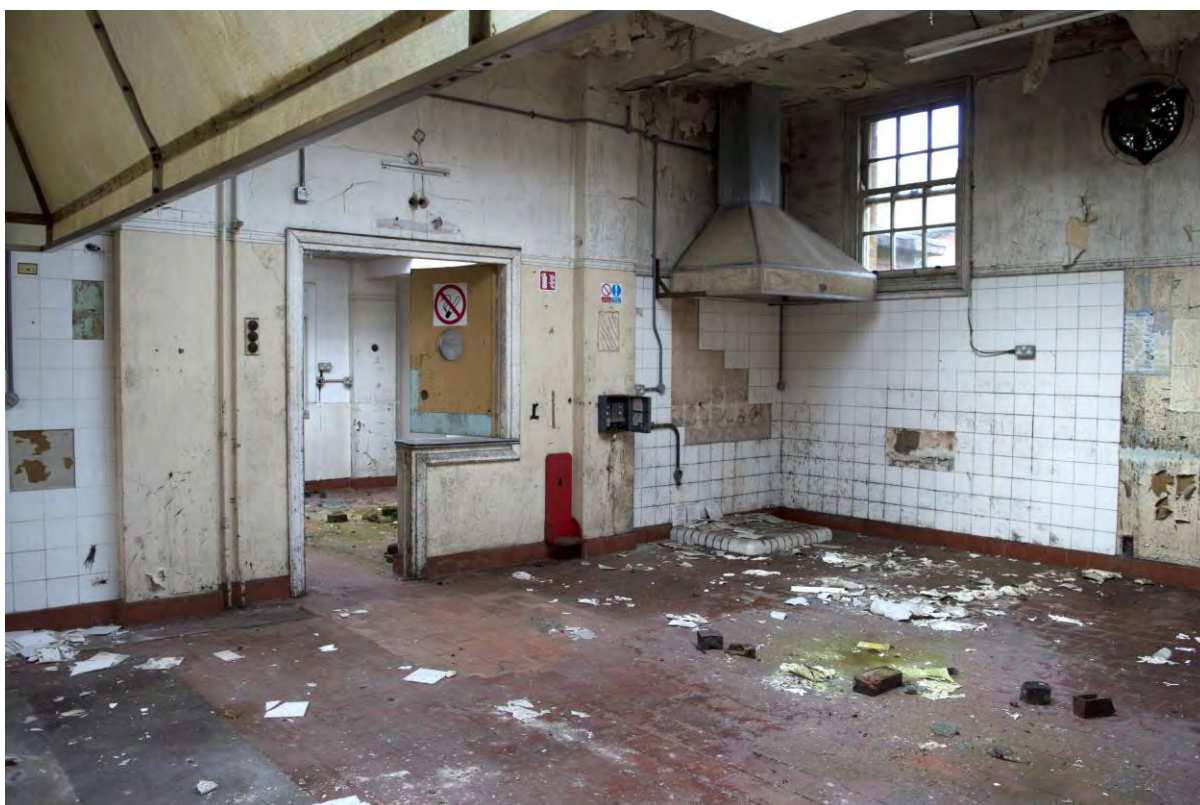
Plate 149 Building 26, nurses' home, scullery and servery, facing north (FHH17-1223)

- 7.7.39 The rooms forming the kitchens occupy the eastern part of the building and are accessed from the large dining room via a door matching those in the main corridor. The room immediately adjoining the dining room functioned as the scullery and servery (Plate 149). The room to its east was the main kitchen, beyond which is a smaller room which served as a vegetable scullery (Fig. 37; Plates 150 & 151). All three rooms are treated in the same manner with smooth plastered walls with integral step-moulding at picture rail height and partly tiled finish, a quarry-tiled floor and skirting. In addition to sash windows to the north and south each room has a central hipped metal roof lantern with opening lights. The kitchen retains modern cooker hoods, and both it and the vegetable scullery contain a moulded white glazed brick plinth of obscure purpose, presumably a base for kitchen equipment of some sort.

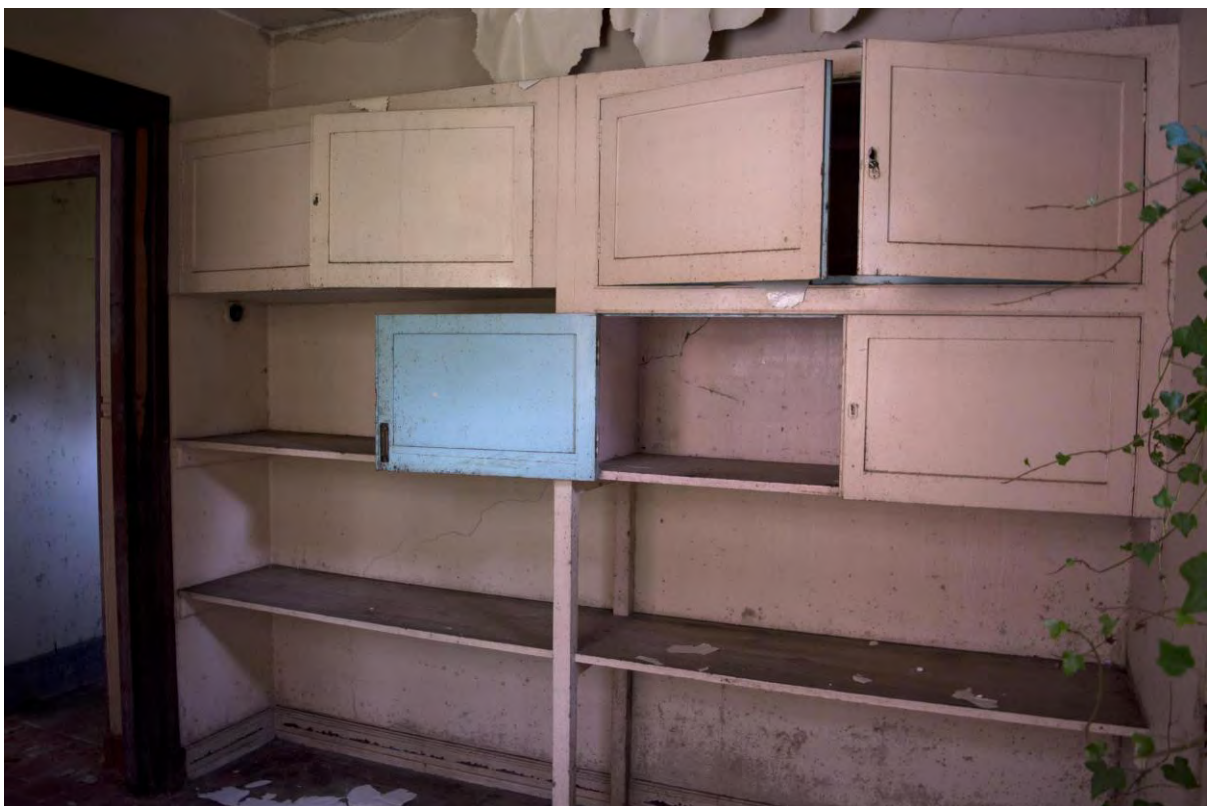
Plate 153 Building 26, nurses' home, vegetable store, facing south (FHH17-1249)

- 7.7.41 The larder, on the north side of the corridor, has been converted to a walk-in refrigerator/freezer with an insulated 'Prestcold' door. It has a concrete floor, insulated walls and a cooling fan. The vegetable store to the south is plain, with plastered walls and concrete floor. It retains a concrete plinth around its perimeter, which is coved to the walls (Plate 153).

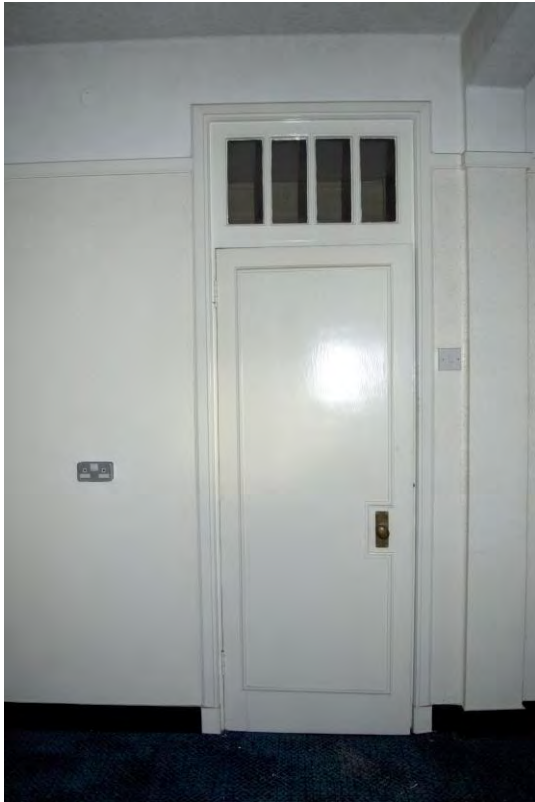
Plate 156 Building 27, nurses' home, first floor corridor (FHH17-0981)

- 7.7.46 As elsewhere, the corridors have smooth-plastered walls and ceiling, a concrete floor, cyma- and ovolo-moulded skirting, and an integral step-moulded dado (Plate 156). Doors off the corridor have a single cyma-moulded
-

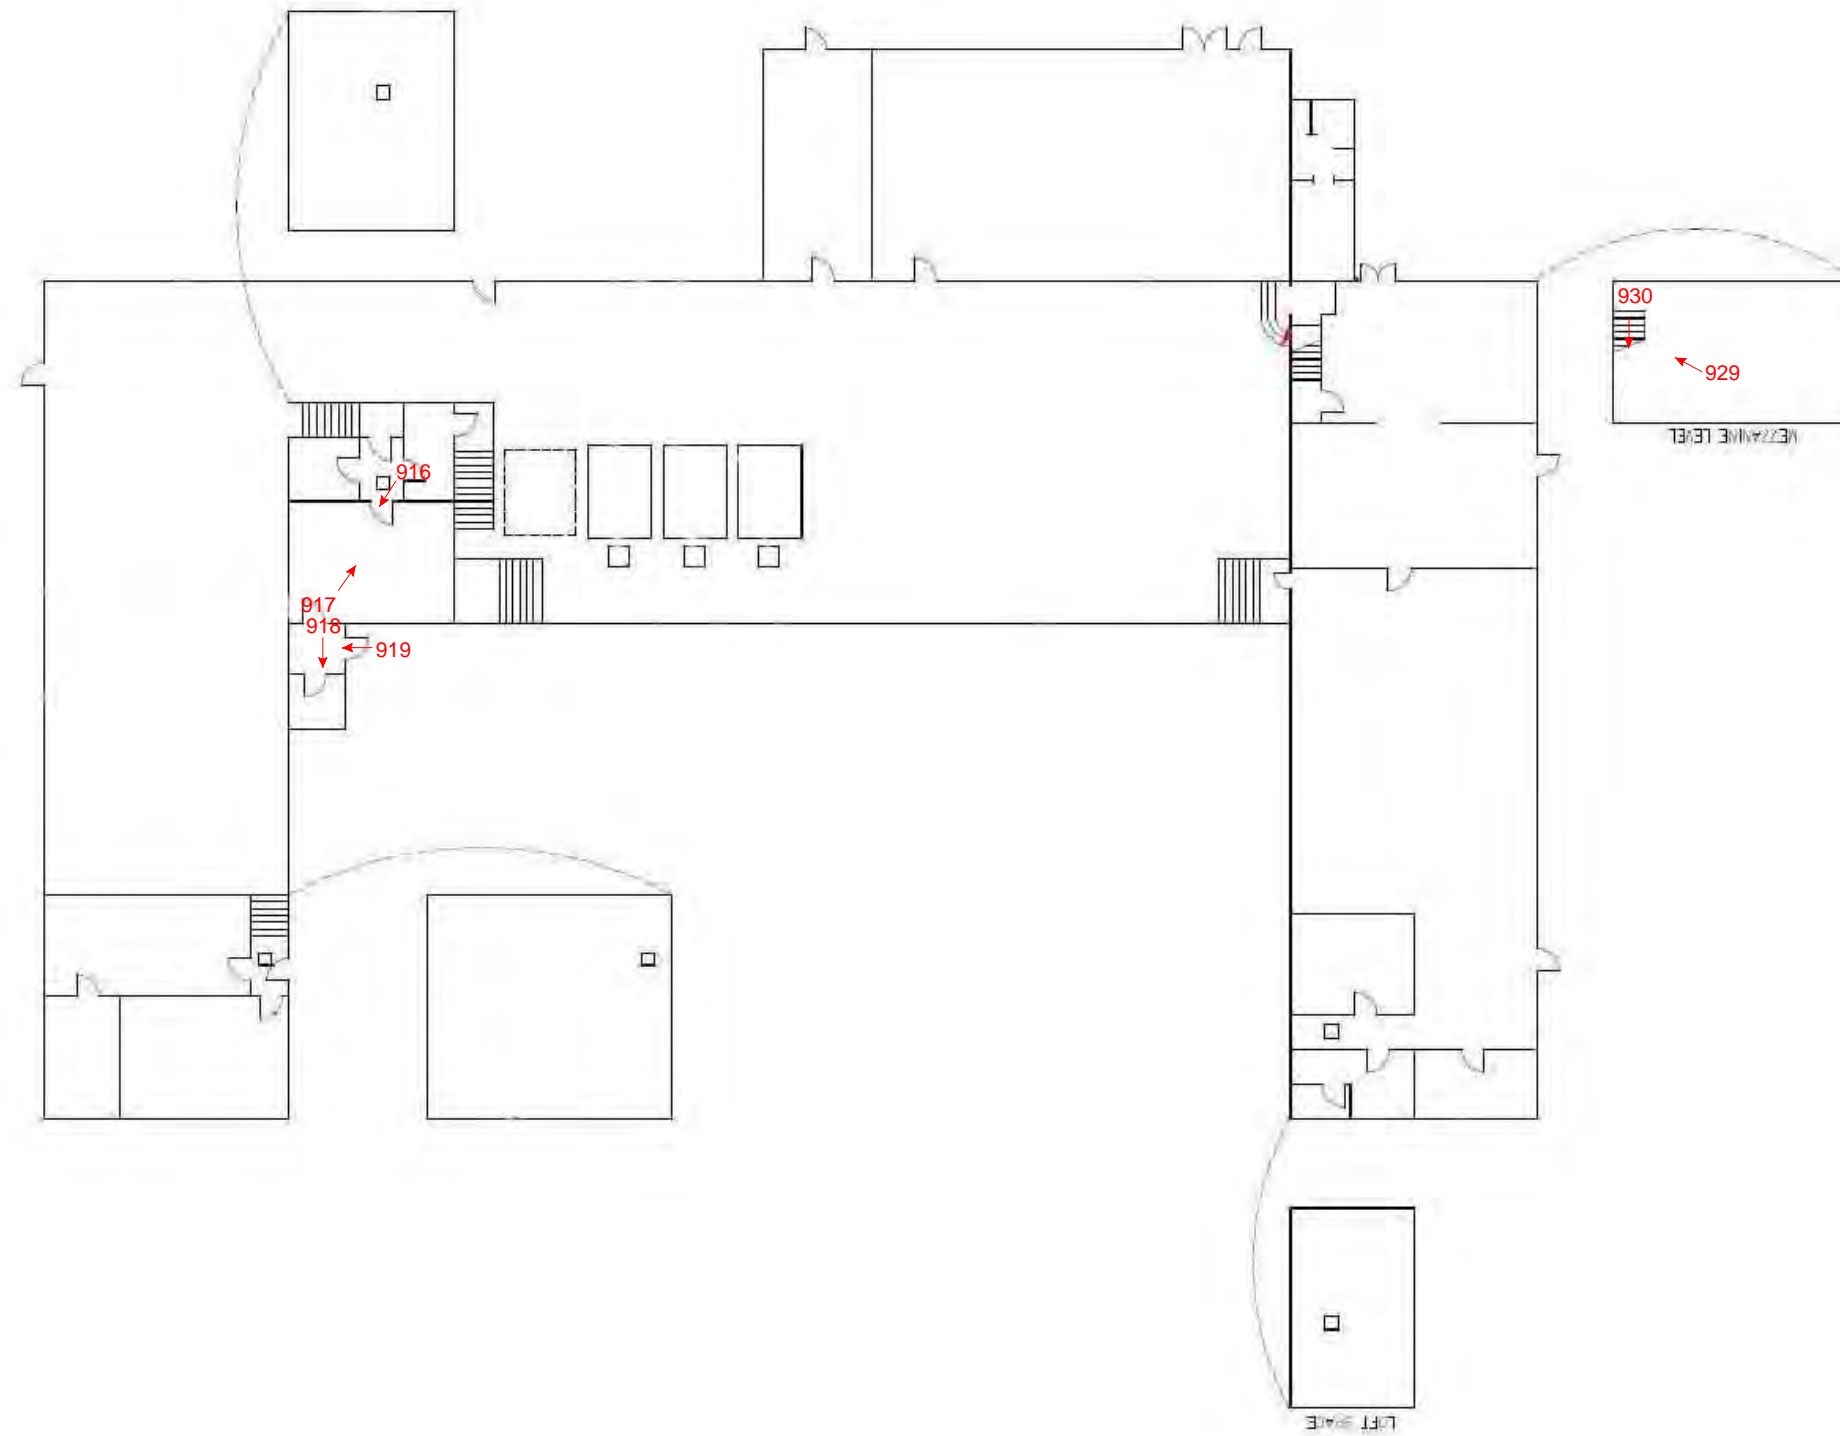
© Archaeology South-East		Harperbury Hospital, Radlett, Hertfordshire	Fig. 17
Project Ref: 160560	Feb 2018	Building 5, Boiler House, Bakery and Workshops, mezzanine floor plan	
Report Ref: 2017303	Drawn by: CPC

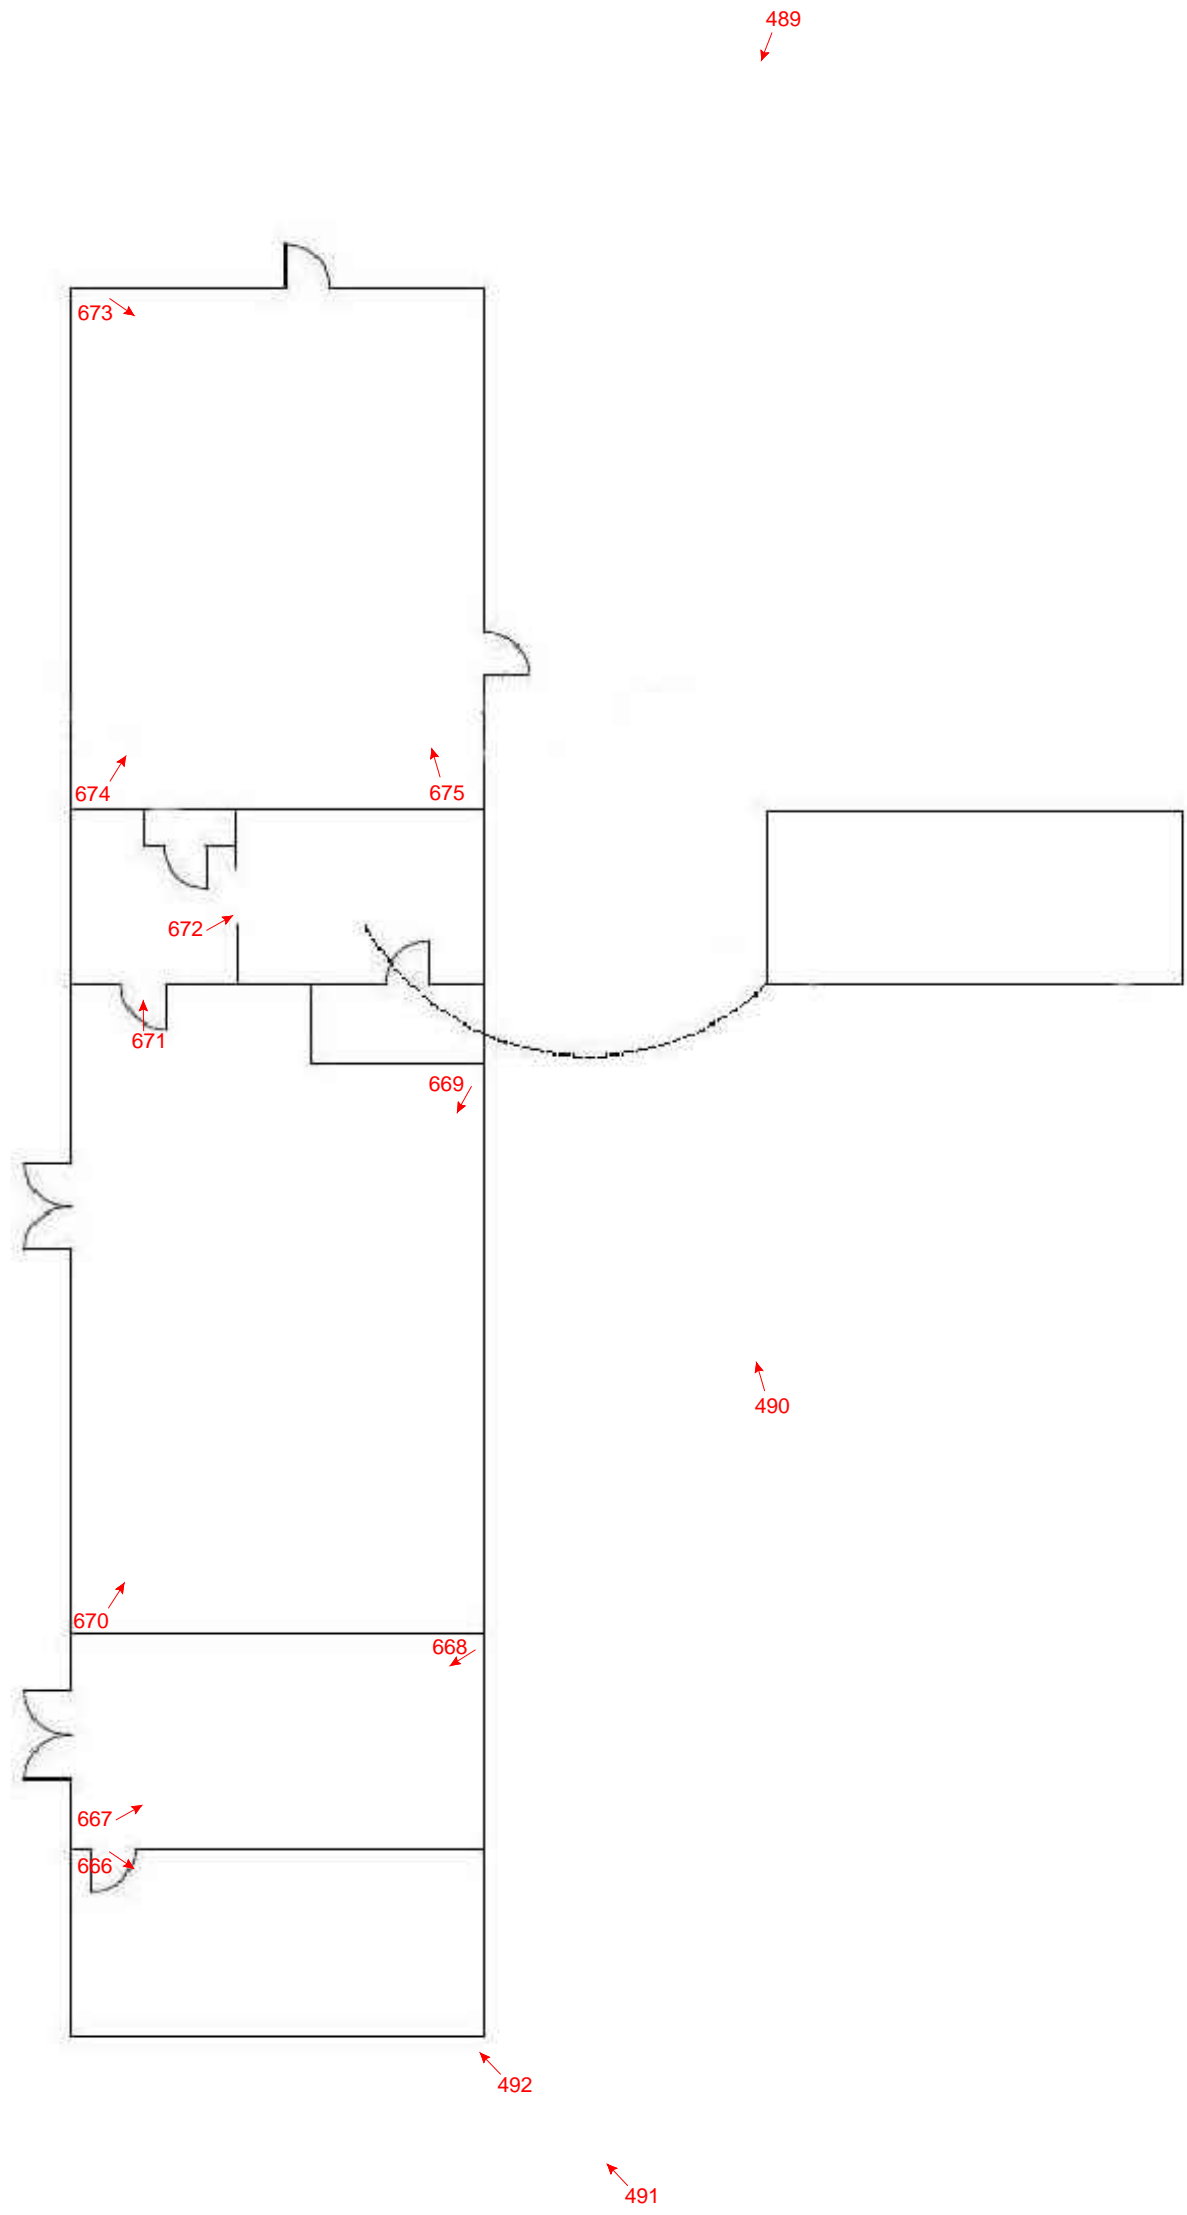
© Archaeology South-East		Harperbury Hospital, Radlett, Hertfordshire	Fig. 21
Project Ref: 160560	Feb 2018	Building 7, Carpenters' Shop and Garages, ground floor plan	
Report Ref: 2017303	Drawn by: CPC

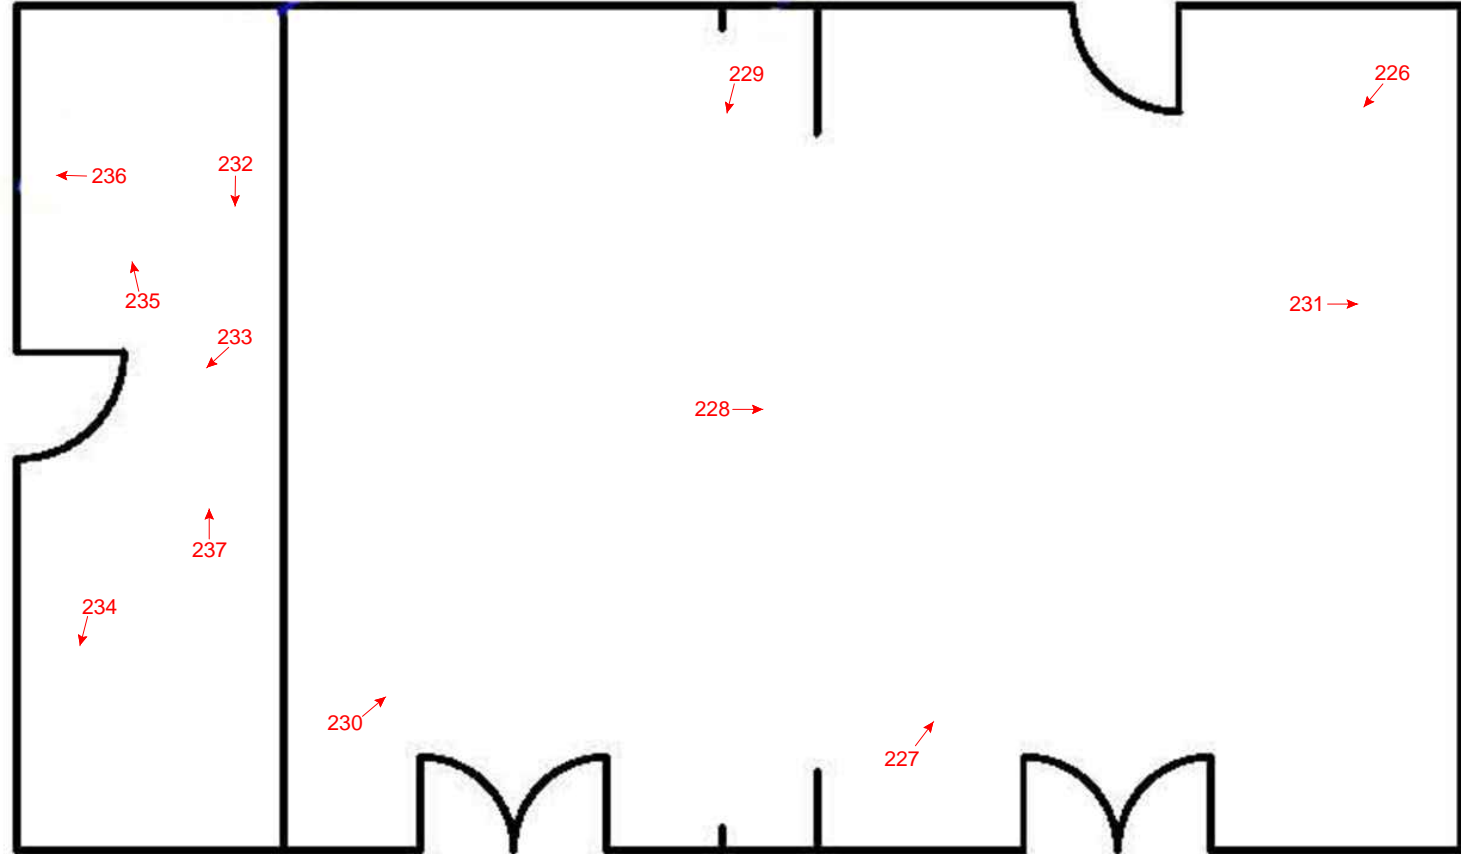
© Archaeology South-East		Harperbury Hospital, Radlett, Hertfordshire	Fig. 28
Project Ref: 160560	Feb 2018	Building 12, Disinfectant Block, ground floor plan	
Report Ref: 2017303	Drawn by: CPC

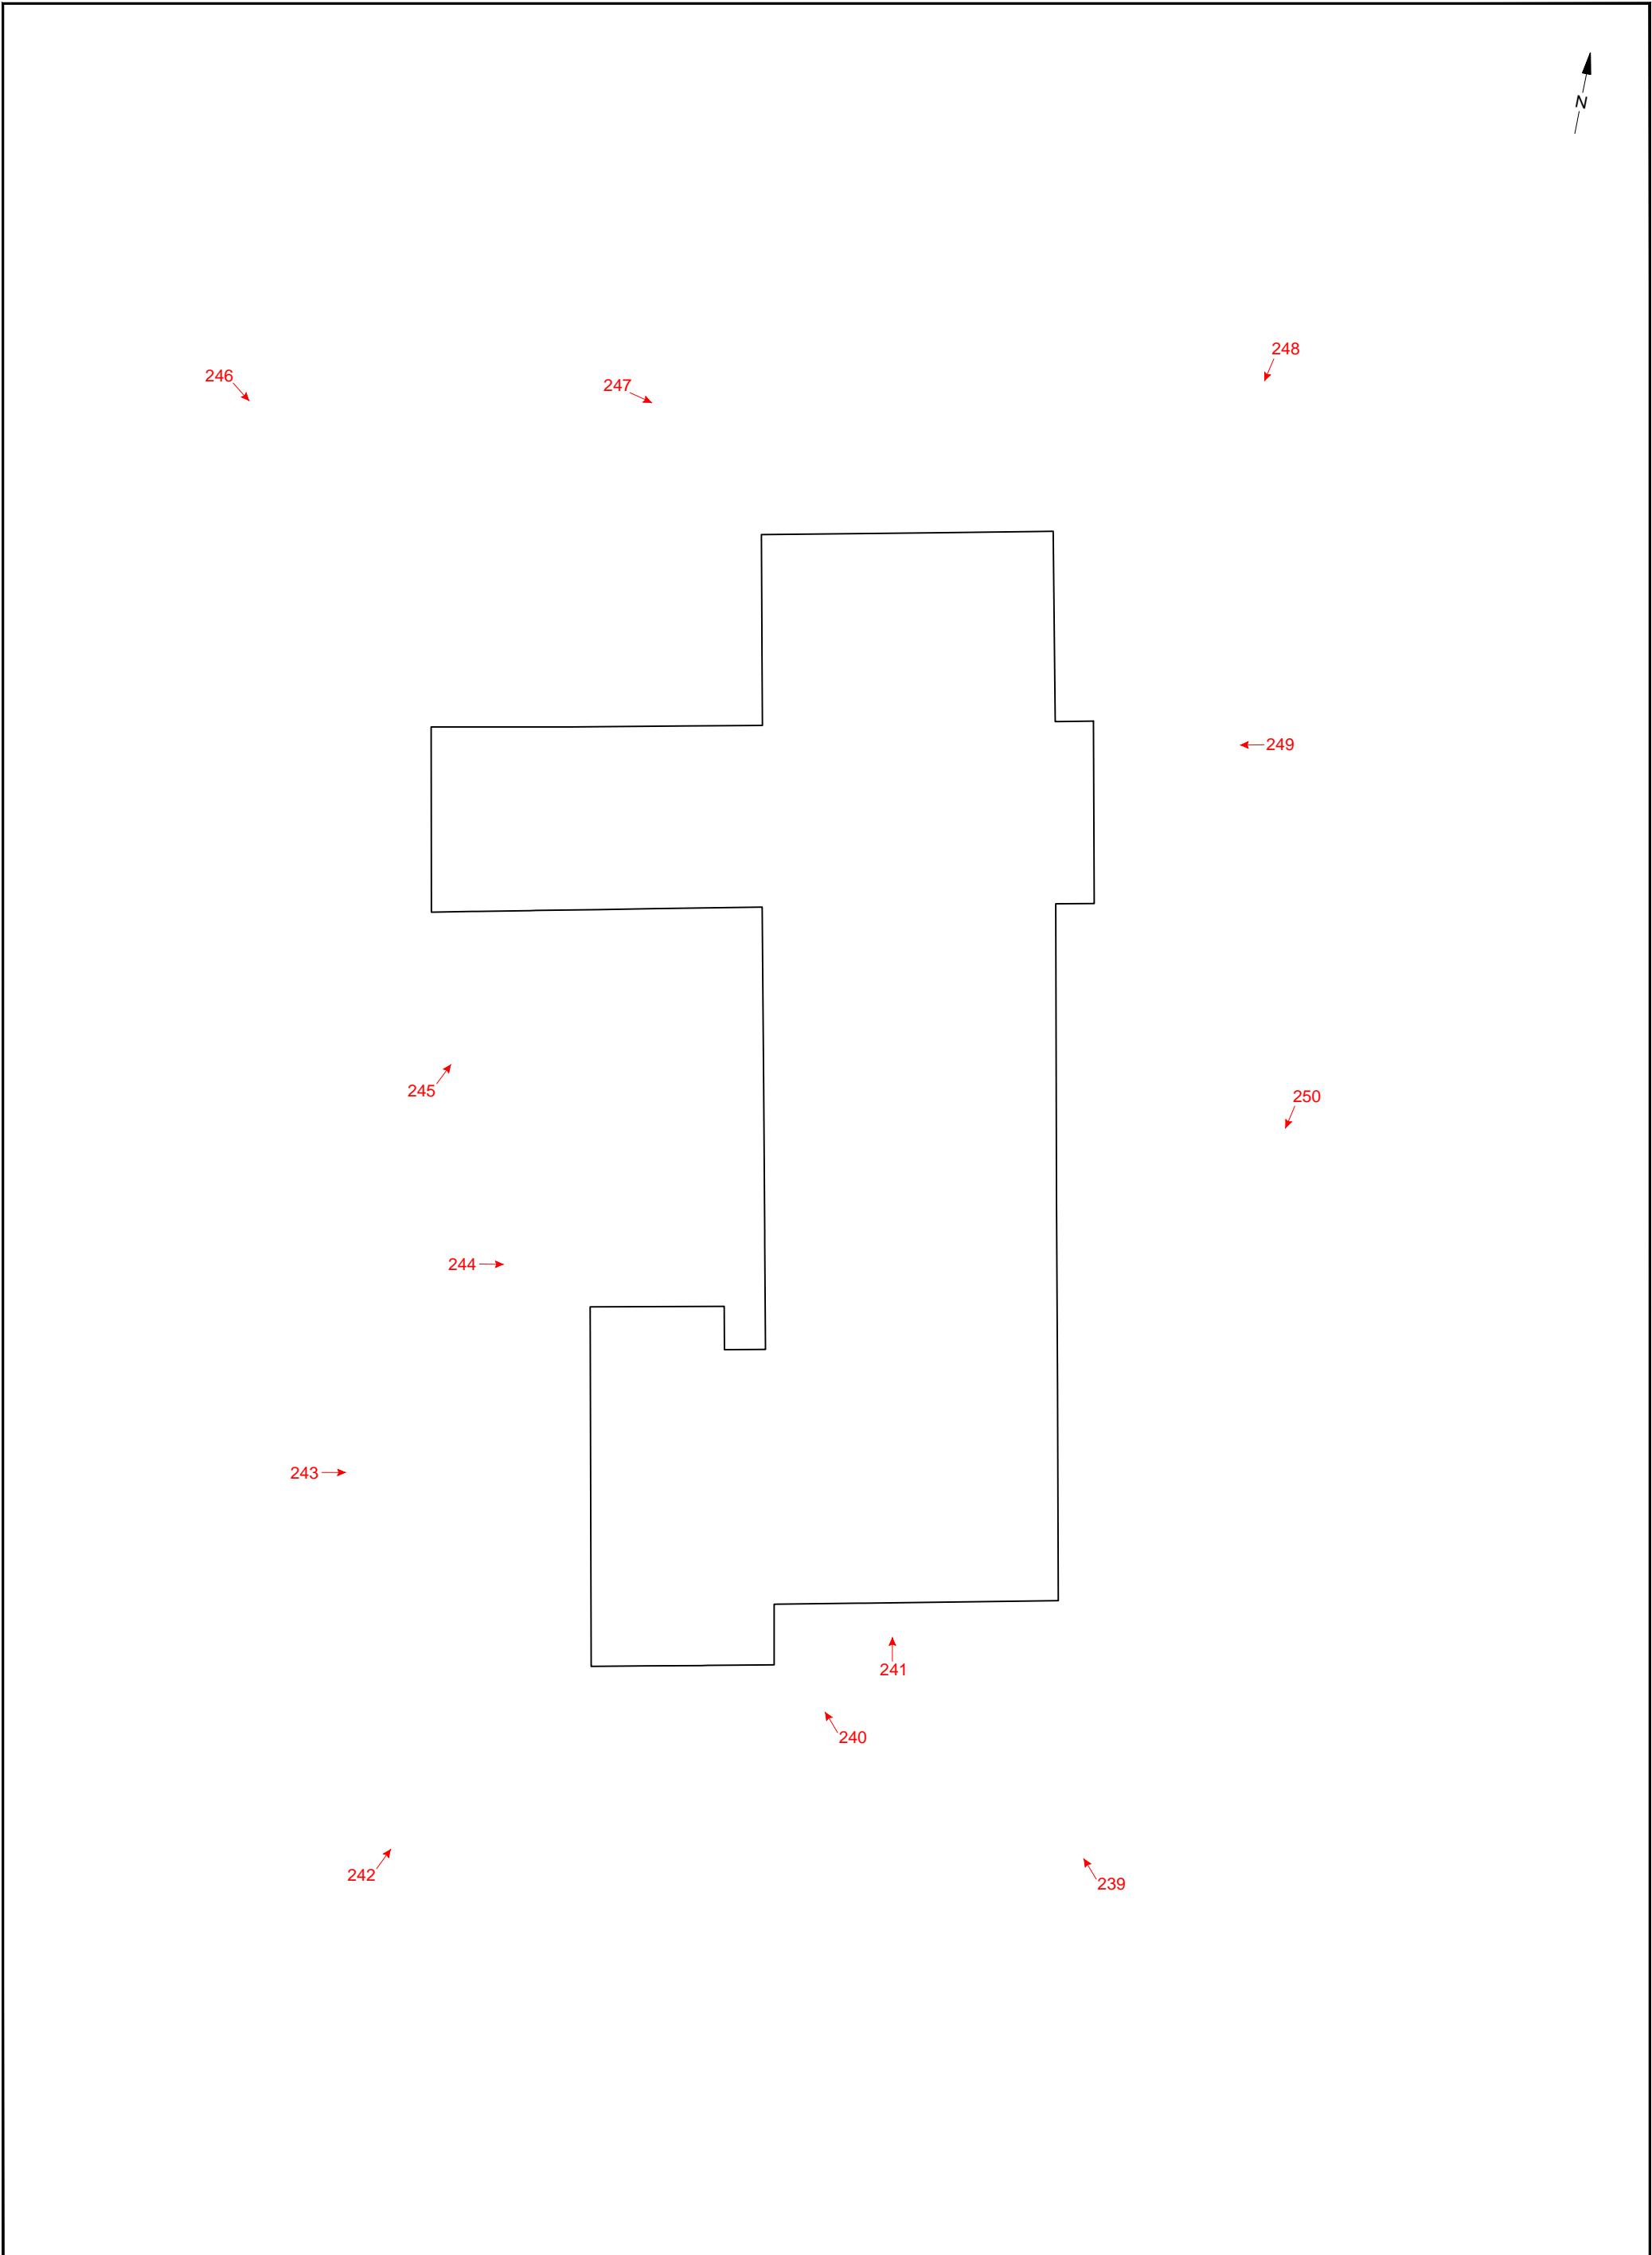
© Archaeology South-East		Harperbury Hospital, Radlett, Hertfordshire	Fig. 29
Project Ref: 160560	Feb 2018	Building 13, Fire Training Centre (originally Sewing Room), ground floor plan	
Report Ref: 2017303	Drawn by: CPC

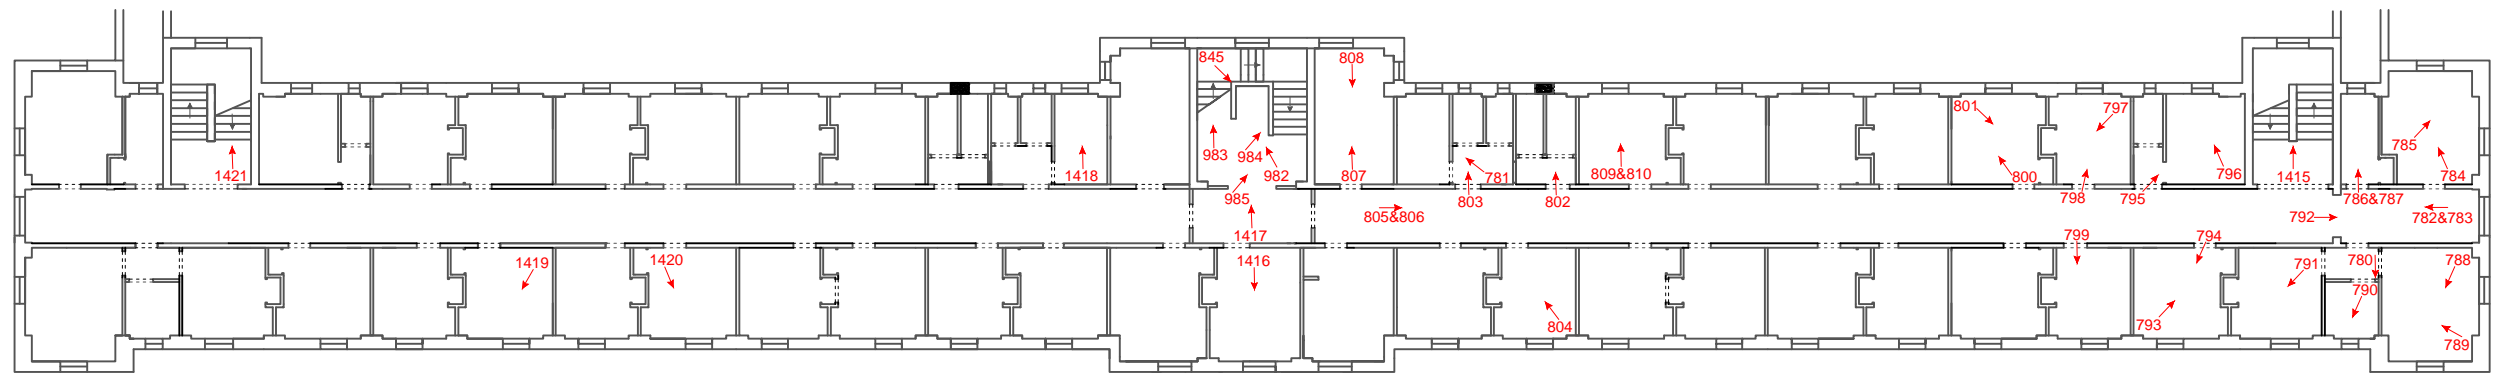
Building 28 First Floor Plan (1:250)

© Archaeology South-East		Harperbury Hospital, Radlett, Hertfordshire	Fig. 35
Project Ref: 160560	Feb 2018	Building 28, Nurses' Home, first floor plan	
Report Ref: 2017303	Drawn by: HS

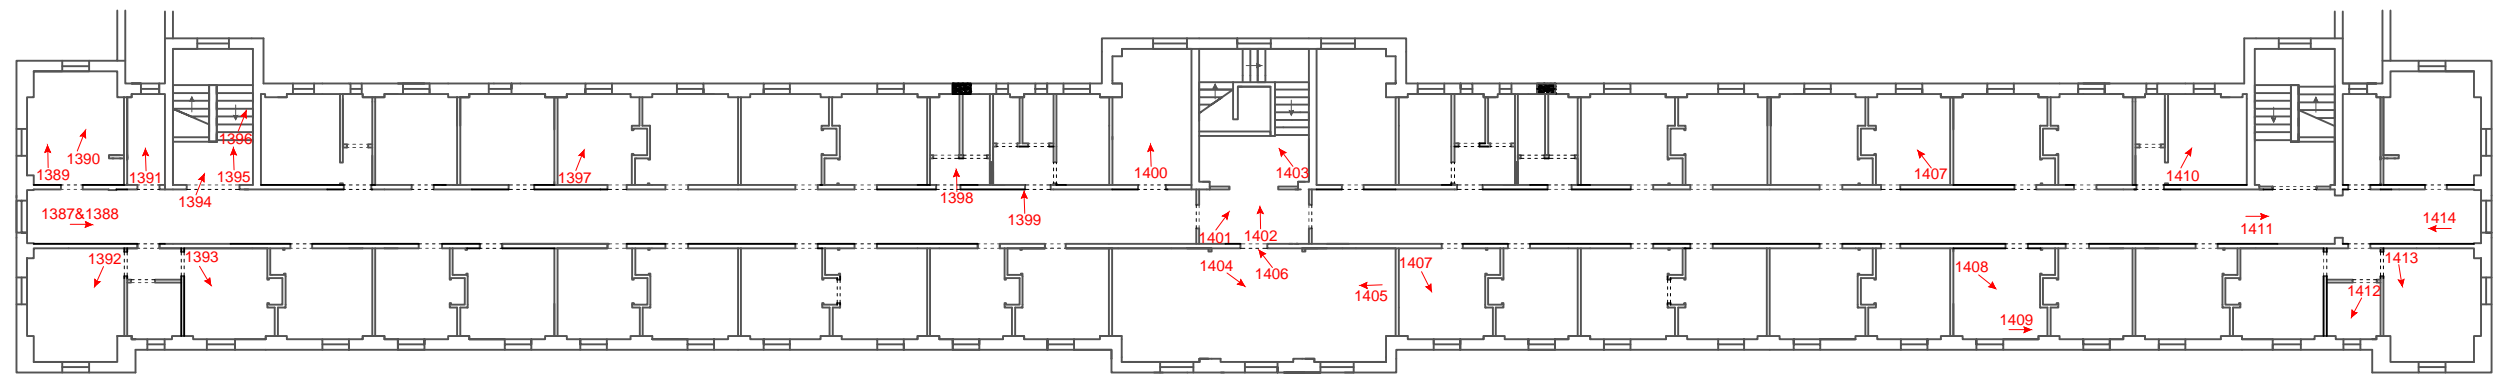
Building 28 Second Floor Plan (1:250)

© Archaeology South-East		Harperbury Hospital, Radlett, Hertfordshire	Fig. 36
Project Ref: 160560	Feb 2018	Building 28, Nurses' Home, second floor plan	
Report Ref: 2017303	Drawn by: HS

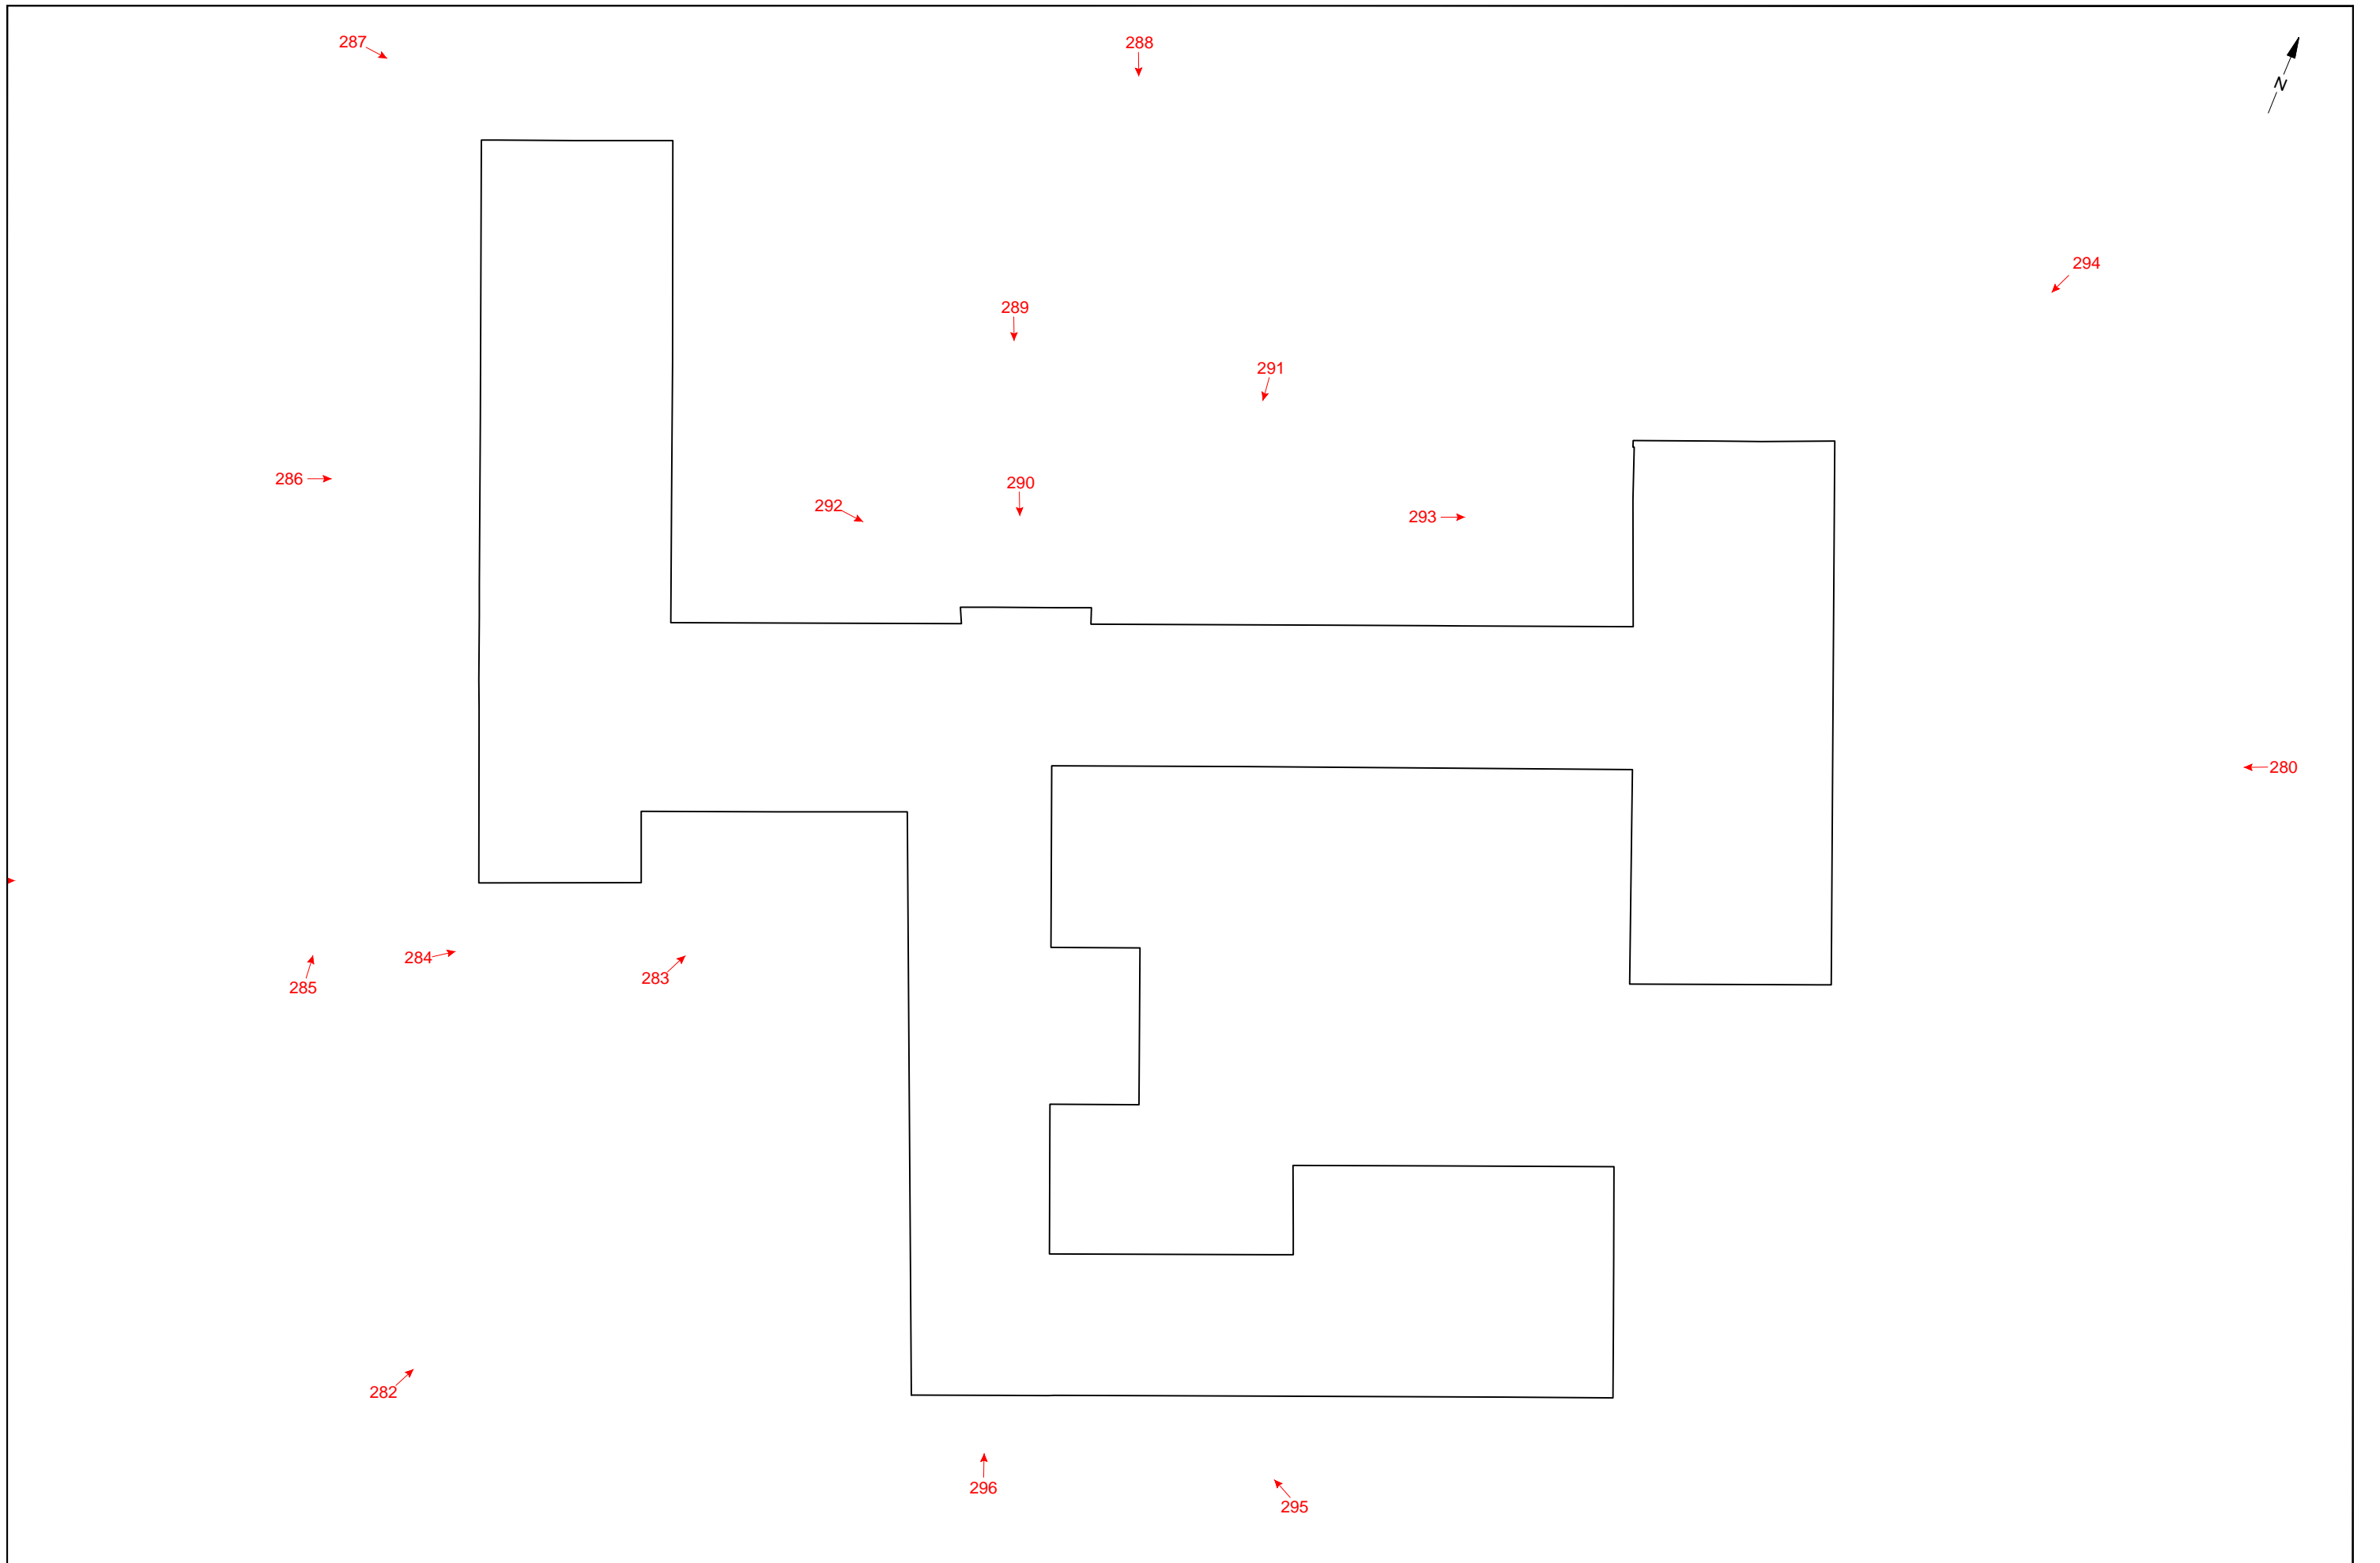
© Archaeology South-East		Harperbury Hospital, Radlett, Hertfordshire	Fig. 42
Project Ref: 160560	Feb 2018	Building 33, Nurses' Library and Postgraduate Centre, ground floor plan	
Report Ref: 2017303	Drawn by: CPC

7.9 Nurses' Library and Postgraduate Centre (Figs. 42 & 43; Plates 170-173)

7.9.7 The building comprises three two-storey ranges arranged around a courtyard, as well as an L-shaped single-storey range at its north-west corner. The entire building has a flat roof. The building's principal elevation faces north, towards a large car park; historic maps indicate that the building was situated originally immediately to the south of a swimming pool and club building (Fig. 42). The building is constructed in Flemish-bonded red-brown brick in an austere modernist style. Most of the windows were boarded up at the time of the survey; however, where visible they were plain-glazed and of steel construction.

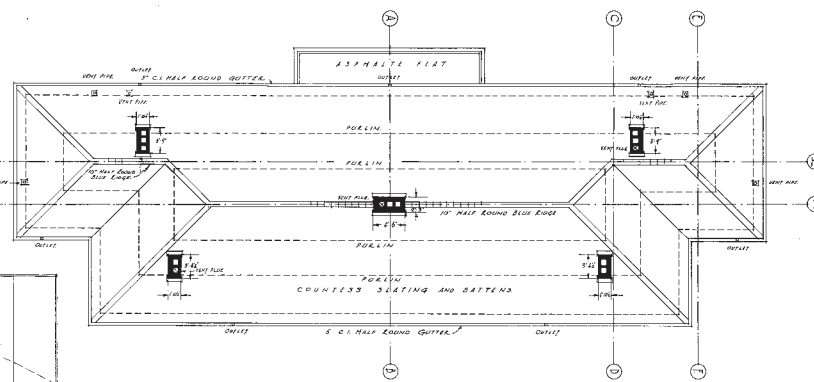
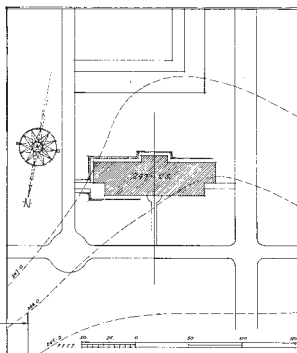
D.S.
DRAWING N° 1. (REVISED 2.2.33)
BLOCK N° 19.

Harperbury Hospital, Radlett, Hertfordshire
Building 34, Male Nurses' Quarters, Floor plans, 1933
