**FORMER HARPERBURY HOSPITAL,
HARPER LANE, RADLETT, HERTFORDSHIRE**

**HISTORIC BUILDINGS RECORD
(HISTORIC ENGLAND LEVELS 2 & 3)**

**Site Code: FHH17
Project No. 160560
Report No. 2017303
OASIS ID: archaeol6-305660**

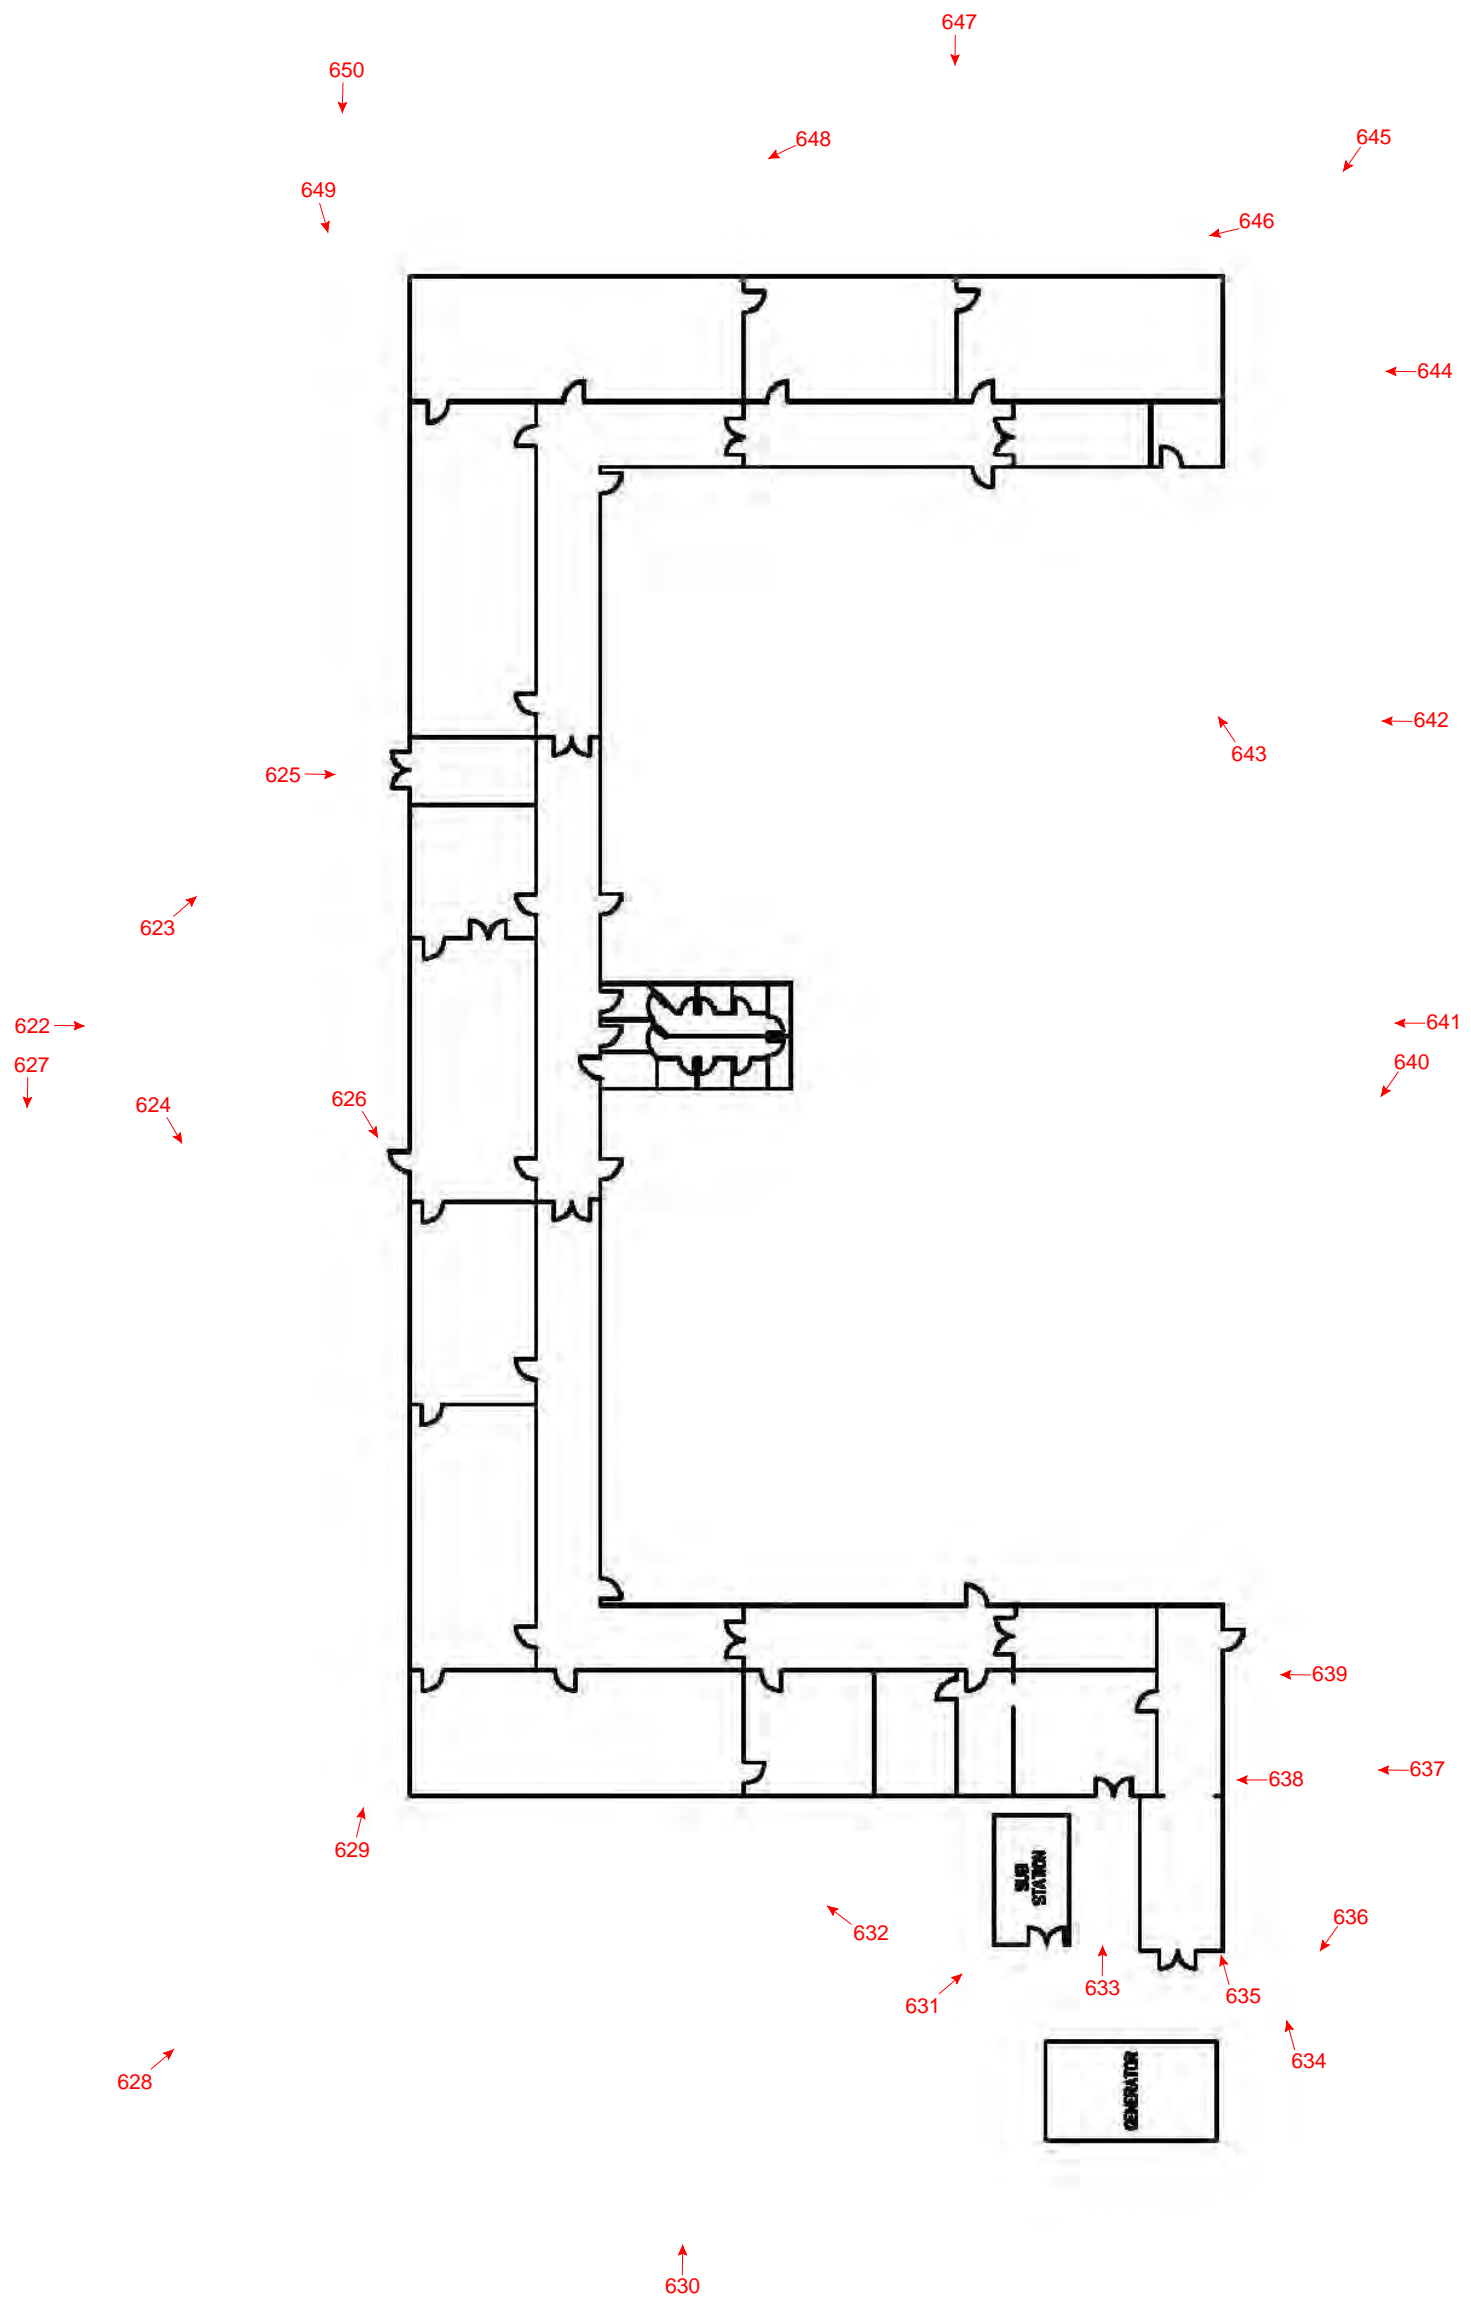
© Archaeology South-East		Harperbury Hospital, Radlett, Hertfordshire	Fig. 46
Project Ref: 160560	Feb 2018	Building 35, Workshops, ground floor plan	
Report Ref: 2017303	Drawn by: CPC

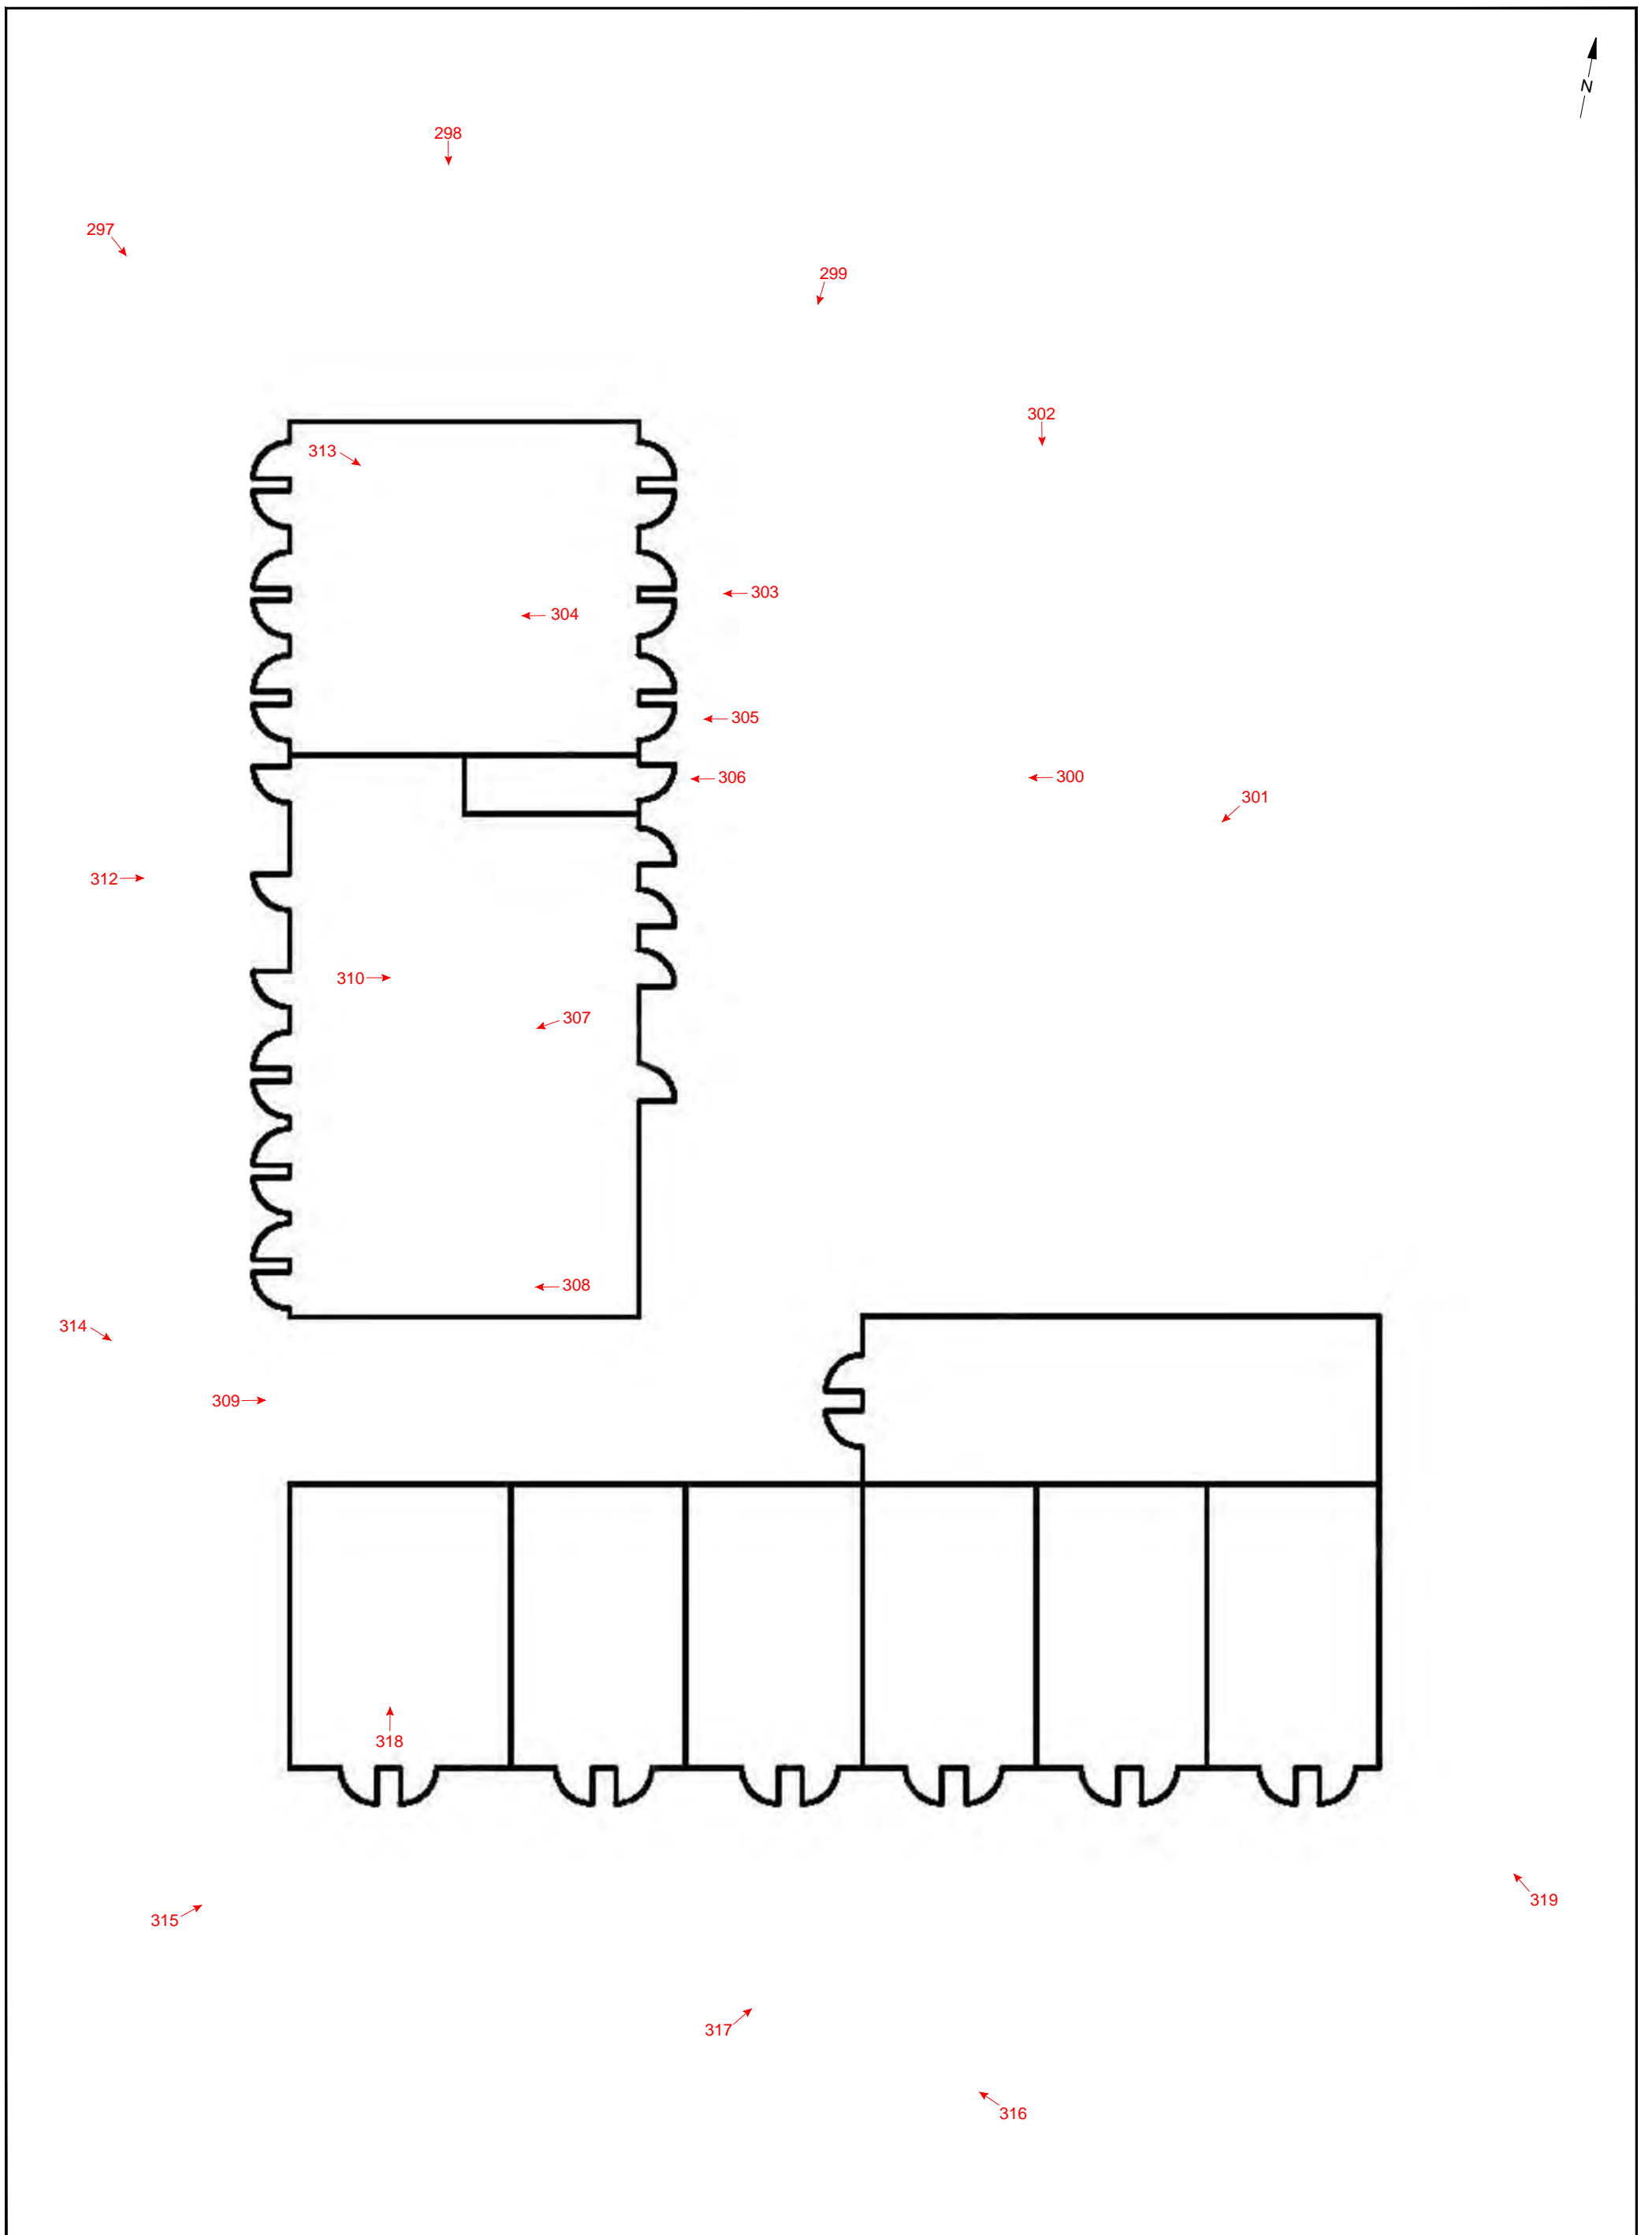
© Archaeology South-East		Harperbury Hospital, Radlett, Hertfordshire	Fig. 49
Project Ref: 160560	Feb 2018	Building 36, Garages, ground floor plan	
Report Ref: 2017303	Drawn by: CPC

7.12 Garages (Fig. 49; Plates 184-186)

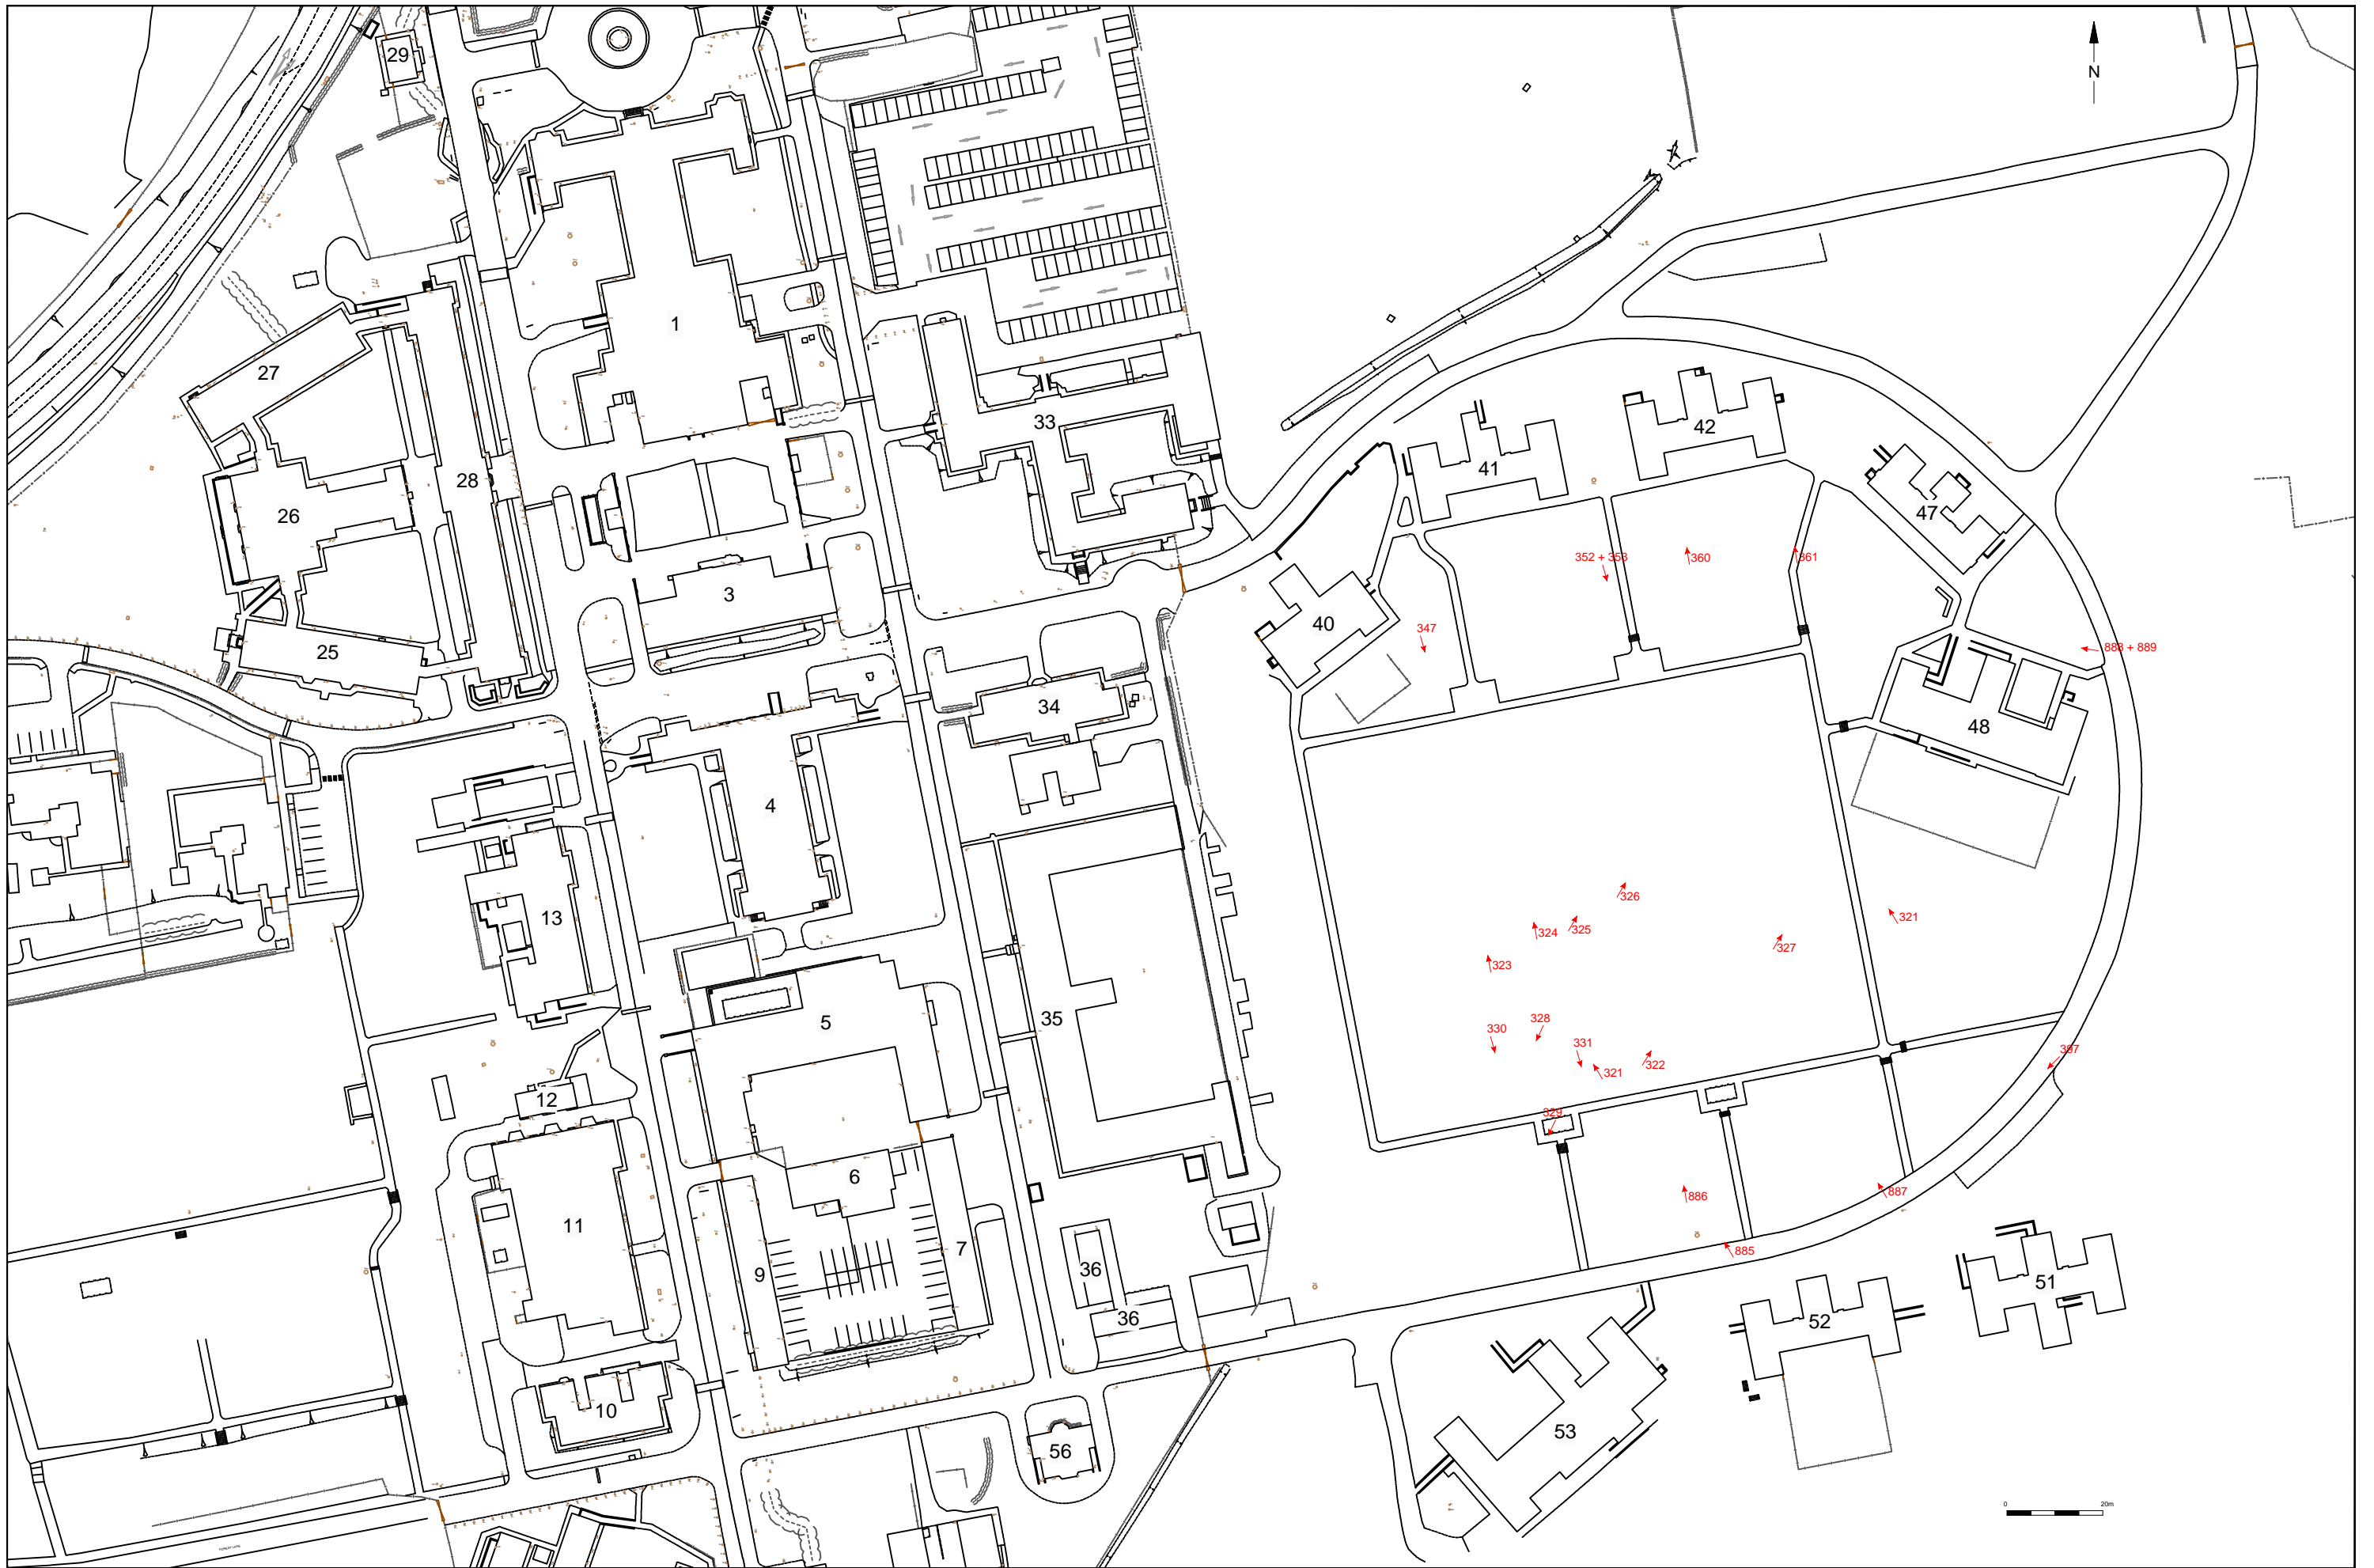
© Archaeology South-East		Harperbury Hospital, Radlett, Hertfordshire	Fig. 50
Project Ref: 160560	Feb 2018	Buildings 40-42, 47-48, 51-53, Male Villas and Pavilions, general layout	
Report Ref: 2017303	Drawn by: CPC

7.13.6 The villas are situated on the eastern side of the hospital site, where they provided accommodation for male patients. They are laid out around a road known as Meadow Way, and at their centre is a large open space which served as a football field (Plates 187 & 188; Fig. 50). There are two different types of building: two-storey villas and single-storey 'pavilions'. Patients were classified with the aim of allowing patients of similar abilities, interests and tastes to live and work together: 'high' and 'medium grade' adult patients were accommodated in the villas, whilst pavilions were occupied by 'low grade' adults, epileptics, physically disabled and sick patients who required a greater level of care (Brown 2008).

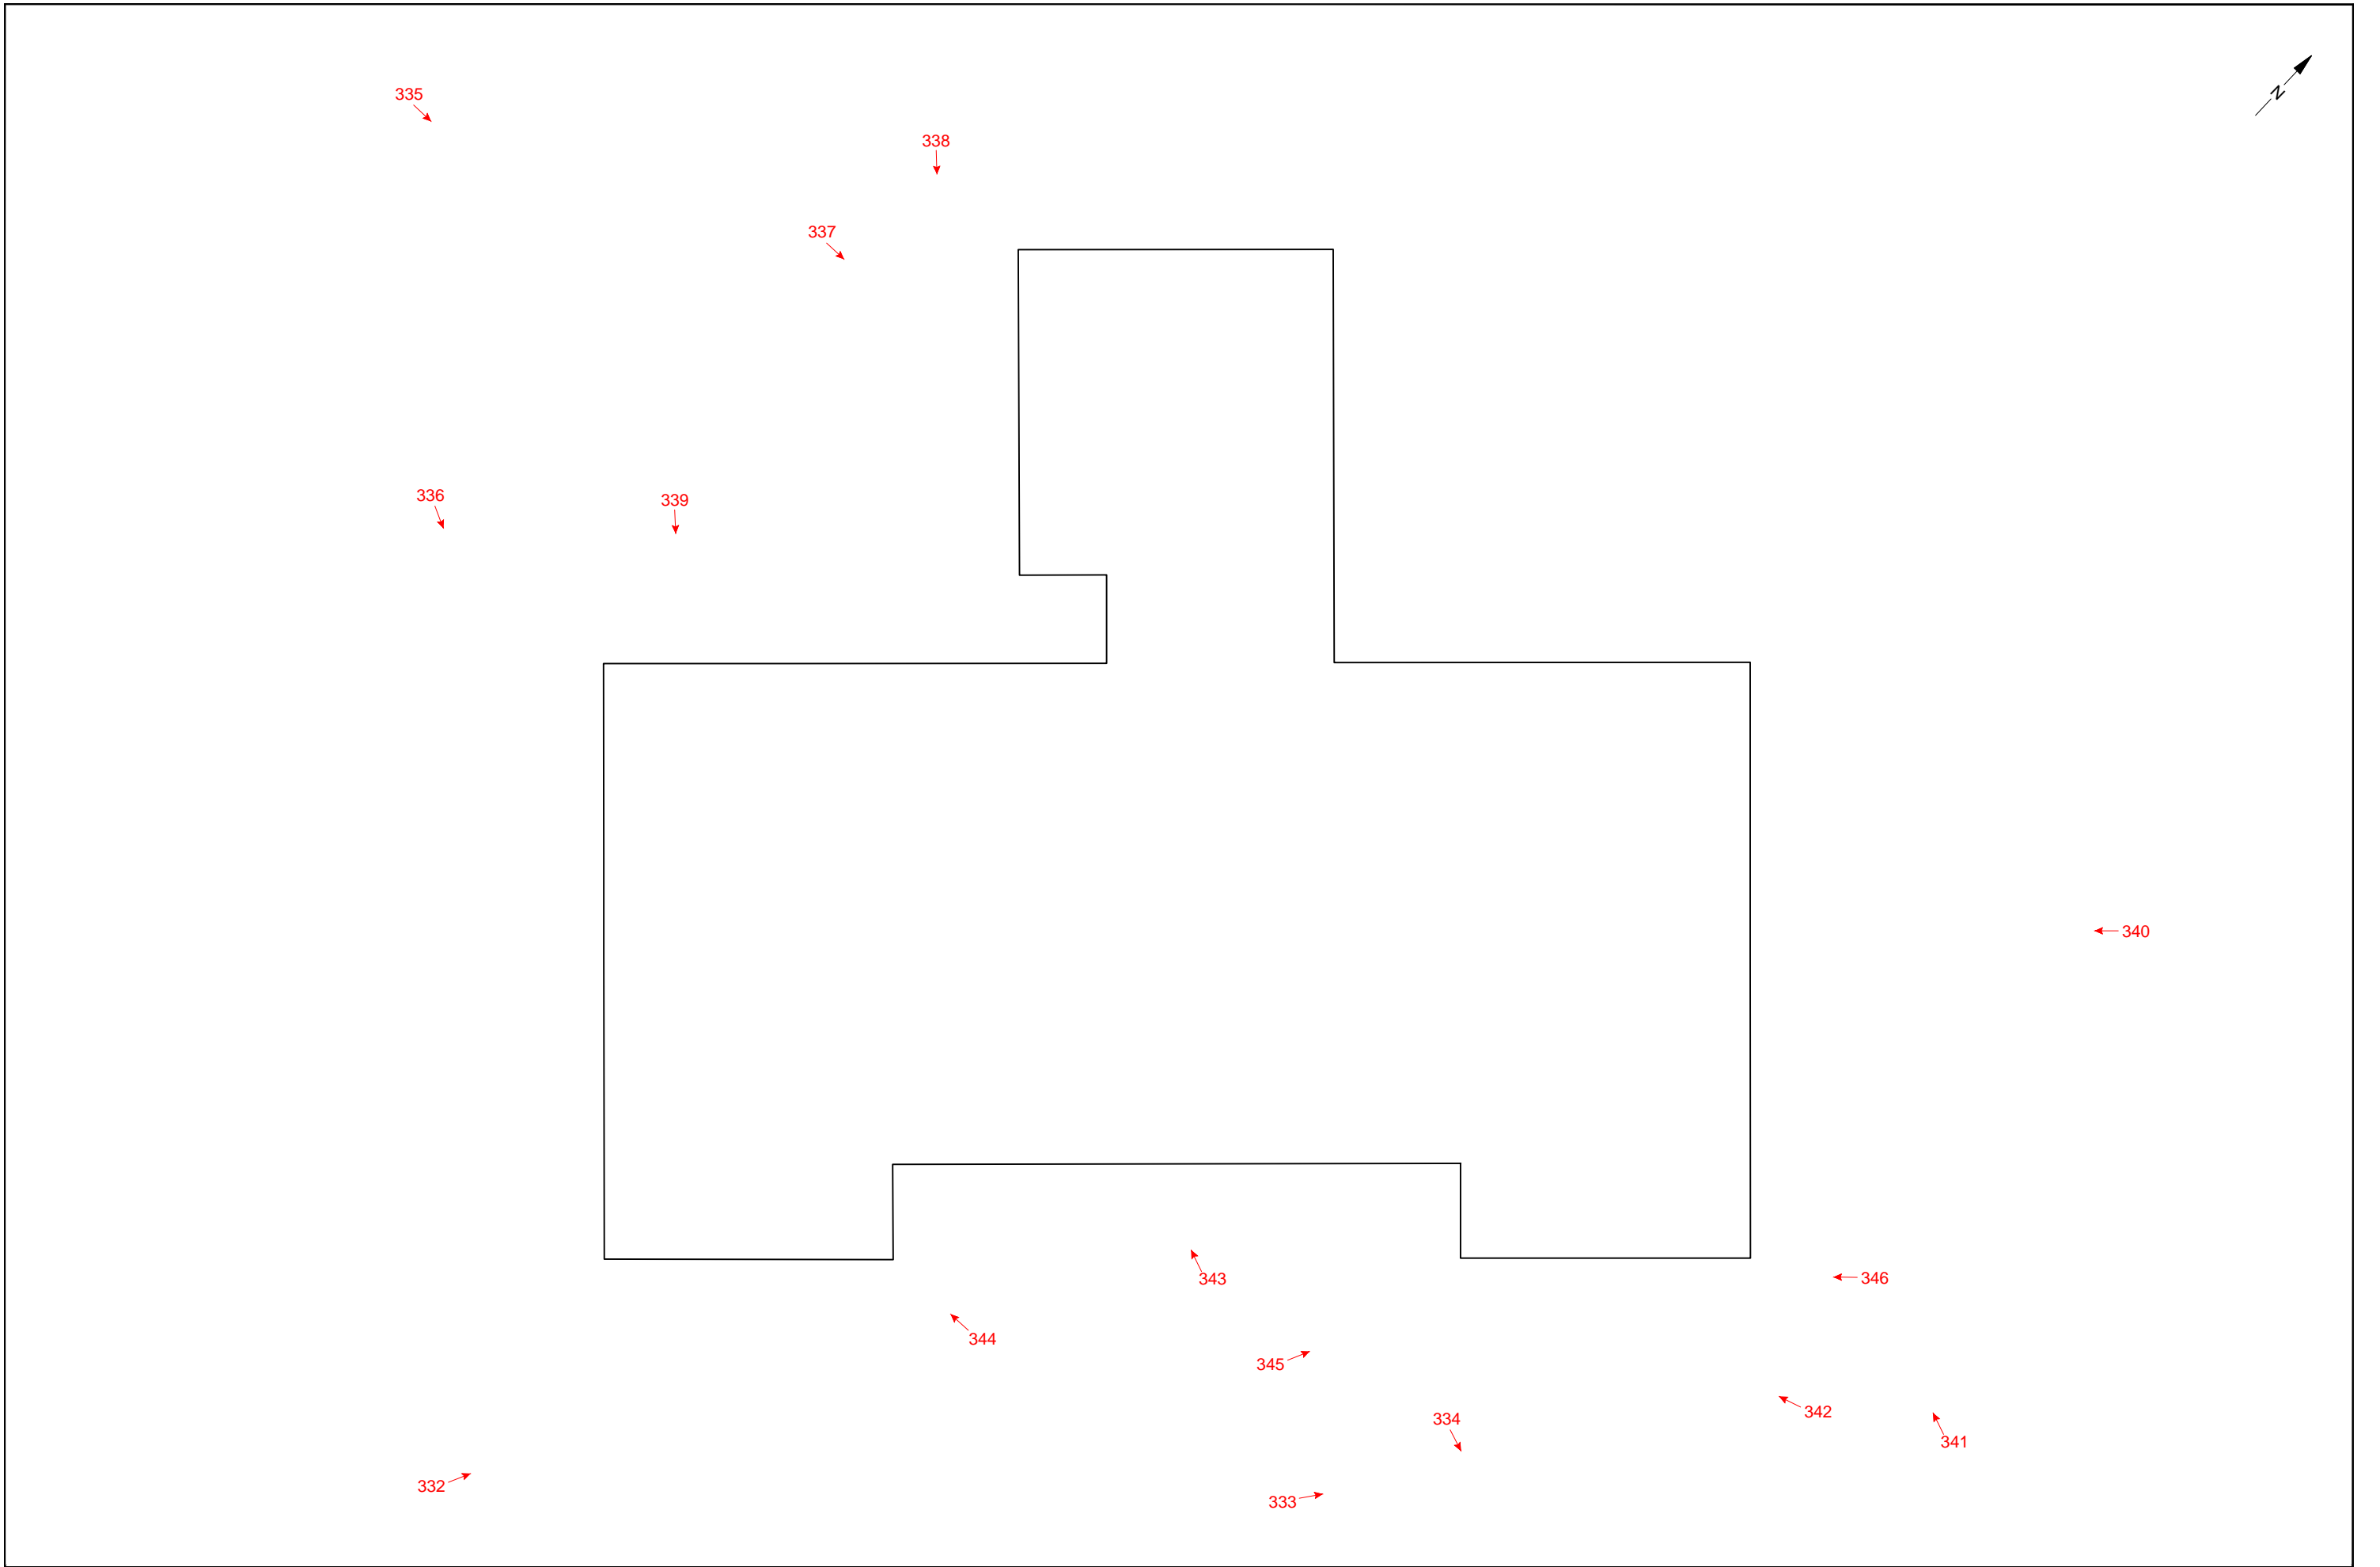
© Archaeology South-East		Harperbury Hospital, Radlett, Hertfordshire	Fig. 51
Project Ref: 160560	Feb 2018	Building 40, Male Villa, ground floor plan	
Report Ref: 2017303	Drawn by: CPC

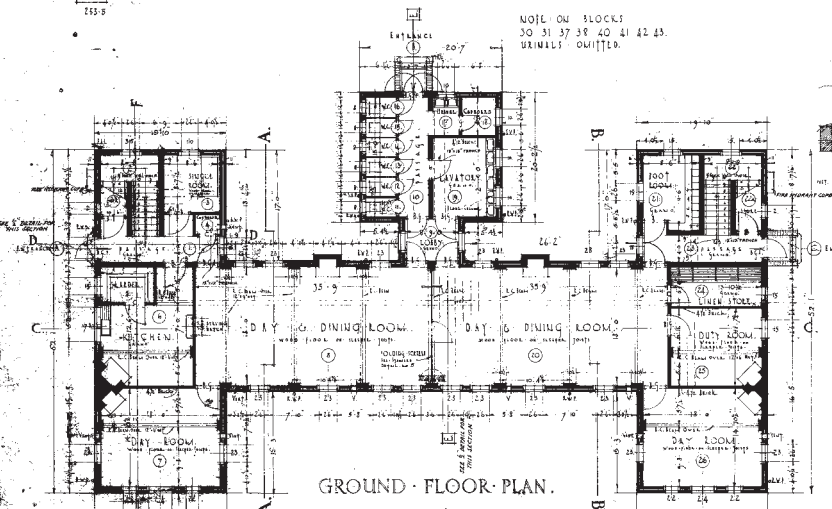
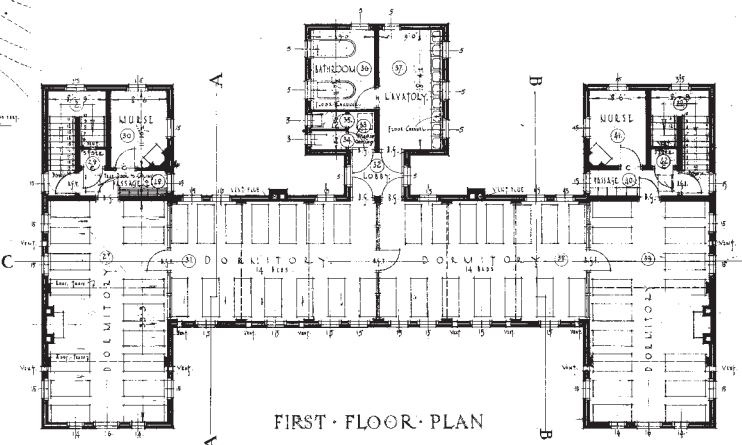
© Archaeology South-East		Harperbury Hospital, Radlett, Hertfordshire		Fig. 58
Project Ref: 160560	Feb 2018	Building 51 & 52, Male Villa, historic floor plans, undated		
Report Ref: 2017303	Drawn by: SC

NOTE: 5'-8" PLANK JOIST, ALL BLOCKS FOR CAVITY AND FLOOR VENTILATION AT GROUND FLOOR LEVEL AT APPROX. 8'-0" INTERVALS ARE DIRECTED.

MIDDLESEX COLONY SHUNLEY HERTS: VILLA FOR 60 ADULTS MALE & FEMALE:

7.13.17 Historic floor plans (Fig. 58) for a standard type of villa for sixty adults, which included Buildings 51 and 52, show the central range was occupied by dining and day rooms at ground floor level, with two fourteen-bed dormitories above. The cross-wings each housed a ground floor day room, with kitchen, larder and single room for a patient to the west, and a duty room for a nurse, linen store and boot room to the east; their first floors comprised a fifteen-bed dormitory and nurse's room. Given the parallels of their form and fenestration pattern, it seems likely that the layouts of Buildings 41 and 42 were broadly similar. A number of villas of the same configuration were also built on the female (west) side of the hospital. Plans from 1978 (not reproduced) show that, by that date, Building 42 was serving as a mixed-sex villa and its dormitories had been subdivided to provide a series of smaller wards. Similarly, c.1993 the first floor dormitories in Building 52 had been subdivided to provide single bedrooms.

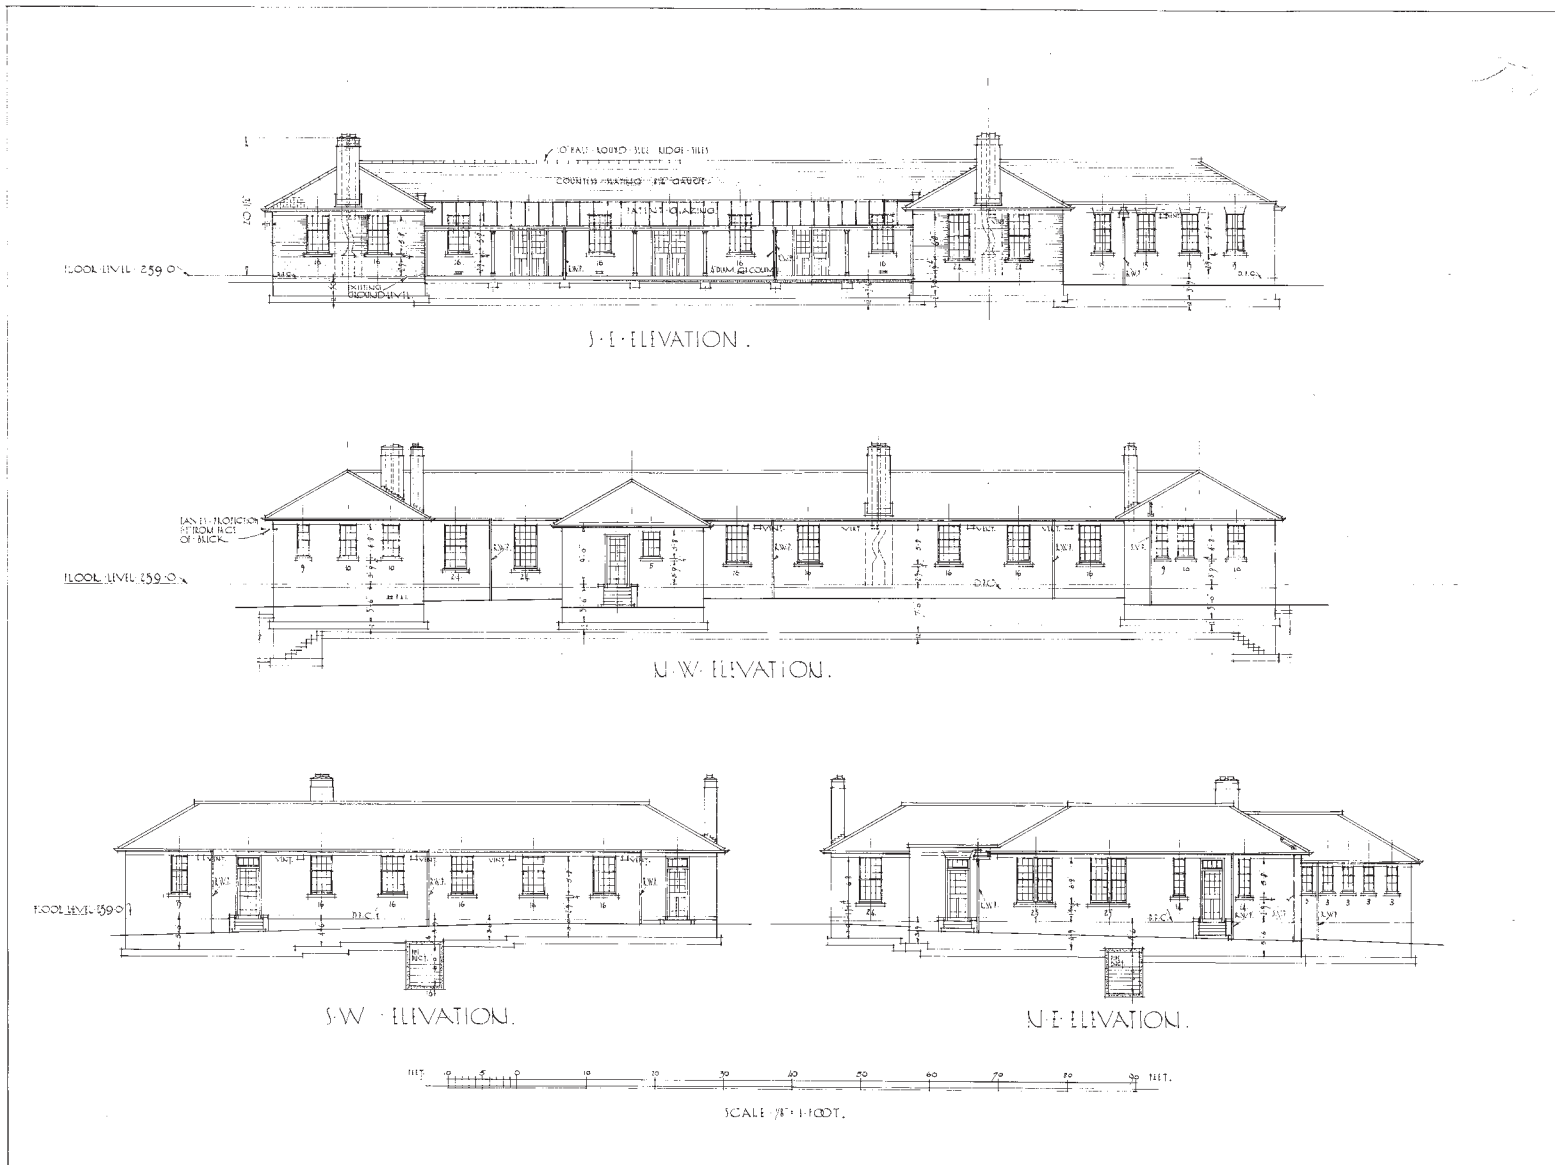
© Archaeology South-East		Harperbury Hospital, Radlett, Hertfordshire	Fig. 65
Project Ref: 160560	Feb 2018	Building 53, Male Pavilion, historic elevation drawings, undated	
Report Ref: 2017303	Drawn by: SC

The MIDDLESEX COLONY SHENLEY PAVILION for 50 SICK PATIENTS

7.13.25 The principal elevation of the main range, between the projecting wings, originally comprised a regular arrangement of sashes and three double doors, which opened onto a verandah with glazed roof (Fig. 65; Plate 205). This would have allowed patients to benefit from sunlight and fresh air. The verandah has latterly been part-enclosed with a flat-roofed brick extension with a parapet clad with painted timber boards, which was added c.1971 (Fig. 66). The surviving section of verandah comprises two cylindrical cast iron columns which carry a later corrugated Perspex roof (Plate 206). The two projecting wings originally each had a pair of sashes; the north-eastern of the two has a door in place of one of its windows. Each of the wings has a tall brick chimneystack to its roof hip. To the north-east of the north-eastern wing is a brick-built structure with a regular arrangement of four windows and a flat roof behind a brick parapet, which the original plans show is contemporaneous with the building's construction (Plate 207).

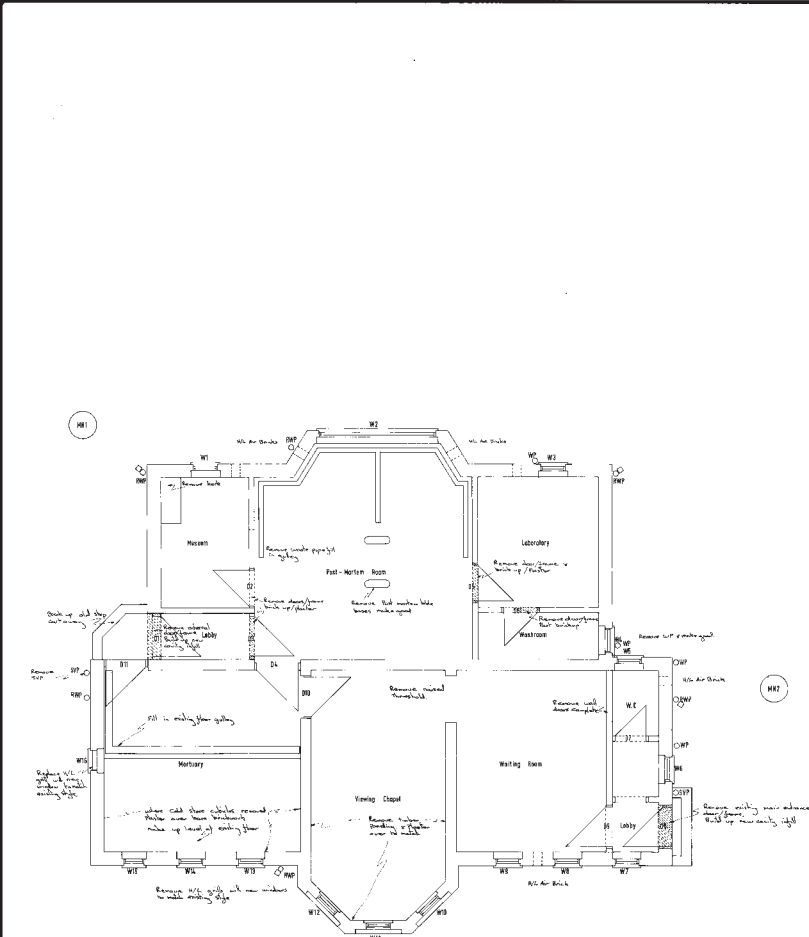
Existing Mortuary Plan

Proposed Art & Speech Therapy Unit Plan

REVISED	
REVISIONS	
NORTH WEST HERTS. HEALTH AUTHORITY	
DISTRICT WORKS OFFICER G. L. GREENWOOD	
JOB	Harperbury Hospital. Mortuary.
TITLE	Plan as Existing & Proposed Conversion to Art & Speech Therapy Dep
SCALE	1:50
DATE	June 1988 DRAWN b.p.h
REVISION	
DRG No:	04613-64-10-B-VP00-02
