**FARM BUILDINGS AT BRICK HOUSE FARM
NEWPORT ROAD, DEBDEN,
SAFFRON WALDEN, ESSEX**

HISTORIC BUILDING RECORDING

Authors:	Lee Prosser PhD Tansy Collins BSc Kathren Henry Peter Thompson MA
NGR: TL 5442 3404	Report No: 4066
District: Uttlesford	Site Code: DNBF12
Approved: Claire Halpin	Project No: 4719
Signed:	Date: April 2012

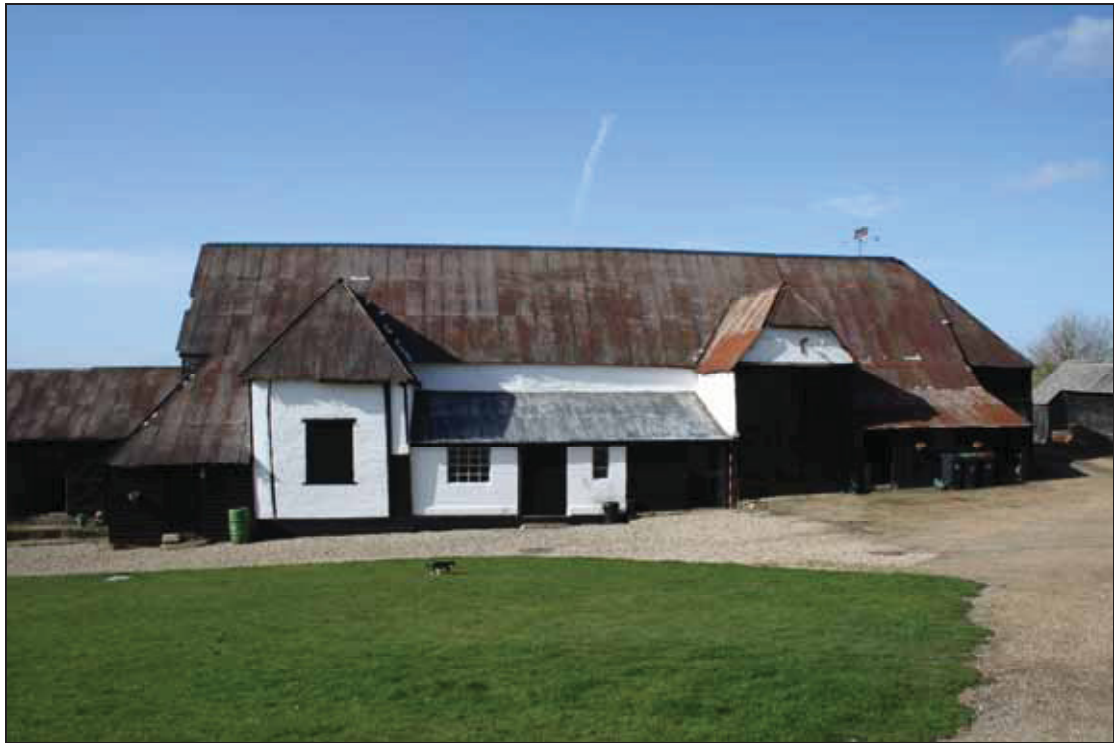
Plate 1 East elevation of Building 1, taken from the east (DP 16)

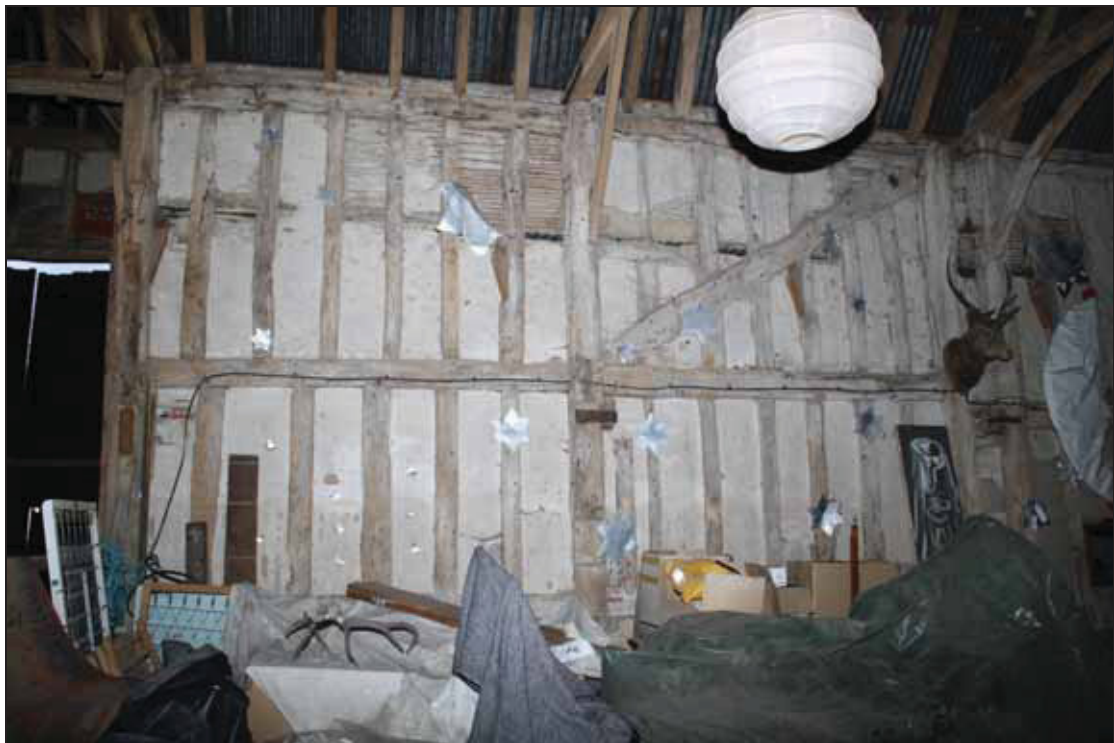
Plate 2 East side of Bays 4 and 5, taken from the west (DP 48)

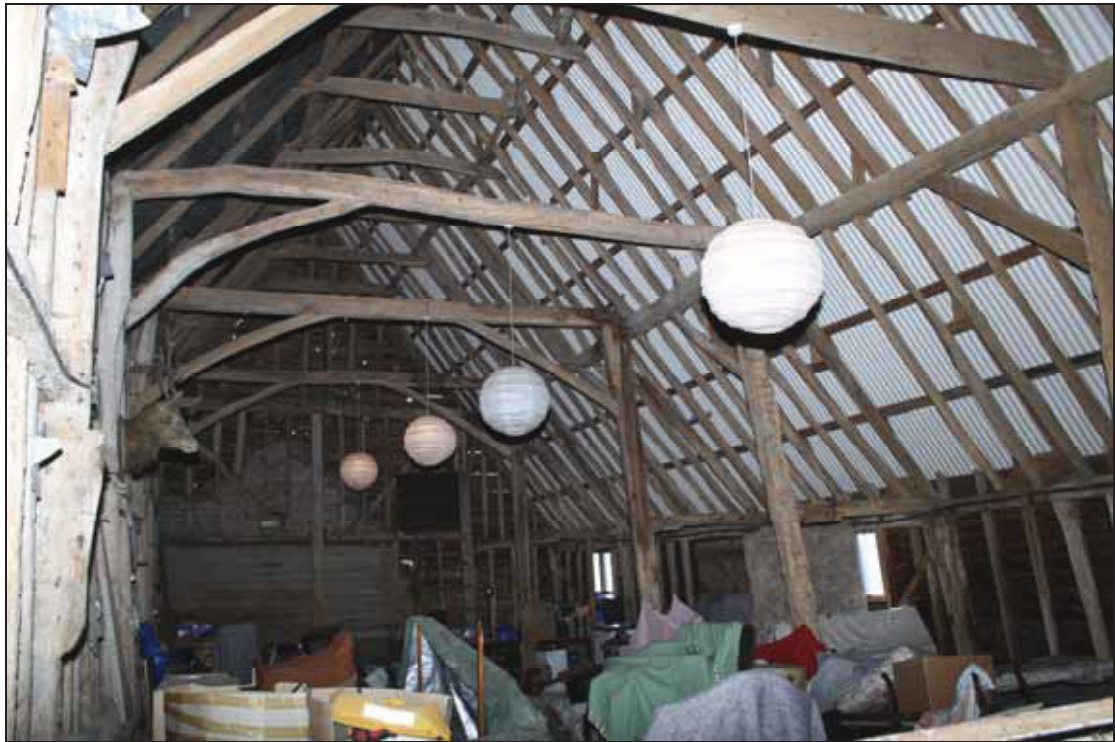
Plate 3 Southern half of Building 1, taken from the north (DP 41)

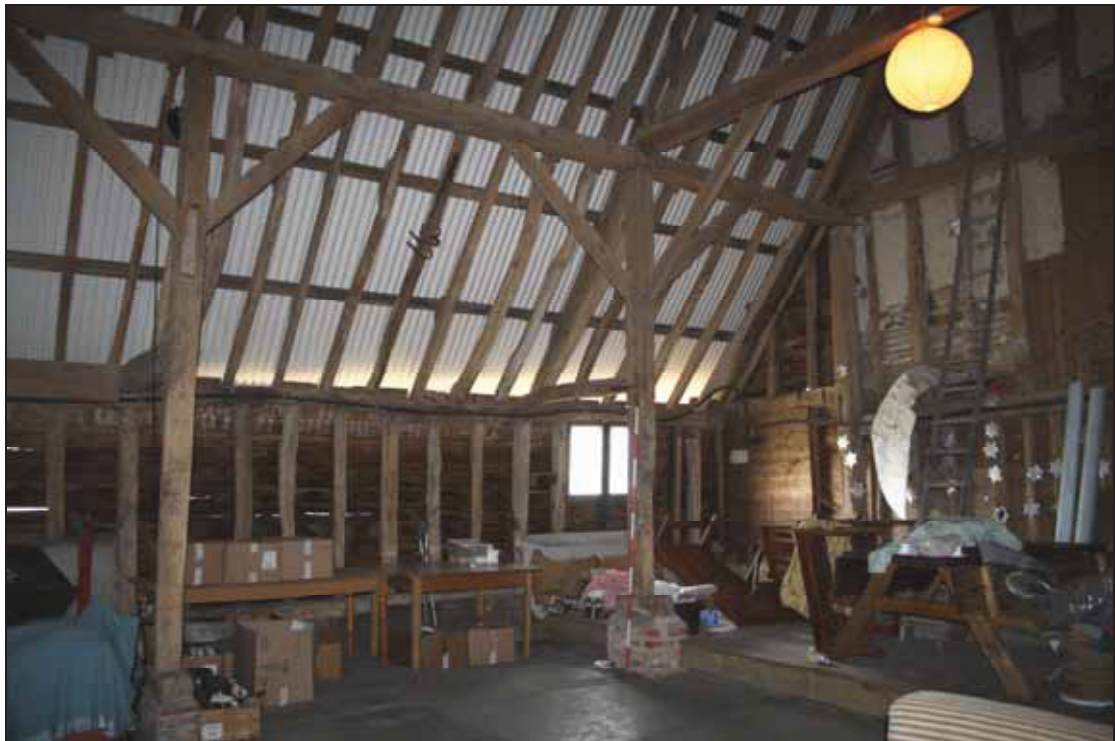
Plate 4 West side of Bays 1 and 2, taken from the south-east (DP 42)

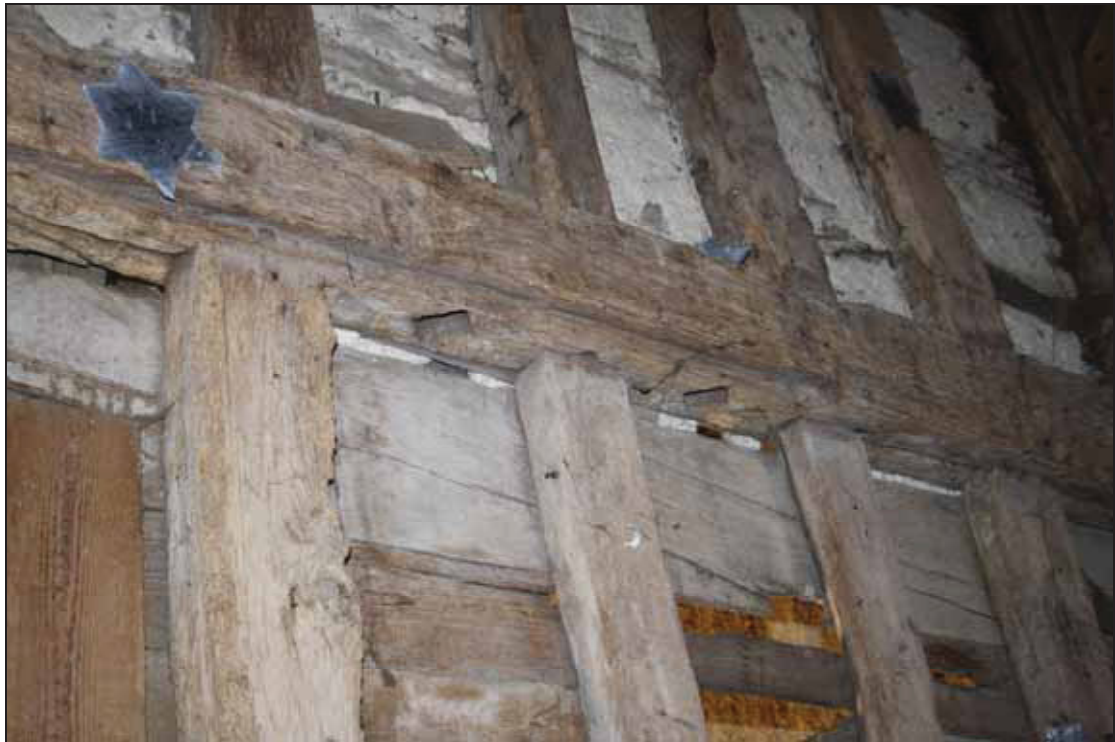
Plate 5 Position of original lower window on the east side of Bay 2 (Building 1), taken from the north-west (DP 46)

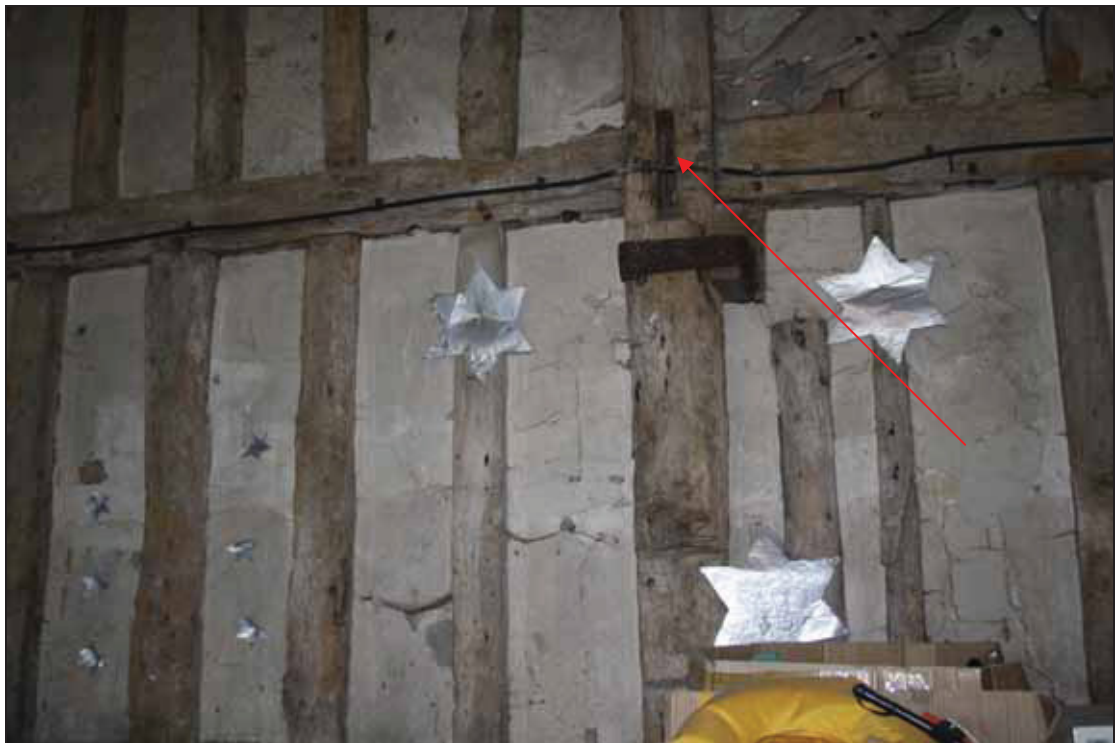
Plate 6 East side of Truss 4 (Building 1) showing original window position in Bay 4 and mortise for lateral binding joist (indicated), taken from the west (DP 53)

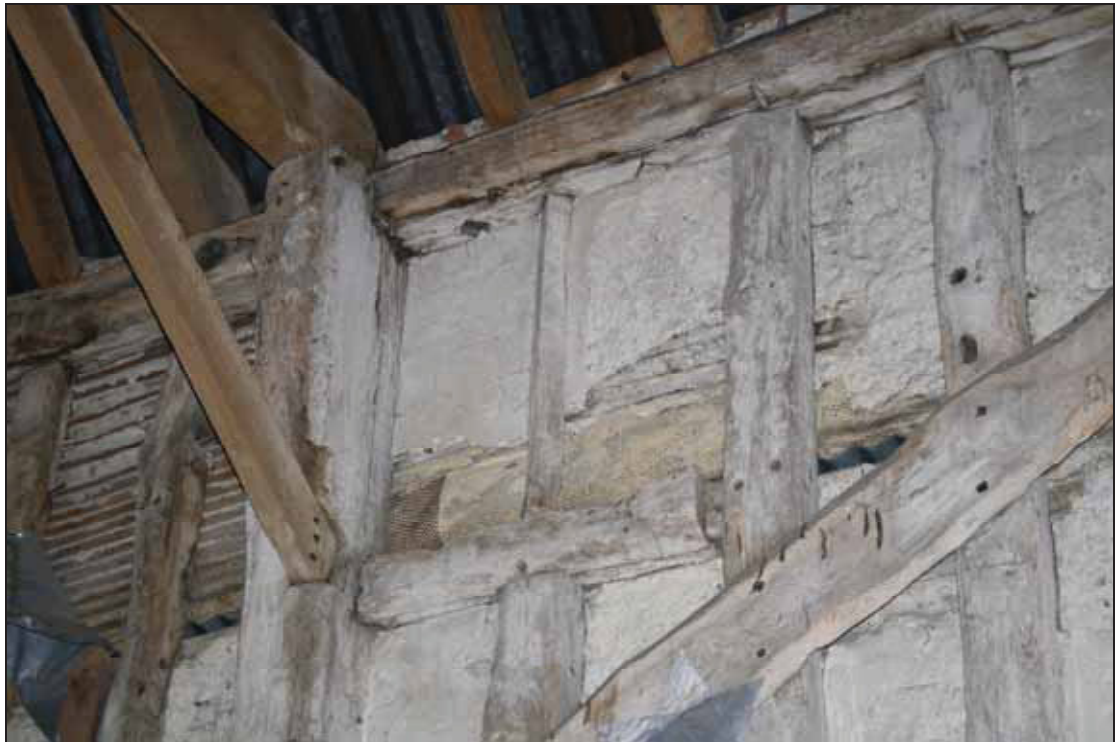
Plate 7 Original upper window on the east side of Bay 5 (Building 1) with original diamond profile mullion, taken from the south-west (DP 51)

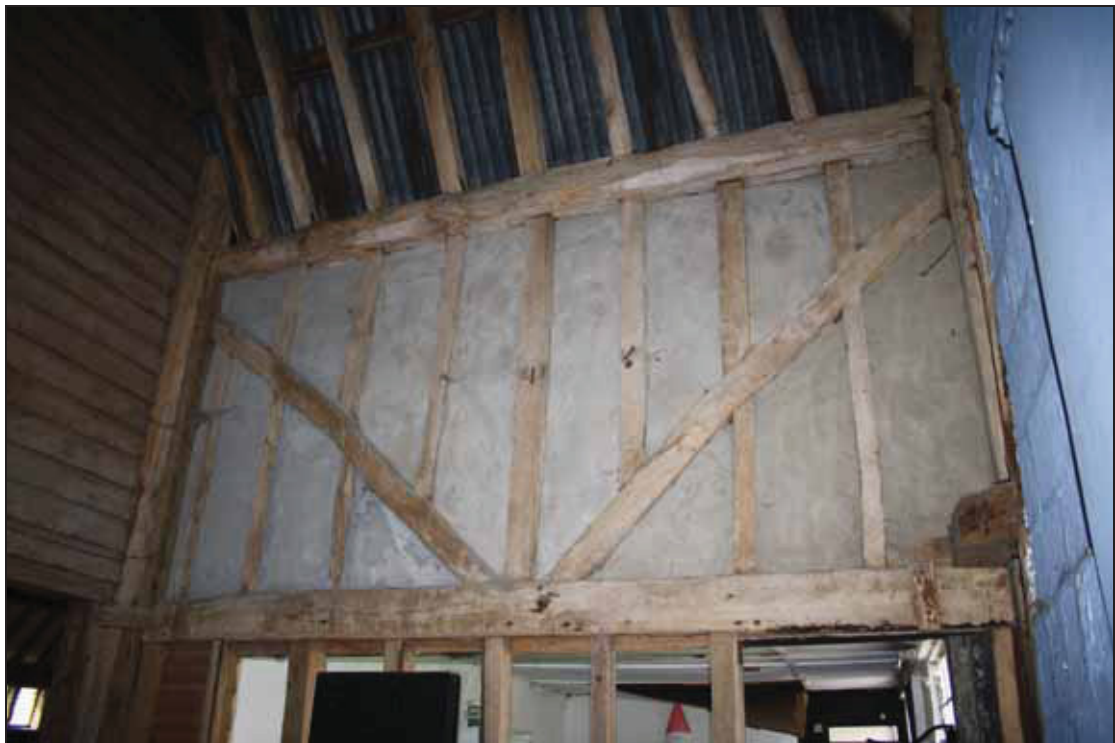
Plate 8 North wall of the south porch at upper level (Building 1), taken from the south (DP 65)

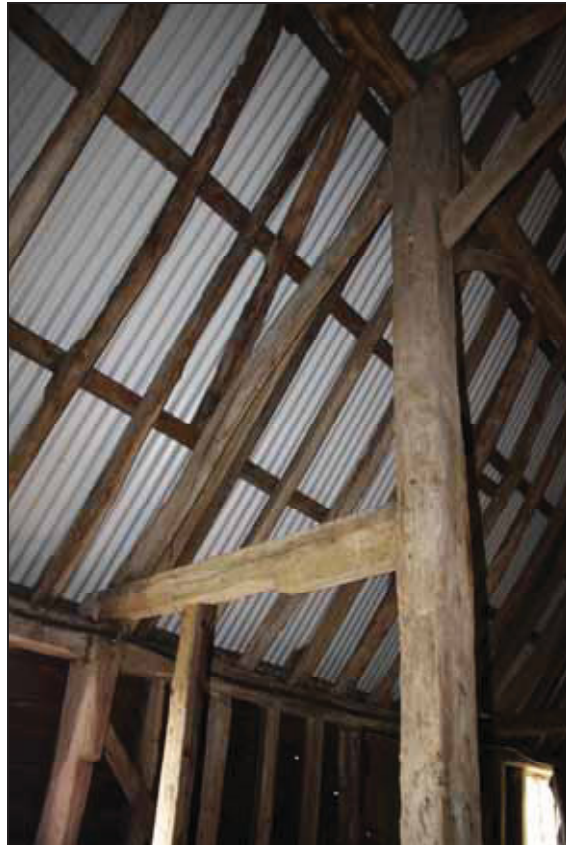
Plate 9 West end of Truss 7 (Building 1) within the aisle, taken from the south-east (DP 62)

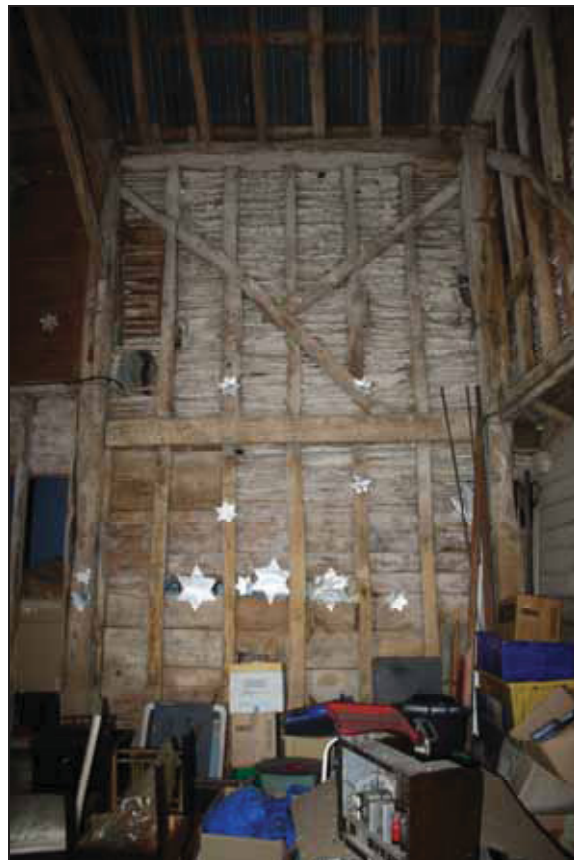
Plate 10 East side of Bay 8, taken from the west (DP 61)

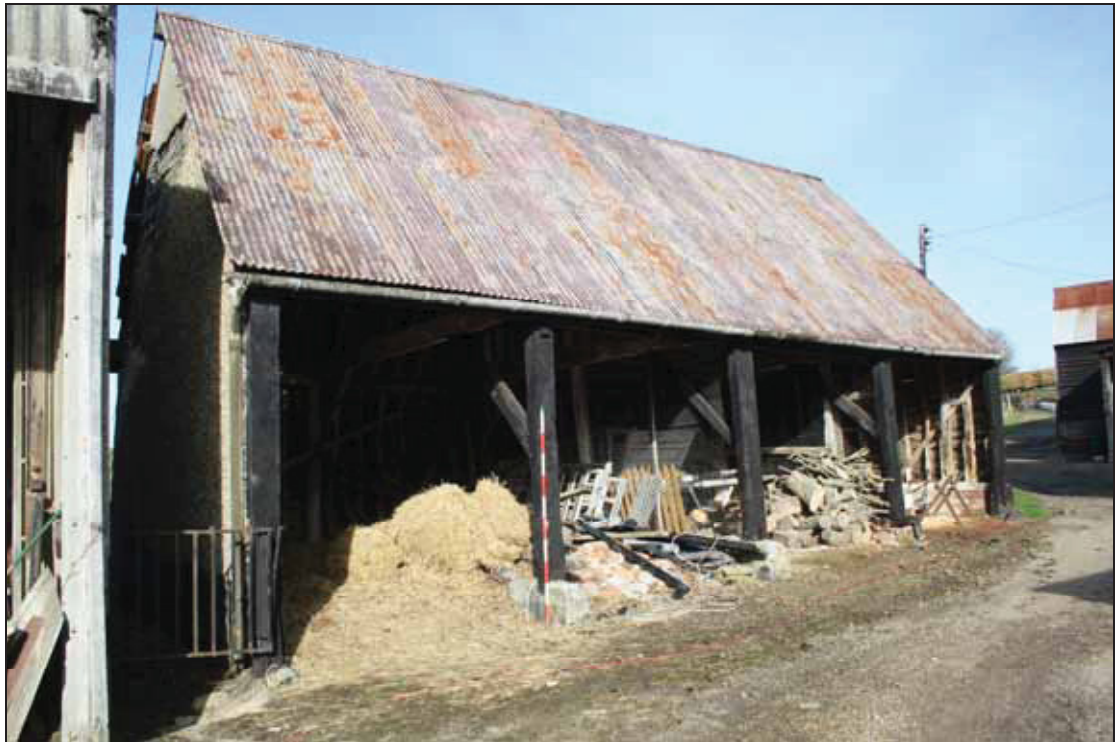
Plate 11 East elevation of Building 2, taken from the south-east (DP 01)

5.2.1 This building is a four-bay cart-shed, open-fronted on the east which rises to a pitched roof covered with corrugated metal sheeting (Plate 11). The walls are largely weatherboarded except on the south, which has been rendered with an unpainted pebbly roughcast of 20th century date. Other elements include a high-set pitching door on the north side within the gable which leads to an independent loft occupying the northern two bays, and given access by an attached metal ladder.

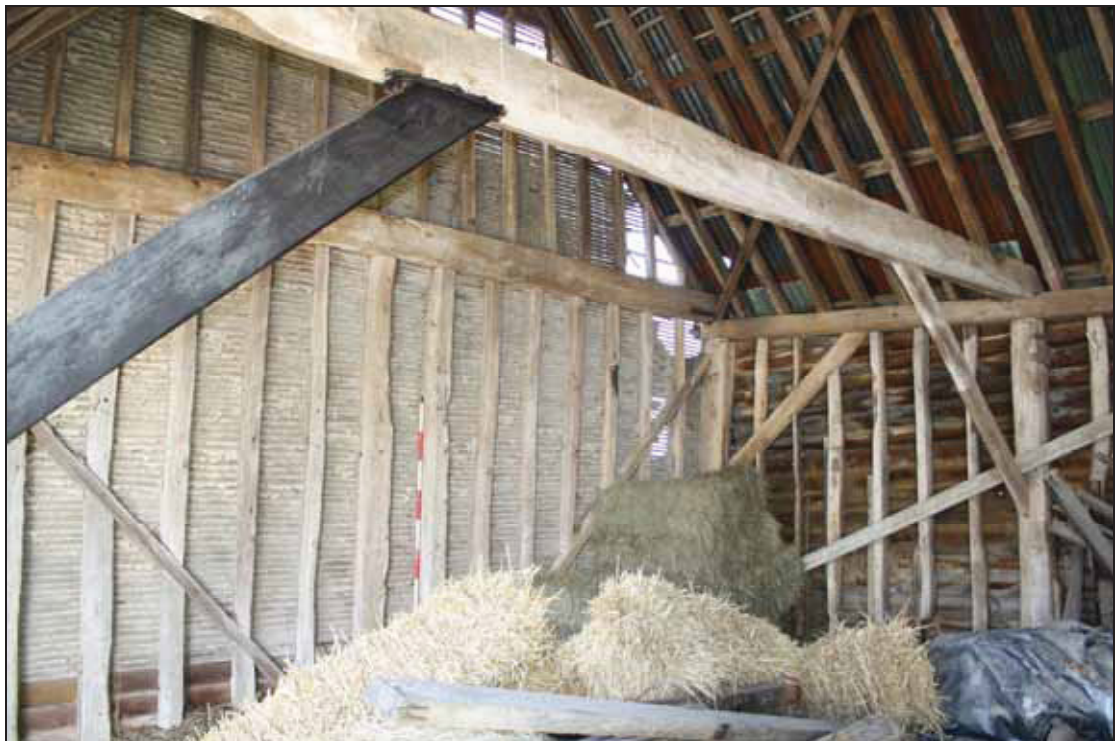
Plate 12 South wall of Building 2, taken from the north-east (DP 31)

5.2.4 The south wall comprises a good sole-plate with a chamfered tie-beam above, with even oak studs (Plate 12). The central studs are of greater scantling and probably incorporate reused members. The studwork is primary-braced with straight downward braces from the outer posts, the east brace preserving a scribed batch mark, while the opposing north wall is similar in form but here apparently with a much higher proportion of reused timber with redundant mortices and nail holes.

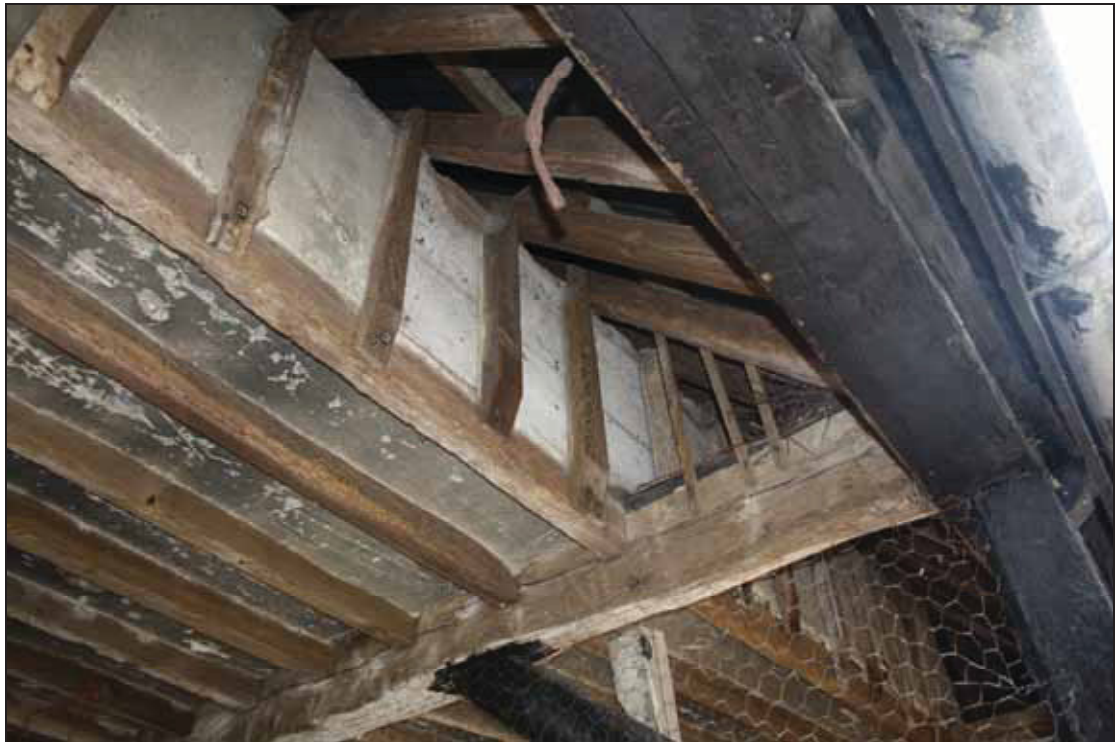
Plate 13 Studwork enclosing the eaves of the loft occupying the north two bays of Building 2, taken from the south-east (DP 75)

5.2.6 The loft in the north bays is supported by close-spaced softwood joists, these housed with a diminished haunch, with lath and plaster infill. Little ashlar pieces enclose the eaves, also infilled with laths and plastered (Plate 13).

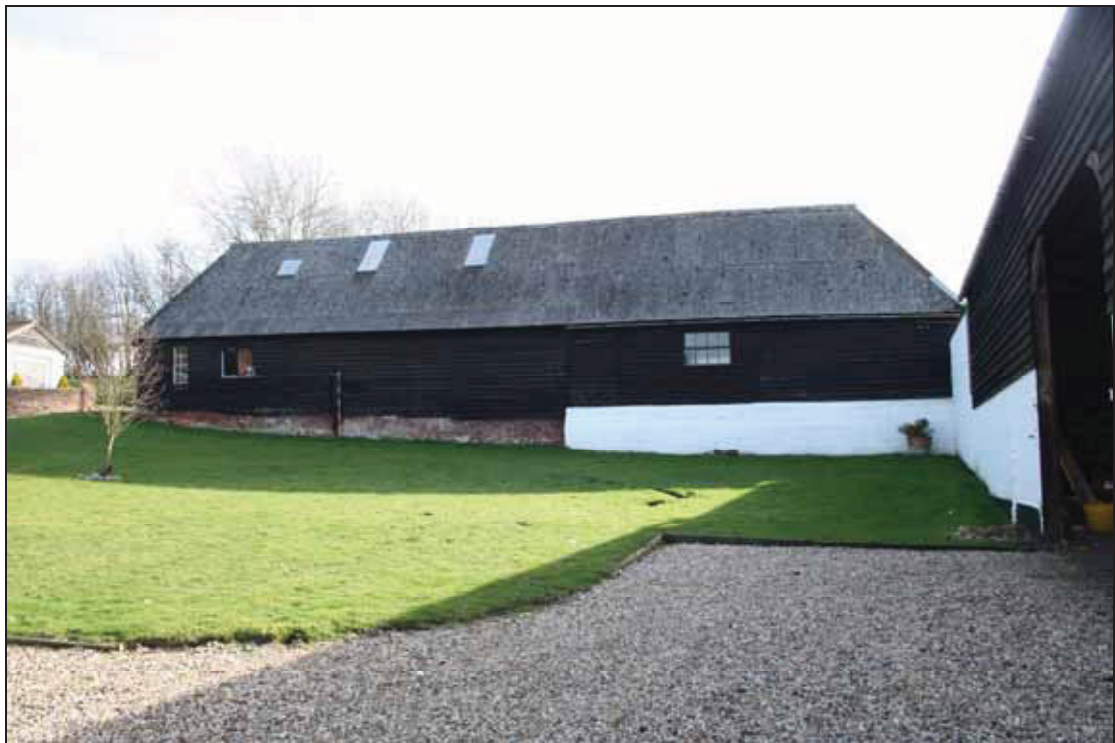
Plate 14 West elevation of Building 3, taken from the west (DP 03)

5.3.1 Building 3 is a flimsy and poorly-constructed barn framing the east side of the farmyard (Plate 14). It is weatherboarded to the exterior over a brick plinth, pierced by a number of metal-framed windows on the east and west, most of which are modern. The north end has a single boarded split door, ledged and braced to the rear giving access to the north bay, while a second

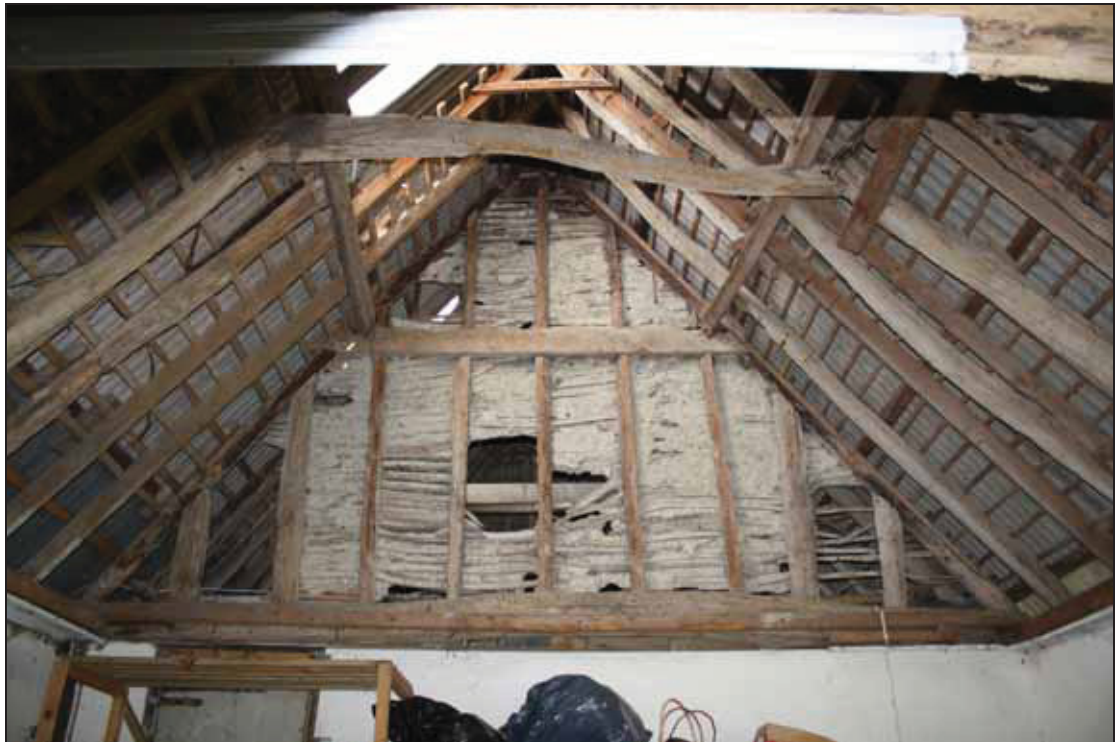
Plate 15 Studwork partition between Bays 5 and 6 (Building 3), taken from the south (DP 27)

5.3.6 The north bay (Bay 6) which is now an office appears to have always been partitioned from the remainder as here lower studwork survives behind modern boarding, while the upper area above the tie-beam comprises exposed studwork with lath and plaster to the rear (Plate 15). This is fairly crude, with the appearance of wattle poles infilled with mortar and no final coat of plaster. A doorway leads through to the north bay and office. It has a little boarded door with strap hinges hung on pintles.

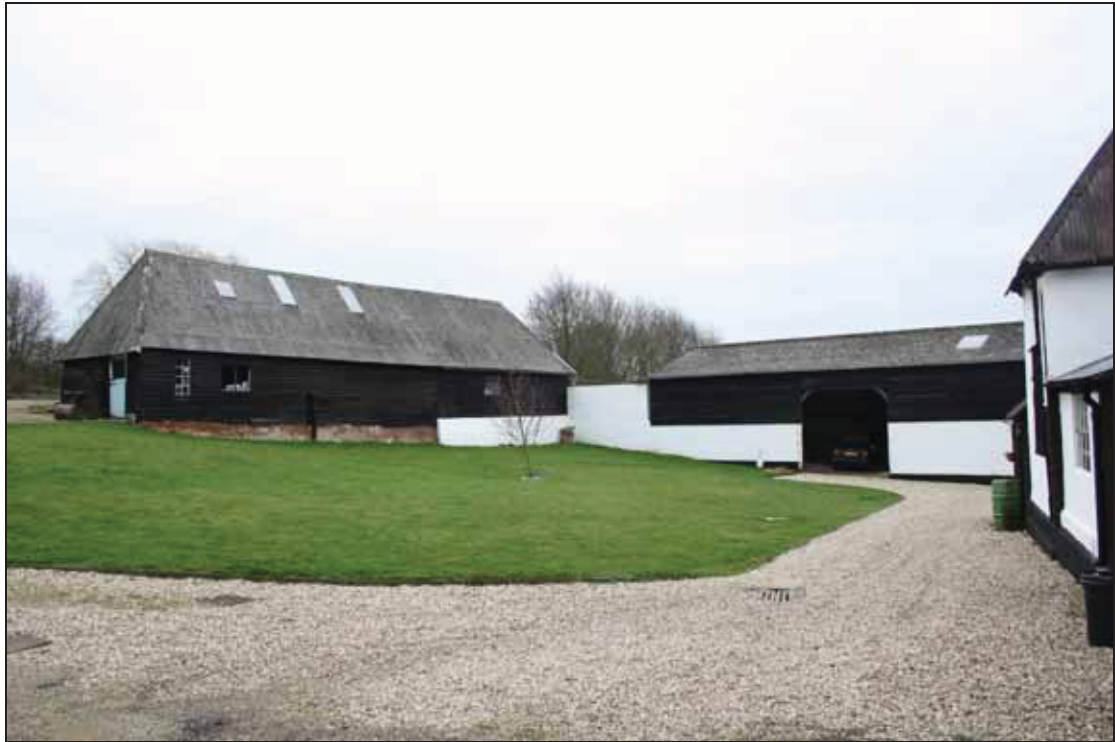
Plate 16 Buildings 3 and 4 (right), taken from the north-west (DP 12)

5.4.2 The external appearance comprises painted blockwork walls at lower level with corrugated sheet cladding above and to the roof, apart from the north side which has a central full-height aperture facing the yard within a weatherboarded façade (Plate 16). The south and east sides cross a change in ground level to the east and there are two lean-to extensions on the south side constructed entirely of breezeblock and corrugated sheeting with a mono-pitch roofed extension at the east end.

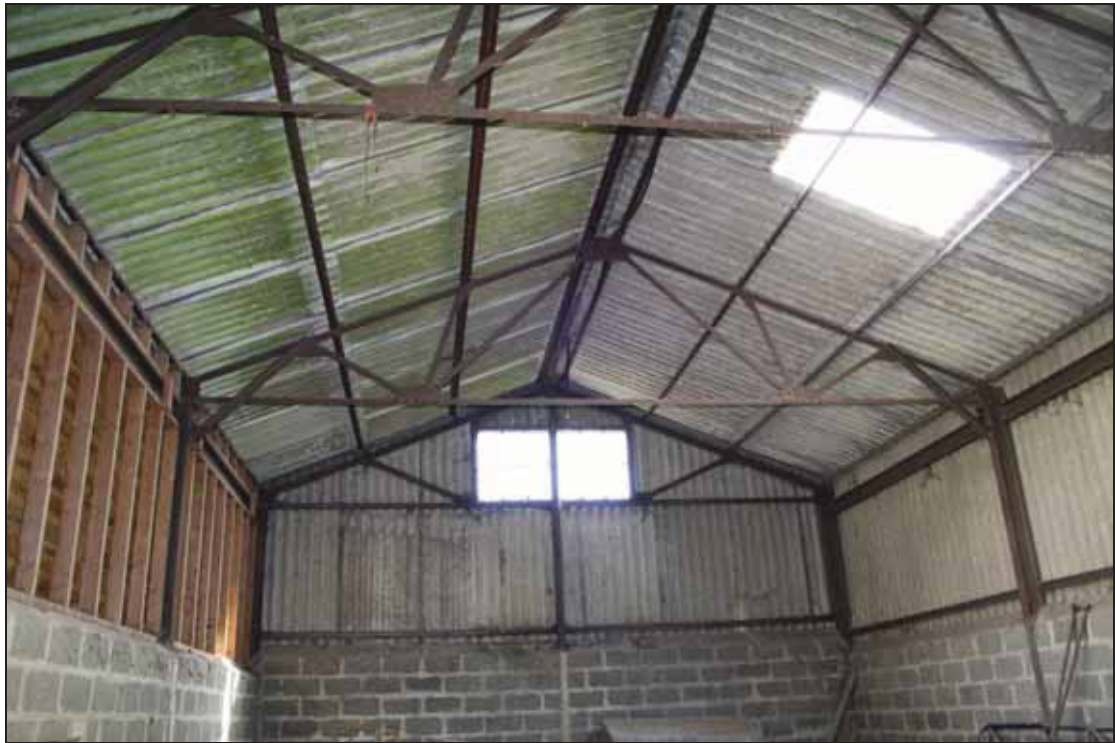
Plate 17 Roof structure of Building 4, taken from the west (DP 23)

5.4.3 The interior of the barn is of five bays with a little midstrey on the south and has blockwork lower walls as noted from the exterior, though with some brickwork on the west. The upper system comprises a steel framework of rudimentary I-section principals secured with plates with composite roof trusses bolted together (Plate 17). Corrugated asbestos sheeting is visible to the rear, apart from the north side facing the house and farmyard which is substituted with modern studwork and external weatherboarding.

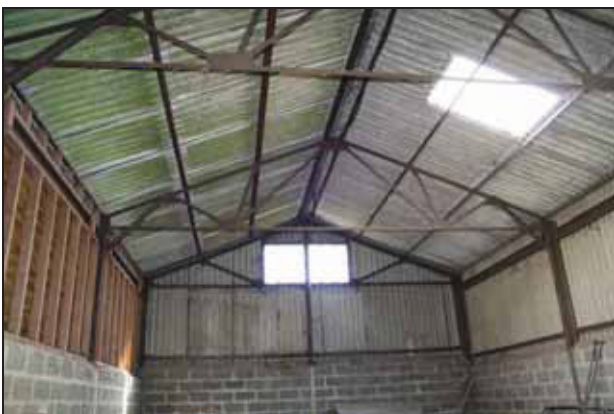
DP 23

Roof structure of Building 4, taken from the west

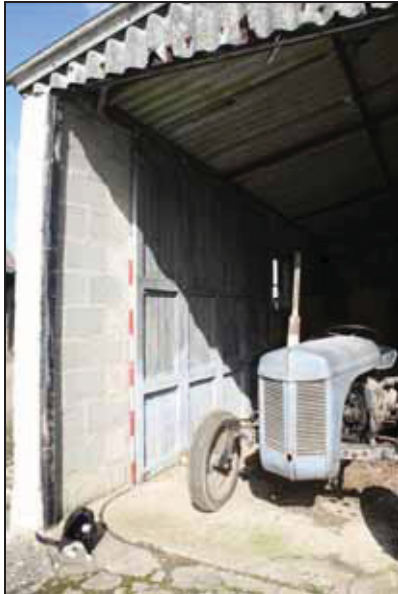
DP 24

West side of Building 4, taken from the east

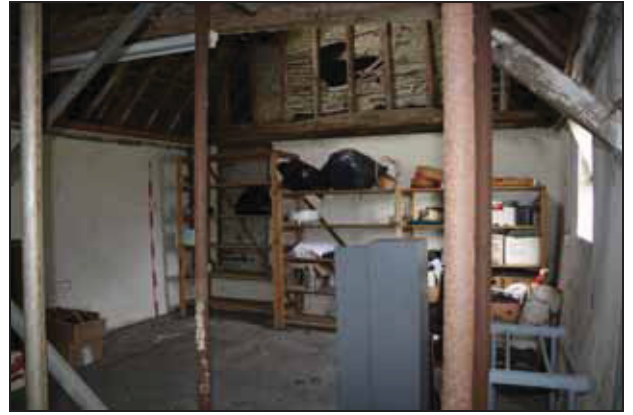
DP 25
Interior of the south-west extension to Building 4,
taken from the south-east

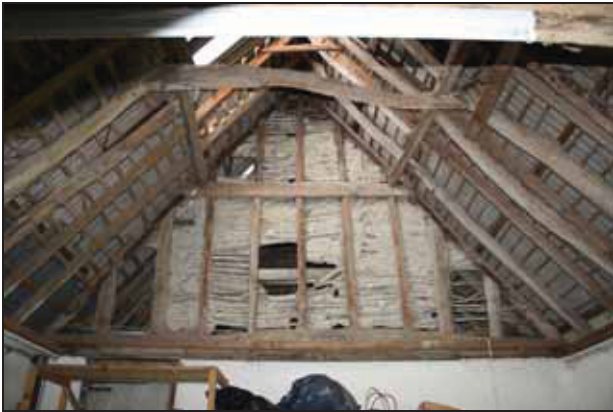
DP 26
Bay 5 (Building 3), taken from the south

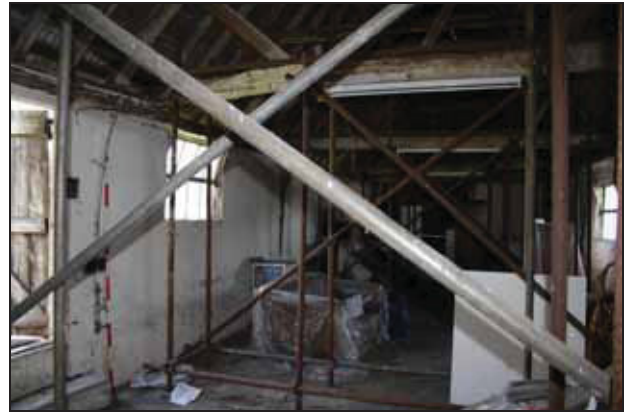
DP 27
Studwork partition between Bays 5 and 6 (Building
3), taken from the south

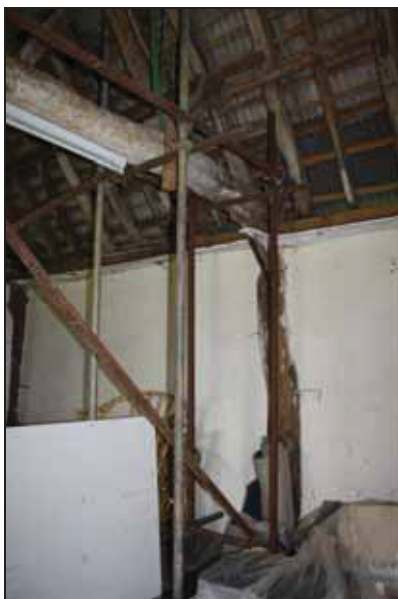
DP 28
East side of Building 3, taken from the north-west

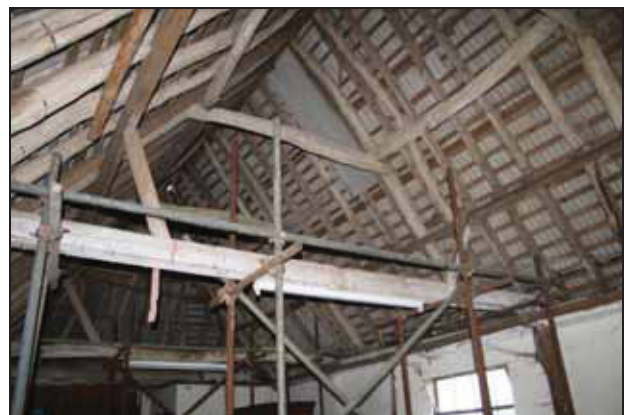
DP 29
West end of the truss between Bays 4 and 5
(Building 3), taken from the north-east

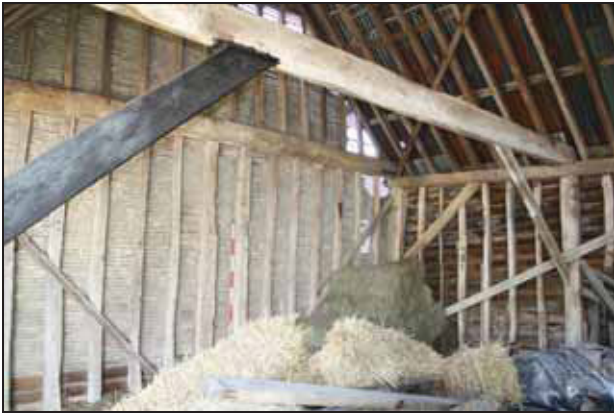
DP 30
Roof structure of Building 3, taken from the north-
east

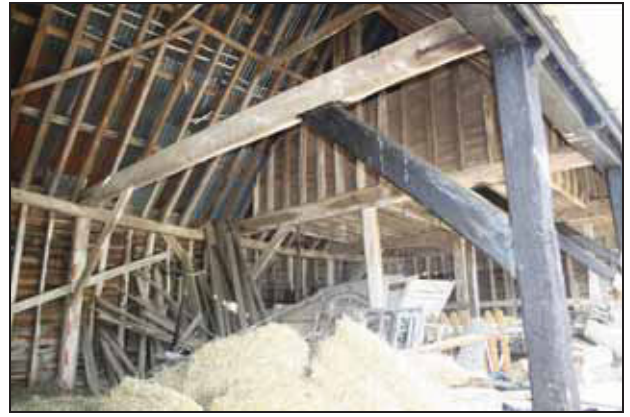
DP 31

South wall of Building 2, taken from the north-east

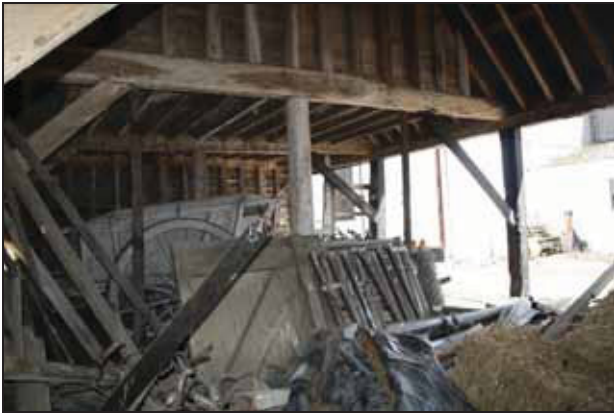
DP 32

Interior of Building 2, taken from the south-east

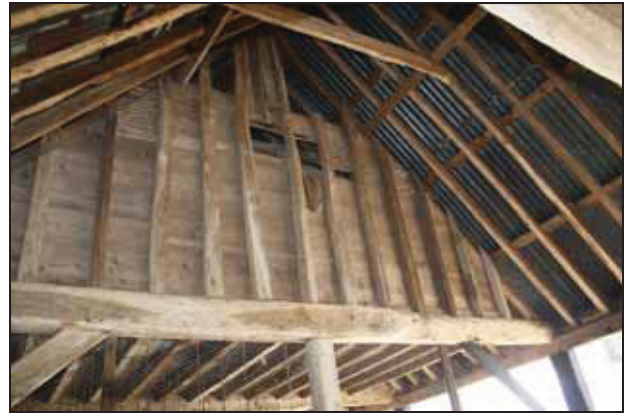
DP 33

Central truss of Building 2, taken from the south

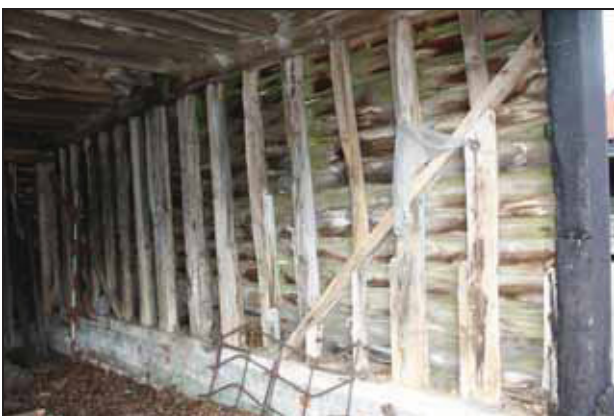
DP 34

Studwork enclosing the loft area occupying the north two bays of Building 2, taken from the south

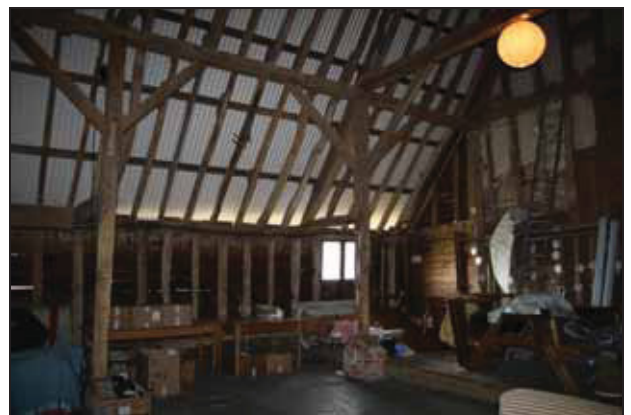
DP 41

Interior of Building 1, taken from the north

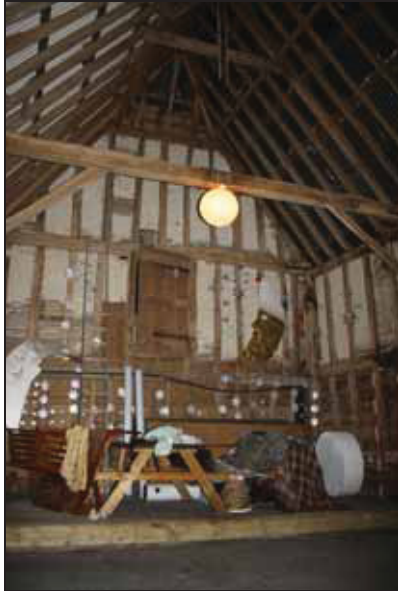
DP 42

West side of Bays 1 and 2 (Building 1), taken from the south-east

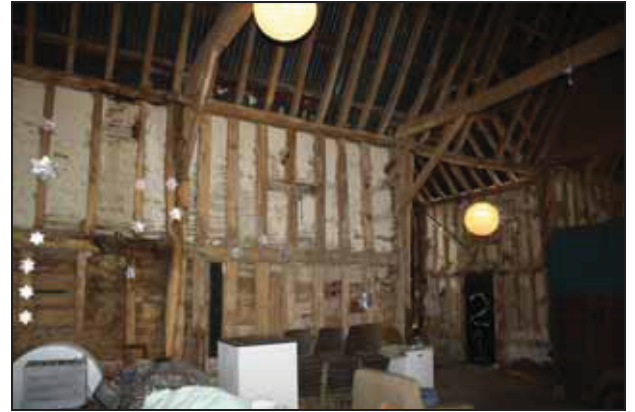
DP 43
North gable end of Building 1, taken from the south

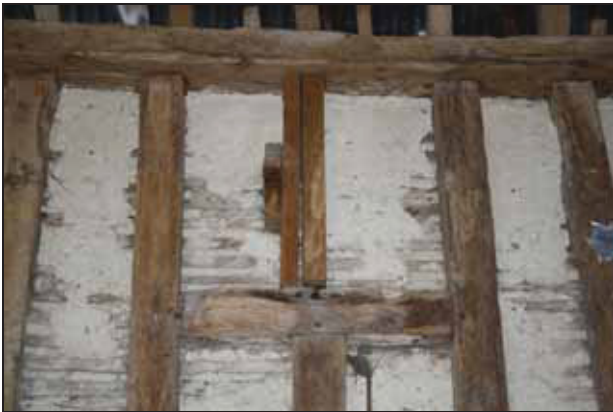
DP 44
East side of Bays 1 and 2 with the porch on the right, taken from the north-west

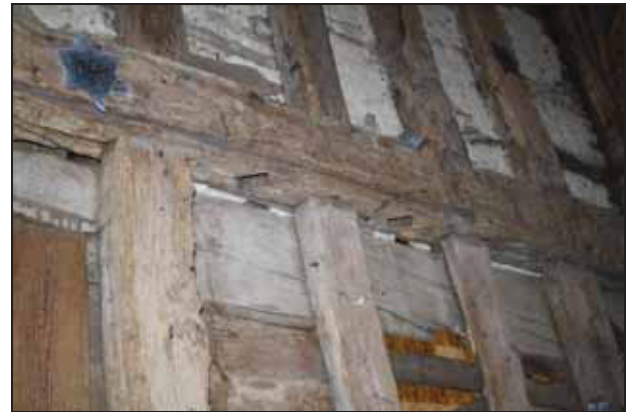
DP 45
Original upper window on the east side of Bay 2 (Building 1), taken from the west

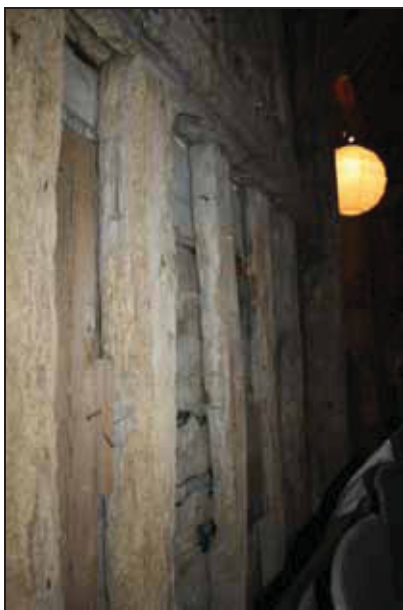
DP 46
Position of original lower window on the east side of Bay 2 (Building 1), taken from the north-west

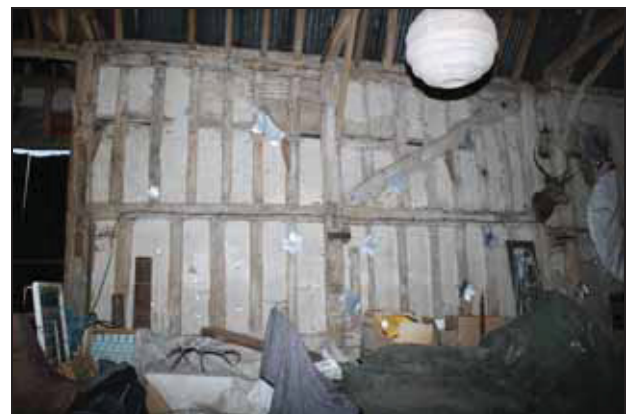
DP 47
Studwork on the east side of Bay 2 showing wattle notches, taken from the north

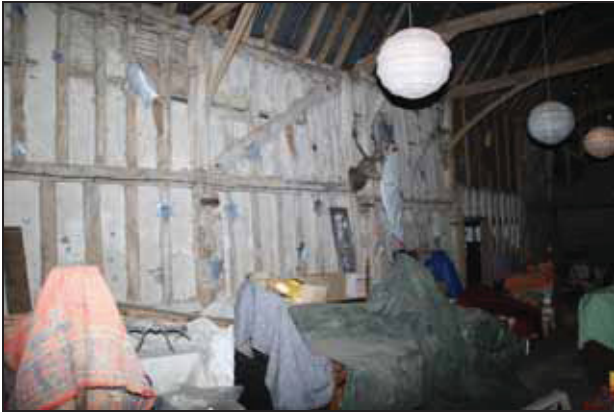
DP 48
East side of Bays 4 and 5, taken from the west

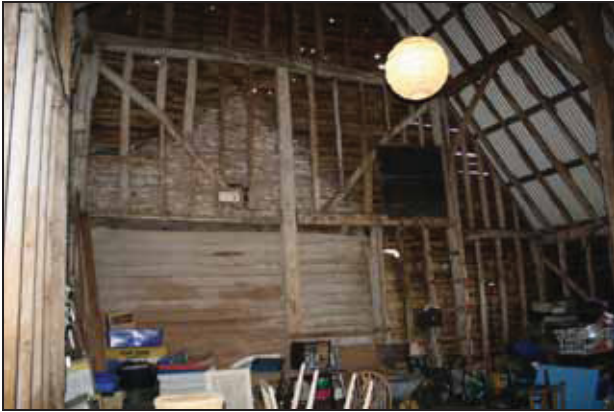
DP 54

East side of Bays 7 and 8 (Building 1), taken from the west

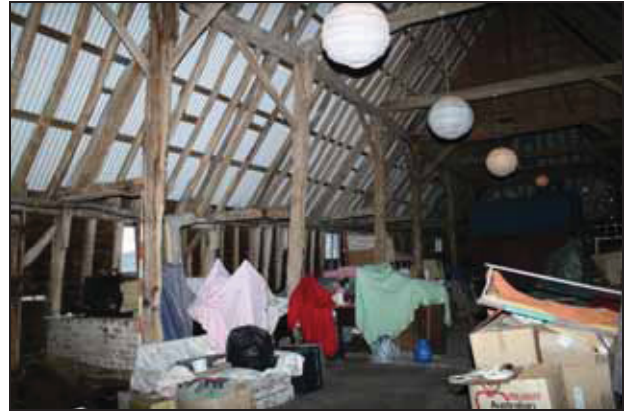
DP 55

South gable end of Building 1, taken from the north

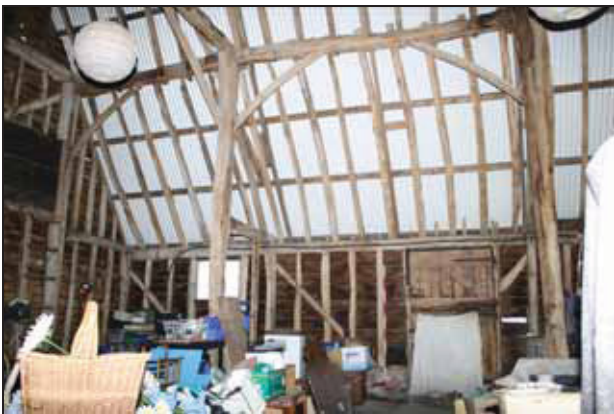
DP 56

West side of Building 1 showing the aisle form, taken from the south-east

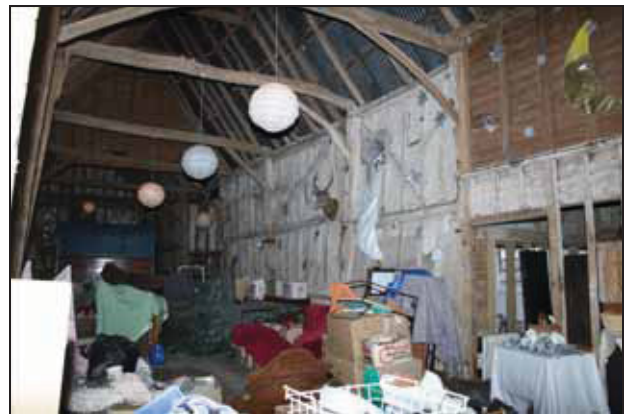
DP 57

West side of Bays 7 and 8 (Building 1), taken from the east

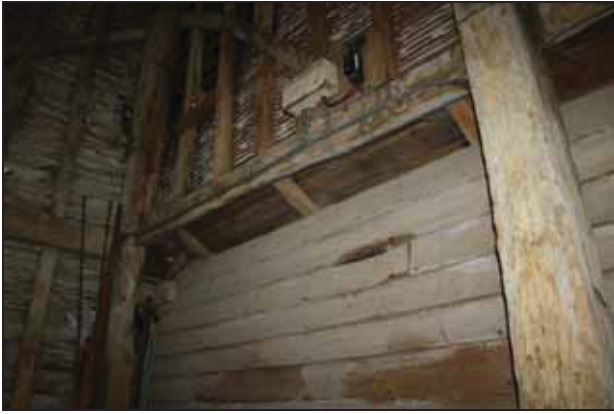
DP 60

East side of Bay 8, taken from the west

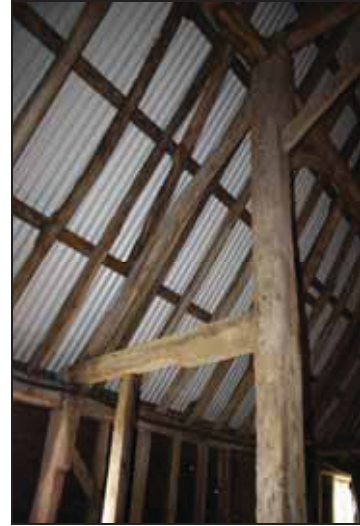
*DP 61
Detail of the south wall (Building 1) showing later boarding to the former outshut at the south end, taken from the north-west*

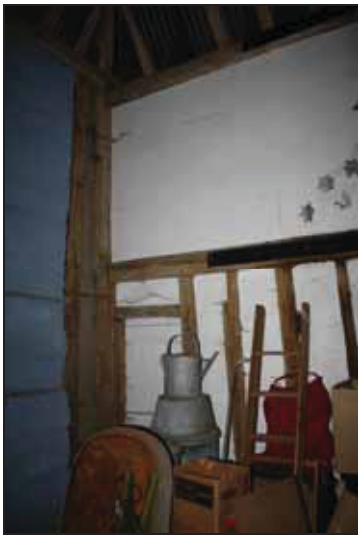
*DP 62
West end of Truss 7 (Building 1) within the aisle, taken from the south-east*

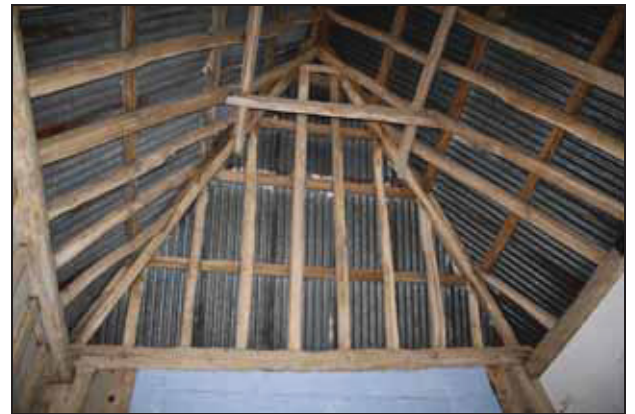
*DP 64
Roof structure of the south porch (Building 1), taken from the west*

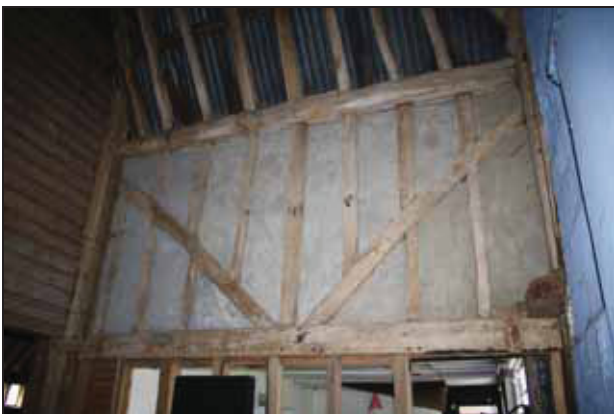
*DP 65
North wall of the south porch at upper level (Building 1), taken from the south*

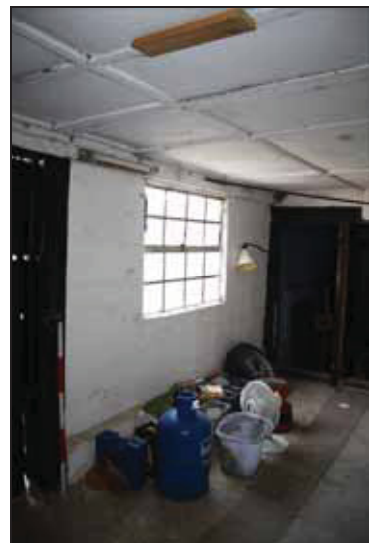
*DP 66
East side of Unit 1 (Building 1), taken from the north-west*

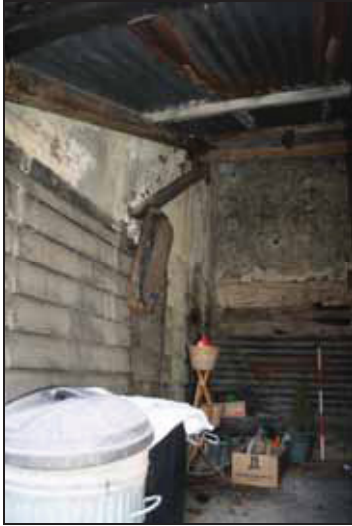
DP 67

South end of Unit 6 showing formerly external walls of porch and barn (Building 1), taken from the east
