**FARM BUILDINGS AT BRICK HOUSE FARM
NEWPORT ROAD, DEBDEN,
SAFFRON WALDEN, ESSEX**

HISTORIC BUILDING RECORDING

Authors:	Lee Prosser PhD Tansy Collins BSc Kathren Henry Peter Thompson MA
NGR: TL 5442 3404	Report No: 4066
District: Uttlesford	Site Code: DNBF12
Approved: Claire Halpin	Project No: 4719
Signed:	Date: April 2012

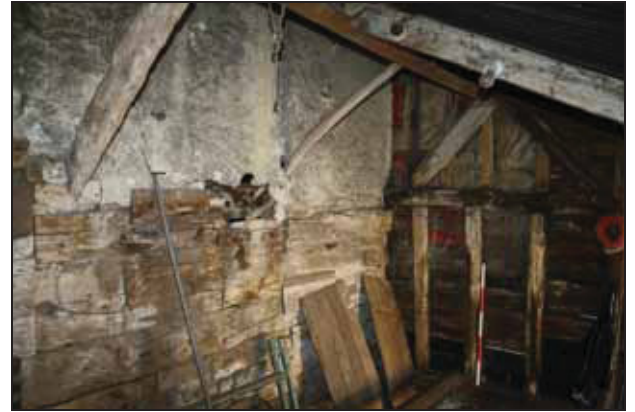
DP 68

West side of Unit 6 showing the formerly external wall of the barn (Building 1), taken from the south-east

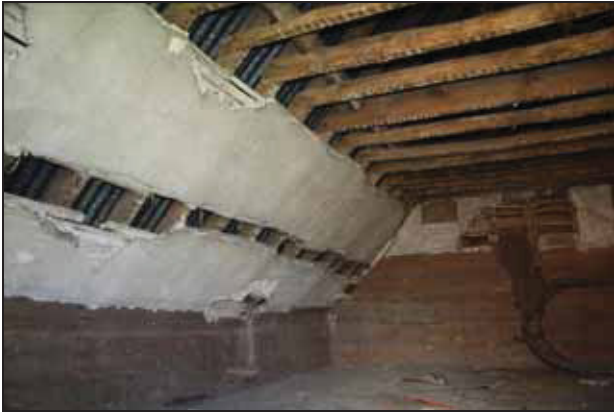
DP 73

Loft over the north two bays of Building 2, taken from the north

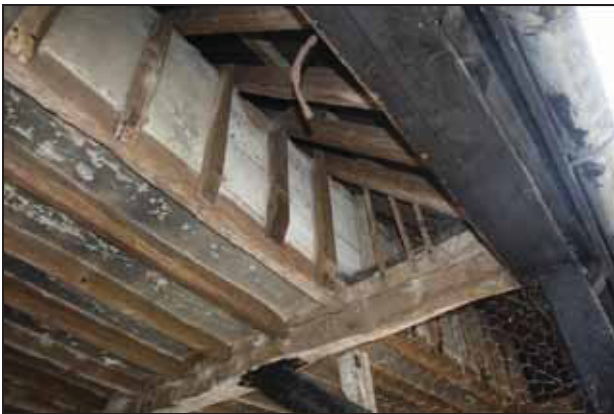
DP 75

Studwork enclosing the eaves of the loft occupying the north two bays of Building 2, taken from the south-east

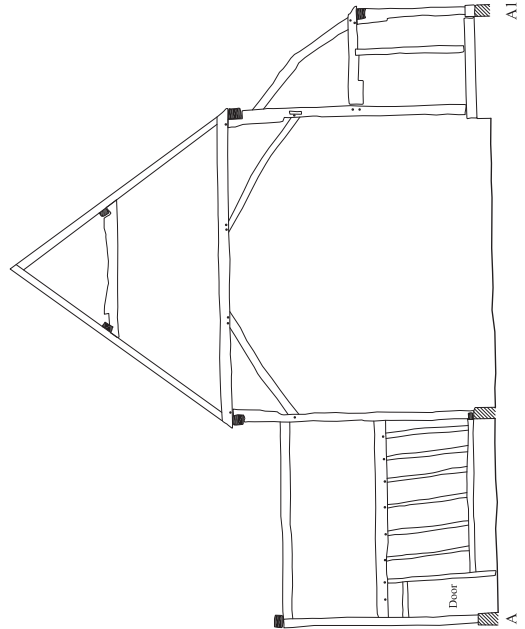
Archaeological Solutions Ltd
Fig. 9 Plan & section of Building 1
 Scale 1:100 at A3

Cross-section - Truss 7

5.1.44 The aisle-sill survives intact and the tie above is double-pegged to the arcade post, while the wall-post has a splay-cut jowl, and is probably the companion piece to the adjoining member of Truss 6. The downward brace from arcade post to tie is properly pegged at the head and base and preserves an assembly mark, in the form of a chiselled 'III' (Plate 9).

Arcade post	7" x 8" (178mm x 203mm)
Aisle sill	9" x 6" (229mm x 152mm)
Aisle-tie (wide end)	7" x 8" (178mm x 203mm)
Wall-post	7" x 4" (178mm x 102mm)
Wall-plate	6" x 6" (152mm x 152mm)

6.2 Of the farm buildings, the main barn has an interesting and complex history, incorporating fragments of an earlier, domestic precursor. Analysis reveals some structural coherence within a very distinct phasing sequence. Phase 1 is represented by the original historic core of the building, which essentially preserves four bays of the east wall of a medieval house or a similar, utilitarian domestic-type building, which might be contemporary with the adjoining Wealden. Medieval timbers surviving *in situ* are depicted on Fig. 12. Conspicuous survivals include unglazed windows with characteristic diamond mullion mortices and shutter grooves, stave holes and notches for wattle and the generally large and closely-spaced nature of the timber elements. Timbers of early date are also distributed elsewhere, reused in the later framing.
