BIRCHWOOD METHODIST CHURCH, BIRCHWOOD AVENUE, HATFIELD, HERTFORDSHIRE

HISTORIC BUILDING RECORDING

Kate Hi	Collins BSc ggs MA ı Henry (Graphics)
NGR: TL 2230 0937	Report No. 4327
District: Welwyn Hatfie	ld Site Code: n/a
Approved: C. Halpin M	IIfA Project No. 5139
Signed:	Date: 6 June 2013

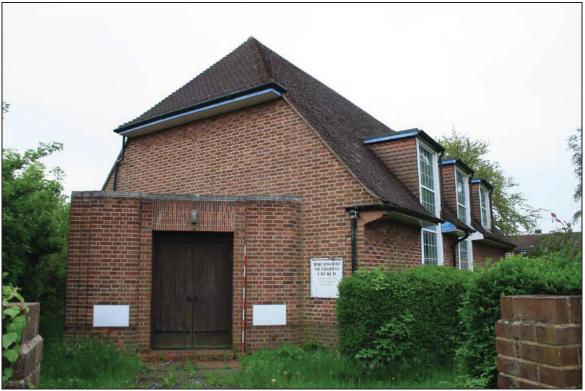
Plate 1

North elevation of the church, taken from the north-west (DP 1)

5.2 The principal church range is aligned north – south with an entrance porch at the north end (Plate 1) and an L-shaped service block attached at the south end on the east. The building is constructed of a brown stock brick laid in Flemish bond. It rises to a half-hipped roof covered with peg-tiles, with wide overhanging eaves which are underboarded and supported at the north and south ends on tile kneelers. The half hip of the roof has the same underboarded eaves.

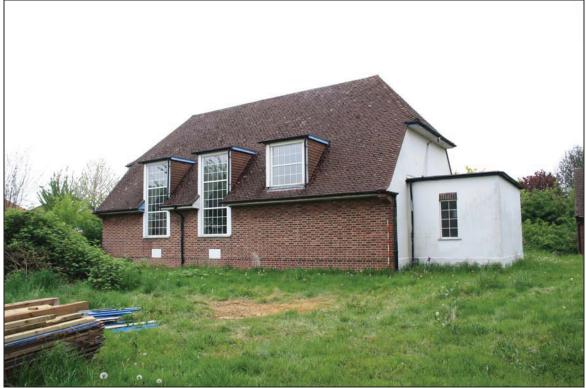
Plate 2

West elevation of the church, taken from the south-west (DP 02)

5.4 The hall is lit from the east and west by two large windows which rise through the eaves to flat-roofed dormers which have tile-hung sides (Plate 2). A third window lies to the north and comprises a standard dormer window. All of these windows have been replaced in UPVC but probably replicate the earlier form of three lights, each light of 15 panes with the north windows having two lights of ten-over-ten form.

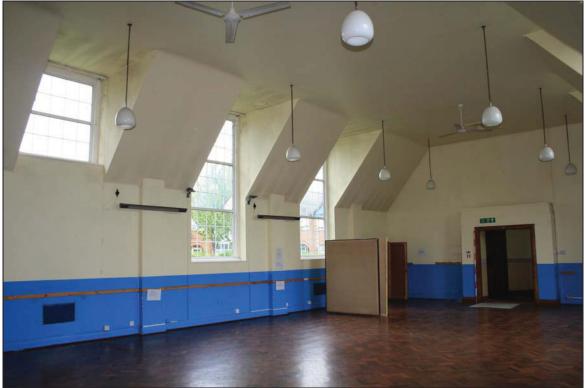
Plate 4

Church hall, taken from the south-east (DP 14)

5.10 The hall itself is a high open space, ceiled at the height of the roof hip above the window heads (Plate 4). Signs of modernisation are evident but good original parquet flooring survives set in a herringbone pattern. A modern skirting board extends around the space and the walls are all painted, punctuated only by four pilasters on either side. A door in the south-east corner leads to the service range, while a wide aperture at the south end leads to the low unit. This is reached up two steps and has narrow floor boarding which retains marks for a former pulpit.

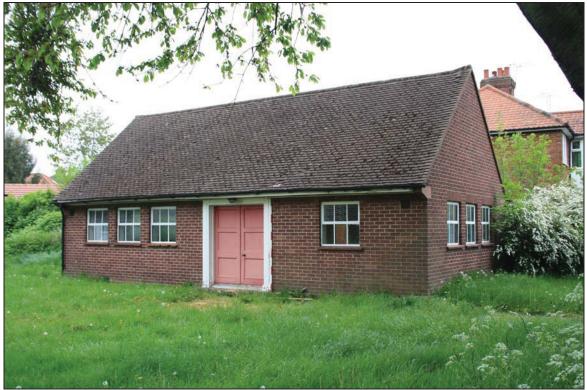
Plate 5

West elevation of Building 2, taken from the south-west (DP 8)

5.15 The building is constructed in a fairly sympathetic style to the main church being of brown stock brick laid in stretcher bond rising to a pitched tile-clad roof. The eaves overhang and are supported at the north and south ends with tiled kneeler as on the main building but here with plain eaves. The original doors and windows survive all round (Plate 5).

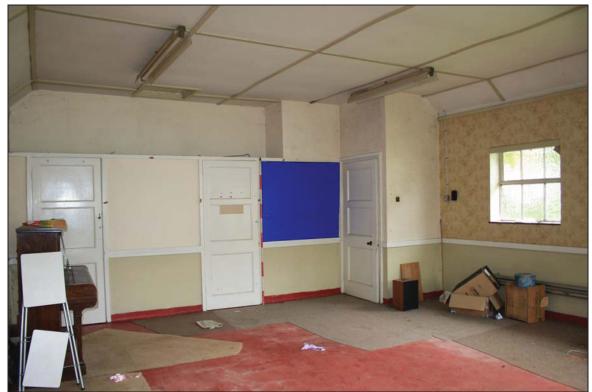
Plate 6

Room GF01 (Building 2), taken from the north-east (DP 20)

5.20 The range is divided into two spaces with a larger room to the north (Room GF01) and a second smaller room to the south (Room GF02). A small entrance lobby on the west gives access to both areas and there are fitted cupboards along the partition dividing the two (Plate 6).

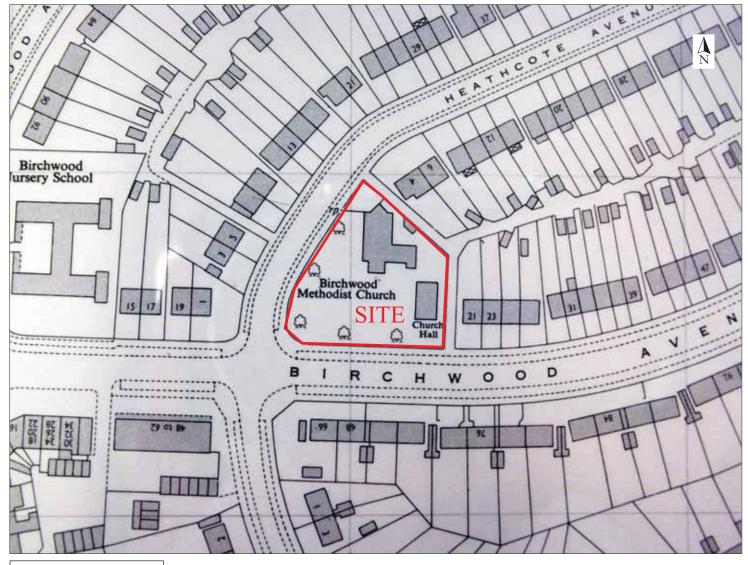
Archa	eological Solutions Ltd
Fig. 4	OS map, 1962
Not to scale	•

Reproduced from the 1962 Ordnance Survey 25" to 1 mile map with the permission of Her Majesty's Stationery Office. © Crown copyright Archaeological Solutions Ltd Licence number 100036680

4.6 It is known that an earlier Methodist church was constructed in French Horn Lane in 1889, but this was sold in 1938 and subsequently used as a furniture store until its demolition in 1968 (Kirby & Busby 1995). The assessment structure represents the replacement of the former Methodist Church. The site was purchased in 1936 and is referred to in documents associated with the St Albans Wesleyan Circuit (HALS ref. NM5E) with the foundation stone laid on the 20th November 1937 and the church opening in 1938. The outline of the church at this point can be seen on the Ordnance Survey (OS) map of 1937 (Fig. 3) which follows the same plan as exists today. By 1962 a second building has been constructed to the south-east of the main church, visible on the OS map (Fig. 4). The church fell into disuse in 2008.
