NEW PASTURES FARM, WARRINGTON,  
OLNEY, BUCKINGHAMSHIRE  
HISTORIC BUILDING RECORDING

**MK HER event number: EMK1232**

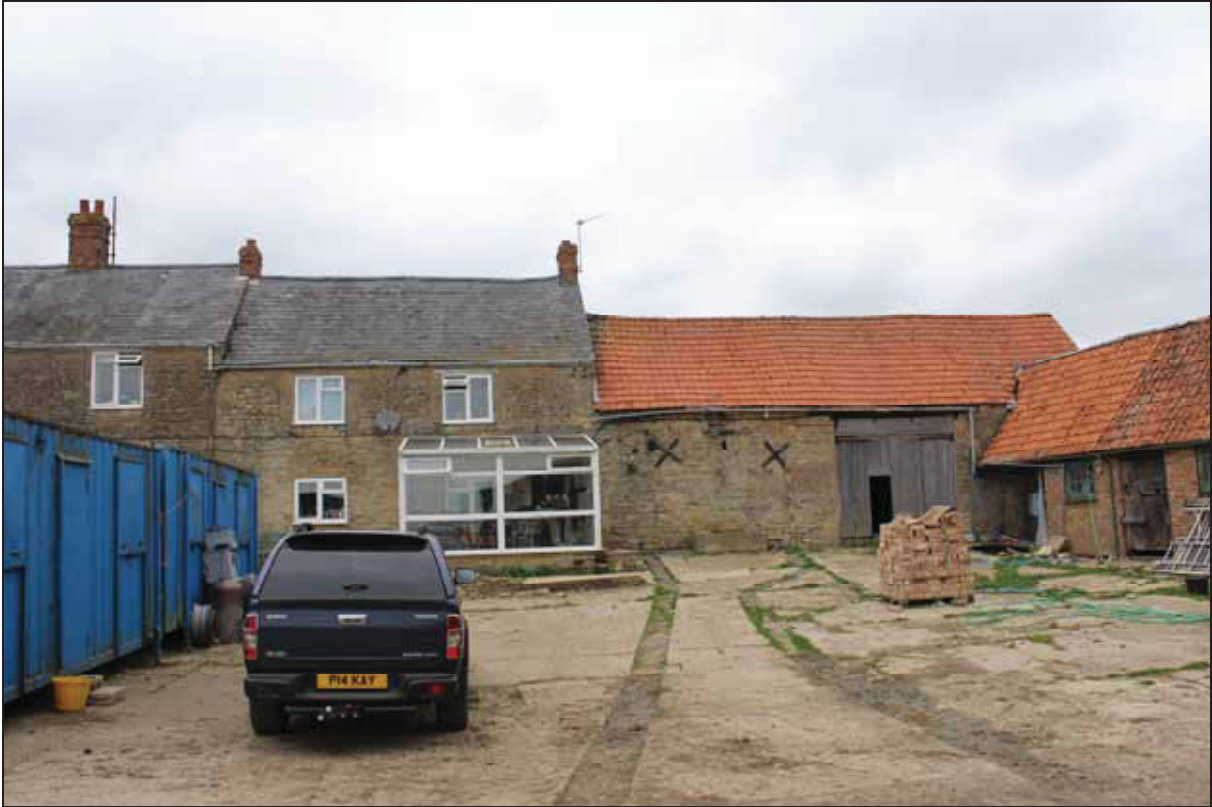
Plate 1 South elevation of the main range and barn, taken from the south (DP 01)

5.3 The main range is the most historic element of the complex and spans two bays fronting south into the yard (Plate 1), the outer corners defined by straight joints in the stone work to the flanking two ranges, that to the west being fairly irregular and likely reflecting the loss of a pre-existing range on this side. The range is constructed of roughly-coursed slender limestone blocks, though the lower courses include somewhat larger blocks. The roof is pitched and covered in grey slate, while chimney stacks lie at either end built of Fletton brickwork. The building is fronted by a raised terrace which is paved with a stone retaining wall.

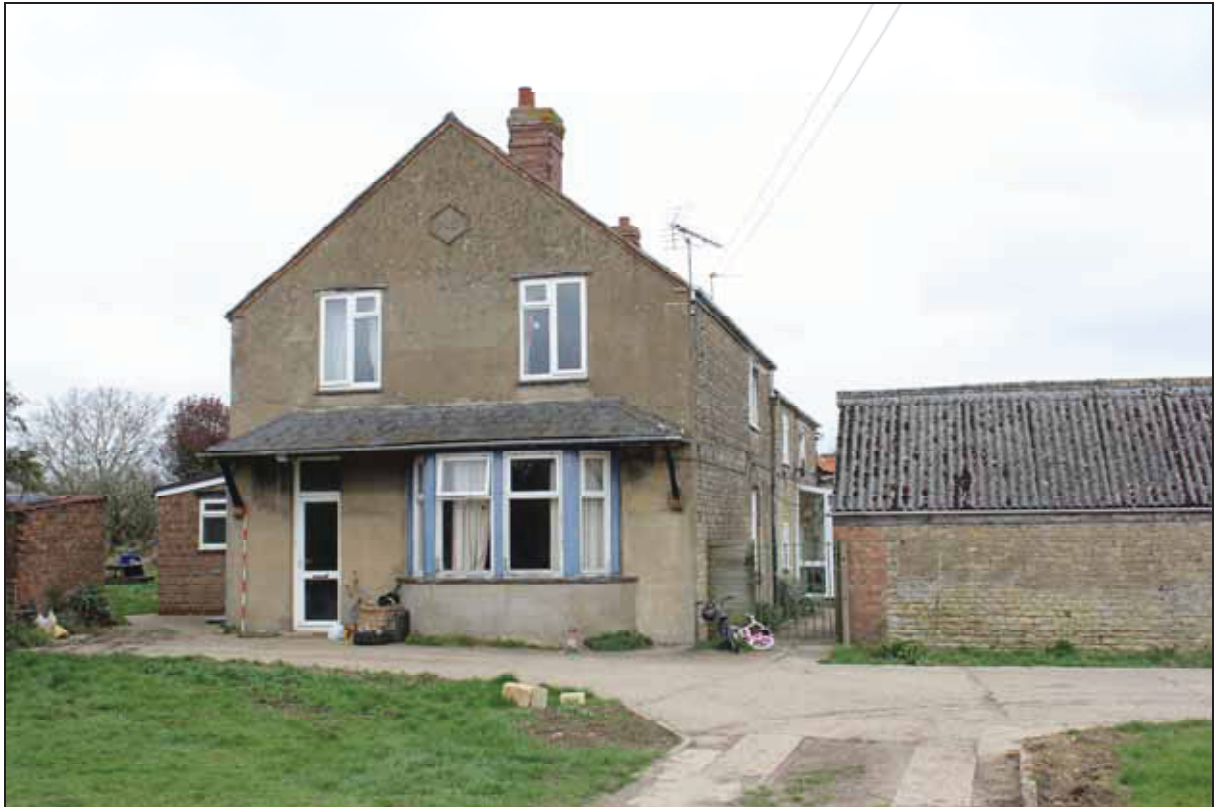
Plate 3 West gable end of west range, taken from the west (DP 1)

5.7 This range lies attached at the west end of the house and was added in 1917 (Plate 3). It is constructed in fairly regularly coursed limestone with Fletton brick dressings to some of the windows and the corners, though the west gable is entirely clad in cement render. On the south the stonework retains the original pointing which is a fairly cementitious sandy mortar with a high number of inclusions.

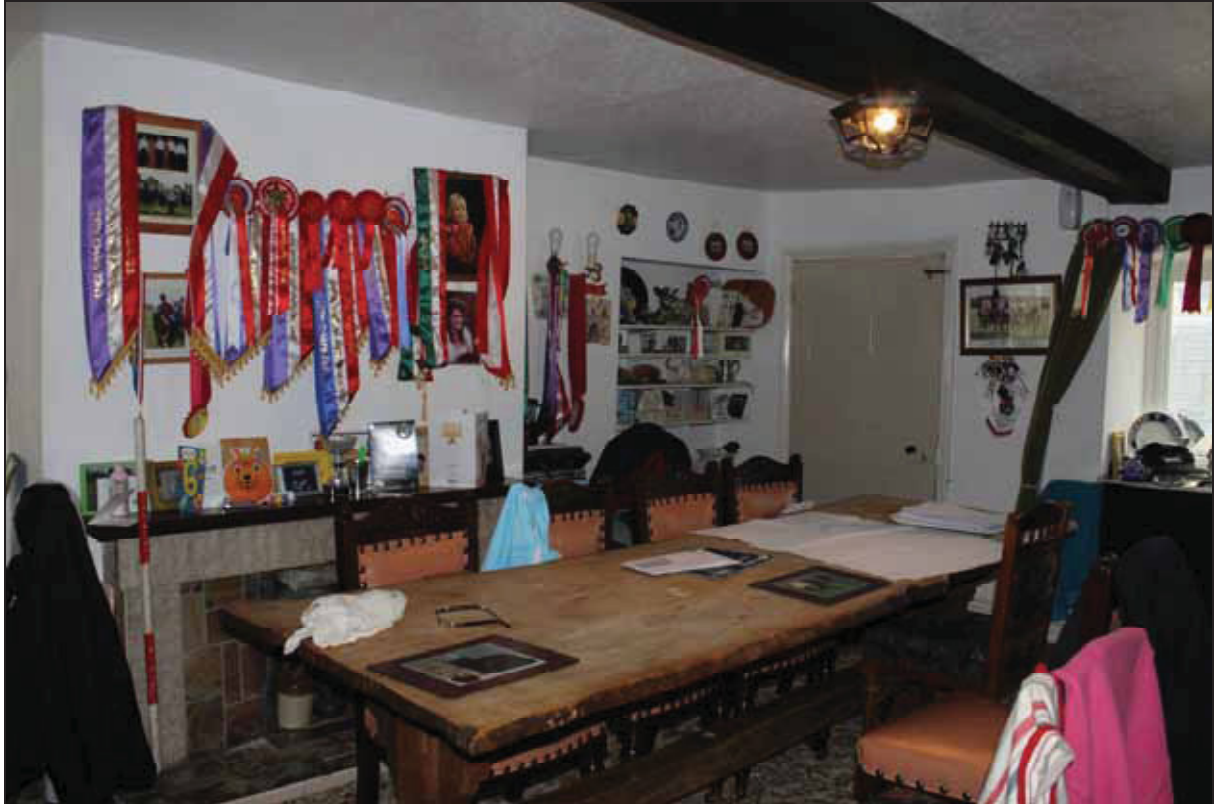
Plate 4 Room GF01, the east bay of the main range, taken from the north-west (DP 35)

5.13 The historic core spans two bays, with the front door leading into the east bay (GF01). As noted the door is perhaps late 19<sup>th</sup> century in date with moulded panels to the exterior and four plain inner panels retaining its original rim-lock. It is hung on rising hinges and set in a moulded surround. A chimney breast expressed on the east has a modern fireplace and adjoining to the south is a full-height recess now containing shelves but marking the position of a former doorway (Plate 4).

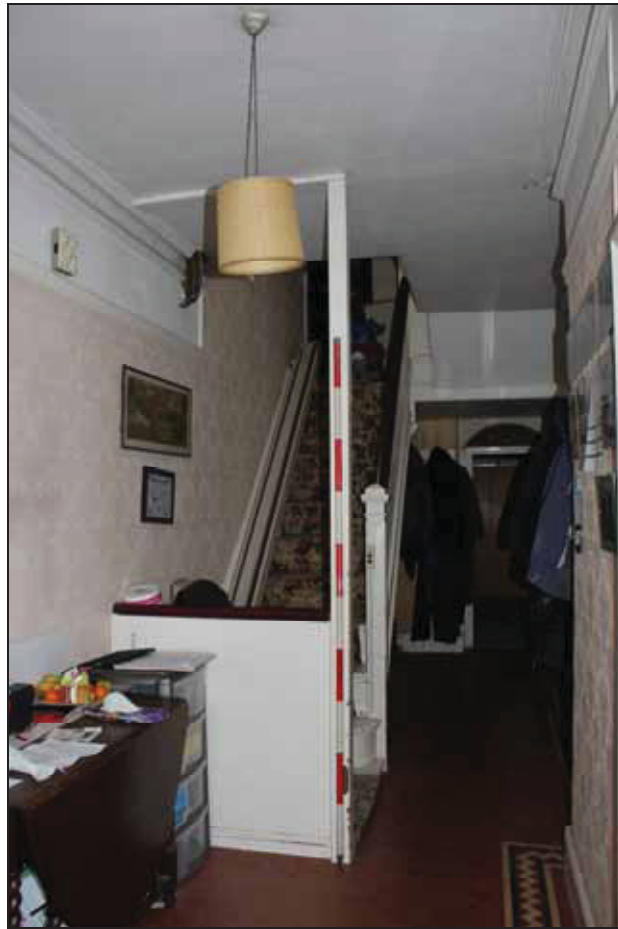
Plate 5 Entrance hall GF05 in the west range, taken from the west (DP 41)

5.18 The range is laid out with two rooms on the south and the entrance hall housing the staircase on the north side (Plate 5), the main range reached though a fairly narrow doorway on the east. The entrance hall itself is floored with decorative tiling red octagonal tiles with yellow and black tiles creating a geometric border.

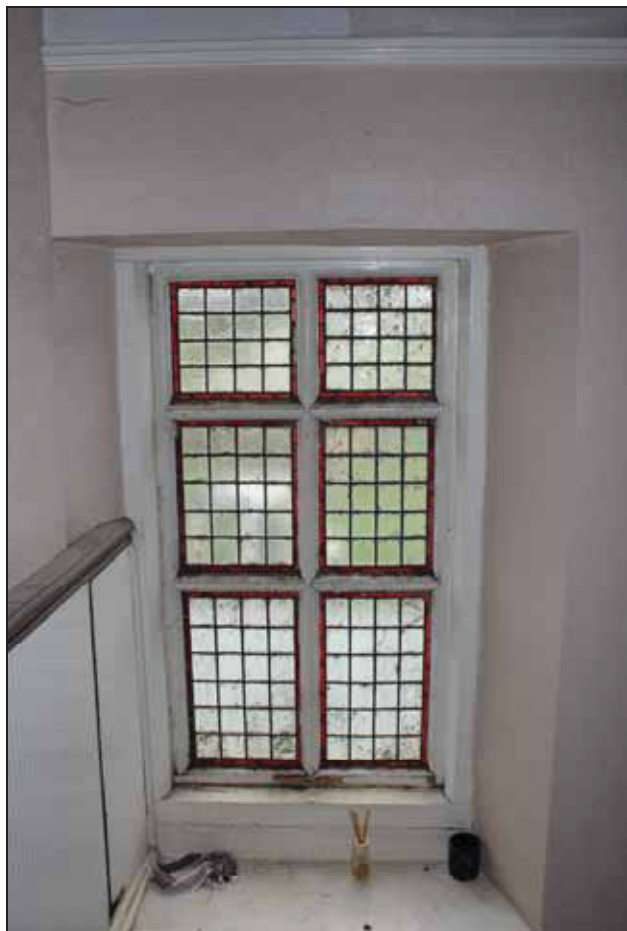
Plate 6 Original stair light in the west range at first floor level, taken from the south (DP 44)

5.25 The staircase rises around a half pace landing to this level in identical form as seen below, with light provided through the large original stair window on the north which retains original lead comes with red glazed margins (Plate 6).

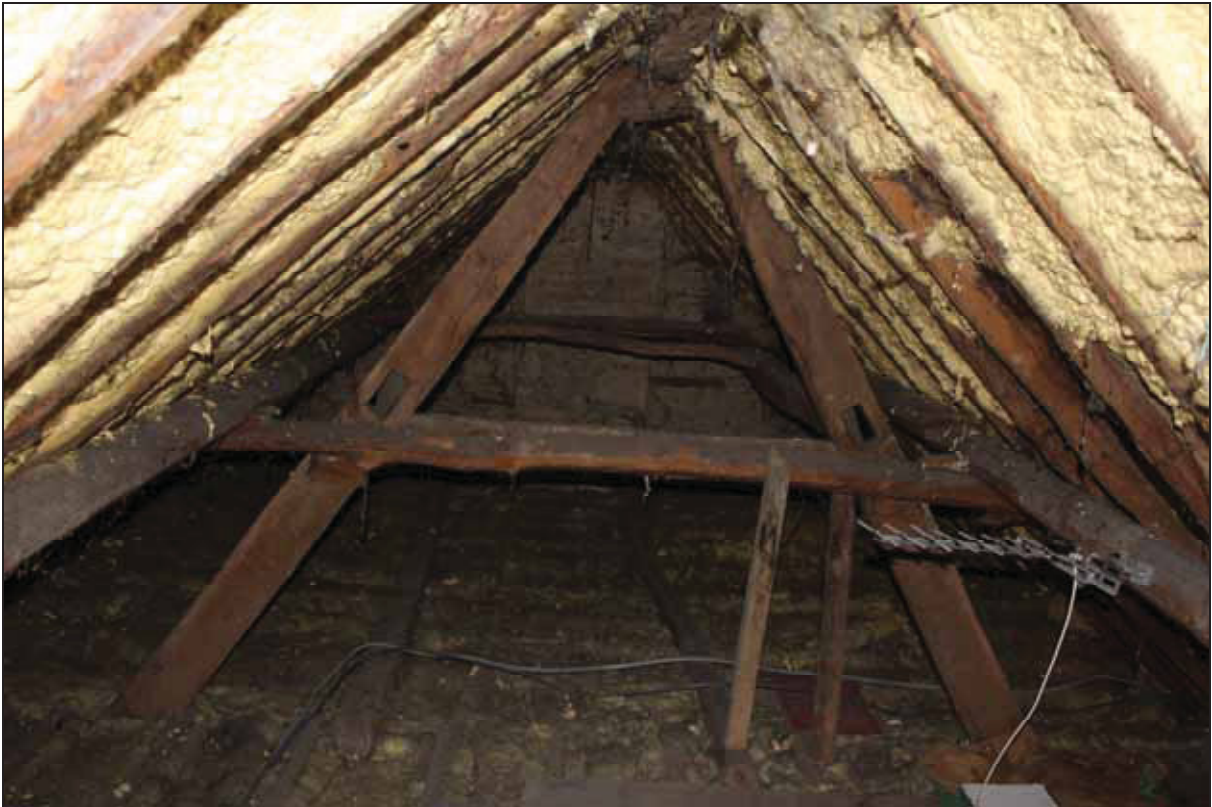
Plate 7      Roof space above the main range showing the original central truss, taken from the east (DP 50)

5.27 The east and west gable ends are visible, constructed of stonework where the raising of the roof is evident in a slight variation in fabric above and below a straight joint defining a steep roof pitch. The lower portions of the central truss are not visible likely being encased in the partition below. What is visible includes a roof of through purlin form with fairly straight rafters which curve slightly at the apex in cruck-like fashion to clasp a ridge purlin retaining much bark, all secured with a short morticed yoke piece (Plate 7). There is a collar which is single-pegged to the rafters and a single through purlin in each pitch. These were jointed with a simple splayed scarf within the through mortice of the rafters though the purlins to the east have been lost. The west purlins survive however, to indicate a pattern of common rafters simply tenoned above and below the purlins.

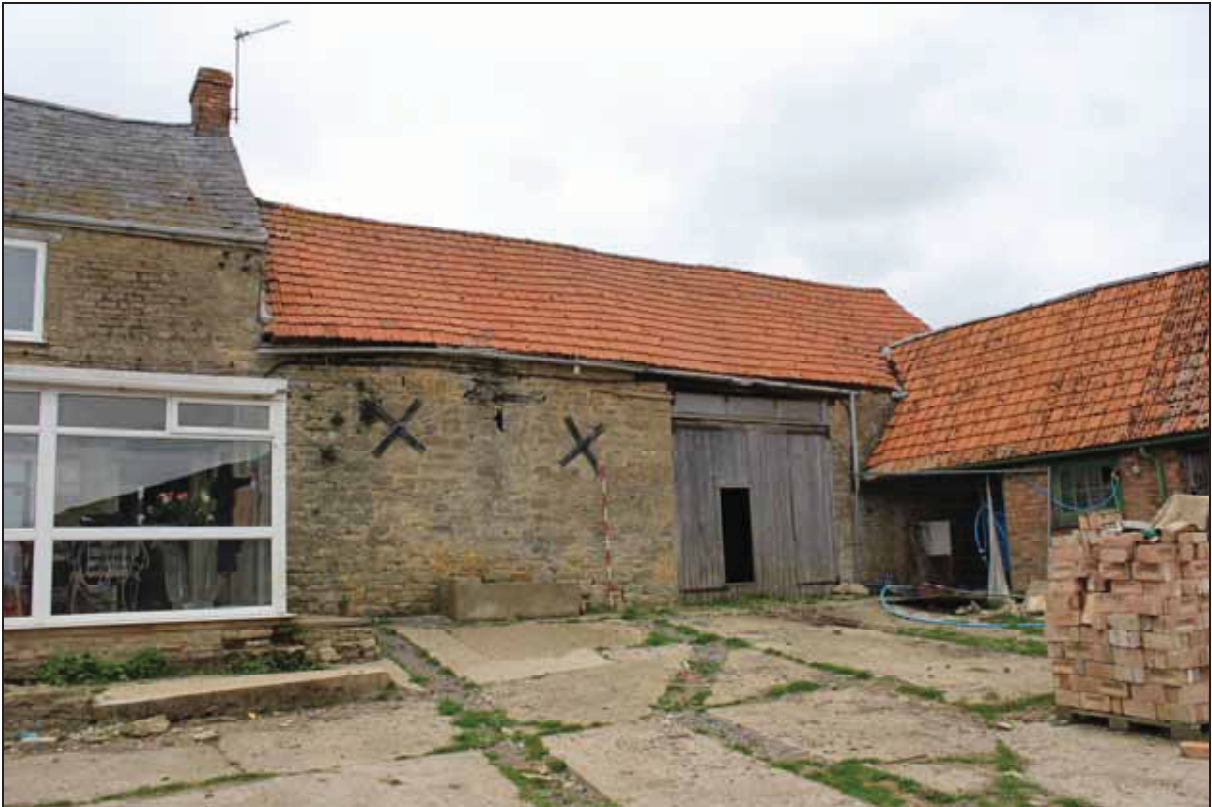
Plate 8      South elevation of the barn, taken from the south-west (DP 14)

5.30 To either side of the doorway are two high-set ventilation slits with timber lintels, the east example now enclosed within the lateral range, while some structural movement is evident from the presence of two cross-shaped tie-plates (Plate 8). The east gable end demonstrates the coursing of the stonework more effectively where less mortar and render survives at upper level though the lower stonework has been repointed in cement. Two ventilation slits have been blocked at lower level but a single example survives in the gable end. Otherwise, an area of concrete hard standing and impressions within the gable end indicate the presence of a former range with a mono-pitched roof.

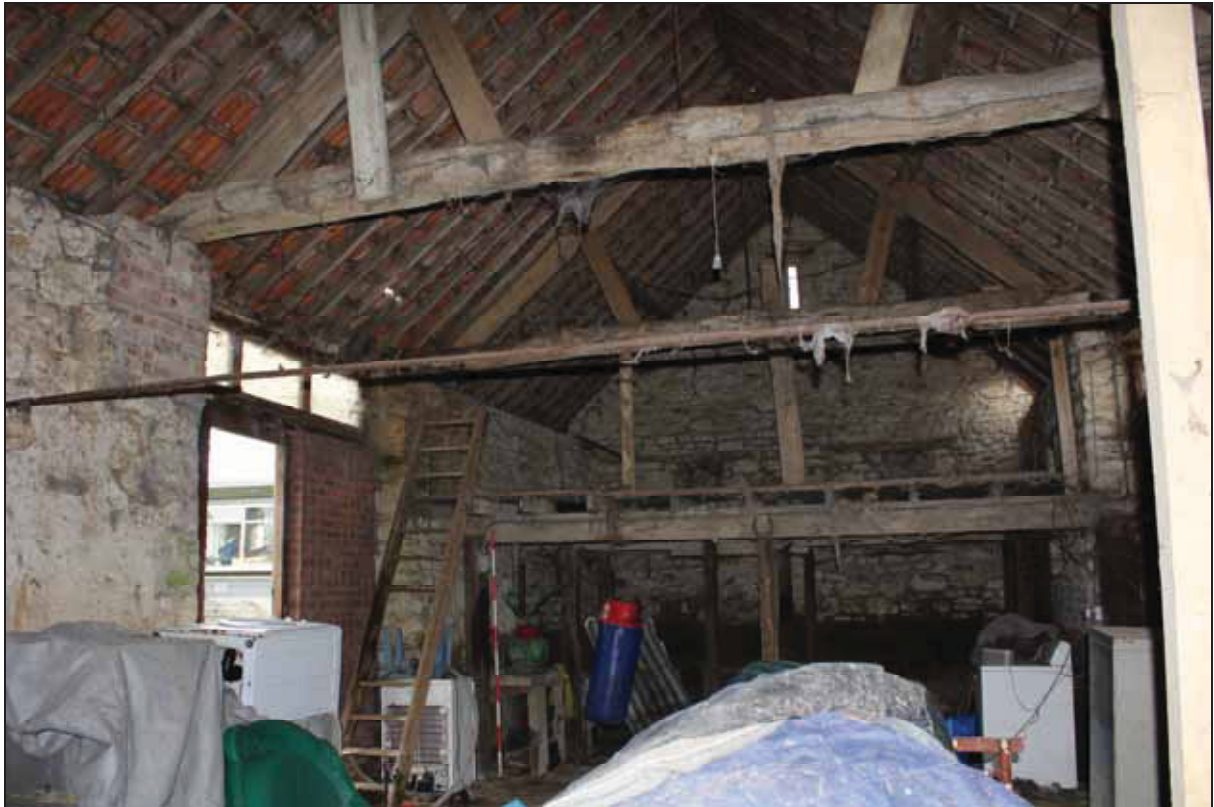
Plate 9 Interior of the barn showing inserted first floor in the east bay and threshing door on the north, taken from the west (DP 50)

5.33 The interior of the barn spans three bays though the west bay is slightly larger and the east bay accommodates an inserted first floor (Plate 9). A brick floor survives in the central bay, while to the east and west the floor is covered with screed cement which continues as render up the walls for approximately 1m height. Otherwise the outer walls reflect the external construction of coursed stone work with multiple phases of repointing, limewashing and applications of lime render.

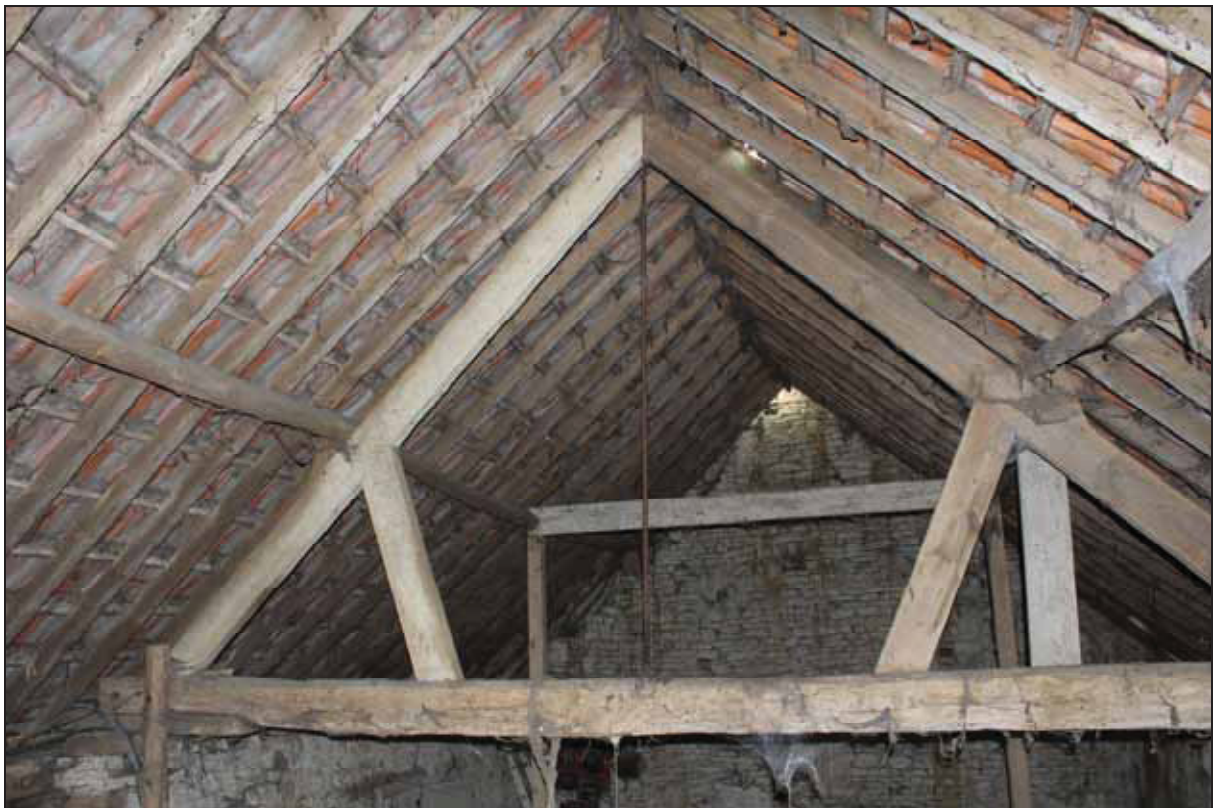
Plate 10 View of the roof structure of the barn, taken from the east (DP 31)

5.37 The roof has been substantially renewed though the tie-beams may be original, these comprising fairly waney robust oak members resting on the outer walls. The roof above is of double-framed construction, all of softwood, with a metal king rod bolted through the tie-beam and rising to the apex (Plate 10). Raking struts rise from the tie-beams to principal rafters. A single purlin in each pitch is supported on cleats and common rafters ride over.

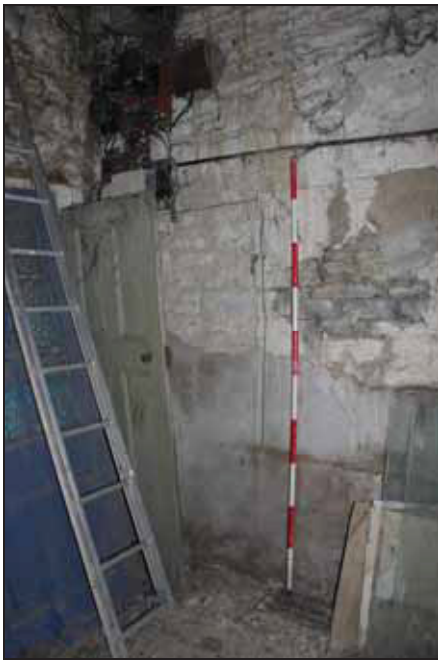
21

*West wall of the barn showing blocked doorway indicated by a straight joint in the stonework, taken from the north-east*

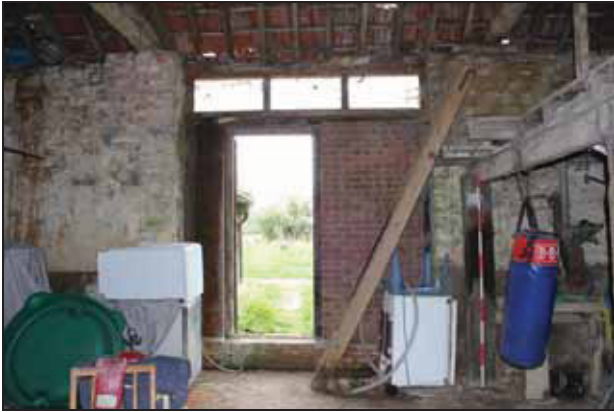
25

*North wall of the barn (central bay) showing partially infilled threshing doorway, taken from the south*

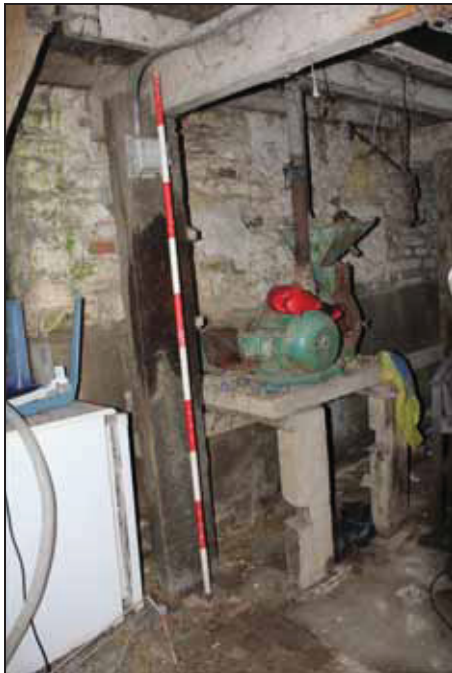
27

*View of relic machinery in the barn consisting of lifting equipment, probably for grain, taken from the south-west*

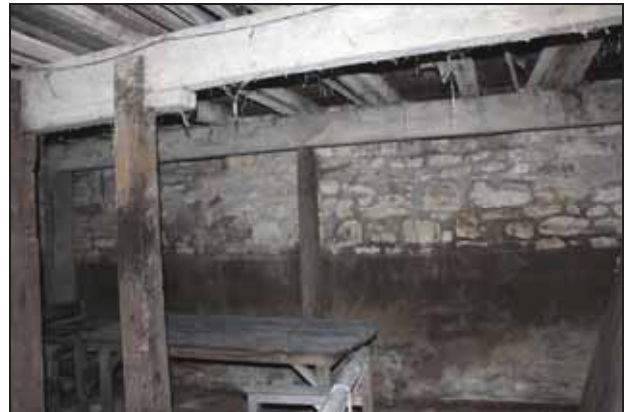
28

*East end of the barn below the inserted floor showing bisected ventilation apertures, taken from the west*

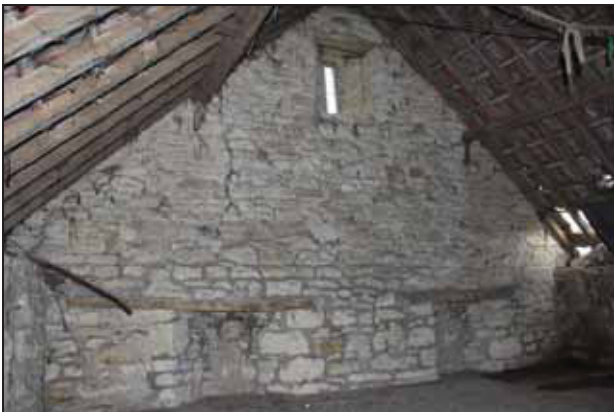
29

*East end of the barn at upper level showing bisected ventilation apertures, taken from the north-west*

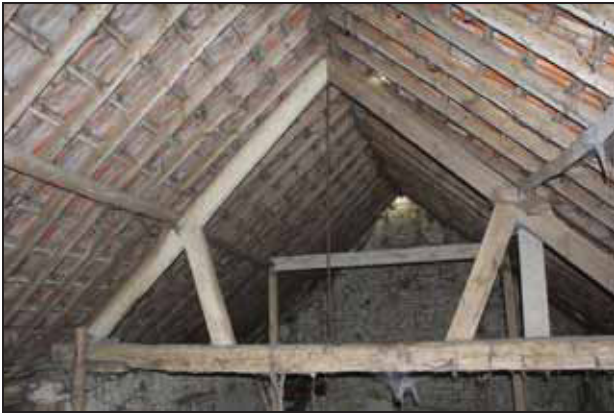
30

*South side of the east bay at upper level in the barn, taken from the north*

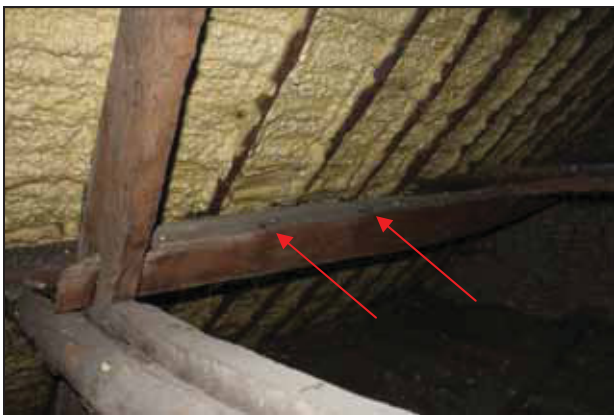
50

*Roof space above the main range showing the original central truss, taken from the east*

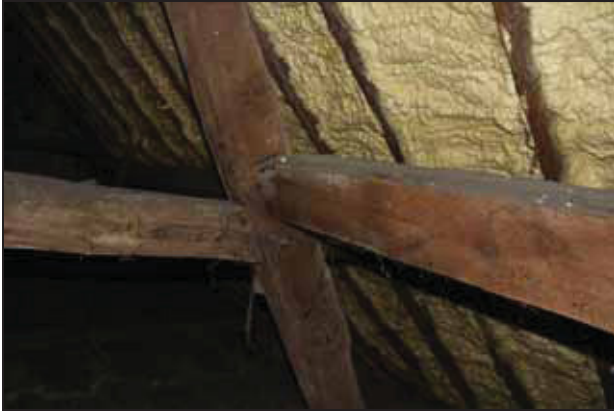
54

*Detail of the original central truss at roof level in the main range, taken from the west*

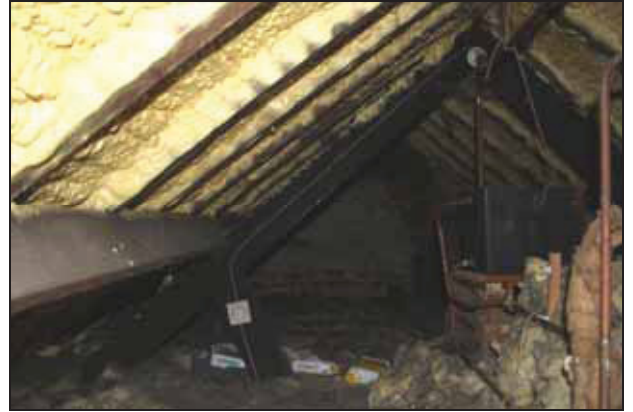
55

*Detail of the original central truss at roof level in the main range, taken from the west*

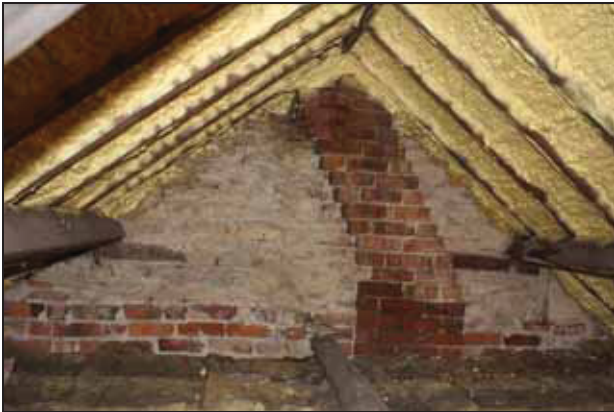
56

*View of the roof over the rear range, taken from the south*
