ARCHAEOLOGICAL SOLUTIONS LTD

20 FISHPOOL STREET, ST. ALBANS,  
HERTFORDSHIRE

HISTORIC BUILDING RECORDING AND  
MONITORING AND RECORDING

Authors:	William Waring Dr Lee Prosser Tansy Collins	
NGR: TL 1429 0719		Report No: 5178
District: St. Albans		Site Code: AS 1839
Approved: Claire Halpin		Project No: 6075
Signed:		Date: August 2016

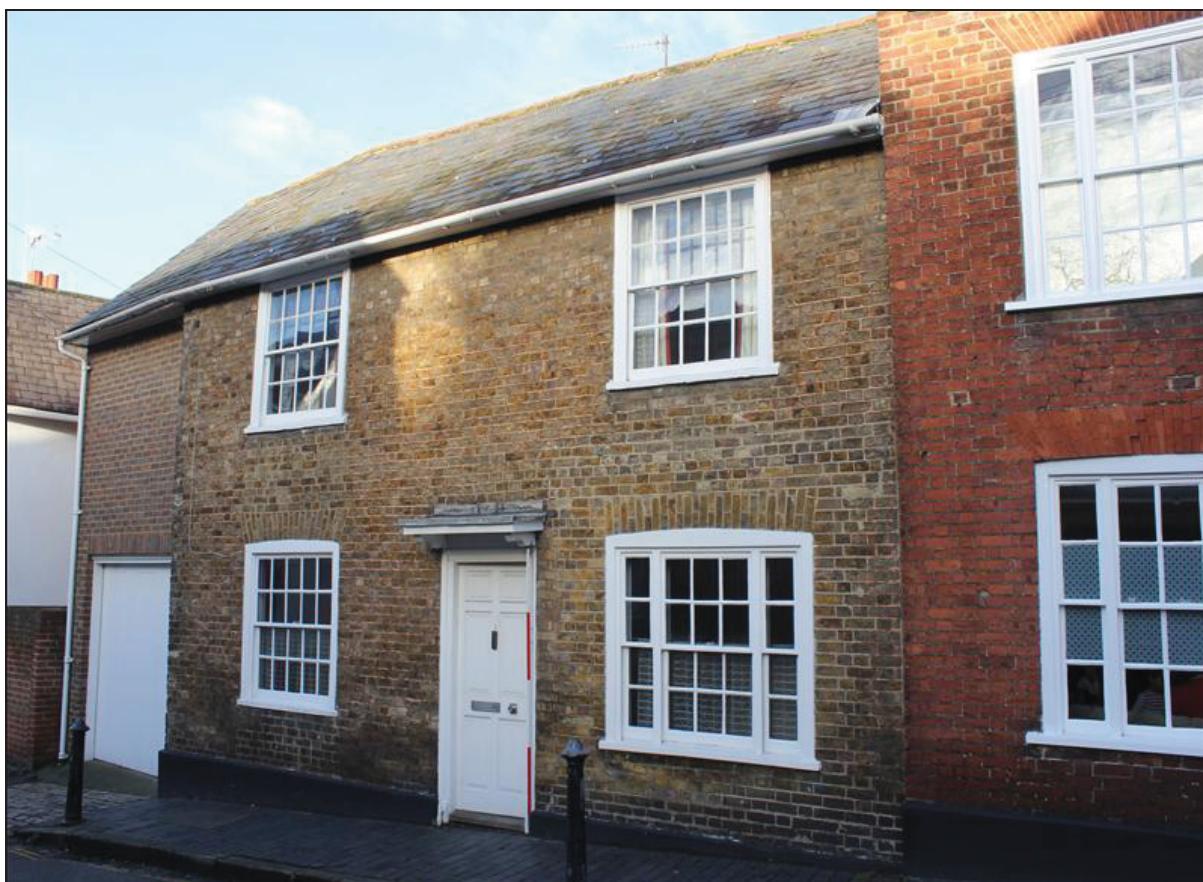
Plate 1 Street front elevation of the assessment building, taken from the south-east (DP 1)

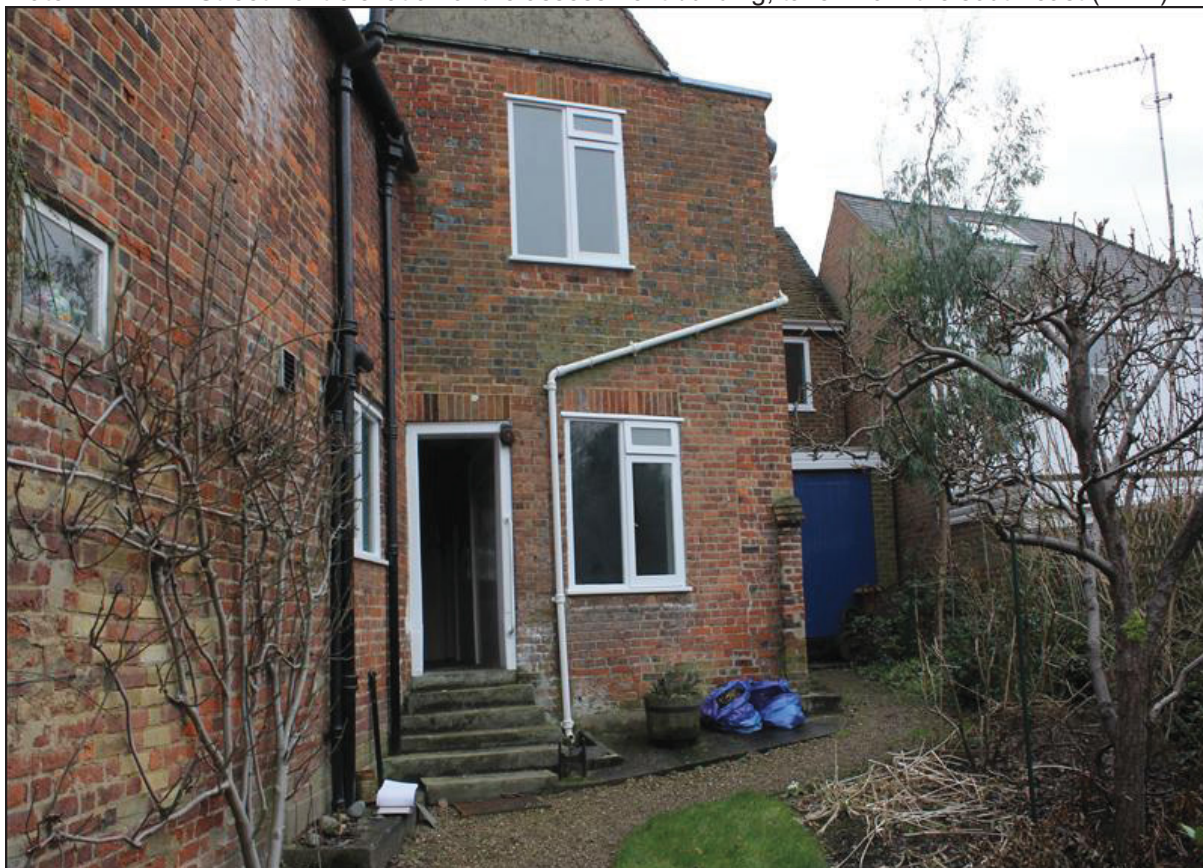
Plate 2 North elevation of the rear range, taken from the north (DP 41)

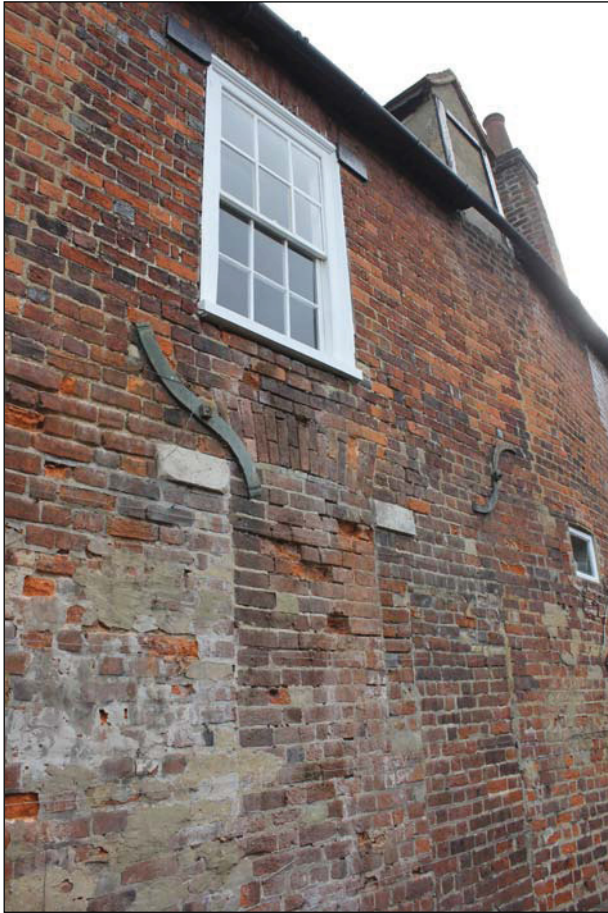
Plate 3 Sash window (first floor) and blocked window (ground floor), taken from the north-west (DP 110)

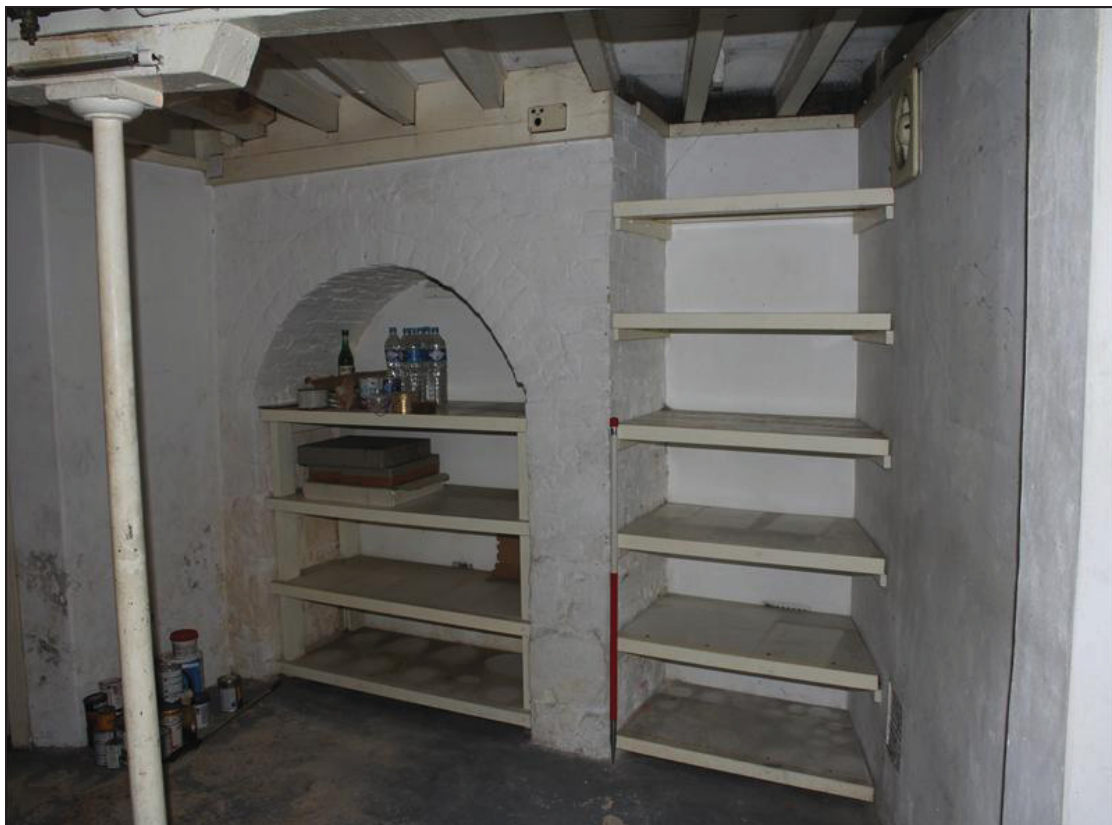
Plate 4 Rear chamber of the cellar showing the brick arch that previously supported the chimney stack, taken from the east (DP 22)

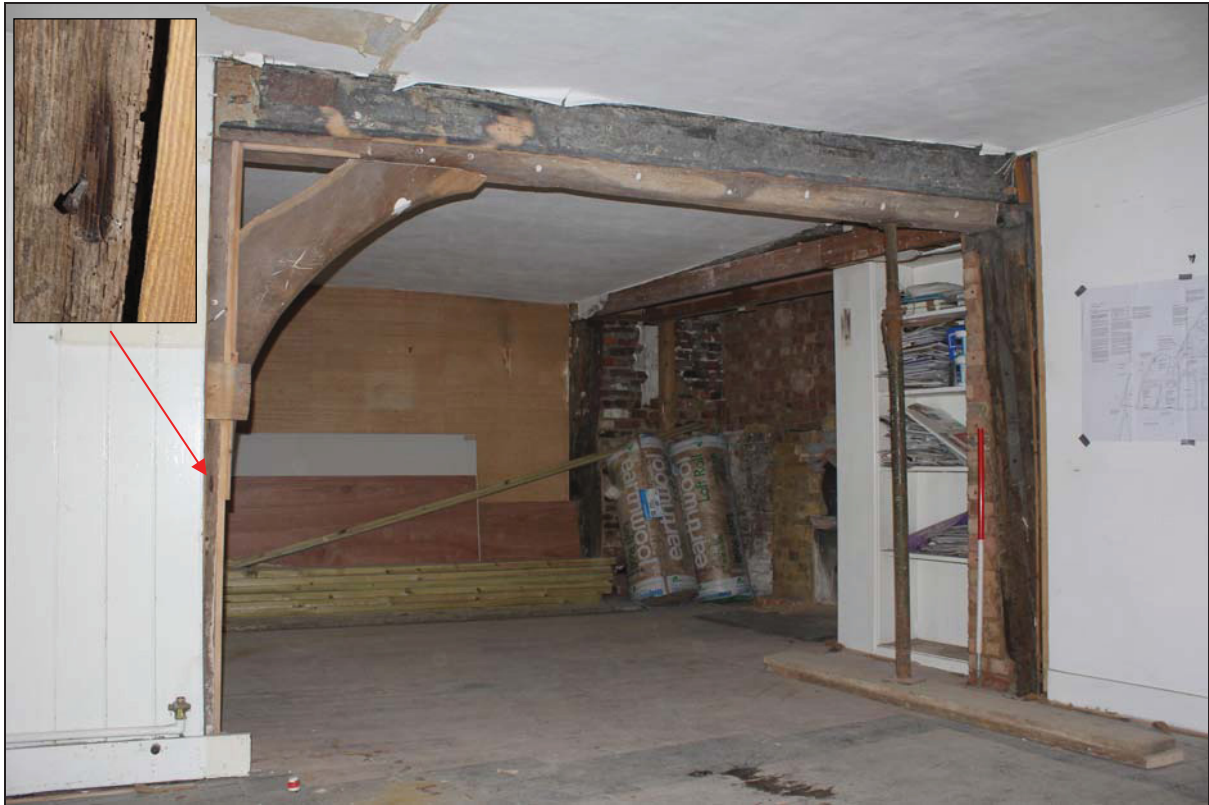
Plate 7 Room GF01 after the removal of dry lining exposing the fabric of the bay division (inset: taper burn), taken from the east (DP 44)

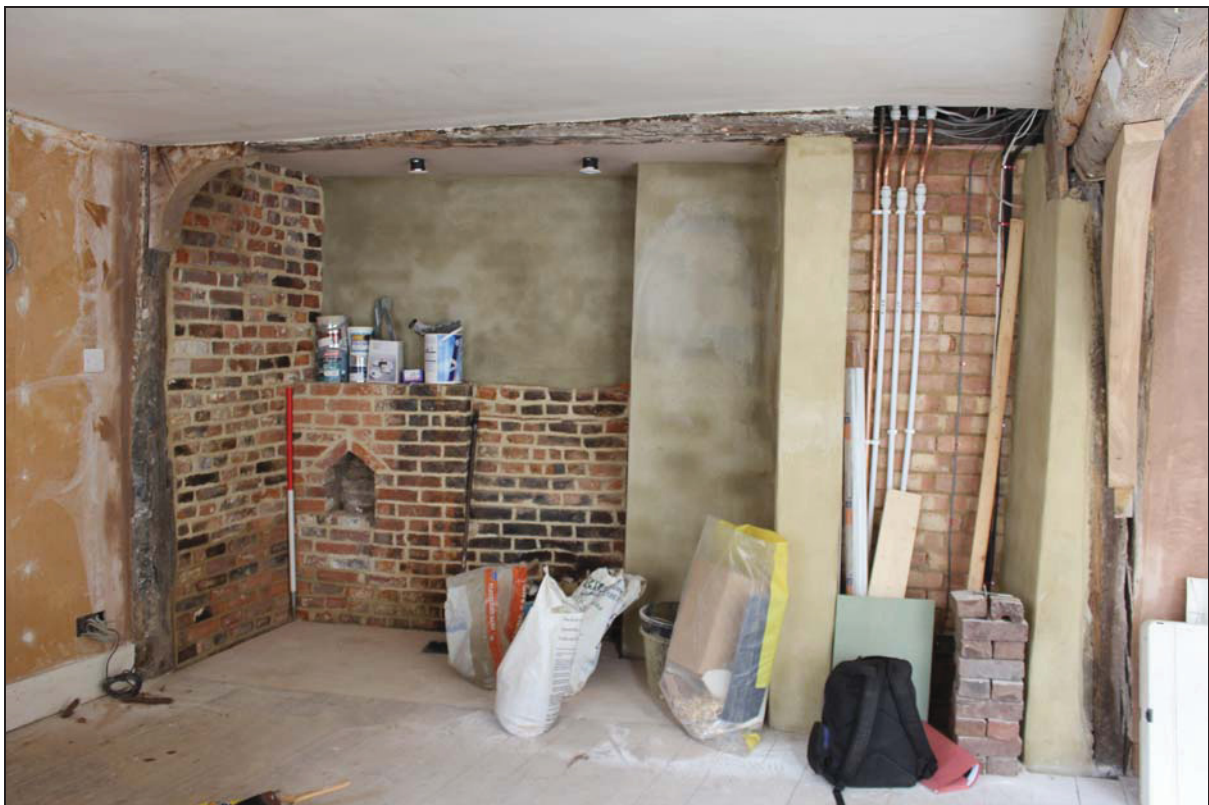
Plate 8 Fireplace on the north side of the west bay (Room GF01) following the removal of modern brickwork to expose the underlying historic brickwork and lantern niche, taken from the south (DP 111)

4.10 The removal of modern Fletton and yellow brick work of the chimney stack has opened up the larger inglenook added on this side and has revealed some early brickwork which incorporates a low lantern niche, though there is still much later brickwork (Plate 8). The addition of the stack on this side resulted in the removal of the studwork in this area. The north-west corner post and mid-rail above the bay survives, the mid-rail with empty mortices for a lower pegged stud and pegged brace, the latter with a companion mortice in the post. There are smaller unpegged mortices in the mid-rail for intermediate studs, and to the east a soffit groove is visible. The rail and hence soffit groove is truncated beyond a modern pier and it is not entirely clear whether the groove relates to the timber in this position.

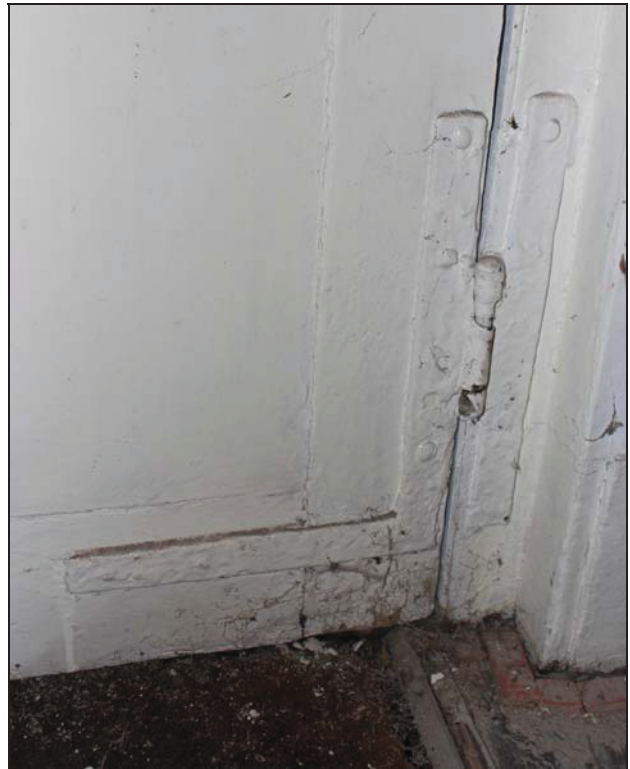
Plate 10 18th century lower HL-hinge on the back door (Room GF02), taken from the south (DP 70)

4.12 This vestibule accommodates the rear entrance as well as the staircase to first floor level and is reached via a step down from the main range where it is floored with noticeably wider floorboards. The back door is of 18<sup>th</sup> century date with flush-panels to the rear and original H-L hinges which retain the original rivets and hence has never been moved (Plates 9 and 10). The staircase rises in a straight flight up the east wall and is enclosed below with painted panelling and a boarded door that leads to the casement. Otherwise, this area is divided from the adjoining space by a partition lined with match-lined boarding and a continuous batten retains the impression of many coat hooks (Plate 11). During the planned works it was revealed that this partition respects no historic wall lines and in addition exposure of a binding joist above the staircase reveals empty mortices for floor joists removed with the insertion of the existing staircase. Small areas of plasterwork have been removed from the east wall here exposing brickwork with a slender stud.

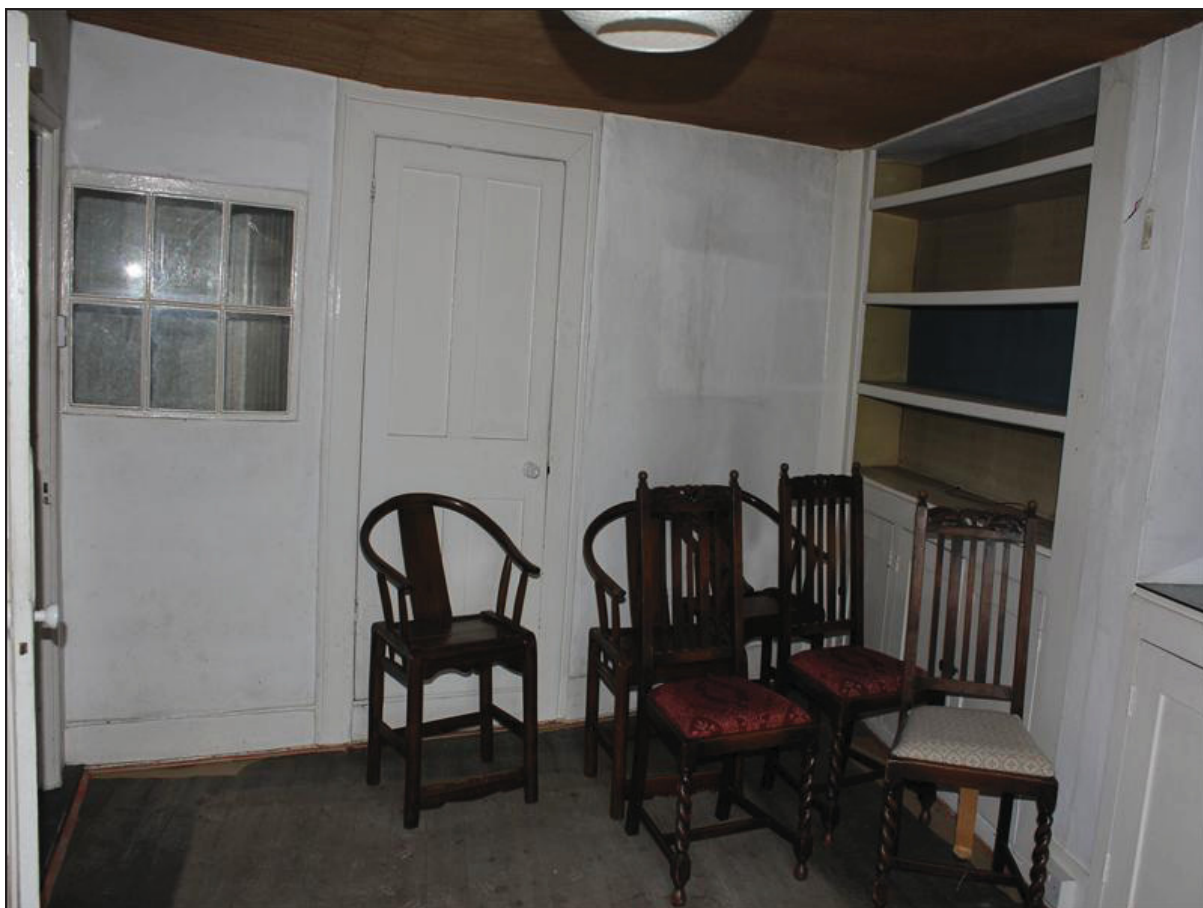
Plate 12 Cupboard and interior window on the south side of Room GF03, taken from the north (DP 14)

4.13 Room GF03 occupies the remainder of the rear range at this level as well as additional space formed when the building was pushed out on this side so that the partition noted above creates an almost regular shaped room with fireplace on the west. The room is entered through a four-panelled Victorian door with 1960s plastic fittings and a 19<sup>th</sup> century ceramic finger plate. A 1970s casement window lights the room from the north, while a four-panel door on the south now encloses a cupboard but formerly gave access from the main range when the space was divided. The chimney breast on the west overlies the supporting brick arch seen in the basement though the fireplace has been altered and now contains cupboards and shelved. Victorian shelves or a fitted dresser adjoins to the south and it is likely that this space formerly comprised a kitchen or scullery (Plate 12).

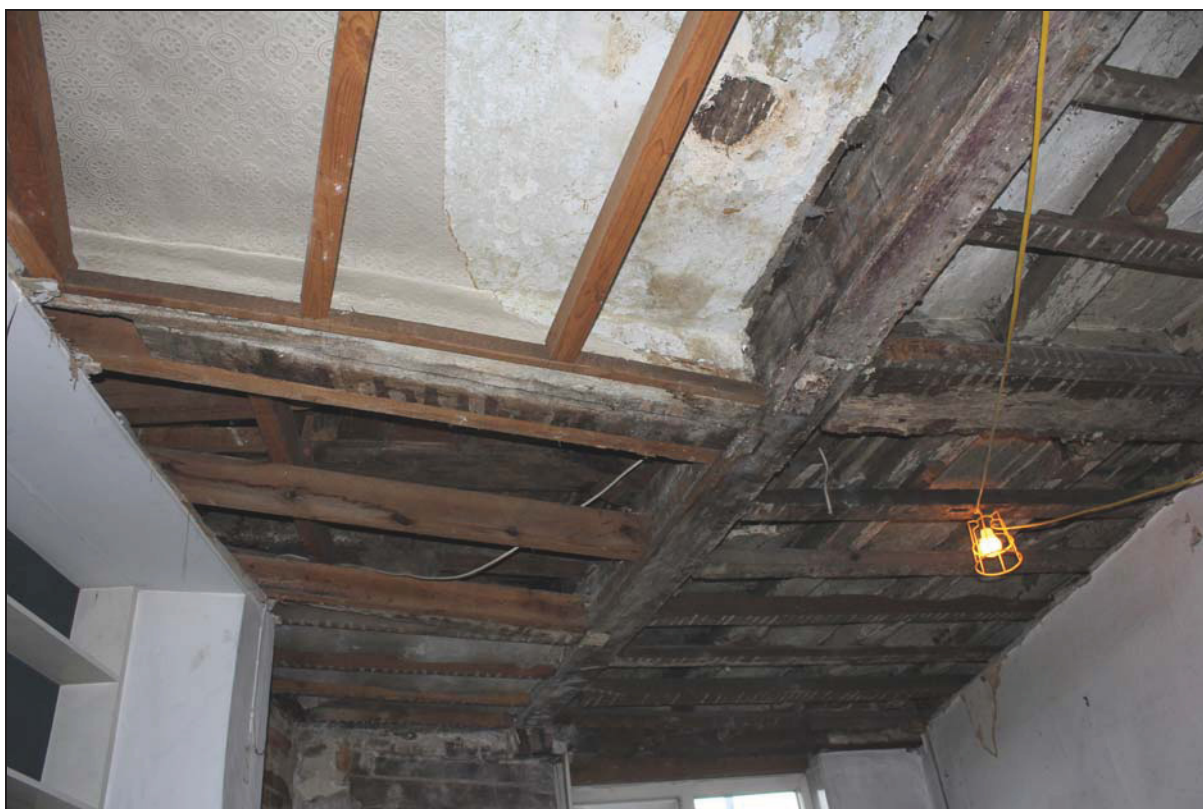
Plate 13 Ceiling of Room GF03, taken from the south (DP 66)

4.14 The planned works saw the removal of the modern ceiling boarding and other lining to the walls which has exposed much historic fabric. Exposure of the ceiling reveals a palimpsest of materials relating to the original structural fabric and later phases (Plate 13). The earliest fabric includes a north-south joist that forms a parallel companion to the east wall of Room GF02, and retains contemporary fabric to the east. The joist is morticed into a truncated post within the existing north wall, while a binding joist is morticed and single-pegged to the main beam and extends over the internal partition to the east and is that visible over the staircase noted above. Common joists are visible that are fairly robust and are jointed with a diminished haunch, some with and some without a pendant soffit. These common joists have historic lath and plaster between that is secured directly to the floorboards above that appear to be wide with some measuring approximately 12" (305mm). There are no mortices in the soffit of the north-south joist for a partition though an empty mortice in the west edge may demonstrate further complexity. At the junction of the north-south joist and east-west binding joist a metal plate and coach bolt appear to serve a post above. This east side of the room was later altered with the application of slender joists below the common joists and level with

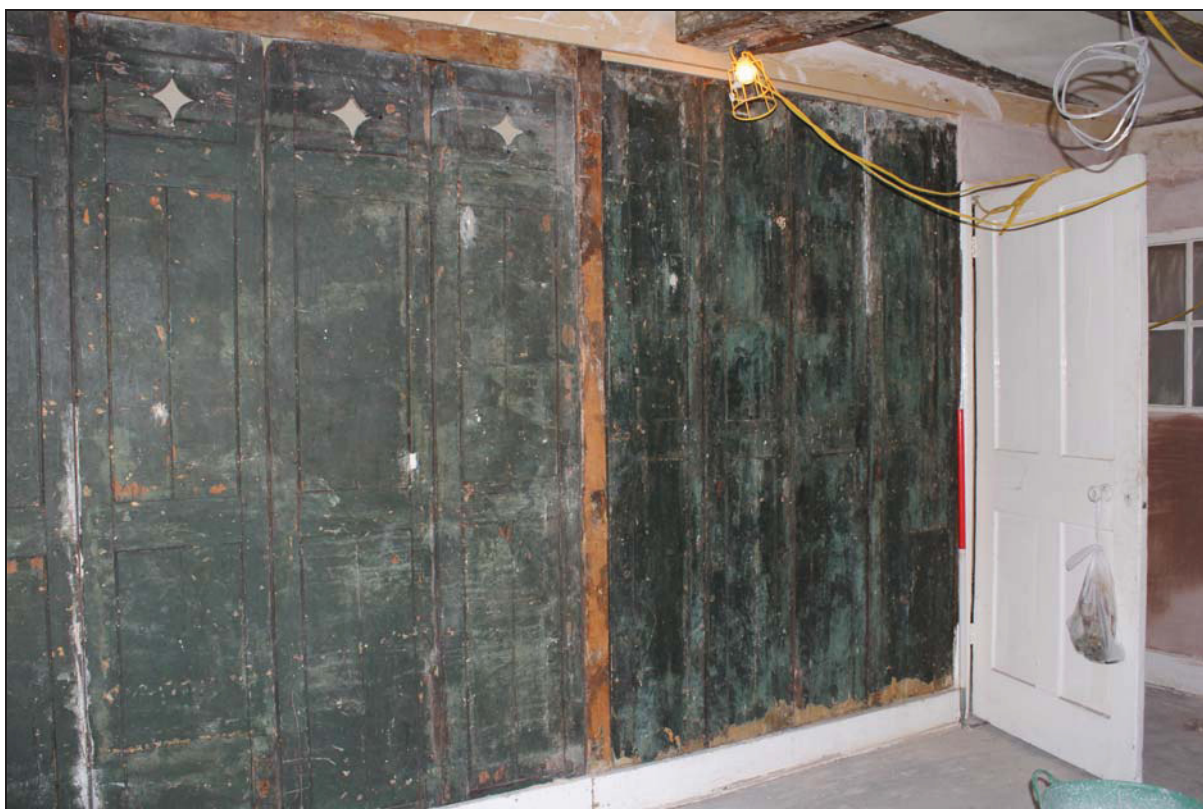
Plate 14 East side of Room GF03 showing historic shutters reused as wall panelling exposed during planned works, taken from the south-west (DP 118)

4.15 The removal of 20<sup>th</sup> century vertical boarding on the east side reveals further historic fabric in the form of reused 18<sup>th</sup> century shutters which were apparently never exposed in this position but wallpapered (Plate 14). The shutters include two different forms, both with flush panels and seemingly enclosed very tall windows or French doors in their original context. They are all painted an identical green and include to the south four individual leaves and a section of a fifth. Two examples have metal plates for locking bars. The examples to the north differ in that each leaf has two lower flush panels with a small upper panel that is decoratively pierced (Plate 15). There are four leaves and a portion of a fifth at the north end that may continue behind later fabric.

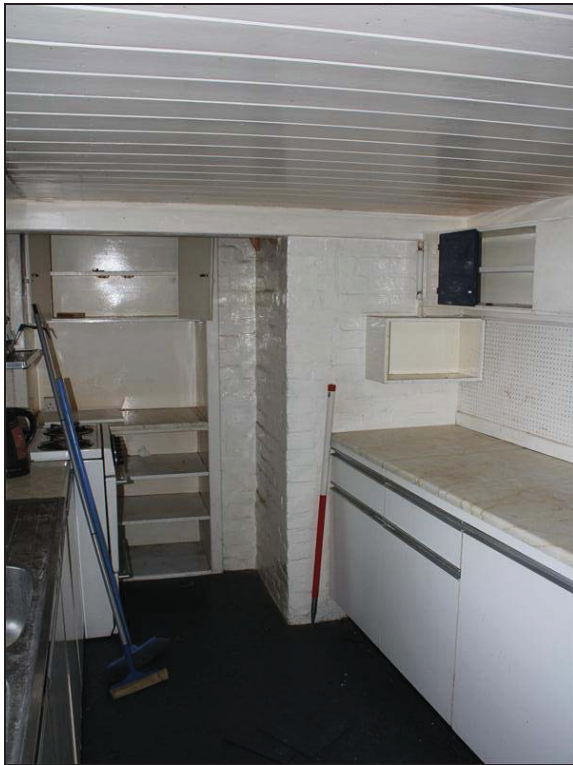
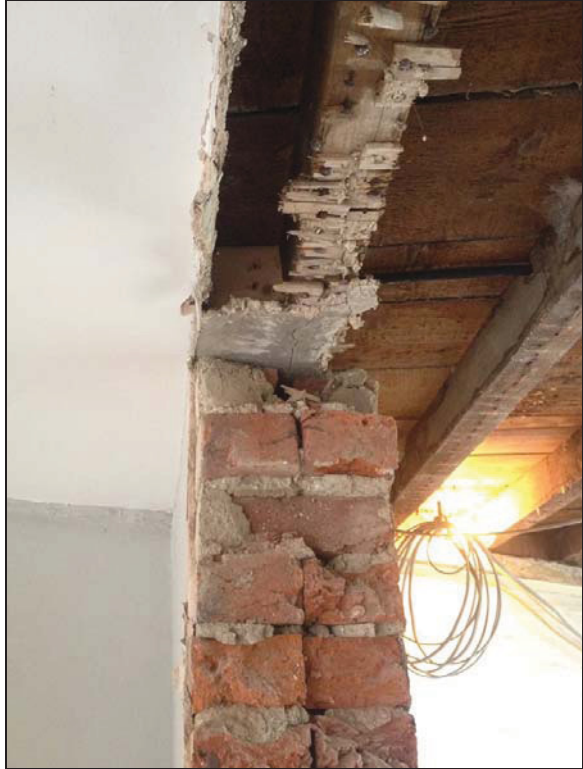
Plate 16 Kitchen GF04 housed in the attached rear range (left) with evidence exposed during monitoring that the lath and plaster ceiling pre-dates the insertion of the brick partitions (DPs 19 and 133)

4.16 GF04 comprises a small kitchen, given access from the corridor via a narrow four-panelled Victorian door. The kitchen is mostly brick-lined and all painted with no features of interest visible (Plate 16). Removal of the kitchen units and lath and plasterwork of the ceiling during the planned works has exposed slender joists of probable 19<sup>th</sup> century date. During the planned works, partitions were removed to enlarge the kitchen space. This reveals that as anticipated, the brick internal partitions are a later insertion built over a stone paved floor, which itself constitutes the raising of an earlier brick floor surface. The top of the wall abuts the lath and plaster of the pre-existing ceiling.

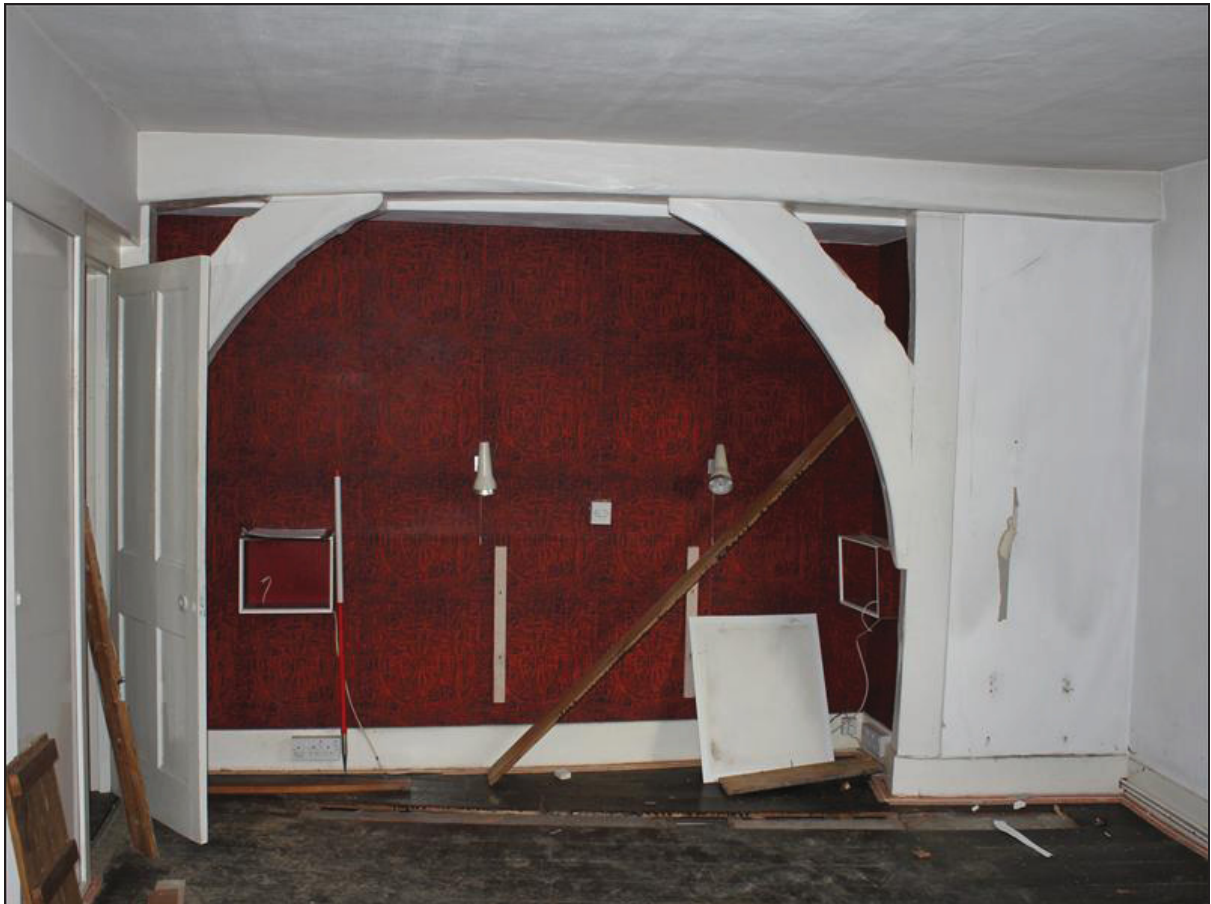
Plate 17 Bay truss of the historic core in Room FF01, taken from the west (DP 37)

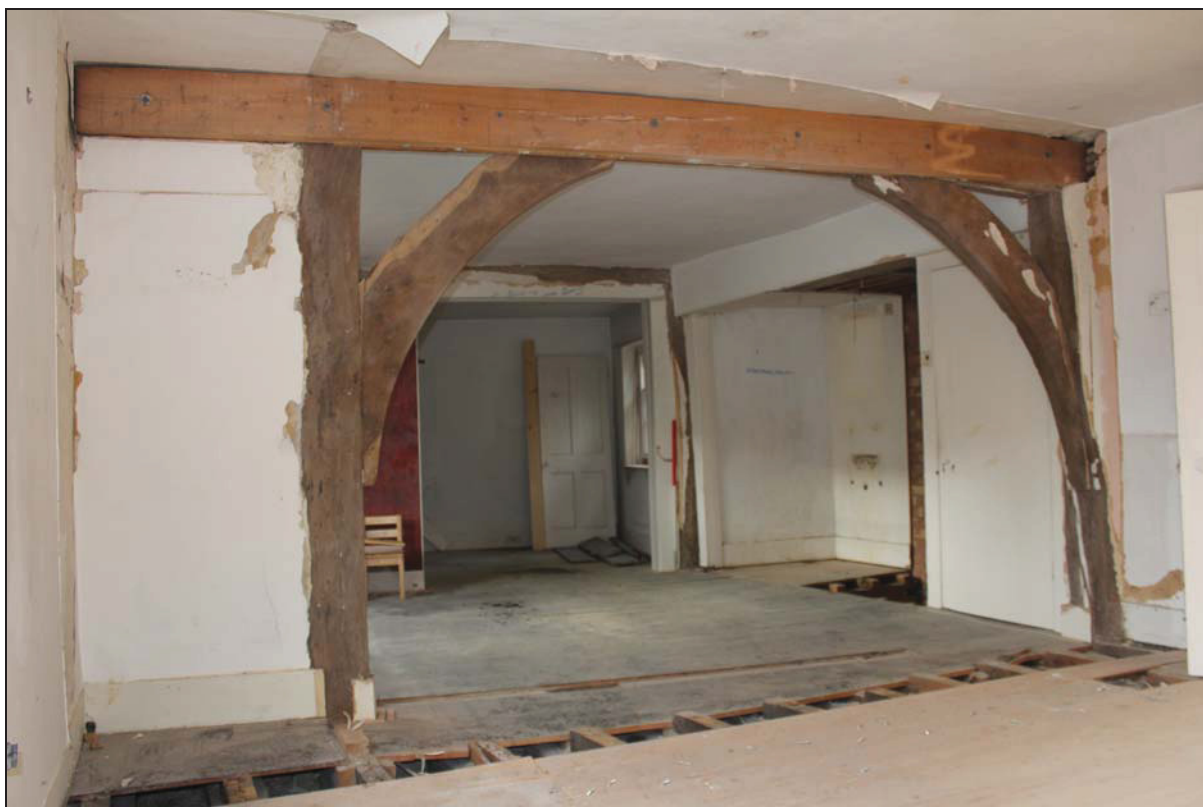
Plate 18 West side of Room FF02 following the removal of a modern partition and exposure of the original truss, taken from the south-west (DP 75)

4.21 As part of the planned works, the modern partition between the two historic bays has been removed and other modern cladding removed (Plate 18). This has revealed little additional diagnostic fabric though the principal structural timbers have been stripped of the thick white paint and this reveals that the southern post has a taper burn in the same position at one seen on the companion post below.

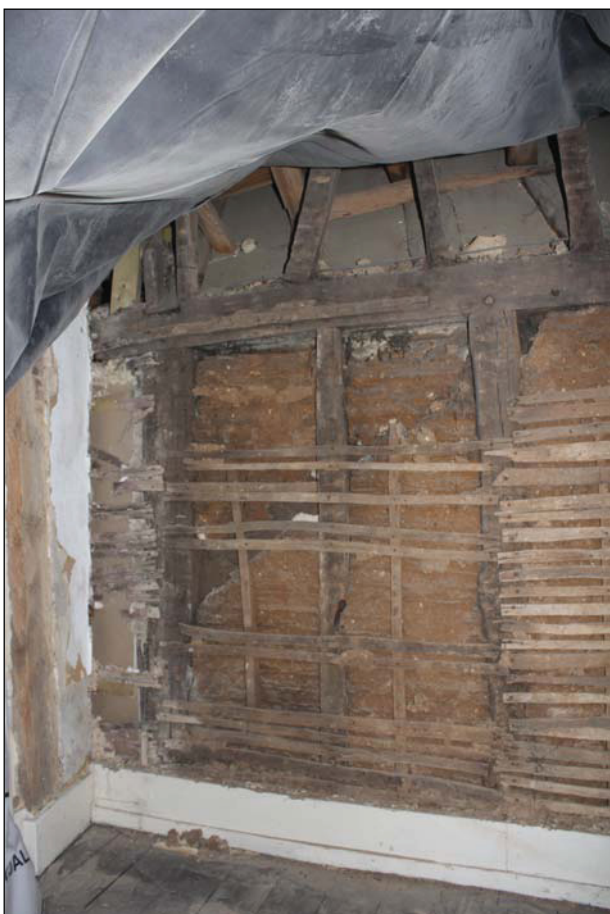
Plate 19 Historic studwork and infill on the east side of Room FF05 with tension brace partially visible, taken from the west (DP 91)

4.23 Areas of plasterwork have fallen away where the plaster was blowing and detached from the underlying timber frame. This reveals what seems to be slender studwork, all nailed, on the west wall and a slender horizontal timber that may mark the position of a former aperture. By contrast, the loss of plasterwork on the east reveals very wide laths, all riven, over a timber-framed wall of substantial interest (Plate 19). It forms the framing of the adjoining building and is all of oak and includes fairly widely spaced pegged studs with intermediates and all infilled with

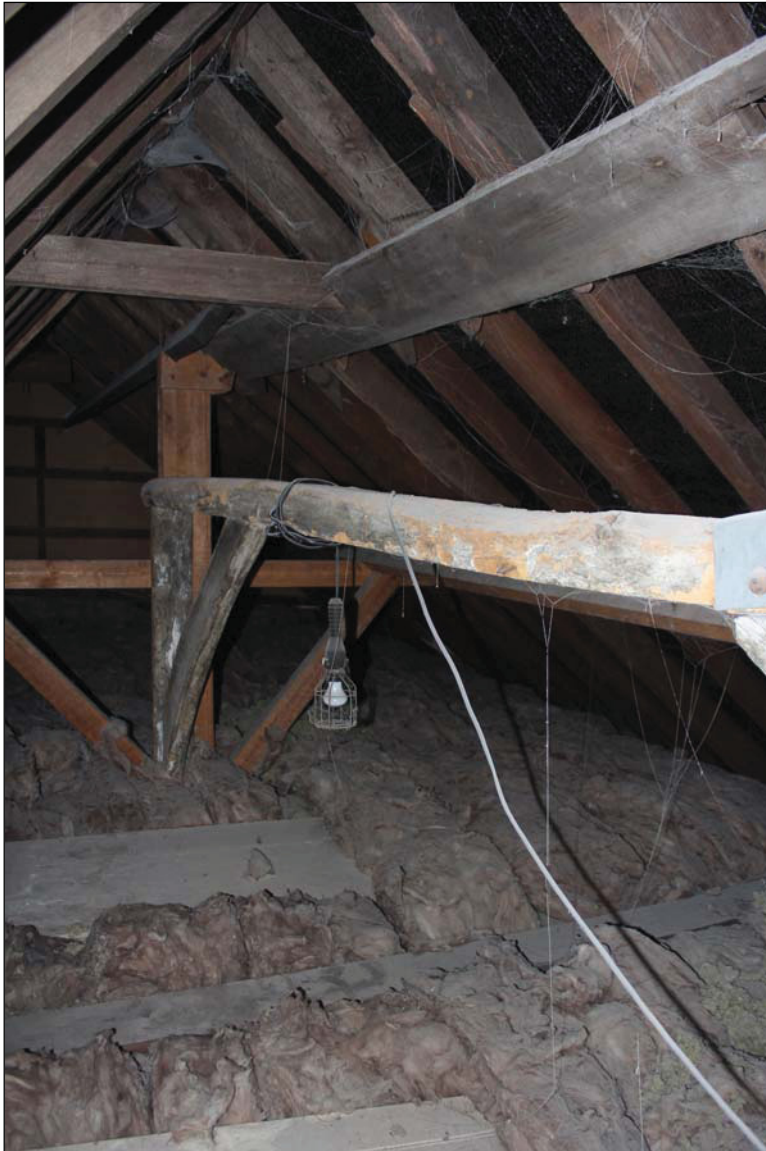
Plate 20 Fragmentary remains of the medieval crown post roof, taken from the west (DP 93)

4.26 The roof of the main range is given access via a removable partition within the attic of the new garage range. It has mostly been refurbished in the mid-20<sup>th</sup> century with large braced purlins and softwood common rafters with inserted intermediate tie-beams. At the core, however, a single bay of a medieval crown-post roof survives (Plate 20). At the bay division a simple crown post retains its west brace and crown purlin extending to the original west gable end. A mortice survives for a second brace to the east but all historic fabric is lost in this area. The western end is also braced and pegged, but the lack of a second peg indicates that this was the end of the building, with evidence of stud mortices in the tie-beam confirming this as a closed truss. The central crown post is itself a reused section of wall-plate which retains two sockets for earlier rafters. On its eastern face is an assembly mark: “ii”, while the west post retains “iiii”. At the far end of the roof, on the eastern side we see a robust, cambered 16<sup>th</sup> century tie-beam of the adjacent property.

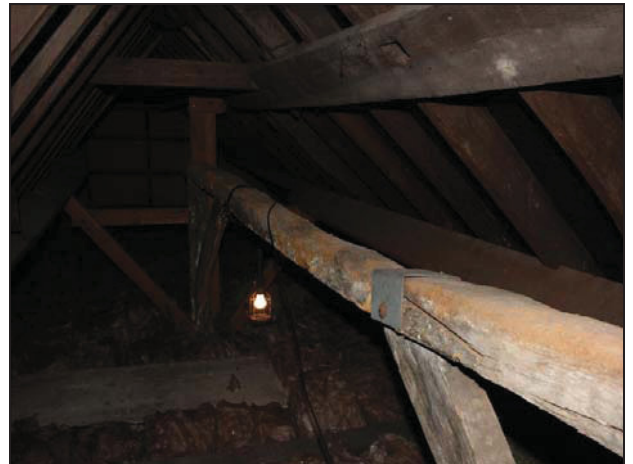
4

*View of remnants of the medieval roof structure below later fabric, taken from the west*

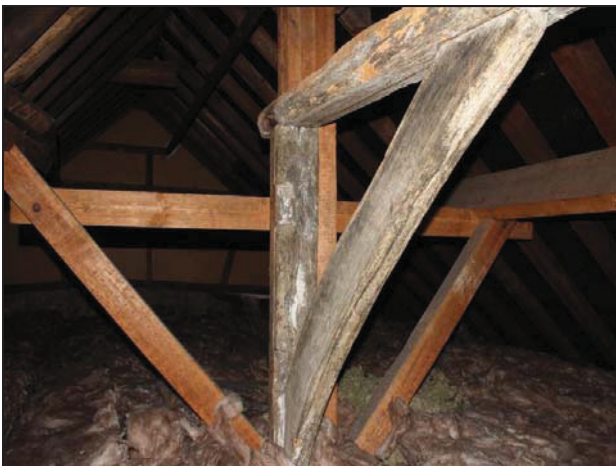
5

*East crown post with lateral brace in roof space above the historic core, taken from the west*

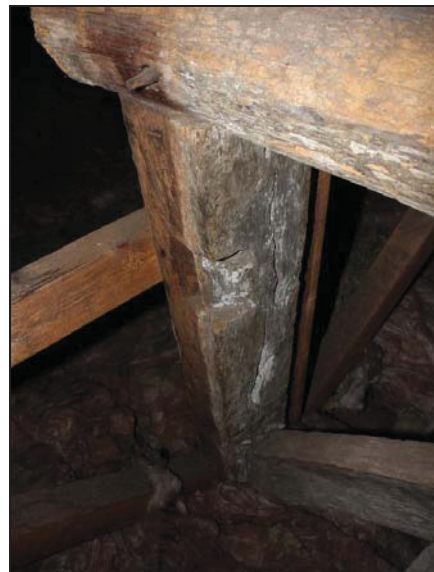
6

*East crown post in roof space above historic core showing evidence of reuse, taken from the west*

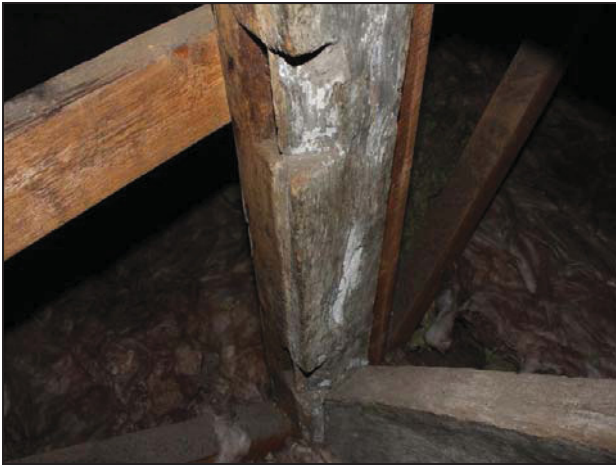
7

*East crown post in roof space above historic core showing evidence of reuse, taken from the west*

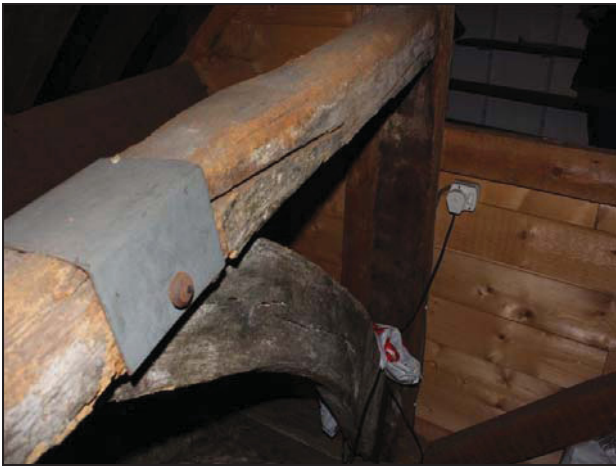
9

*Crown post and repaired collar purlin in roof space above the historic core, taken from the east*

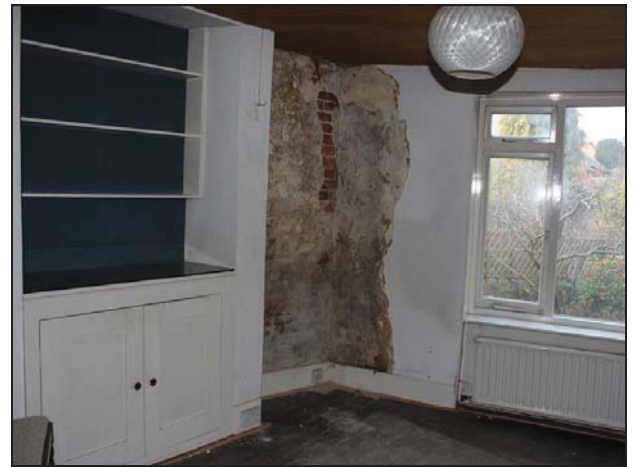
16

*Cupboards and shelving that replaced the chimney stack on the west side of Room GF03, taken from the south-east*

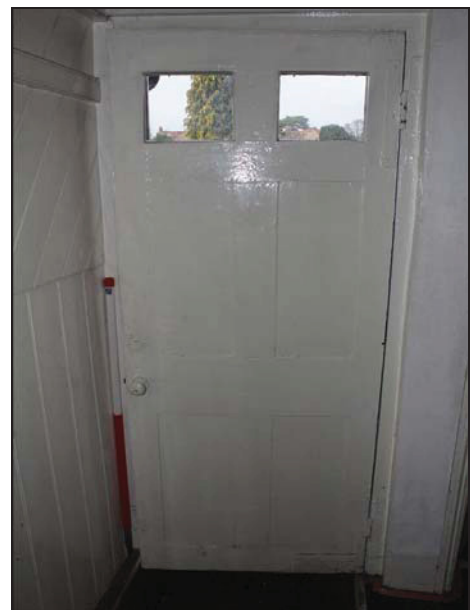
18

*18<sup>th</sup> century back door (GF02), taken from the south*

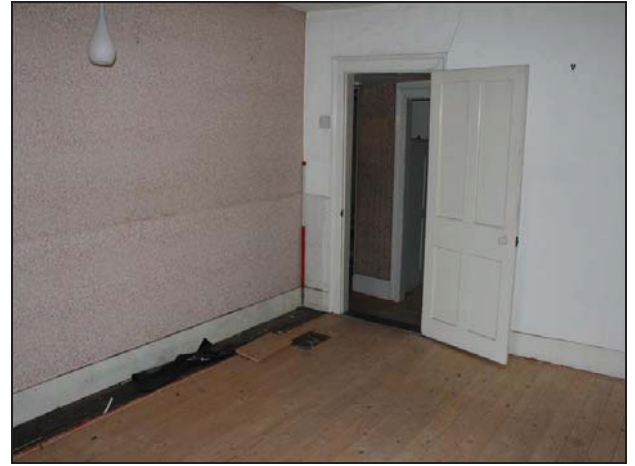
25

*First floor landing FF03, taken from the west*

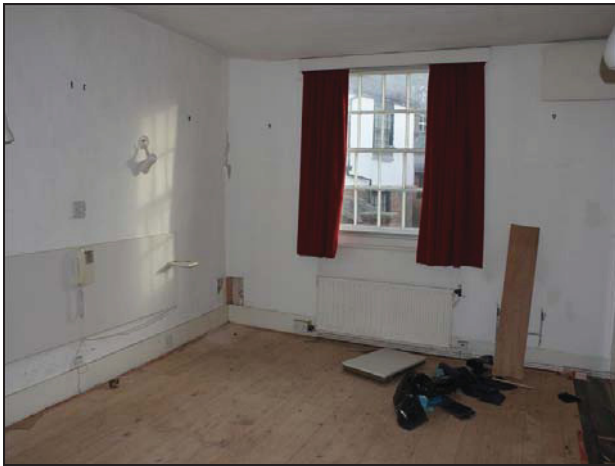
26

*Room FF02, taken from the south-east*

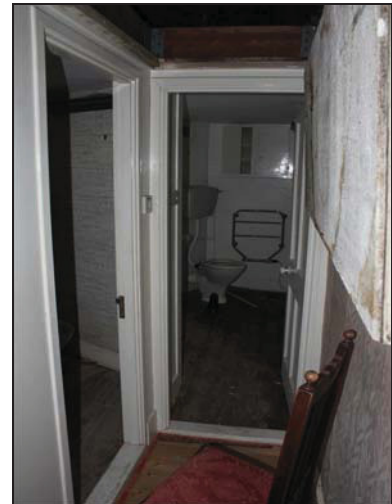
27

*Room FF02, taken from the north-west*

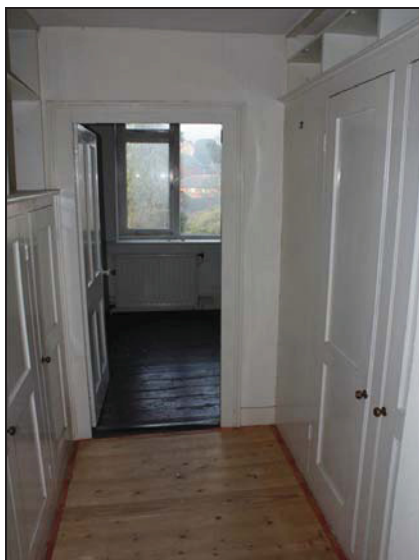
28

*Rooms FF06 and FF07, taken from the south*

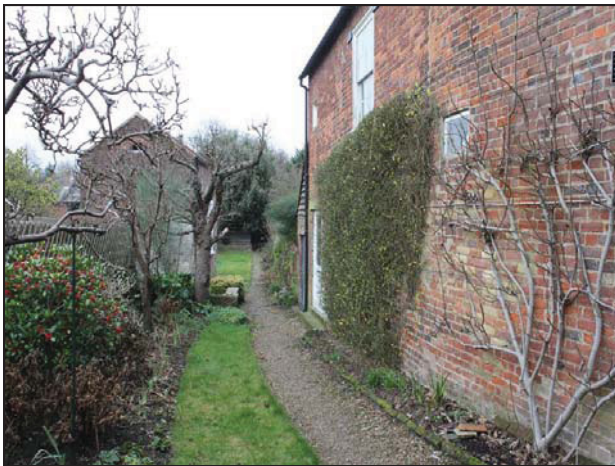
38

*North elevation of the rear range, taken from the north*

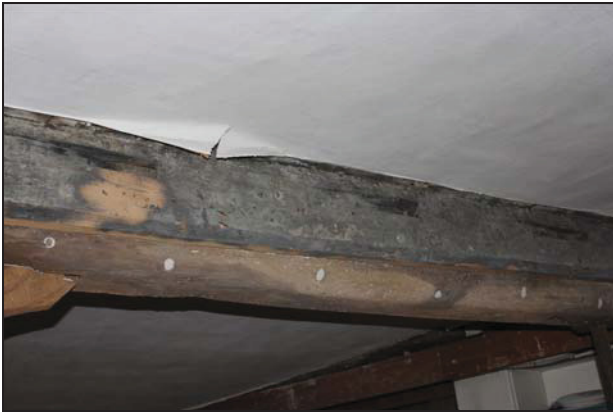
48

*Detail of the binding joist in Room GF01 after removal of modern cladding exposing an applied timber as well as fragments of historic wall paper, taken from the east*

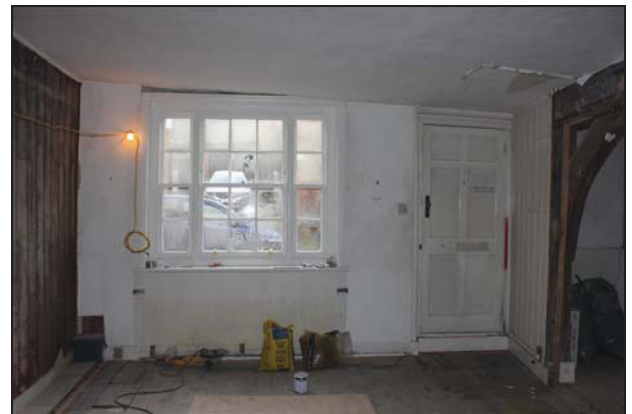
57

*South side of Room GF01 (west bay) showing ten-over-ten sash window, taken from the north-east*

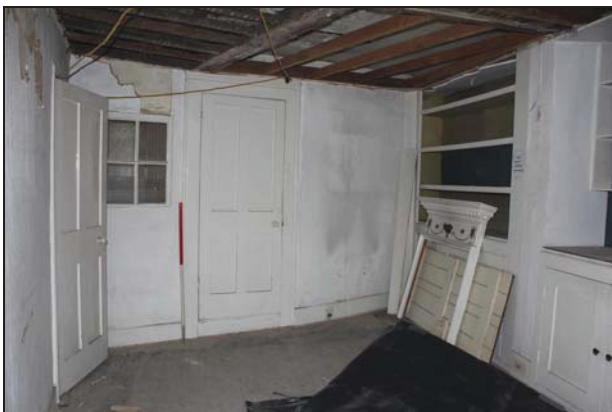
58

*South side of Room GF01 (east bay) showing tripartite sash window and front door, taken from the north*

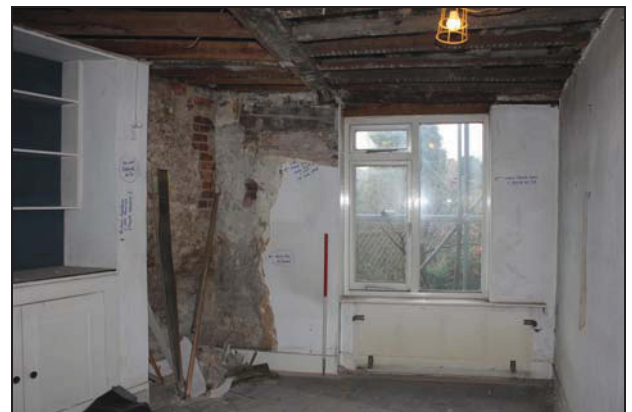
59

*South end of Room GF03 after removal of the ceiling cladding, taken from the north*

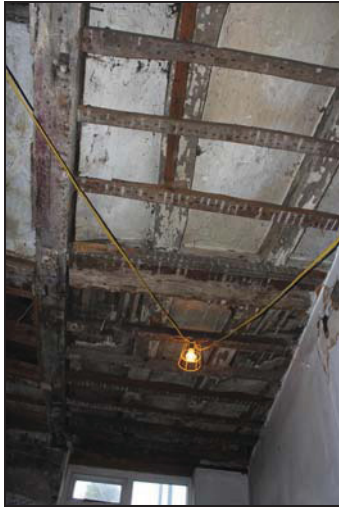
60

*North end of Room GF03 after removal of the ceiling cladding and some plasterwork exposing underlying historic fabric, taken from the south*

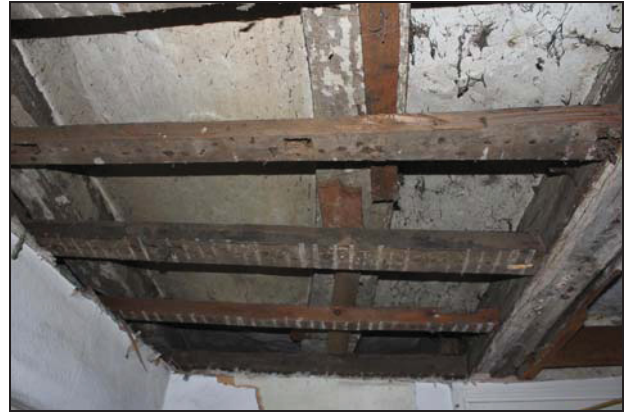
61

*Ceiling on the east side of Room GF03 showing original timber joisting and early infill with later slender applied joists below, taken from the south*

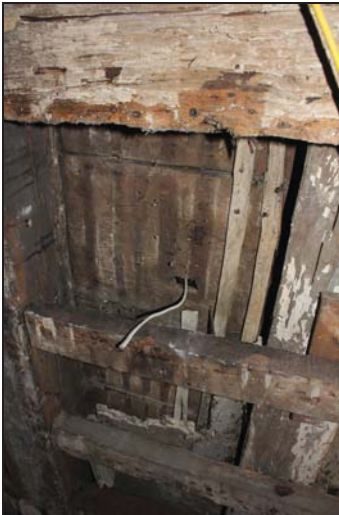
62

*Detail of the ceiling on the east side of Room GF03 showing original timber joists and early infill with later slender applied joists below, taken from the north*

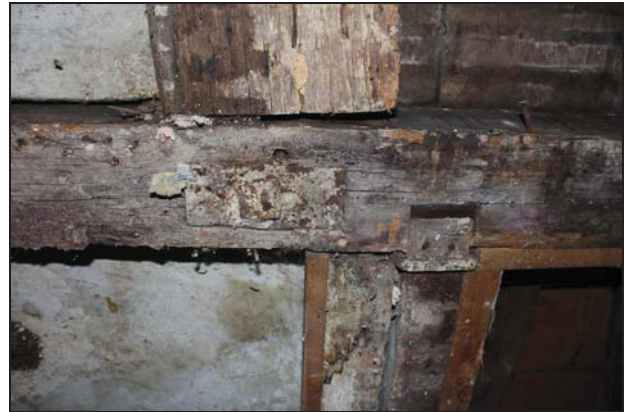
63

*Detail of the ceiling on the east side of Room GF03 showing lath and plaster ceiling infill applied to the floorboards above, taken from the south*

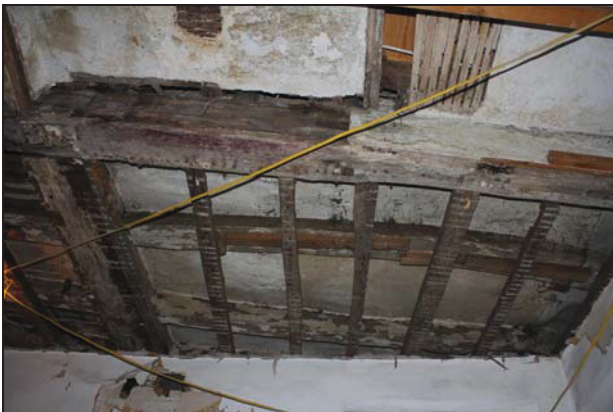
64

*North-south ceiling beam in Room GF03 with original pegged joist (top), later nailed fabric and later reinforcing coach bolt, taken from the west*

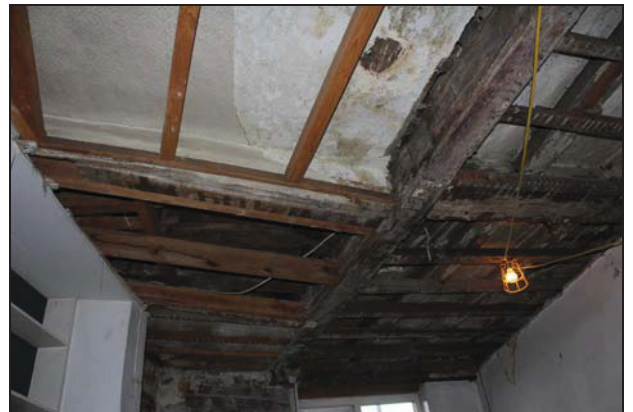
65

*Ceiling on the east side of Room GF03 showing original timber joisting and early infill with later slender applied joists below, taken from the west*

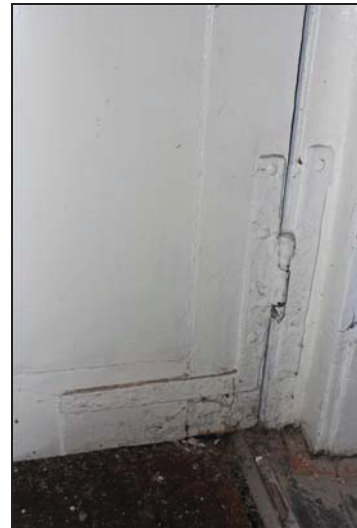
69

*18<sup>th</sup> century upper H-hinge on the back door (Room GF02), taken from the south*
