ARCHAEOLOGICAL SOLUTIONS LTD

20 FISHPOOL STREET, ST. ALBANS,  
HERTFORDSHIRE

HISTORIC BUILDING RECORDING AND  
MONITORING AND RECORDING

Authors:	William Waring Dr Lee Prosser Tansy Collins	
NGR: TL 1429 0719		Report No: 5178
District: St. Albans		Site Code: AS 1839
Approved: Claire Halpin		Project No: 6075
Signed:		Date: August 2016

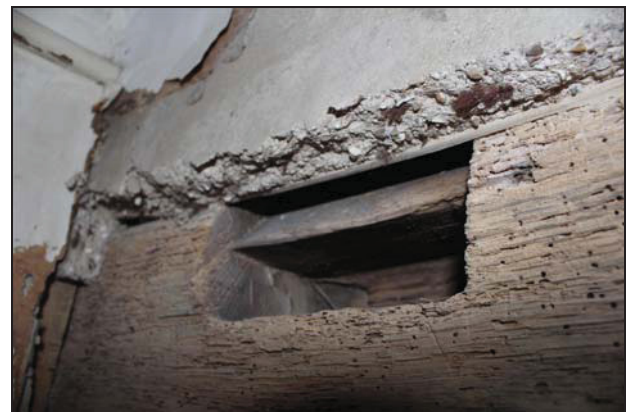
71

*Binding joist visible above the existing staircase (Room GF02) showing empty mortices for common joists presumably removed with the insertion of the staircase, taken from the south*

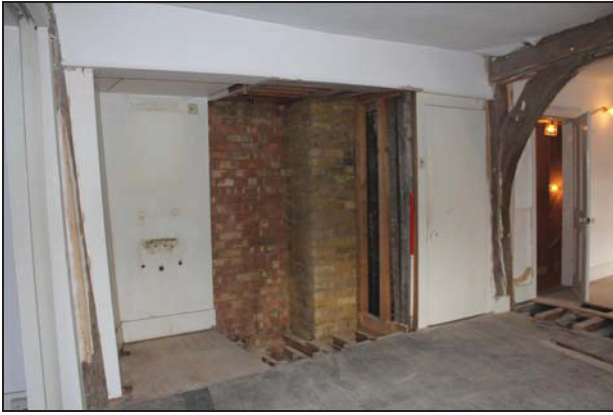
78

*East side of Room FF01 after removal of modern partition and paint from the historic truss members, taken from the west*

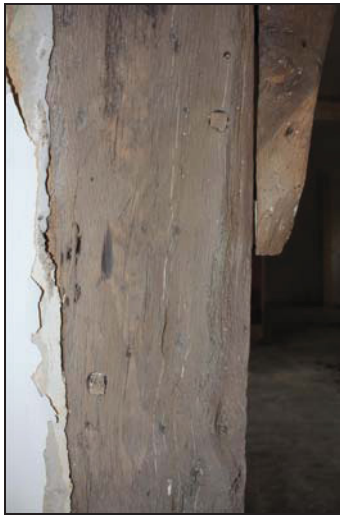
80

*Detail of the south brace and post in Room FF01 after removal of paintwork, taken from the north-west*

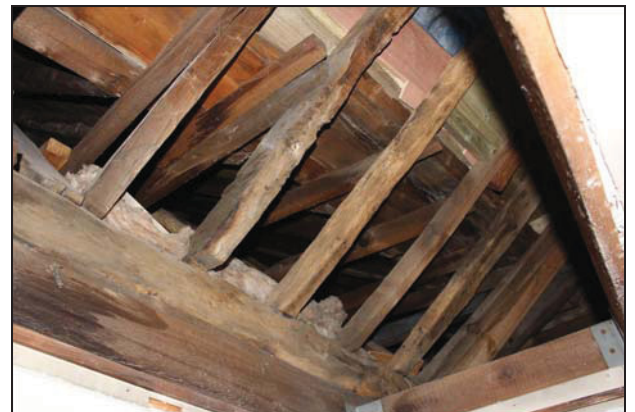
83

*Roof structure over the rear range with slender rafters and occasional reused pieces, taken from the south*

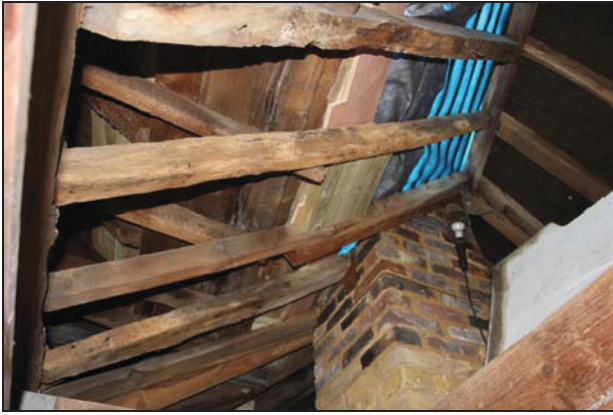
84

*Roof structure over the rear range with slender rafters and occasional reused pieces over historic timber associated with the range to the east, taken from the north-west*

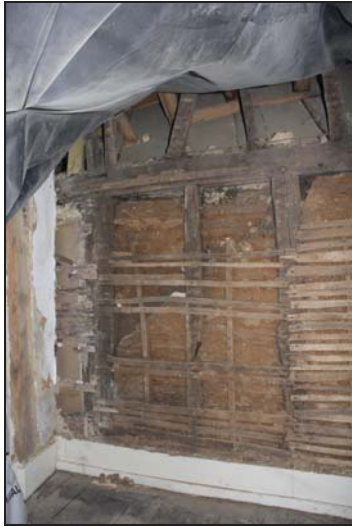
90  
Historic studwork and infill on the east side of Room FF05, taken from the west

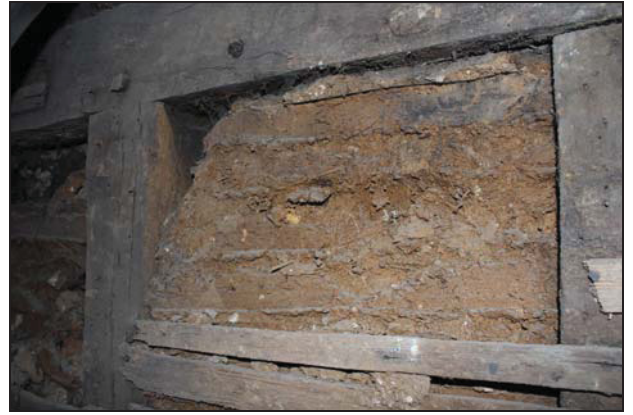
91  
*Historic studwork and infill on the east side of Room FF05 with tension brace partially visible, taken from the west*

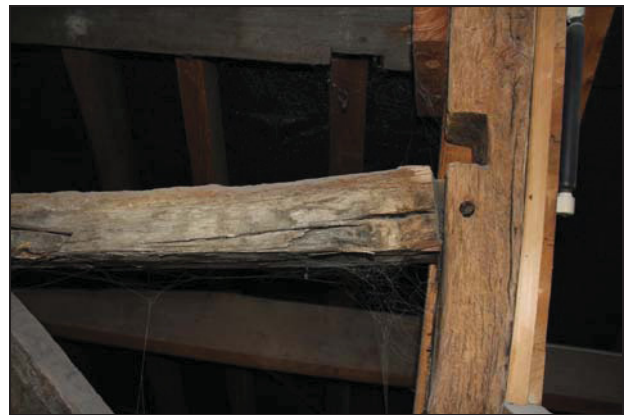
93  
*Fragmentary remains of the medieval crown post roof, taken from the west*

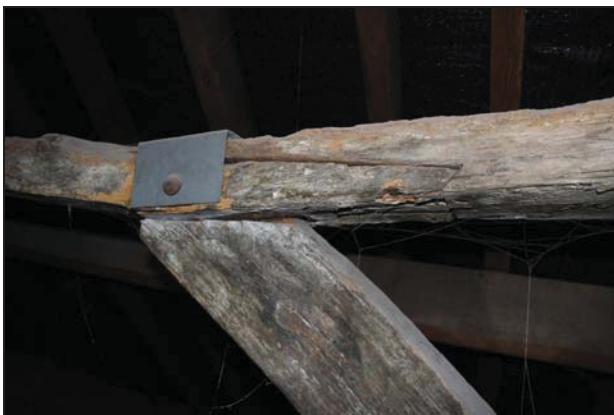
94  
*Detail of the medieval roof structure showing the crown purlin pegged to the post of the former west gable end, taken from the north*

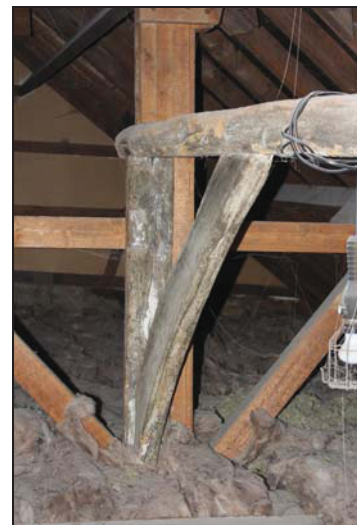
95  
*Detail of the medieval roof structure showing splayed scarf joint, taken from the north-west*

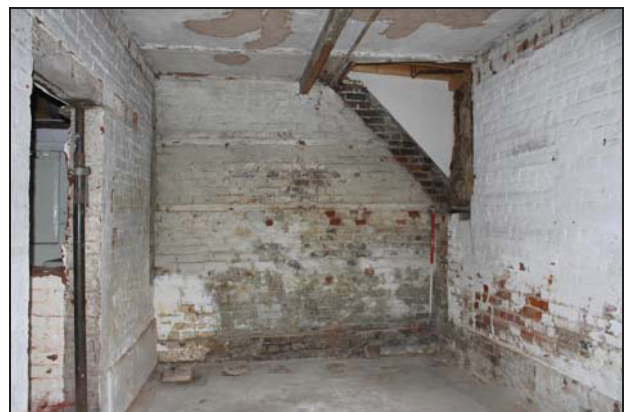
101

*Detail of the brickwork on the west side of the rear range, taken from the west*

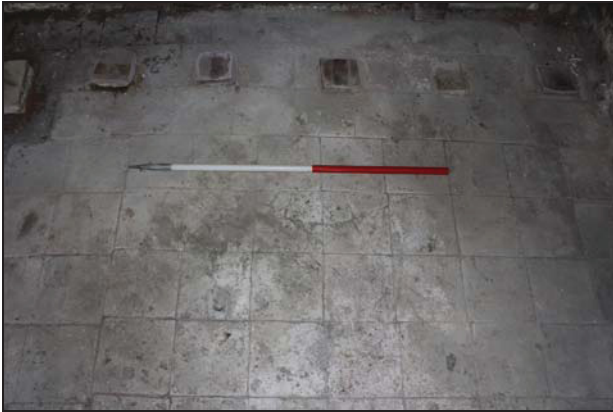
102

*Room GF05 (attached outbuilding), taken from the west*

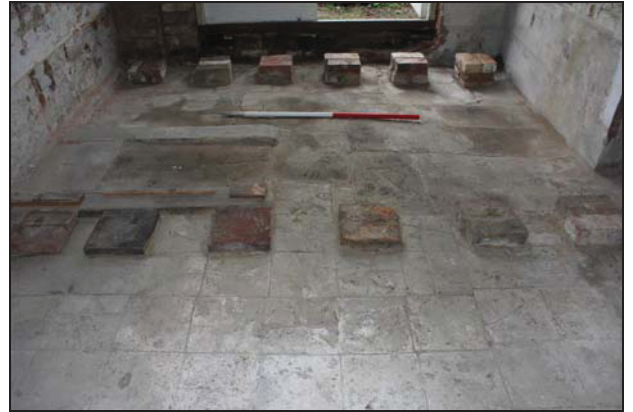
103

*Paved floor of Room GF05 (attached outbuilding), taken from the west*

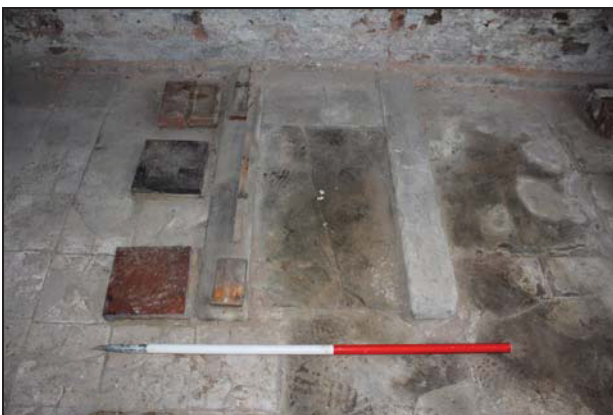
104

*Paved floor of Room GF05 (attached outbuilding) with brick piers added to raise the floor level, taken from the east*

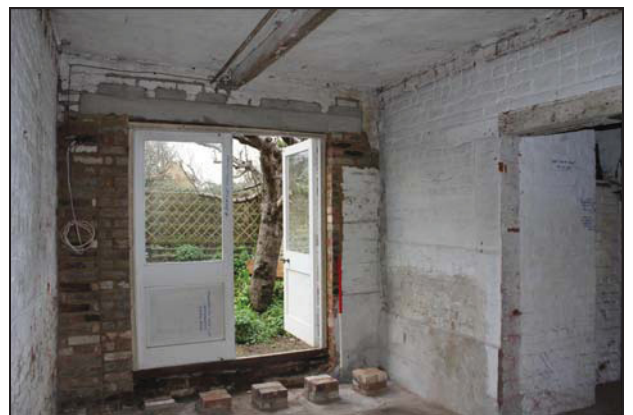
105

*Paved floor of Room GF05 (attached outbuilding) with concrete pads for supporting some lost equipment, taken from the south*

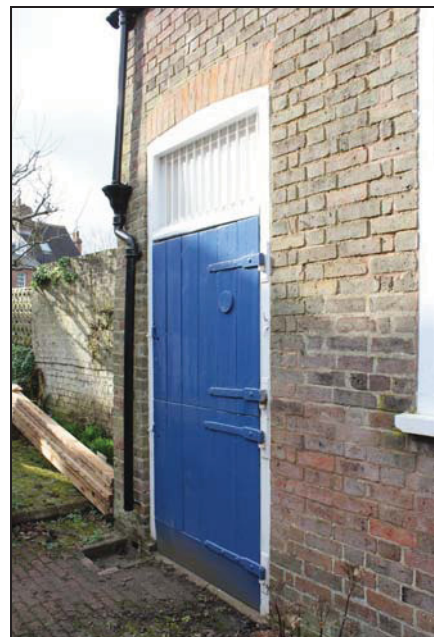
107

*Reused 18<sup>th</sup> century door with modern hinges in Room GF05a (attached outbuilding), taken from the west*

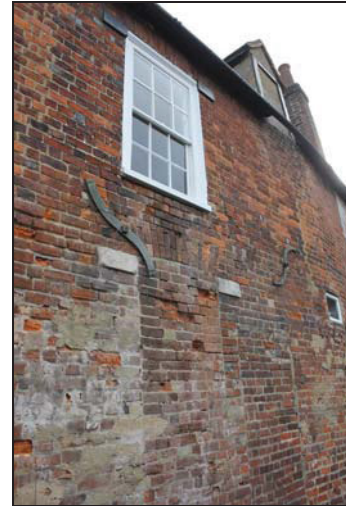
109

*Blocked window and doorway to the attached outbuilding, taken from the north-west*

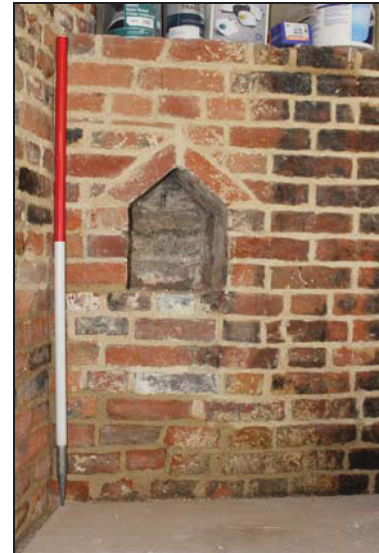
111

*Fireplace on the north side of the west bay (Room GF01) following the removal of modern brickwork to expose the underlying historic brickwork and lantern niche, taken from the south*

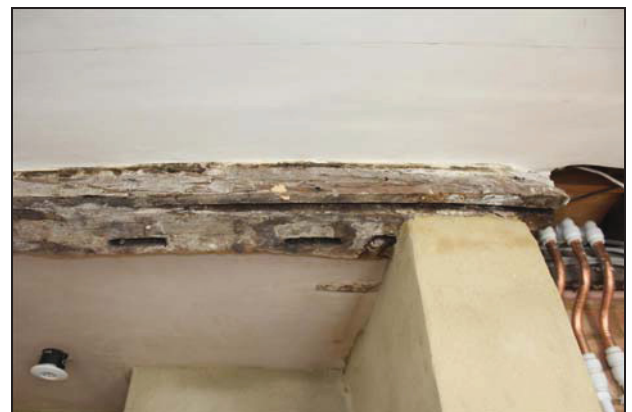
113

*Mid-rail on the north side of the west bay (GF01) showing brace and stud mortices, taken from the south-west*

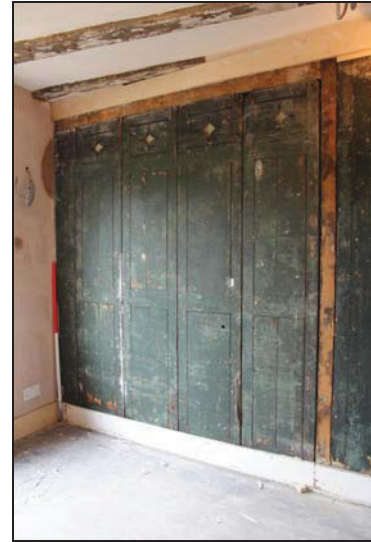
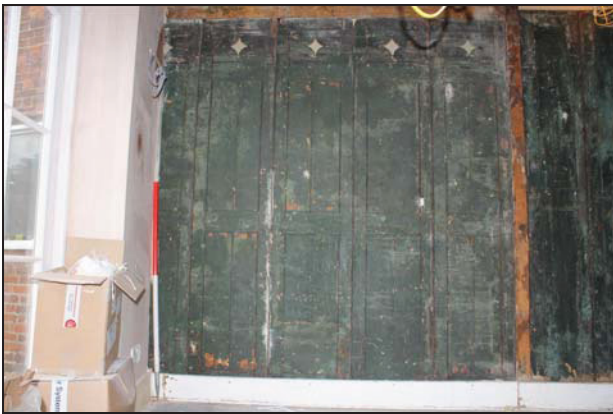
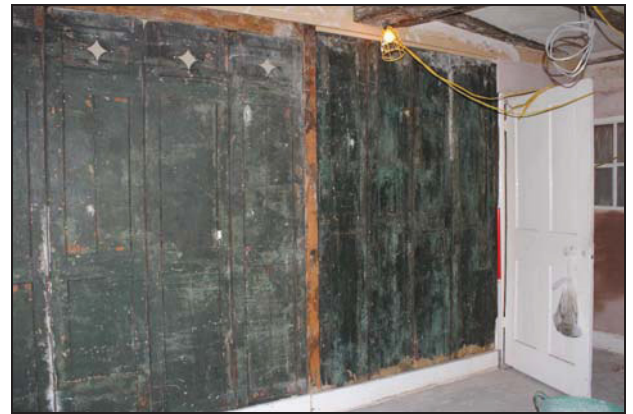
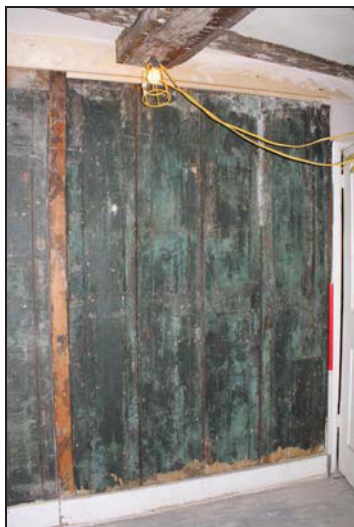
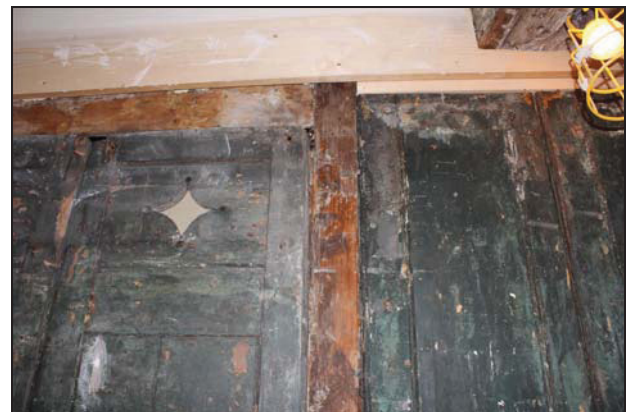
*East side of Room GF03 showing historic shutters reused as wall panelling exposed during planned works, taken from the south-west*

*East side of Room GF03 showing historic shutters reused as wall panelling exposed during planned works, taken from the west*

*East side of Room GF03 showing historic shutters reused as wall panelling exposed during planned works, taken from the north-west*

4.13 Room GF03 occupies the remainder of the rear range at this level as well as additional space formed when the building was pushed out on this side so that the partition noted above creates an almost regular shaped room with fireplace on the west. The room is entered through a four-panelled Victorian door with 1960s plastic fittings and a 19<sup>th</sup> century ceramic finger plate. A 1970s casement window lights the room from the north, while a four-panel door on the south now encloses a cupboard but formerly gave access from the main range when the space was divided. The chimney breast on the west overlies the supporting brick arch seen in the basement though the fireplace has been altered and now contains cupboards and shelved. Victorian shelves or a fitted dresser adjoins to the south and it is likely that this space formerly comprised a kitchen or scullery (Plate 12).

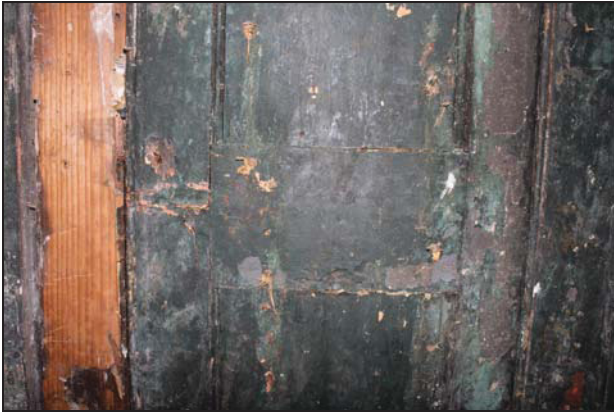
120

*East side of Room GF03 showing detail of different forms of panelled shutters reused as wall panelling exposed during planned works, taken from the west*

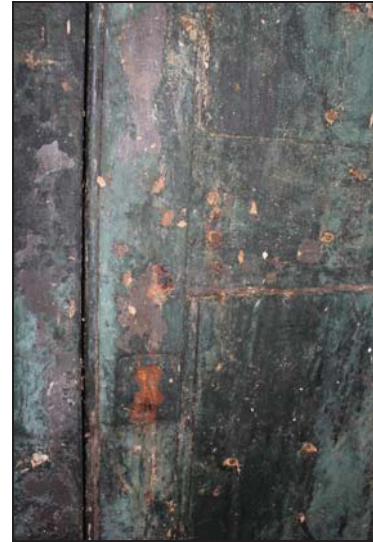
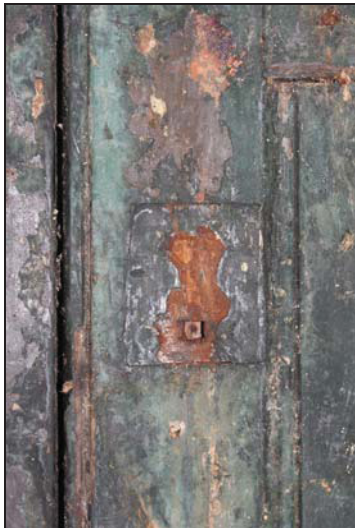
*East side of Room GF03 showing detail of flush panelling exposed during planned works, taken from the west*

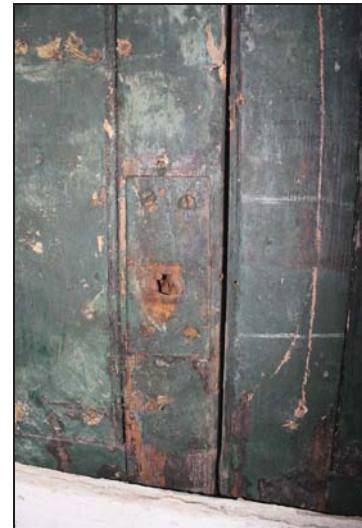
123

*East side of Room GF03 showing plate for locking bar on reused shutters exposed during planned works, taken from the west*

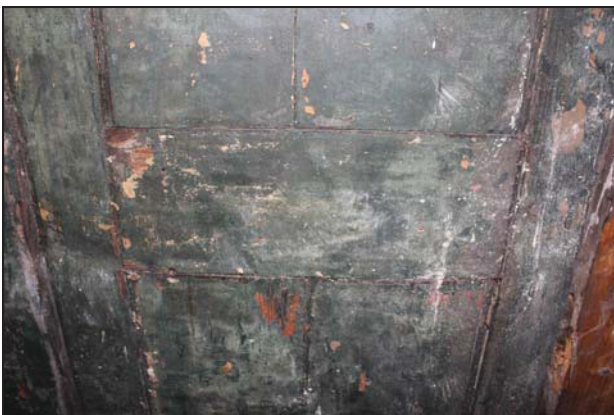
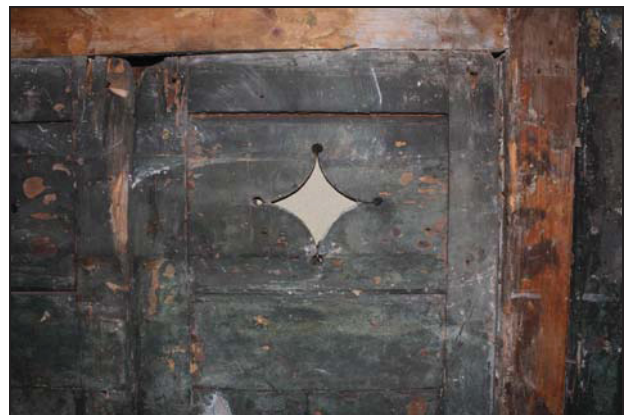
*East side of Room GF03 showing plate on reused shutters exposed during planned works, taken from the west*

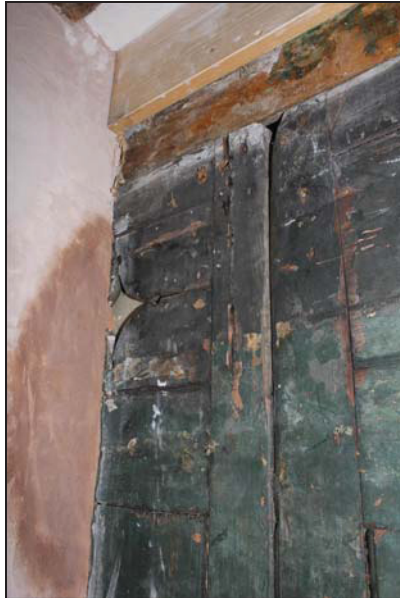
126

*East side of Room GF03 showing decorative detail on reused shutters exposed during planned works, taken from the west*

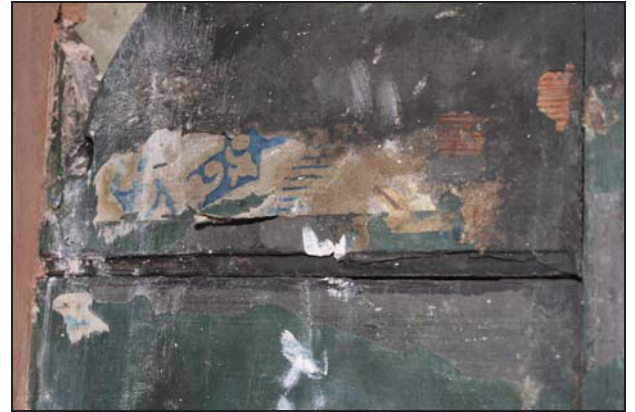
127

*East side of Room GF03 showing cut down and reused panelling exposed during planned works, taken from the west*

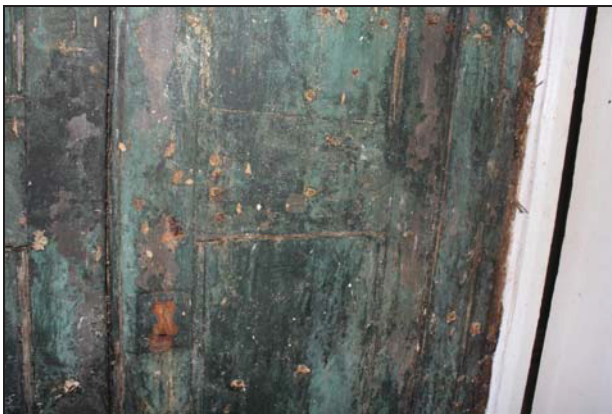
128

*East side of Room GF03 showing fragment of historic wallpaper on reused panelling exposed during planned works, taken from the west*

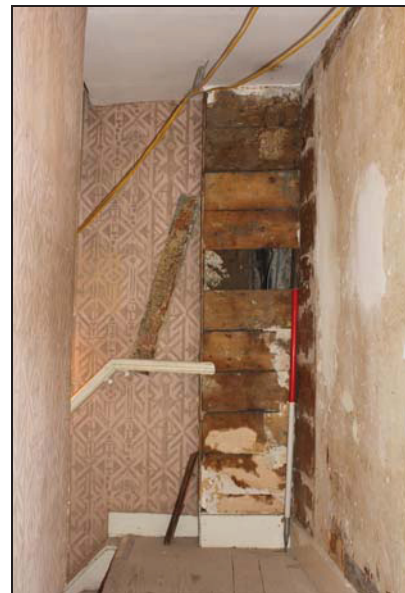
129

*East side of Room GF03 showing detail of flush panelling exposed during planned works, taken from the west*

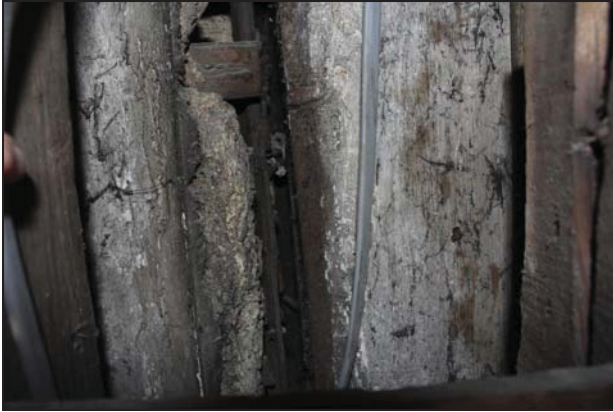
130

*Corridor FF03 showing boarding enclosing inserted post, taken from the west*

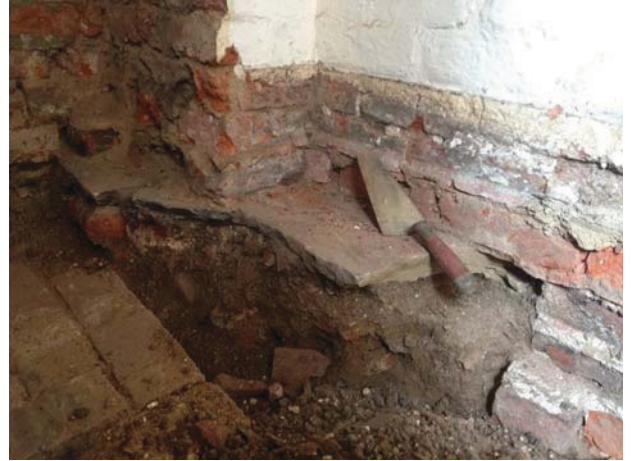
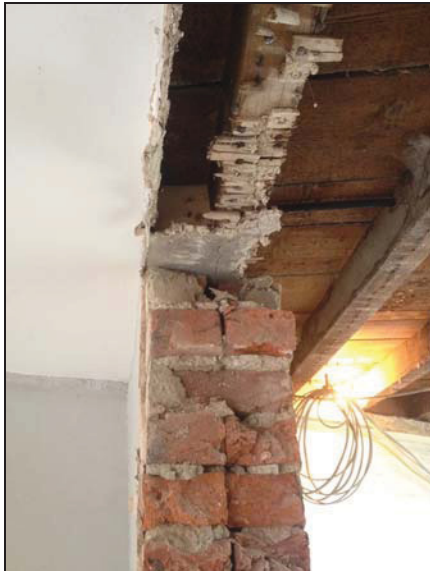
*View of historic lath and plaster surviving at the east end of Corridor FF03 (left) with boarding and probable alteration (right), taken from the west*
