**RAILWAY STREET / MILL ROAD, HERTFORD,  
HERTFORDSHIRE**

**ASSESSMENT AND RECORDING OF THE ARCHITECTURAL  
STONEMWORK**

Authors: Tansy Collins MSt Lee Prosser PhD FSA Lauren Wilson MA	
NGR: TL 32920 12915	Report No: 5600
District: East Herts	Site Code: AS 745
Approved: Claire Halpin	Project No: 6928
MCIfA	Date: 19 June 2018

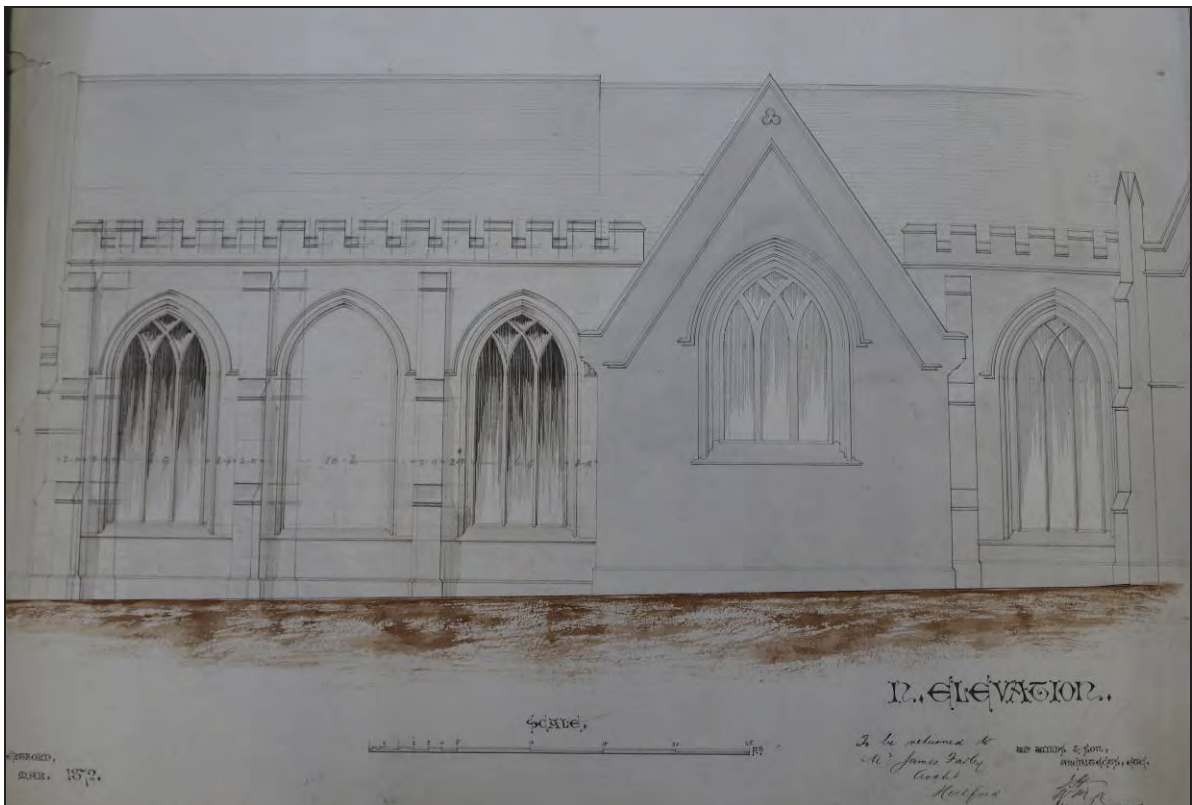
2.4 Architect's drawing of the north elevation of old All Saints, 1872 (HALS ref: D/EHX D4/28)

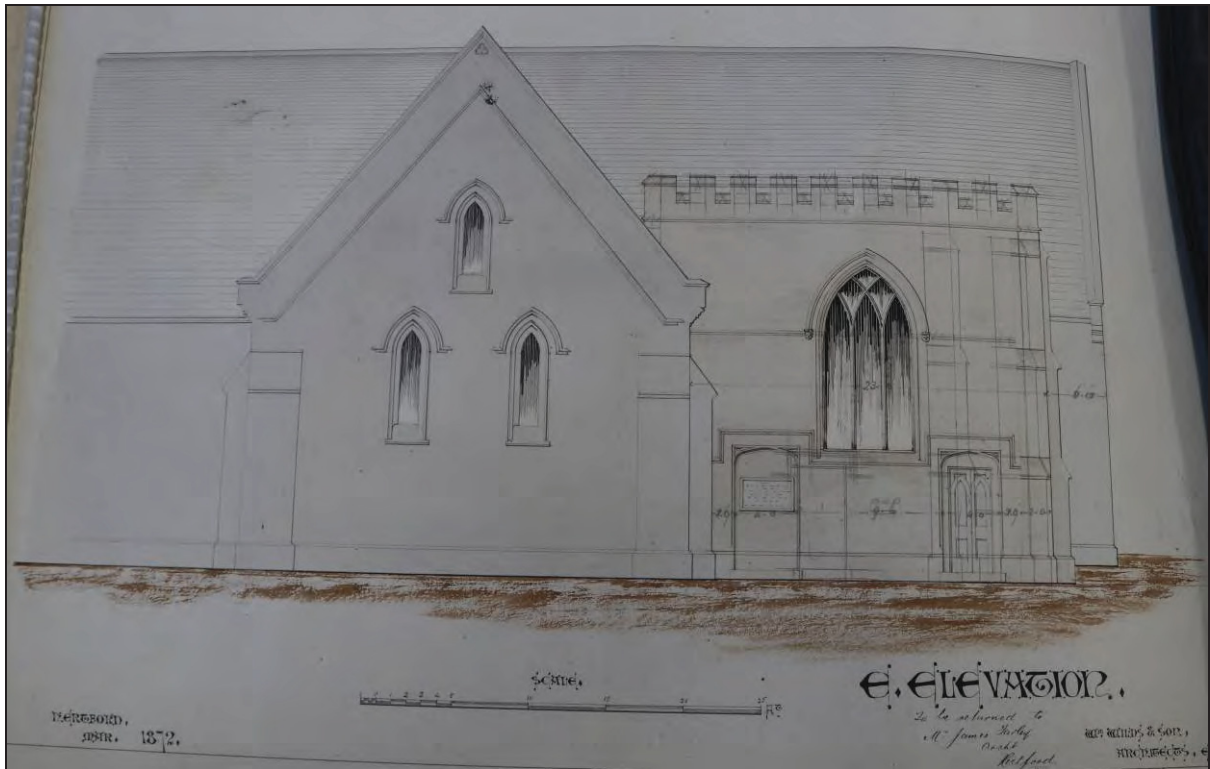
2.5 Architect's drawing of the east elevation of old All Saints, 1872 (HALS ref: D/EHxD4/28)

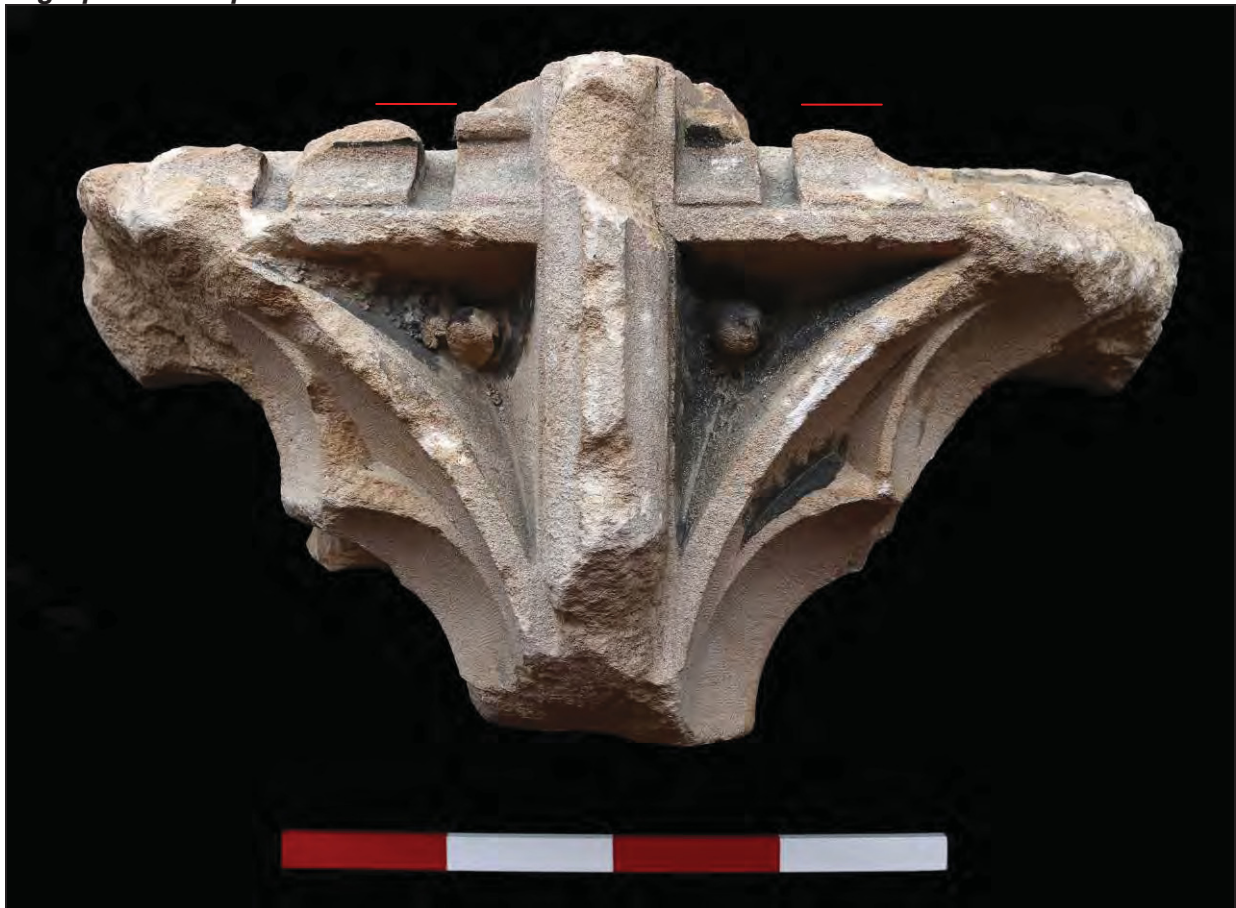
Face of transom and mullion (section line indicated)

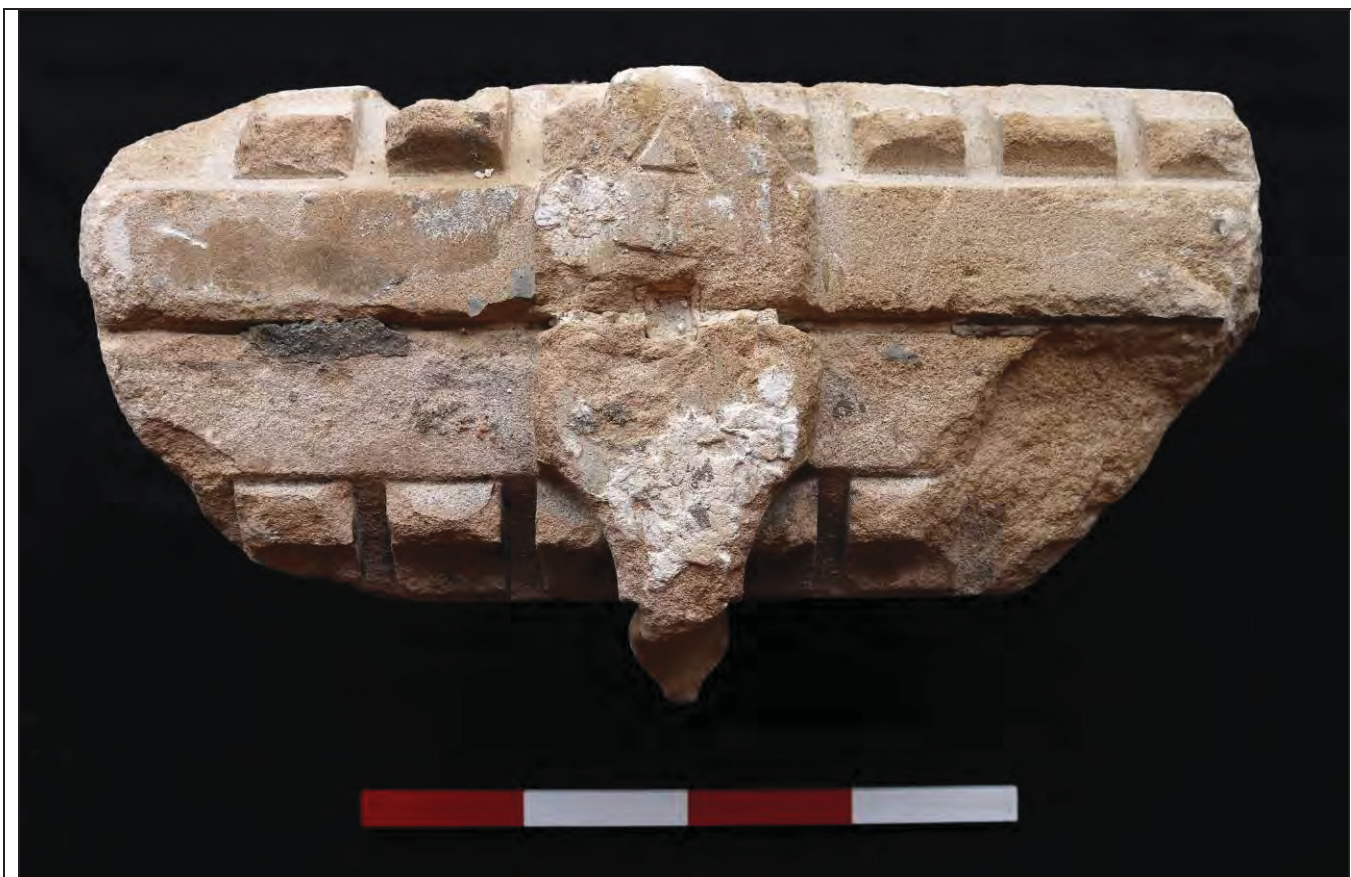
Top of transom and mullion

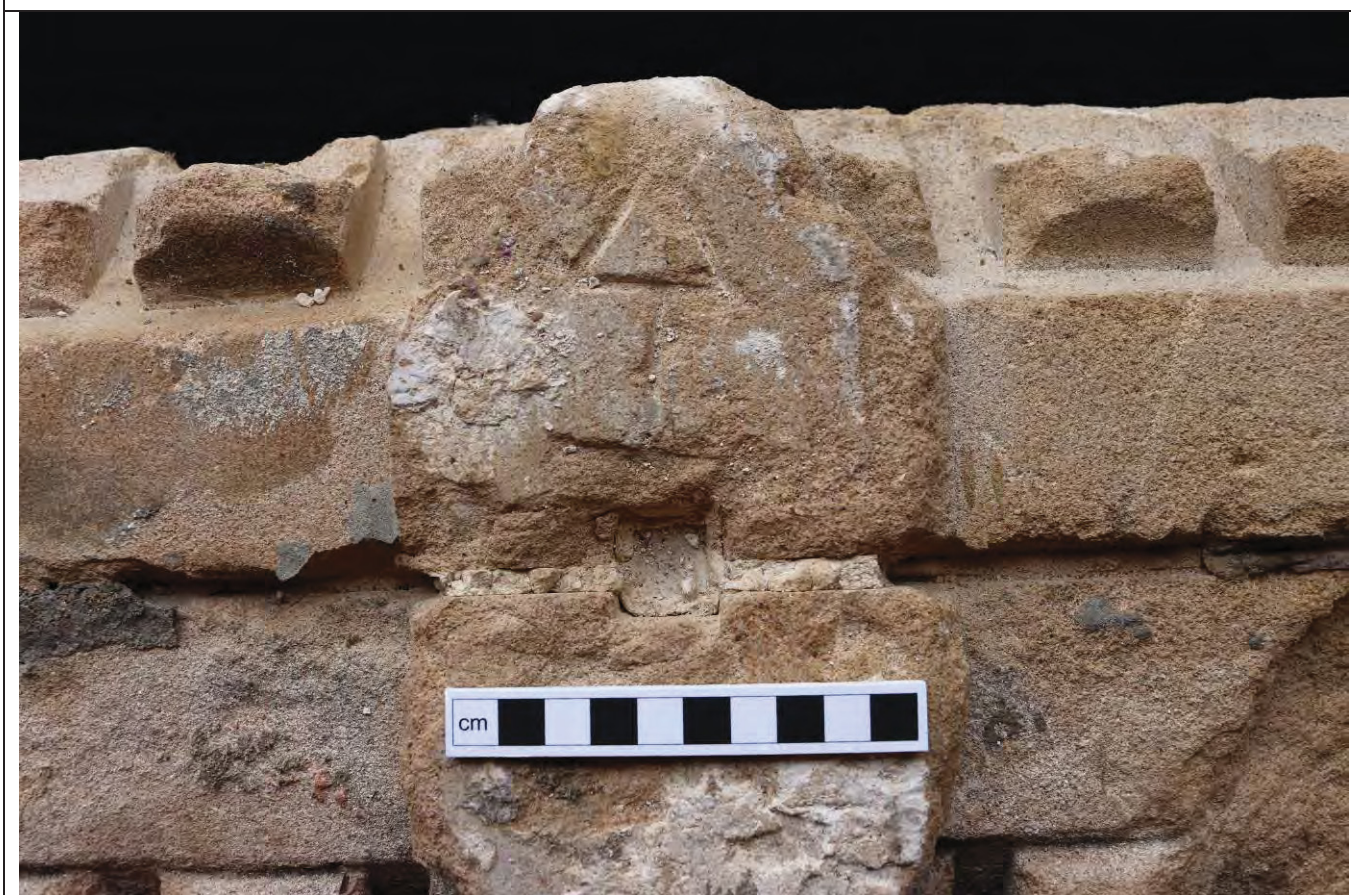
Detail: top of mullion showing mason's mark

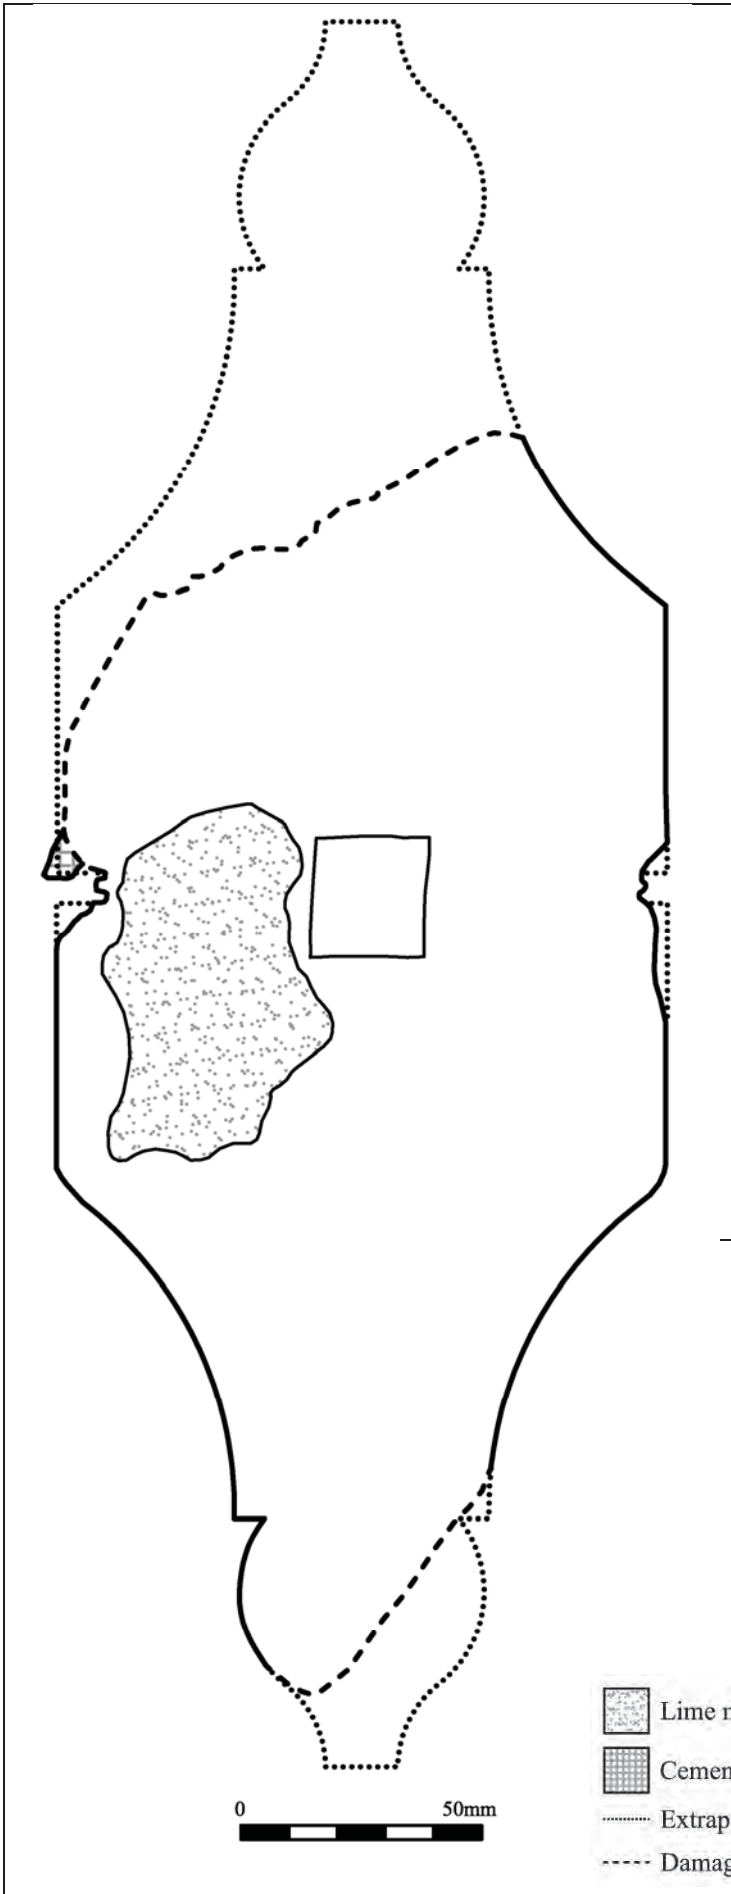
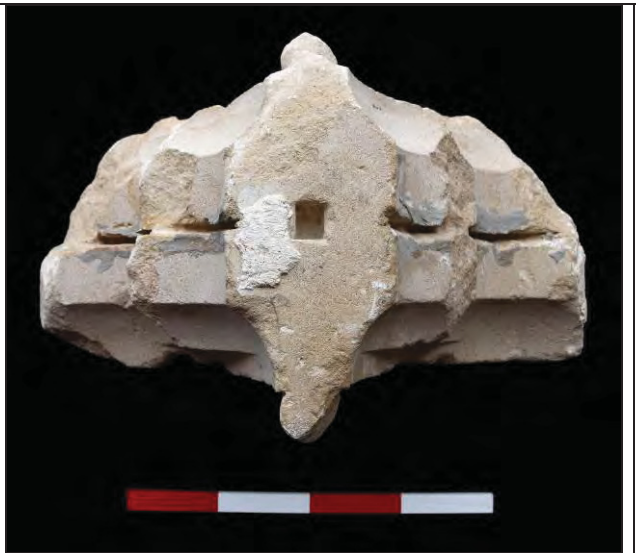
Base (mullion top view drawn)

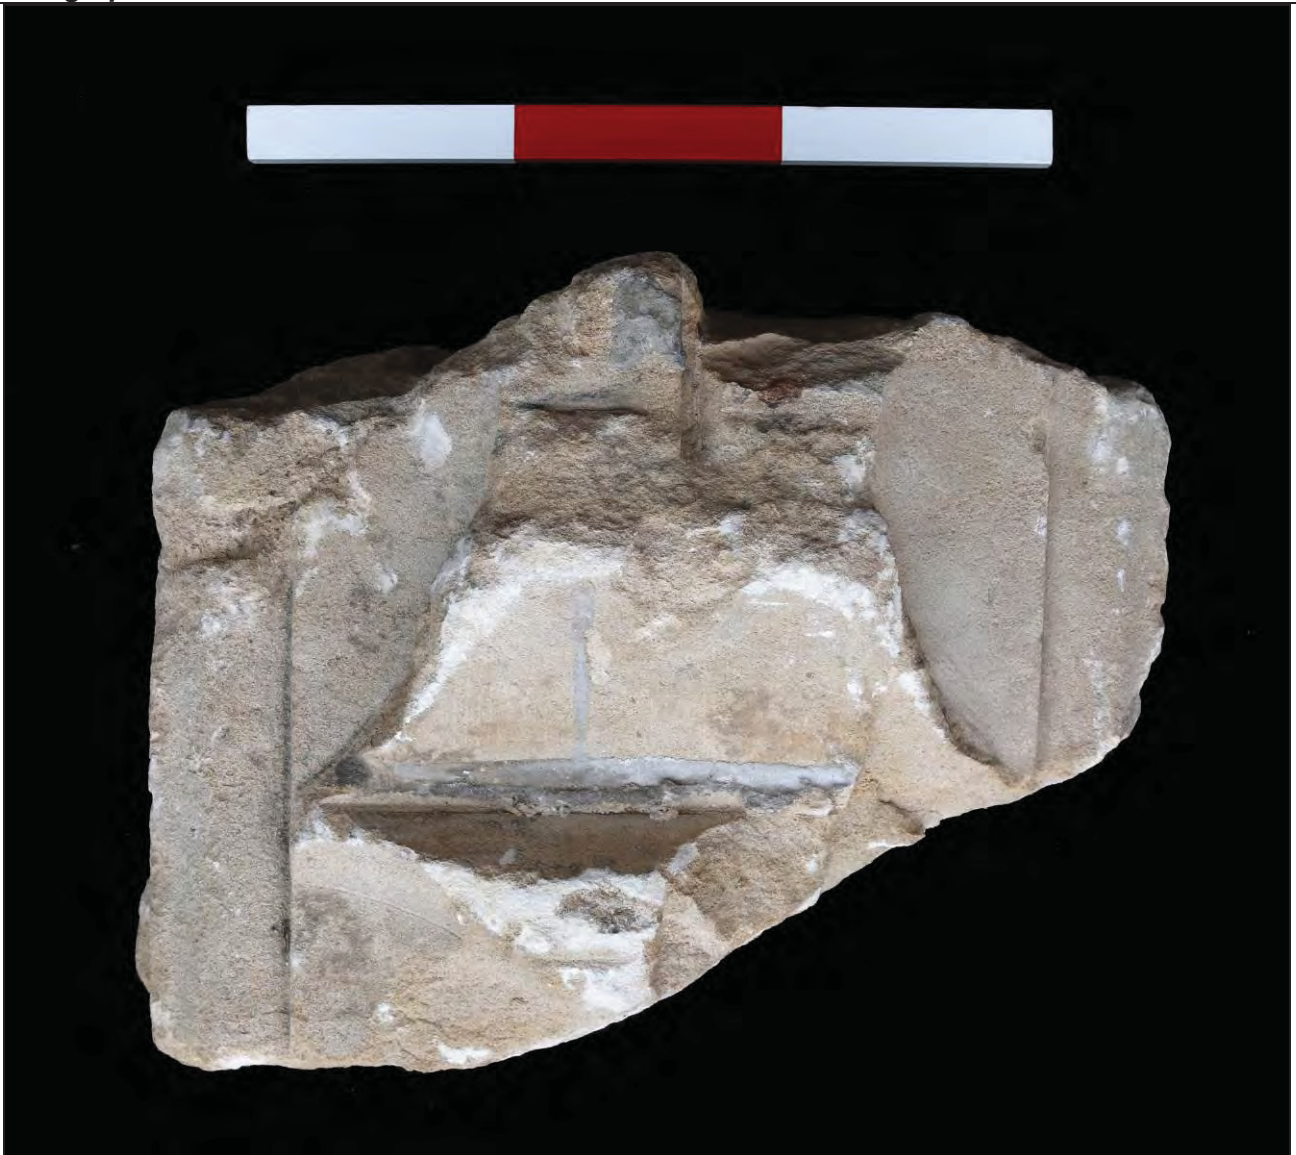
Inner face

4.18 A single piece (#02) is of much interest and although damaged is an interesting study. It includes a fairly robust angle stop, but what is most marked is that this lower section was clearly unglazed, while the the upper sections may have

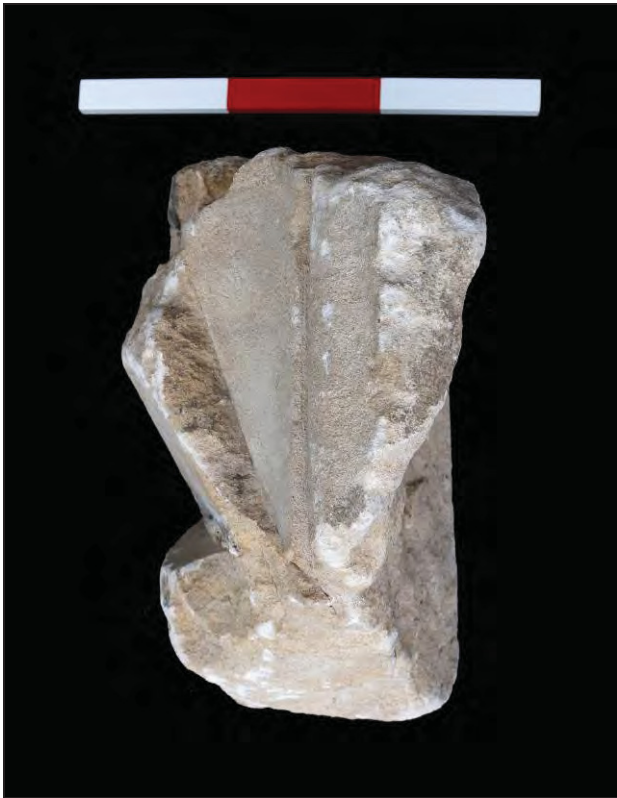
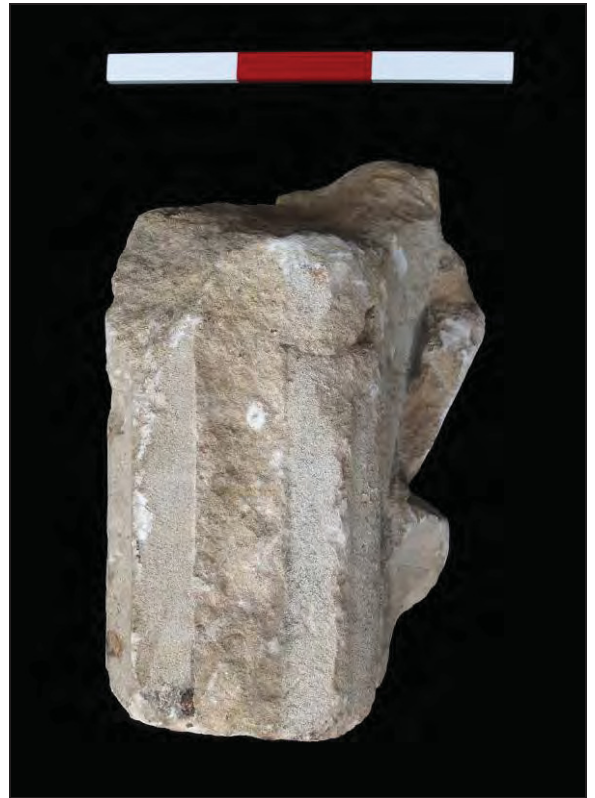
Side with profile

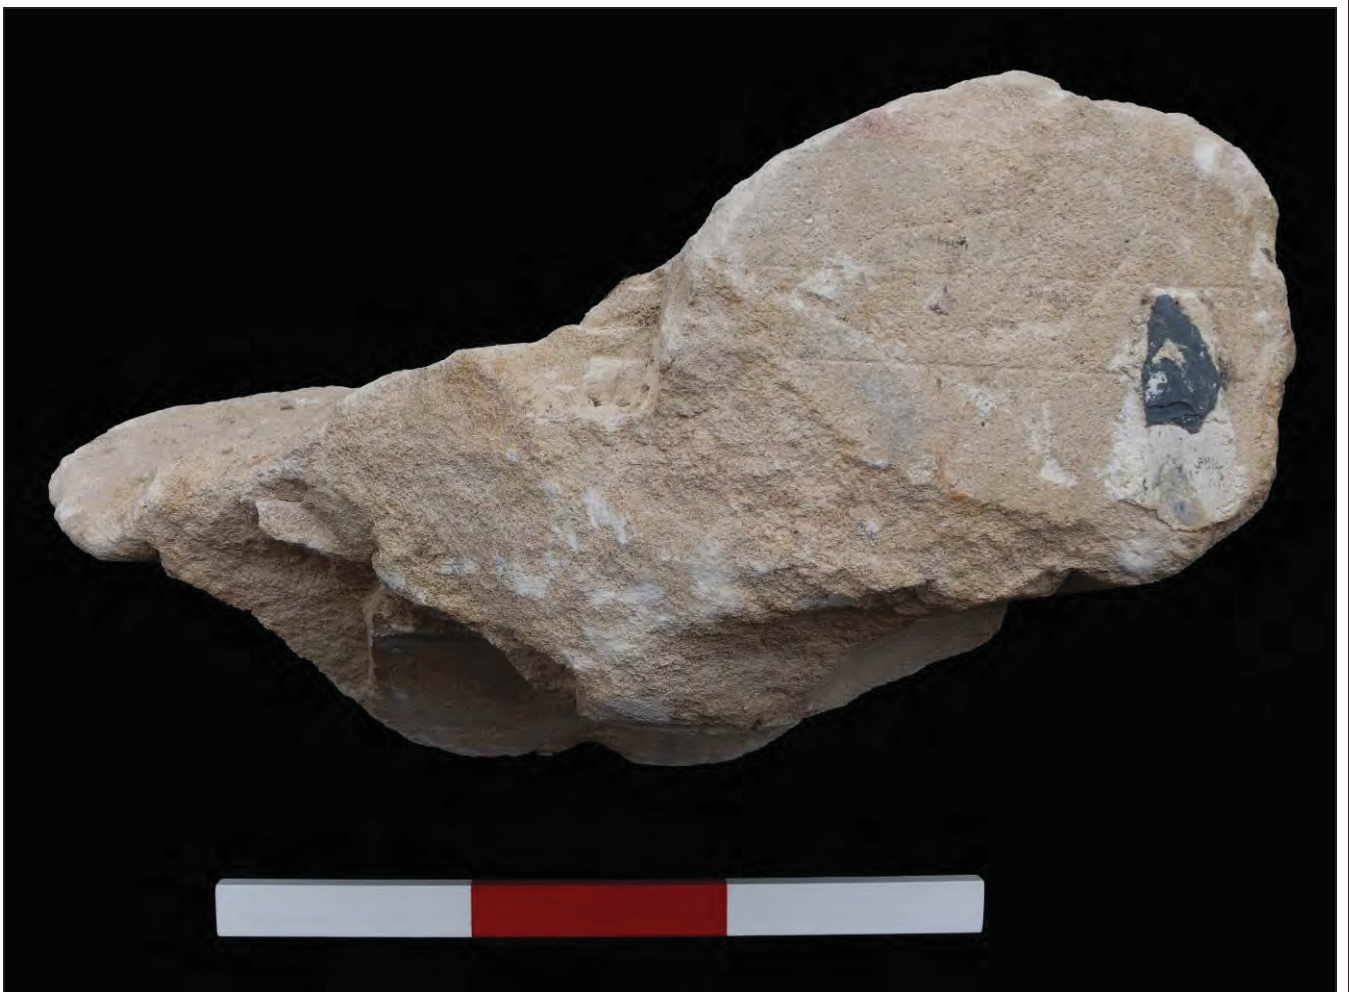
Base with setting out lines and socket

4.37 In addition to the setting out lines noted above, a number of other pieces displayed similar setting out lines, often to mark the position of the sockets, for

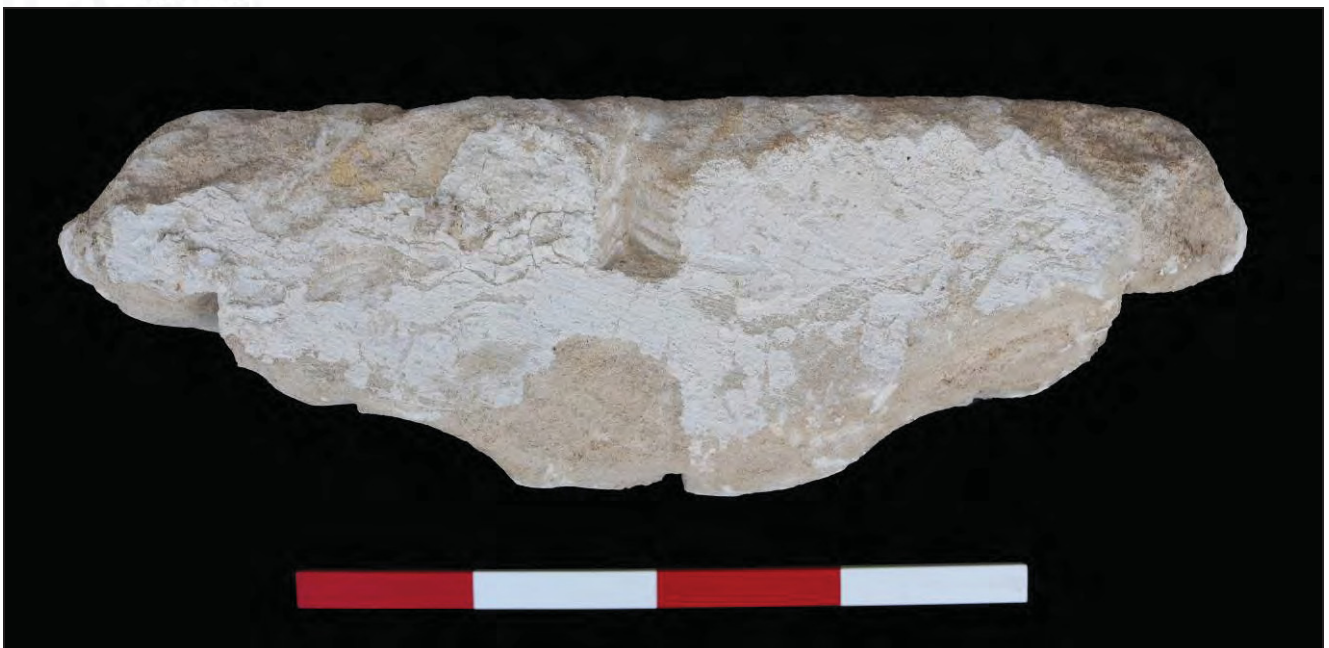
The rear is entirely flat with traces of mortar and there is a partially damaged mason's mark. The front of the piece has mirrored mouldings to either side of a central glazing groove which comprises a series of hollow and roll mouldings. These are an expanded version of mullion mouldings noted for Pieces #01, #10 and #17, and is defined by Morris as the 'first family of roll and chamfer mullions (fifth variety)' (1979. pp.2-4), which is an elaboration of the second variety.

Profile

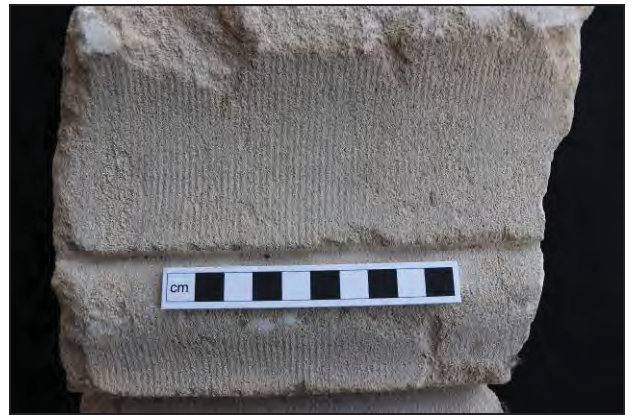
Detail: tooling marks

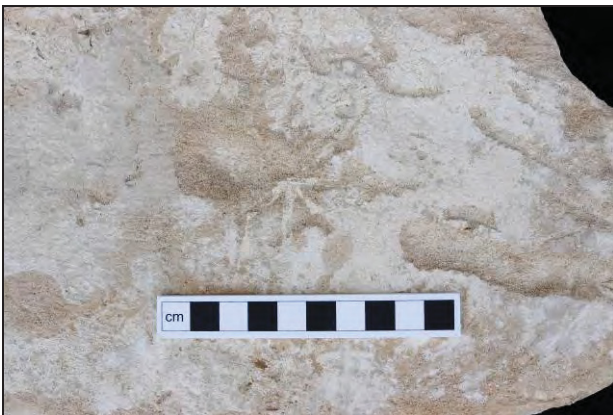
Detail: rear face with mason's mark

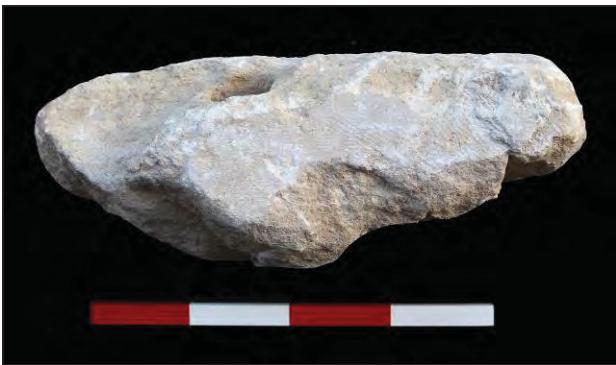
The main face replicates the profile of Piece #03 and retains hard cementitious material in the glazing grooves. There is no difference in levels to either side of the glazing which may suggest it is a jamb rather than a sill. The bottom side of the piece is damaged but areas of faced stone remain with fine tooling marks, as well as a fairly large rectangular socket positioned at an angle. The top side is damaged.

Base with large socket

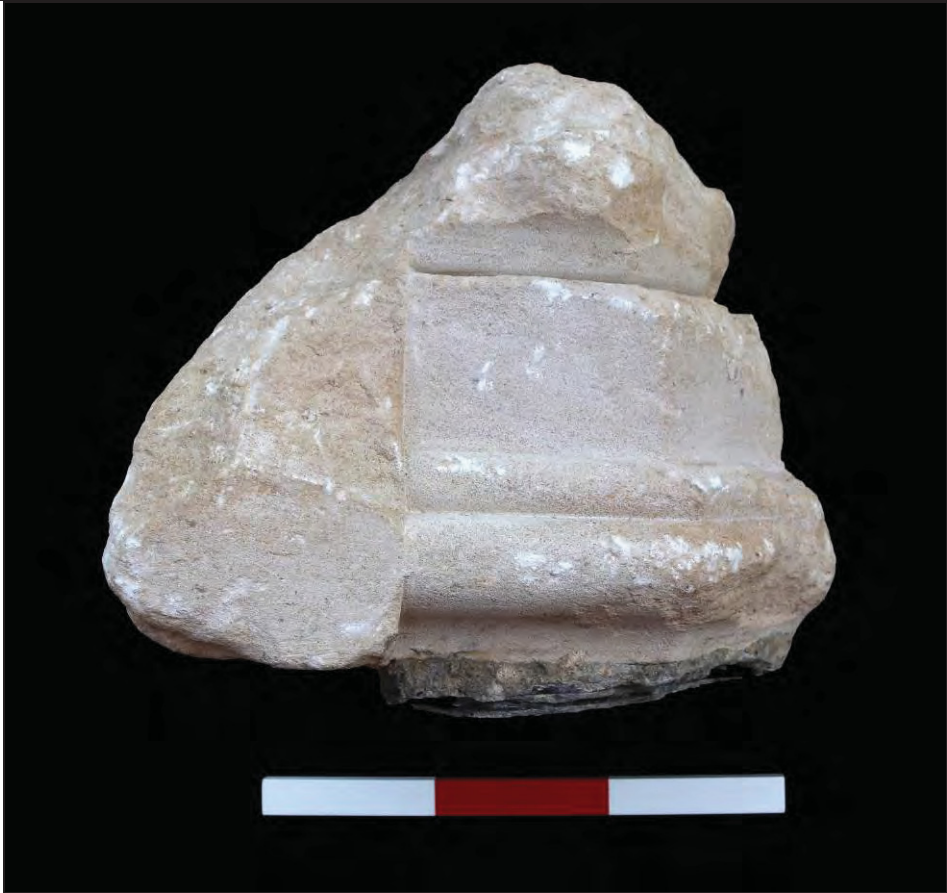
The shaft stands over composite roll mouldings but is fractured on two sides and the upper face where the column would rise.

Side view

4.23 Piece #05 is a large fragment of column base or capital, possibly an engaged column of possible pentagonal section. The shaft stands over composite roll mouldings but is fractured on two sides and the upper face where the column would rise.

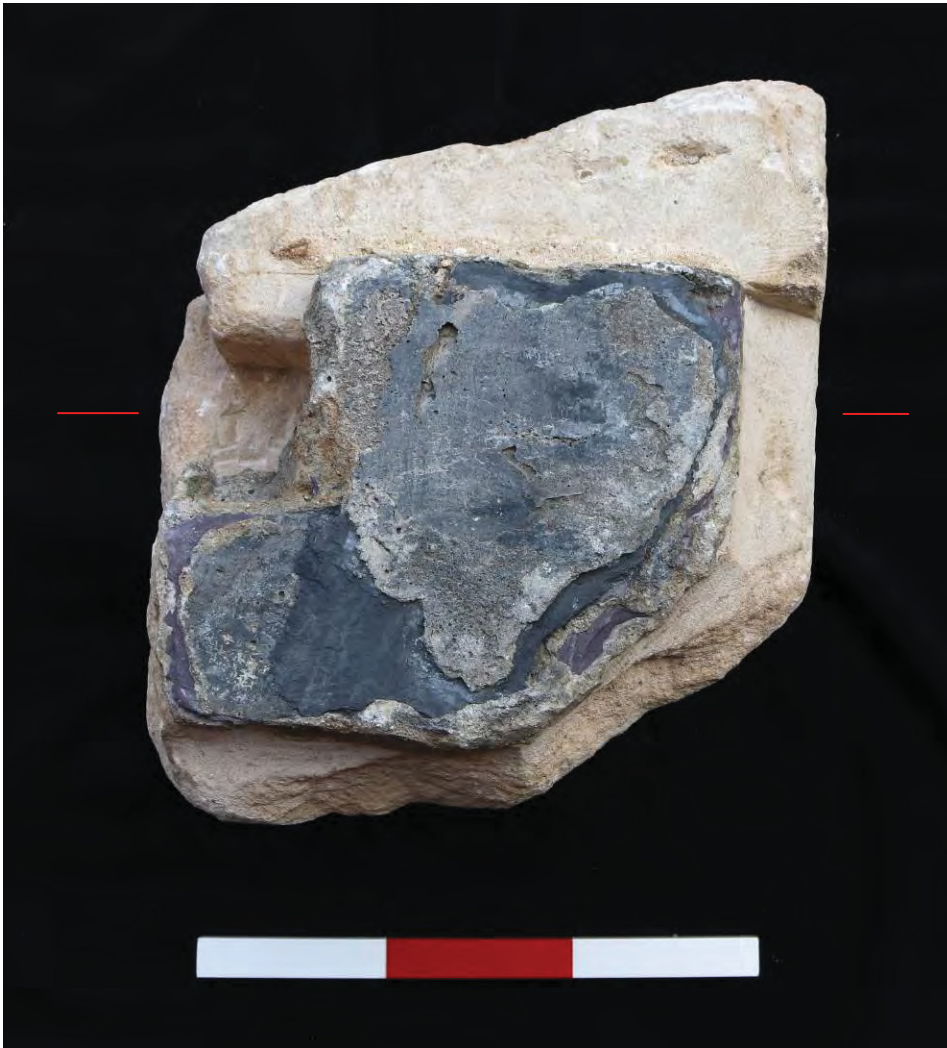
The base has a large socket, which would have measured approximately 50x50mm but is truncated. There is also a damp-proof course of grey Welsh slate attached with a hard cementitious mortar. This would normally be expected to be Victorian in date.

Base

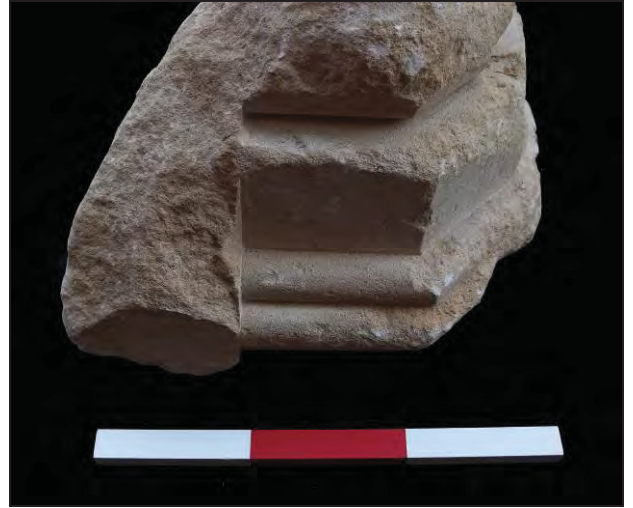
Oblique view of moldings

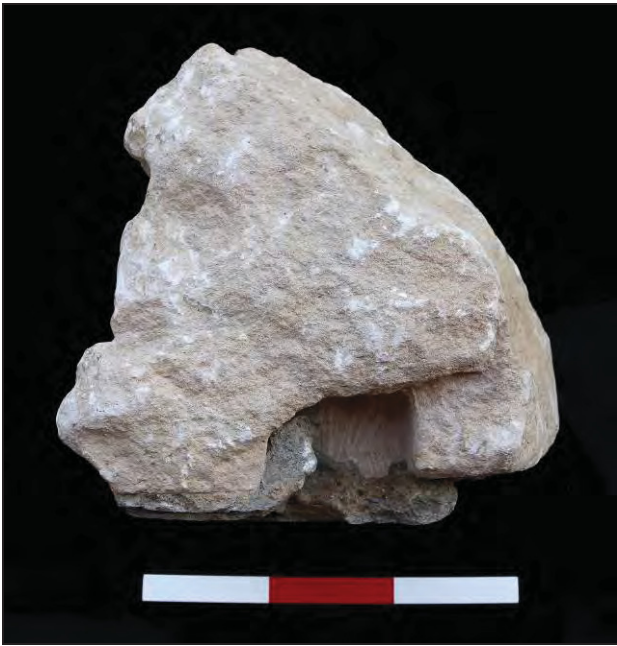
Side view of socket in the base

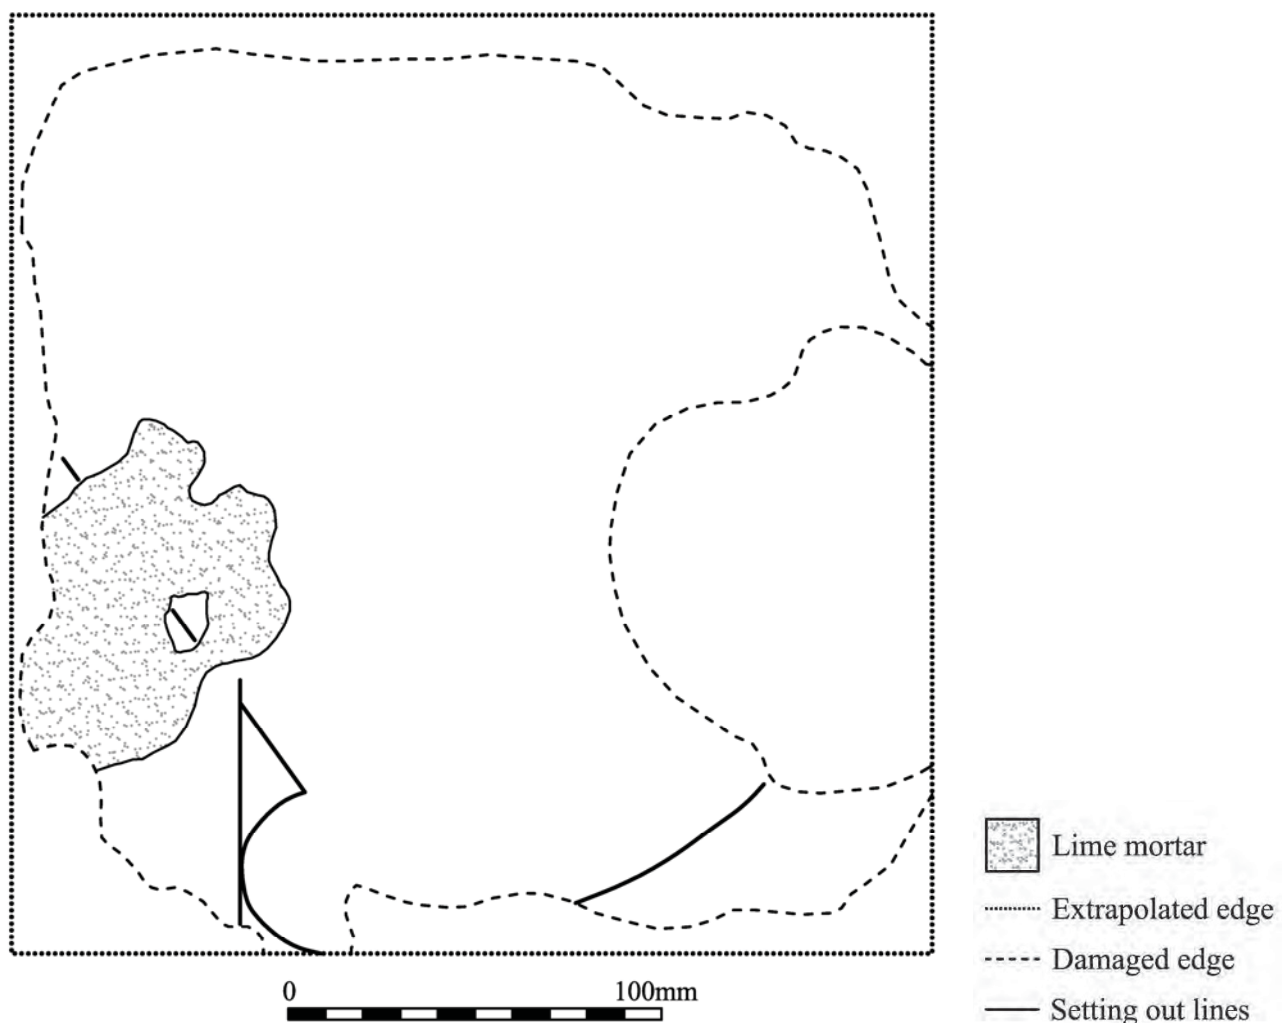
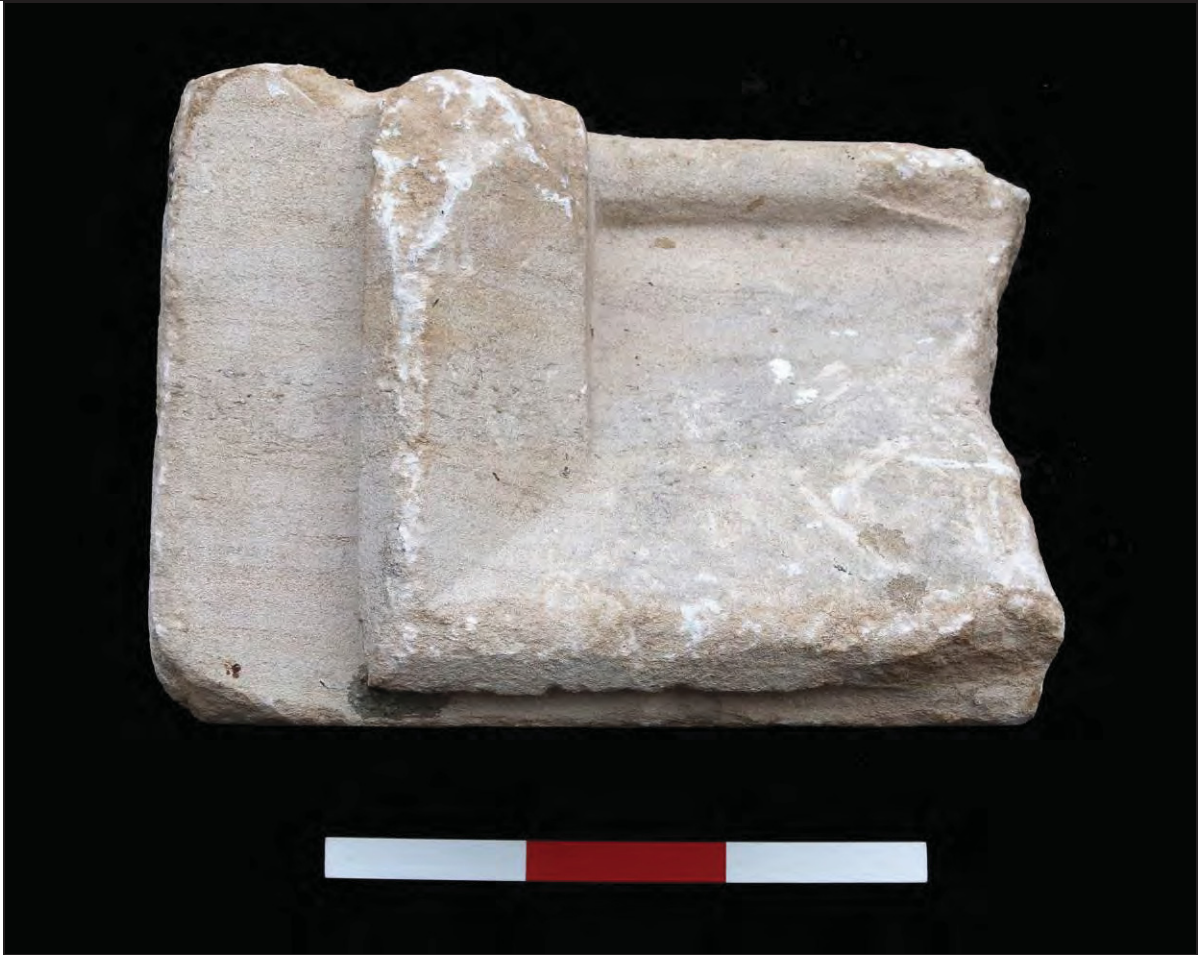
**Photographs and side view:**

This piece consists of a robust generally rectangular block, with one half consisting of a large round moulding that then returns as a deep chamfer with a rounded lip. The other half forms a rectangular terminus where all sides are faced and mortar survives on two sides. The deep chamfer terminates on the outer face with a pronounced secondary moulding that defines the edge of the original architectural component, turning and extending along the rectangular end. The opposite end is a broken face. The piece bears marked similarities with a distinct type of battlement seen on a number of churches.

The flat side of the rectangular terminus preserves some areas of white lime mortar, but most significantly displays scribed setting out marks for the curved moulding profile opposite. There is also a single setting out line corresponding with the junction between the squared end and the curved section.

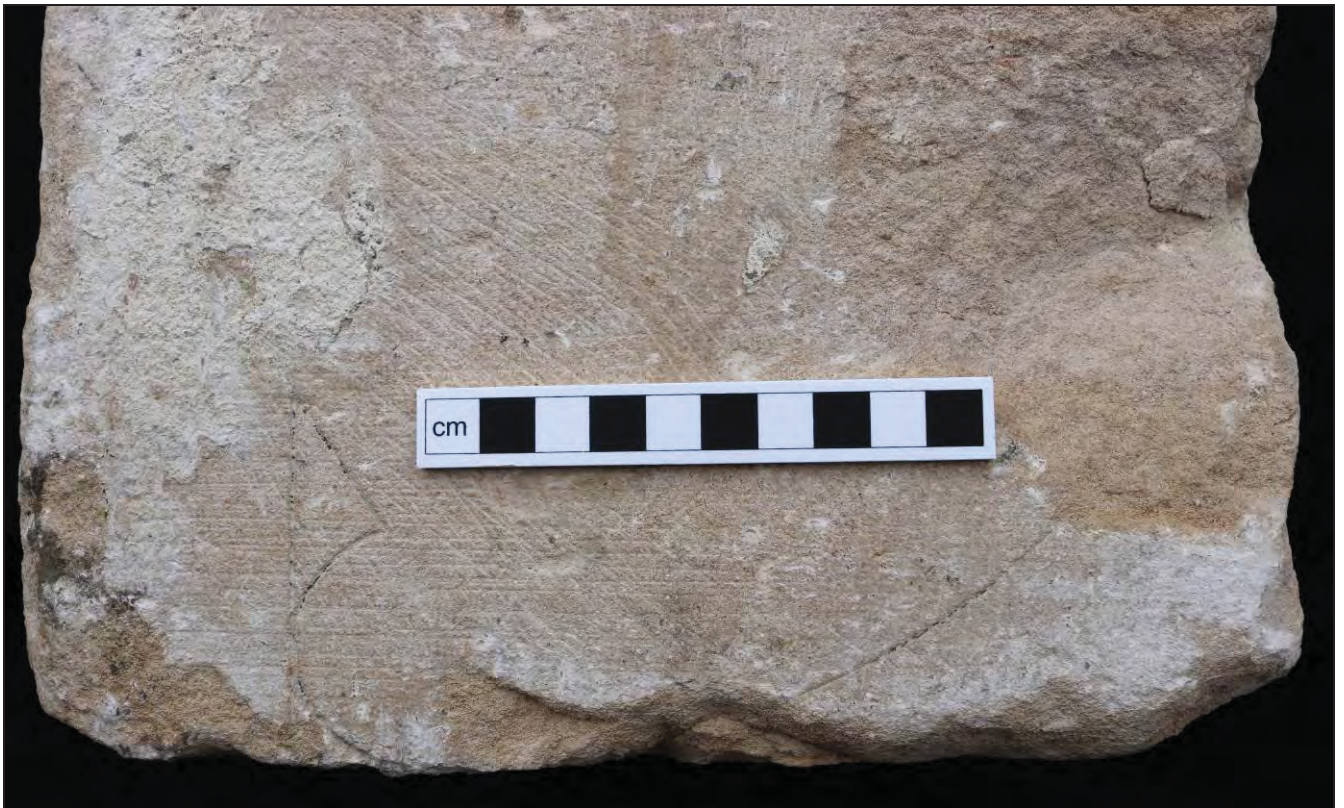
Detail of the setting out lines

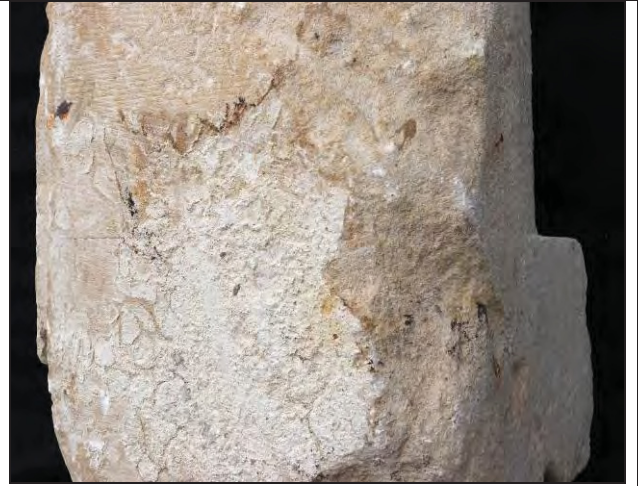
Side with setting out line

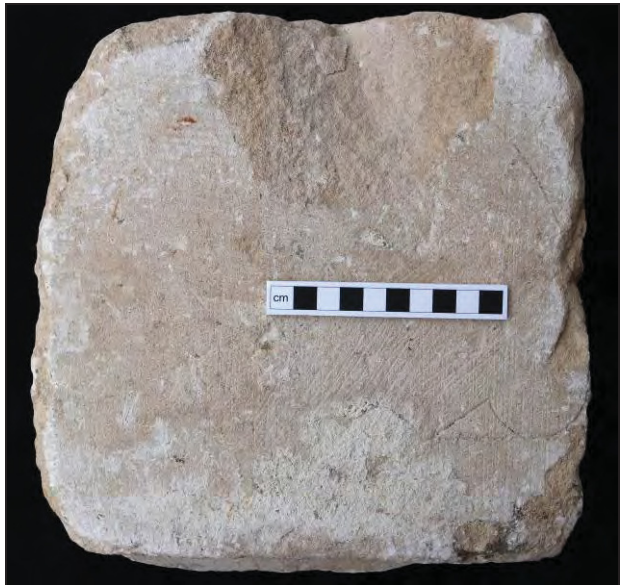
Edge with setting out lines for round moulding

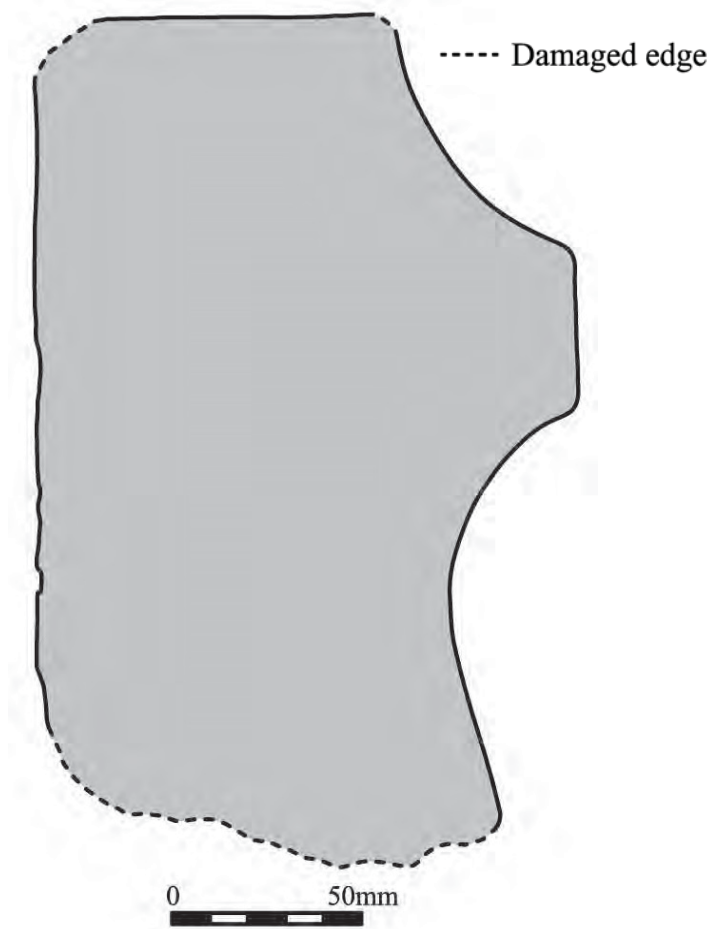
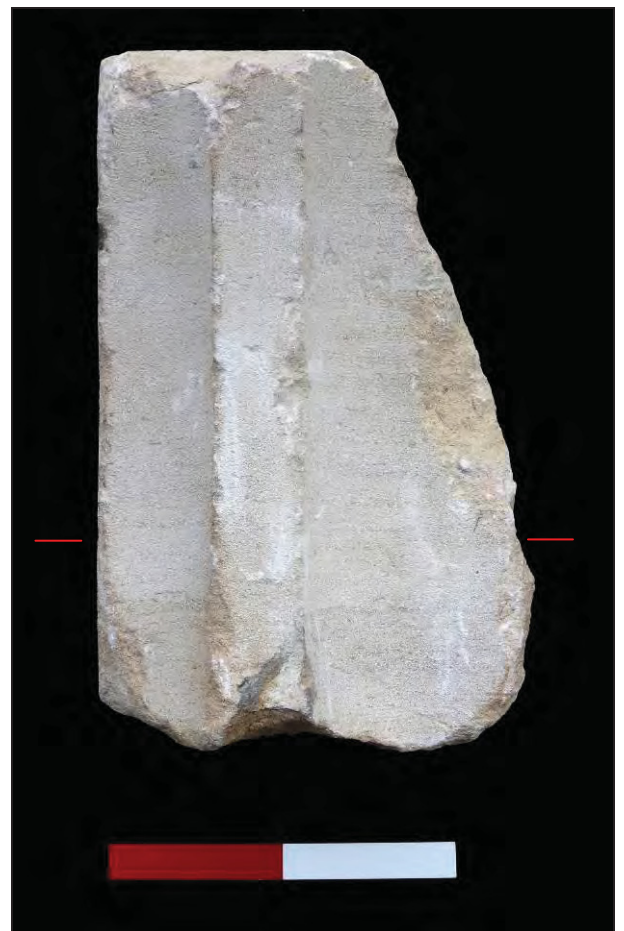
**Photographs and cross-section:**

Inner face

The top is broken, while the bottom retains some faced area but has been damaged.

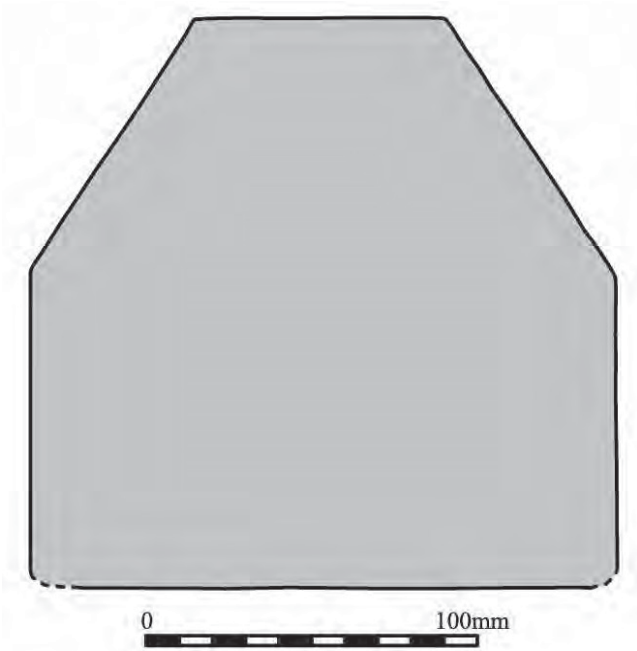
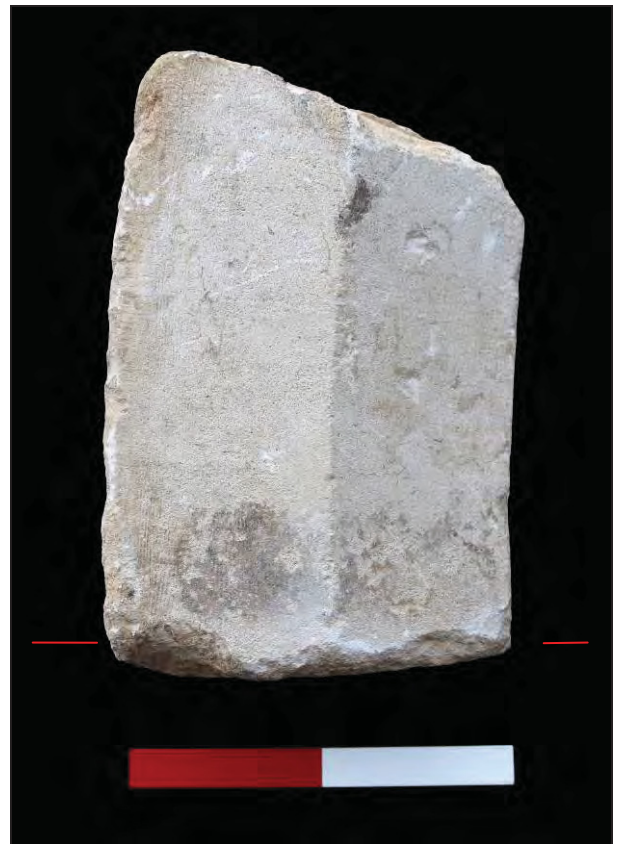
**Photographs and cross-section:**

----- Damaged edge

The facing on one side has been fractured and the top is broken. The base is partially complete with some traces of mortar.

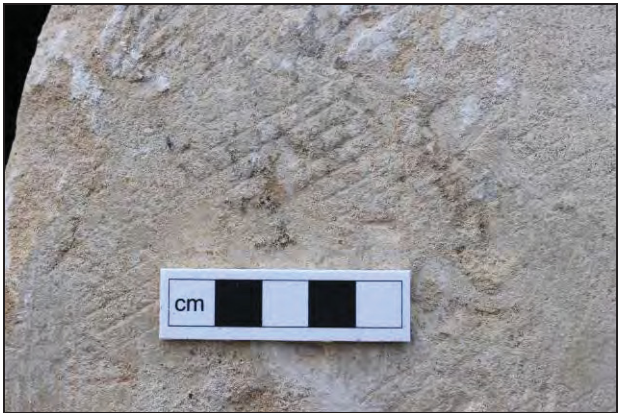
Detail of the tooling marks
