**RAILWAY STREET / MILL ROAD, HERTFORD,  
HERTFORDSHIRE**

**ASSESSMENT AND RECORDING OF THE ARCHITECTURAL  
STONEMWORK**

Authors: Tansy Collins MSt Lee Prosser PhD FSA Lauren Wilson MA	
NGR: TL 32920 12915	Report No: 5600
District: East Herts	Site Code: AS 745
Approved: Claire Halpin	Project No: 6928
MCIfA	Date: 19 June 2018

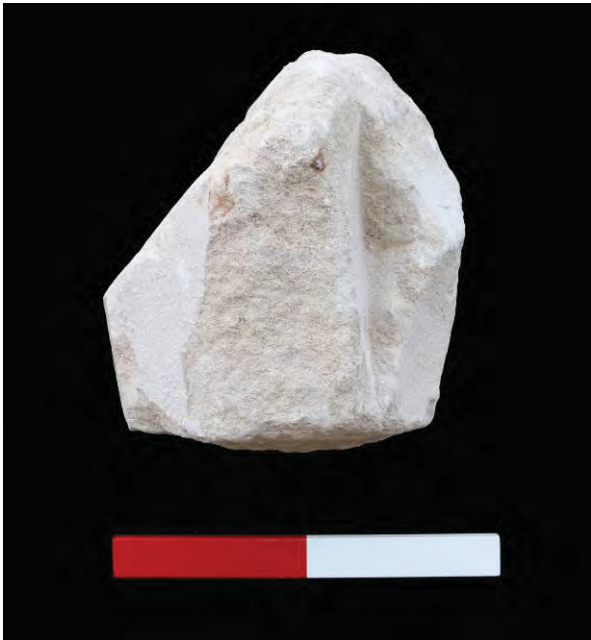
**Photographs:**

Inner face

It is substantially damaged but includes a cusping to either side of a truncated mullion moulding. There is a small section of glazing groove surviving.

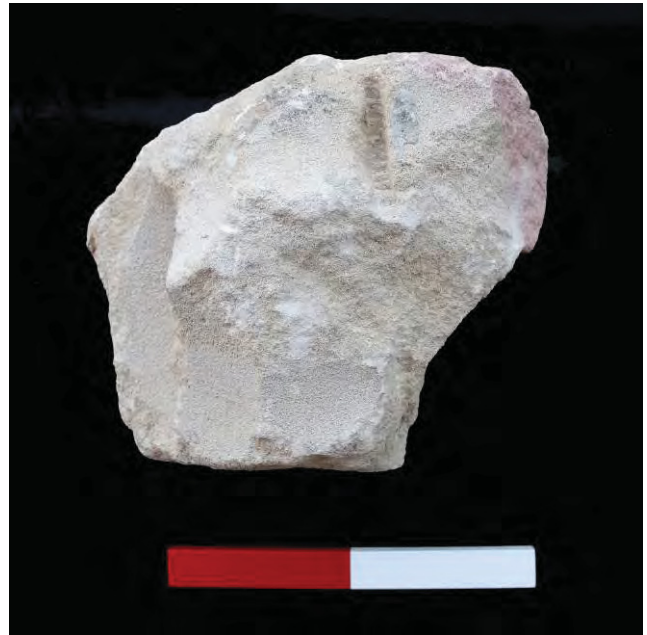
Side with glazing groove

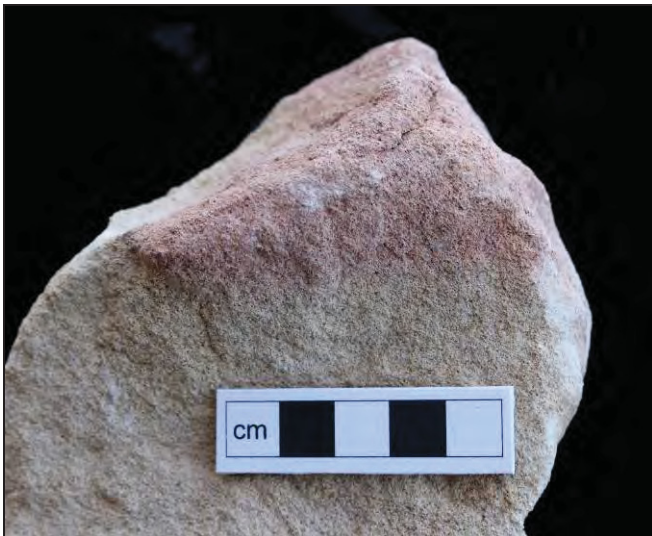
Heat reddening

The most conspicuous feature is an area of reddened heat/fire damage.

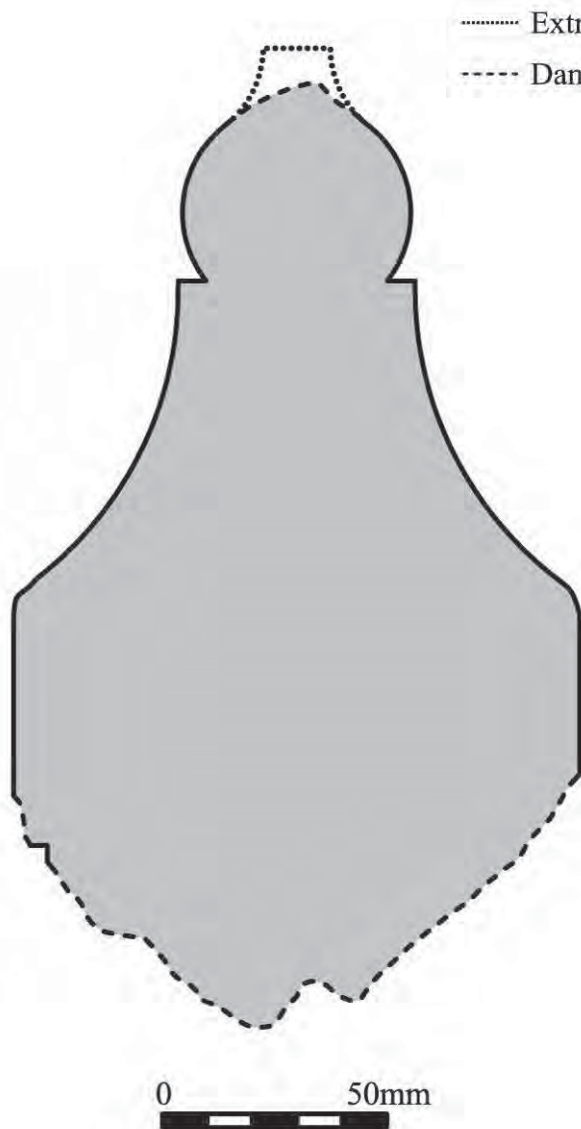
**Photographs and cross-section:**

----- Extrapolated edge  
 - - - - - Damaged edge

Fragment of window mullion, substantially damaged so that only there is no area intact to obtain a complete moulding profile.

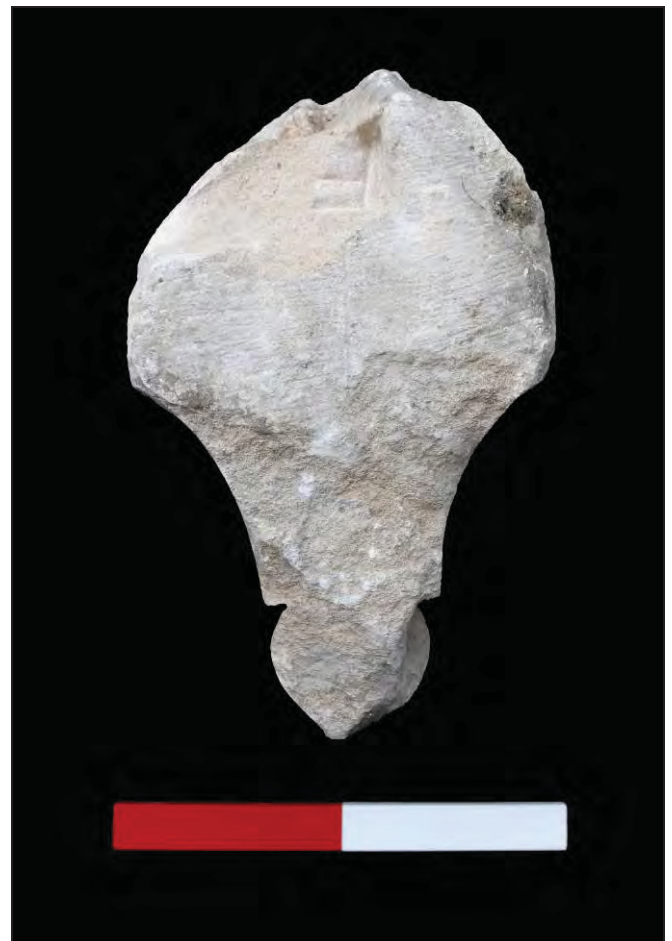
Lower face with mason's mark

The top of the section is broken but the base is partially intact and fine parallel tooling marks are visible.

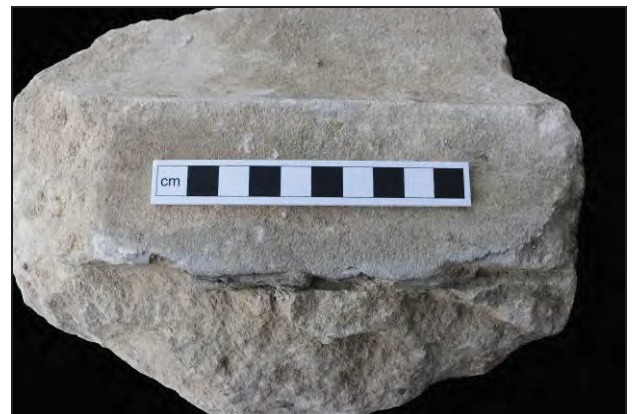
Detail showing cementitious mortar

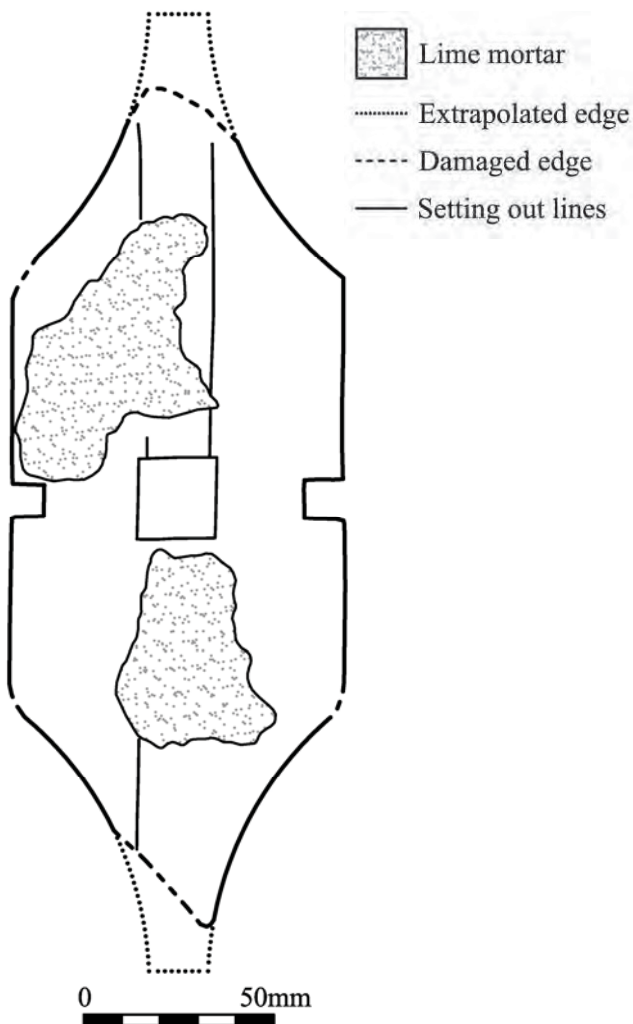
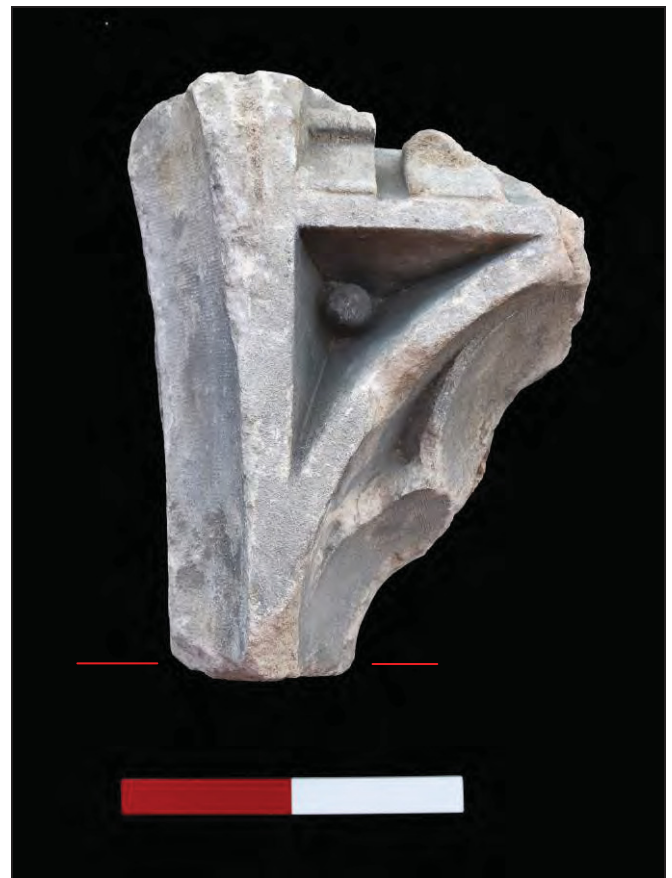
**Photographs and base view:**

Face

The top of the piece is complex and partly fractured but includes a short section of the embattled supertransom, the profile of the mullion with a square socket, and the angled face of the adjoining arch complete with socket to secure the next piece. There are faint setting out lines as well as a chiselled mason's mark, possibly for assembly.

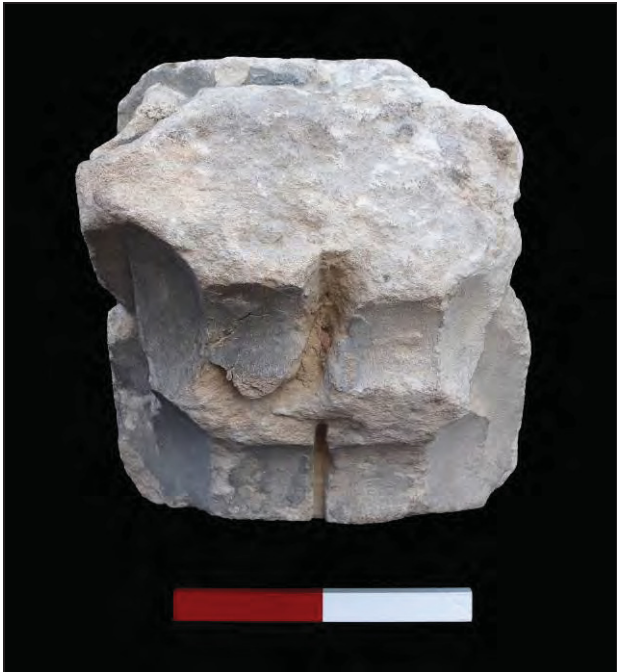
Side with glazing groove

Glazing grooves are present on both sides and the top of the supertransom, one with cementitious repair evident. Fine tooling marks are visible. Traces of sulphation are evident on the external face.

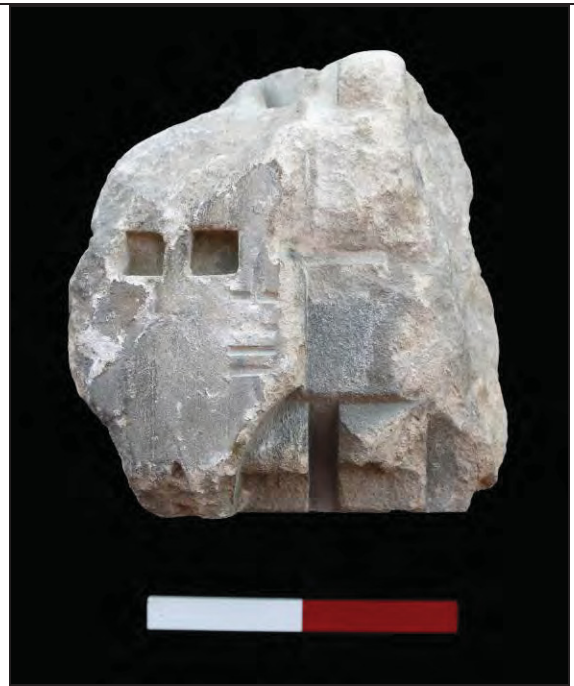
Top with sockets and mason's marks

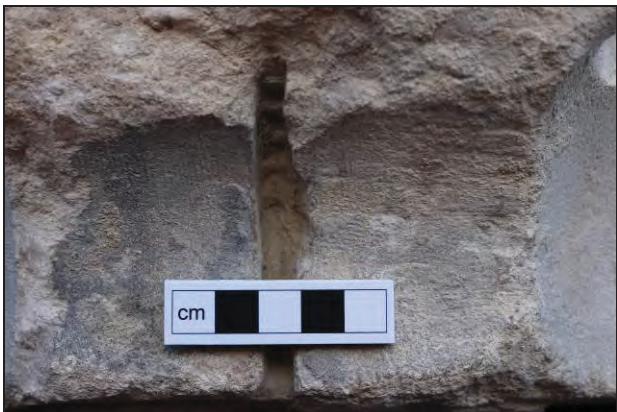
Detail of glazing groove

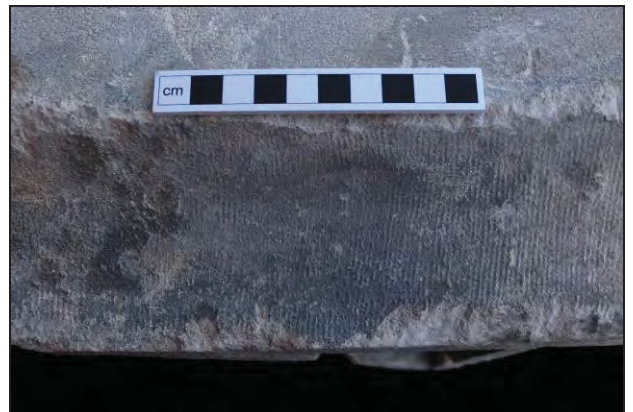
Detail of tooling marks

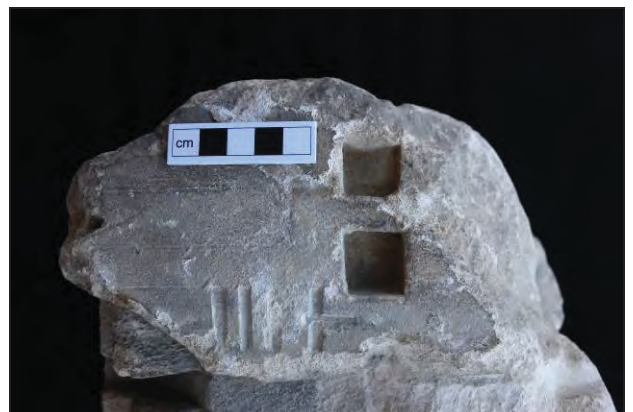
Detail of top with sockets and mason's mark

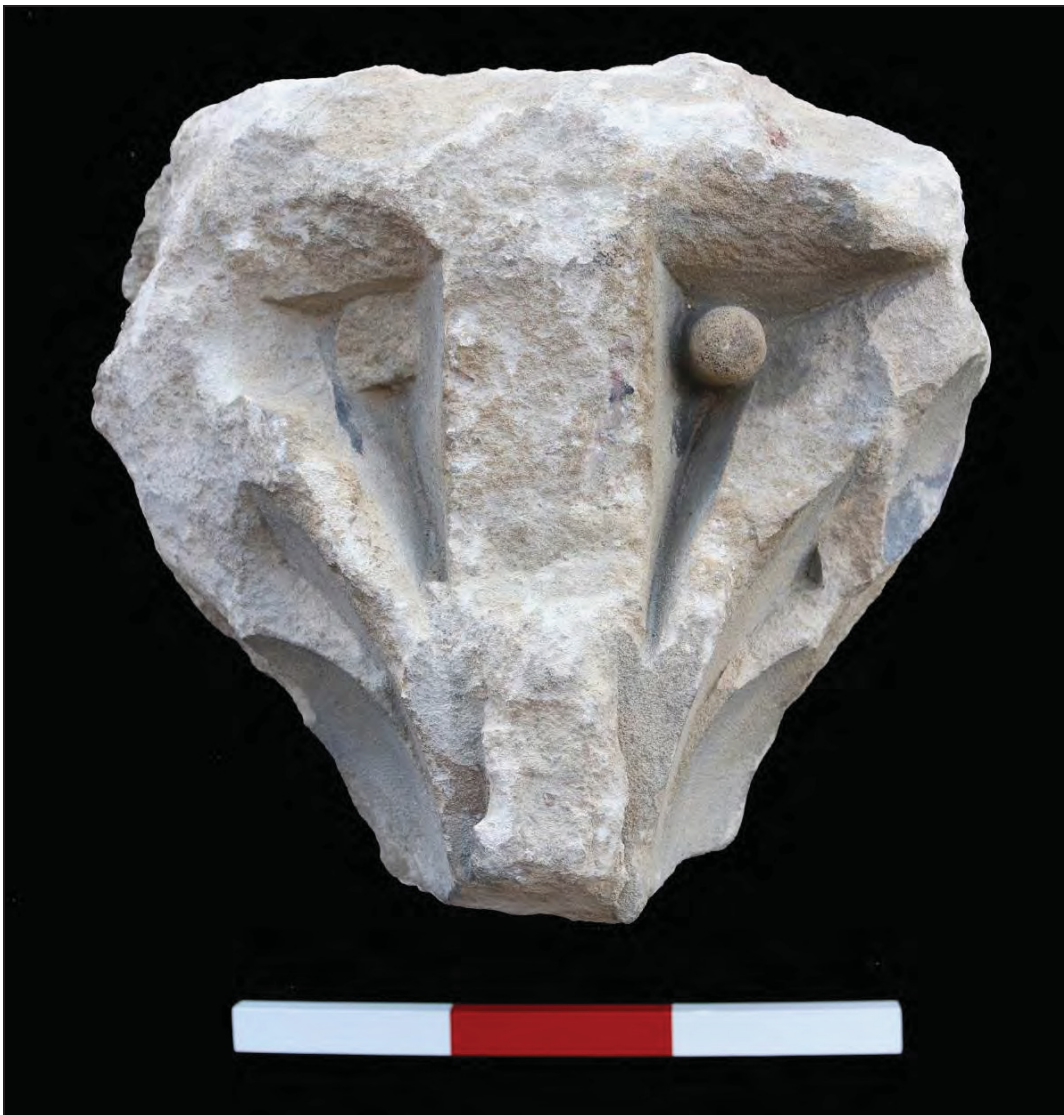
**Photographs:**

The most complete face includes a fractured mullion with cusping to tracery to both sides and pellets in the spandrels, which have some sulphation. The rear face is mostly abraded but the cusped tracery survives in part. The sides have glazing grooves.

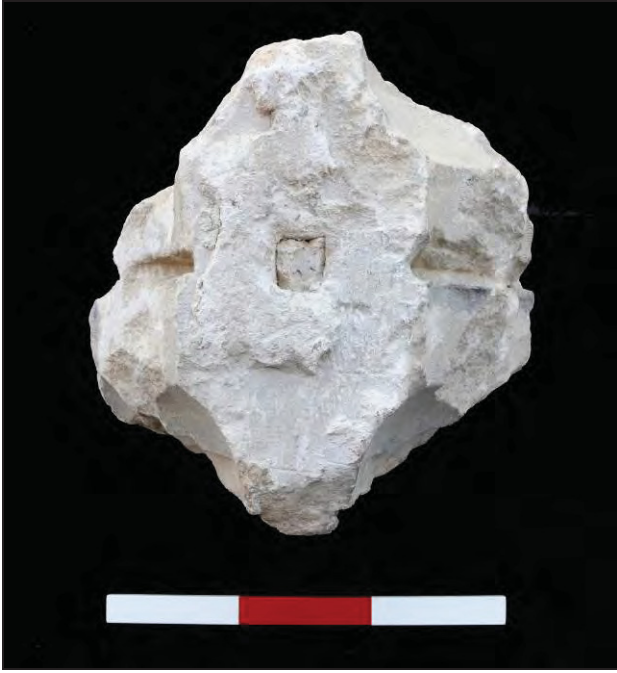
Base with socket

The top is fractured and the base partially preserves the profile of the mullion with a small square socket and the remains of lime mortar.

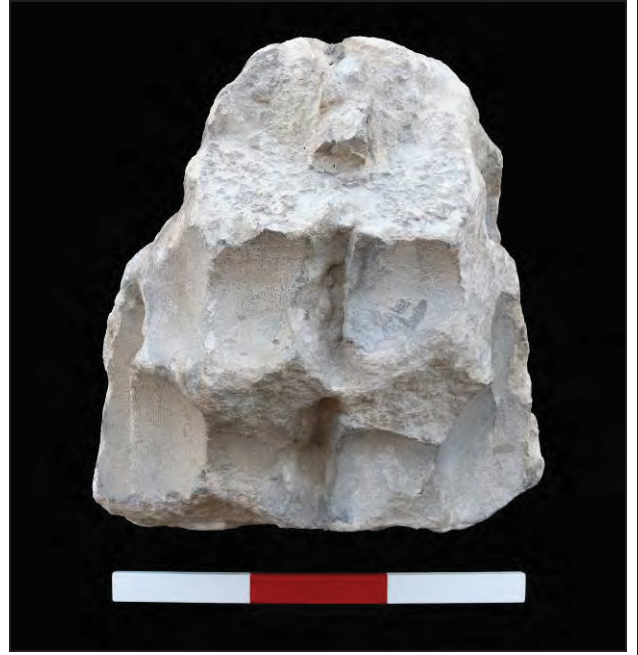
Side with glazing groove

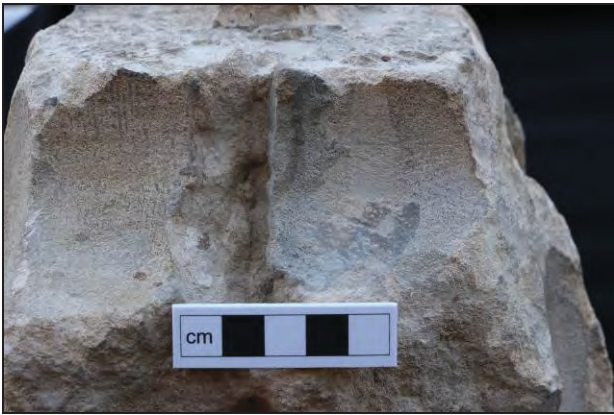
Detail of glazing groove

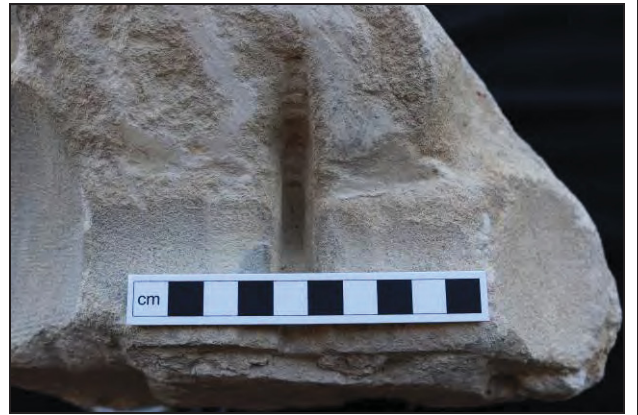
Detail of glazing groove

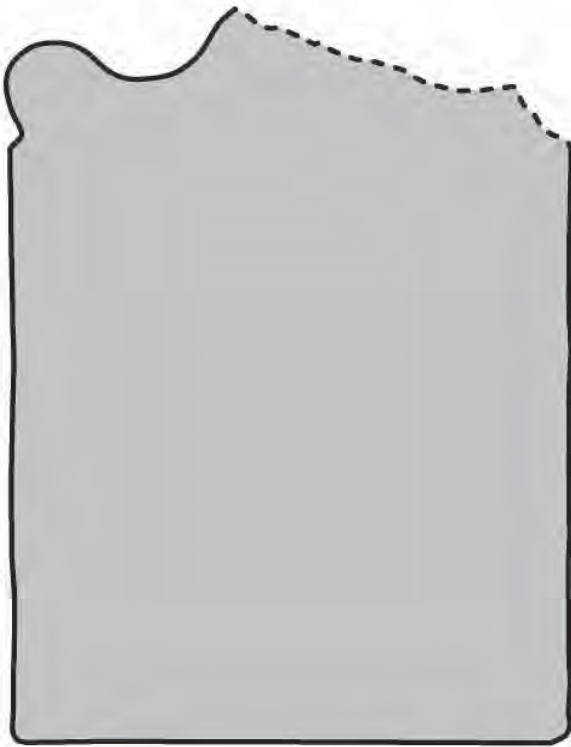
Fine tooling scabbling marks are visible.

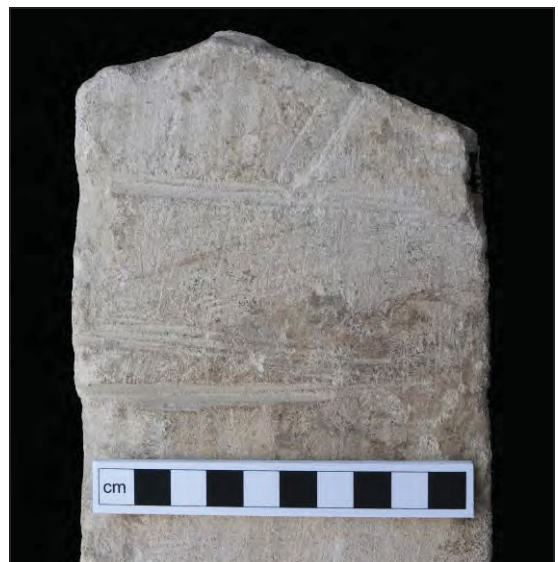
Detail of tooling marks

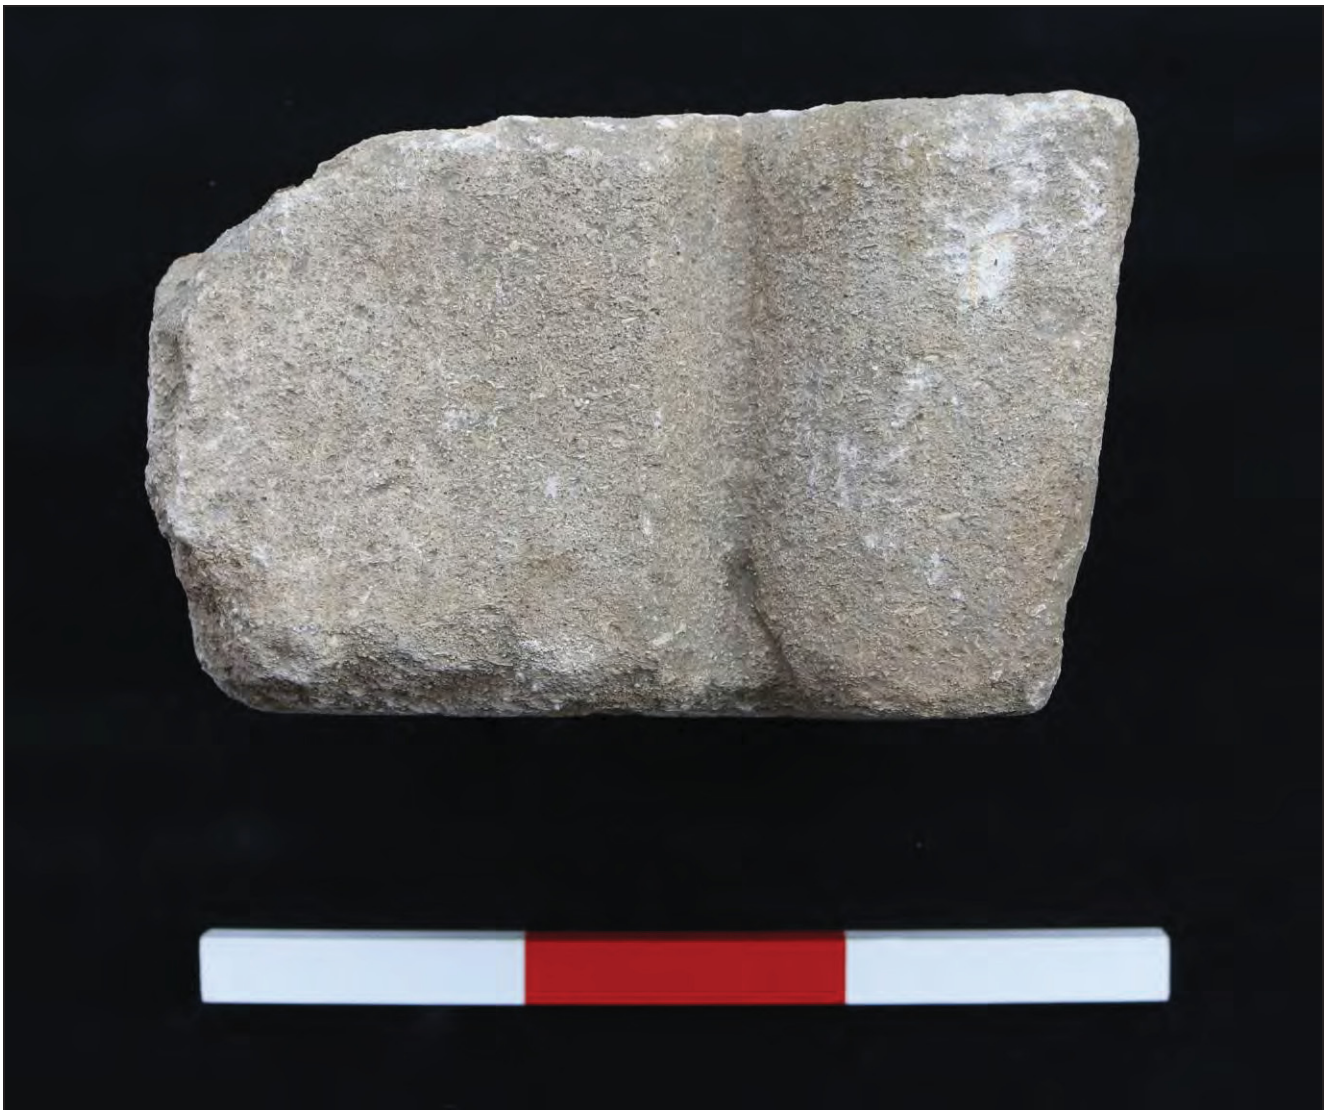
It consists of a roughly squared with a single crude moulding on one side. There are some crude tooling marks on one side.

Inner face

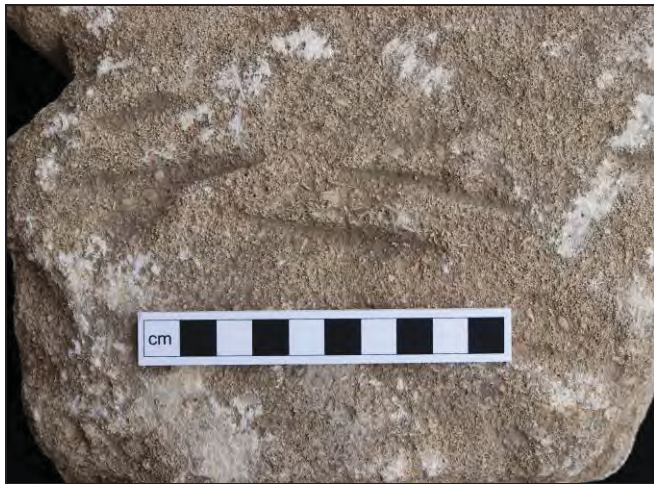
Detail showing tooling marks

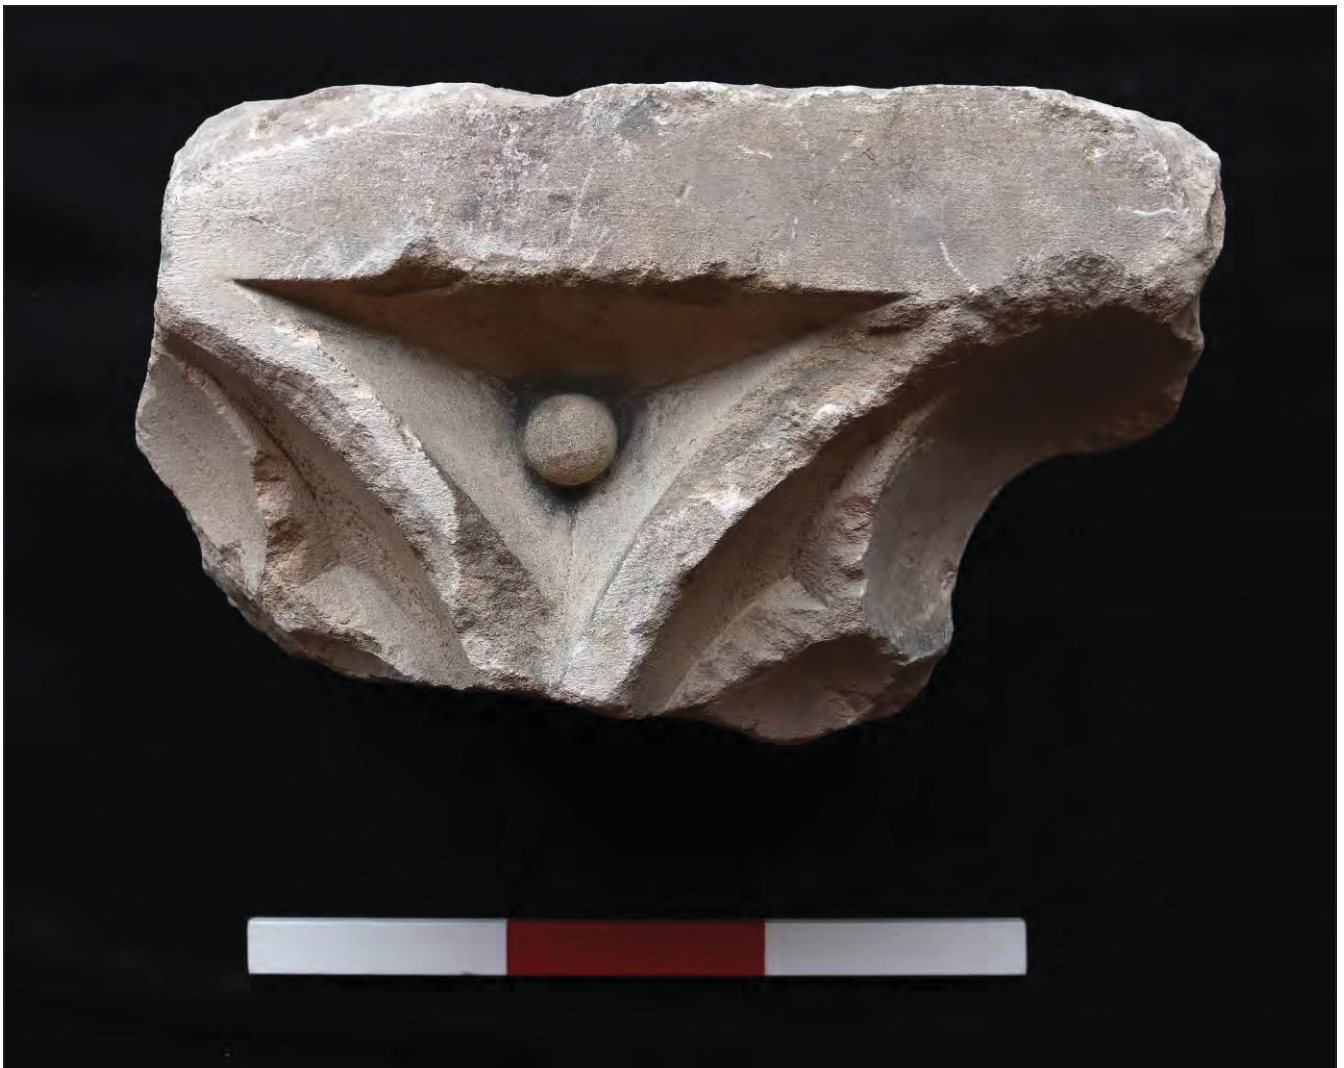
The base is broken but would have formed a mullion and to both sides on the most well-preserved face tracery cusping is visible. The opposite face is of identical form but substantially damaged. Above the position of the mullion the triangular depression contains a pellet as in spandrels elsewhere.

Face

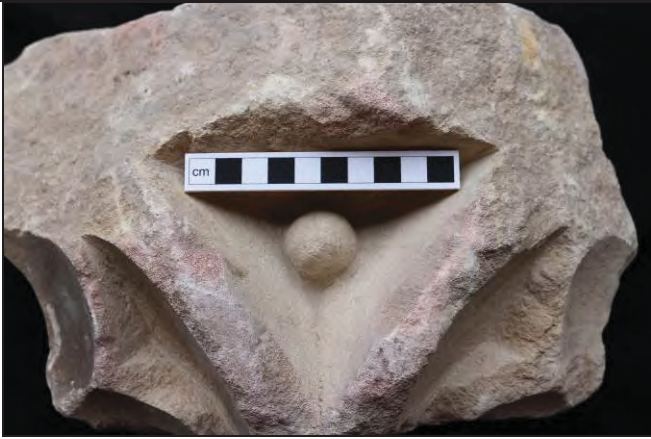
One side of the piece displays reddening from heat damage.

Rear with reddening

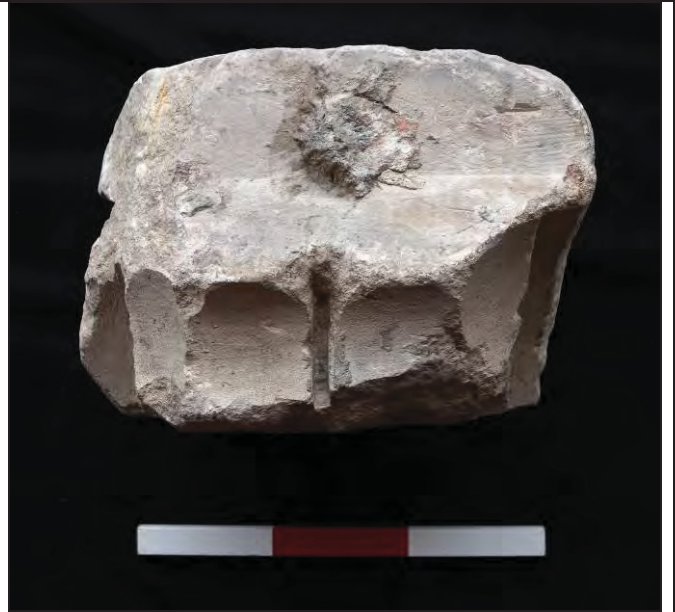
Side with glazing groove

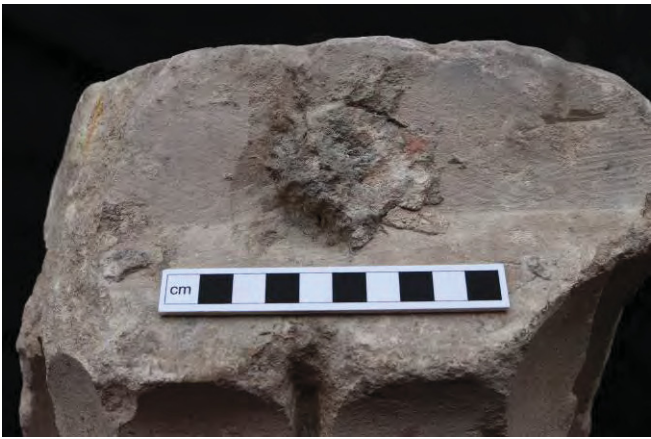
Side with large socket

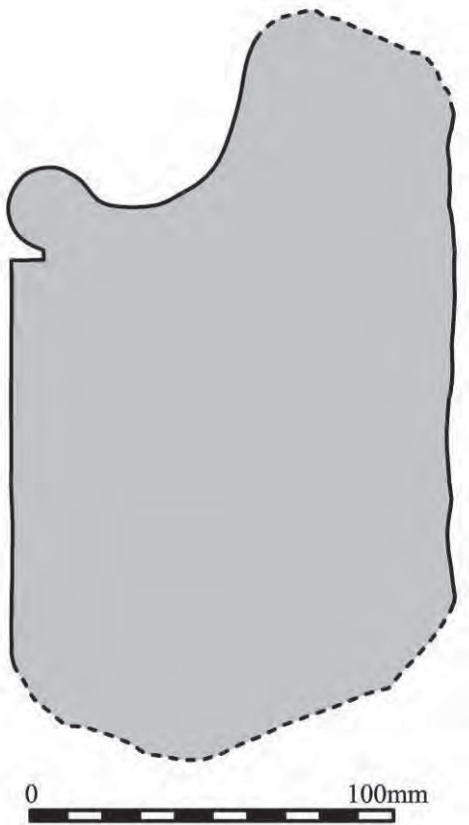
It consists of a simple squared piece of masonry, flat on two sides with a single hollow and roll moulding along one edge. Mortar is present along the front face where the roll moulding would be exposed suggesting its reuse in a different context. It has minor traces of fire damage.

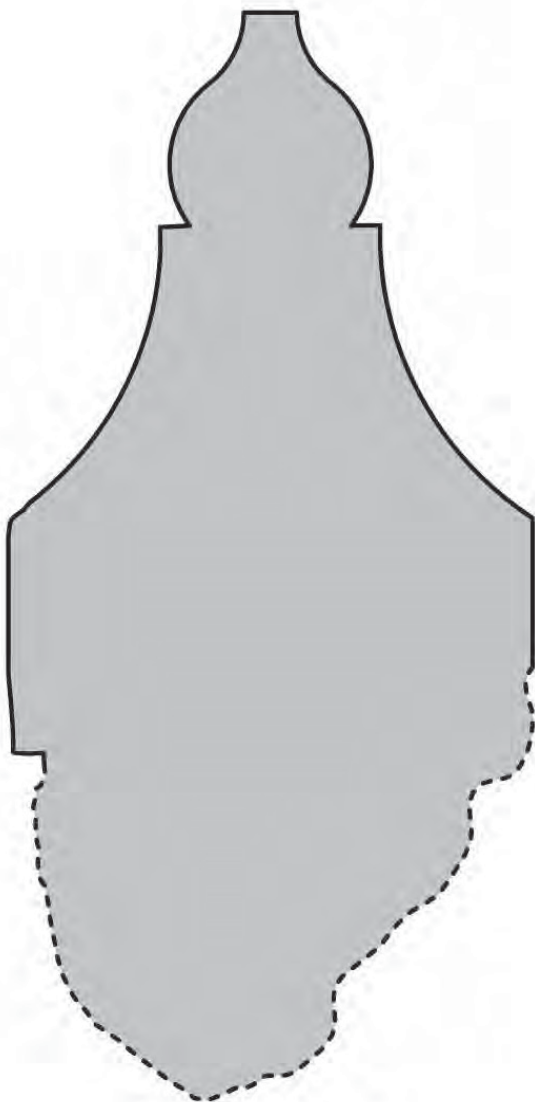
Substantially damaged with the bottom broken off and one side truncated back to the glazing groove. The sides from the glazing grooves on both sides are straight to the front which has a hollow and roll moulding to a fillet, defined by Morris as the 'first family of roll and chamfer mullions (second variety)' (1979. pp.1-2).

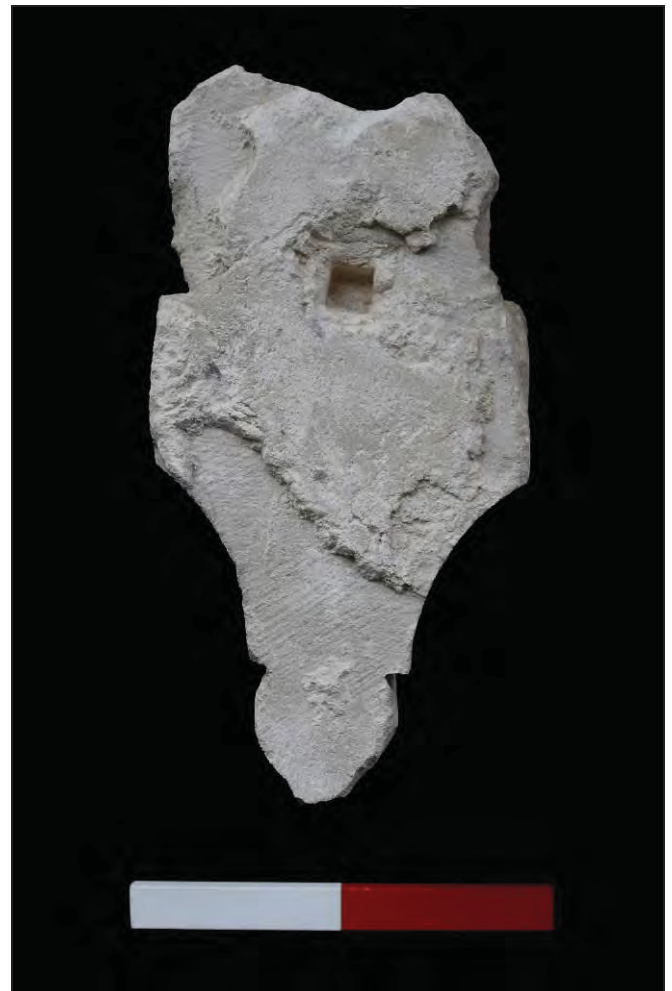
The bottom survives intact and includes parallel tooling marks and a square socket along with lime mortar. Scabbling marks are visible elsewhere on the piece.

Base with socket and tooling marks

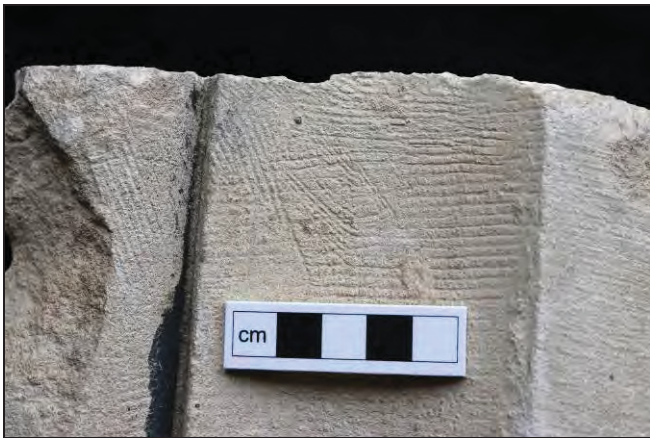
Detail of tooling marks

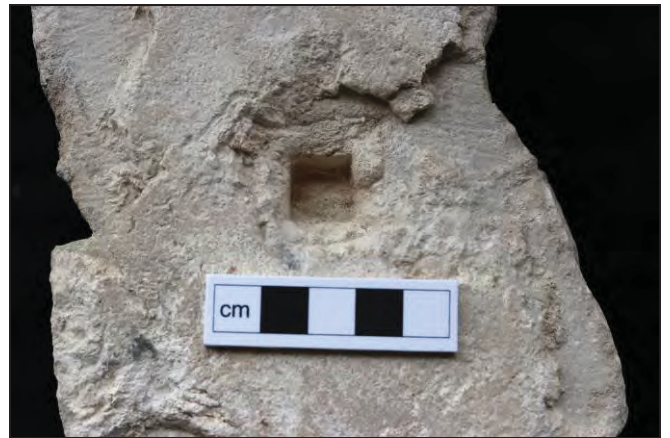
Detail showing socket

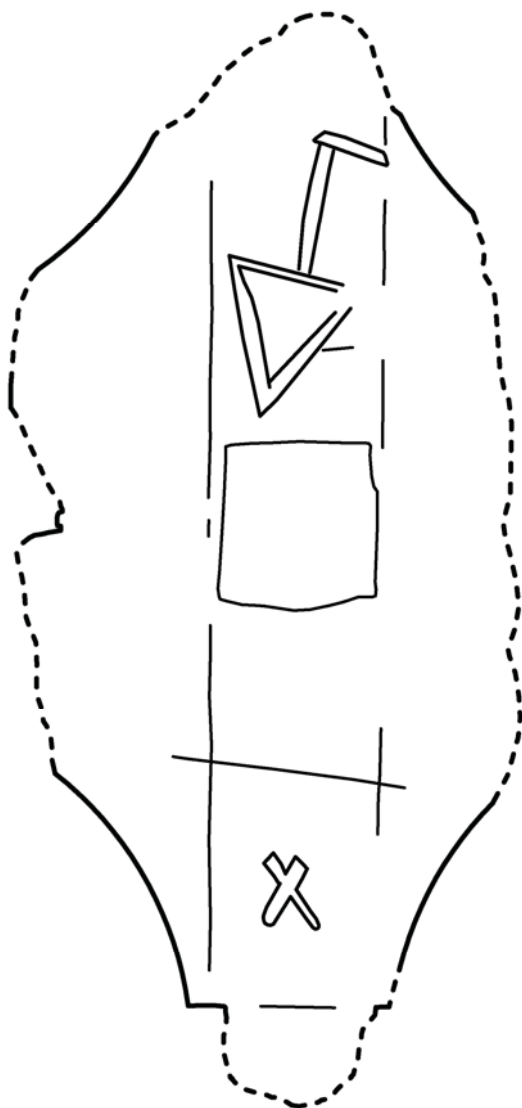
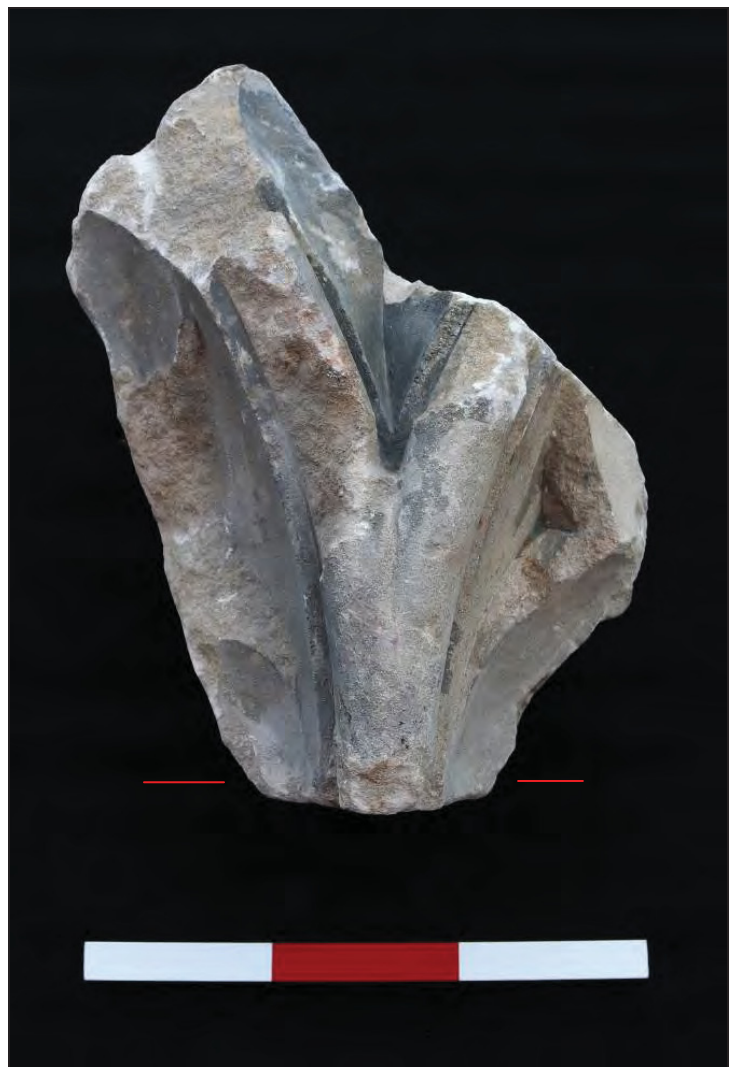
Springer for two cusped arches from a mullion. Damage on much of the top.

Face

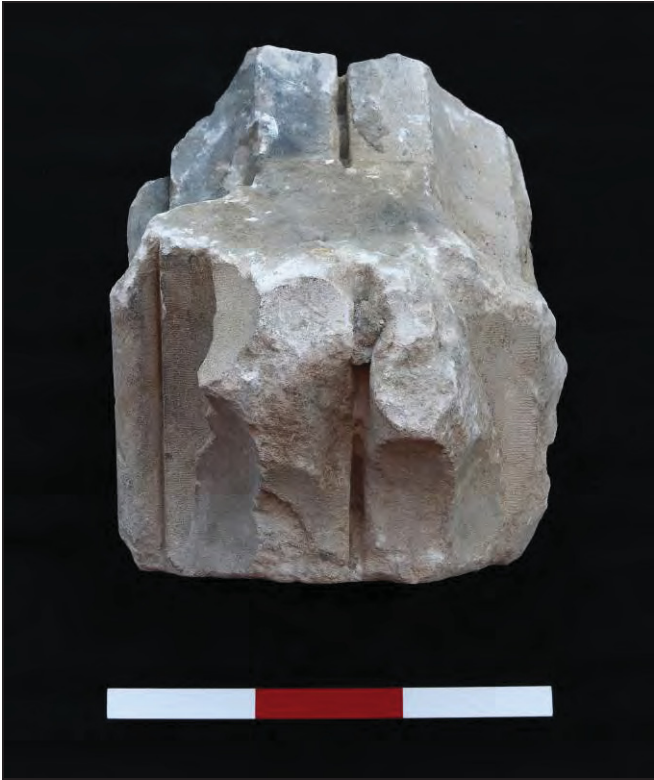
Side with glazing groove

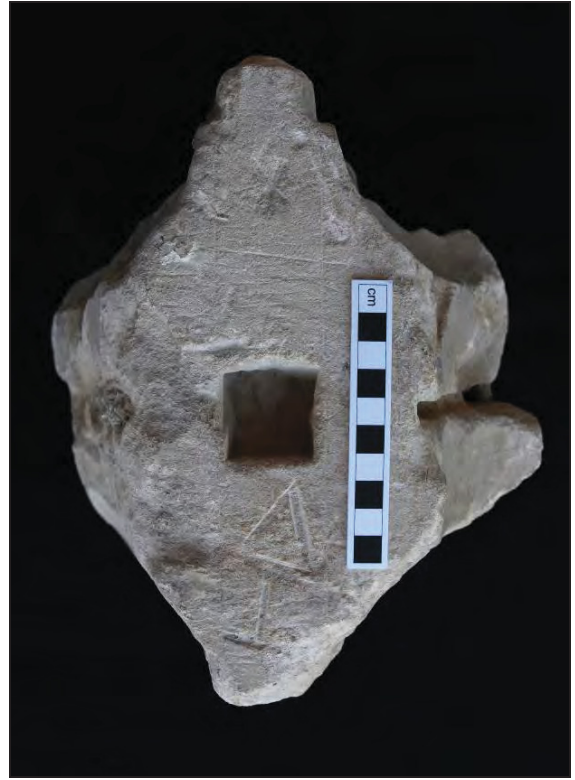
The base is largely intact though abraded and preserves a square socket, the same mason's mark as on Piece #01, a second chiselled cross mark and setting out lines for the socket.

Face with socket and mason's mark

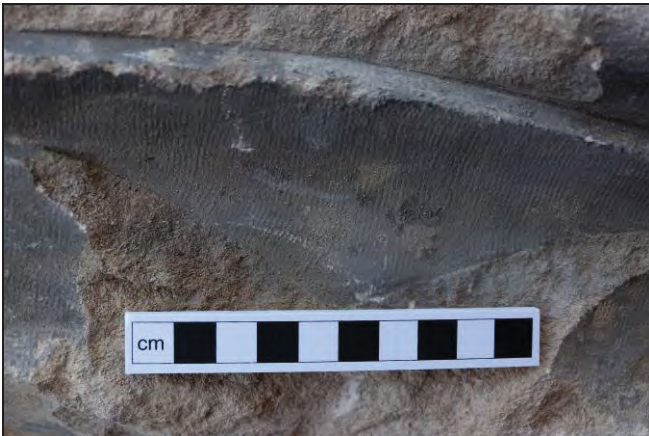
Detail of tooling marks

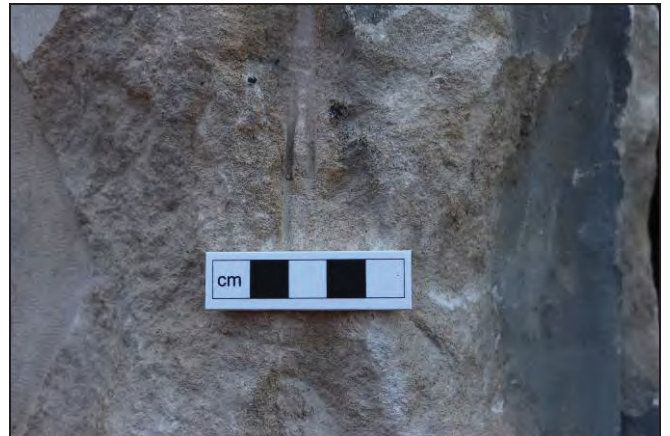
Detail of glazing groove

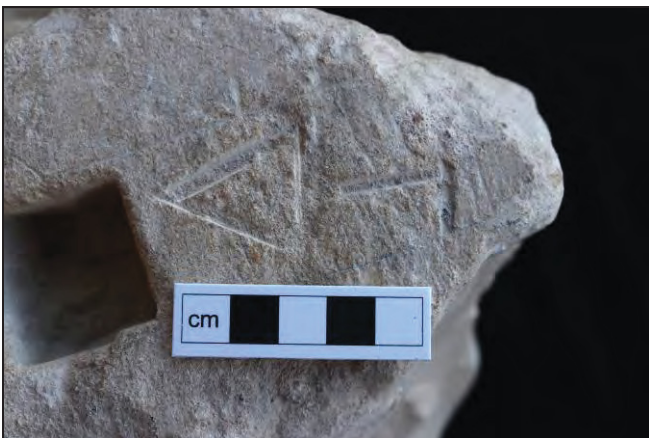
Detail of mason's mark

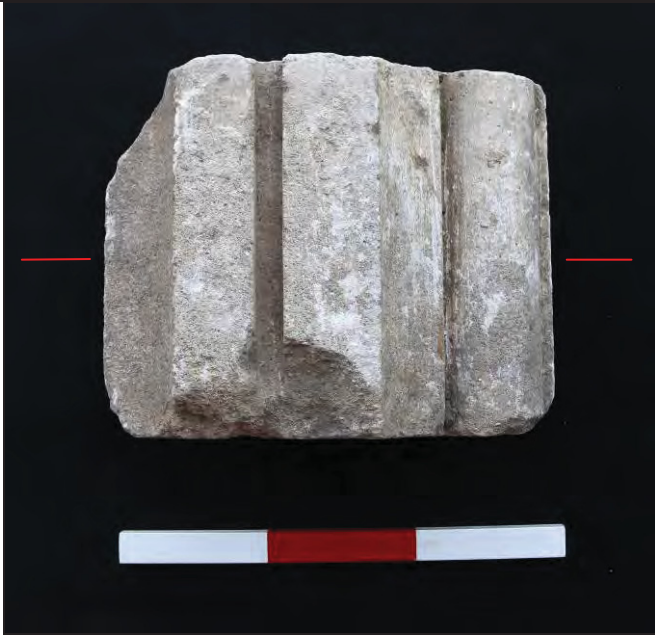
Side with side glazing groove

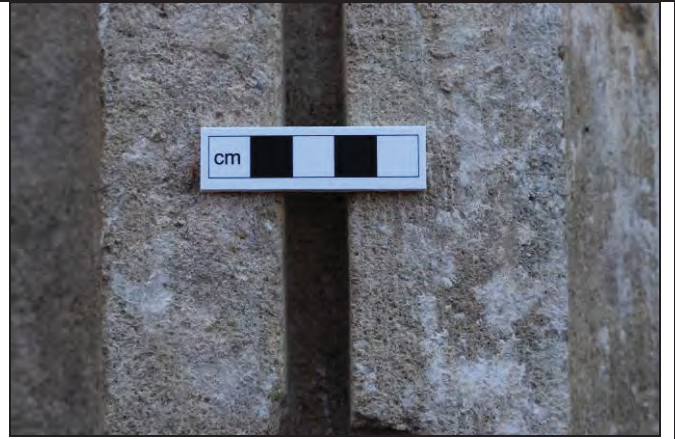
Detail of the wide glazing groove

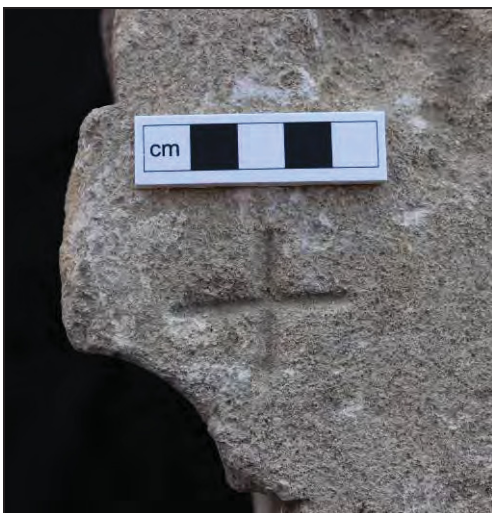
Detail of mason's mark

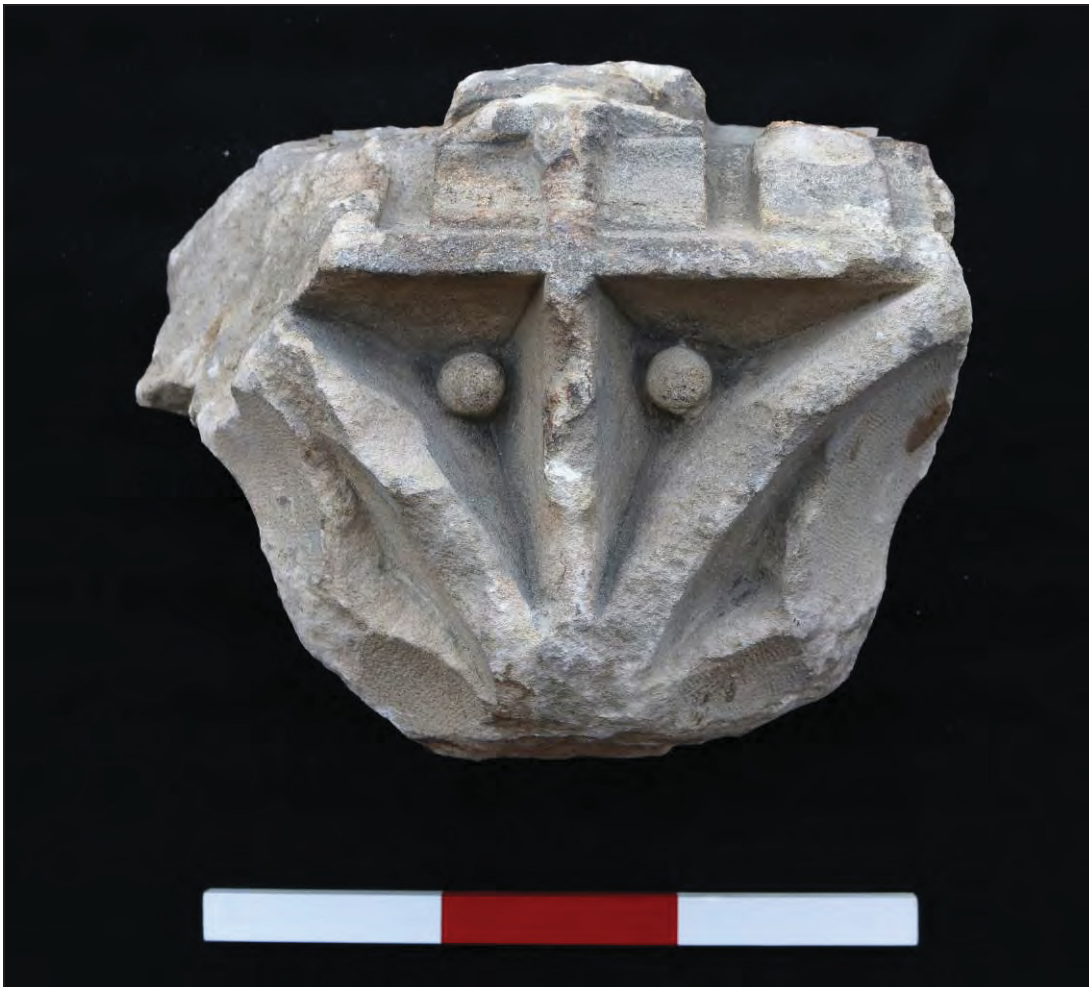
The front and rear faces are identical and include a heavily abraded mullion moulding with pellets in the hollow spandrels to trefoil-headed tracery on either side. Sulphation is present on one side only. Glazing grooves partially survive on both sides.

Face

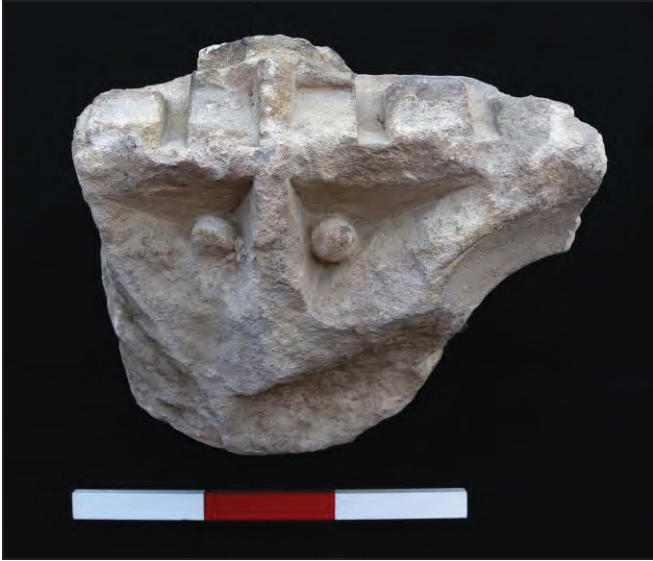
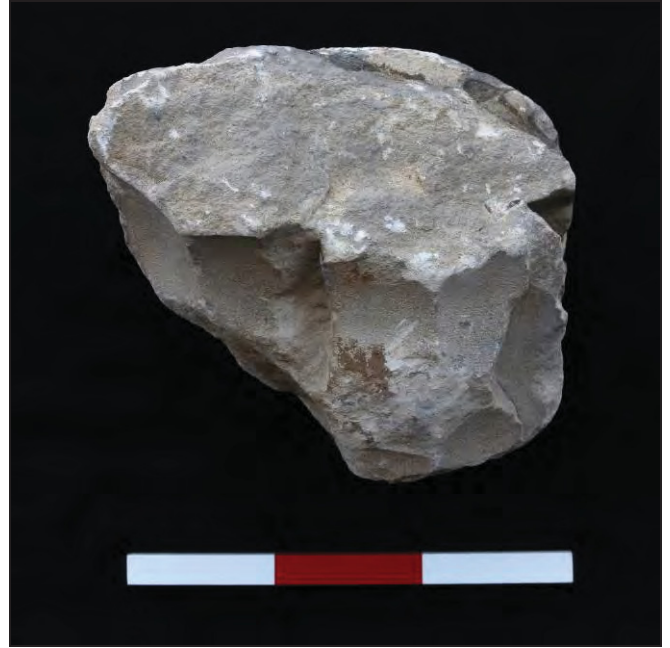
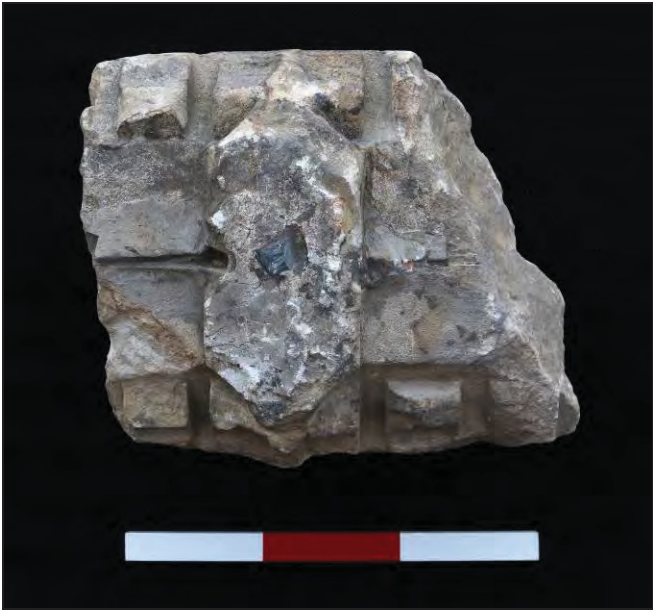
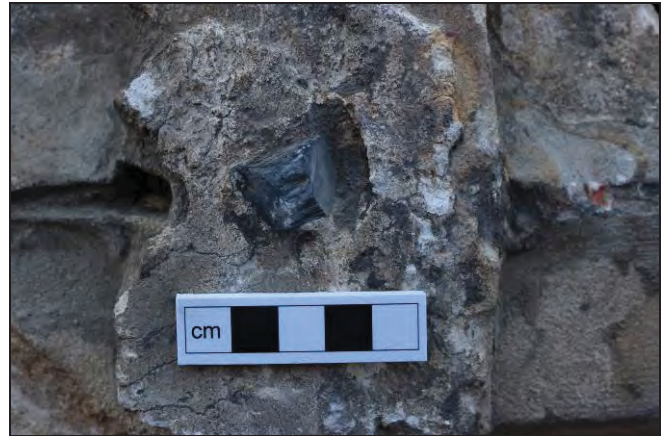
Rear face

Side

Top with mullion profile

Detail of top with lead filled socket
