**RAILWAY STREET / MILL ROAD, HERTFORD,  
HERTFORDSHIRE**

**ASSESSMENT AND RECORDING OF THE ARCHITECTURAL  
STONEMWORK**

Authors: Tansy Collins MSt Lee Prosser PhD FSA Lauren Wilson MA	
NGR: TL 32920 12915	Report No: 5600
District: East Herts	Site Code: AS 745
Approved: Claire Halpin	Project No: 6928
MCIfA	Date: 19 June 2018

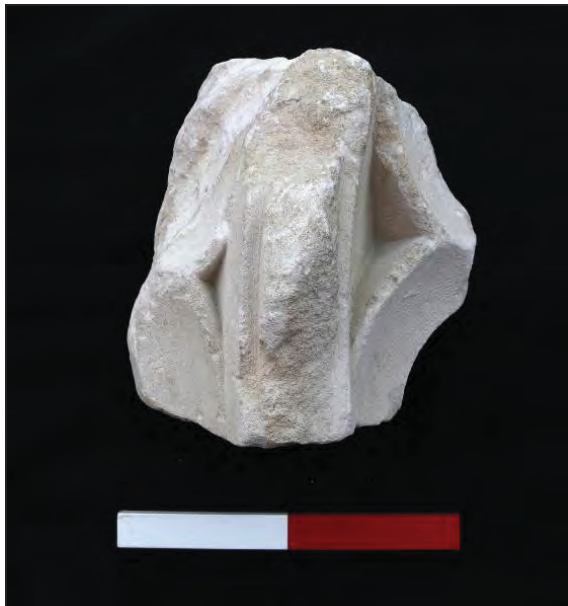
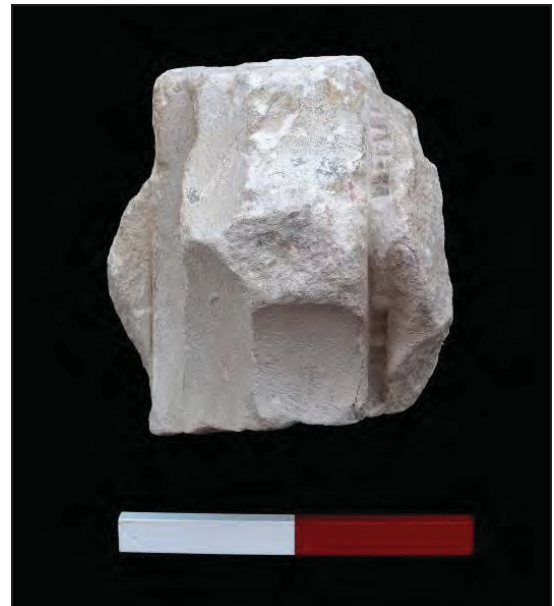
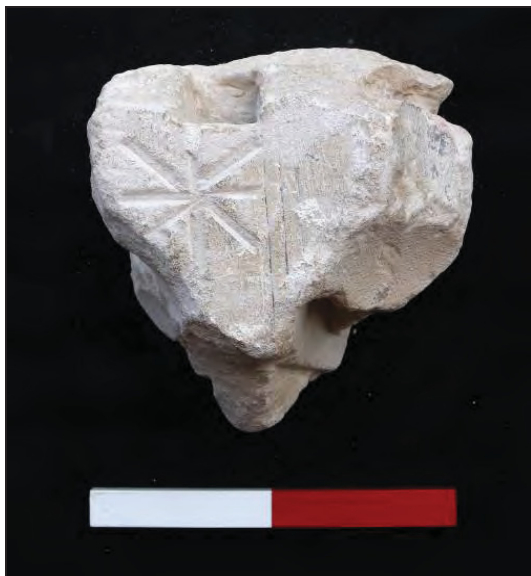
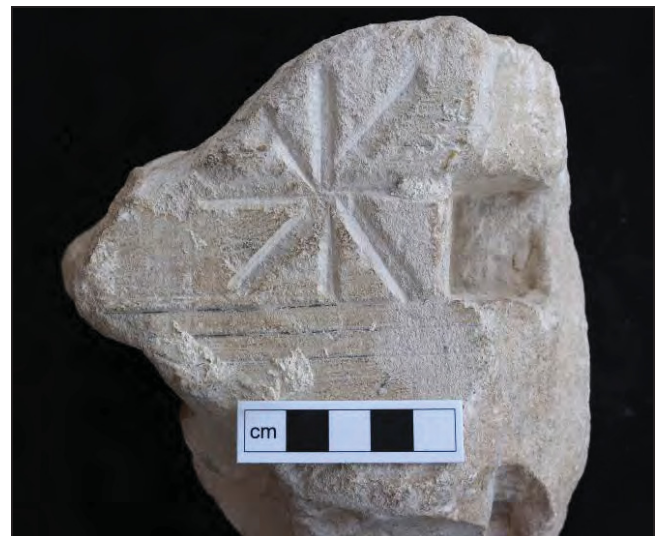
<b>Piece identification number</b>	<b>21</b>	<b>Fabric:</b> Fine shelly Oolitic limestone	<b>Context:</b> L2008	<b>Dimensions (mm):</b> 188x170x170mm
------------------------------------	-----------	---	--------------------------	--

Fragment of tracery. Sides and rear broken and abraded so its exact position within a window is not entirely discernible.

The sides has glazing grooves though the rear face has been completely truncated. The top is truncated but the base partially survives and preserves a good mason's mark (a star), a number of parallel setting out lines and the remains of a socket.

Inner face

Side with glazing groove

Base with socket and mason's mark

Detail of mason's mark

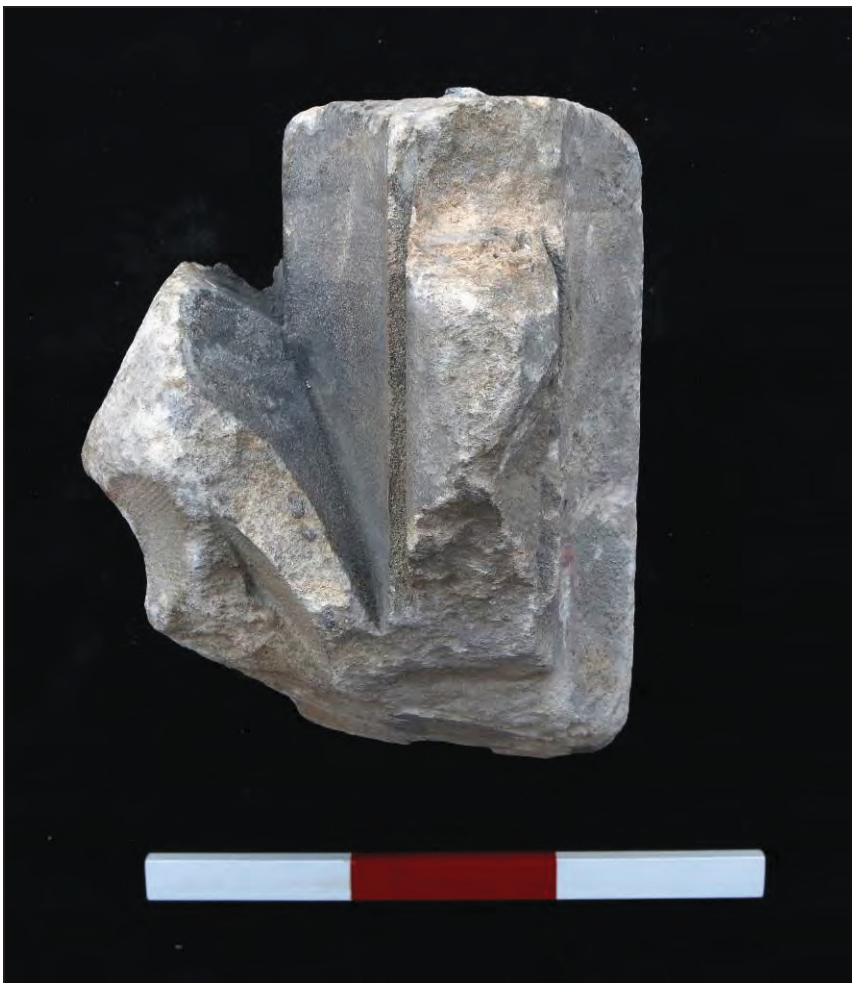
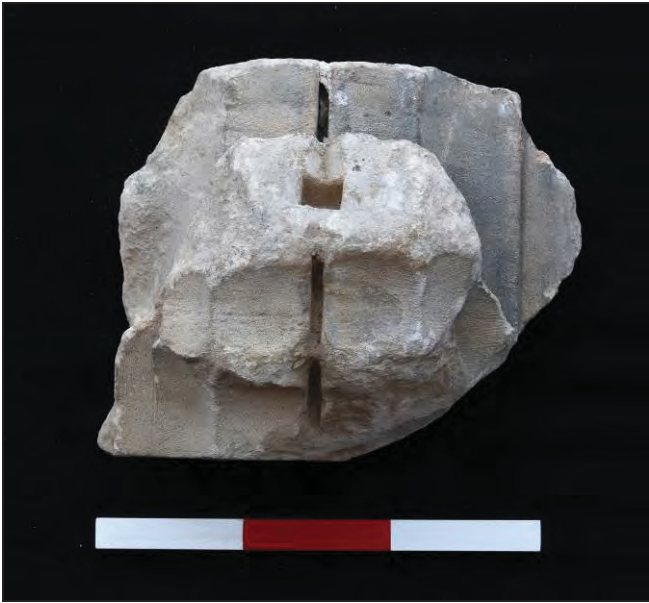
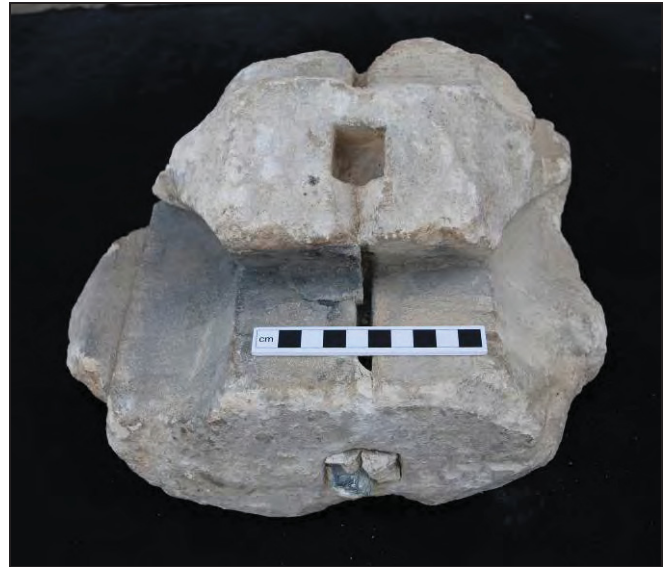
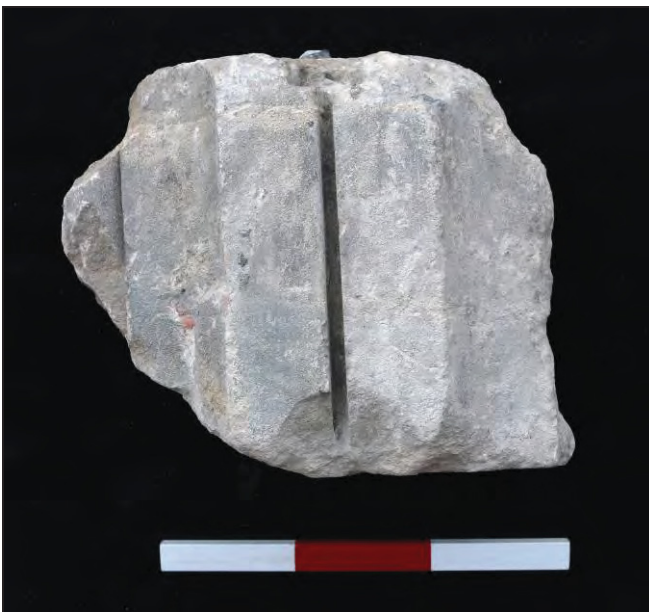
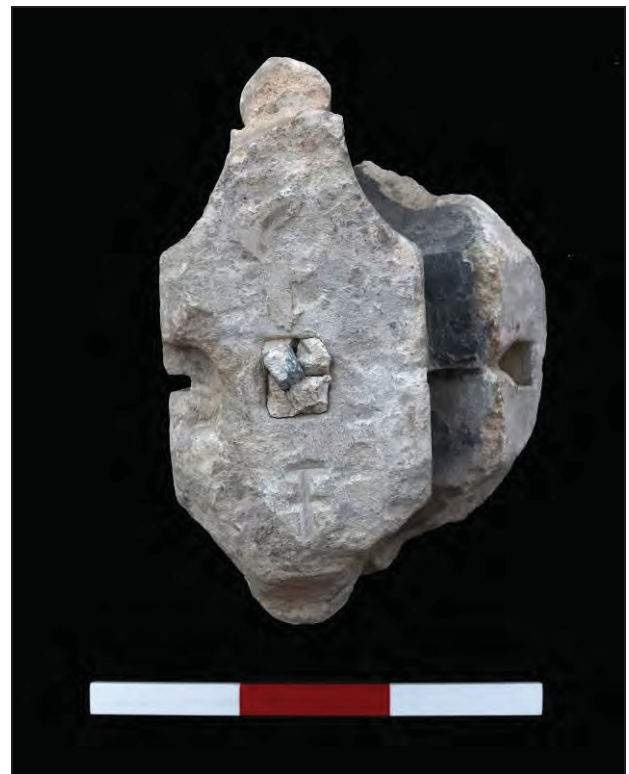
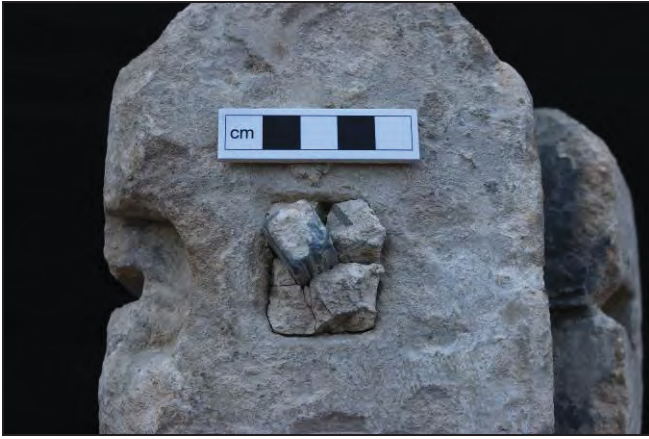
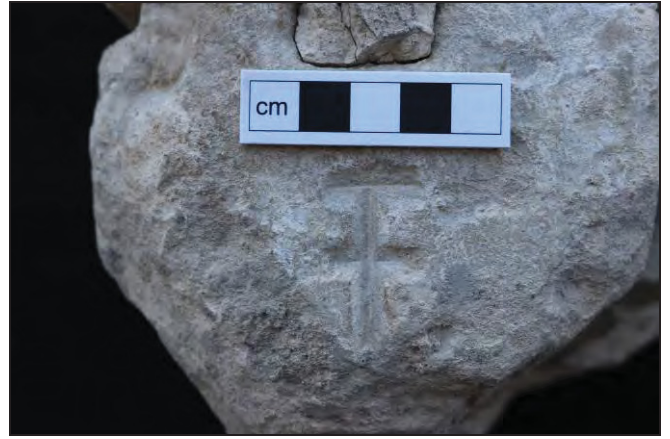
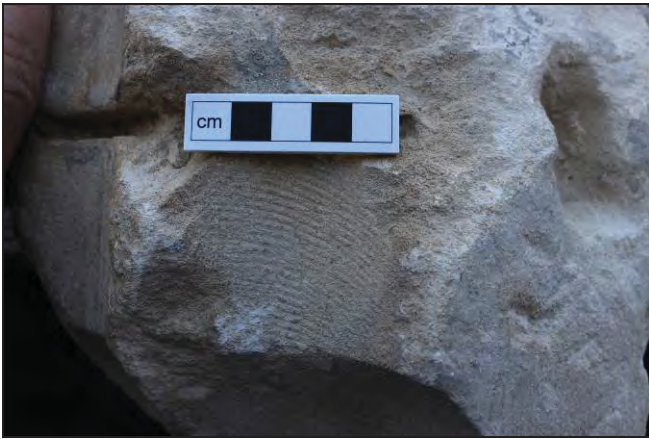
<b>Piece identification number</b>	<b>22</b>	<b>Fabric:</b> <i>Fine shelly Oolitic limestone</i>	<b>Context:</b> L2008	<b>Dimensions (mm):</b> 253x300x190mm
------------------------------------	-----------	--	--------------------------	--

The mullion is not complete and there is much abrasion and fracturing though it appears that both faces are identical. One face includes the mullion moulding with a hollow chamfer to a roll moulding much as some other pieces in the assemblage such as #01 and #17, defined by Morris as the 'first family of roll and chamfer mullions (second variety)' (1979. pp.1-2).

The mullion is vertical with a continuous glazing groove on one side and on the other cusped tracery rises, perhaps defining the position of a hollow spandrel. On one face there is atmospheric sulphation. The top of the tracery and responding side of the mullion also has a glazing groove and preserves traces of cementitious mortar repair.

Fine parallel tooling marks and scabbling marks are visible.

Inner face

Side showing section of cusping with socket

Oblique view with sockets and glazing grooves

Side showing glazing groove

Top with socket and mason's mark

Detail of lead-filled socket

Detail of mason's mark

Detail of fine tooling

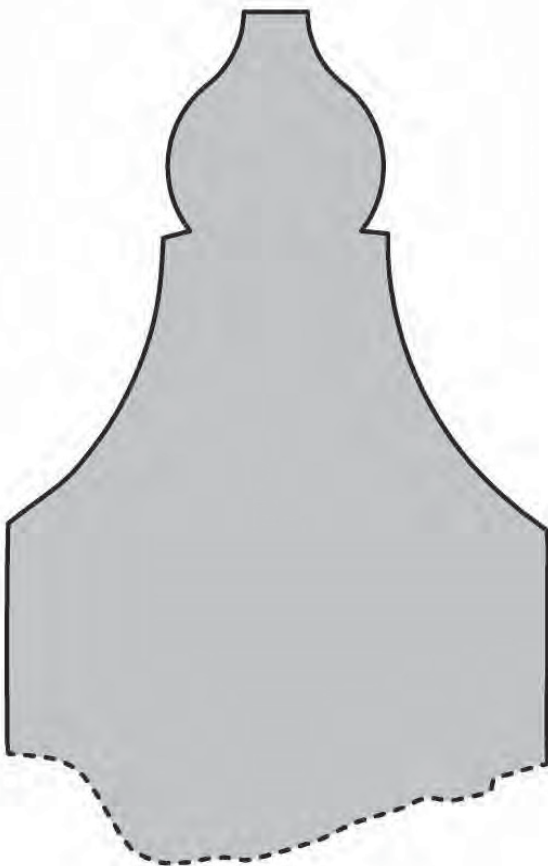
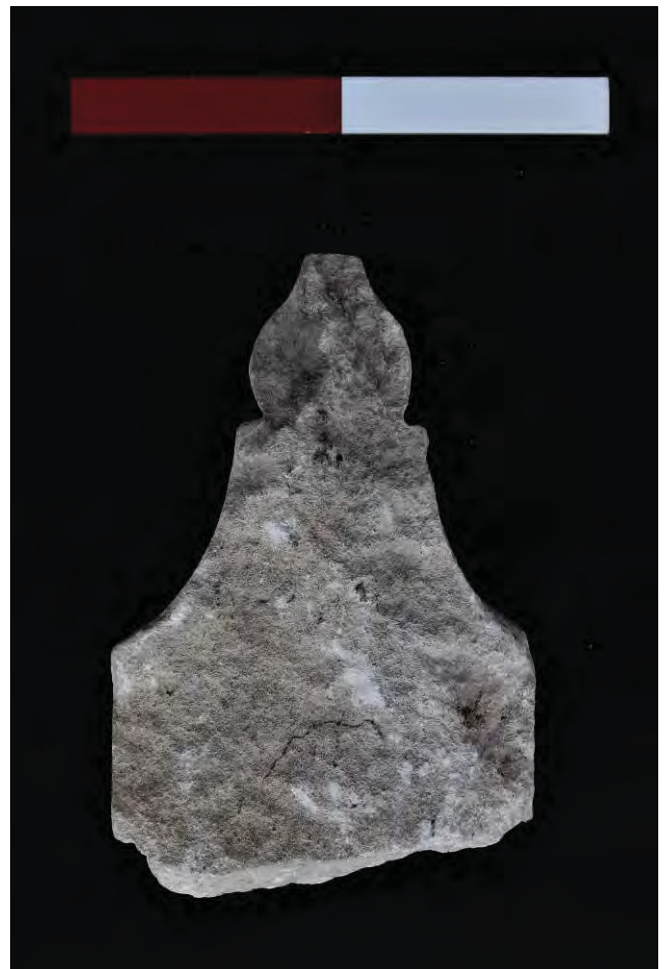
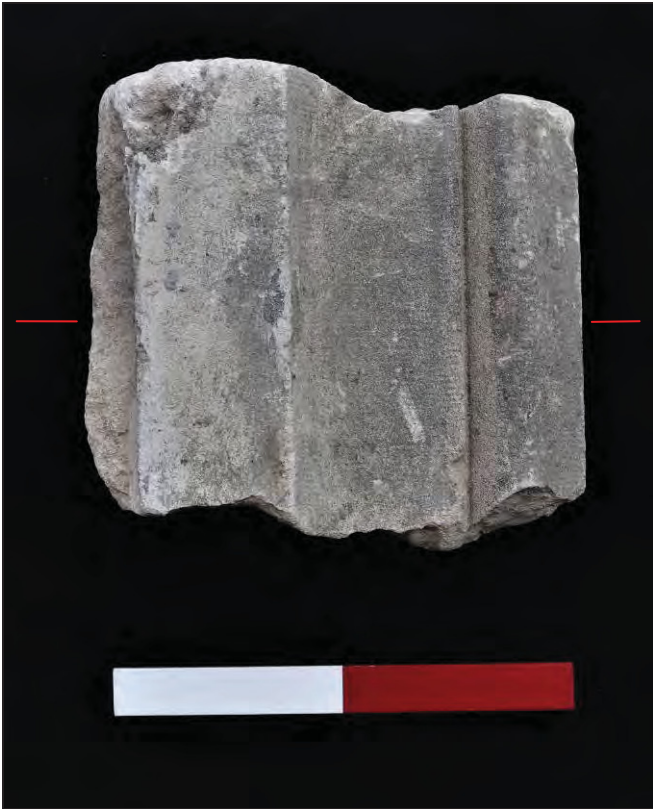
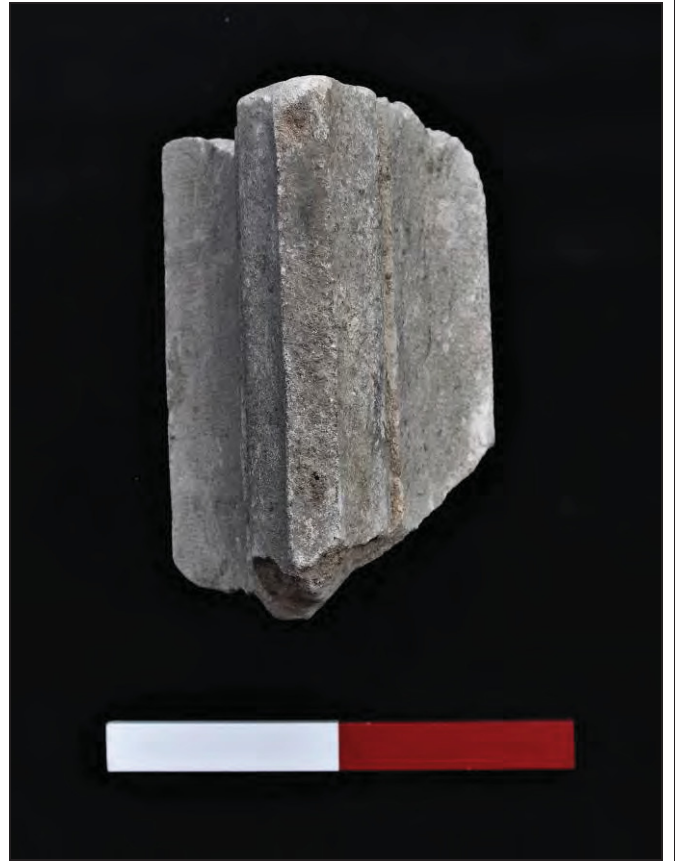
<b>Piece identification number</b>	<b>23</b>	<b>Fabric:</b> <i>Fine shelly Oolitic limestone</i>	<b>Context:</b> <i>L2008</i>	<b>Dimensions (mm):</b> <i>180x130x193mm</i>
------------------------------------	-----------	--	---------------------------------	---

The top and bottom of the piece are both truncated and the rear side to the level of the glazing groove is also broken.

The front, however, preserves the profile of the mullion in good condition with straight sides to a concave and roll moulding to a fillet, defined by Morris as the 'first family of roll and chamfer mullions (second variety)' (1979. pp.1-2).

Scabbling marks are visible.

Top

Side

Inner face

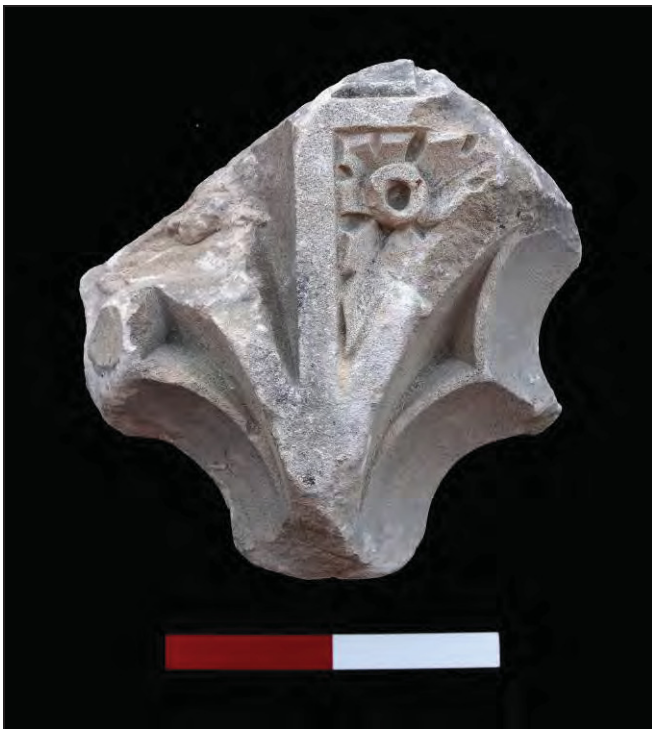
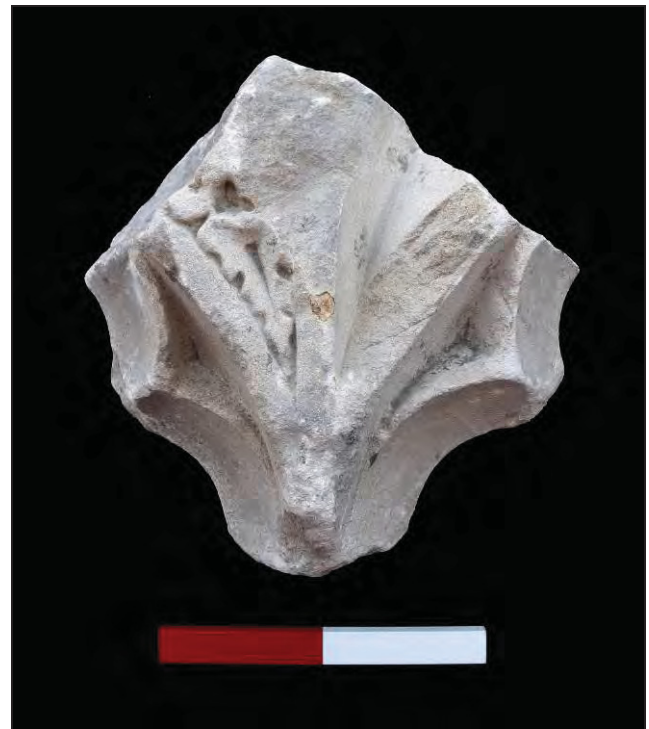
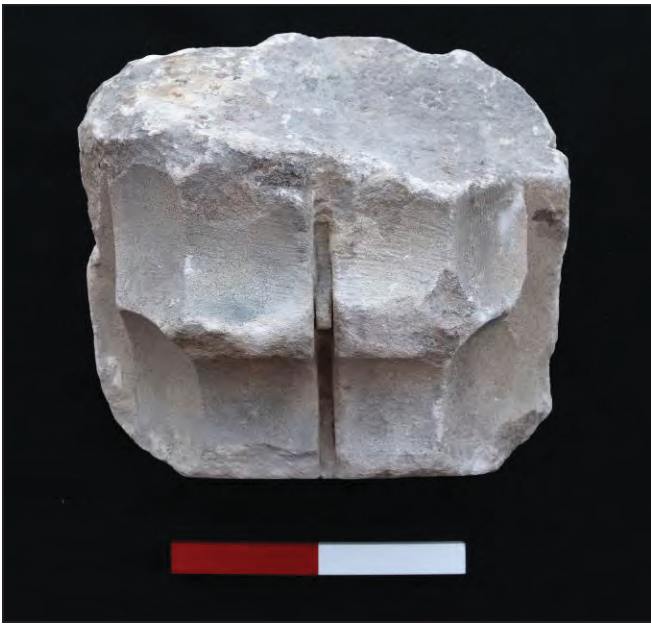
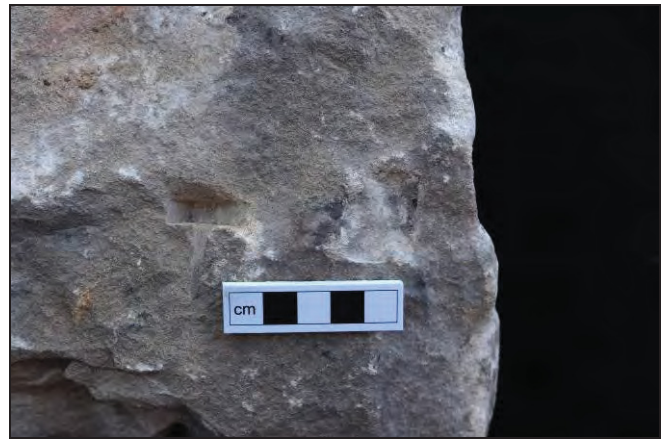
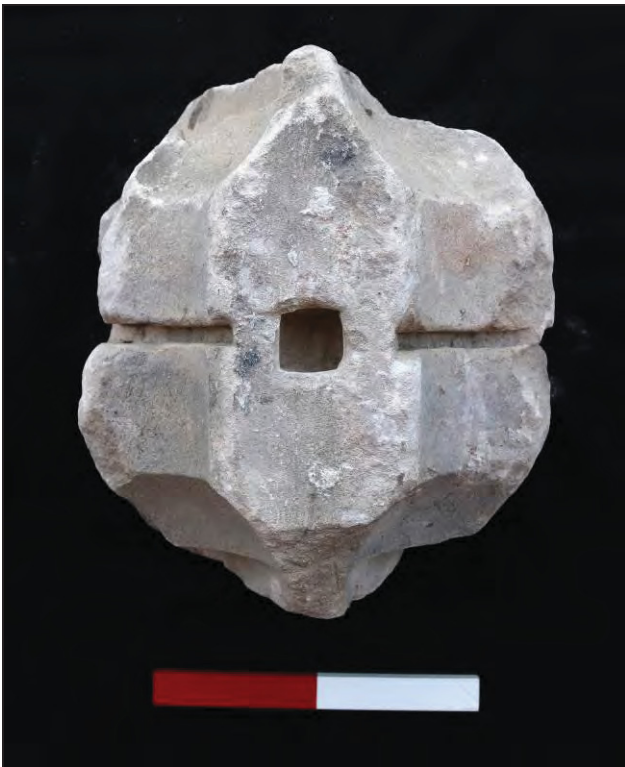
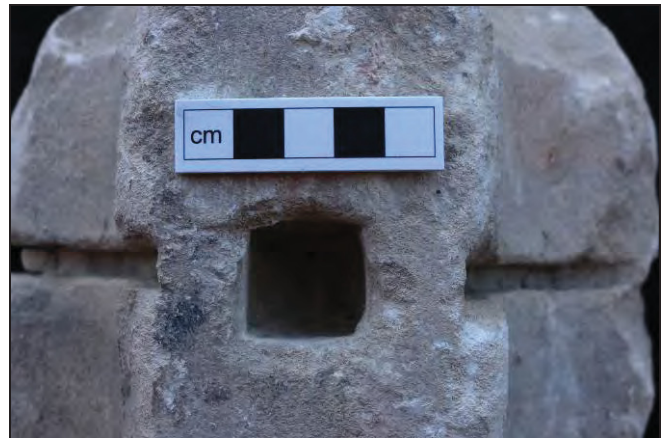
<b>Piece identification number</b>	<b>24</b>	<b>Fabric:</b> <i>Fine shelly Oolitic limestone</i>	<b>Context:</b> L2008	<b>Dimensions (mm):</b> 232x240x260mm
------------------------------------	-----------	--	--------------------------	--

Window mullion together with part of supertransom to one side and the possible springer for a subarcuation on the other. There is much damage but enough survives to demonstrate the general form.

There is atmospheric sulphation on one side.

Inner face

Rear face

Side with glazing groove

Detail showing truncated glazing groove and possible socket base

Base showing socket

Detail showing socket

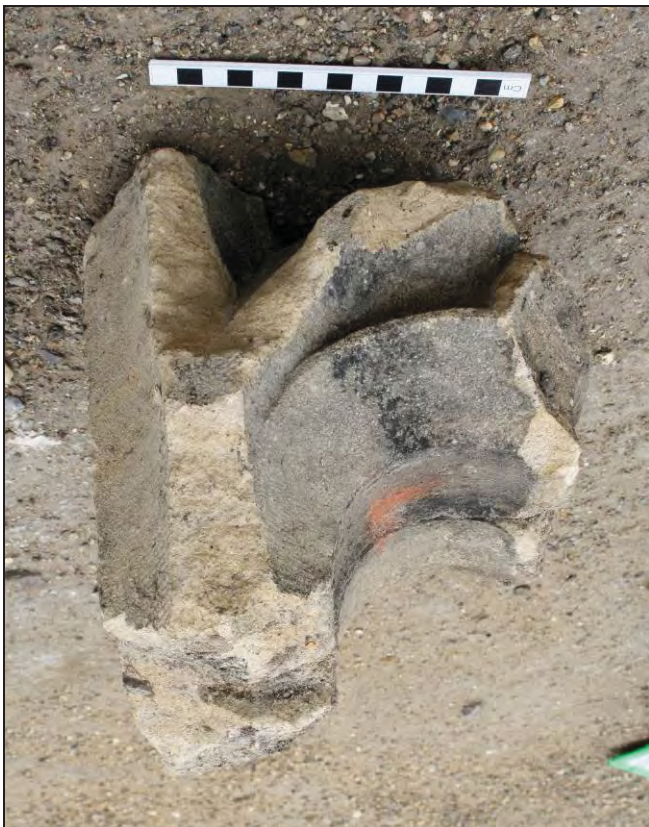
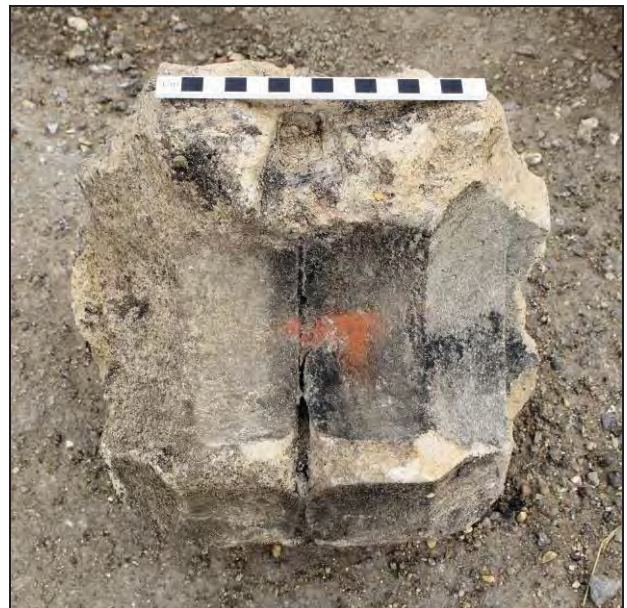
<b>Piece identification number</b>	<b>25 – photograph only</b>	<b>Context:</b> L2008	<b>Source:</b> Porzorski 2010
------------------------------------	-----------------------------	--------------------------	----------------------------------

Glazing groove visible and possible socket in the base of the mullion.

Inner face

Side

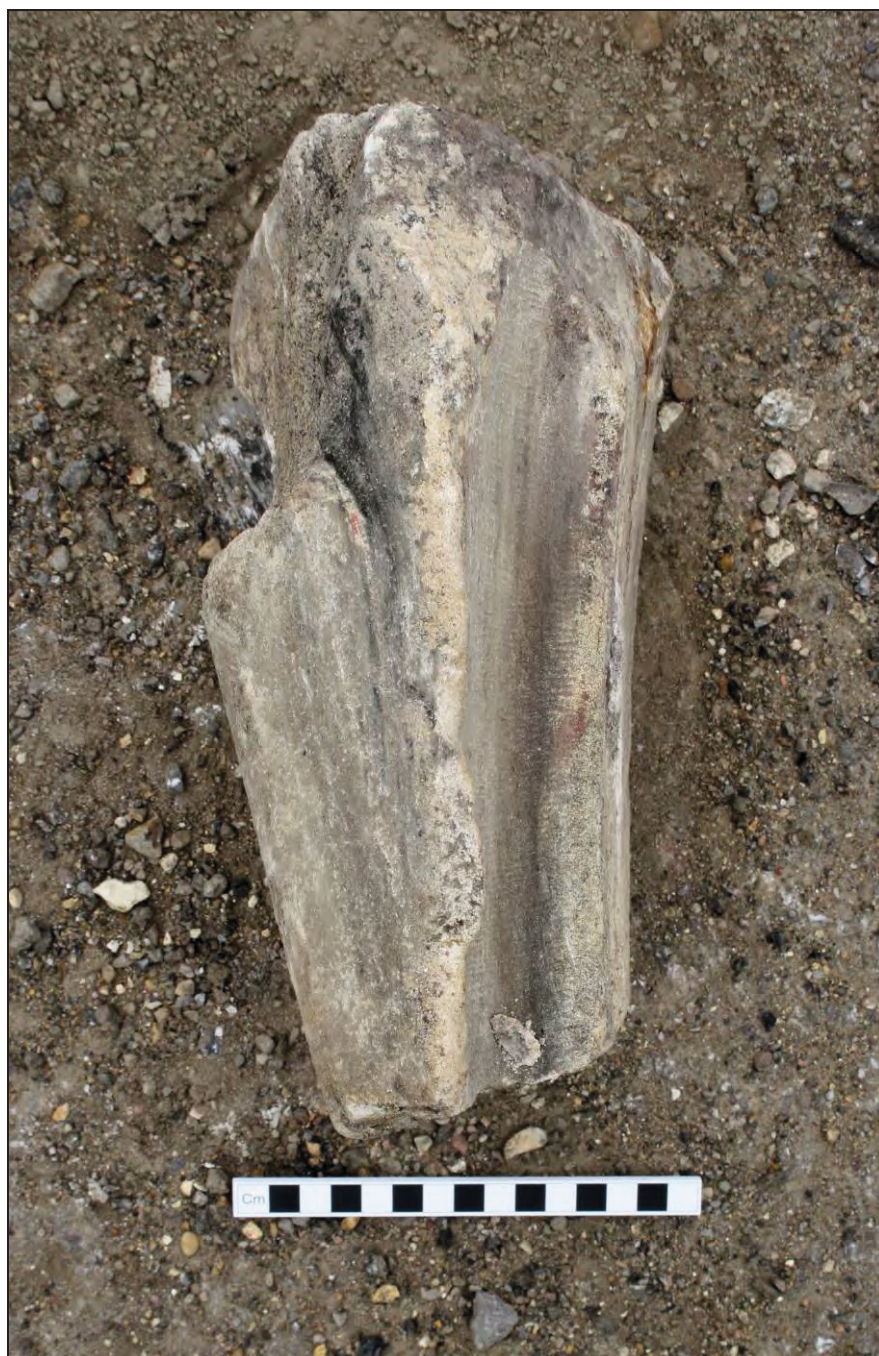
<b>Piece identification number</b>	<b>26 – photograph only</b>	<b>Context:</b> L2008	<b>Source:</b> Porzorski 2010
------------------------------------	-----------------------------	--------------------------	----------------------------------

Fine tooling marks visible.

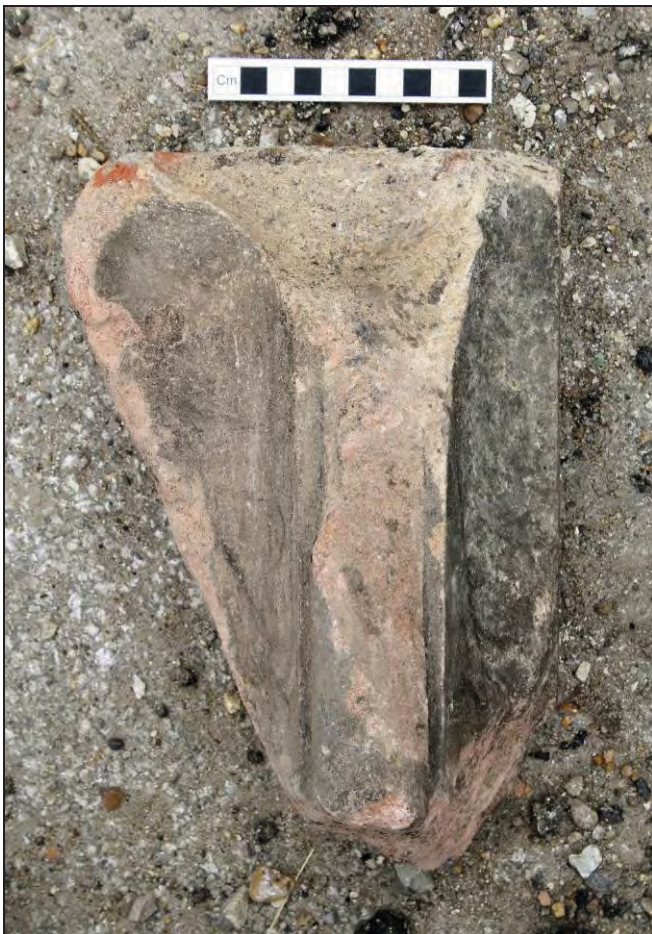
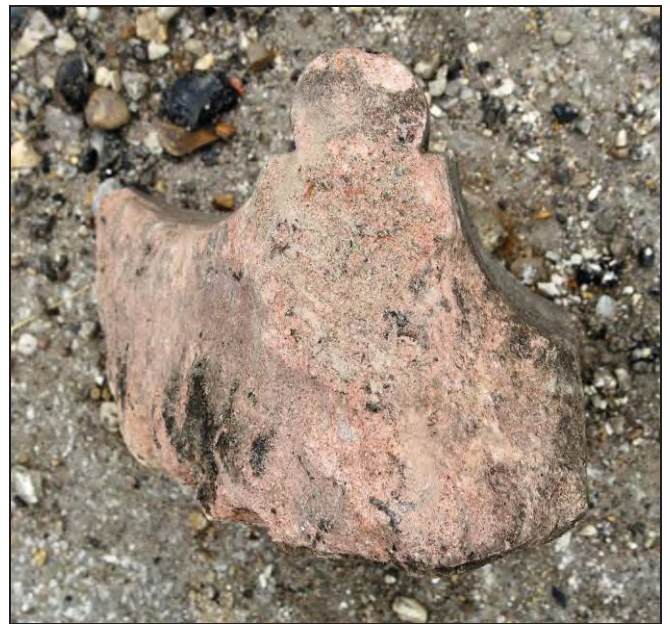
<b>Piece identification number</b>	<b>27 – photograph only</b>	<b>Context:</b> L2008	<b>Source:</b> Porzorski 2010
------------------------------------	-----------------------------	--------------------------	----------------------------------

Substantially reddened from heat damage.

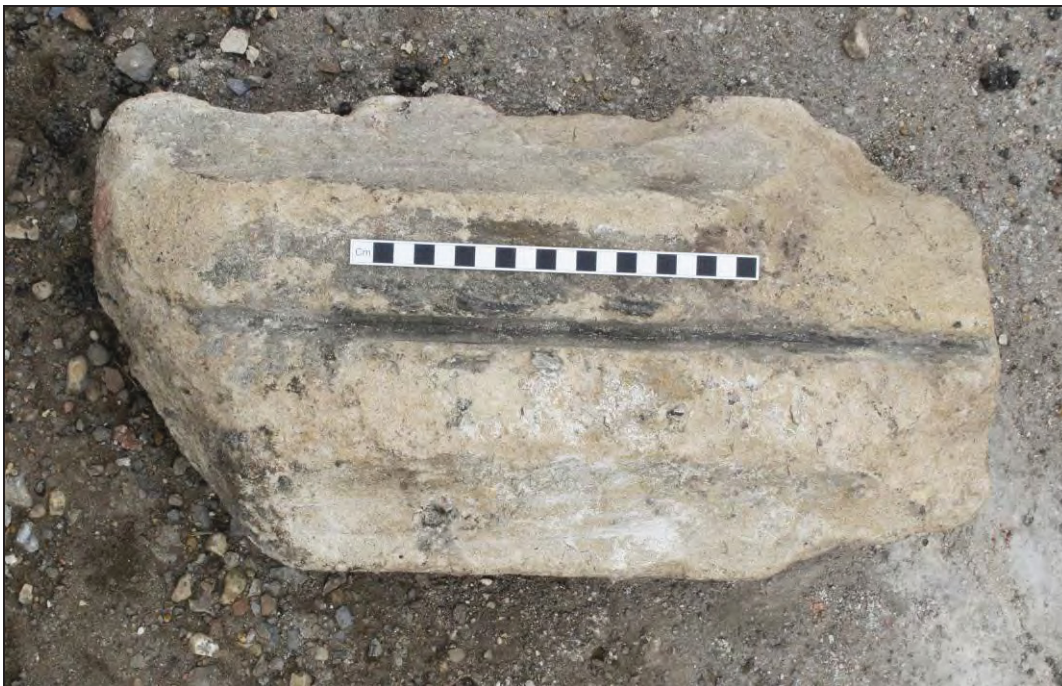
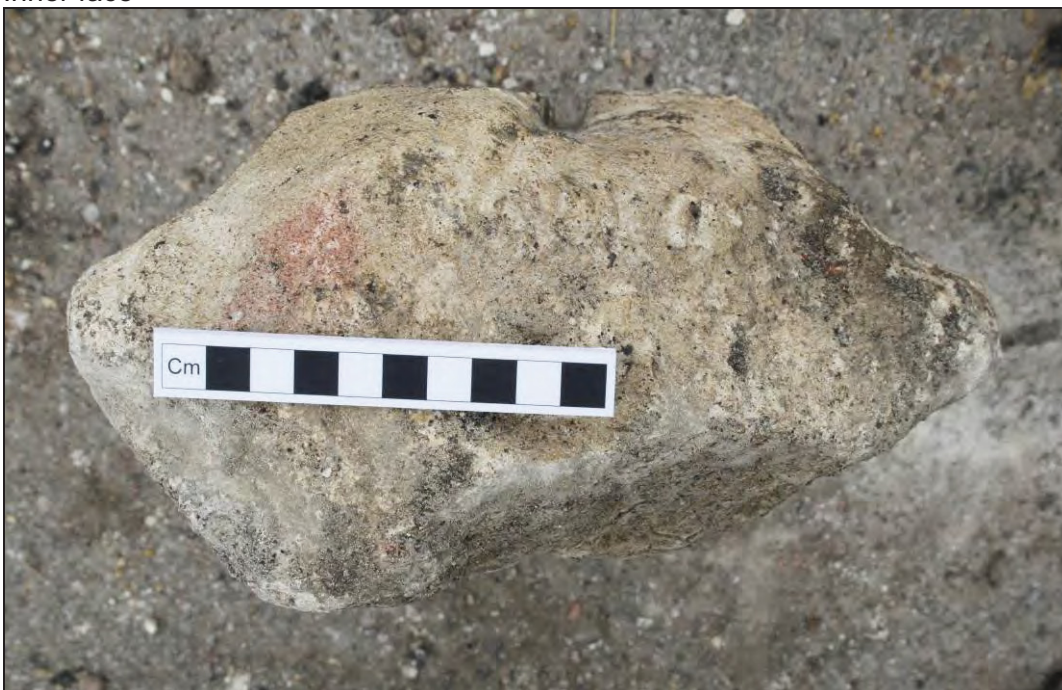
<b>Piece identification number</b>	<b>28 – photograph only</b>	<b>Context:</b> L2008	<b>Source:</b> Porzorski 2010
------------------------------------	-----------------------------	--------------------------	----------------------------------

Some areas possibly reddened from heat damage.

Inner face

Rear face

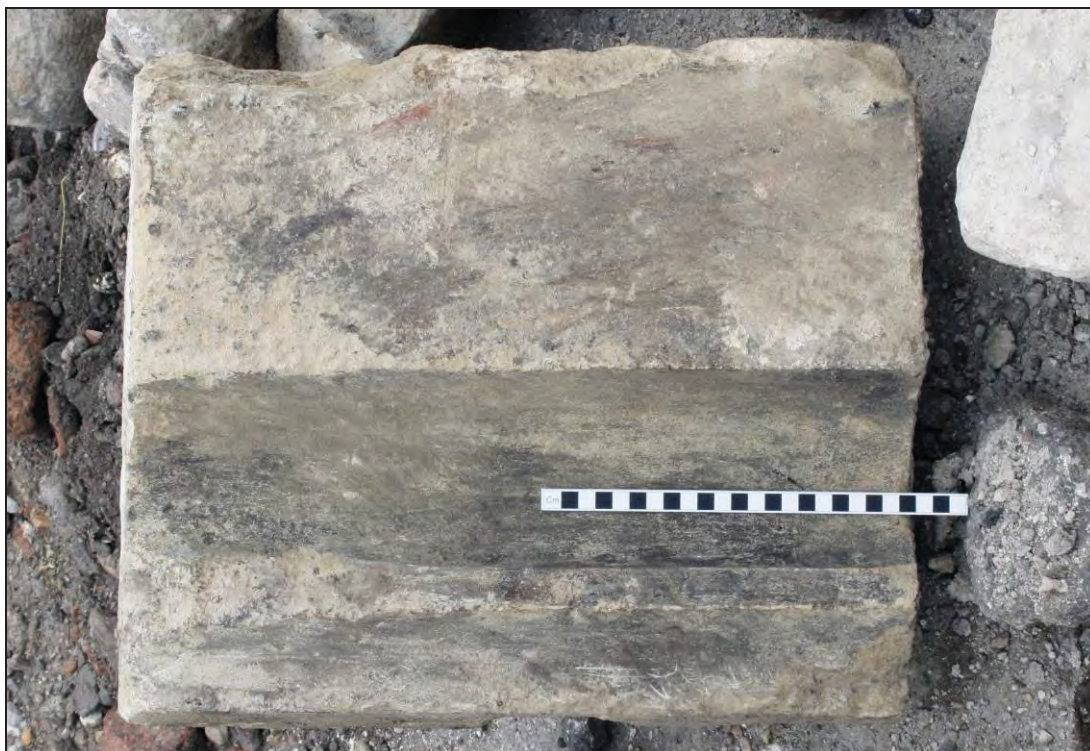
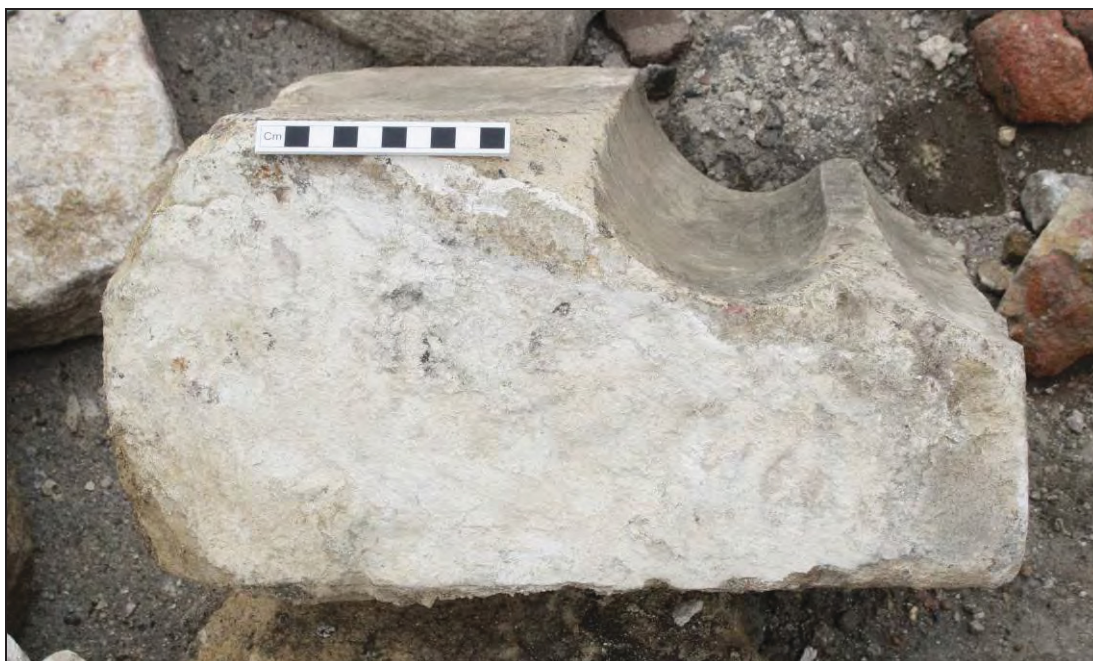
<b>Piece identification number</b>	<b>29 – photograph only</b>	<b>Context:</b>	<b>Source:</b>
		L2008	Porzorski 2010

Lime mortar evident.

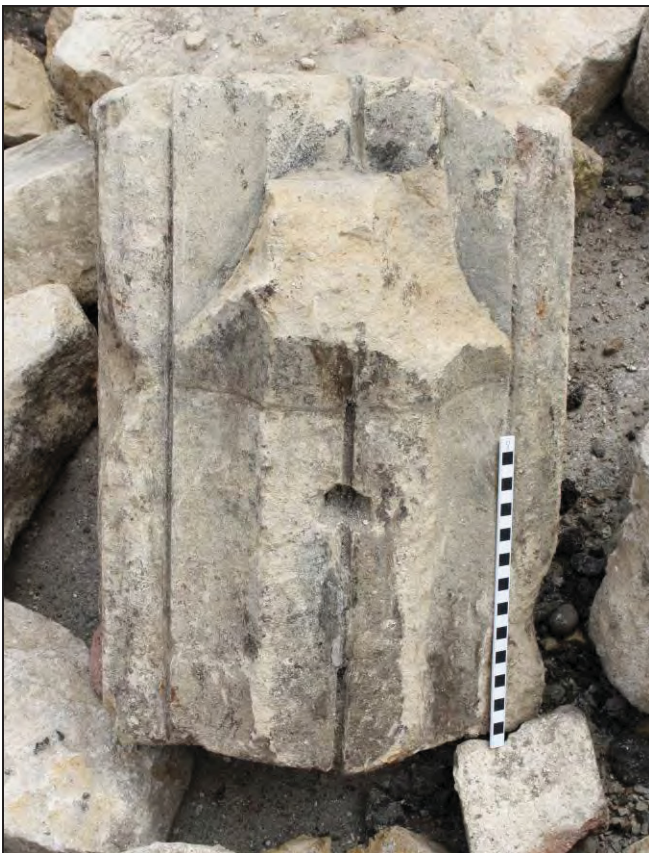
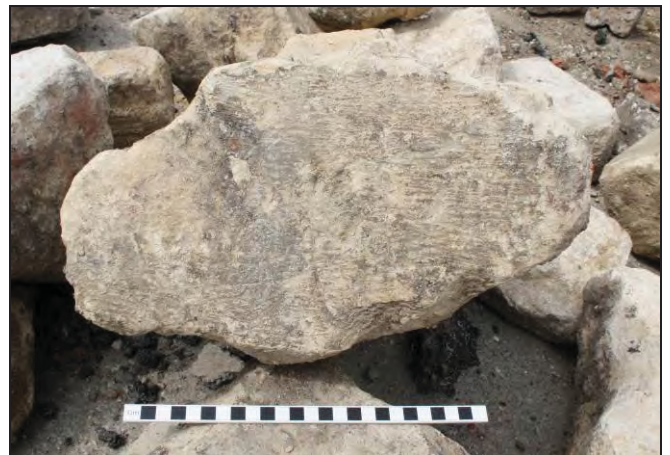
<b>Piece identification number</b>	<b>30 – photograph only</b>	<b>Context:</b> L2008	<b>Source:</b> Porzorski 2010
------------------------------------	-----------------------------	--------------------------	----------------------------------

One end of the piece has fairly close-spaced but not entirely regular tooling marks.

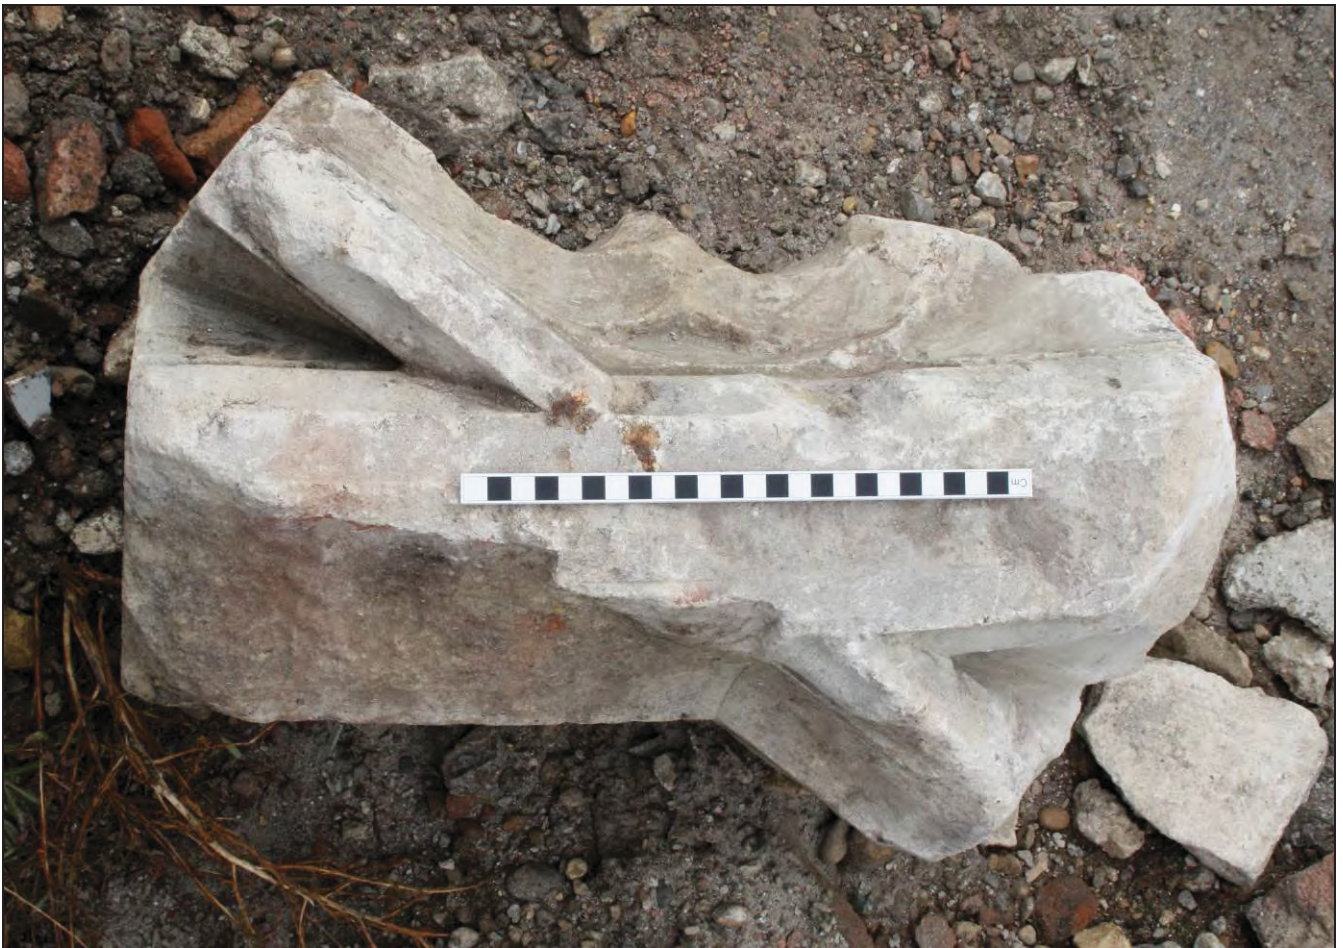
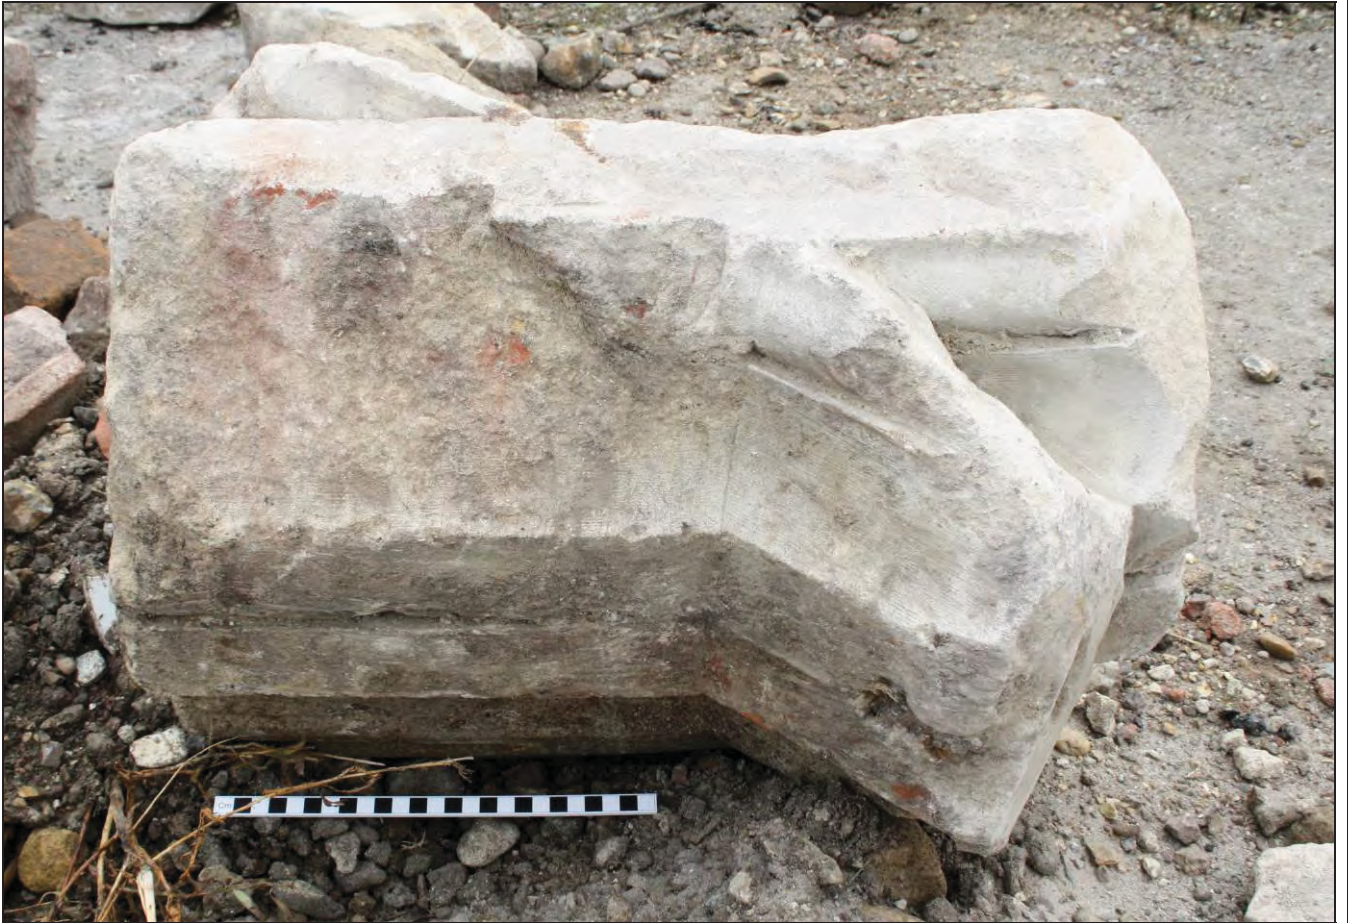
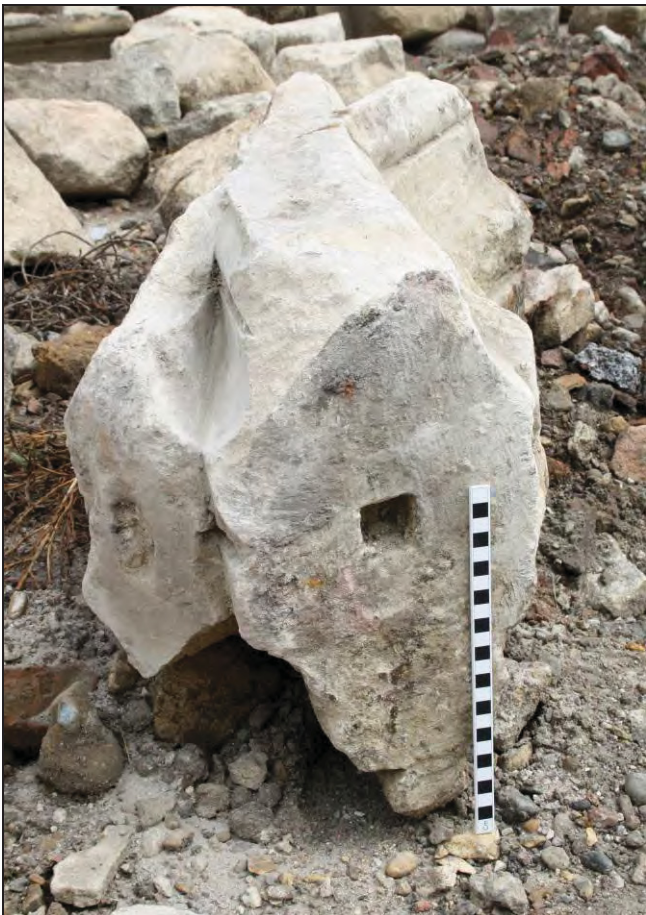
<b>Piece identification number</b>	<b>31 – photograph only</b>	<b>Context:</b> L2008	<b>Source:</b> Porzorski 2010
------------------------------------	-----------------------------	--------------------------	----------------------------------

It includes a section of intersecting tracery with one arm of more robust form and one fairly slender. The wider element is damaged so no moulding profile is evident, but the narrower section is defined by Morris as the 'first family of roll and chamfer mullions (second variety)' (1979. pp.1-2).

There is some reddening.
