**RAILWAY STREET / MILL ROAD, HERTFORD,  
HERTFORDSHIRE**

**ASSESSMENT AND RECORDING OF THE ARCHITECTURAL  
STONEMWORK**

Authors: Tansy Collins MSt Lee Prosser PhD FSA Lauren Wilson MA	
NGR: TL 32920 12915	Report No: 5600
District: East Herts	Site Code: AS 745
Approved: Claire Halpin	Project No: 6928
MCIfA	Date: 19 June 2018

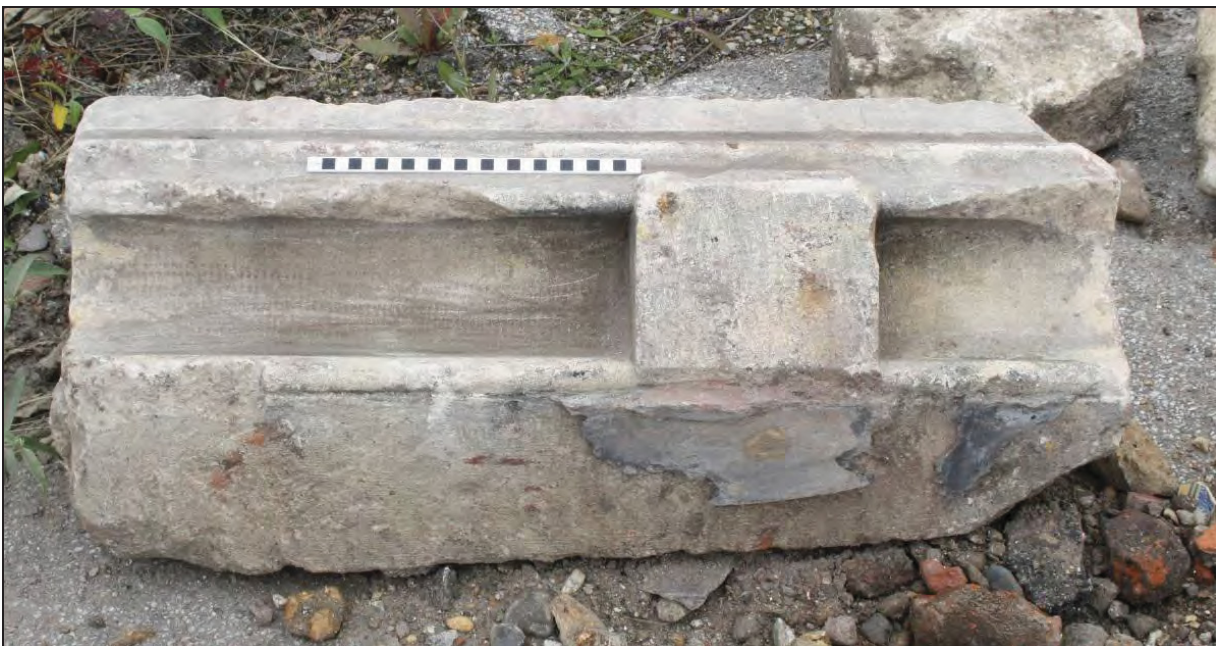
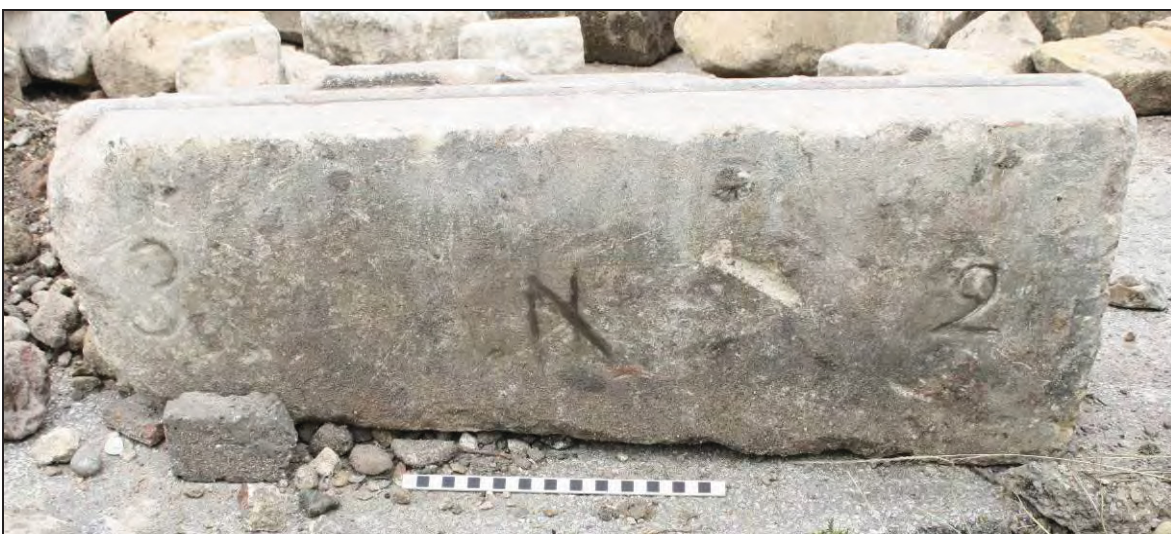
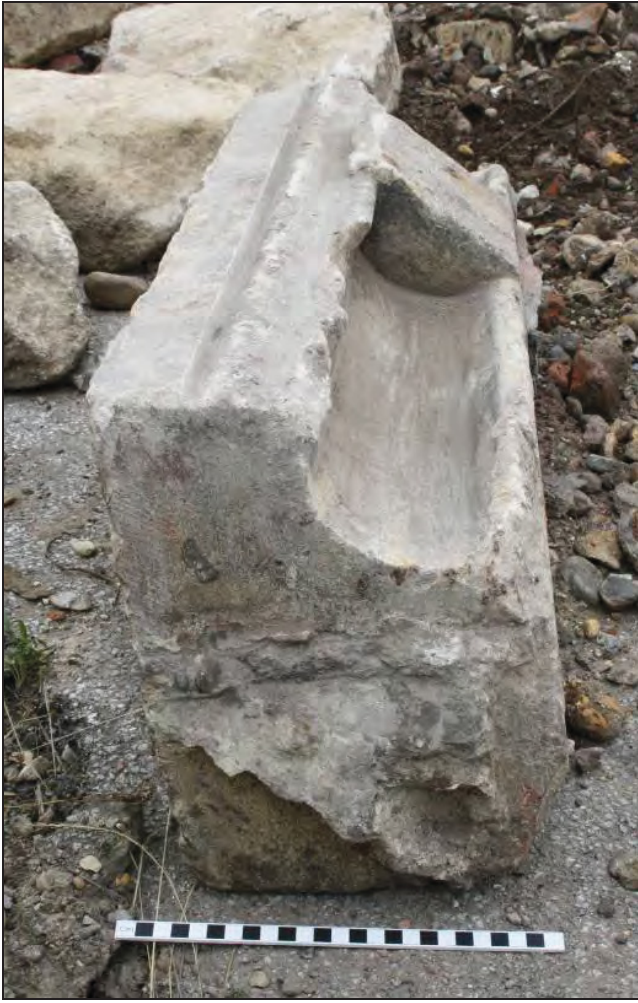
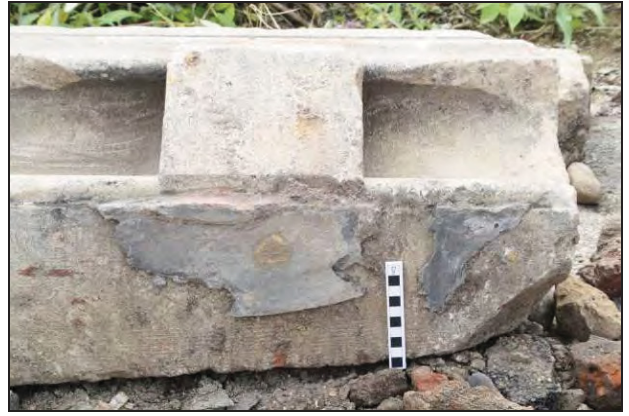
On one long side Arabic numerals and a letter have been carved. These include a “3 N 2”

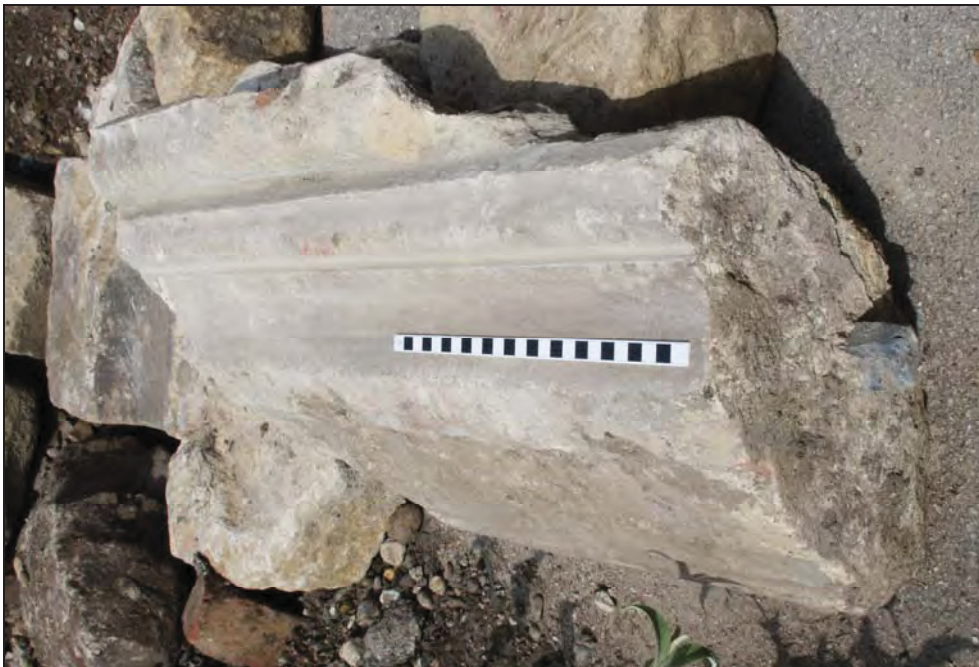
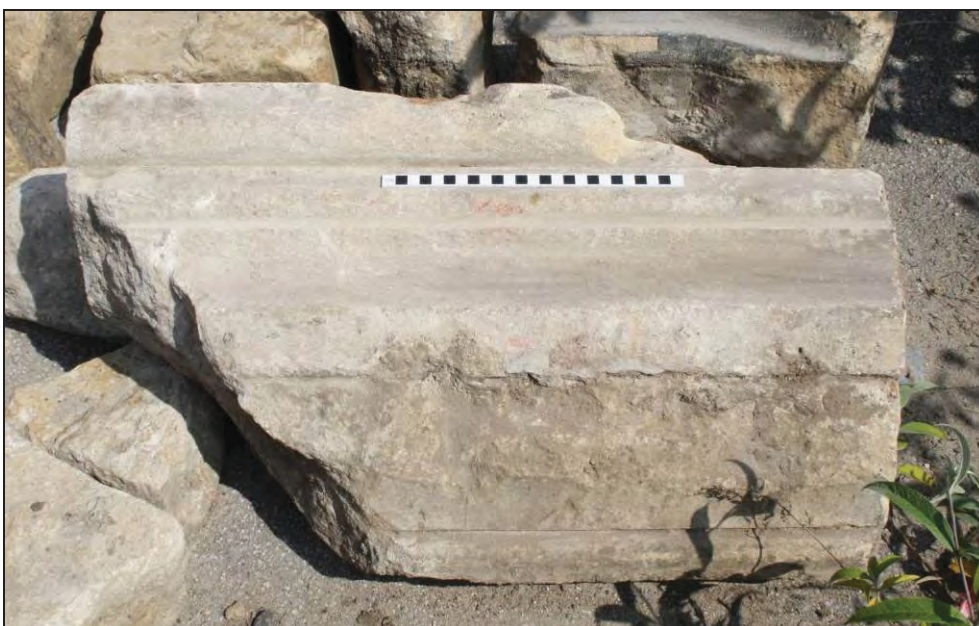
<b>Piece identification number</b>	<b>33 – photograph only</b>	<b>Context:</b> L2008	<b>Source:</b> Porzorski 2010
------------------------------------	-----------------------------	--------------------------	----------------------------------

Large section of principal window mullion. Broken at one end and to one side of the glazing groove.

Much larger in profile than the window mullion Pieces #01, #10 and #17, and the moulding profile comprises a series of hollow and roll mouldings of the same form as jambs #03 and #04. These are an expanded version of mullion mouldings noted for Pieces #01, #10 and #17, and is defined by Morris as the ‘first family of roll and chamfer mullions (fifth variety)’ (1979. pp.2-4), which is an elaboration of the second variety.

The bottom end is abraded but fairly complete and retains what appears to be a lead dowel in a socket to position the next piece.

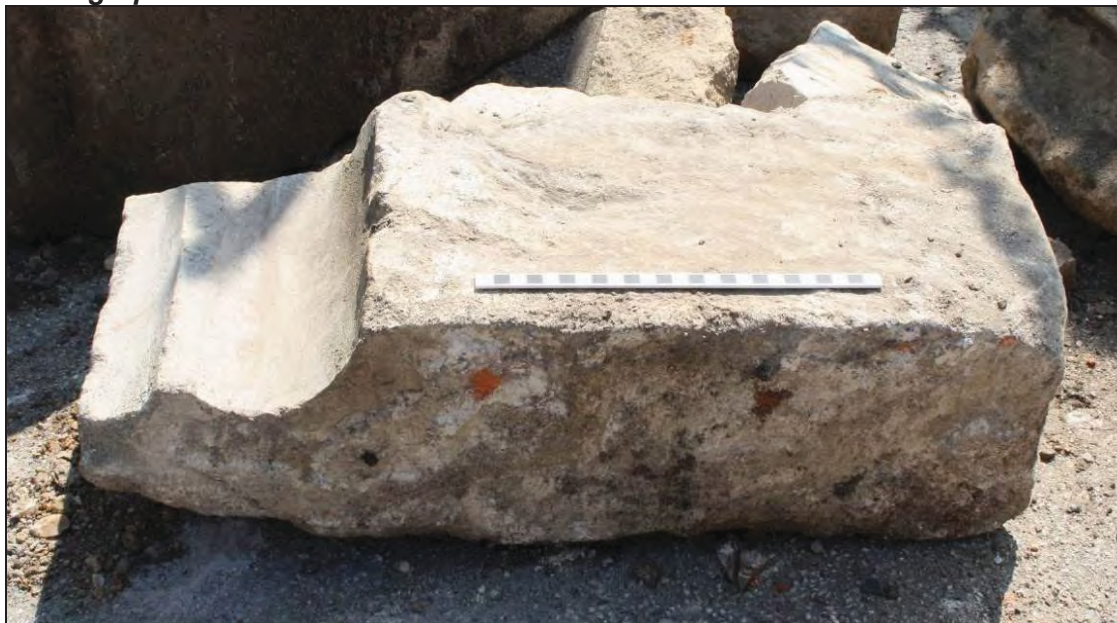
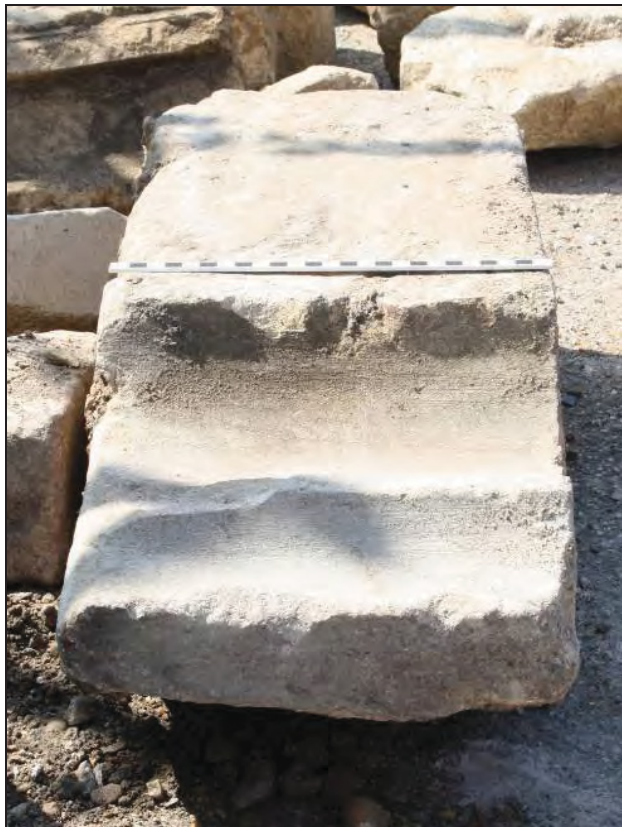
<b>Piece identification number</b>	<b>34 – photograph only</b>	<b>Context:</b> L2008	<b>Source:</b> Porzorski 2010
------------------------------------	-----------------------------	--------------------------	----------------------------------

Large rectangular block, indeterminate use. Dressed on five faces with a large and small hollow moulding to one end.

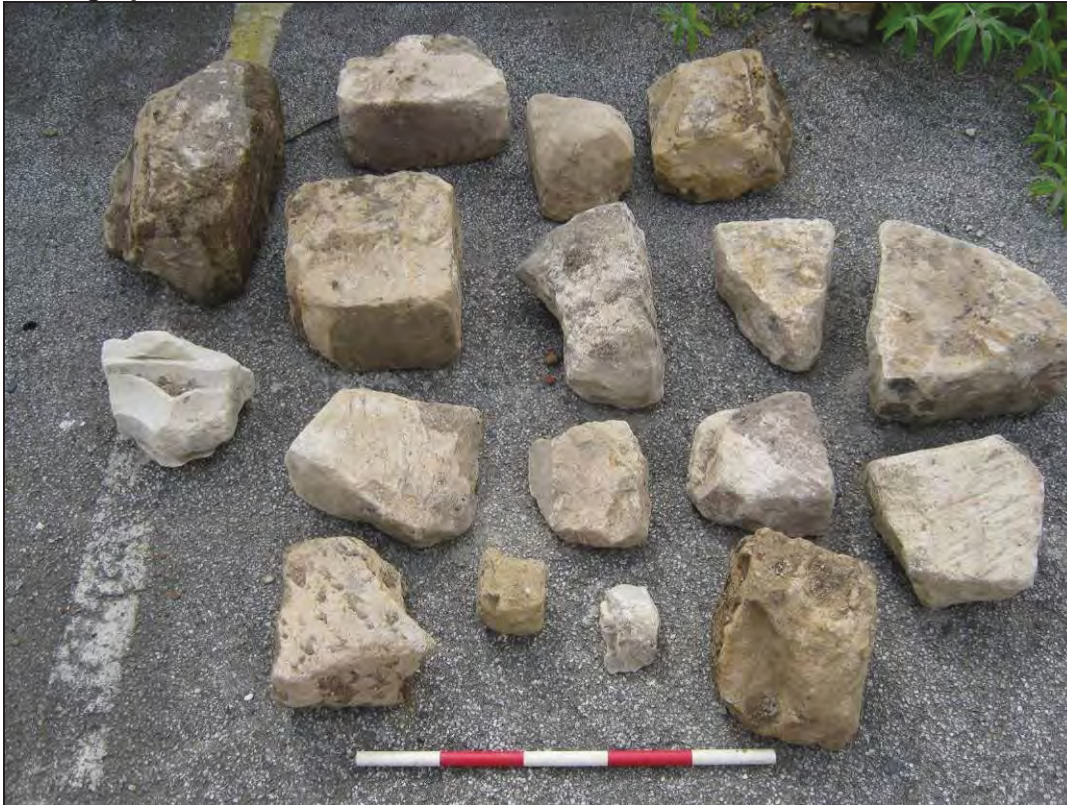
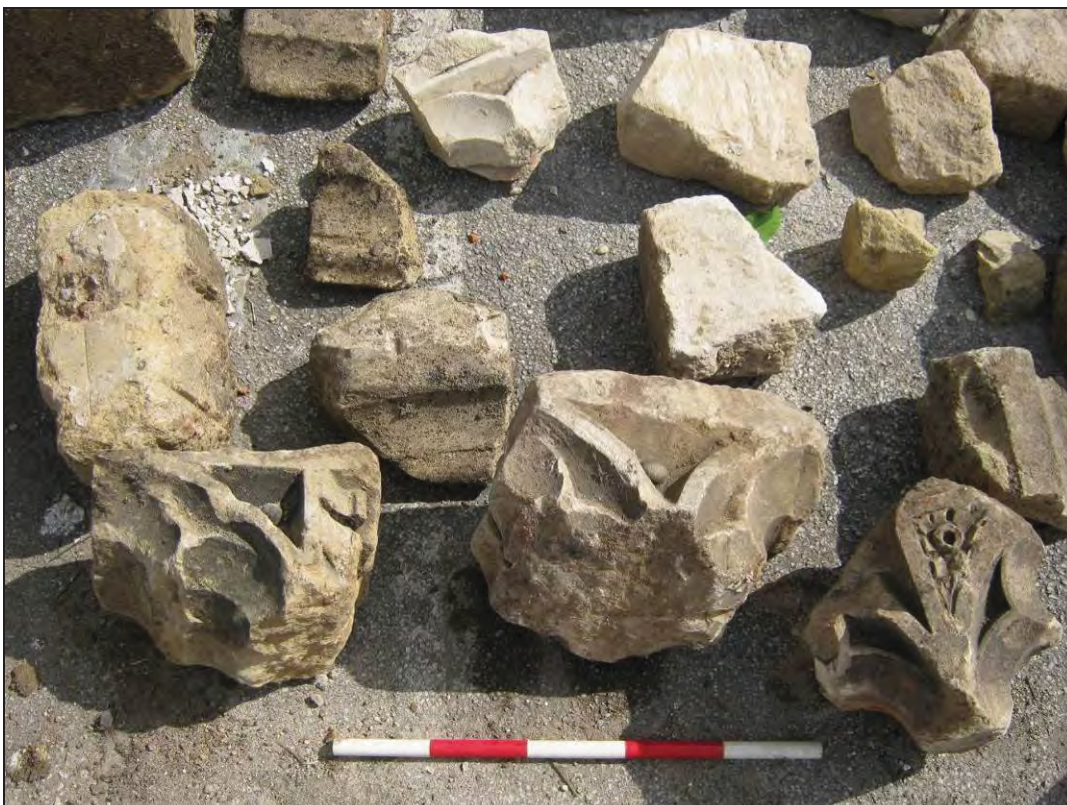
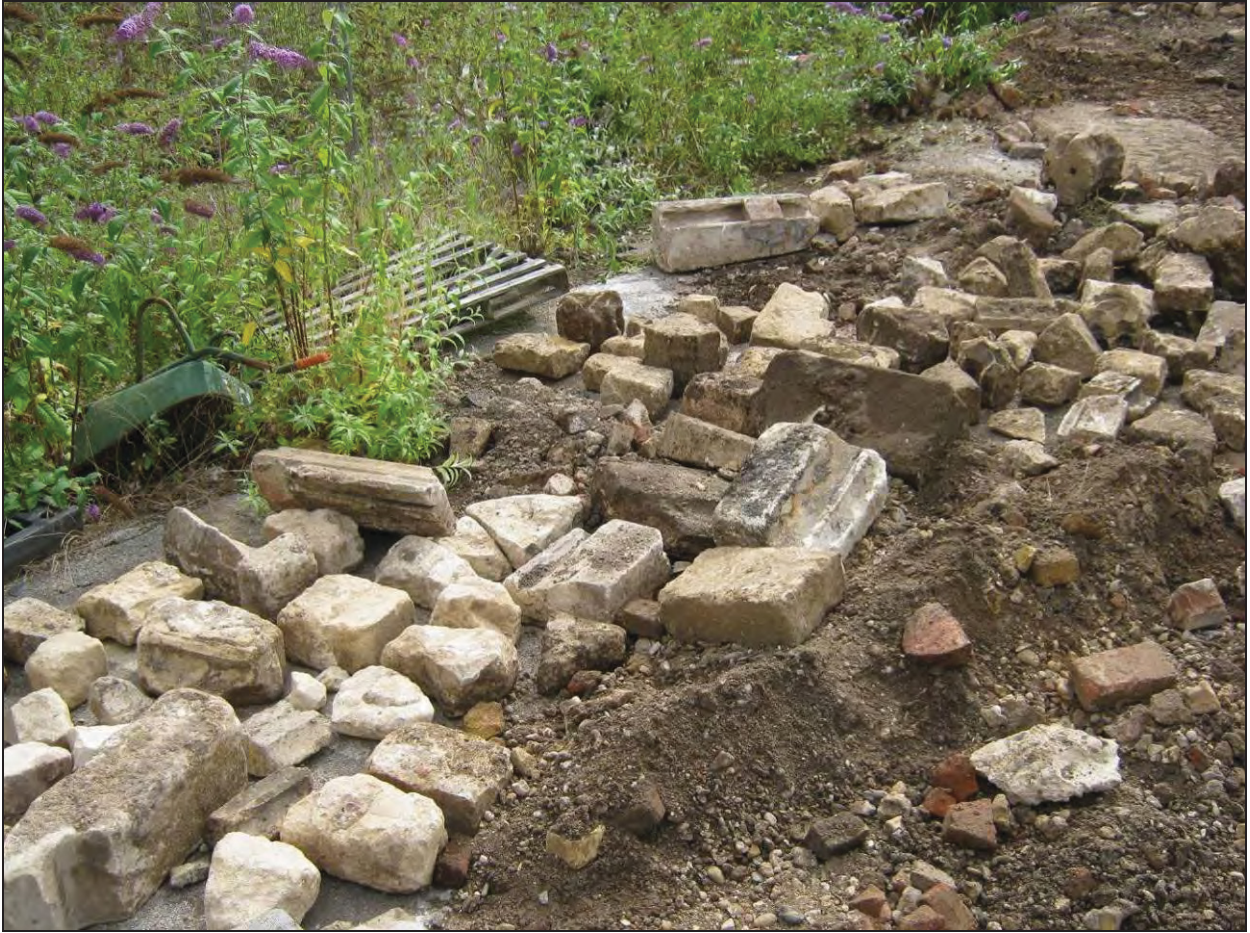
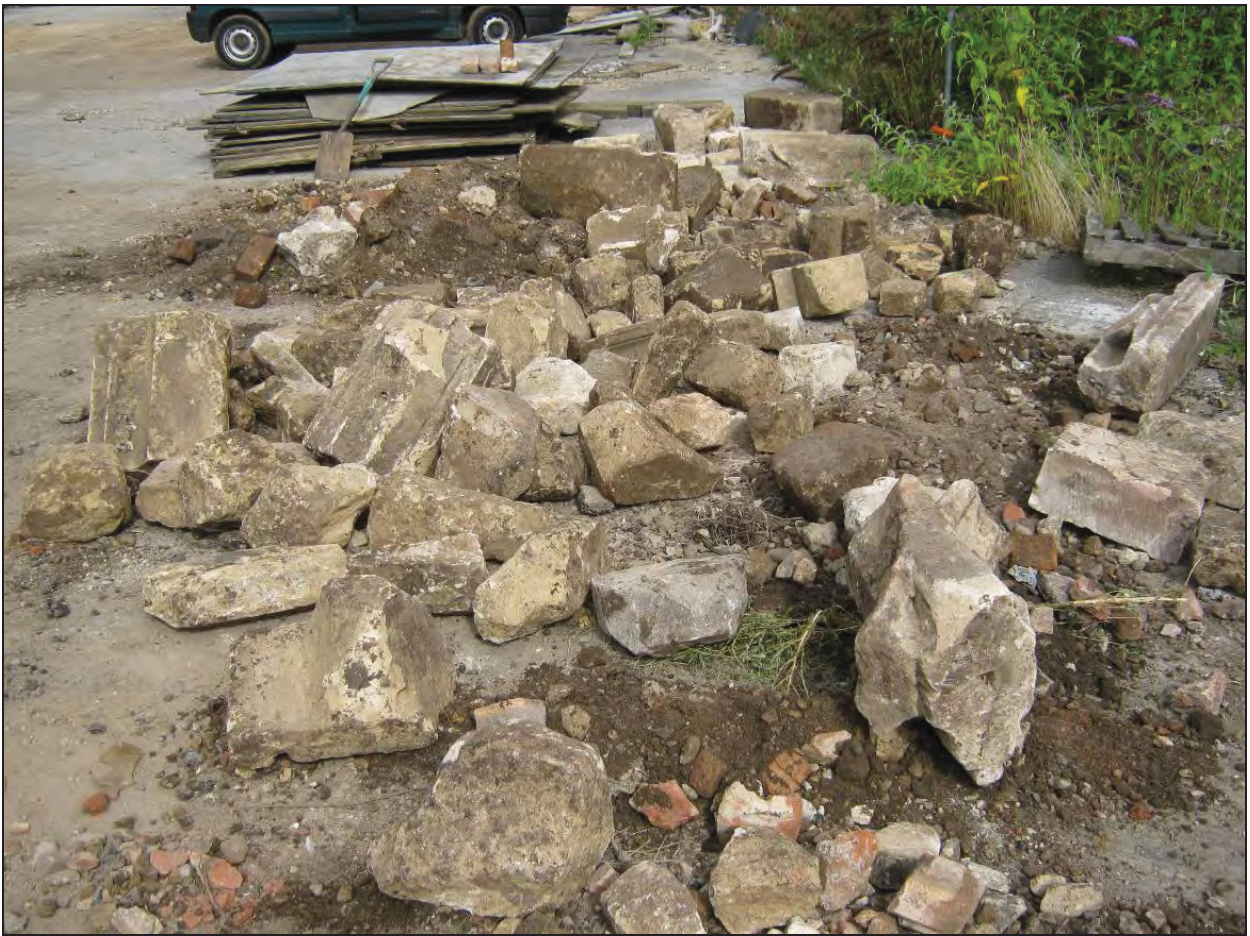
<i>Piece identification number</i>	<b>GENERAL SHOTS SHOWING STONE ON SITE</b>	<b>SHOTS ON</b>	<i>Context:</i> L2008	<i>Source:</i> Porzorski 2010
------------------------------------	--	-----------------	--------------------------	----------------------------------

General shots showing selection of stonework on site during the 2010 investigation.

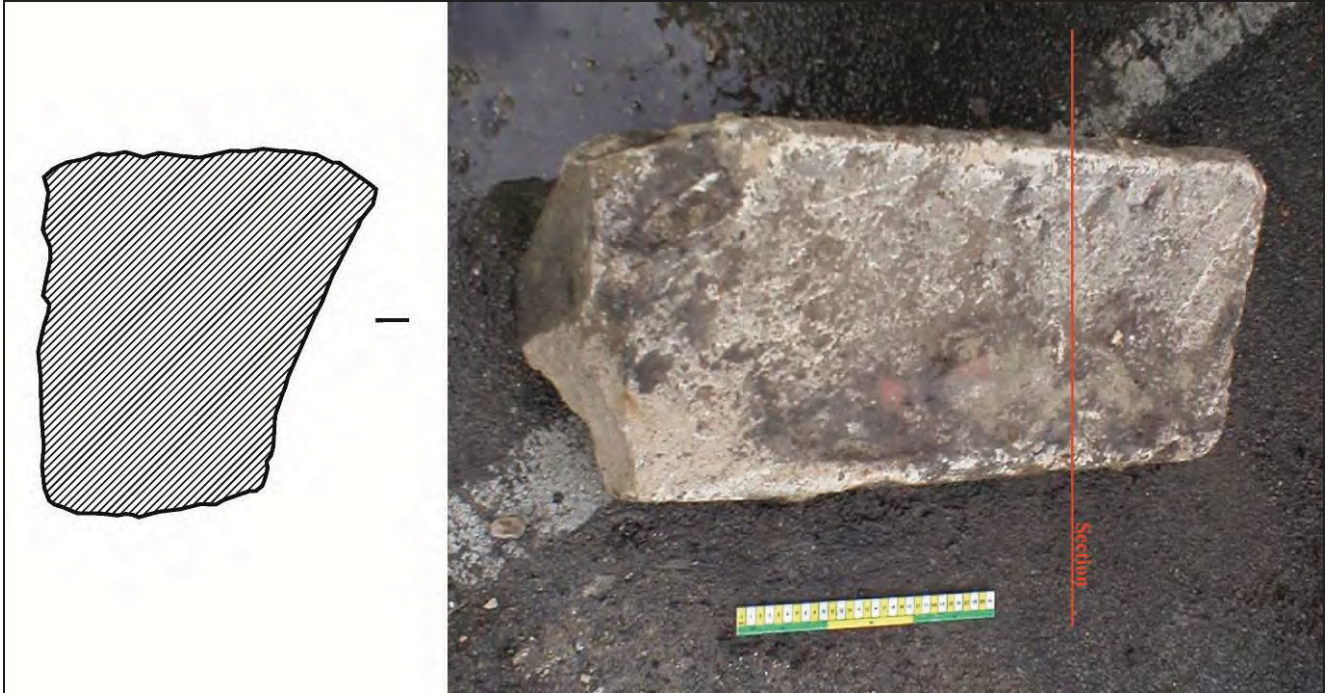
**35**

Worked stone block, perhaps chamfered on one side but little additional information is visible.

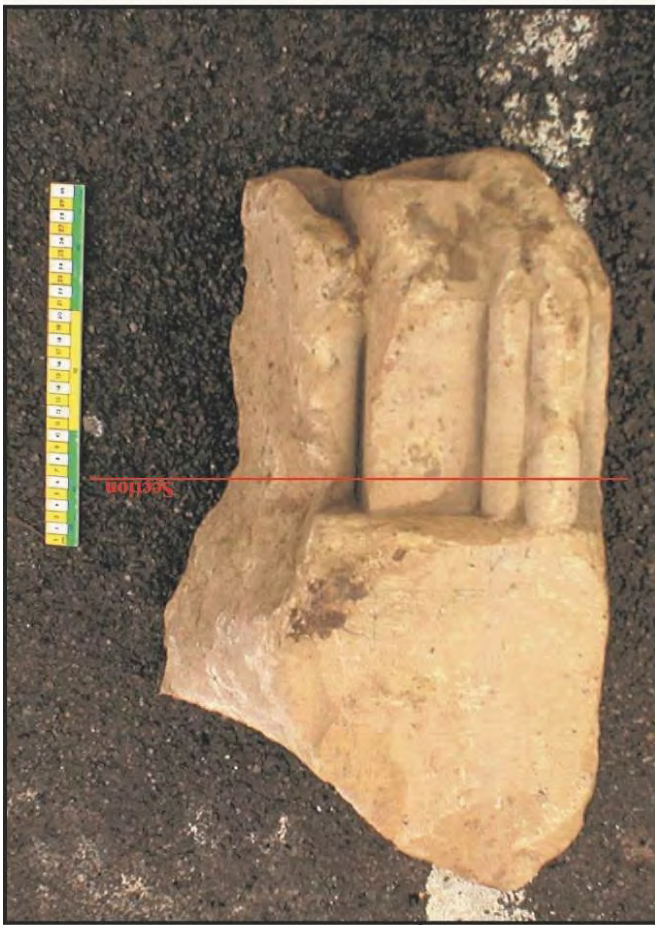
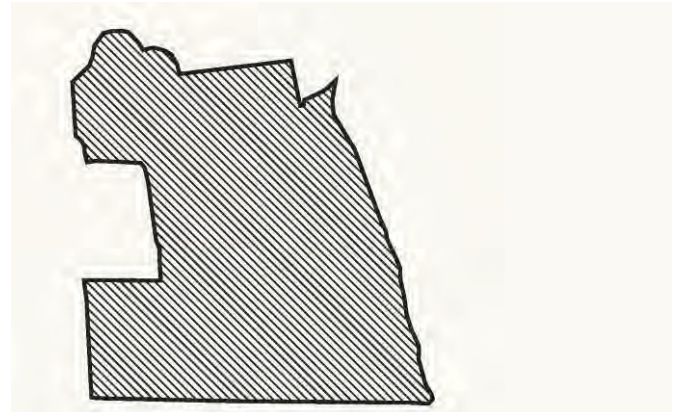
**36**

It is fractured but the base appears to have been a dressed block with a series of vertical roll mouldings, perhaps either for a doorway or arch.

The profile drawn suggests a deep socket on the rear.

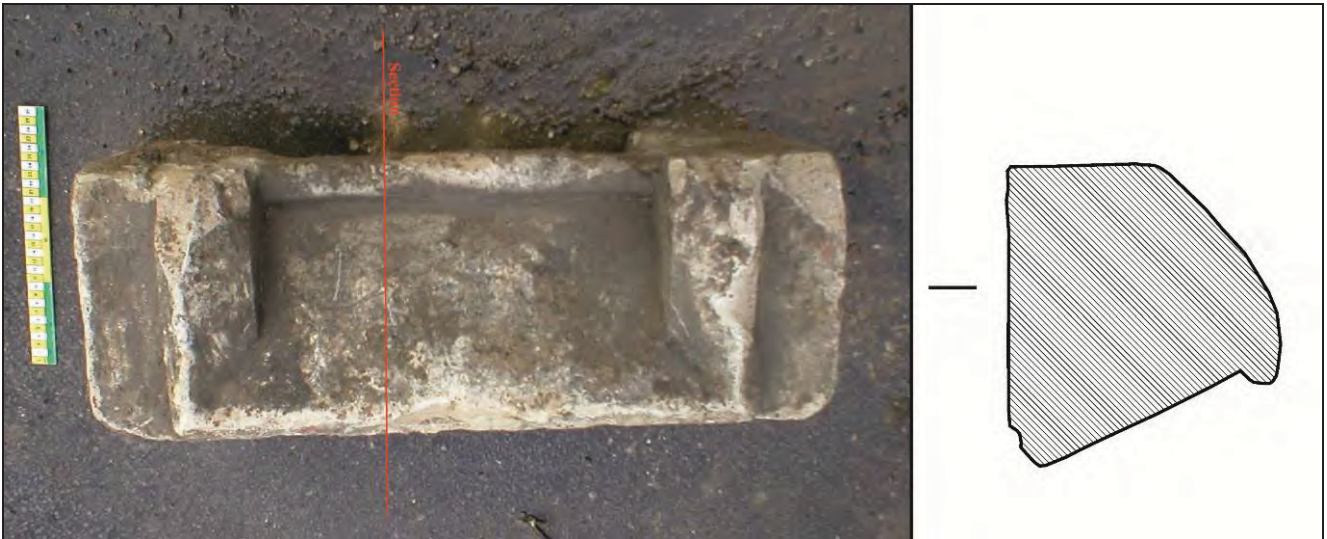
**37**

The photograph shows only one side of the piece. It consists of a large rectangular block with a deep chamfer and round moulding, and likely continues as a large round moulding to the rear. The chamfer terminates with the pronounced secondary string course moulding that would have extended up the adjacent merlons.

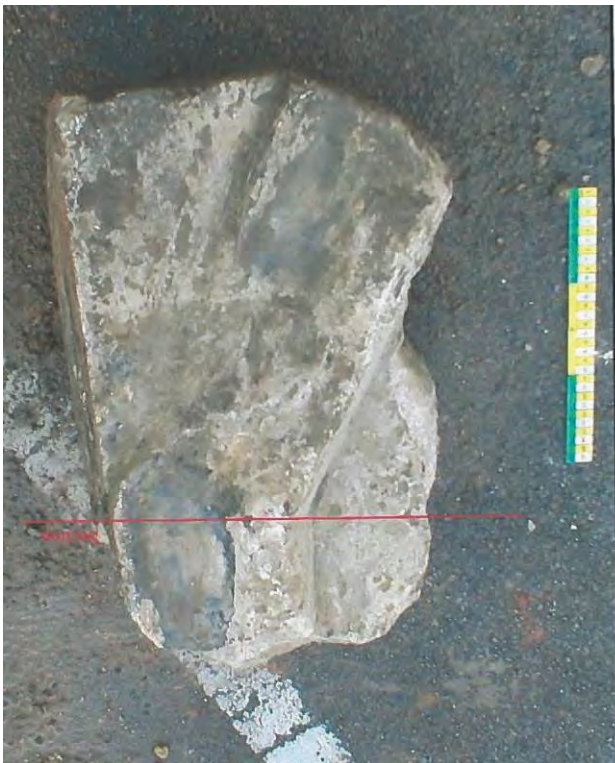
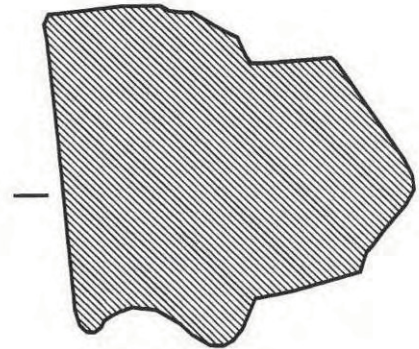
**38**

Indeterminate piece, perhaps the springing of an arch.

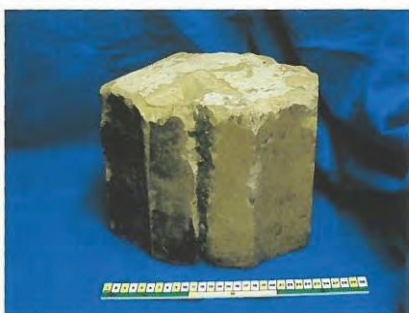
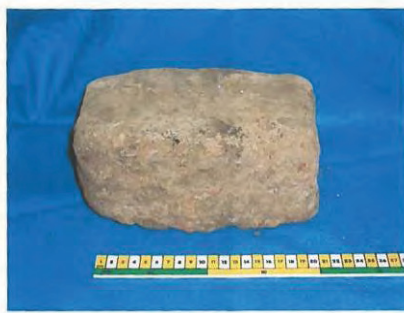
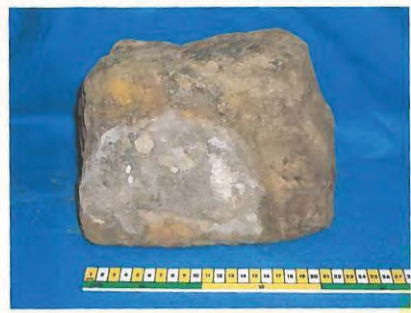
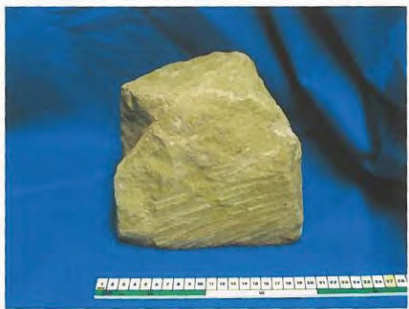
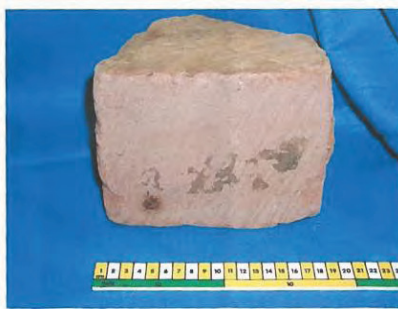
<b>Piece identification number</b>	<b>39-43</b>	<b>Source:</b> Crank, 2003
------------------------------------	--------------	-------------------------------

Pieces #42 and #43 do not appear to be moulded but do display fairly rough tooling marks.

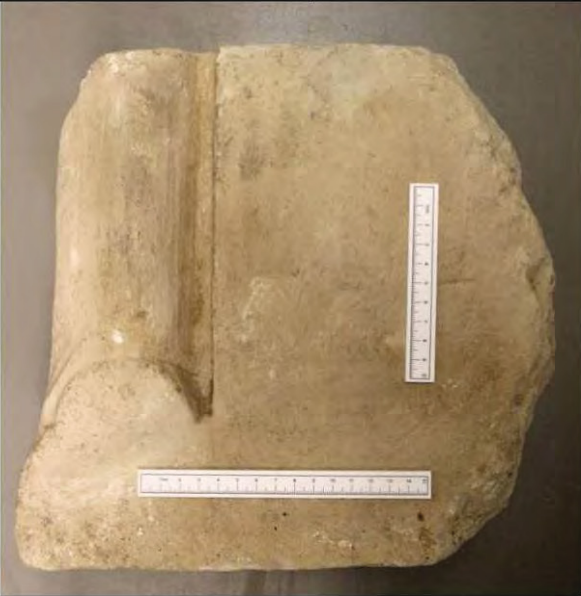
<p>Plate 9: Moulded face of carved stone from (103)</p>

<p>79-81 Railway Street HN886</p>	<p>The excavation located a total of 2 pieces of worked stone were recovered from two contexts, demolition layer (103) and masonry fragment (116). The fragment from layer (103) was an approximate cuboid with moulding along the edge of one face. It appears to be Totterhoe Clunch and measures 295mm long by 195mm wide and 270mm high. The upper and lower faces had been roughly trimmed and have coarse tool marks. The other faces were smoothly worked and had tool marks forming radial lines, possibly indicating that these faces had been sawn. The corner of the stone has been carved into a semi-circle, with thumb mouldings on the two adjacent faces (Plate 9). A series of incised lines, representing the mason's markings, are visible on the upper and lower faces (Plate 10). This piece of stone was used in the discussion to support the conclusion that a wall [107] was part of the Priory Church. A fragment of worked sandstone was recovered from structure (116). This measured 260mm long by 205mm wide and 70mm high. It was worked on five sides with visible tool marks on one side and a single incised line on one face. Thought to represent a piece of fallen masonry.</p>

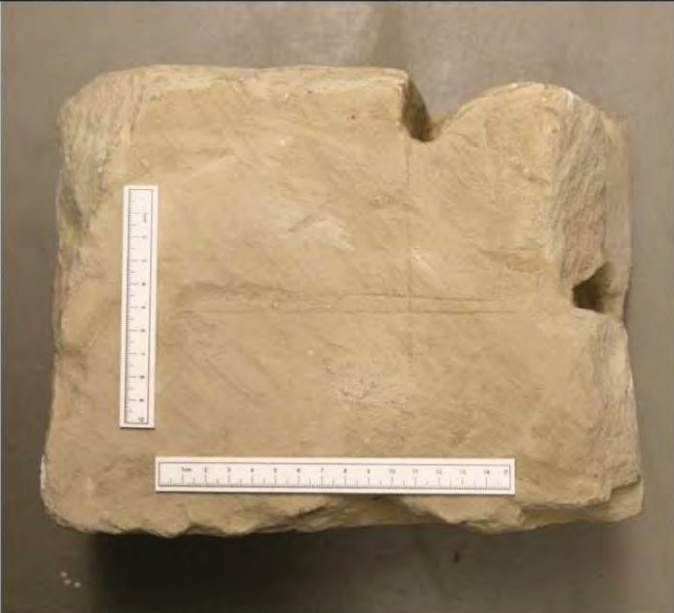
<p>Plate 10: Upper face of carved stone from (103)</p>

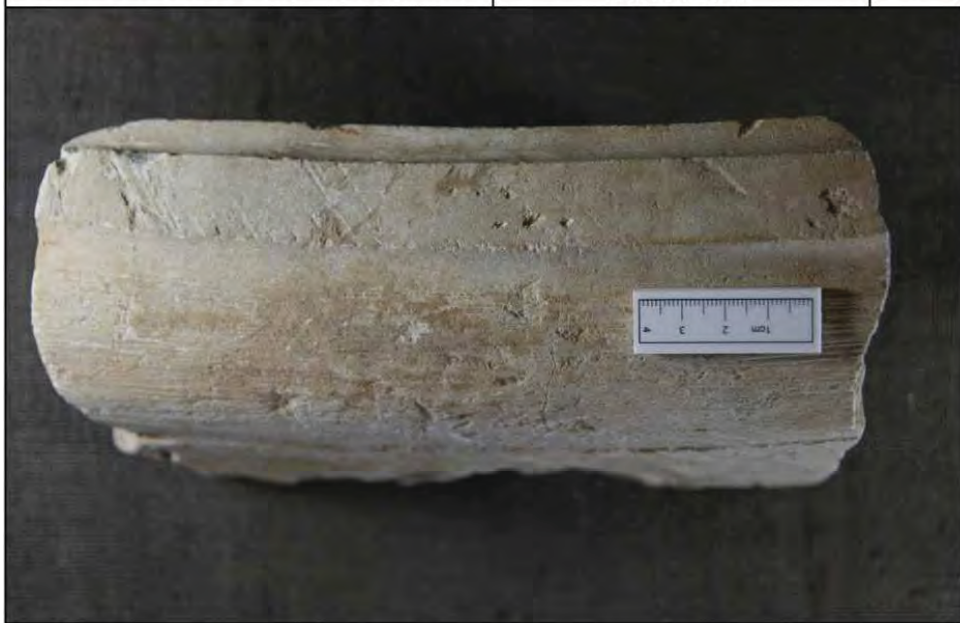
Plate 11: Carved stone from [101] - side view

The piece weighs 3720g and is formed from Totternhoe Clunch and measures 205mm in length, 135mm in width and 65mm in depth. Its front face is curved along one edge, and the rear has a channel approximately 25mm in width and 15mm in depth. Keying lines have been incised to the upper and rear faces and to the front face beyond the curve (Plates 9 - 12). The fragment is broken at the bottom.

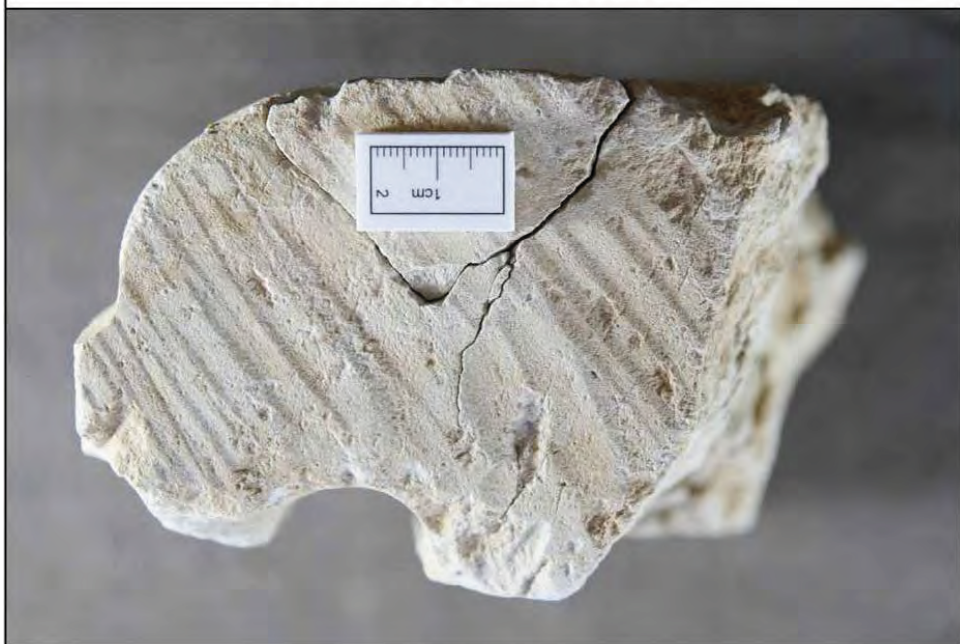
Plate 12: Carved stone, from [101] - section
