**Church of St Michael and All Angels,  
Waddesdon, Buckinghamshire**

**Archaeological Watching Brief**

**Site Code: WCB17/52**

**An Archaeological Watching Brief (Drainage)  
For the Incumbent and Church Wardens of  
St Michael and All Angels**

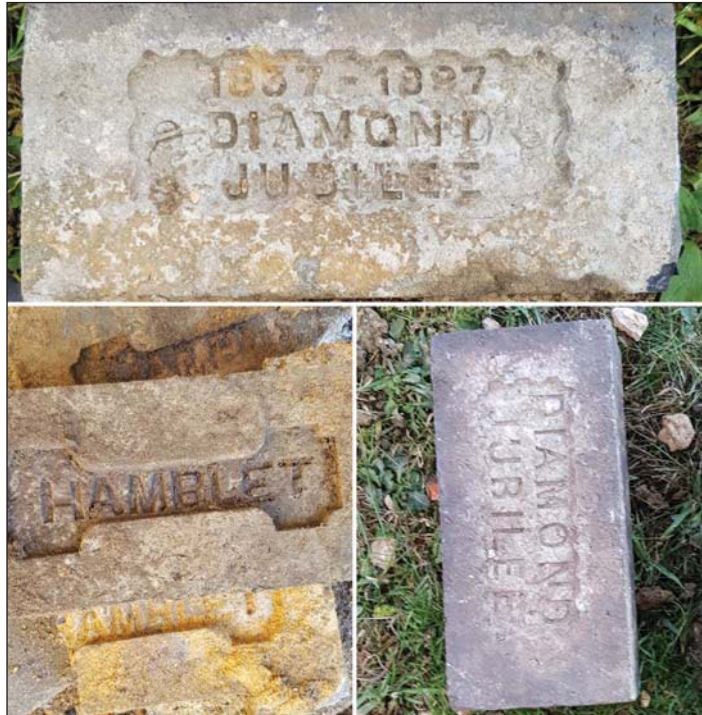
Plate 1. Selection of stamped bricks from the Victorian drainage trough.

During excavation to the east of the south aisle, the brick trough contained stamped bricks like these to the north. These were stamped 'Hamblet' (Pl. 1), which was an active brick maker between 1883-1915 suggesting a similar date for this drain as the northern one, *c.* 1900. Two courses of red brick fronted the foundation, though the two recorded courses were partial, broken in places and with poorer construction than the north drain. The land drain adjoining the wall at 0.65m was at the corner where the chancel and nave join. The reason there were only two courses was likely due to the fact that the brickwork was constructed on top of a stone step of the original stone foundation, at 0.35m deep. This construction had also been observed and dismantled in Test Pit 2 of the 2017 investigation. It may have been laid initially to attempt to drain the ground next to the wall, but with negligible effect as the scheme would just retain wetness trapped behind the original foundation.

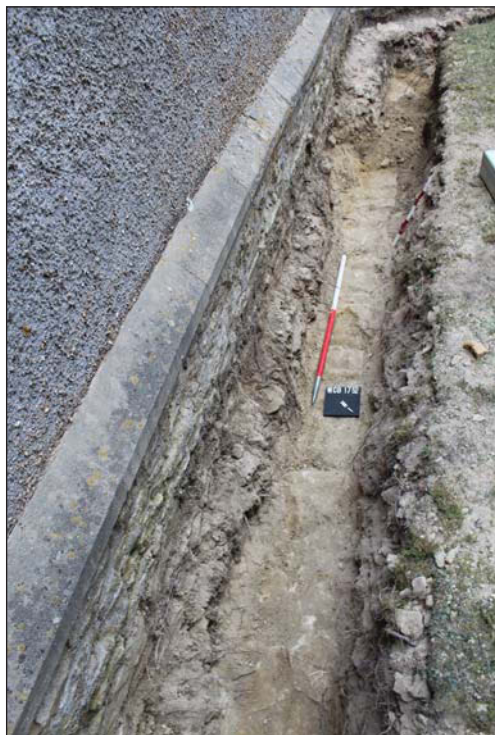
Plate 2. Underlying stone foundation (wall 150) to East Chancel wall, looking north,  
Scales: horizontal 1m, vertical 0.5m.

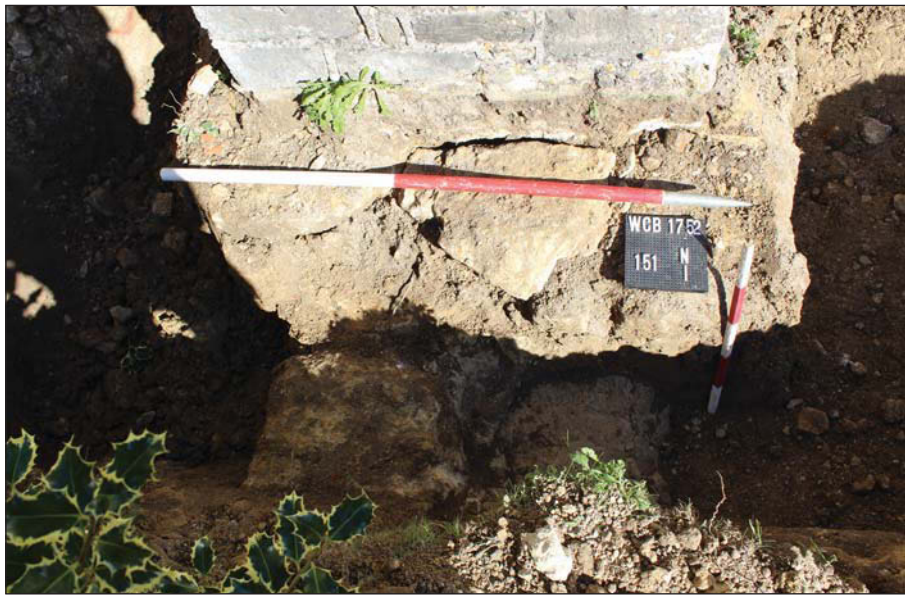
Plate 3. Wall 151 under south aisle buttress, looking north, Scales: 1m and 0.5m

sub-rounded stone blocks making up the only visible face of the wall. It is likely to extend lower than the bottom of the excavated pipe trench (0.6m). It was not as wide as the upper foundation for the existing buttress and it is not obvious to what period of construction this work should be attributed. Investigation of this feature during the interior works may offer a chance to identify how it relates to the south aisle. On excavation of the trench to both sides of the south porch, the top surviving foundation of the 15th-century structure was located under the upper, rubble foundation of the 20th-century one, at a depth of 0.44m. The stones of this foundation had an 'ashlar' face to the exposed west face. The foundation was offset eastward 0.28m to the west of the overlying foundation and westwards, 0.22m to the east on its eastern side. The 1902 rebuild, therefore, was a like-for-like scale replacement. The brick fronting continued, fronting the south-west foundation and the re-excavation of Test Pit 2 from the 2017 works marked the end of the drainage run.

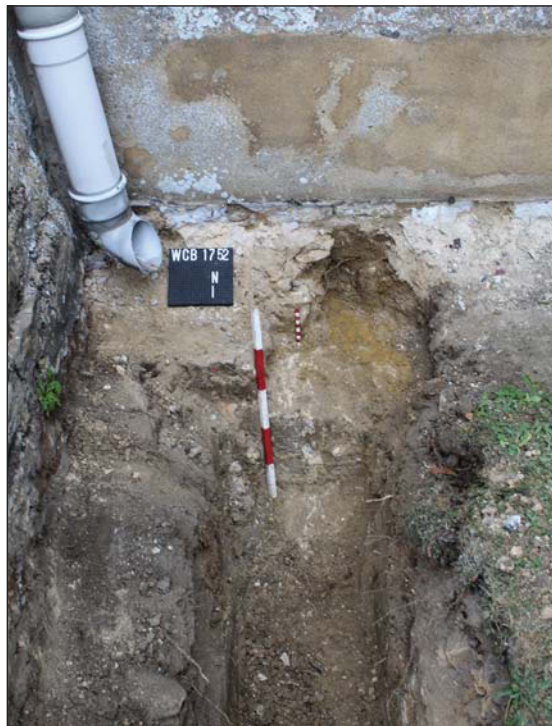
Plate 4. The overlying 15th century foundation, with a lower foundation course beneath.

century foundation, linking into the construction of the buttress, was observed at a shallow depth below ground level, stepping out 0.38m from the wall. This supported the wall above, along the south-east of the Chancel and ran under the later 18th-century buttress to the right of the south Chancel doorway. The wall of the Chancel here is also thicker than the earlier wall, protruding 0.25m into the interior. This step on the Chancel foundation is consistent at 0.45m, taken in addition to the chamfered step to create an overall step of 0.68m. The earlier foundation contained no such step, which was exposed on the SW side of the Chancel. No underlying, earlier mortared masonry was located, even at a depth of 0.6m. Under the 15th-century stepped foundation, at 0.68m deep there was an underlying south mortared foundation, with the southern facing edge visible and positioned slightly skewed to the other (Pl. 4). It is likely a contemporary of the east wall (150). The southern edge is 0.51m from the exterior wall near the buttress but 0.58m from the wall near the east side of the south door buttress. The top and the south edge of the stone were only exposed at the base of the trench at 0.68m. The stone was mostly sub-angular and mortared, though the greater thickness of this was under the later foundation.

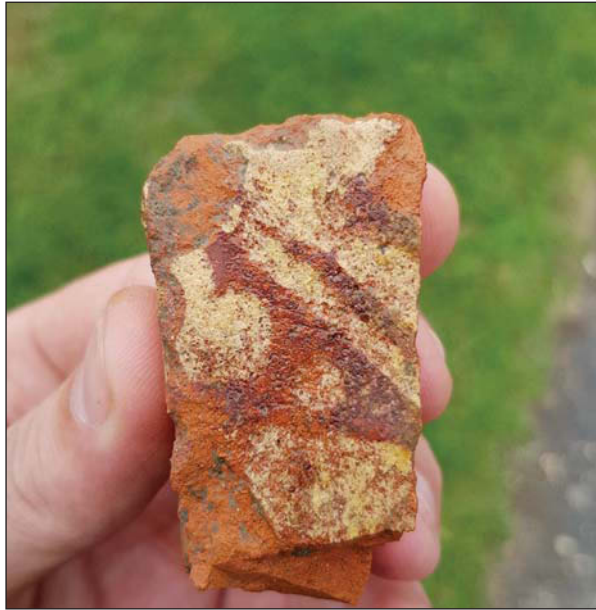
Plate 5. Medieval 'Penn' tile, recovered from the pipe trench north of the boiler room.
