Two Hall and Crosswing Buildings in East Bedfordshire

J. M. BAILEY

INTRODUCTION

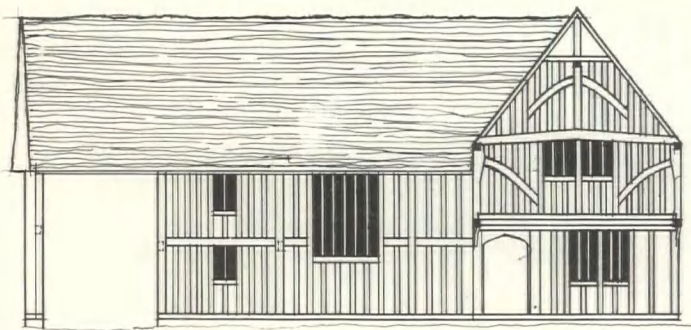
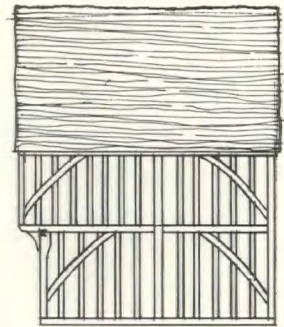
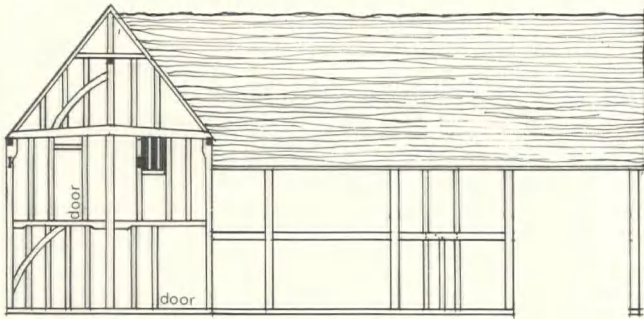
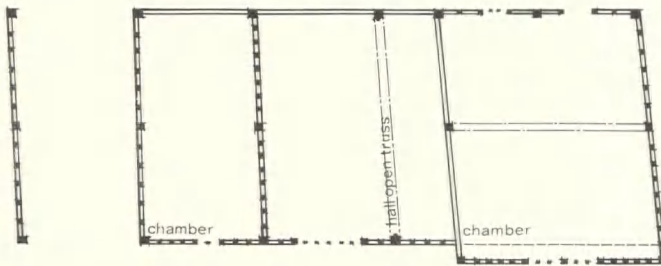
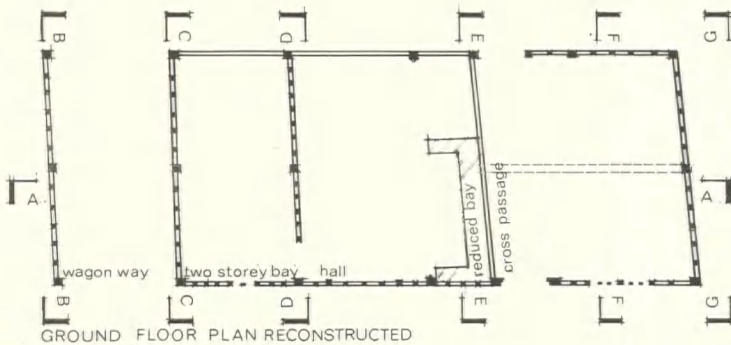
Fig 1 Sun House, Potton: plans, elevations and sections.
Scale as figure 6.

RECONSTRUCTED FRONT ELEVATION

ELEVATION ON G G

RECONSTRUCTED REAR ELEVATION

FIRST FLOOR PLAN

GROUND FLOOR PLAN RECONSTRUCTED

The plan of the building (fig 1) is shown in reconstructed form with studs located from surviving mortices indicated. Also indicated in figures 1 and 2 are the reconstructed elevations and sections, again with the missing studs; a front elevation with all conjectural studs shown in full line is shown in figure 1 for clarity.

The side and rear elevations of the cross wing could be reconstructed completely (fig 1). The front elevation above bressummer level was complete except for limited damage caused by an inserted window. Below bressummer level the front elevation has been reconstructed from evidence on the underside of the mid plate.

The front elevation of the cross wing is shown in its fully reconstructed form in figure 1. When facing the front from the outside, there was a doorway on the left. Under the mid plate there is evidence of the slot for spandrel panels and there is a hollow mould on the outside extending the width of the door opening. Further along the underside of the mid plate, there were mortices for the window mullions for two three-light windows. As no studs remain in the lower half of this elevation, the sill height of the windows is conjectural. The first floor of the front elevation is infilled with close set studs. There is positive evidence from mortices under the beam of two three-light windows on centre of the wing. Tension braces curve downwards from the corner posts to tenon into the sides of the infill studs. The gable is also close-studded and here braces from either side of the crown post curve downwards to tenon into studs on either side.

The rear elevation, when reconstructed (fig 1), indicates that there may have been a contemporary extension built onto part of the rear of the cross wing. When looking from the rear there is a surviving blocked doorway to the left hand side of the elevation at first floor level. Alternatively, this could have been external access to first floor

The external elevation (north) of the wing is infilled with close set studs. Arch braces are at both ground and first floor. (fig 1, section GG).

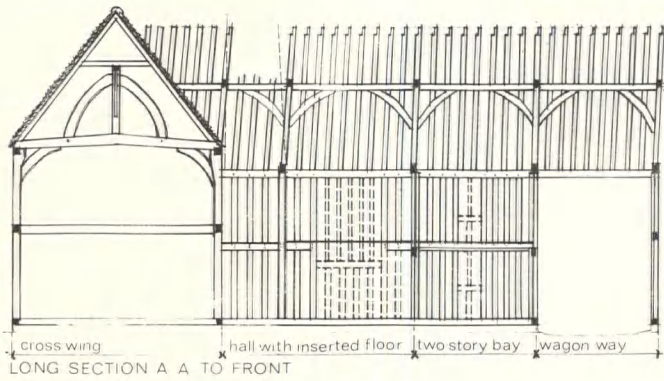
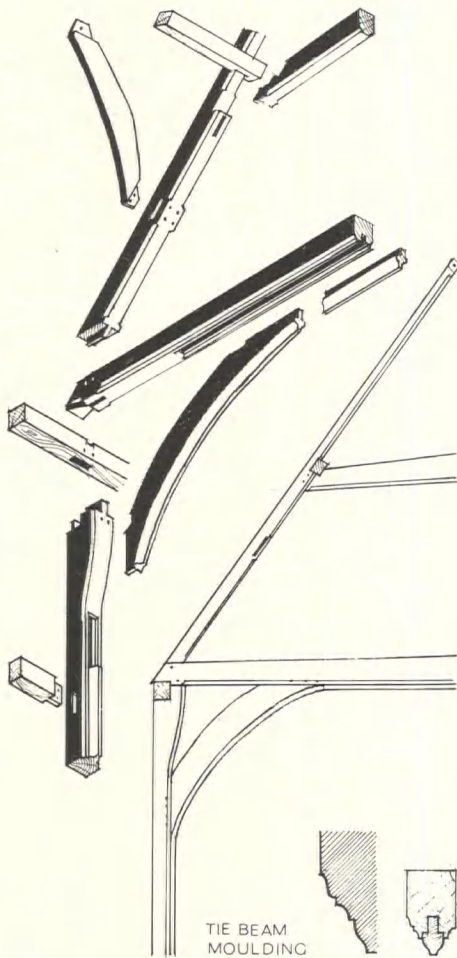
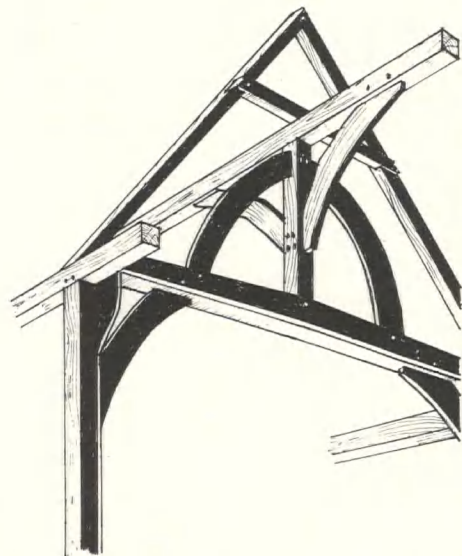
Fig 2 Sun House, Potton: sections and framing details.
Scale for sections as figure 6.

SECTION F F

DETAILS OF HALL TRUSS

CROWN POST TRUSS TO CROSS WING

The construction of the internal elevation of the wing cannot be completely determined as much of the evidence is hidden by the inserted chimney (fig 2, section EE). On this elevation, unlike the other, the end girth appears to be continuous, unbroken by the centre post. At first floor level the wall is close studded with curving braces on the hall side. In the part of the ground floor level in the rear half which can be analysed, there is evidence of a door opening towards the centre. Interestingly this overlaps the inserted fireplaces which must indicate that the hall remained in use as such and was unfloored after the cross wing was built, with the screen passage now being within the new cross wing. Also, the smoking extends over the entire new truss, strutted across the later wing top plate. This must also limit the possibility of a smoke hood being used in conjunction with a floored hall.

Section AA (fig 2) is taken on the centre truss of the cross wing. A cross passage almost certainly ran through on the hall side, but as the present ceiling is plastered we cannot see if there was a partition running across the wing.

A complete roof remains and is of crown post construction. Each crown post is braced upwards to the purlins (fig 2 detail) and downwards to the tie beams. In each instance the braces tenon centrally into post, purlin or tie. The central crown post is square without chamfer or moulding.

What was originally the central hall open truss is shown reconstructed and in exploded view in figure 2. Simple chamfers with plain stops run down the principal rafters and along the underside of the collars. The chamfers stop neatly above and below the intersection of the wind braces. The chamfer is also found along the underside of the top plate.

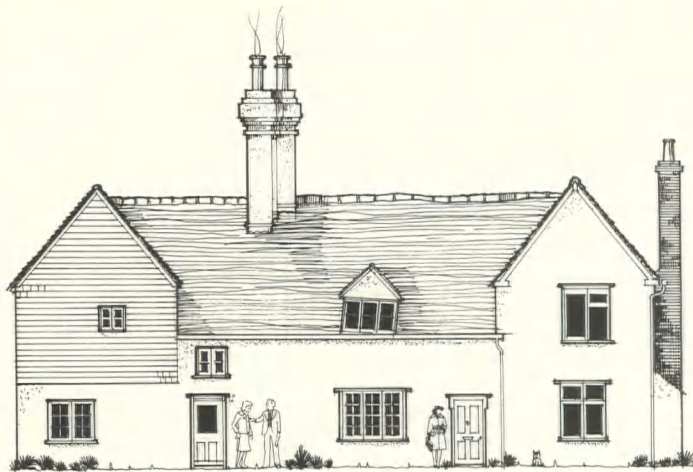
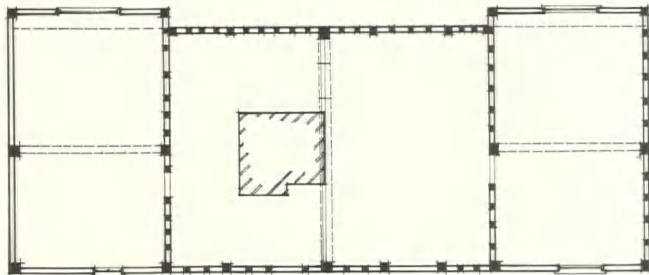
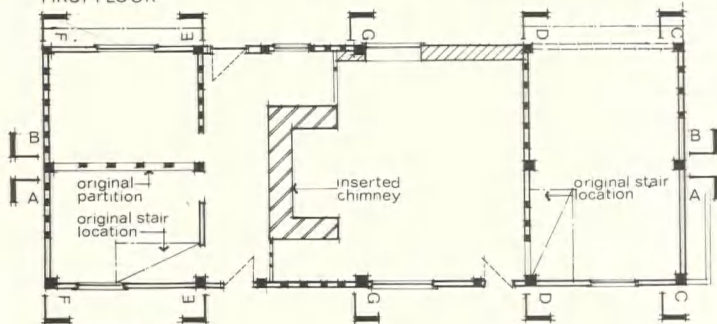
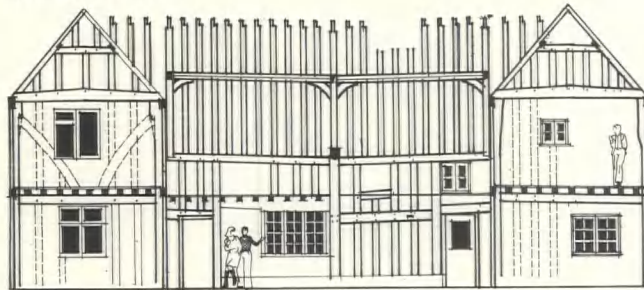
Fig 6 Clawdershill Farm, Shillington: plans, elevation and sections.

SOUTH ELEVATION

FIRST FLOOR

GROUND FLOOR

SECTION A A

The hall roof is one of the few known butt-purlin constructions in the county, the general roof construction in Bedfordshire being clasped purlin. The roof structure is also uncommon in that there are no tie beams at either end. The principal rafters seat directly onto the wall plate (fig 6, section DD). The inner flank walls of the wing form the ends of the hall and stabilise its structure. Top, mid and sill plates tenon into the frame of the cross wings at either end without any form of cross tie other than the conventional central truss (fig 7, section GG). This central truss is elaborately carved with the braces spanning up to the underside of the tie springing from moulded capitals (fig 7). Hollow mouldings run up the principal rafters along the underside of the collar and the purlins. There are curving panels between principal rafter and underside of collar and these also have hollow chamfers. The underside of the tie beam is moulded, as is usual on a building of this quality, more extravagantly on the side facing towards the high end. On this side there is an ogee above a hollow. Towards the low end are two hollows. The mouldings on either side terminate in staggered returned stops.

With the exception of the front, jettied, elevation, this wing could be analysed in full. The side of the wing flanking the east end of the hall is shown in section DD on figure 6, close studded at both first and ground levels with tension braces at first floor between posts and girth. A door at ground floor level leads into the parlour at the south end of the partition. Evidence survives of the rail and spandrel panel at the head of the door. The external wall is also close studded (section CC) but there is not enough evidence to show any tension braces on this elevation at both levels. There is only a brace mortice visible in the ground floor front post. Presumably though, there must have been a symmetrical arrangement. The rear of the wing is infilled completely with studs and there is evidence of internal tension braces at first floor (section AA).

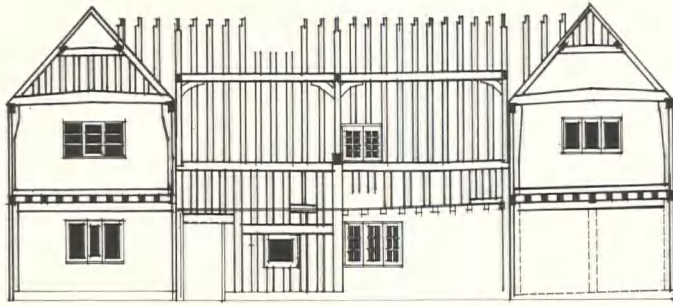
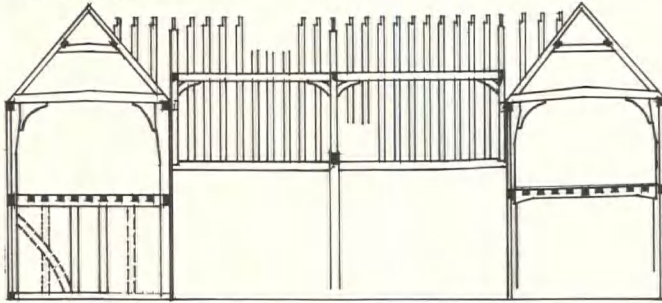
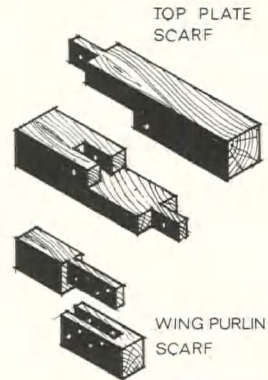
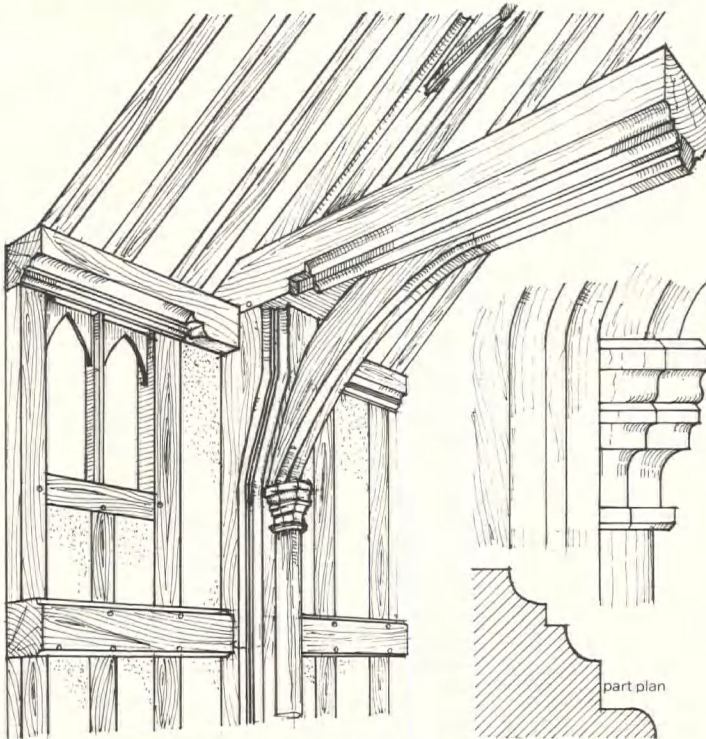
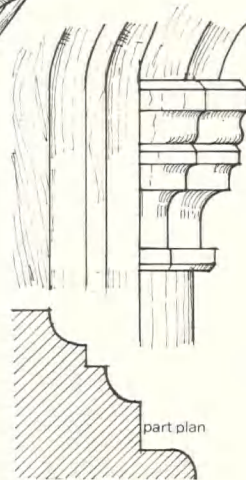
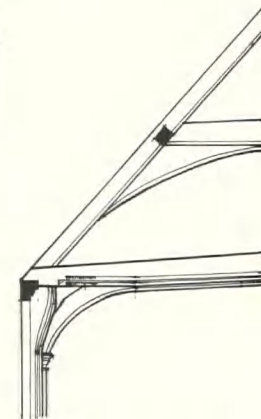
Fig 7 Clawdershill Farm, Shillington: sections and framing details.
Scale as figure 6.

SECTION B B

SIMPLIFIED SECTION, TO NORTH, ON CENTRE LINE OF HALL

TOP PLATE SCARF

RECONSTRUCTED DETAIL OF HALL TRUSS

DETAIL OF POST

PART SECTION OF TRUSS

The post moulding is shown detailed separately in figure 7 together with a section through the moulding running down the inside face of the post. It is not known how this moulding was terminated at the base of the post.

Both top plates are extravagantly moulded and the elaborate stops executed with care (see detailed drawings (fig 7)). Large sections of the front and rear elevations of the hall have been destroyed at low level. Fortunately, on both of the elevations the intermediate full height posts dividing the bays into modules survive. These are distinguishable by being much larger in section than the studs and chamfered. We can therefore, on the drawings, carry these down to the sill and from evidence of mortices in them produce the partially reconstructed elevations in figure 8. The only area where there is some uncertainty is in the front elevation at the lower level of the high end. From the symmetry of the arrangement it seems logical that there may have been two further windows in this bay; these have been

There were no partitions at either first or ground floor and the central truss is open at both levels (simplified section in fig 7). The truss has solid knees at the junction between posts and underside of the tie beam and there are nostuds between tie and collar. Simple chamfers with plain stops run along the underside of the tie beam and down the posts. The posts reduce below the binding joist to provide it with an additional seating in this cross wing only. There are nine joists at the front of the wing and the same number to the rear. They tenon in either side of the binding joist and rest on the mid plate at the rear and jetty over the mid plate at the front of the building. It should be noted that the central joist is deeper in section than the others. This is presumably to provide greater rigidity as it does not occur in the other wing where there is a cross partition at ground floor level.

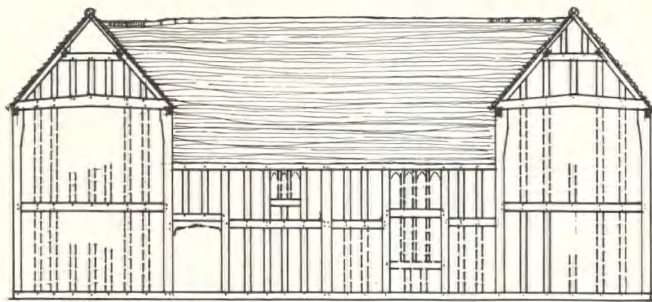
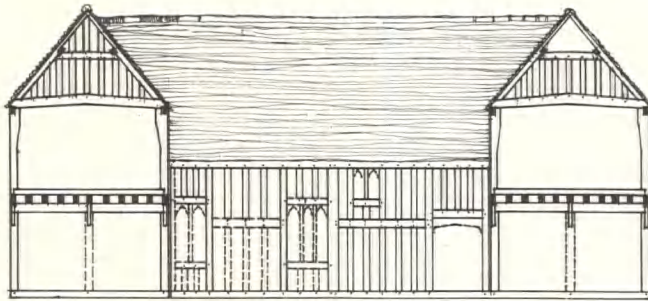
Fig 8 Clawdershill Farm, Shillington: reconstructed elevations, plan form and joint detail. Scale for elevations as figure 6.

RECONSTRUCTED SOUTH ELEVATION

RECONSTRUCTED NORTH ELEVATION
