HILL FARM, CHALFONT ST. PETER

C. F. STELL, F.S.A.

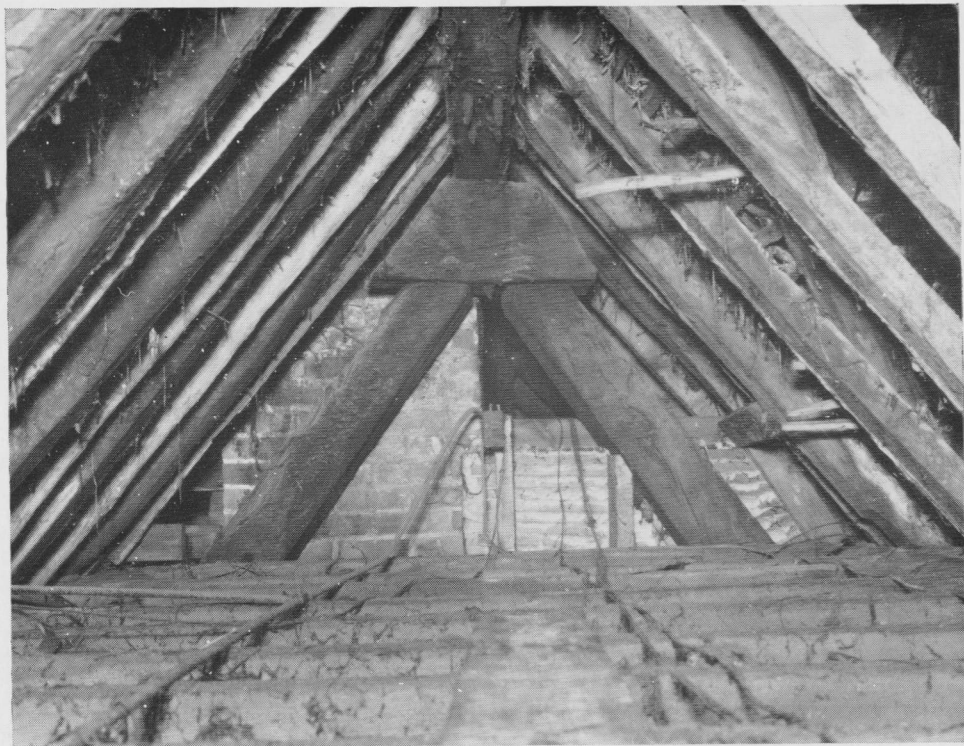
PLATE Xa. CHALFONT ST. PETER. Hill Farm. Apex of cruck truss.

The structure dates from the fourteenth century, the oldest portion being a hall of two bays with an open cruck truss in the centre (a-b on plan, Fig. 2) having chamfered arched braces below a collar. The cruck blades—of which the lower part of one is missing—taper from 11 in. square at the base to 7 in. square at the apex where they are linked by a heavy yoke, 10½ in. by 2 ft. 3 in.

(maximum), on the face, and which supports a square-set ridge (Plate Xa and b, and Fig. 1).
