# THE ALMS HOUSE SUTTON CHENEY HISTORIC BUILDING RECORDING

Document Title	Historic Building Recording
Prepared for	Mr Andrew Copson
Prepared by	TEP - Warrington
Document Ref	8357.05

1. The Environment Partnership (TEP) Ltd was appointed to undertake a programme of Level 3 Historic Building Recording of the Grade II Listed Alms House at Sutton Cheney. The building was founded in 1612 by Sir William Roberts, one of the freeholders of Sutton Cheney whose tomb is located in the neighbouring 13th century St James' Church.

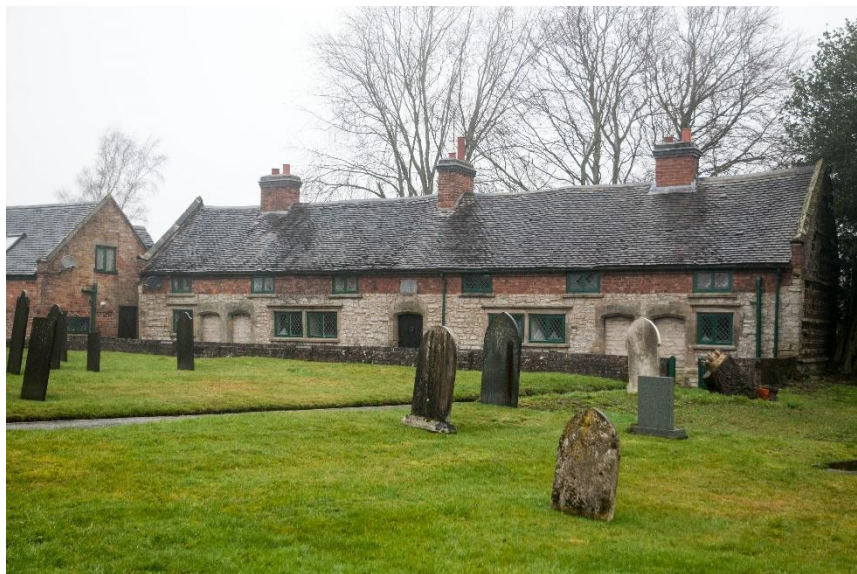
*Figure 2 General view of the west elevation from the churchyard, looking north-east*

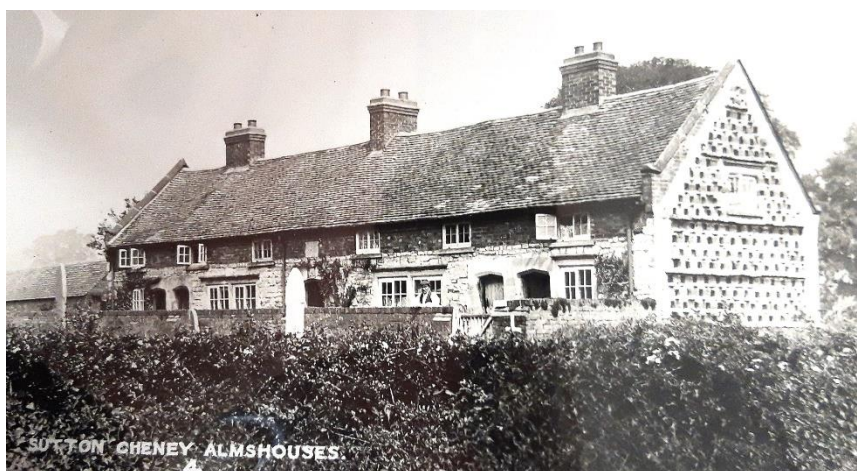
*Figure 3 Undated early 20th century view of the Alms House, showing the west and south elevations (Ensor 2020)*

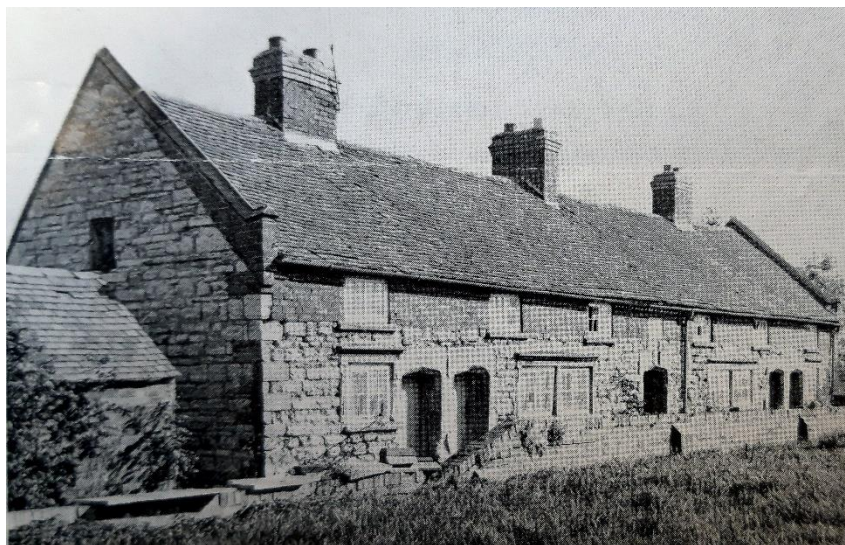
*Figure 4 Undated early 20th century view of the west and north elevations (Ensor 2020)*

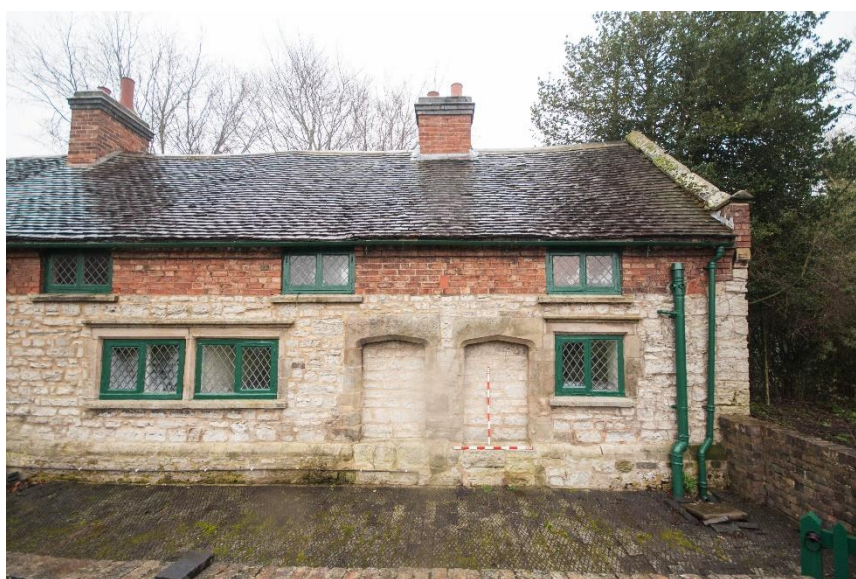
*Figure 5 The southern end of the west elevation, showing blocked paired doors and the raised eaves*

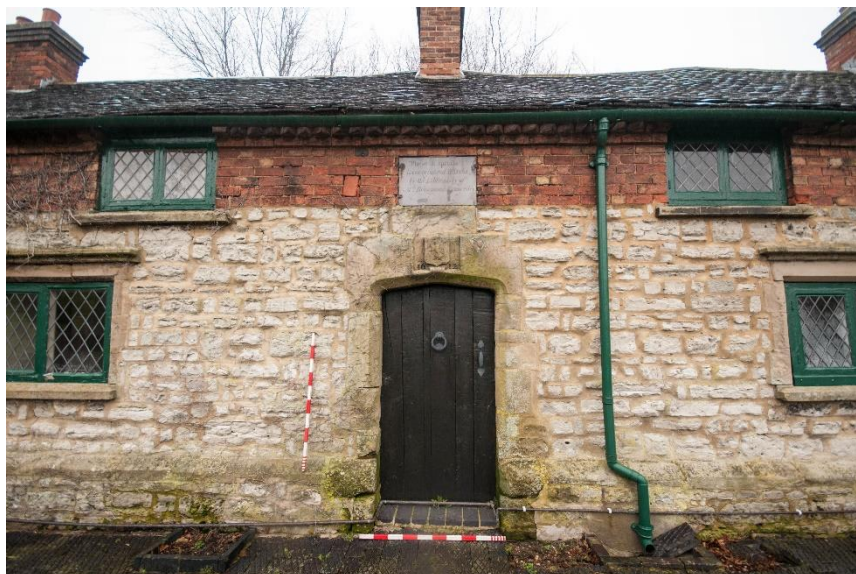
*Figure 6 The central doorway to the former through passage with commemorative plaques above*

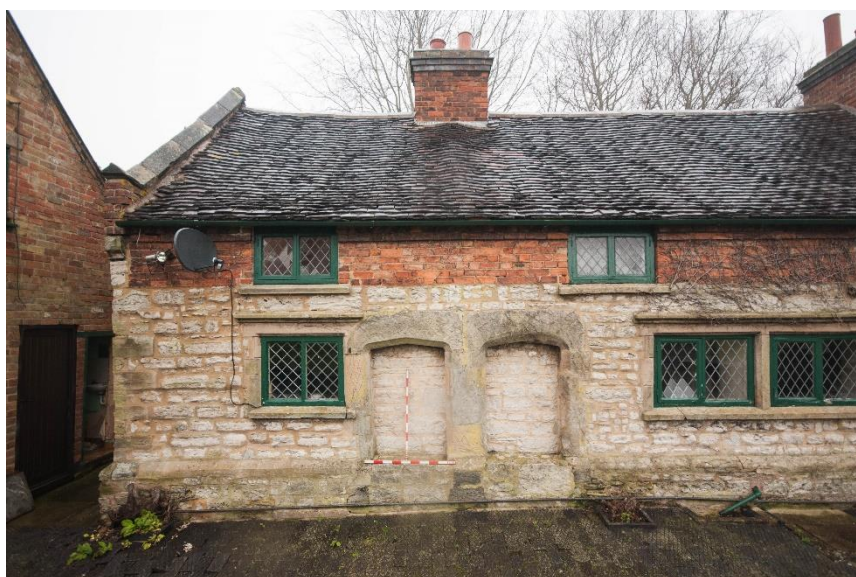
*Figure 7 The north end of the west elevation with blocked paired doorways and modern windows in the historic openings*

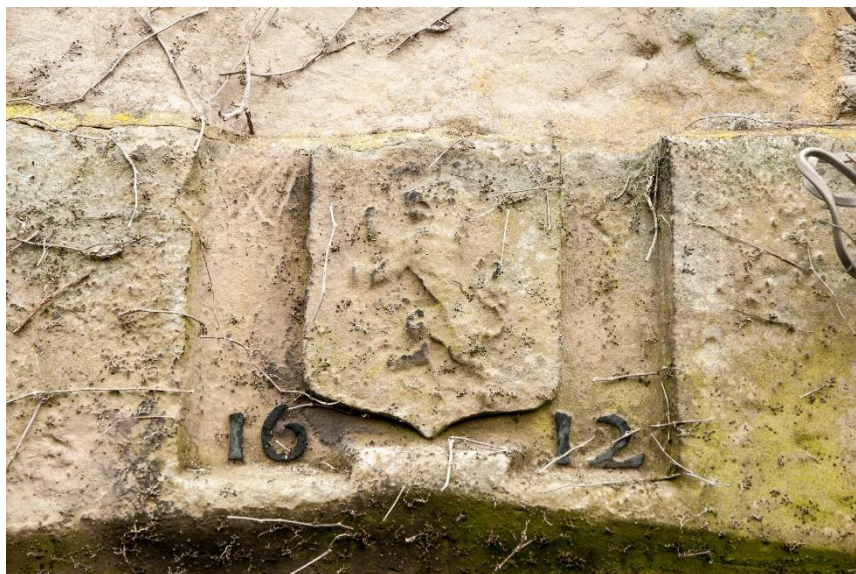
Figure 8 Detail of the commemorative plaque with date and shield; note the carved initials W and R in the upper corners

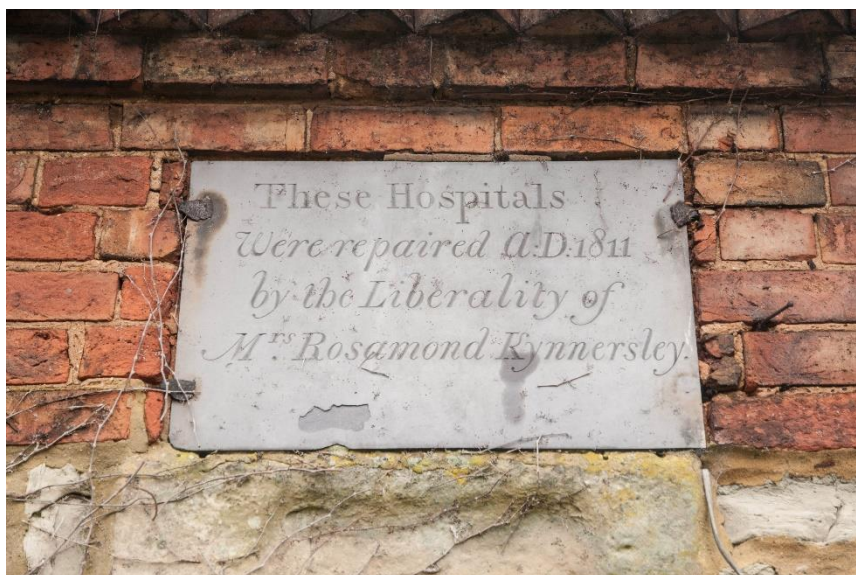
Figure 9 Commemorative plaque marking the 1811 phase of repairs

4.6 In 1811, as is recorded by a commemorative plaque, the building was repaired 'by the liberality of Mrs Rosamund Kynnersley'. The full extent of the works is not certain but it included the raising of the roof level on the eastern side and was likely accompanied by repairs to the internal timberwork. It is possible, though not certain, that during this phase of repairs an upper floor level was added to the building. Other minor repairs and alterations may have taken place during the later part of the 19th century.

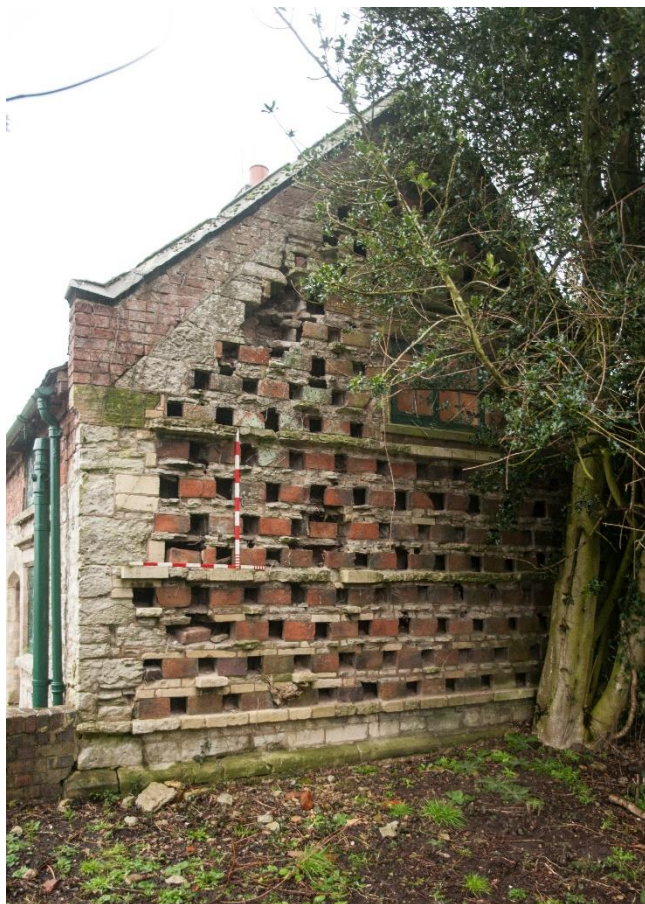
Figure 10 The south elevation with nesting holes and flight ledges

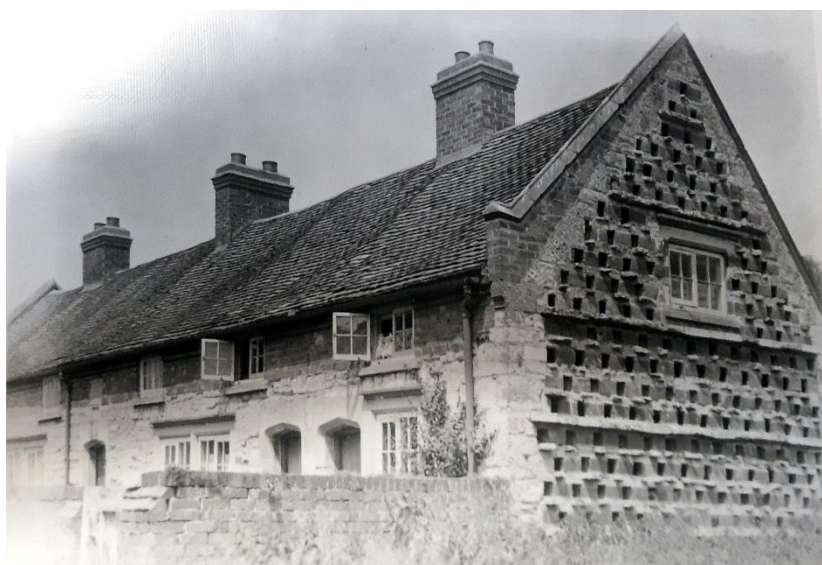
Figure 11 Undated early 20th century of the south elevation (Ensor 2020)

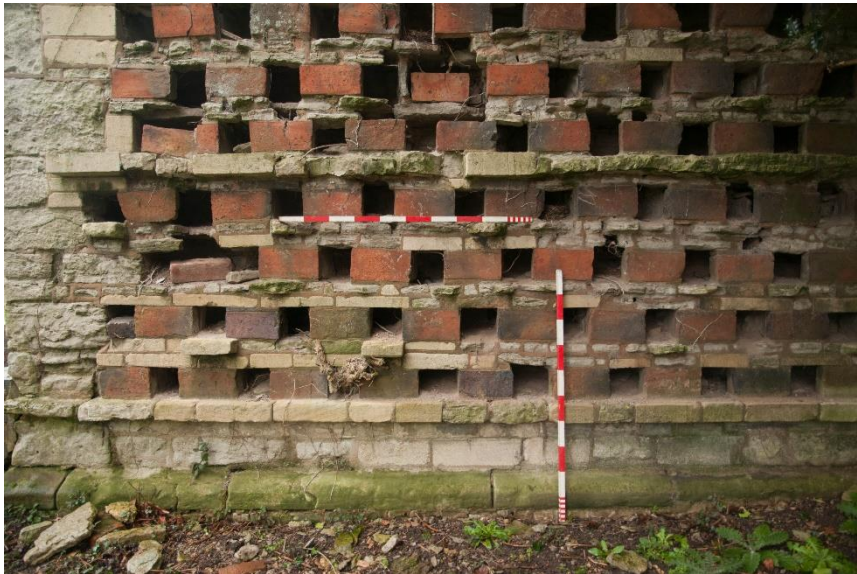
Figure 12 Detail of the nesting holes and ledges

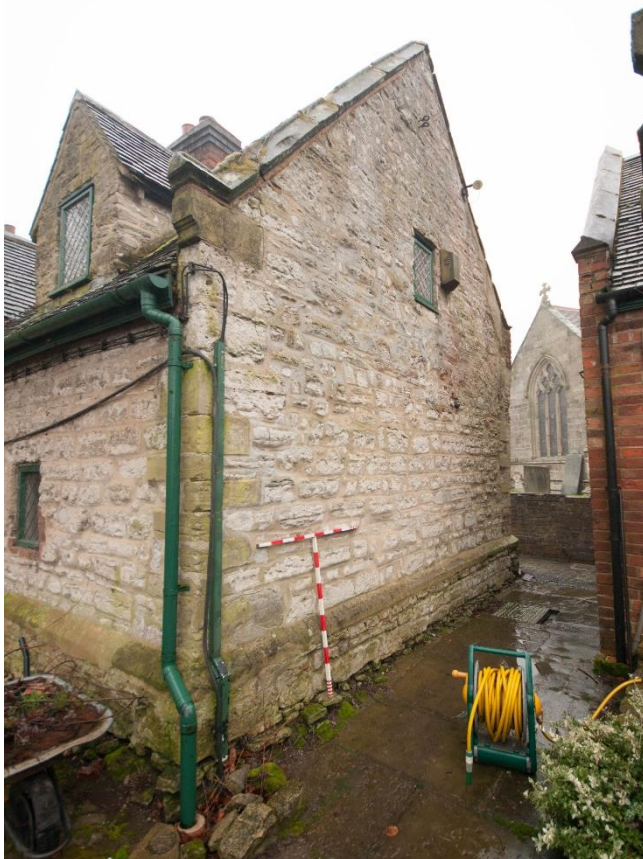
Figure 13 The north elevation, looking south-west

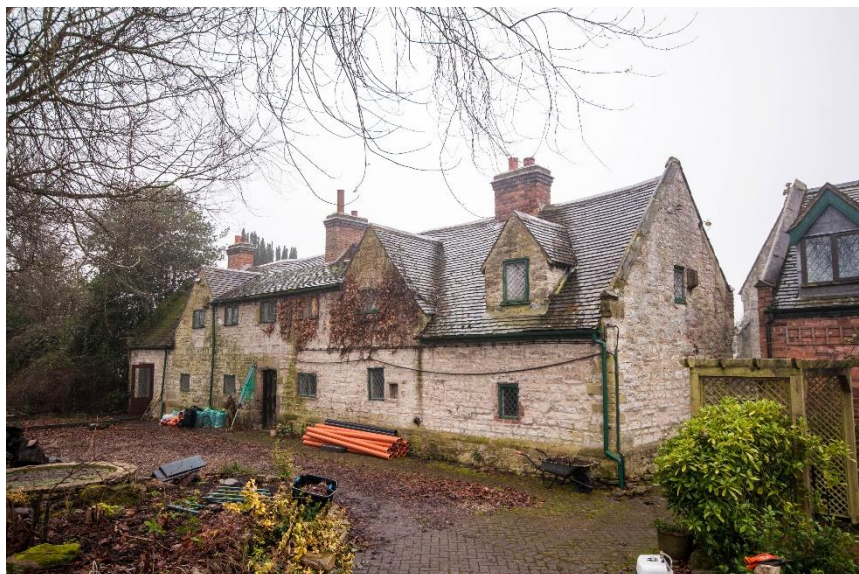
*Figure 14 General view of the building from the north-east, showing the north and east elevations*

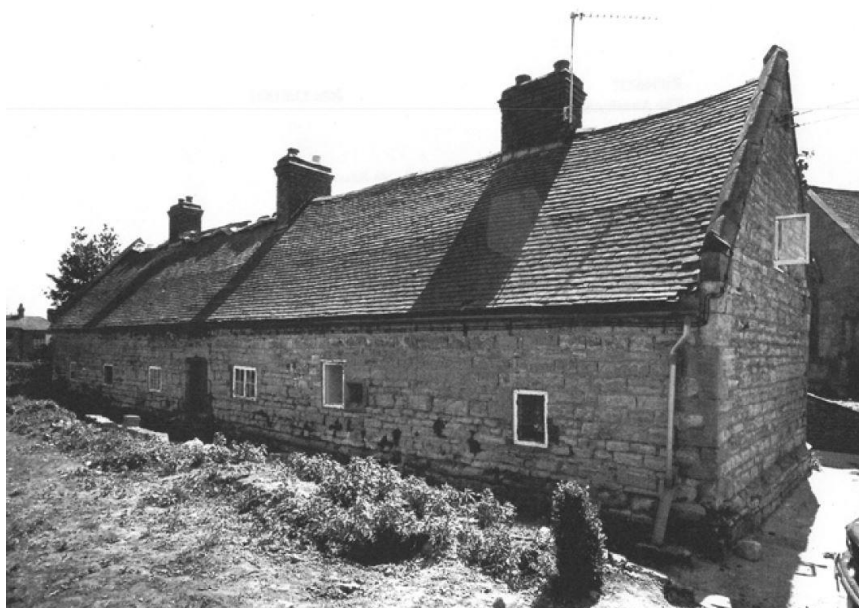
*Figure 15 Undated early 20th century view of the east elevation prior to modern alterations, looking south-west (Ensor 2020)*

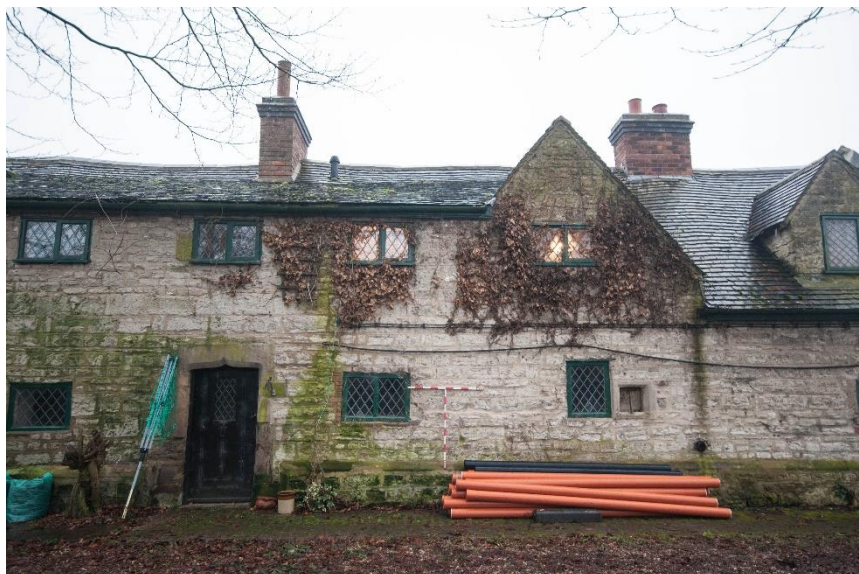
*Figure 16 View of the east elevation showing the 1970s dormer overlying the earlier wall level*

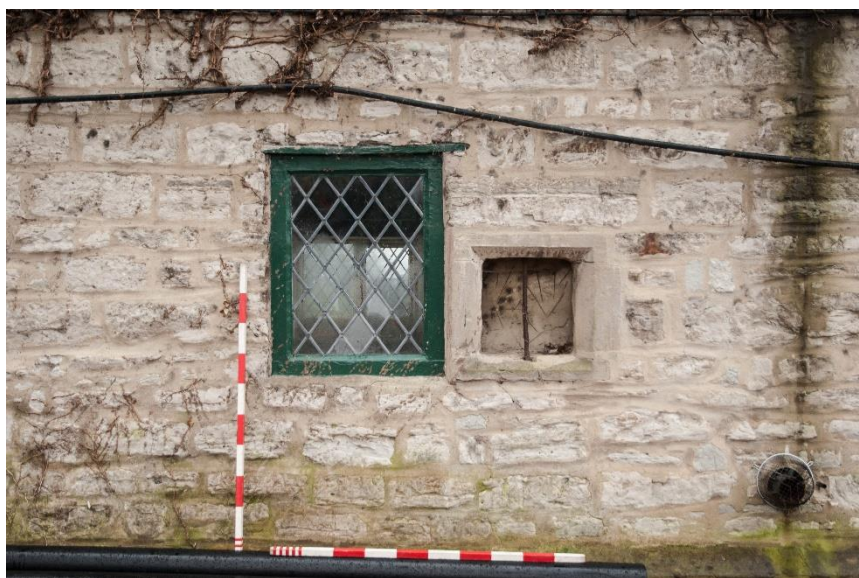
*Figure 17 Detail of windows on the east elevation, showing the small blocked opening*

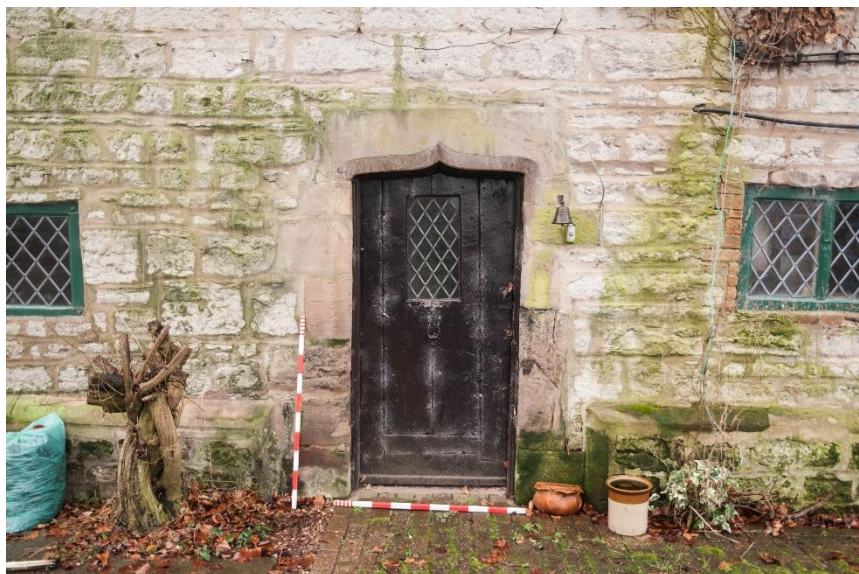
*Figure 18 The through passage opening on the east elevation*

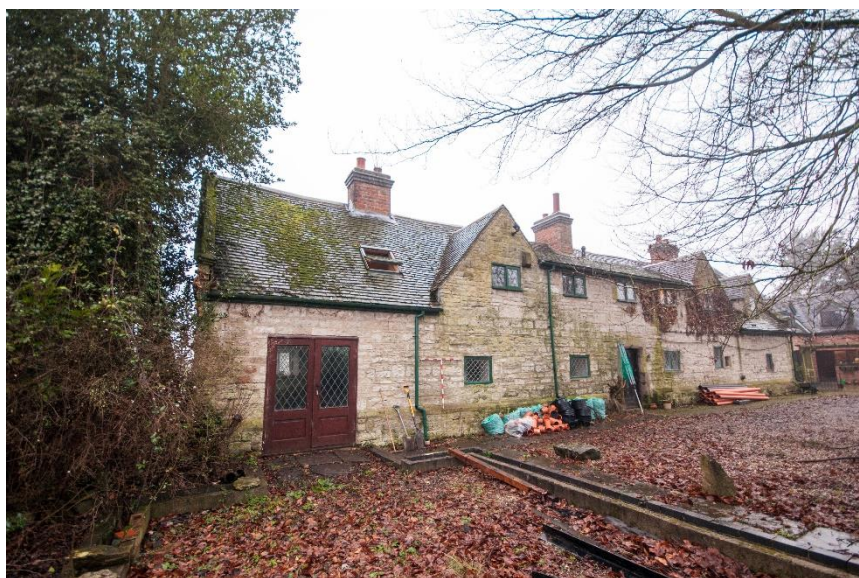
*Figure 19 View of the east elevation, looking north-west*

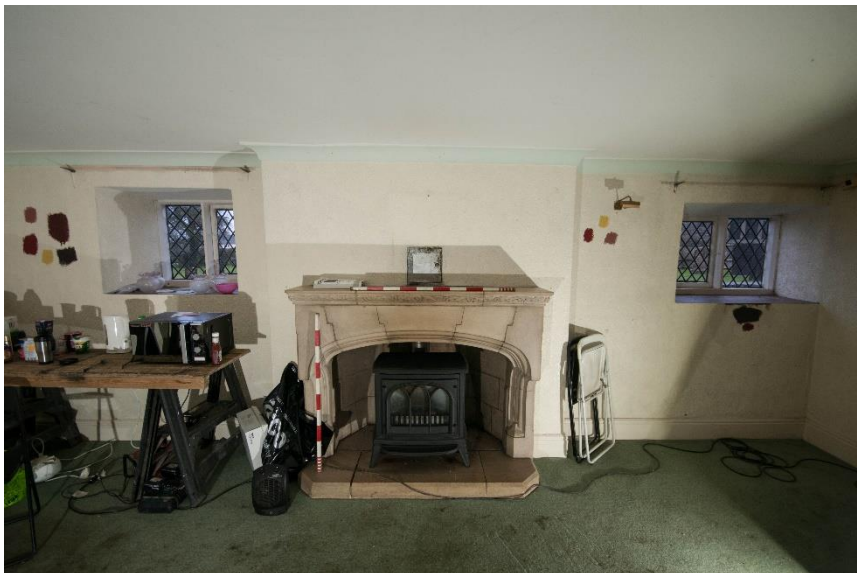
*Figure 21 Room G1, view of the modern fireplace flanked by windows*

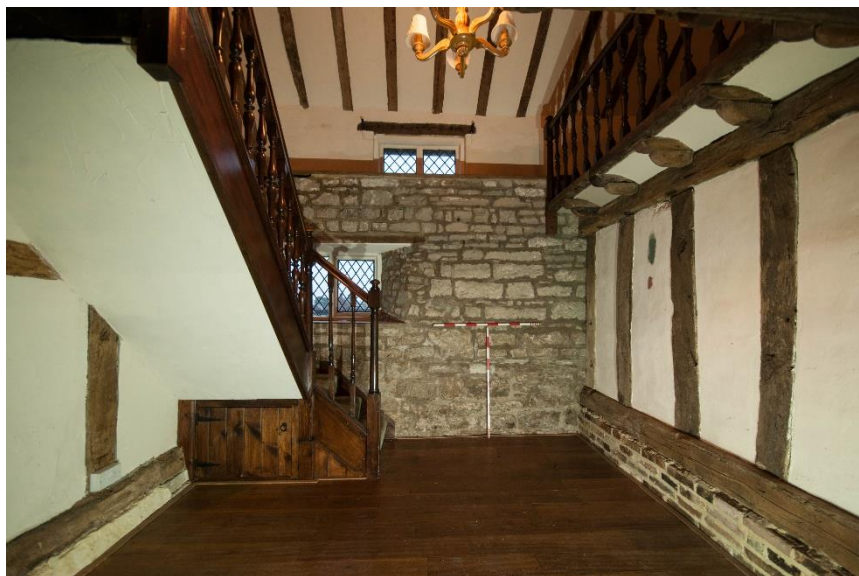
*Figure 22 Room G2, looking east, showing the stair up and projecting galleried walkway*

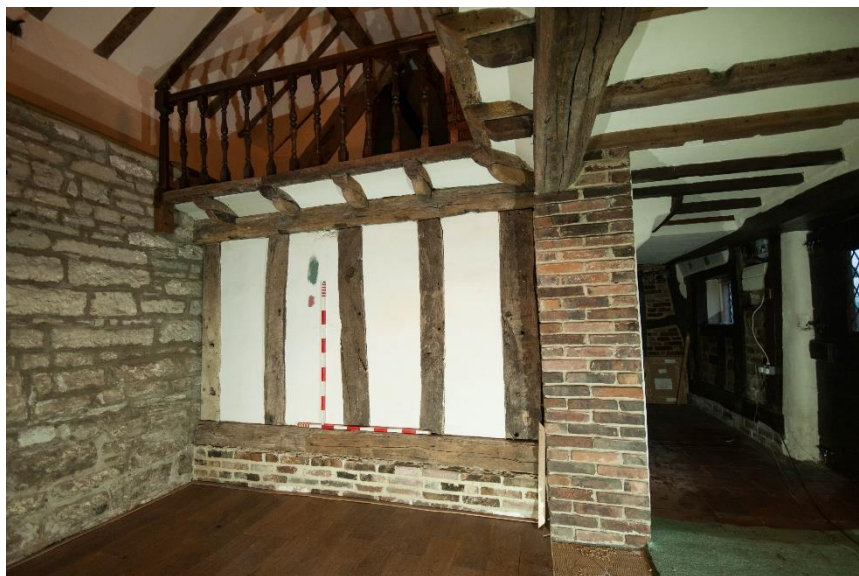
*Figure 23 Room G2, looking north and showing modern brickwork with a modern stud partition behind the modern fireplace*

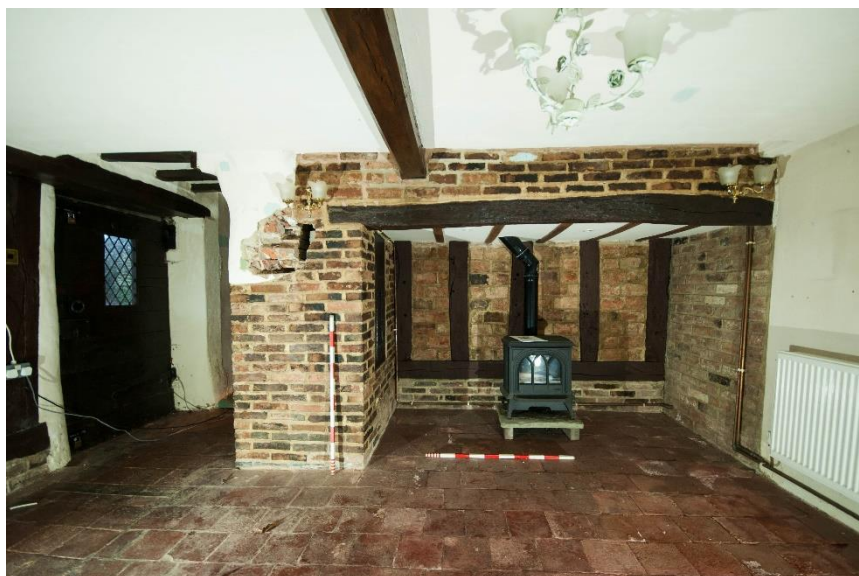
Figure 25 Room G3, looking south and showing the modern brick built 'inglenook'

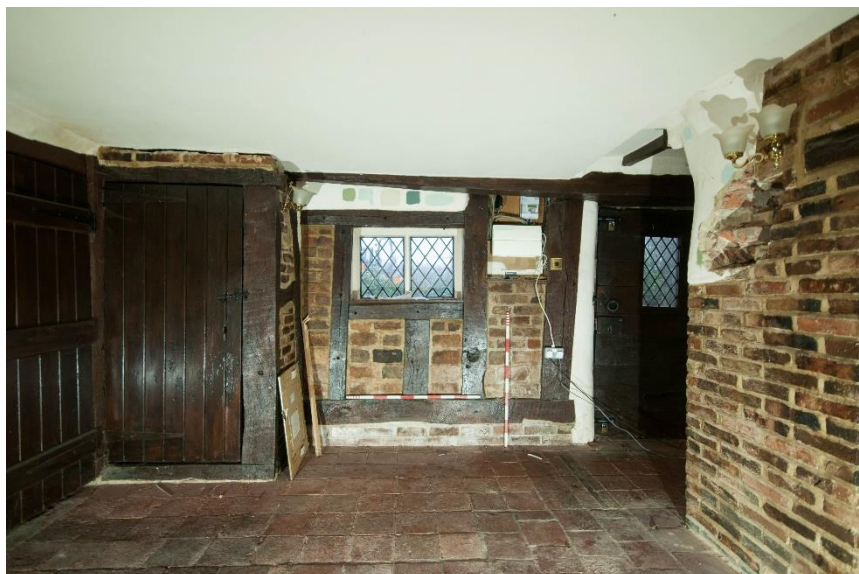
*Figure 26 Room G3, looking east, showing the modern rebuilding of the wall*

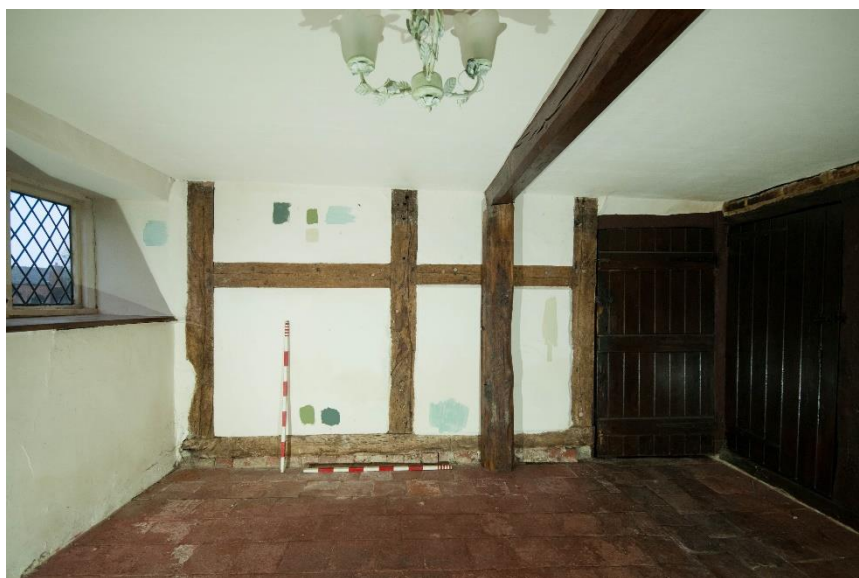
*Figure 27 The north wall of Room G3; note the modern beam supported on a free standing post*

- 5.50 The south wall is an original partition and comprises four studs rising from a timber sill over a brick footing course, and with timbers rail above mid-height (Fig 27). A doorway was inserted in the eastern end of the wall during the 1977 work, requiring the removal of the rail and cutting of the sill and partial removal of the brick footing. The partition forms a cohesive whole with a partition and roof truss on the floor above. Viewed from within Room G3 it can be seen that the timbers are properly jointed together, each tenon held in place with two wooden pegs. Scribed set out lines used by the carpenters to accurately set out their work remain visible on some of the joins (Fig 28). The door is plank and ledged with a thumb latch and is swung on iron strap hinges.

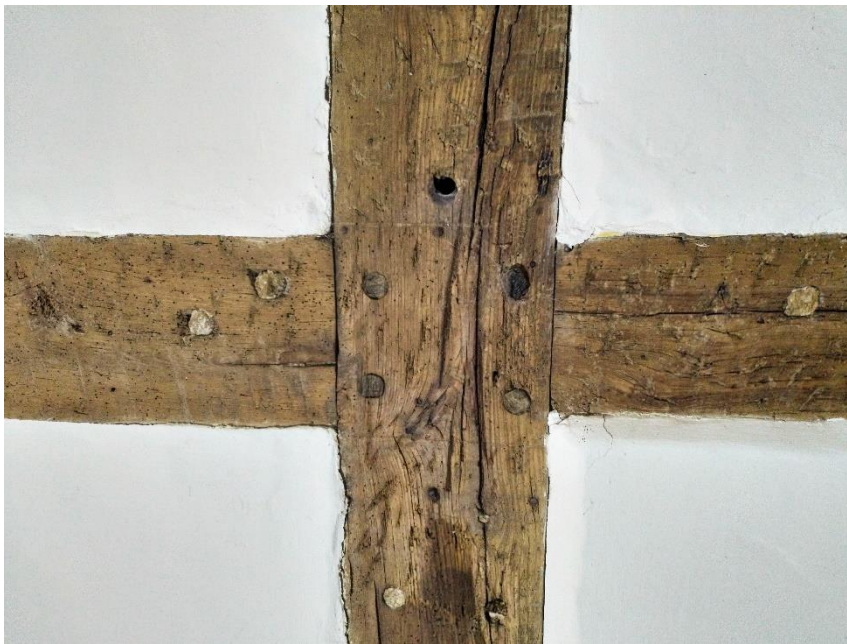
Figure 28 Detail of the timber joins on the north wall of Room G3, showing pegs and faint set-out lines

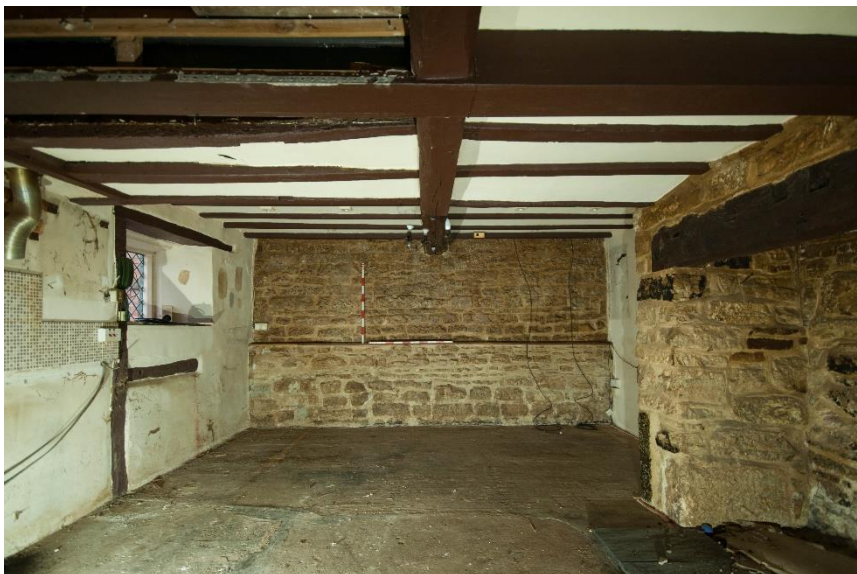
Figure 29 Room G4, looking north

- 5.46 The room measures c6.5m x 4.4m and occupies the northern extent of the building, encompassing two of the original rooms with the partition having been removed to create one space (Fig 29).

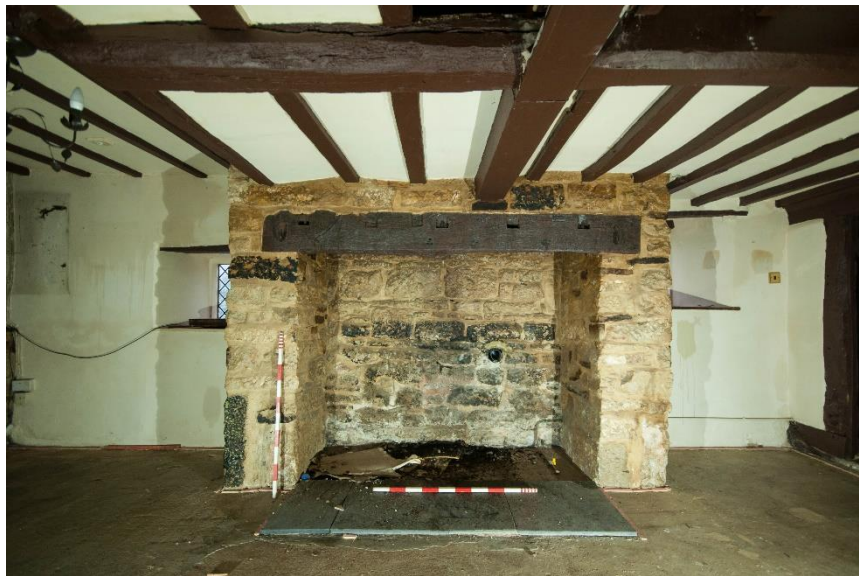
*Figure 30 Room G4, showing the modern fireplace with re-used lintel*

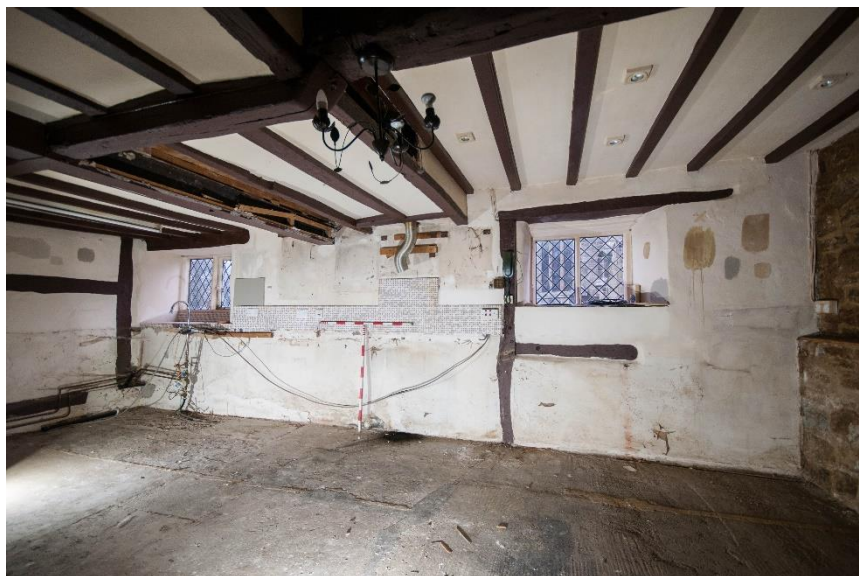
*Figure 31 Room G4, the west wall; the blocked paired openings are positioned between the windows*

- 5.53 A timber post and part of a rail, both embedded in the surrounding stonework, are visible immediately adjacent to and below the north most window in the west wall (Fig 31). Their purpose and date is uncertain however these may relate to the former paired doorways which are located next to this window. The doorways are blocked and no evidence for them can be seen from inside the room.

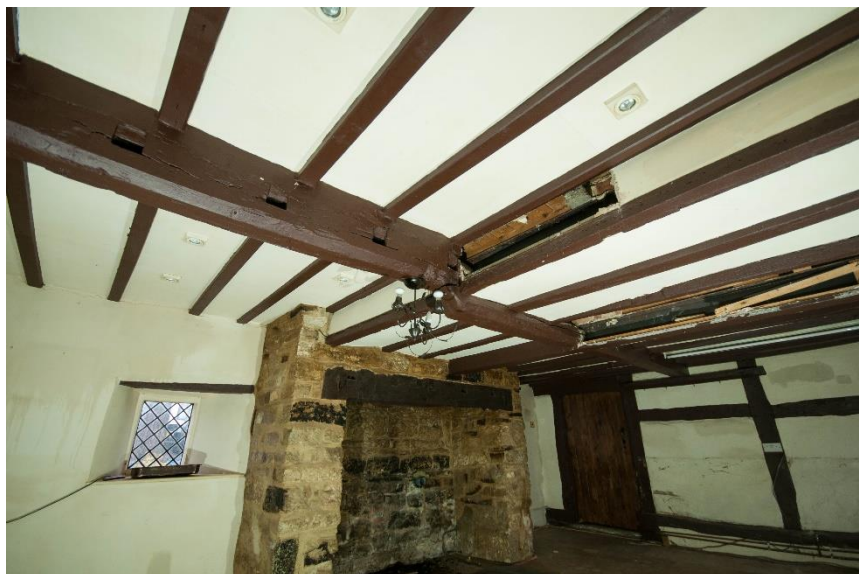
*Figure 32 Room G4, view of the spine beam with defunct joist slot; note the change in ceiling level marking the position of an RSJ*

- 5.52 At the north end of the room there is a spine beam supporting the joists (Fig 32). The timber is fairly deep with chamfered edges and includes empty diminished tenon joints for former joists. The proportion of the beam, the style of joist slots, and the deep narrow joists indicated by these slots would be typical for 17th to 18th century construction. The modern joists now in place are smaller and are carried over the top of the beam. The south end of the beam has been truncated immediately adjacent to one of the empty joist slots and the beam is carried on a Rolled Steel Joist (RSJ) which was inserted during the 1970s works at which in turn is embedded into the stonework of the modern stone fireplace. At the truncation the ceiling level is dropped down. A short length of modern timber beam is continued for c1m to join a second RSJ which is also carried over the modern fireplace. The south side of the ceiling is then continued at the same level. At the south wall the end of the spine beam is carried on a rail which is attached to the timber studs of the earlier wall. It is unclear if the joists in this area are functional or for aesthetic effect since the overlying floorboards visible in a gap are carried on the RSJs and not the visible wooden joist.

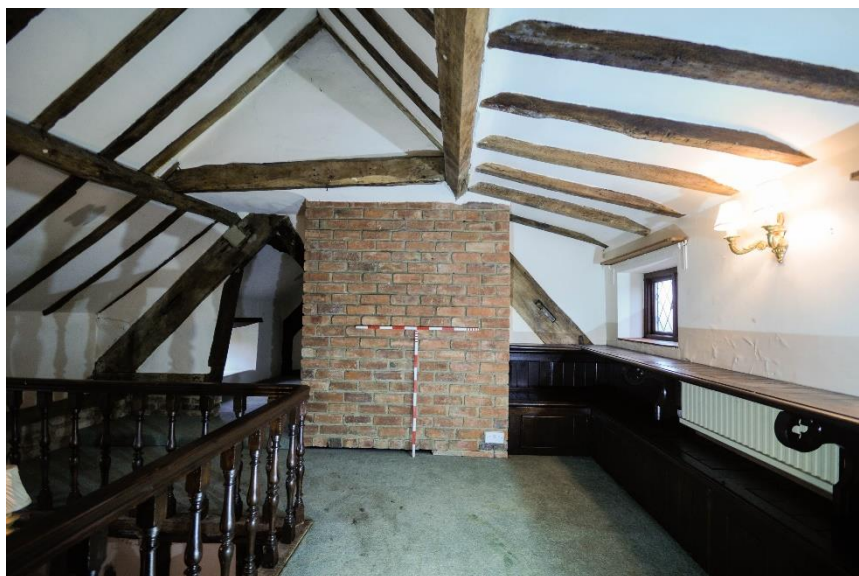
*Figure 33 Room F1, looking north and showing railings to the galleried walkway and modern brick chimney;*

- 5.55 The first floor space is primarily contained within the roof which was raised in pitch on its eastern side in 1811, and also raised on the west side by the construction of an elongated dormer in 1977 (Fig 33). Room F1 forms the central circulation space of the first floor with a galleried well to Room G2. The stair rises on the south side of the room against one of the original partitioning walls. A walkway leads around the south, east, and north sides of the room with wooden balusters lining the edge of the well. The room is a little wider than the other rooms in the upper level as it also includes width of the former central through passage.

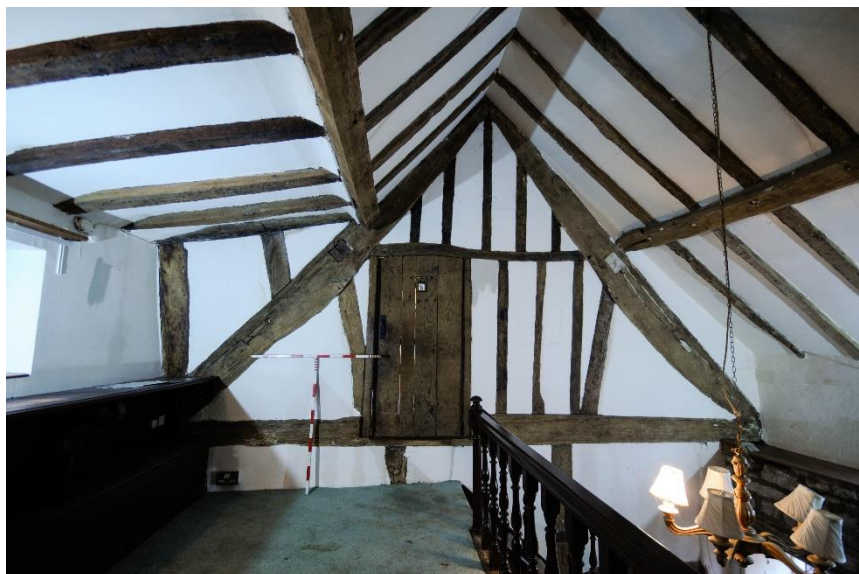
*Figure 34 Room F1, looking south and showing one of the original partitions*

- 5.59 The southern partition wall is incorporated into one of the roof trusses and includes a tie beam spanning the east and west walls and which provides footing for the principal rafters which are tenoned into the top of the tie beam and each held in place with three pegs (Fig 34, Drawing 2). The ends of the beam overlie the top of the wall and the remains of a former timber wall plate (Fig 37). The wall plate would have formerly spanned the full length of the top of the wall and supported the ends of the common rafters. The end of the remaining section at the west side of the partition has the visible remains of a splayed scarf joint with tongue.

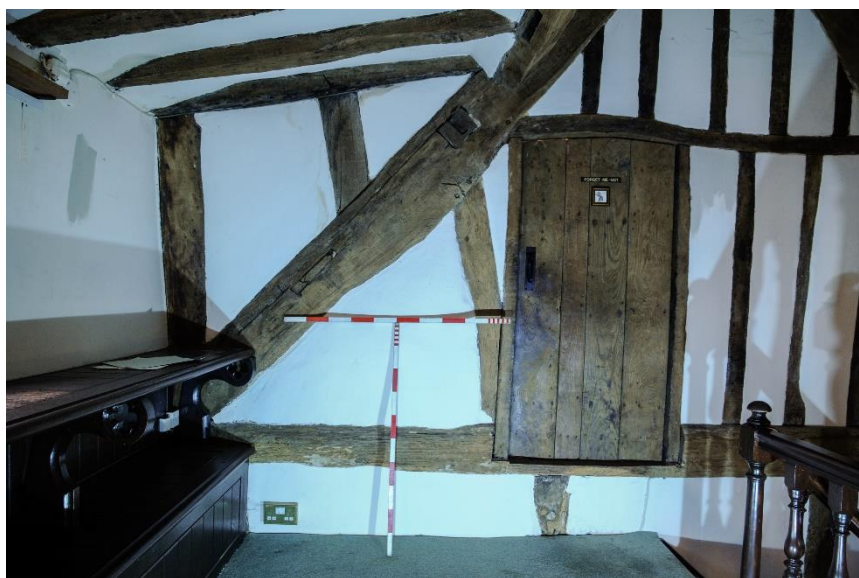
*Figure 35 Room F1, historic partition with inserted door. Also showing modern dormer framing*

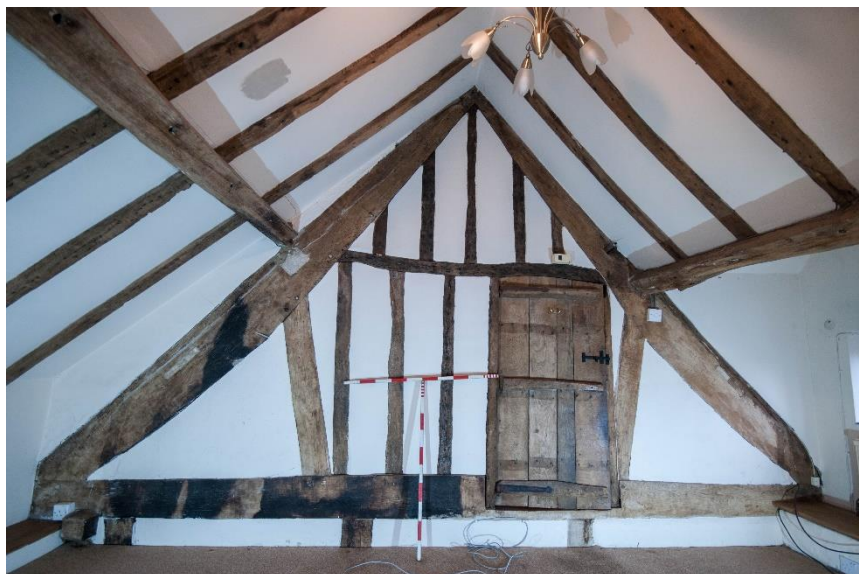
*Figure 36 Room F2, the south side of the historic partition*

- 5.64 An examination of the south side of this partition (viewed from Room F2) reveals marks from the sawing of the timbers and scribed set out lines relating to the setting out and cutting of the joints. At the western footing of the principal rafter and tie beam can be seen an example of a crescent gouge; these are a form of assembly mark used by carpenters to enable correct assembly of the timber framing on site. The south side of the partition displays some areas of blackening which may be indicative of smoke blackening resulting from open fires within the building (Fig 36). It is possible that this blackening was formerly more prevalent on the timbers and has been removed by sanding elsewhere. This may provide evidence that as originally built the Alms House did not have an upper floor and the rooms were heated with open fires though this interpretation is not conclusive.

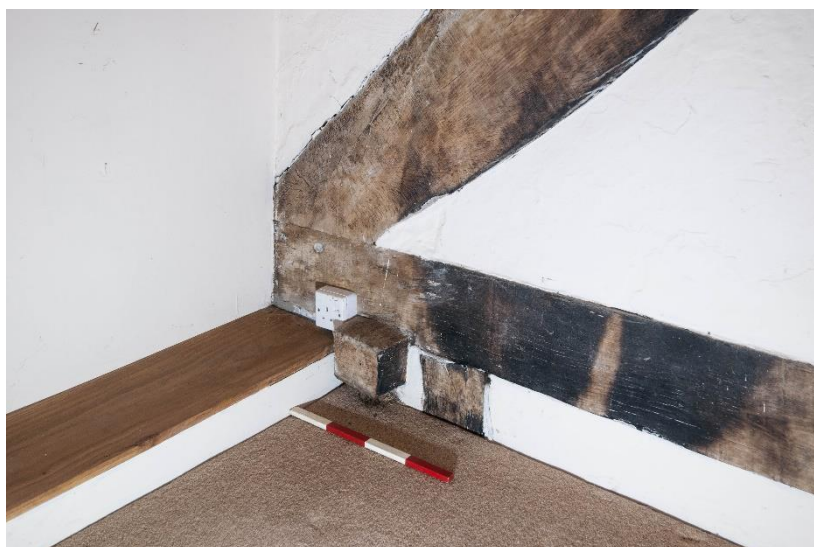
*Figure 37 Room F2, detail of the truss / tie beam join with remnant wall plate*

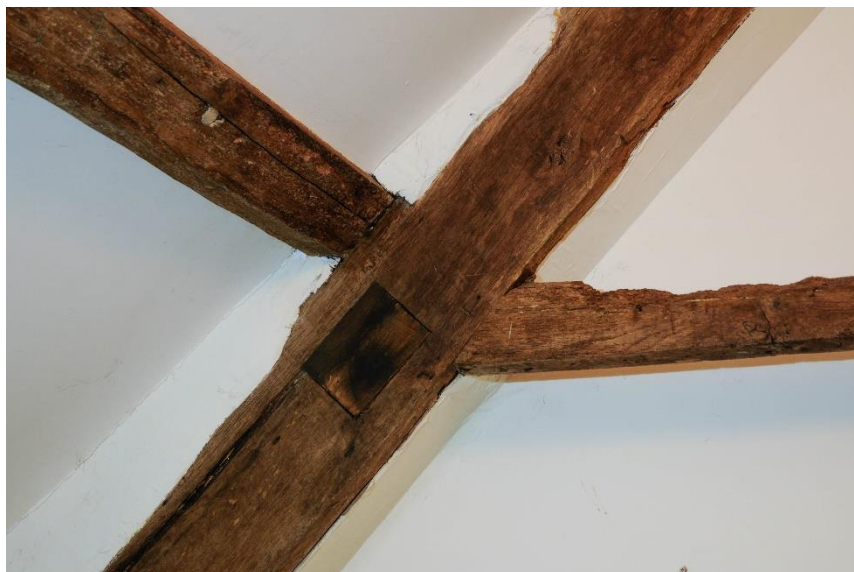
*Figure 38 Room F2, detail of west side of partition showing moved purlin, and join to collar*

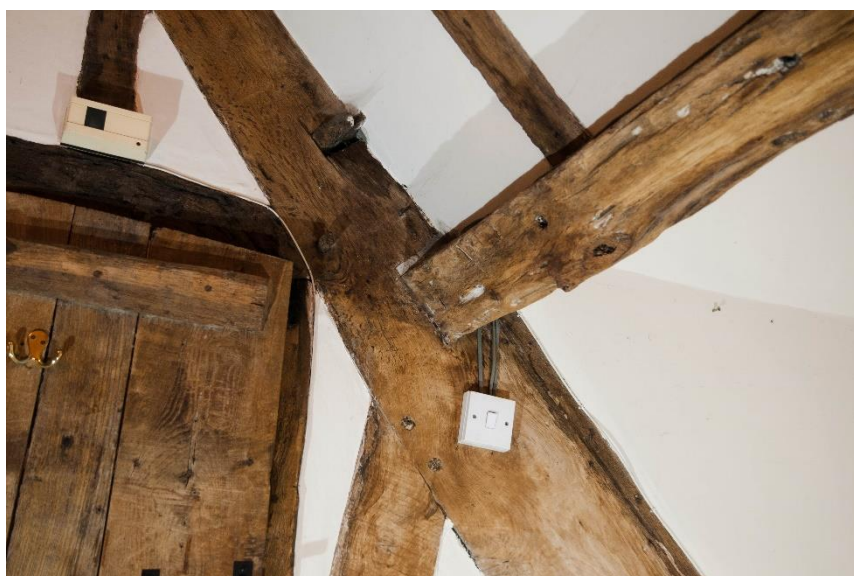
*Figure 39 Room F2, detail of east side of partition, showing purlin in situ*

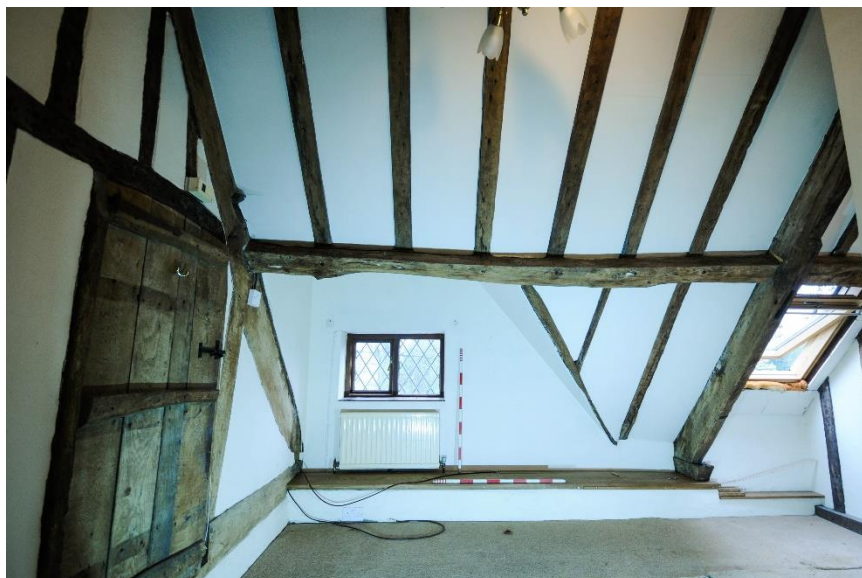
Figure 40 Room F2, looking east; note removed joists to accommodate modern dormer

- 5.68 The purlin on the east side of the room retains a waney edge (i.e. the timber partly retains its natural shape) and remains in its original joint. On both sides of the roof the common rafters are passed over the top of the purlins and appear to be pegged in place. The lower ends of the common rafters on the east side of the roof are cut below the purlins in order to accommodate the modern dormer (Fig 40).

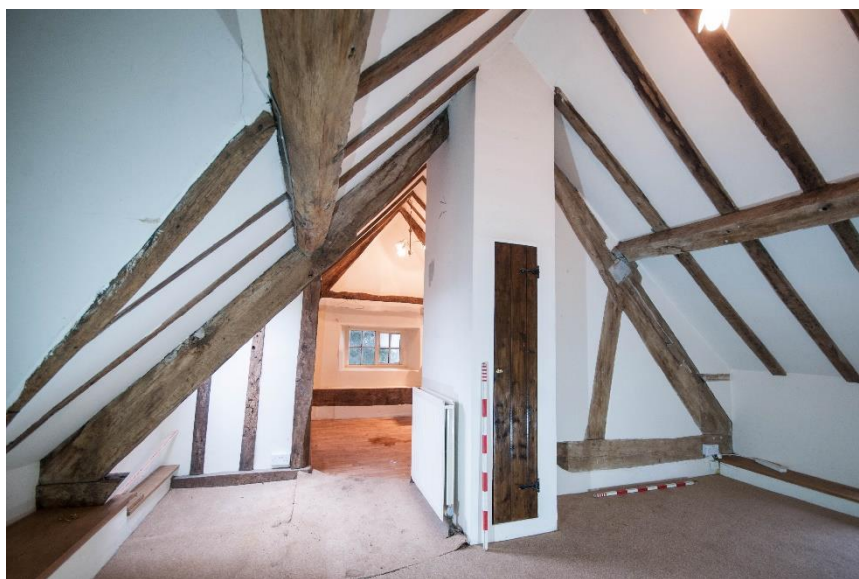
Figure 41 Room F2, looking south and showing modern chimney; note truncated tie beam

- 5.67 Adjacent to the stack on its western side is exposed a timber partition and roof truss which is of the same form as that described in Room F1 (Fig 41). On this example where the western purlin has been removed and placed on the back of the principal rafter blade, it is held in place by means of a timber cleat (Fig 42).

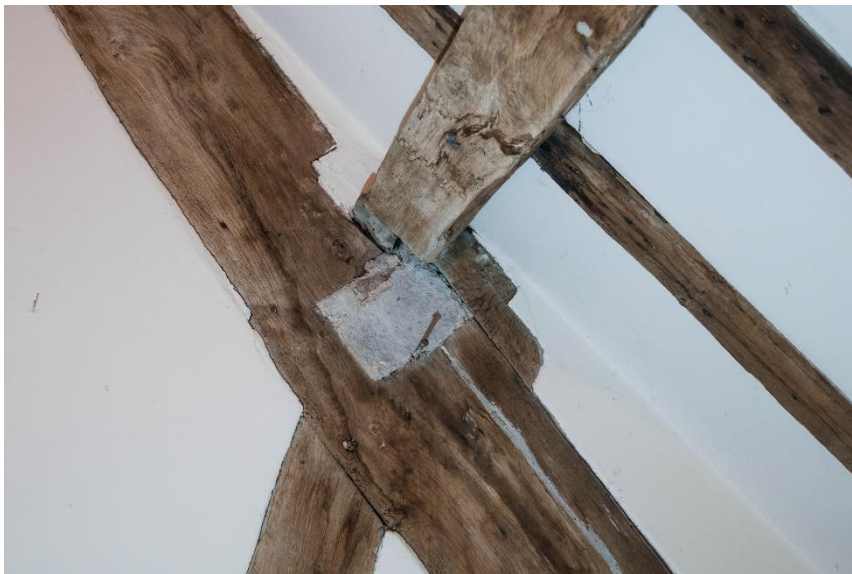
*Figure 42 Room F2, detail of altered purlin on south partition*

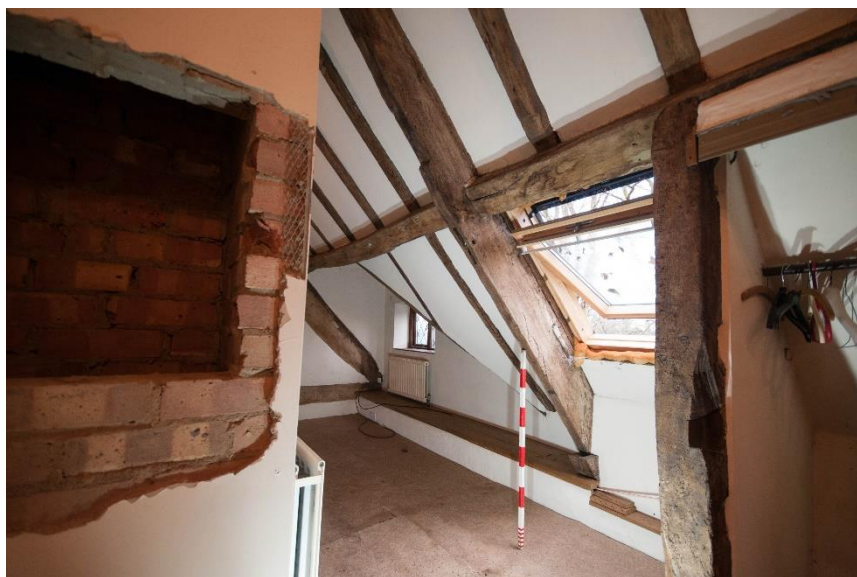
*Figure 43 Room F3, looking north to F2, showing intervening partition. Note modern chimney to left*

- 5.69 Rooms F2 and F3 are open to each other with access around the modern stack. A roof truss located on one of the former partitions was altered to accommodate this by having its collar and a section of the tie beam largely removed. A modern velux window was inserted immediately adjacent to this truss (Fig 43).
