# THE ALMS HOUSE SUTTON CHENEY HISTORIC BUILDING RECORDING

Document Title	Historic Building Recording
Prepared for	Mr Andrew Copson
Prepared by	TEP - Warrington
Document Ref	8357.05

1. The Environment Partnership (TEP) Ltd was appointed to undertake a programme of Level 3 Historic Building Recording of the Grade II Listed Alms House at Sutton Cheney. The building was founded in 1612 by Sir William Roberts, one of the freeholders of Sutton Cheney whose tomb is located in the neighbouring 13th century St James' Church.

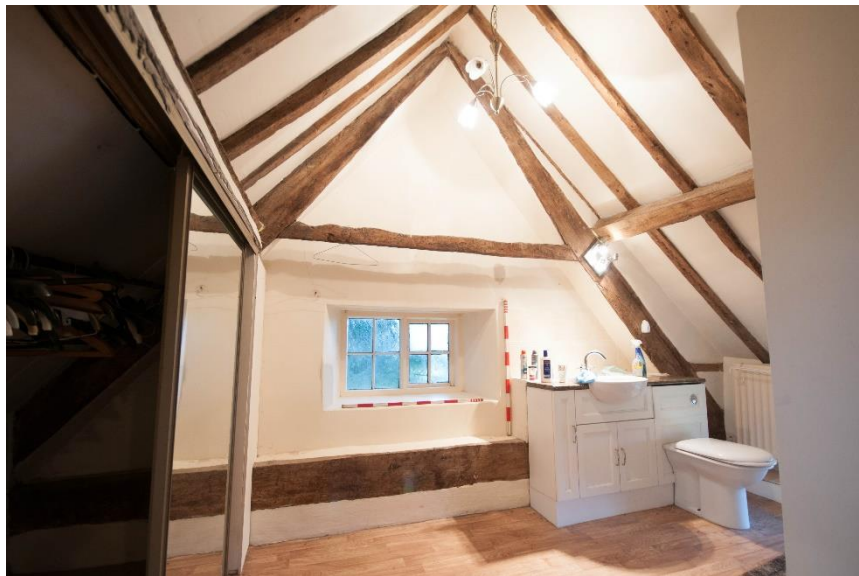
*Figure 44 Room F3, looking south and showing roof truss partly embedded in the south wall*

- 5.71 At the south side of the room is the end roof truss which is embedded into the stonework of the wall (Fig 44). This is of the same form as those elsewhere in the building, comprising oak blades tapered at the apex and foot, carried on a timber tie beam, and with a collar towards the top. All of the members are tenon-joined and held with oak pegs and faint scribed set out lines can be seen. No assembly marks were noted.
- 5.72 The eastern purlin remains in its original join within the truss blade while that on the west has been removed from its position placed on top of the blade (Fig 45). The common rafters are carried on the back of the purlin and are likely pegged in place.

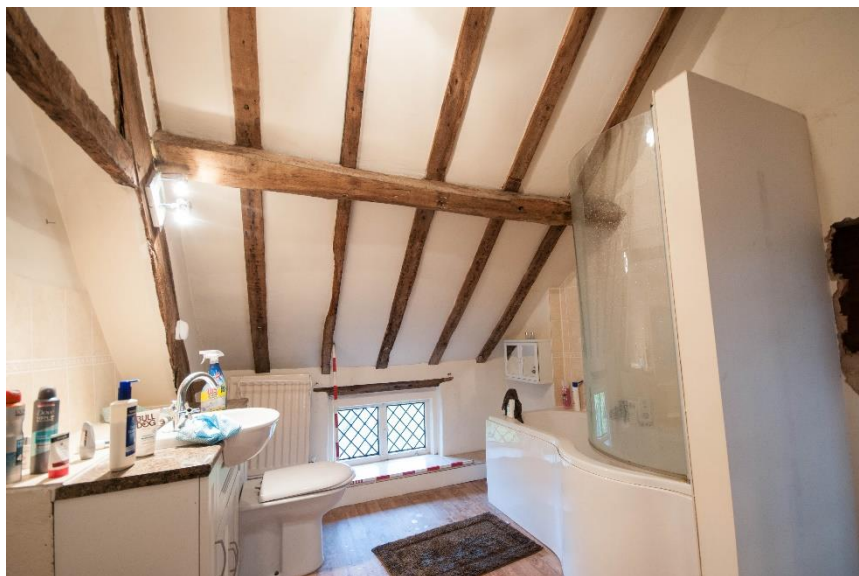
*Figure 45 Room F2, looking west and showing purlin and rafters*

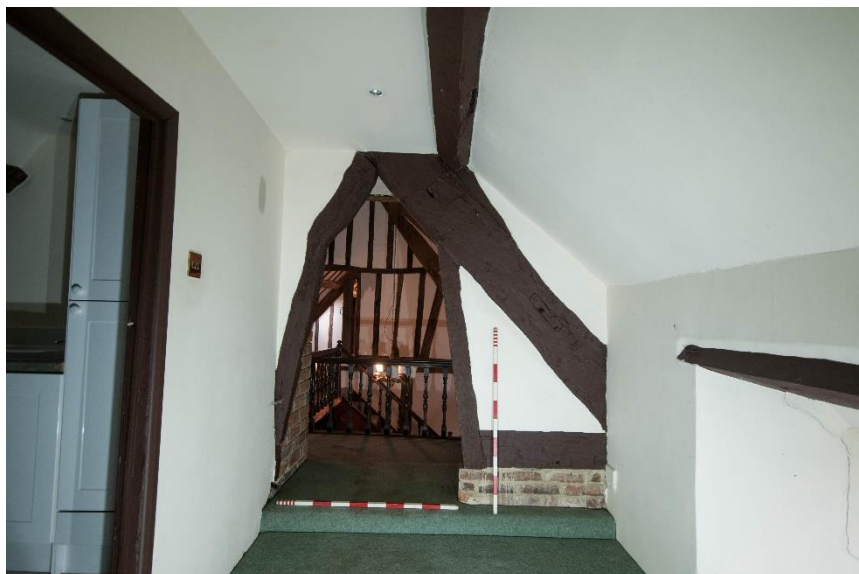
Figure 46 Room F4, looking south. Showing timber partition with inserted opening. Note truncated tie beam

- 5.73 These two rooms comprise a short corridor separated into two sections by a door inserted into one of the historic partitions (Fig 46, 47). Room F4 provides access to F6 and Room F5 provides access to rooms F7 and F8. No historic fixtures or fittings remain within these spaces.
- 5.74 On the west side the two rooms are bound by the roof pitch and the 1811 brickwork, and on the east are bound by modern stud partitions.
- 5.75 As noted elsewhere in the building, in order to accommodate modern alterations that combined formerly separate rooms into a joined space, the intervening partitions were altered by the cutting of tie beams and removal of struts and collar.

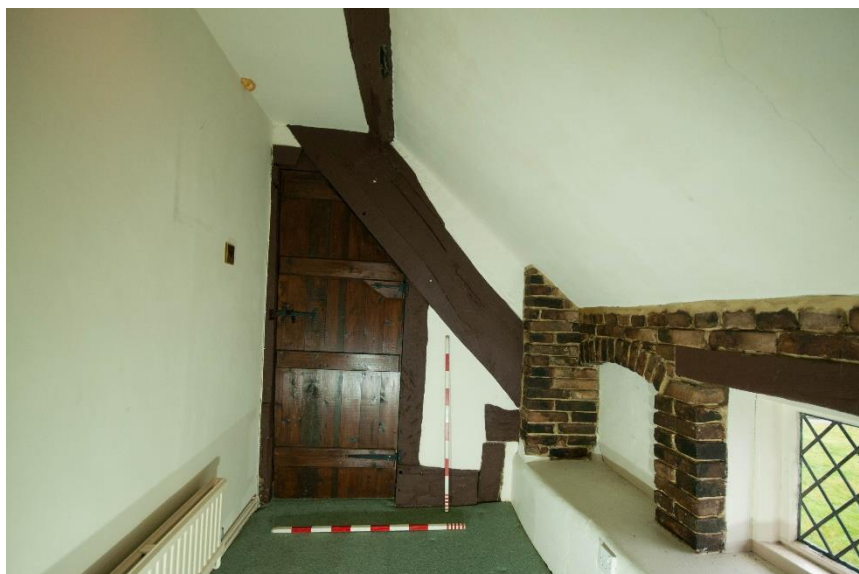
Figure 47 Room F5, looking south. Showing timber partition with inserted door. Note truncated tie beam

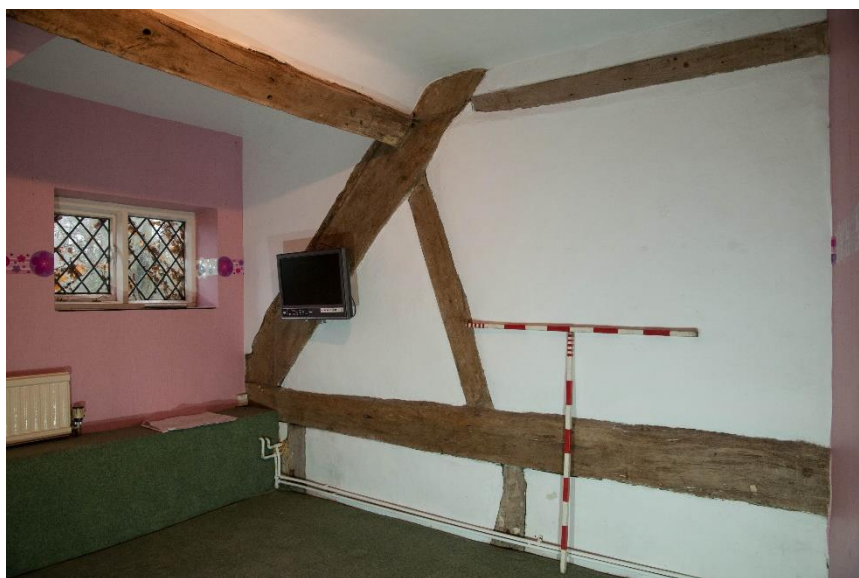
Figure 49 Room F7, showing the partition to Room F6

- 5.77 Room F7 is a simple bedroom, the east wall is wallpapered and the west wall is a modern stud partition. Dividing Rooms F6 and F7 is one of the historic partitions which is exposed to view in both rooms and is of the same form as elsewhere, comprising oak principal rafters seated on a tie beam, joined by a collar and supported by struts (Fig 49, 50). Directly below the tie beam can be seen the top of two supporting studs.

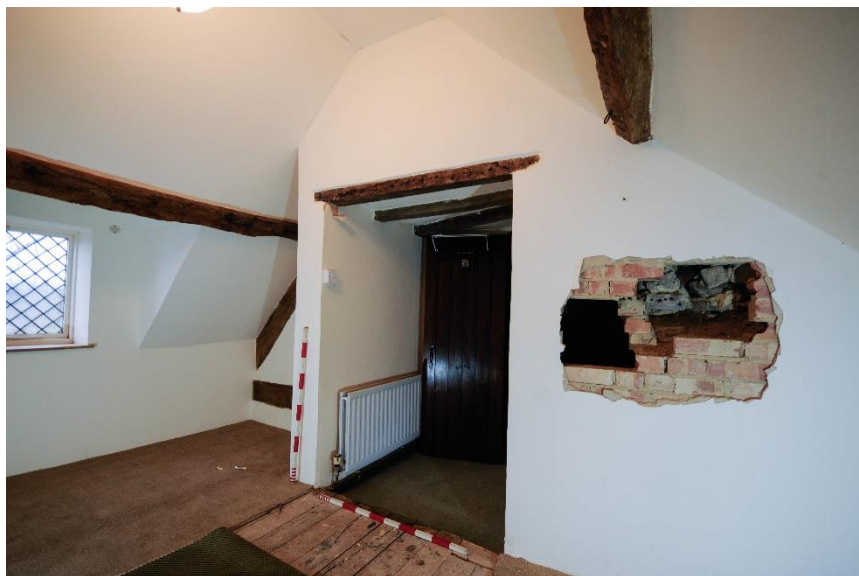
Figure 51 Room F8, looking south-east. Note modern brick flue

- 5.81 A small area of plaster was removed from the wall adjacent to the doorway from Room F5 revealing that the underlying fabric is modern bricks and includes a flue connecting to the earlier chimney (Fig 51). The present doorway passes through where a chimney stack was formerly located and in order to retain a functional flue it was diverted over and to the west side of the entrance way. As described in Room G4 there is a change of levels at this point. No evidence for the earlier chimney stack or the former stair that was located in the south-east corner of this room was visible.

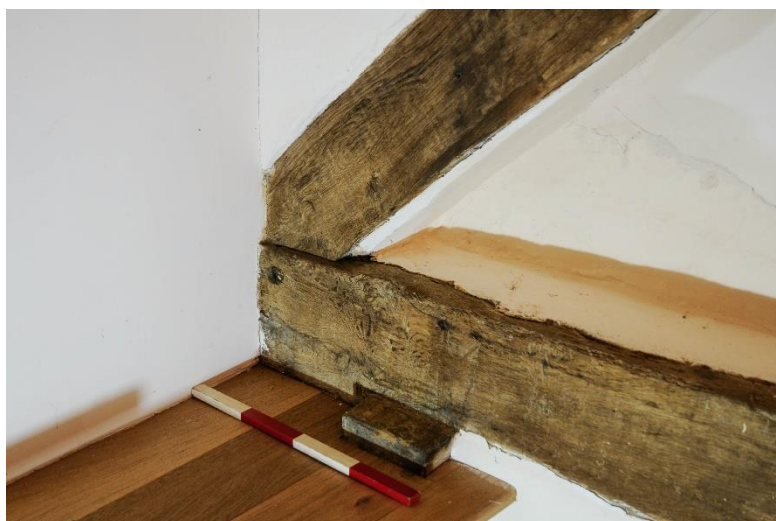
*Figure 53 Rom F8, detail of rafter / tie beam join with remnant wallplate*

- 5.79 This is northern room and presently serves as a bedroom. The northern truss is partly embedded in the northern wall as was also noted on the southern truss. As also recorded in Room G4, directly below this, the north wall is again stepped and reduced in thickness (Fig 52). The position of the tie beam at eaves level marks the level at which the wall was reduced (Fig 53). A short section of the former wall plate survives in situ at the west side of the truss.
