**WOOD END FARM
WOOD END, NASH
BUCKINGHAMSHIRE**

HISTORIC BUILDING RECORDING

Document: 2016/81
Version: 1.0
May 2016

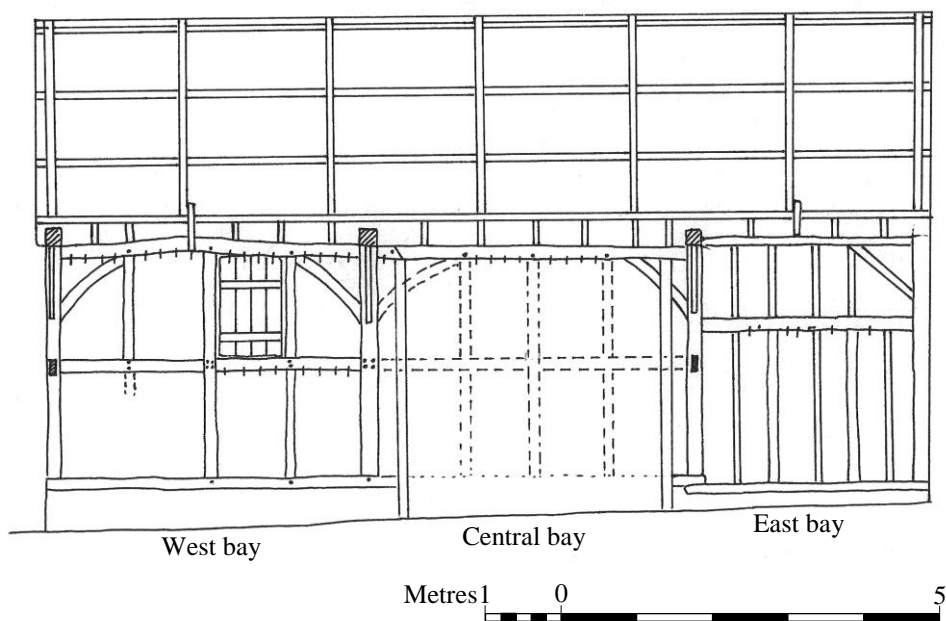
Figure 7: Barn 1, internal elevation of north wall

*Note. Dashed lines show timbers inferred from empty mortise holes.
The 'ticks' on the lower side of beams indicate the position of stave holes.

This building has been extended and converted to residential use during the present development works. It has been combined with former dairy building and is now known as the Dairy Barn. This barn is located on the south side of the farmyard; it is aligned east-west and is 11.6m long by 5m wide. The timber-frame stands on a low sill wall of brick and is weather-boarded externally (Images 4 to 6). In plan there are three bays with a double door in the north side of the central bay. At the time of the initial survey the barn contained farm machinery which partly obscured the structure, particularly in the southwest corner. The frame contains evidence for two phases of construction, with the west and central bays being the earliest, the eastern bay being a later extension (Figures 7 and 8).

The earliest part of the building consists of the west bay and the central bay. The three transverse frames at the bay divisions in this part of the building have jowled posts and curved braces to the tie beams. The side walls in each bay are divided by an intermediate full height post, with a mid rail and studs defining two rows of four panels. The upper row has curved head braces to each principle post. The wall at the west end of the building has a mid rail, curved head braces and four sets of studs which divide the wall into two rows of four rectangular panels (Image 8). The wall plates have splayed, bridled scarf joins. Stave holes and grooves show that the

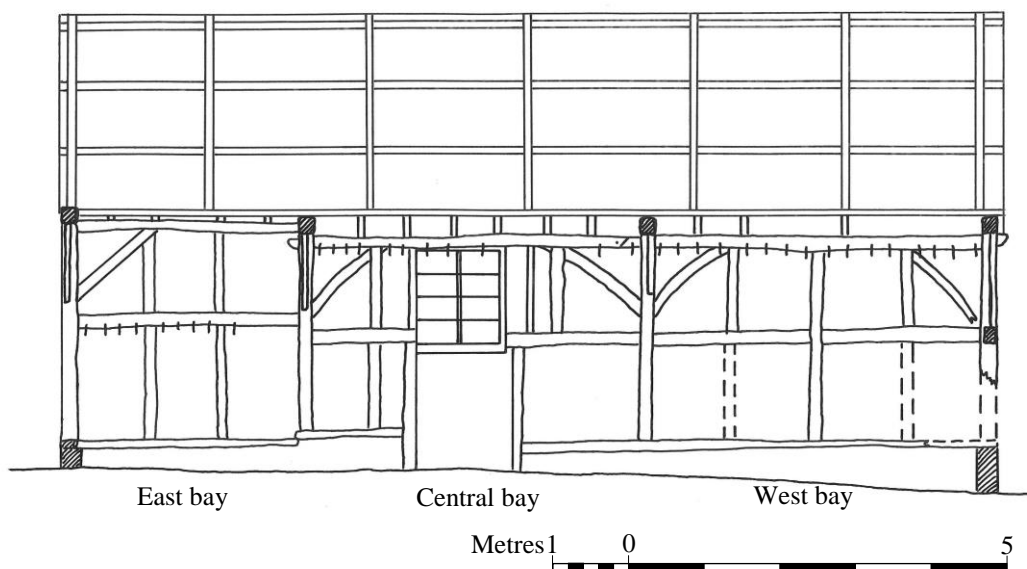
Figure 8: Barn 1, internal view of south wall

*Note. Dashed lines show timbers inferred from empty mortise holes.
The 'ticks' on the lower side of beams indicate the position of stave holes.

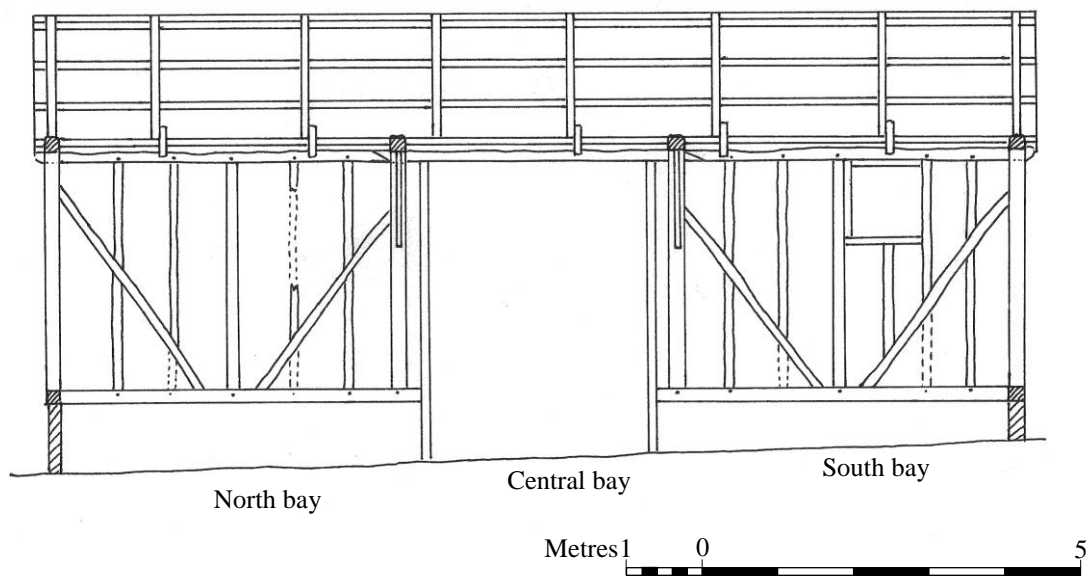
Figure 9: Barn 2, internal view of east wall

*Note. Dashed lines show reconstructed frame based on presence of empty mortise holes or by inference from surviving structure.

Barn 2 was dismantled and replaced by a new building as part of the development works. It was located at the west end of the farmyard, aligned approximately north-south and measured 13m long by 5m wide (Figures 9 and 10). The timber-frame was on a sill wall of brick with a mixture of limestone and brick used in the north end wall (Image 19). In plan it consisted of three bays with a full height double door in the east side and a three-quarter height pair of narrow doors in the west side of the central bay.

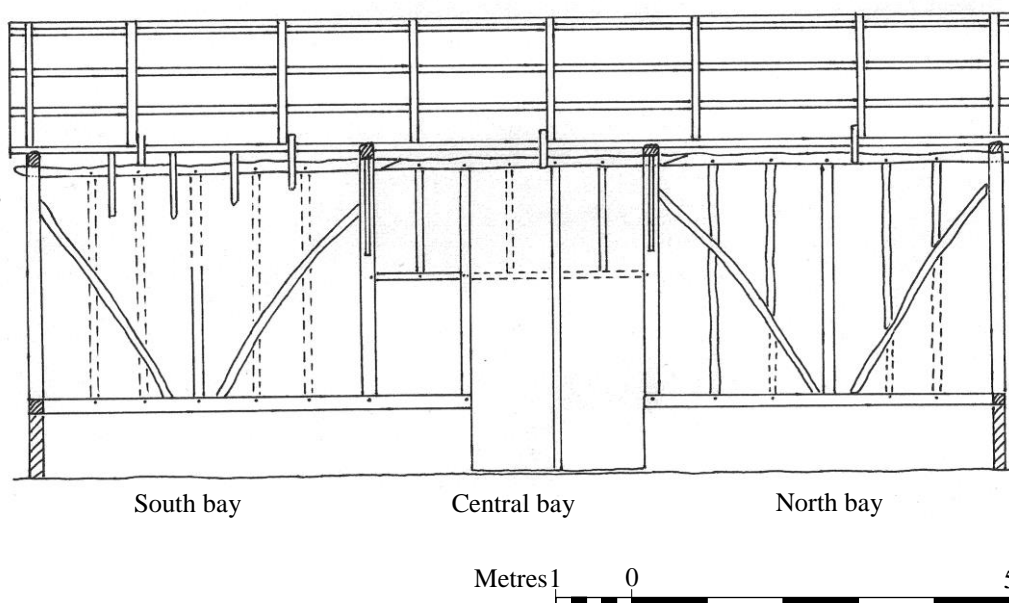
Figure 10: Barn 2, internal view of west wall

*Note. Dashed lines show reconstructed frame based on presence of empty mortise holes or by inference from surviving structure.

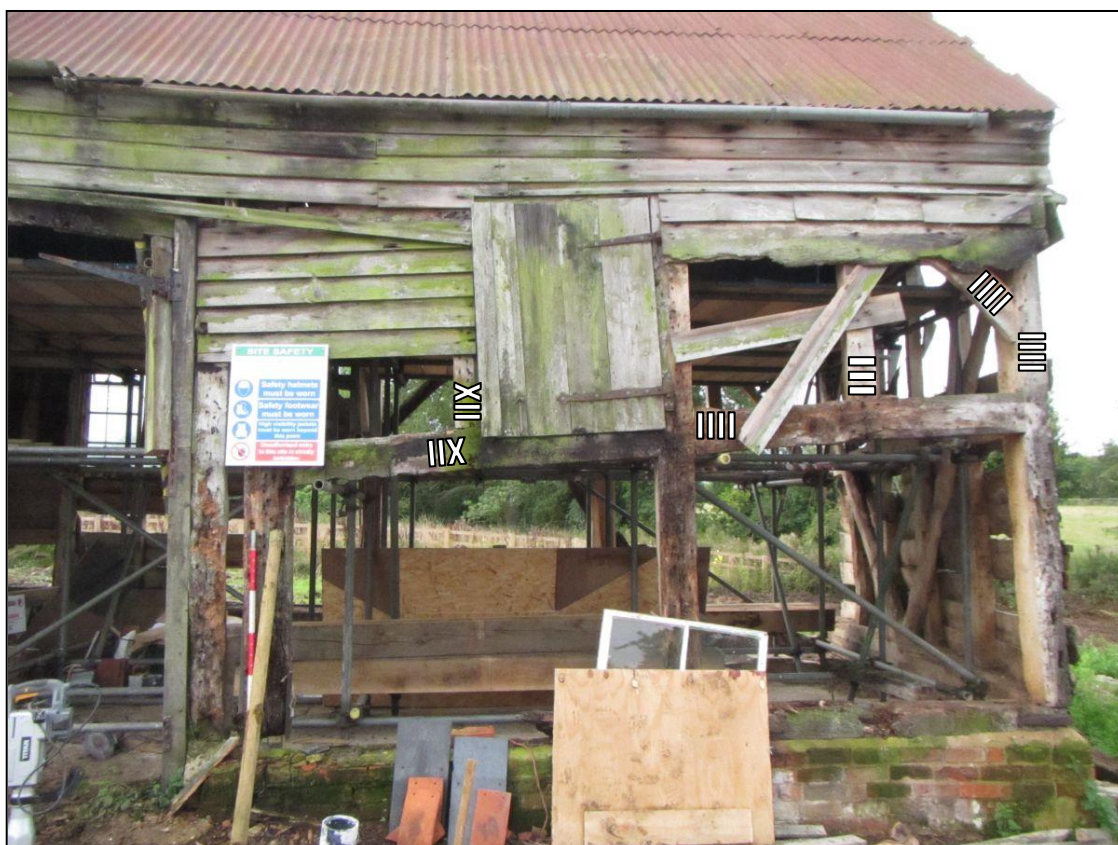
Image 5: Barn 1, exterior of north side

Showing north side of west bay under repair. Image annotated to indicate location of assembly marks (Scale 1m)

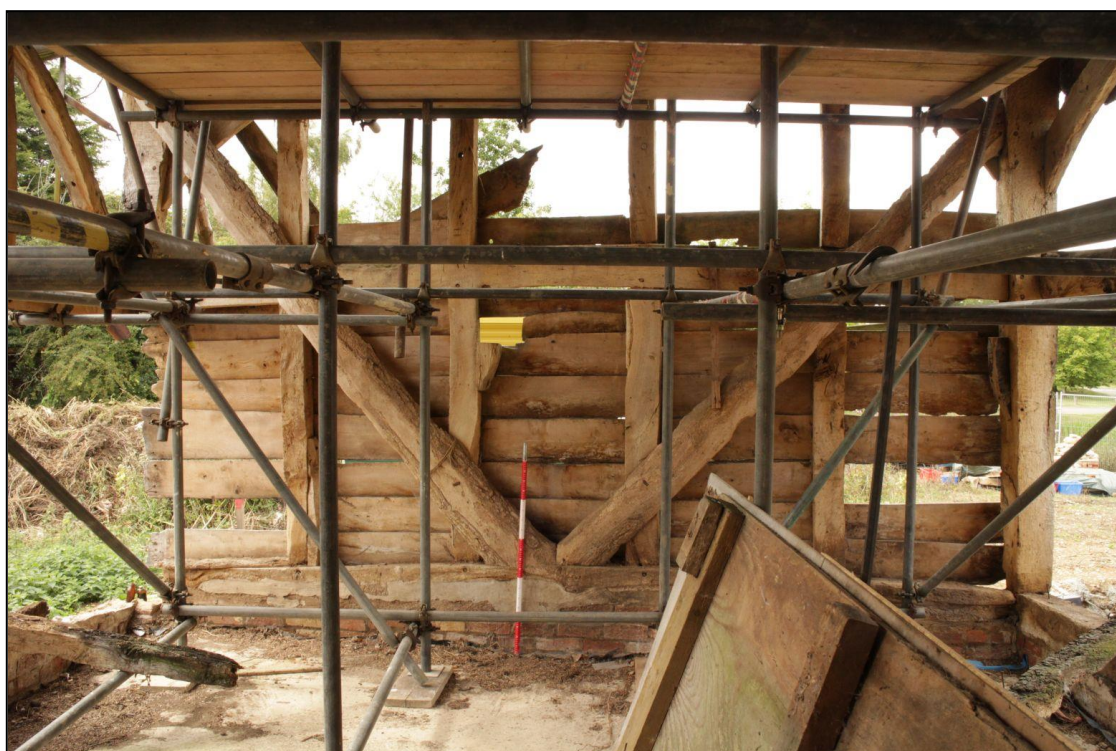
Image 8: Barn 1, interior west end

West end of building under repair (Scale 1m)

walls of the west and central bays originally had wattle and daub infill. The stave holes in the upper part of the frame pass the arch braces on the inside, indicating that the bracing was visible externally. It is clear that the transverse frame on the east side of the central bay was formerly an end wall. The posts in this frame have cut-off tenons for a former mid rail and in the underside of the tie-beam there are four empty mortises for studs and stave holes for wattle infill (Image 12). In contrast with the other the walls, the west end of the building has no stave holes or grooves to indicate a former wattle infill. The west end wall has been reinforced with two diagonal braces that are fixed with large T-headed nails (Image 8).

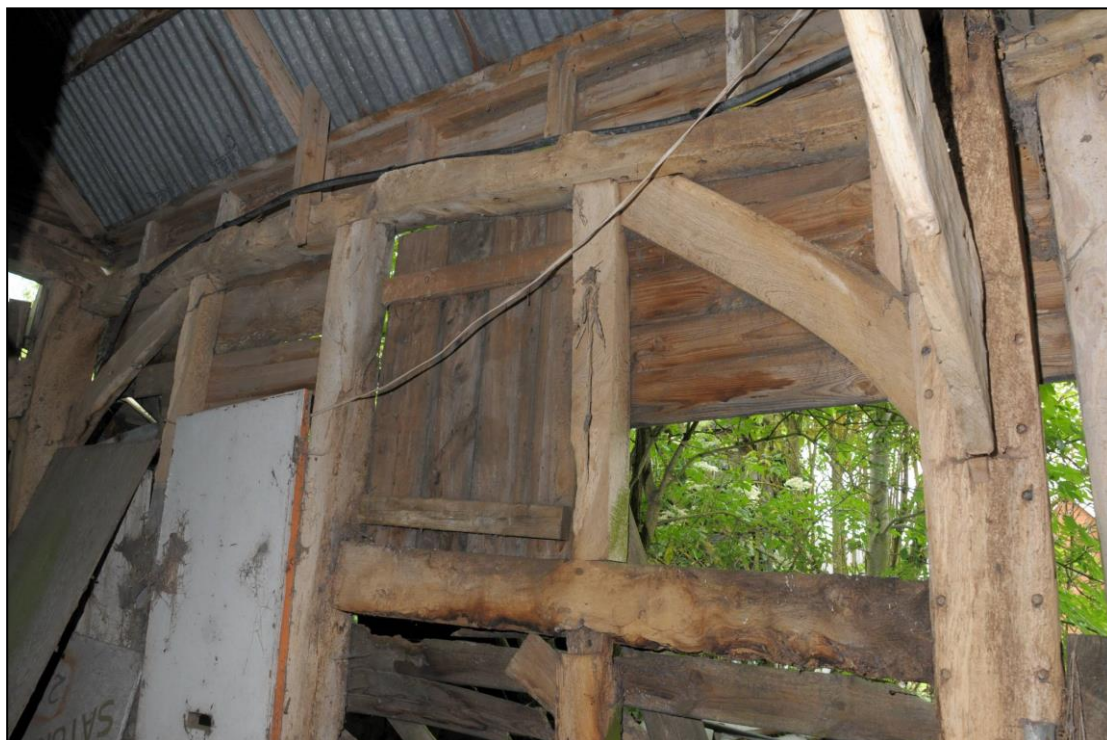
Image 9: Barn 1, interior north wall

Wall framing and high level door in north side of west bay. Looking northwest

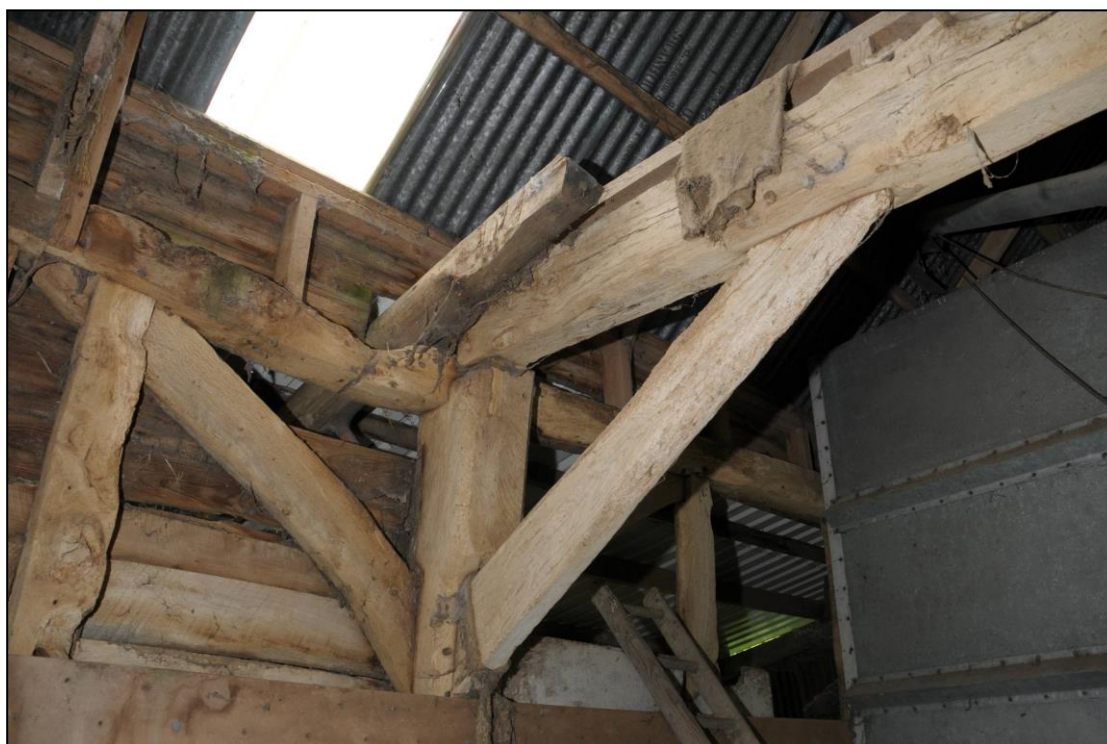
Image 10: Barn 1, interior south wall

Looking south-west showing south end of tie beam between the central and west bays

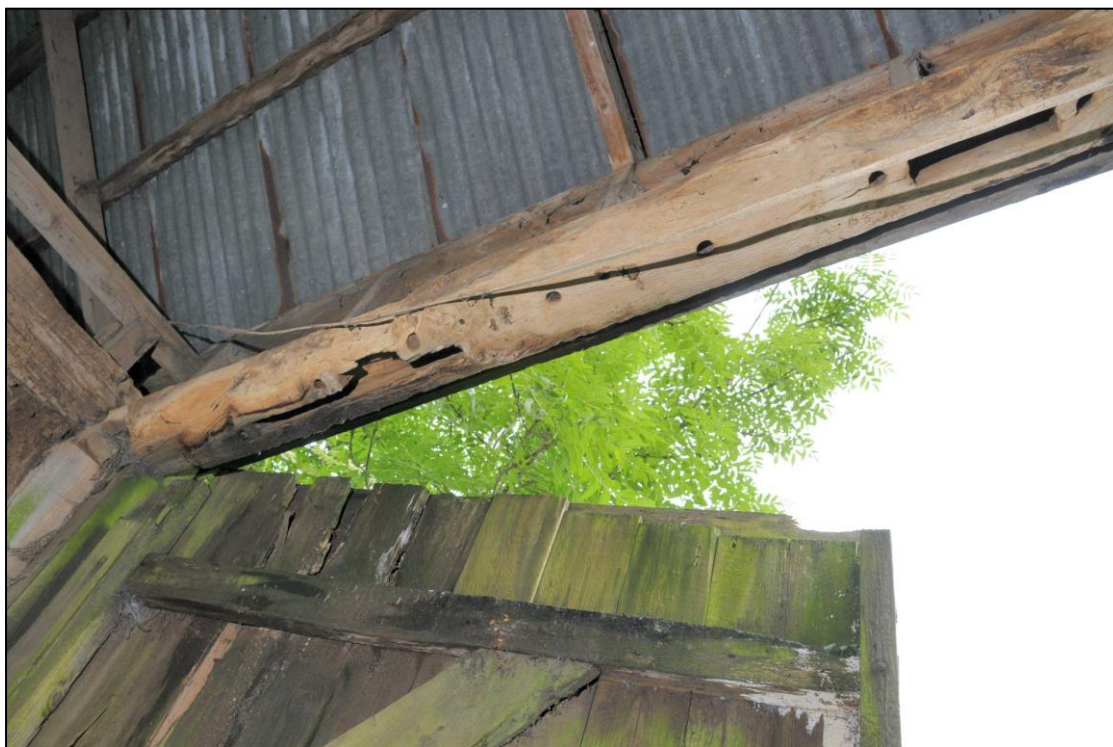
Image 11: Barn 1, interior north wall

Wall plate above door opening showing empty stave holes and mortises

The two bays at this end of the barn show evidence of a number of modifications. The full height door in the central bay has been inserted into what would have been a framed wall as demonstrated by empty mortises and stave holes in the underside of the wall plate (Image 11) and mortises in the sides of the two principle posts (figure 7). A narrower opening in the southern wall also appears to be a later insertion. At the time of the survey the upper part of this opening contained a metal framed window. A high level door in the north wall of the western bay was inserted after the removal of the wattle infill because stave holes also continue above this door opening (Image 9). Other possible evidence for later repairs or modifications can be seen in the frame on the west side of the central bay (Image 10). Here the principle posts have distinctively cut jowls with a splay at the base of the jowl and chamfered sides. The heads of the posts are joined to the tie beam with slip tenons which may be evidence of repair as these could have been inserted into the join. In addition the braces to the tie beam in this frame are straight, contrasting with the curved braces in the other transverse frames.

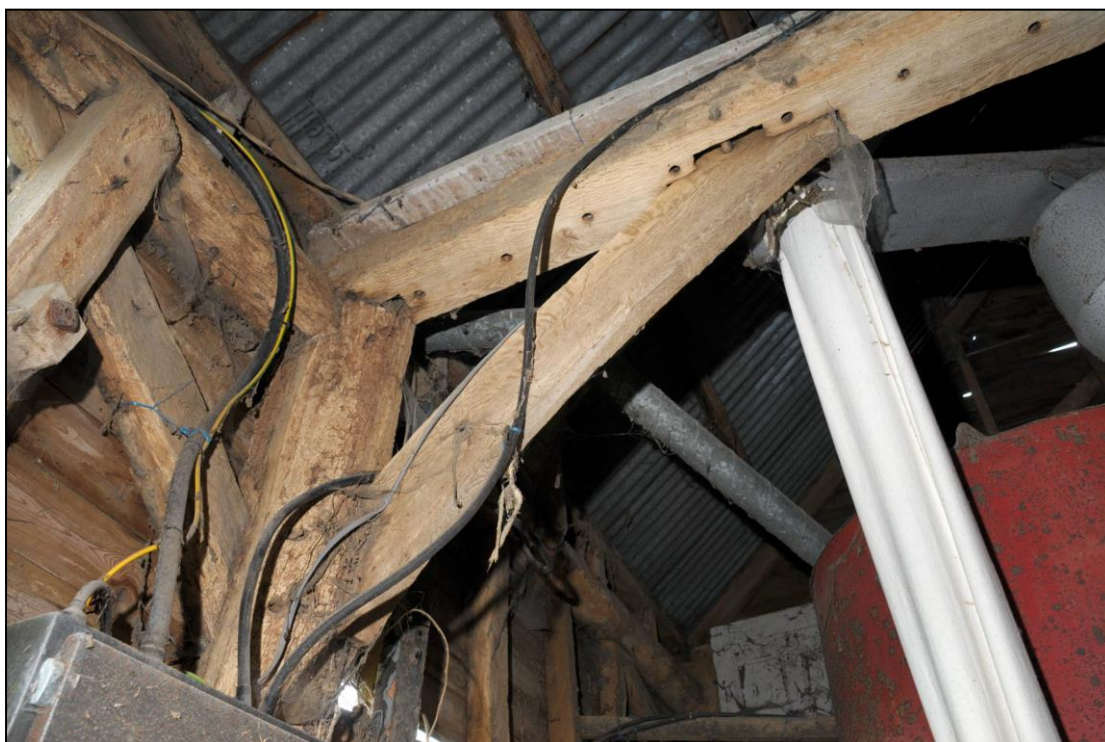
Image 12: Barn 1, interior north wall

Looking north-east showing north end of tie beam between central and east bays showing stave holes in underside of tie beam

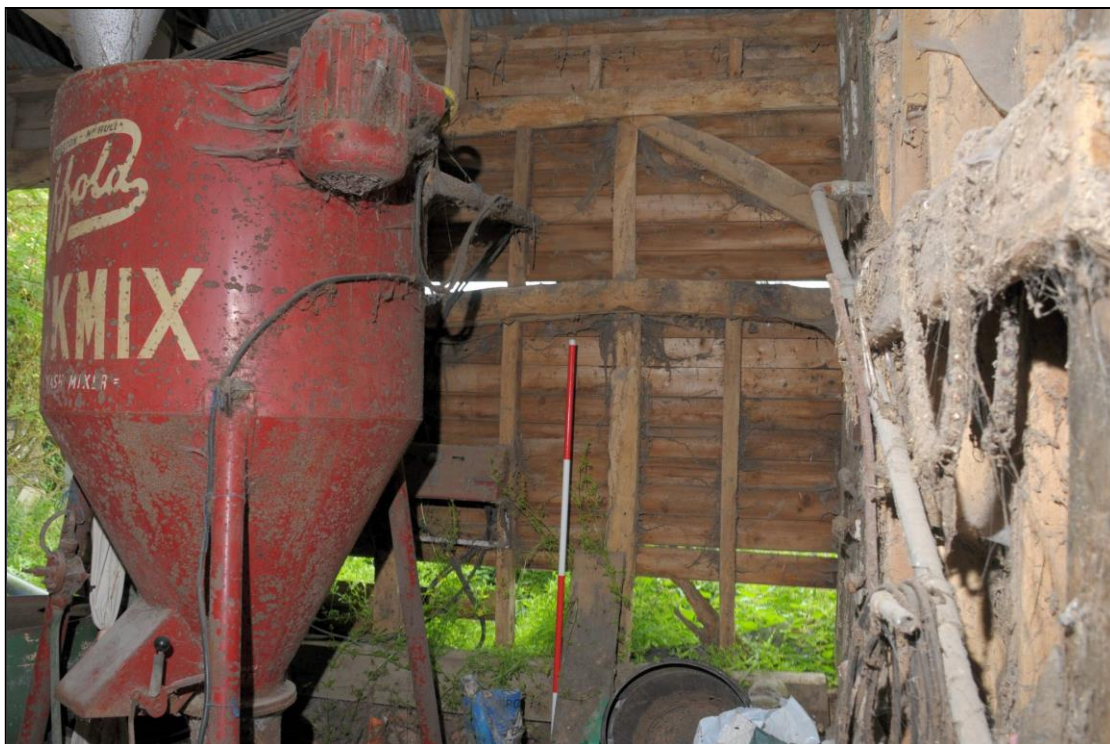
Image 13: Barn 1, interior north wall

North wall of east bay, showing contrast with framing in earlier bays with straight bracing and narrower, relatively closely spaced studs (Scale 2m)

The eastern bay differs in character to the central and western bays and is clearly a later addition (Image 13). Sill beams and wall plates in the eastern bay are discontinuous with those to the west. The framing of the side walls includes rails located in the upper part of the wall and straight braces, contrasting with the framing of the earlier parts of the building. This bay appears to have been clad in weatherboard from the outset as it lacks any stave holes in the wall plates. Stave holes and empty mortises in the rails indicate that some of the timber is re-used.

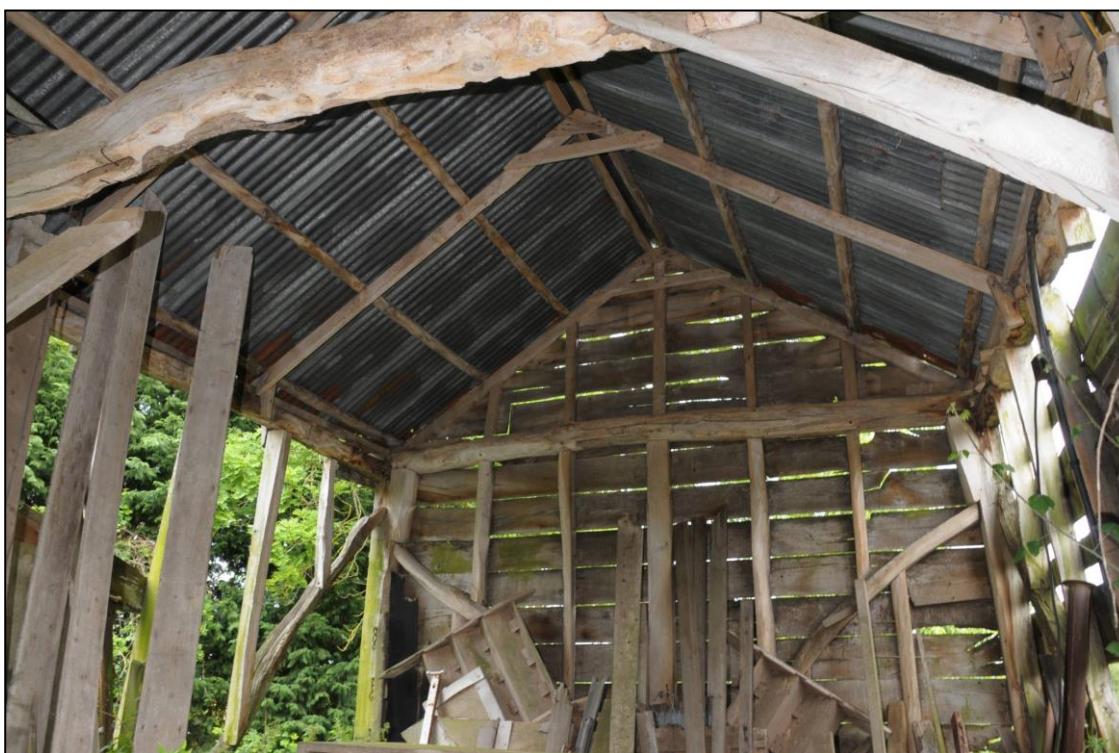
Image 16: Barn 2, interior

North end wall showing primary bracing

fixings (Image 16). The jowls of the corner/principle posts in the end walls were cut to form a slight notch for the top end of the braces (Image 17). Intermediate posts and studs were tenoned and pegged into the sill beam and wall plate at top and bottom and nailed to the braces. In the transverse frames the braces below the tie beams were straight with mortise and peg fixings. The wall plates had splayed scarf joints fixed with bolts or spikes (Image 18).

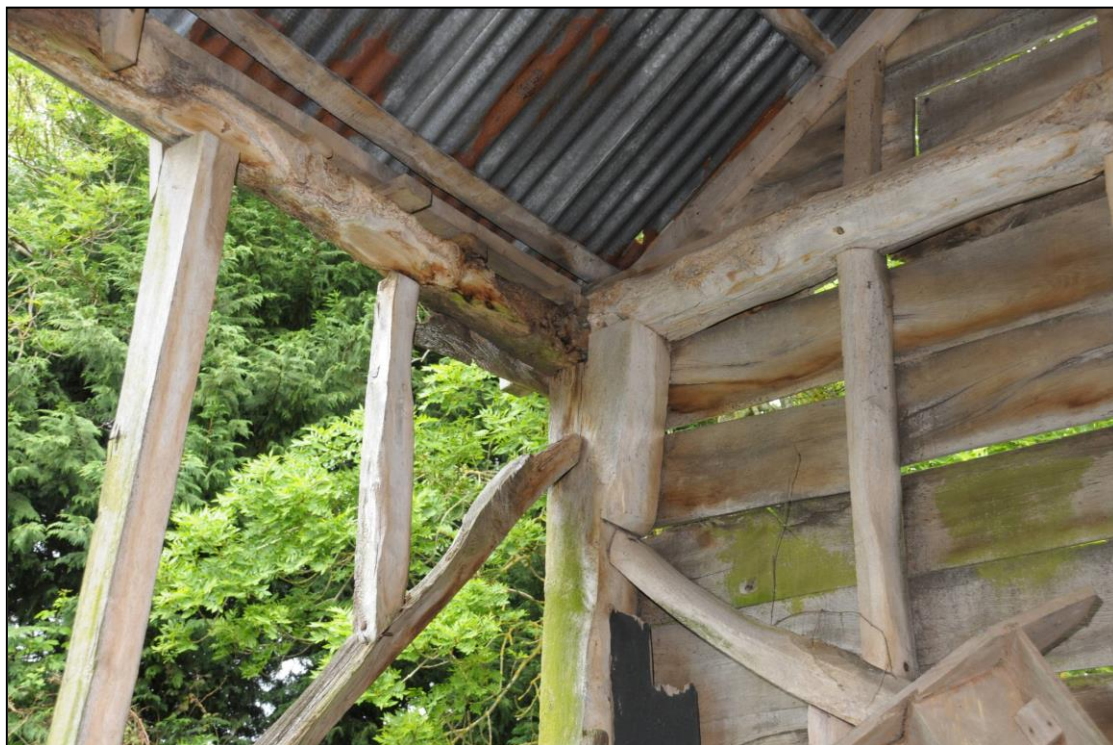
Image 17: Barn 2, interior

Showing detail of north-west corner post

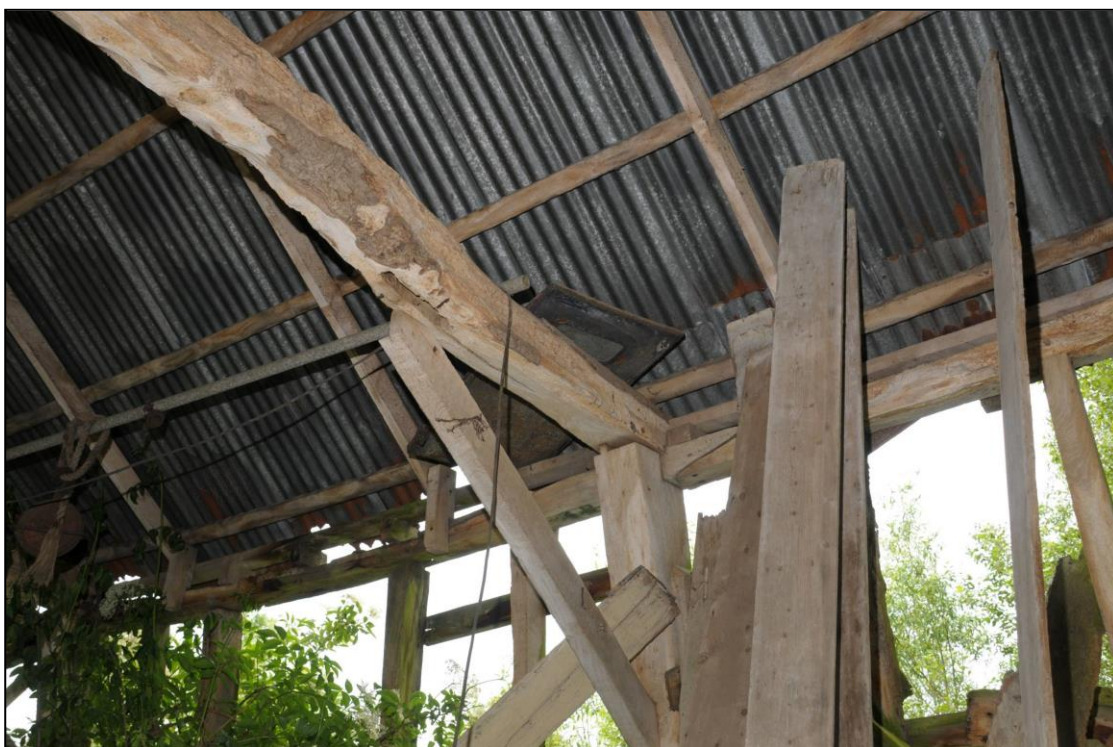
Image 18: Barn 2, interior

West wall, showing detail of tie beam on north side of the central bay
Shows splayed scarf in wall plate

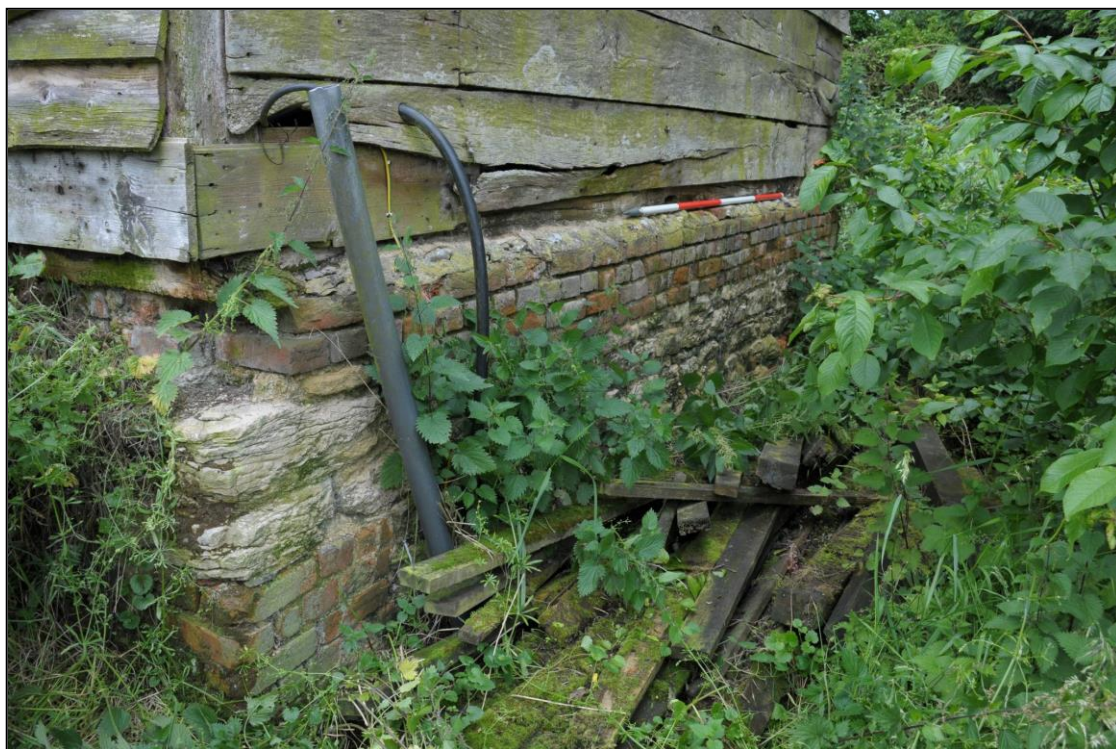
Image 19: Barn 2, exterior detail

Detail of sill wall at north-east corner of building showing mixed brick and limestone construction

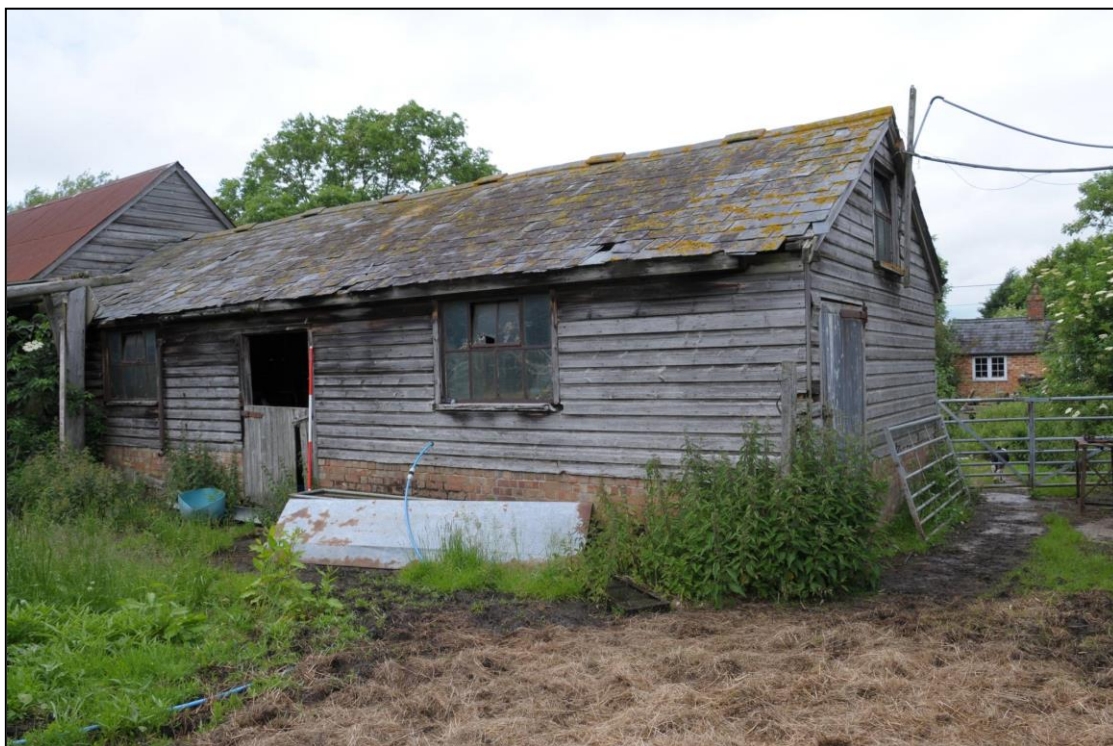
Image 20: Dairy, exterior

Looking north-west showing south side and east end of building (Scale 2m)

The building is constructed with a brick base approximately 0.8m high and a timber frame with closely spaced vertical studs, clad externally in horizontal tongue and groove boards (Images 20 and 21). The internal fittings and openings have been modified as part of the conversion. At the time of the survey the walls were lined internally with galvanised sheets extending to eaves level along the sides and east end, being slightly lower at the west end. The timber frame was visible internally in the east gable whilst at the west, above the galvanised sheets the wall was lined with horizontal planks. The floor was concreted with an incised chevron pattern.

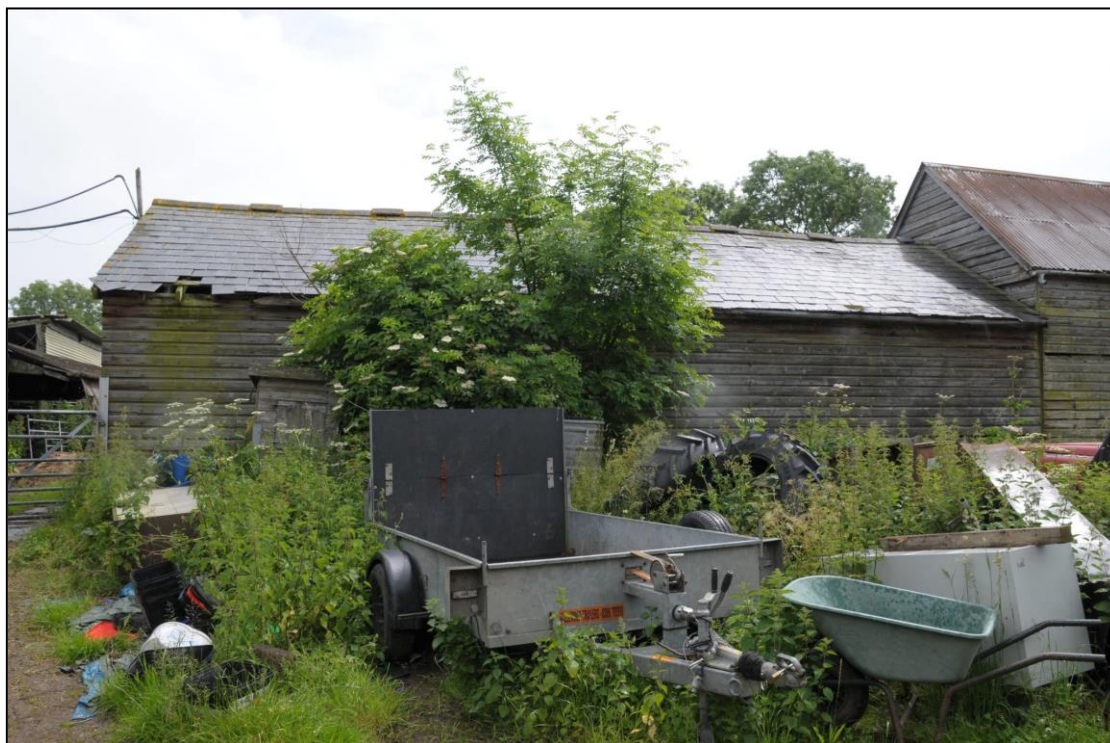
Image 21: Dairy, exterior

Looking south, showing north side of building

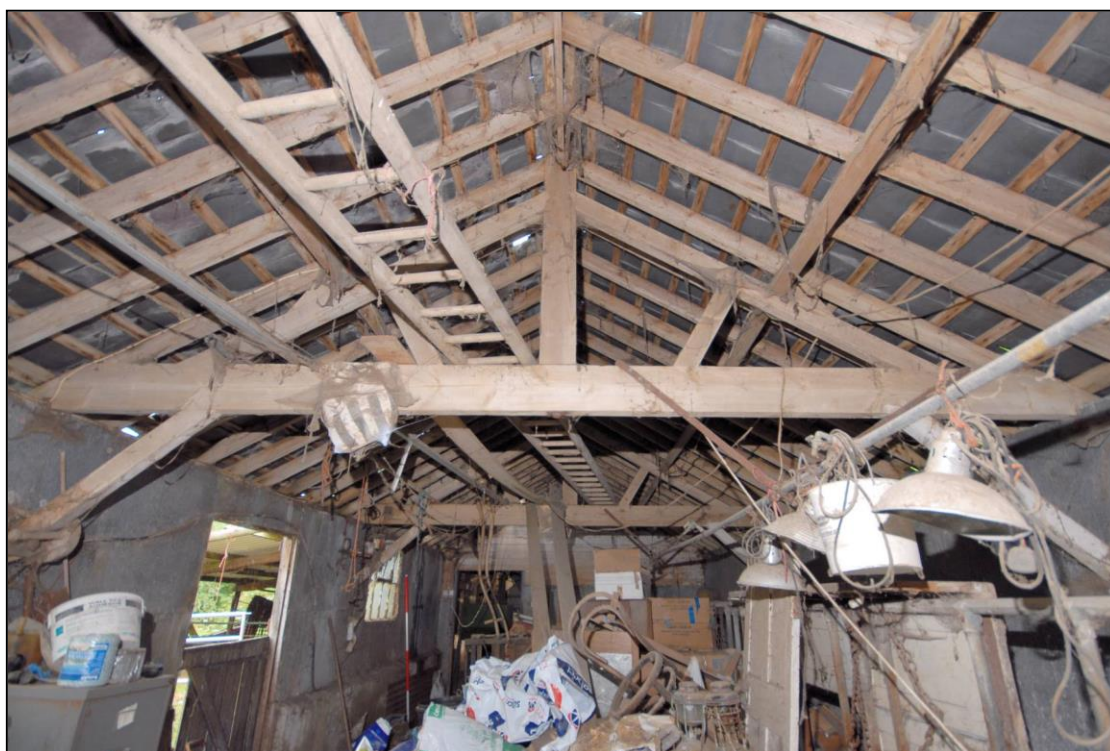
Image 22: Dairy, interior

General view of the interior looking west

The roof is supported by king-post roof trusses with a single purlin each side and a ridge plank (Image 22). Several small ventilation slots were formed along the ridge of the slate roof by lodging the ridge tiles on the edges of the tiles to either side.

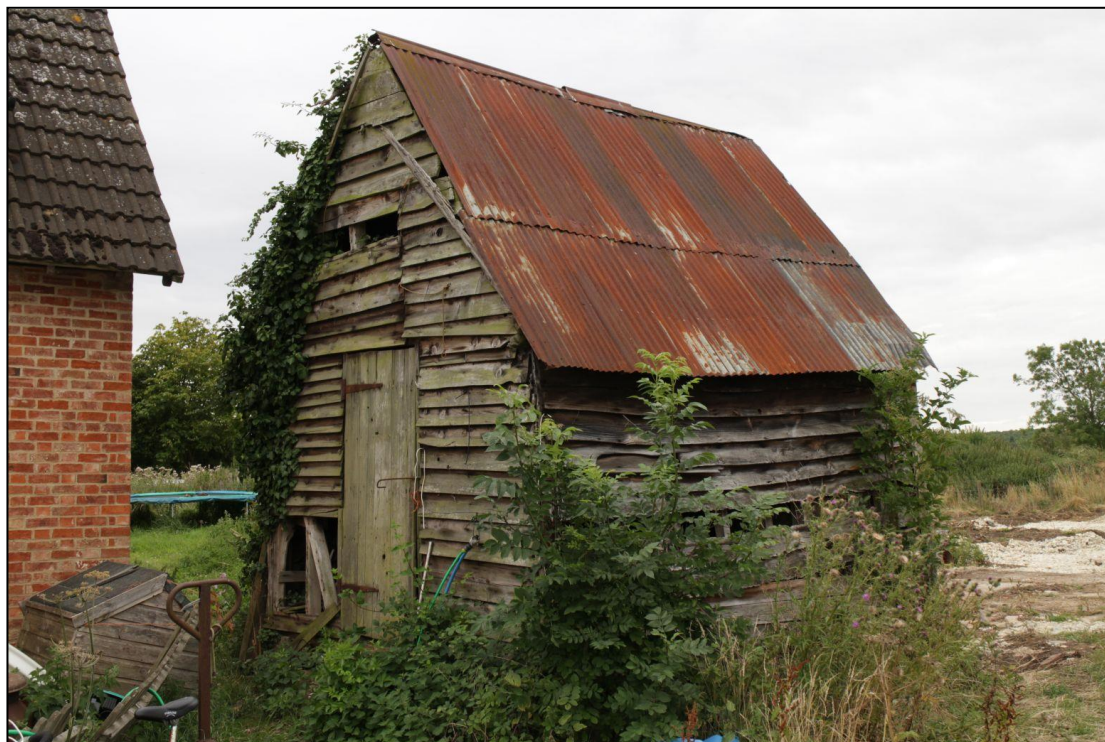
Image 25: Granary exterior

Looking south-east, showing north end and west side

This is a small staddle granary, 4m long by 3.5m wide. It is raised on short brick piers with brick steps providing access to a single door in the north end (Figure 11, Images 25 and 26). The frame has four corner posts with jowled heads which join the wall plates and tie beams in a standard tie beam lap dovetail assembly with pegged fixings (Image 28). The north-west corner post was the most accessible at the time of the survey. It is 130mm wide by 150mm deep, increasing to 160mm wide by 200mm deep at the jowl top. It has a pair of tenons at the junction with the tie beam instead of the more usual single centre tenon. The floor is supported by sill beams which are tenoned into the sides of the posts, however these have decayed and the junctions have been supported with a combination of metal straps and brickwork inserted below the sill. The walls have primary bracing with straight tension braces nailed to the corner posts and sills with the studs nailed to the braces (Image 27). The studs vary in width from 70mm to 100mm. All of the timber used in the frame is sawn and includes some with waney edges. The walls are clad externally in horizontal weatherboarding. The east wall has a small fixed light located centrally at the top of the wall.

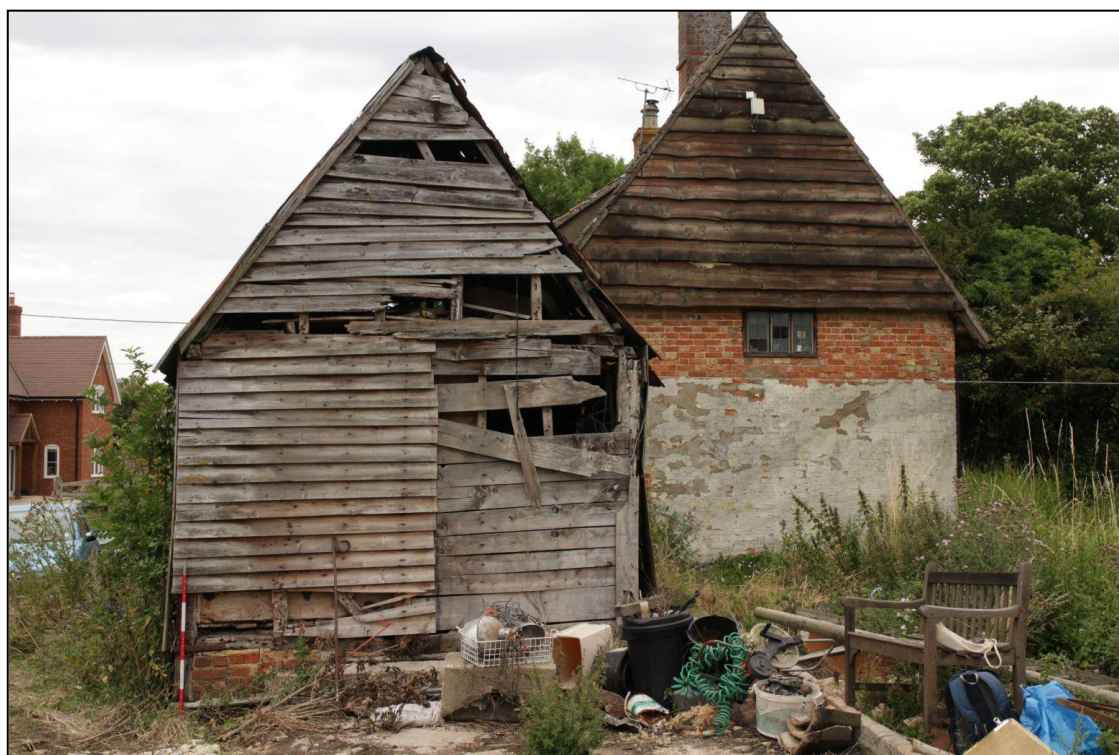
Image 26: Granary exterior

Looking north, showing south end (Scale 1m)

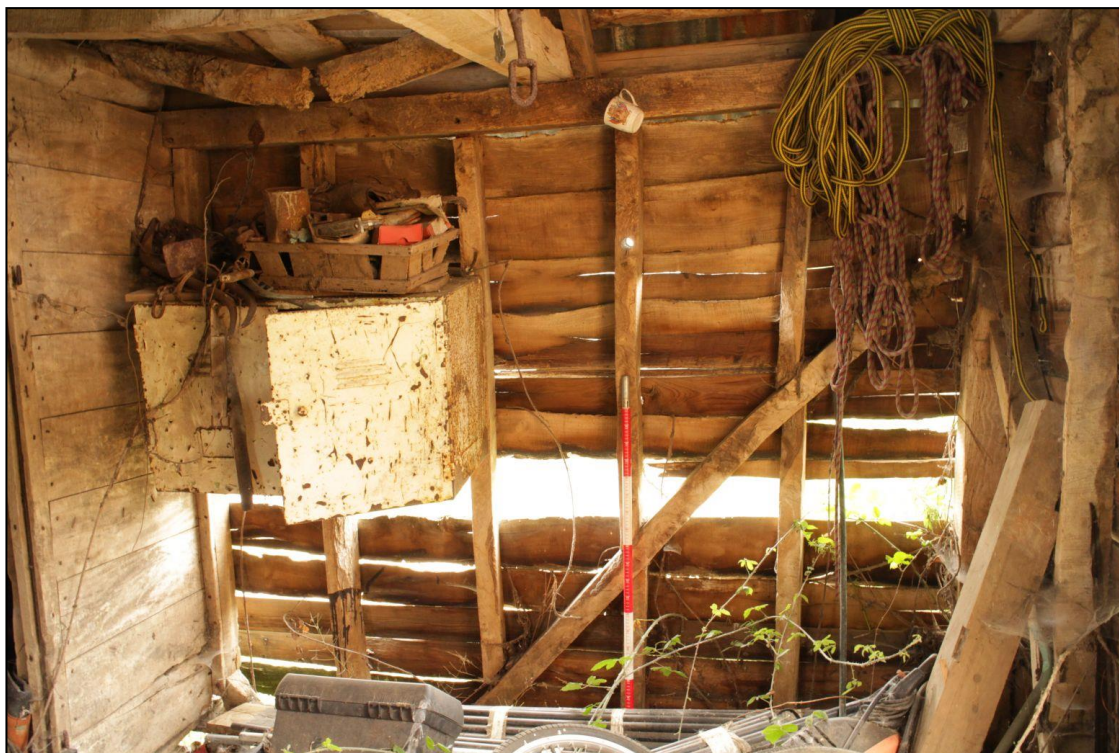
Image 27: Granary interior, west wall

Looking south-west, showing west wall with primary bracing and north side of enclosed compartment in the left of the image (Scale 1m)

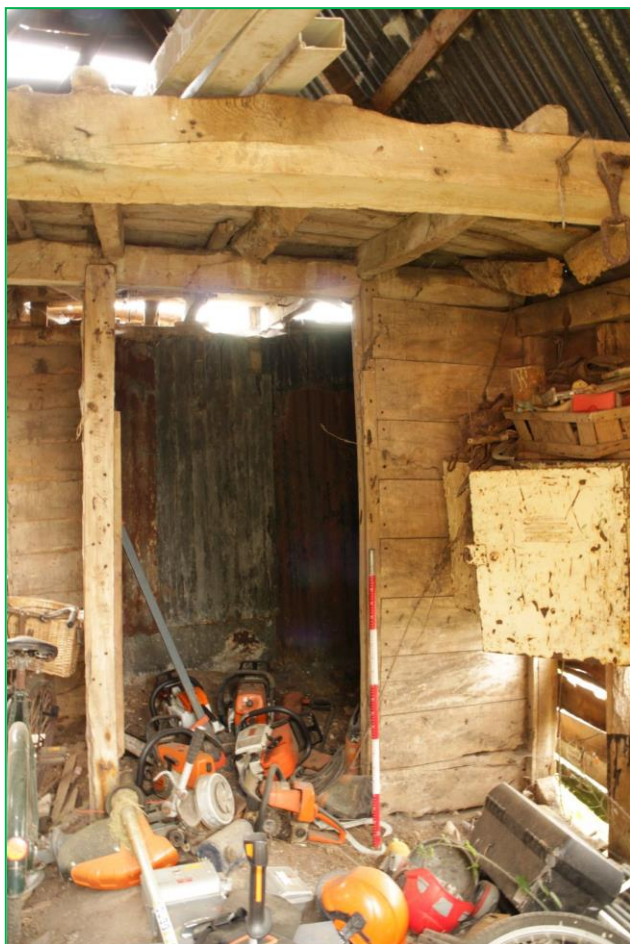
Image 28: Granary interior

Looking north-west, showing north-west corner post

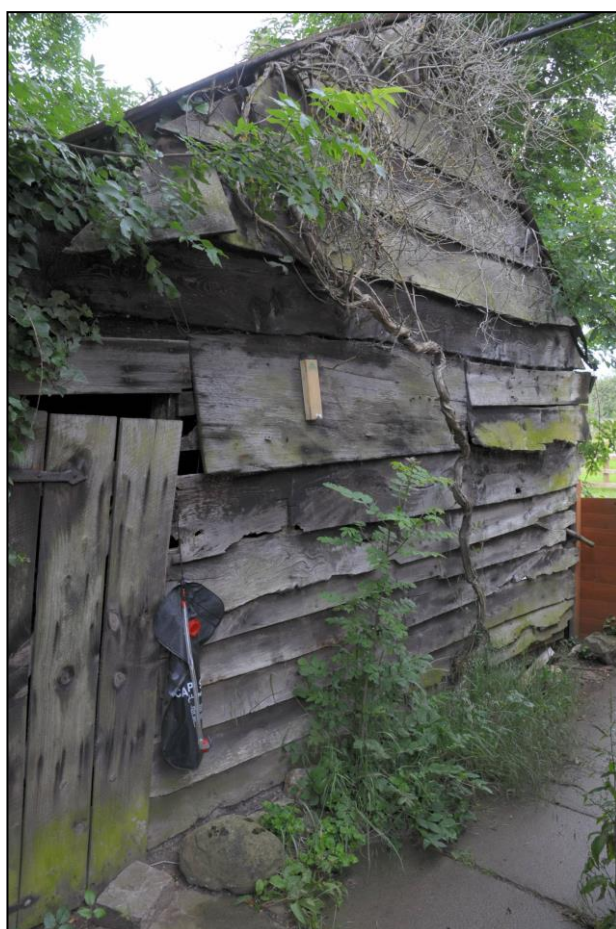
Image 31: Buildings 1 and 2, exterior

Looking southeast, showing north side of buildings

Buildings 1 and 2 form an east-west aligned range located at the north side of the farmyard which forms part of the street frontage (Image 31). In the development

These are single storey wooden buildings used as a workshop and for storage. Externally buildings 1 and 2 are distinguished by a slight break in the line of the corrugated iron roofs with building 2 at the eastern end being slightly higher (Image 31). Building 1 was timber framed with closely set studs supporting weather-board cladding. The roof is supported by a king post roof truss. The western end of building 2 was inaccessible. The eastern end of building 2 is separated internally by a partition extending up to eaves level. The roof structure consists of a king post truss situated above the partition with the western half of the building (Image 33). The walls consist of closely set vertical studs with primary tension bracing. It is accessed by a door in the east end (Image 32).

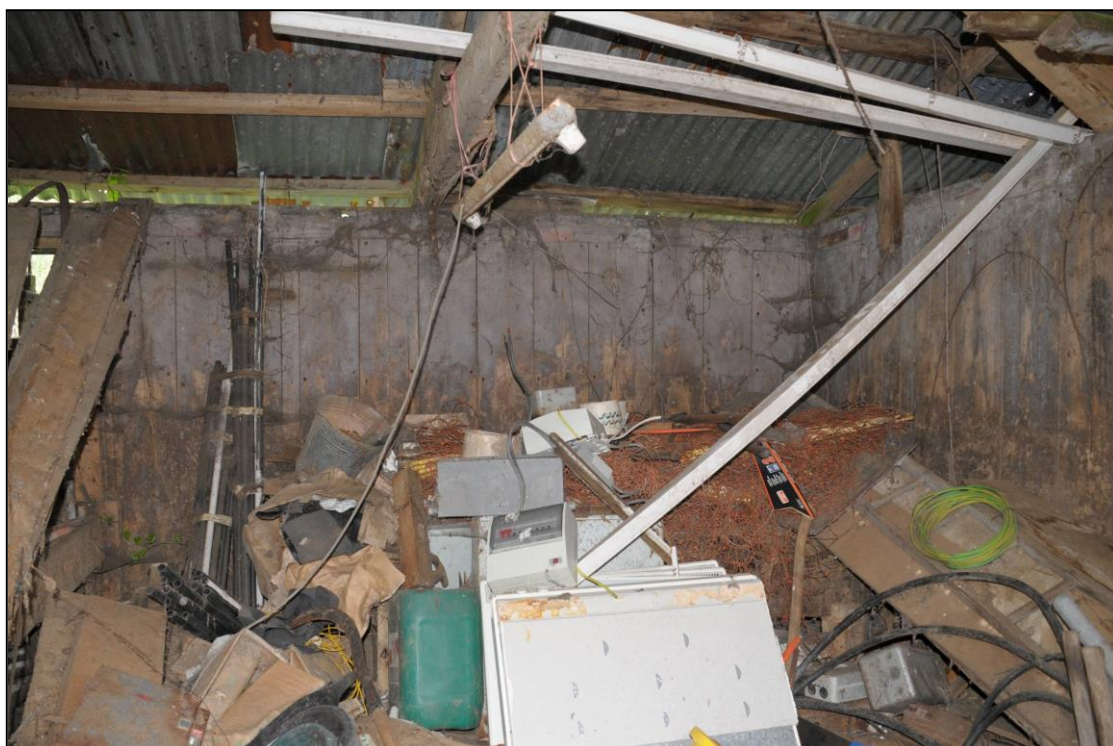
Image 35: Building 3, interior

Interior view looking northeast

Building 3 was at the north end of the range (Image 35). The exterior was covered with horizontal weatherboarding and the interior lined with flush vertical planks with horizontal battens. The roof had a king post truss made from reused timber with a corrugated iron covering. It had one door located in the southern end of its west wall and was lit by two windows placed high up at either end of the east wall. A wooden hayrack set just below the windows extended along most of the east wall. The interior was open to the adjacent building to the south (building 4), with a divider formed by metal railings.

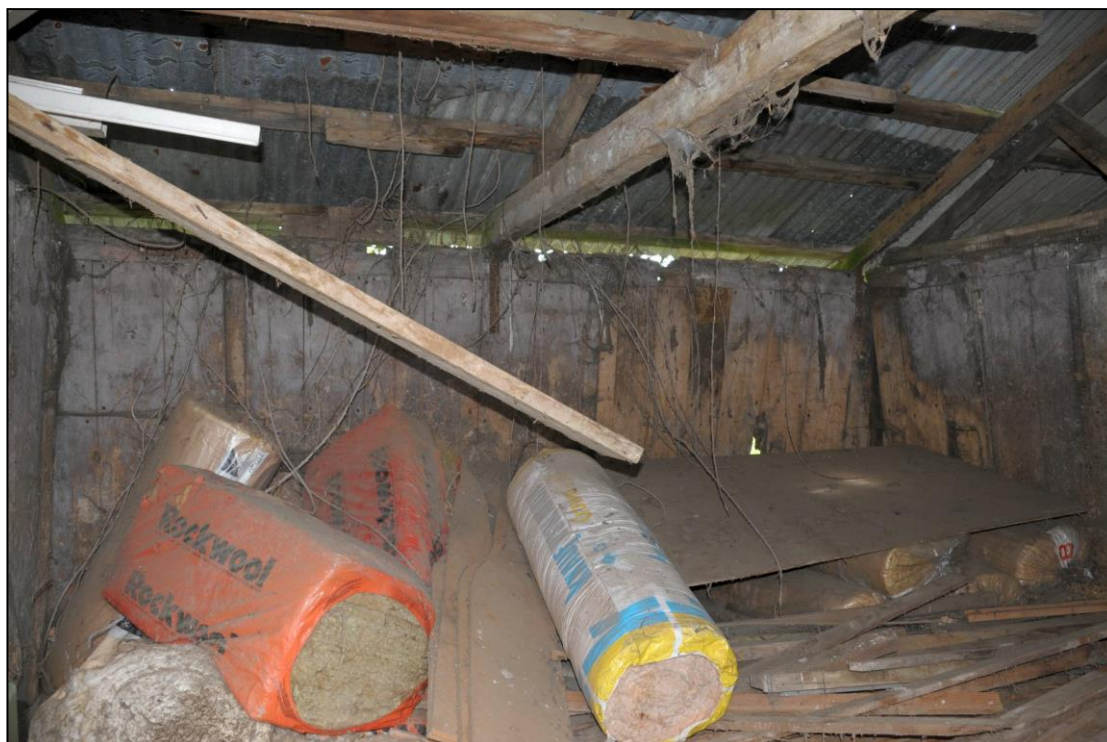
Image 36: Building 4, interior

Interior view of northern section, looking east

Building 4 was in the mid part of the row (Images 36 and 37). The structure was clad in flush vertical boards inside and out. It was divided into two compartments by a partition in the same material as the external wall. The walls are believed to be reused material from railway wagons (pers. com. John King). There were two doors in the west wall. The roof consisted of king post trusses with a corrugated iron covering. A low level wooden hay rack and manger were located against the west wall in the southern compartment (Image 38).
