**WOOD END FARM
WOOD END, NASH
BUCKINGHAMSHIRE**

HISTORIC BUILDING RECORDING

Document: 2016/81
Version: 1.0
May 2016

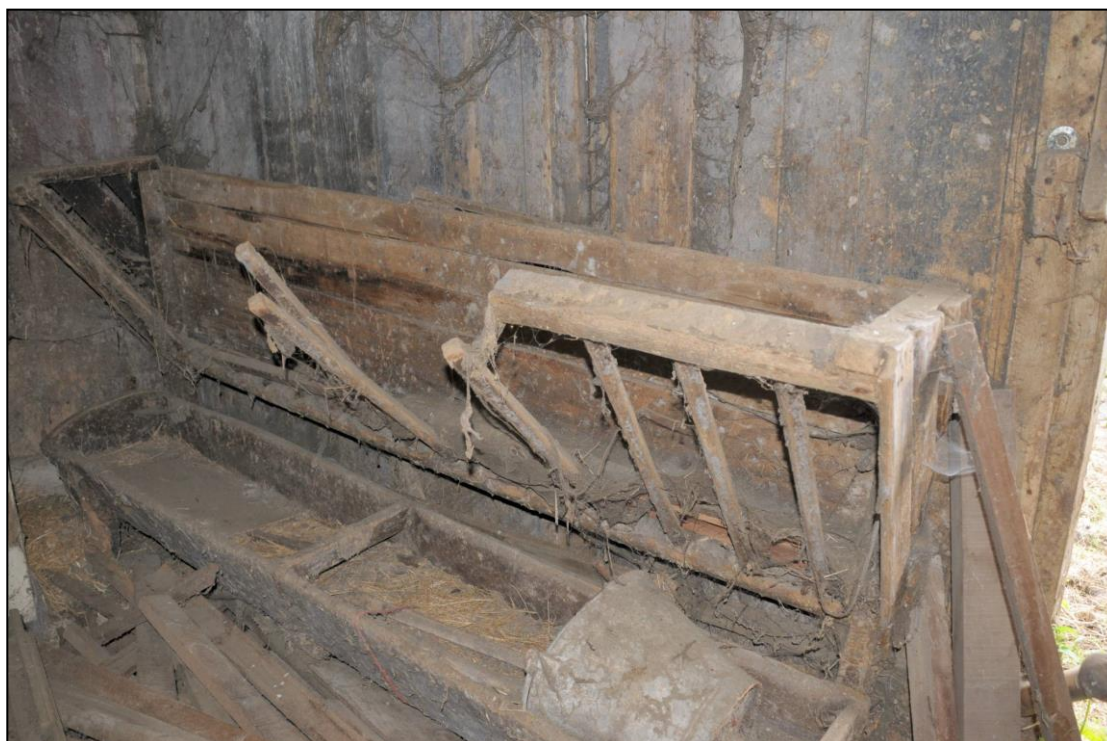
Image 37: Building 4, interior

Interior view of southern section, looking east

Building 4 was in the mid part of the row (Images 36 and 37). The structure was clad in flush vertical boards inside and out. It was divided into two compartments by a partition in the same material as the external wall. The walls are believed to be reused material from railway wagons (pers. com. John King). There were two doors in the west wall. The roof consisted of king post trusses with a corrugated iron covering. A low level wooden hay rack and manger were located against the west wall in the southern compartment (Image 38).

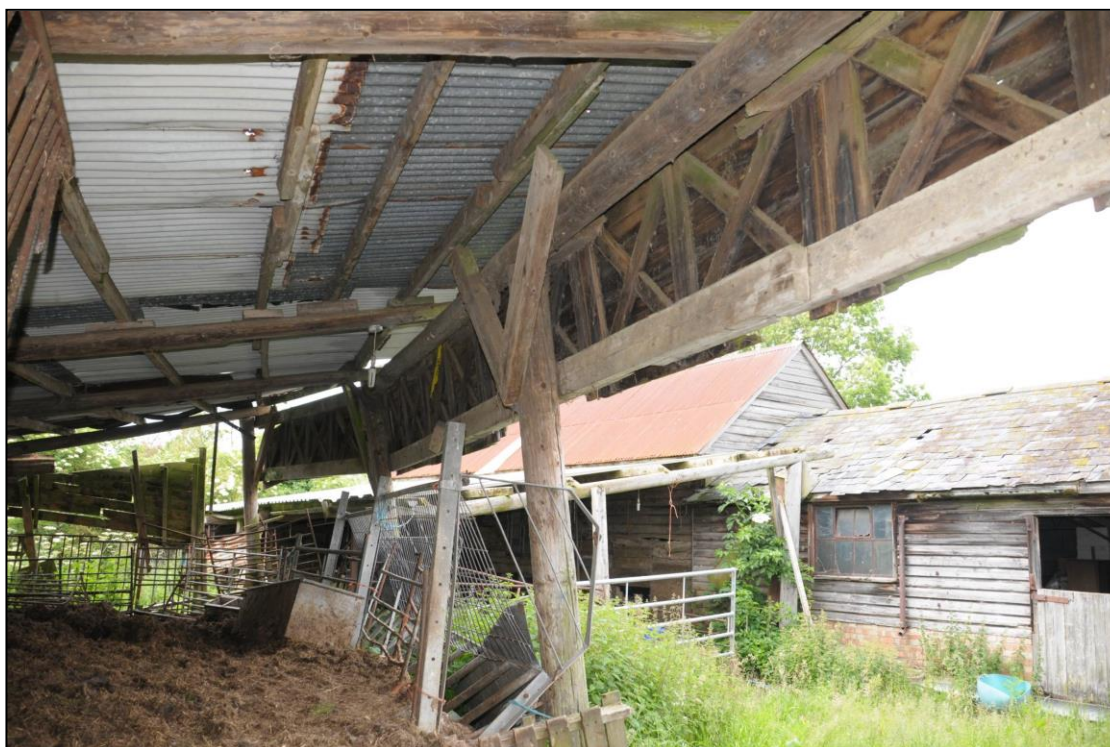
Image 39: Building 5, interior

Interior looking southeast

Building 5 abutted the south side of building 4 (Images 39). The south wall of building 4 was carried up to eaves height to form a partition between the two structures. The east, south and west sides of the building were constructed from panels of narrow vertical planks with internal horizontal battens. The roof was covered in corrugated metal.
