**HOLME MILLS, LANGFORD ROAD
BIGGLESWADE
BEDFORDSHIRE**

**ARCHAEOLOGICAL OBSERVATION
INVESTIGATION, RECORDING
ANALYSIS AND PUBLICATION**

Project: HM1622
Document: 2012/102

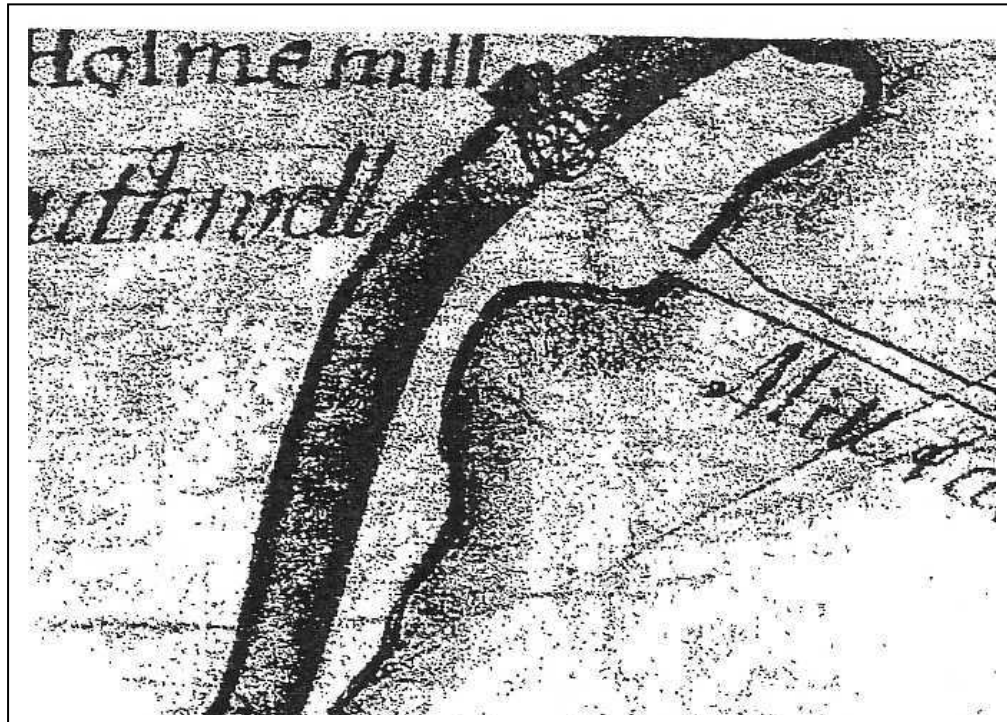
Map 1: Detail of 1702 map showing the external mill wheel with building to the east. Ref PRO E178 6756.

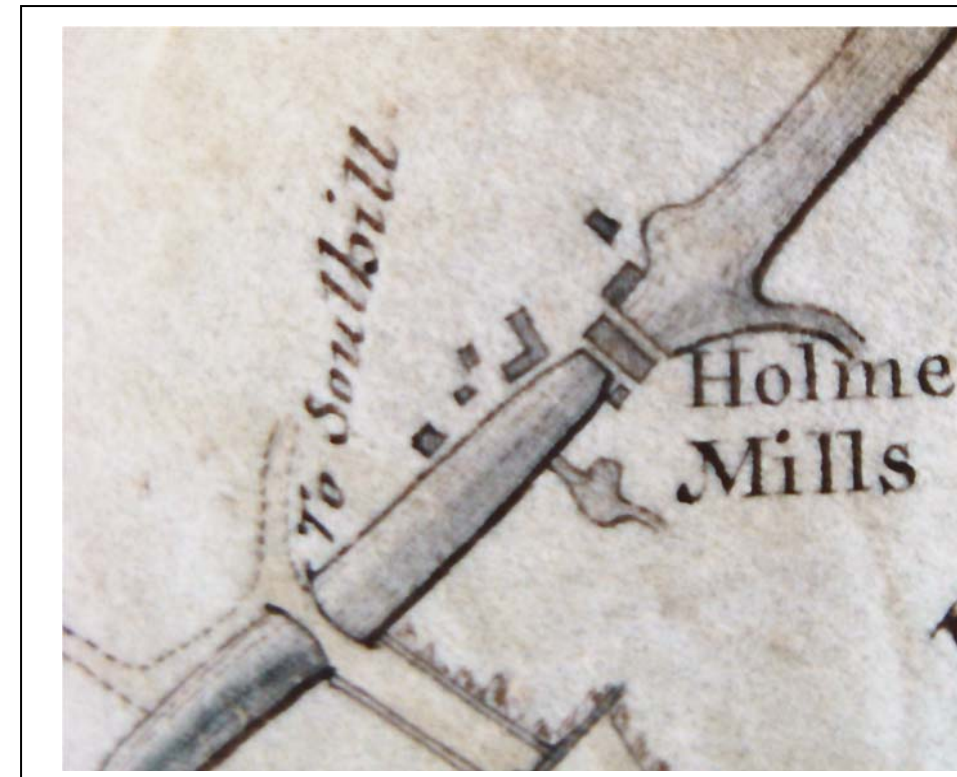
Map 2: Detail of the 1781 Plan and Survey of Holme Estate, showing the mill and associated buildings. Ref BLARS HF 400/1.

The Ironstone footings indicate that the mill had a similar width to the current building, though of shorter length; the eastern gable wall was exposed during ground reduction (Figure 5: images 3 and 4). Traces of the Ironstone footings were exposed beneath both the northern and southern walls of the standing mill (Figure 6: images 5 and 7 and Figure 7: images 8 and 10). The gable wall was substantial, 0.7m wide with no interruptions in it. It would appear that this also defined the western side of a bypass leat (see below). No material was recovered to date these footings. However, a smaller mill is shown on the 1781 map (Figure 2: Map 2), with the mill race running centrally through the building, indicating an internal wheel.

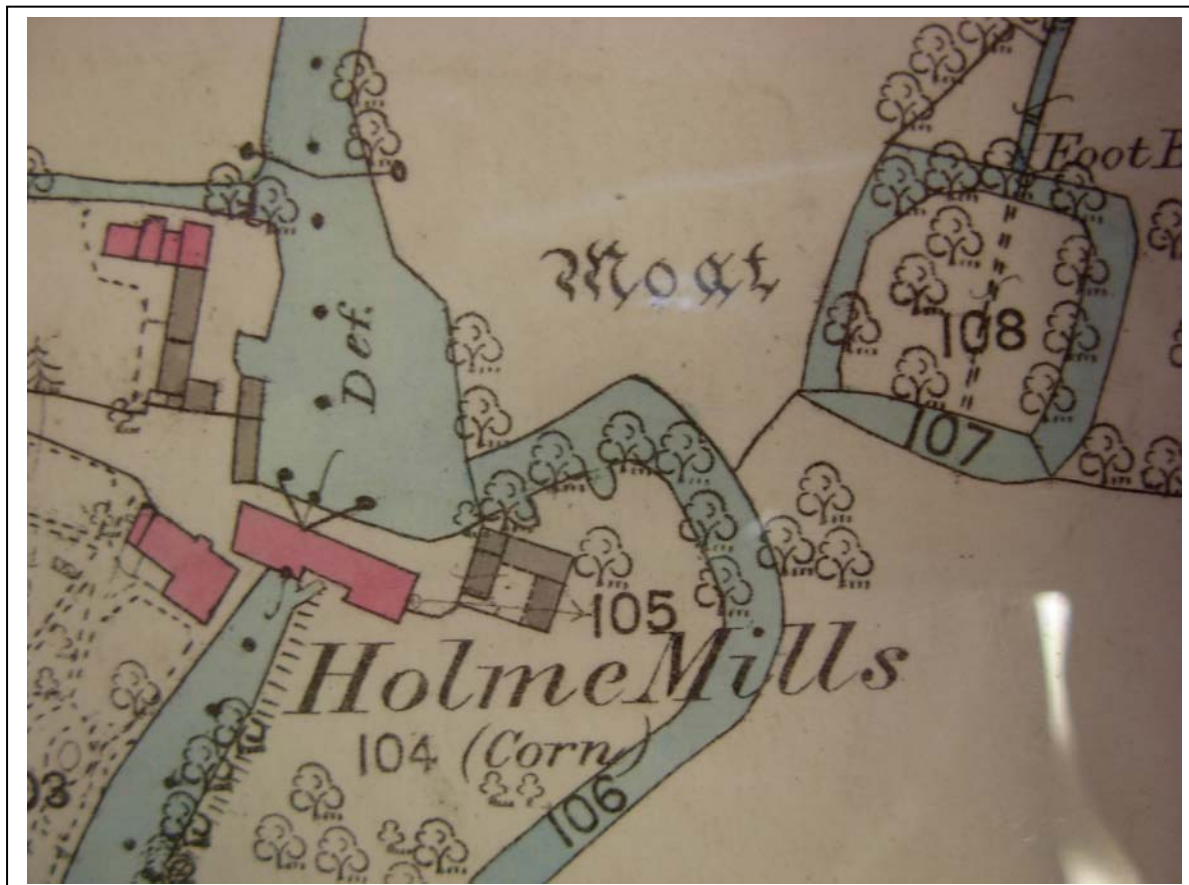
Map 3: Detail of the 1884 1st edition Ordnance Survey map showing the mill and associated buildings.

It is likely that the identified wall footings relate to an L-shaped range of buildings shown to the NW of the mill on the 1884 1st edition Ordnance Survey map (Figure 2: Map 3) and still present, though modified on the 1926 map (Figure 2: Map 4). The area to the east was occupied by buildings in more recent times.

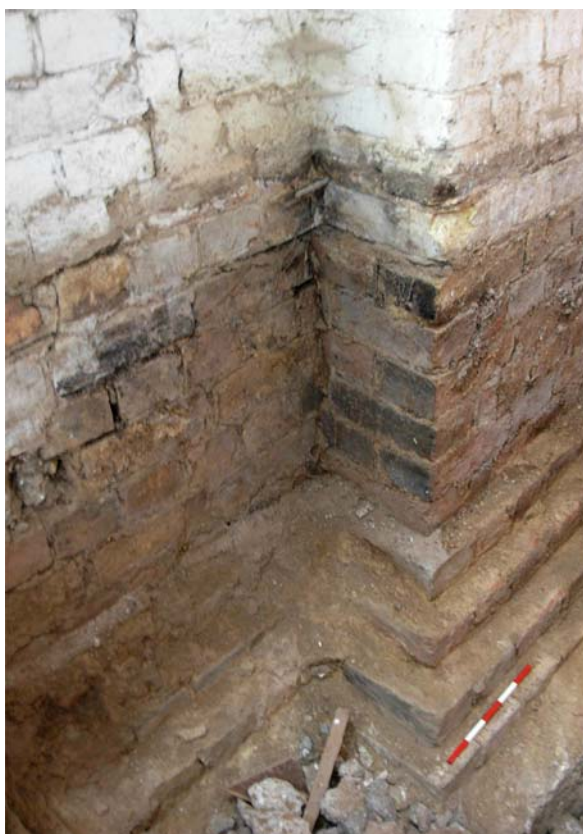
Image 1: Detail of stepped eastern gable wall of Mill Building revealed in the test pit, with Fletton bricks forming the superstructure — grey scar of modern concrete floor visible at top of image. Concrete underpinning is visible at the bottom of the image. Scale 25cm in 5cm divisions.

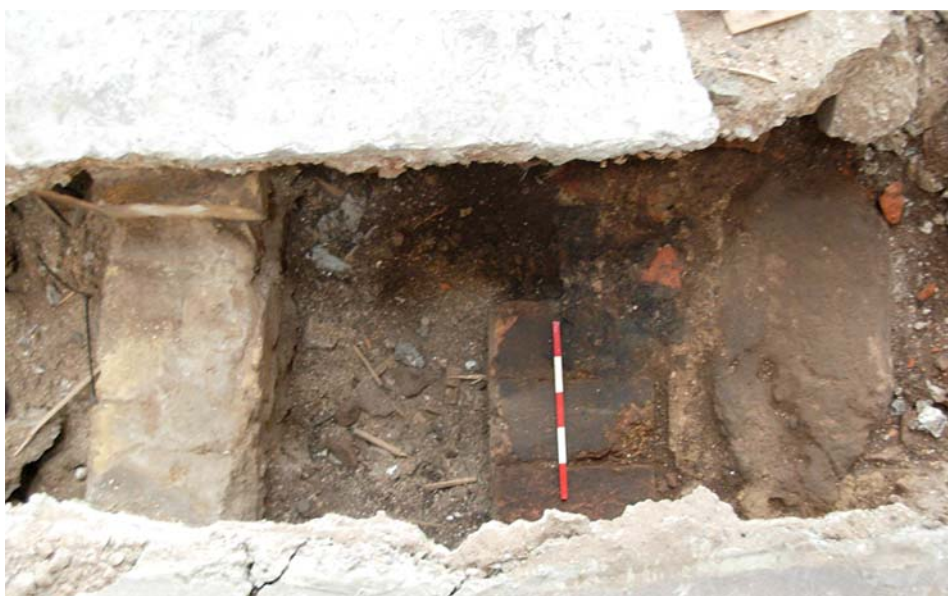
Image 2: Detail of three walls of contrasting materials, revealed in the narrow part of the test pit. The red brick of the footing beneath the scale shows discoloration due to burning. Scale 25cm in 5cm divisions.

The initial test pit also revealed a single wall composed of Fletton bricks (Figure 3: light yellow feature and Figure 4: image 2). The footing was aligned N-S and was formed of a single brick, at least two courses deep; the bricks measured 216mm by 108mm (8½” by 4¼”). This was perpendicular to the standing walls of the mill, with the two other walls of contrasting materials on a divergent alignment. The narrow wall would appear to be a minor partition; though the use of Fletton bricks indicates that the builder would use these for below ground footings.

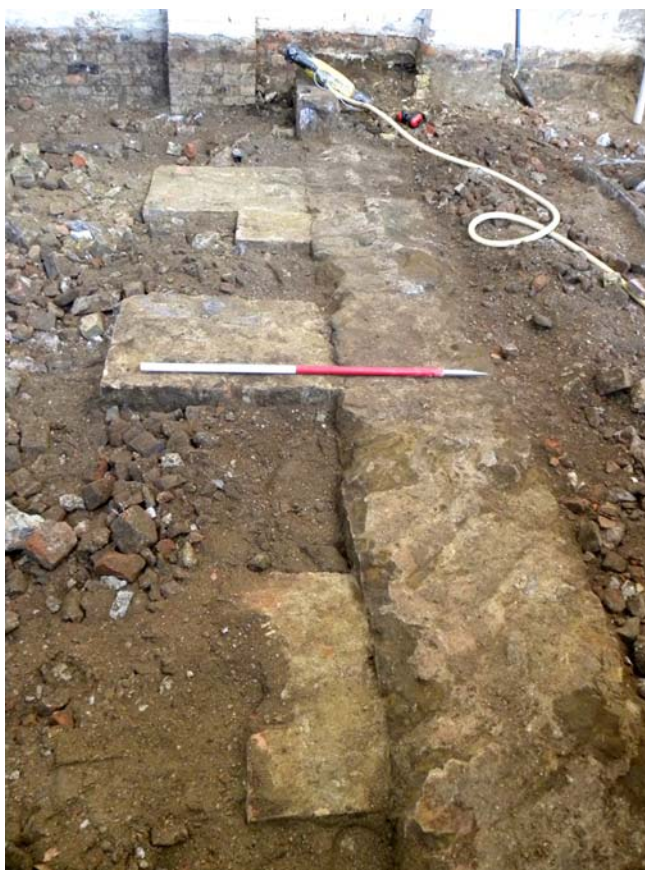
Image 3: Looking south along possible eastern gable wall of ironstone mill, with plinths to left associated with later mill. At the top of the image an ironstone wall footing can be seen to the right of this (though only brick to the left). Scale 1m in 50cm divisions.

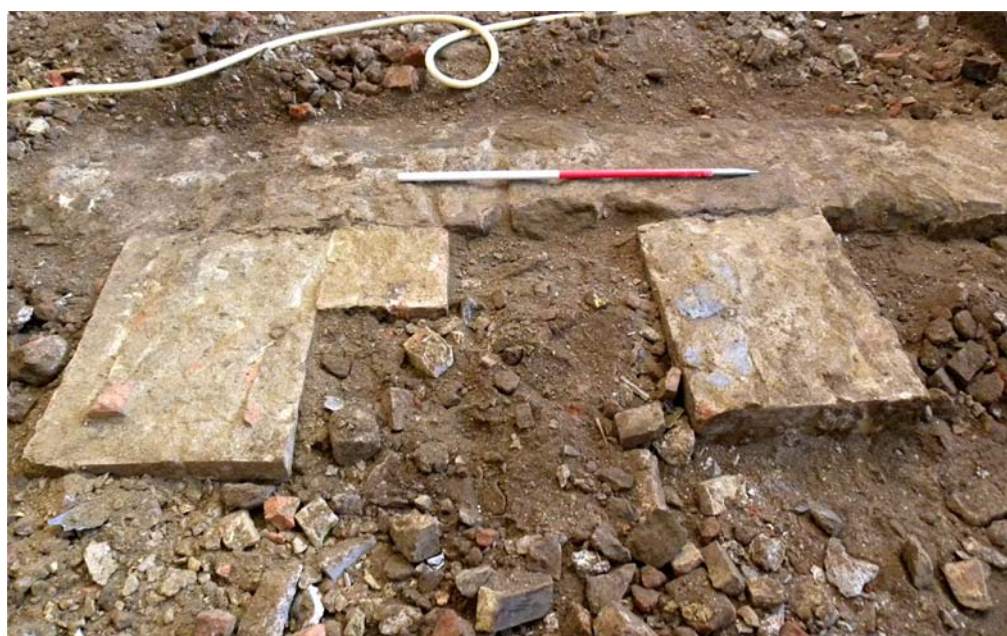
Image 4: Eastern face of ironstone wall with later plinths butting-up. Scale 1m in 50cm divisions.

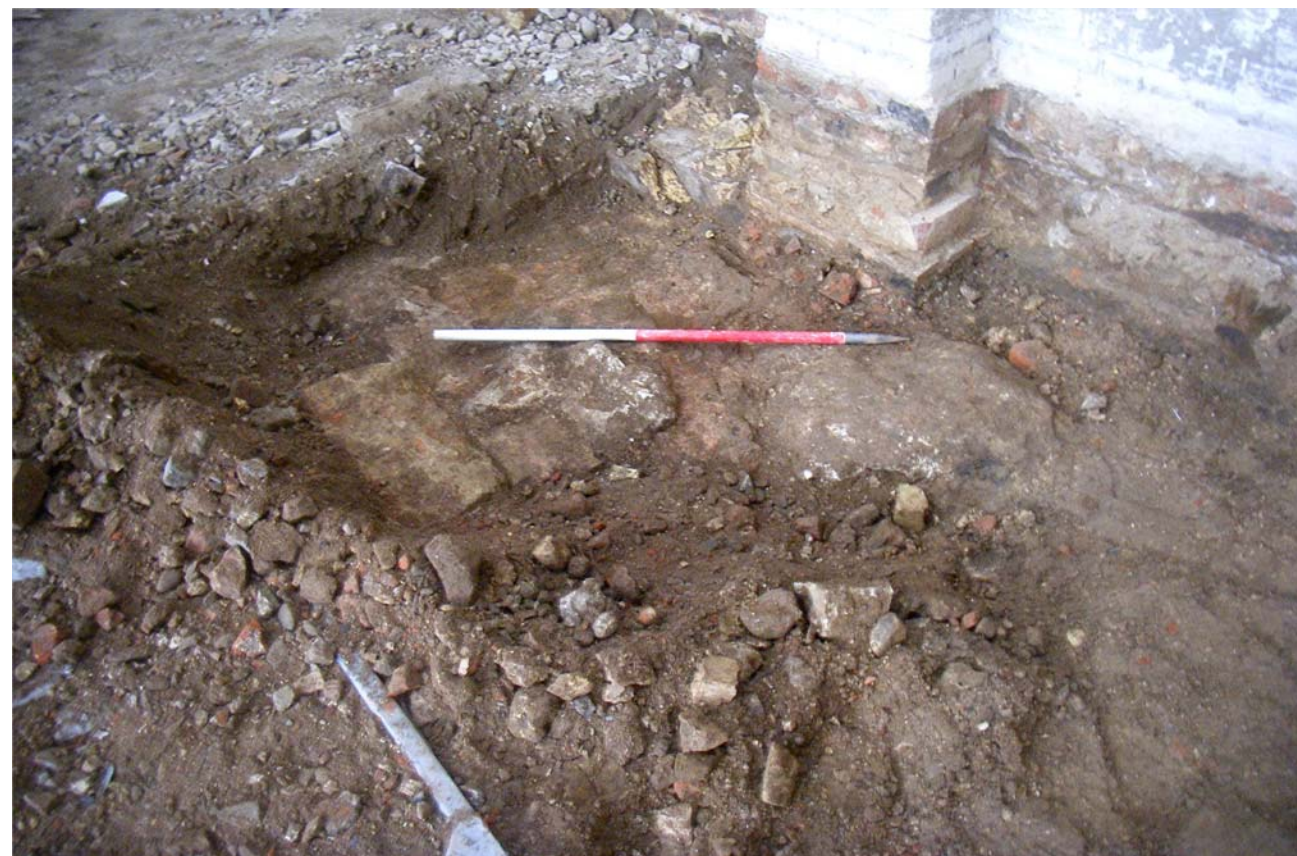
Image 5: Complex structural remains revealed beneath the modern mill floor. Evidence for possibly two phases of Ironstone wall footings was revealed. The earlier is visible underneath the photo scale — partly obscured by the stub of a later red brick E-W cross-wall, extending to the off-set buttress. Ironstone footings are visible beneath the brick walls of the standing mill, with the Ironstone eastern gable wall just visible at the limit of stripping — see image 6. Scale 1m in 50cm divisions.

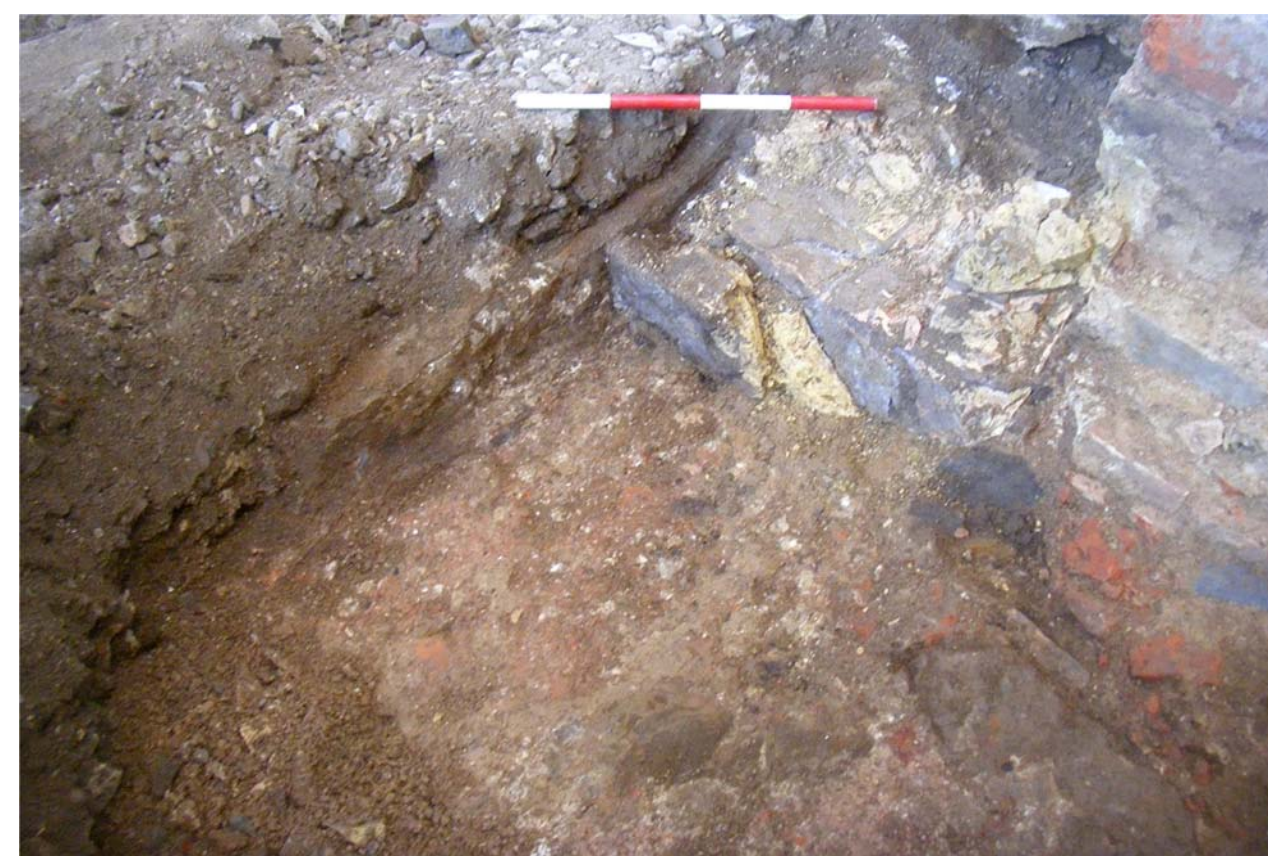
Image 6: The interior (western face) of the eastern gable of the Ironstone mill is just visible extending from the section. Beyond the buttress are the damaged remains of a Fletton brick plinth base, with the partially robbed out footing of an Ironstone wall in the foreground — this is possibly an earlier phase of Ironstone mill. Scale 40cm in 10cm divisions.

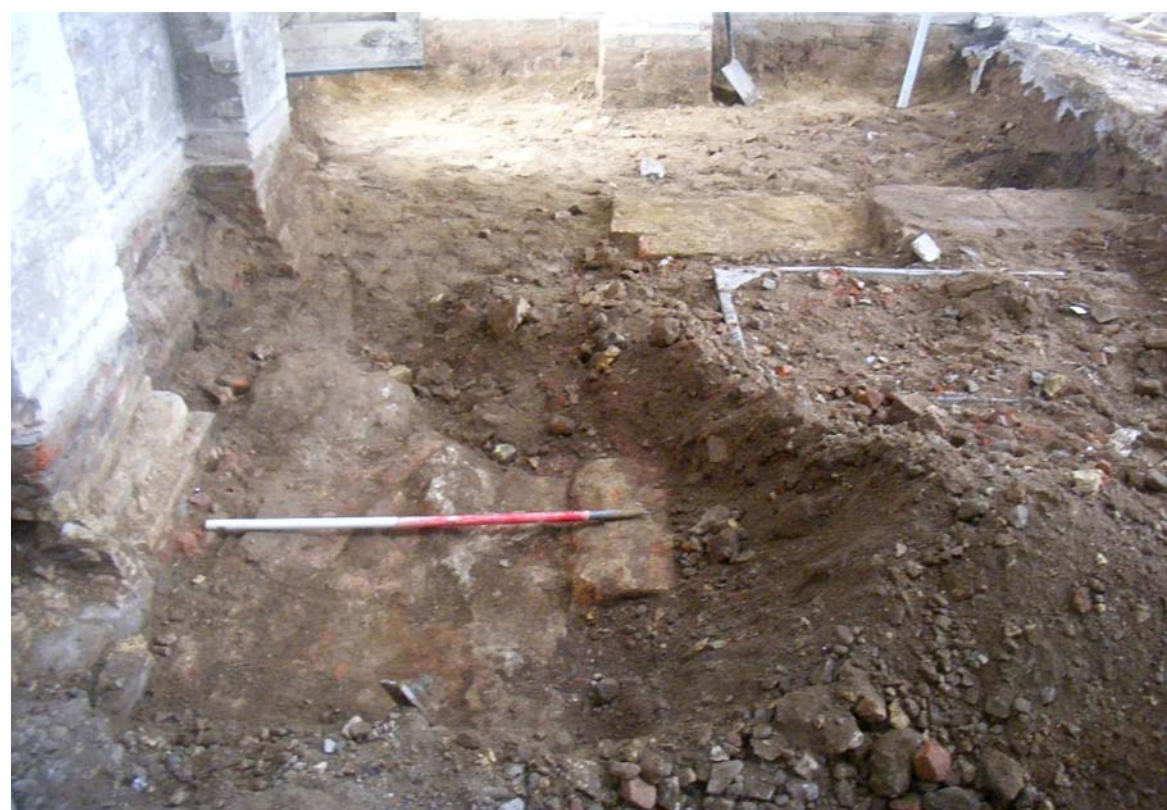
Image 7: General view of area looking west from location of Ironstone eastern gable wall, with traces of earlier Ironstone wall exposed in foreground, with curving face in the middle distance. Scale 1m in 50cm divisions.

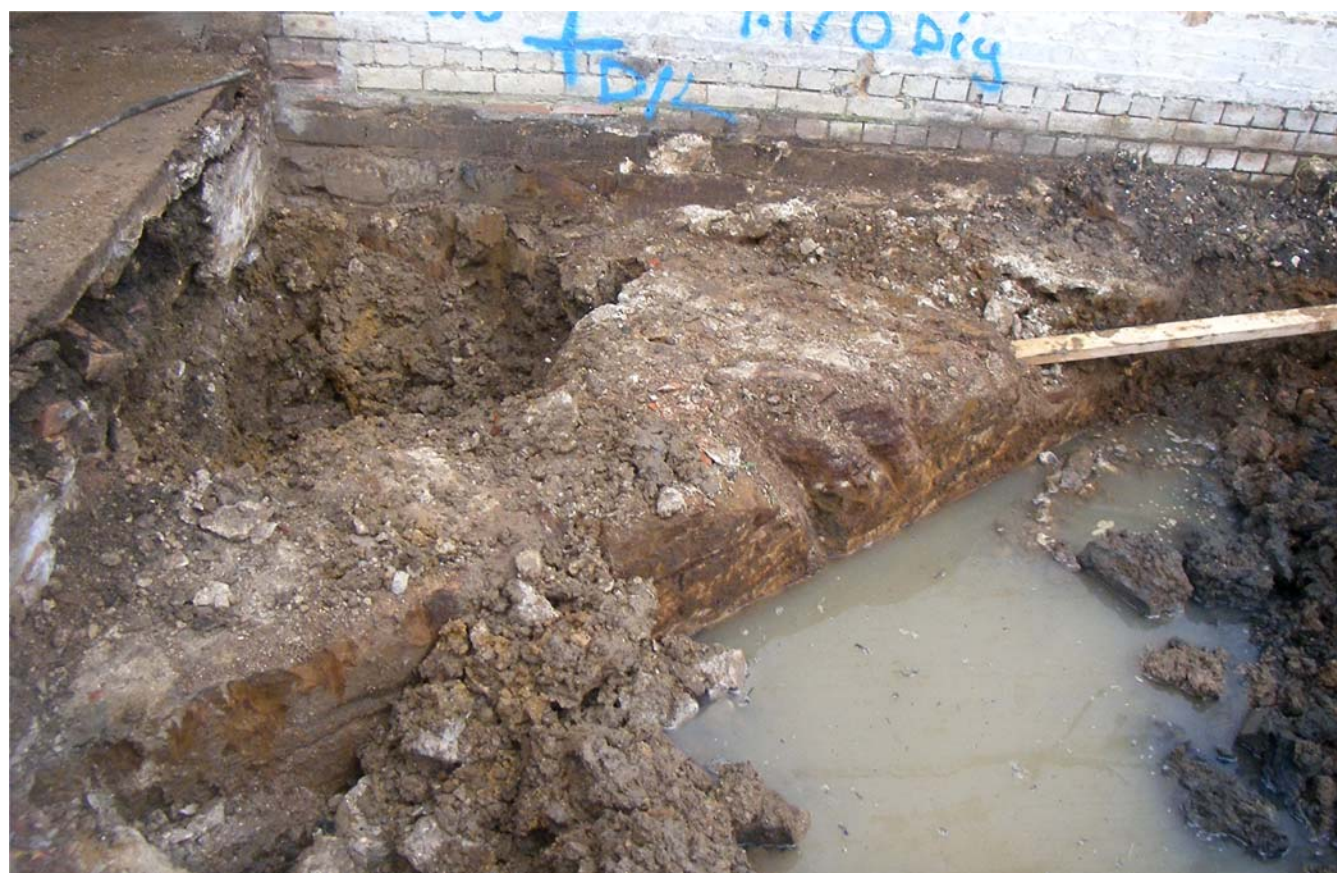
Image 8: General view of substantial Ironstone wall of the bypass leat, extending into southern elevation of the mill. Part of the Ironstone mill footing can be seen to the top left of the image — see image 10 below.

Excavation of the lift pit located immediately to the south of the Mill Building revealed a substantial Ironstone wall, 0.75m (2'6") thick, aligned NE-SW though curving in the north to link to the eastern gable wall of the Ironstone mill (Figure 3 and Figure 7: images 8 and 9). The Ironstone was bonded with a thin band of white mortar. The form of the wall suggests that it was the western side of a water channel. As this angled diversion would have caused the water to lose valuable energy, this is interpreted as a bypass leat rather than the mill race to feed the waterwheel. The bypass leat would have taken excess water from the mill race and diverted it around the eastern side of the mill. This would suggest that the mill wheel was located to the west, though it is not clear if the wheel was an internal feature or whether the wheel extended from the western gable of the building

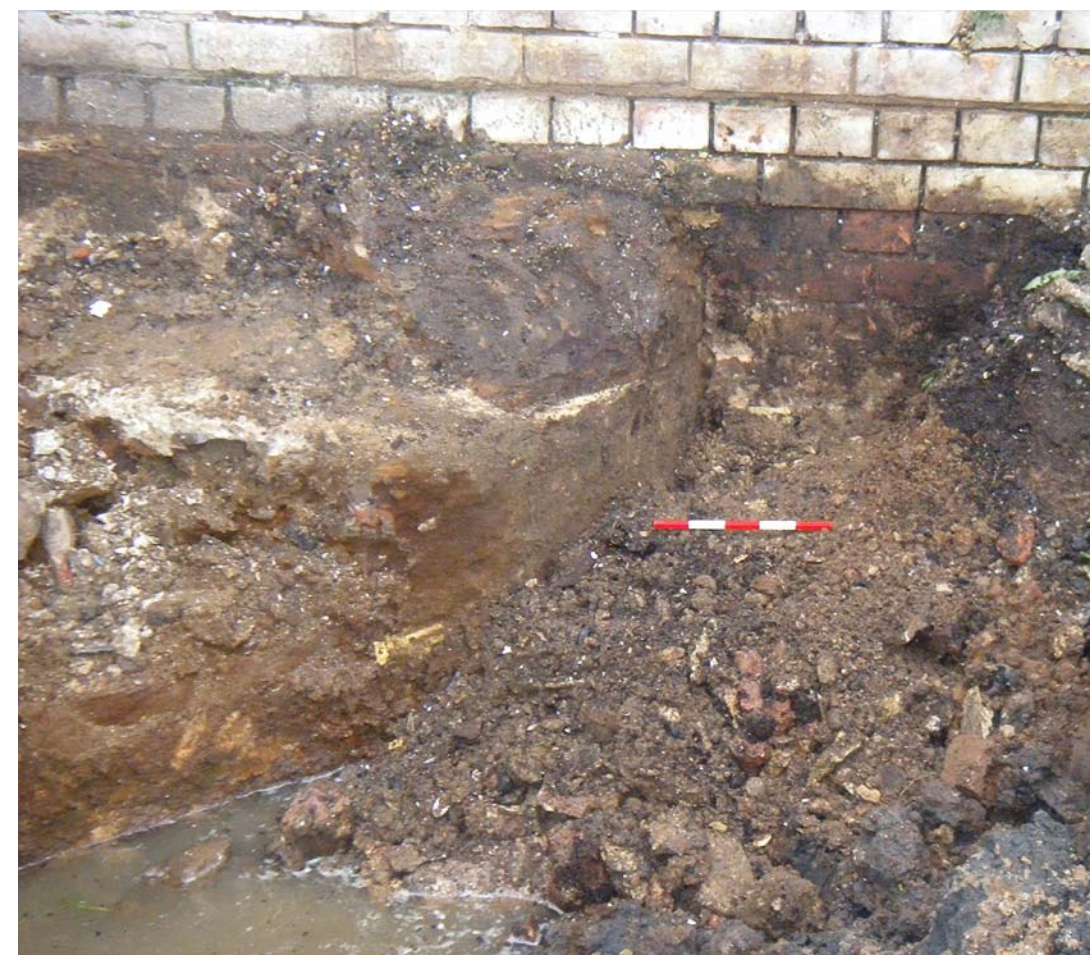
Image 9: Detail of the intersection of the Ironstone wall and the mill. The red bricks appear to define a blocking of the channel, prior to the current mill (white bricks). Scale 25cm in 5cm divisions.

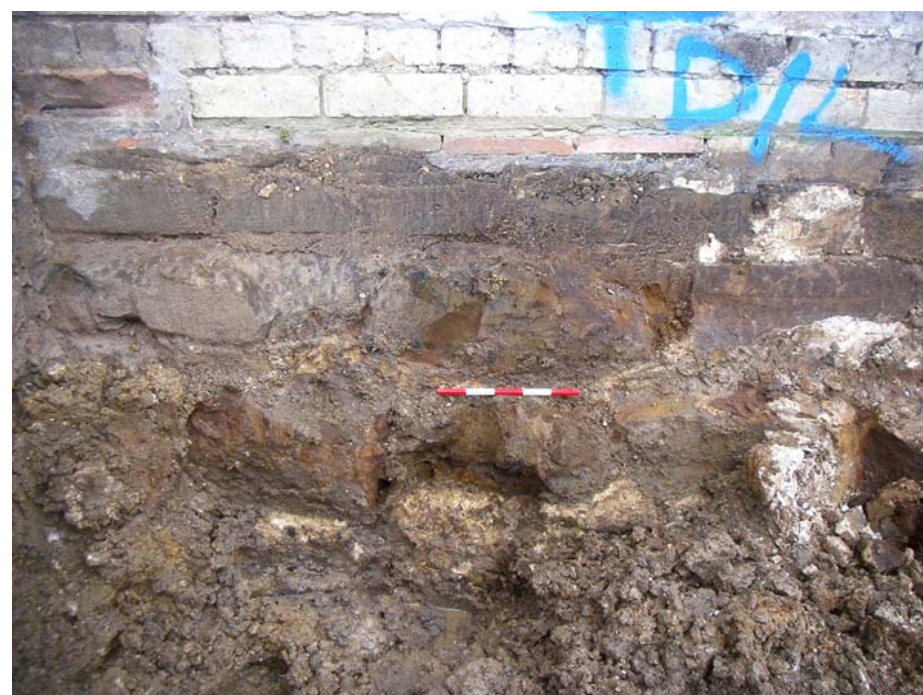
Image 10: Detail of the Ironstone footing seen in the top left corner of image 8. Scale 25cm in 5cm divisions.

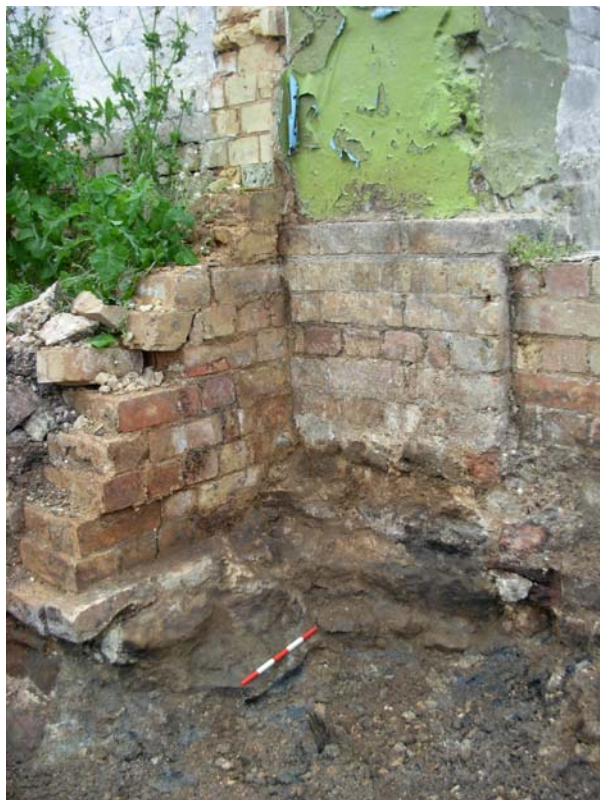
Image 11: Ironstone wall footings of ancillary building, exposed beneath later brick walls situated at SE corner of the Mill Building. Scale 25cm in 5cm divisions.

to the SE corner of the Mill Building, traces of substantial Ironstone footings were revealed (Figure 3 – solid brown features and Figure 8: images 11 and 12). The perpendicular wall footings were at least 0.7m and 1.65m long, being lost to modern disturbance, by at least 0.45m wide and at least 0.35m deep, continuing below the level of machining. The Ironstone was bonded with a thin band of white mortar similar to that used on the bypass leat wall to the west. The N-S footing would appear to be straight, suggesting that it was not defining the eastern side of the leat, which presumably would have been in the area not investigated to the west (Figure 3). The size and form of this ancillary building, situated to the east of the leat is unknown, with the continuation being lost to later buildings with deep foundations.

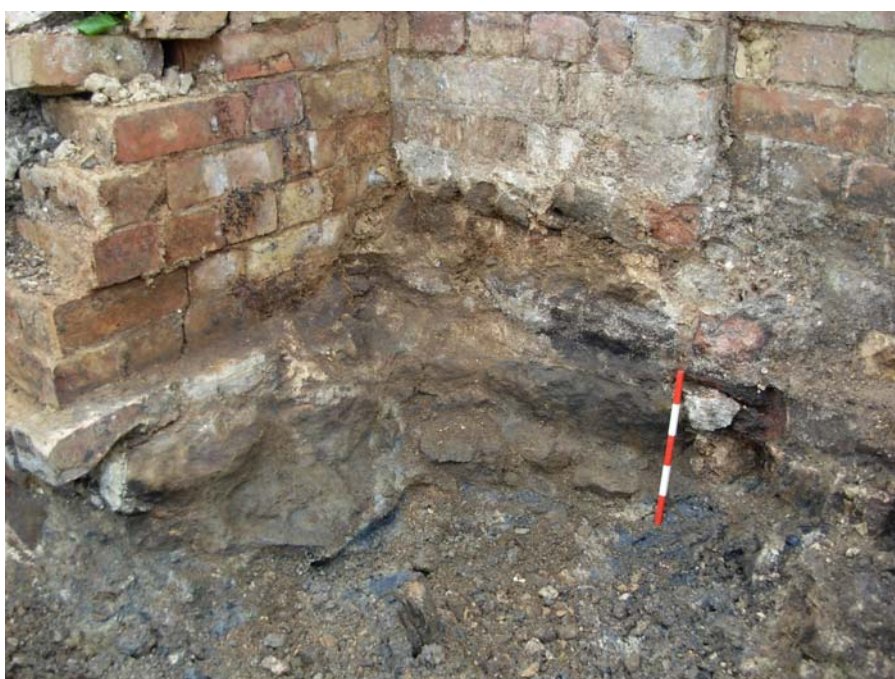
Image 12: Detail of the Ironstone footings of the ancillary building. Scale 25cm in 5cm divisions.

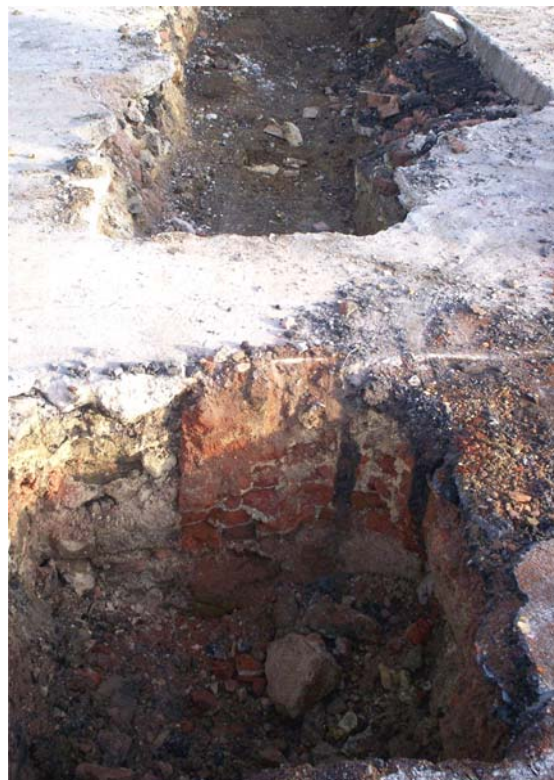
Image 13: Piling pit revealing earlier brick wall beneath the modern surface.

At a depth of 0.6m below the present ground level, a series of red brick wall footings for a range of buildings aligned N-S were revealed in the NE corner of the footprint of the Mill Store (Figure 10: images 13 and 14). These extended at least 5.1m N-S with two perpendicular walls heading to the west and continuing beyond the area of investigation. These walls defined a room some 2.2m long N-S. To the east of this, traces of sequential internal floors were identified 0.3m below the present ground level, extending up to 7m to the east. In some areas two superimposed internal surfaces were revealed (Figure 10: image 15). Set on a very thin bed of mortar, the lower brick surface was composed of pale, possibly Fletton bricks. Above this was a band of off-white mortar, which incorporated roofing slate fragments. Set into this was the upper floor, comprising modern black rectangular tiles with a pattern of diamond-shaped grooves moulded into the surface. The form of the bricks suggests that they were not directly associated with the red brick wall footings to the west.

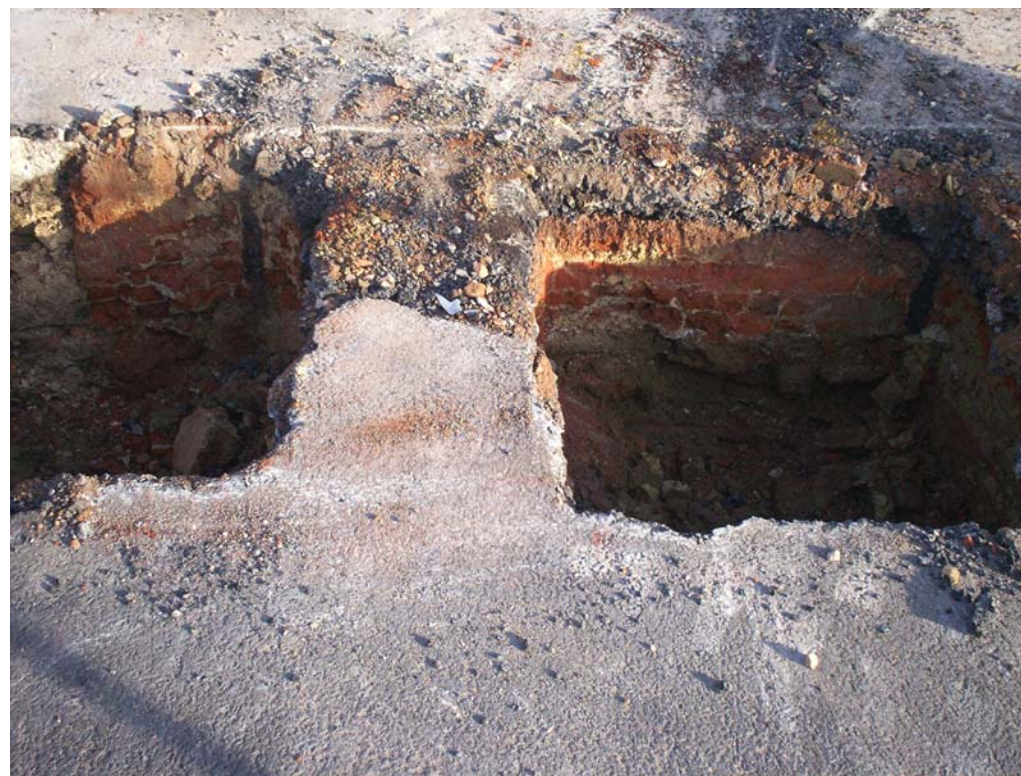
Image 14: Continuation of brick wall beneath the modern surface in an adjacent piling pit.

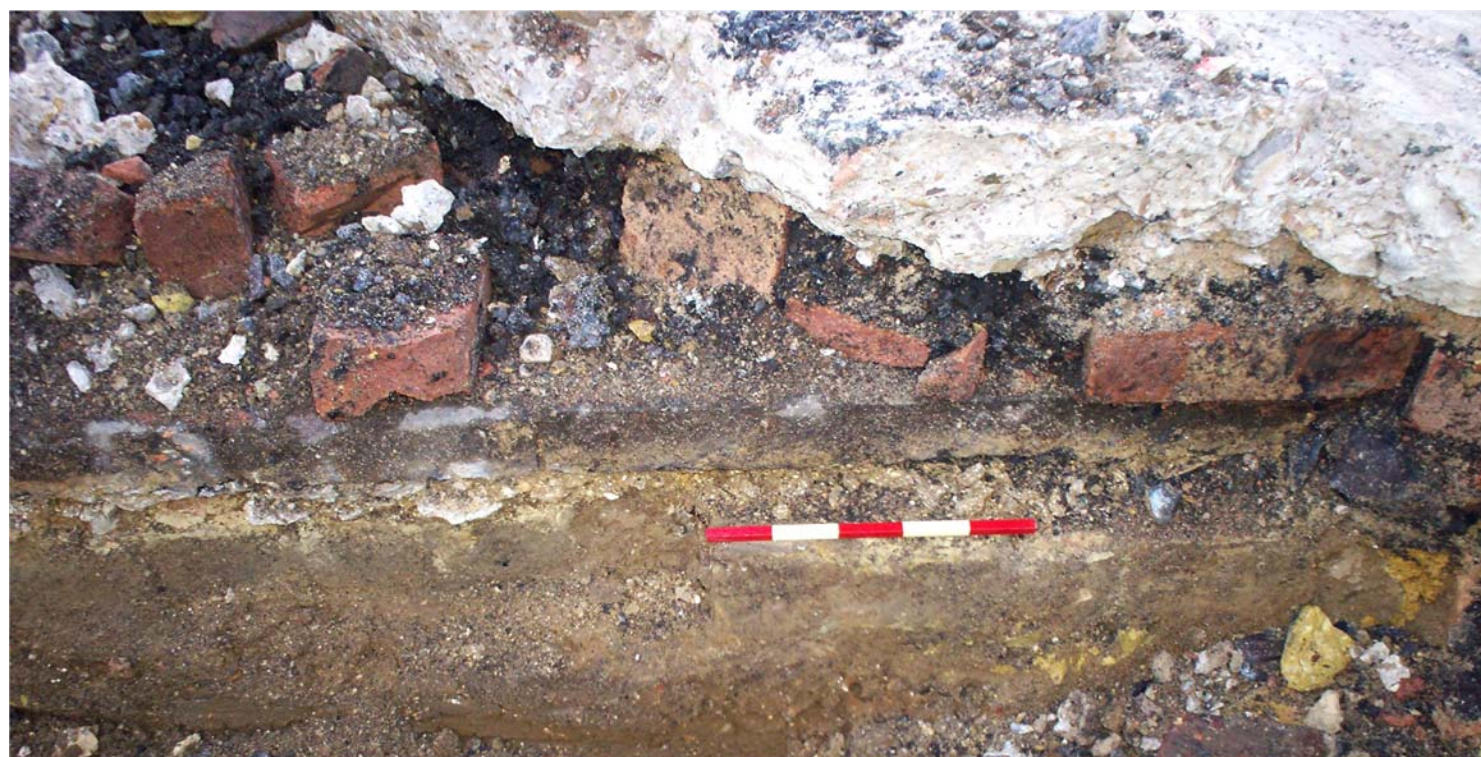
Image 15: Detail of section through sequential surfaces to the east of the red brick building. Scale 25cm in 5cm divisions.

Construction of the Mill Store required extensive ground disturbance following clearance of the modern buildings. As the building required piled footings, initially a series of small pits 1.1m square were dug on the sites of the individual piles to ensure there were no obstructions. However, due to an extensive layer of brick rubble, probably associated with construction of the modern surface, together with the presence of numerous concrete foundations and services larger areas had to be opened. The revision to the work programme were discussed with the Central Bedfordshire Council Archaeologist and it was determined that continued observation of this work was the best strategy. These groundworks revealed traces of wall footings of a brick building, with sequential floor to the east (Figure 9 and Figure 10: images 13-15).
