**ST LUKES THEATRE PROJECT
ST PETERS STREET
BEDFORD**

**BUILDING RECORDING
AND ARCHAEOLOGICAL INVESTIGATION**

Project: SLT2134

Report no: 2013/81 v.1.1

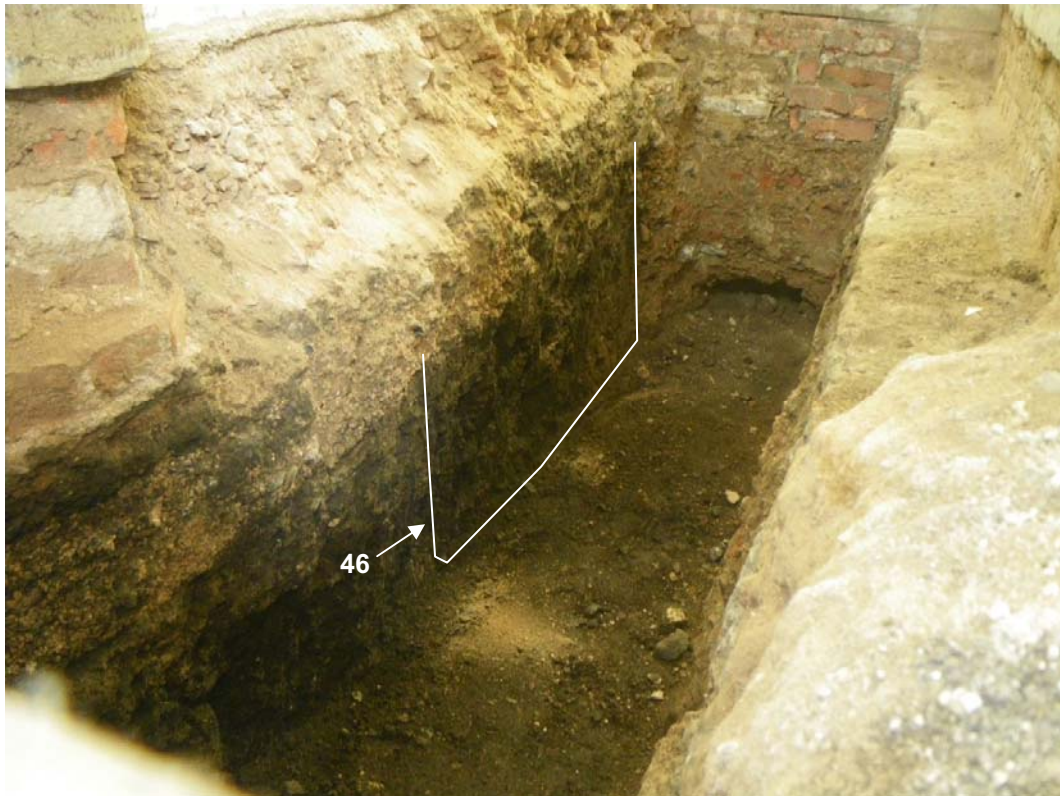
Figure 6: Location of late Saxon pit [46], looking NNW

Four pits (Features [04], [46], [51] and [66]) revealed Saxo-Norman pottery. With the exception of pit [66] these pits were situated in the south-western part and near the western boundary of the site. They were generally 1.5m in diameter and 0.9m deep. Pit [51] was 4.1m wide (Figures 6 and 7). The pottery was largely unabraded and in the case of pits [51] and [66] was deposited together with a large amount of animal bone, suggesting the pits were rubbish pits and the pottery was found in primary contexts.

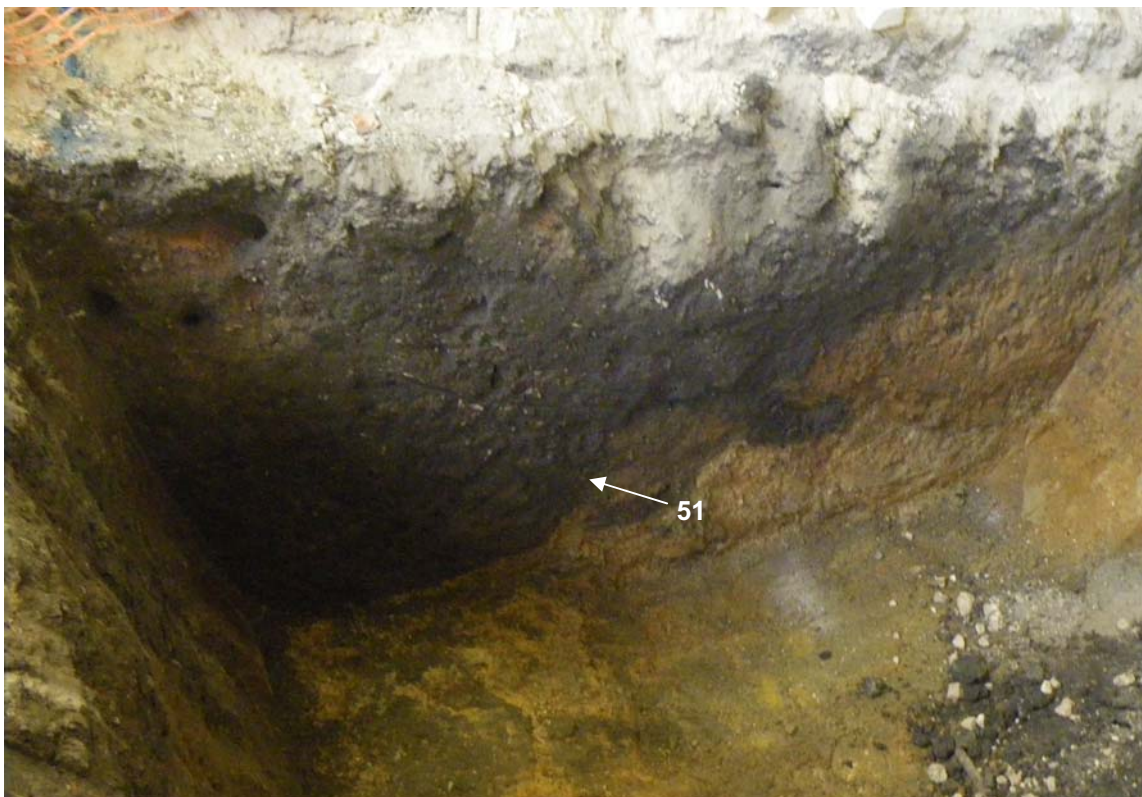
Figure 7: Late Saxon pit [51], east facing section

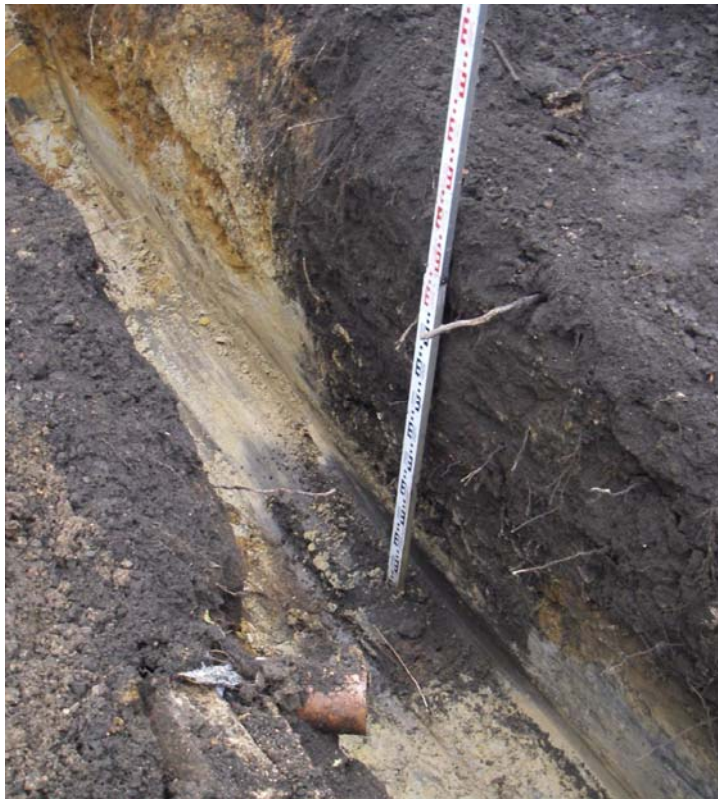
Figure 8: Possible post-medieval pit [10]

Further pits were recorded across the whole of the site. These varied in size from 1.5m-4m in width and 0.9m-1.9m in depth (Figures 8 and 9). The pits tended to have steep to vertical or stepped sides with a wide concave to flattish base. Often the base could not be observed because it was below the water table or had to be machined out. The pits had one or two main fills which consisted of sterile friable dark brown sandy silts with occasional brick and tile fragments and lenses of orange gravel. The tile is dated to the late/post-medieval period.

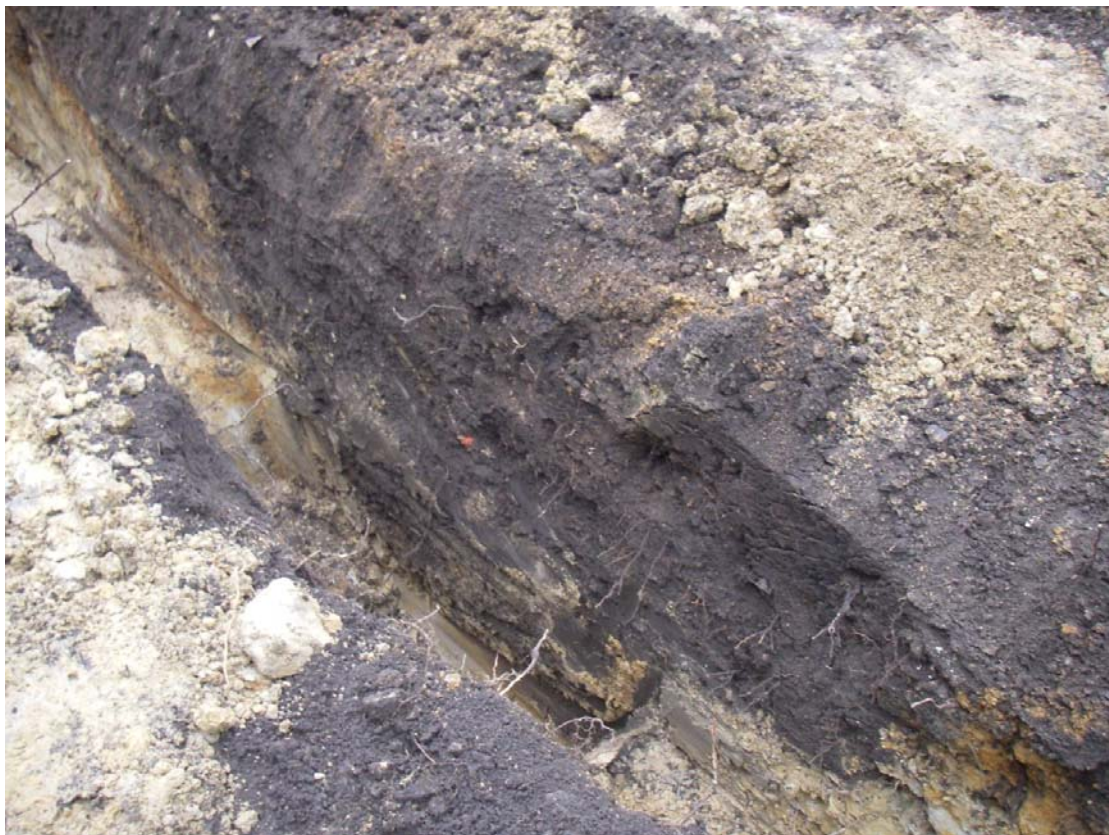
Figure 9: Possible post-medieval pit [12]

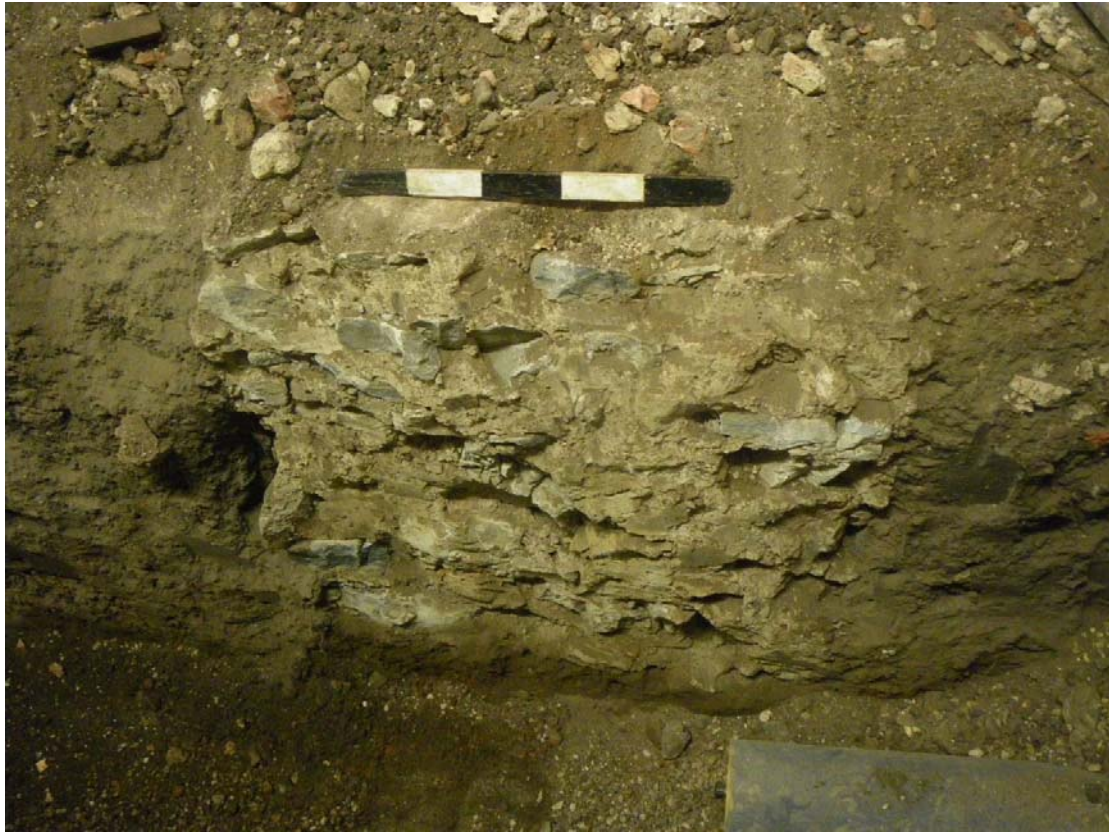
Figure 10: Wall foundation fragment [44] of 1751 chapel

A wall (44), on an east-west alignment, was revealed in a foundation trench in the western wing of the existing chapel (Figures 3, 5 and 10). The wall was 0.97m wide, survived to a height of 1.0m and was exposed for a length of 1.8m. In the east, the wall was truncated by the foundation for the current chapel wall.

It is likely that the wall represents a foundation of the predecessor to the current chapel dating to 1751. The location of the wall coincides with the external rear wall of the first chapel (Figure 5).

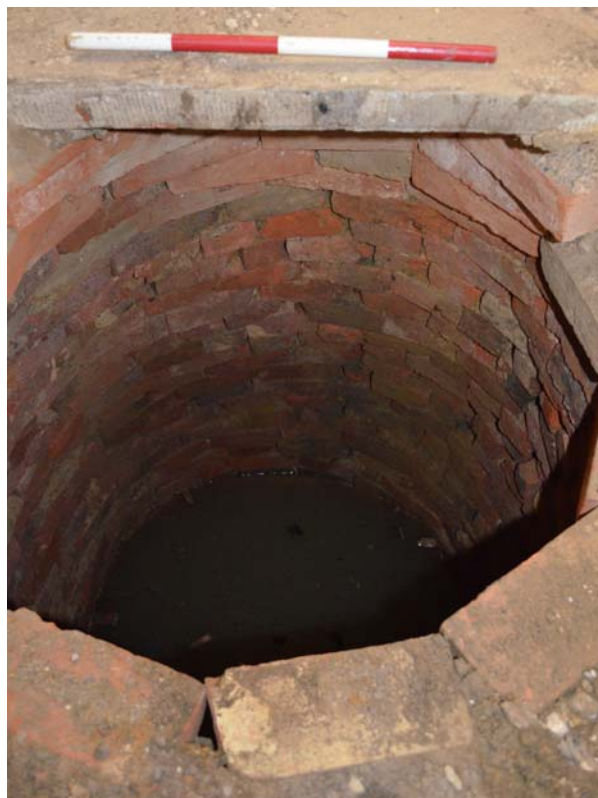
Figure 11: Well (69)

A well was exposed during ground reduction within the chapel (Figures 3 and 11). The well was constructed of red industrial brick with no mortar and measured 0.75-0.9m in diameter and was 4.5m deep. It was capped with a stone paving slab. The position of the well suggests that it was located to the rear of the original chapel and possibly contemporary with it.
