**ALL SAINTS' CHURCH
EMBERTON
MILTON KEYNES**

**ARCHAEOLOGICAL OBSERVATION
INVESTIGATION AND RECORDING**

Document: 2013/141
Version: 1.0

Produced for:
Emberton Parochial Church Council

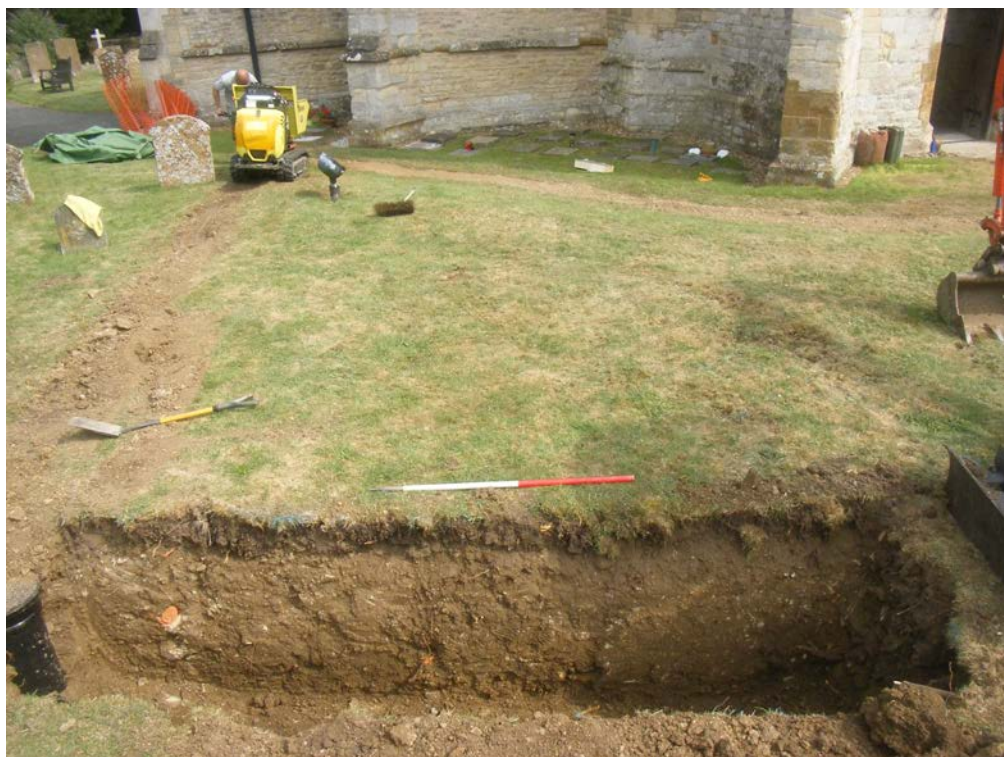
Image 3: View of Trench-arch 1 at north-west corner of tower (1m scale)

Trench-arch 1 was located at the west end of the church and was aligned north-south (Image 3). The trench was excavated 1m wide and 4m long and *c.* 1m deep. The soil build-up in the trench-arch comprised a *c.* 0.1m-thick layer of topsoil of friable dark grey brown clay silt with moderate small to medium stones over *c.* 0.9m of re-worked graveyard soil¹ comprising friable mid grey brown clay silt with moderate inclusions of small to medium stones, fragments of brick/tile and slate as well as moderate amount of fragmented human remains. The underlying geology was not encountered in the trench. No cut features were observed in the trench.

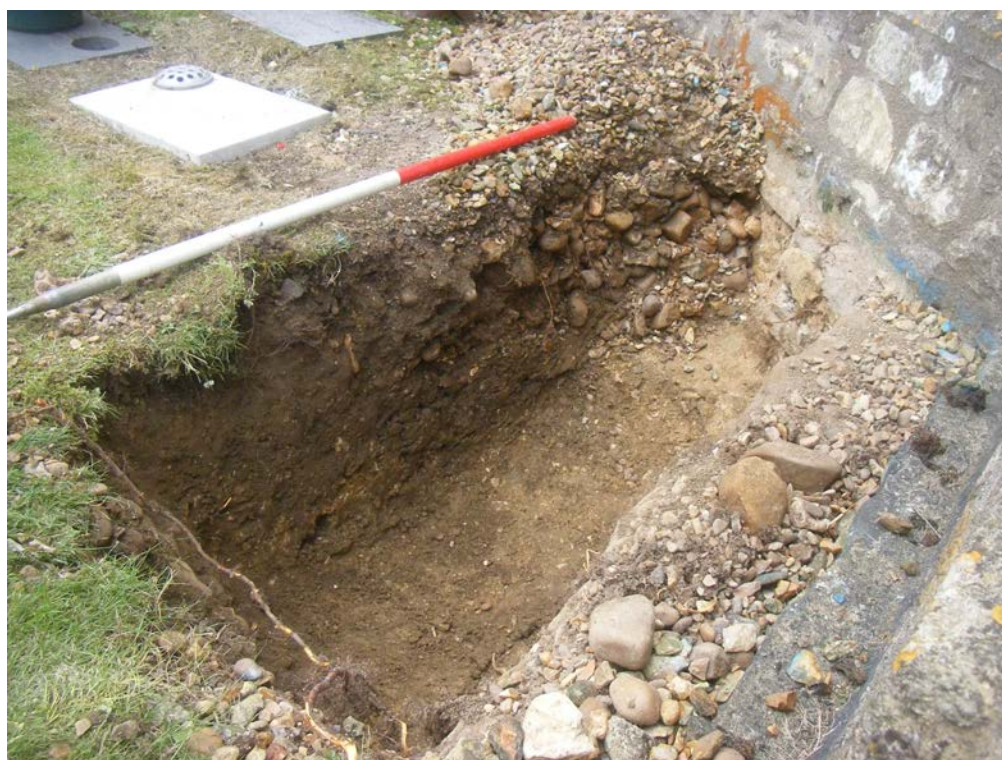
Image 4: Foundations of current church and 20th-century French drain at north-west corner of north aisle (1m scale).

The French drain along the foundations of the current church (Image 4) is a repeatedly refurbished feature, dating from the 1800s. It was last renewed in the late 20th century. Due to these works the original foundation trenches for the church foundations are no longer present.

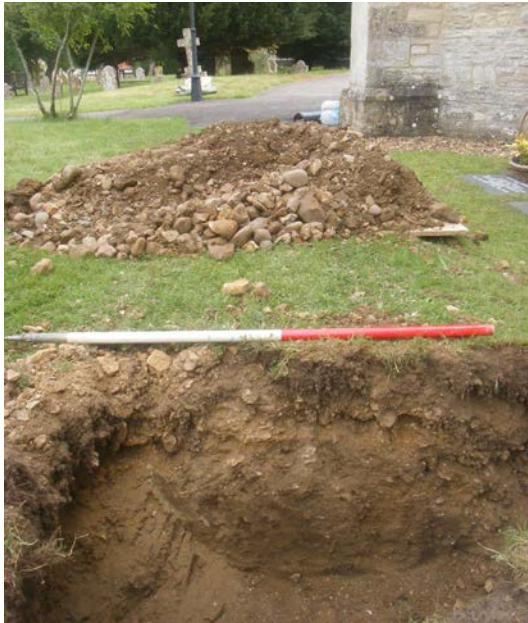
Image 5: Gravel layer of 19th-century path in trench section north of church looking east (1m scale).

Remains of a former gravel path were observed in the trench, *c.* 1m from the north aisle buttress (Image 5). This path corresponds with a path layout depicted on 1st and 2nd edition 25-inch OS maps.

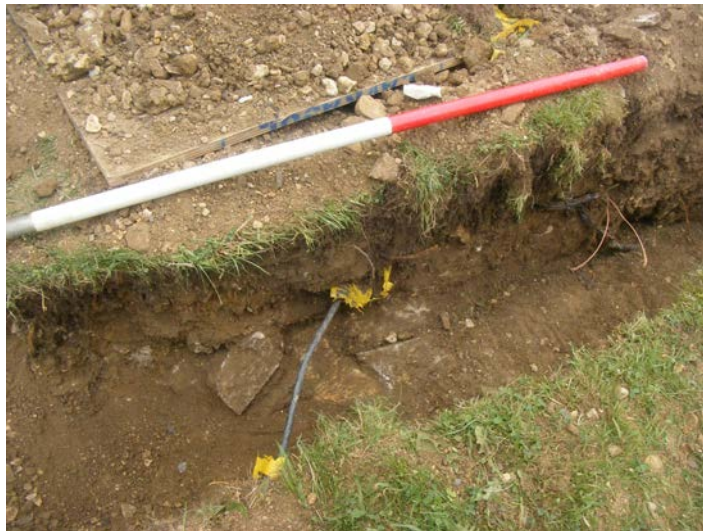
Image 6: Remains of probable limestone wall, looking south-west (1m scale).

The remains of a possible dry stone wall were encountered *c.* 4m into the trench to the north of the church (Image 6). The remains comprised large limestone slabs in a parallel arrangement. The wall was 0.5m wide and on a north-south alignment *c.* 0.3m below the current surface within the reworked graveyard soil. A cut for the wall, mortar or alternative bonding for the stones was not observed. One slab was removed in the course of the excavation. A modern electric cable runs across the feature but has had no negative impact on it.

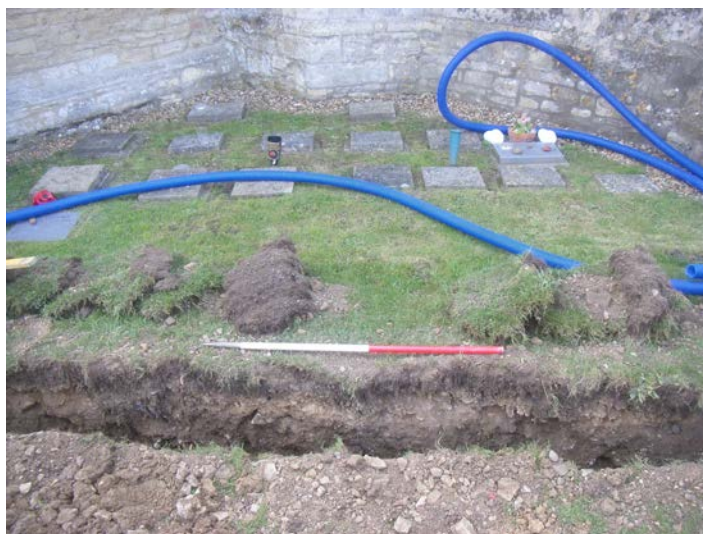
Image 7: Water pipe trench north-west of tower looking south-east (scale 1m)

The trench for the water supply pipe leading to the new kitchen unit and toilet was arched around the west and south-west end of the church (Images 7 and 8). The 0.3m-wide trench was excavated to a maximum depth of 0.6m.

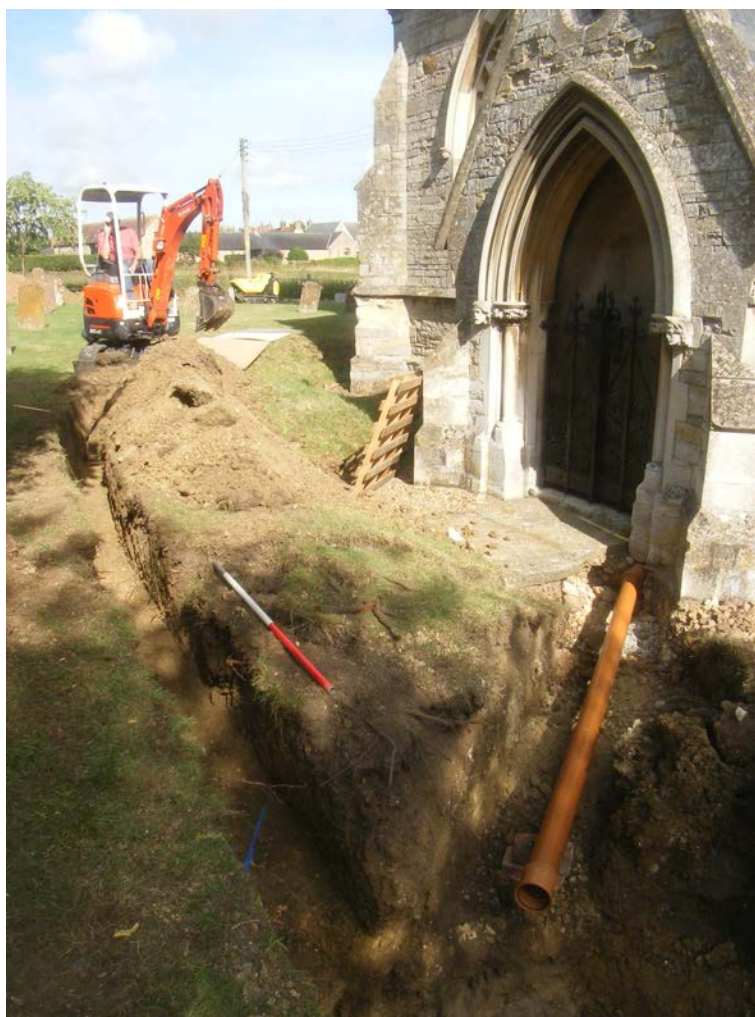
Image 8: Water pipe trench in front of south porch (1m scale)

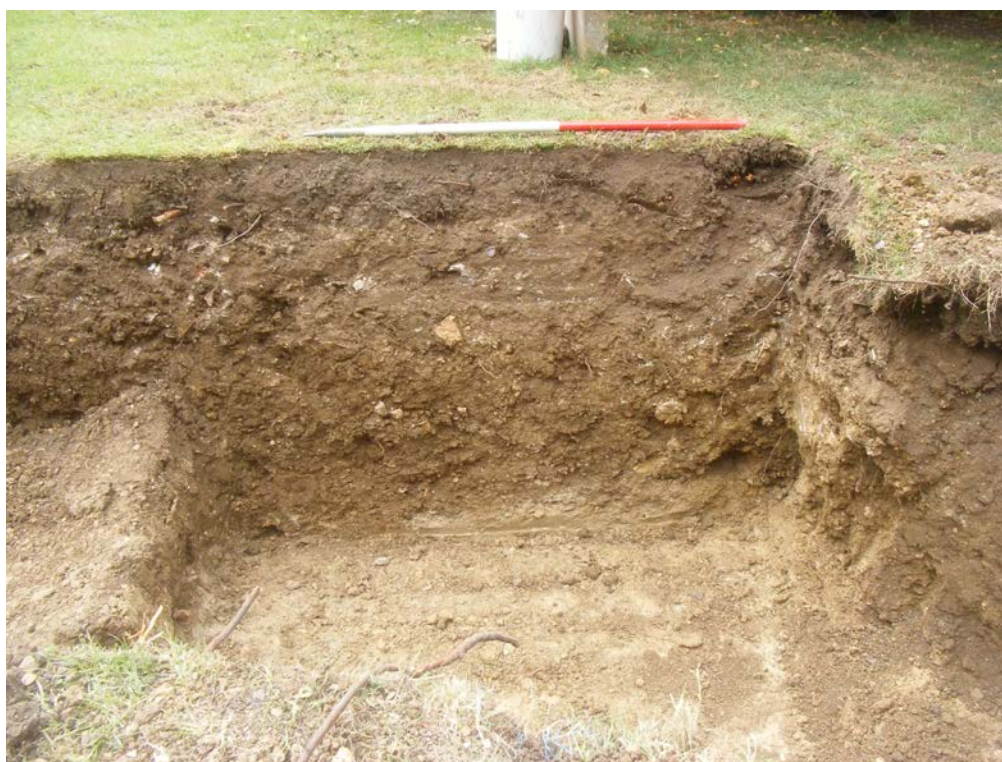
Image 9: Pump pit south-east of south porch, depth c. 1.2m (scale 1m)

Trench-arch 2 and associated pump pit and pipe trenches were excavated south of the church to take the waste water from the toilet that was installed in the south porch. The pit for the sewage tank and pump for trench-arch 2 was excavated *c.* 4m south-east of the south porch, measuring 1.4m by 1.4m and 1.5m in depth (Image 9). The pipe trench leading from the east side of the doorway to the pit was 0.3m wide and had a maximum depth of 1.1m. Trench-arch 2 was excavated east of the pump pit; it was 1.2m wide and 6.4m long. Its depth varied from 0.4–0.6m with the deepest part being in the centre of the trench (Images 10 and 11).

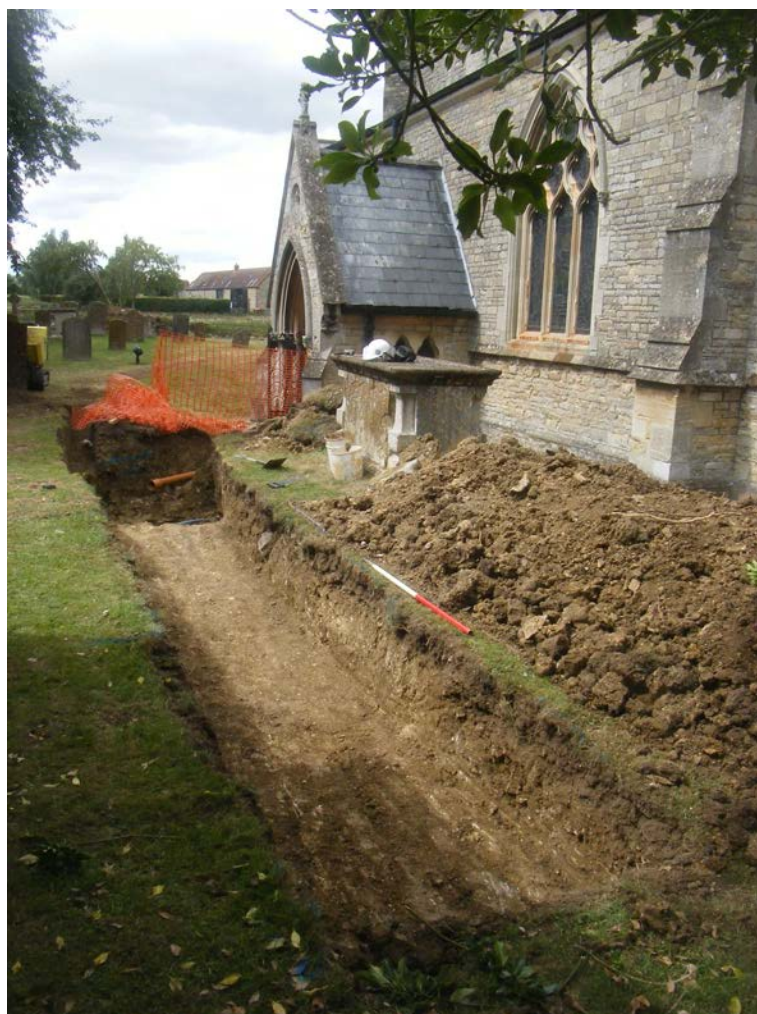
Image 10: Trench-arch 2 south of church looking north-west (1m scale)

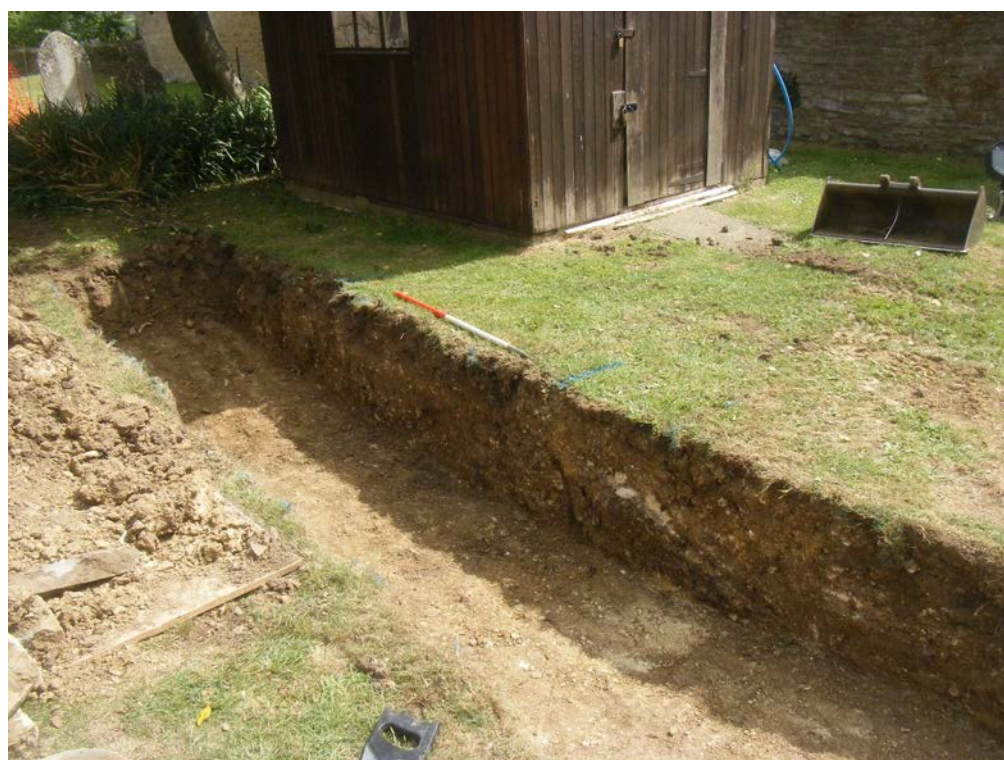
Image 11: Trench-arch 2, south of church looking south-east (1m scale)
