**BINGO EXTENSION
ASPECTS LEISURE PARK
BEDFORD**

ARCHAEOLOGICAL MITIGATION

Version 1.1

Produced for:
Roc Associates Building Consultancy Ltd
Feldon House
3 Banbury Street
Kineton
Warwick CV35 0JS

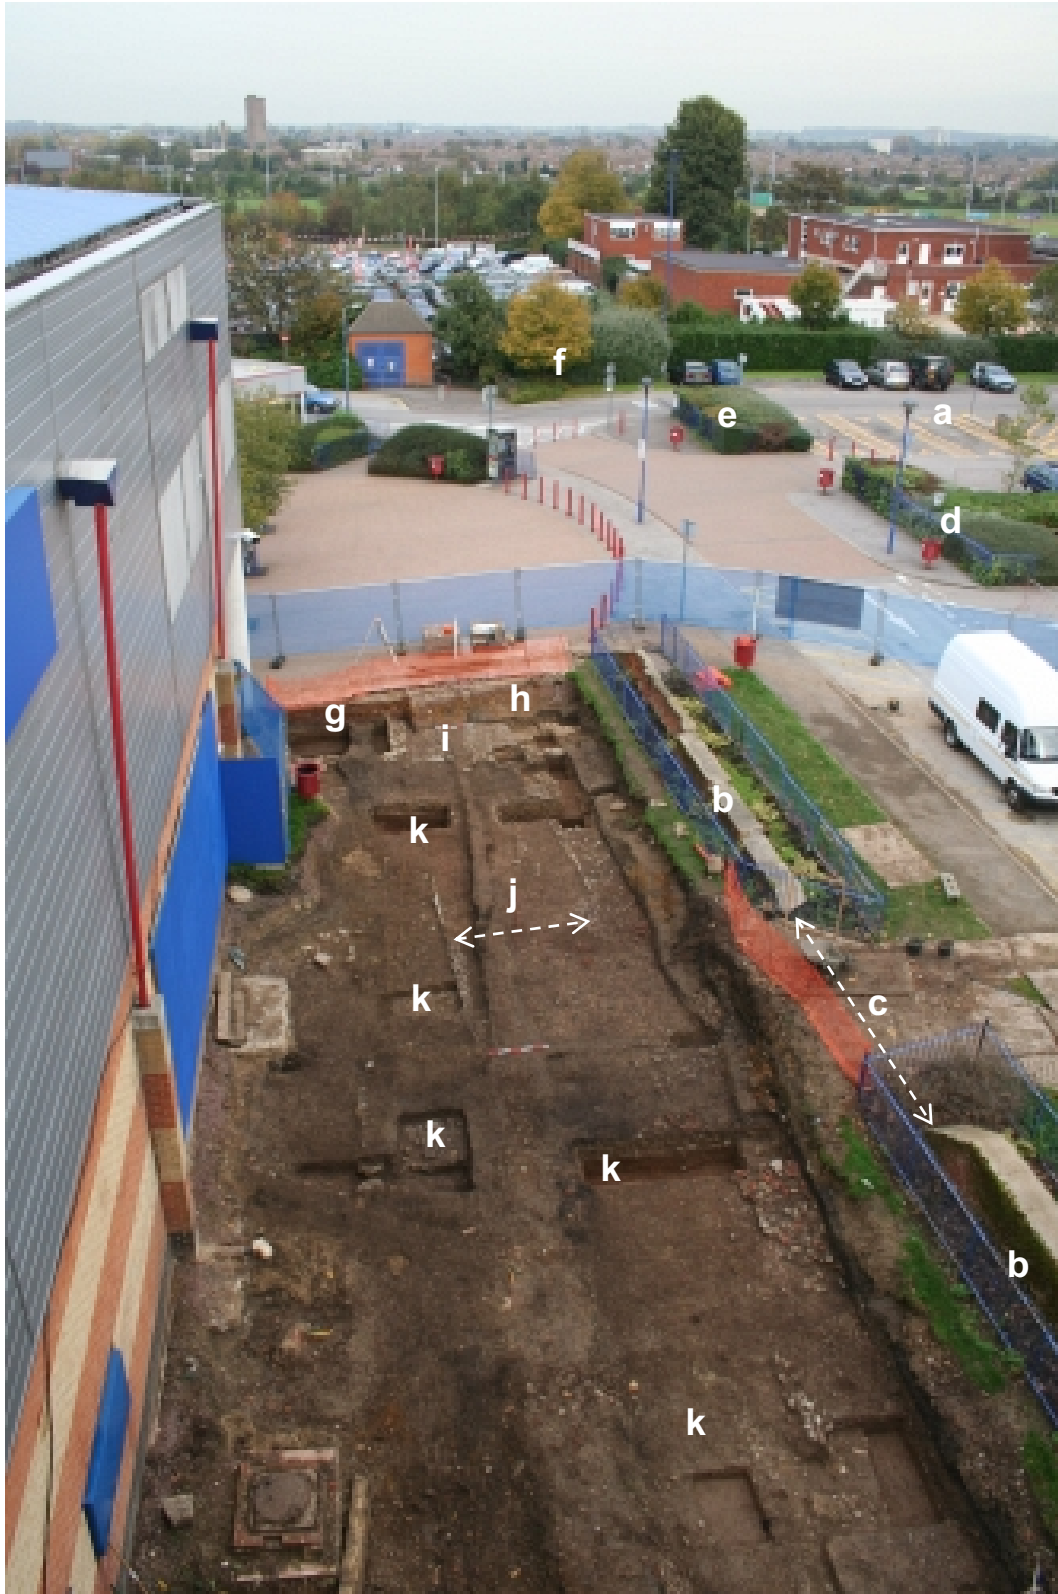
Photograph 1: Excavation Area 1 in its setting

Looking north with the bingo hall on the left. The locations of key structures are indicated as follows: site of medieval monastic church beneath the car park (a); Tudor brick wall (b); possible location of an original gateway marked by a gap in wall (c); Tudor brick piers within planting (d), (e) and (f); remains of medieval and post-medieval buildings (g) and (h) either side of a cobbled surface (i); and post-medieval kerbed trackway (j) with medieval metal surface (k) beneath.

Cut into the make-up layers (G3.14) was a pair of parallel trenches into which had been set large limestone fragments, placed on edge to form kerb stones at either side of the trackway (Figures 7 and 12; Photographs 1–4). In places the kerb stones were no longer *in situ*.

The cobbled surface overlay layer G3.14. In places it was very fragmentary and the edges of the surviving remnants were very irregular and ragged, suggesting that the surface had been allowed to become very heavily worn. However, the surface had clearly originally been contained by the north–south kerbstones G3.13 and lay between buildings L3.2 and L3.3 (Figures 7 and 12; Photographs 1–3, 6, 7 and 9).

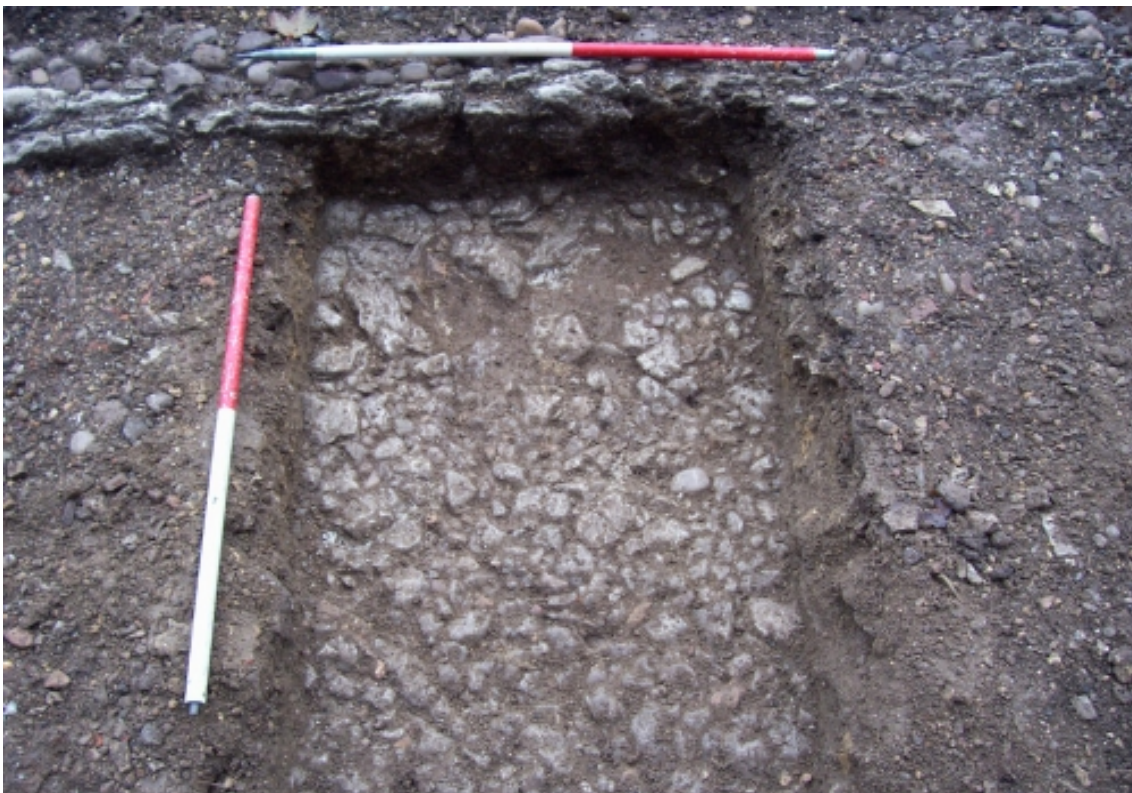
Photograph 4: Part of the medieval metallised surface (looking east)

The surface G2.11 (centre) was revealed beneath post-medieval make-up G3.14. The kerb (G3.13) on the western edge of the post-medieval track is also visible at the top of the picture.

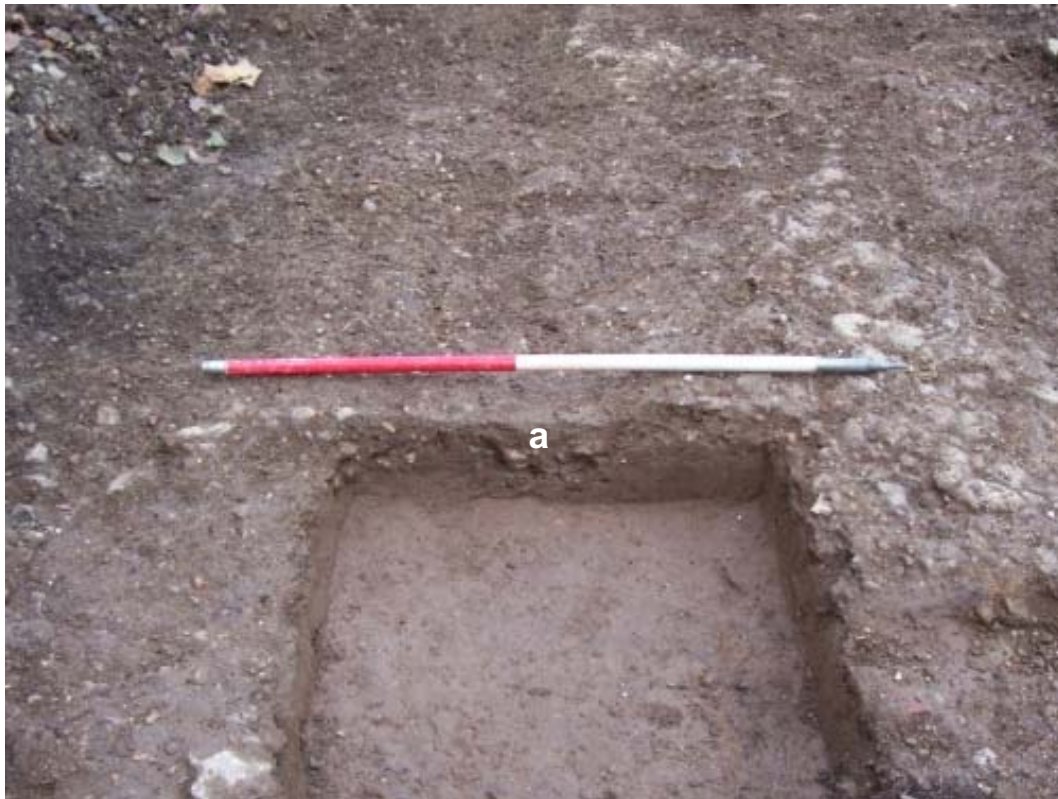
Photograph 5: Medieval surface with wheel rut see in south-facing section
The slight wheel rut G2.12 (a) was observed as a depression in the metallated surface G2.11

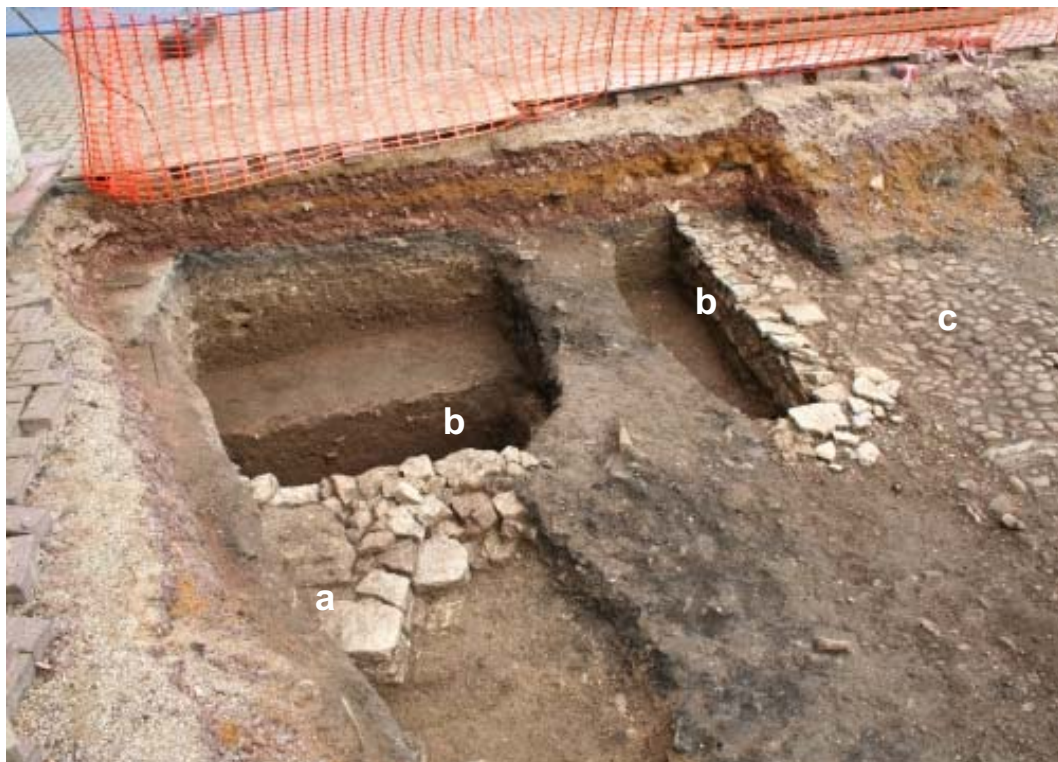
Photograph 6: Structures in the north-west corner of Area 1 (looking north)
These include medieval wall G2.21 (a) and post-medieval wall G3.61 (b) and surface G3.11 (c).
Deposits and surfaces G1.11, G3.32, G3.33, G3.41 and G3.51 are visible in the south-facing section

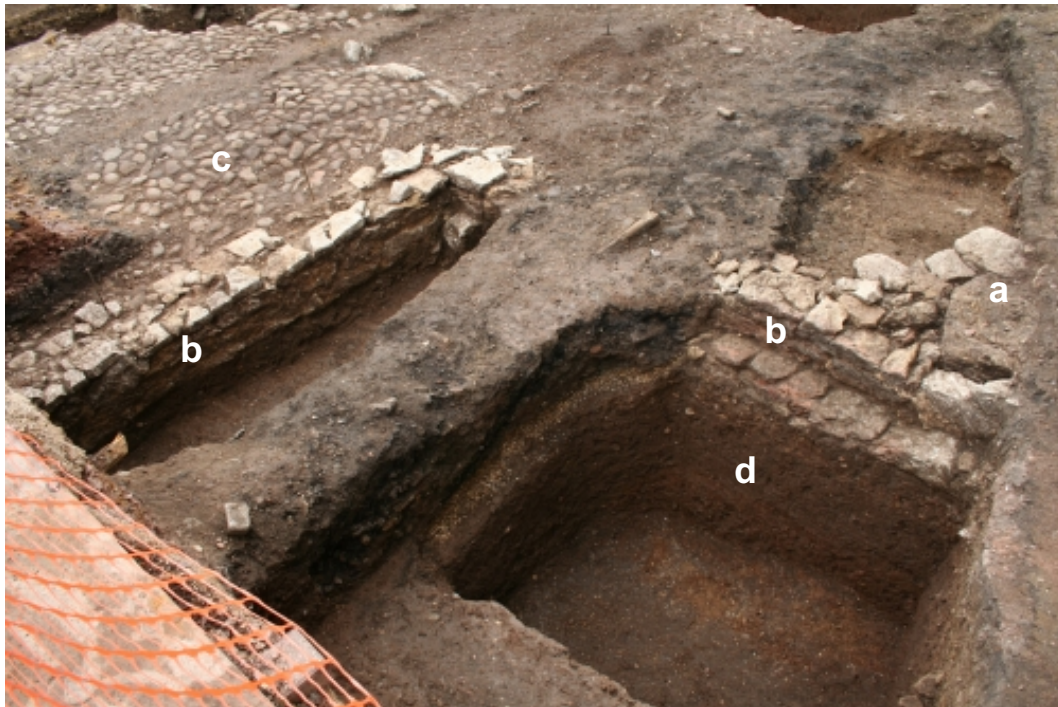
Photograph 7: Structures in the north-west corner of Area 1 (looking north)
These include medieval wall G2.21 (a) and post-medieval wall G3.61 (b) and surface G3.11 (c).
The deep accumulation of alluvial deposits G1.11 is visible below (d).

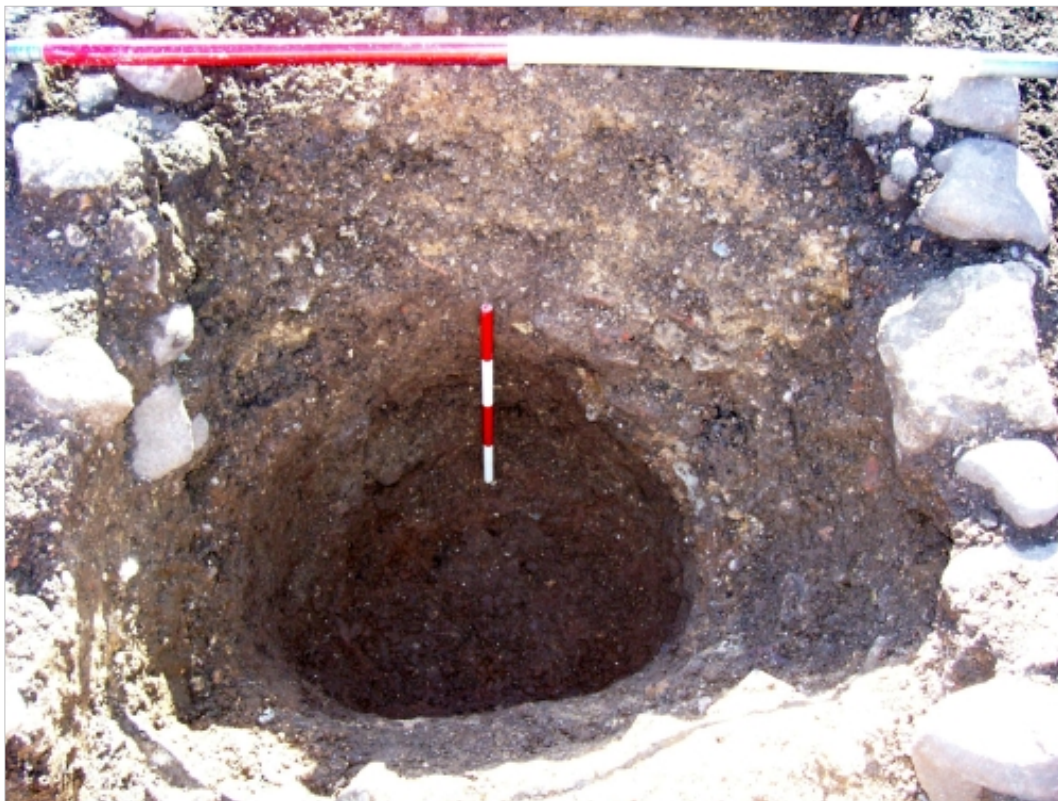
Photograph 8: Pit or possible gate-post setting G2.42
(looking north)

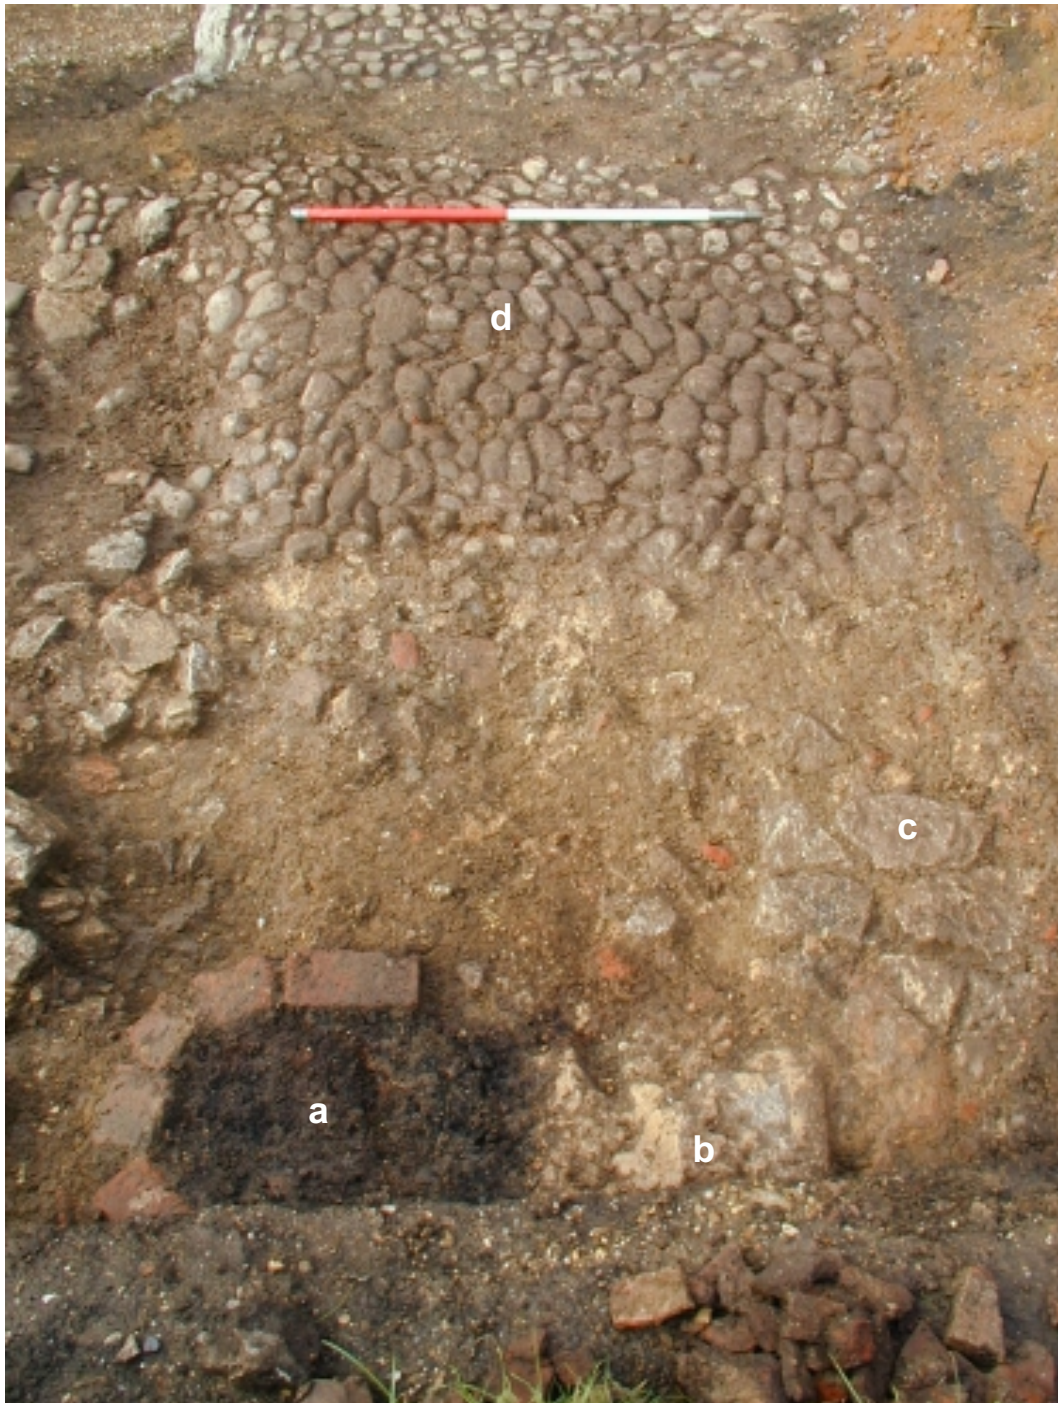
Photograph 9: Post-medieval structures at the north end of Area 1 (looking west)

The simple Tudor brick hearth (a) abutted a wall (b) that emerged from the edge of excavation.

Also shown are stone surfaces G3.24 (c) and cobbled surface G3.11 (d)

A stone structure was identified 0.92m north of and extending parallel to wall (G3.21) (Figures 7 and 11; Photographs 2 and 9). It consisted of roughly hewn limestone blocks with the occasional red brick (ranging in size from 240 x 210 x 30mm to 140 x 100 x 60mm), bedded in sand and mortar. A single, intact course of stone survived, along with a single brick of the second course. It is possible that the stone was used for the footings of an otherwise brick wall. The footing was set into layer G3.22, suggesting that the wall was an internal partition to building L3.2, or possibly a base for a furnace attached to hearth G3.25.

Abutting wall footing G3.23 was a horseshoe-shaped structure made from a single course of red bricks (Figure 7; Photograph 9). The bricks were 210 x 100 x 60 mm in size and were pressed into layer G3.22 laid end-to-end with brick fragments used to construct the curve. Although the structure contained burnt material, it showed no visible evidence of having been subjected to intense heat so is unlikely to have been the seat of the fire. It could represent the base of a receptacle for cold or cooling ash or furnace waste and might be better interpreted as the remains of a sort of forehearth structure attached to a furnace constructed on the wall footing G3.23.

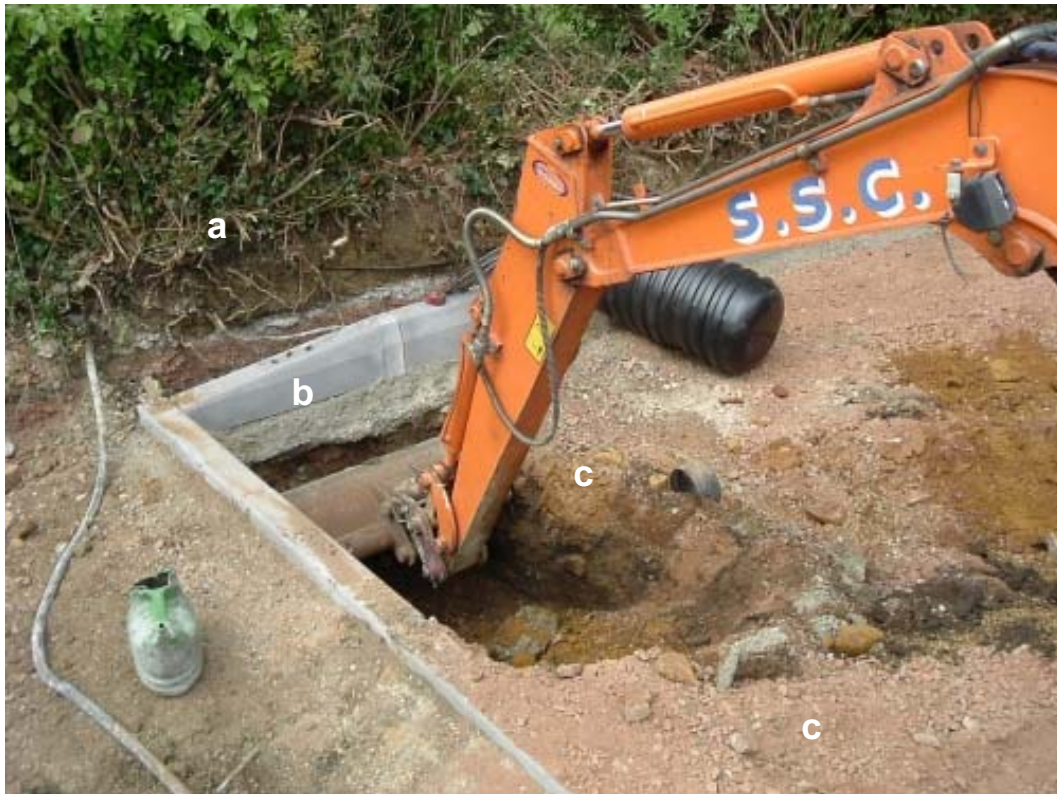
Photograph 10: Sump pit in the south-east corner of Area 3 under excavation
Looking north-west to show existing ground surface (a) with new kerb (b) and sub-base (c) in place.

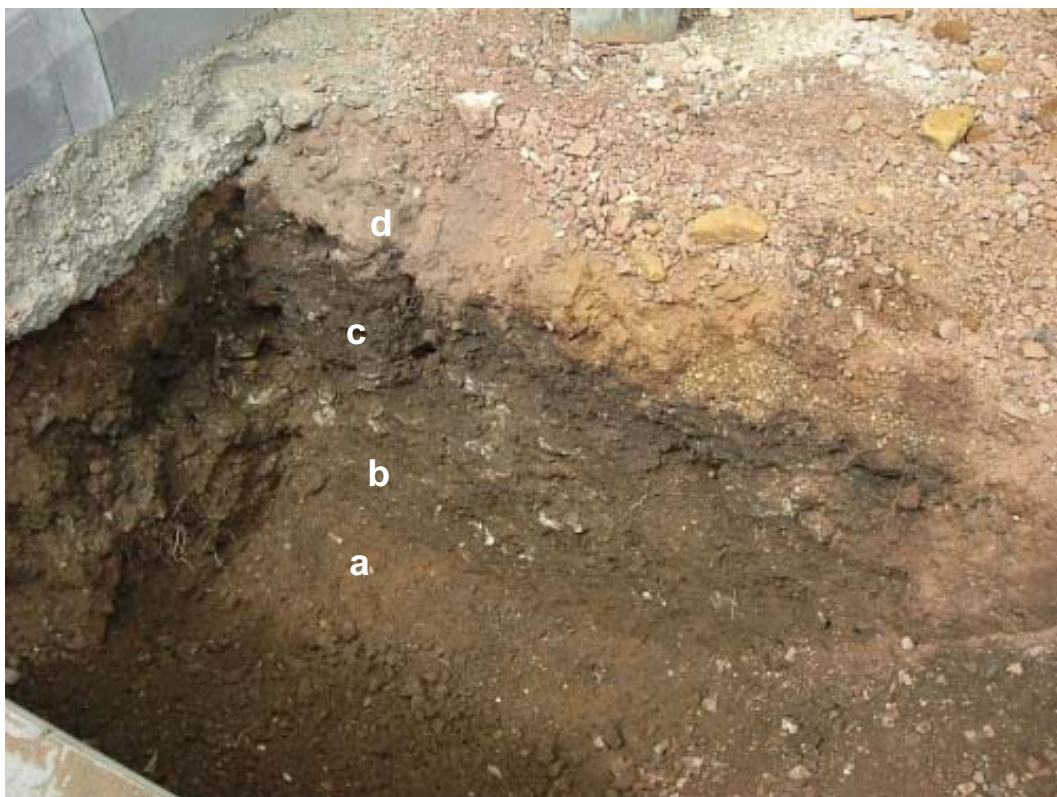
Photograph 11: South-facing section of completed sump pit in Area 3
The possible undisturbed subsoil G1.13 (a) lies below buried soil G3.52 (b), made ground (c) and newly laid sub-base (d). The pit is c. 1m deep, measured from the top of the new kerb.

A similar deposit (G3.52) was encountered in Area 3 during excavation of two small pits for drainage sumps (Photograph 11).

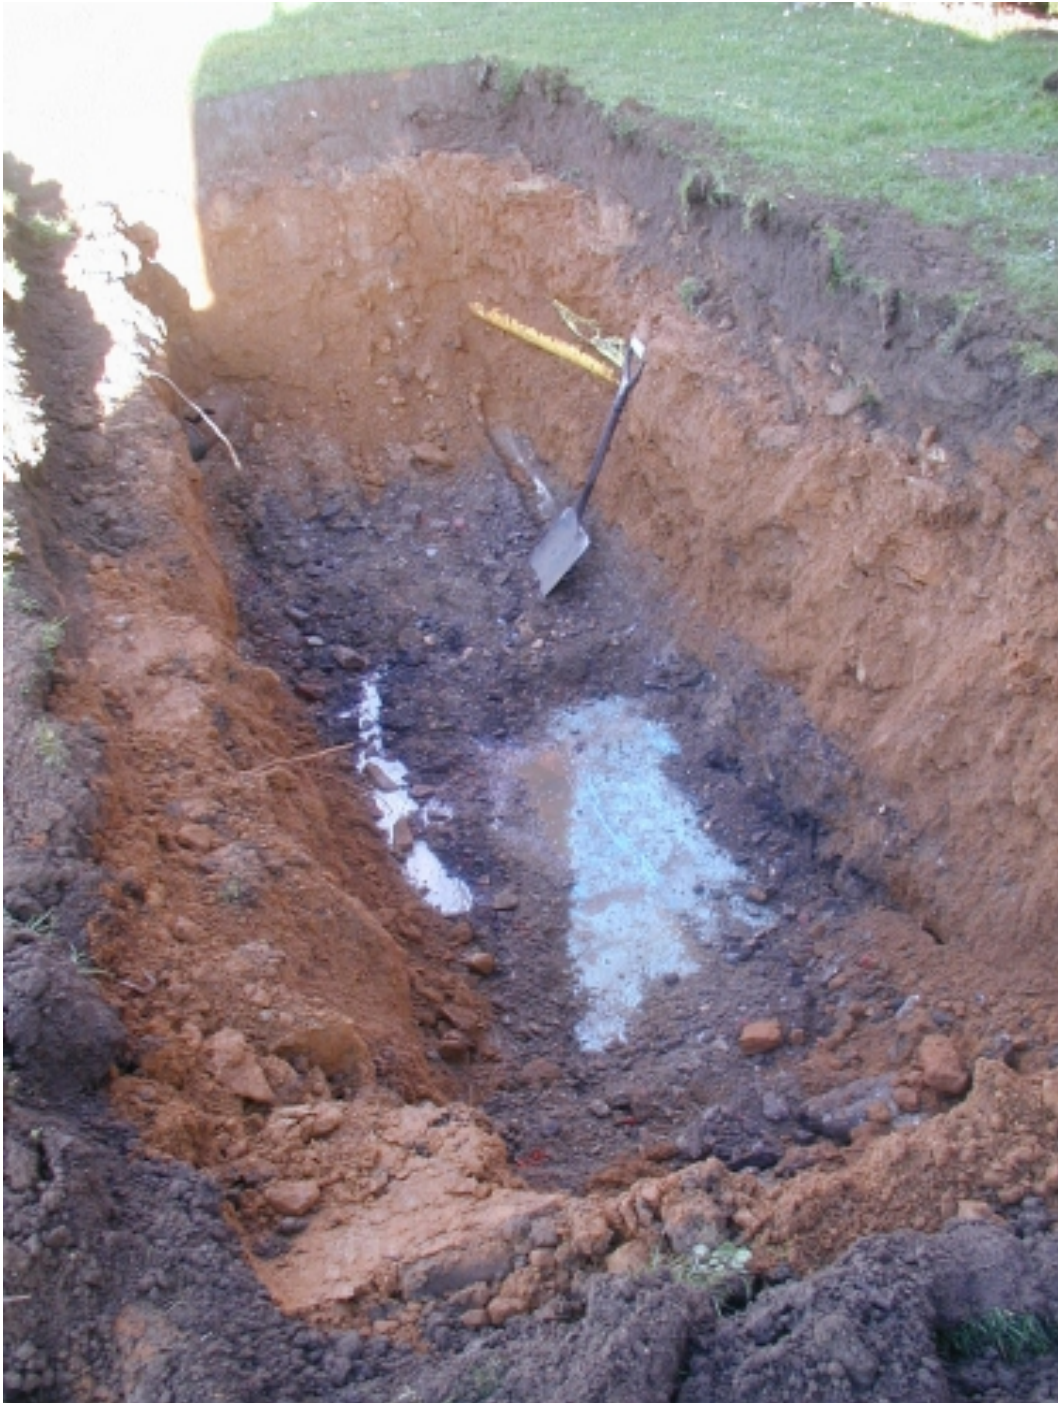
Photograph 12: The intact blue concrete bottom of the Newnham Baths swimming pool in Area 2, showing the nature of the deposits used to backfill it

The machine-excavated trench bottomed out on a slab of light blue reinforced concrete at a depth of *c.* 1.4m below ground level (Photograph 12). The excavated deposits (G4.41) on top of this slab comprised a layer of mixed grey-brown soil and building rubble beneath a homogeneous dump of light orangey-brown road stone. This was covered directly by topsoil. This concrete slab is unquestionably the base of the former swimming pool, and this observation confirms that the pool lining was left *in situ*.

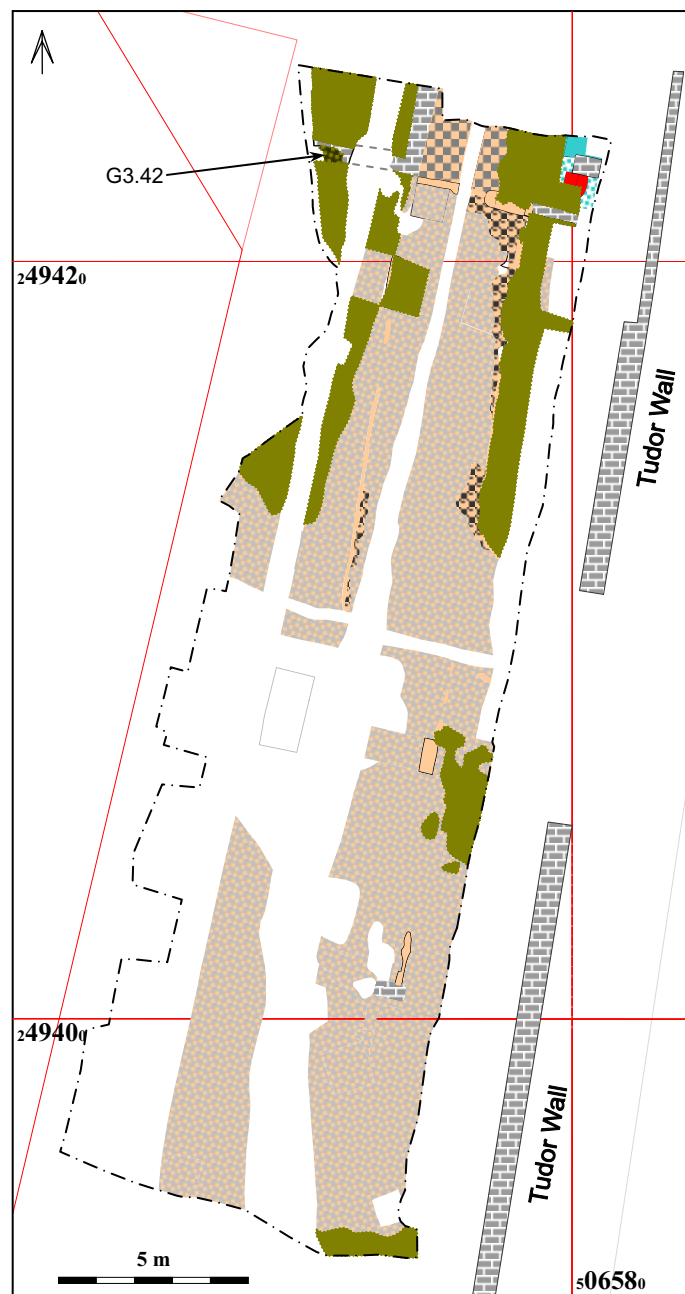
Figure 8: Post-medieval demolition deposits

A series of widespread dumped deposits (G3.41) covered much of the excavation area, particular concentrated in the east and north (Figure 8). These layers varied from loose to compact, mid-dark grey brown silty clays to gravel. All contained high percentages of bricks (similar to those within the standing ‘Tudor’ wall), tile and small-medium stones with occasional oyster shells.
