**WOLVERTON AQUEDUCT LOCKS,  
WOLVERTON,  
MILTON KEYNES**

**ARCHAEOLOGICAL  
FIELD EVALUATION**

Document: 2005/34  
Project: WA 1080

16<sup>th</sup> May 2005

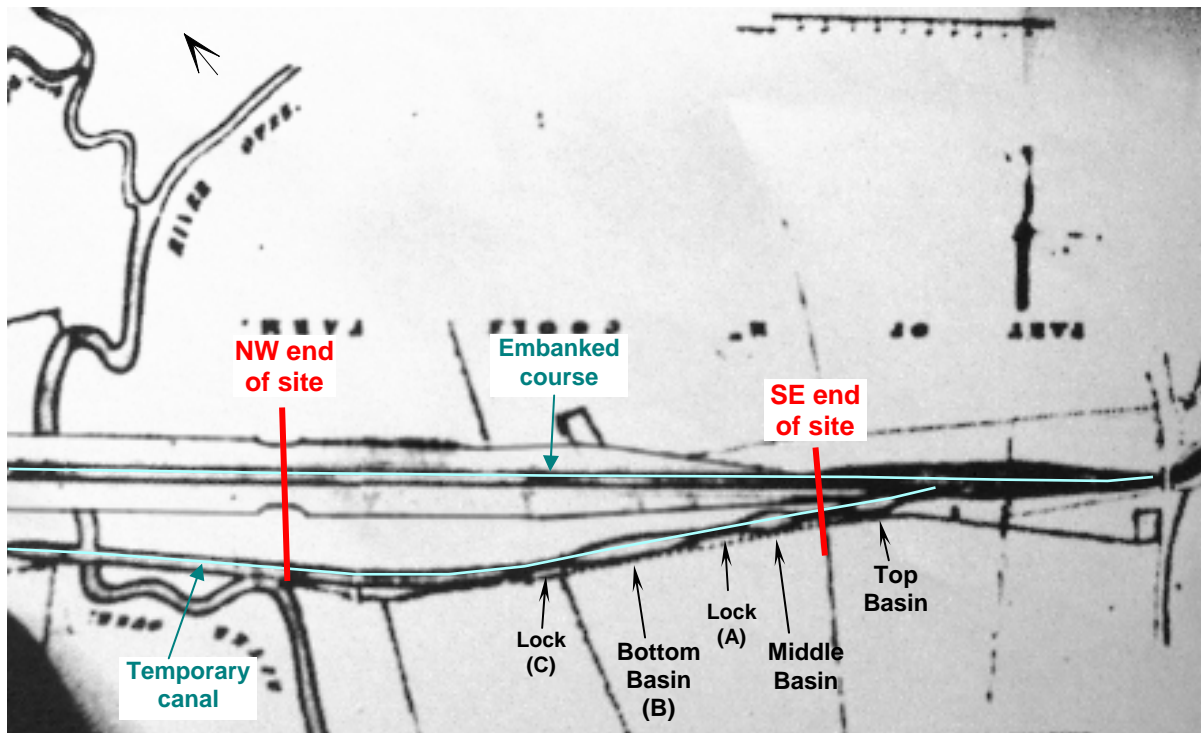
**Figure 2:** Detail from historical map showing both temporary canal and embanked course.

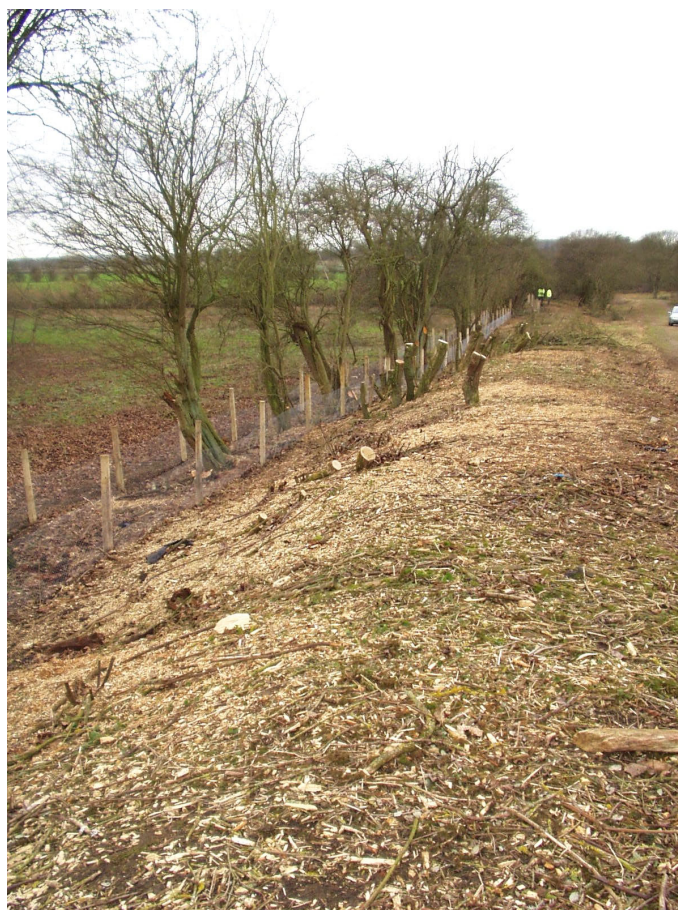
**Photograph 1:** Western side of embankment near modern ramp (looking north-west).

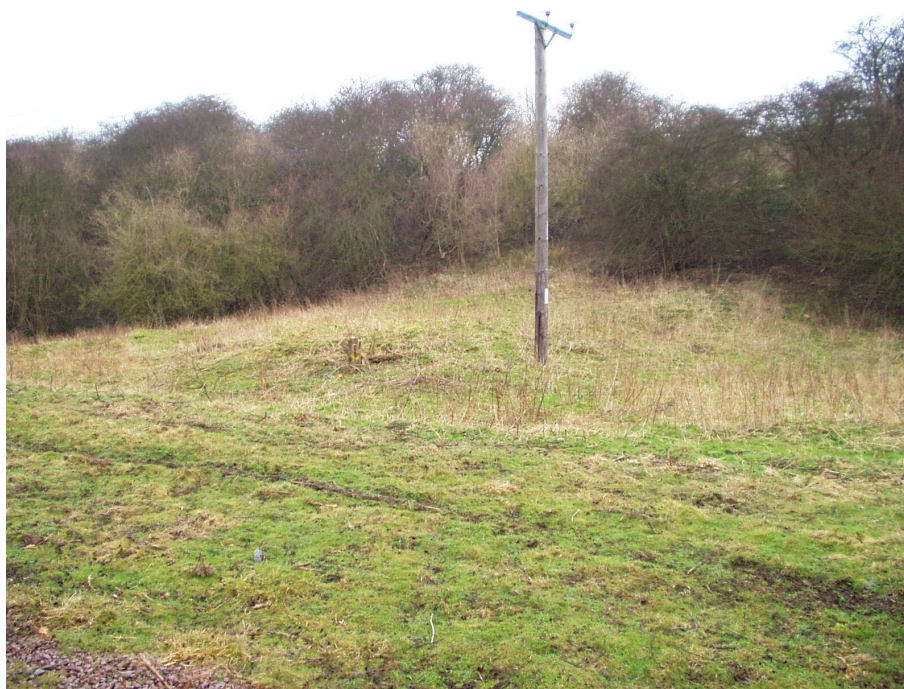
**Photograph 2:** Main debris tail (D) sloping down western side of embankment.

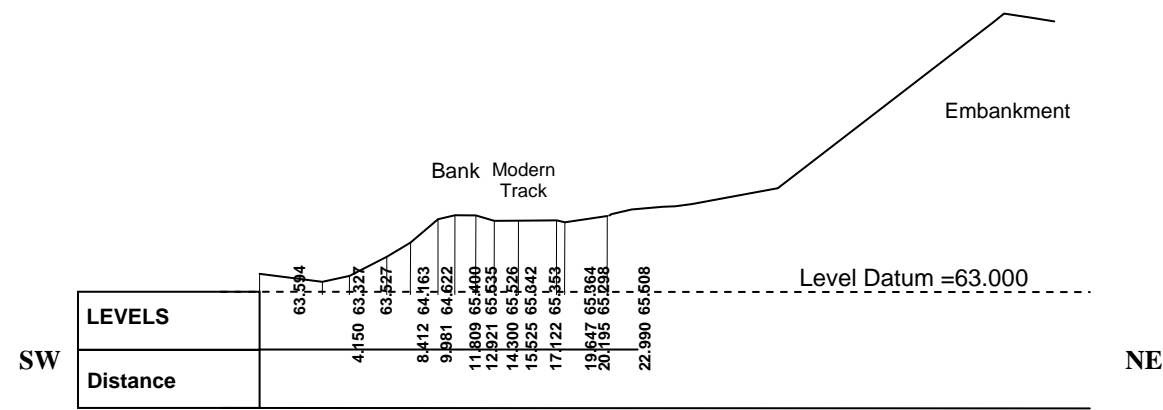
Profile 1; Combination of GPS survey and EDM survey

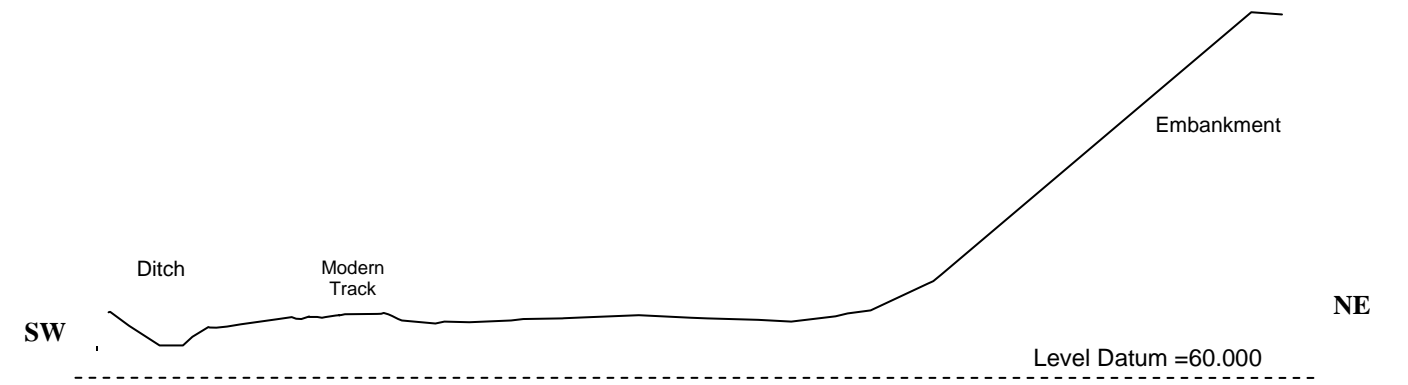
Profile 3; EDM survey

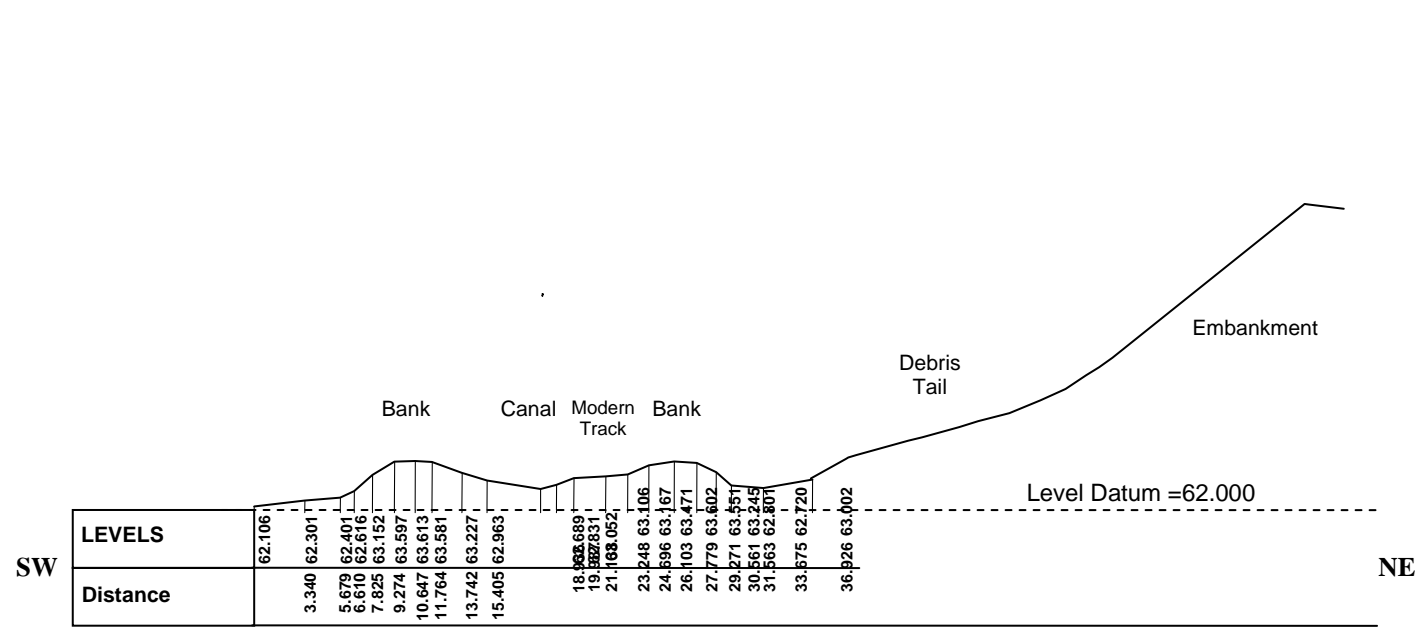
Profile 2; Combination of GPS survey and EDM survey

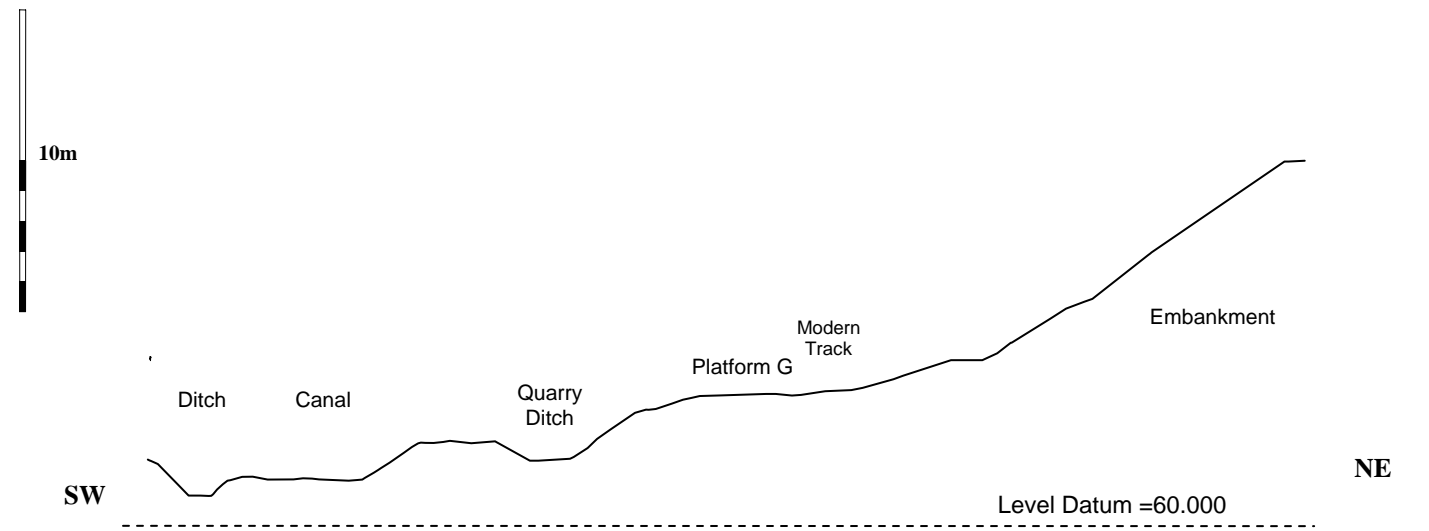
Profile 4; EDM survey

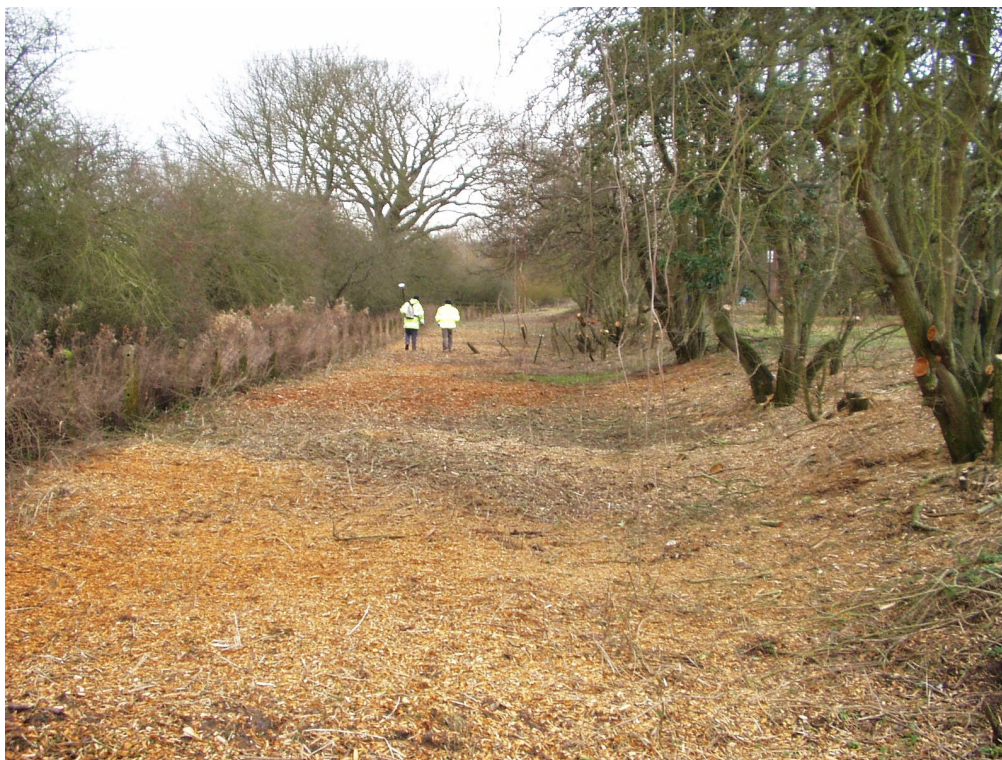
**Photograph 3:** GPS survey of cut section of canal near diverted course of river.

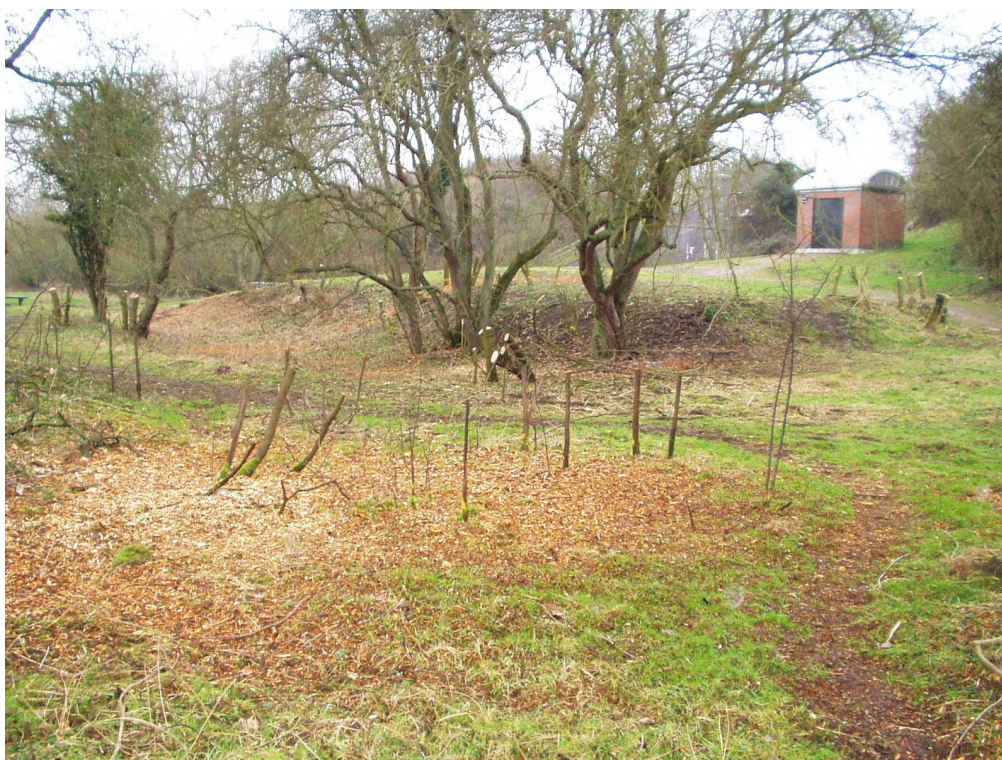
**Photograph 4:** Platform (G) from south-west with modern track and pumping station.

The trench was opened to investigate the undisturbed western area of the roughly square platform (**G**). Below a shallow topsoil (700) and subsoil (701) a series of deposits including a gravel surface composed of a mid grey brown clay gravel (702) and several smaller spreads of probably underlying material (705-707) were revealed (Figure 18 and Figure 21: photograph 19). A variety of materials, including both local (red) and imported (yellow) brick fragments had been used to raise the level of the ground to form the platform with (702) defining an associated surface. The only trace of activity associated with the platform was a severely truncated posthole [703] roughly circular in plan, 0.3m across but only 0.06m deep (Figure 20: section 2). The function of the platform remains uncertain; no evidence for the presence of a substantial building was recovered.

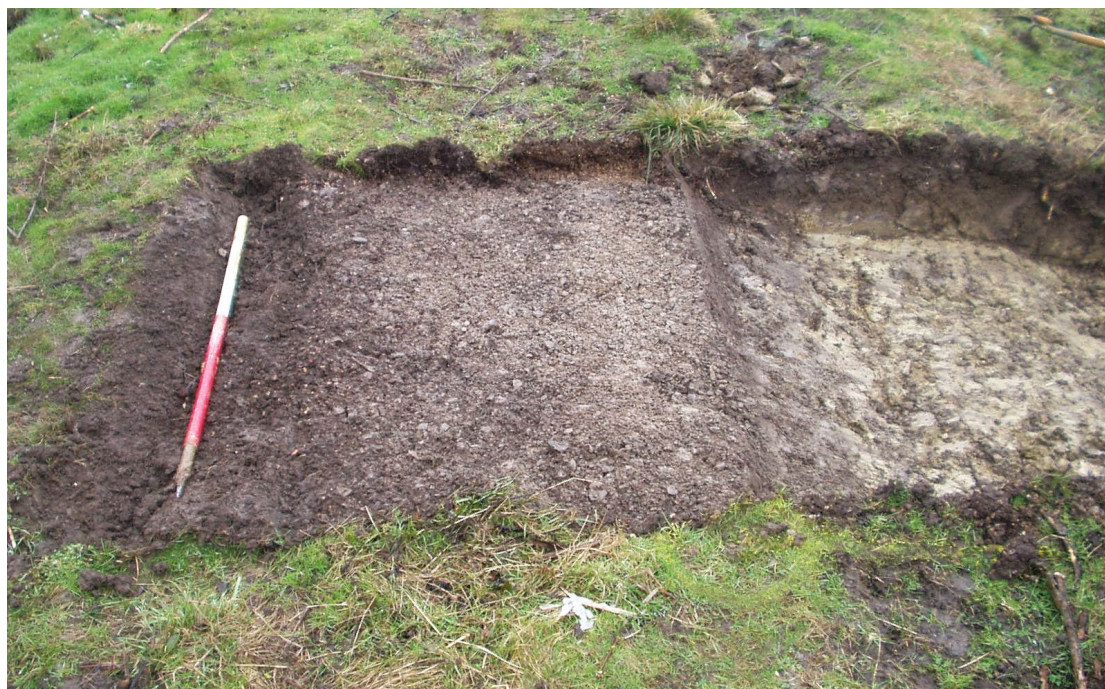
**Photograph 5:** Recent path (201) in Trench 2. Scale 1 metre in 0.5m divisions.

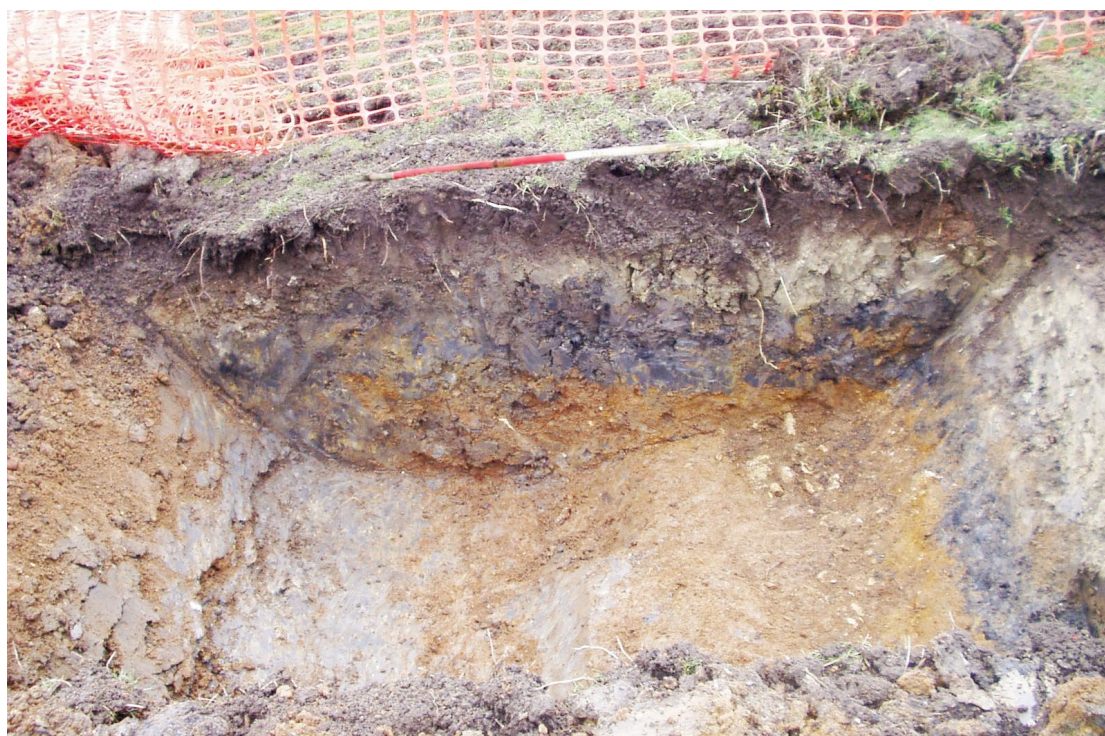
**Photograph 6:** Alternating layers forming bank in Trench 1. Scale 1 metre

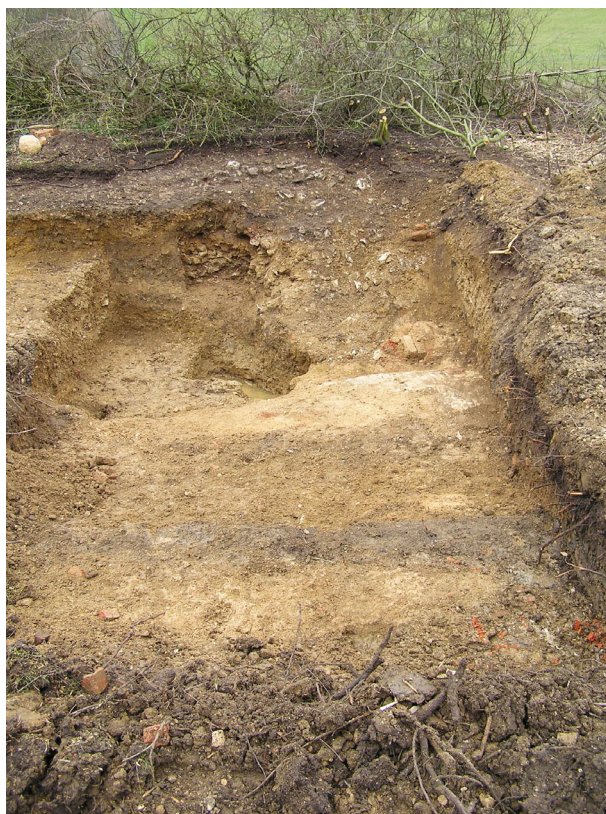
**Photograph 7:** General view of final northern extension of Trench 4, showing remnant lining. The dark bands define later disturbance comprising an old field boundary [414] and the cut for a modern overflow pipe [416] (narrow grey band).

The side of the canal had two distinctive ‘shoulders’ or narrow steps (Figure 11: section 3, Figure 13: photograph 7 and Figure 15: photograph 11). The upper shoulder corresponded to the base of the channel for the ground paddle (see 3.2.2.2.2 below). The side of the canal in this area had a defined inwards curve to the north-east (Figure 12). A lower ‘shoulder’ was at a depth of 1.4m below the present ground level (61.54m AOD), the canal extending at least 0.4m below this level (Figure 16: photograph 13). However, at this point water inundation was too severe to enable further investigation. The levels indicate that the base was lower than the lock in Trench 3, suggesting that this was associated with the construction of the embanked section of canal rather than indicating a deeper, early phase of use.

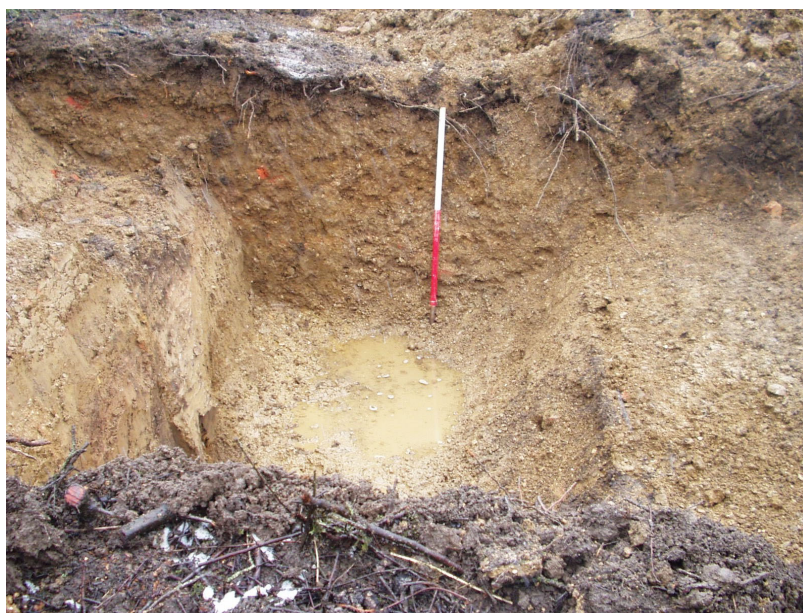
**Photograph 8:** Clay lining (305) with gravel backfill (304) to right, base of lower part is full depth of canal in this trench. Scale 1 metre.

305	Lining	Firm dark brown grey clay frequent flecks manganese staining Vertical face of material 0.8m deep on west side of canal, abutted by canal infill. This is interpreted as a watertight clay lining to the canal, which would have originally been faced with bricks.	<input type="checkbox"/>	<input type="checkbox"/>

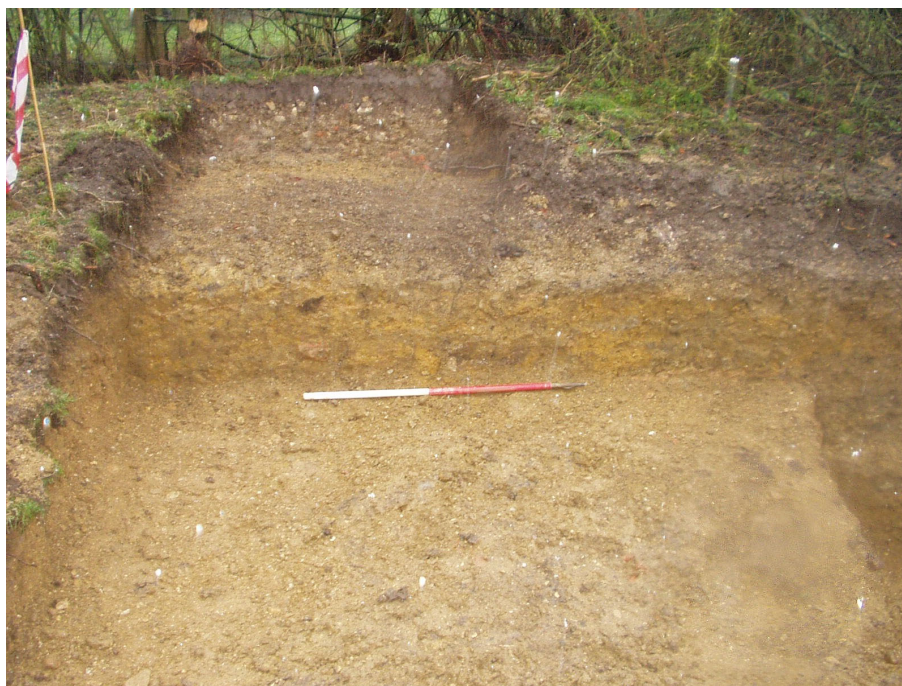
**Photograph 9:** Gravel backfill of canal in foreground, revealing yellow clay lining (404) (looking west). Scale 1 metre.

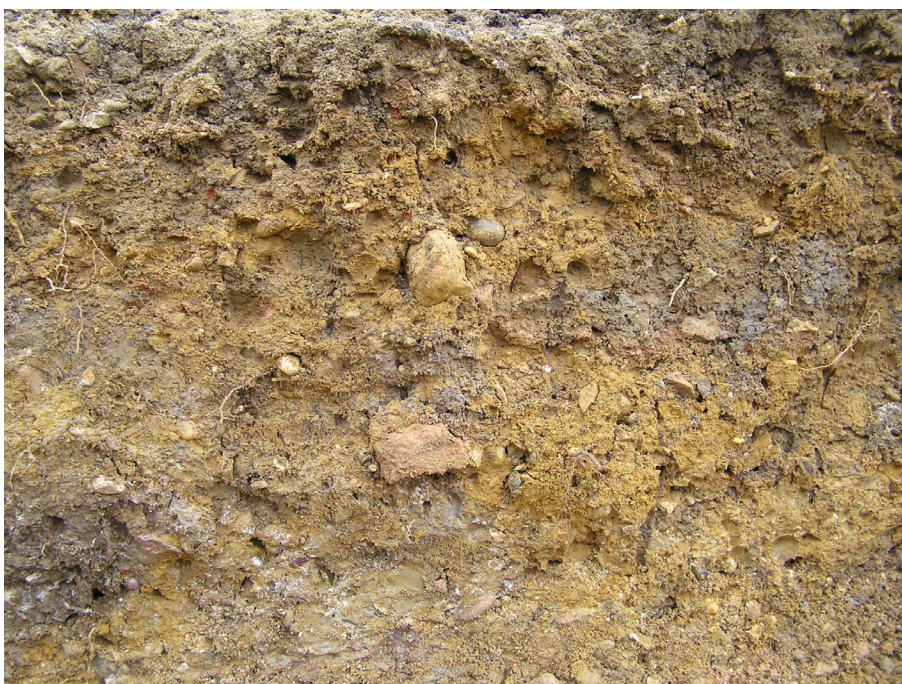
**Photograph 10:** Detail of clay lining with impressed brick fragment – possible evidence for keying to original facing.

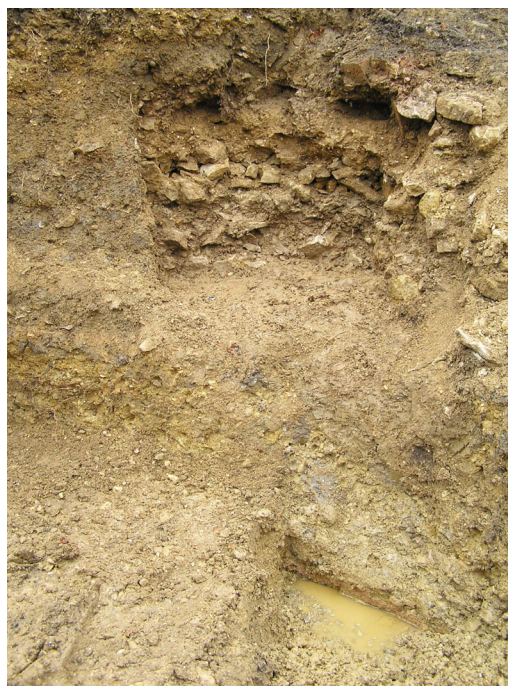
**Photograph 11:** Investigation of ground paddle channel and form of canal in Trench 4. Two narrow 'steps' or 'shoulders' are clearly visible in the canal lining.

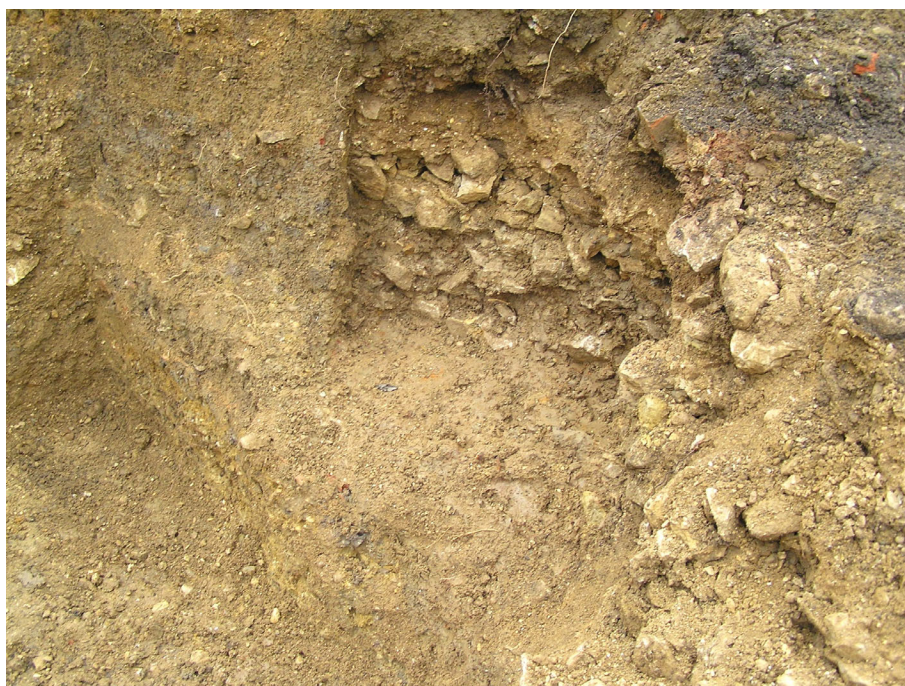
**Photograph 12:** Investigation of backfilled ground paddle channel, consisting of compacted limestone fragments.

An extensive spread of slabby limestone rubble was revealed in Trench 4. The trench was subsequently extended to allow further investigation of this feature. Investigation indicated that the band of limestone (405) was at least 1.8m east-west by 1.6m wide, sloping down into the backfill of the canal. This deposit contrasted sharply with the canal backfill, from which only a few fragments of limestone were recovered. Investigation indicated that the limestone filled a vertically sided, flat based cut [406], 0.86m high. The limestone had been compacted to fill this void, with a sequence of bands being discernable (Figure 11: section 4 and Figure 15: photograph 12). This feature is interpreted as the robber cut for the channel associated with the lock’s ground paddle. This would have been used to move water in the upper part of the lock, with paddles or openings on the lock gates opened

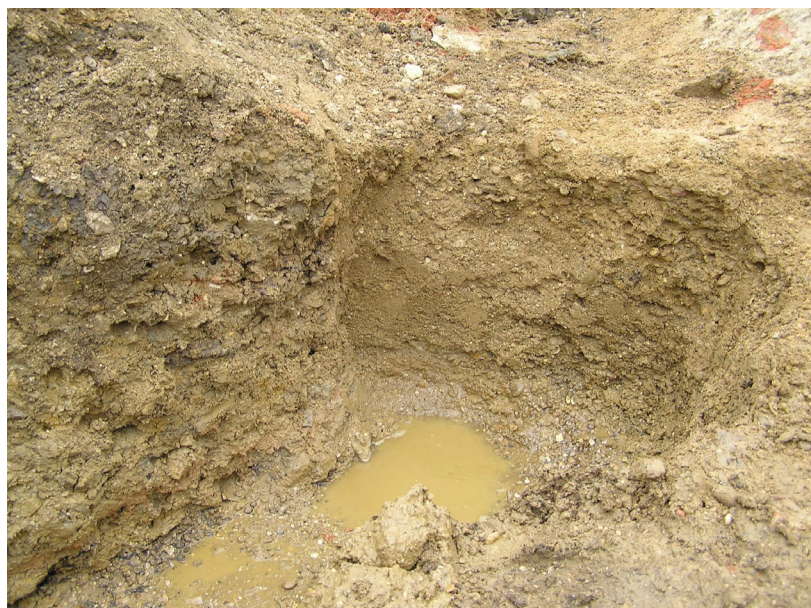
**Photograph 13:** The stepped edge of the canal is visible to the left with gravel fill (413) sealed beneath the mortar/concrete and brick structure (411).

<b>Context:</b>	<b>Type:</b>	<b>Description:</b>	<b>Excavated:</b>	<b>Finds Present:</b>
411	Concrete	Cemented light yellow grey sandy limestone occasional medium-large ceramic building material Concrete layer with occasional whole bricks still in situ. A semi-circular step, defining an area c. 2.2m across on the west side of canal forming a "bath" shaped deeper depression.	<input type="checkbox"/>	<input checked="" type="checkbox"/>
413	Fill	Loose mid yellow brown sandy gravel occasional small ceramic building material, frequent small stones Gravel fill at least 0.6m thick, extending below the concrete structure (411). The levels suggest that this material was associated with the construction of the canal rather than indicating the backfill of a deeper, earlier form of the canal. This deposit merges into (402) beyond the concrete structure (411).	<input checked="" type="checkbox"/>	<input type="checkbox"/>

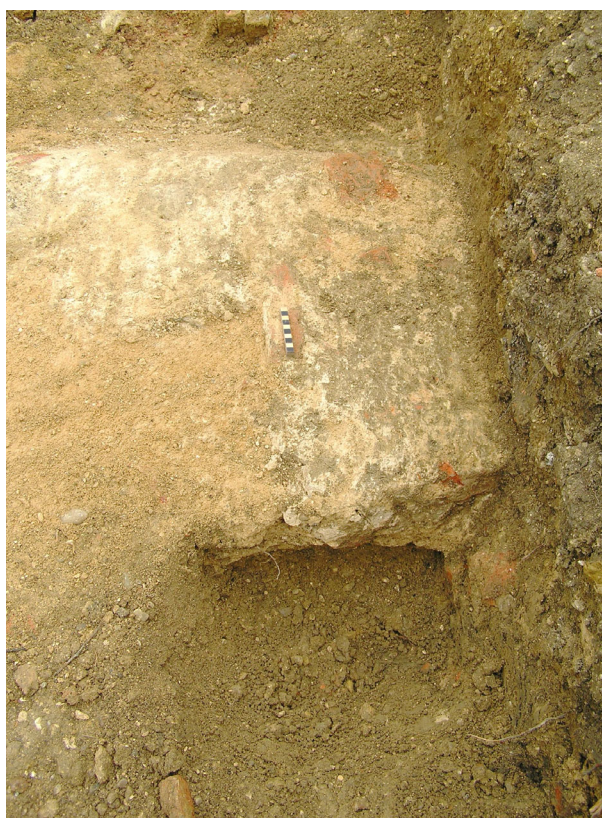
**Photograph 14:** Detail of concrete structure (411) with truncation by old field boundary [414] in the foreground. Scale 10cm.

At a depth below ground level of between 1.1m in the west and 0.45m in the east, the northern extension to Trench 4 revealed an extensive area of concrete tempered with small stones (411). It measured c.4.9m east-west by 2.9m and was up to 0.25m thick (Figure 12, Figure 16: photograph 14 and Figure 17: photograph 15). In the west a deeper ‘channel’ orientated north-west to south-east was at least 1.2m long, 1.4m wide and 0.28 m below the wide ‘shelf’ to the east, which was at c.62.24m AOD. Towards the northern limit an off-white concrete incorporating whole bricks as well as smaller fragments was defined. This had a good edge with a more friable yellowier mortar/concrete in the area to the south. The yellowier material was softer and had suffered from disturbance associated with later activity.

414	Ditch	<b>Linear profile: vertical dimensions: max breadth 1.3m, min depth 0.3m, min length 2.9m Post-canal field boundary, utilising associated earthworks. Small section opened, indicating vertical upper edge with concrete structure (411). The ditch was at least 0.3m deep. Continues to north-west as [303].</b>	<input checked="" type="checkbox"/>	<input type="checkbox"/>
415	Fill	Loose dark grey brown silty clay occasional small ceramic building material, moderate small stones Good contrast with (417).	<input checked="" type="checkbox"/>	<input type="checkbox"/>
416	Drain	<b>Modern narrow pipe trench associate with concrete outflow to the north-west. Continuation not distinguished from ditch fill in Trench 3.</b>	<input type="checkbox"/>	<input type="checkbox"/>
417	Fill	Compact mid blue grey silty clay Unusual material contrasting with adjacent ditch fill (415).	<input type="checkbox"/>	<input type="checkbox"/>

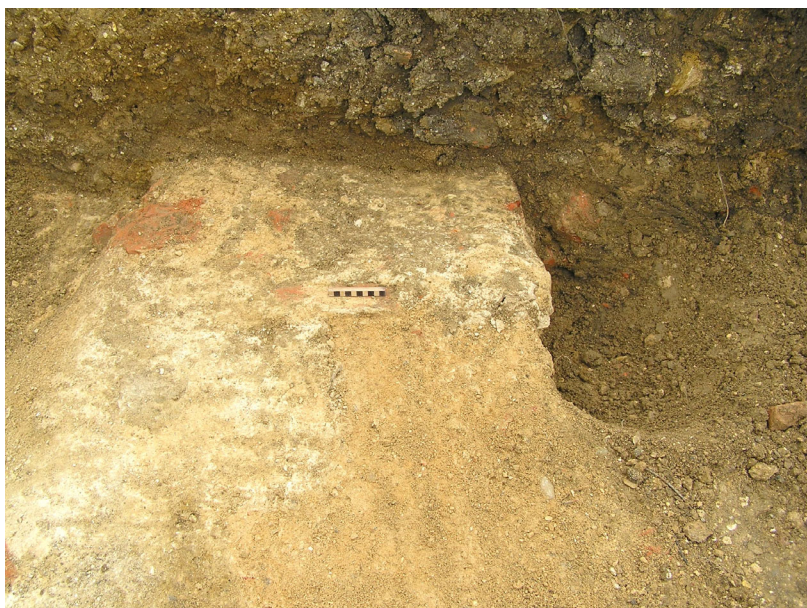
**Photograph 15:** Detail of concrete and brick structure (411) showing shelf to centre of image with deeper element to the left. The old field boundary [414] is the dark band on the right.

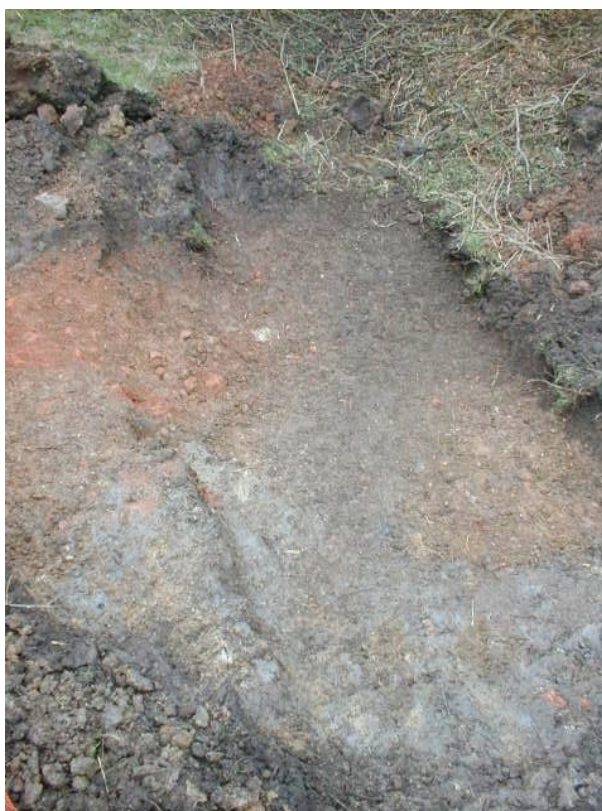
**Photograph 16:** Overflow ditch [505] prior to excavation.

Situated on the eastern side of the lock earthworks, Trench 5 was opened to investigate the junction of the linear feature (E) with the canal bank (Figure 12). The ditch was well-defined, contrasting with different bank materials to the east and west (Figure 17: photograph 16). The cut was up to 0.85m wide tapering to 0.64m to the north. In section the cut had a distinctive U-shaped profile up to 0.5m deep, filled with a mid grey brown silty clay (Figure 11 section 6). Further north the feature was much shallower at 0.2m. The fill (506) contained ten red brick fragments (2.0kg), similar to those recovered from Trenches 3 and 4.

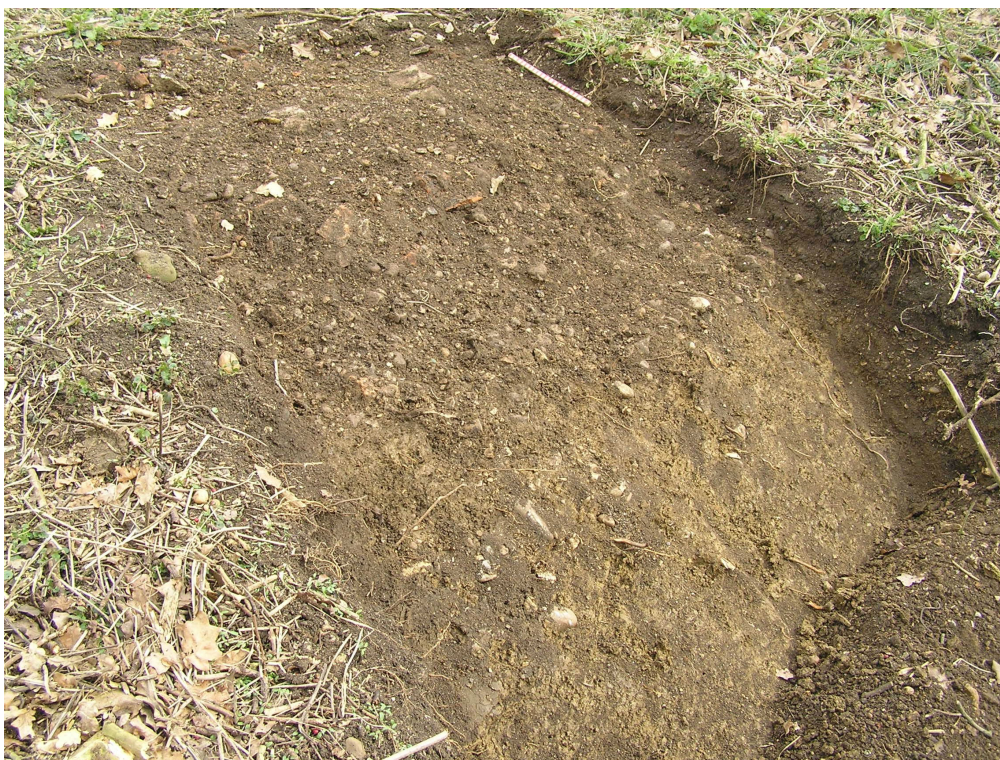
**Photograph 17:** Upper path (601) associated with cut section of canal in Trench 6.

The trench revealed a well-defined gravel path (601) on the top of the earthwork (Figure 19: photograph 17). It was at least 1.8m wide, composed of small-medium stones in a grey brown silty clay material. There were frequent small-medium brick fragments in the surface. This material sloped down the convex eastern edge of the canal. The location of this path suggests that it was not a

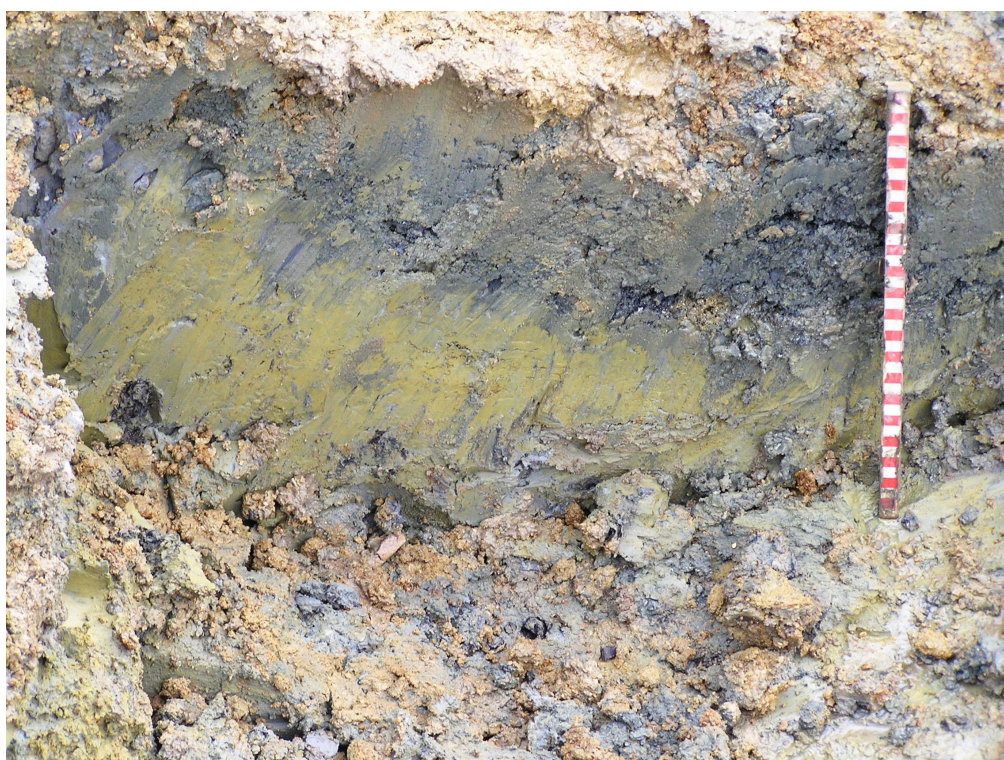
**Photograph 18:** Sloping edge of cut section of canal [608].

The eastern side of the canal [608] had a c.45 degree slope and a roughly level base (Figure 19: photograph 18 and Figure 20: section 1). A yellow brown clay (609) up to 0.20m thick lined the cut. Below this was a stiff mid grey brown clay up to 0.18m thick (611), which had a horizontal boundary with (609). This deposit was directly above the yellow gravel (610) which formed the river terrace in this area. It is not clear if (611) was also part of the lining for the canal, rather that a naturally accumulated river-borne deposit. However, as a clay lining of 18 inches (c.0.46m) was often used, the yellow clay would appear to have been too thin on its own to form an adequate lining.

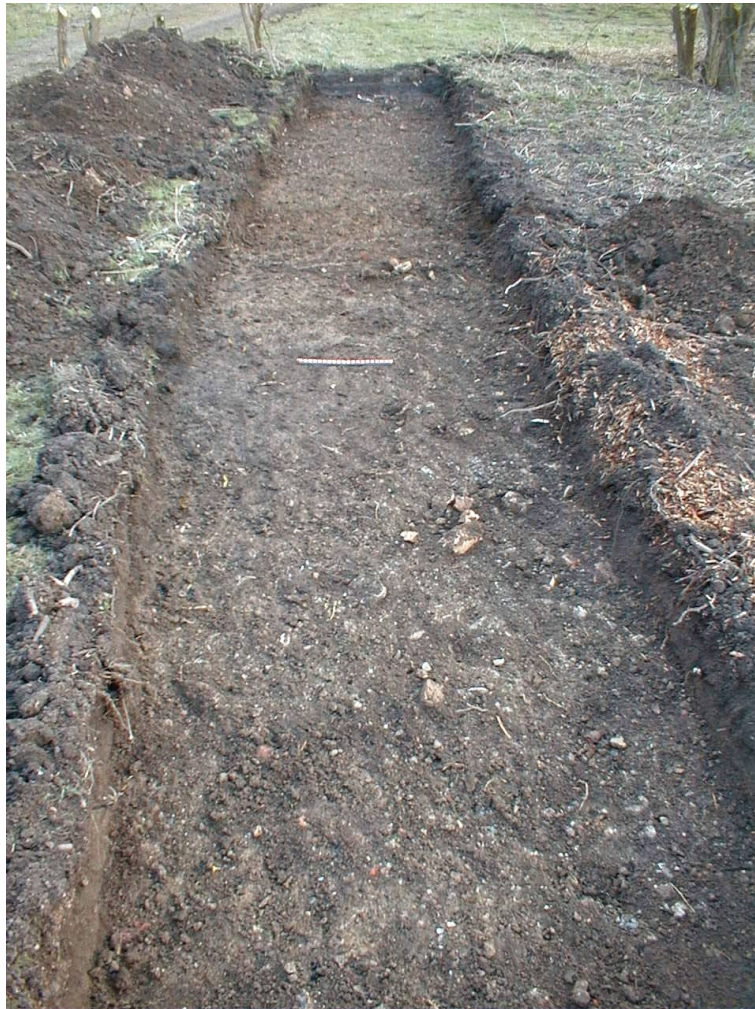
**Photograph 19:** Gravel surface (702) in Trench 7, with traces of underlying rubble associated with platform (G).
