**BEDFORD SANITARY LAUNDRY
DERWENT PLACE
BEDFORD
BEDFORDSHIRE**

HISTORIC BUILDING RECORDING

Project: DP2687
OASIS ref: albionar1-248459
BEDFM 2016:22

Document: 2016/120
Version 1.1

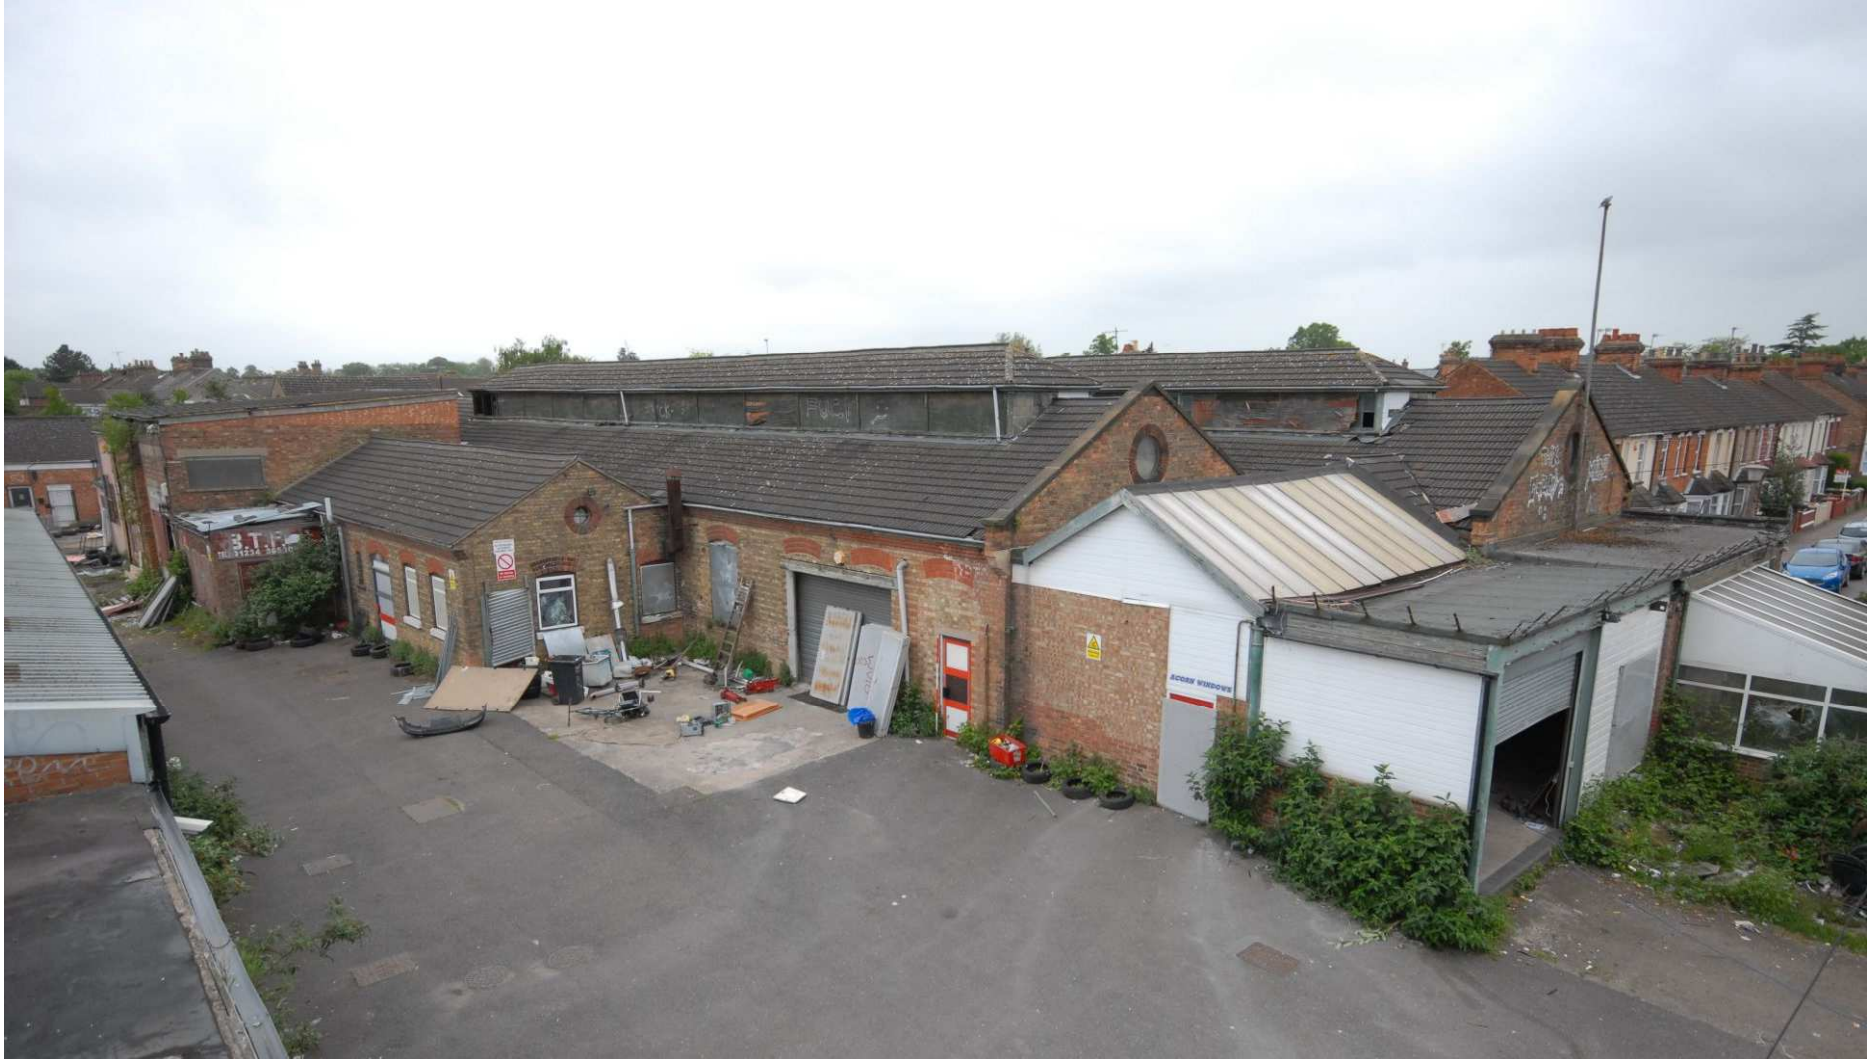
Figure 8: Bedford Sanitary Laundry eastern side, looking SW from footbridge across railway

The 1957 drawings, if they are a correct representation, suggest that originally the “Boiler House” was a much higher structure (Figure 7a). Probably in 1957 this was lowered and the high pitched roof replaced by a near-flat roof. The change of roof is indicated by a change in brick colour (Figure 8).

Most likely after the laundry ceased trading and with the conversion of the building to new purposes, many original windows and doors were blocked and new rectangular double size and often double-height doors and gates were inserted (Figure 8). Two walls were also inserted into the “Ironing and Finishing Room” and one wall removed, creating three separate units. Most floors and ceilings within the building are new insertions.

with the gable wall extending higher than the roof forming a classically shaped gable cornice topped with stone and accommodating a round, red brick-framed window each (Figures 8 and 10). A moulded stone pedestal supports the base of each cornice where it juts out from the main building line.

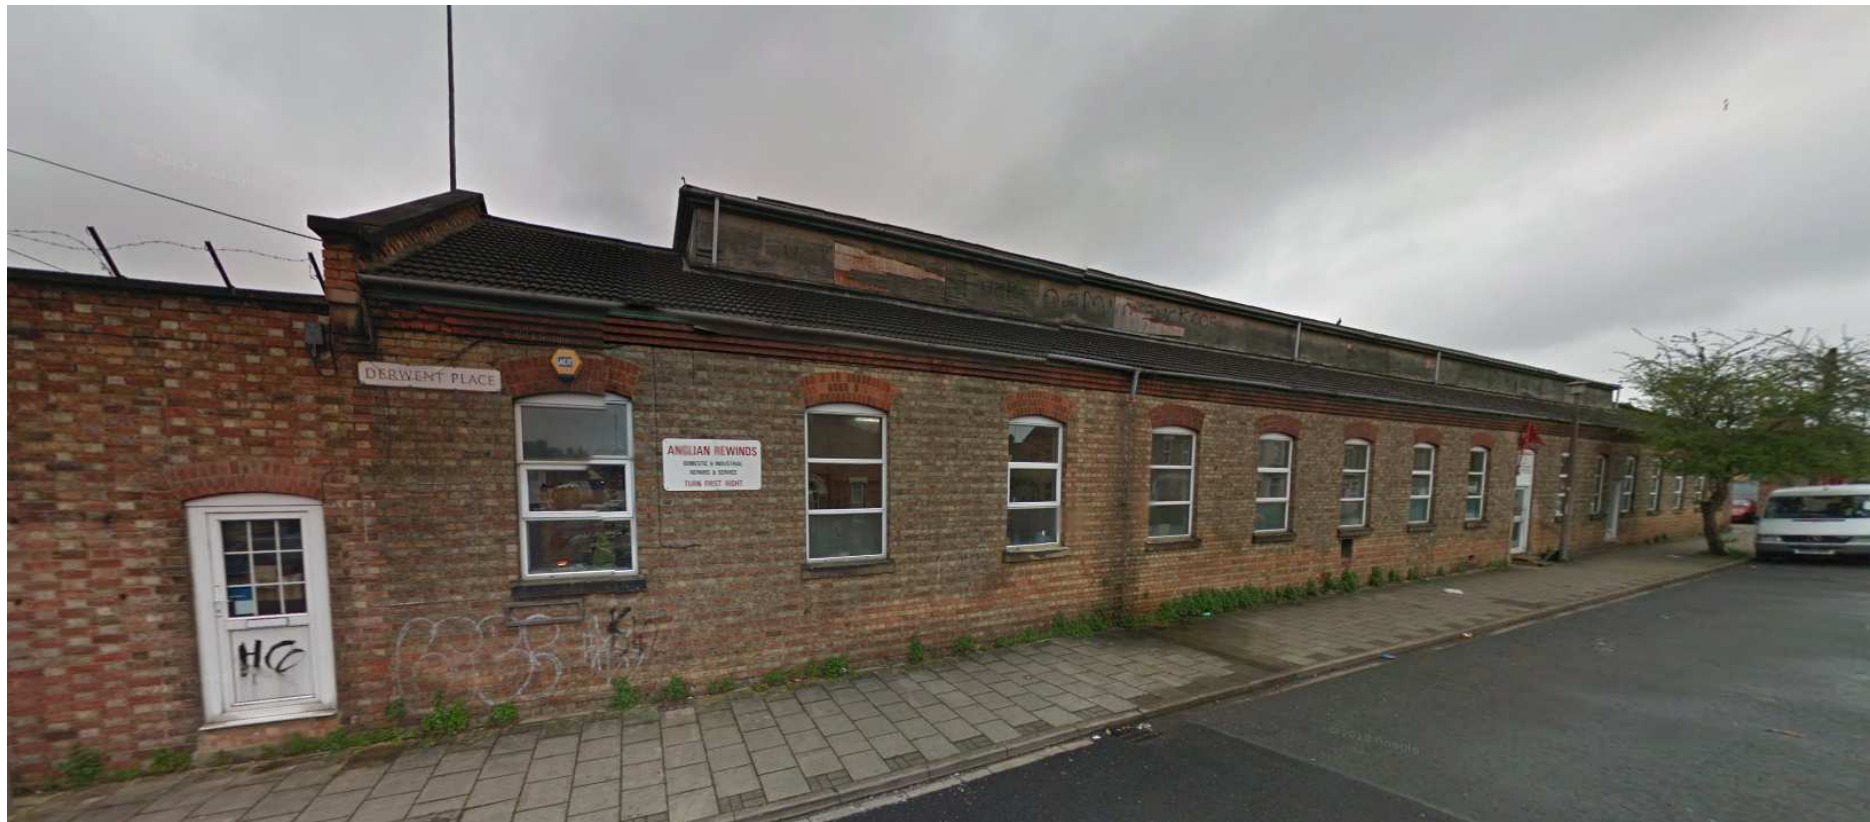
Figure 9: Bedford Sanitary Laundry western façade along Derwent Place¹

The original building consisted of two large, parallel building ranges which housed the main washing, drying, ironing and finishing facilities and lit by a closely spaced windows along each façade (Figure 9). Each building range has a pitched, slate roof

The laundry is built in a mixture of red and yellow bricks, many of which feature both colours and evidence of differential firing and stacking marks. The original construction method is English Bond throughout. For the main ‘public’ wall facing Derwent Place yellow headers were used alternating with reddish stretchers, creating a patterned façade (Figure 9). The rear walls of the laundry buildings are also in English Bond but generally of a more uniform colour. The 1957 extension facing Derwent Place was constructed in a Flemish Bond matching the original wall in red and yellow patterning if not in bond (Figure 9).

The arches of each window and door are kept in a bright red, smooth brick with a distinctive contrast to the more textured brick of the walls. A stepped frieze of the same red brick runs along the top of each building below the roof line. Window sills are grey stone (Figure 9).

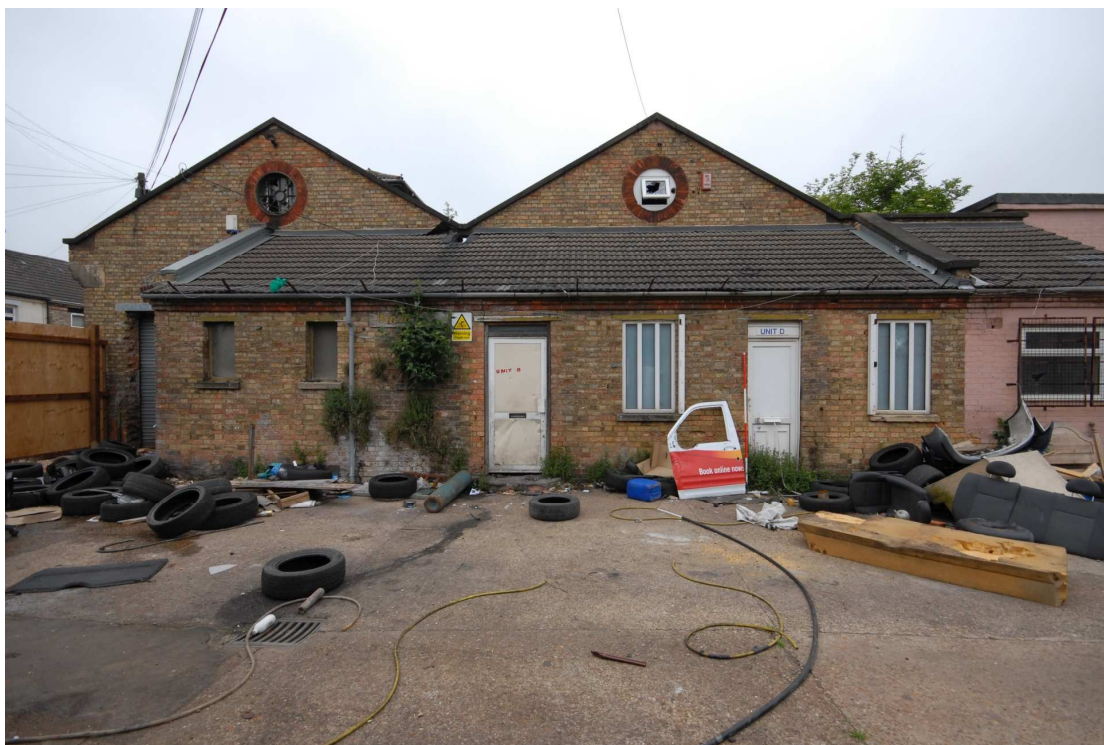
Figure 10: Southern side of laundry, showing 'lean-to' WCs and cloakroom. Looking S.

The boiler house, engine rooms, engineers shop, and coal store were located at the rear of the laundry, possibly in flat-roofed buildings. A smaller private wash-house and store was also located to its rear in a structure mirroring the main ranges in form but smaller in size. The staff entrance, “Cloak Room” and W.Cs at the southern end of the building are a lower, lean-to building with a sloping roof. The windows are simple rectangular openings with a stone sill and wooden lintel (Figure 10).

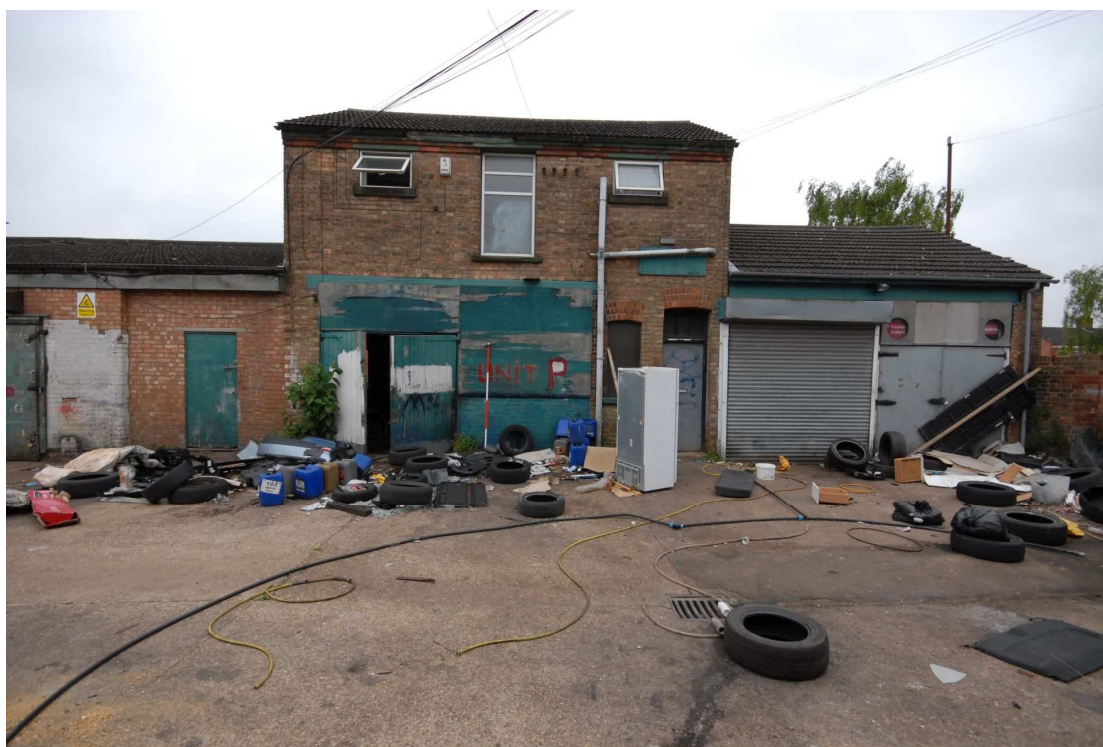
Figure 11: Former stables with loft and coachhouse along southern wall of laundry complex. Looking N.

The stables along the southern wall are a two-storey building with a one-storey coach house adjacent. They are built in the same style as the main laundry building. New windows and doors have been inserted and the whole front of the coach house has been replaced with a double-sized garage door with a roll-down blind (Figure 11). The interior of those buildings was not surveyed.

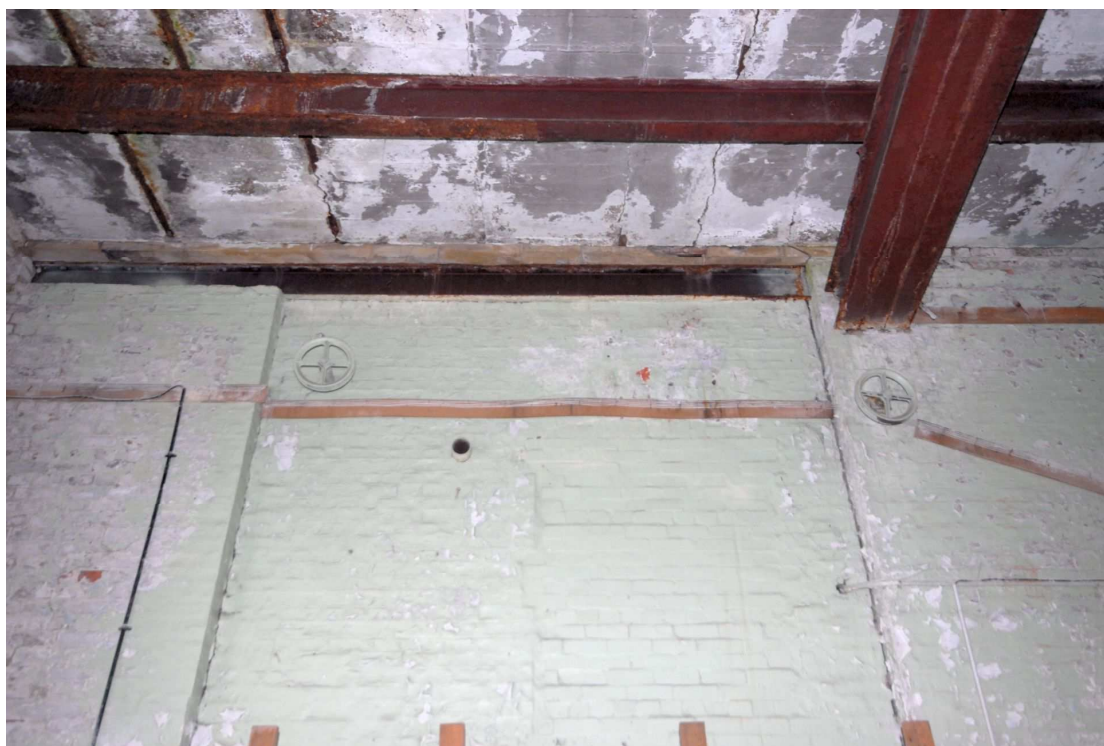
Figure 13: Wheels for possible rope fittings to operate ventilation shafts at southern wall of boiler house (not original ceiling).

Because of the extensive conversion and re-use of the laundry building, none of its interior fixtures and fittings survive. The rooms were stripped of all their original elements and in a lot of cases new concrete floors were laid which showed no footprints of former machinery. One of the few surviving original fittings is a herringbone parquet floor in the former “Mess Room” (Figure 12). Two wheels with a concave groove for ropes, high on the walls of the former “Boiler House”, are most likely also original and were probably used to operate ventilation vents (Figure 13).

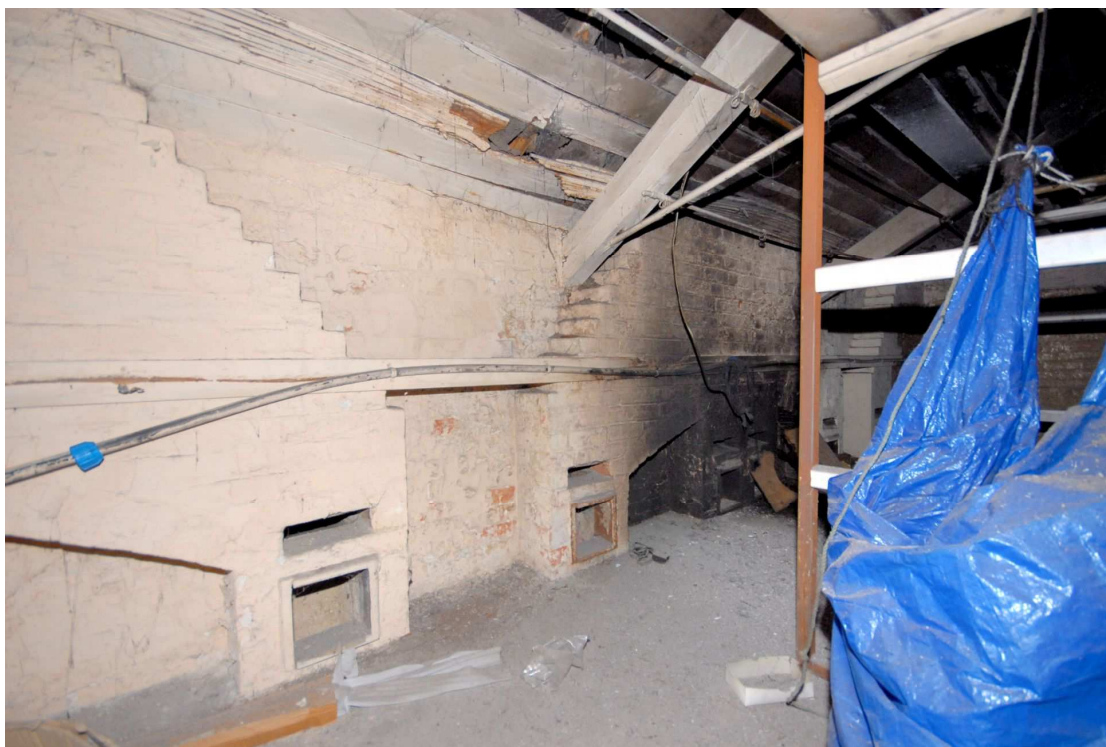
Figure 14: Flues in area of former “Drying Closets”, sharing wall with boiler room.

In the former area indicated as “Drying Closets” on the 1906 plan, a series of flues are still part of the wall construction (Figure 14). These would have heated the rooms and helped to dry the clothes in the closets. Hooks within some of the roof girders may have held wires or lines used to string up clothes (Figure 15).

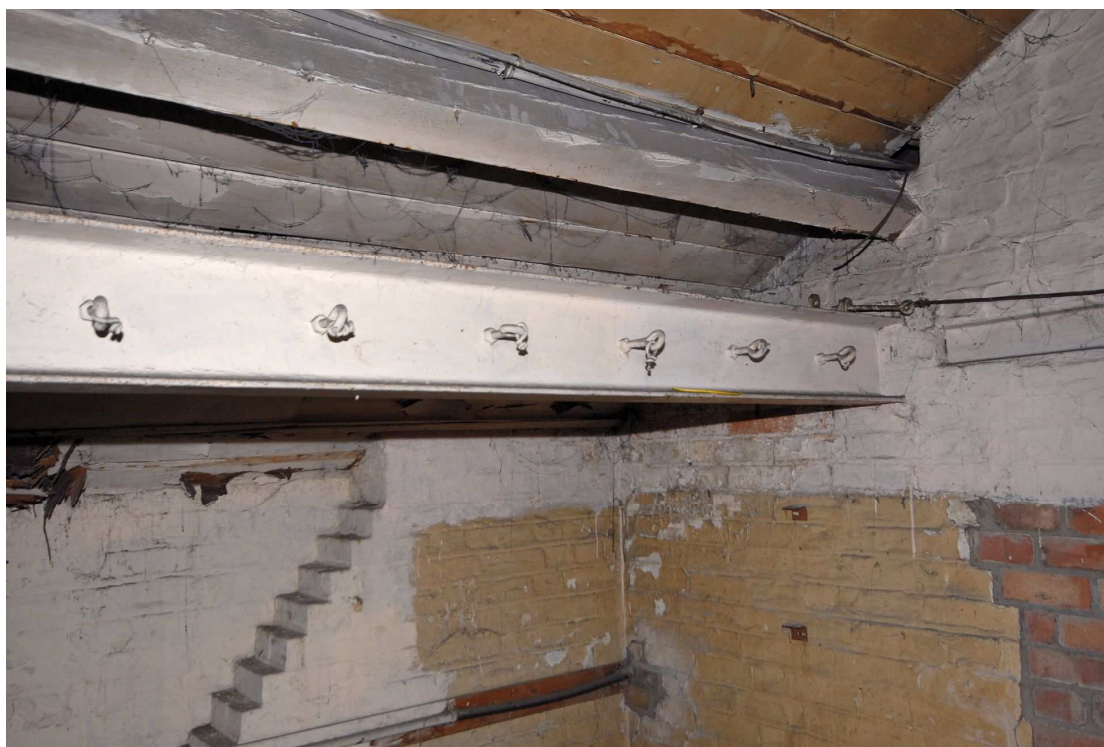
Figure 15: Hooks in area of former “Drying Closets” for rope or wire attachments.

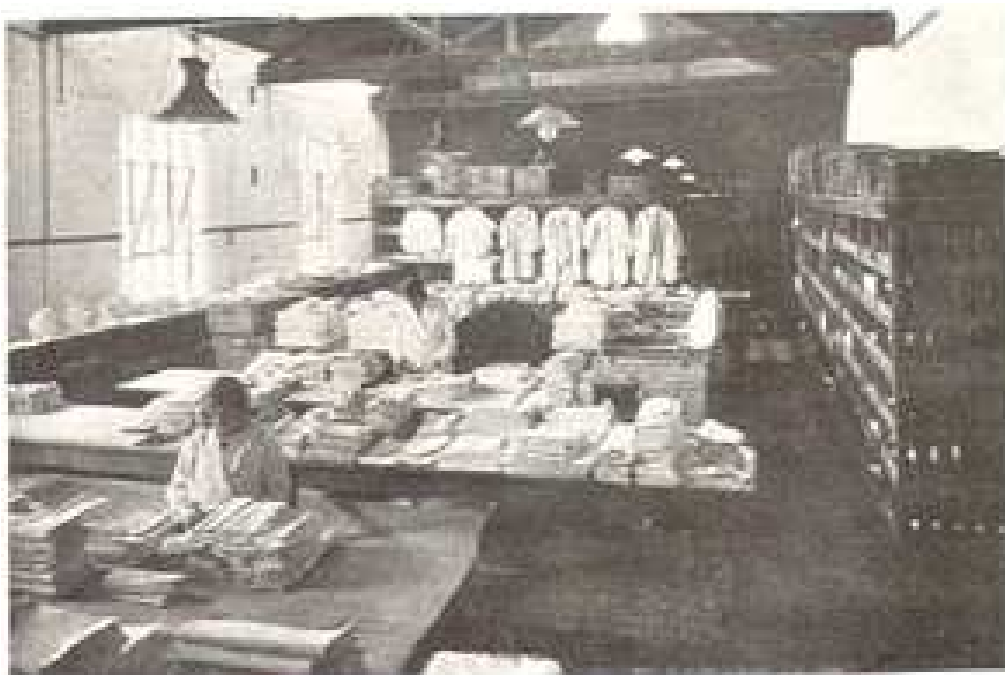
Figure 16: “Sorting and Packing Room” historic photograph.
Image from Bedford Directory 1898, p.261.

Figures 16 and 17 show an original photograph taken in the “sorting and packing room” in c.1900 and a photograph of the same room today. An early newspaper cutting reports that (after “sorting and packing”) in the early years customers at places outside Bedford were sent their clean washing by rail⁸. The laundry did lease land from the railway for use as drying grounds⁹. It is likely that linen was brought to the laundry and taken away by customers, first using a horse and cart and later cars. The horse and cart would also have been used to transport coal to the laundry for fuel.

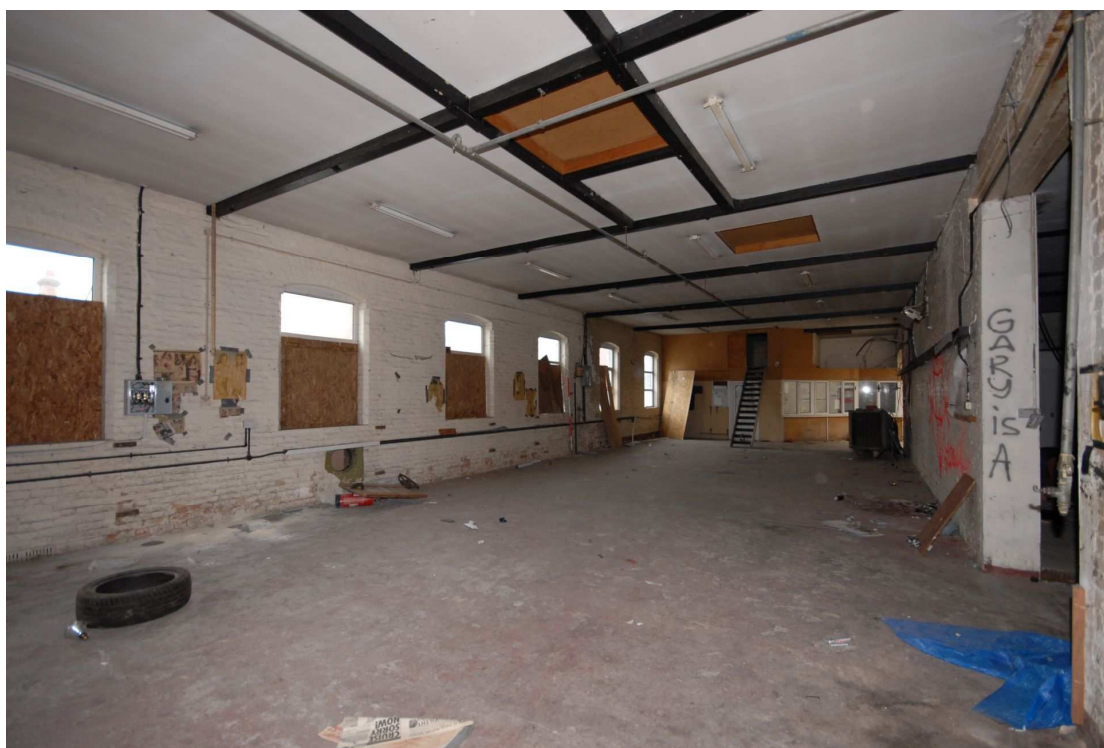
Figure 17: Former “Sorting and Packing Room”. Image taken in same direction as historical photograph in Figure 16.

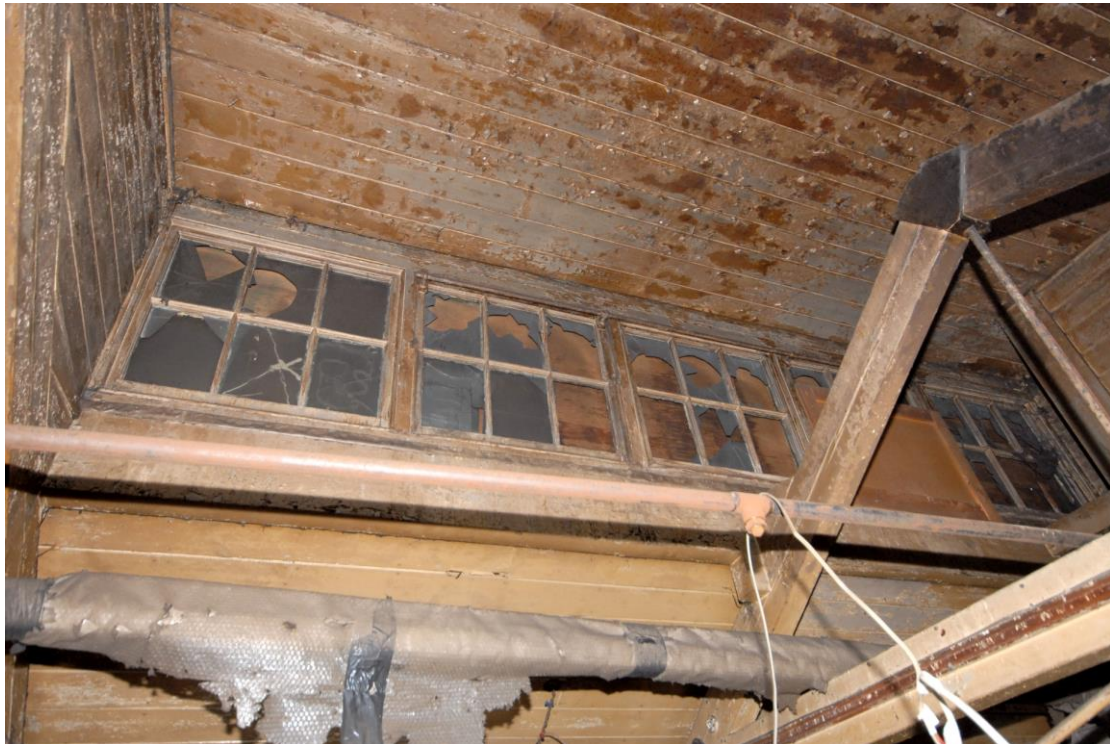
Figure 18: Interior photograph of roof clerestory windows in drying closets room

Each roof had a glass clerestory along its length, providing further light and ventilation into the rooms below. This was boarded up at the time of the survey. The original window frames, some with fittings above the windows, which may have served to open them, survive behind the boards (Figure 18).
