# DRYBECK FARM, KILLINGTON, KENDAL, CUMBRIA

## Archaeological Building Recording

Planning Application Ref:  
SL/2008/1213

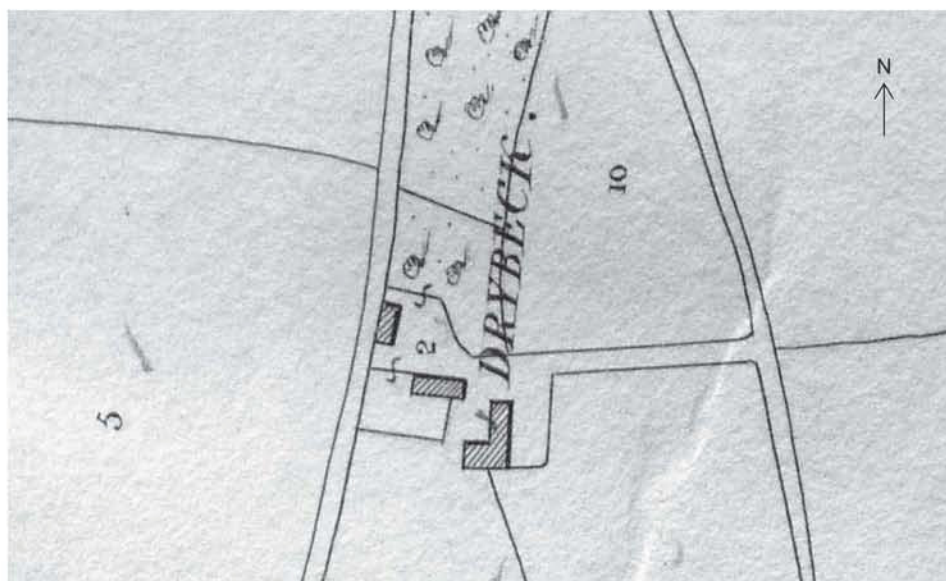
Plate 1: Extract from the Tithe Map of 1841 (CRO(K) WDRC/8/232 1841)

3.3.2 **Tithe Map 1841:** this shows the areas of land for which tithes were payable and is the first detailed map of the area (Plate 1). It shows the farmhouse as a simple linear block orientated east/west, with the barns to the south-east forming a simple L-shape, and another building to the north-west. The general field pattern is also indicated quite clearly and it is apparent that at this time the road to the north split just before Drybeck, with one arm turning south-east and running beyond the farm. This map has an accompanying schedule that gives details of the owner and occupier of each plot of land, as well as its name, and description. In this case Plot 2, which comprises the farm, is said to belong to Edmund Hornby and is occupied by John Bradshaw, although little specific detail about the buildings present is given.

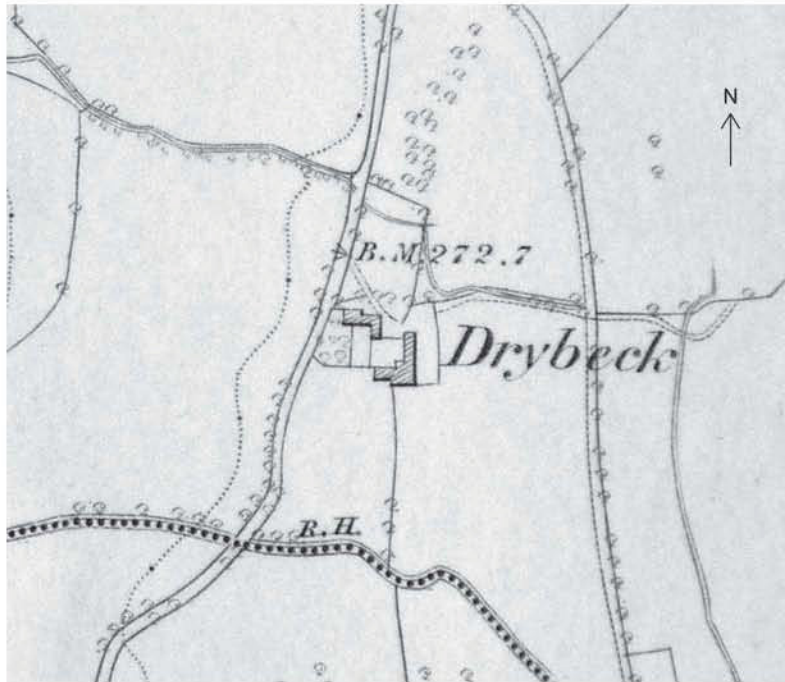
**Plate 2: Extract from the Ordnance Survey map of 1862**

3.3.3 **Ordnance Survey 1862:** this is the first detailed Ordnance Survey map of the area. It shows essentially the same features as the previous map but with more detail, and is perhaps more reliable (Plate 2). By this time the farmhouse is shown with projecting sections at the east end of the south side and the west end of the north side, while the barns have clearly had a number of additions made. The details of the associated field system are essentially the same, and the track to the east of the farm is still present, although the small building previously shown to the north-west of the house is gone and there is more detail shown in terms of gardens and tracks directly associated with the farm. In addition, a small stream is shown running roughly east/west to the north-west of the house, before crossing the enclosure immediately north of the house, turning south before continuing to the east and disappearing under the track. This is perhaps the beck from which the farm takes its name, although there is another stream to the south that forms the parish boundary, which is perhaps more likely (see *Section 3.1.1* above).

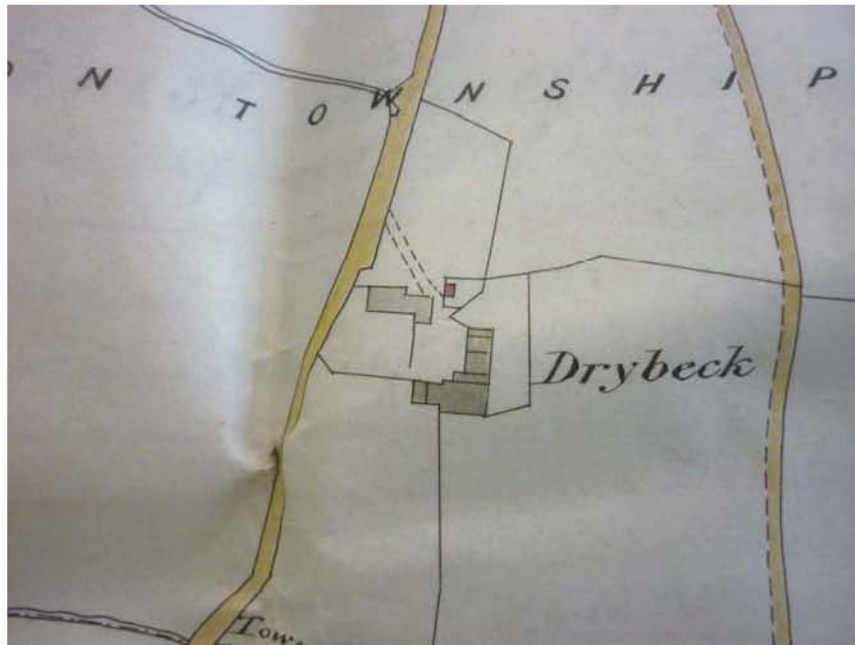
Plate 3: Extract from a plan with the deeds dated 1882

3.3.4 **Plan with deeds, 1882:** this is a detailed plan that shows much of the same detail of the previous one, although an additional small outbuilding is evident to the north-east of the house. Divisions are shown within the barns, but these seem to be largely at odds with the actual building and were clearly not based on an actual survey of the site. The tracks around the farm seem to have been somewhat simplified by this time; the track to the east is not marked.

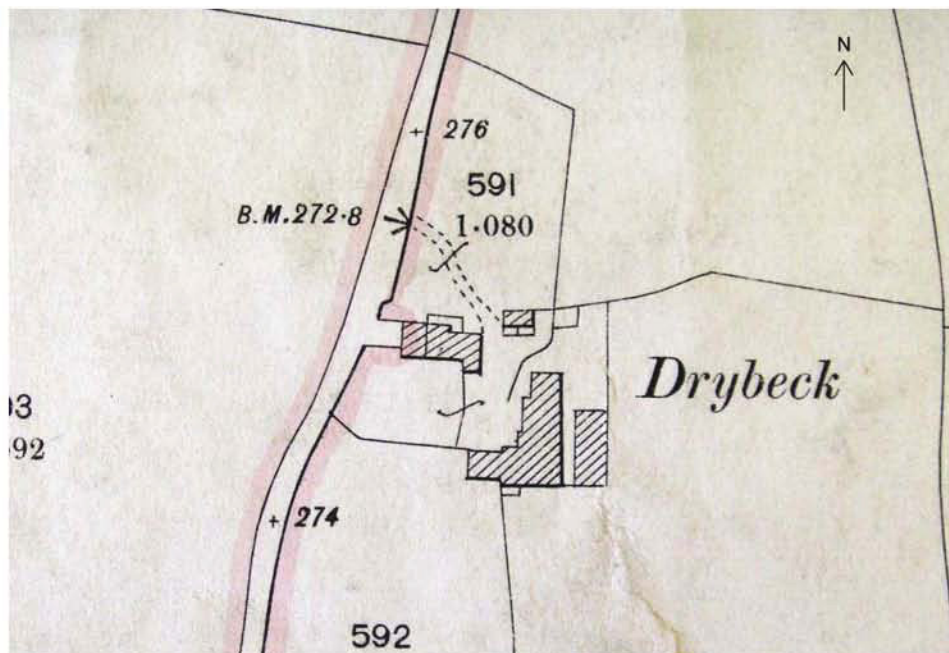
Plate 4: Extract from the Ordnance Survey map of 1898

3.3.5 **Ordnance Survey 1898:** this plan shows a similar layout to the farmhouse and barns, with some alterations (Plate 4); the house has a division shown at the west end, the barns have been extended on the west side, the building to the north-east has been enlarged to the east, and a new rectangular outbuilding has been built to the east. Interestingly, the stream to the north is no longer marked. The Ratings Valuation of 1910, which makes use of this map, states that at this time it was occupied by George Willan and owned by GGS Hornby Esq of Dalton Hall (CRO(W) WT/DV/2/51 1910).

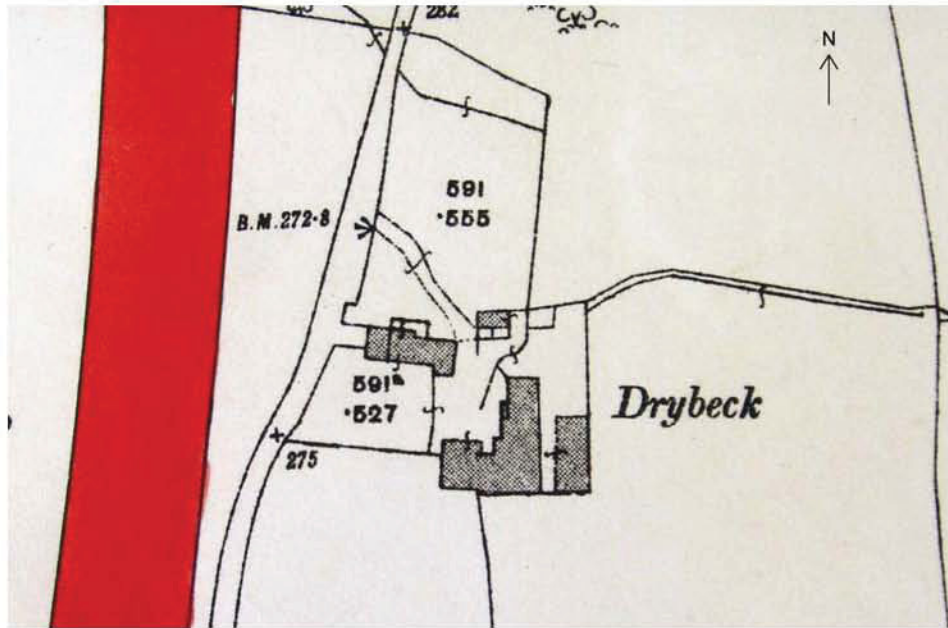
Plate 5: Extract from the Ordnance Survey map of 1914

3.3.6 **Ordnance Survey 1914:** this shows a similar arrangement to the previous plan, although there are some differences (Plate 5). An additional extension has been added to the north side of the west end of the barn and the stream to the north of the site is depicted again.

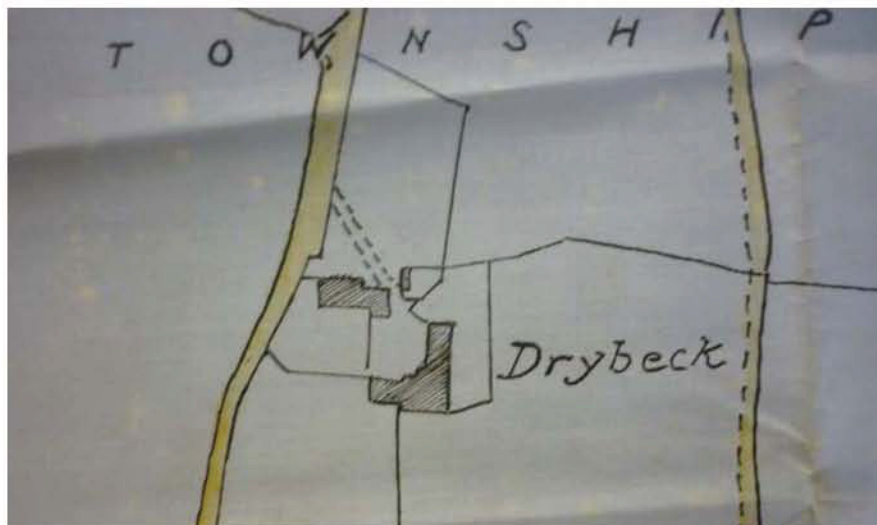
Plate 6: Extract of a plan from the deeds dated 1930

3.3.7 *Plan with deeds, 1930*: this is a plan accompanying the abstract of title dated 1930 (Deeds 1930a). It is apparent, however, that it is based on the early plan of 1882 as it shows a number of features that had either been altered or did not even exist by this date, such as the outshut to the north-east of the house and the road to the east of the site. It cannot, therefore, be taken as being truly representative of the arrangement of the farm at this time.

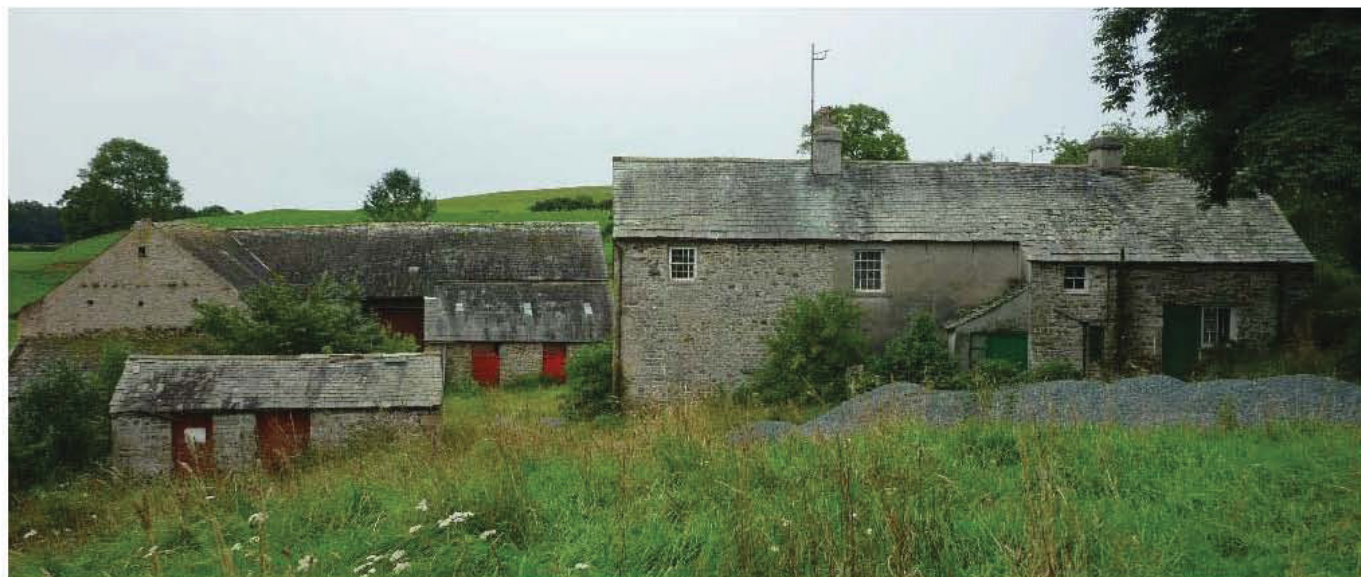
Plate 7: View of the site from the north

4.1.1 **Farmhouse:** the two-storey stone-built farmhouse (Plate 7) was built into the hillside, which slopes down towards the east and means that the west end is built into the slope, with the lower rooms effectively below ground level (see Figure 1). Local stone was used in its construction, which was a mix of angular blocks of yellowish-white and some pinker gritstone, slate, and limestone, with a grey slate roof and iron rainwater goods. The gritstone was used for dressed details such as quoins, sills, lintels, and window surrounds. The roof had U-shaped stone ridge tiles with square section at the east end for finials, and two chimneys, both with a string course and a drip course; the east chimney was rough cast and had two ceramic pots, the west was smooth rendered with no pots (see Figure 2). The main section of the farmhouse was aligned east/west, with a projecting part on the north side at the west end, and it had been extended to the west and possibly also to the east (see Figure 5 and Figure 6). The timber used for the windows was machine cut but internally the timber was largely hand-finished.

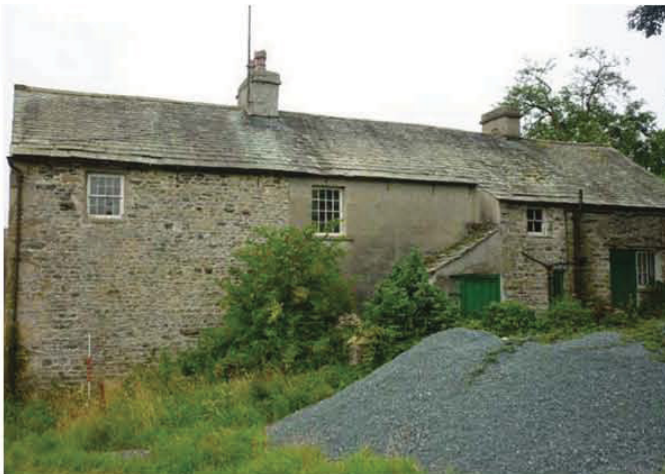
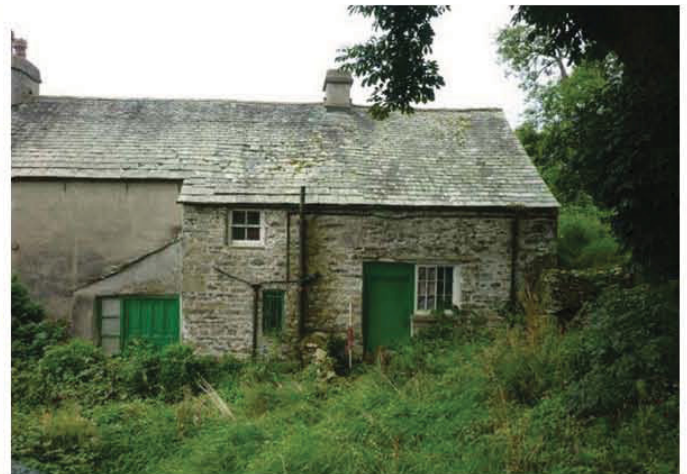
4.2.1 **Farmhouse – north elevation:** the east end of the north elevation (Plate 8) had dressed quoins at the corner and traces of whitewash and occasional through stones in rows. There was a blocked window at the level of the cellar which had a thin stone lintel and recent cement pointing. There was a relatively early 16-light sash window, without horns, on the first floor with a timber lintel and stone sill and cement over the jambs. The central section of this elevation was finished with a smooth cement render and was butted by a garden wall with a small modern aluminium vent above. There was a 16-light fixed casement window on the first floor of the rendered section. There was a return wall to the north at the west end with a small monopitch porch, sloping down to the east. In the resulting corner there was a large doorway with an eight-panel door with three lights to the east on a short wall. The main wall to the west had quoins at the corner, which were more irregular than those to the east. There was a small four-light sash window to the east on the first floor, with a stone sill and timber lintel. There was a narrow window on the ground floor with a decayed timber lintel, covered with concrete, and a stone sill. There were two iron bars fixed across this single-light window. There was a boundary wall butting against this section of the elevation to the west of this window. The farmhouse had obviously been extended to the west and there were rough quoins at the junction. There was a large doorway in this extension, which had been reduced to form a 12-light sideways sash window, with a stone lintel, on the west side, and a plank door to the east in a beaded surround with planks over and a chamfered timber beam above (Plate 9). There were some through stones in this section and quoins at the west end.

Plate 8 (left): East end of the north external elevation of the farmhouse

Plate 9 (right): West end of the north external elevation of the farmhouse

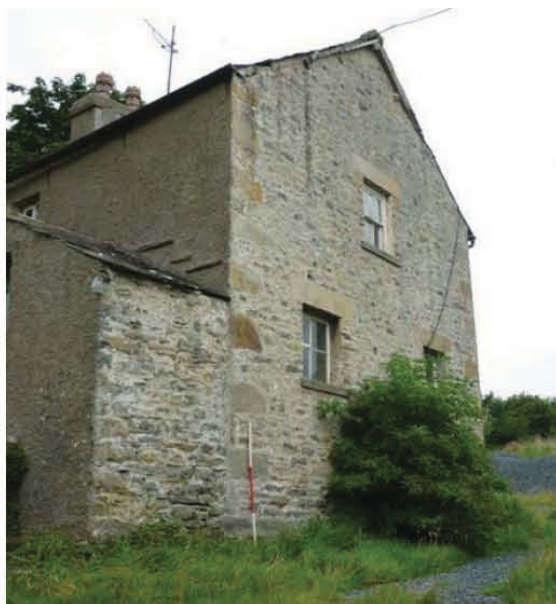
Plate 10: East external elevation of the farmhouse

4.2.2 **Farmhouse – east elevation:** the east elevation formed the gable end and extended to cellar level (Plate 10). It had a rough render, apart from the wall for the projecting porch which was not rendered. There was a butt joint and a slight plinth to the porch. The gable end had neat quoins at the corners and a plinth. There were three windows in this elevation, two at ground level, and the wall plate and the ends of the purlins were exposed below the roofline. Both of the ground floor windows had stone sills and lintels and fixed four-light casements, the window on the first floor was the same except that it was a six-light sash.

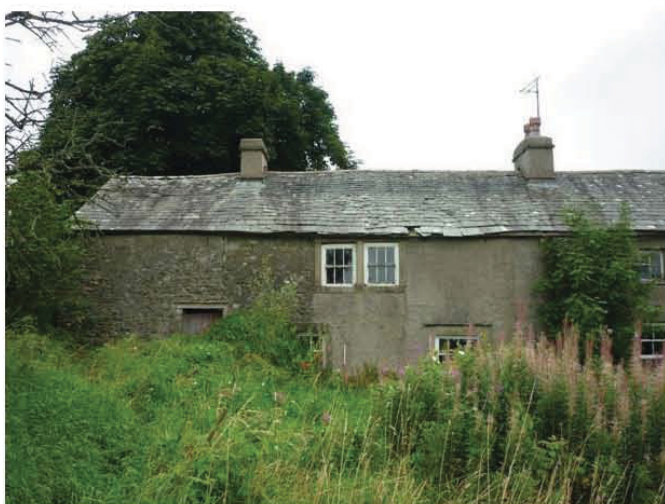
Plate 11 (left): West end of the south external elevation of the farmhouse

4.2.3 **Farmhouse – south elevation**: the ground floor doorway on the west side of the south elevation had a timber lintel with a drip course above and a plank door. There was a butt joint evident between the west end and the central section, where there were some quoins and a piece of timber which had been re-used at the top of the central section (Plate 11). The east end of the elevation, including the porch, and part of the centre had a patchy render (Plate 12). The window on the first floor of the central section was split into two parts, with ill-fitting square stone surrounds and sills which were probably re-used. The east side of this window also had a groove cut into it. The casements were both six-light sash. There were two central windows on the ground floor with similar surrounds; the one to the west had square surrounds and a four-light sash casement, the one to the east was similar but had an eight-light sash and a drip course above it. The east end had a large bulge in the wall and a stone mounting block against it. There were two further windows to the east; the one on the first floor had plain reveals, a stone sill, and a four-light casement (one hinged), and the one on the ground floor had plain reveals, a slate sill, a four-light sash and an overlong drip course some distance above it, probably denoting the position of an earlier mullion window. The projecting gabled porch to the east was longer on the east side and plain, with a plank door with one light and a beaded surround (Plate 12). A flight of concrete steps led up to the porch and V-shaped stone ridge tiles were used on the roof with square ones at the end for finial.

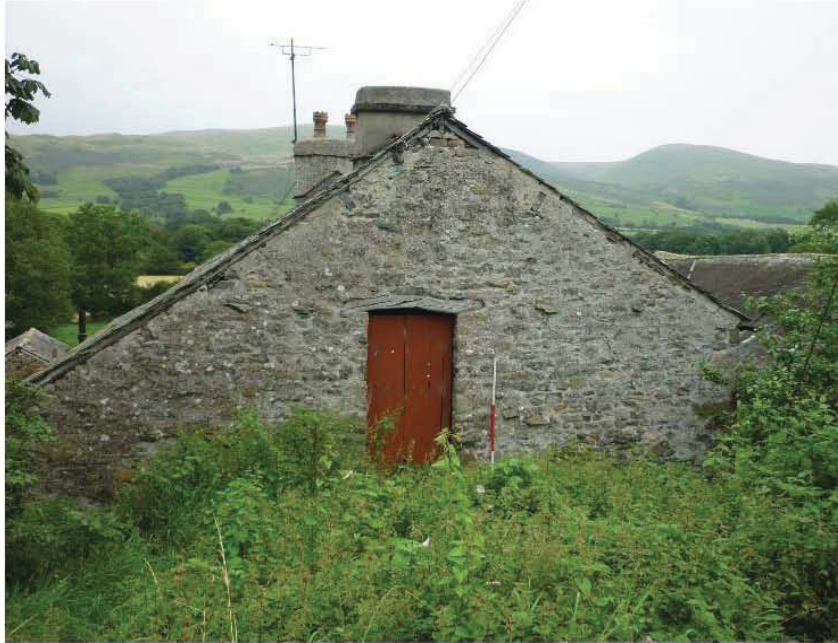
Plate 13: West external elevation of the farmhouse

4.2.4 **Farmhouse – west elevation:** the west elevation formed the gable end, which extended slightly further on the north side (Plate 13), and had a fairly plain patchy render. The ground to the west was built up against it and there were retaining walls running to the west on either side. Through stones and the ends of purlins and the ridge purlin were visible. There was a central doorway at first floor level (which is effectively the ground level on this side), which housed a beaded plank door which pivoted on the south side and had a rough timber lintel.

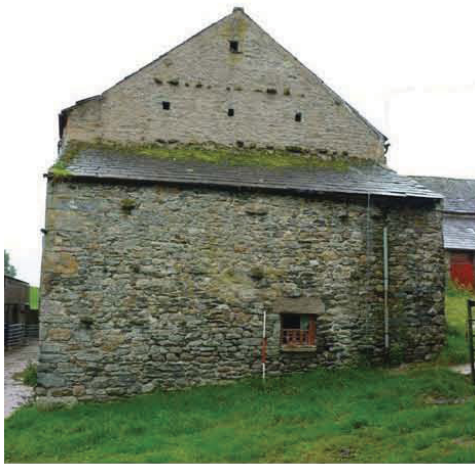
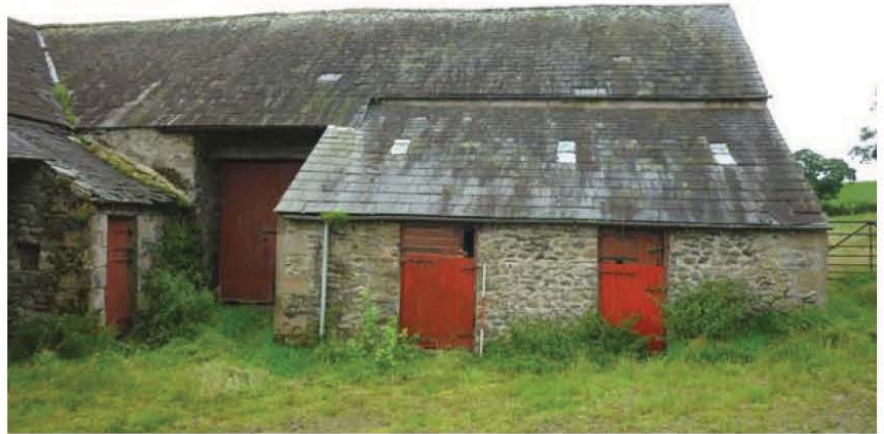
4.2.5 **Barns – north elevation:** the east end of the north elevation formed the gable end of the north/south arm of the range (Plate 14). The lower part was covered by the side wall of a monopitch outshut, with rough quoins at the east side and which had a rounded corner to the west and a small window with a timber cover and a stone sill and lintel. Some through stones were present. The upper section, forming the gable end, had a rough cement render, two rows of through stones and a row of three square vents and an owl hole above. There was a slight step in the roof on the east side, possibly where there had been some damage. The west end of the elevation comprised the north side of the east/west arm of the range and was partially obscured on the east side by a porched entrance and outshuts against the west elevation of the north/south arm of the range (Plate 15). There was a large wagon doorway slightly recessed in the centre on the north side of the east/west arm of the range, which had a heavy timber lintel and double plank door (Plate 16). The wall returned to the north, to the west of the wagon door, to form a monopitch outshut with neat quoins at the corners and which was accessible via two split plank doors (Plate 15). The upper part of the wall, which was visible above the outshut, had cement render.

**Plate 14 (top left): East end of the north external elevation of the barns**

**Plate 15 (top right): West end of the north external elevation of the barns**

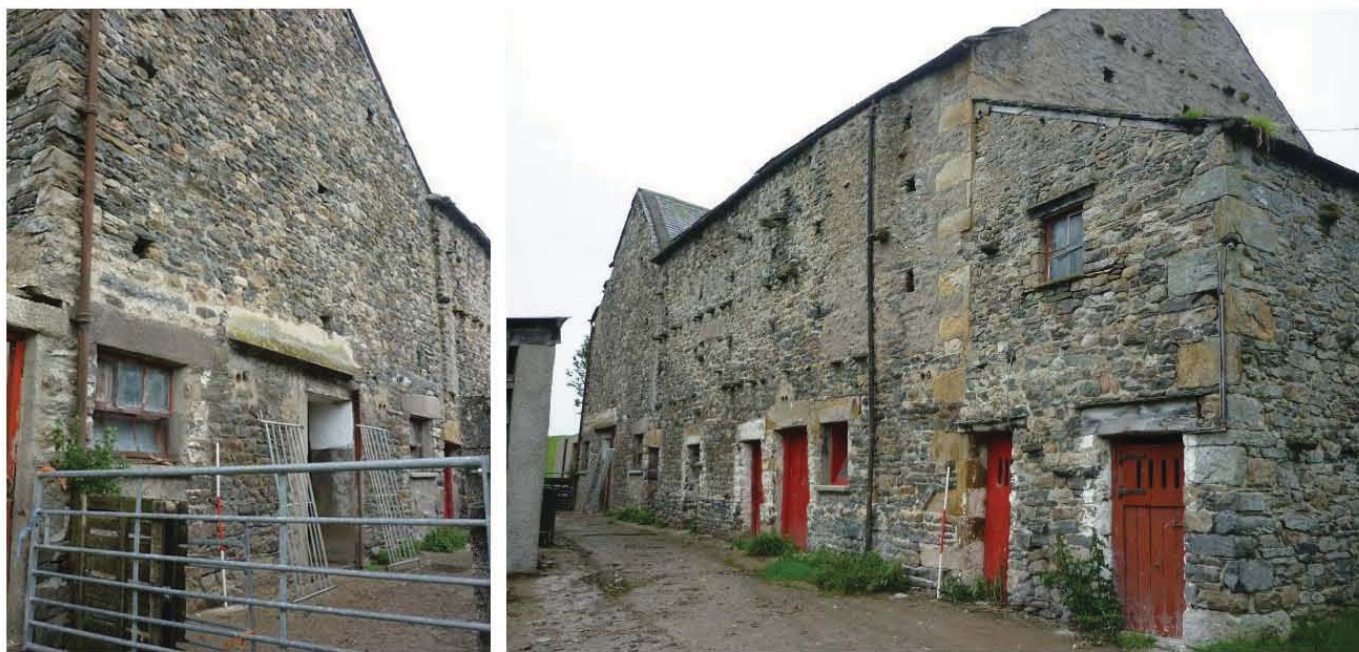
**4.2.6 Barns – east elevation:** the south end of the east elevation was continued by a monopitch concrete block built outshut with a doorway on the north side which housed a plank door with a stop-chamfered surround. The first section of the wall to the north formed the gable end of the east/west arm of the range, which had two rows of three square vents, one above of two vents, and an owl hole above that and through stones. The gable end had a central doorway on the lower floor level, with a stone lintel, above which was a projecting concrete skim, and a pair of pipe vents either side (Plate 17). There were six-light, tilting casement windows flanking the doorway, both of which had stone lintels and concrete sills. Both of the windows had formerly been doorways, the lower parts of which were now blocked. There was a clear butt joint where the north/south arm of the range had been added to, to the north. The north/south arm had three rows of square vents and three rows of through stones and there were four doorways in this section (Plate 18), all with thick stone lintels and plank doors, all of which had vents or windows. Between the middle two doorways was an upper floor doorway, with a stone sill and lintel, which was blocked. There was a pair of pipe vents above the fourth door from the south in this section of

the range. The door to the north of centre in this row of four doors had extensive graffiti carved into its planks: 'JWB', 'BTS', 'TF', 'NP', 'EV', and others. The door had beaded planks and old hinges still attached which were unused. There was a three-light tilting casement window to the north of these four doors which had a stone lintel and concrete sill. There was a concrete skim over the upper part of the wall at the north end, but the quoins were still visible. The range had been extended further by a monopitch outshut to the north, which had quoins at the north end (Plate 18). The upper floor of this outshut had a four-light casement window, with a timber lintel and stone sill. There were two doors on the lower floor level, both had rough chamfered timber lintels and at least one of the split plank doors had been re-used.

Plate 17 (left): South end of the east external elevation of the barns

Plate 18 (right): East external elevation of the barns

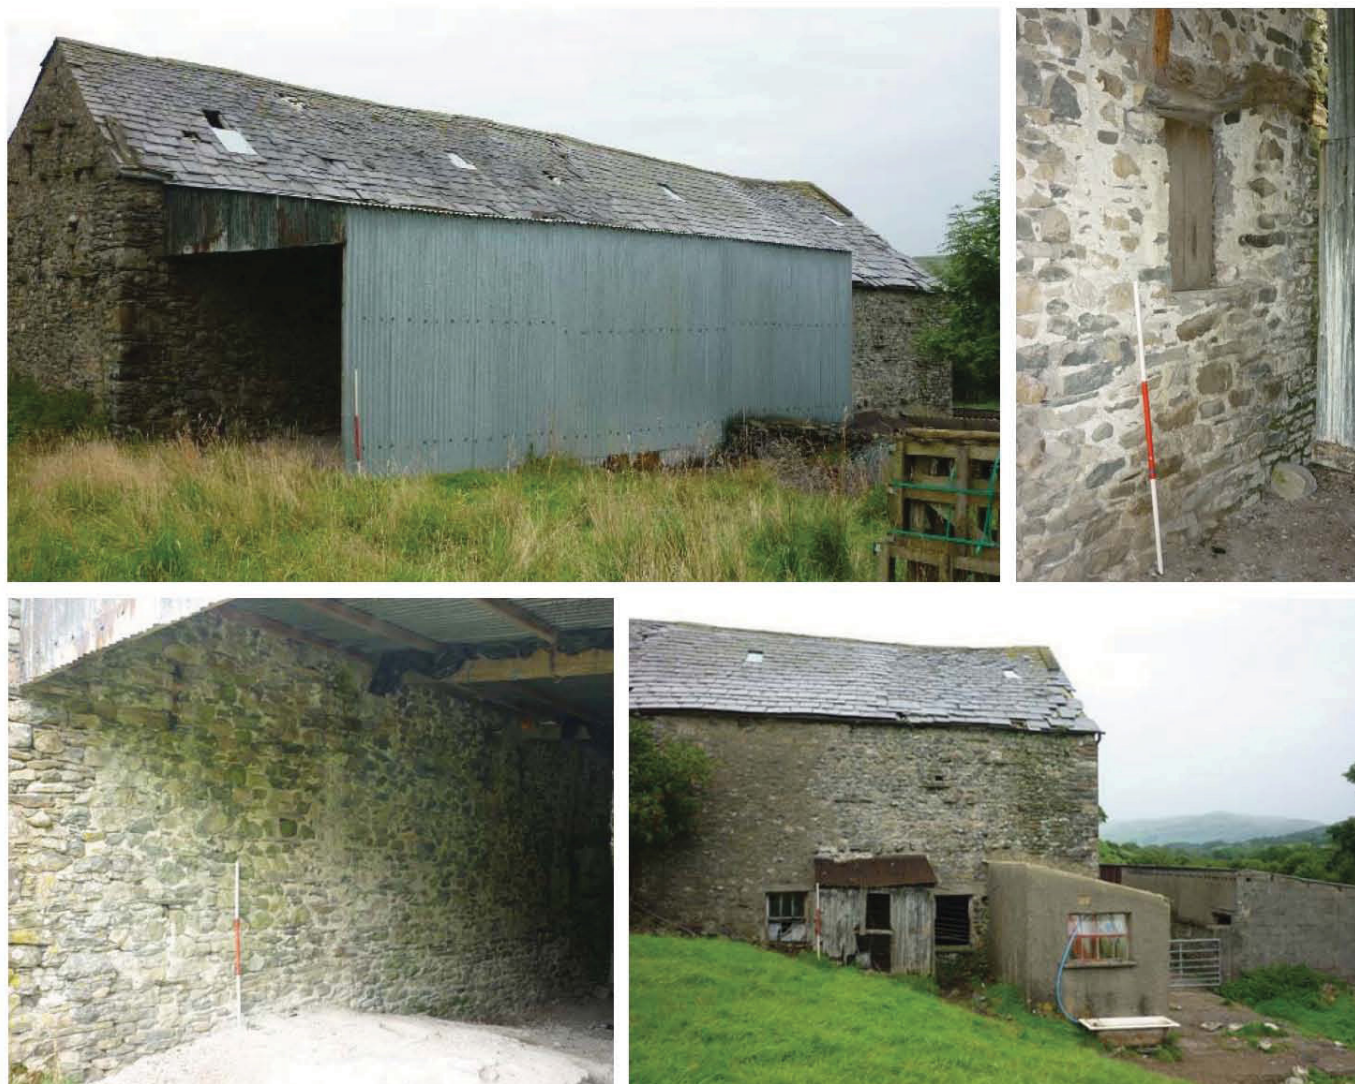
4.2.7 **Barns – south elevation:** the south elevation was mostly obscured by modern additions at the west end and was fairly plain (Plate 19). There was a raised, narrow doorway near the centre (Plate 20), opposite the wagon door on the north side and blocked slit vent slots were evident in places and through stones (Plate 21). The doorway housed a roughly placed plank door and a thick rough timber lintel extending to the east (Plate 20), which had possibly been re-used, above which there was a square vent. Beyond this, the ground dropped away and the elevation was butted by a boundary wall. Unfortunately, there was a rough concrete render obscuring some detail. There was a window to the lower floor with a concrete lintel and a six-light casement and more through stones and attached outshuts to the east (Plate 22). One outshut had a timber monopitch roof, sloping to the south, the other had a concrete block construction sloping to the east. The timber monopitch outshut had a door to the east, which was constructed from planks and concrete blocks inside against the wall of the barn, and another to the south with an electric motor sat on top. There was another window between it and a concrete outshut. This window had a concrete lintel. The concrete outshut had an eight-light tilting metal casement window on the south side with a concrete sill and vent above.

Plate 19 (top left): West end of the south external elevation of the barns

Plate 20 (top right): Raised narrow doorway in the south external elevation of the barns

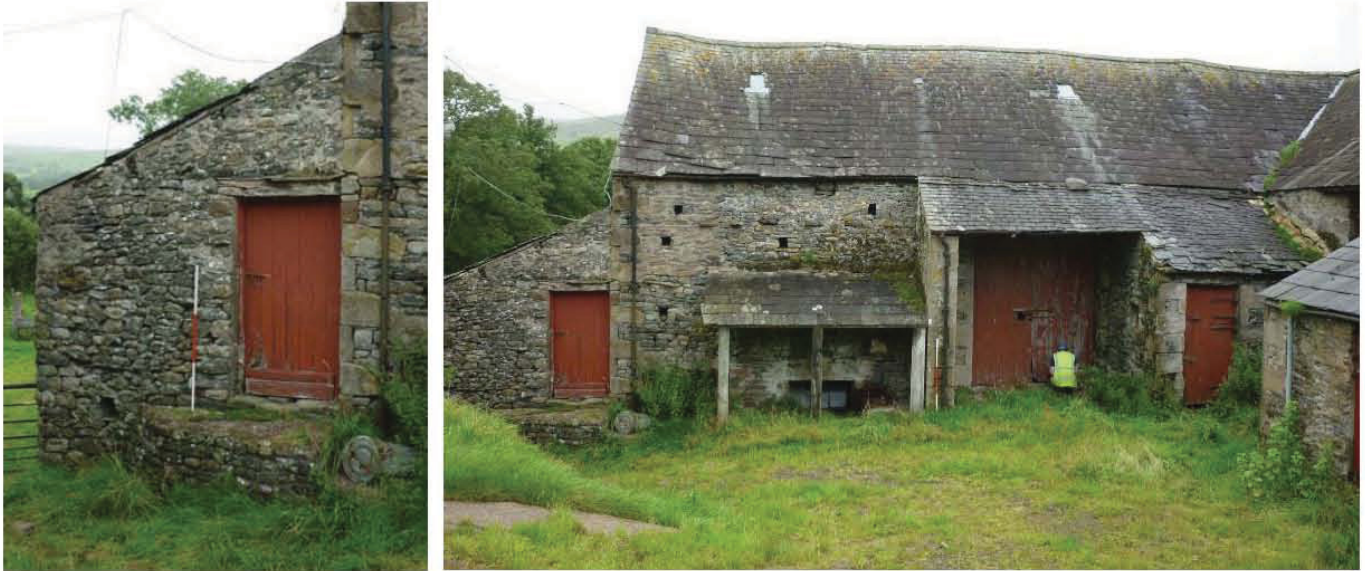
4.2.8 **Barns – west elevation:** the west elevation had a monopitch outshut at the far north end, with a single doorway with a plank door and timber lintel (Plate 23). The door was slightly above ground level with a step and a projecting round block in front. The lower part of the door had a moulded rail. This outshut evidently butts onto the main north/south section of the range, which was dressed with quoins at the corner (Plate 24). There was a large pipe inserted in the wall at the lower ground floor level and two more windows to the south of this, one a six-light fixed casement with a timber lintel and the other a three-light tilting casement with a concrete lintel. Both windows were covered and enclosed by a lean-to with a slate roof on a basic timber structure supported by three timber posts the southernmost of which was a railway sleeper. In the area above this lean-to there were various square vents and through stones and a blocked square aperture below the roof line. The wall returned to the south of the lean-to and formed a canopy for a wagon doorway. One side wall to the north was dressed with quoins and the canopy roof was supported by a basic timber structure. The wagon door had a double plank door and stop-chamfered timber lintel flanking the wall to the north, which had a small alcove in it. The south side of the canopy was supported on an outshut which extended beyond it to the west with a monopitch roof and dressed quoins at the north-west corner. There was a small window in the north side with a two-light tilting casement and a stone sill and lintel. This outshut butted the wall of the north/south arm of the

range to the east and the return wall to the south had a split plank door, quoined jambs, and stone lintel. The south end of the elevation was the gable end of the east/west arm of the range (Plate 25); the monopitch outshut to the north was apparently part of the same build as there was no obvious butt crack. The northern end of the gable was plain, with dressed quoins at the corner and a group of six pipes as vents. The southern end had two rows of three slot vents and there were two more slot vents in a third row above, with an owl hole at the top, and two rows of through stones.

Plate 23 (top left): North end of the east external elevation of the barns

Plate 24 (top right): Centre of the east external elevation of the barns

Plate 25 (bottom): South end of the east external elevation of the barns

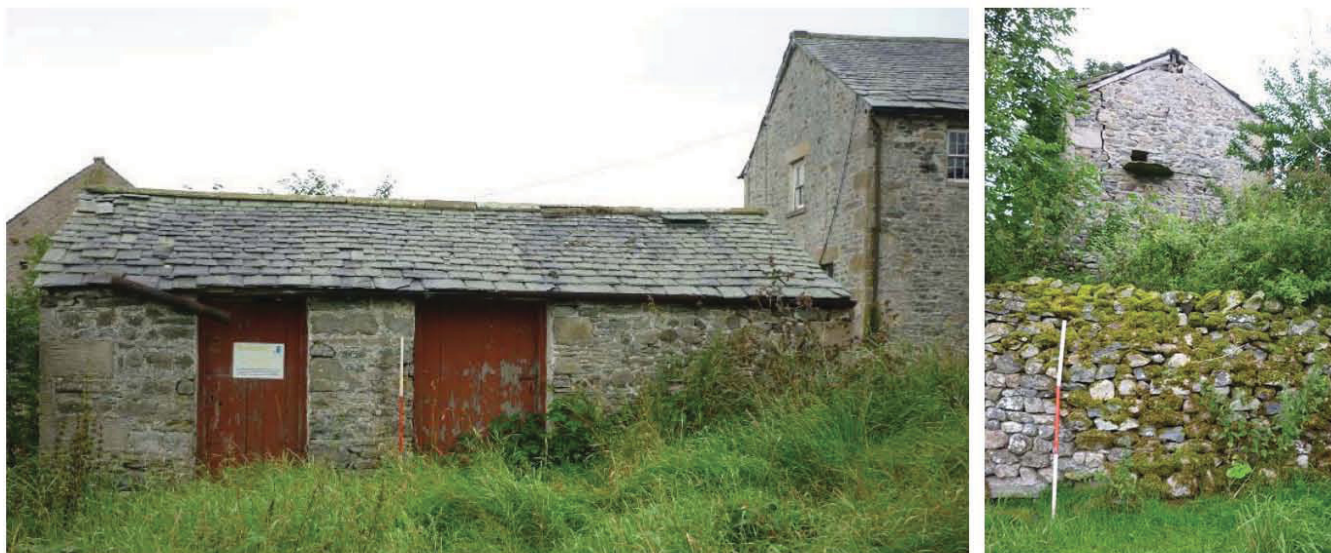
4.2.9 **Pigsty – north elevation:** there were two doorways on the east side of the north elevation of the pigsty, housing plank doors with stop-chamfered surrounds (Plate 26).

4.2.10 **Pigsty – east elevation:** the east elevation formed the plain gable end extending over both floors (Plate 27). The rafters and wall plate were visible along the top of the wall and the ridge purlin was exposed. There was a small aperture with a massive projecting stone sill.

Plate 26 (left): North external elevation of the pigsty

Plate 27 (right): East external elevation of the pigsty

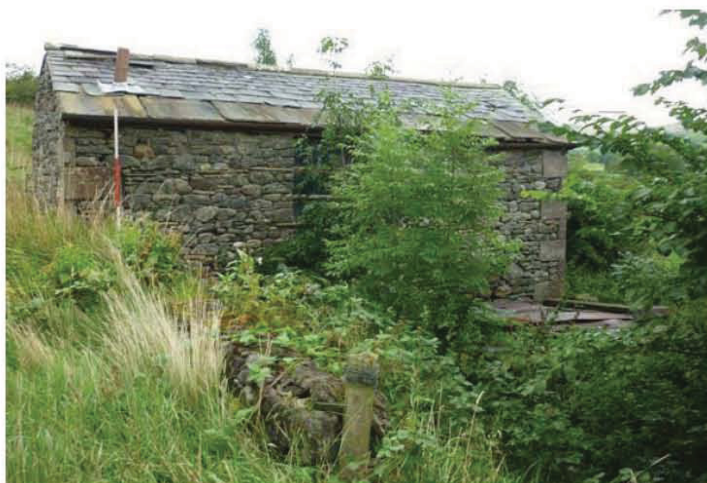
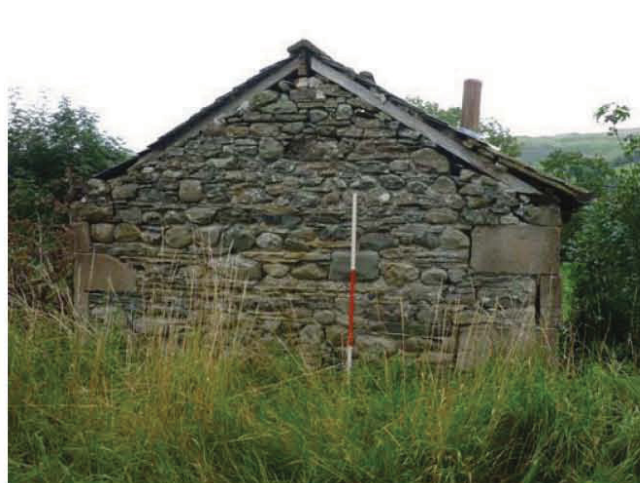
4.2.11 *Pigsty – south elevation*: the pigsty had a ceramic pipe through the roof forming a flue and a single four-light casement window on the south side of the upper floor, of which the upper row of three were tilting (Plate 28). On the lower level there were two low entrances with heavy stone lintels.

4.2.12 *Pigsty – west elevation*: this west elevation was the gable end and the wall plate and rafters were exposed as well as the ridge purlin, which had a brick and another timber below (Plate 29).

Plate 28 (left): South external elevation of the pigsty

Plate 29 (right): West external elevation of the pigsty

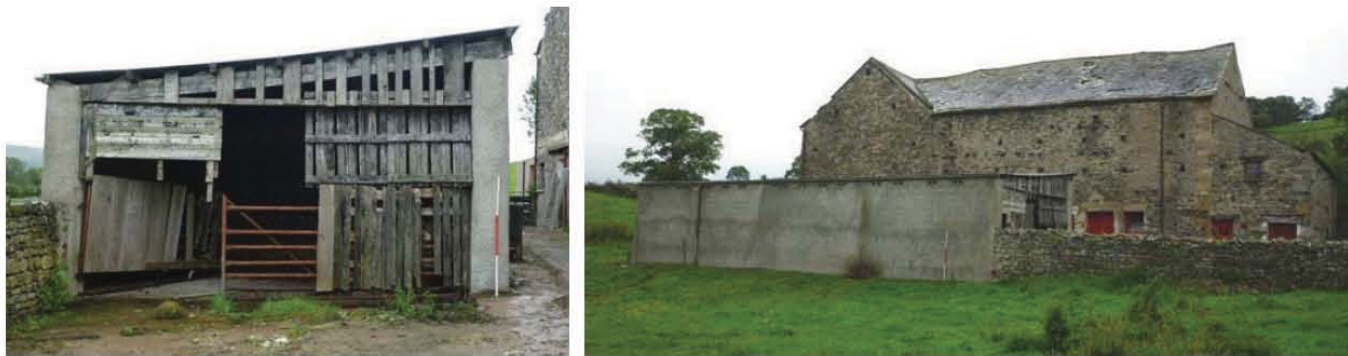
4.2.13 *East outbuilding – north elevation*: the north end of the building was mostly open between a pair of rendered columns at either end (Plate 30). There was a rough timber cover over the upper part of the opening and a metal gate over the lower part.

4.2.14 *East outbuilding – east elevation*: the east elevation had a roughcast render throughout and plastic rainwater goods and was butted by the field boundary to the north (Plate 31).

Plate 30 (left): North external elevation of the east outbuilding

Plate 31 (right): East external elevation of the east outbuilding

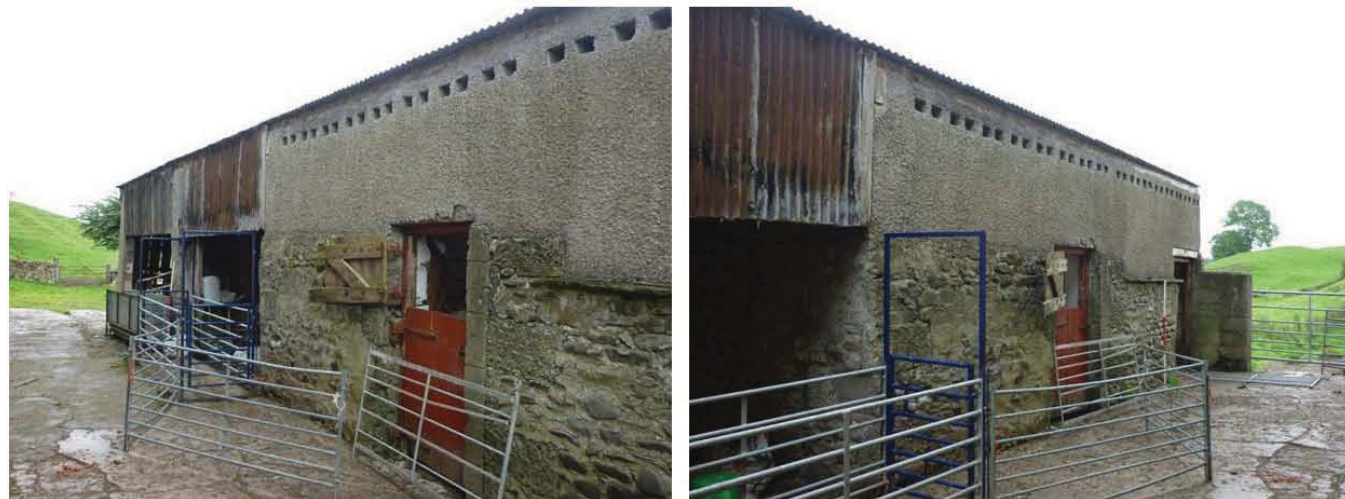
4.2.16 **East outbuilding – west elevation:** there were two large openings in the west side of the building to the north, both of which were gated (Plate 32). There were another two doorways, each with red doors, at the south end with concrete render above, one with a split plank door and the other with a batten door (Plate 33). There were some 'quoins' in concrete blocks around these two doors but most of the rest of the wall was a rough stone build with cobbles.

Plate 32 (left): North end of the west external elevation of the east outbuilding

Plate 33 (right): South end of the west external elevation of the east building

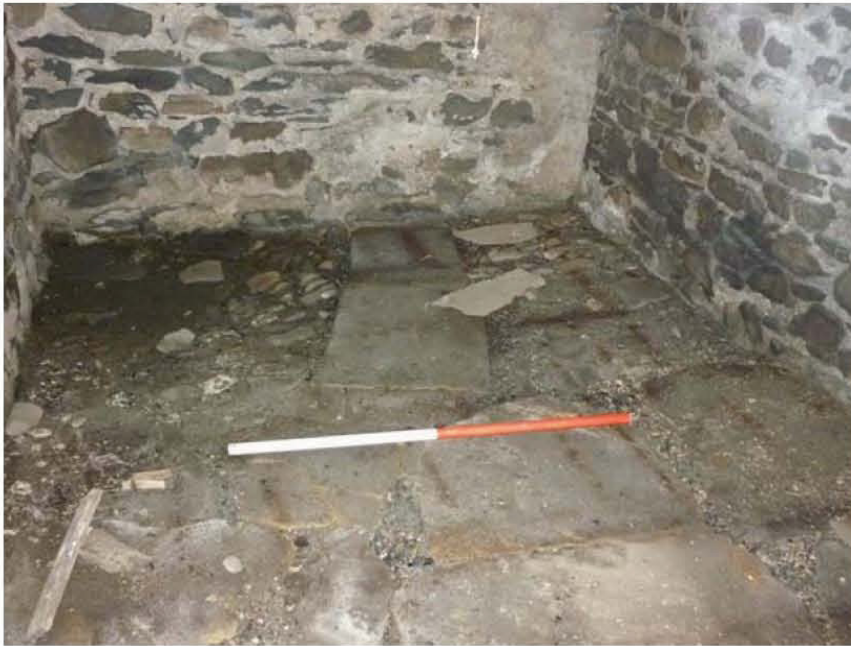
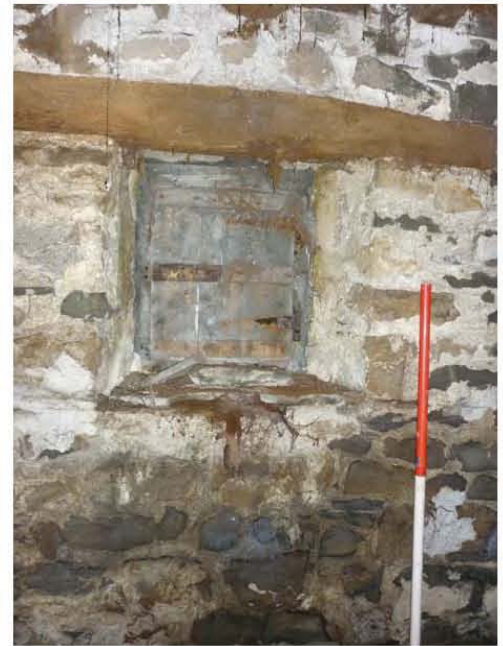
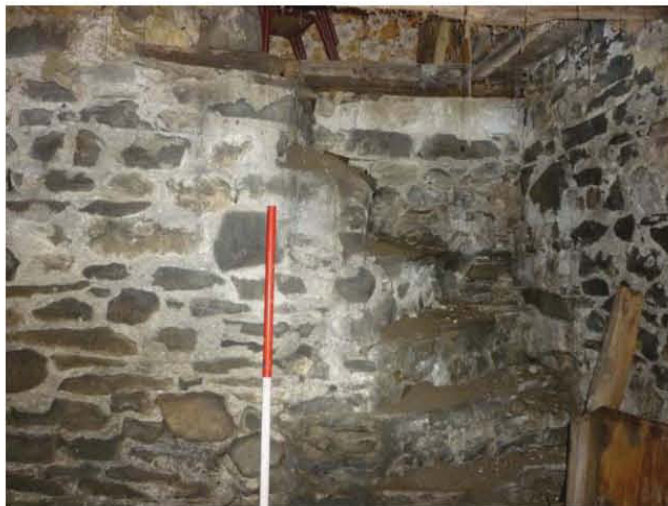
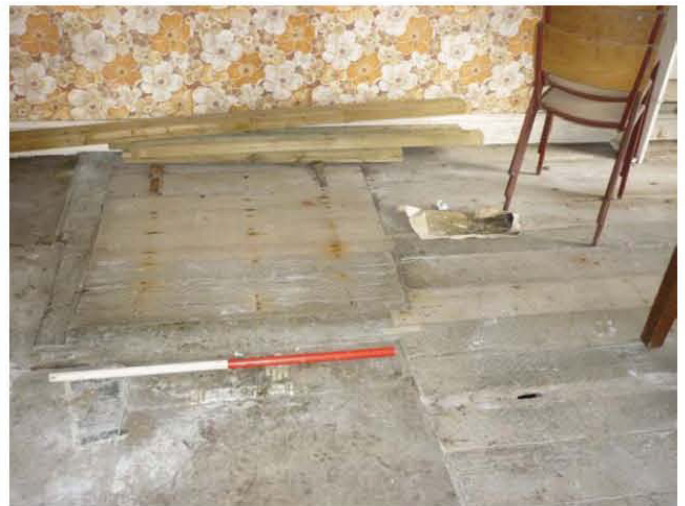
Plate 34 (top left): Flag floor in the cellar, facing south

Plate 35 (top right): Hatch in the north elevation of the cellar

Plate 36 (bottom left): Cellar stairs

Plate 37 (bottom right): Hatch to the cellar in ground floor Room 2

4.3.1 **Farmhouse – cellar:** the cellar had a patchy flag floor and cobbles in the north-east corner (Plate 34). The ceiling had hand-finished joists, aligned north/south, and some re-used timber and rough hand-sawn boards aligned east/west. The walls were all fairly plain, with lime pointing and rough stone build. The north elevation had a small aperture with a plank and batten hatch with strap hinges, below a large rough timber lintel and above a stone sill (Plate 35). The east elevation had some later concrete render over on the south side. The south elevation had a wall plate along the top. There was a large hatch on the west side which was accessed by a flight of stone stairs incorporated into the west elevation (Plate 36 and Plate 37).

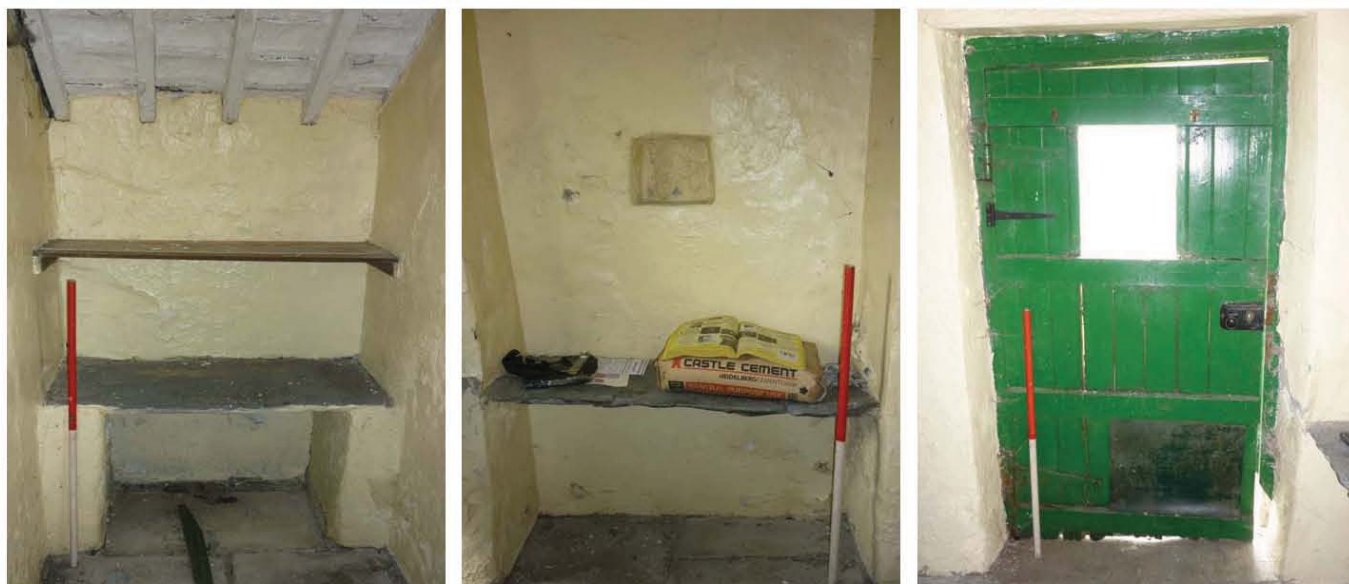
**Plate 38 (left): East side of the porch**

**Plate 39 (centre): West side of the porch**

**Plate 40 (right): Detail of the porch door**

4.3.2 **Farmhouse – ground floor Room 1:** the floor of the porch was flagged and augmented with stone and concrete by the door on the south side. It had a gabled roof built of just rafters and one joist on the east side, all of which were whitewashed and appeared to be machine cut. There was a slate shelf on blocks on the east side with a timber shelf above it (Plate 38) and a slate shelf built into the wall on the west side (Plate 39). The walls were all plastered and painted. The north elevation had a door through to Room 2, which had a beaded surround and a plank door with an early latch. The east elevation was plain, with shelves attached. The south elevation had a doorway to the outside with a plank and batten door and old as well as more modern strap hinges (Plate 40). There was a single light in the centre cutting through one of the sections. The west elevation was plain apart from the slate shelf and a small alcove (Plate 39).
