# DRYBECK FARM, KILLINGTON, KENDAL, CUMBRIA

## Archaeological Building Recording

Planning Application Ref:  
SL/2008/1213

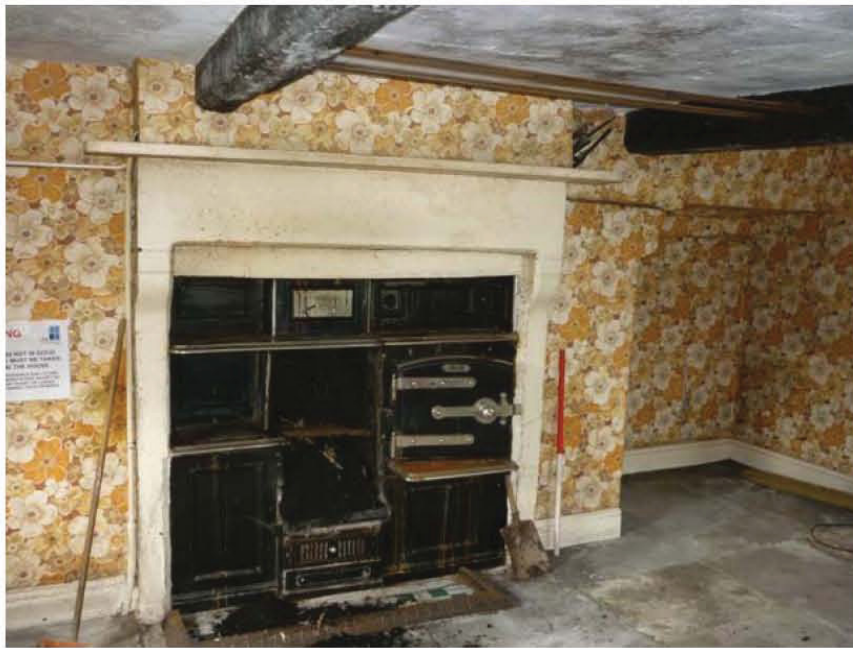
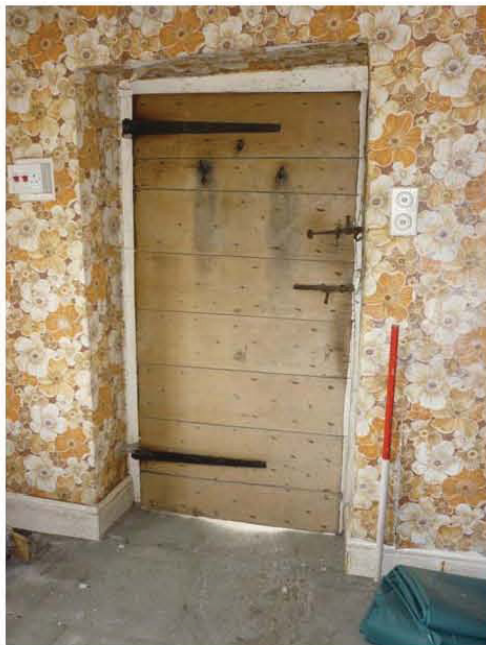
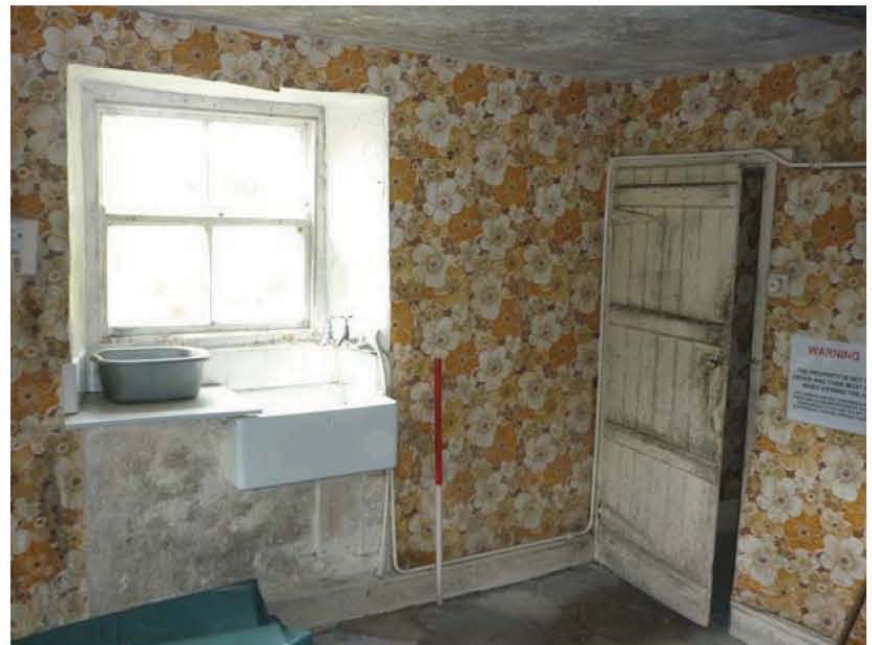
Plate 41 (top): Range in the west elevation of ground floor Room 2 of the farmhouse

Plate 42 (bottom left): Door to the porch of the farmhouse, viewed from ground floor Room 2 of the farmhouse

Plate 43 (bottom right): Sink and doorway in the south-west corner of ground floor Room 2 of the farmhouse

**4.3.3 Farmhouse – ground floor Room 2:** this room had a flag floor, apart from a section in the north-east corner which was boarded over, covering the area of the cellar; there was a hatch down to the cellar on the west side with large nails and strap hinges (Plate 37). The ceiling was finished with plaster and had two hand-finished chamfered beams, orientated east/west (Plate 41). The north beam was much wider at the east end where the timber originally forked. All the walls were finished with plaster and flowery wallpaper and had moulded skirting. The north elevation was fairly plain with a slight recess below the stairs at the west end and a 20<sup>th</sup> century cupboard at the east end. The east elevation was also plain with two plain windows with splayed jambs and timber boards over the sills. The doorway on the east side of the south elevation had a rough surround and an ill-fitting door made of double nailed planks with an early latch (Plate 42). The window to the west of this had splayed jambs and had probably originally been full length to the floor and now incorporated a butler sink and drainer with a tile surround (Plate 43). On the west elevation, the doorway on the south side had a beaded plank and batten door with strap hinges and an early latch. The central chimney breast had a stepping section to the wall at the top on either side. The projecting fire surround was chamfered on the inside, with a timber mantle shelf above and the fireplace incorporated a relatively late range (Plate 41). The wall was recessed to the north, beneath the stairs.

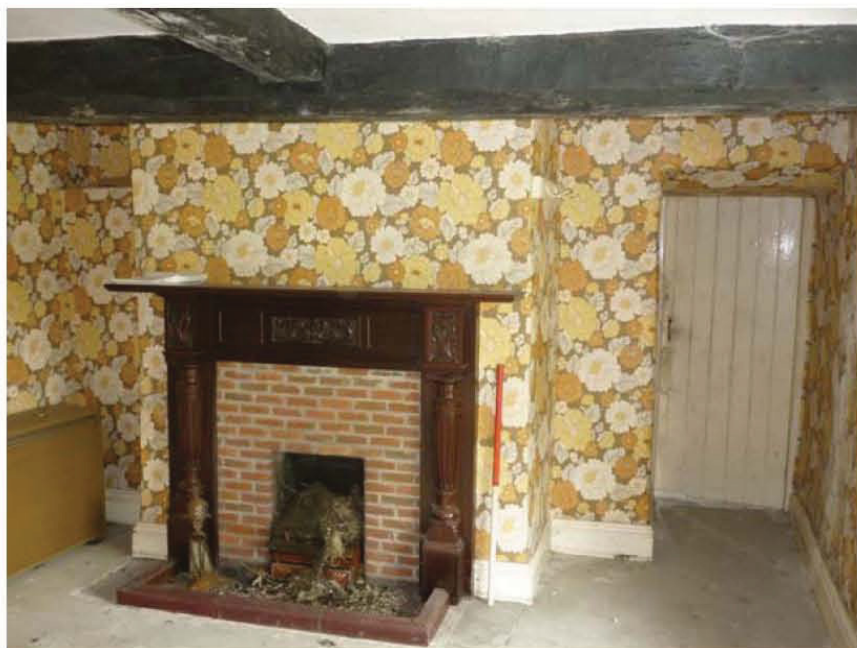
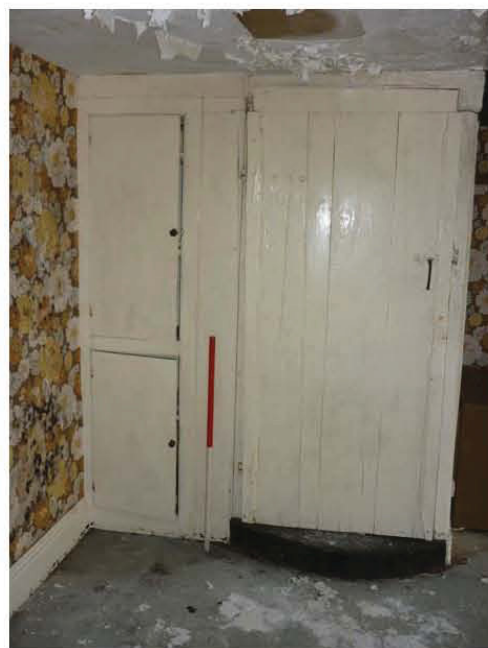
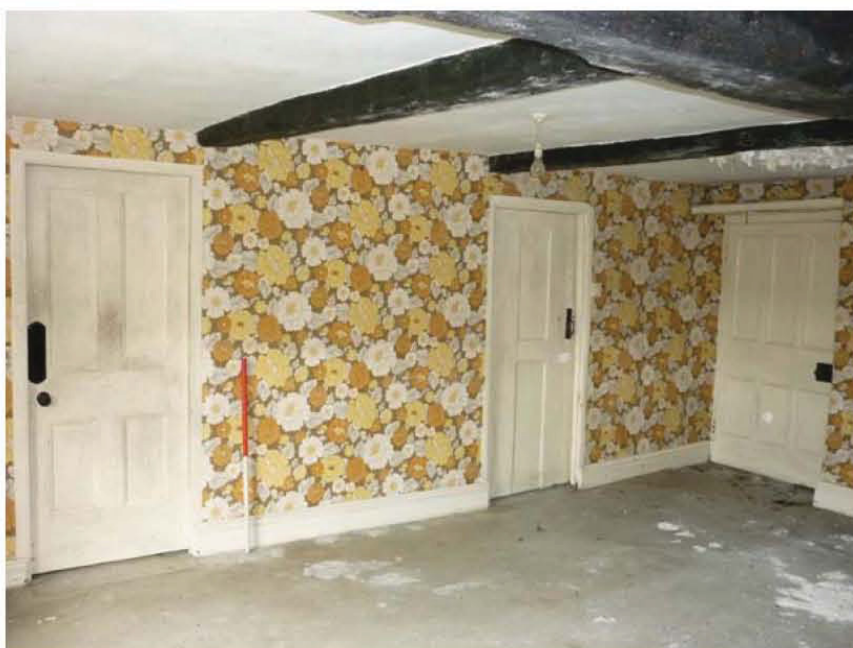
**Plate 44 (top left): East elevation of ground floor Room 3 of the farmhouse, showing the bressummer beam**

**Plate 45 (top right): Doorway to the stairs in ground floor Room 3 of the farmhouse**

**Plate 46 (bottom): General view of the north-west corner, ground floor Room 3 of the farmhouse**

4.3.4 **Farmhouse – ground floor Room 3:** this room had a concrete floor, which perhaps covered flags, and the ceiling was finished with plaster. There was a north/south aligned bressummer beam at the east end, which was stop-chamfered at the south end and had a gouge cut on the south side (Plate 44). It was apparently cut through at the north end to incorporate a doorway to the stairs (Plate 45). There were two east/west beams attached to the bressummer, which were stop chamfered at each end (Plate 46). The walls were all finished with plaster, flowery wallpaper, and skirting board. The north elevation had a wide doorway on the west side with a heavy timber shelf over it which continued into the wall. The door had six moulded panels and a lock. The east elevation had a built-in cupboard below the beam on the north side. The cupboard had two plain doors with battens on the inside and brass knob

handles, and shelves inside and the remnants of a flag floor in the base. The door to the stairs, immediately to the south of the cupboard, had plank and batten construction with moulded edging, an early latch, and strap hinges on pins (Plate 45), and had moulded strips on the surround to the south. The wall then returned to the east to form a slight alcove next to the chimney breast (Plate 44). In the top of the wall the chimney breast had a modern timber surround with brick infill and grate. The door to the south, where the wall was noted to be particularly thick, had a plank and batten door. The south elevation had a window to the west side, with wide splayed jambs, a timber sill (stepping up at the window), and a beaded strip surrounding the top and sides. The west elevation had two doorways, the southern one had a beaded surround and a four-panel moulded door while the north one had a moulded surround and two-panel door with mouldings and a latch (Plate 46). The west door had chamfered wide battens and early strap hinges but now used later ones.

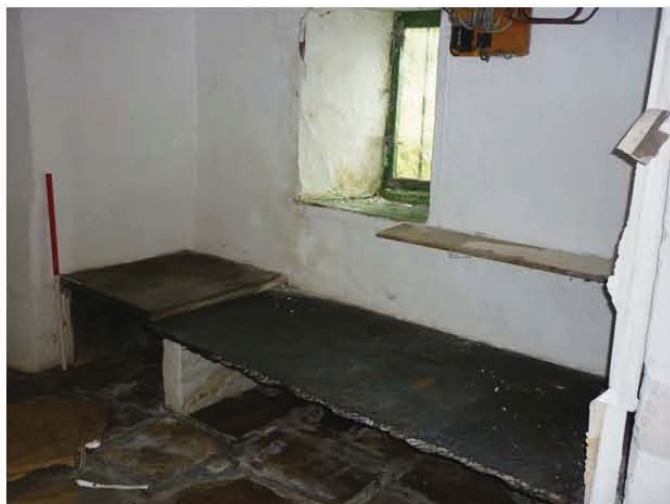
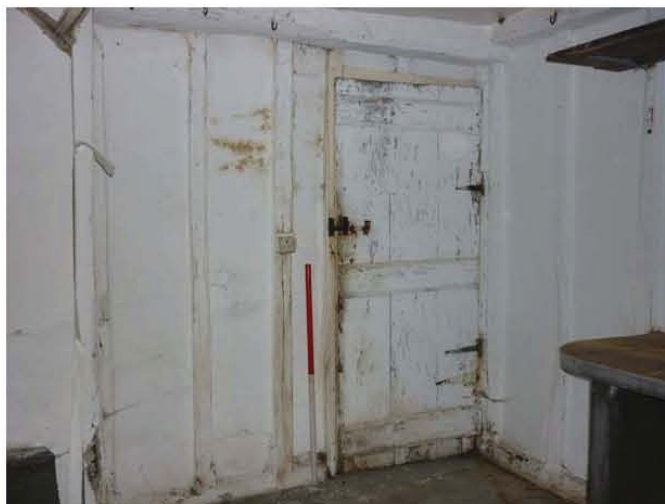
Plate 47 (left): Slate bench against the north elevation of ground floor Room 5 of the farmhouse

Plate 48 (right): Plank and batten door on the east elevation of ground floor Room 5 of the farmhouse

4.3.6 **Farmhouse – ground floor Room 5:** this room had a flag floor with stone benches on the north and south sides on stone blocks and there was some concrete on the south side. The ceiling was finished with plaster board and paint and one area of hand-sawn joists was exposed. There were wide rough boards over the walls, which were all whitewashed. The north elevation had stone benches against the wall, and a narrow central window with splayed jambs and a timber plank sill and timber surround, and electrical fittings attached, including a fuse box, etc, and timber shelves (Plate 47). The east elevation was stone on the north side, then a thinner stud partition wall. The studs were visible below a rough hand-finished north/south beam, which had meat hooks attached. There was a rough plank and batten door on the south side (Plate 48). The south elevation had a similar stud wall below an east/west beam, which was fixed to a north/south beam at the east end and into the wall at the west. There was a stone shelf against it and a timber shelf attached. The west elevation was plain apart from a doorway, with splayed jambs, which might have been a window formerly. There was a step up to Room 7 through this doorway.

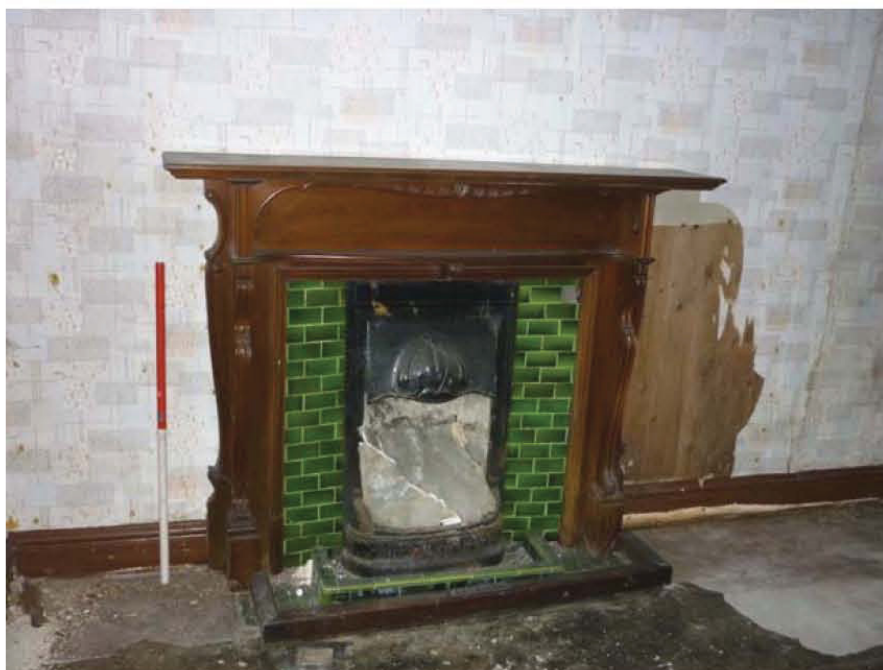
**Plate 49: Fireplace in ground floor Room 6 of the farmhouse**

4.3.7 **Farmhouse – ground floor Room 6:** this room had a concrete floor and plastered ceiling. The east/west beam was plastered over and the north/south beam was visible against the east wall, which had also been plastered over. The walls were finished with wallpaper and a moulded skirting. The north and east elevations were plain stud walls. The door in the east elevation had four plain panels and a plain surround. There was a central window in the south elevation, which had splayed jambs and board over the sill. There was a modern fireplace in the west elevation with an elaborate timber surround with tiles and an art nouveau style iron grate and hood (Plate 49). The hood had perhaps been added to an existing fireplace as the surround and grate were plain; it had beaded decoration but the tiles evidently went behind it.

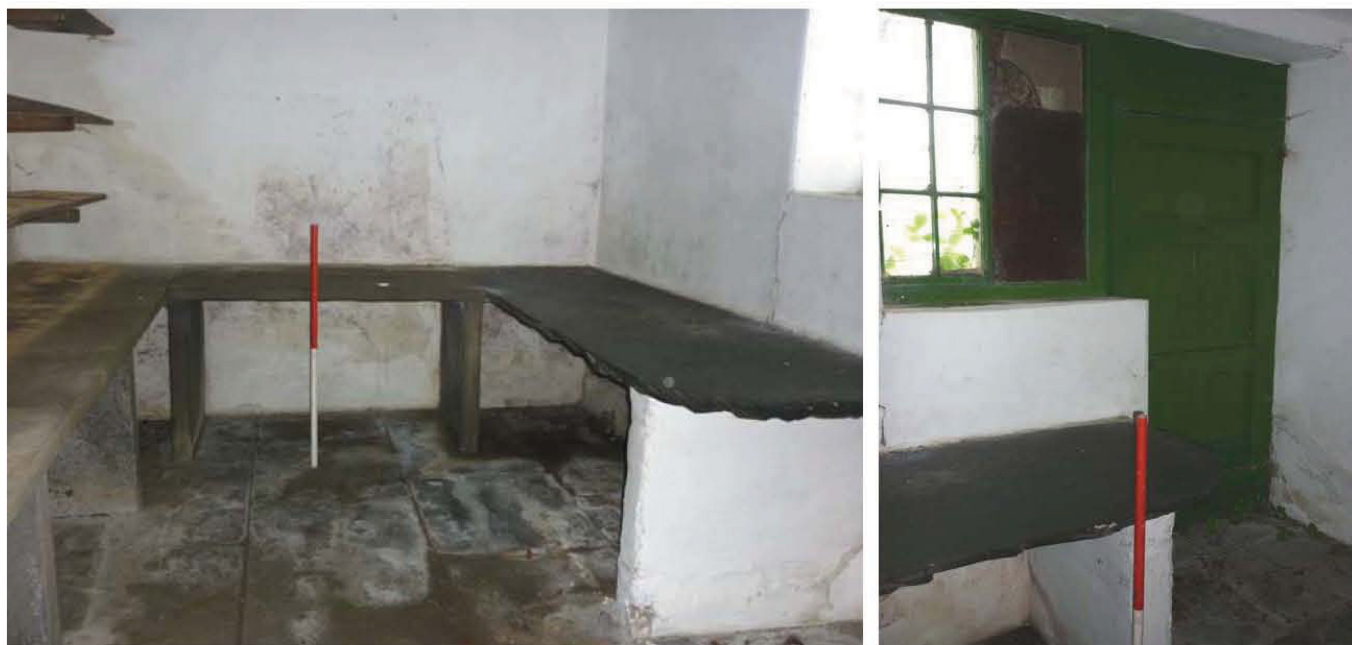
**Plate 50 (left): Stone benches around the walls of ground floor Room 7 of the farmhouse**

**Plate 51 (right): Doorway in the north elevation of ground floor Room 7 of the farmhouse**

4.3.8 **Farmhouse – ground floor Room 7:** the floor was flagged and there were stone benches against the north, south and west walls (Plate 50). The north elevation had a doorway on the east side, with a plank and batten door and a window on the west side (Plate 51). A crack the width of the original door was visible on the north side below the window, so the stone bench in front of it must have been added later. Unlike the other benches, which were gritstone and had holes in them, the bench against the north elevation was made from slate. The ceiling was plastered and whitewashed, as were the walls. The east elevation had a door on the south side with no surround. The south elevation had timber shelves on brackets above the stone bench whereas the west elevation was plain except for the stone bench.

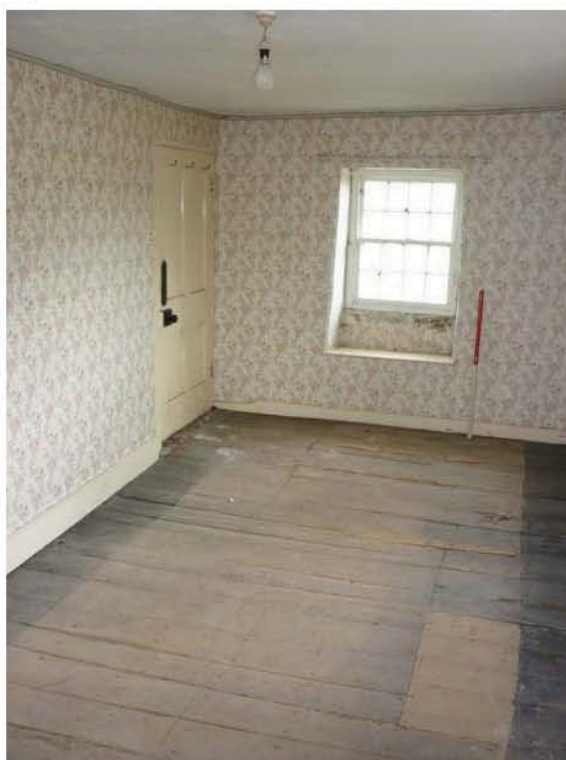
Plate 52: North-west corner of first floor Room 1 of the farmhouse

4.3.10 **Farmhouse – first floor Room 1:** the rough board floors of this room sloped down to the south and were stained along the east and west sides (Plate 52). They looked early and were aligned loosely east/west but had been oddly cut and patched, especially along the east side. The ceiling was plastered and the walls were finished with floral wall paper and moulded skirting. The north elevation housed a window with splayed jambs and a timber sill set below the base of the casement and perhaps forming a small window seat. The east elevation had a central window with splayed jambs and a timber sill. The south elevation was plain. The west elevation was a stud partition wall and had a door on the north side with a plain surround and a four-panel door.

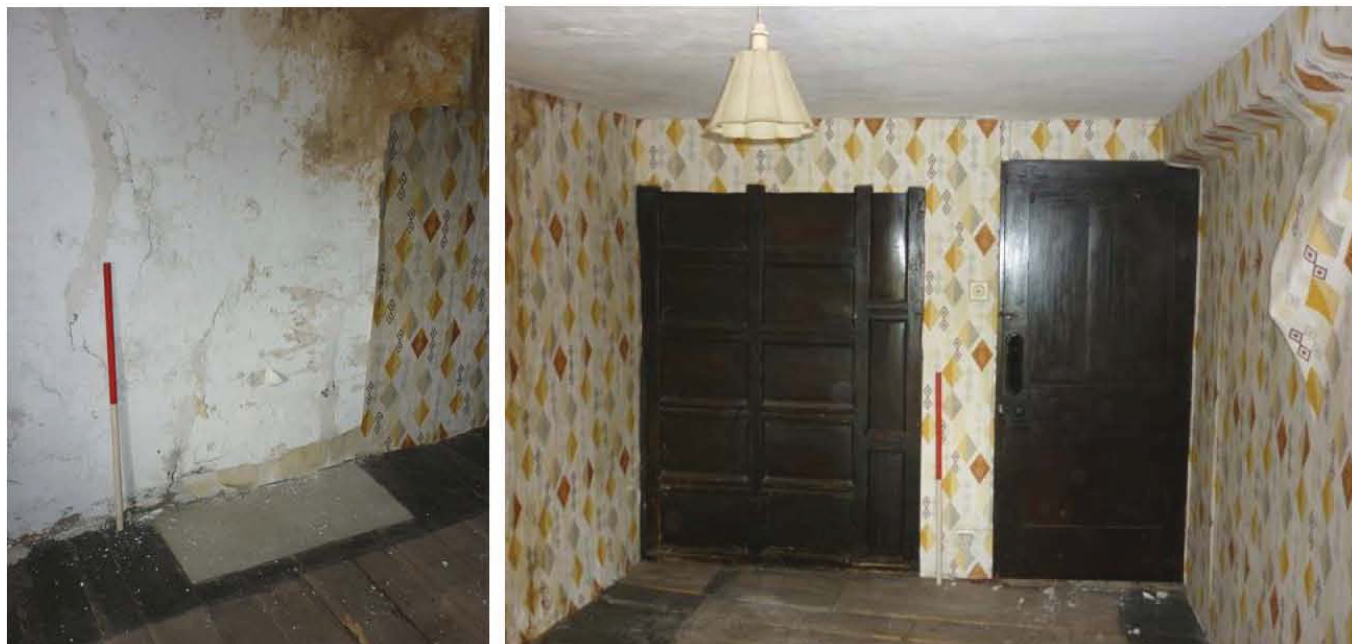
**Plate 53 (left): Concrete hearth in the west elevation of first floor Room 3 of the farmhouse**

**Plate 54 (right): Wood panelling on the north elevation of first floor Room 3 of the farmhouse**

4.3.12 **Farmhouse – first floor Room 3:** the board floor in this room was early and hand-finished in several sections, which were nailed with hand-made nails. The ceiling was plastered and the beams had been plastered and wallpapered over. Against the east elevation there was a concrete hearth stone on west side (Plate 53) and the walls were finished with wall paper. A section of the north elevation had moulded timber panelling on the west side which had evidently been re-used and been fairly crudely nailed to the wall with early hand-made nails (Plate 54; see Figure 9). The door to the east had four plain

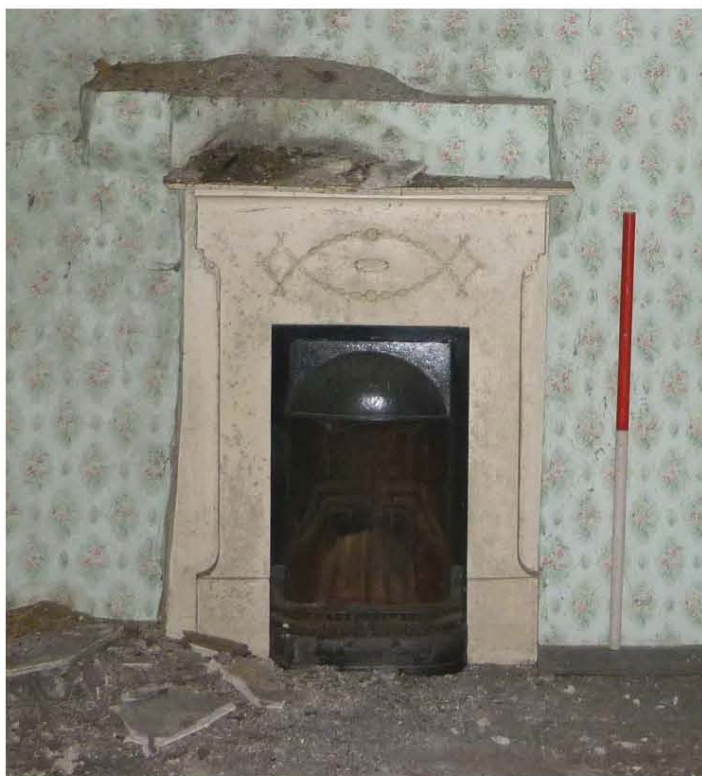
**Plate 55 (left): Fireplace in first floor Room 4 of the farmhouse**

4.3.13 **Farmhouse – first floor Room 4:** the floor was tongue and groove boarded and was stained (and stained darker still along the east and west sides). The boards were aligned east/west apart from a section on the east side where the boards were aligned north/south. The ceiling was plastered and had a single north/south beam (tie beam or truss), which was hand-finished and stop-chamfered at the south end on the west side. The walls were finished with floral wallpaper. The north elevation was a stud wall and angled slightly with a slight return at the west end. There was a doorway at this end with a beaded plank and batten door and an early latch and plain surround. The east elevation had a fireplace on the north side with a cast iron grate and moulded mantle surround decorated with floral motifs (Plate 55). There was a projecting block above it, possibly for an earlier fireplace. The south elevation had a window on the west side, which had a splayed jamb on the east side and a timber sill, and the west elevation was a plain stud partition wall.

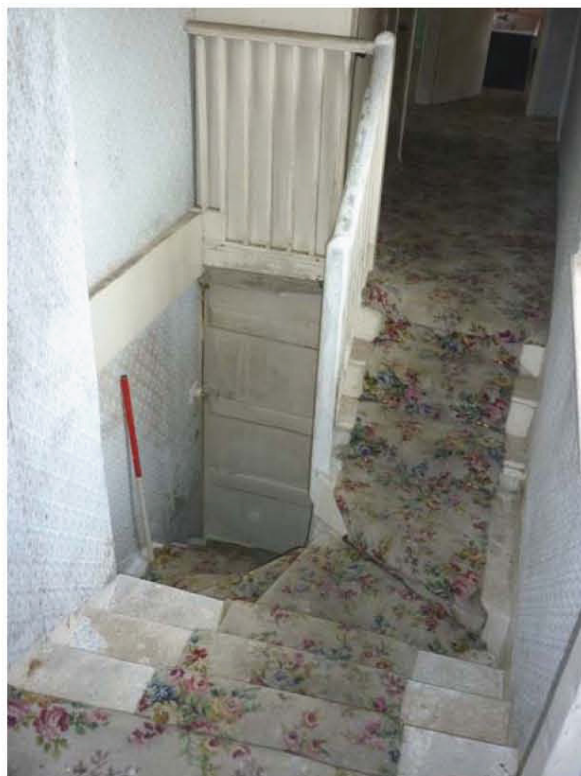
**Plate 56 (right): Stairwell in first floor Room 5 of the farmhouse**

4.3.14 **Farmhouse – first floor Room 5:** this room formed a corridor from the stairs to the west. There was carpet over the timber stairs from the ground floor and to the east and west (Plate 56). There was a simple hand rail on the west side, with square spindles and newels with a slight stop-chamfer, and a modern cupboard against the south wall, beyond the stairs to the west. The ceiling was plastered and the north/south beam was evident on the west side and the walls were finished with floral wallpaper. The north elevation had a window on the east side with splayed jambs and a timber sill. There was a doorway with a plain surround and joints pegged at the corners in the east elevation, leading to Room 2. There was modern boxing in the centre of the south elevation and a cupboard to the west, the door to which had a beaded plank and batten door and the surround had some beading to the west. The west elevation had two doorways which both housed beaded plank and batten doors with plain surrounds and early latches.

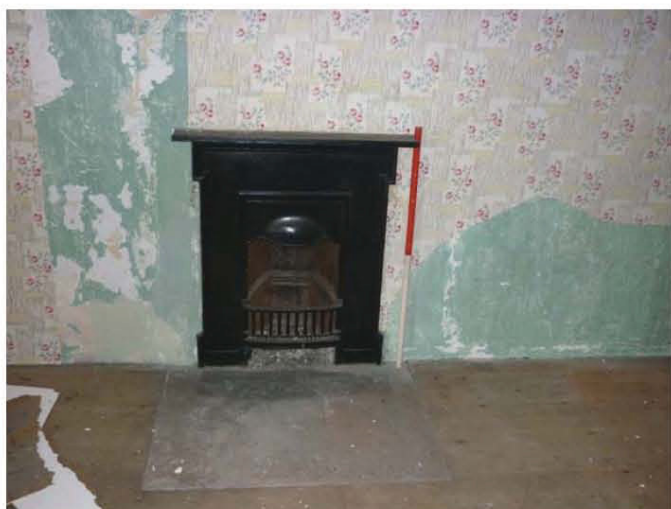
**Plate 57 (left): Hearth in the west elevation of first floor Room 6 of the farmhouse**

4.3.15 *Farmhouse – first floor Room 6*: this room had wide boards for the floor, which was very neatly made, and incorporated a hearth stone on the west side (Plate 57). The ceiling was plasterboard on fairly modern joists where they were exposed. There was a single hand-finished north/south beam against the east elevation and the walls were finished with paint and floral wallpaper (Plate 58). The north elevation was plain. There was a doorway in the east elevation, to the north, with a plank and batten door and plain surround. There was a section of moulded panelling to the south, which was a little irregular and nailed on to the stud partition, suggesting it had been re-used (Plate 58; Figure 9). The south elevation had a window on the east side with a splayed jamb on the west side and a timber sill. The west elevation had a fireplace on the south side with an iron surround and mantle and beaded moulding which was lugged and shouldered (Plate 58).

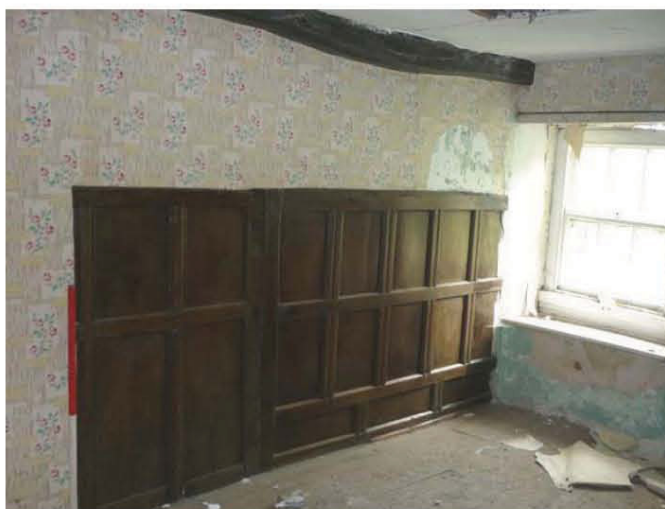
**Plate 58 (right): Wood panelling on the east elevation of first floor Room 6 of the farmhouse**

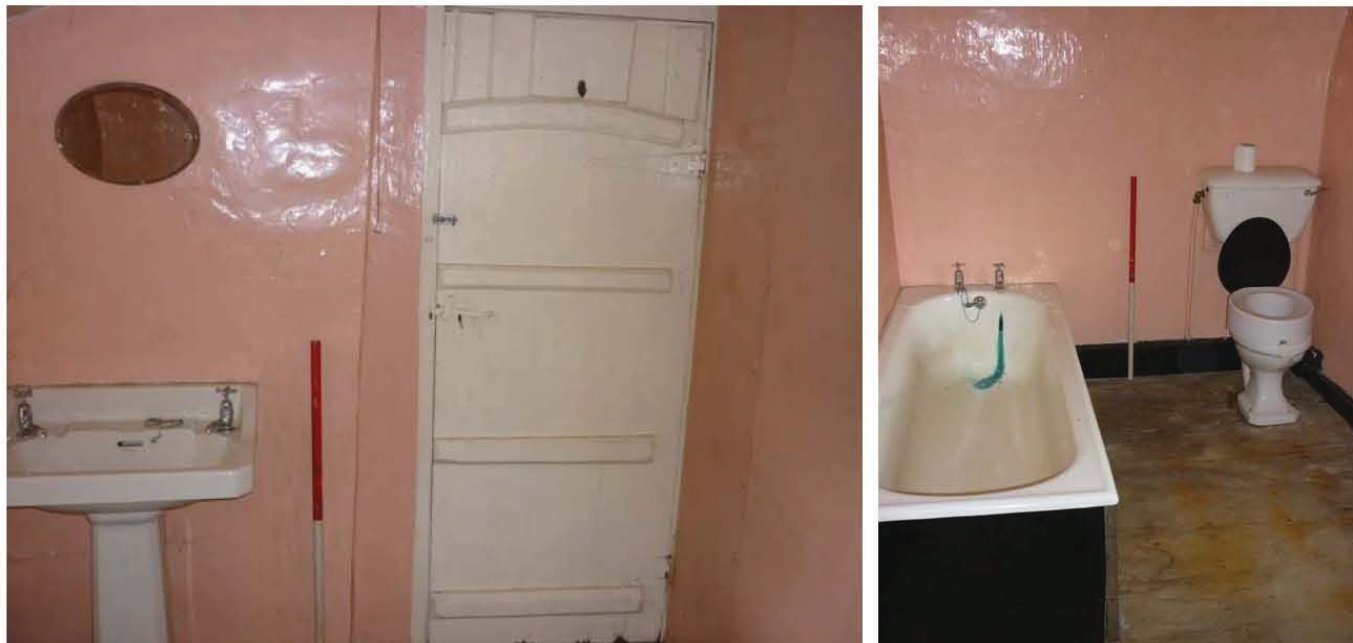
Plate 59 (left): Projecting section of the east elevation of the first floor Room 7 of the farmhouse

Plate 60 (right): West elevation of the bathroom, first floor Room 7 of the farmhouse

4.3.16 **Farmhouse – first floor Room 7:** this was the bathroom. It had wide floor boards which were neatly finished and nailed. The ceiling was plastered and there was a single east/west purlin on the north side, sloping down to the north. The walls were plastered and painted. The north elevation had a window on the east side with splayed jambs and a timber sill. The east elevation projected to the north, beyond the line of the house to the east, where there was a 'TWYFORDS' sink attached (Plate 59). The south elevation was plain with a bath attached. Similarly, the west elevation was plain apart from where the bath and toilet were attached (Plate 60).

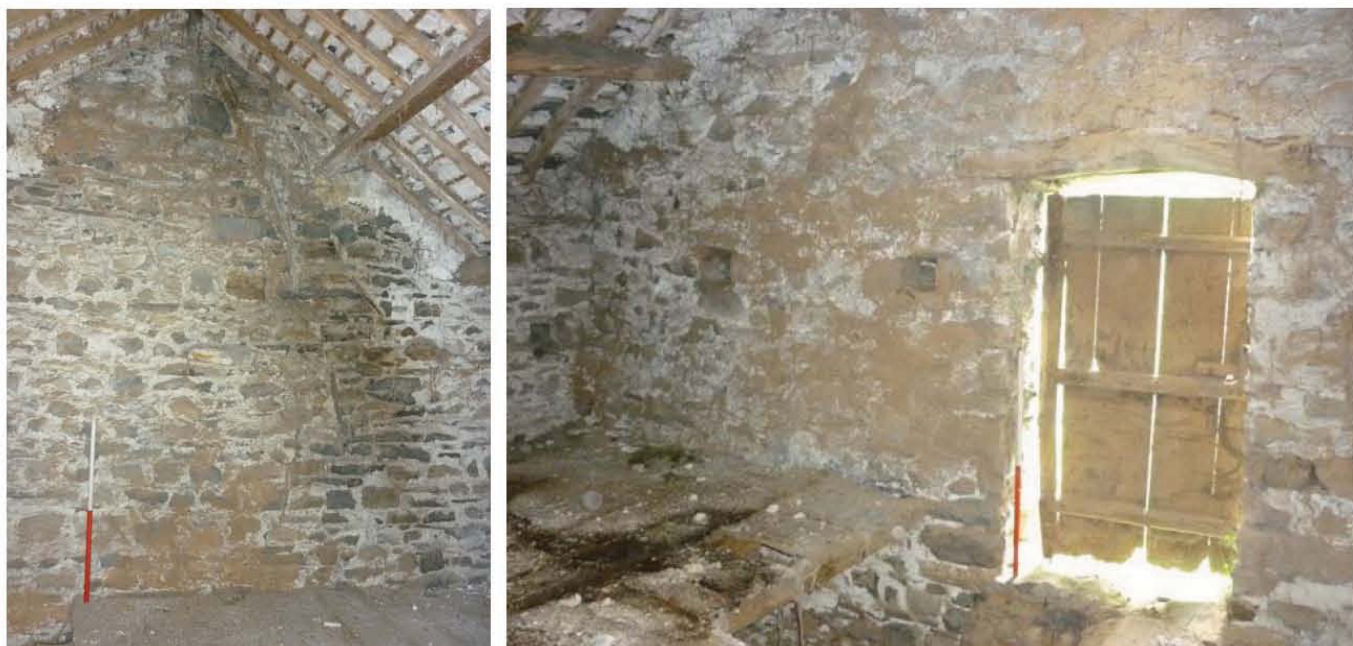
Plate 61 (left): East elevation of first floor Room 8 of the farmhouse

Plate 62 (right): West elevation of first floor Room 8 of the farmhouse

4.3.17 **Farmhouse – first floor Room 8:** the board floor was raised on the south side, which was covered by much larger and rougher boards; most of which were aligned north/south but some (possibly on top) were aligned east/west. The beams sat on the floor to the north, which had neat tongue and groove boards aligned north/south. The room was open to the roof and there were two purlins per pitch and a ridge plank. The timber was a mix of hand-finished and machine cut, the lower ones tended to be hand-finished. The walls were exposed stone with lime pointing. The north elevation was slightly lower than the south and the top of the wall was exposed. The east elevation was gabled and plain apart from some angled slabs for a possible flue on the south side (Plate 61). The south elevation was similar to the north elevation but set higher, with a small square vent(?) on the west side. The west elevation had a central doorway with a rough timber lintel and plank and batten door, which was very early and stop-chamfered (Plate 62). There were two small square vents/alcoves to the south of this door.

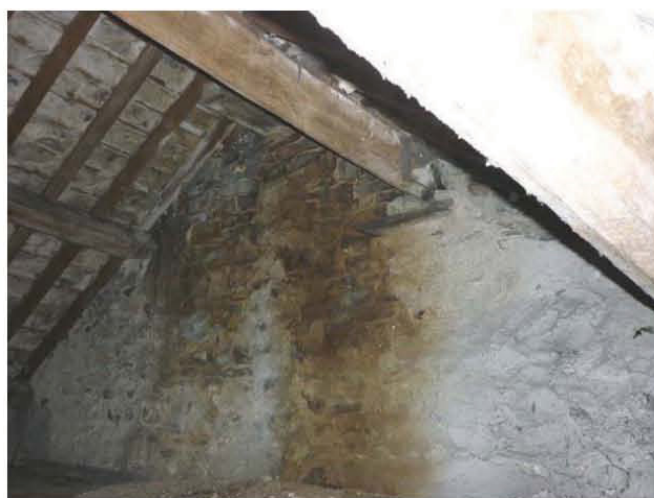
Plate 63: West wall in the roof space above first floor Rooms 1 to 3 of the farmhouse

4.3.18 **Farmhouse – roof space:** although it was not possible to access the roof space above Rooms F1 to F3, it was possible to see some of the details of the structure through a hatch in the ceiling in F2. The joists appeared to be hand-sawn and open to the roof. There was a single tie-beam truss with a collar, which was hand-finished and pegged, with two purlins per pitch which overlapped at the truss, and there was a projecting timber in the west wall below a diagonally set ridge purlin (Plate 63). Above Rooms F4 to F7 the joists appeared to be modern machine cut timbers and the area was split into two bays. To the east there were some earlier timbers used and to the west they were all hand-sawn. There were two trusses of the basic tie-beam type with a basic lap joint at the junction of the principals (Plate 64 and Plate 65). There were two purlins per pitch, overlapping at the trusses, and a diagonally set ridge purlin. All the timber, including the rafters, was hand-finished and some of the principals were obviously re-used crucks. The tie-beam was also re-used. The east elevation had rough plaster in places and some trace of a window was evident in the other side (Plate 66). There was timber projecting below the ridge purlin and a large slab projecting below the purlin to the north, which also carried through to the roof space. The west elevation also had some patchy rough plaster on the north side and angled slabs for a flue were evident on the south side (Plate 67). The wall also returns slightly at the north end, corresponding to the stairs.

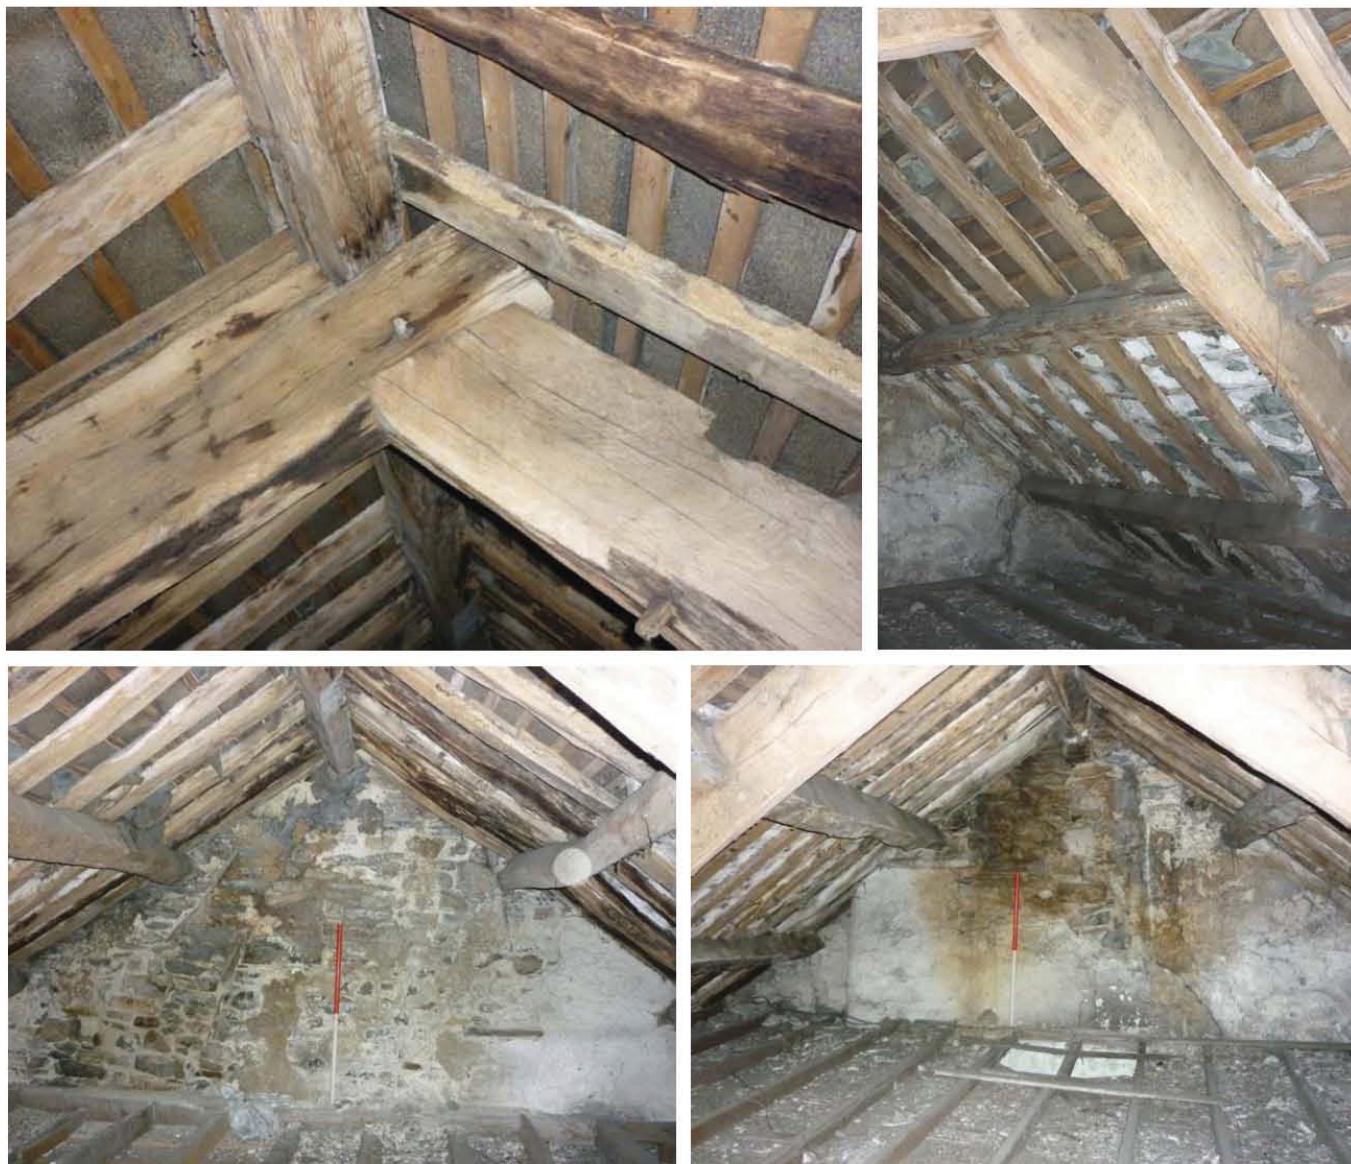
**Plate 64 (top left):** Detail of lap joint in the truss above first floor Rooms 4 to 7 of the farmhouse

**Plate 65 (top right):** Roof structure in the roof space above first floor Rooms 4 to 7 of the farmhouse

**Plate 66 (bottom left):** East wall in the roof space above first floor Room 4 and 5 of the farmhouse

**Plate 67 (bottom right):** West wall in the roof space above first floor Room 6 and 7 of the farmhouse

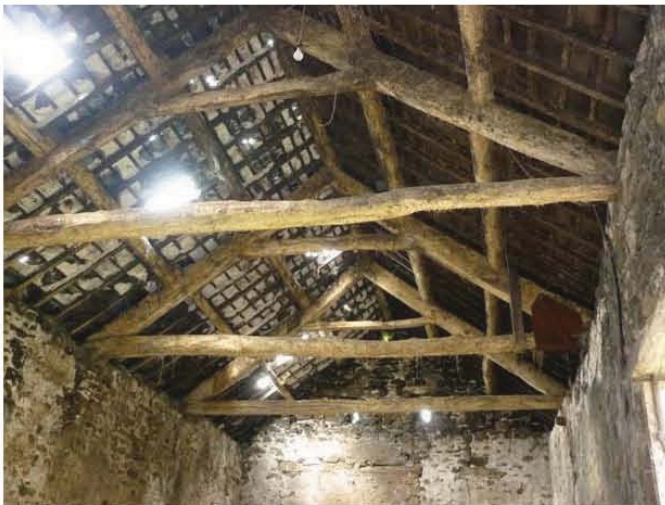
**Plate 68: Roof structure of upper floor Room 1 of the barns**

4.3.19 **Barns – upper floor Room 1:** this formed the main east/west section of the range. The floor was a mixture of boards, aligned east/west, at the east end, flags in concrete, and cobbles in a raised area at the west end. The cobbled floor was raised again in the south-west corner and edged with rough boulders (Plate 75). The room was open to the roof and there were seven tie-beam trusses along the bay, which were mostly all the same, with collars and hand-finished (Plate 68), but the ones east of the returns in the north and south walls were sawn timber and had a collar bolted to them. Some of the timbers were evidently re-used and were probably re-used cruck blades in some cases. Two trusses at the east end sat on a block beam at the north end, across an open section into Room 2. This block beam was in turn supported by a later iron I-beam, supported by two upright iron beams, which ran across into the tie-beam of the southern truss in Room 2 (Plate 69). The eastern truss in Room 1 was also slightly different as the tie-beam had been cut out at both ends and the cut section bolted higher up. The 'block' to the north is actually the sawn-off north end of the tie-beam. The original collar had also been removed and a new one bolted on. All the walls were exposed stone with lime pointing. There were two purlins per pitch and a diagonal ridge overlapped at the trusses. The west end of the north elevation was relatively

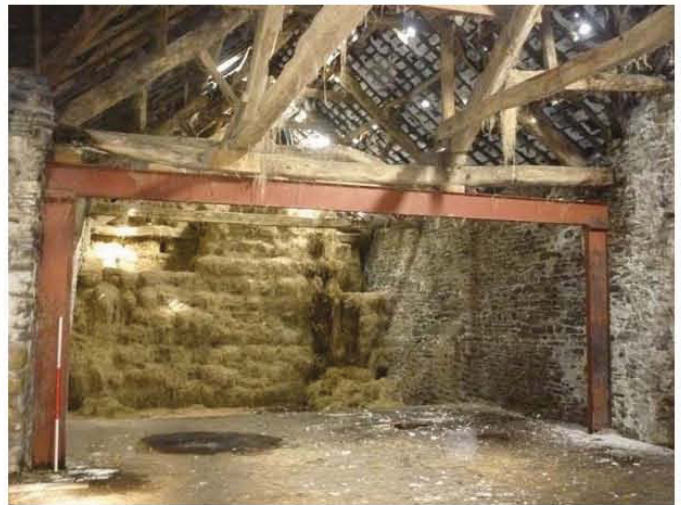
**Plate 69: Iron I-beam structure supporting the east end trusses of upper floor Room 1 of the barns**

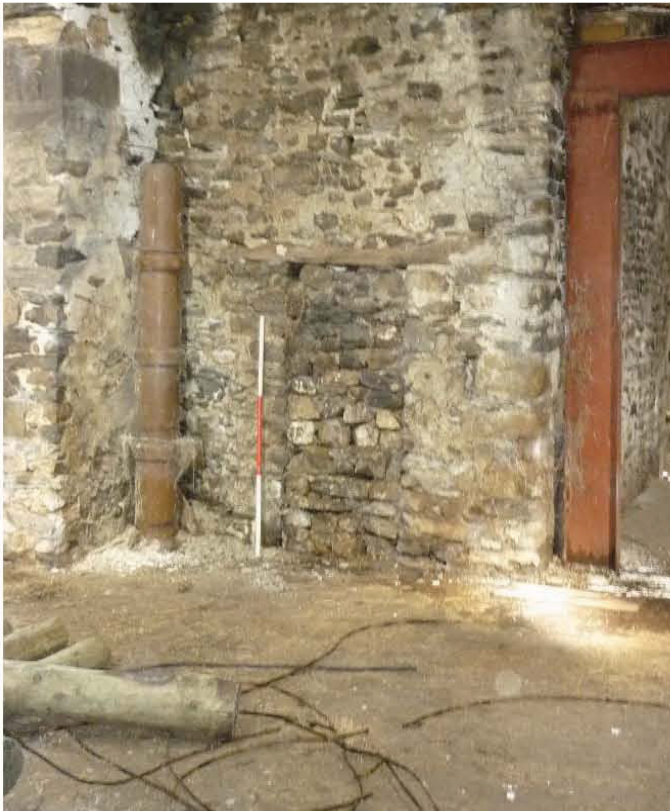
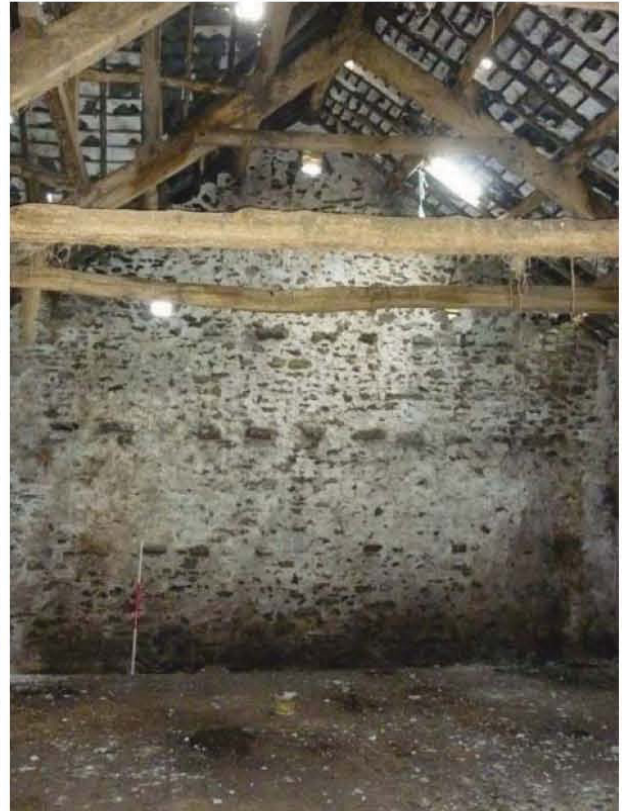
**Plate 70 (left): Blocked doorway in the north elevation of upper floor Room 1 of the barns**

**Plate 71 (right): East elevation of upper floor Room 1 of the barns**

plain, apart from an aperture to the east, which meets the wagon doorway, which had a timber lintel and a timber plank and batten sliding door. The wagon doorway had neatly dressed quoins in the west jamb and a double plank and batten door on pivots. There were less obvious quoins in the east jamb. The wall then returned to the north where there was a large ceramic pipe set vertically into the floor (Plate 70). The wall continued with a blocked doorway with a timber lintel. The east end was open and was presumably knocked through and supported by a complete re-arrangement of the beams and trusses (see Plate 69). The east elevation was originally the gable end and had three rows of through stones, one vent slot visible, and an owl hole, which was still being used (Plate 71). The east end of the south elevation was plain with some modern cement render up to a 'chute' built in pallets near to the return wall (Plate 72). The wall returned to the north and then continued to the west where there was a partially blocked wagon door, below a very large re-used timber lintel (a re-used cruck blade), and a small door was included in the blocking (Plate 73). The west end of this elevation had at least three blocked vents, one leaving an alcove. The west elevation was the gable end and had three blocked vents at ground level, although these were covered with concrete pointing, and there more vent slots in a row above with timber lintels (Plate 74). There were two more open slots above that, and an owl hole near the apex.

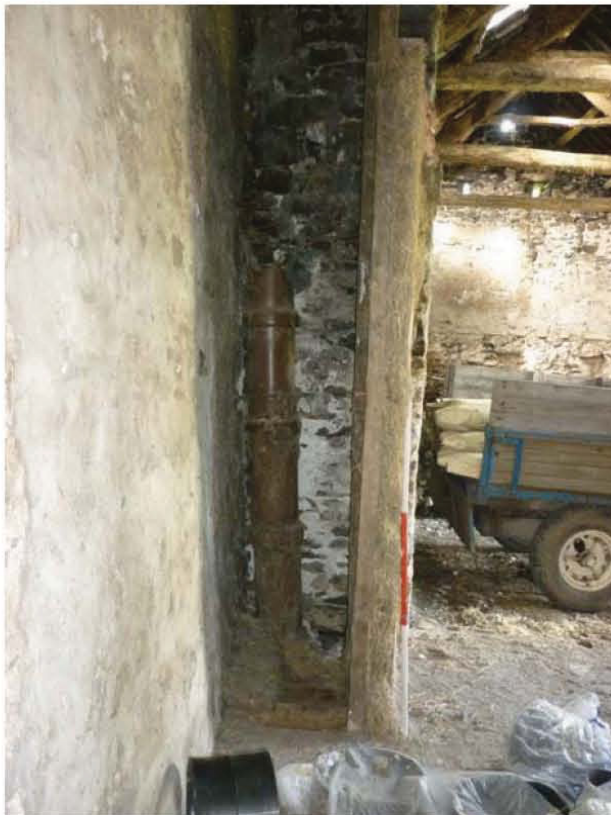
**Plate 72 (left): 'Chute' in upper floor Room 1 of the barns**

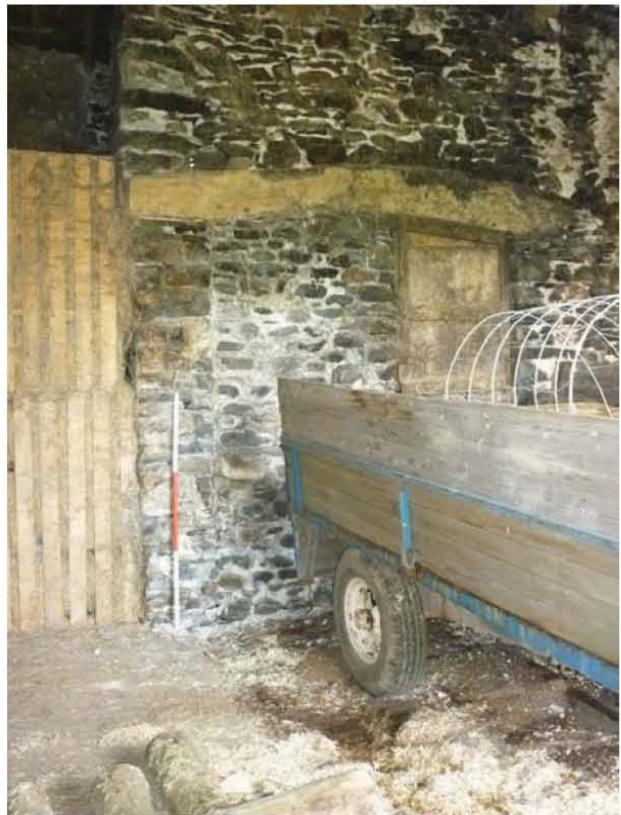
**Plate 73 (right): Blocked wagon doorway in the south elevation of upper floor Room 1 of the barns**

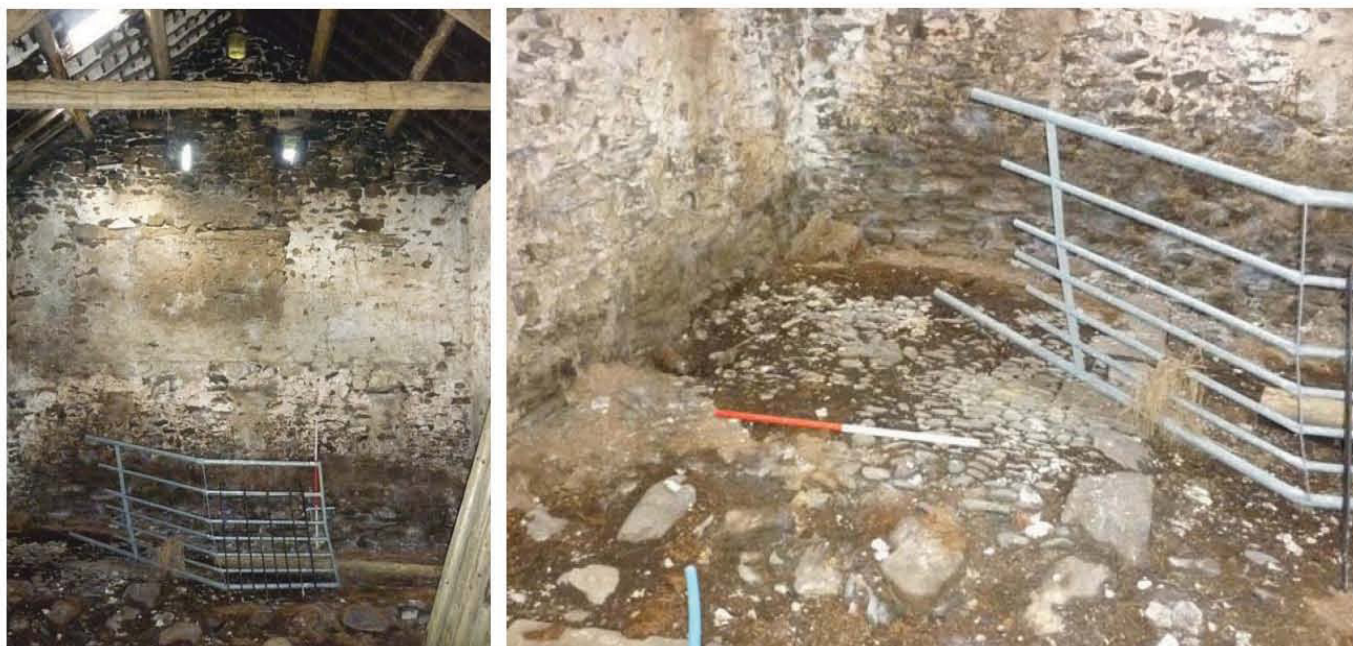
Plate 74 (left): West elevation of upper floor Room 1 of the barns

Plate 75 (right): Detail of the cobbled surface in upper floor Room 1 of the barns

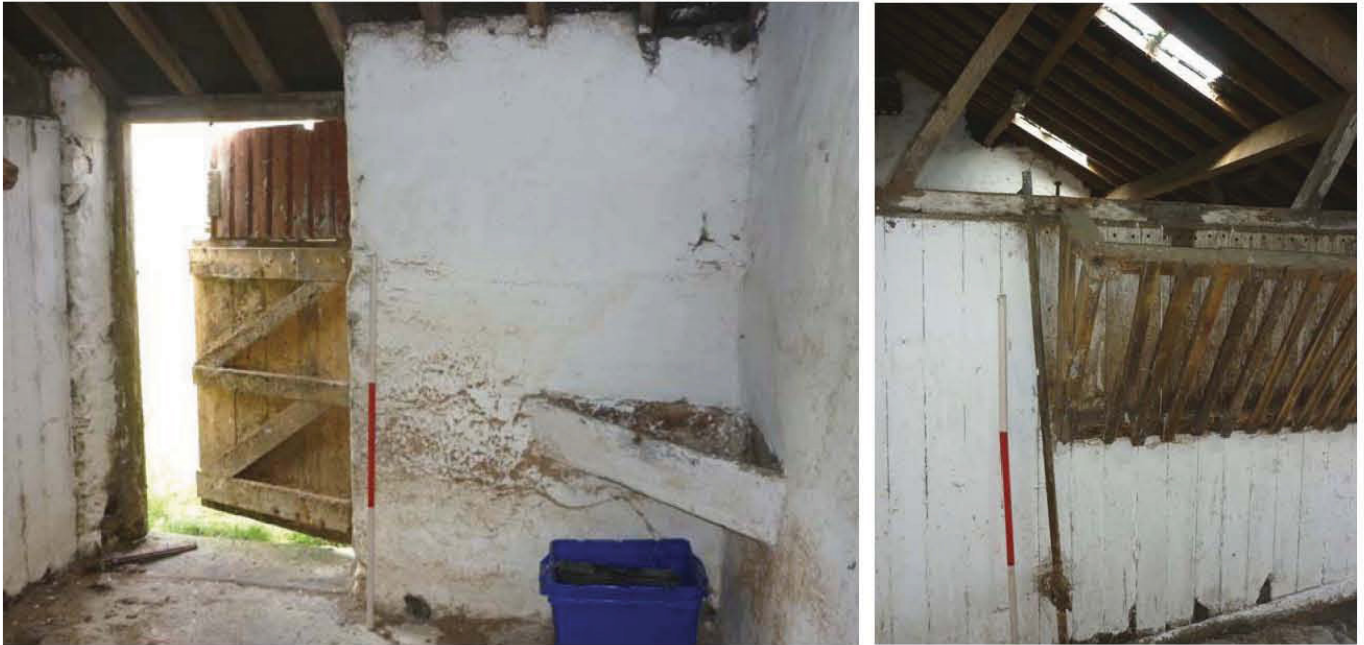
**Plate 76 (left): North elevation of upper floor Room 3a of the barns**

**Plate 77 (right): West elevation of upper floor Room 3a of the barns**

4.3.21 **Barns – upper floor Room 3a:** this formed the east side of the outshut to the north of the main east/west section of the barn. The floor was concrete and raised on the south side, with a V-shaped and X-shaped grid impressed into the surface and a shallow channel running north/south on the east side. The north side sloped towards a ceramic pipe in the base of the wall. The room was open to the roof which ran across all three parts of the outshut and comprised a single half-truss, with two angled braces on the beam and principal, and three purlins. All the timber was machine cut. The north elevation had a split plank and batten door on the west side with a chamfered surround (Plate 76). Again, machine cut timber was used. There was a piece of timber across the north-east corner which formed a trough. The east elevation was plain apart from a square aperture at the top on the south side (this appeared triangular on the outside) and there was an iron pole against the wall. The south elevation had a small hatch on the east side, with a beaded plank and batten door and an iron ring set into a sloping sill. The west elevation had a timber plank construction, which was fixed below the truss, and a timber manger attached (Plate 77). There was an iron post against the wall to the south of the manger.
