# DRYBECK FARM, KILLINGTON, KENDAL, CUMBRIA

## Archaeological Building Recording

Planning Application Ref:  
SL/2008/1213

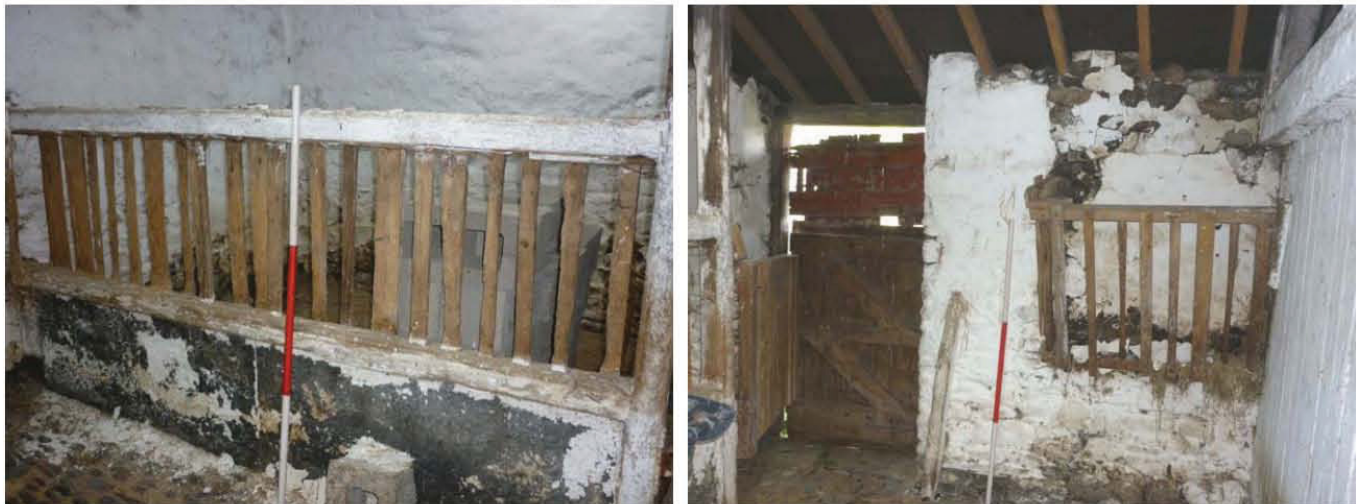
**Plate 78 (left): Dividing wall in upper floor Room 3b of the barns**

**Plate 79 (right): East end of the north elevation of upper floor Room 3b of the barns**

4.3.22 **Barns – upper floor Room 3b**: this formed the west side of the outshut to the north of the main east/west section of the barn. The west side of the room had a cobbled floor which was divided by a low wall (made of stone flags?) and topped with open stop-chamfered timber railings (Plate 78). There was a post with a swing gate at the north end. The room was open to the roof (see *Section 4.3.21* above). The north elevation had a central doorway with a split plank and batten door, with a chamfered surround, and there were timber troughs attached to the east and west (Plate 79). The east elevation was constructed from a plank wall with a rail along the bottom (see Plate 77). The south elevation was plain. The west elevation was plain except for a square vent at the top at the south, which was triangular towards the outside and filled with ceramic pipes.

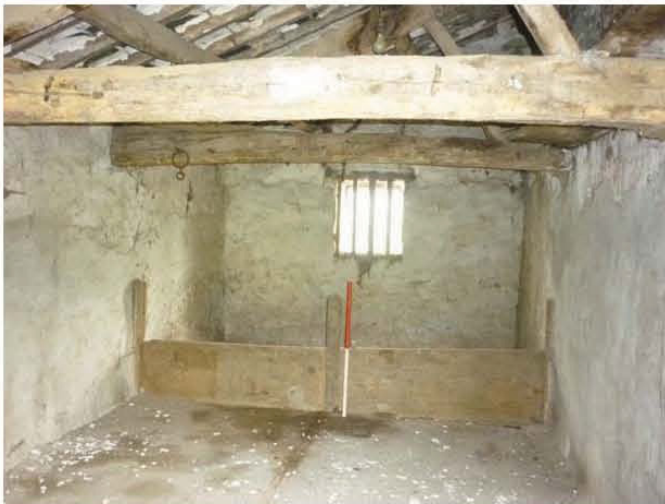
Plate 80 (top left): Stall at the east end of upper floor Room 5 of the barns

4.3.24 **Barns – upper floor Room 5:** the concrete floor of this room had scars for timber partitions across the centre which remained *in situ* at the east end (Plate 80). There were two half trusses in the roof, each with an angled brace and three purlins overlapping at the trusses, hand-finished throughout (Plate 81). A large plank shelf was supported on the tie beams at the north and south ends. The north elevation was fairly plain and had two timber posts attached with runners for removable plank partitions. There was a further horizontal batten to the west and a possible scar of another post at the west end. Graffiti was scored into the plaster here: 'E.V. Sept 3 1922', 'E.V. 1920 EV'; and written in pencil: "AW 1919", as well as a pair of hand prints impressed in the plaster to the east (Plate 82). The east elevation was plain apart from a small four-light casement window with a timber grill over it. The crane from the fire was hung above it over an iron spike. The east wall butted against the south elevation, which had been the external gable end of the barn. The lower part of the south elevation was part plastered and whitewashed but the upper part was not, where a row of projecting through stones and two square vents were visible. There was some graffiti painted at the west end, which read 'W.P. BLACOW 1866' (Plate 83). The door on the south side of the west elevation was a machine cut plank and batten door, with a plain surround and a machine cut timber lintel. There was a small alcove (possibly a vent?) and electrical fittings and an upright post for partitions attached north of the door.

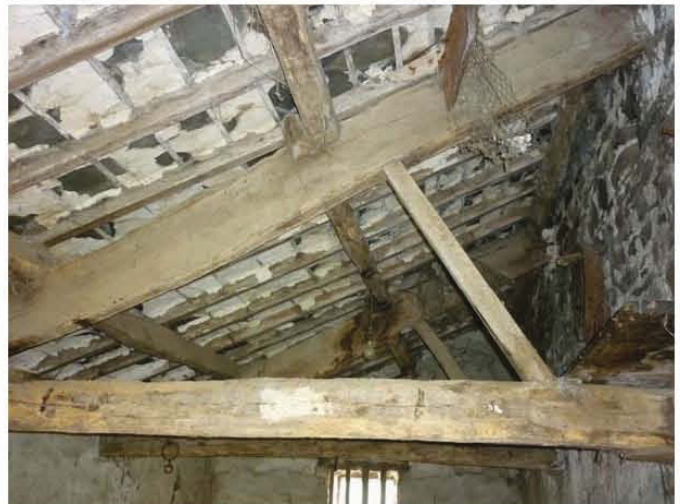
Plate 81 (top right): Truss in upper floor Room 5 of the barns

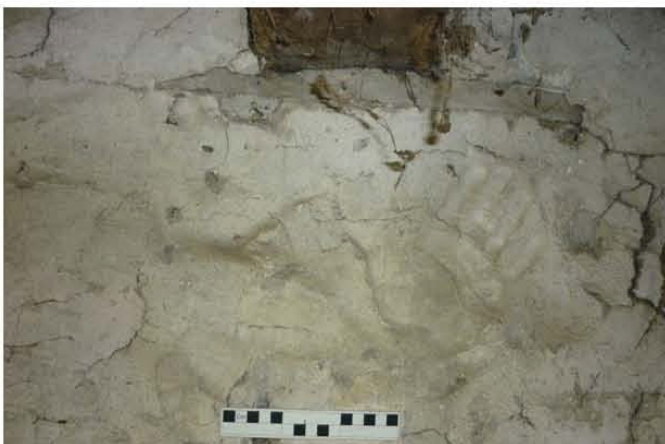
Plate 82 (bottom left): Handprint impressions in the north elevation of upper floor Room 5 of the barns

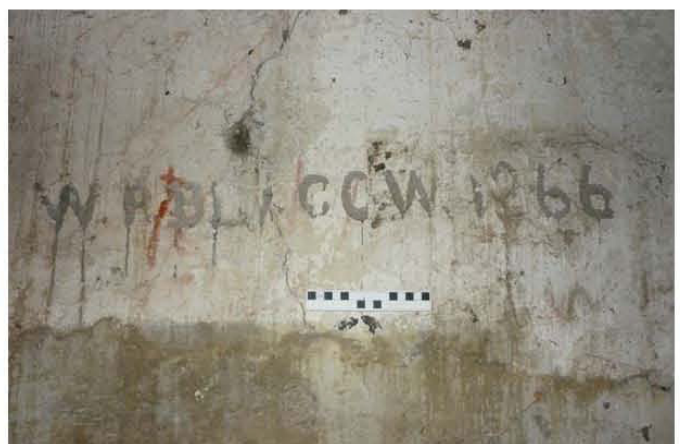
Plate 83 (bottom right): Graffiti on the south elevation of upper floor Room 5 of the barns

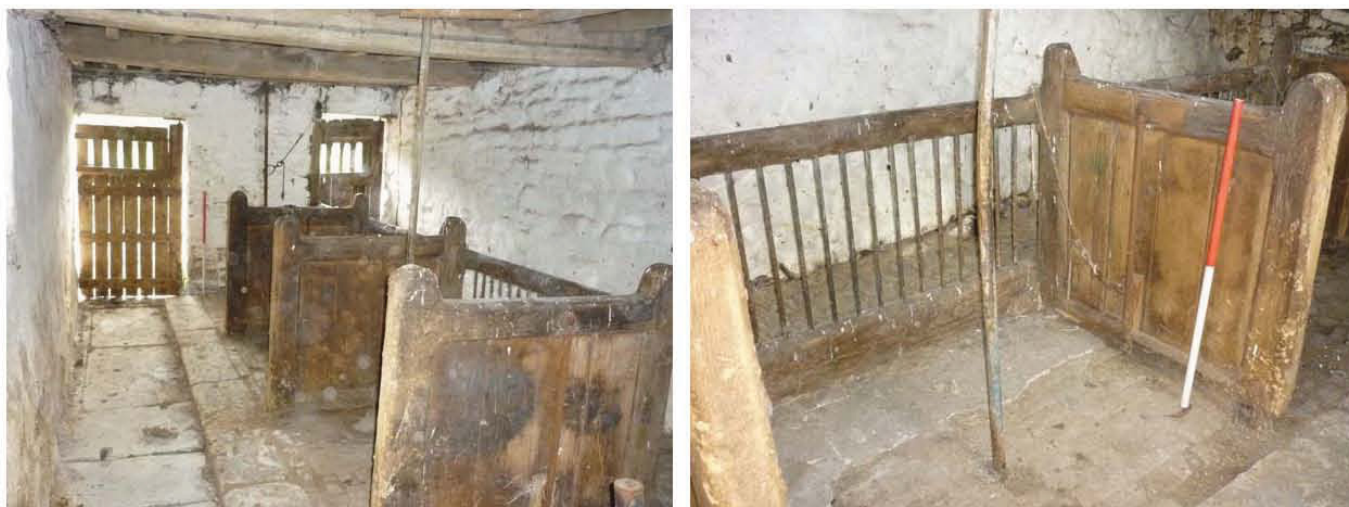
Plate 84 (left): Timber stalls in lower floor Room 1 of the barns

Plate 85 (right): Detail of the stalls in lower floor Room 1 of the barns

4.3.25 **Barns – lower floor Room 1**: the floor was a mix of stone flags along the north side of the room, forming a channel to the door to the east, which stepped up to the south, with larger stones edging a brick floor (Plate 84). There were fairly small rough bricks within the stalls, with patchy plaster cover in places (Plate 85). There were cobbles on the south side of the room forming a channel to the door to the east and a run of four stall partitions down the centre of the room, each built from timber planks and posts and rails. The posts were square and stop-chamfered, with rounded tops, pegged joints, and an iron bar attached. There was another iron upright post (possibly a re-used scaffold bar?) in the centre, sub-dividing each stall. The ceiling was hand-finished, with hand-sawn beams, aligned north/south, and roughly chamfered joists. Additional timbers were used in places, including a very rough one at the west end on a timber corbel. There was a rail along the south side of the stalls, with a timber rail at the top and bottom and iron railings below, which formed a passage. The walls were finished with whitewash. The west elevation was plain, apart from a small plain window, with a stone sill and hand-sawn timber lintel. The window was filled by a timber grill. The doorway on the north side of the east elevation had a split plank and batten door and a fairly rough stop-chamfered timber lintel. The door on the south side had a rough plank and batten door with four vents. The post on the north side, with a stop-chamfer, was really part of the stalls. The south elevation was plain. The west elevation was plain apart from the timber against it on the south side and a small aperture/vent on the north which had a timber lintel.

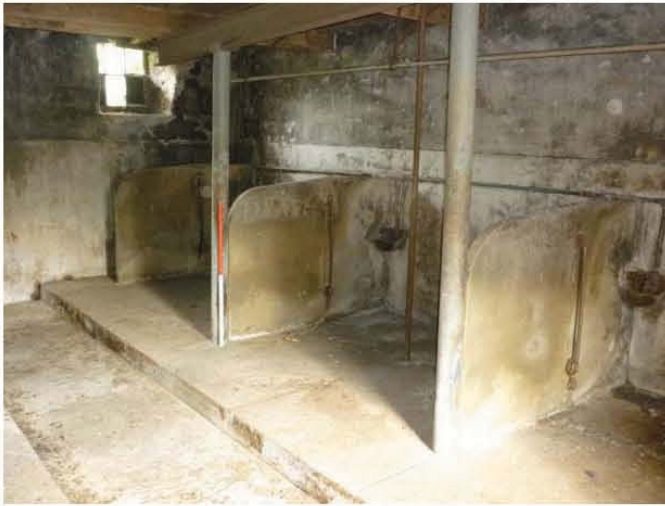
Plate 86 (left): Concrete stalls in lower floor Room 2 of the barns

4.3.26 **Barns – lower floor Room 2**: the floor was concrete with a lower east/west aligned drainage channel and a raised floor on the north side (Plate 86). There were three concrete stalls on the north side against iron posts, with bracketed tops, below an east/west iron I-beam. There was a narrow and shallow drainage channel, running north/south, within each stall. The ceiling was largely east/west joists and tongue and groove boards, all hand-sawn, but the three north/south beams appeared to have been added and were all re-used timber. At least one of the beams was a re-used cruck blade and another was a large rail from a stud wall with grooves for studs. There were various iron straps added and a large post below the central beam and an iron I-beam aligned east/west and another aligned north/south on top of this. There were additional brackets for water pipes on the north side. The walls were finished with a concrete skim. The north elevation was plain, with the stalls, water pipes and small metal troughs attached (Plate 87). The troughs were labelled 'BAMFORDS UTTOXETER'. The east elevation had a central three-light tilting casement window with a sloping sill and an iron bar across it, which continued to the north. There was a plank and batten door with a plain surround to the south. The south elevation was plain. To the south side of the west elevation there was a three-light tilting casement window with a concrete lintel. To the north there was a six-light fixed casement window, with a stone sill and re-used timber lintel. There was a pipe vent to the north just below the ceiling.

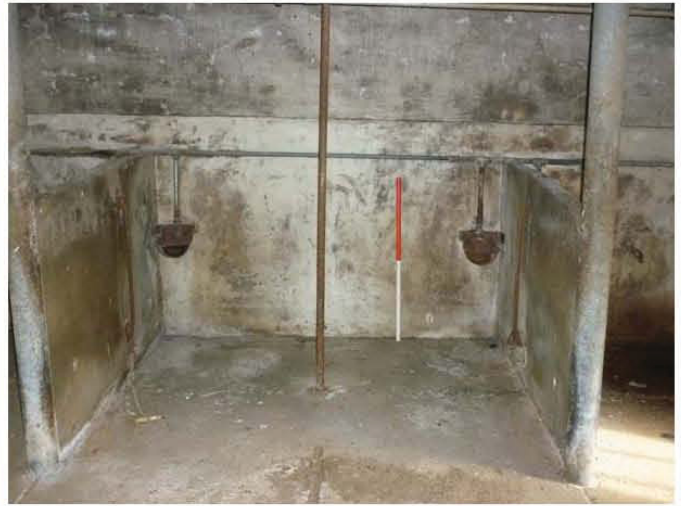
Plate 87 (right): Detail of the stalls in lower floor Room 2 of the barns

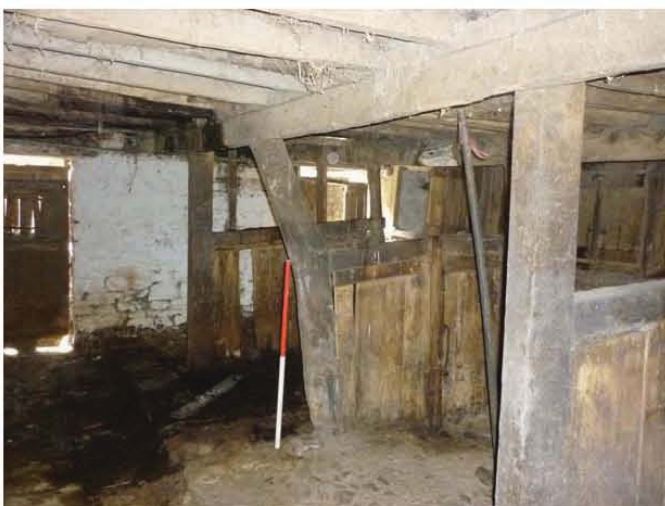
Plate 88 (left): The north side of lower floor Room 3 of the barns

4.3.27 **Barns – lower floor Room 3**: the floor was a mix of flags on the north side, forming a lowered drainage channel (Plate 88), and larger stones forming a stepped edge to the cobbled area within the stalls (Plate 91) and the central feeding channel (Plate 90). Scored concrete was used to the south, including in the drainage channel, although this also had stone edging (Plate 89). There were two lots of three stall partitions either side of a central feed passage (Plate 89 and Plate 90). The stall and passage walls were all timber-built using upright posts with stop-chamfered decoration and plank walls between the rails and timber fixing posts (Plate 91). The south side of the feed channel had sliding shutters, comprising plank and batten doors fitted to a grooved rail (Plate 89). The timbers were all hand-sawn, although some was more modern and some of it was hand finished: the joists on the north side in particular, and on the south side where the ceiling was raised, and the timber joists were all hand-sawn. The timbers were nailed together with hand-made nails. The walls were typically whitewashed. The north elevation was plain and had a blocked window at the west side, leaving an alcove below a rough timber lintel and the scars of the window in the jambs. The east elevation had three doorways, which each had a plank and batten door with vents or windows and rough timber lintels. The south elevation had the stubs of the original wall on the east and west sides with a massive east/west beam added across the top. The wall was built of brick in a stretcher bond. The west elevation was plain. The north beam was too short and extended with a corbelled and jointed piece at the west end and rested on a stone corbel.

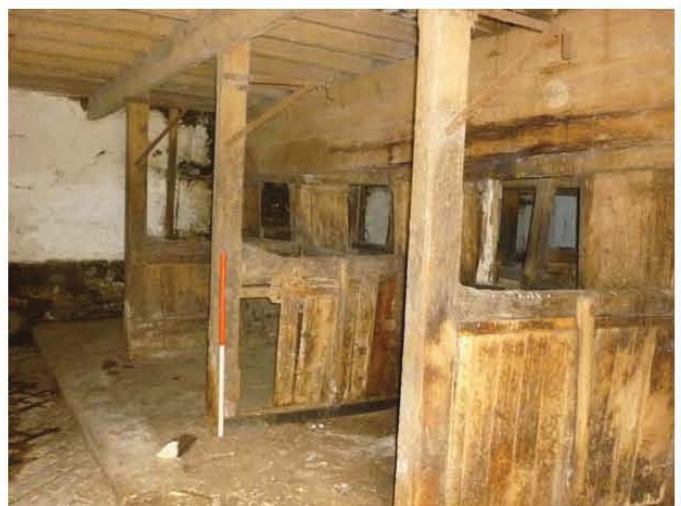
Plate 89 (right): The south side of lower floor Room 3 of the barns

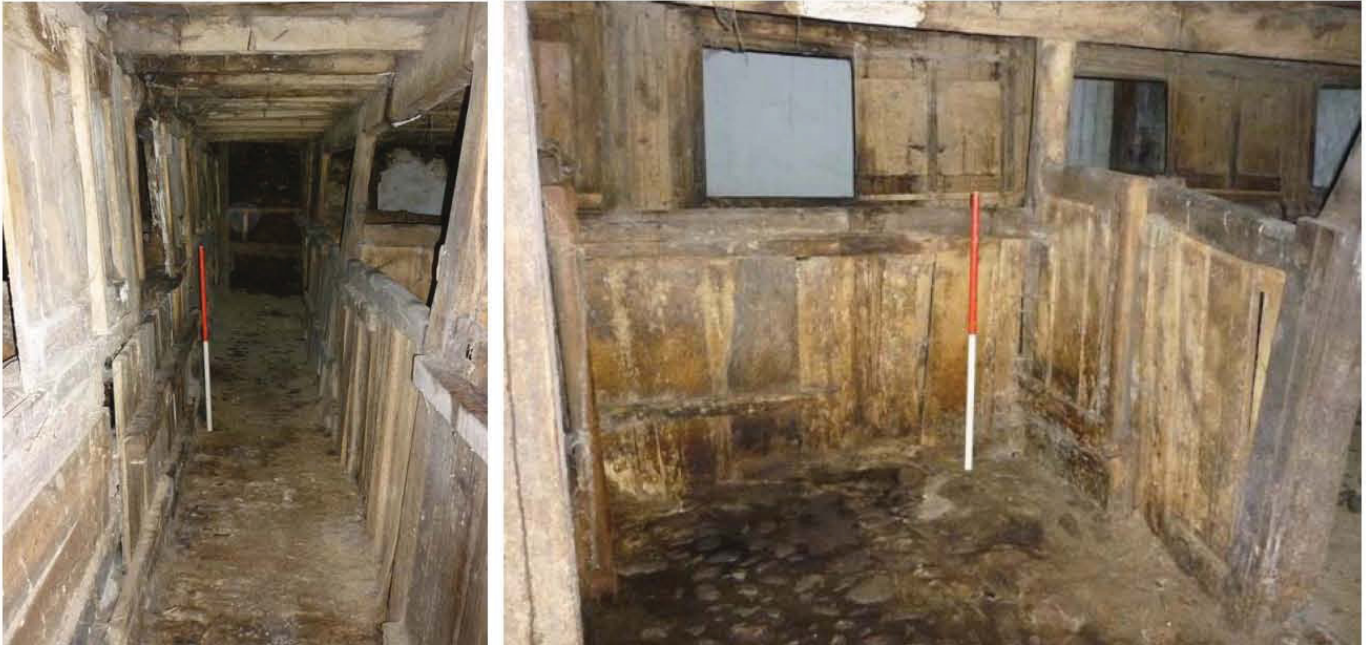
Plate 90 (left): Feeding passage between the rows of stalls in lower floor Room 3 of the barns

Plate 91 (right): Detail of the timber stalls in lower floor Room 3 of the barns

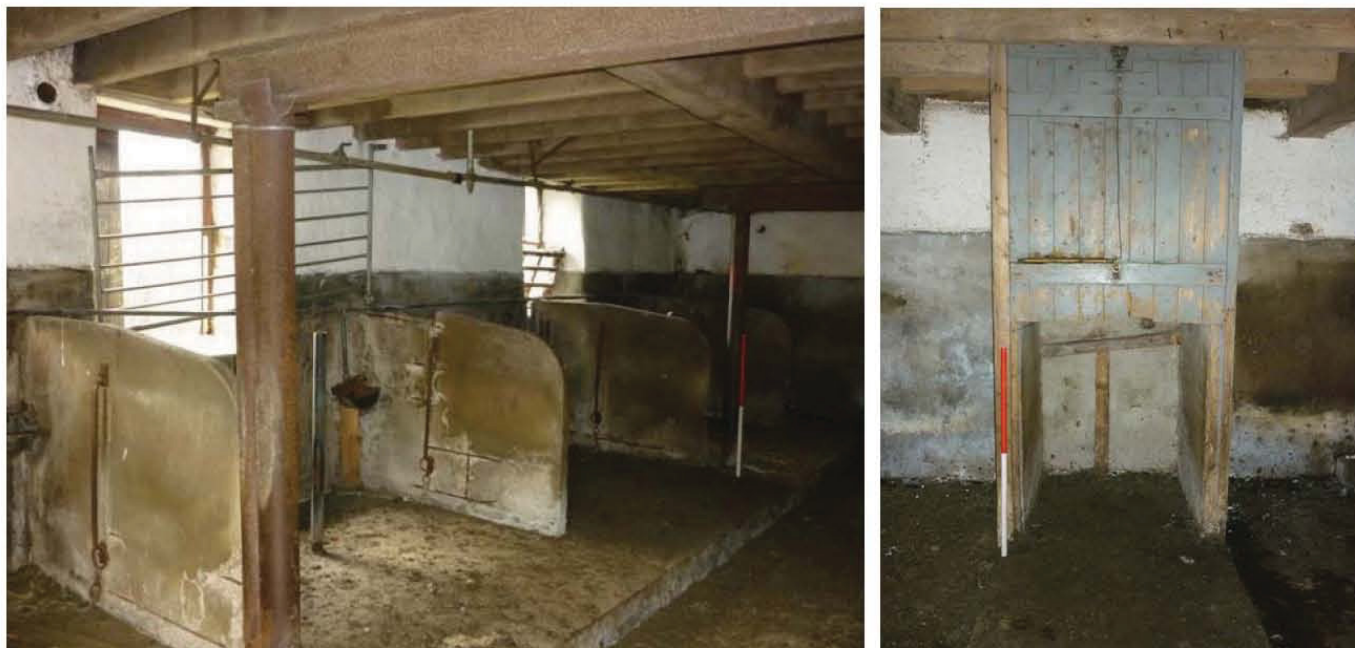
Plate 92 (left): Concrete stalls against the south wall of lower floor Room 4 of the barns

Plate 93 (right): Detail of structure against the west elevation of lower floor Room 4 of the barns

4.3.28 **Barns – lower floor Room 4:** there were two channels in the concrete floor and four concrete stalls with iron fixing bars against both the north and south walls (Plate 92). The ceiling comprised two east/west beams, with slots for further posts and corresponding stop-chamfers, and there were Baltic marks on the north one. The joists appeared to all have been machine cut. The cross-beams were supported by two iron I-beams, which were in turn supported by upright iron posts. The walls were finished with a skim of concrete over the lower part and whitewashed over the upper section. The north elevation was plain apart from four ceramic pipe/drains at ceiling level at the west end. The metal troughs were marked 'BAMFORDS UTTOXETER' and had water pipes attached. The east elevation had a plain central door, which was flanked by a pair of windows and had water pipes and electricity cables attached. Each window had plain surrounds and a six-light tilting metal casement with two iron bars across and there was a pair of pipe vents either side of the door. The south elevation had a pipe vent either side of the two windows, which had sloping sills, one with a six-light casement the bottom three of which were tilting. The stalls each had similar troughs and pipes to the north elevation. The west elevation had a ceramic pipe through a gap in the ceiling to the space above in the south-west corner of the room. There was a central structure built with side walls built from brick and concrete against the west wall and a timber plank front with a sliding cover (Plate 93). There was a slight recess along the wall top in the centre.

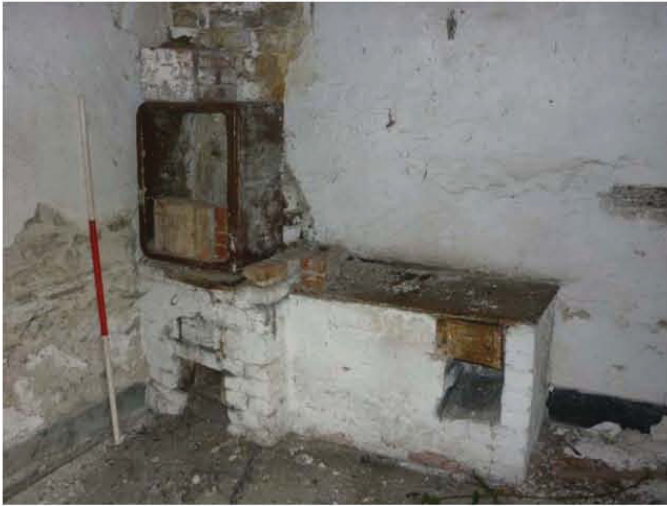
Plate 94 (left): Oven in the south-west corner of upper floor Room 1 of the pigsty

4.3.29 **Pigsty – upper floor Room 1**: the floor of the west room of this small outbuilding was concrete with a brick-built ‘oven’ on the west side of the room (Plate 94). This low brick-built structure had an aperture towards its north end with an iron door and grill, and slightly projected on the south side with a hearth with an iron surround and grill and the remains of a door. The remainder of the west elevation was plain. The room was open to the roof, which was just rafters and ridge board and an additional north/south aligned timber, which was full of nails, and there were louvre slates on the west side. All of the timbers were hand-sawn. The walls were whitewashed and had concrete skirting. The north elevation was plain, with a doorway on the east side which had a plank and batten door and a plain surround. The central window in the south elevation had splayed jambs and a five-light tilting casement, a stone sill, and a thin timber lintel (Plate 95). The south-west corner of the room was angled, containing the flue, which was made of re-used ceramic pipes. This angled section was built from frogged machine-made bricks in angled section. The east elevation was a stud partition wall with a doorway on the south side, with a plank and batten door with wide planks and strap hinges. There was a small room beyond with a stud wall to the north, which was whitewashed (Plate 96). This small room had a timber floor, which was missing sections on the east side, and three timbers across at mid height. The walls were largely plain, with a small aperture with a stone sill to the east.

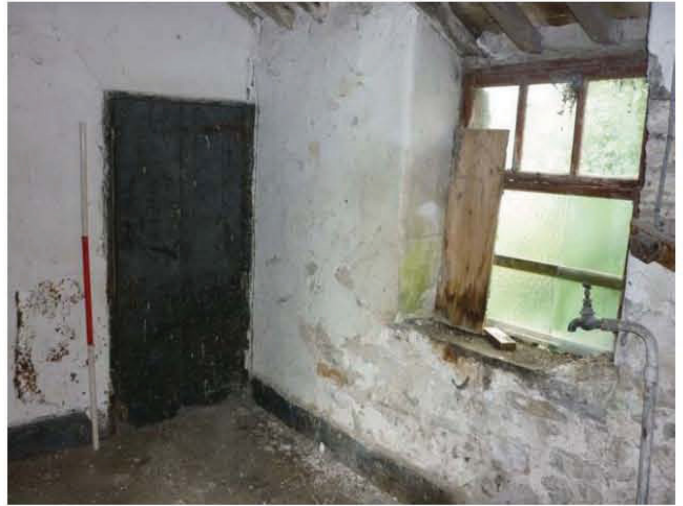
Plate 95 (right): South-east corner of upper floor Room 1 of the pigsty

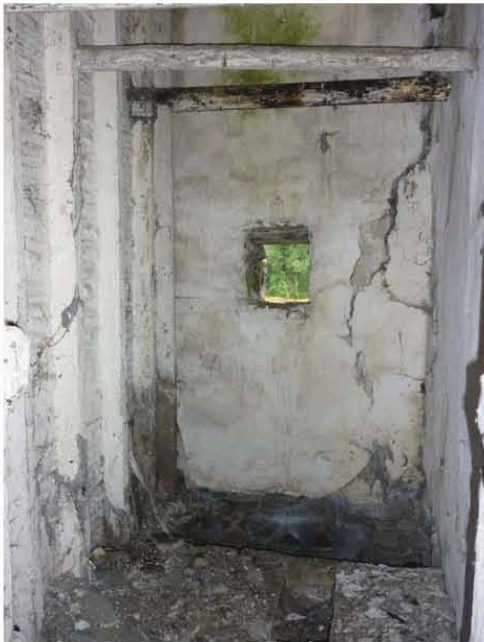
Plate 96 (left): Aperture in the east elevation of upper floor Room 1 of the pigsty

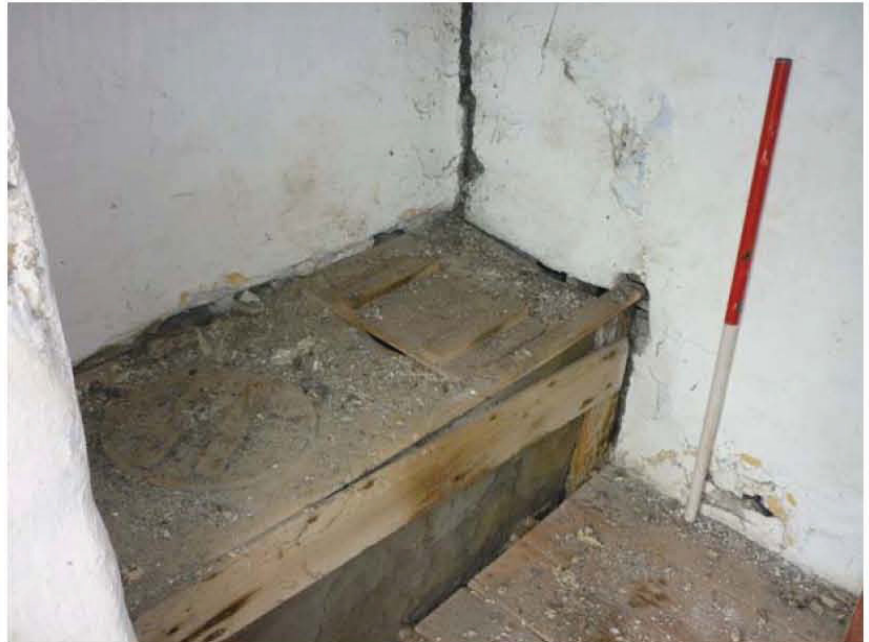
Plate 97 (right): Toilet in upper floor Room 2 of the pigsty

4.3.30 **Pigsty – upper floor Room 2**: the small room on the east side of this small outbuilding had an incomplete board floor with east/west tongue and groove boards. It had a raised shelf forming a toilet on the east side, which had a timber top and a stone flag side, with circular and rectangular holes in the top with covers (Plate 97). All the walls were plain and whitewashed. The south and west elevations were timber stud partition walls. The roof was the same as the room to the west (see *Section 4.3.29* above). There was a plank and batten door with a plain surround in the north elevation and the lintel was formed from the wall plate.

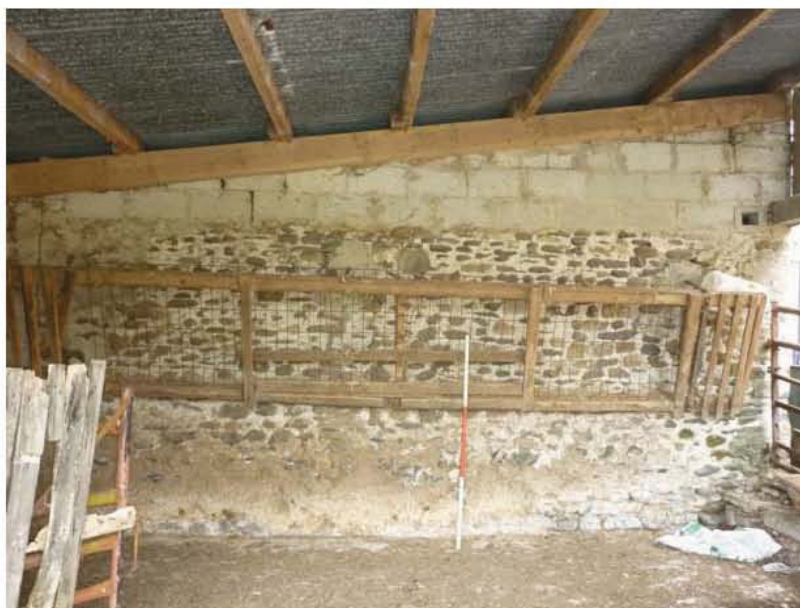
**Plate 98: Manger attached to the south wall of Room 1 of the east outbuilding**

from stone, with a rough cobble build, and the top was raised with concrete blocks. There was a timber manger attached. The west elevation was open and had a low stone wall along the base, which was at the same level as the ground on the west side. The wall comprised some large stones, which were probably thresholds for two doorways. There was a concrete block column at the north-west corner, with a gate over, and a manger attached to the timber section at the north end.

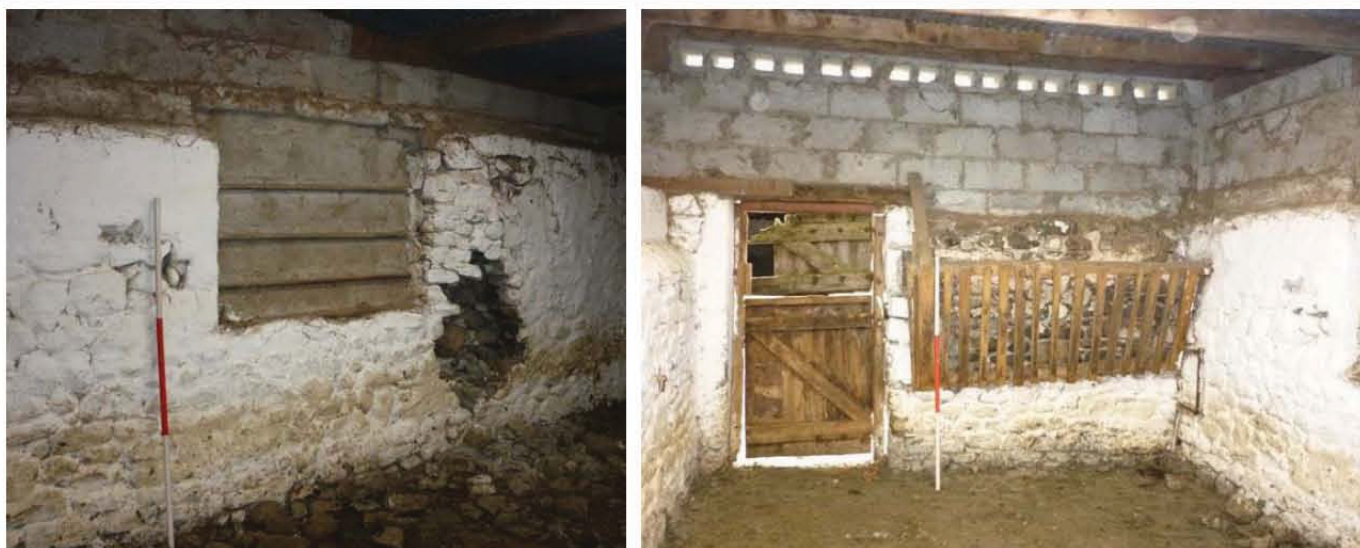
Plate 99 (left): North elevation of Room 3 of the east outbuilding

Plate 100 (right): West elevation of Room 3 of the east outbuilding

**4.3.35 East outbuilding – Room 3:** the flag floor had patchy concrete over it and the roof was the same as the rest of the east outbuilding (see *Section 4.3.33*). The walls were whitewashed apart from the east elevation. The lower part of the north elevation was part stone and was topped with concrete blocks. It had a large hole on the east side (Plate 99). There was a central window, which was blocked with concrete blocks, leaving an alcove (Plate 99), with iron bars across, and there were pipes attached to the west. The lower part of the east elevation had a plain concrete finish and the upper part was concrete blocks, some of which were set on edge to form vents. The south elevation was plain, the lower part built of stone with an iron ring attached on the west side, but this did not extend to the full height and was topped with concrete blocks. The west elevation had a doorway inserted on the south side (Plate 100). The south jamb was definitely rebuilt and concrete block ‘quoins’ were used on the north side. The remains of the surround with a stop-chamfer were visible, and it housed a split plank and batten door. The upper part of the wall was made from concrete blocks, as per the east elevation.

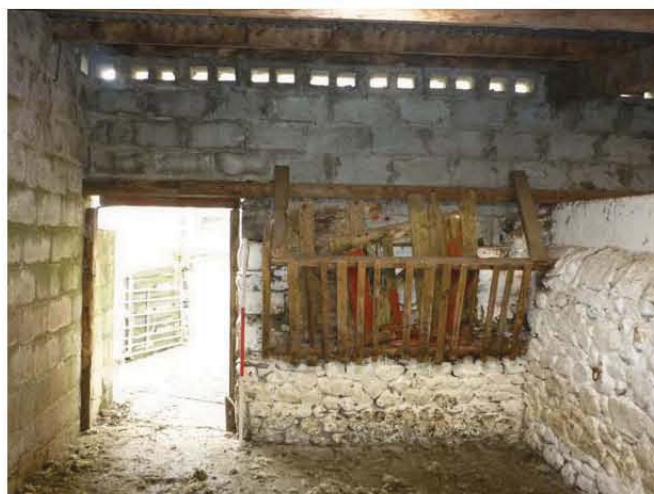
Plate 101: West elevation of Room 4 of the east outbuilding

4.3.36 **East outbuilding – Room 4:** this room had a concrete floor and the roof was the same as the rest of the east outbuilding (see Section 4.3.33). The north and west walls were whitewashed and the north elevation was the same as the south elevation of Room 3 of the east outbuilding (see Section 4.3.35 above). There was an iron ring attached on the west side. The lower part of the east elevation was plain, covered with concrete, and the upper part was built from concrete blocks, some of which were set on edge to form vents. The south elevation was entirely constructed from concrete blocks. The lower part of the west elevation was stone, with a manger attached on the north side and a doorway on the south with the remains of a stop-chamfered surround that extended into concrete blocks above and which incorporated a timber lintel (Plate 101). The blocks were set on edge to form vents in the upper part of the wall.

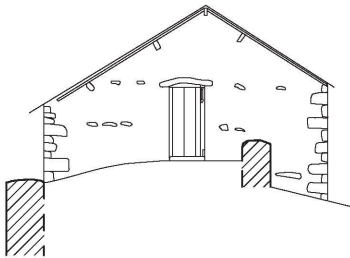
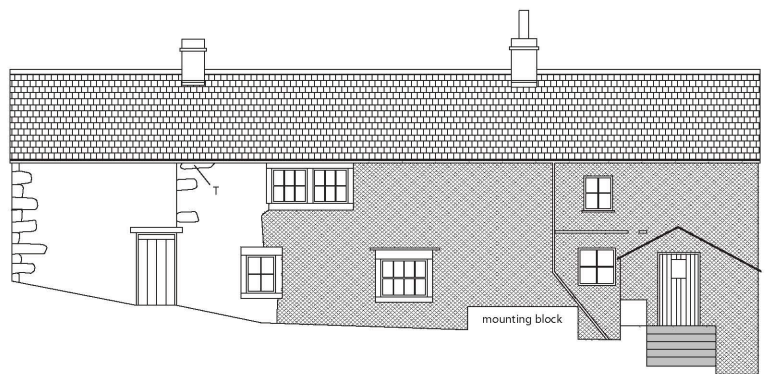
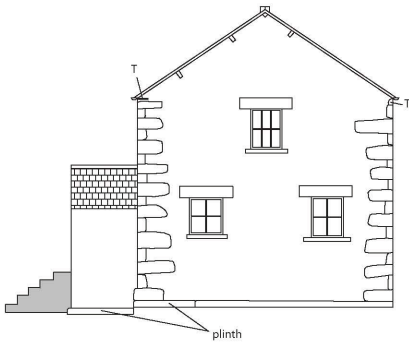
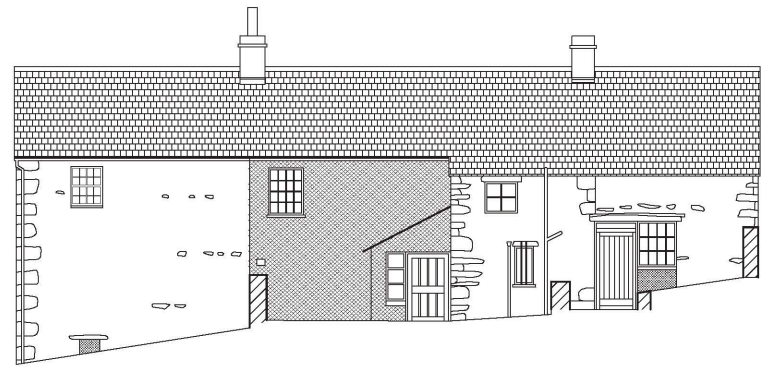
Figure 2: External elevations of the farmhouse

WEST ELEVATION OF THE FARMHOUSE

SOUTH ELEVATION OF THE FARMHOUSE

EAST ELEVATION OF THE FARMHOUSE

NORTH ELEVATION OF THE FARMHOUSE

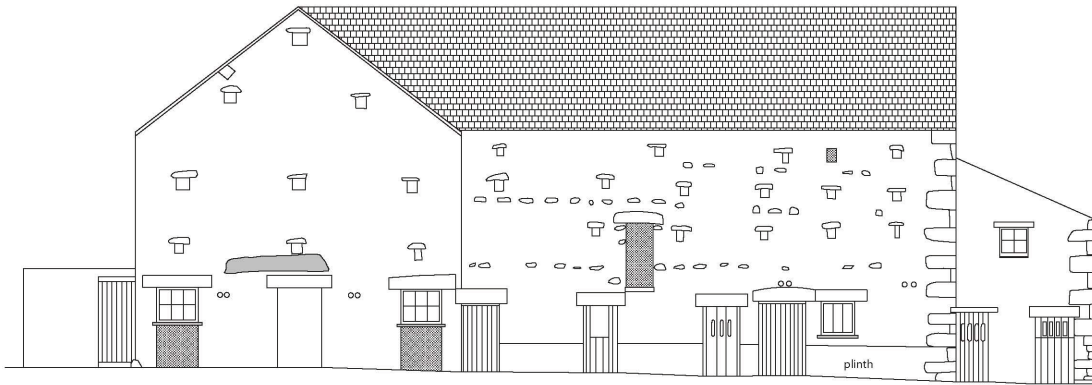
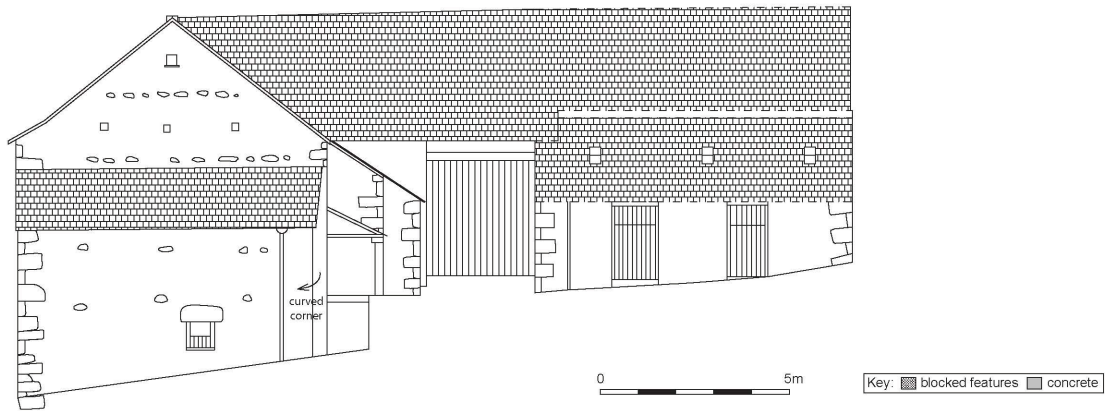
Figure 3: East and north external elevations of the barns

EAST ELEVATION OF THE BARN

NORTH ELEVATION OF THE BARN

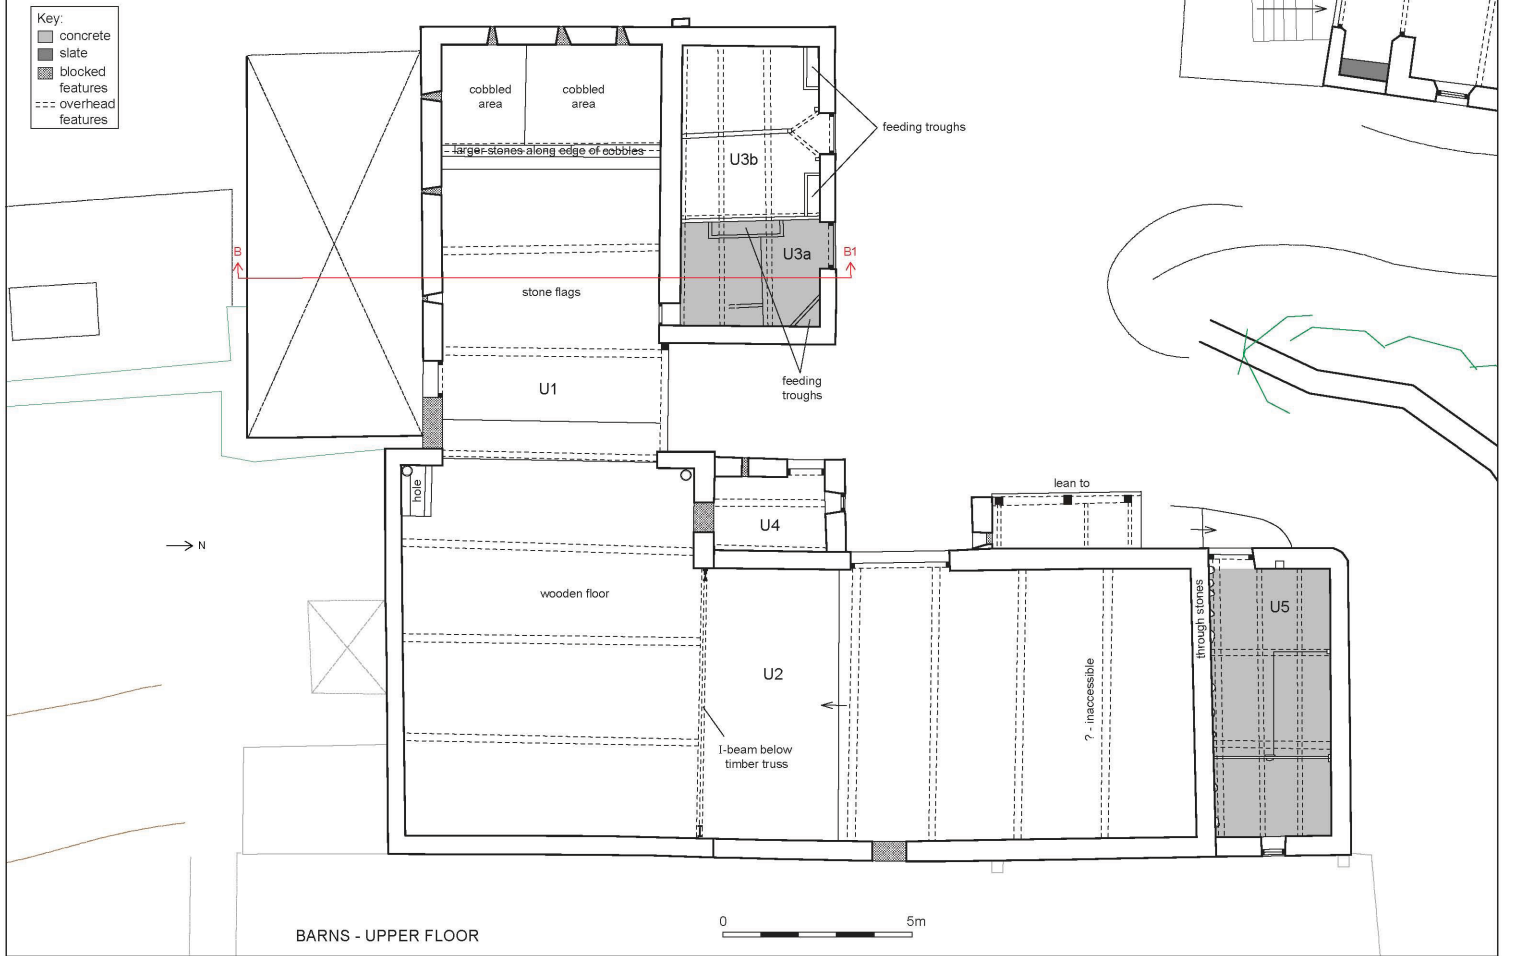
Figure 7: Upper floor plan of the barns

BARNs - UPPER FLOOR

4.1.2 **Barns:** the barns formed an L-shaped range to the south-east of the farmhouse, with a north/south arm extending over two floors (with the shippon below) and the east/west arm extending over two floors at the east end only (see Figure 1, Figure 7 and Figure 8). The range was a stone build with dressed gritstone quoins (see Figure 3 and Figure 4). The rest of the fabric was a mix of slates, volcanics, and limestone, with much water worn simple cobbles used for the floors. The range had a slate roof with V-shaped ridge stones and iron rainwater goods. Glass panes formed skylights. Machine-cut timber was used for the external doors and windows whereas hand-sawn timber was used internally.

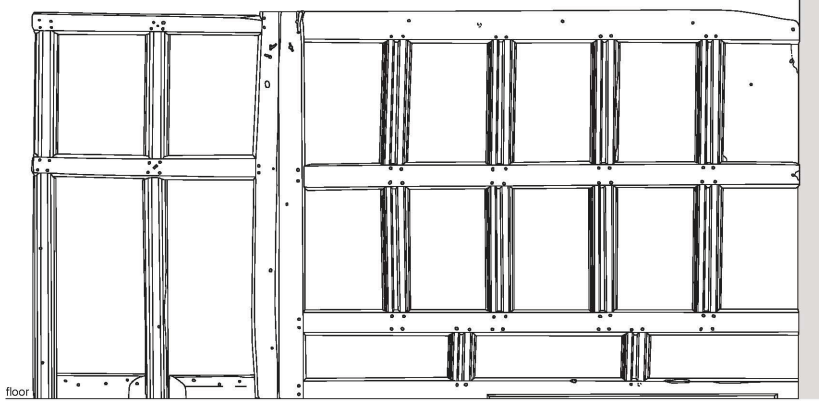
TIMBER PANELLING ON THE EAST ELEVATION OF ROOM F6

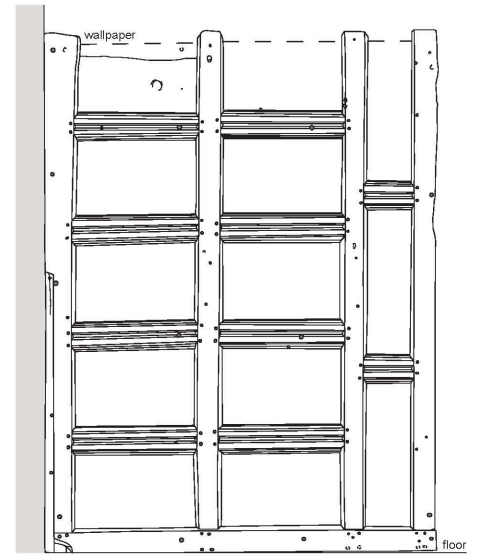
TIMBER PANELLING ON THE NORTH ELEVATION OF ROOM F3
