ROYAL HOTEL, MAIN STREET, HEYSHAM, LANCASHIRE

Archaeological Building Recording

Client: Daniel Thwaites

October 2016

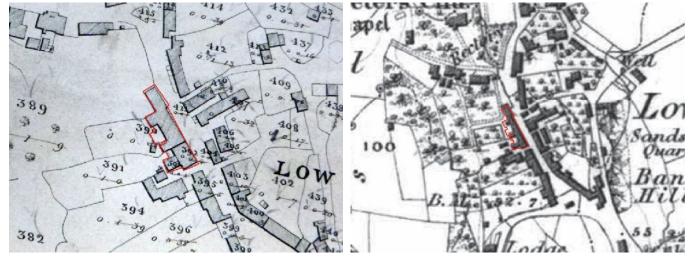
Plate 1 (left): Extract from the Tithe Map of 1838

Plate 2 (right): Extract from the Ordnance Survey map of 1848

- 3.1.2 **Tithe Map 1838**: the footprint of the block of buildings to the west side of Main Street was fairly well established by 1838 (Plate 1). The only elements which are not present by this point are the toilet block and porch to the west side and the flat-roofed extension to the kitchens. The main building of the Royal Hotel, the shop to the north, and the disused cottages and the barn to the south as they stand today are all present. The north end of the block is marked 390, the east/west division at the south end corresponds to the north edge of the cottage and barn, marked 392, and the disused cottage to the rear is marked 393. These numbers are recorded in the accompanying schedule (LRO DRB 1/105 1838b):

3.1.3 *Ordnance Survey 1848*: the first edition Ordnance Survey map, which was surveyed in 1845, is at a scale of 1:10,560 and as such lacks detail (Plate 2). The block of buildings shown at the location of the Royal Hotel corresponds broadly with that depicted on the tithe map.

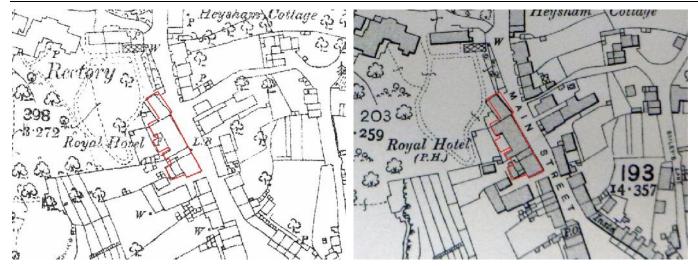
Plate 3 (left): Extract from the Ordnance Survey map of 1891
Plate 4 (right): Extract from the Ordnance Survey map of 1913

- 3.1.4 **Ordnance Survey 1891**: this is the first 1:2,500 scale Ordnance Survey map to depict the site, and is therefore considerably more detailed than its predecessor. The arrangement of buildings is the same as that show on the tithe map (Plate 3; cf. Plate 1). Further internal divisions are shown, the one at the north end corresponds to the north side of the taller north end of the Royal Hotel, the second division at the south end marks the edge of the disused cottage and the north side of the barn, and the division to the east represents a subdivision within the cottage(s) to the west of the barn. The cottage onto Main Street appears to extend further to the west than it did previously or does at any later stage.

- 3.1.5 **Ordnance Survey 1913**: this shows essentially the same information as the previous map, although the cottage onto Main Street has been foreshortened, in line with the west side of the barn, and additions appear to have been made and a further internal division is shown within the east side of the cottage(s) to the rear of the barn (Plate 4; cf. Plate 3).

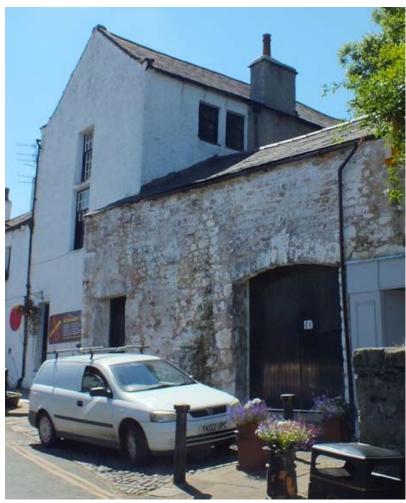
Plate 6: The north elevation viewed from Main Street

4.2.1 **North elevation**: only the top part of the tall section of the main building of the Royal Hotel was visible from the north end. It had four three over six light sash windows at the top and a chimney in the centre. This comprised a narrow stack with tabling and a single pot. This end had sandstone ridge tiles.

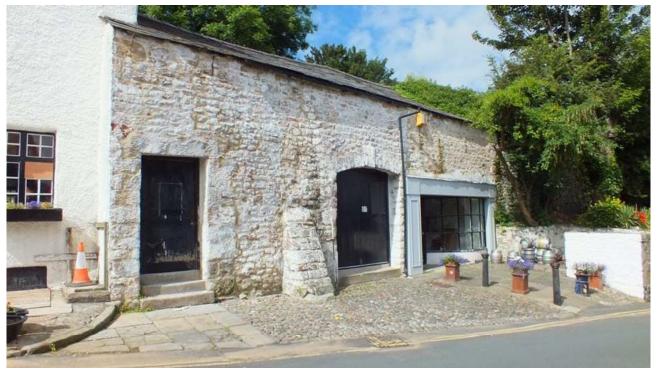
Plate 7: The north end of the east external elevation

4.2.2 **East elevation**: the east elevation was very long. The north end comprised a separate shop and housed the current cellar and wine store (G1 and F1, G3 and F3, and G2 and F2 respectively), which were at a slightly different angle to the rest of the block. The ground floor at the north end was dominated by the curved shop window of 15 large lights leading to a modern door with 15 lights (Plate 7 and Plate 8). There was a plain sign above that and modern pilasters on either side, made from timber, with moulded areas. The elevation of the shop was plain above that, with extruded mortar. There was a large wagon doorway to the south (to G2) with a flattened arch with a pair of key stones and modern timber door doors with a notice board attached. There were quoins in the jambs and a concrete step up at the base and a projecting buttress to the south (Plate 7). There was a further door to the south, up three concrete steps, with a heavy stone lintel and a modern beaded plank and batten door and a pintel on the south side for an earlier door. There were large quoins and a return at the south end of the north building (G3/F3), which was finished with render.

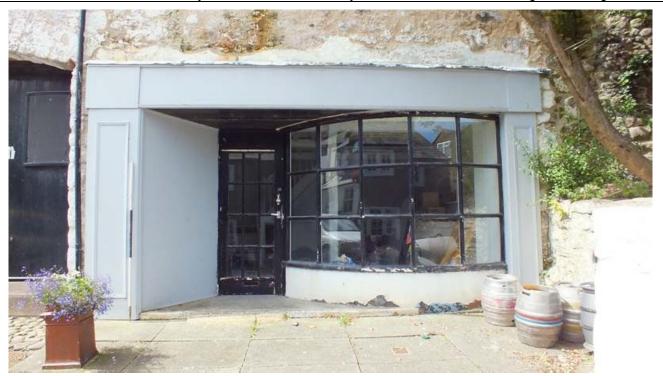
Plate 8: The east external elevation of the shop at the north end

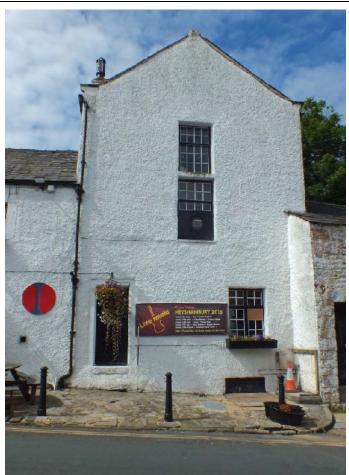
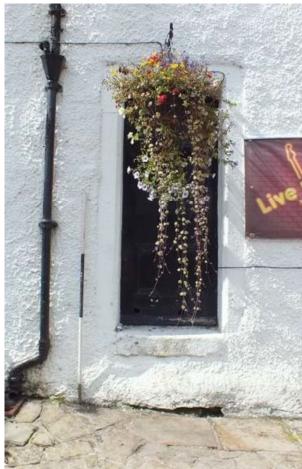
Plate 9 (left): Tall gable at the north end of the main building of the Royal Hotel
Plate 10 (right): Doorway in the gable at the north end of the main building of the Royal Hotel

4.2.3 The main part of the Royal Hotel building was to the south of the cellar (G3) (Plate 11). The north end was the gable (Plate 9), set over three stories, with basement/cellar access on the north side. The basement/cellar access had a timber, tongue and groove door, with a window above of 20 lights and a hinged casement. There was a further doorway to the south, raised off the ground, with chamfered stone jambs (Plate 10). The door was fairly early, with two moulded panels in the bottom and two glazed areas above. There were originally two doorways at first and second floor level in the centre of the gable, however, the bottom half of the lower one was filled with board and had a 12-light window over with a sash top, and the upper one now had a 20-light sash window. There were kneelers on either side at the top of the gable and what may have been a finial base at the centre.

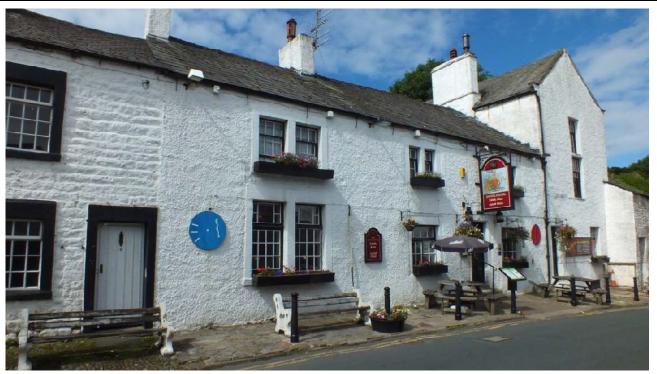
Plate 11: The east external elevation of the main building of the Royal Hotel

To the south of this, the rest of the elevation was effectively side on to the taller gable at the north end and only two-storeys high (Plate 11). There was a pair of windows at the north end of this section, either side of the main entrance to the Royal Hotel, both of which were 12-light hinged casements in square surrounds. There was also a pair of windows on the floor above, both paired six-light sash windows, again with square surrounds (Plate 11; see Plate 12 for detail). The doorway to the hotel had square stone jambs and lintel and was chamfered to run-out stops at the foot of the jambs. The door was a studded tongue and groove board door, with elaborate strap hinges, accessed via three concrete steps. The south end of the main part of the Royal Hotel had different windows to the south after a gap. The ground floor window was larger and paired originally with eight over nine lights, which had been modified. The first floor window was a paired nine-light sash. Both had square surrounds (Plate 13). This part of the Royal Hotel had a row of five projecting stone corbels below the gutter and a pair of roughcast chimneystacks, both towards the south end. The north stack had one ceramic pot and the south had two. The south end of the elevation, including the disused cottage (2) and barn to the south, was painted dressed blocks in courses (Plate 14). The doorway to the cottage (2), at the north end, had a square surround and a possibly modern timber door with battens across (Plate 15). The 16-light window to the south had a hinged top and there was another the same above that on the first floor, both with square stone surrounds and projecting sill (Plate 15). There was a chimney at the south end of the cottage (2) with tabling at the top and three pots. The wagon door to the south, accessing the barn, had a dressed flat arch with keystone and large quoins and was a tongue and groove plank and batten door (Plate 14). There was another doorway at the south end with large quoins in the jambs and a heavy stone lintel and a plain panel door and there were large quoins at the south-east corner.

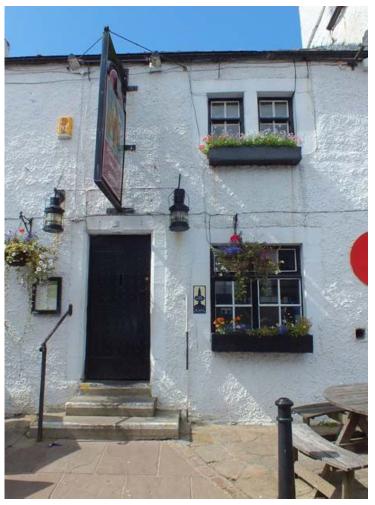
Plate 12: Main entrance to the Royal Hotel and windows to the north, viewed from Main Street

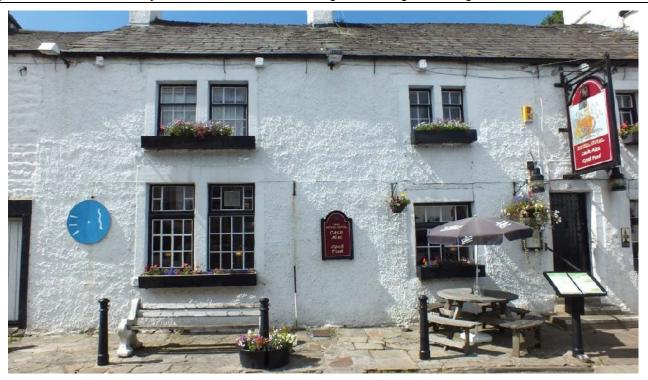
Plate 13: South end of the main building of the Royal Hotel, viewed from Main Street

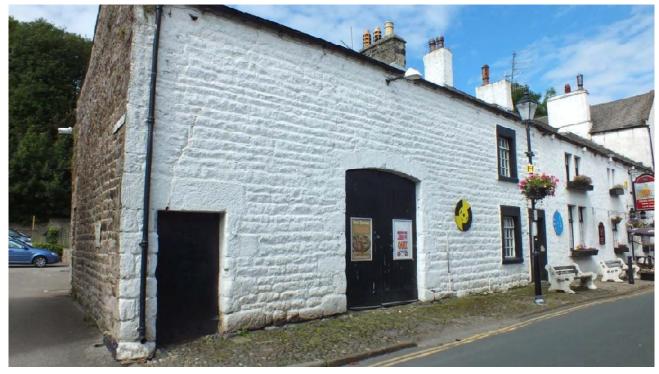
Plate 14: East external elevation of the barn and disused cottage (2)

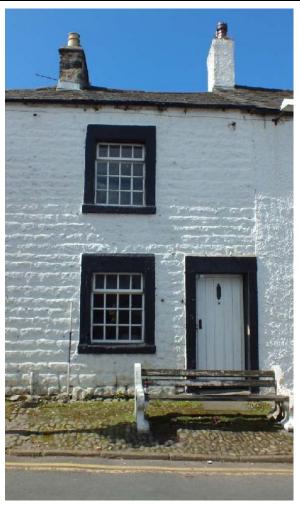
Plate 15: Disused cottage (2) to the south of the Royal Hotel

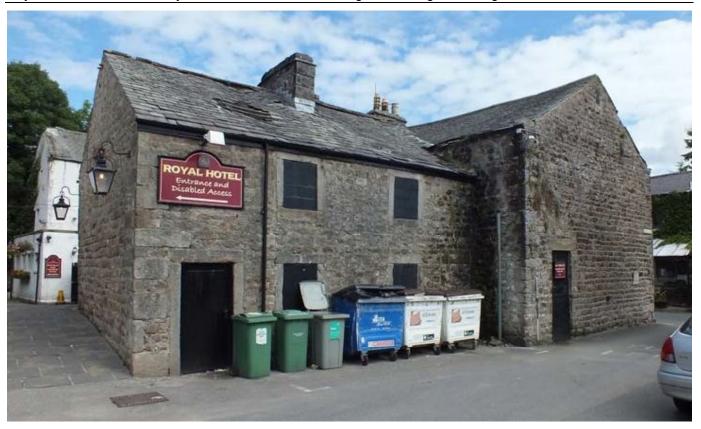
Plate 16: South external elevation viewed from the carpark

4.2.3 **South elevation**: the south end of the block comprised the disused cottage (1), to the west, and barn, to the east (Plate 16). The east end, forming the south gable end of the barn, was made from stone laid in good courses, with large quoins at the east end. The top included part of a former stone coping, which was now missing, and there was a small owl hole near the apex. The slate roof of the disused cottage (1) was noted to be greener and there were sandstone ridge tiles on this section. There was a doorway in the west side of the gable-end, which appeared inserted. It had a very neatly dressed lintel and timber over the door. There were quoins at the return at the west side of the barn and quoins at the west corner of the disused cottage (1). At the east side of the cottage (1) there was a blocked doorway with a stone square surround. There were two pairs of windows to the west of that, one per floor, all of which had square surrounds and were blocked with concrete blocks. The cottage (1) had a central stone chimneystack on top with tabling. There was a possible butt joint to the west of the windows of the cottage (1), although this seems unlikely and it may have just been a crack developing in the masonry. To the west of that there was a doorway with stone square surround and modern tongue and groove plank door. To the north of the cottage (1), the toilet block (G8) had a row of top opening leaded windows in its south elevation. The taller north end of the main building of the Royal Hotel had a small, fixed, fourlight window in the south elevation and a rectangular chimneystack, with two lots of tabling and two pots, above (Plate 20 and Plate 21).

4.2.4 **West elevation**: the quoins at the west side of the barn were visible at the south end (Plate 16). The elevation then stepped out to the west, forming the gable end of the disused cottage (1) to the rear of the barn. The cottage (1) had quoins at the corners and a presumably reused three-light mullion window on the first floor, which was chamfered and rebated and blocked with board (Plate 17). One of the quoins in the north side had the letters S, T, and A carved into it (Plate 18). The return of the cottage (1) to the east (forming its north elevation) was mostly covered by flat-roofed modern additions and was fairly plain (Plate 19) apart from a small window on the west side on the first floor with an overlong sill and rough stone lintel, which was blocked with board. There was possibly another window against the back of the disused cottage (2) facing onto Main Street, but this area and the inside of the cottage (1) to the rear of the barn were inaccessible.

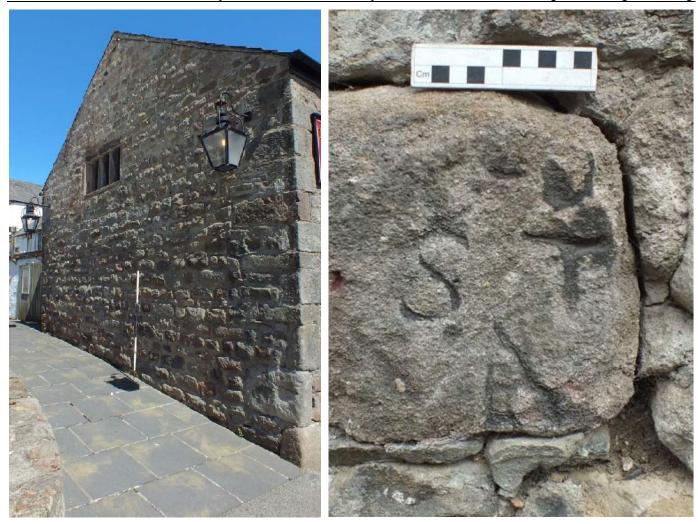
Plate 17 (left): West external elevation of the disused cottage (1)
Plate 18 (right): Letters carved into one of the quoins on the disused cottage (1)

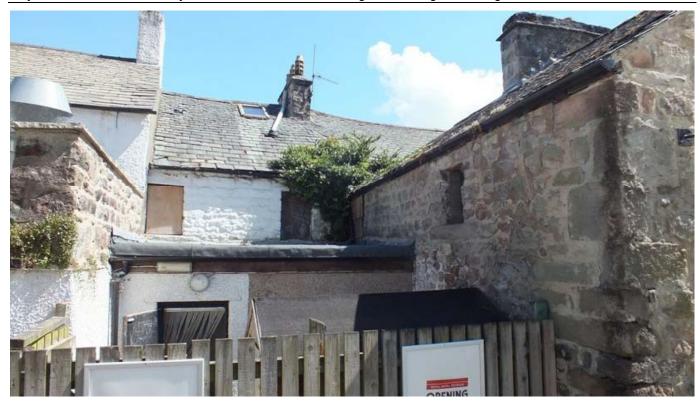
Plate 19: The rear of the cottage (2) facing onto Main Street

The rest of the main building of the Royal Hotel to the north was also obscured by modern flatroofed additions (Plate 20), including the toilet block (G7 and G8). The rear of the disused cottage (2) onto Main Street was only visible at first floor level. Its painted stone blocks were visible and it had two first floor level windows, with stone lintels, covered with boards (Plate 19). The main part of the Royal Hotel to the north of that had a first floor window, with a nine-light sash casement, at the south end above the first floor extension to the kitchens, and a central window with a modern three-light hinged casement within a former three-light mullion window above the toilet block (Plate 21). The mullion bars had been removed and the north end had been completely smashed (Plate 22). To the north of that was another tall 10-light stair window above the toilet block. The toilet block had four top opening four-light leaded windows in the west elevation and there was a nine-light sash to the north of that, in a chamfered surround, which was formerly a two-light mullion above what is now the door to the beer garden. The door to the beer garden was housed within a modern timber porch with a slate roof (Plate 23) north of the toilet block. There was a large, rectangular chimneystack, with two lots of tabling and two pots, at the junction of the main section and the taller north end of the Royal Hotel (Plate 20). The north end was an opposing gable. There were two tall windows on the ground floor, comprising pairs of four over eight fixed light casements (Plate 24). There were two more windows above on the first floor, which comprised eight over 16-light sash windows, although the south one had been modified and partly filled with board and vents, with a dressed stone sill serving both. There were two more small three over six light sash windows on the top floor, slightly out of line with those on the ground and first floors. The top of the elevation had kneelers at either end and flattened out at the centre as if for a chimney and was capped with slate.

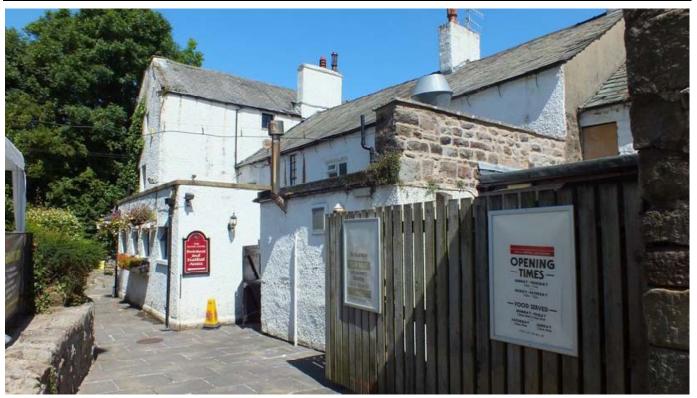
Plate 20: Flat-roofed extensions to the rear of the Royal Hotel

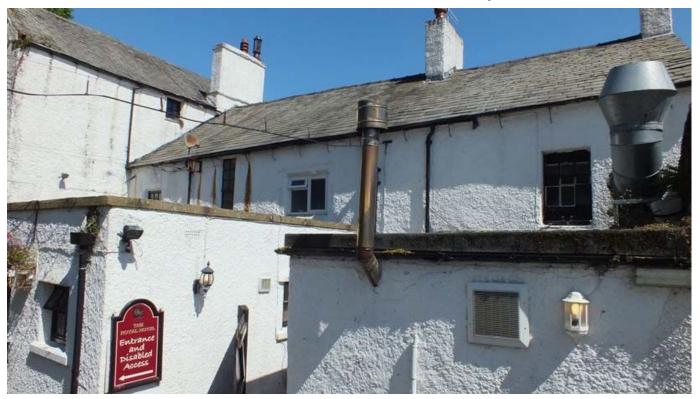
Plate 21: The west external elevation of the main building of the Royal Hotel

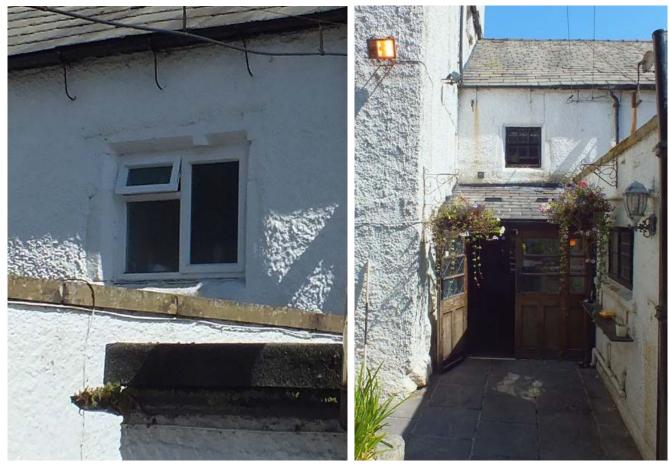
Plate 22 (left): Cut through mullion window to the rear of the Royal Hotel
Plate 23 (right): Porch through to the beer garden

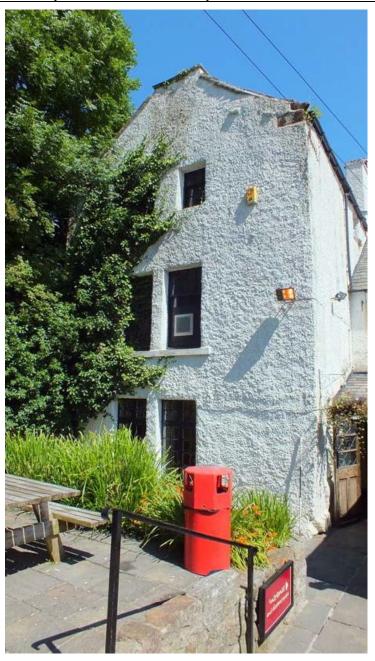
Plate 24: The west external elevation of the taller north end of the Royal Hotel

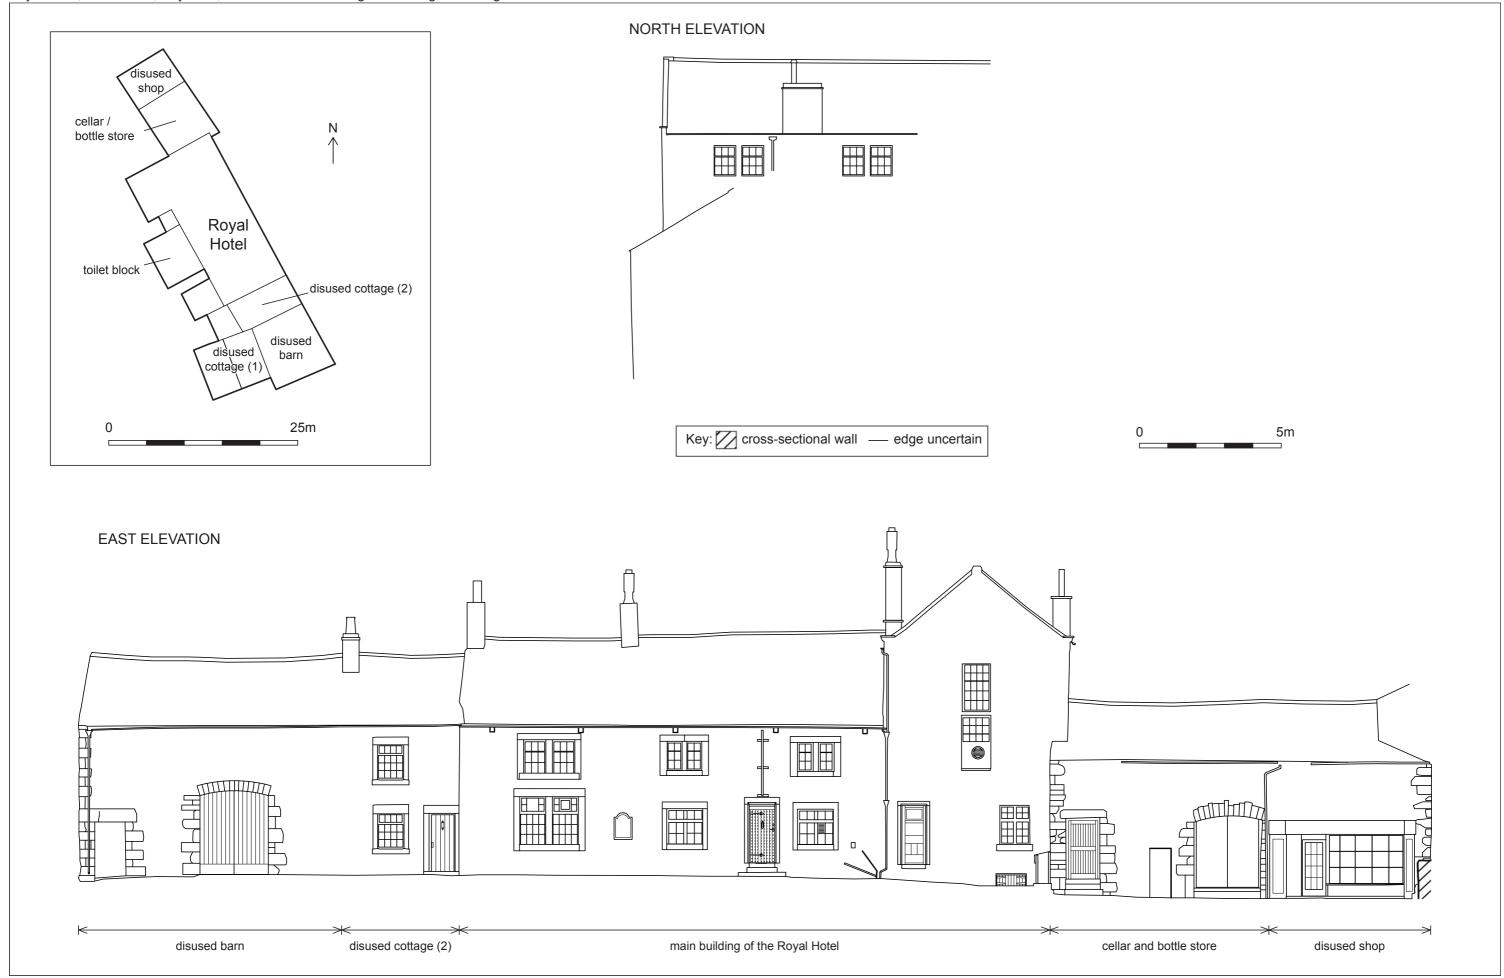
Figure 2: North and east external elevations

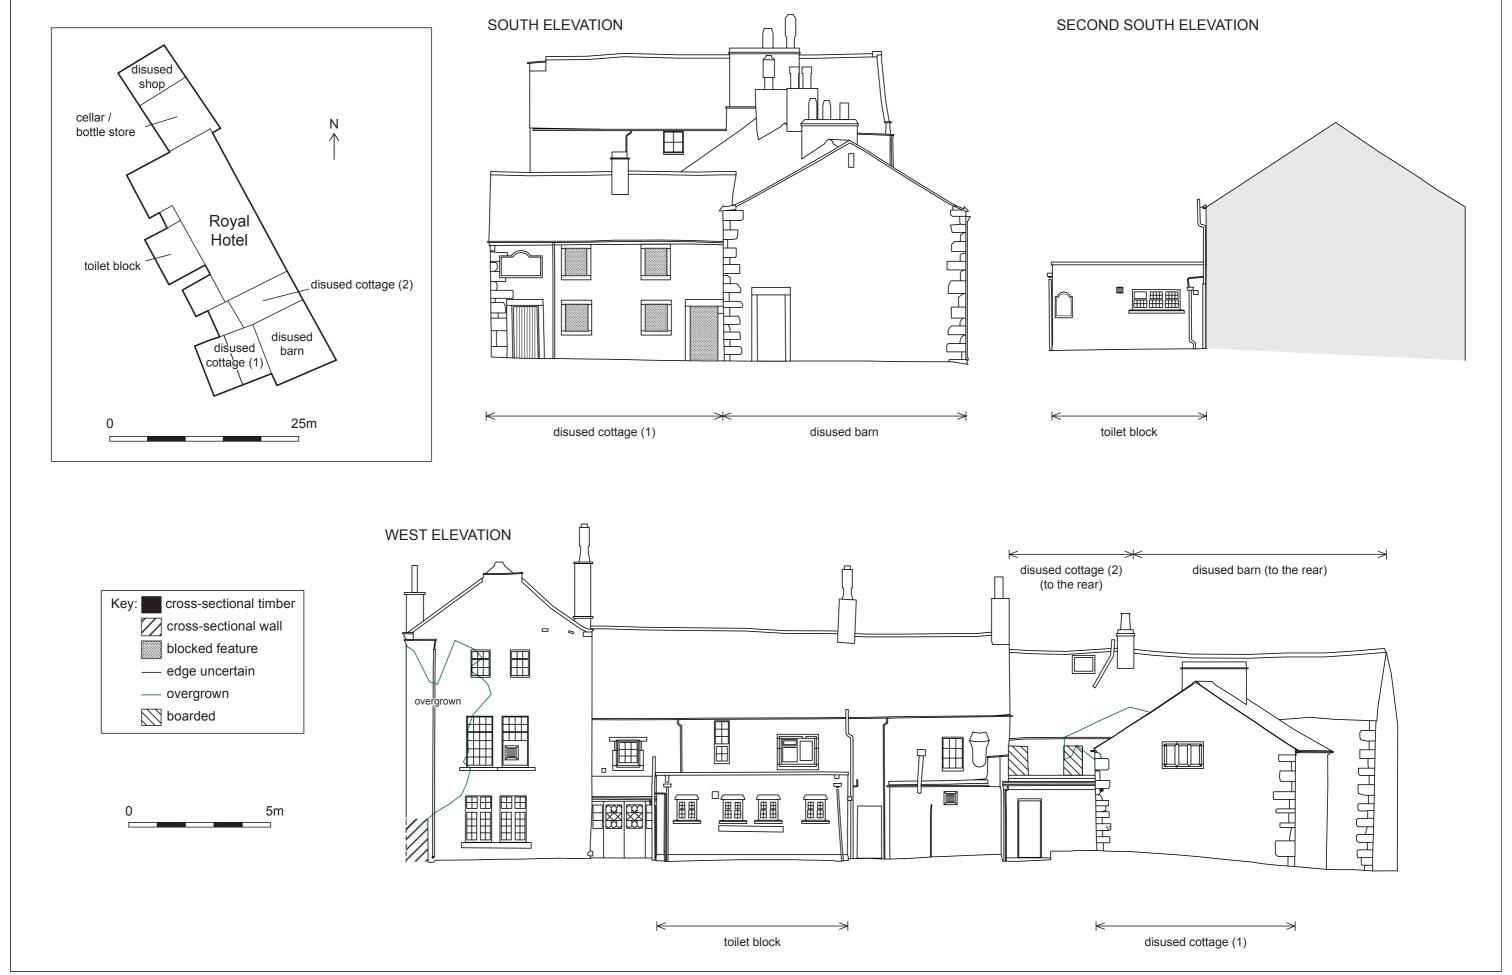
Figure 3: South and west external elevations

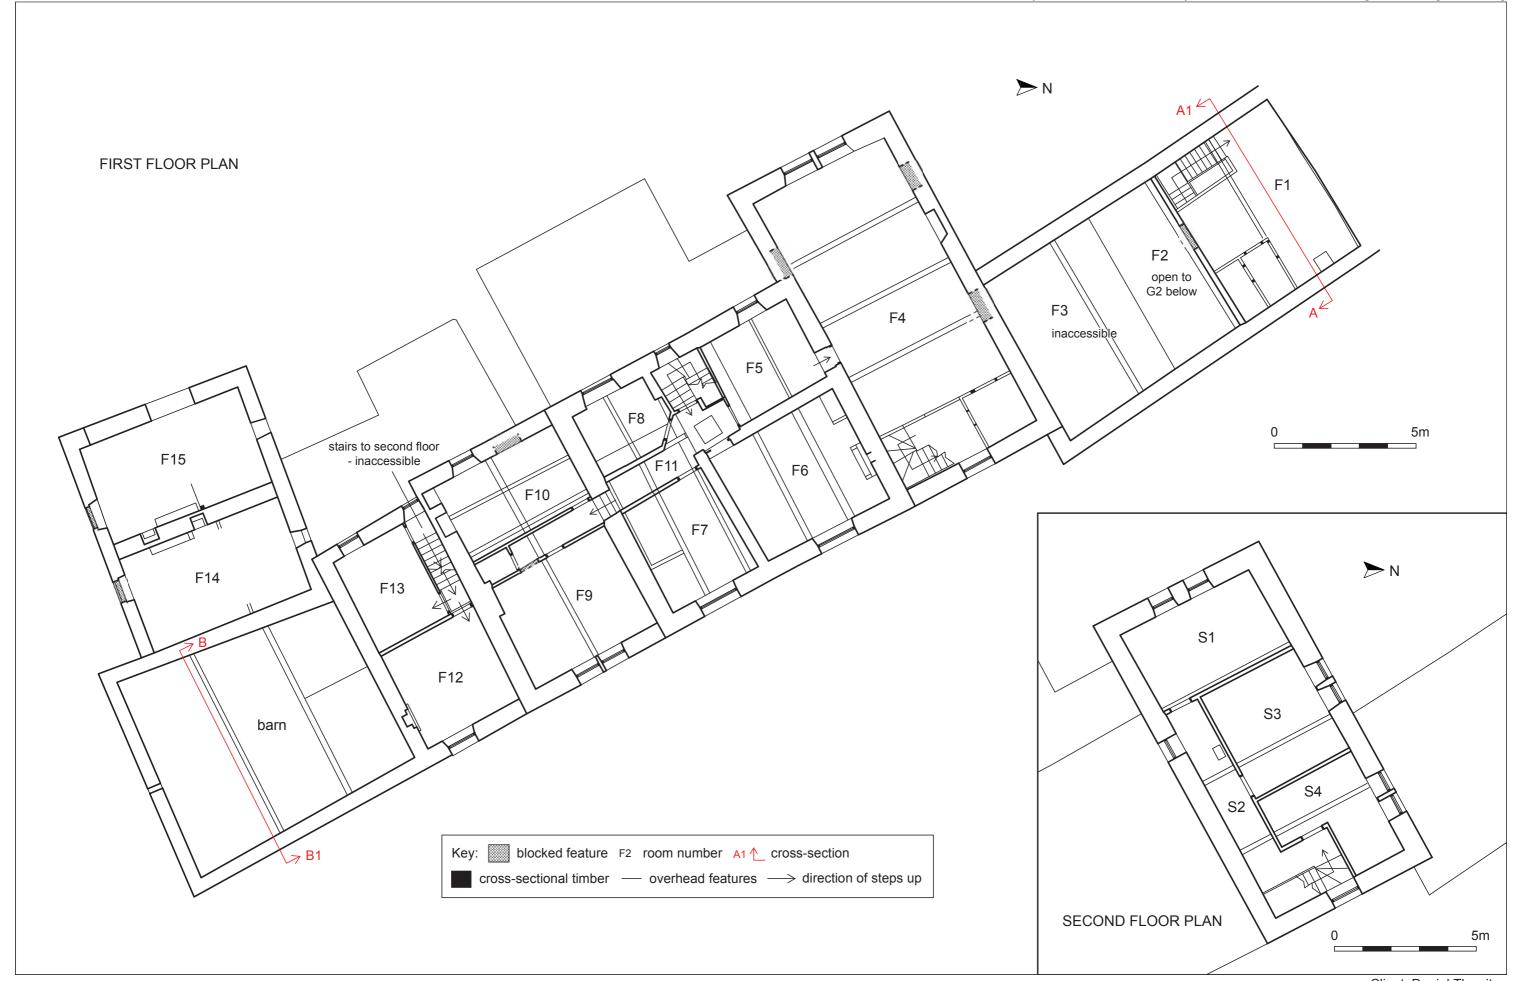
Figure 5: First and second floor plans

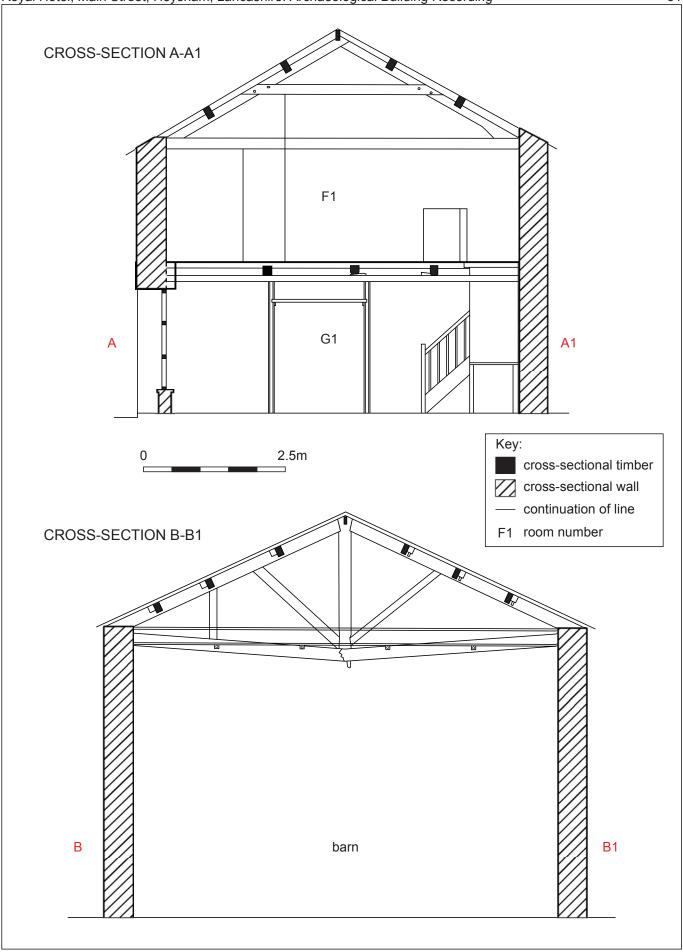
Figure 6: Cross-sections A-A1 and B-B1

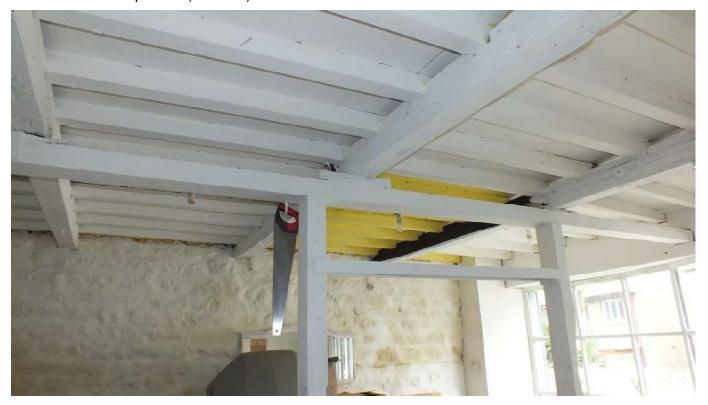
Plate 25: The ceiling of the disused shop (G1)

4.3.1 **Ground floor Room 1 (G1)**: the disused shop at the north end of the block had a concrete floor and the walls were all painted. The ceiling comprised three north/south beams with east/west joists supported on a further east/west beam on two posts, all of which were machine cut (Plate 25). The posts were very worn at the base (Plate 26). The north elevation was plain, painted stone, with dressed blocks in courses. The east elevation was mostly filled on the north side by the large shop window, which curved round, and there was modern hardboard panelling on the north side (Plate 27). The door to the south of the window was glazed and there was a cupboard set into the wall to the south of this with a plain surround. Inside the cupboard was a waste water pipe on the south wall which was concrete. The north side of the cupboard was angled with modern timber. The south elevation was tiled on the east side and had a sink against it on a timber bench. The rest was partially covered with rusticated (modern) planking and a cupboard then rough 'country cottage' style plaster. The west elevation had the very plain, modern, timber stairs against it to the south, with a desk below them on the north side, and to the north of them the stone wall was painted (Plate 28).

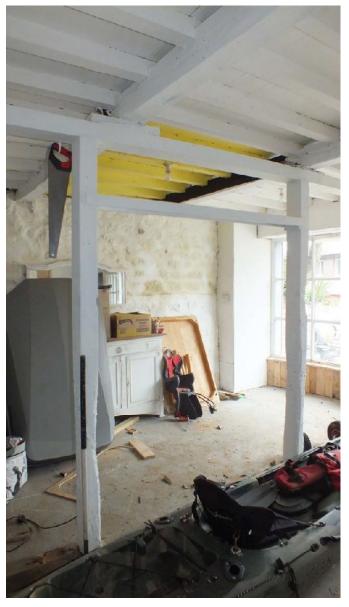
Plate 26: Timber posts supporting the joists in G1

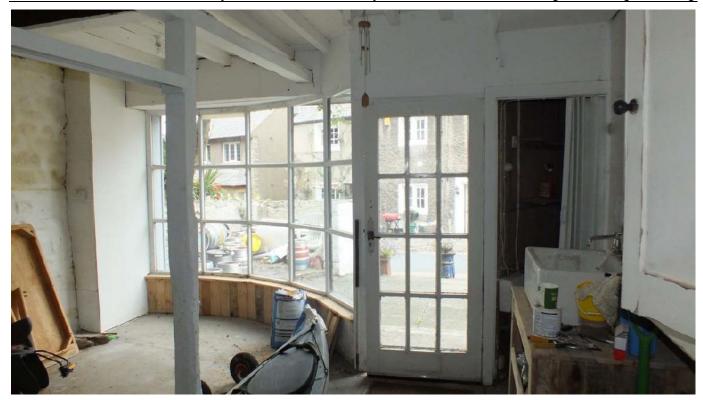
Plate 27: The east elevation of G1

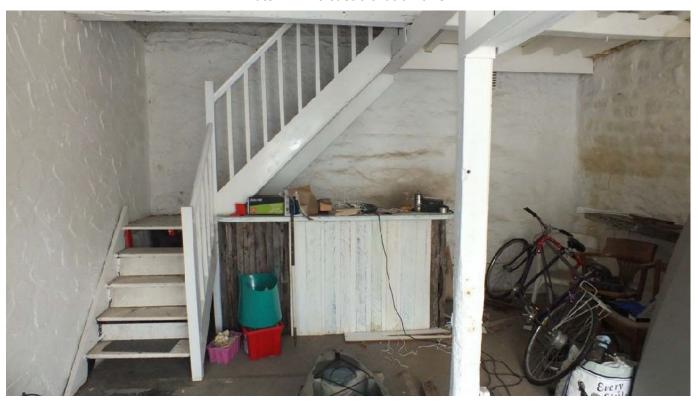
Plate 28: The west elevation of G1

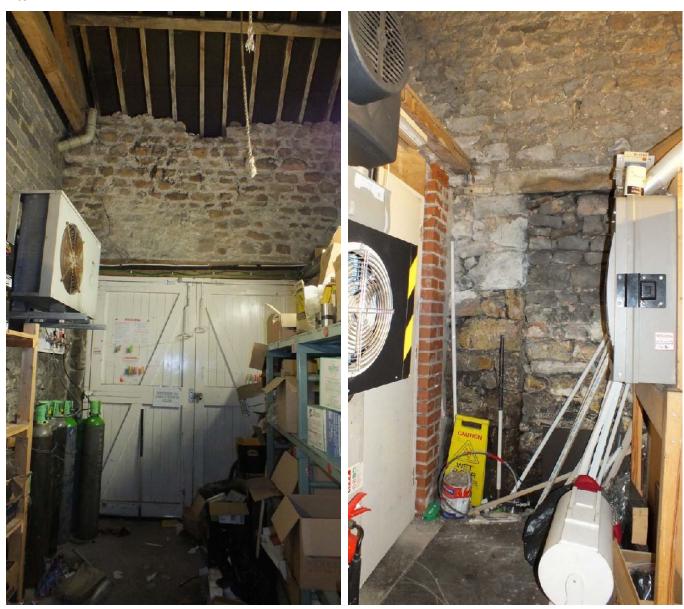
Plate 29 (left): Wagon door in the east elevation of G2 Plate 30 (right): Blocked door in the west elevation of G2

4.3.2 **Ground floor Room 2 (G2)**: this room was in use as a bottle store. It had a concrete floor and was open to the roof. The truss is described as part of the description of F2. The walls were mostly exposed stone. The room was also open to the first floor (F3) above the low south wall. The upper part of the north elevation was continued in concrete block and was thinner than the stone wall below. The east elevation had a large wagon door, which was a double plank and batten door with a machine cut timber

lintel. The south elevation was only to the base of the level of the first floor and was open above (to F2/F3). It was topped with boards for the floor/ceiling beyond. A doorway had been inserted at the west end up a flight of timber steps, with a modern four panel door (although it was plain from this side). The west elevation had a blocked doorway on the south side, blocked with stone, with a machine cut timber lintel.

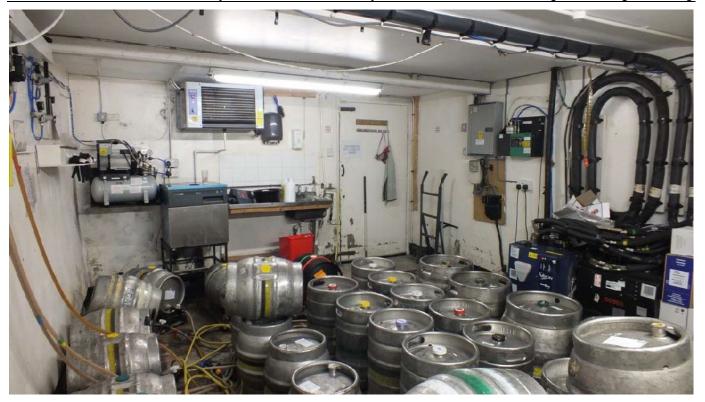
Plate 31: East elevation of G3

4.3.3 **Ground floor Room 3 (G3)**: this was the beer cellar and was mostly covered with kegs and pipes tapping beer to the bar (Plate 31). It had a concrete floor with a ceramic drain to the east side and a modern plaster ceiling with three thin, north/south, stop-chamfered beams across (Plate 32). The walls were plastered and painted. The doorway on the west side of the north elevation had a modern four-panel door. The east elevation had a door on the south side with a plain door and surround (Plate 31). The south elevation had a flight of three concrete steps up on the west side to a door (to G4) with 18 chamfered panels (Plate 33). There was a small alcove to the south end of the west elevation with an iron grill vent to the outside (Plate 34).

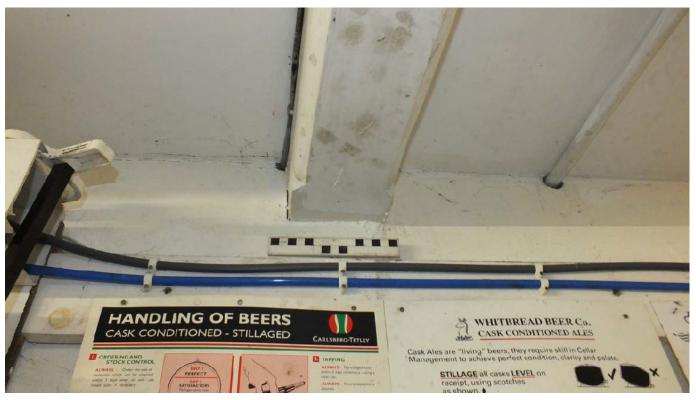
Plate 32: Detail of chamfering on one of the beams above G3

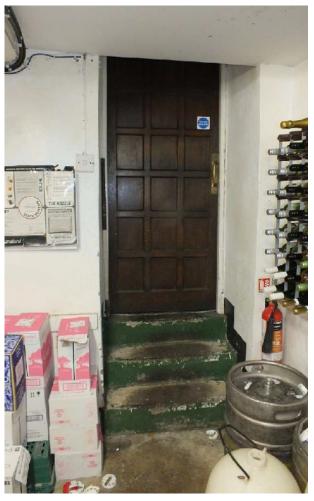
Plate 33: Steps at the west side of the south elevation of G3

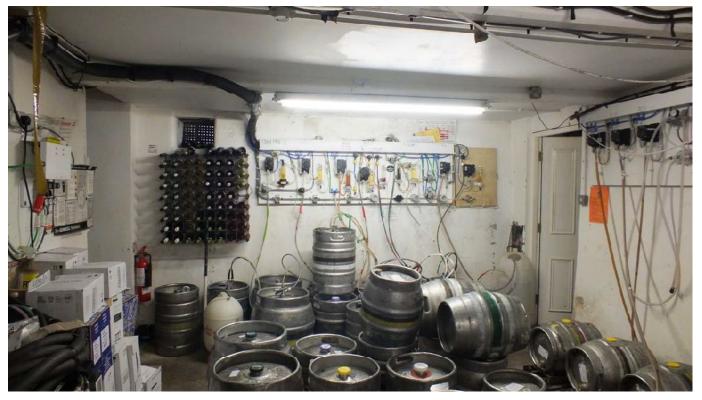
Plate 34: West elevation of G3

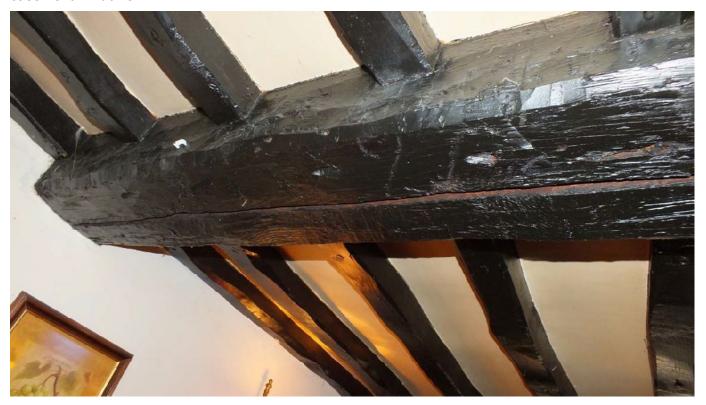
Plate 35: Timber marks on one of the beams in G4

4.3.4 **Ground floor Room 4 (G4)**: the bar and dining area at the north end of the Royal Hotel had a carpeted floor, the walls were plastered and painted, and there was a bar/serving area in the south-east corner. The ceiling was supported by six north/south beams and joists, all of which were hand-finished, and there were Baltic timber marks on at least one of the beams (Plate 35). There was a plaster plaque with a fleur-de-lis attached on the north elevation to the west side of the fireplace (Plate 36) and a relatively modern 18 panel chamfered door to the east of that. The fireplace had a stone surround with modern stone and a doorway to the east with a relatively modern door with 18 chamfered panels There was a pair of four over six hinged casement windows above a timber sill on the east elevation, north of the serving area, and two doorways in the south elevation with plain surrounds, but no doors, and an inserted opening between, with a nine-light fixed casement window and a slight pillar projecting on the west side supporting one of the beams. The west elevation had a pair of large four over eight light hinged casement windows.

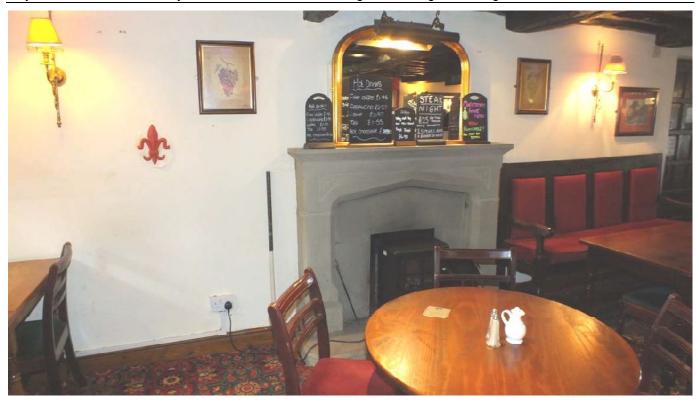
Plate 36: The north elevation of G4

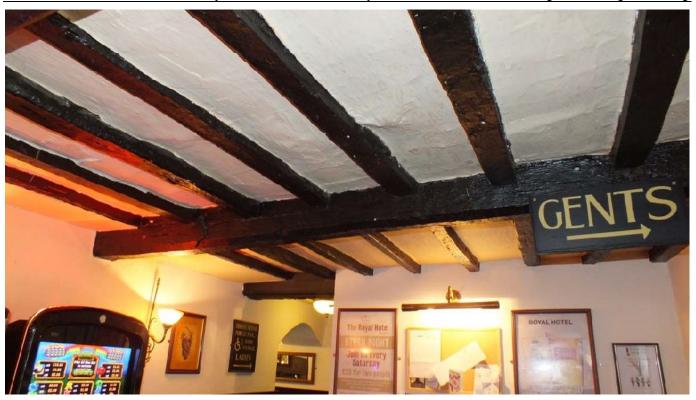
Plate 37: Beams in the ceiling at the north end of G5

4.3.5 Ground floor Room 5 (G5): several small lobby rooms and short corridors linked rooms in the main part of the Royal Hotel together. These have been grouped as G5, including the porch on the west. Mostly these rooms had plaster ceilings with exposed, hand-finished beams and reused crucks, particularly in the north-west section (Plate 37 and Plate 38), and they were carpeted throughout. The walls were mostly rough plaster and paint with (possibly 20th century) panelling over the lower part, with run-out stop chamfer divisions forming pairs of panels (Plate 39). The north elevation had a doorway inserted to G4 and another incorporated a nine-light fixed casement window to the east. The north side of the corridor to the front door, along the side of the snug (G6), had a row of windows with leaded decoration and stained glass (Plate 40) and the inside doorway at the east end was the same (Plate 41). The door had panels in the base and a glazed (leaded) top. The return to the west was plain. There was a low doorway (to G9) on the south elevation, with a beaded surround, but no door (Plate 41), and there were modern doors to the kitchens (through to G11) and toilets to the west. The west elevation had a four-panel door leading to a cupboard/cloakroom under the stairs (Plate 42), with a low arched opening at the west end, which was blocked, and a doorway filled with brick in the south side (Plate 43). It had a flag floor and the timber of the stairs was all hand finished. The door to the stairs to the north was a modern four-panel door (Plate 42). The double door to the porch to the north was timber with glazed (leaded) sections above (Plate 44). The porch was also very modern, with similar timber and glazed doors to the beer garden, to the west, and access to the toilets, to the south.

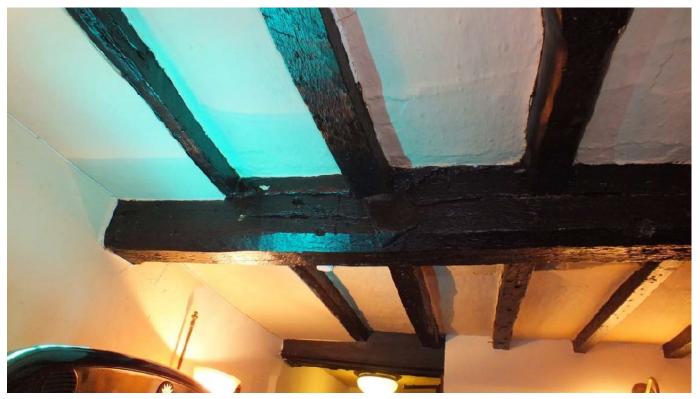
Plate 38: Detail of reused beams in the ceiling of G5

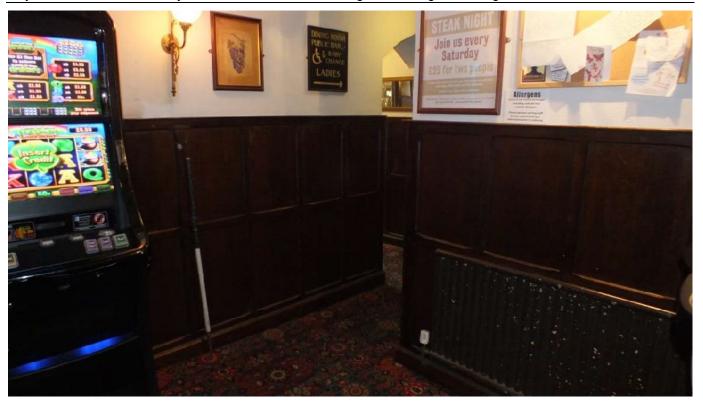
Plate 39: Example of the panelling in G5

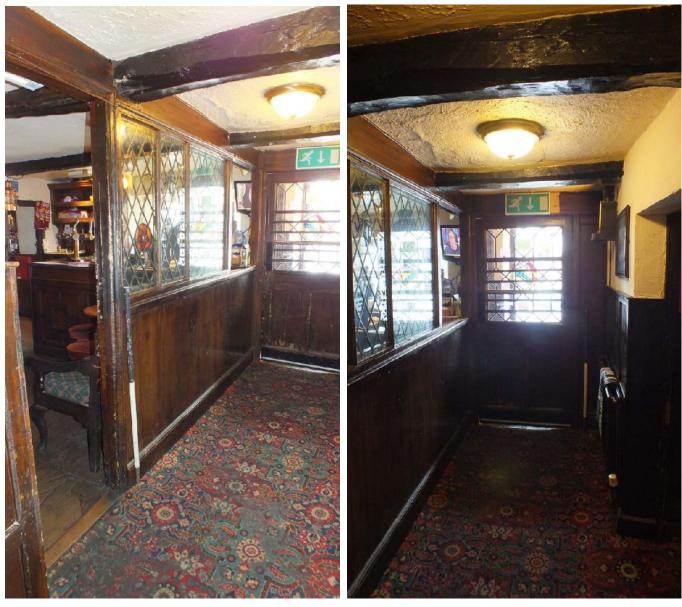
Plate 40 (left): Corridor (G5) along the side of the snug (G6)
Plate 41 (right): Main entrance to the Royal Hotel

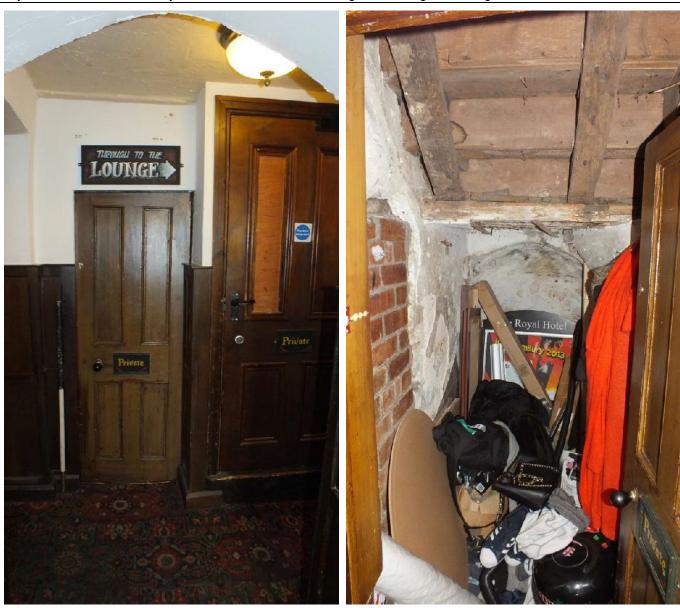
Plate 42 (left): Doorways to the stairs and cupboard/cloakroom to the left Plate 43 (right): Inside the cupboard/cloakroom below the stiars

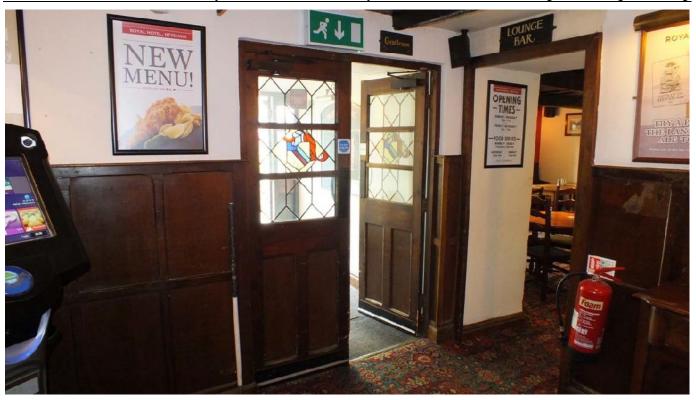
Plate 44: Doorways to the porch and G4 at the north end of G5

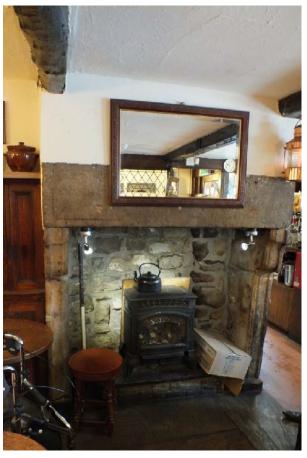
Plate 45: Fireplace in G6

4.3.6 **Ground floor Room 6 (G6)**: the snug had a modern stone flag floor and plaster ceiling, with two hand-finished north/south beams across it, the east one of which was neater and chamfered. The bar/serving area was on the east side. The walls were plastered and painted and mostly plain. There was panelling with a geometric pattern on the north and west elevations. The north elevation had a stone fire surround, with a lintel on scrolled corbels and dressed edges (Plate 45). The doorway to the east side had a plain surround. The window in the east elevation had splayed jambs and a hinged four over eightlight casement window. The south elevation was a timber wall with glazed top and leaded decoration with a door on the west side.

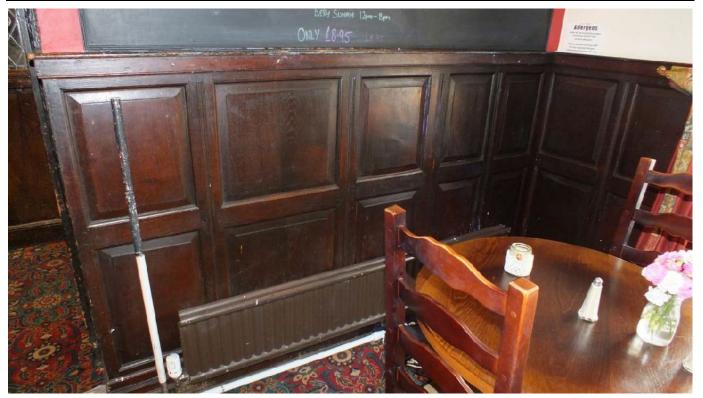
Plate 46: Panelling on the north and east sides of G9

- 4.3.9 **Ground floor Room 9 (G9)**: this formed another part of the bar, adjacent to the dining area. The floor was finished with carpet and it had a plaster and paint ceiling, with a beam orientated east/west finished with modern beaded boxing. The walls were largely finished with plaster and paint with raised and fielded panelling over the lower part with fluted bars between, perhaps not original as some of the joints are not well formed (Plate 46). The north elevation had a doorway with a plain square surround, while the east elevation had a large window with square jambs with moulded surrounds with recesses, presumably for shutting, behind and a timber window seat (Plate 47). The south elevation had a large opening, evidently inserted, providing access into Room G10. The west elevation had a doorway south of the centre with a flanking stud wall on the north side and modern door.

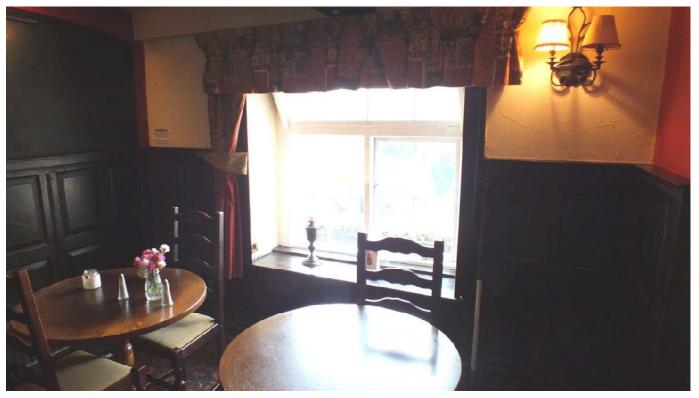
Plate 47: Window in the east elevation G9

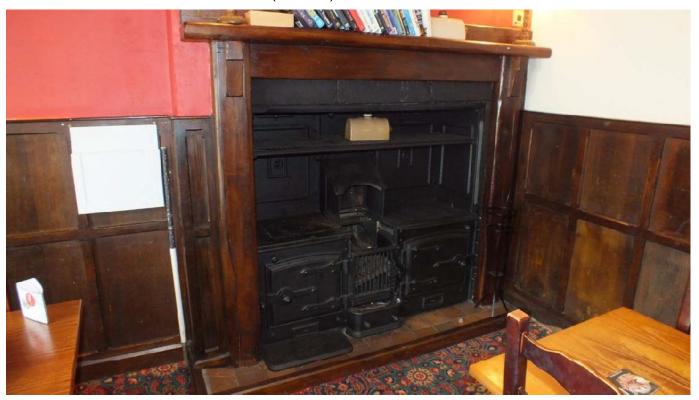
Plate 48: Fireplace and range in the south elevation of G10

around the fireplace, which had a stone lintel (Plate 48) and housed an iron range () with a maker's plate marked 'A BELL & SONS LANCASTER' (Plate 49).

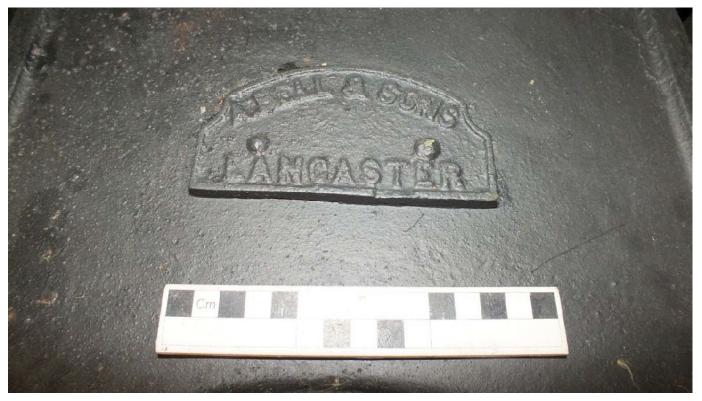
Plate 49: Maker's plate on the range in G10

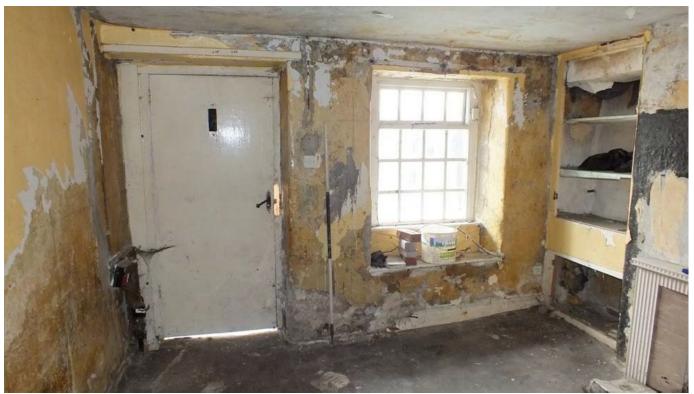
Plate 50: East elevation in Room G12

4.3.12 *Ground floor Room 12 (G12)*: this originally comprised the eastern ground floor room of a small cottage attached to the barn to the south. It had a concrete floor and a flat plaster ceiling, which was finished with flock wallpaper and paint as we the walls. The north elevation was plain, with electrical fittings such as the fuse box on the east side and a small timber shelf across the north-west corner. The east elevation has a doorway on the north side with a modern single panel door, with a window to the south with a 16-light timber casement, the top four of which are hinged and there is a timber seat below with a skirting board with a plain moulding below (Plate 50). The south elevation had a central fireplace with a mid-20th century tiled surround and a projecting tiled hearth. Either side were cupboards set into the recess of the wall each with two shelves (the east with a further space at the bottom not present in the west) (Plate 51). The doors had been removed but the openings had beaded edges. The west elevation had a central doorway with moulded surrounds and a plain door.
