ROYAL HOTEL, MAIN STREET, HEYSHAM, LANCASHIRE

Archaeological Building Recording

Client: Daniel Thwaites

October 2016

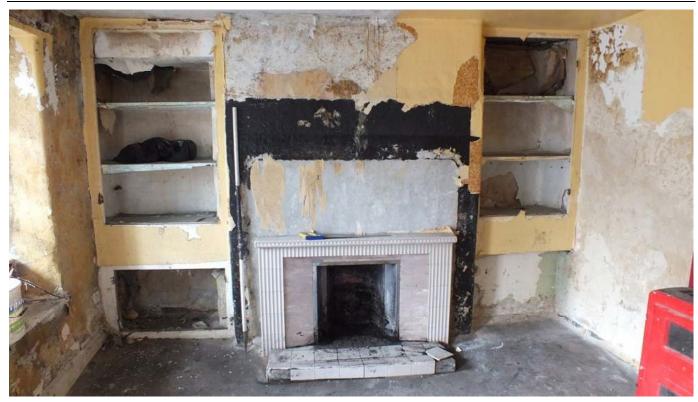
Plate 51: South elevation in Room G12

4.3.12 *Ground floor Room 12 (G12)*: this originally comprised the eastern ground floor room of a small cottage attached to the barn to the south. It had a concrete floor and a flat plaster ceiling, which was finished with flock wallpaper and paint as we the walls. The north elevation was plain, with electrical fittings such as the fuse box on the east side and a small timber shelf across the north-west corner. The east elevation has a doorway on the north side with a modern single panel door, with a window to the south with a 16-light timber casement, the top four of which are hinged and there is a timber seat below with a skirting board with a plain moulding below (Plate 50). The south elevation had a central fireplace with a mid-20th century tiled surround and a projecting tiled hearth. Either side were cupboards set into the recess of the wall each with two shelves (the east with a further space at the bottom not present in the west) (Plate 51). The doors had been removed but the openings had beaded edges. The west elevation had a central doorway with moulded surrounds and a plain door.

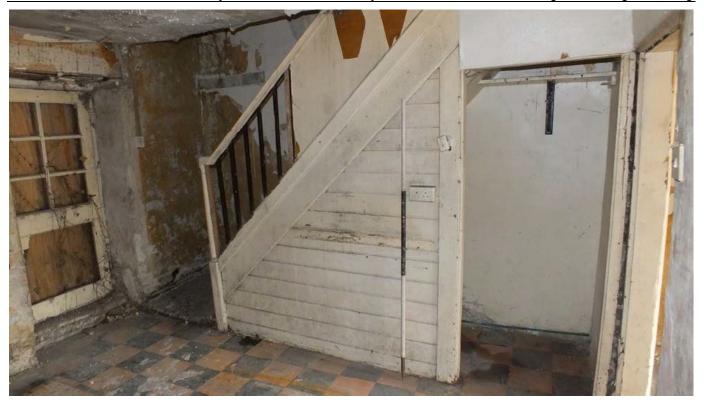
Plate 52: Stairs against the north elevation of Room G13

4.3.13 *Ground floor Room 13*: this originally comprised the western ground floor room of the cottage attached to the barn. It had a concrete floor finished with linoleum and the ceiling was flat plaster. The walls too were finished with plaster and painted flock wallpaper, although the north elevation was largely covered by beaded tongue and grove planks along the outer edge of the staircase, forming a small cupboard beneath with a doorway with a beaded surround but no door finished internally with chipboard sheeting (Plate 52). The stairs themselves had a moulded hand rail and square section balusters ending at a turned newel post at the west. Beyond the stairs the north elevation proper was plain, and the stairs were timber planks. The east elevation was also plain, with a doorway on the north side with a moulded surround. The south elevation was also relatively plain, although with lots of modern patching to the plaster and a projecting fireplace on the west side with a timber mantle above a mid-20th century tiled hearth (Plate 53). To the west was a narrow alcove with a stone lintel, extending almost the full thickness of the wall and finished with modern boards. The west elevation had a window on the south side with a rough timber lintel, a two-light hinged timber casement, and a gap in the sill below that evidently originally housed a sink as some tiles remained below the casement (Plate 53). There was a doorway to the north of this with a modern door with six-lights and a panel below and a concrete step up.

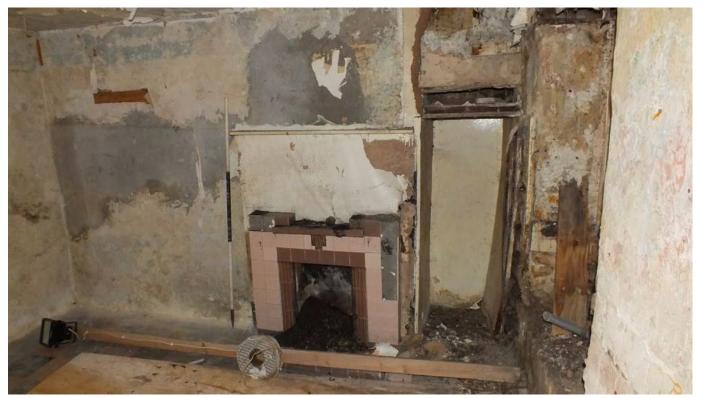
Plate 53: Fireplace and alcove, south elevation of Room G13

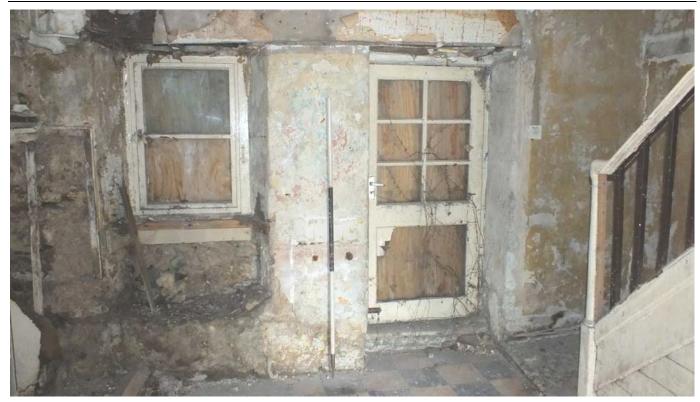
Plate 54: Window and doorway, west elevation, Room G13

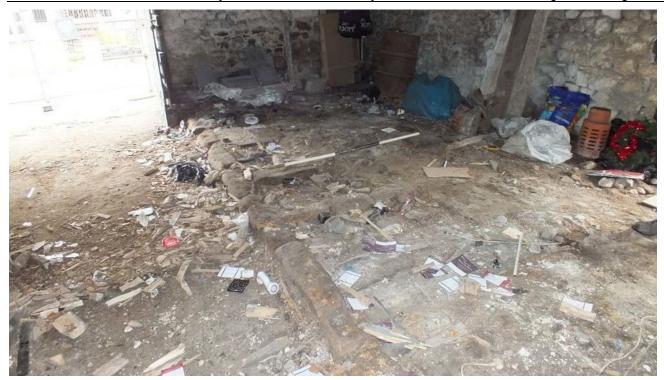
Plate 55: Raised floor on the south side of the barn

4.3.14 Ground floor of the barn: the barn at the south end of the block had an earth floor but was raised on the south side and cobbled with a rough stone flooring with some timber set into it (Plate 55). The walls were exposed stone of roughly dressed blocks in courses. It was open to the roof, which is described as part of the first floor descriptions below. The north elevation was essentially plain apart from two rows of square throughstones (Plate 56). The east elevation was also plain apart from the wagon door in the centre, with a flattened stone arch (Plate 57), and a door on the south side with a rough and reused timber lintel, although there was a further sawn off timber sticking out of the wall to the north of this. The south elevation made much more use of cobbles, in bands, with dressed blocks higher up. There was a small alcove with a low stone lintel near the centre and a doorway on the west side (Plate 58). The doorway did not appear to be inserted from this side, although it had certainly been repointed externally. Internally, it had a reused timber lintel and remains of a frame, which was chamfered and had an over-light. It was possibly early 20th century, perhaps inserted and then whitewashed over the jambs. There was timber set in on the south side of the west elevation which may have been a lintel for a blocked door and there was a line of quoins to the north of this, ending with a large quoin part way up (Plate 59). This line of quoins corresponded with a set of quoins further to the north, which were butted against by the north elevation. Sections below the trusses were rebuilt in concrete block in both the east and west elevations.

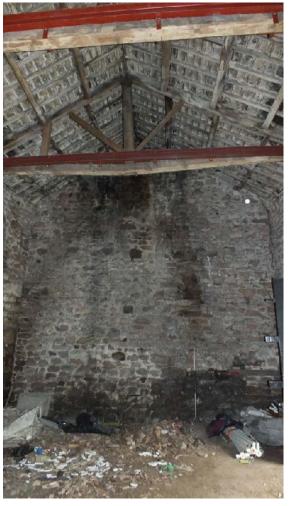
Plate 56 (left): North elevation of the barn

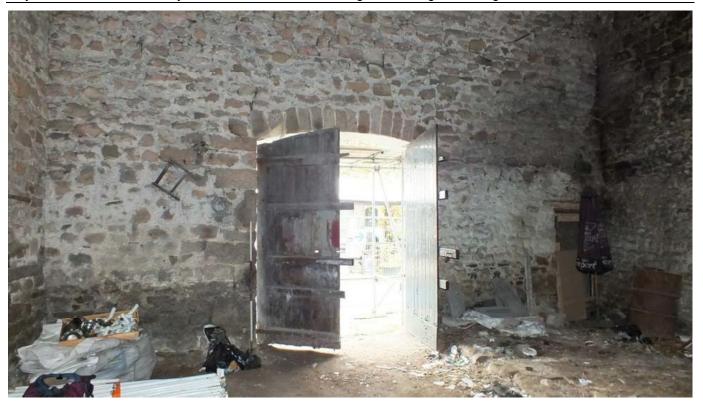
Plate 57: East elevation of the barn

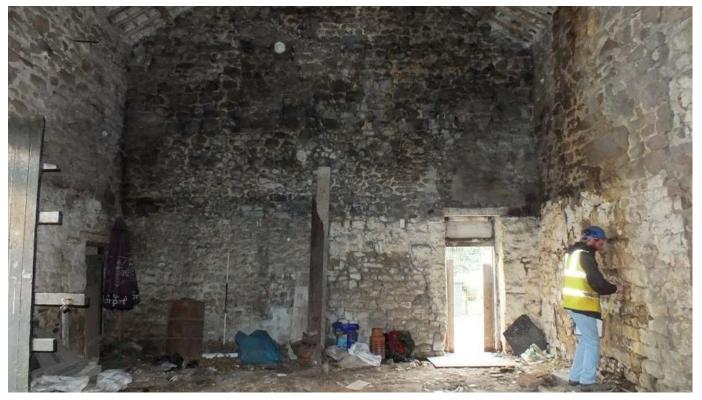
Plate 58: South elevation of the barn

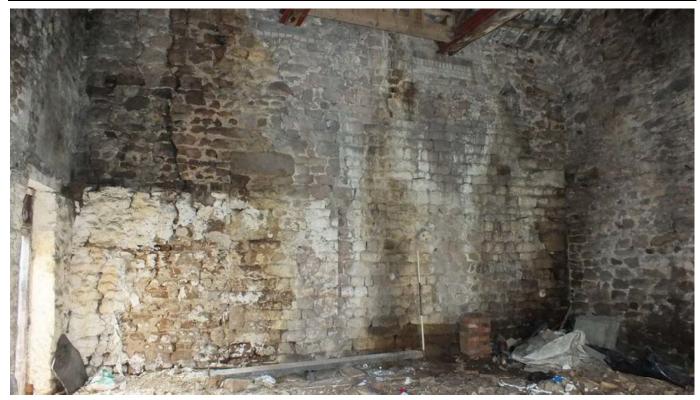
Plate 59: West elevation of the barn

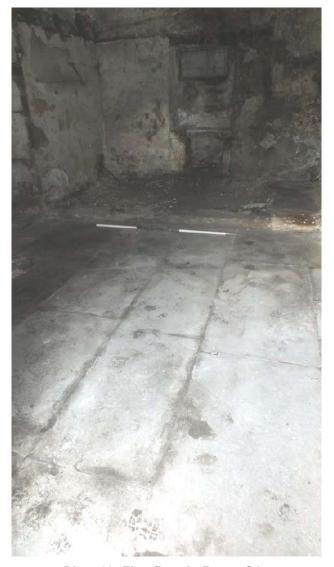
Plate 60: Flag floor in Room G14

4.3.15 Ground floor Room 14 (G14): this comprises the easternmost of the two cottages to the west of the barn. It had a largely flag floor, with large well-finished stone flags (Plate 60), although the majority of the north end was raised by approximately 0.1m with stone edging and beyond this the floor was just earth, with some flags present on the east side (Plate 61). The room had been opened out into the upper floor through the removal of the first floor, therefore exposing the roof, which had been covered by plasterboard sheets attached to the joists, with a further section of suspended ceiling added to form a small attic. Throughout the walls are finished with the remains of lime plaster, although in many areas this was completely removed. The north elevation had a window at ground floor level with a rough timber lintel and square jambs extending to the ground into which brick pillars have been set on either side, presumably to support a sink that is now missing (Plate 62). The window had mostly been blocked with stone, but a small aperture had been left at the top with a plain timber casement, although this too had been blocked externally with concrete blocks. At first floor level there was a further small window the jambs of which extend to the roof. It had a small single-light timber casement, blocked externally with board. In the north-east corner there is the scar of a former staircase, corresponding with the flagged section of floor in the raised part on the north side of the room. The scar of the stairs continues onto the north side of the east elevation, where the plaster was otherwise largely missing (Plate 63). There was a small alcove south of the centre, with a stone lintel and jamb, a narrow notch in the base and internal plaster (Plate 64). At the south end of the ground floor there was an evident butt joint, corresponding with that visible in the barn but without quoins. At first floor level there was a row of holes for joists and the scar of a stud wall on the north side. The south elevation had a doorway on the east side with square jambs, mostly solid stone with rebates, and a chamfered timber lintel (Plate 65). To the west was a window with square jambs, stepped sill and rough timber lintel. At first floor level there was a further window over this, its square jambs extending to the roof, which had been blocked externally with concrete blocks. The west elevation had a large fireplace on the ground floor within a projecting chimney breast south of the centre with a stone surround and lintel and projecting concrete hearth (Plate 66). The base was loosely filled with brick to house a smaller grate. Immediately north of the fireplace was an alcove built into the wall with the scars for two shelves. At first floor level the holes for the joists were still visible and the scar for the stud wall, matching that to the east, as well as an opening for a small fireplace. This was very plain, with no grate remaining. Across the wall at first floor level, scored into the

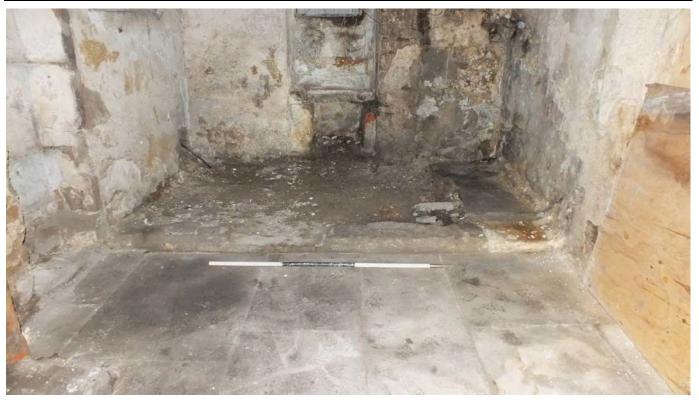
Plate 61: Raised floor on the north side of Room G14

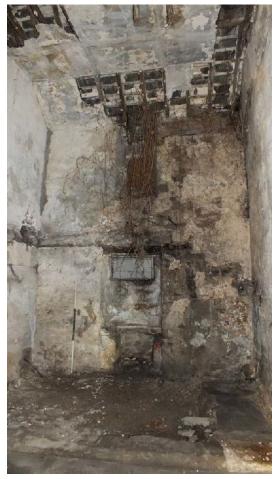
Plate 62: North elevation in Room G14

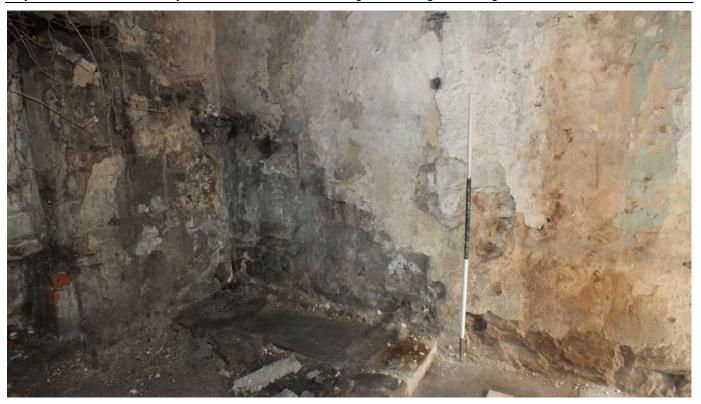
Plate 63: Scar of former staircase in the north-east corner of Room G14

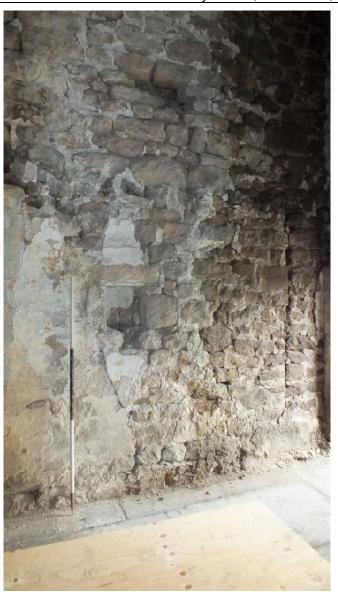
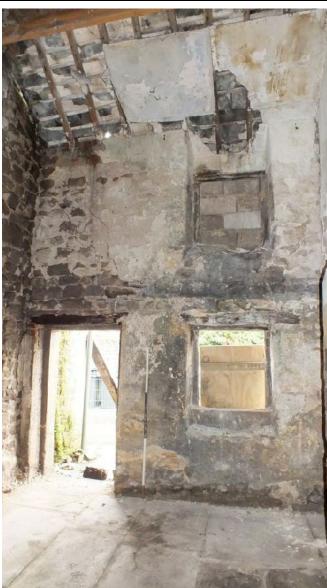
Plate 64 (left): Alcove in east elevation, Room G14
Plate 65 (right): South elevation, Room G14

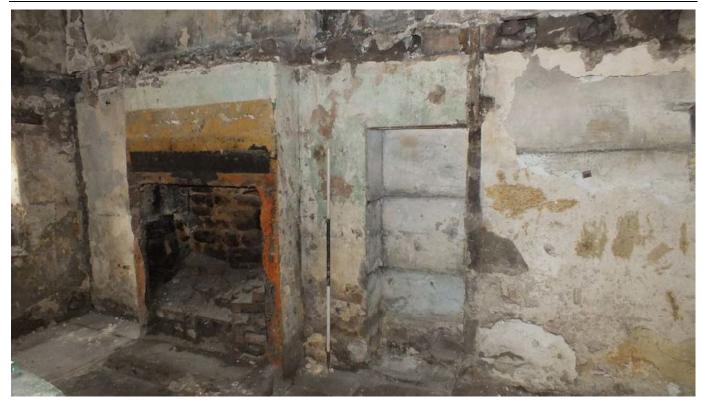
Plate 66: Fireplace and alcove, west elevation, Room G14

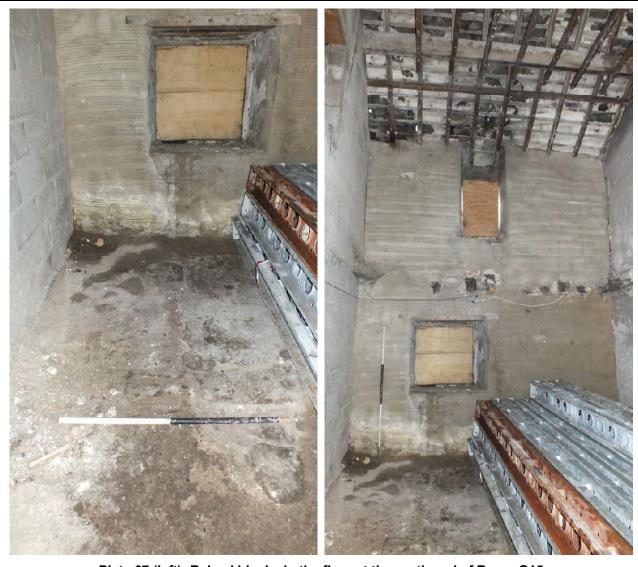
Plate 67 (left): Raised blocks in the floor at the north end of Room G15

Plate 68 (right): North elevation in Room G15

4.3.16 Ground floor Room 15 (G15): this comprised the westernmost of the two cottages to the west of the barn. The floor was rough concrete, slightly raised along the north side with stone blocks along the edge (Plate 67) at least some of which had a groove along the top, along with a separate block on the west side with a square hole in the top. The first floor had been removed so it was open to the roof, which had a single purlin per pitch and a ridge purlin, as well as additional timbers attached to form a suspended ceiling across the centre. The walls are mainly finished with modern concrete scratch coat although the east elevation retains its original lime plaster. The north elevation had a window on the ground floor with a very plain modern finish and plain modern timber lintel and casement, which had been blocked externally with boards (Plate 68). The joist holes are visible at first floor level and there was a further window on the first floor, the jambs of which extended to the roof and which was blocked externally by timber boards. The east elevation had a large fireplace south of the centre with a stone surround and brick infilling at the base to form a smaller grate (Plate 69). To the north of this was a shallow alcove with scars for three shelves, a rough timber lintel and the scar of a projecting wall on the north side. At first floor level there was a visible scar for the actual floor and a fireplace to the south, which was plain but had an iron grate. The south elevation had a ground floor window and doorway, both with square surrounds and rough and re-used timber lintels; the window also had a stepped sill and was blocked externally with concrete blocks. The doorway had a modern plank and batten door. At first floor level the joist holes of the upper floor were visible and the remains of a plain skirting board. There was a window on the east side with square jambs, which extended to the roof and was blocked externally with concrete blocks. The west elevation was largely plain and evidently mostly rebuilt in concrete block, with only a small section at the south side retaining its original stonework. The holes for the joists were present at first floor level and there was a single window at first floor level within the rebuilt section, with a modern timber lintel.

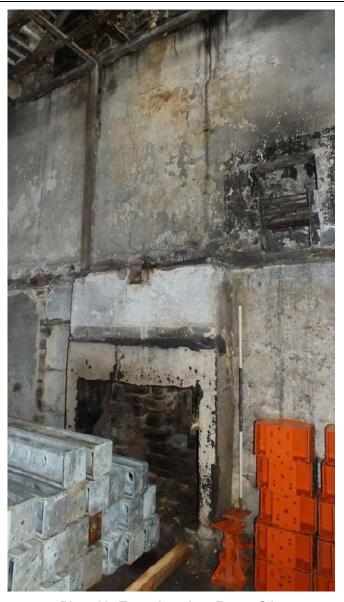
Plate 69: East elevation, Room G15

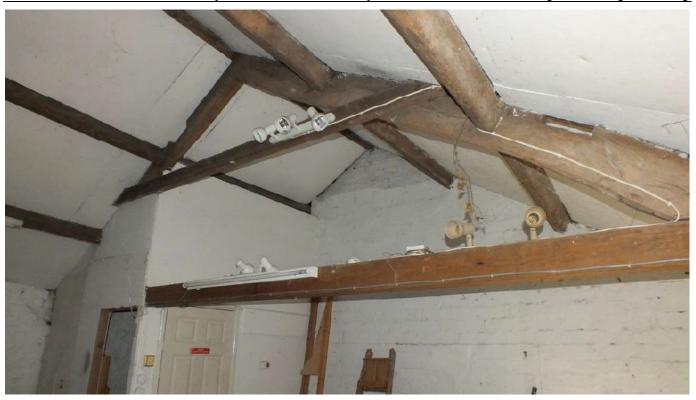
Plate 70: Truss in the disused shop (F1)

4.3.17 *First floor Room 1 (F1)*: the space above the disused shop had a chipboard floor and was open to the roof. The ceiling joists were boarded over but there was a single east/west truss across the centre of the room, with a collar bolted on, two purlins per pitch and a ridge plank (Plate 70). The principals were lap jointed east on west and all of the timber was machine cut. The walls were mainly painted stone and plain. The south wall was painted concrete block. The south-east corner had modern stud walls inserted with a modern panel door from the west and a doorway from the north, with no door, just broken through the stud wall, into the small cubicles. The cubicle to the south had a toilet in it on the east side and the north cubicle had shelves for storage. The stairs to the ground floor were in the south-west corner. The north elevation was stepped out part way along by 0.1m, roughly 0.7m from its base, and there were tall through stones in the east elevation (Plate 71).

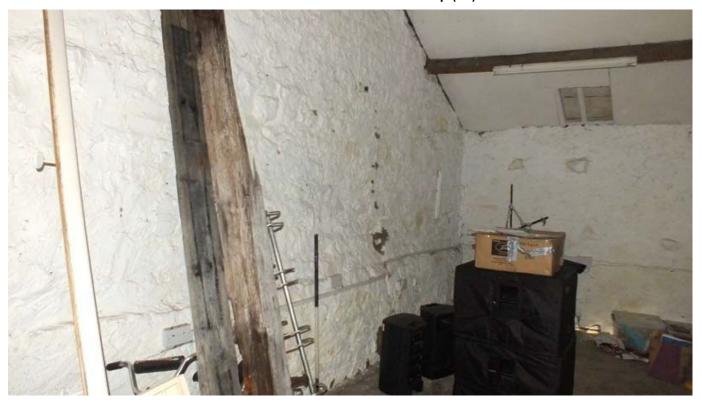
Plate 71: North elevation of F1

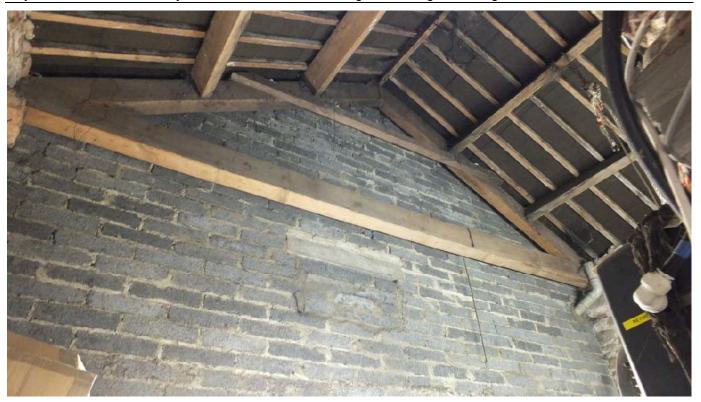
Plate 72: Truss visible on north side of F2

4.3.18 *First floor Room 2 (F2)*: the space above the bottle store on the ground floor (G2) had a tie beam truss against the north elevation like that in F1 to the north (Plate 72). The timber used was machine sawn and there was a stone corbel below the west end of the truss. There had been a small aperture in the concrete section of the north elevation of this space above G2 but this had been blocked with concrete block.

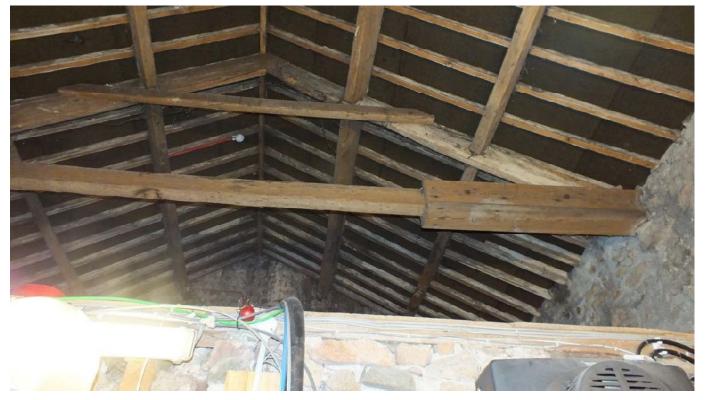
Plate 73: West end of truss visible on south side of F3

4.3.19 *First floor Room 3 (F3)*: the truss in the space (F3) above the beer cellar (G3) was the same as that above the bottle store (described as part of F2), although it had extra timber boxed round the west end of the beam (Plate 73) and there was a timber corbel below the east end (Plate 74; Plate 75). The space above F2 was not accessible.

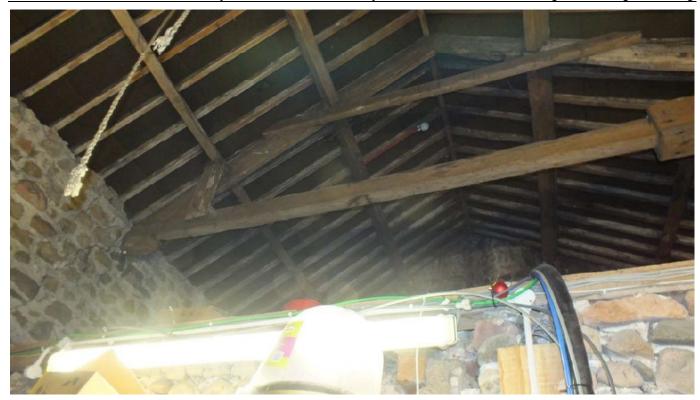
Plate 74: East end of truss visible on south side of F3

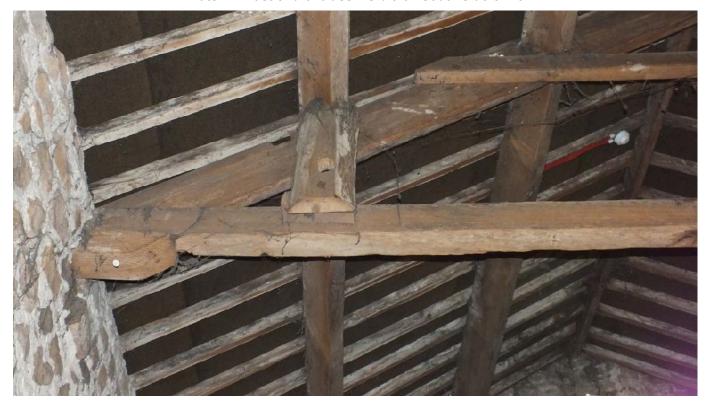
Plate 75: Timber corbel below the east end of the truss on the south side of F3

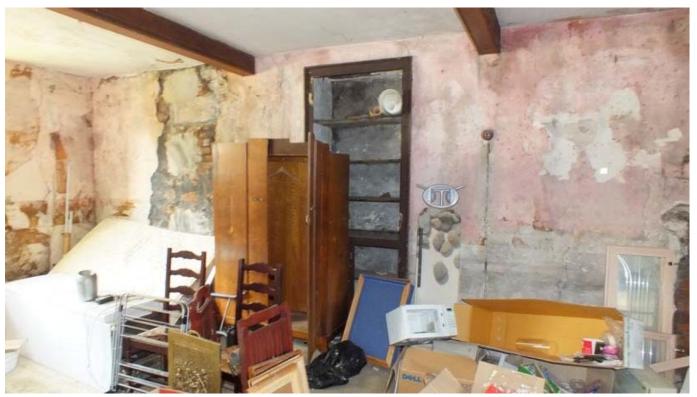
Plate 76: The south end of the west elevation of F4

4.3.20 *First floor Room 4 (F4)*: the room on the first floor in the taller north end of the Royal Hotel had a modern chipboard floor and rough plaster walls and plaster ceiling and three beaded beams, aligned north/south. The north elevation had brick blocking on the east and west sides, either side of an alcove with two shelved and moulded surrounds (Plate 76 and Plate 77). The north-east corner was built out with timber stud walls (Plate 78) to form a small room with part of a panelled door to the west and a small,

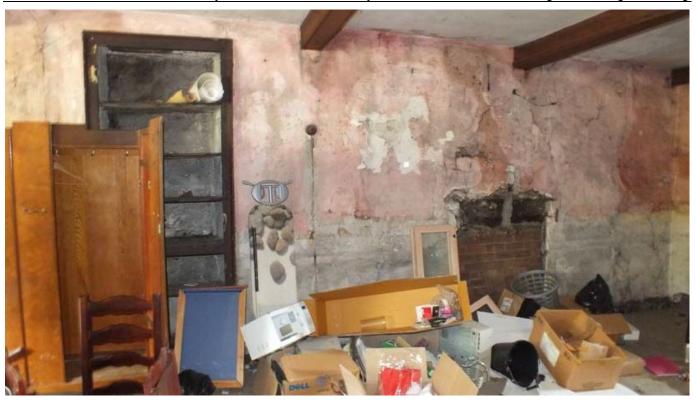
Plate 77: The north end of the west elevation of F4

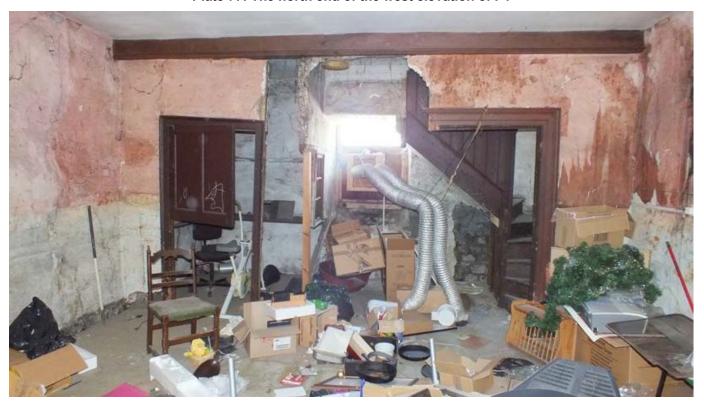
Plate 78: The east north end of F4

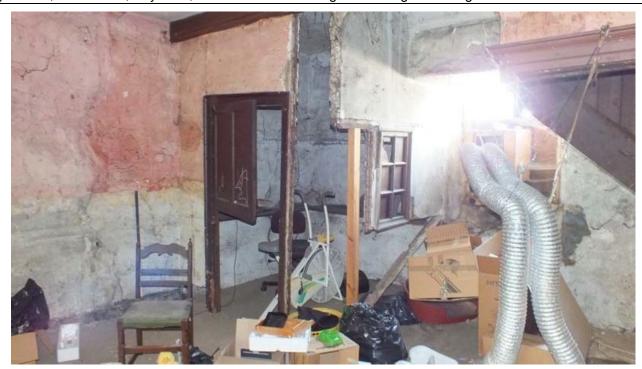
Plate 79: Small room in the north-east corner of F4

six-light casement window to the south (Plate 79). There was a large opening to the south of this room in the east elevation, the top part of which was glazed and the rest had vents in. The stairs to the south-east corner had beaded timber panelling and a plank door (Plate 80). The south elevation had a central doorway, which was either rebuilt or inserted with a concrete lintel and machine-made brick (Plate 81). The door was a possibly 20th century plain panel door. There was a further blocked fireplace to the west of that with 20th century brick infill and a stone lintel, as per the one to the north-east. There were two sash windows over a timber sill in the west elevation, presumably originally eight over 16-light sash windows which had been modified: the lower parts had been boarded and a vent had been inserted in the one to the east (Plate 82).

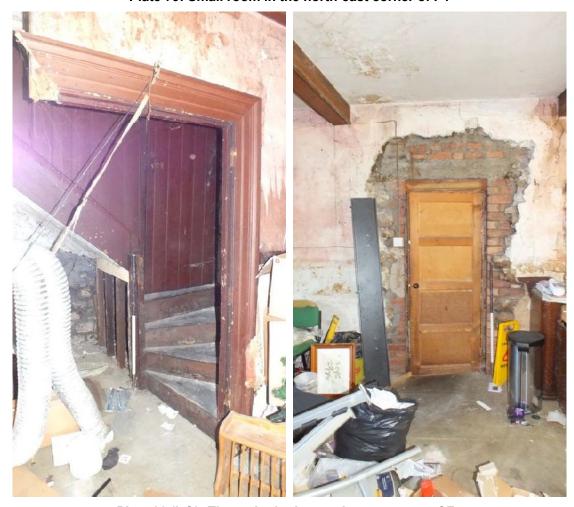
Plate 80 (left): The stairs in the south-east corner of F4
Plate 81 (right): Inserted doorway in the south elevation of F4

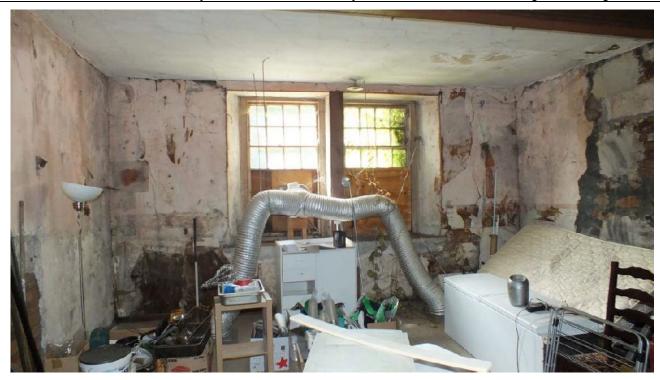
Plate 82: The west end of F4

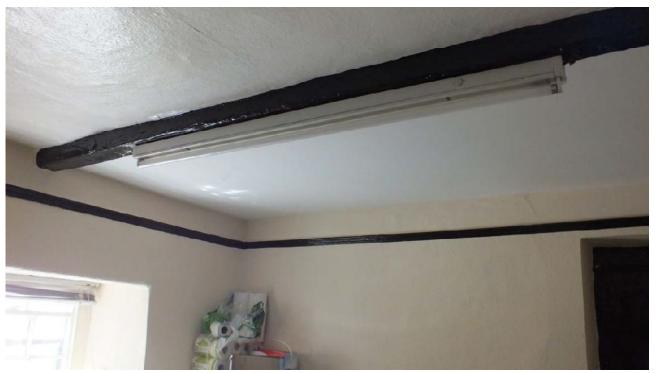
Plate 83: Beam in F5

4.3.21 *First floor Room 5 (F5)*: this was the first floor kitchen and utility room. It had a vinyl floor, flock wallpaper and a picture rail, and wallpapered ceiling, with a narrow, east/west aligned, hand finished beam (Plate 83). The moulded doorway to the north was very narrow and probably a later insertion. The window to the west was a three over six light sash. The door to the south had six raised and fielded panels and a narrow moulded surround (Plate 84).

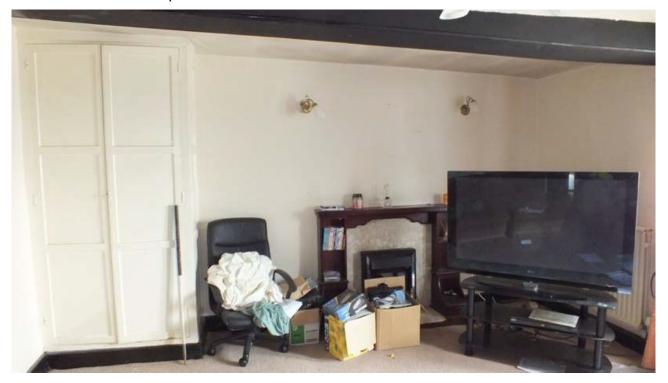
Plate 85: The north end of F6

4.3.22 *First floor Room 6 (F6)*: the sitting room/living room on the first floor had a carpeted floor, skirting board, flock wallpaper on the walls, and two beaded east/west beams across the plaster ceiling. The surround of the fireplace to the north was modern and the boiler cupboard in the north-west corner was also 20th century. The two windows to the east were two over four sash windows and the door to the west had four raised and fielded panels.

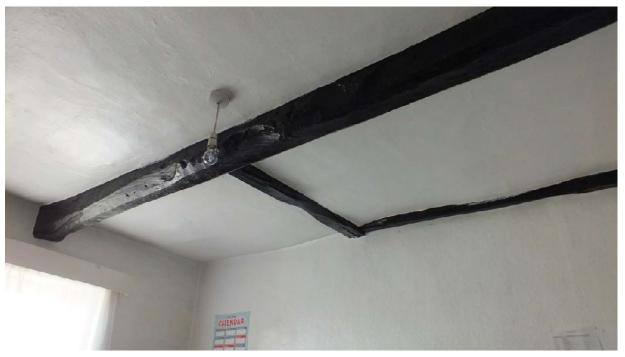
Plate 87: Beams across the ceiling in F7

4.3.23 *First floor Room 7 (F7)*: the bedroom opposite the bathroom on the first floor had a carpeted floor and plaster ceiling with two, east/west aligned, hand-finished beams across it and a further one on the south wall and a joining piece north/south. There were Baltic marks on the east end of the central beam, which had a chamfered end. There were a pair of two over four light sash windows to the east side of the room and a one over three panel door to the west with plain surrounds.

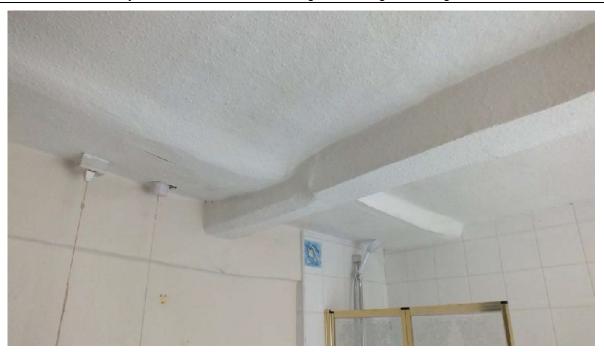
Plate 90: The ceiling in F8

4.3.24 *First floor Room 8 (F8)*: this was the bathroom. It had a vinyl floor and was plastered and wallpapered over the ceiling, including the east/west beam and step in the ceiling on the east side (). The window to the west had a modern casement and there was a one over three panel door to the north-east corner, where the wall was angled.

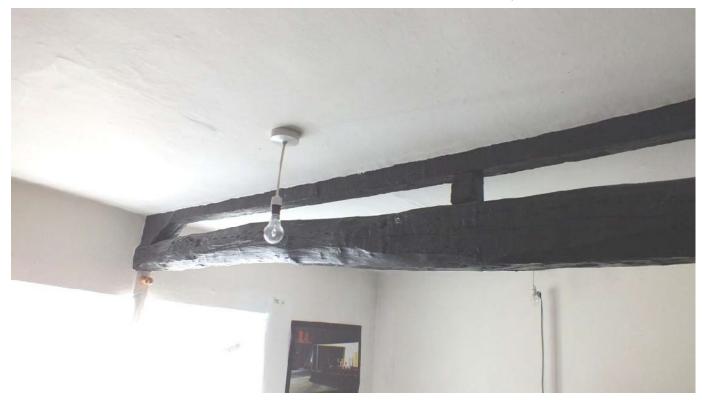
Plate 93: Beam in F9

4.3.25 *First floor Room 9 (F9)*: the bedroom at the south-east end of the Royal Hotel had a carpeted floor and a rough east/west beam across the ceiling. It had a pair of three over six light sash windows to the east, a door to the west with four raised and fielded panels, and a chimneybreast in the south wall.

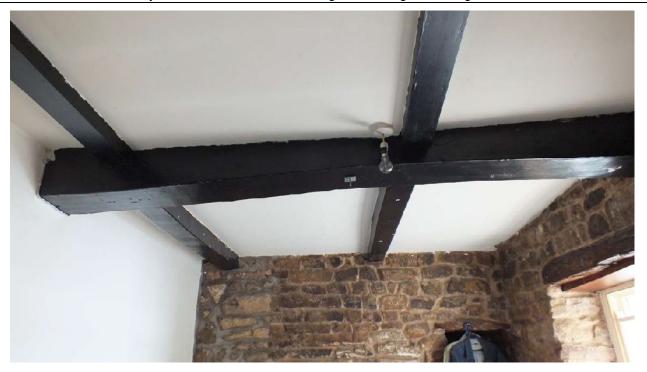
Plate 94: Beams across the ceiling in F10

4.3.26 *First floor Room 10 (F10)*: the bedroom at the south-west end of the Royal Hotel had a carpeted floor and plastered ceiling, with two beams north/south and one centrally east/west (Plate 94). The walls were mostly plastered and finished with flock wallpaper but the south and west elevations were exposed stone (Plate 95). The fireplace to the south had a stone lintel and the alcove in the south-west corner had a timber lintel. There had been two windows in the west elevation (Plate 96): the one to the south was a three over six light sash and had a rough reused cruck timber lintel; the one to the north also had a timber lintel but was blocked. The door in the north end of the east elevation had four raised and fielded panels (Plate 97).

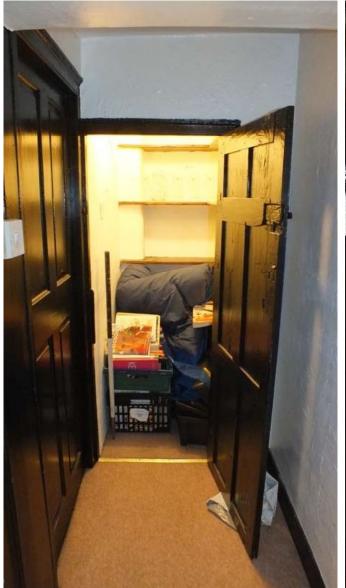
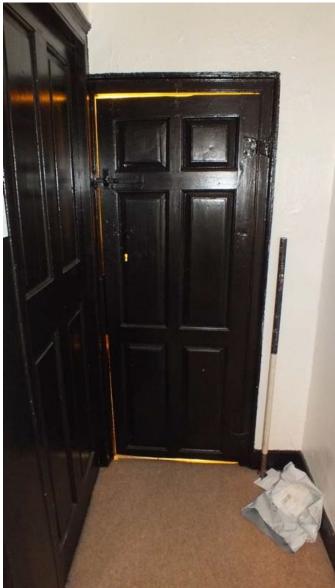
4.3.27 *First floor Room 11 (F11)*: the corridor on the first floor was aligned broadly north/south and stepped up at the south end. There was a cupboard at the south end with three L-shaped shelves (Plate 98) and a raised and fielded six-panel door with early 'butterfly' hinges (Plate 99). The door to the east at the south end next to that had four raised and fielded panels, but did not go anywhere (Plate 100). There was a door to the north to F5, doors on the east side to F6, F7 and F9 (Plate 101), doors to the west to F8 and F10 (each of which is described as part of the description for each room), and a large 18-panel door with an over-light at the top of the stairs (Plate 102) at the north-west end with a modern glazed (frosted) panel north of that. The stairs down were plain timber and there was a stair light to the west and a reused cruck beam in the north wall (Plate 103).

Plate 98 (left): Cupboard at the south end of F11

Plate 99 (right): Raised and fielded cupboard door at the south end of F11

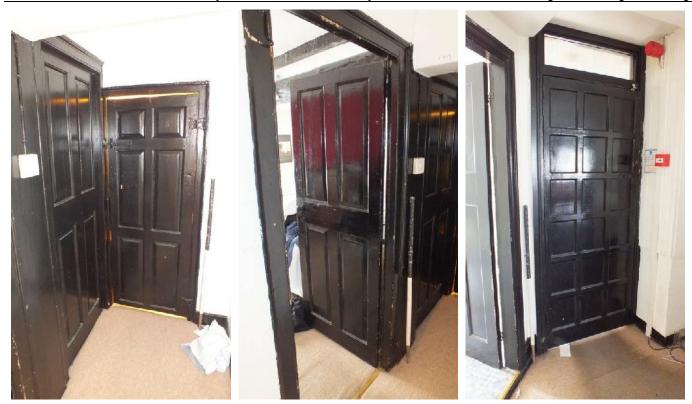
Plate 100 (left): Cupboard door and redundant door at the end of F11

Plate 101 (centre): Door to F9 from F11

Plate 102 (right): Doors to the bathroom (F8) and stairs at the north end of F11

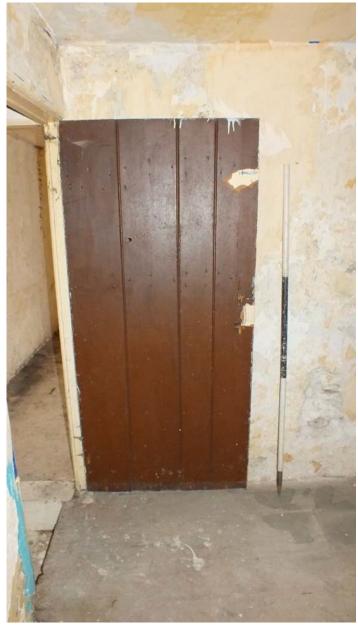
Plate 104: Door in the north elevation of Room F12

the walls were also finished with plaster and wallpaper, although most of this had been stripped. The north elevation had doorways on the east and west sides leading to the stairs. The west had a modern surround and no door, while the east had a narrow moulded surround and early plank door with the scar for an early handle but modern sheeting attached over the south face (Plate 104). The east and south elevations were plain, while the west had a window on the south side with plain square jambs, a rough timber lintel and timber window seat (Plate 105). The adjoining staircase had timber stairs and painted plaster walls, although the stairs to the floor above were missing and so this could not be accessed. It was apparent, however, that it comprised two further small rooms. There were doorways off the stairs to the south and east with narrow moulded surrounds. The south elevation is a stud partition and there was a small window into the stairs with a modern two-light hinged timber casement and a timber sill.

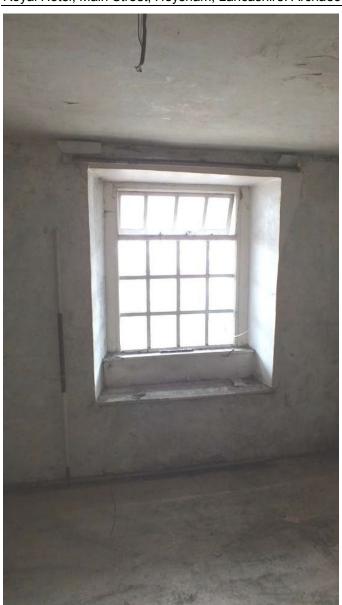
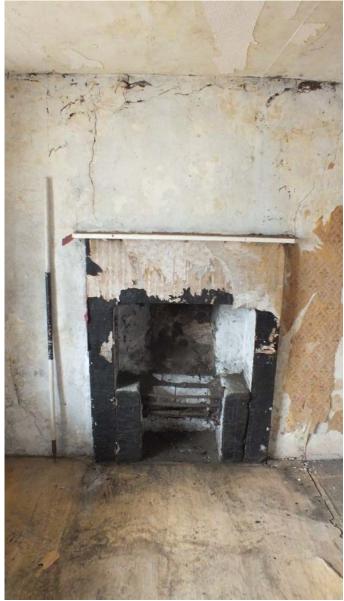
Plate 106 (left): Window in the east elevation of Room F13
Plate 107 (right): Fireplace in the south elevation of Room F13

4.3.29 *First floor Room 13 (F13)*: the floor was finished with linoleum over timber floorboards (not tongue and groove) and the ceiling was flat lath and plaster. The walls were finished with paint and the remnants of wallpaper over plaster. The north elevation was plain, with an iron pipe set into it on the east side. The east elevation contained a single window on the south side, with splayed jambs, a 16-light modern hinged timber casement and a timber seat below (Plate 106). The south elevation has a fireplace on the east side with a stone surround and internal supports holding an iron grate (Plate 107). The west elevation was a stud partition with a doorway on the north side with a narrow moulded surround.

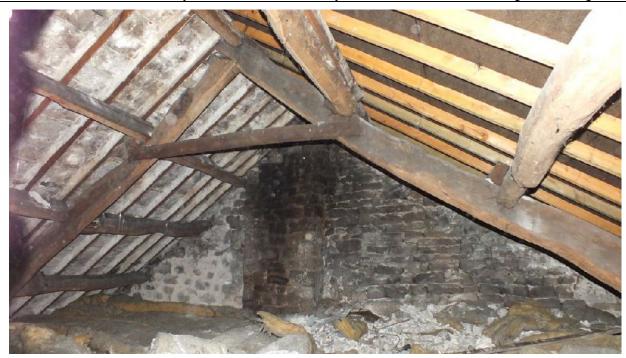
Plate 108: Truss and chimney breast in the south part of the roof space

4.3.30 **Roof space above F5-F10**: there were two trusses in the north part above the main building of the Royal Hotel and one in the southern section. Both were simple tie beam trusses with collars and the timber was hand-finished (Plate 108 and Plate 109). The south end was separated by a wall where the steps were and there was a small access hatch. It was not easily accessible but evidently had a projecting chimney stack east of the centre. The south part had a similar style of truss and just the one. There was a butt joint on the west side in the north wall of the north section, with the wall apparently running off to the north or perhaps forming one side of a blocked window, and a projecting chimney stack on the east side.

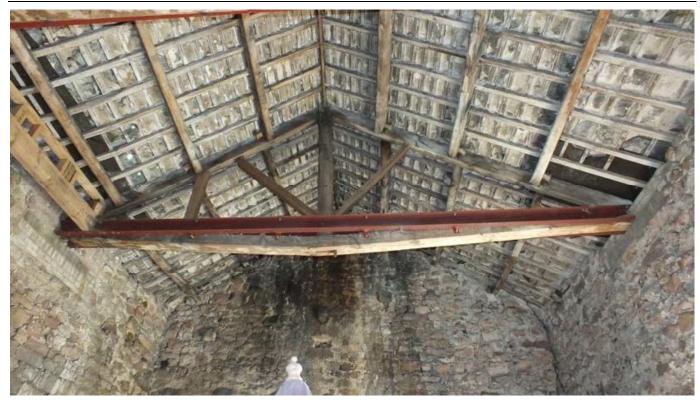
Plate 110: Truss in the barn

4.3.31 *First floor of the barn*: the roof of the barn was supported by two 'king post' type trusses with angled braces and additional queen braces, although only one survived on the north truss, and steel I-beam supports were strapped on to the tie beam (Plate 110). There were three purlins per pitch and a ridge plank. All of the roof timbers were neatly hand-finished and run-out stop chamfered.

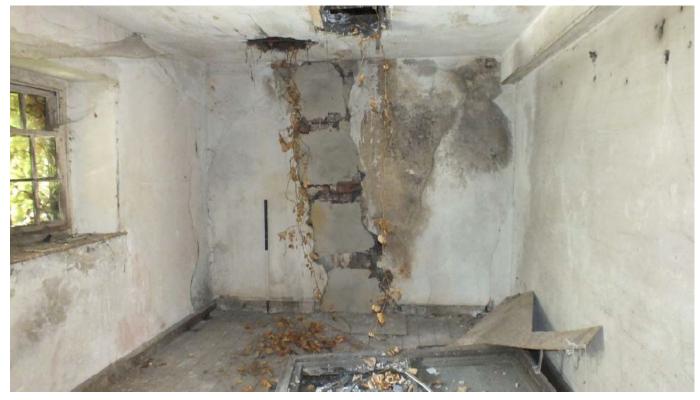
Plate 111: North end of S1

4.3.32 **Second floor room 1 (S1)**: the room at the west side of the second floor was not in use. It had a tongue and groove floor, aligned north/south, and plain plaster walls with moulded skirting. The north elevation had a scar up the centre of the brick for a flue (Plate 111), the east elevation had a beaded beam along it and a doorway on the south side with a moulded surround but no door, the south elevation was plain, and the west elevation had two three over six light sash windows with timber sills (Plate 112).

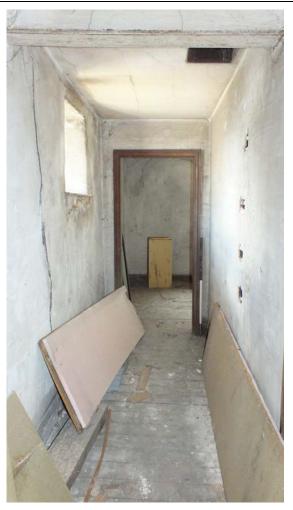
Plate 113: Looking west along the corridor (S2) on the second floor

4.3.33 **Second floor room 2 (S2)**: this room formed the corridor to the south side of the second floor and turned north at the east end to the stairs. It had stud walls along its north and west sides, tongue and groove board floors, and a plaster ceiling (Plate 113). The doorways to the rooms to the north and west (S2 to S4) had moulded surrounds, but no doors. The stairs at the east end had turned post and spindles below the hand rail (Plate 114). The window in the stairwell was an eight over 12-light sash with a timber sill. The window in the south elevation was a modern four-light fixed casement.

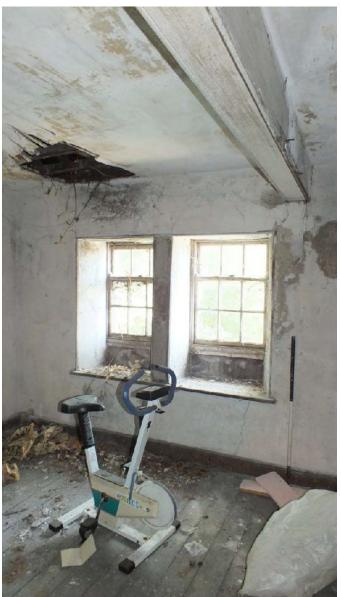
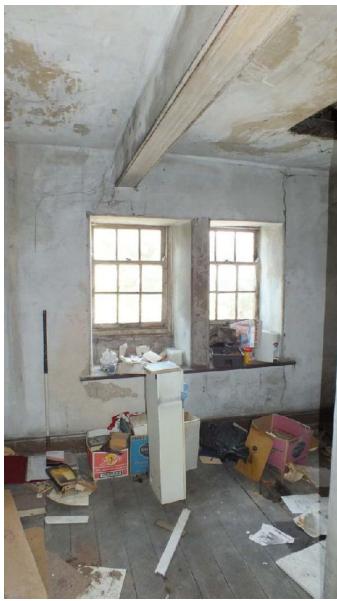
Plate 115 (left): The north elevation of S3 Plate 116 (right): The north elevation of S4

- 4.3.34 **Second floor room 3 (S3)**: this room was very plain and fairly empty. It had tongue and groove floors (as did the rest of this floor), a beaded beam, moulded skirting, and a door to the corridor (S2) to the south. There were a pair of windows to the north, both of which were three over six light sash windows, with a continuous timber sill (Plate 115).
- 4.3.35 **Second floor room 4 (S4)**: this room was similar to S3. It had tongue and groove boards and three over six light sash windows to the north (Plate 116). The doorway to the corridor (S2) had a moulded surround.

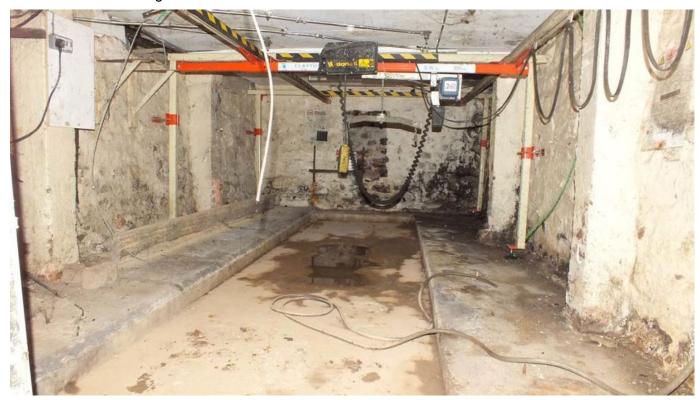
Plate 117: The west end of the cellar below Room G4

- 4.3.36 **Roof space above the second floor**: the roof space above the second floor was not fully accessible. There were three tie beam trusses (possibly Baltic timbers) with two purlins per pitch.
- 4.3.37 **Cellar below Room G4**: this comprised a relatively small space that was only briefly examined. It had a concrete floor, stepped up on the north and south sides with a pair of brick pillars against each wall each supporting two timber beams (Plate 117). The walls were stone, but finished with whitewash. There was a square hole set into the floor in the south-east corner, which apparently acted as a sump as it was full of water and had a pump set into it. Against it was a set of timber steps that originally lead up to Room G4, although the access was now blocked. The access hatch into the street, which was covered

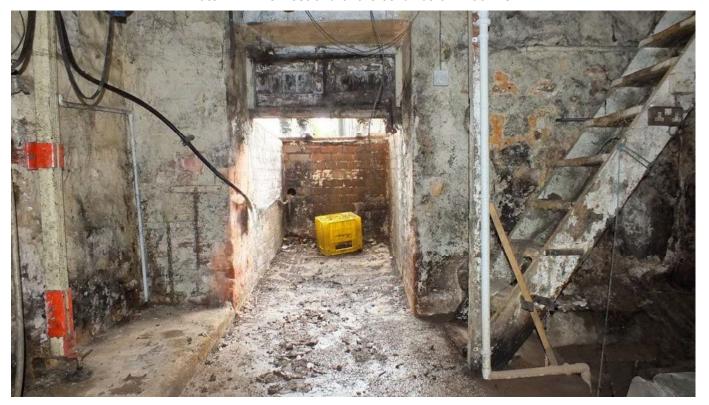
Plate 118: The east end of the cellar below Room G4

by thick timber boards, was at the east end (Plate 118). There were numerous modern fittings throughout connected to the storage and movement of barrels.
