Archaeological building recording at Martins Farm, Crowland, South Holland, Lincolnshire

Joe Prentice and
Angela Warner
Report 11/157
July 2011

**ARCHAEOLOGICAL BUILDING RECORDING
AT MARTINS FARM, CROWLAND,
SOUTH HOLLAND, LINCOLNSHIRE:
JULY 2011**

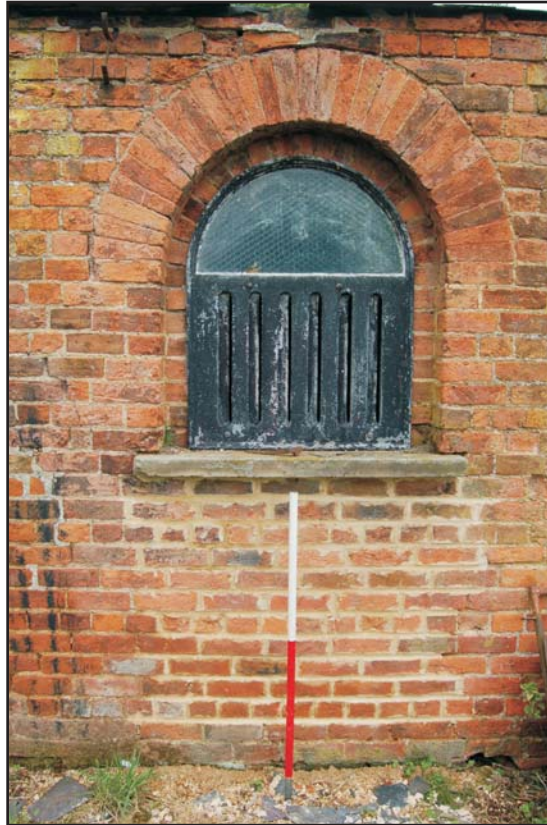
Plate 17

The south range arched window with cast iron frame and ventilation slats, looking east
