Building recording at Sunny Hill Farmhouse  
Old End, Padbury, Buckinghamshire  
July 2012

Report 12/138

**BUILDING RECORDING AT  
SUNNY HILL FARMHOUSE  
OLD END, PADBURY  
BUCKINGHAMSHIRE  
JULY-SEPTEMBER 2012**

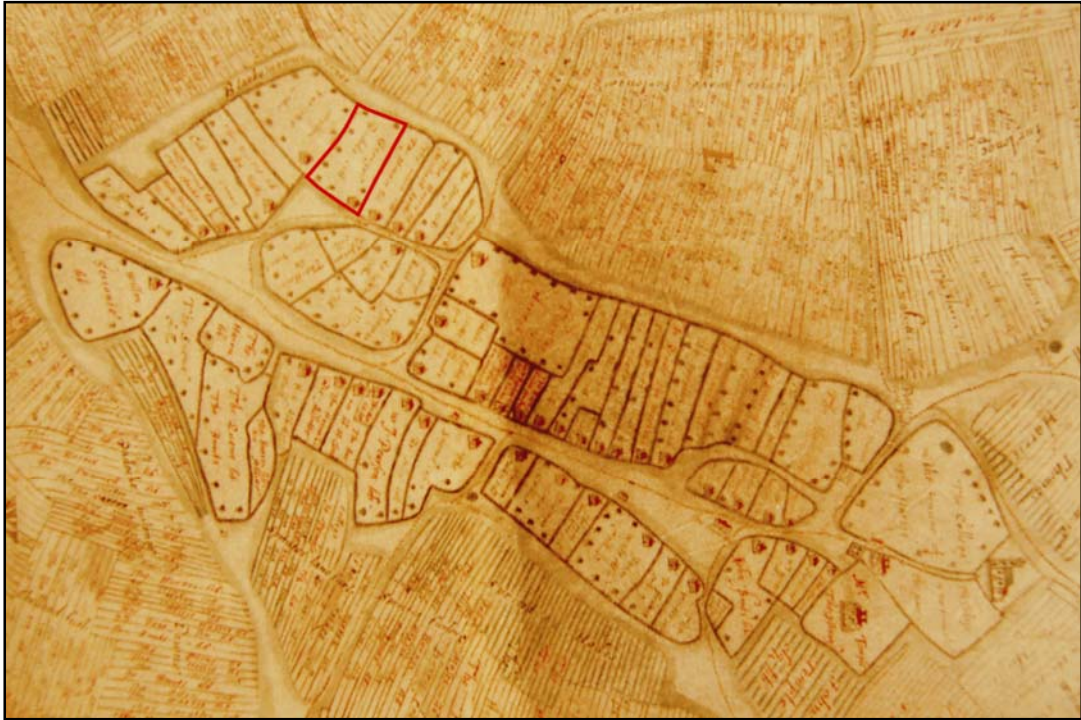
All Souls College Estate Map of 1590 with plot highlighted Fig 2

The position of Sunny Hill Farmhouse falls within a plot of land belong to a George Budde (Figs 2 and 3, highlighted). The buildings on this land are not accurately rendered, and are represented by a generic depiction of a single building.

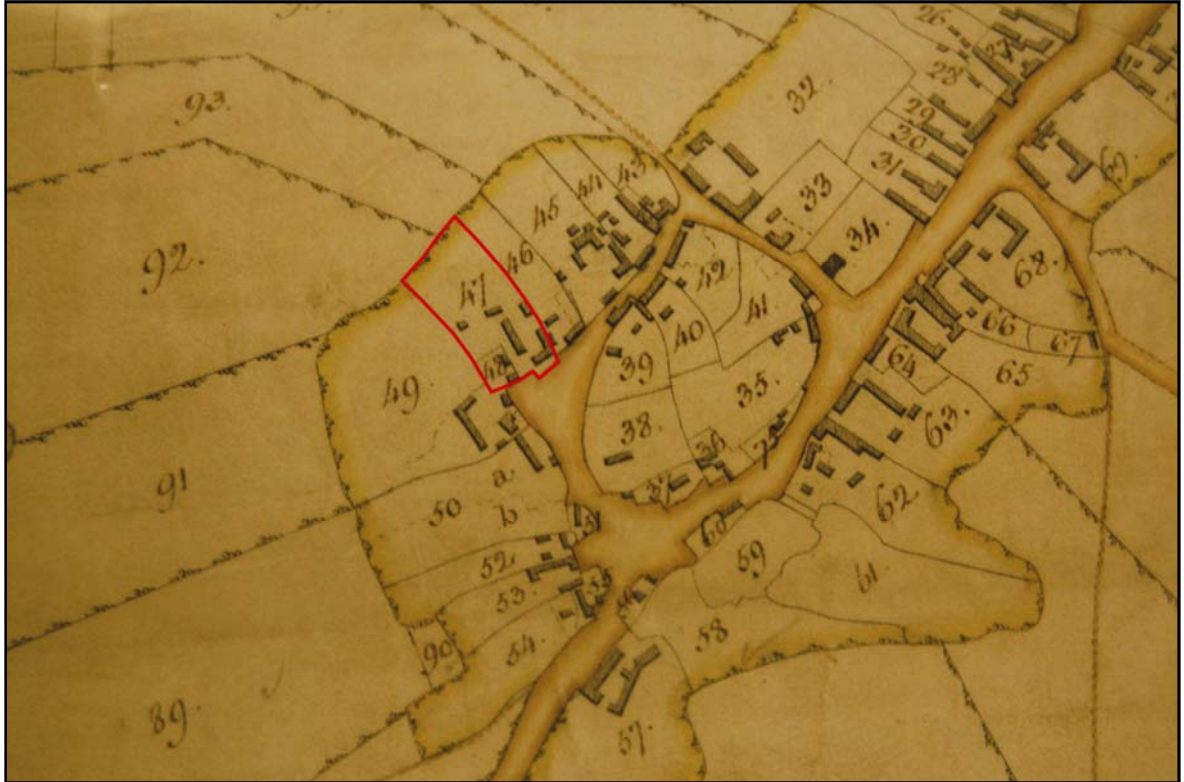
Inclosure map of 1796 showing the layout of buildings Fig 4

The general layout of the village and position of boundaries has changed little since the 16th-century. A large L-shaped building with adjacent structures is depicted in the position of the current farmhouse. This indicates the presence of an eastern, north-south aligned range in the space now occupied by the modern garage. The rebuilding of this part of the structure in the mid 19th-century has left little, if any, evidence of the previous fabric or form of the building in this area.

This map shows the farmhouse in its current form. The north-south range visible on the 1796 Inclosure map (Fig 4) has been demolished and replaced with a smaller structure abutting the main farmhouse and a separate range of buildings to the north. Interestingly, a line is depicted across the centre of the main farmhouse. This seems to represent a join which is visible on the north and south elevations of the structure and which will be discussed further in this report (Figs 8 and 12).

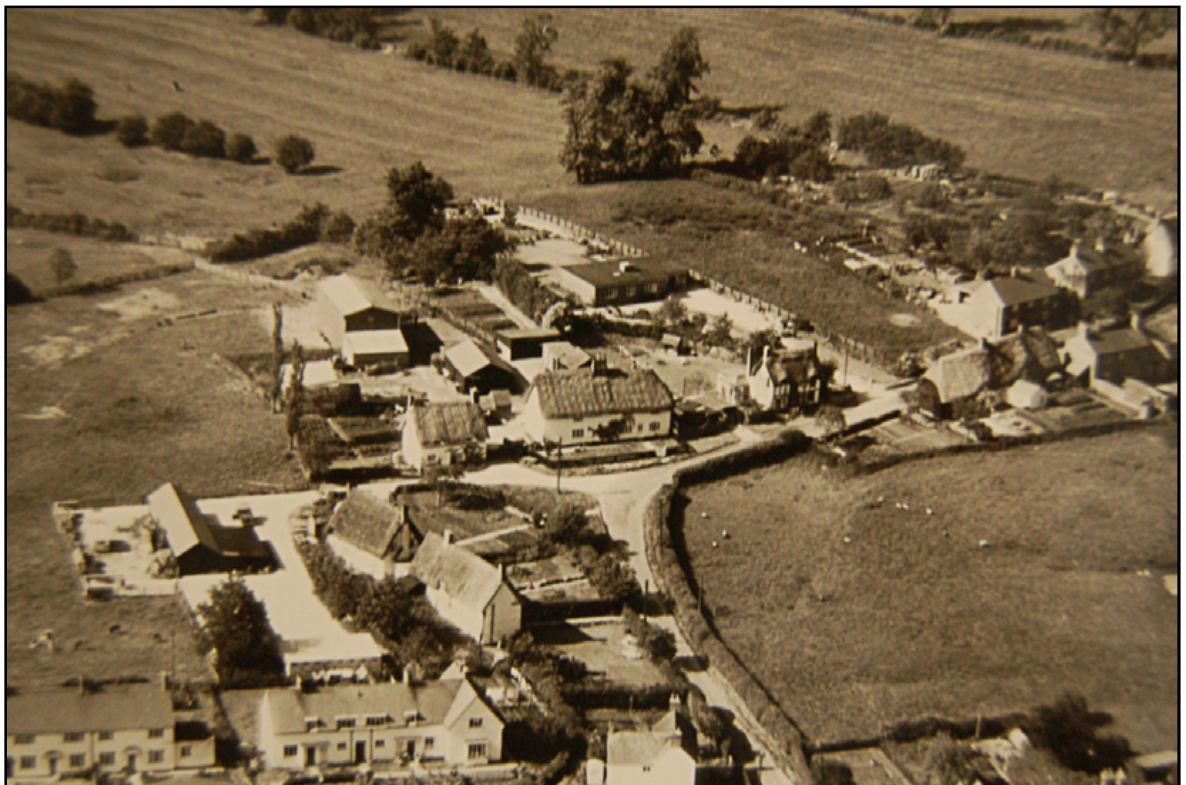
Mid 20th-century aerial photograph showing Sunny Hill Farmhouse Fig 6

The farmhouse appears in one of a series of aerial photographs taken between 1955 and the mid 1970s of Padbury and several other Buckinghamshire towns and villages. There are no visible or obvious changes between what was present during this survey and what is shown in the photograph.

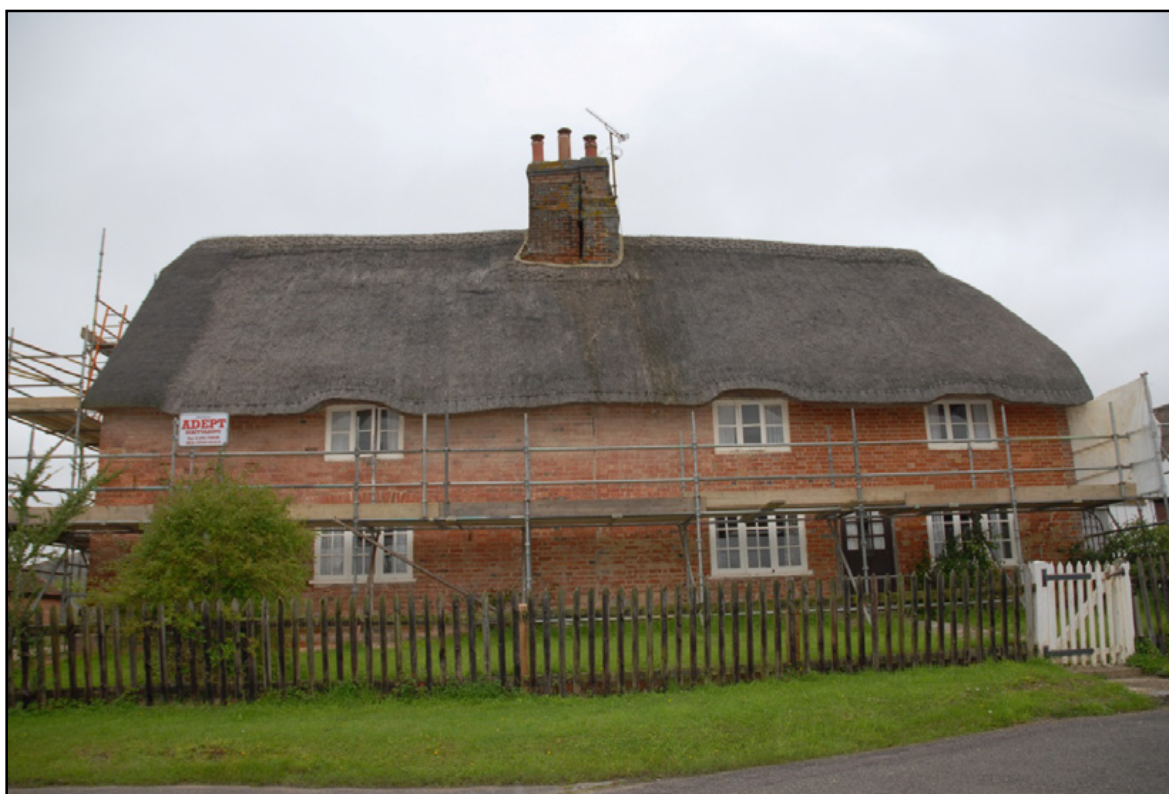
The southern elevation showing the central join Fig 8

The farmhouse shows evidence of having previously been divided into two distinct areas. Externally, opposing joins running from the eaves to the ground can be seen on both the north and south elevations. These joins align with the vertical division of the chimney, central to the structure. There is a noticeable change in roof structure on the north side of the building where the thatch steps down by approximately 1m (Fig 12). As discussed above, this change in roof structure is also visible from within the attic. The chimney structure as viewed from within the Attic consists of two separate, abutting flues. Externally they both appear to be brick-built, however, the western chimney is stone-built, changing to brick where it rises above the thatch (Figs 8 and 67). The division of the structure can be seen in the 1880 Ordnance Survey map (Fig 5). It is unclear if the two areas of the building had differing functions such as domestic and working. A single

A three light window each of six panes, two fixed and central light side hung, is built into the southern wall (Figs 8 and 70).

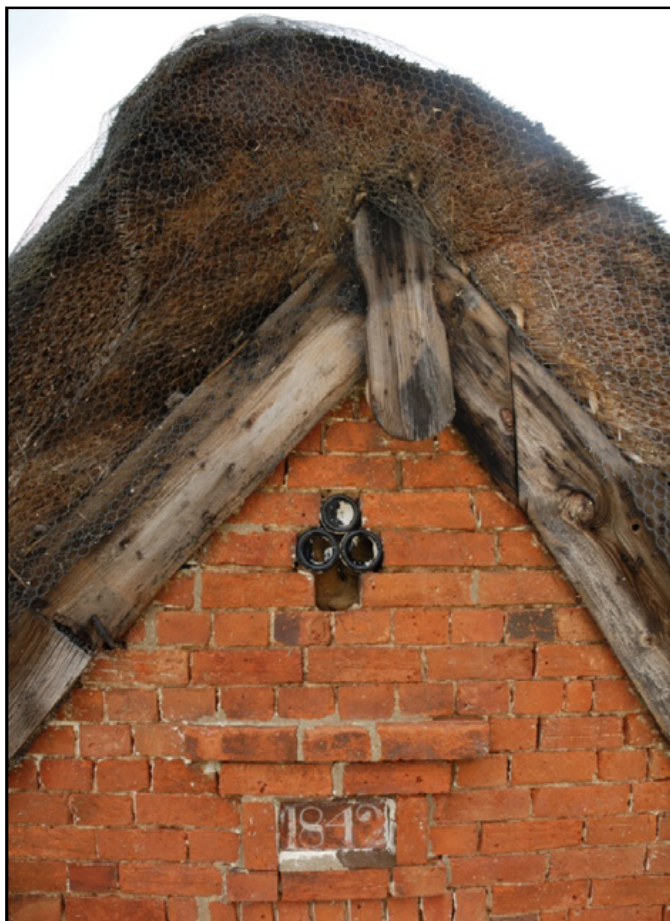
Western gable, decorative element with "1842" written beneath Fig 11

The main (southern) facade of the structure as well as the upper portion of the western gable and the eastern elevation were re-built in red brick in 1842. A decorative element with "1842" written is present below the ridge on the west elevation (Fig 11). An existing ground floor partition which is to be removed as part of the works, appears contemporary with the original construction of the farmhouse (see page 27). This wall shows evidence of multiple alterations both modern and 19th-century including the addition of a partition which divides the Bathroom and Dressing Room (Figs 16 and 42). A further alteration of unknown date, though earlier than the 1842 works, is visible in the partition in the form of a panel of brick with timber bond (Figs 44, 45 and 69). This brickwork was partially demolished to allow the insertion of the 1842 brickwork (Figs 44, 45 and 69). The whole partition was thickened in the 20th-century by a layer of breeze block, plastered and wallpapered over.

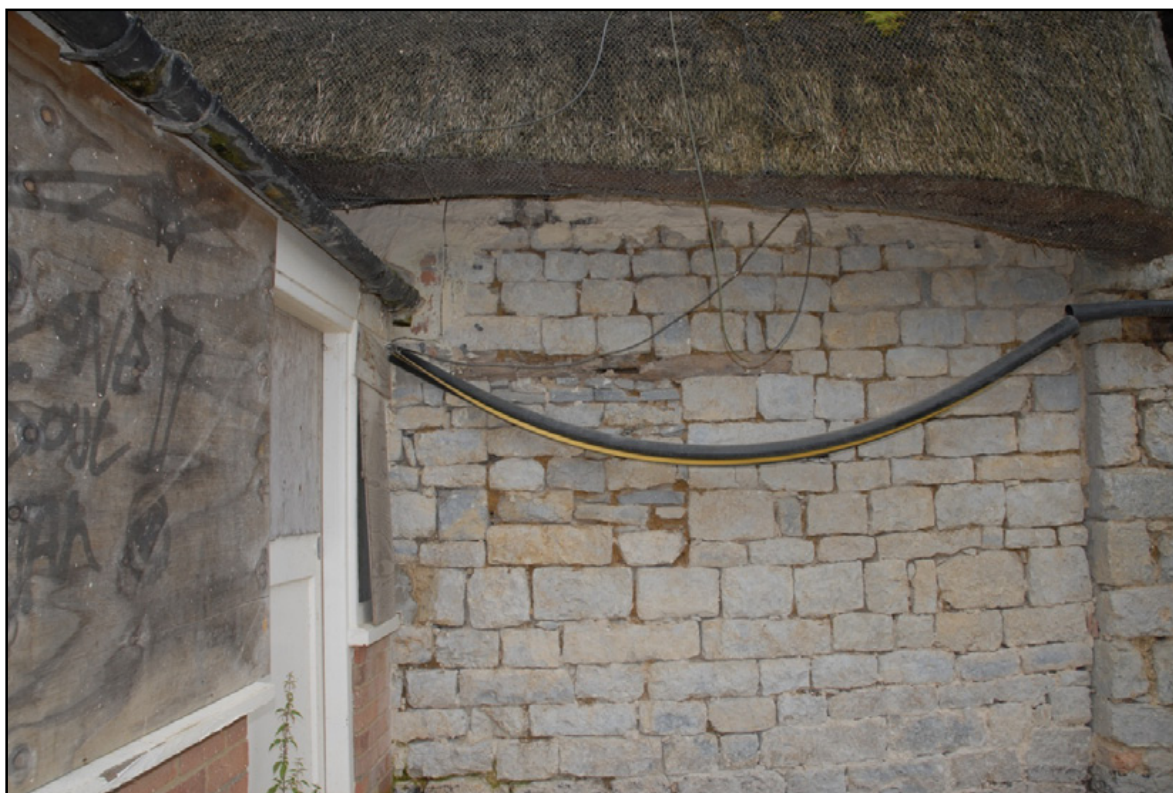
The blocked window Fig 13

blocked window was noted on the northern elevation, to the east of the existing door (Figs 13 and 70).

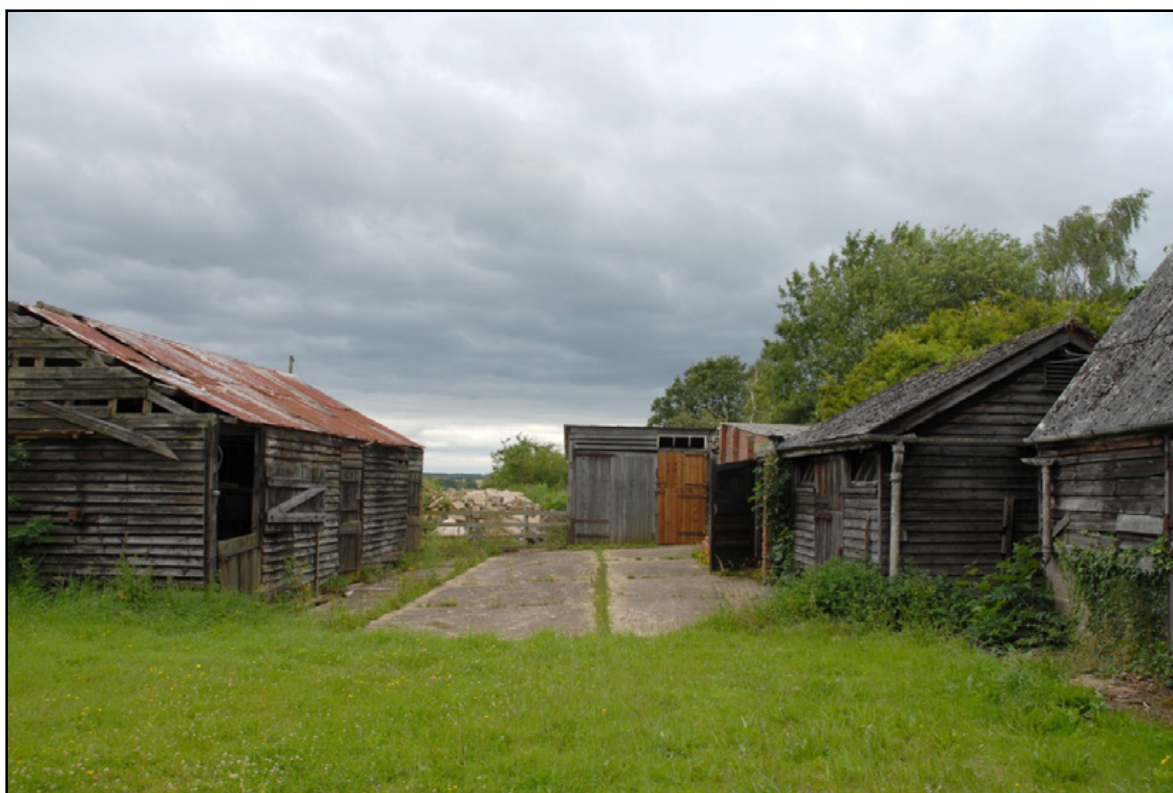
The farmyard and associated structures Fig 14

The building is a two storey 17th-18th-century farmhouse with an attic. It comprises an earlier, roughly coursed stone-built and thatched structure with later brick-built facades dated to 1842. A modern brick garage has been constructed against the eastern corner of the northern elevation (Figs 12 and 17). The main access is via the southern, street facing elevation with a secondary entry via the garage and a door in the north elevation. A lawn surrounds the front and sides of the building, with a short wooden fence where it meets the road (Fig 8). The north elevation faces a concrete yard surrounded by modern structures. The farmyard comprises mainly modern structures such as sheds and barns, though a small shed or animal shelter is of a 19th-century origin (Figs 14 and 15).

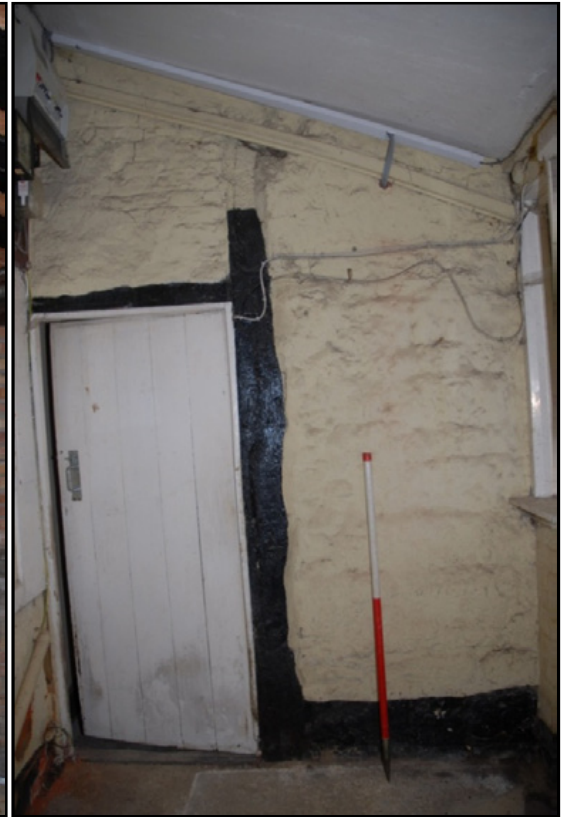
The south wall of the Lobby Fig 19

This area, c3m by 1.6m, provides covered passage between the Garage and the Kitchen (Fig 16). There are three doorways providing access to the Garage, the yard and the Kitchen. The southern doorway to the hall appears to be part of the older, pre 19th-century structure. The doorway is built into a stone rubble wall and is flanked by a black painted timber beam and topped with a black painted timber lintel (Fig 19).

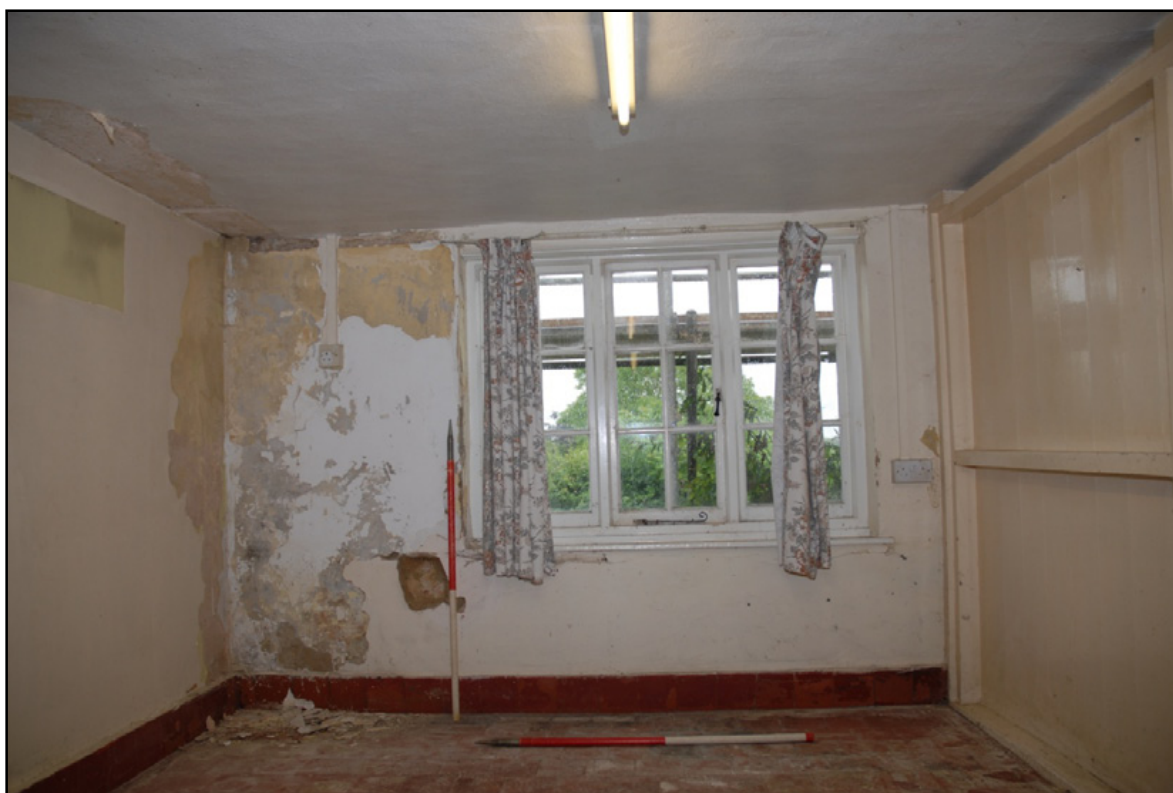
The south wall of the Dining Room Fig 23

An off centre, three light window each of six panes, two fixed and central light side hung, is built into the southern, brick built, 19th-century wall (Fig 23).

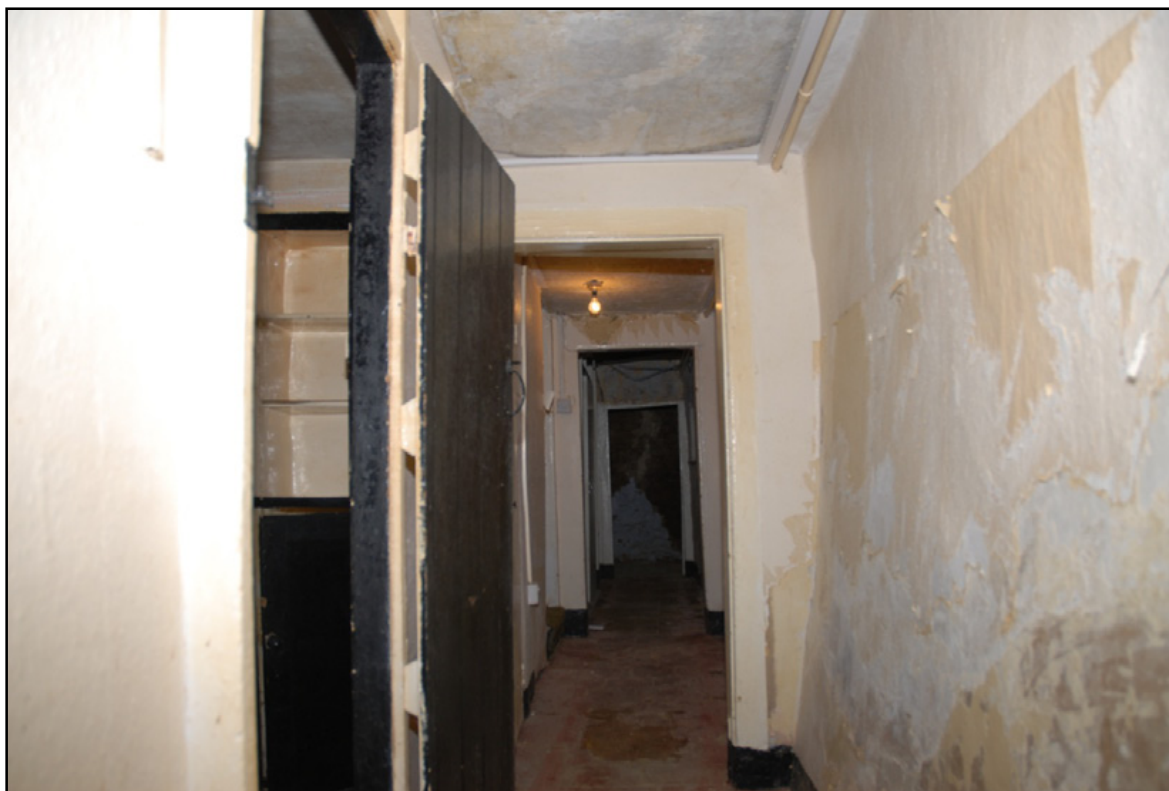
View down the Corridor, looking west Fig 25

A door midway along the north wall, opposite the entrance to the staircase, opens onto the north courtyard. The Corridor was once divided into two by a door to the west of this area (Fig 25). This division of the corridor seems to align with the division of the building as a whole.

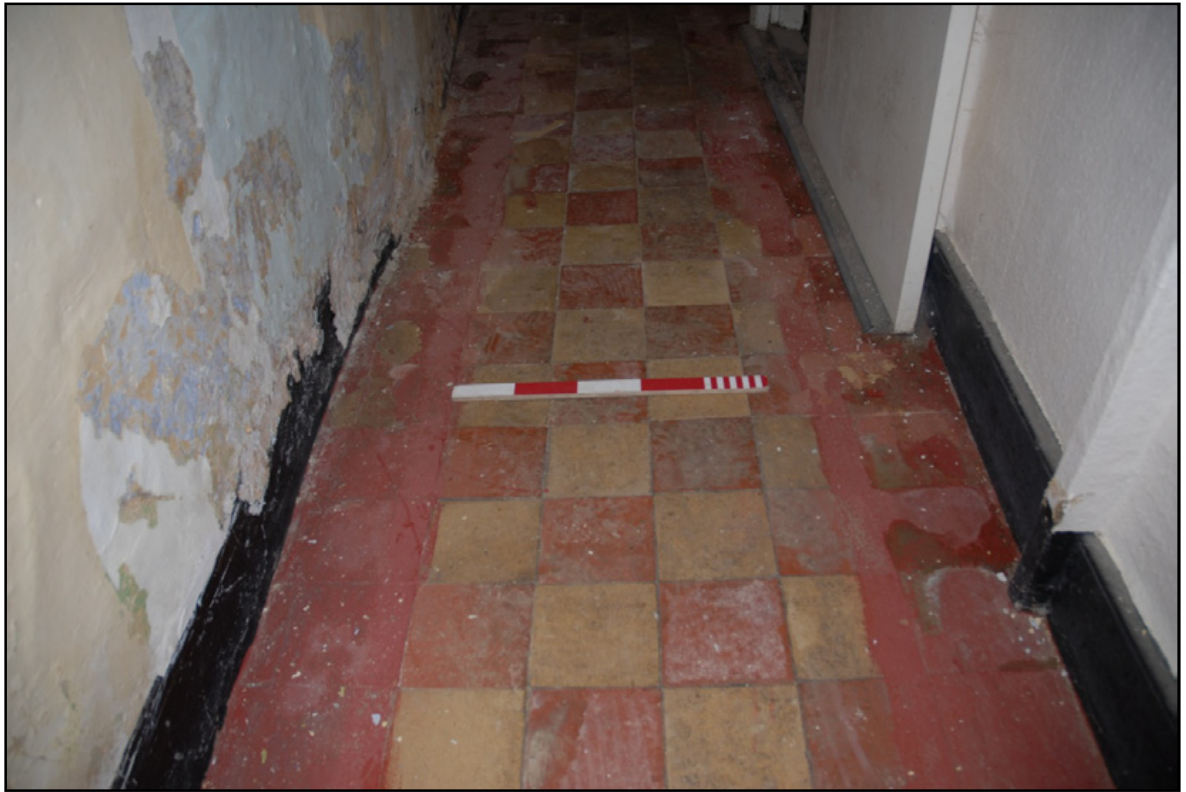
The tile floor in the Corridor Fig 26

A 19th-century floor of red and yellow tiles bordered by red tiles remains along the extent of the corridor (Fig 26).

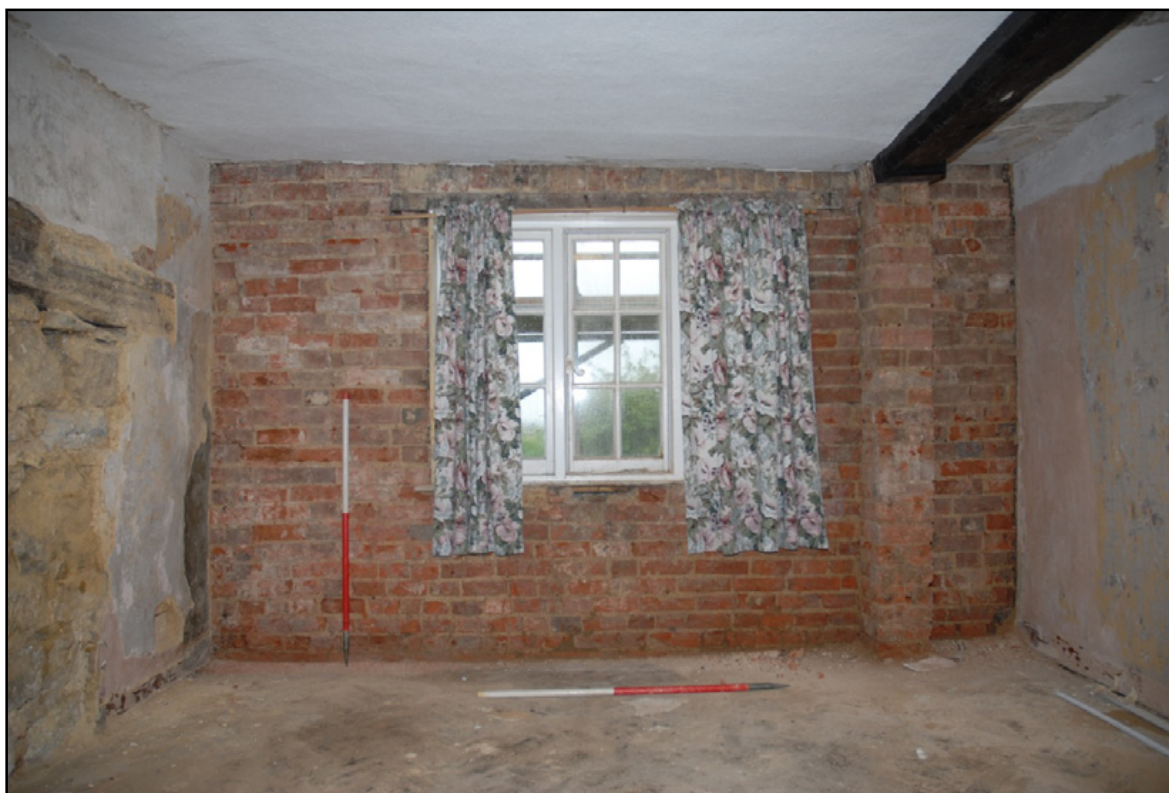
The south wall of the Sitting Room Fig 33

A black painted beam runs from the north outer wall, across the north corridor to the south wall of the Sitting Room where it rests atop a short brick plinth which abuts the front wall (Figs 33 and 34). Prior to the 19th-century alterations, this beam would have been secured within the original stone wall. The south end of the beam was then cut back to accommodate the thinner brick wall. Laths, possibly from the partition on the first floor, extend through the ceiling and are nailed to the beam where it sits on the plinth.

A three light window each of six panes, two fixed and central light side hung, is built into the southern wall (Fig 33).

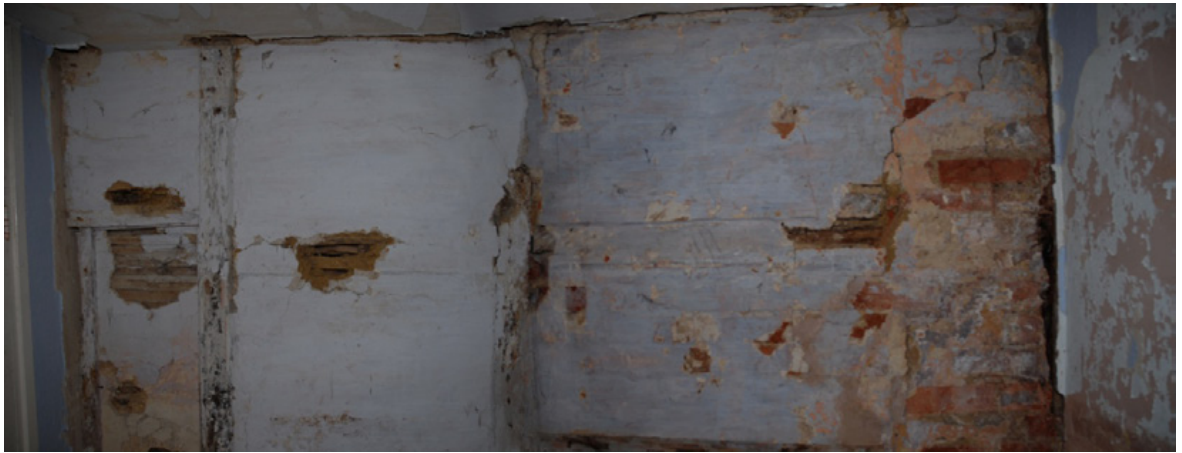
Composite of the east partition within the Dressing Room Fig 35

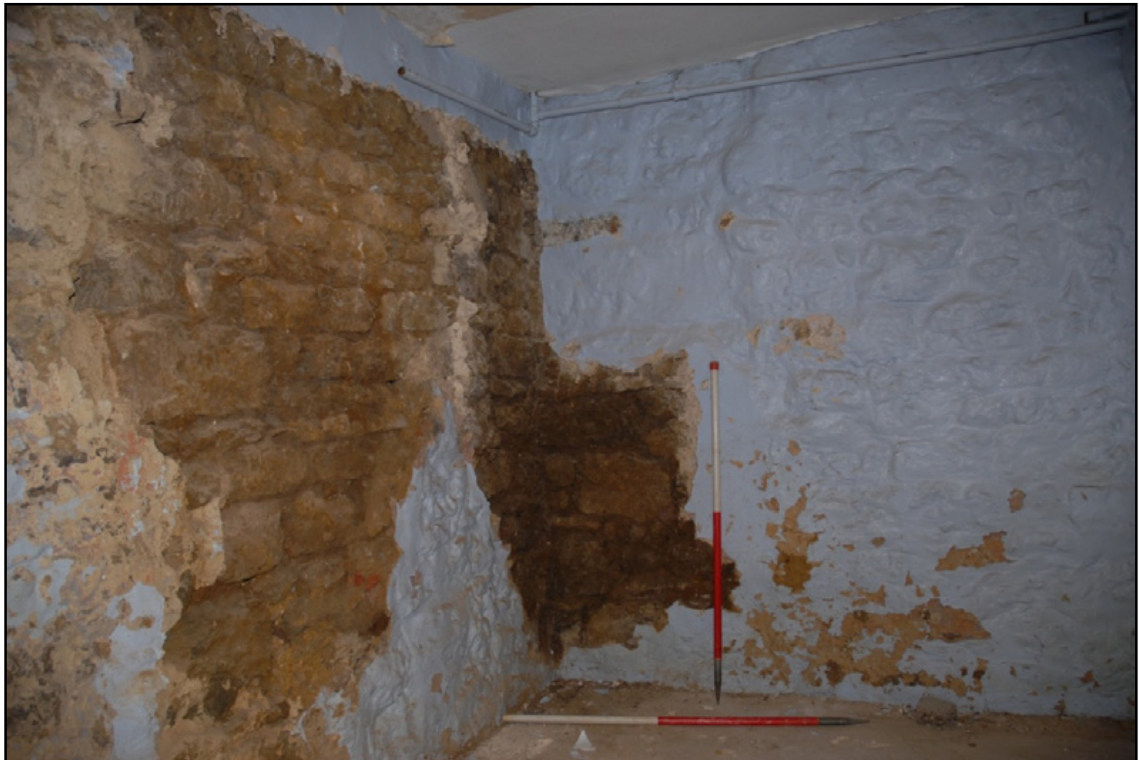
Composite of the east partition within the Bathroom Fig 36

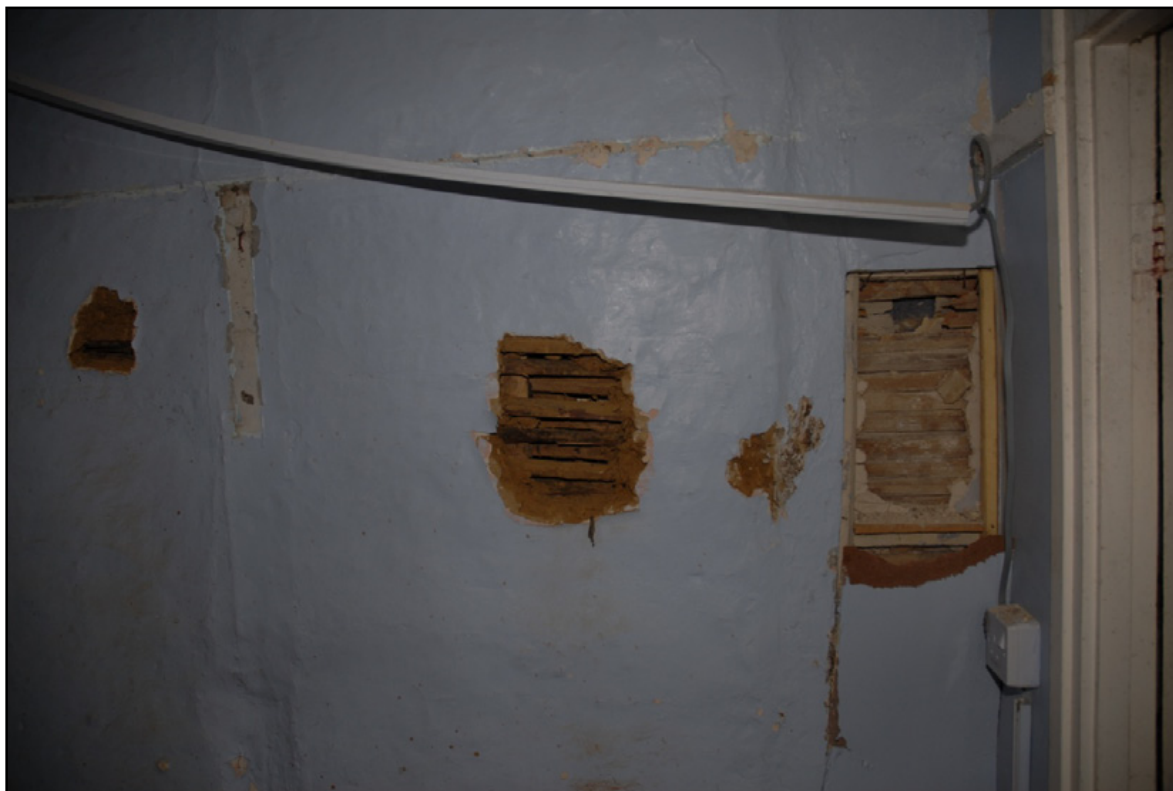
The north and west walls of the Dressing Room Fig 37

The western wall which runs the length of both the Bathroom and Dressing Room is of stone rubble, plastered internally and painted blue (Fig 37). A deep two light window with splayed reveals and timber lintel is positioned centrally to the western elevation (Figs 39 and 42). The partition between the Bathroom and Dressing Room divides this window at the former mullion. It is constructed of lath and plaster covered in blue painted woodchip wallpaper. A panelled door in the partition provides access between Bathroom and Dressing Room (Fig 41).

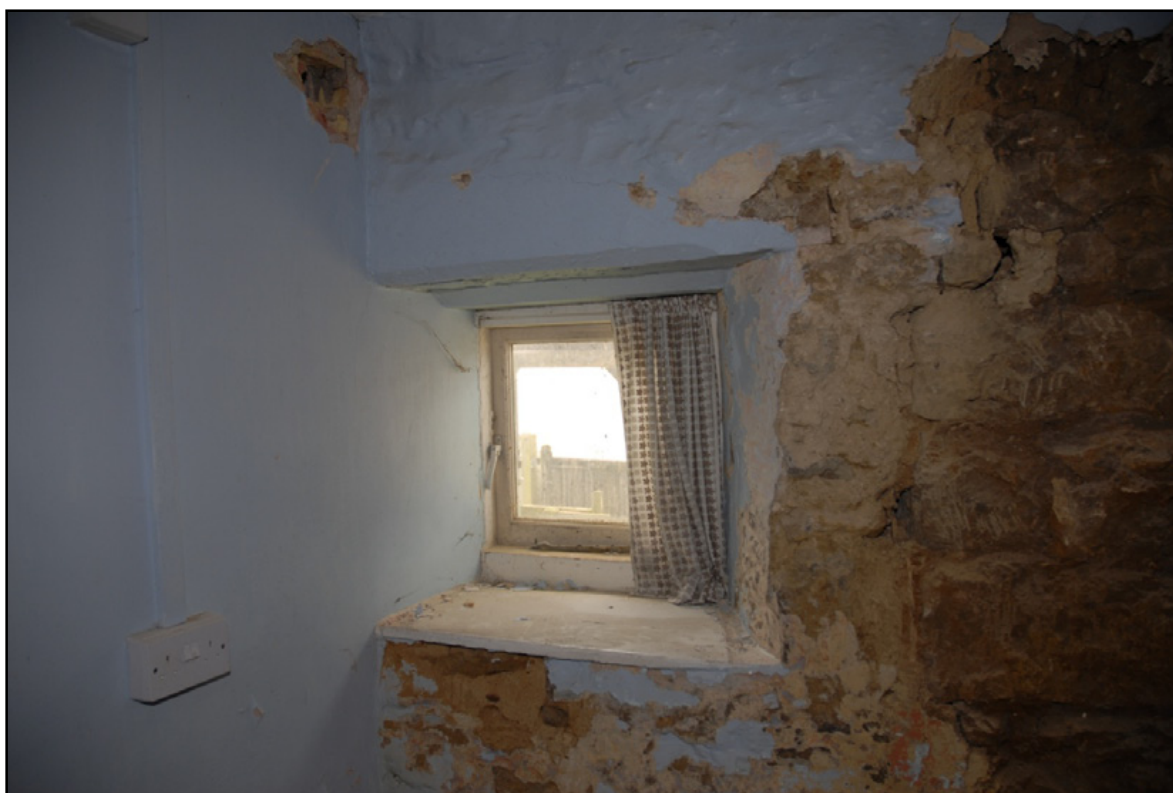
Detail of the fabric in the east partition in the Dressing Room Fig 38

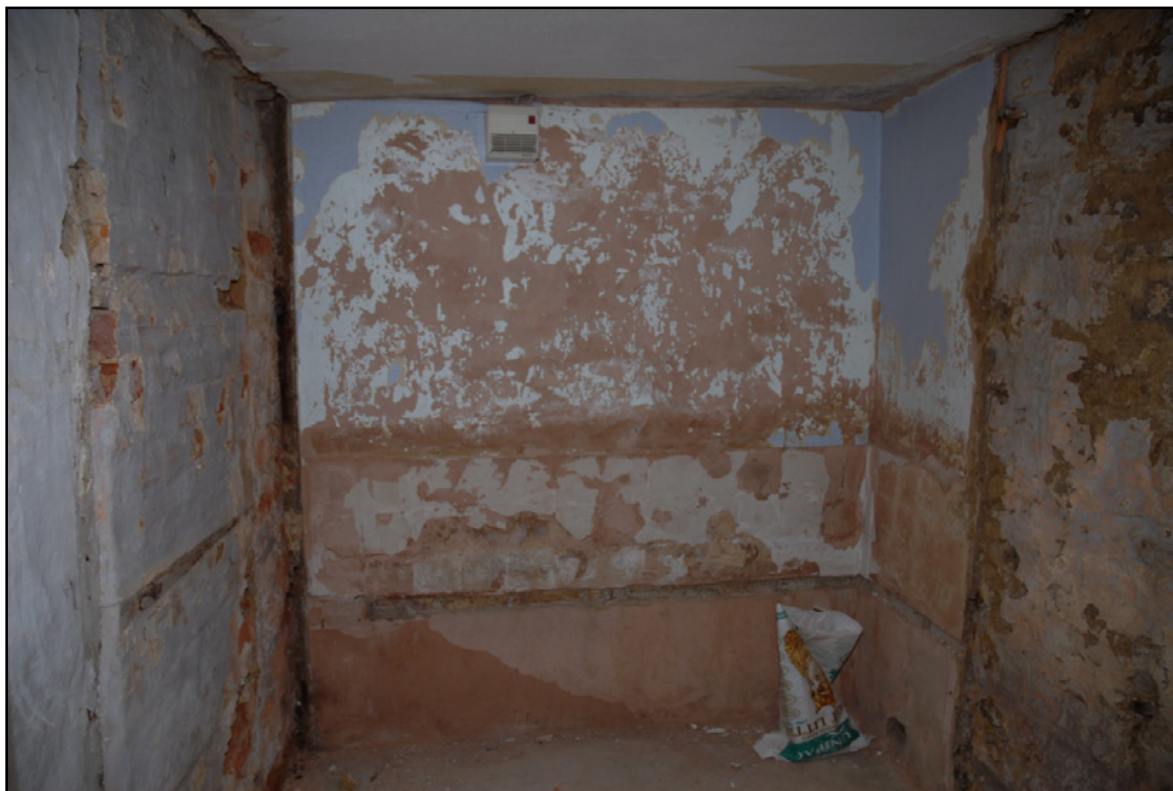
The window in the Dressing Room Fig 39

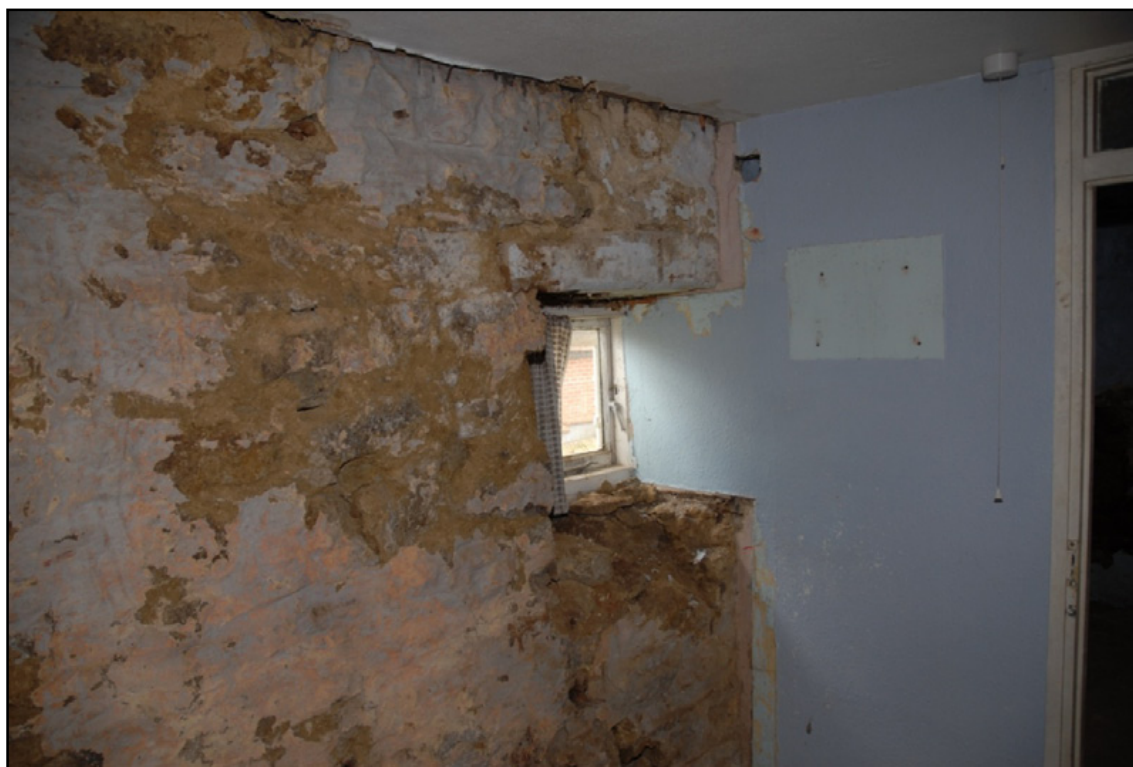
The central partition looking through into the Dressing Room Fig 41

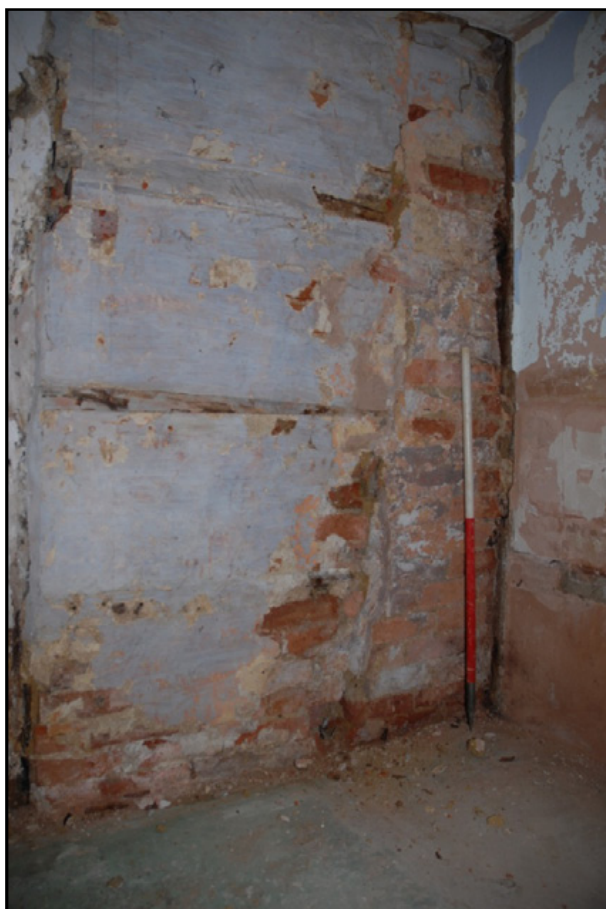
The window in the west wall of the Bathroom Fig 42

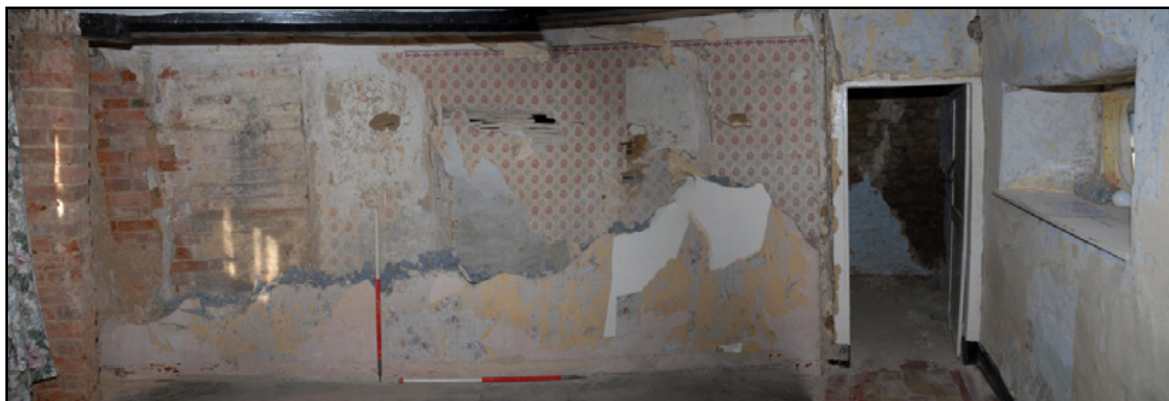
The east partition wall abutting the south wall in the bathroom showing timber bond Fig 43

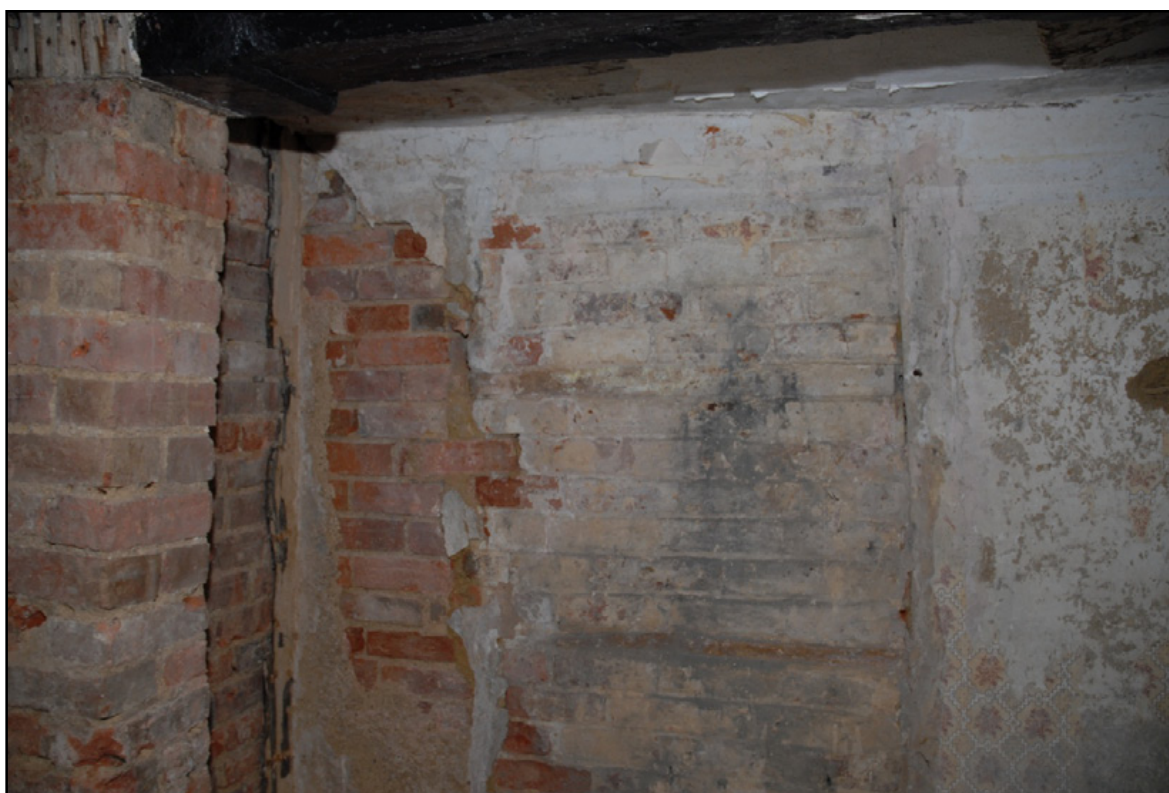
The east face of the ground floor partition (photo composite) Fig 44

The whole wall was later thickened by the construction of a breeze block wall with nails driven into the underlying timber studs. This was plastered over and wallpapered (Fig 44).

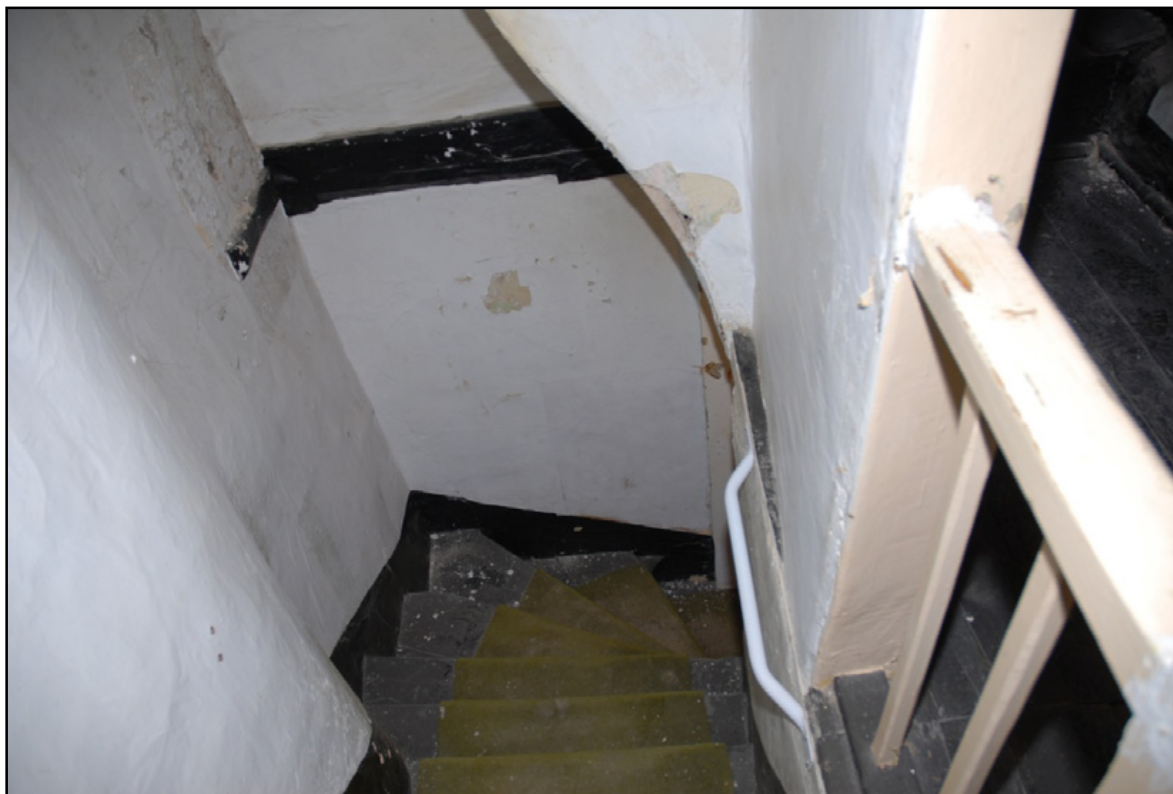
The staircase with chimneys to the left Fig 47

The first floor is accessed via a staircase located to the north of the central chimneys (Fig 46). The entrance to the stair is opposite the ground floor entrance in the north Corridor. It turns a 90 degree angle to the east to meet the first floor landing. A black painted skirting board runs the length of the stair. The north of the eastern chimney structure juts out slightly into the staircase (Fig 47). A white painted wooden banister is present at landing level on the first floor.

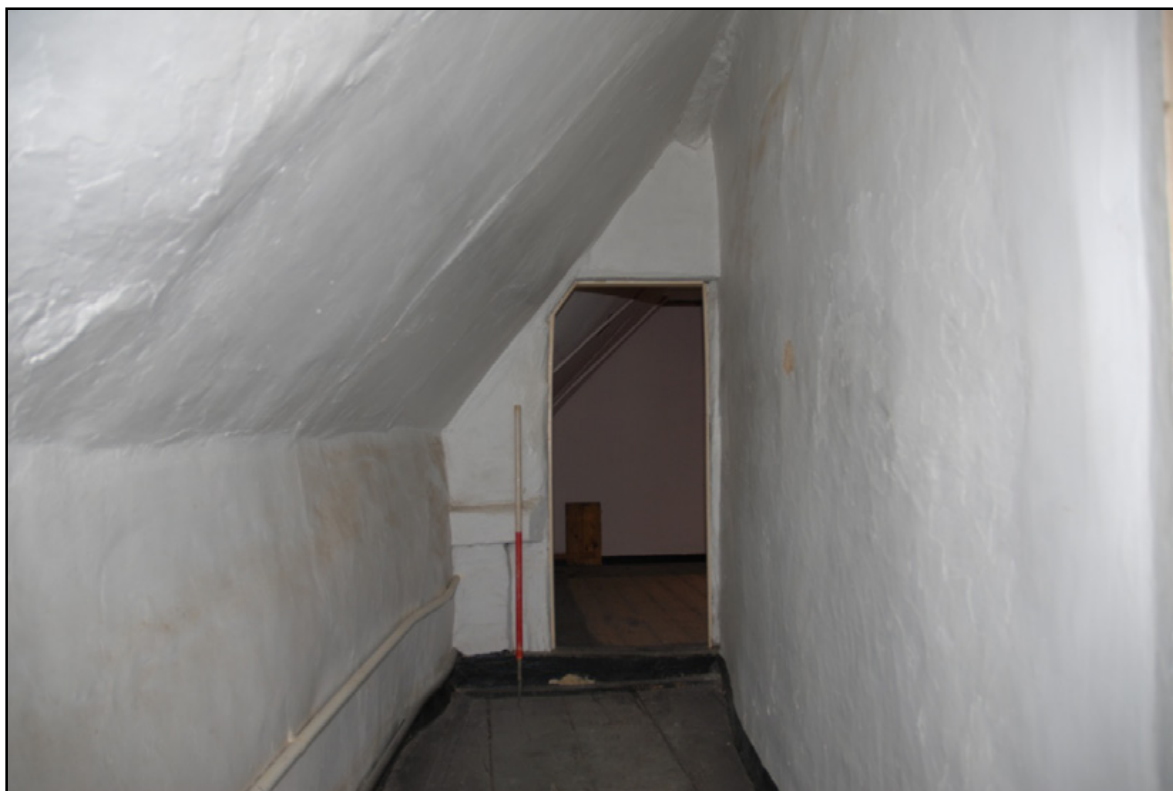
The first floor corridor, looking east Fig 48

Providing access to all the rooms on the first floor as well as the attic, the Corridor is approximately 8.5m in length. The width of the Corridor varies but has a general narrowing towards the west from c 1.2m at the east to 1.0m at the west. The north wall of the Corridor is undulating and leans inwards at the top, dramatically so at the eastern end, reflecting the eaves which start lower down in this area (Fig 48).

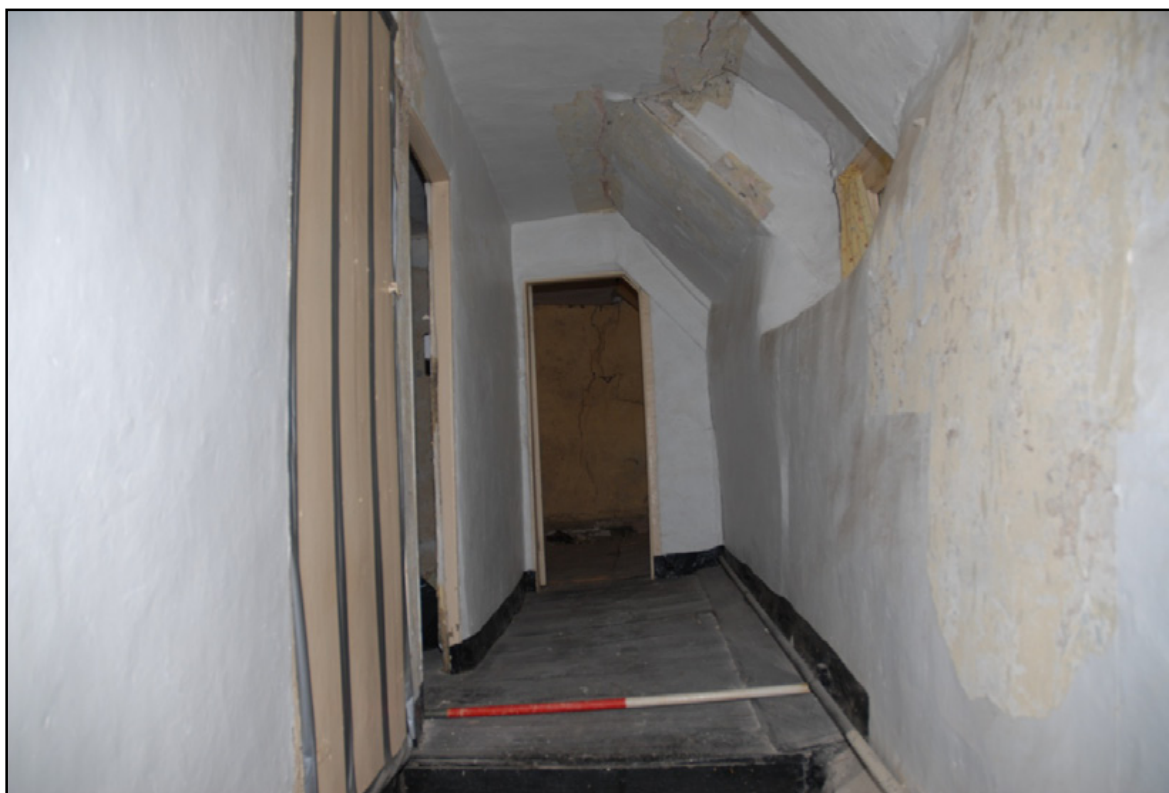
The first floor corridor, looking west Fig 49

Black painted timber skirting boards run the length of the Corridor above the uneven floor boards. The level of the Corridor steps upwards by 0.25m immediately to the west of the stairs to the attic (Fig 49).
