Building recording at Sunny Hill Farmhouse  
Old End, Padbury, Buckinghamshire  
July 2012

Report 12/138

**BUILDING RECORDING AT  
SUNNY HILL FARMHOUSE  
OLD END, PADBURY  
BUCKINGHAMSHIRE  
JULY-SEPTEMBER 2012**

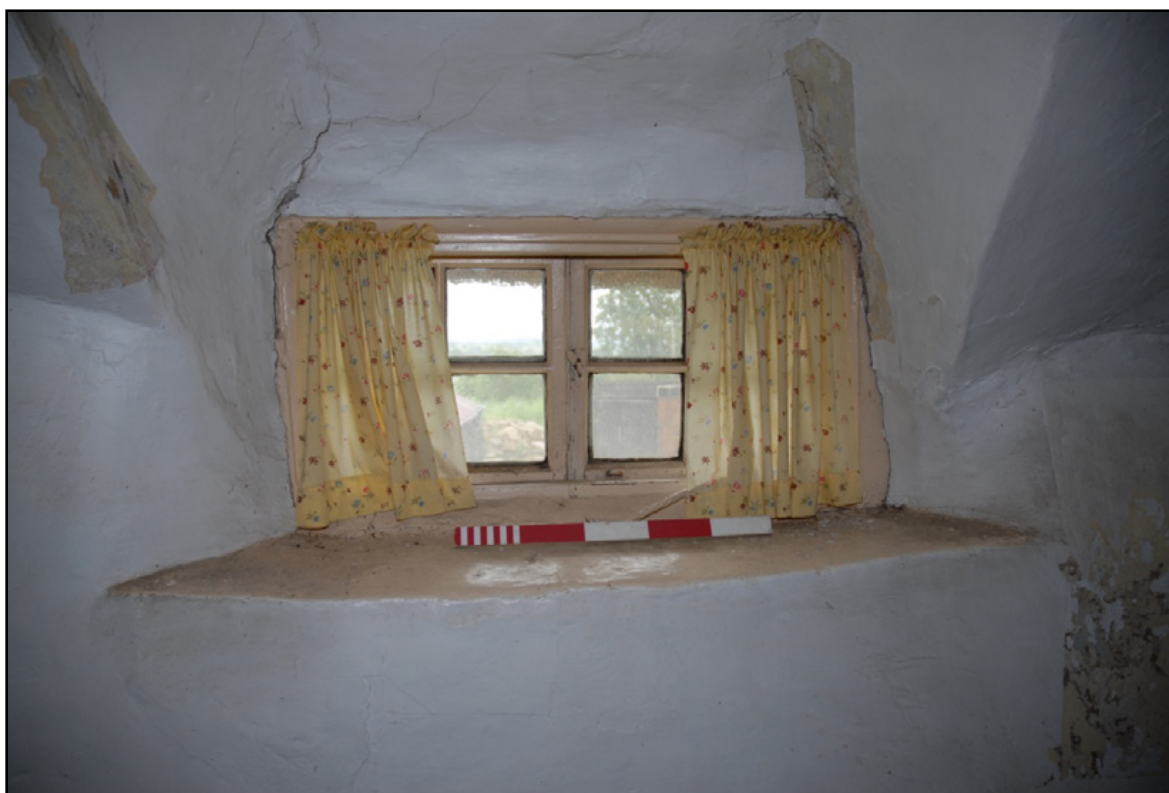
The window in the north wall of the first floor corridor Fig 50

There is a deep set, two light window, each of four panes with splayed reveals in the north wall, at eaves level (Fig 50).

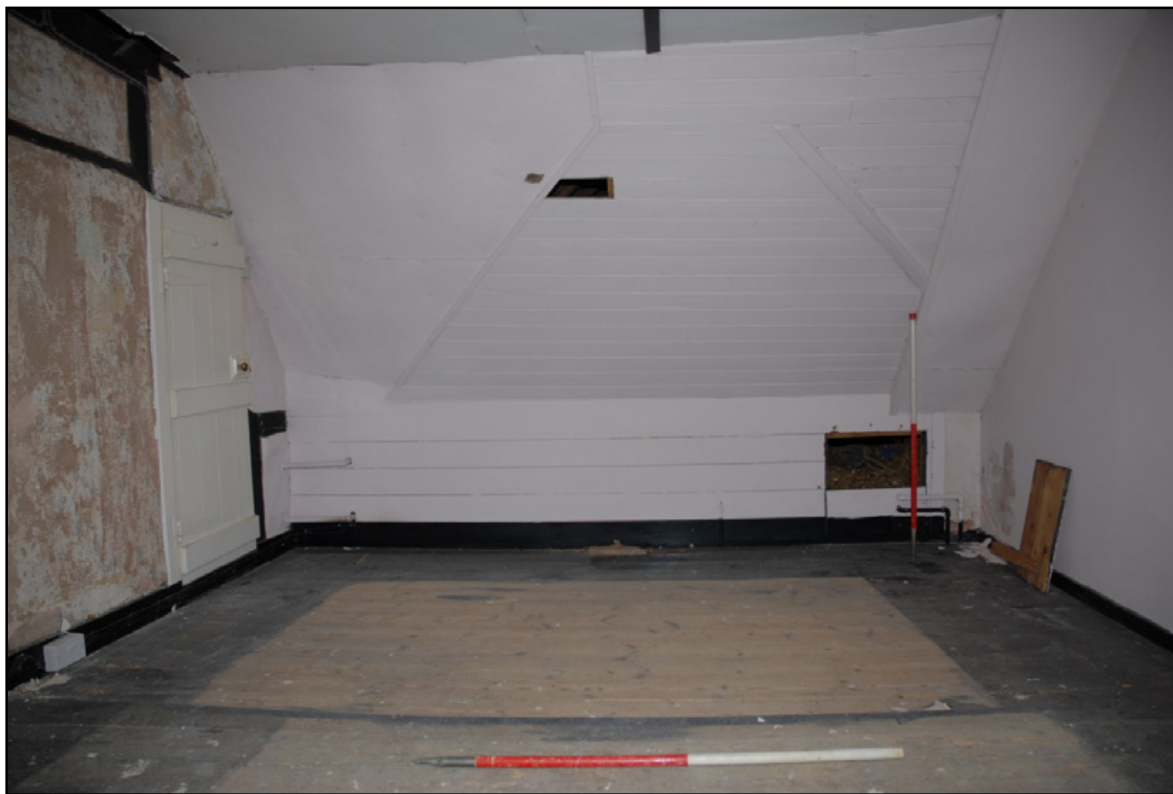
Bedroom 1, looking north showing the stepped floor Fig 51

Measuring 3.7m by 5.1m, Bedroom 1 encompasses the eastern end of the farmhouse (Fig 46). The north of the room is separated from the chimney and modern garage by a stud partition (Figs 20 and 51). This space is accessible by a small hatch in the stud partition. The partition slopes inwards from a height of 0.7m, reflecting the slope of the hatch behind.

Access to the room is via a white painted plank and batten door with strap hinges in the western wall (Fig 51). This wall is of lath and plaster wallpapered over. A timber, showing signs of reuse in the form of defunct lap joints, remains within the wall (Fig 53). In the attic, a partition can be seen extending upwards through the ceiling and up into the roof space, positioned above this wall (Fig 68). Several of the beams in this partition descend through the ceiling level and can be seen in this wall (Fig 53, *See The Attic*).

The room has a floor of wood boards running east-west. The floor level drops by approximately 500mm in the north half of the room. A wooden step runs the width of the room level with the eastern window (Figs 46 and 51). The purpose of this step is uncertain, perhaps relating to a former use of the building contemporary with the trap door in Bedroom 2. The floorboards in the centre of the room retain a cleaner colour than the edges of the room indicating a former square carpet. Black skirting runs the full length of the room.

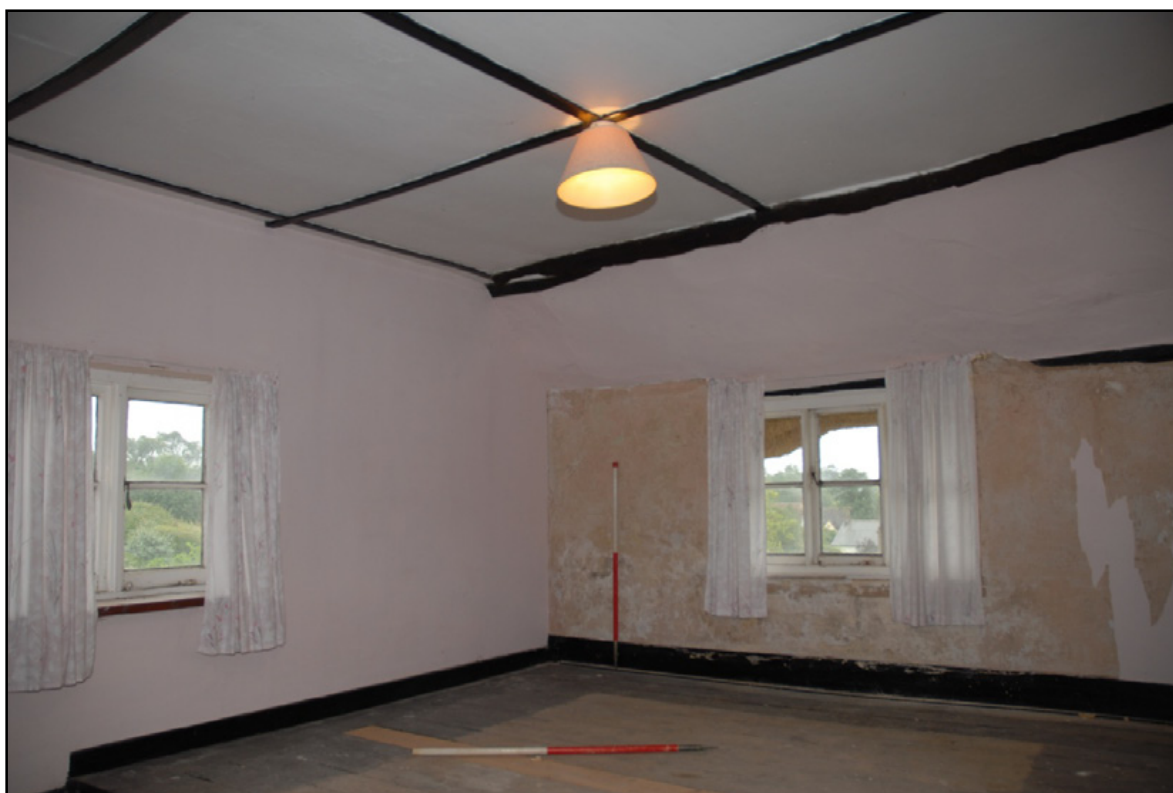
Bedroom 1 showing the timber frame in the ceiling, looking south-east Fig 52

The south wall is of red brick, constructed in 1842. A three light window with two panes each is built centrally in the wall (Figs 52 and 70). The brick portion of the wall gives way to lath and plaster where it meets the slope of the roof at the top of the window (Fig 54).

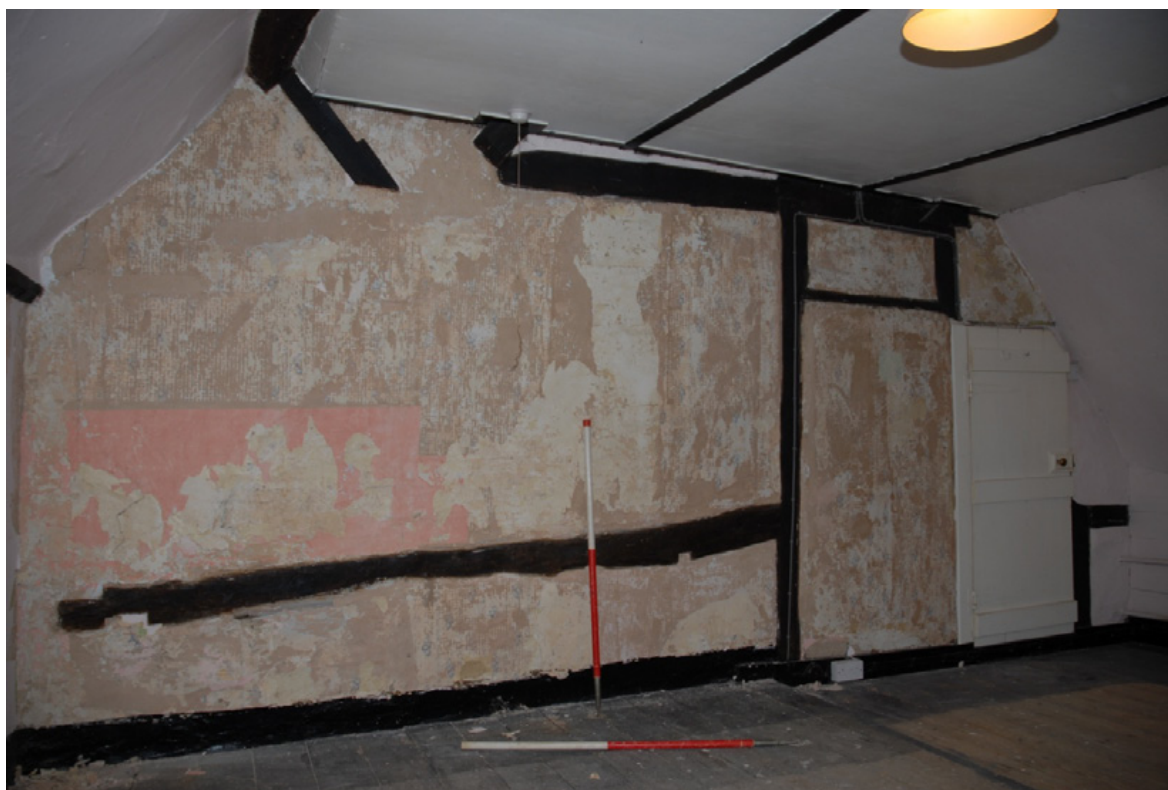
The west wall of Bedroom 1 showing the timber frame and defunct lap joints in the horizontal timber Fig 53

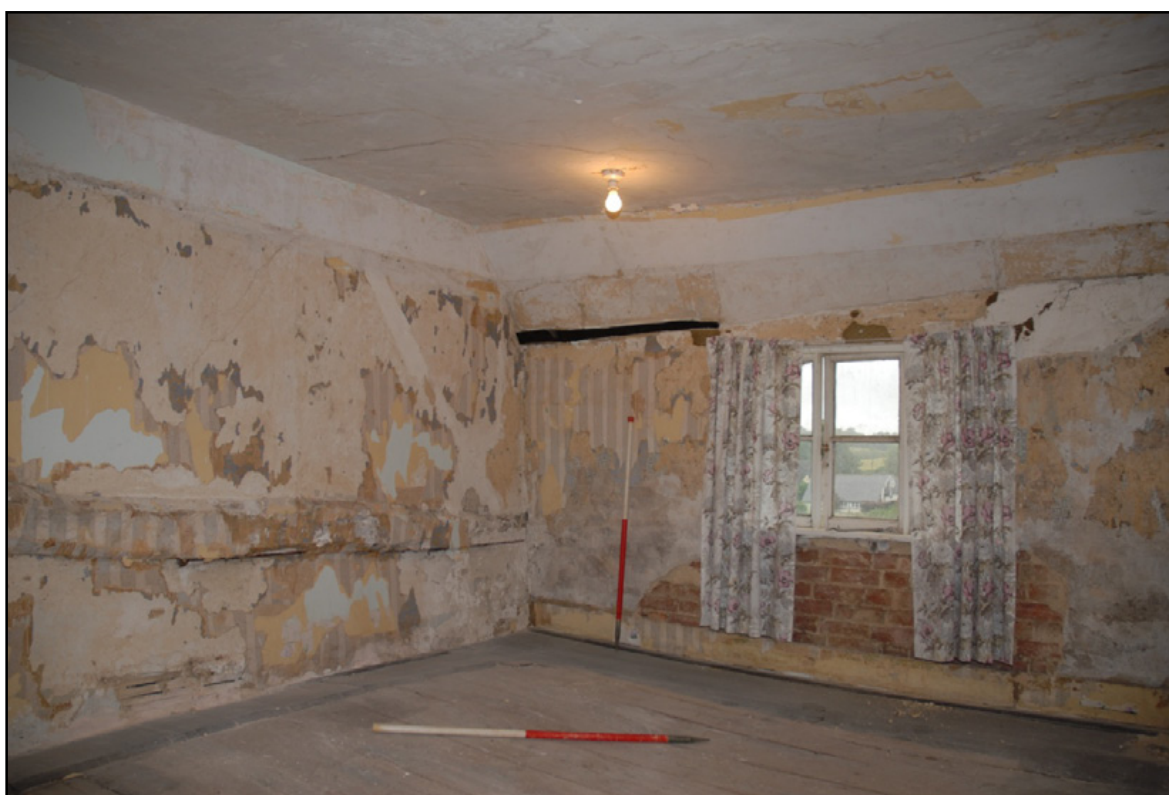
Bedroom 2, looking south-east showing the timber beam in the east wall Fig 54

This room has a very irregular shape with undulating walls and a floor that dips in the middle. The eastern wall is lath and plaster with a prominent timber beam running nearly the full width of the wall (Figs 54 and 56). The same beam can be seen on the eastern face in Bedroom 1. The north and western walls are also of lath and plaster wallpapered over.

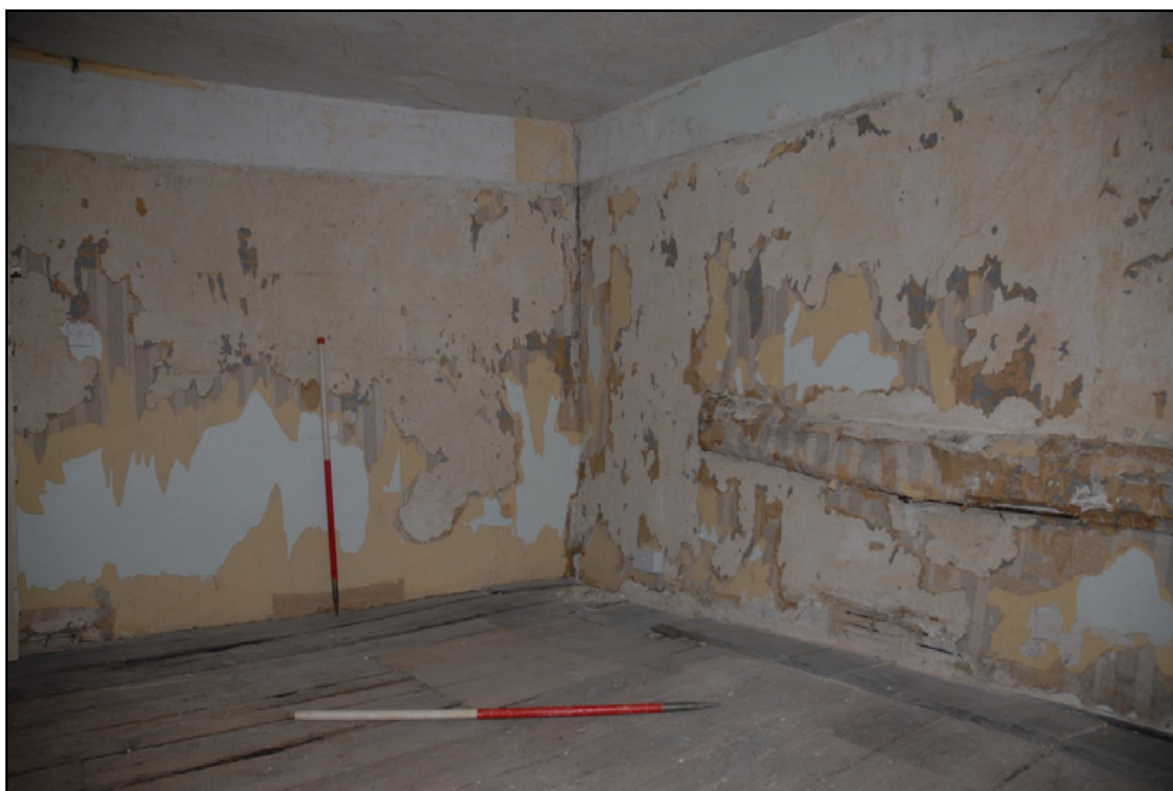
The north-east corner of Bedroom 2 showing the trapdoor and timber beam in the east wall Fig 56

The floor of the room is of uneven floor boards with an edge of chamfered boards where it meets the eastern wall (Figs 56 and 57). A trapdoor c 0.7 by 0.8m is set into the floor in the north eastern corner of the room (Fig 57). This is the upper access to the trap door seen in the ceiling of the Snug on the ground floor (Fig 29).

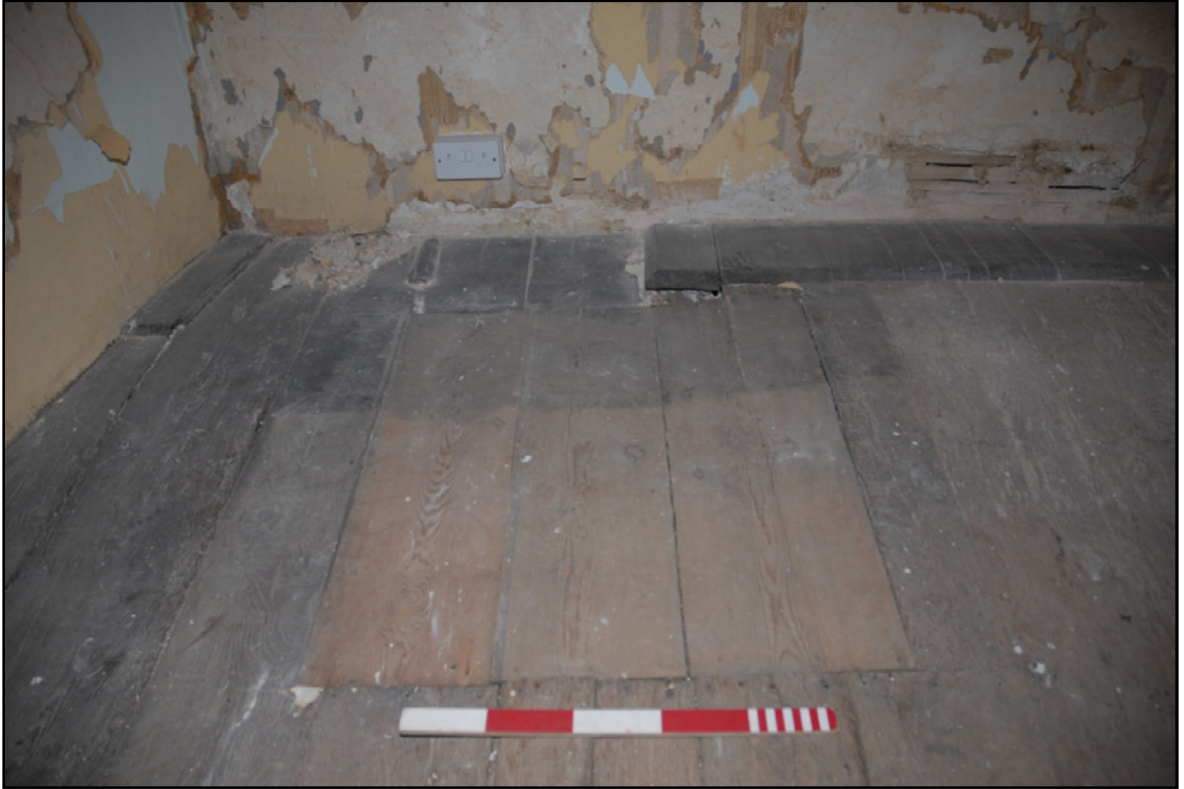
The trapdoor in Bedroom 2 showing the chamfered border Fig 57

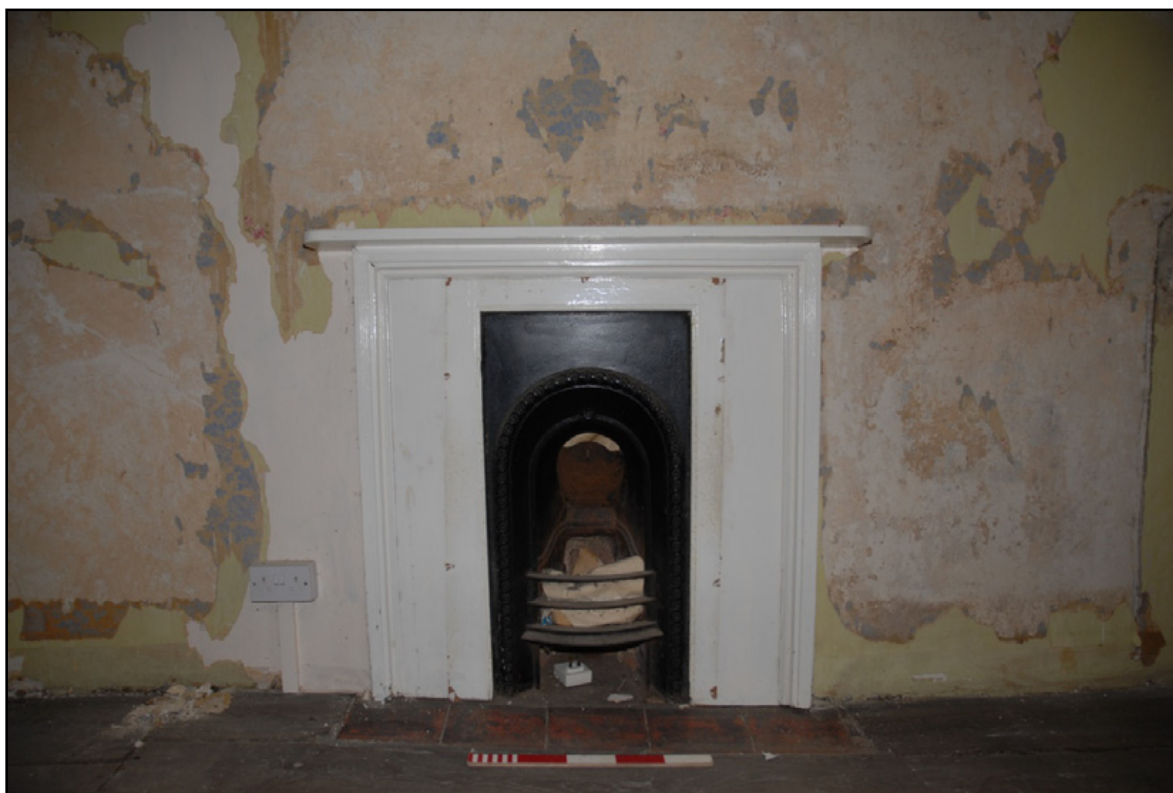
The fireplace in Bedroom 3, looking east Fig 60

This is the smallest bedroom, measuring 4.3m by 2.7m (Fig 46). It is accessed via a white painted plank and batten door with strap hinges in the north wall (Fig 58). A small, plain, 19th-century fireplace is built into the eastern wall. This has a white painted wood surround with a mantle shelf and a black painted iron grate (Fig 60). A hearth of square red tiles is level with the floor.

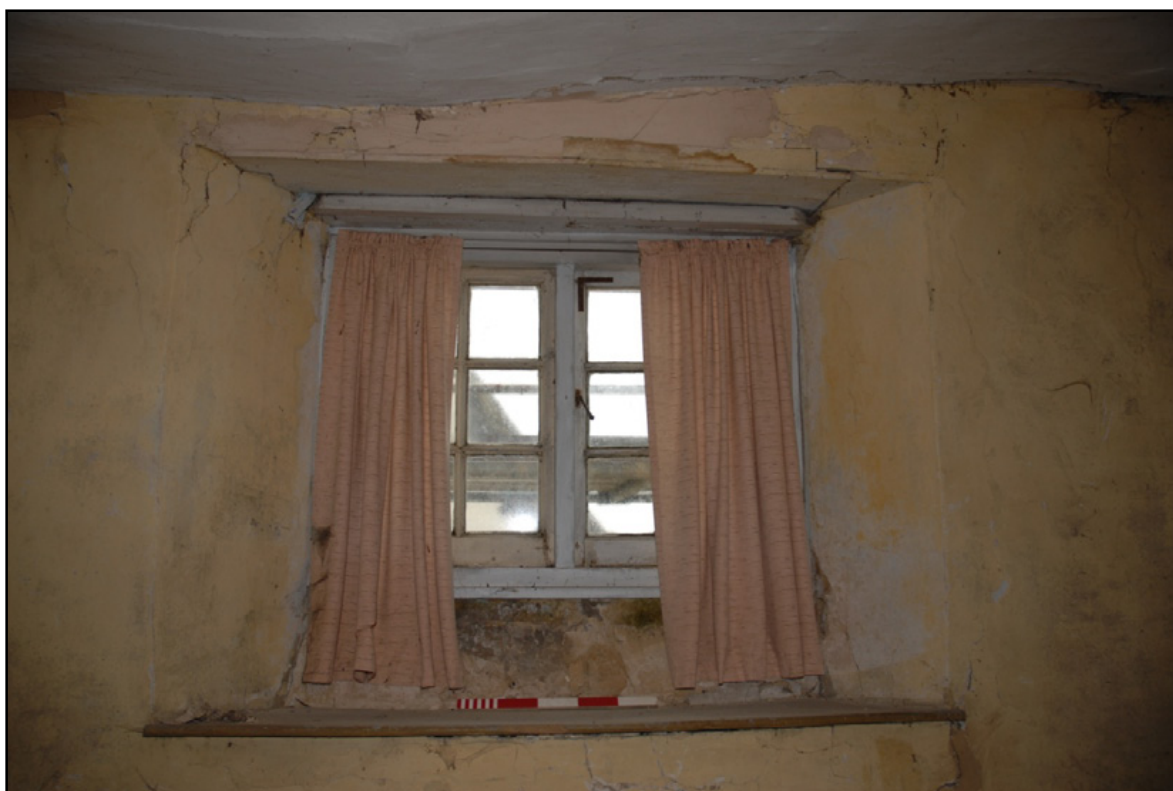
The window in the west wall of Bedroom 4 Fig 63

Bedroom 4 measures approximately 5.4 by 2.8m. The north and western walls are stone rubble, plastered and painted a yellow colour (Figs 61 and 62). The room is lit by a deep wooden framed two light window, each of six panes with splayed reveals and timber lintel and sill is in the middle of the western wall (Fig 63).

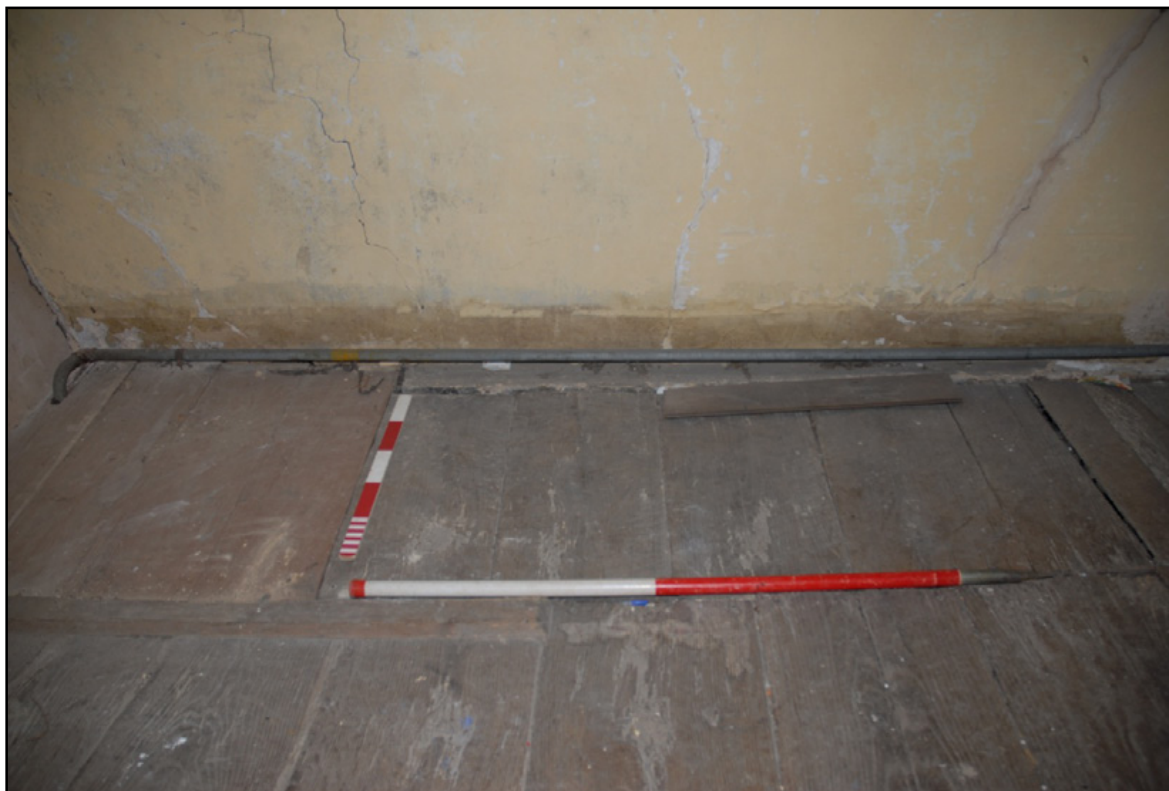
The raised floor boards at the north end of Bedroom 4, with trapdoor to the left Fig 64

The floor, which is of rough, uneven floorboards running north-south, dips towards the centre of the room from the north and south walls. Two strips of boards, sloping upwards from floor level are present against the north and south walls. A squared trapdoor roughly 0.8m by 0.8m is built into the north-west corner of the room (Fig 64). It is unclear whether this trapdoor originally went through to the room below as no evidence of it can be seen in the ceiling of the ground floor Dressing Room.

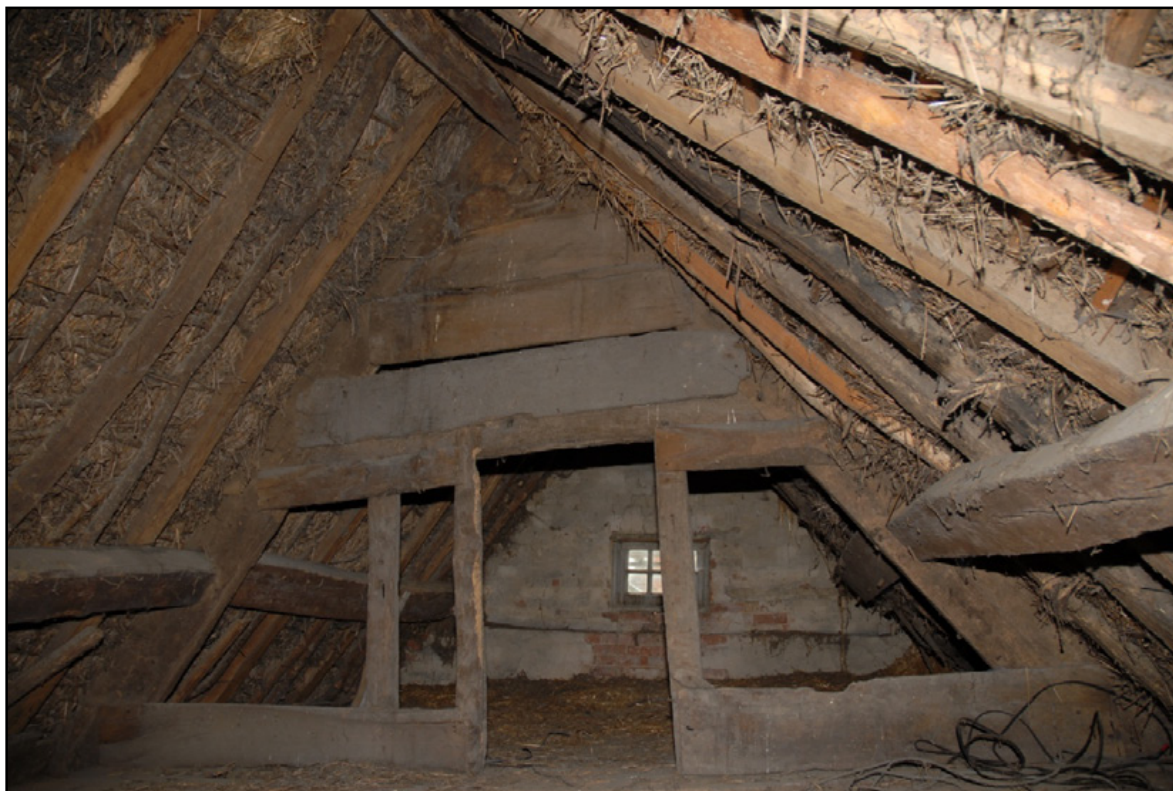
The modified queen post truss, looking west toward the west gable Fig 65

A modified queen post truss supports the roof structure at the west (Figs 65, 66 and 69). It comprises three upright timbers supporting a straining beam between the principal rafters. Two purlins pass through the principal rafters either side of the truss. The upper extent of the truss is covered by flat timber boards fixed to the principal rafters above the straining beam. Several of the timbers show signs of re-use.

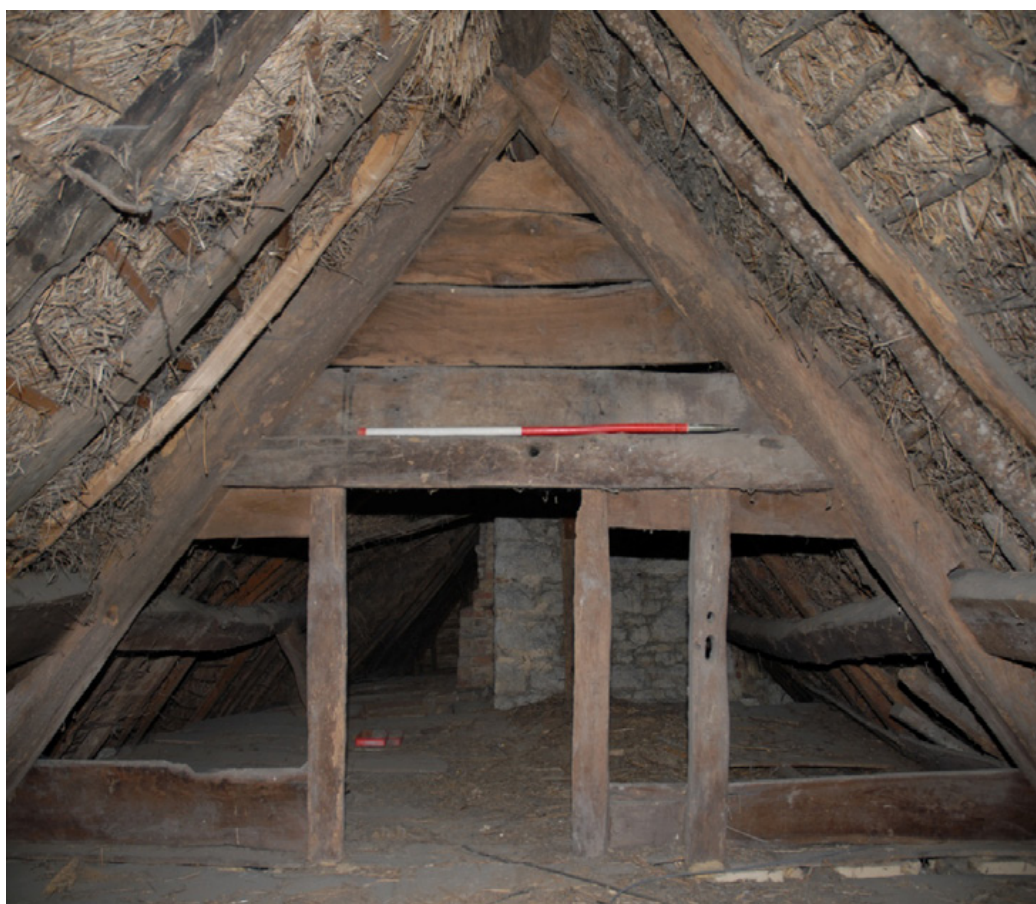
The modified queen post truss, looking east Fig 66

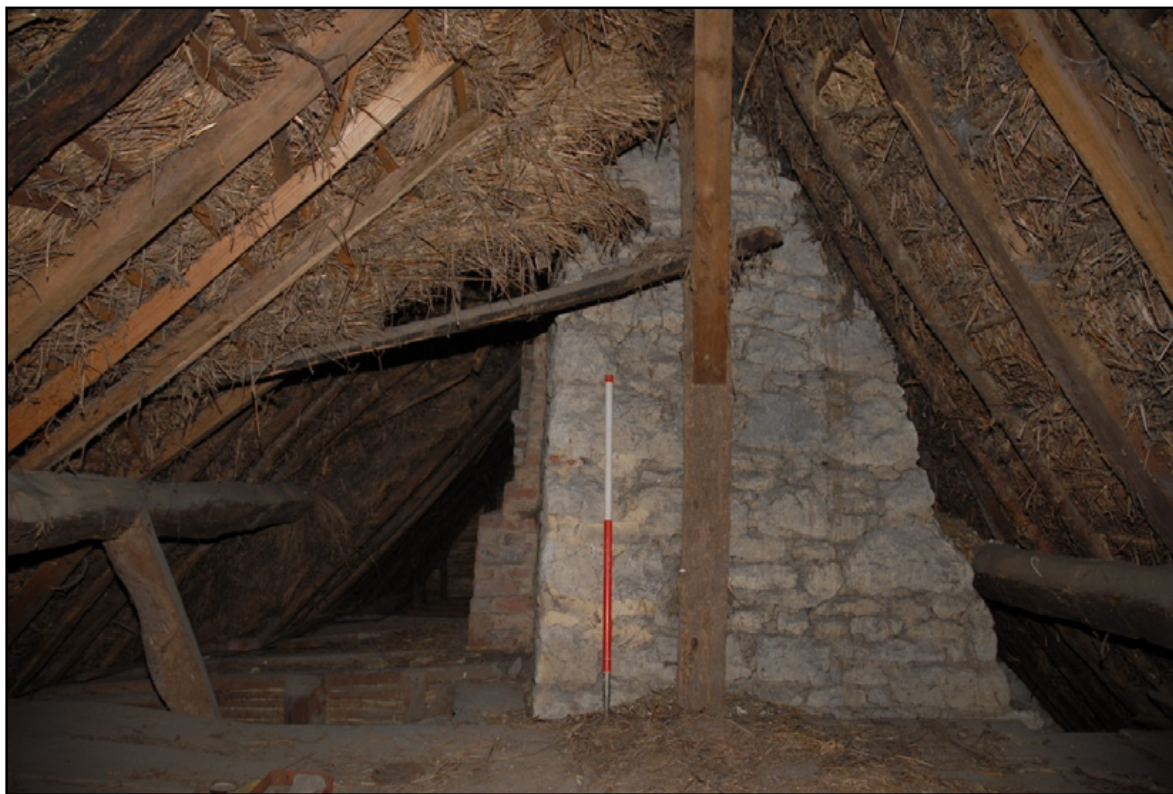
The west face of the central chimneys, looking east Fig 67

The centre of the Attic space is dominated by the large structures of the two central chimneys which rise through the building and out through the roof (Fig 67).

An upright beam with lateral props supports the roof structure on the western side of the central chimney (Fig 67). The two purlins, one on either side of the roof structure run from the western gable to midway down the building. The southern purlin is lost from sight behind the chimneys and the northern purlin stops at a step in the roof structure (Fig 67). A third purlin runs along the stepped roof, just above the joists (Fig 68). This change in roof structure is coincidental with a pair of joins visible on the north and south elevations and indicates a previous division of the building. The roof is hipped at the east gable and overhangs further here than on other elevations.

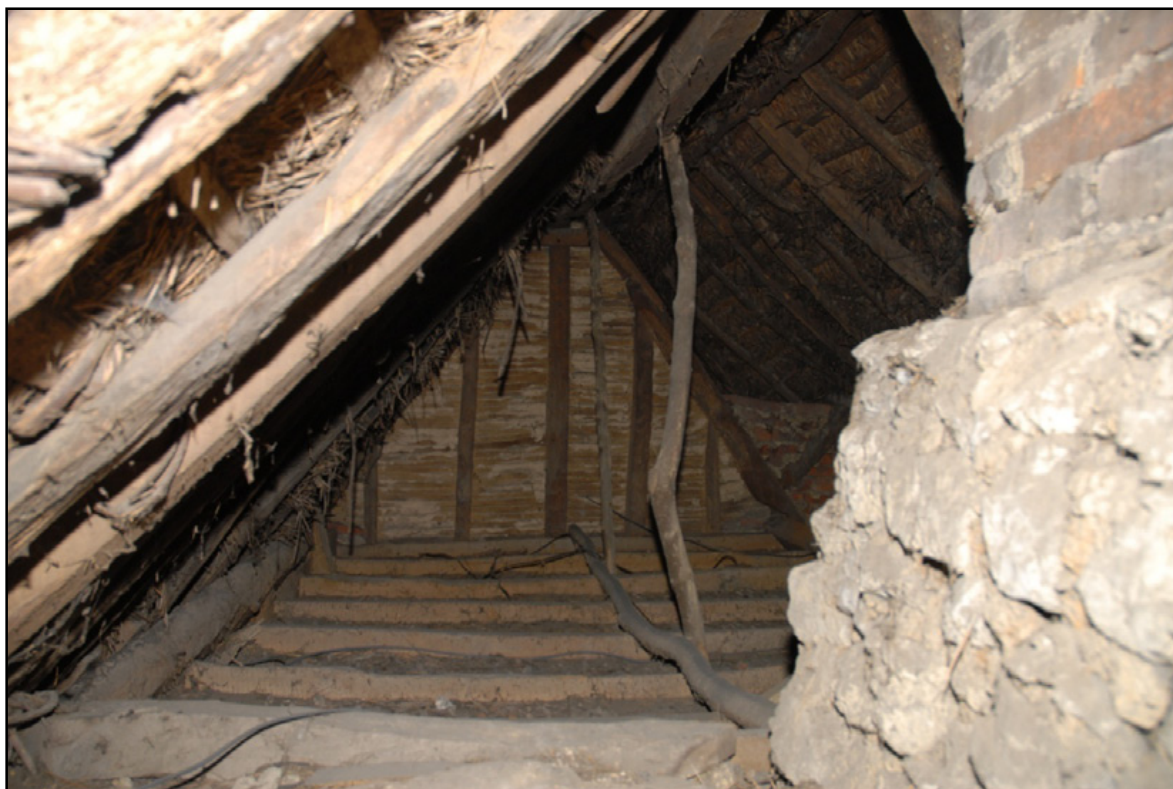
The eastern roof partition above Bedroom 1, looking east Fig 68

To the east of the chimneys, a pair of waney edged, upright timbers provide some support for the ridge (Fig 68). A rough timber runs down the centre of the roof above the joists from the chimneys to the partition at the eastern end (Fig 68). As noted in Bedroom 1, the western lath and plaster wall of that room rises through the ceiling level and into the attic, creating an internal partition (Fig 68). The partition was extended southwards in brick during the 19th-century alterations. Interestingly, the thatch does not rest against the southern common rafter but is held further out by the brick extension of the partition (Fig 68). This could indicate that the partition did not fully divide the roof space, the partition was partially demolished and re-built or that the roof pitch was extended southwards during the 19th-century, thus creating the gap.
