Bankend Rig Windfarm, South Lanarkshire: Archaeological Mitigation

Data Structure Report

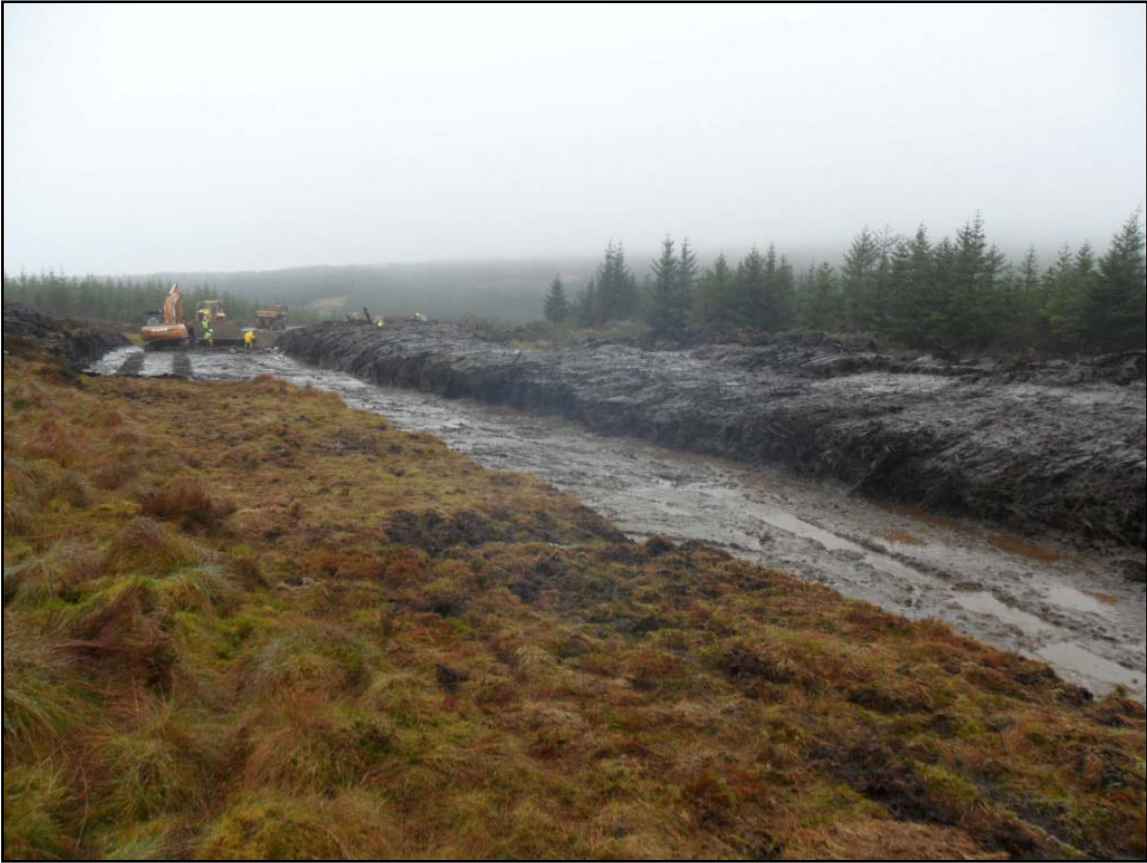
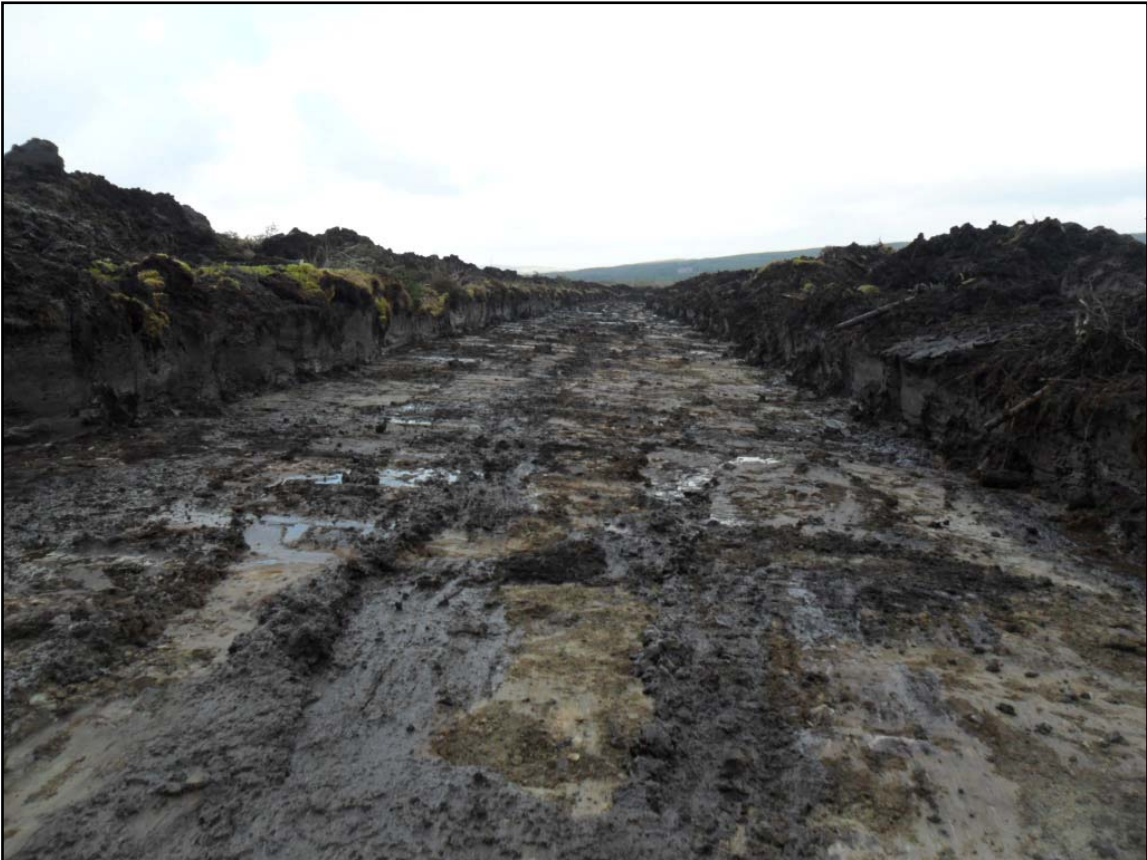
Figure 6a: Spur 2, working shot

Figure 6b: Spur 2, post ground reduction

33. Generally Spur 2 was characterised by thick deposits of peat (2001), due to the generally waterlogged nature of the area (Figures 6a and 6b). Monitoring works within Spur 2 encountered 1 to 2.2m thickness of peat as the uppermost deposit during ground reduction. Past approximately chainage 500, the route of the access road gradually ascends a hill; due to this, the thickness of the peat changes according to location within the spur. An interface layer was encountered immediately below the peat, throughout Spur 2. This was (2002), and consisted of very firm dark brown sandy clay, varying from 0.02m to 0.1m thickness. It contained frequent unworked natural tree branches (small to medium), with occasional plant roots and occasional green and blonde naturally occurring sandstone fragments. Deposit (2002) seemed to form an intermediate layer between the peat and the natural subsoil.
