# Hillside Farm, Kilmacolm: Archaeological Mitigation

Data Structure Report

by Louise Turner

issued 31<sup>st</sup> October 2014

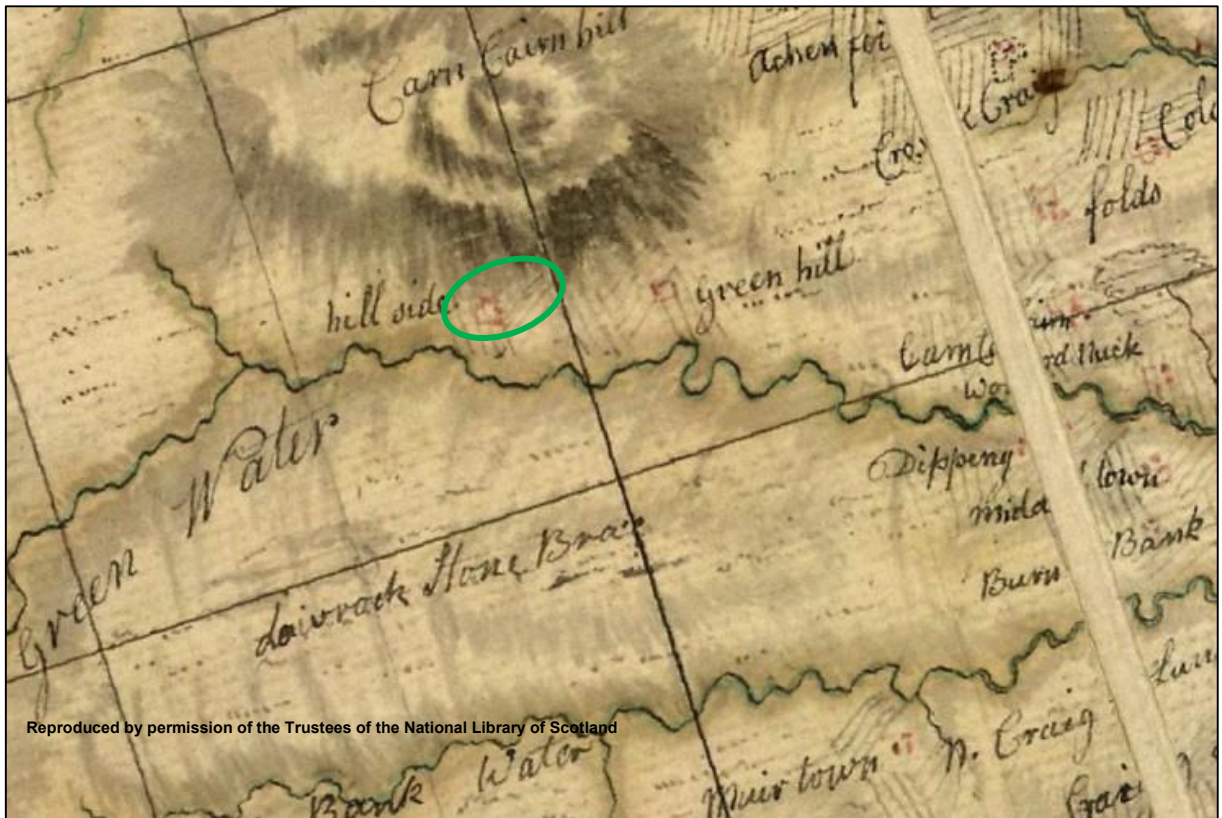
Figure 1a: Extract from Roy's Military Map of Scotland (1752-55) (Development area circled in green)

11. Hillside farm is shown at this time as a rectangular structure aligned roughly east-west (Figure 1a), with three smaller, rectangular, free-standing, ancillary structures located to the north and north-east. A right-angled stretch of walling connects the westernmost ancillary structure with the main dwelling house, forming a rudimentary yard. To the south of this walling, the map shows cultivated ground running down towards the Green Water.

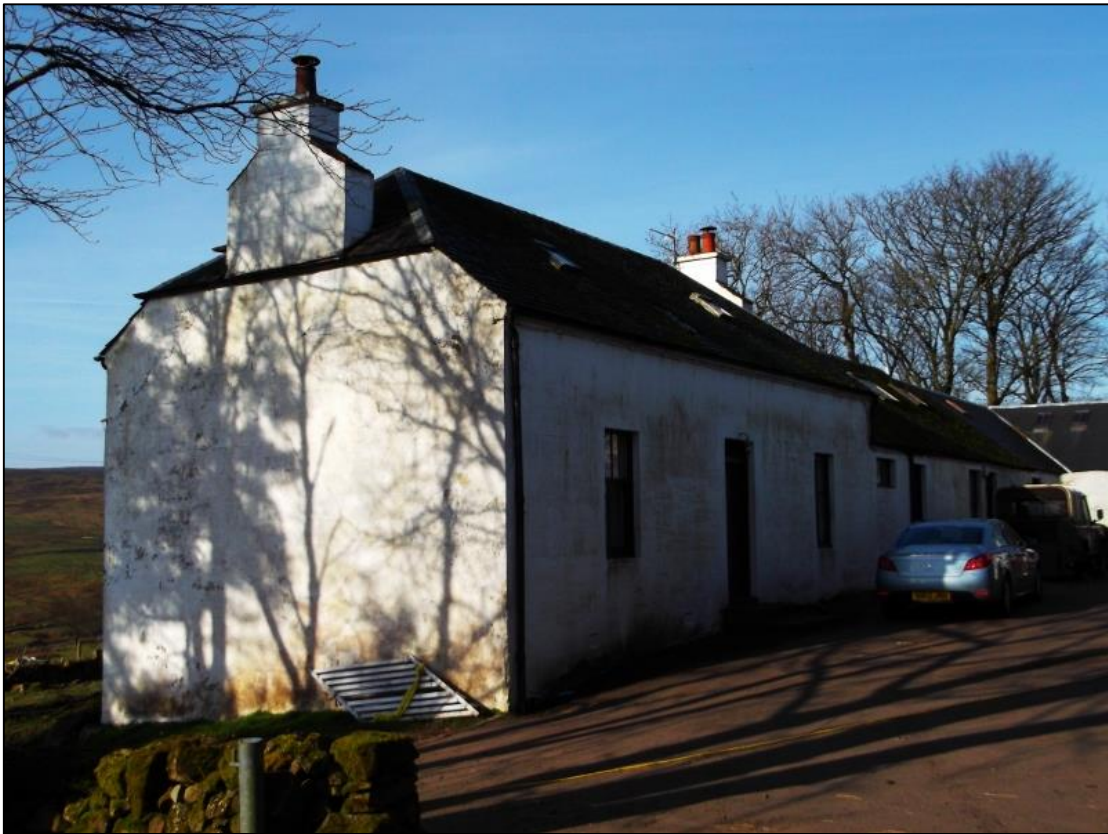
Figure 3a: View showing north elevation of farmhouse, pre-demolition

16. The site itself comprised the site of a 19<sup>th</sup> century farmhouse which had originally been a three bay structure, either one storey, or one storey and attic in height (Figure 3a). The roof had originally been hipped at the east end, but the wallhead was subsequently raised to form the modern one-storey and attic structure which was demolished as part of the earliest phase of works.

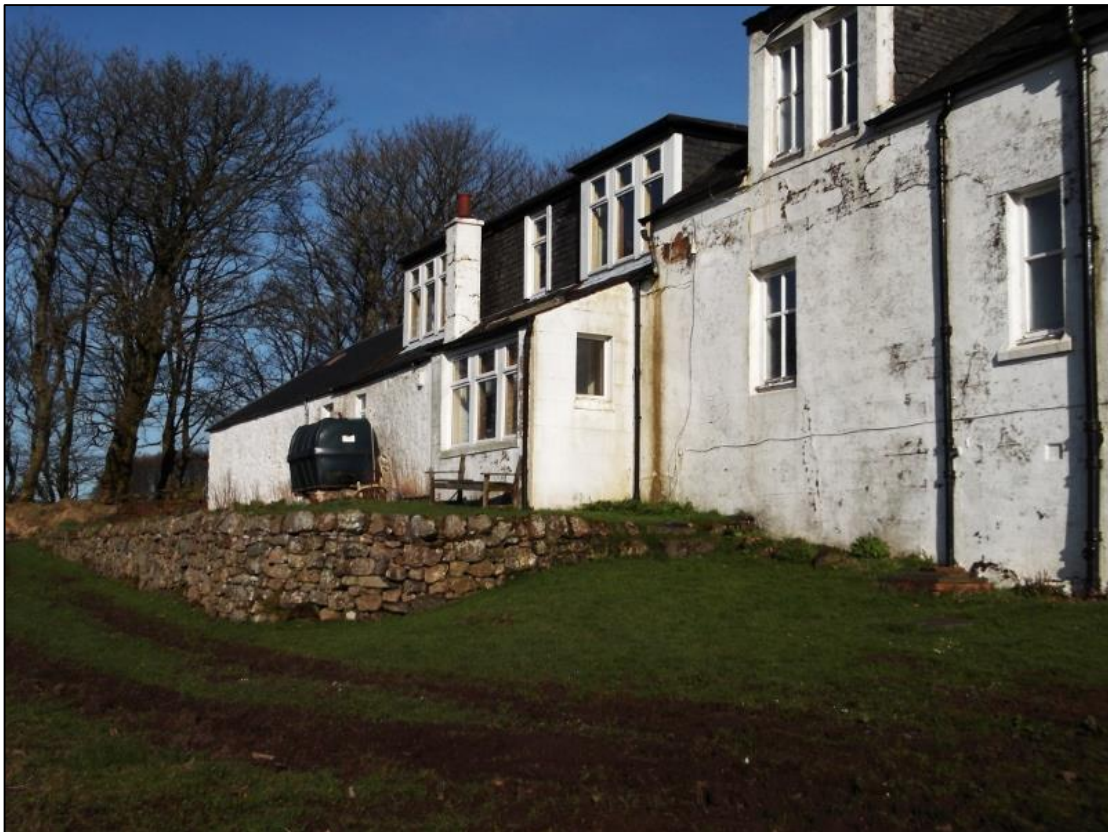
Figure 3b: Rear of farmhouse, with revetment wall forming garden terrace

17. The farmhouse itself had occupied a raised platform in the landscape which had been extended to the rear at the east side to form a small raised terrace used as a garden/seating area (Figures 3b; 5a). Both the raised platform and the terrace remained extant at the commencement of the on-site works in April 2014.

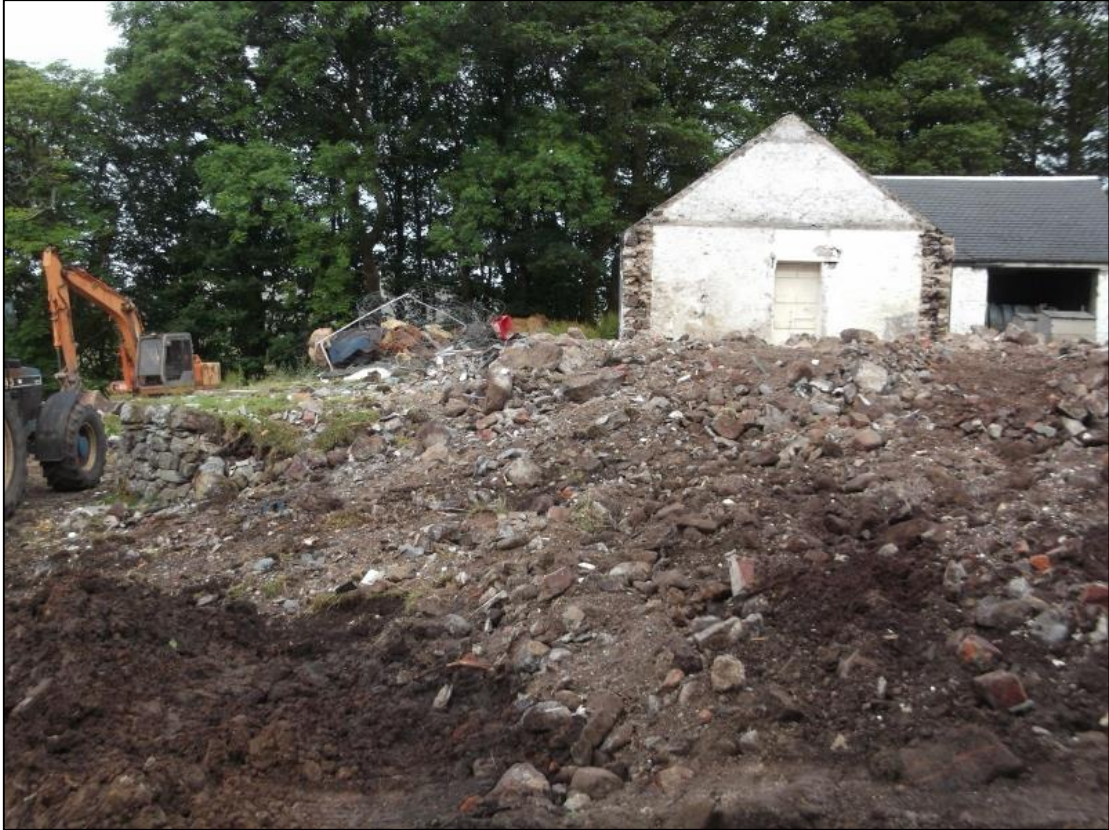
Figure 5a: View of house platform, post-demolition, with extant garden terrace to left

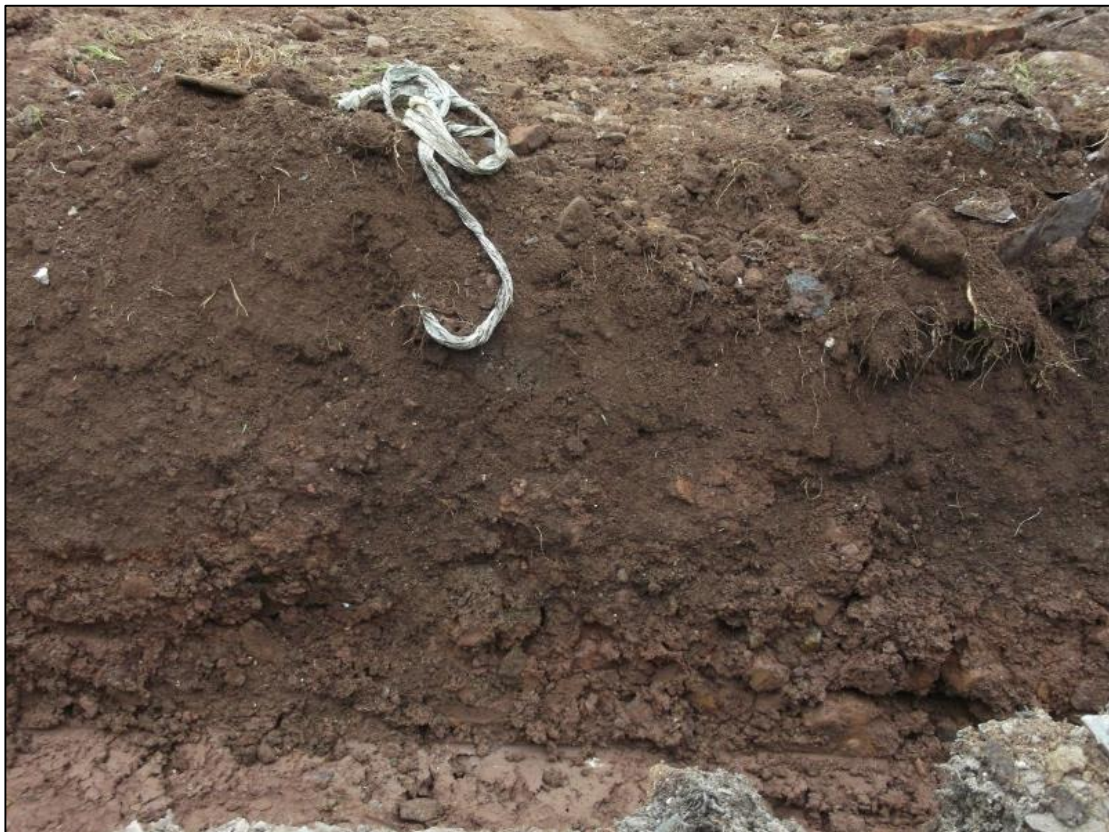
Figure 5b: Soil profile in Trench *a* (SSE-facing), showing topsoil (101) overlying subsoil (103)

26. The initial trench, Trench *a*, followed the same line as the front elevation of the extant barn, running WNW-ESE. It comprised a deposit of humic dark-brown sandy silt (101), which had modern finds present (Figure 5b). These included chunks of sandstone, slate, brick and occasional sherds of glazed white earthenware. This layer overlay a compact red-brown silty clay (102), very prone to waterlogging, which appeared to represent the natural subsoil and was characterised as such.

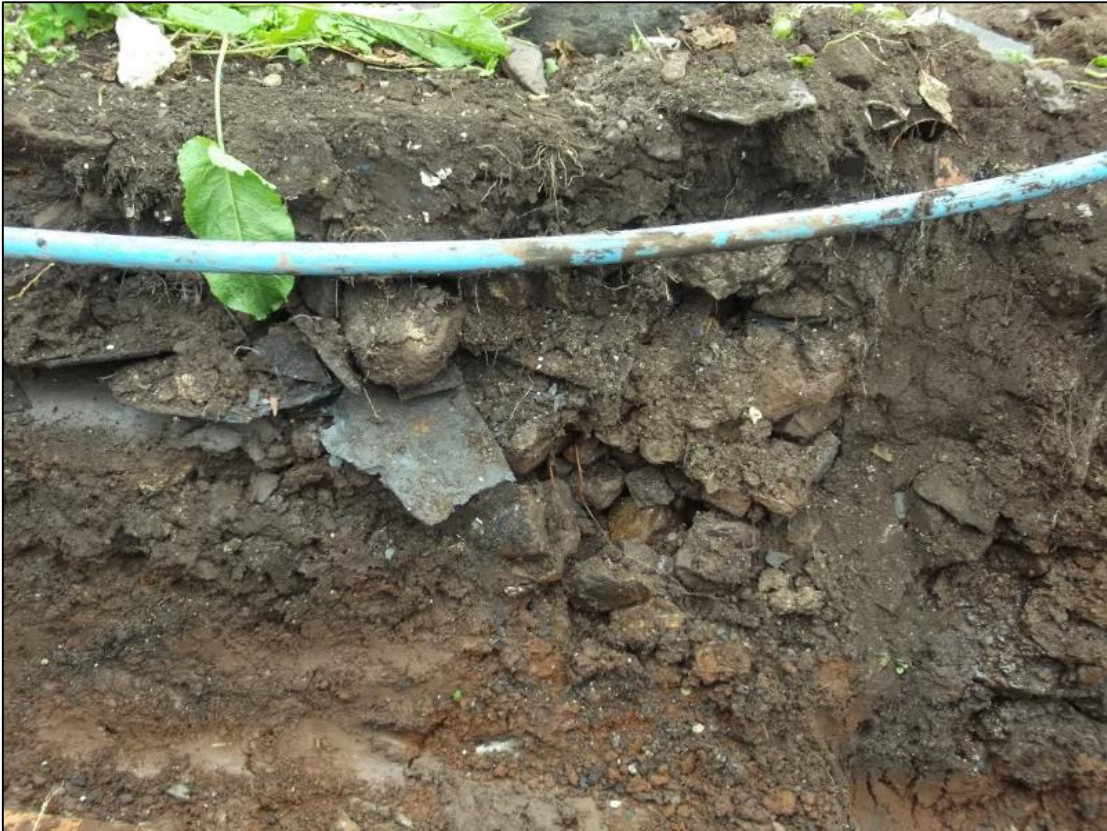
Figure 6a: Soil profile in Trench *b* (SSE-facing), showing dump of stone (104) and ashy layer (103)

28. These modern surfaces were absent in Trench *b*, which followed the line of the rear elevation of the proposed house structure. This trench contrasted with Trench *a* in that it presented a more complicated soil profile with buried features within. Beneath a thin layer of topsoil (101), there was identified a broad deposit of loose, blackish brown silty sand (105), characterised in particular by a high concentration of sandstone rubble, bricks, slates and white-glazed white earthenware (Figure 6a). This in turn overlay a thin ashy black layer which measured 0.15m deep (103).

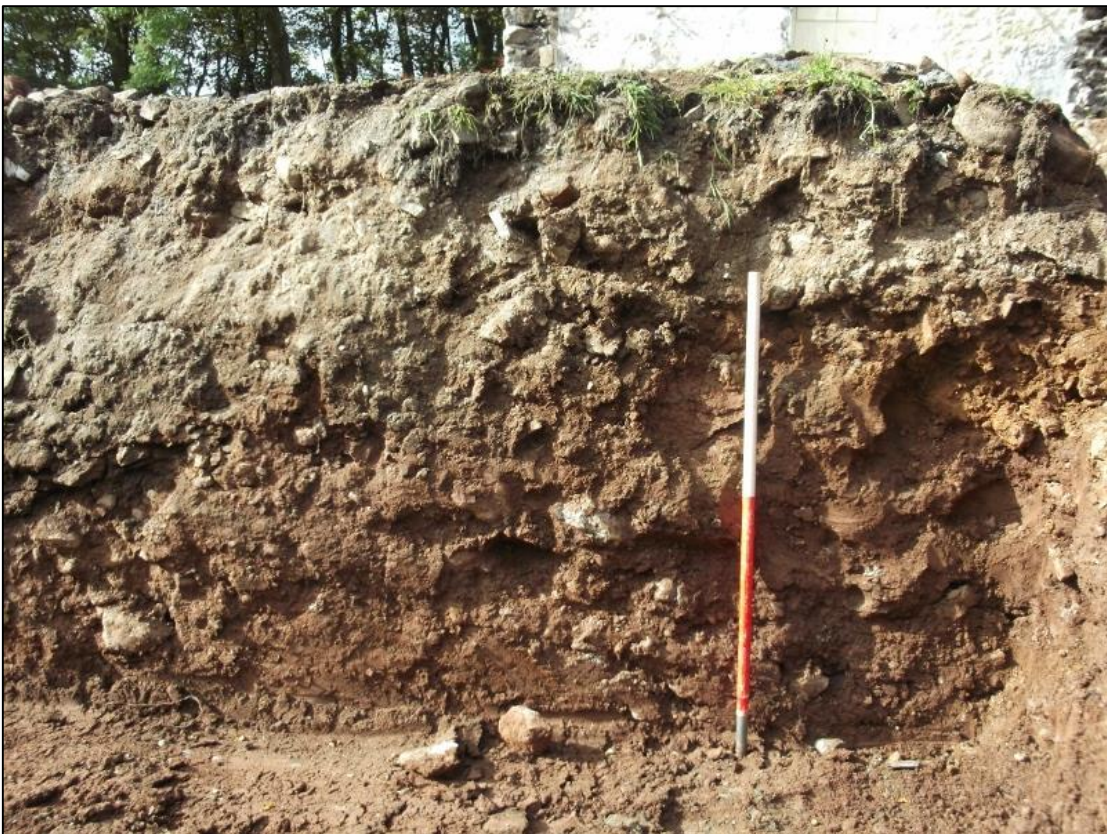
Figure 6b: Soil profile across NNW-SSE axis of site ('Trench *c*'), showing gravel mound (106) and made ground (105)

30. With the cutting of the first NNE-SSW trench (Trench *c*). it was possible to obtain a more detailed insight into the changing nature of the soil horizons across the site (Figure 6b). However, this initial understanding was further clarified with the extension of Trench *c* into Open Area *f*. This showed that the subsoil was dominated by a red-brown gravelly deposit set within a silty clay matrix (106), with a red-brown silty clay similar to that characterised by (102) underlying it. This suggested that the overlying gravels had already been removed in Trench *a*, and that the new foundation trench had in fact removed the fill of an earlier foundation cut created for the building of the earlier farmhouse.

31. Also of interest in this particular trench was the presence of made ground overlying the gravelly clay subsoil (106). This was characterised as (105), the stony layer previously identified in Trench *b*.

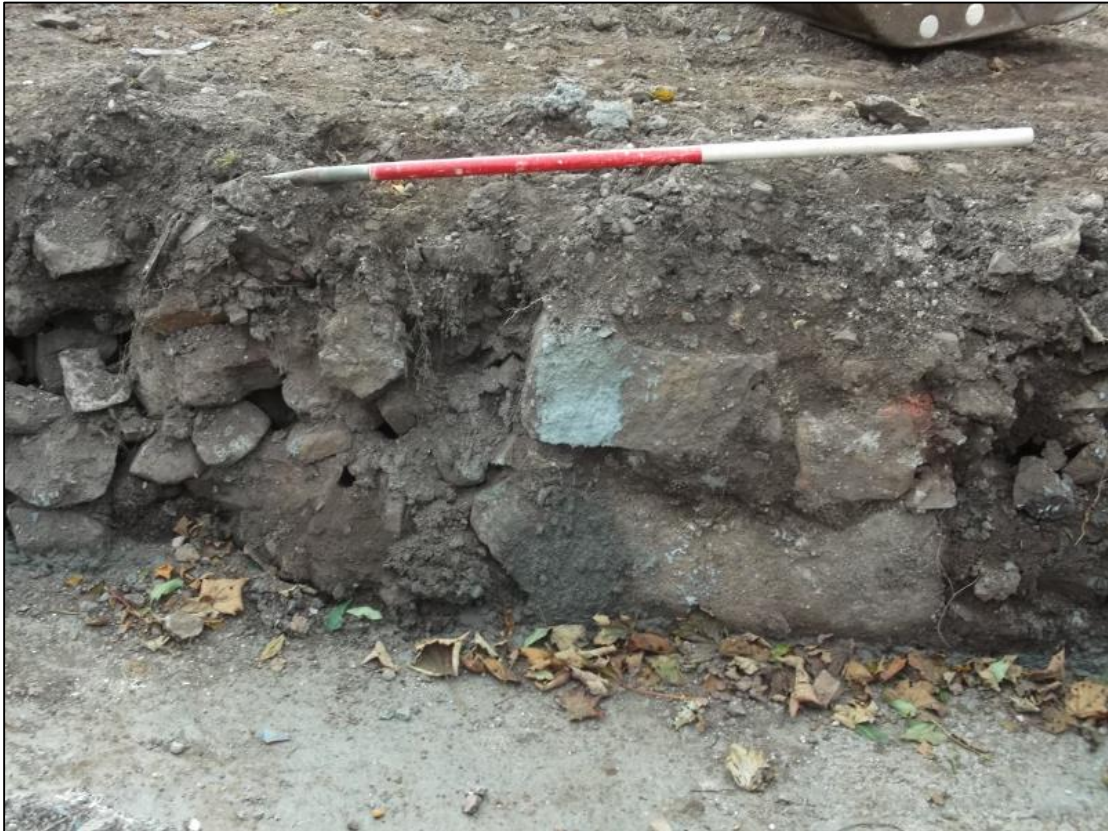
Figure 7a: Wall footing (111), abutting stony layer (112) in NNW-facing section of Trench b/g

32. The eastwards extension of Trench *b* to form Trench *g* provided further insights. An examination of the north-facing section of this trench revealed a relict wall (111) sitting amongst a dump of stony material (112) (Figure 7a). Though given a separate number, (112) was clearly very similar in character to (105), and indeed may have formed part of the same deposit. Deposit (111) was notable for producing numerous finds of glazed white earthenware, slates and glass, as well as a copper alloy pipe which carried water from a spring to the rear of the farm buildings for distribution to the nearby cottages and houses that had accumulated along the access road to the farm.

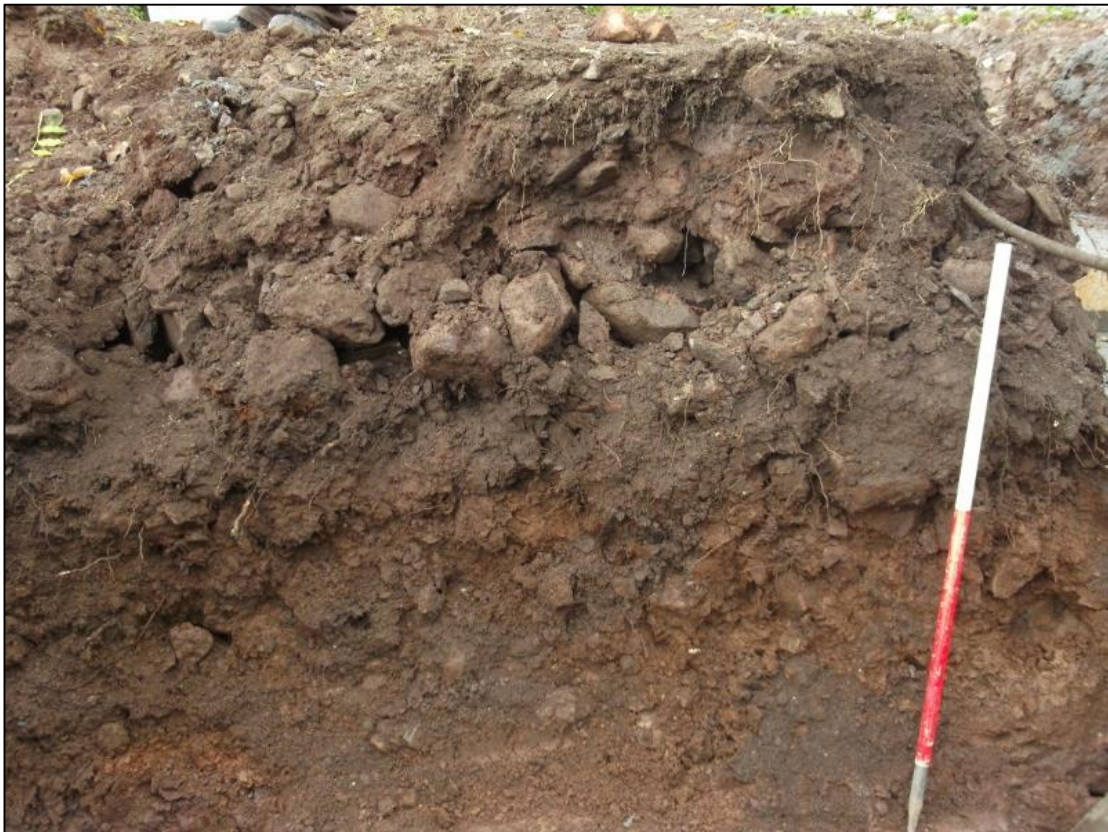
Figure 7b: Stony layer (112) revealed within truncated garden terrace.

33. The digging of the drainage trench which ran south from the farm buildings required the truncation of the garden terrace at its eastern end, the removal of which revealed the continuation of the stony layer (112) (Figure 7b). This had been concealed beneath a layer of redeposited topsoil (113) 0.3m deep, which was subsequently grassed over to form a lawn. Deposit (112) itself overlay stony subsoil (106), which proved to be the natural subsoil across the entire extent of the southern portion of the site.
