# **6 Main Street, Dundonald: Archaeological Mitigation**

Data Structure Report

issued 18<sup>th</sup> September 2014

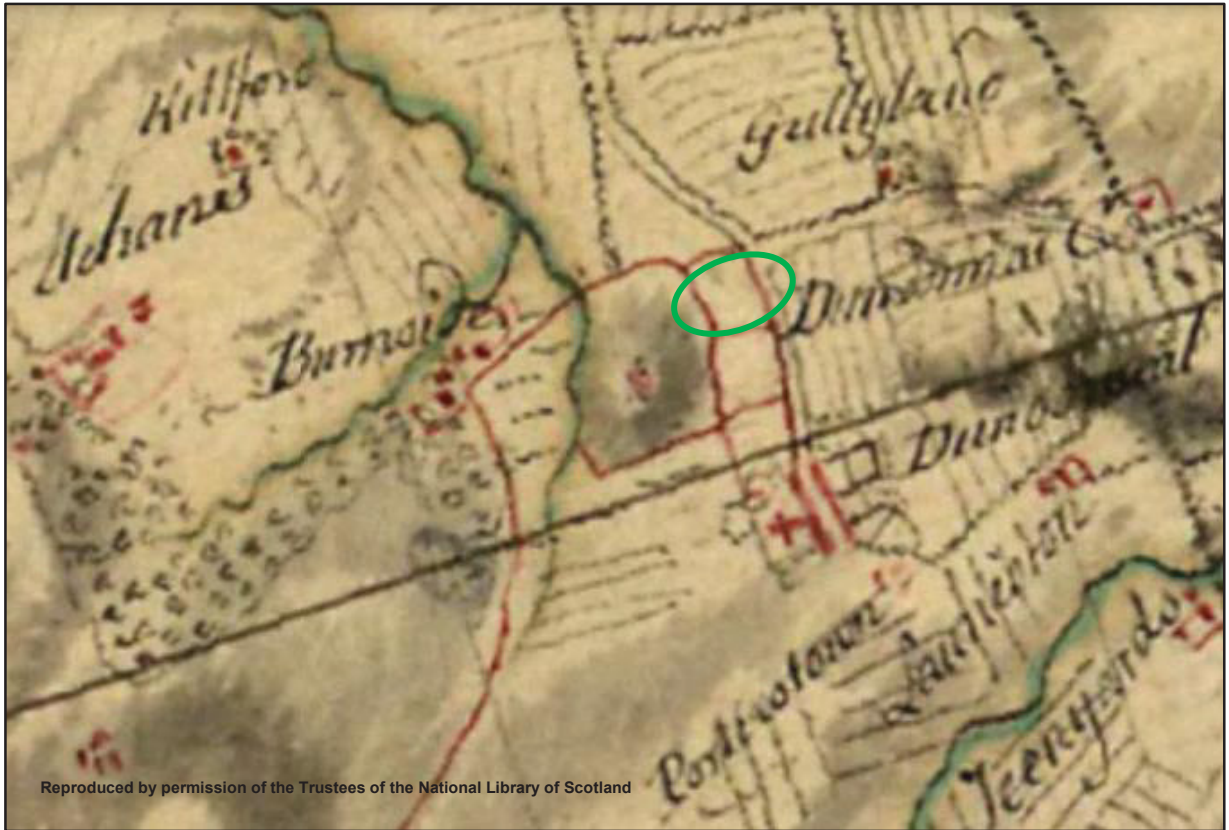
Figure 1a: Extract from Roy's Military Map of Scotland (1752-55), with development area circled in green

9. Roy's map depicts the Kirkton as centred on the Parish Church (see Figure 1a). The church itself is cruciform on plan – this is the precursor to the modern church, built in the early 1480s and dedicated to St Giles (Canmore ID: 41973). By the time Roy's map was surveyed, a formal street frontage had been established along both sides of the Main Street in close proximity to the church, the core of this historic settlement lying a significant distance to the south of the development area.

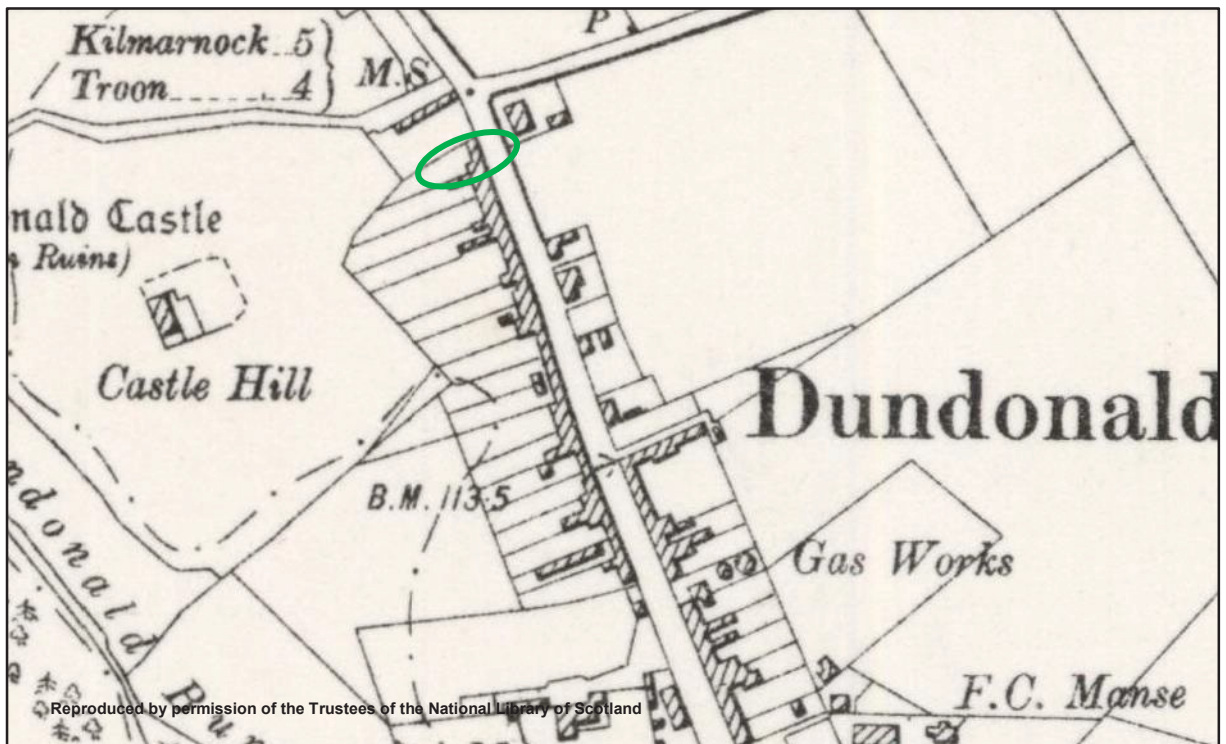
Figure 2b: Extract from Ordnance Survey 2<sup>nd</sup> Edition Map of 1897 (Development area circled in green)

18. Unfortunately, the level of detail available in the later 2<sup>nd</sup> edition Ordnance Survey map of 1897 means that this theory cannot be supported: though areas of woodland are shown, the individual trees located in every property are not (see Figure 2b). That the property at 6 Main Street has been subject to further improvement in the intervening decades is however, clearly evident: the structure has been extended to the northeast, removing the earlier extension which abutted the NW gable wall and extending the frontage so that it now runs the entire width of the plot and forms a 'house-and-a-half' type structure (Figure 3b).

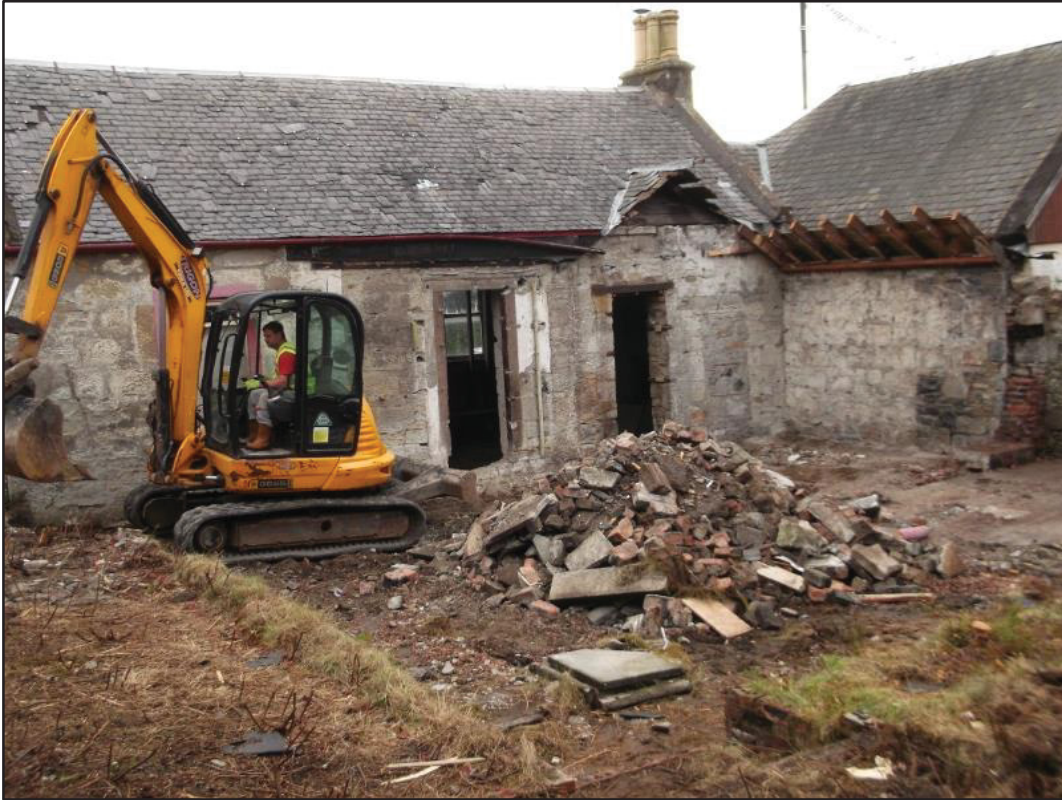
Figure 3a: Pre-excitation view from W, showing SW end of extant mid-19<sup>th</sup> century cottage and upstanding SE wall of outshot

15. Shown as occupying the plot at this time is an 'L'-shaped structure which abuts its neighbour on the southeast. This building corresponds to the extant cottage which currently occupies the site (Figure 3a). The footprint of the cottage extends northeastwards across roughly two-thirds the full breadth of the house plot, with the rear elevation of the cottage and the northeast elevation of the outshot overlooking a yard which has, presumably, been levelled.

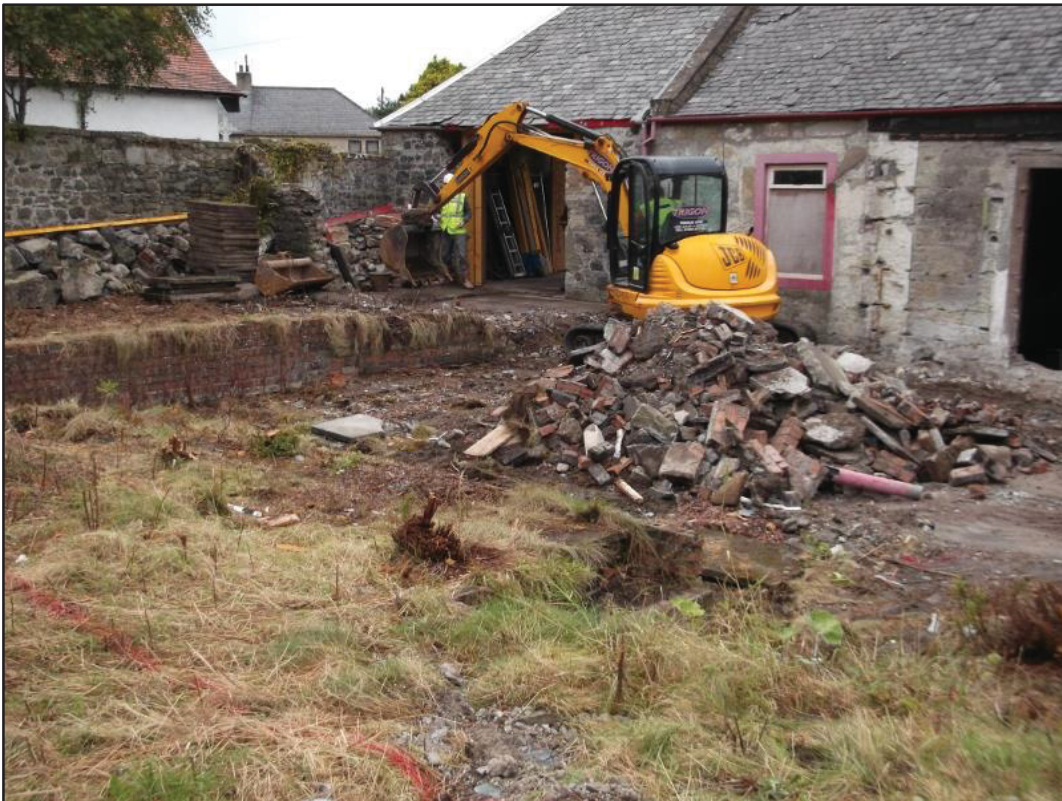
Figure 3b: Pre-excitation view from S, showing NE end of extant mid-19<sup>th</sup> century cottage and late 19<sup>th</sup> century extension

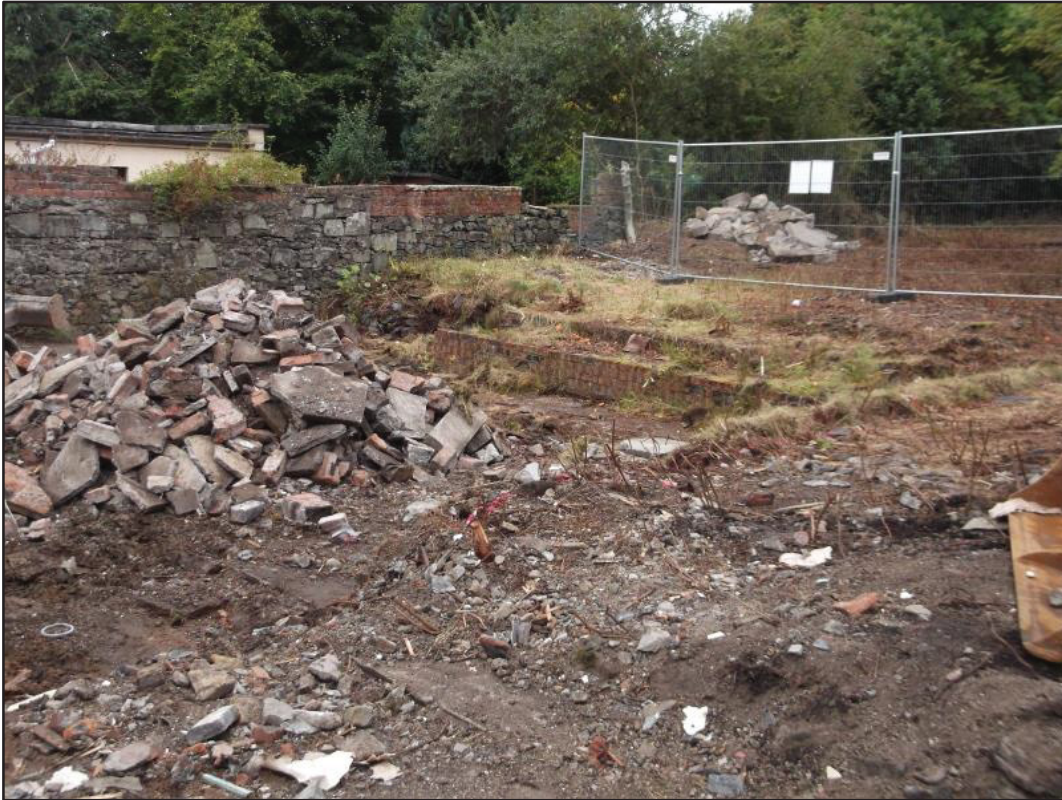
Figure 5a: Looking S across garden plot to rear of cottage, towards (from l to r), SE boundary wall, drystone revetment wall (004) and late 20<sup>th</sup> century brick revetted terraces.

30. It was clear that the garden plot to the rear of the cottage had already been subject to significant landscaping since the mid-19<sup>th</sup> century (Figure 5a). The ground surface along the length of the plot sloped upwards towards the castle and the hill, the land here heavily overgrown, planted with grass and relict fruit trees.

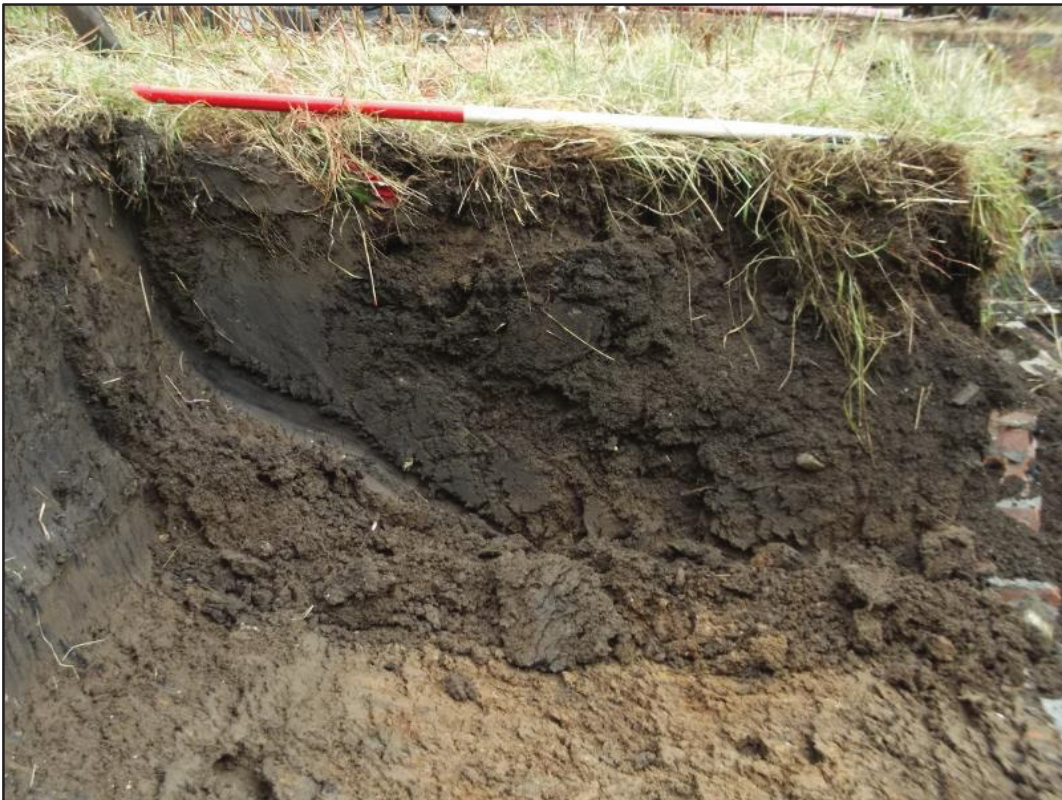
Figure 5b: Section through ground to the rear of modern brick revetment, showing topsoil/garden soil (001) directly overlying subsoil (003)

32. Work began at the SW side of the garden, close to the boundary wall which divided the garden plot from the adjacent property to the SW. It was soon possible to establish the nature of the soil profile in the area to the rear of the 20<sup>th</sup> century brick revetment wall (Figure 5b): here, a deep, fairly homogenous deposit of a dark, humic soil up to 0.6m deep (001) directly overlay a compact yellow-brown sandy clay (003). The latter was interpreted as natural subsoil.

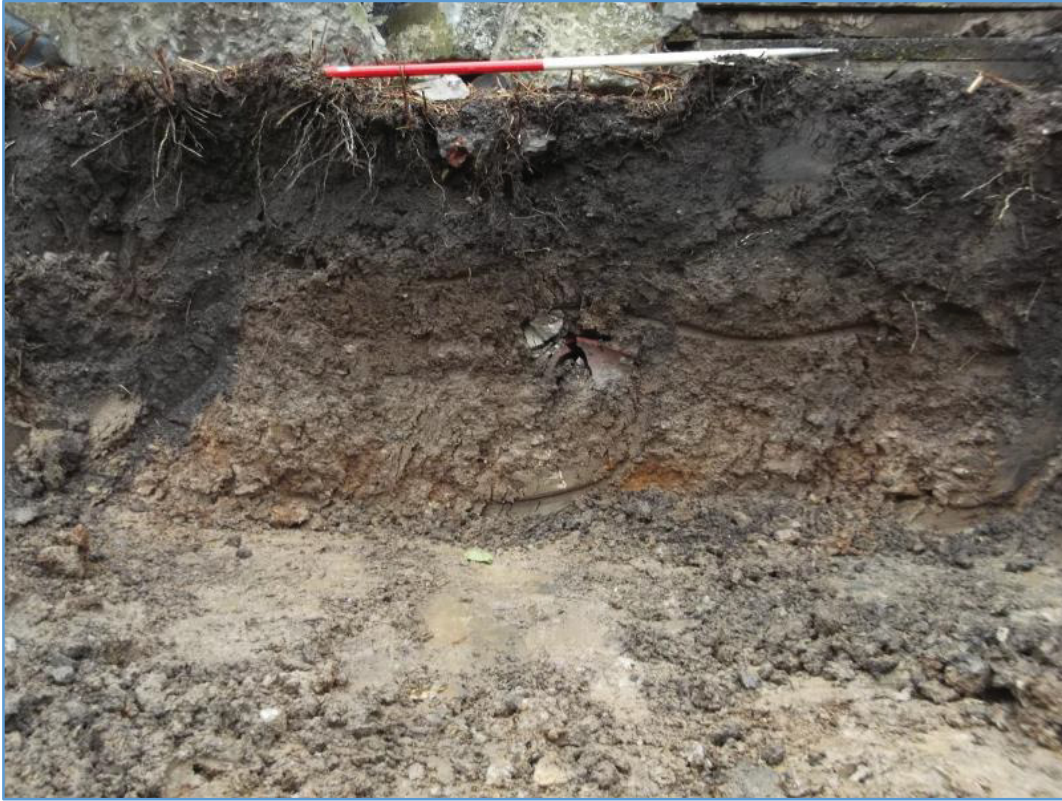
Figure 6a: SW-facing section at NE side of site, showing topsoil (001) overlying interface layer (002) and with natural (003) at relatively shallow depth below

33. This soil profile continued across the SW half of the site, that is, for a distance of approximately 6m. At this point, the level of the subsoil began to rise: topsoil/garden soil (001) became much reduced in depth (to around 0.3m), and an intermediate deposit (002) was identified between (001) and the underlying natural (003) (Figure 6a). This gentle rise in the level of the subsoil continued across the remainder of the site, with the natural subsoil lying only 0.4m below the modern ground level on the northeast side.

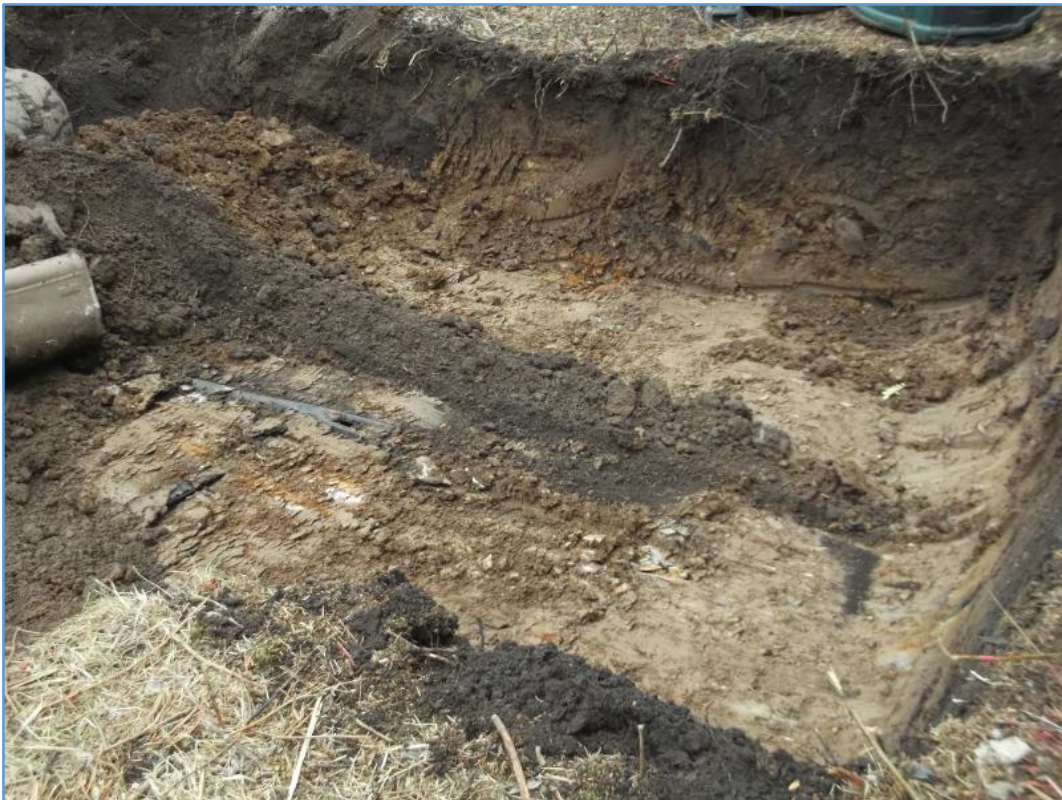
Figure 6b: View of base of trench at W corner, showing late 19<sup>th</sup>/early 20<sup>th</sup> century cast iron drain pipes sunk into subsoil

34. Some artefacts were encountered within (002). These comprised the occasional sherd of modern ceramic, dominated by plain white-glazed white earthenware with occasional transfer-printed sherds present. There had also been significant disturbance of underlying deposits (002) and (003) through the digging of service trenches (005), (006) and (007) (Figure 6b), and wall foundations. The service pipes varied in character from cast iron to
