Old Knock Castle, North Ayrshire: Archaeological Mitigation

Data Structure Report

by Louise Turner issued 27th August 2015 on behalf of Mr Bruce Walker

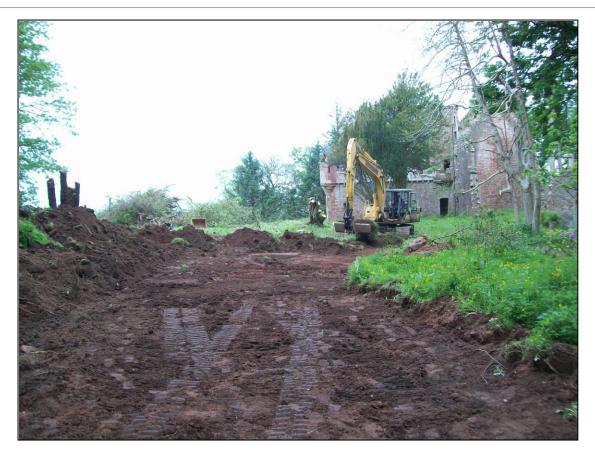
Figure 2a: Looking west along line of access road, post-excavation

- 14. The findings of this initial set of exploratory works revealed no significant archaeology (Figure 2a), but provided a valuable insight into the broad trends which might be expected to occur across the development area. Towards the eastern, upslope, end of the access track, the topsoil was very shallow, measuring only 0.1m deep, loosely compacted and very rooty in character. The subsoil throughout the length of the track was broadly similar in character, comprising a brownish pink-red silty clay, moderately compacted. This was characterised variously as (002) and (004), with (002) representing a more stony variant occurring at the western end of the track and (004) a less stony deposit encountered at the east end. Outcropping sandstone was evident at shallow depth at various points along the length of the track.

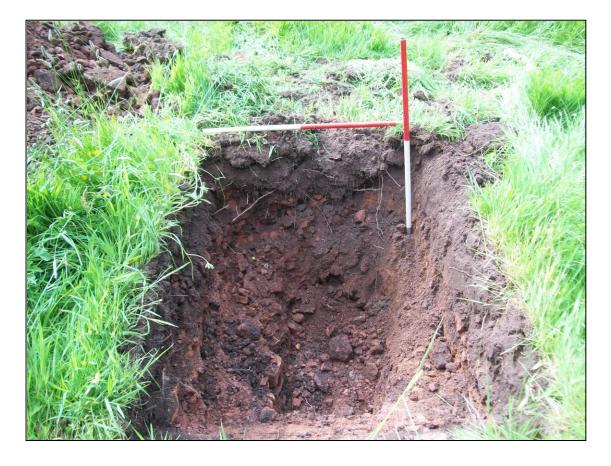
Figure 2b: Post-excavation view of Percolation pit 2, from S

- 17. The percolation pits were located between 12 and 15m west of the castle's component structures, with Pp1 measuring $2.54 \times 1.45m$ in extent and Pp2 measuring $1.7 \times 1.3m$ in extent. Neither revealed any significant archaeology. The topsoil was similar to (001), though more grey black in colour, perhaps reflecting more intensive horticultural use of this portion of the site, which lay within a grassy sward as opposed to a wooded area. Topsoil depth varied between 0.2 and 0.3m, with (001) immediately overlying sandstone bedrock in both instances (Figure 2b).

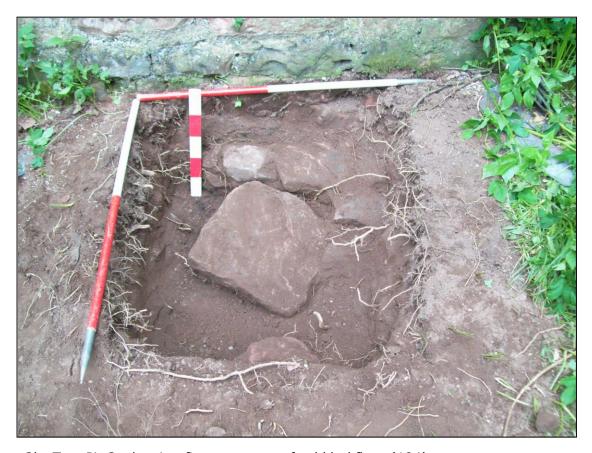
Figure 3b: Test Pit 3, showing first exposure of cobbled floor (104)

- 25. Beneath (102), a line of stones (104) was seen to extend eastwards from the western wall of the tower-house. This feature was thought at first to comprise part of a wall, perhaps representing a broadening of the adjacent found. However, as work progressed it soon became apparent that this was not the case: (104) represented instead the fragmented remains of a paved or cobbled surface, potentially contemporary with the E Range.

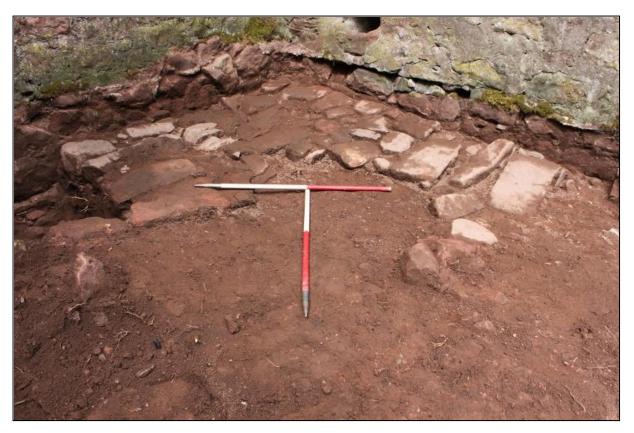
Figure 4a: Cobbled surface [104], post-excavation

- 26. Cobbled surface (104) had been truncated along its S and E edges, surviving as a roughly 'L'-shaped feature which measured a maximum of 2.9m from E-W by 1.8m transversely (Figures 4a & 5). A concentration of heat-affected stones (114) was identified within this feature in the vicinity of the W wall (i.e. the external E wall of the tower-house) following their removal, the soil beneath also showed signs of heating (Figure 4b), indicating that this had once been the site of a substantial fireplace, perhaps arguing that the ground floor room of the E range may once have functioned as the kitchen.

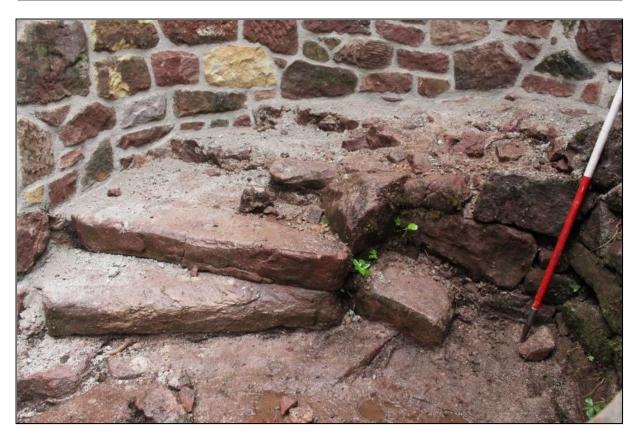
Figure 6a: NE stair turret, pre-excavation

- 37. In addition to these ground-breaking works undertaken within the footprint of the E range, soft sediments were stripped from the interior of the NE stair turret (Figures 6a and b). This revealed two *in situ* treads from an original turnpike stair (207) which had been obscured beneath a capping of crushed masonry set within a matrix of lime mortar (201). This capping was similar in character to the mortar-rich layer (211) which was present within the revetment walling and along the former line of the E wall, and appears to be linked with the same episode of consolidation, probably undertaken as part of 19th century rebuilding works.

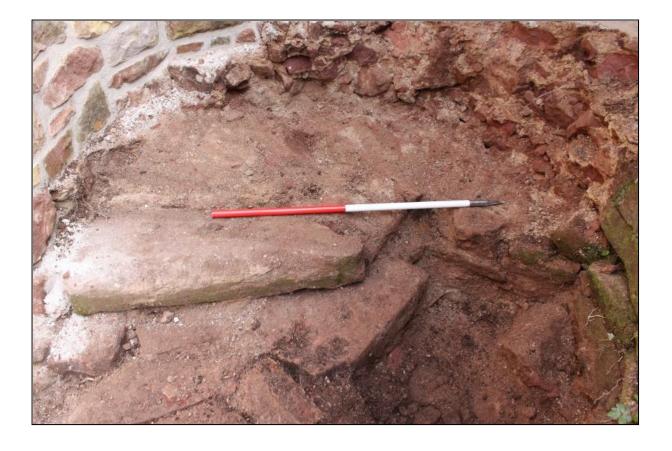
Figure 6b: Consolidating material removed, stair and remains of newel-post revealed

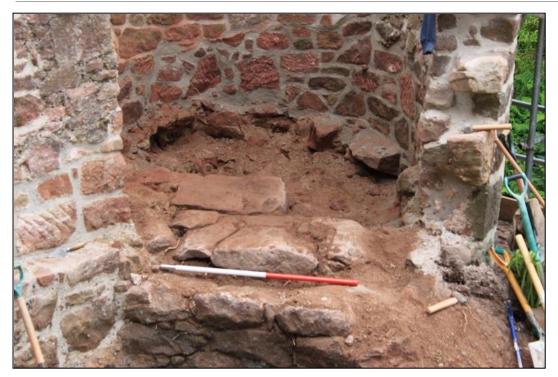
Figure 7a: Stairs removed, possible level surface revealed beneath

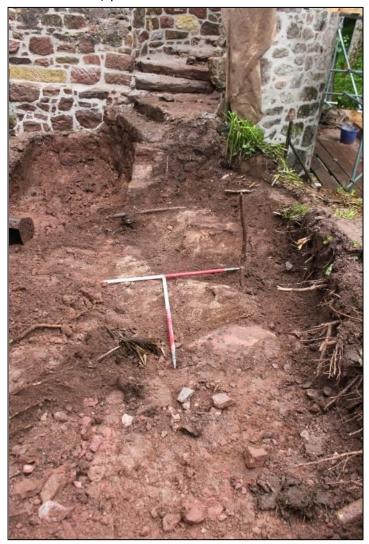
Figure 7b: Masses of mortared stone marking line of external E wall of E Range

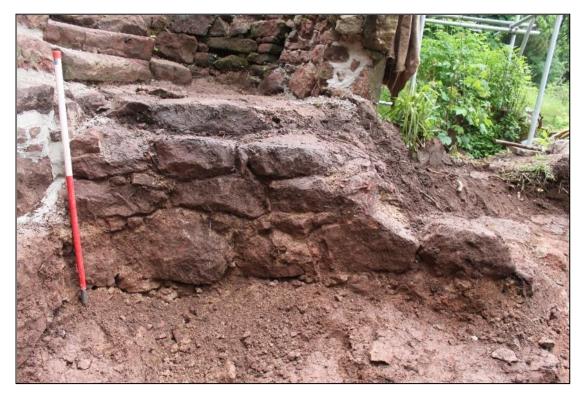
Figure 8a: SW-Facing Revetment of NE Stair Tower, showing Mortared Mass (211) ('Consolidation Later') overlying earlier wall (212)

- 36. The mortar-rich layer (211) was also present within the fabric of the adjacent SW-facing wall that formed the revetment to the NE stair tower (Figure 8a). Here, it overlay two adjacent blocks of roughly-worked sandstone which together appeared to represent the remains of a wall face [212]. With [212] arguably representing the surviving remnants of an earlier perhaps original wall, the mortared layer (211) clearly represents an earlier consolidation layer which was laid as a means of creating a stable surface upon which new fabric could be laid, perhaps during 19th century rebuilding activities.

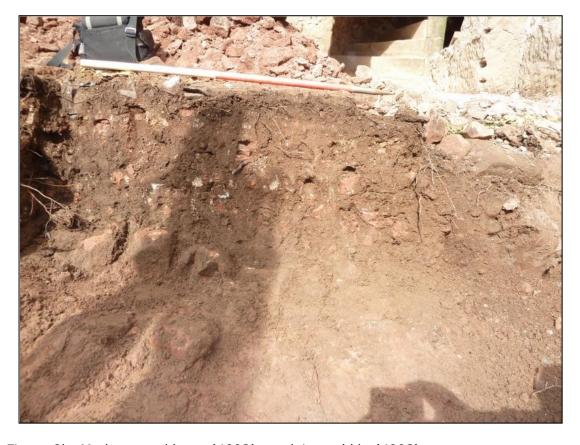
Figure 8b: Made ground layer (4002) overlying rubble (4003)

- 39. In the angle between tower-house and barmkin wall, the ground was characterised by a modern layer of infill between 0.6 and 0.7m deep, characterised by (4002), a dark brown, humic silty clay with frequent inclusions of rubble and modern finds (Figure 8b). This was similar in character to the overburden/demolition layer noted elsewhere across the site (e.g. (010). It directly overlay a thinner layer (4003) of sandstone rubble 0.2 to 0.3m deep, which in turn overlay the natural subsoil.

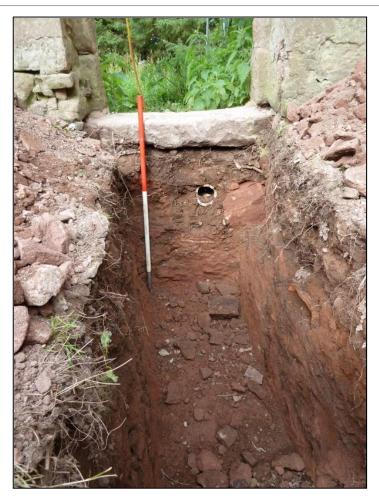
Figure 9a: Possible cut [4018] underlying (4002) beneath threshold of inserted entrance in barmkin wall.

- 41. The other source of interest during this stage of the works was an exposed section revealed during the cutting of the drainage trench in the vicinity of the narrow doorway which pierced the barmkin wall, allowing access from the courtyard to the adjacent W terrace beyond. A possible cut [4018] could clearly be seen between overburden (4002) and the underlying contexts. This may have comprised nothing more than a cut for the insertion of services (as evidenced by the *in-situ* salt-glazed heavy ceramic pipe), though considered more broadly, it is possible that the digging and infilling of the service trench took place as part of wider landscaping/levelling works which extended more broadly across the extent of the courtyard area (Figure 9a). It is likely that these same extensive landscaping activities resulted in the truncation and partial removal of the original floor of the east range.

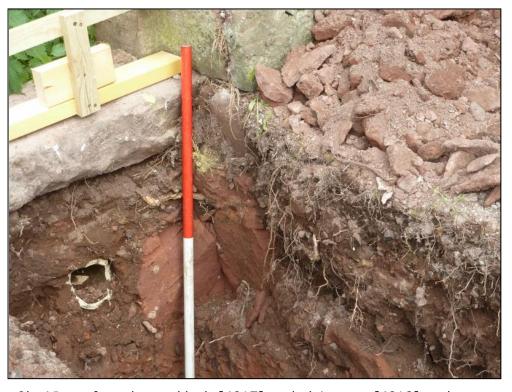
Figure 9b: View of sandstone block [4017] underlying cut [4018] and accompanying fill (4002) beneath threshold of inserted entrance in barmkin wall

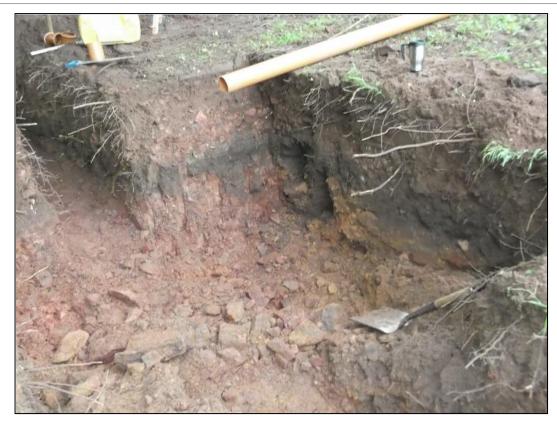
Figure 10a: Septic Tank Chamber (post-excavation) showing dark brown/black layer (504) underlying topsoil (501) and thin crushed sandstone layer (503)

- 46. At the N end of the terrace, the level of the bedrock sloped downwards to the north and east, and here the soil profile was more complex. Here, a thin band of topsoil (501) 0.3m deep overlay a thin layer of crushed sandstone (503) 0.2m deep, which in turn overlay a layer of dark brown/black sandy clay (504) which was very humic in character (Figure 10a). This lower band of 'topsoil' was interpreted originally as hillwash, but as more trenches were opened, this interpretation was revised on account of several factors: firstly, it formed an extensive spread across much of the NW corner of the terrace secondly, its depth varied markedly across its extent, from 0.4m at the NW corner, tapering to 0.2m in the S before it finally petered out.

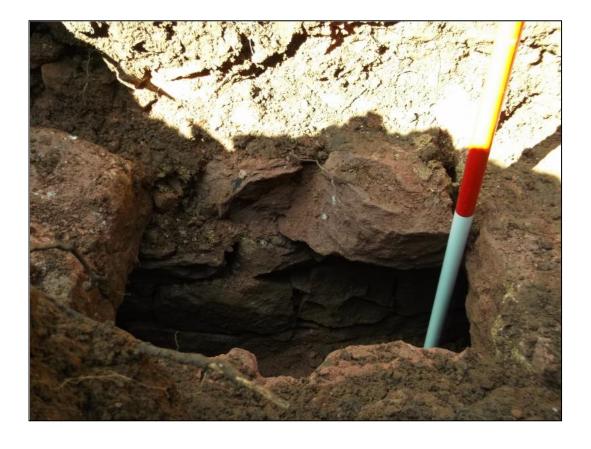
Figure 10b: Culvert [511] with capstone removed, showing supporting wall [510] and internal channel

- 50. Measuring 0.65m wide, and with an internal channel measuring 0.45m deep and 0.5m wide, the culvert comprised two parallel rubble-built walls (510), of drystone construction (Figures 10b and 11a). The base of the culvert appears to have comprised bedrock, with the culvert closed by way of a line of massive squared sandstone slabs (509) mortared into place above. The interior of the culvert was empty, and with the exception of one capstone broken during its removal for initial investigation, the structure was left undisturbed and intact and the trenches rerouted where necessary in order to avoid it.

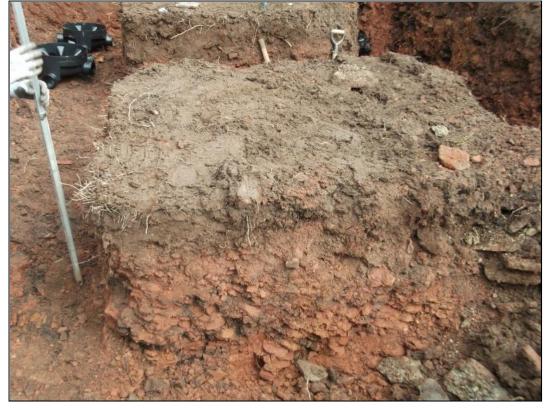
Figure 11b: Topsoil (501) overlying bedrock (502), with modern pit [507]/(508) to right of baulk

- 52. The only other feature identified during this stage of the works was a modern pit [507]/(508) occupying a roughly central location within the W terrace. Measuring approximately 2m by 2m in extent by 1m deep, the fill of this pit was dominated by pea gravel and broken concrete slab, with occasional linseed putty tubs and scaffold bands also present (Figure 11b). These items were consistent with modern demolition and consolidation works, placing the feature within the closing years of the 20th century or later.

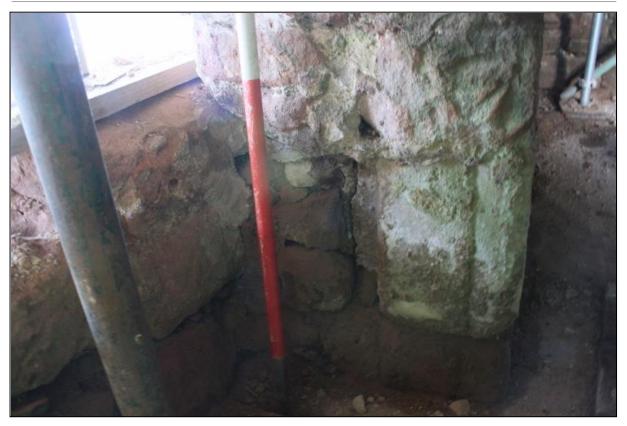
Figure 12a: Ground floor opening, W wall of tower-house, showing straight embrasure and cable-moulding

- 54. Those works which involved physical changes to the tower-house structure took place on 12th December 2012, and 2nd-3rd of April 2013. The first stage involved the enlargement of a pre-existing window at ground floor level at the S end of the W wall. The existing embrasure extended down to floor level: the lowermost courses revealed a thick cable moulding on their inner edges which defined the edges of an earlier window embrasure or doorway (Figure 12a).

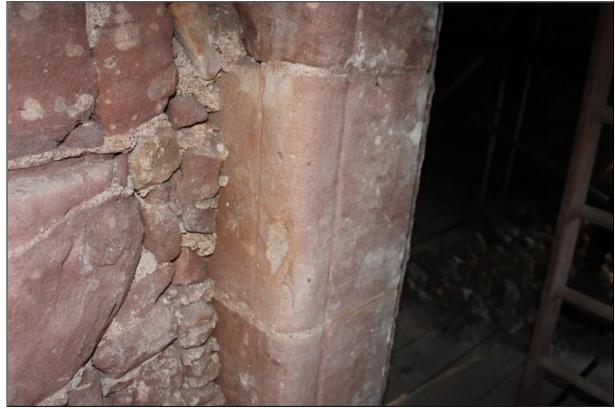
Figure 12b: $1^{\rm st}$ floor opening between tower-house and SW stair, showing abutting masonry with no trace of tusking, and flattened cable-moulding

- 58. Much less intrusive was the re-opening of a blocked doorway at 1st floor level at the S side of the W wall, allowing access from the tower-house into the adjacent stair-tower at the SW corner. The removal of the later infill revealed that the earlier opening survived in relict form (Figure 12b). The internal faces of the rybats were edged with broad, flat cable mouldings, which differed markedly from the more clearly-defined circular-sectioned mouldings which survived in vestigial form in the ground floor opening described earlier. The marked difference in character would suggest a different date of construction, though it was clear when studying the exposed masonry in section that the masonry of tower-house and adjacent SW stair-tower were not tied in to one another, again hinting at different phases of construction.
