# **Fountain Court, Culzean, South Ayrshire: Archaeological Mitigation**

Data Structure Report

on behalf of The National Trust for Scotland

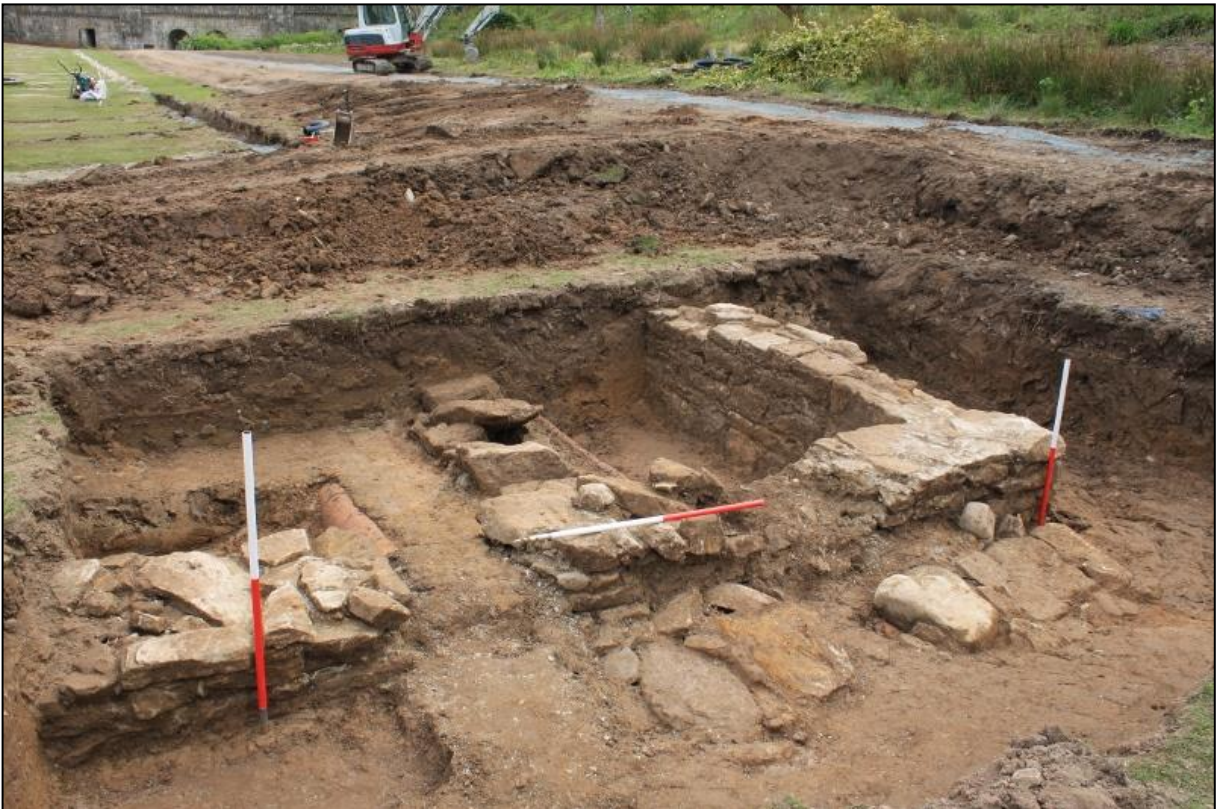
Figure 7b: Excavation area from the west showing wall [008] cut by later features

33. The southwestern section of the wall (running northwest to southeast) had been cut by three separate features: stone culvert [010], red tile drain [017] and red tile drain [018] (Figure 7b).

34. Stone culvert [010] formed an 'L' shape within the excavation area (Figure 7b). It entered from the northeast for a length of 2.7m before running through the base of the wall [008]. On the other side, [010] immediately turned to the southeast to run adjacent to the wall's external southwest facing elevation for 1.9m, before appearing to head south to drain out of the southern corner. The culvert was formed of unworked sub-angular sandstones. The sides comprised stones measuring an average size of 0.24m by 0.2m by 0.1m sitting two courses high, while the overlying course of capping stones measured an average size of 0.5m by 0.4m by 0.15m (Figure 10a). There was no lining along the base with the sides of the culvert sitting directly on top of the natural subsoil (014). The full structure measured up to 0.85m wide and 0.37m high, with the top of the culvert sitting approximately 650 to 750mm below ground level.

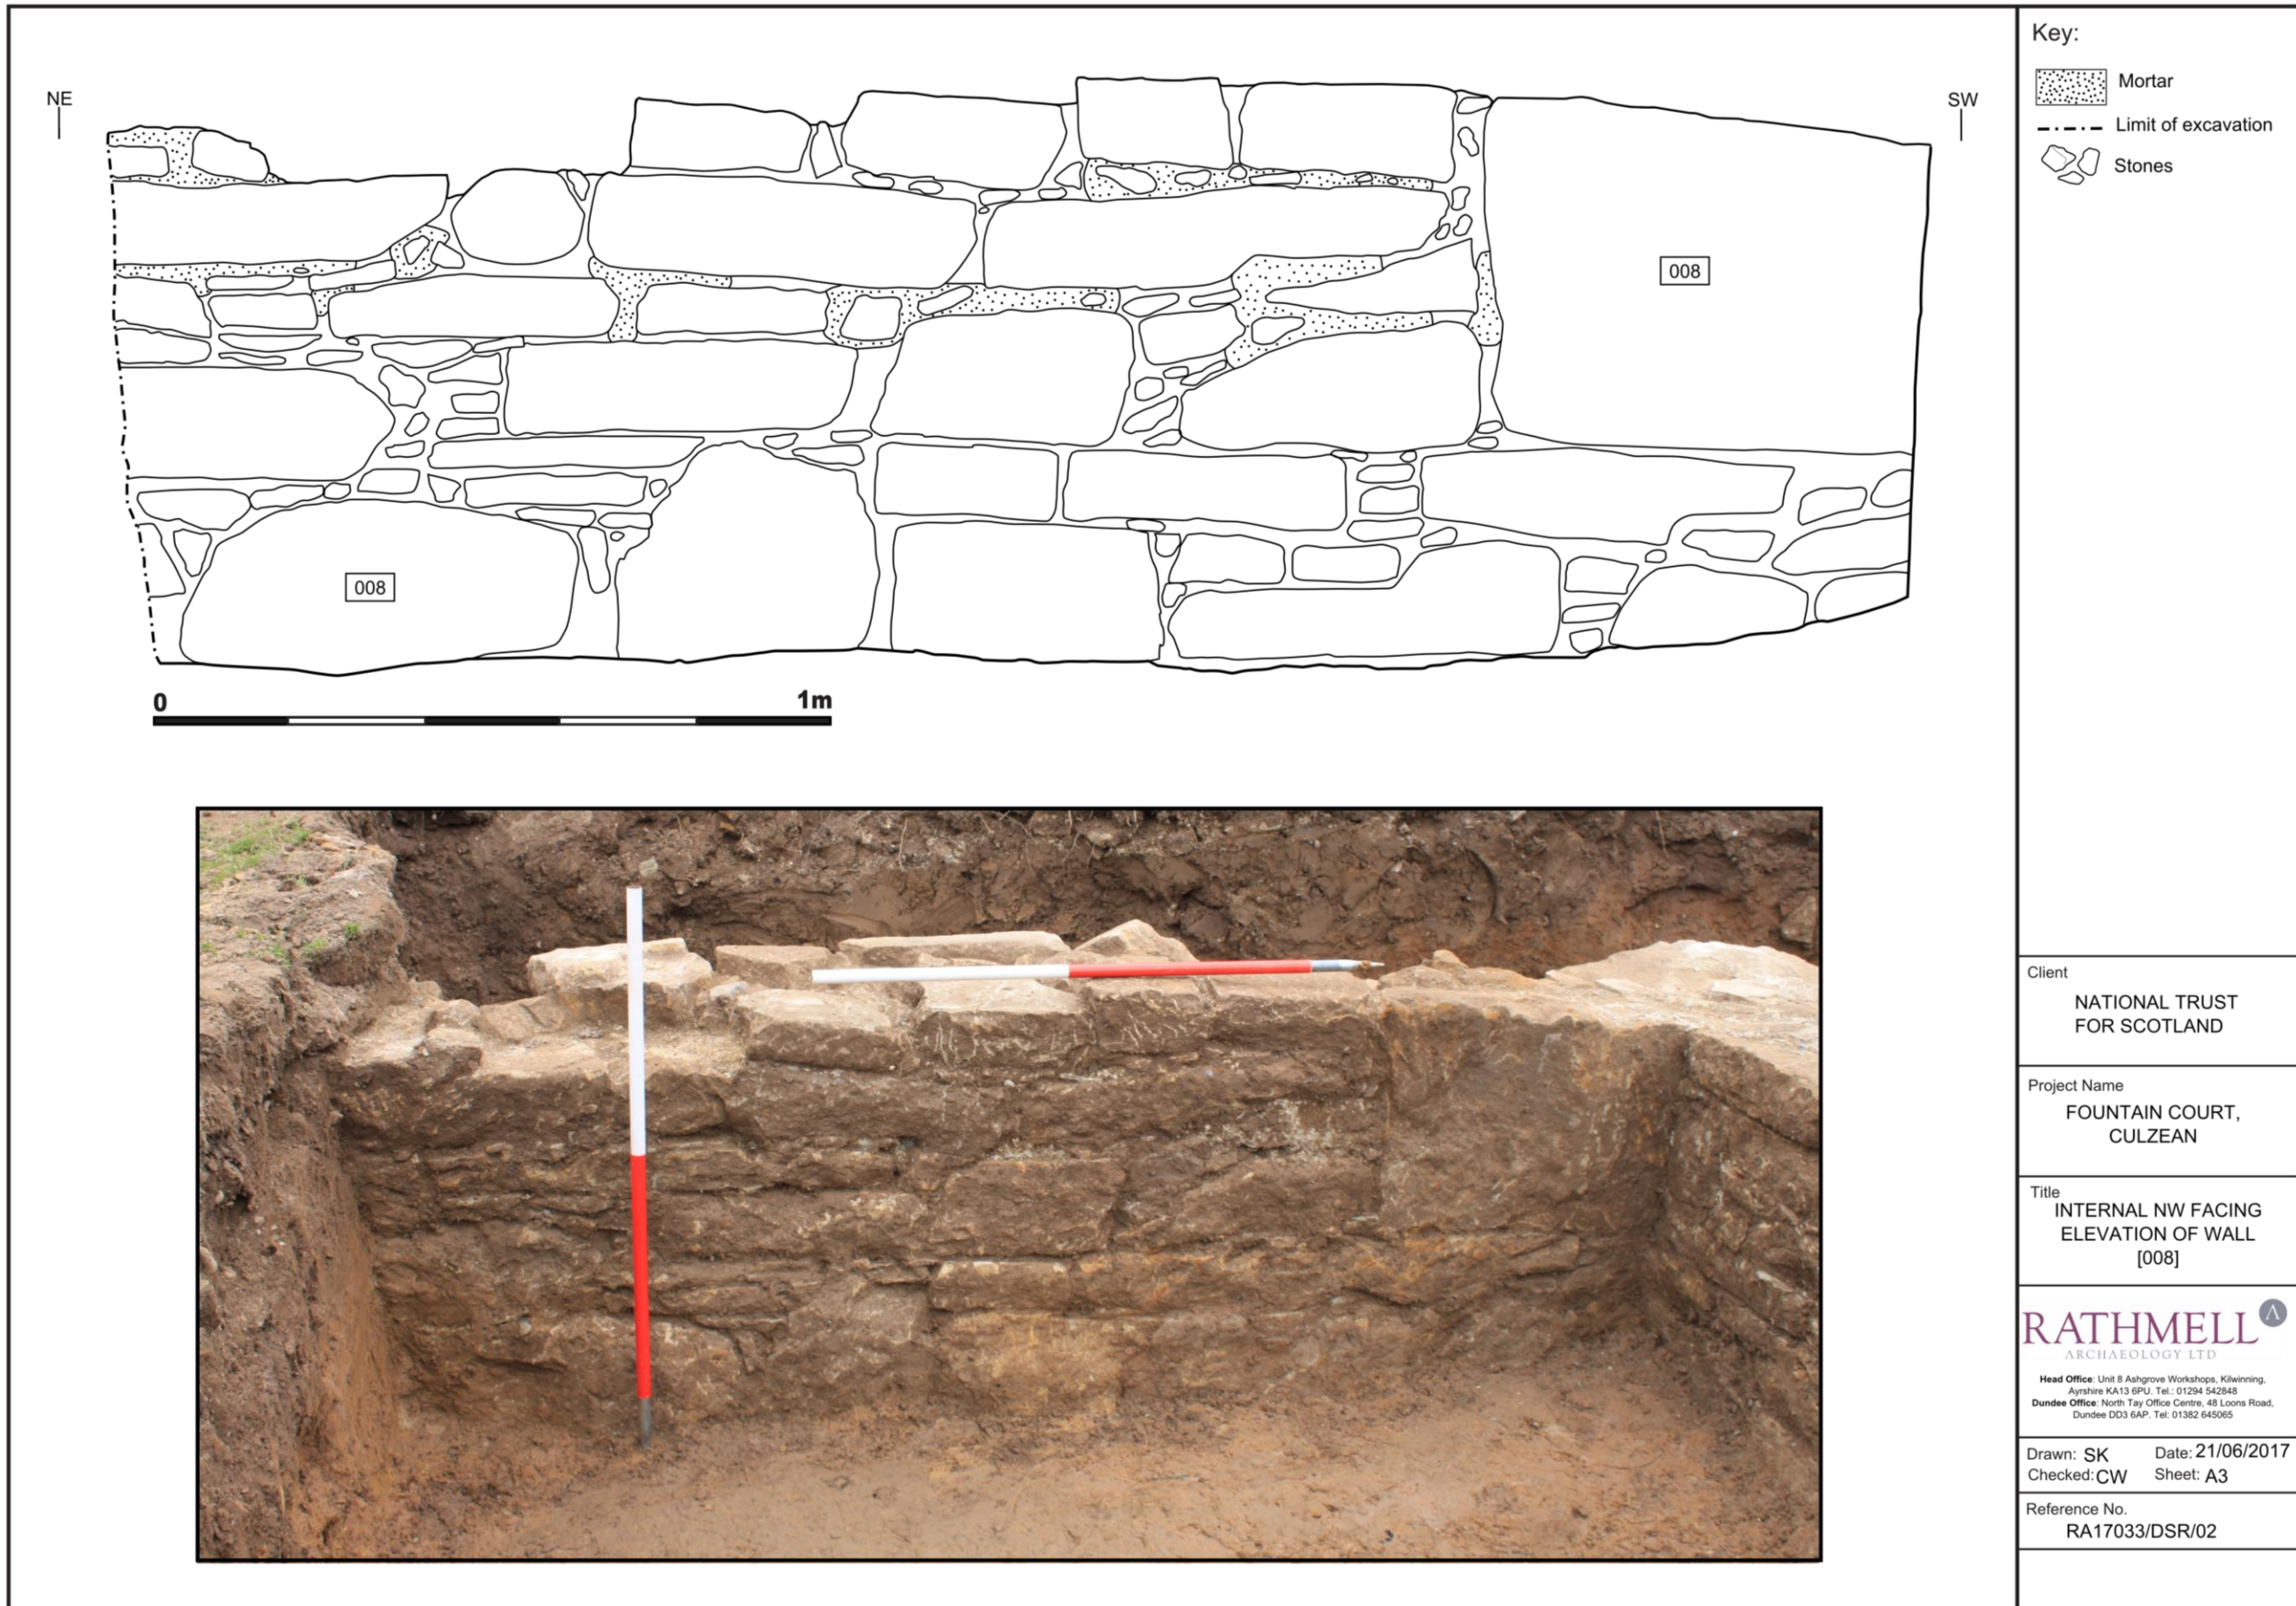
Figure 8: Internal northwest facing elevation of wall [008]

32. The internal faces of the two sections (facing northwest and northeast) had a nice finish with larger squared blocks used (Figure 8), while the external faces (facing southwest and southeast) were formed using smaller unworked sub-angular stones which were more randomly placed (Figure 9). No wall cuts were visible, with the base of the wall sitting directly on top of natural subsoil (014). The foundation course was formed of the same stones as the main fabric although was stepped slightly wider by approximately 0.05-0.1m on either side.

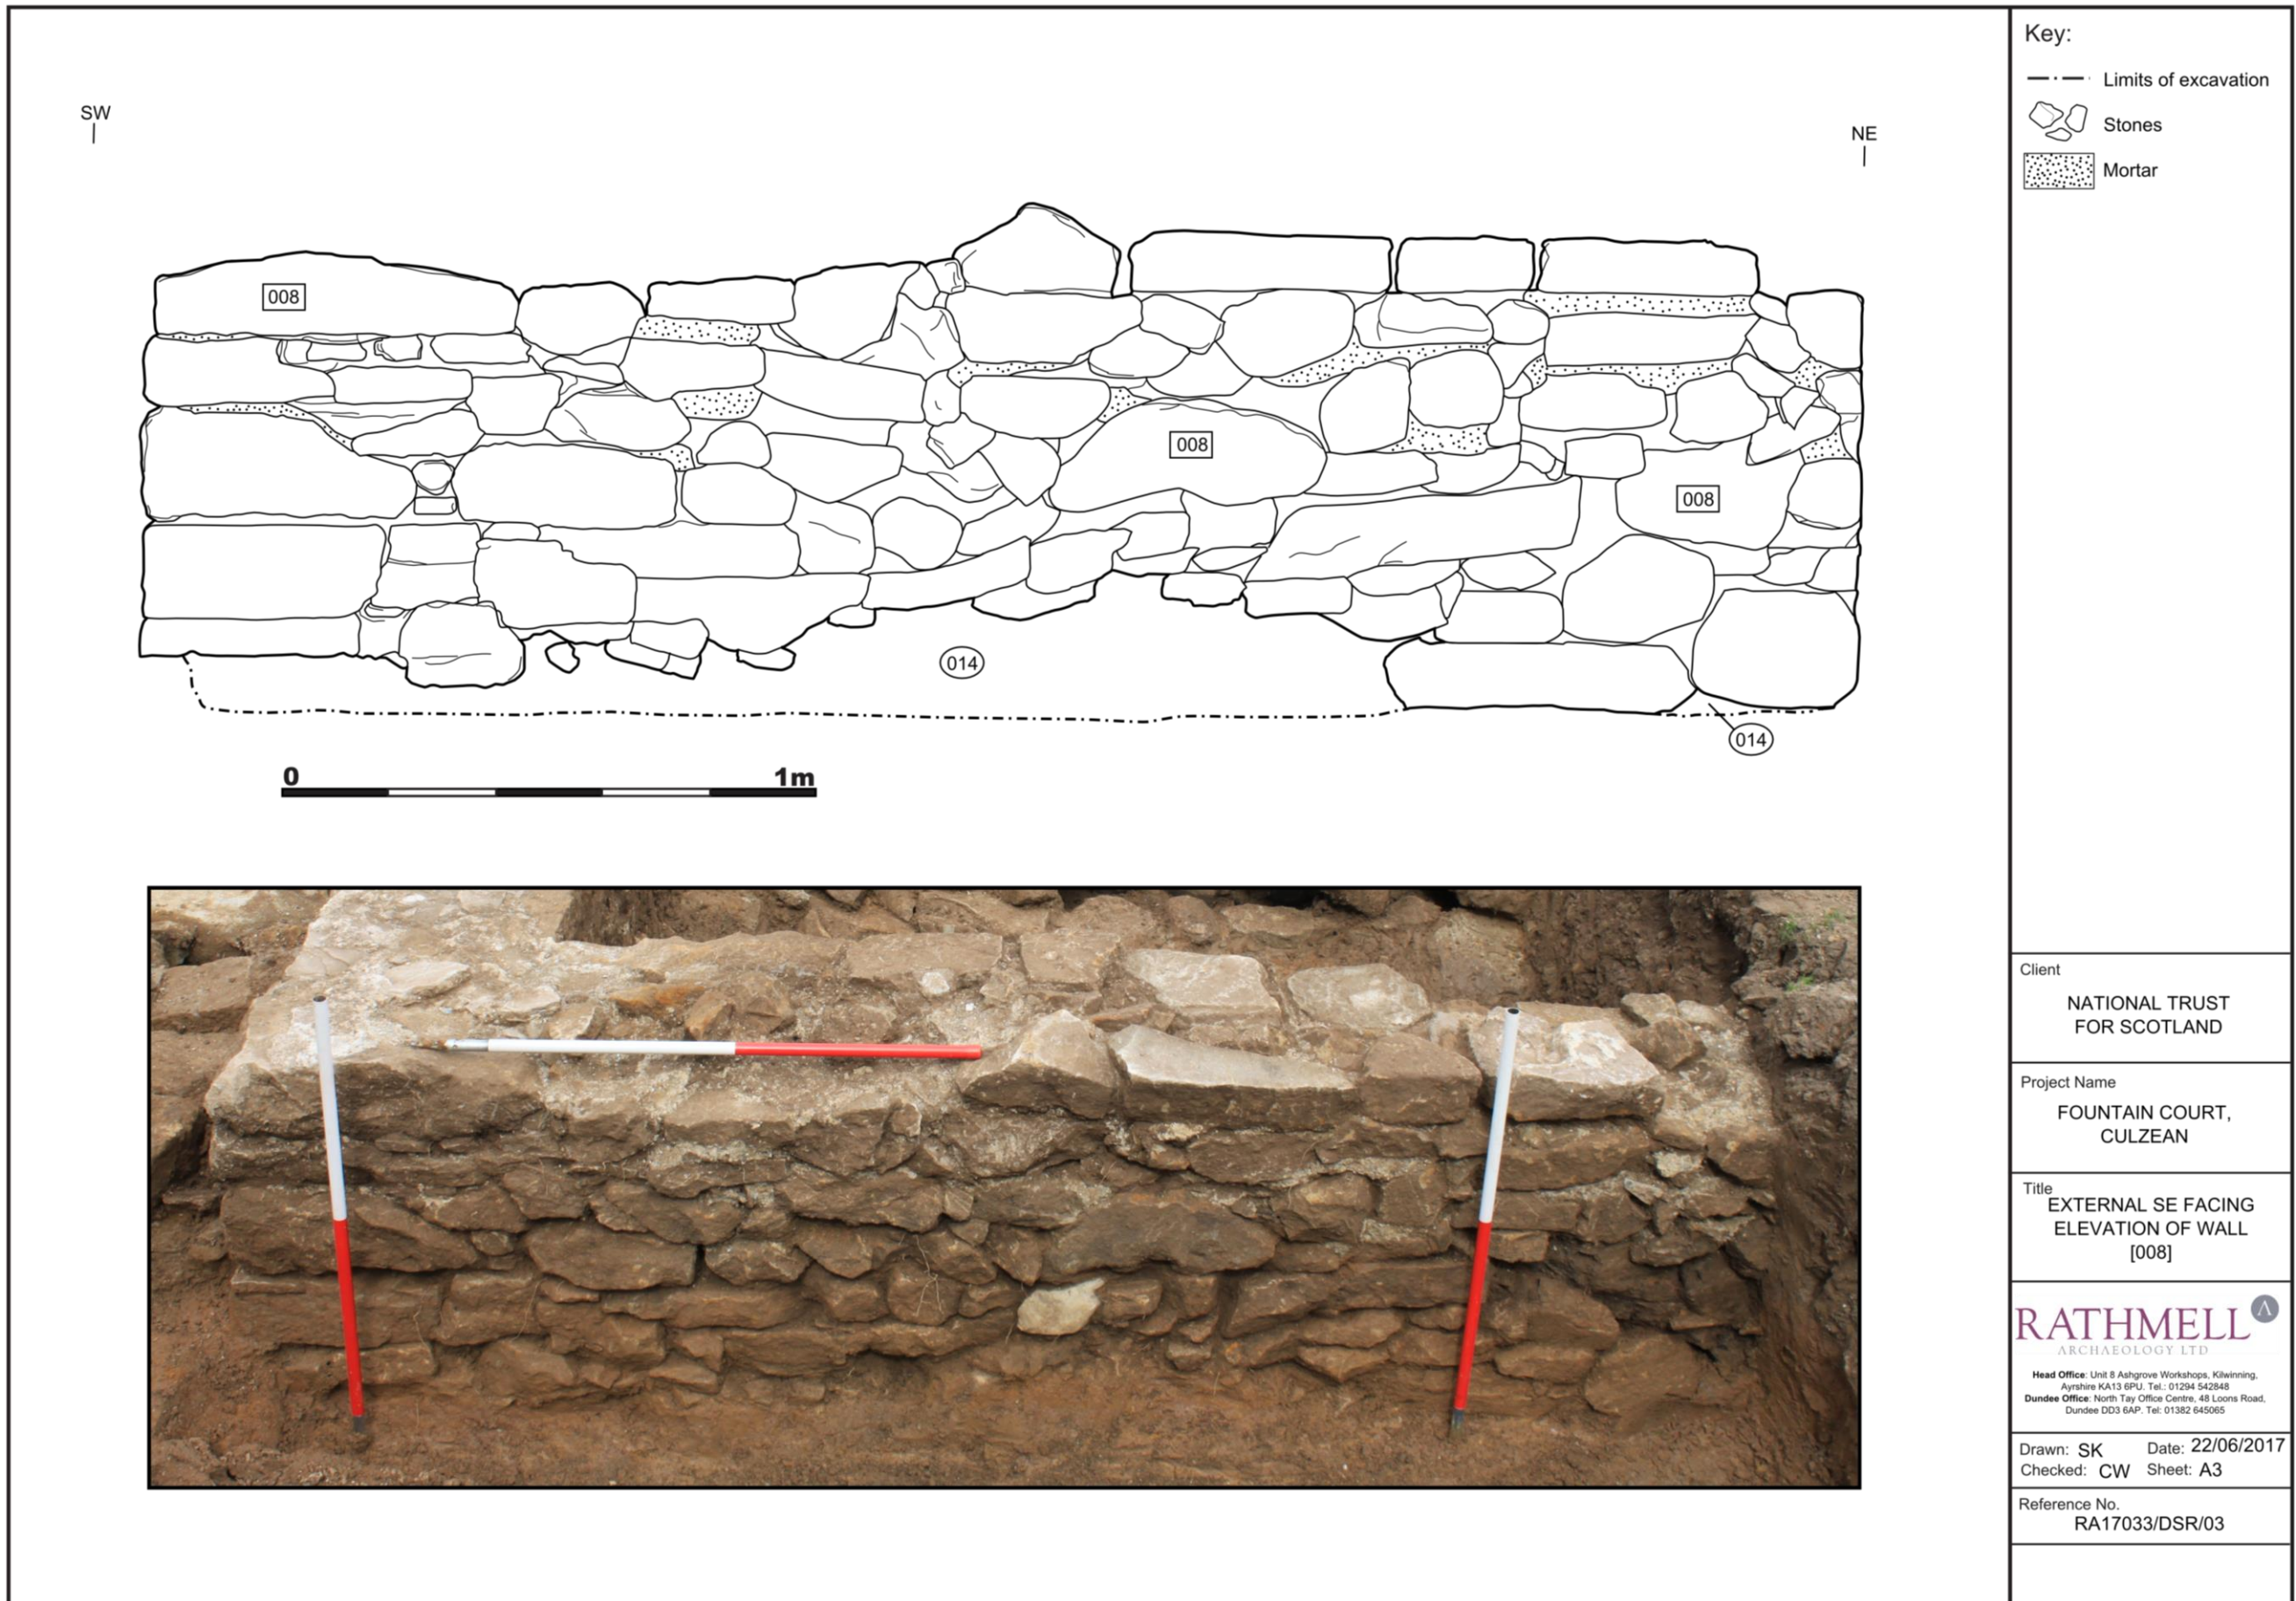
Figure 9: External southeast facing elevation of wall [008]

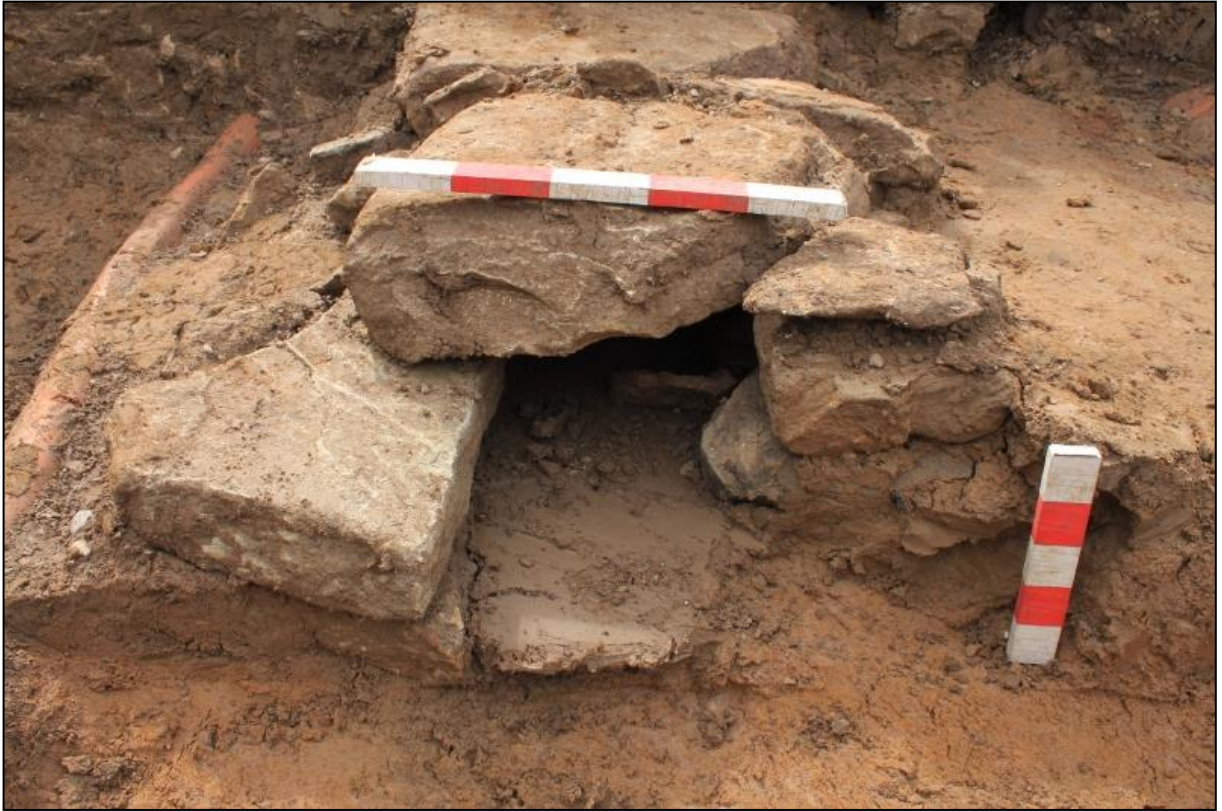
Figure 10a: Northeast facing section through culvert [010] with drain [018] to the left

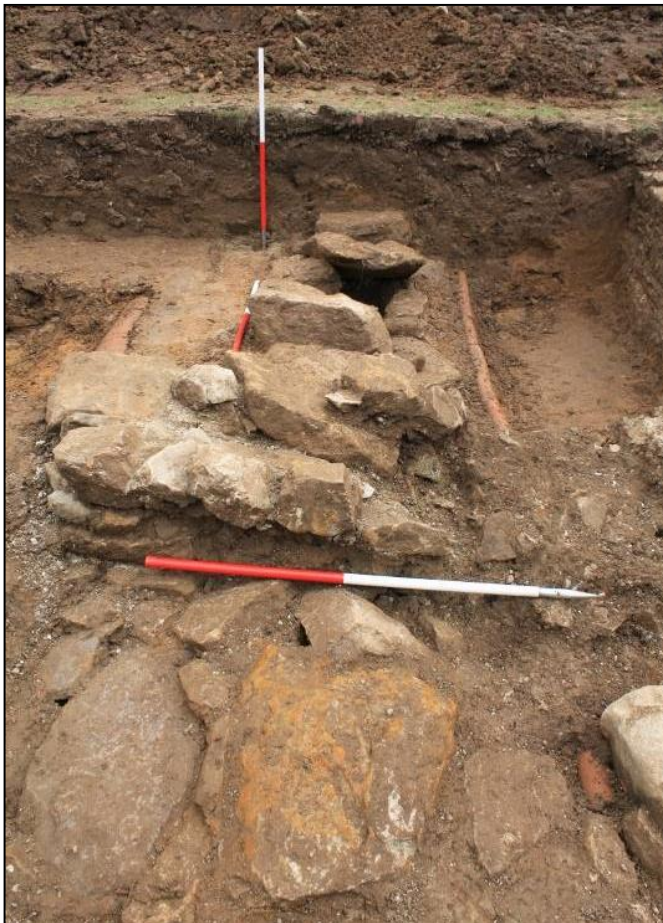
Figure 10b: Culvert [010] running through base of wall [008], taken from the southwest

35. The culvert ran through the base of the wall [008] with a gap measuring 170mm deep between the top of the culvert and the overlying section of wall (Figure 10b). This gap had been filled by deposit (015) which consisted of a very compact mid-brown silty clay with moderate small stones and occasional charcoal flecks.

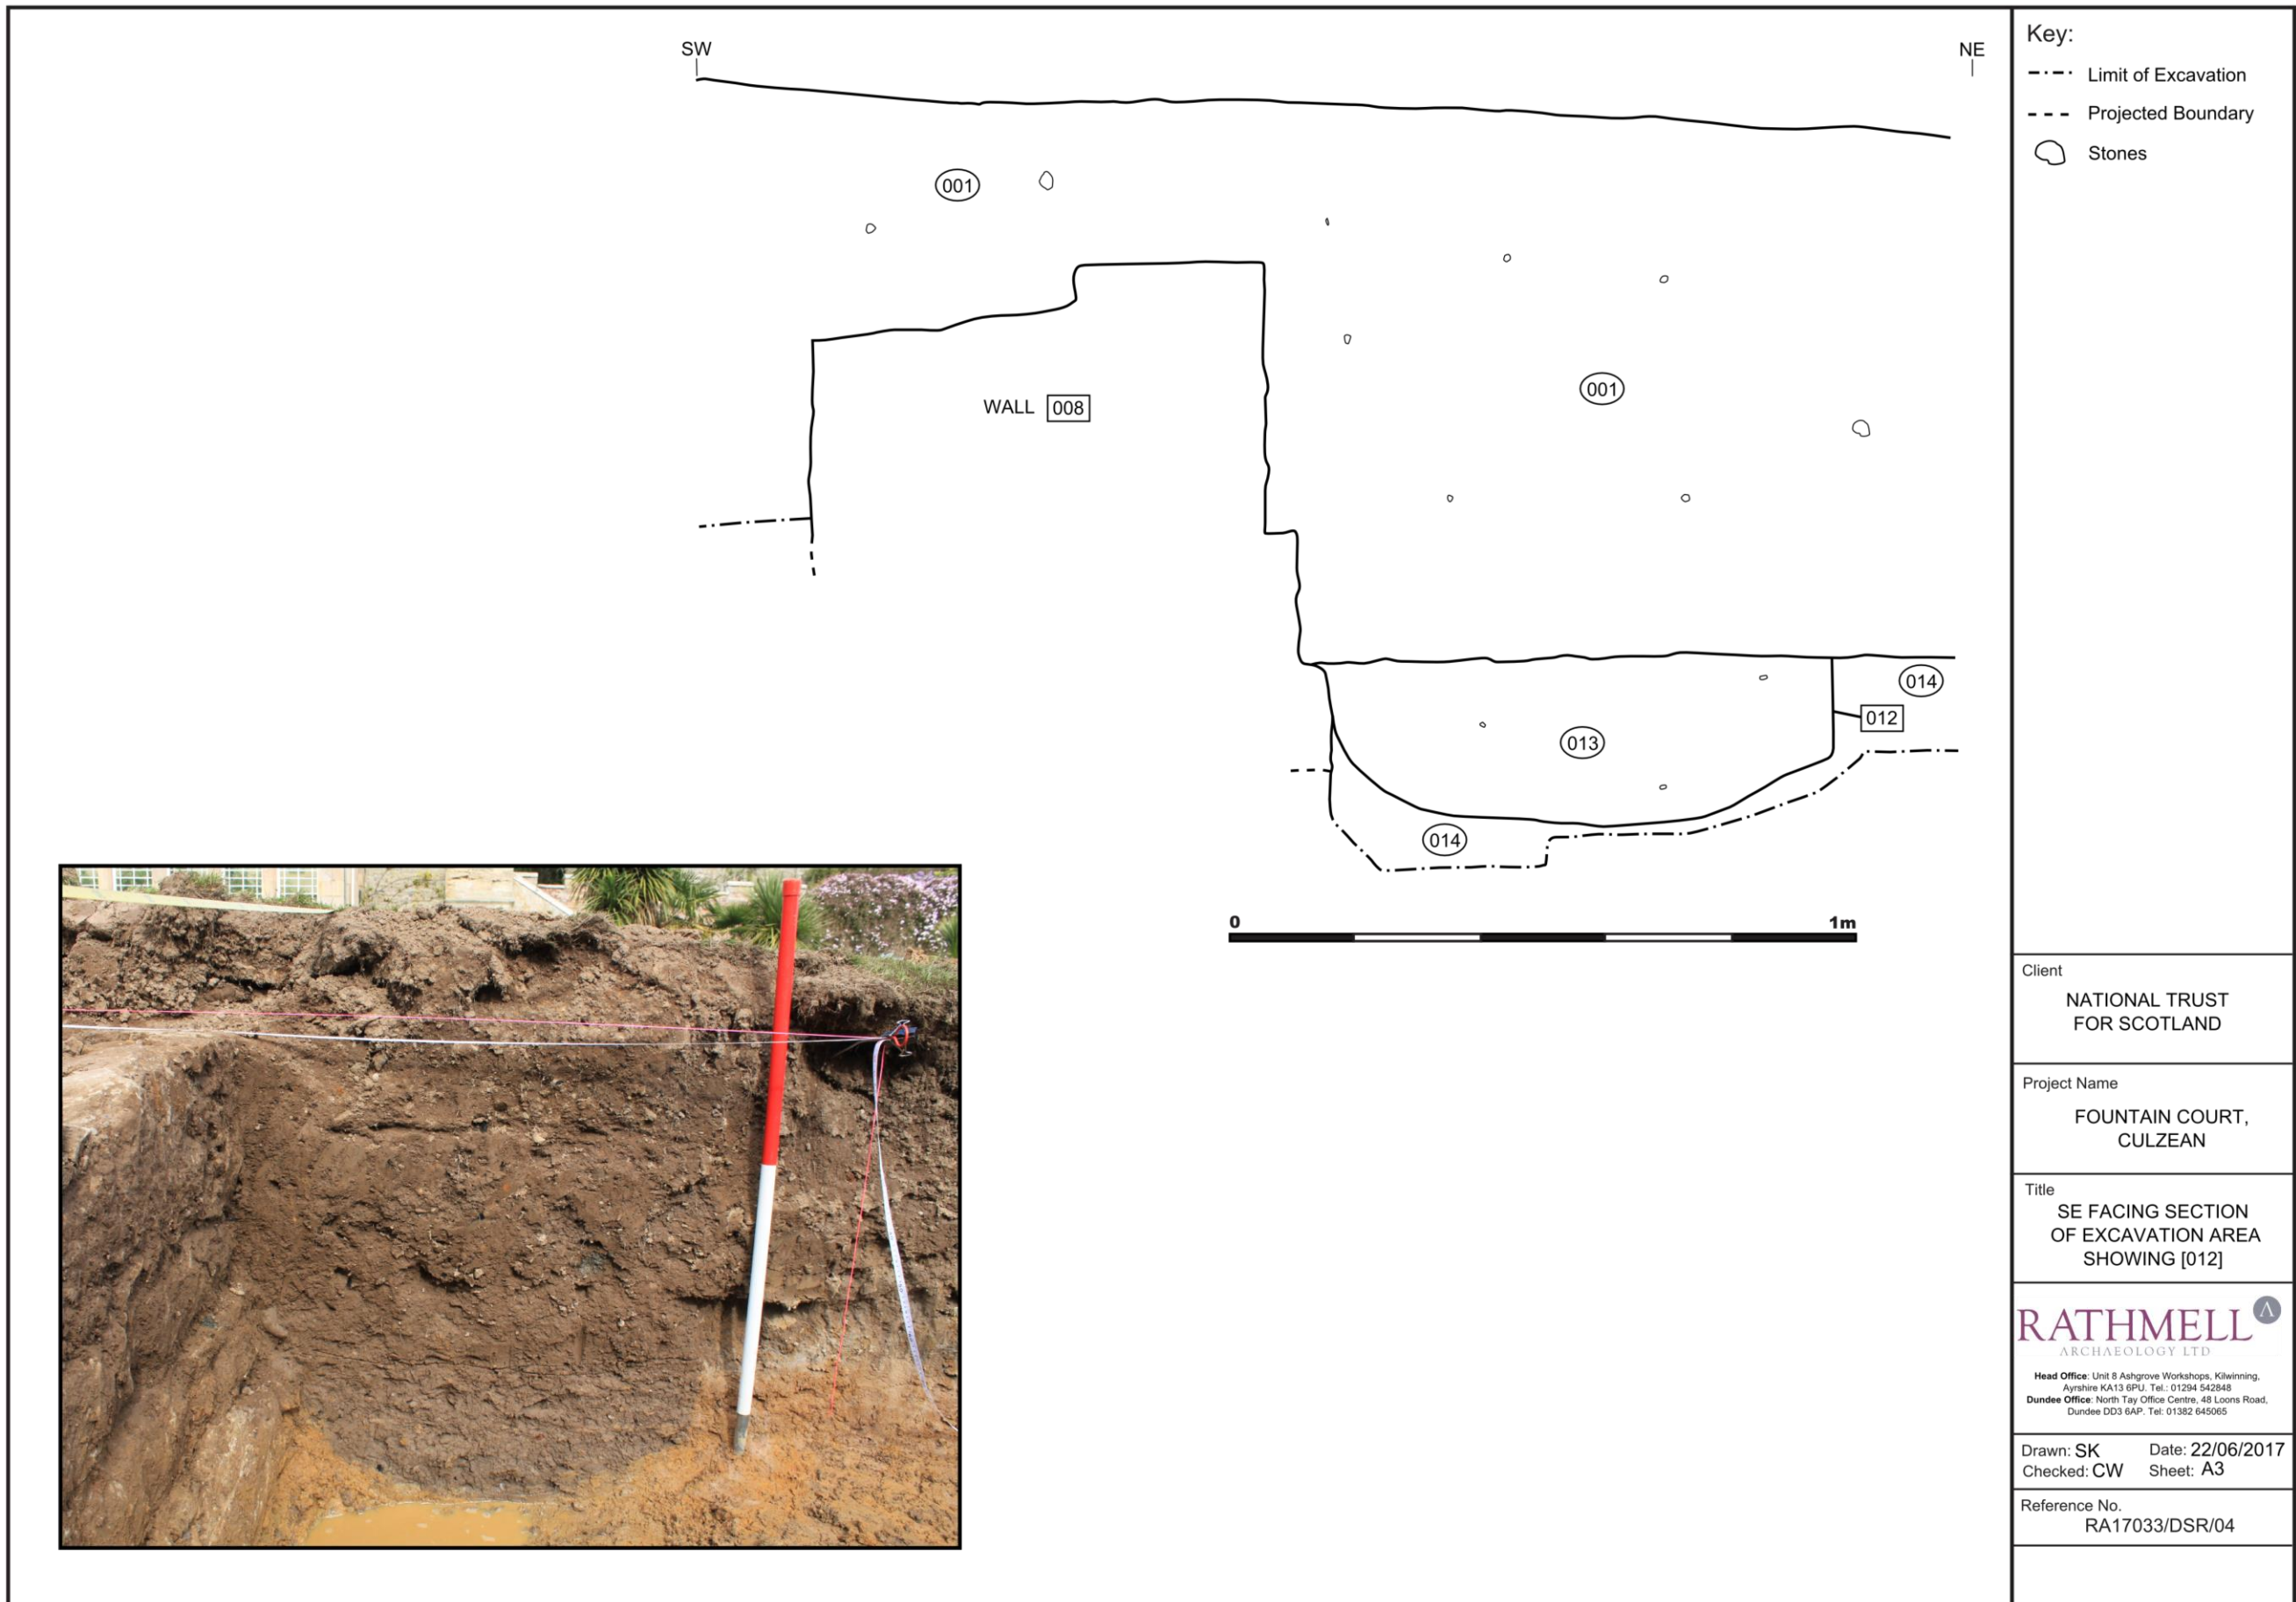
Figure 11: Southeast facing section of excavation area showing [012]

38. Abutting the northeast face of wall [008] at the very northwestern edge of the excavation area, sat feature [012]. This feature was mainly visible in section (Figure 11) running only 0.14m into the excavation area. It is possible that this feature was linear shaped running southeast to northwest, with the southeastern end having rounded corners in plan. In section, the cut has steeply sloping sides and a fairly flat base with rounded bottom breaks of slope on either side. It measured 0.8m wide and 270mm deep, with the top of the cut sat at approximately 850mm below ground level underlying (001). The feature was filled by (013), a very compact pale/mid-grey brown silty clay with occasional small stones and charcoal flecks.

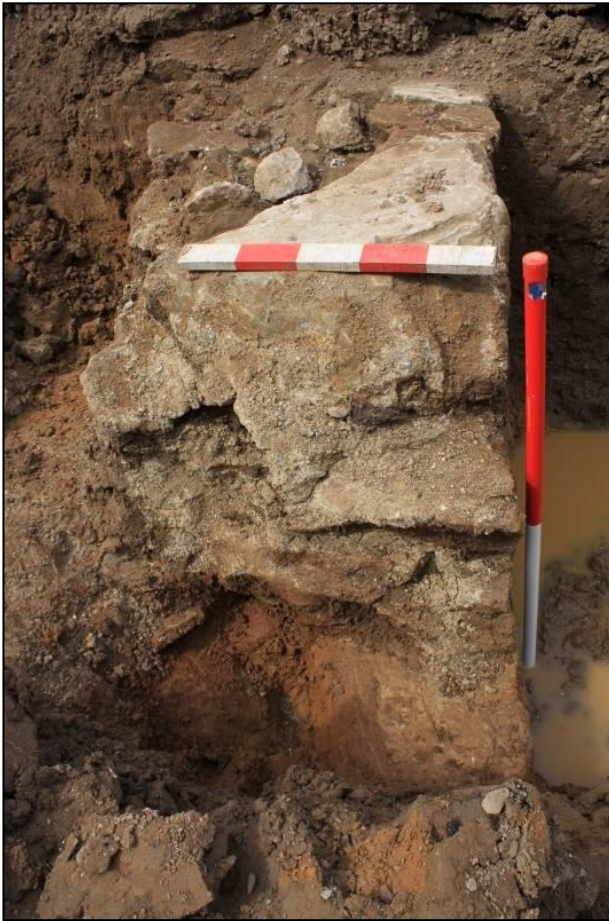
Figure 12a: Southeast facing section through wall [008]

31. [008] ran into the trench from the northwest for a length of 4.4m, before it turned at a right angle to head to the northeast for a length of 2.6m continuing outwith the trench on this side. As seen elsewhere, the wall was formed of blond sandstone blocks each measuring  $\leq 0.49\text{m}$  by 0.64m by 0.16m in size. The wall measured 0.6m wide and a maximum height of 0.8m. The upper courses of the wall (approximately forming the top 0.4m) were lime mortar bonded, while the lower courses were packed with the natural clay (Figure 12a).

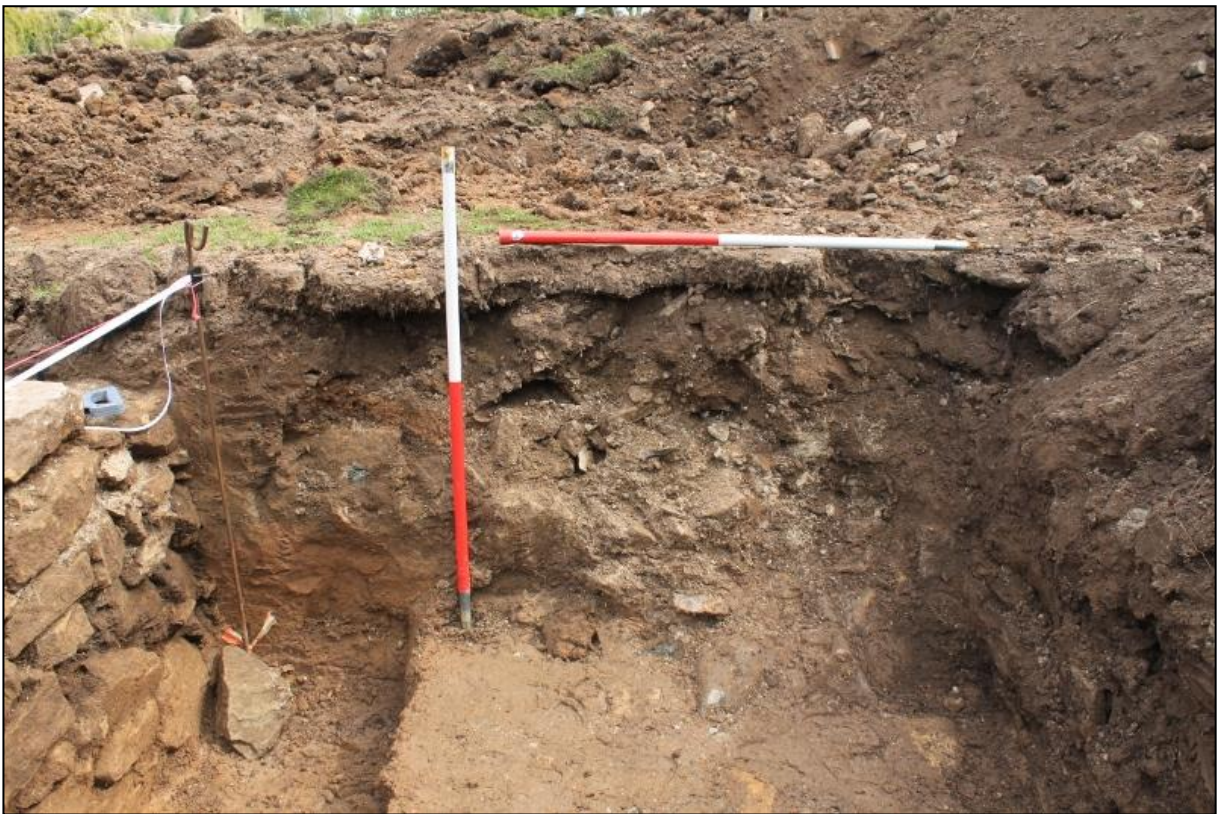
Figure 12b: Southwest facing section of trench showing (016)

39. At the southeastern edge of the excavation, 0.75m to the southeast of wall [008] sat a linear deposit of stones (016) running southwest to northeast and continuing beyond the area in both directions. The stones consisted of loose sandstone rubble of varying sizes (average being 0.2m by 0.2m) mixed with mortar, which extended to 0.8m wide and 700mm deep (Figure 12b). The top of the deposit sat 250mm below ground level underlying (001).
