# **Nithbank Royal Infirmary: Historic Building Recording**

Data Structure Report

by Louise Turner and Thomas Rees

**RATHMELL**    
ARCHAEOLOGY LTD

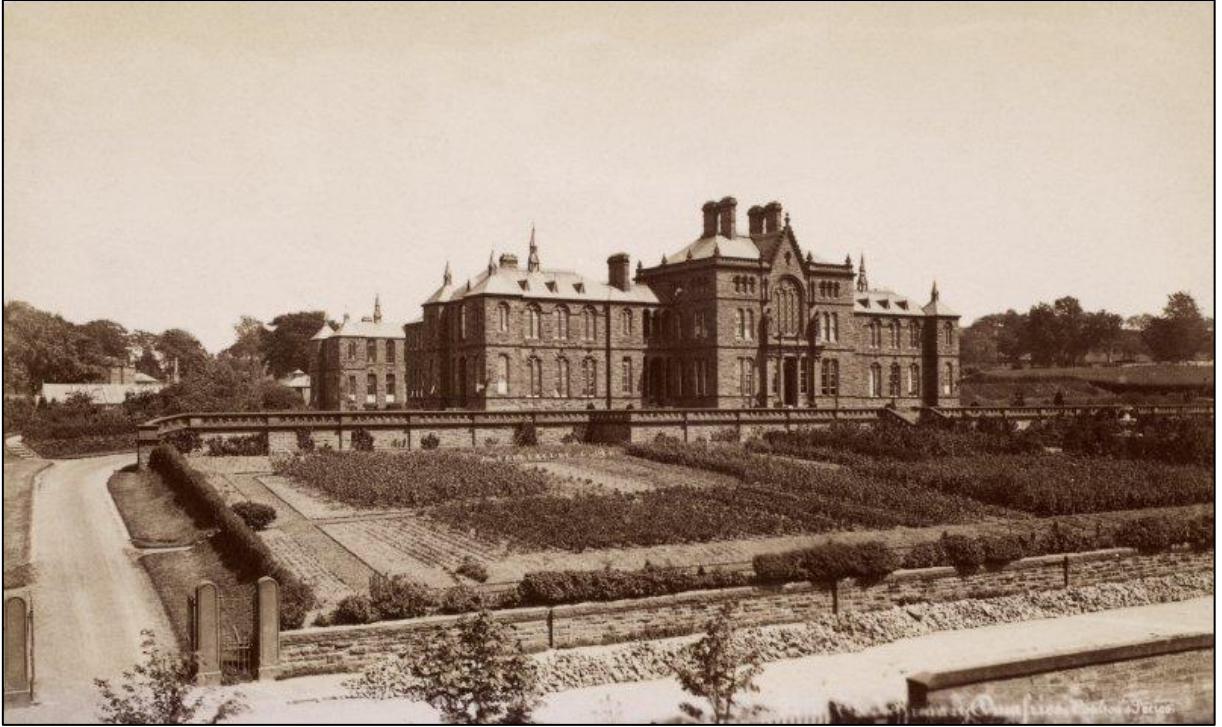
Figure 1a: 19th century view of the main hospital building at Nithbank

10. The original hospital is a good example of its date and notable for its pavilion plan layout (Figure 1a). The former hospital has a considerable amount of high-quality architectural detailing to its entrance elevation and external decoration in general and is an important example of John Starforth's work. The pavilion plan form, or Nightingale wards, were widely adopted from the 1860s and are notable for their large interlinked rooms, corridors and service pavilions. The design of the hospital at Nithbank is typical of the mid-nineteenth century move towards more ornate and architectural compositions for this building type.

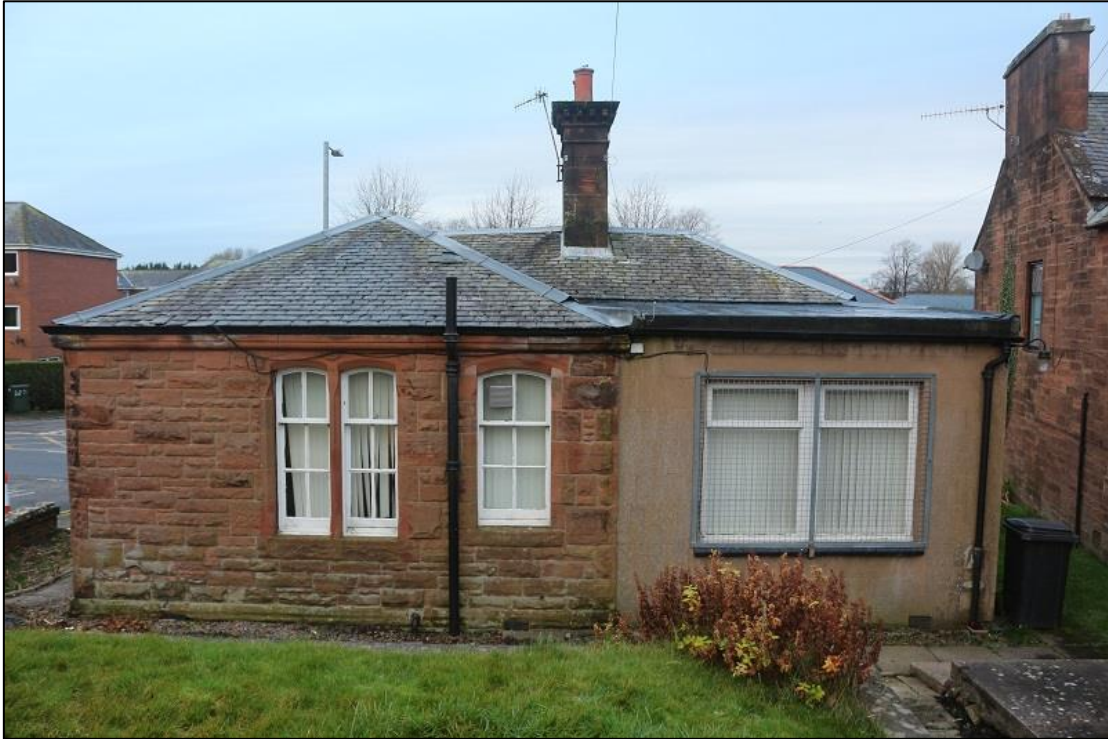
Figure 6a: North Lodge – E Elevation, With Extension to Original Structure on N Side of Building

different dimensions (see Figure 6a). The presence of vertical pinning in the masonry immediately to the N of this variant (i.e. adjacent to the modern extension) may indicate that the walling has been rebuilt in this location (no such pinnings are evident elsewhere) and that the window may have been relocated from either the E side of the N wall of the main building or the E wall of the projecting outshot when the wall was removed to make way for the extension. A further simple window comprising a small rectangular opening abuts the rear entrance on its W side.

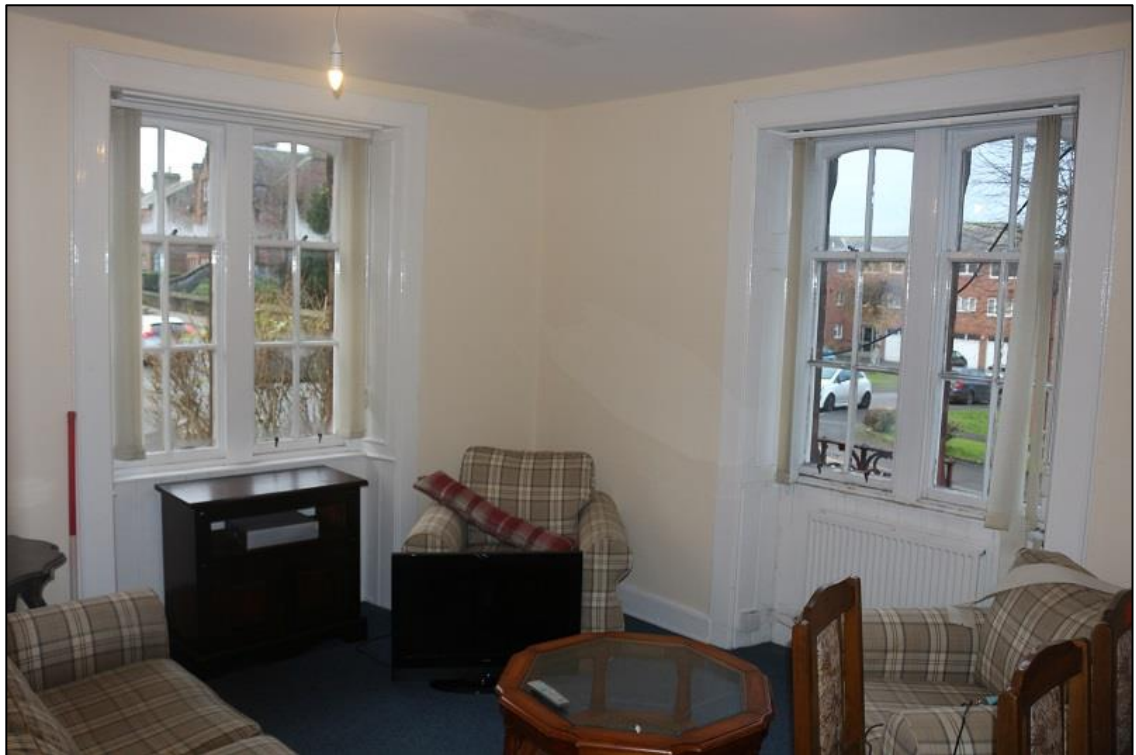
Figure 7b: Room NL3, Showing Absence of Cornice

29. In most circumstances, the presence (or absence) of a cornice is a good indicator for the survival of original fabric, particularly in the public rooms, but in this instance, its survival appears to be sporadic. Room NL3, for example, has no trace of a cornice surviving (Figure 7b), despite its location at the front of the building (inferring a principal room) and the survival of what appears to be original timber panelling around the windows embrasures. This suggests that its absence reflects an earlier need to strip out the original plasterwork and replace it with new.

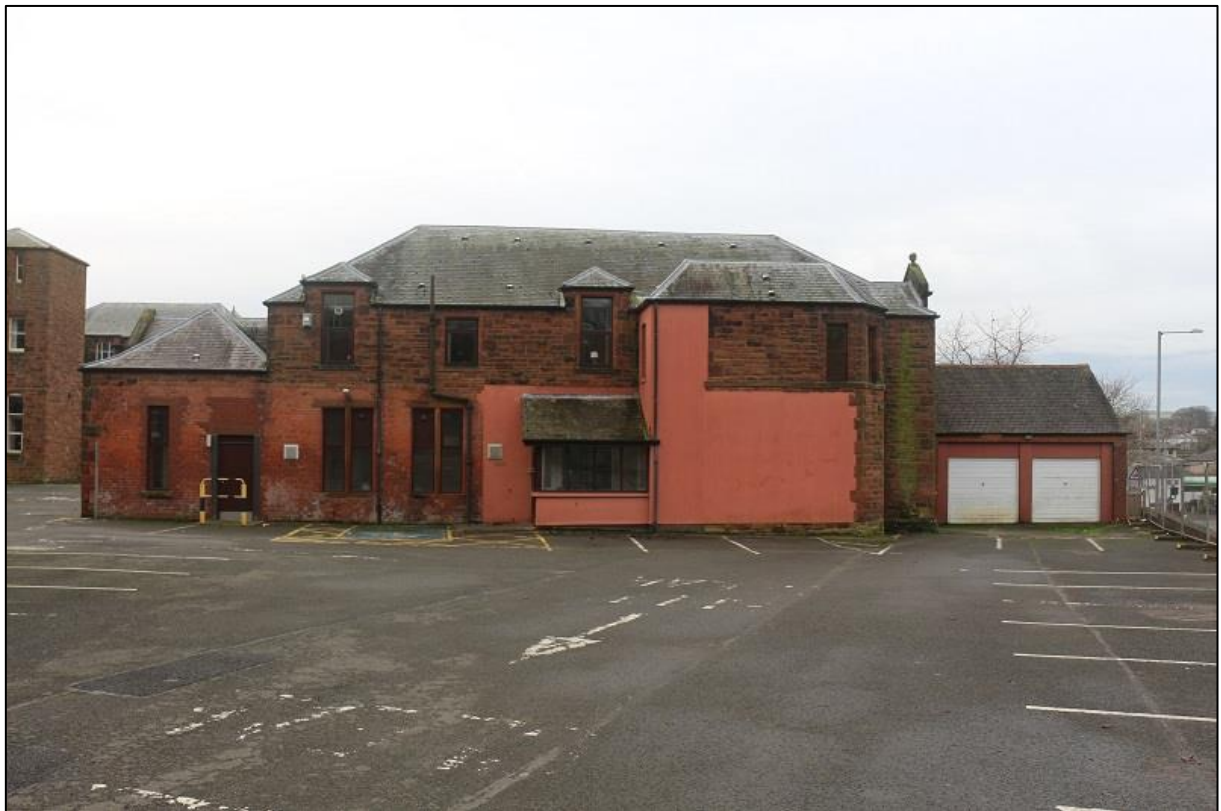
Figure 12b: Occupational Health Building: E Elevation

49. There is also evidence for the existence of a rear doorway located in what is now the S wall of OH1. This possible doorway now survives as an arched window opening (Figure 15b) which is incongruous both in its location and its character (no other arched window openings being present within the building). Compare this with the arched doorway which frames the main entrance and its presence sits more comfortably within the range of features occurring. With map evidence indicating that there was once an outshot running ENE from the N end of the building, it is possible that the arched opening may have functioned as an internal doorway, allowing access into the rooms contained in the outshot, the remains of which are evidenced by the rendered surfaces at ground and first floor level at the north end of the E Elevation (see Figure 12b)

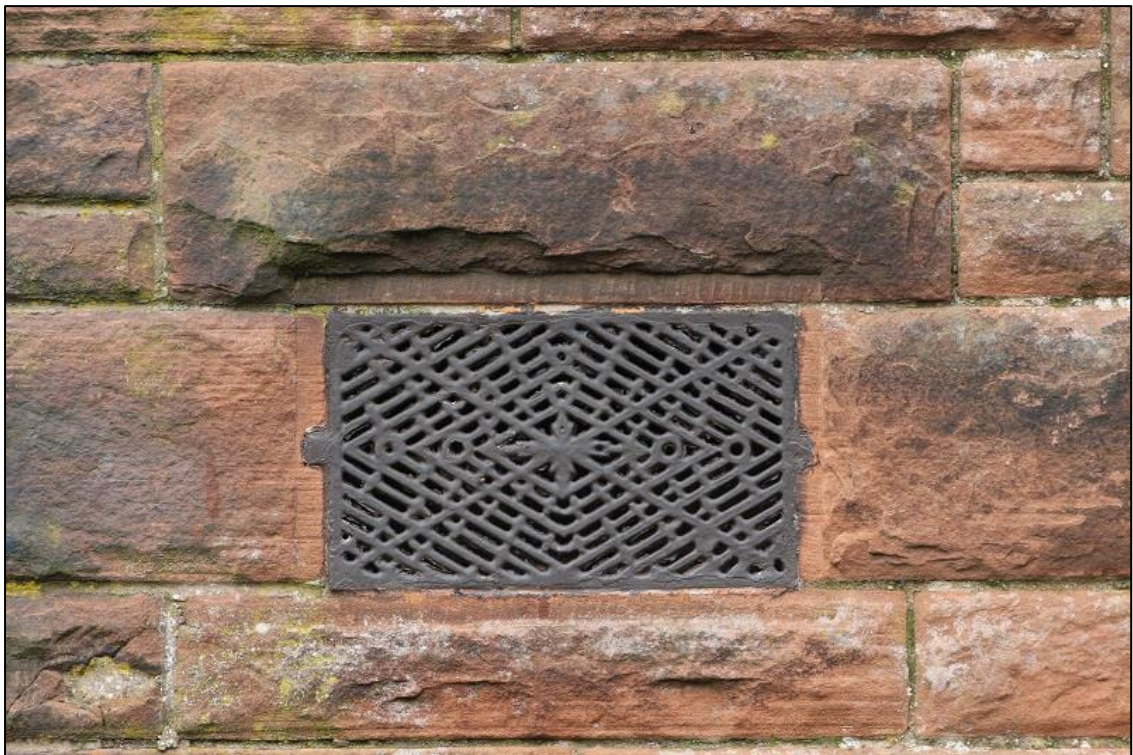
Figure 13b: Occupational Health Building – Cast Iron Ventilator Grille, W Elevation

more ornate character are a series of ventilator grilles set in particular within the basal plinth of the W elevation (Figure 13b). The presence of these original features indicates that the building employed gas lighting from its earliest stages of use. There, is, in addition a small cruciform feature composed of ferrous metal and located close to the wallhead towards the south end of the East Elevation: this appears to represent a single wall- or cross-tie of original date which is set within the fabric, unusual for its ornate character as well as its isolated presence (Figure 14a).

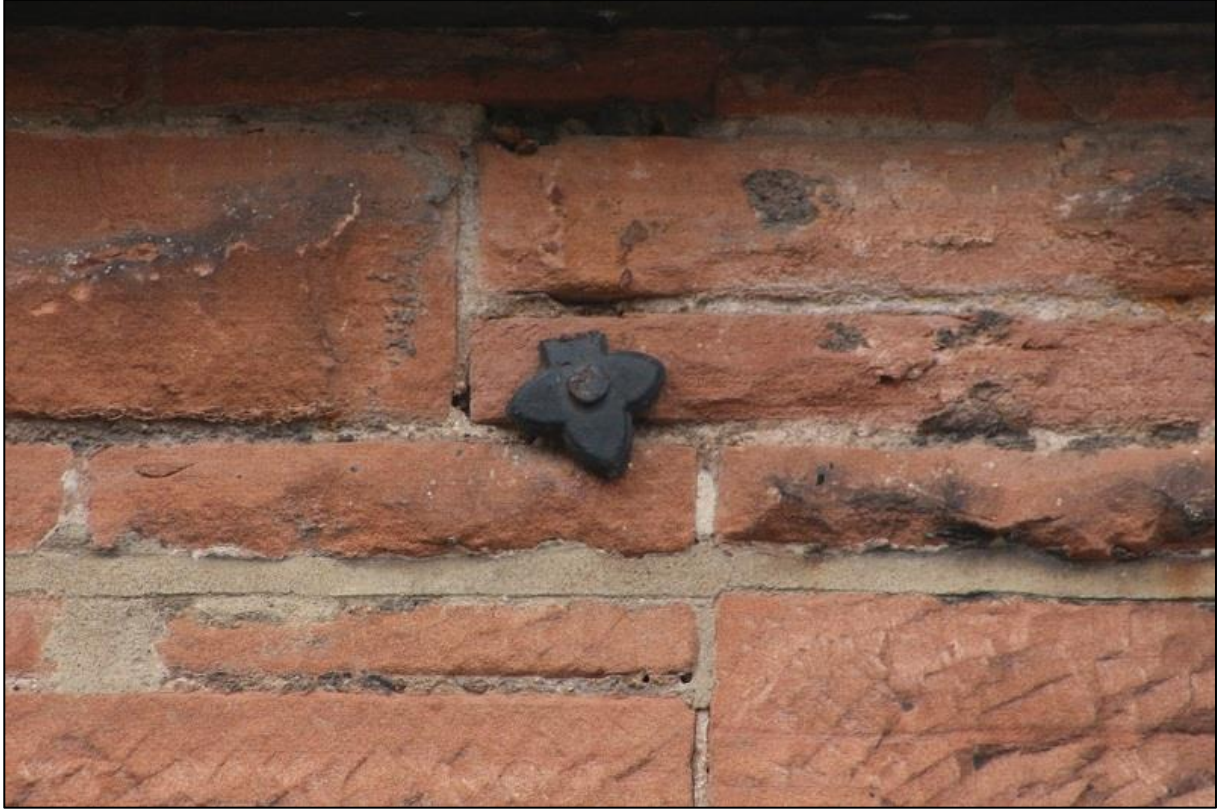
Figure 14a: Occupational Health Building – Cast Cross-Tie set at High Level, S End E Elevation

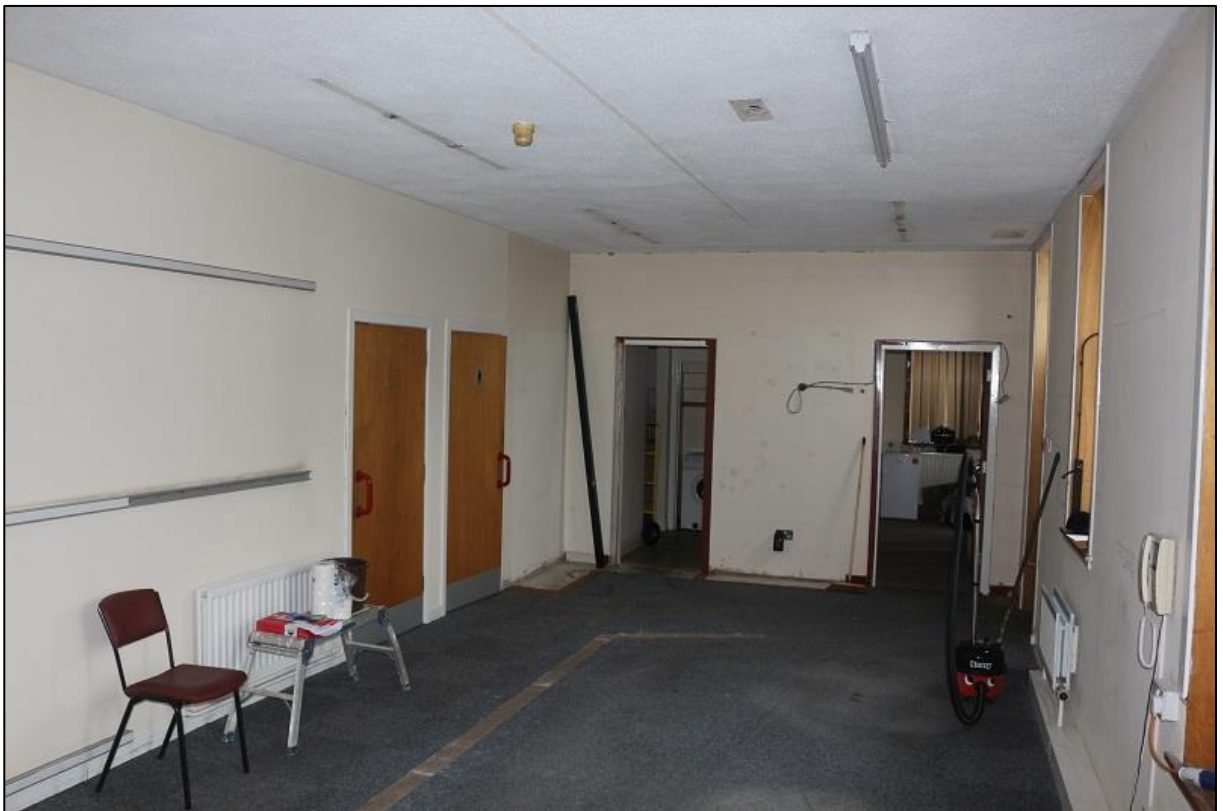
Figure 14b: Occupational Health Building – Interior of Room OH5, showing Original Internal S Wall

47. Only one internal room division can be confidently described as being extant during the original phase of construction and occupation. This is the division between the apsidal-ended room OH6, located at ground floor level in the SW corner of the building, and the large room OH 5, which sits immediately to its N side (Figure 14b), and which is separated by a stone cross wall which supports the external S wall at first floor level.

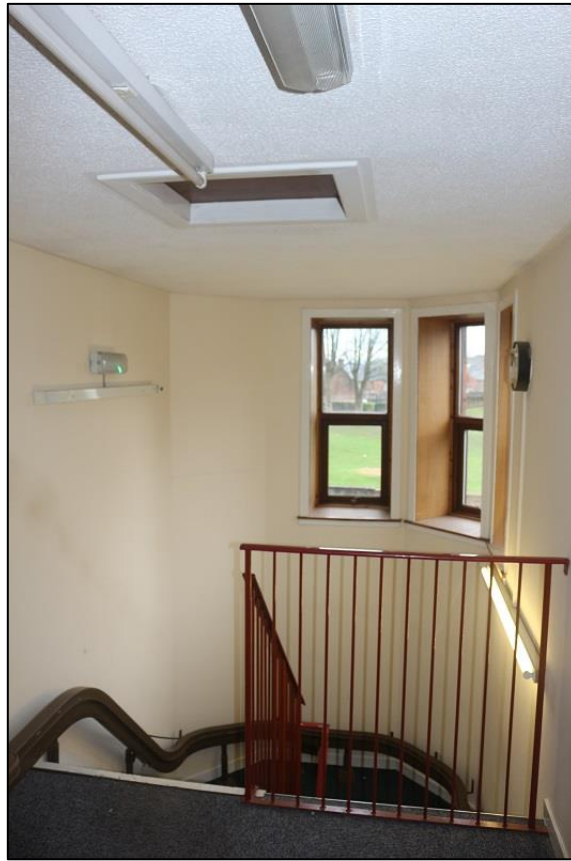
Figure 15a: Occupational Health Building – View of Main Stair OH1 From First Floor Landing OH13

48. Despite the poor levels of survival evident throughout the interior of the structure, some observations can be made. Firstly, it is likely that the position of the main stair matched that used by the main stair which remains in use today (Figure 15a), i.e. access to the upper storey was via the apsidal-ended room OH1 located in the NE corner of the structure (with the S part of OH1 representing a modern extension). It is possible, however, that a new opening was slapped through the former S wall of OH1 when the extension was added, and that prior to this date, access to the stair was via the main entrance corridor OH4 and inner chamber OH2.

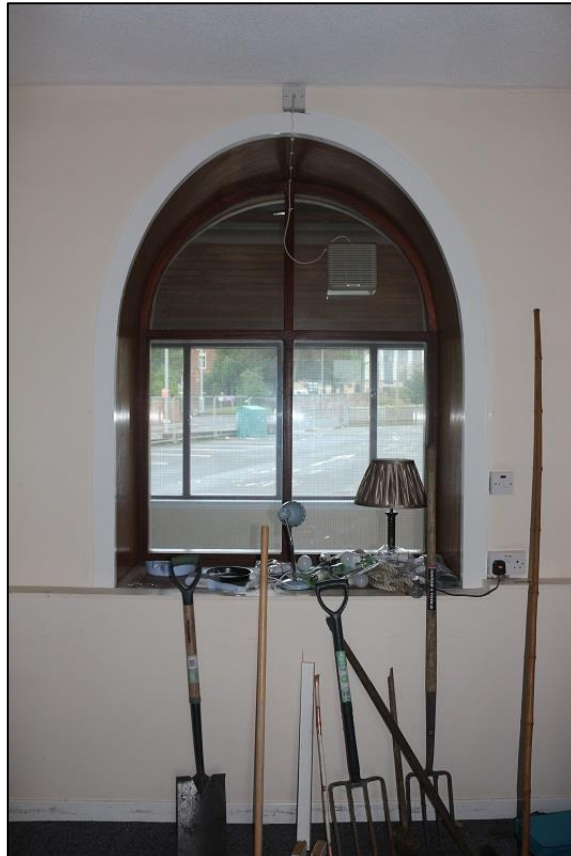
Figure 15b: Occupational Health Building – Possible Doorway in E Wall

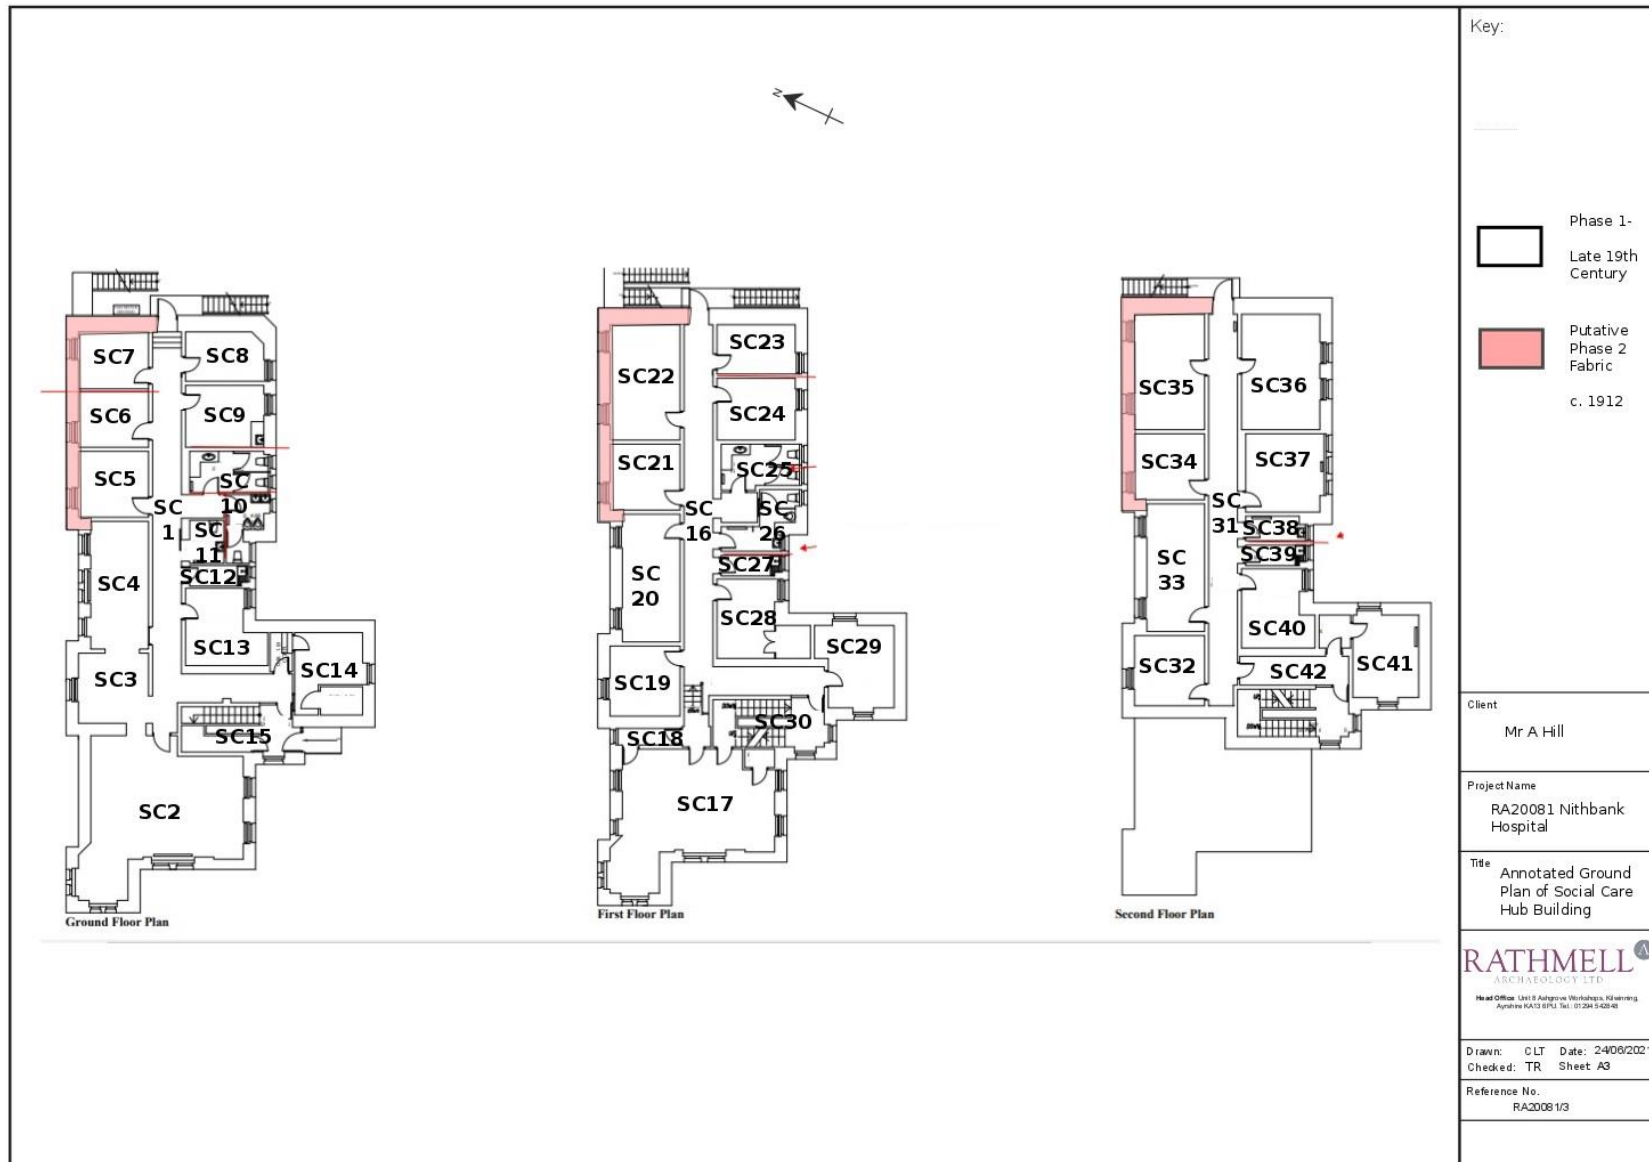
Figure 16: Ground Plan of Social Care Hub Building

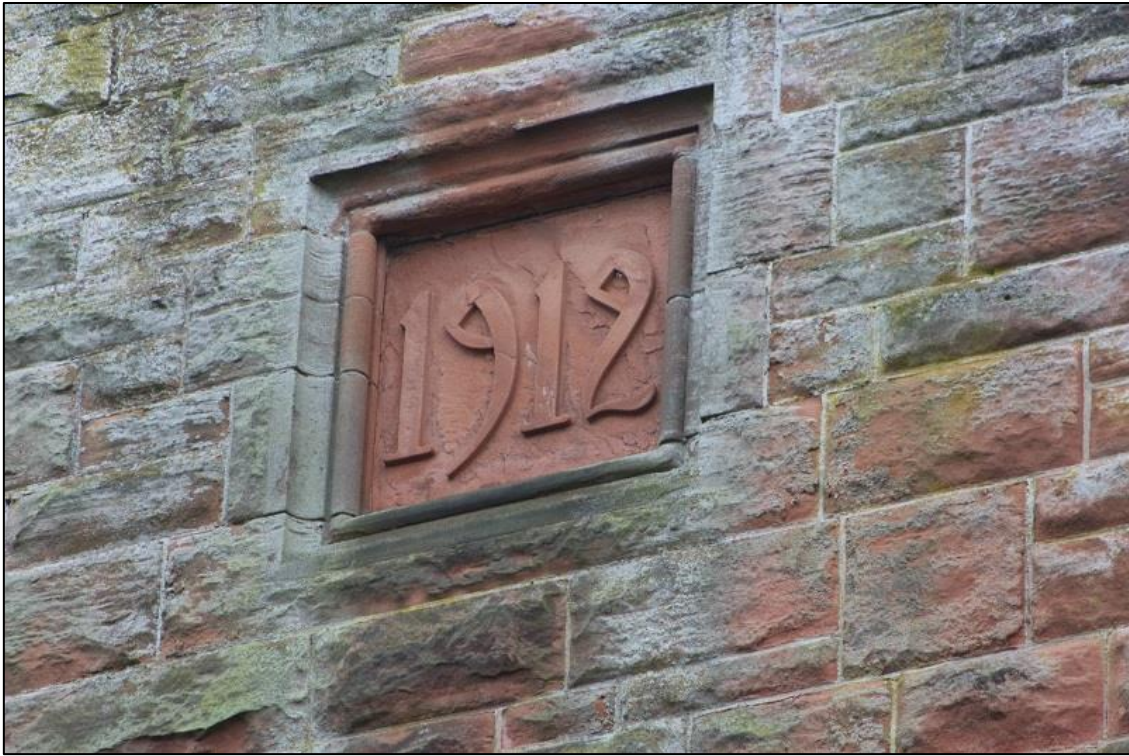
Figure 17a: Social Care Building – Datestone marked '1912'

51. Map evidence suggests two phases of construction in this building, and this is supported by the presence of a datestone marked '1912' (Figure 17a) set high in the pedimented gable at the eastern end of the N elevation (Figure 17b). The building is three storeys high and eight by three bays in extent, with a three-storey outshot extending from the S

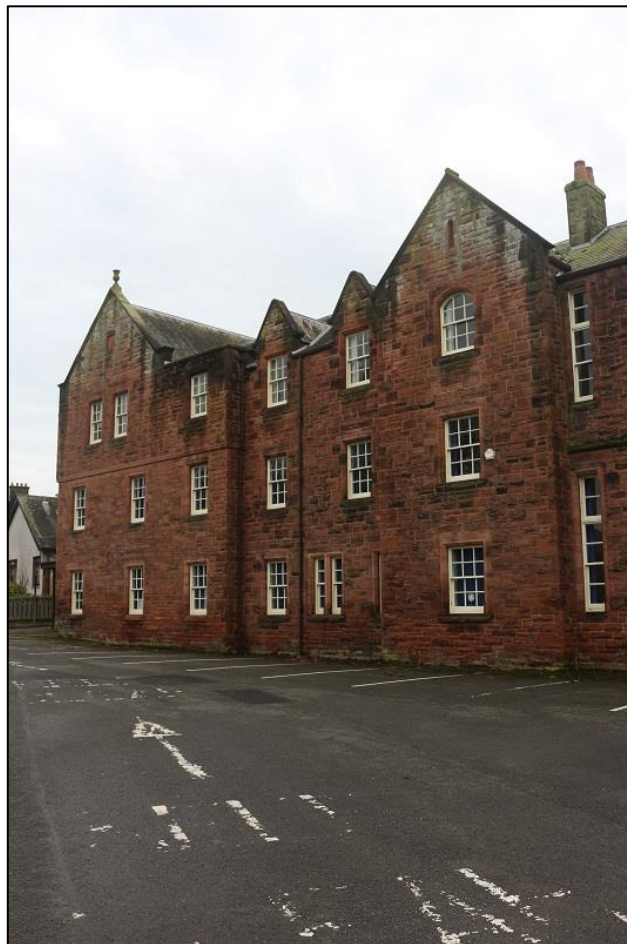
Figure 17b: Social Care Building – East End of N Elevation, Site of Datestone

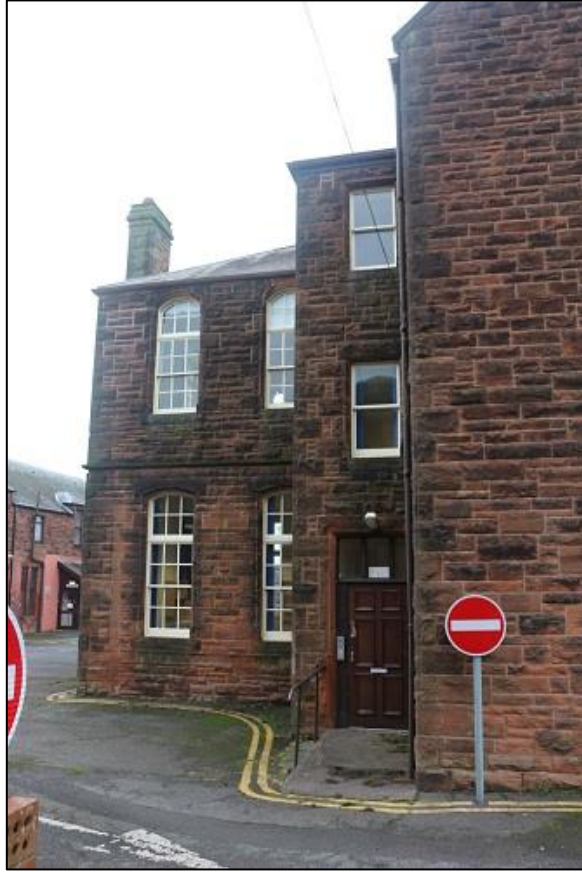
Figure 18a: Social Care Building – Main Entrance in S Elevation

elevation and one extant square corner turret on the NW corner. The roof is slated, and the masonry comprises bull-faced squared coursed rubble throughout. The main entrance is via a doorway that sits immediately to the W of the outshot on the S elevation (Figure 18a), with secondary access (i.e. a fire escape) via doors on every level in the E elevation (Figure 18b). These discharge an external stair constructed of steel sourced from prominent Scottish steel producers, Colville.

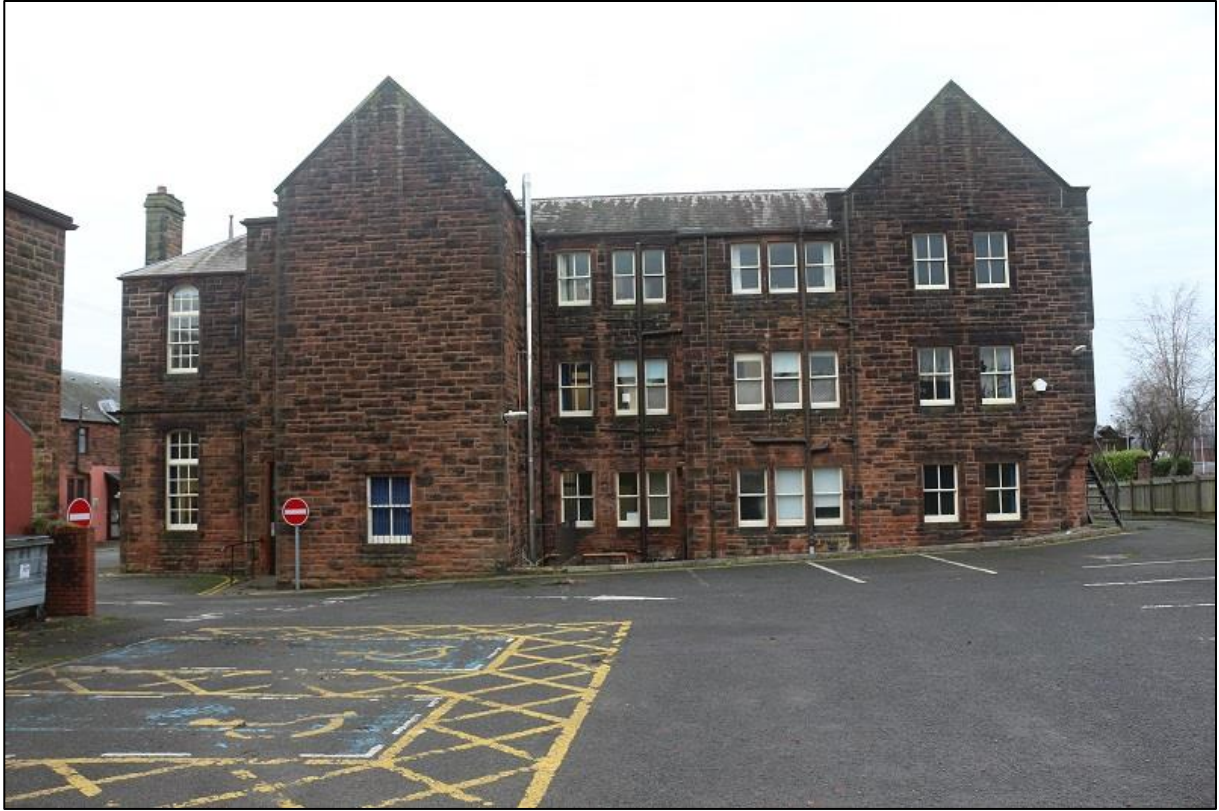
Figure 19a: Social Care Building – S Elevation

52. Between the two main elevations it is on the face of it ambiguous as to which, if either, might constitute the principal elevation. Entrance is via the S elevation, but the location and character of the doorway does not emphasise this feature in any way (Figure 19a). Although no means of entry is present within the N elevation, some features imply this may have functioned as the principal elevation (Figure 19b). Firstly, there is its overall character: the smaller windows, which are in the majority of cases distributed evenly across the elevation, give it a character consistent with Scots vernacular buildings of the 16<sup>th</sup> or 17<sup>th</sup> century. By contrast, the windows in the S elevation, particularly those to the E of the projecting outshot, appear entirely utilitarian and functional in character, placed with the purpose of maximising the amount of light entering the building. Ornamental flourishes are absent, with plain lintels and rybats present. These can be contrasted with the windows in the N elevation, where lintels and rybats are chamfered, and in particular with the windows in the projecting NW corner tower and nearby bays in the W elevation and W end of the S elevation, where the window openings combine segmental or cusped openings with chamfered rybats and lintels (Figure 20a).

57. Moving on, we see the use of similar small panes throughout the N (arguably the principal) elevation and the W elevation, too (Figures 19a and 22a). These contrast with the larger panes used in the large windows which occur in the eastern portion of the S elevation, which bear closer resemblance to the sash-and-case windows which are commonly used in buildings of the Victorian or Edwardian era. The presence of brass window latches (Figure 21b) further supports the suggestion that these windows are original features associated – if not with the late 19<sup>th</sup> century structure itself – with the remodelling which took place c. 1912.

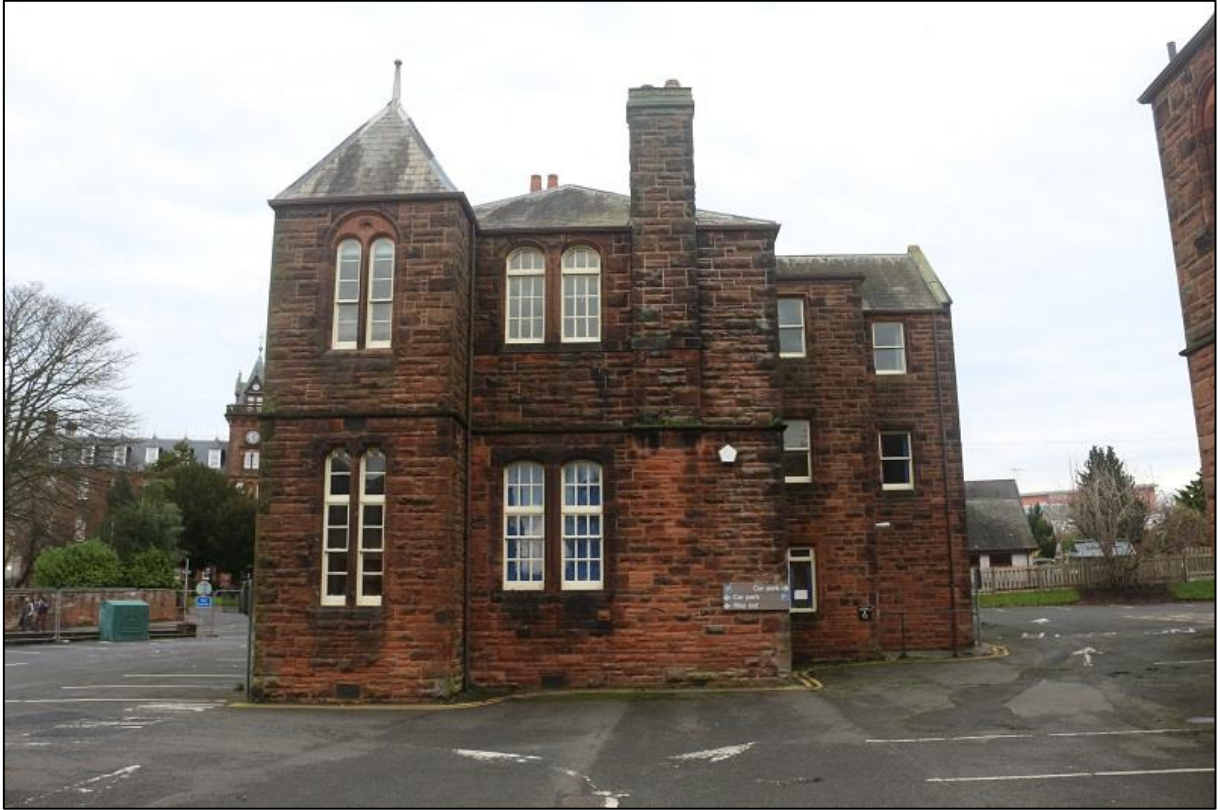
Figure 20a: Social Care Building – Cusped & Segmental Windows in W Elevation

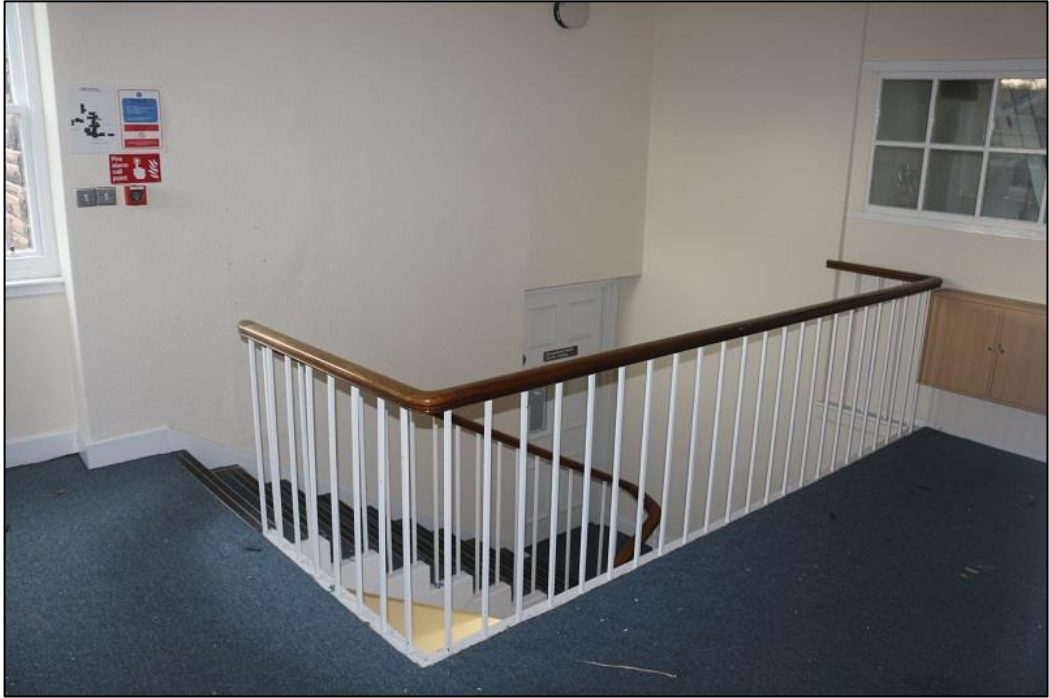
Figure 21a: Social Care Building – Stair at Second Floor Level

55. The use of hardwood timber in the bannister rail of the main stair (Figure 21a), coupled with its plain and austere character, indicates a feature likely to have originated in the early to mid-20<sup>th</sup> century. This date is supported by the presence of an internal glazed panel that sits adjacent to the door into the second floor landing: here, the small rectangular panes of glass are in keeping with buildings contemporary with the arts and crafts movement of the earlier part of the 20<sup>th</sup> century.

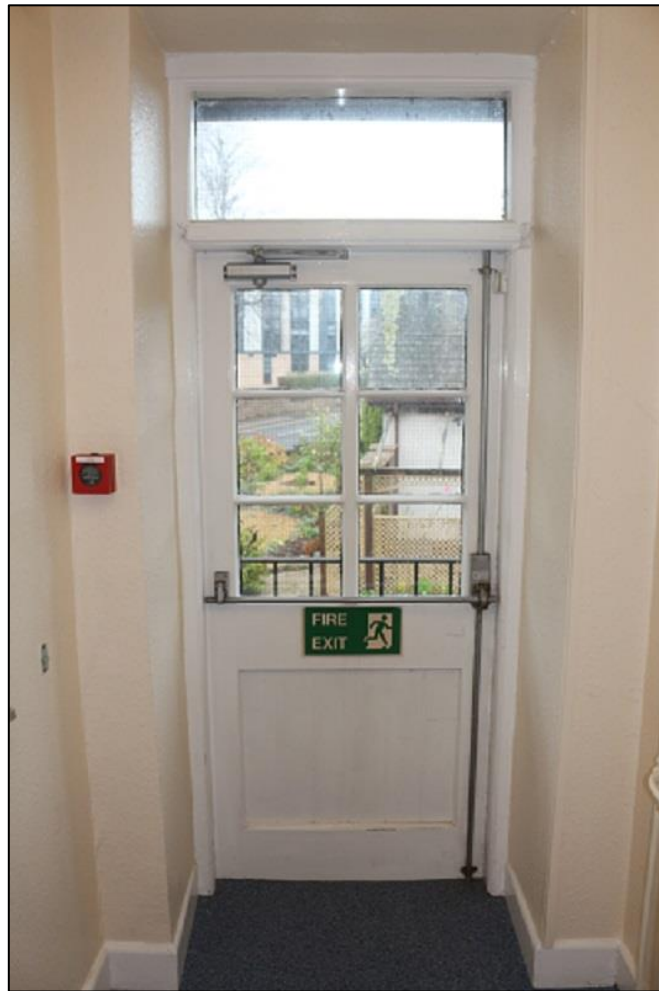
Figure 21b: Social Care Building – Door Onto Fire Escape, 2<sup>nd</sup> Floor Level

58. We can infer that the character of the external doors onto the fire escape at first and second floor levels also belong to this earlier 20<sup>th</sup> century phase of building (Figure 21b), as the division of the door into a lower panelled section and an upper glazed portion

60. This contrast may reflect different origins for the windows: the windows which are subdivided into small panes may have been replacements inserted during the early 20<sup>th</sup> century, while the large-paned windows are contemporary with the earliest phase of the building, i.e. with their origins in the late 19<sup>th</sup> century. An alternative explanation is, however, possible. The windows which are subdivided into small panes are largely located within the N-facing (potentially the principal) elevation, and on those elevations and portions of elevations that are located on a perambulatory route which passes around the N side of the structure. From this we can perhaps infer that the large glazed panes in the eastern portion of the S elevation are intended purely for function, while those in the N and W elevations in particular have a decorative role and are thus more complex in their character as a result. This contrast is also reflected in the lintels and rybats, and has been discussed more fully elsewhere in these findings. Further evidence of the historic character of the windows is provided by the survival of brass latches and other fittings (Figure 21b).

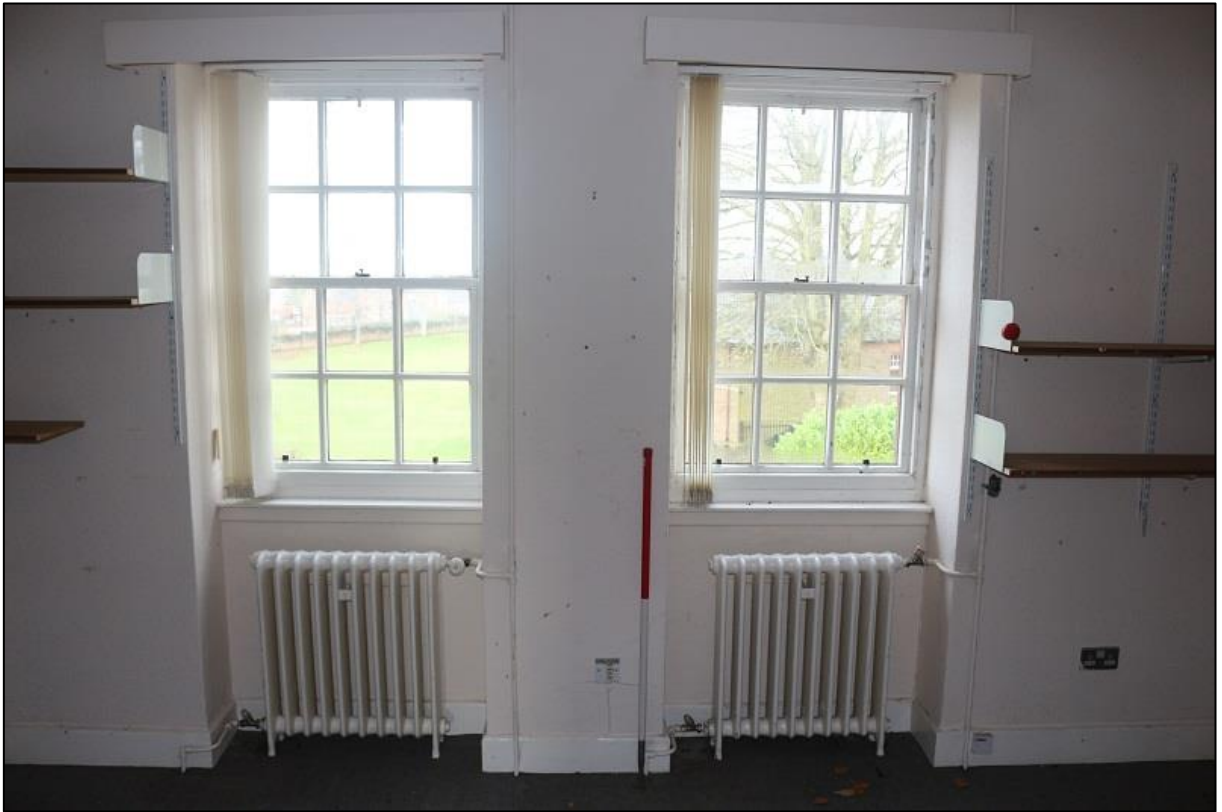
Figure 22a: Social Care Building – Windows
