The Former Black Bull Hotel, Killearn: Archaeological Mitigation

Data Structure Report

on behalf of Killearn Developments Ltd.

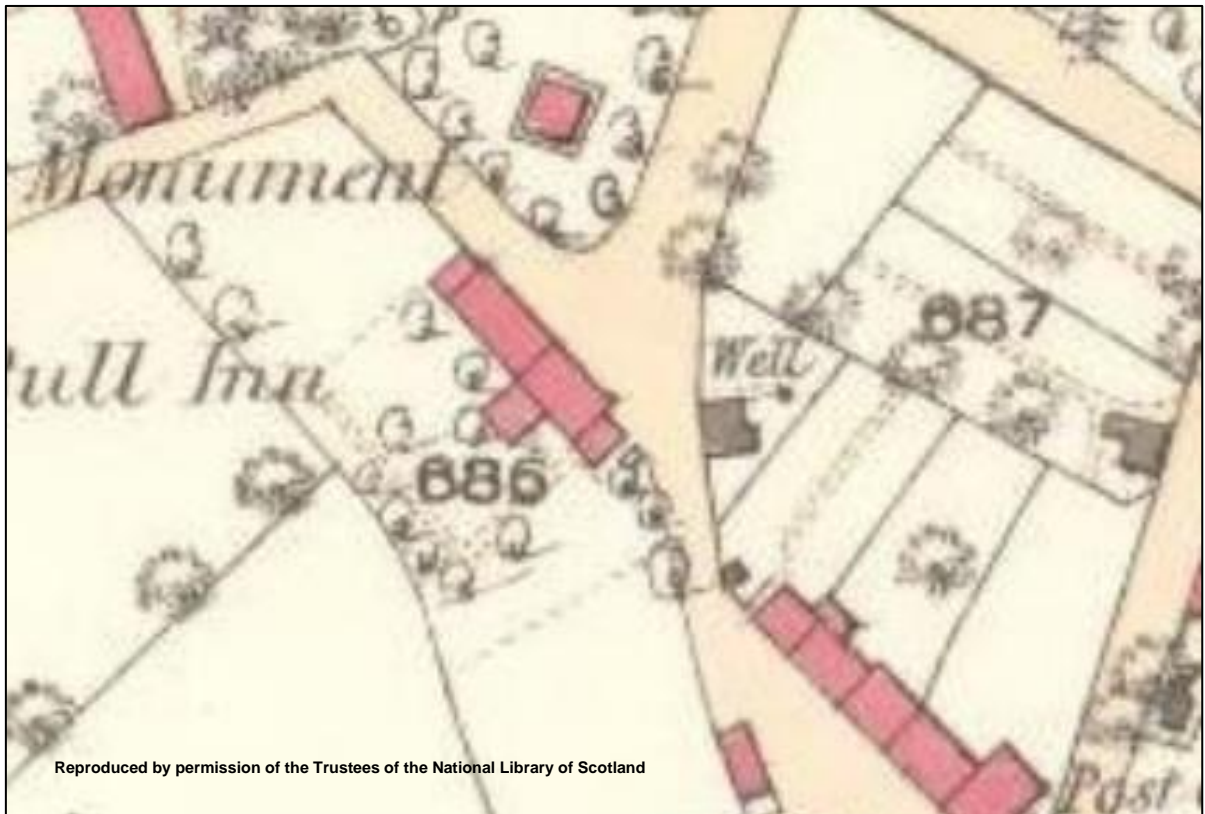
Figure 1a: Extract from 1st Edition Ordnance Survey Map Of 1865

18. At this time, the inn took the form of a rectilinear structure, shown as subdivided into two elements (Figure 1a), with small rectangular outshots adjoining the rear (SW) and side (NW and SE) elevations. Historic images are available which show the structure's front (NE) elevation, as it was during this period (Figure 1b): here we see that the SE portion of the building comprises a three-bay, two-storey building with chimneys at either gable end

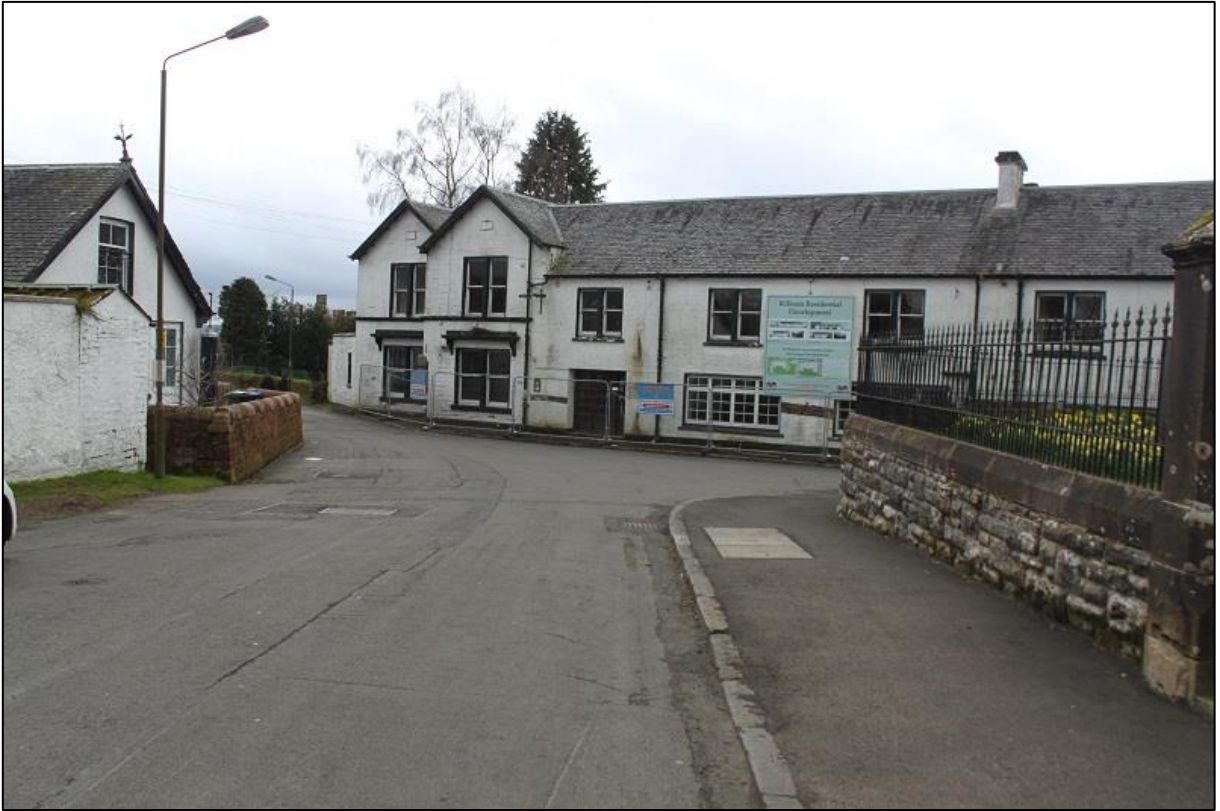
Figure 3a: The Former Black Bull Hotel, Killearn – NE (Front) Elevation

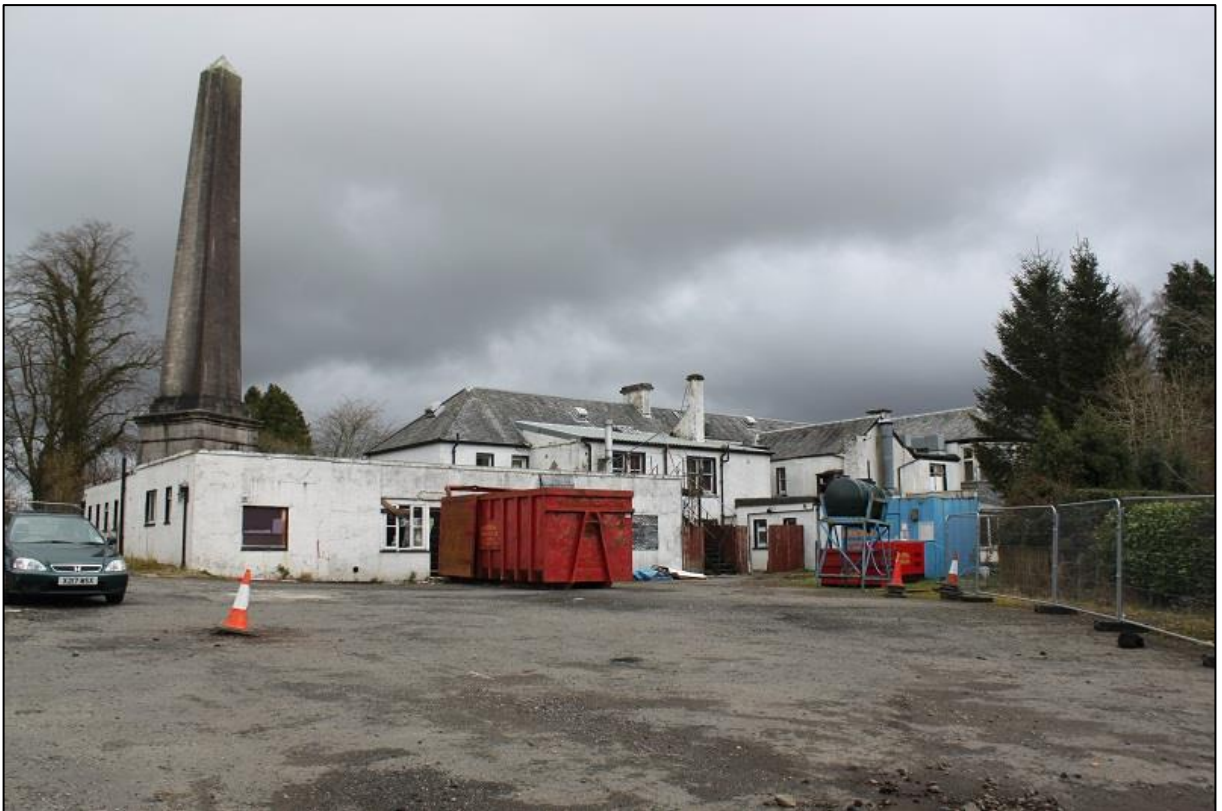
Figure 3b: The Former Black Bull Hotel, Killearn – SW (Rear) Elevation

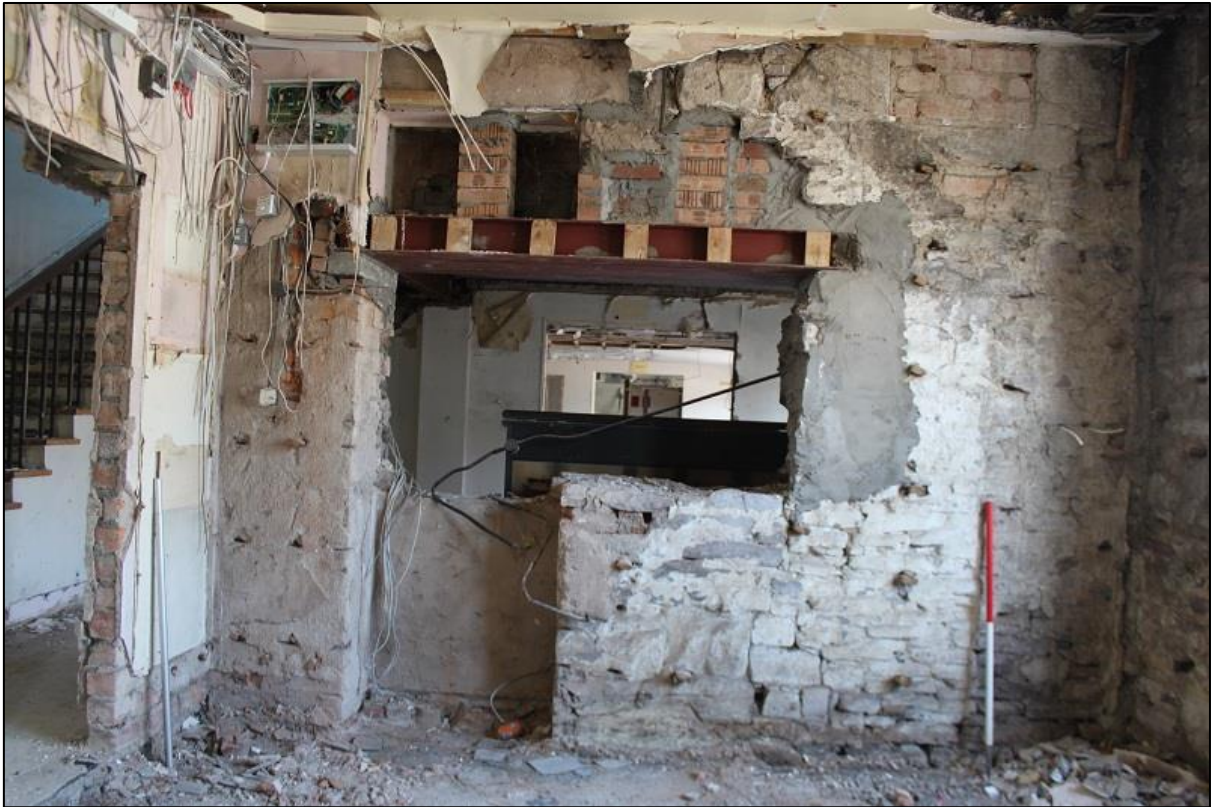
Figure 5a: NW Wall of Room g, Showing Surviving Early fabric at NE Side & Basal Levels

32. Room g now forms part of the late 19th century wing, so we can infer from the contrast in fabrics between the adjoining NW and NE walls that the wing was built onto the existing gable-end wall of the pre-1860s two-storey building. Much of the NW wall had been removed through the creation of a large hatch, inserted when Room g was later converted into a bar area (Figure 5a). However, early fabric survived below the level of the hatch over much of the NW Wall's length (except where a doorway had been slapped through at the SW end) and this same fabric survived to ceiling height at the NE side.

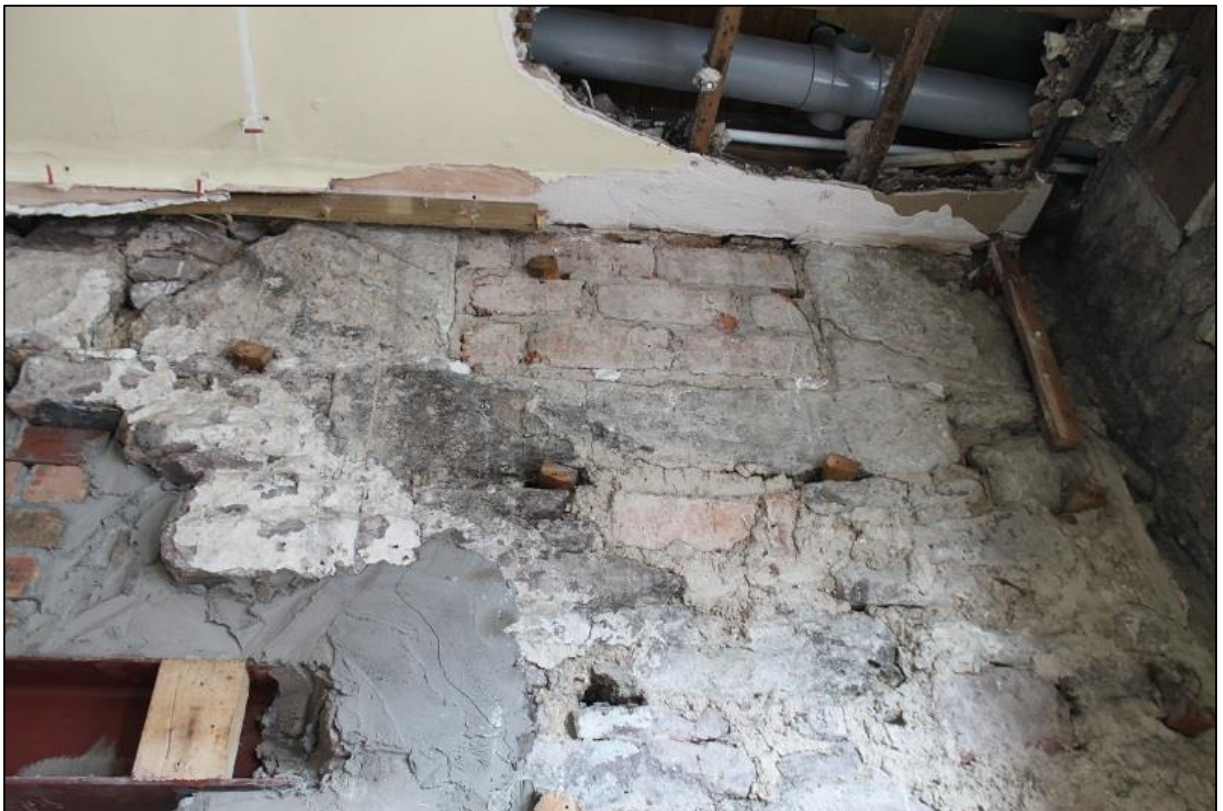
Figure 5b: Room g, NW Wall, Blocked Window at Original 1st Floor Level

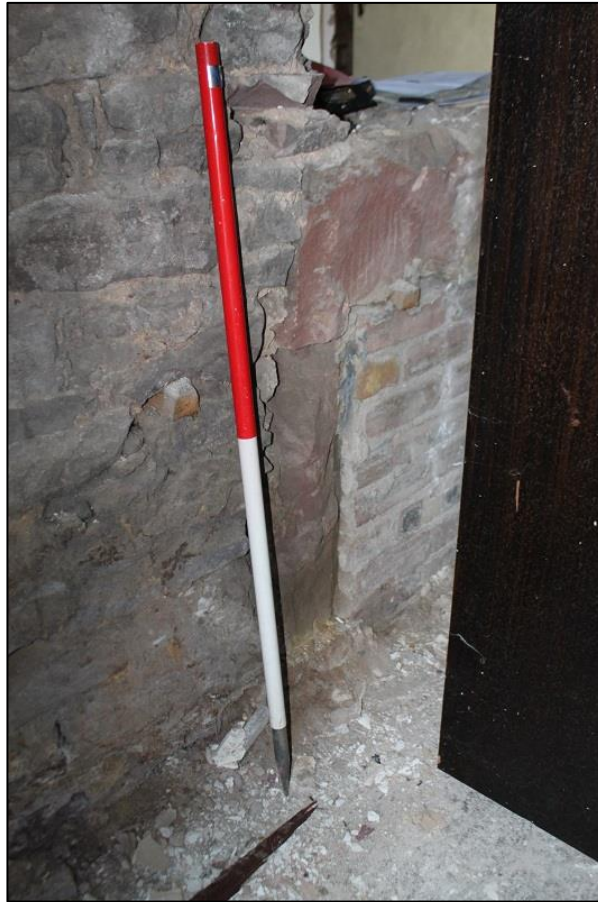
Figure 6a: Relict Fireplace in SE Wall, Room h

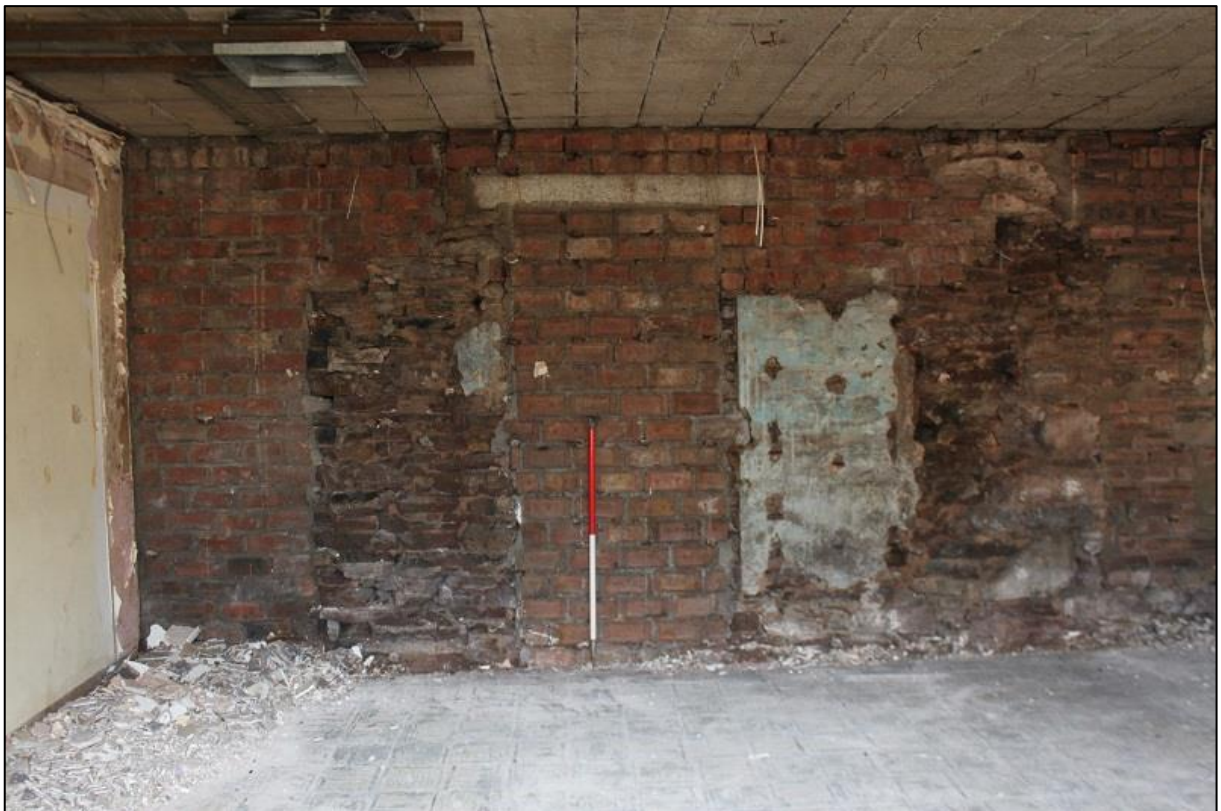
Figure 6b: Room j, Rear SW Wall

36. The character of the early fabric was very similar here to that seen in Rooms g/h, with regular courses of small, roughly worked or unworked blocks present. However, the stonework seemed much darker, as if heated or sooted. With the earlier fireplaces located at either gable end, however, this seemed an unlikely source of the unusual colour. The possibility was considered that this might represent a fragment of earlier, Phase 1, fabric incorporated into the pre-1860 building, but the fact that the sandstone was predominantly darker than the pale stone noted elsewhere in association with Phase 2, and also potentially with Phase 1, with the use of red sandstone consistent instead with late 19th century masonry characteristic of the SE wing. The alternative possibility must therefore be considered that the darker fabric represents late 19th century alterations to the structure. Unfortunately, more recent changes to the fabric, carried out from c. 1919 onwards, have meant that these remnants of the early fabric are too fragmentary to allow a coherent narrative to be constructed in this part of the building.

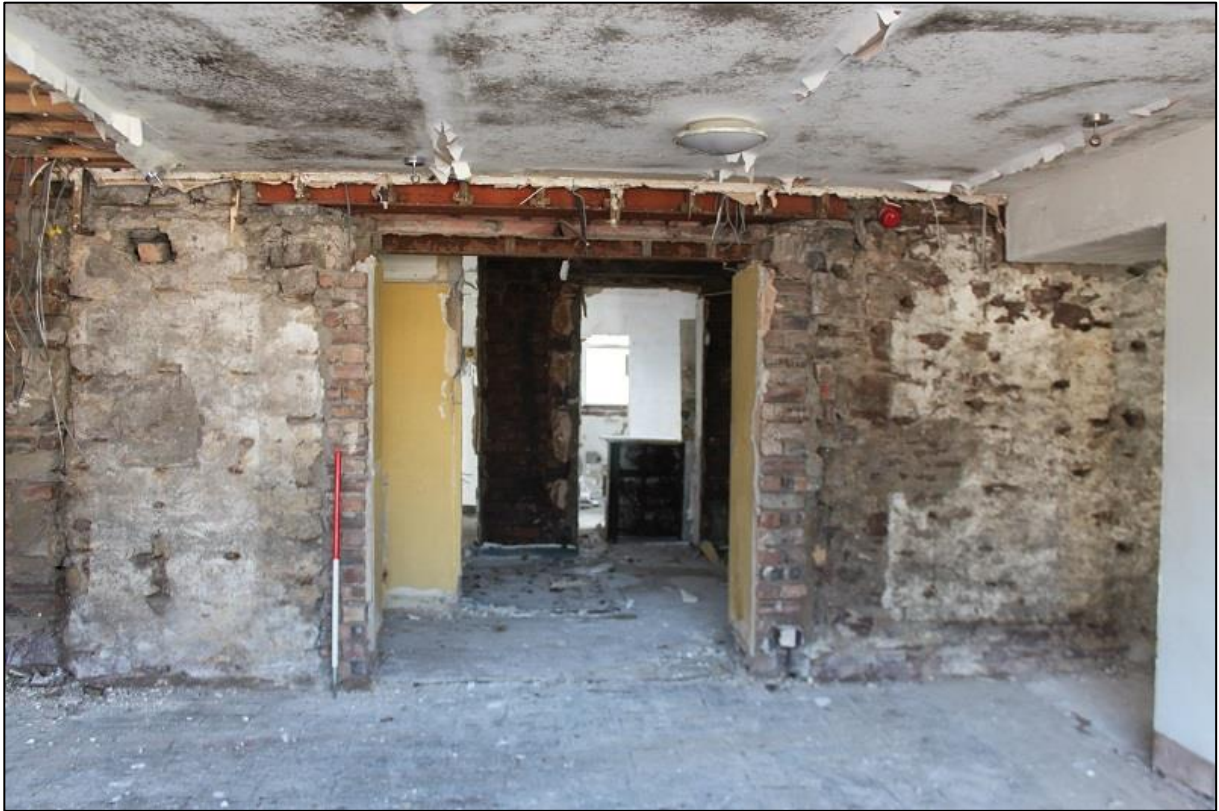
Figure 7a: Roof j, Opening at NW End of SW Wall

37. Towards the NW end of this SW wall, within Room j, a large opening, spanned by steel beam lintels, allowed access into Corridor k to the rear (Figure 7a). Close inspection revealed that the opening comprised a splayed embrasure which has been squared off at a later date using red brick. In addition to a recent steel beam lintel, there was a large red sandstone lintel spanning the opening. This suggested that the opening had its origins in an earlier phase of the building's history. The fact that the embrasure was splayed, as opposed to straight, suggests that the opening may have been for a window rather than a doorway, and the presence of the large sandstone lintel is consistent with the late 19th century fabric of the building. It, therefore, seems likely that this represents a later window opening created during the Phase 3 remodelling of the structure and later remodelled into an entranceway during the Phase 4-5 works.

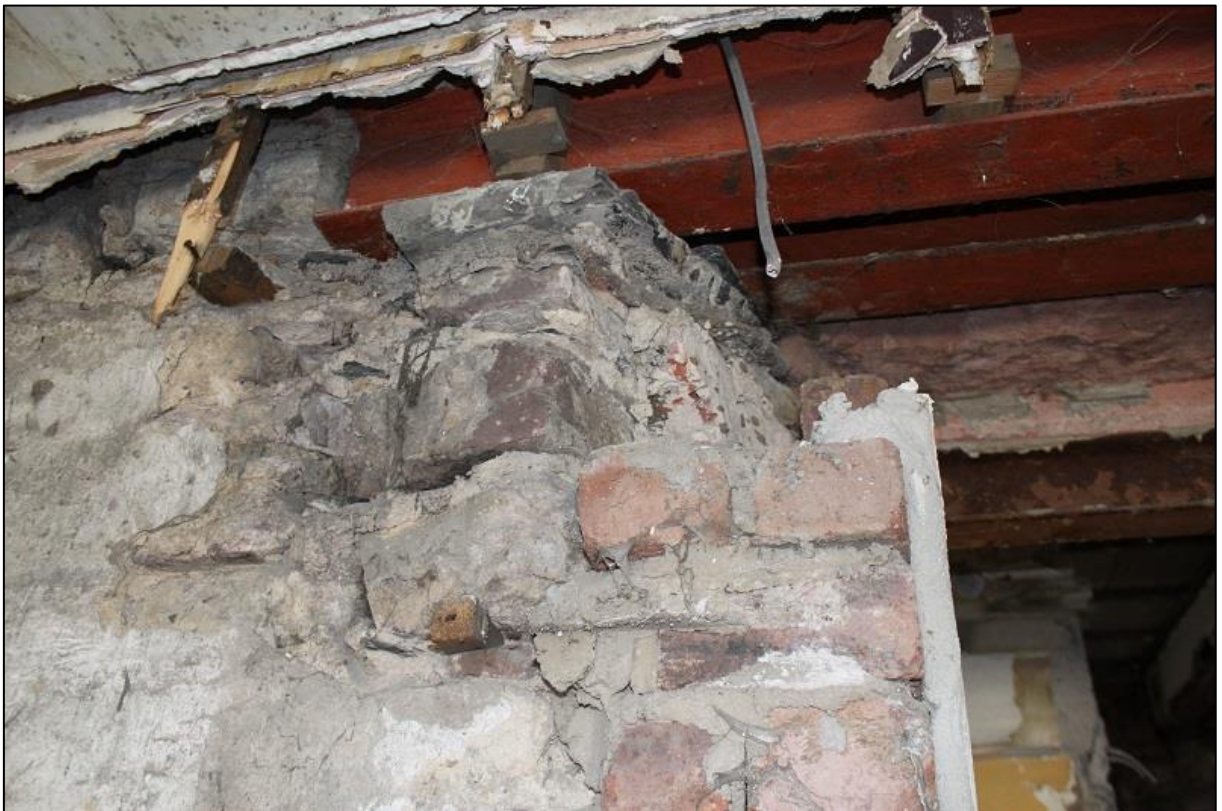
Figure 7b: Room j, Splayed Embrasure and Sandstone Lintel Over Opening in SW Wall

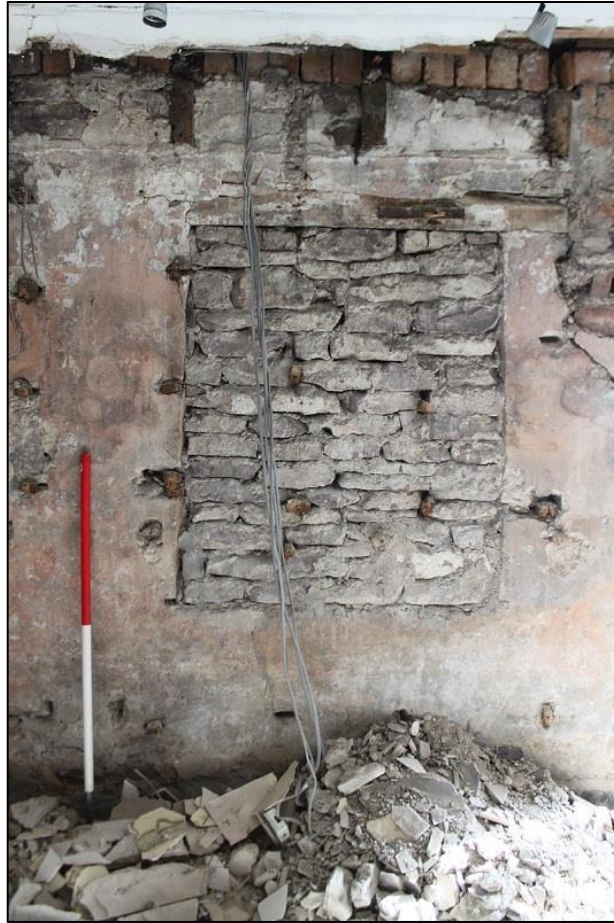
Figure 9a: Room q, blocked window and raised wallhead, NW end NE Wall

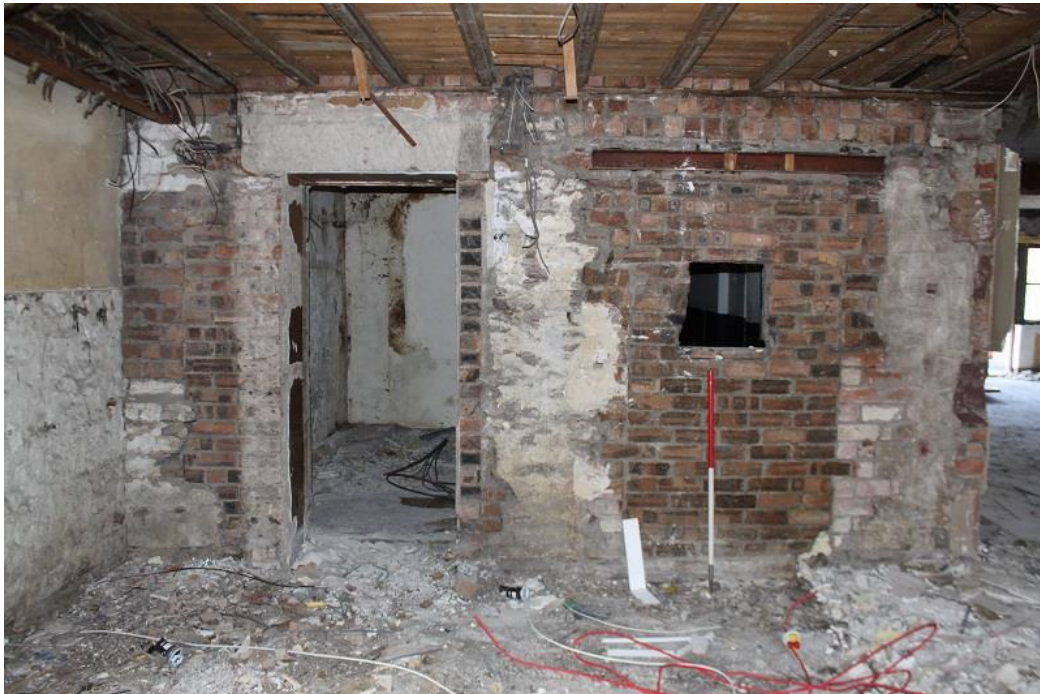
Figure 9b: Room r, SE End of SW wall (adjoining Room q), Relict Fabric with later Openings

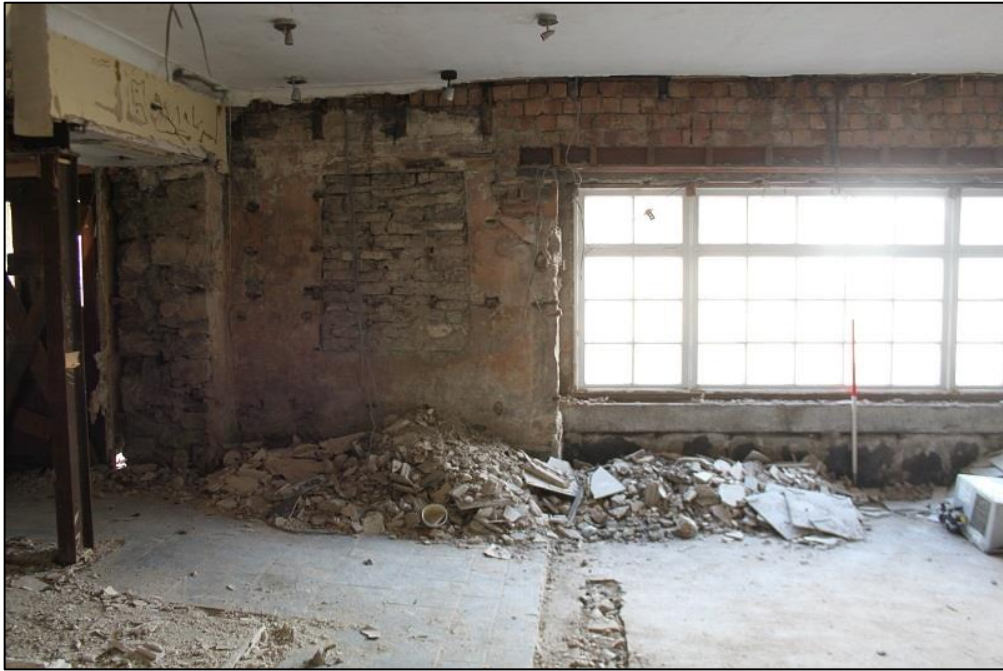
Figure 10a: Room q, Wider View, With Wall Return to LHS of Blocked Window

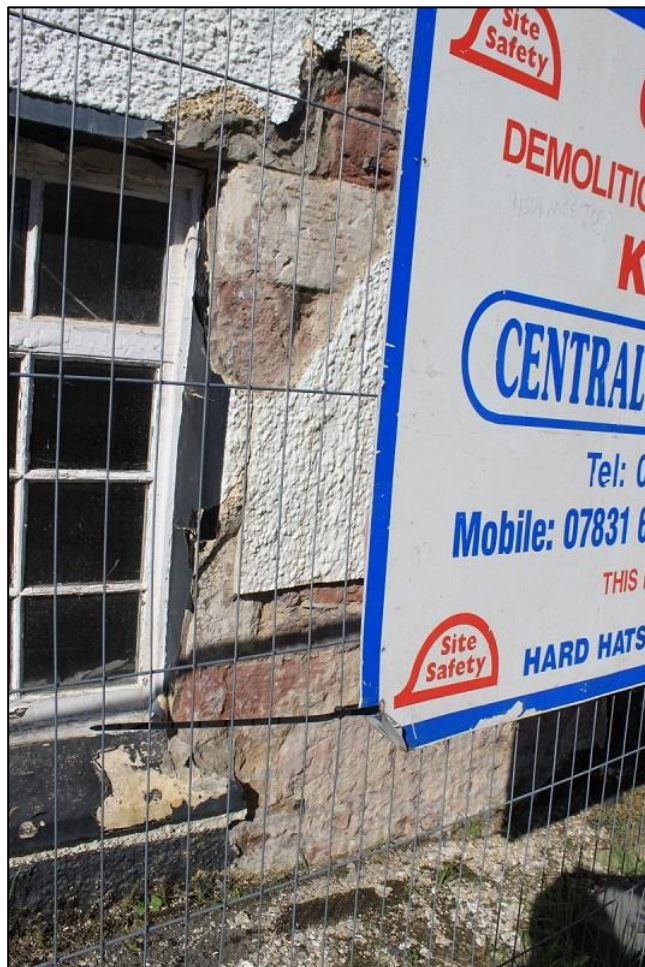
Figure 10b: Relict Margin of Blocked Window, NW end Extant Window in NE Elevation (Exterior, Room q)

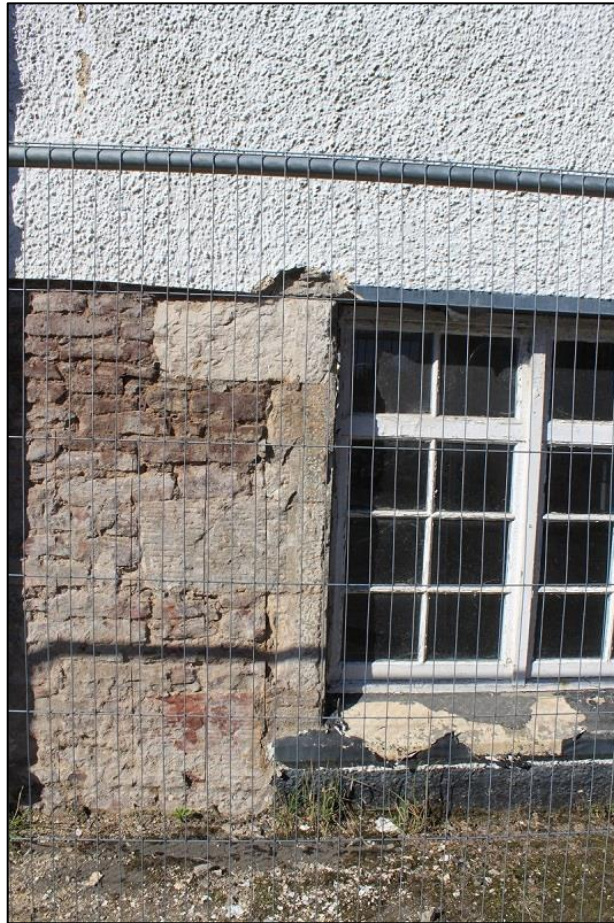
Figure 11a: Relict Margin and Sill at SE End of Window in NE Elevation (Exterior, Room q)

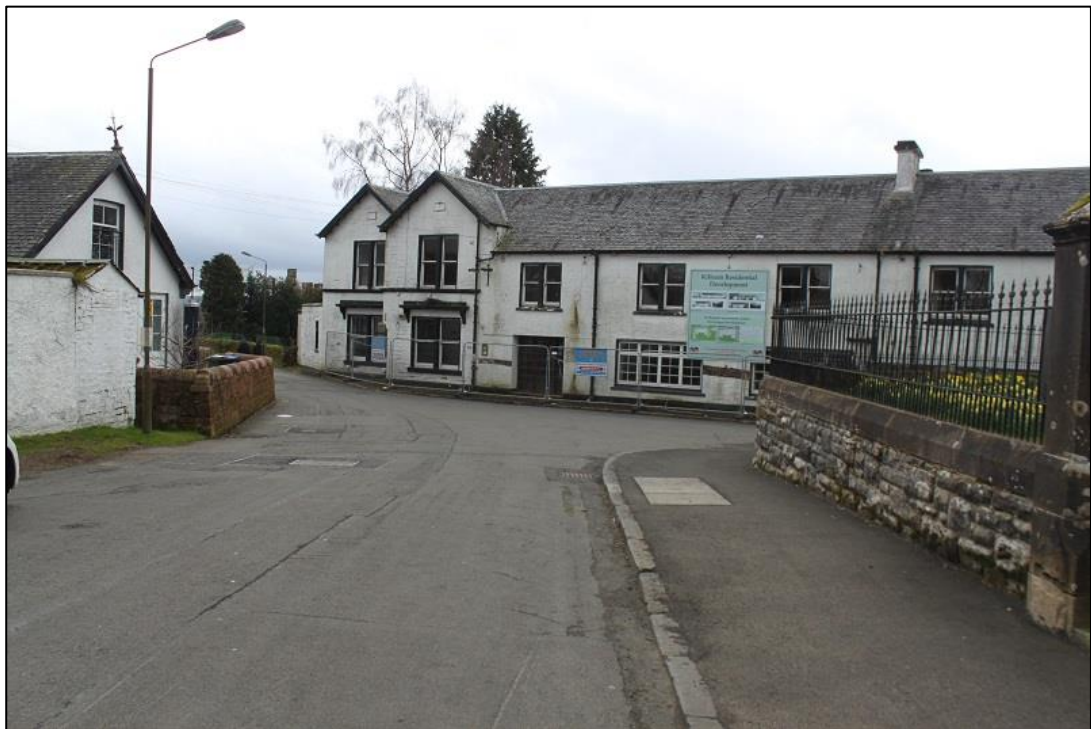
Figure 11b: SE End of NE Elevation, with Late 19th Century SE Wing to Left of Picture

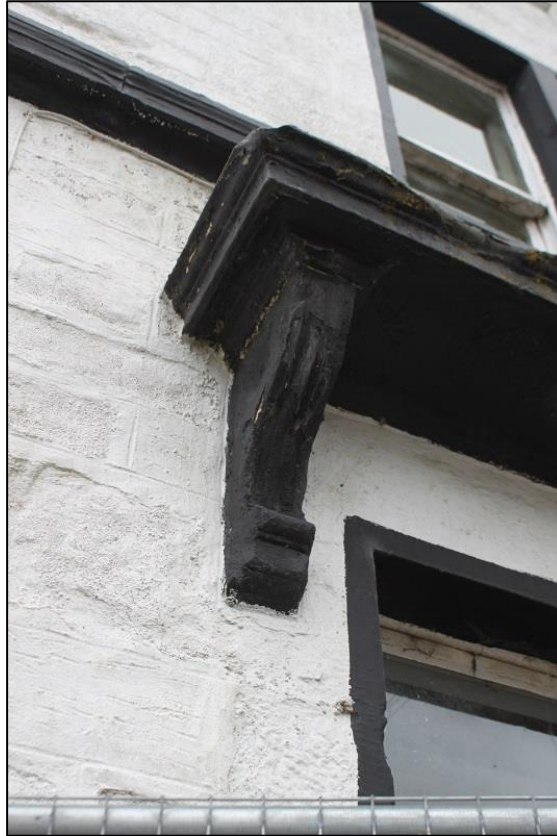
Figure 12a: SE Wing (Phase 2, Late 19th Century) – Corbels Supporting Projecting Cornice Moulding

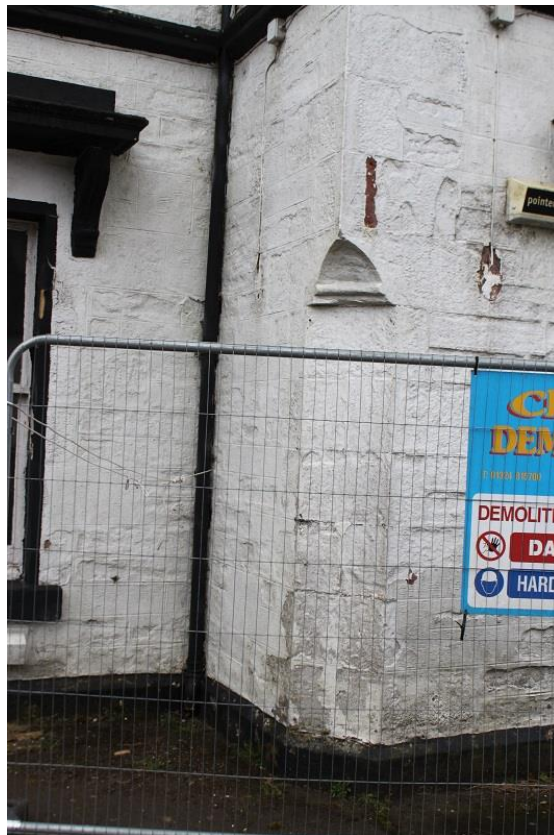
Figure 12b: SE Wing (Late 19th Century) – Facetted Edge to Corner with Mouldings Above

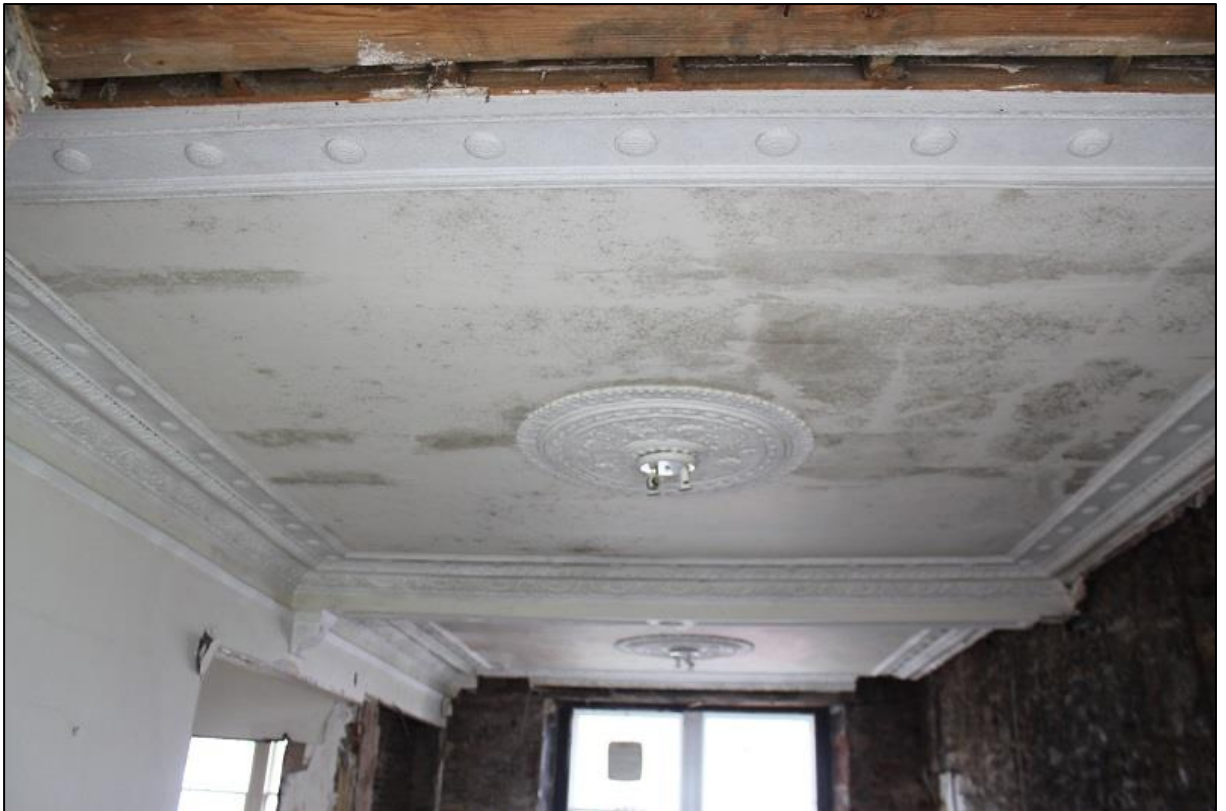
Figure 13a: SE Wing (Late 19th Century) – Room a, Ground Floor Ceiling

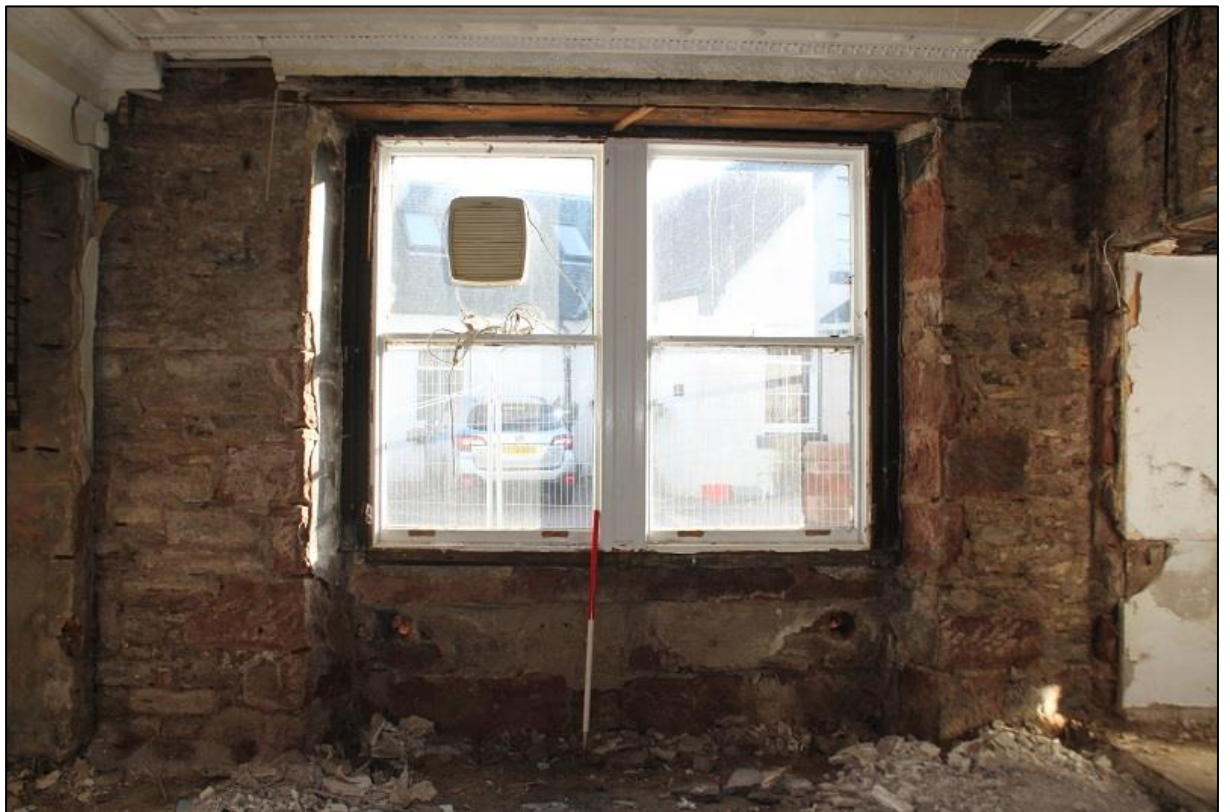
Figure 13b: SE Wing (Late 19th Century) –Red Sandstone in Fabric, Room a, NE Wall

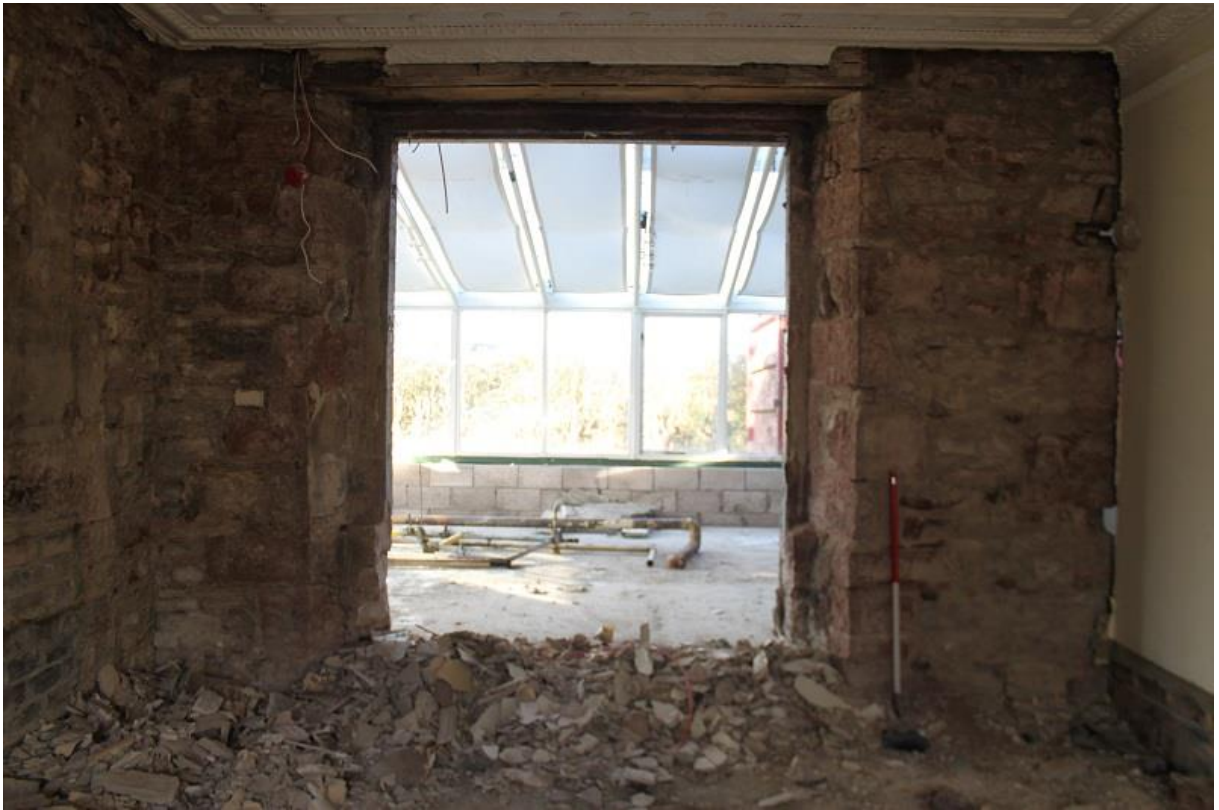
Figure 14a: SE Wing (Late 19th Century) – Room a, Former Window in SW Wall

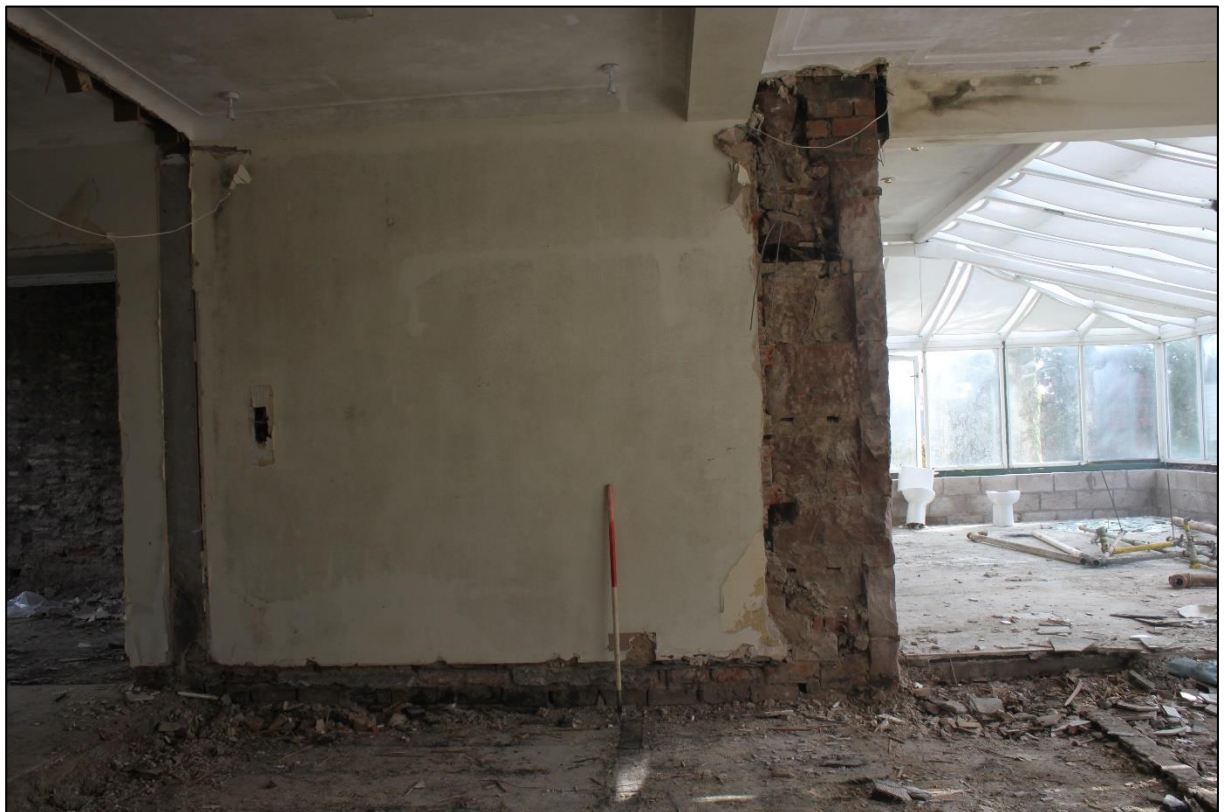
Figure 14b: SE Wing (Late 19th Century) – Rear SW Wall within Room d (Ground Floor)

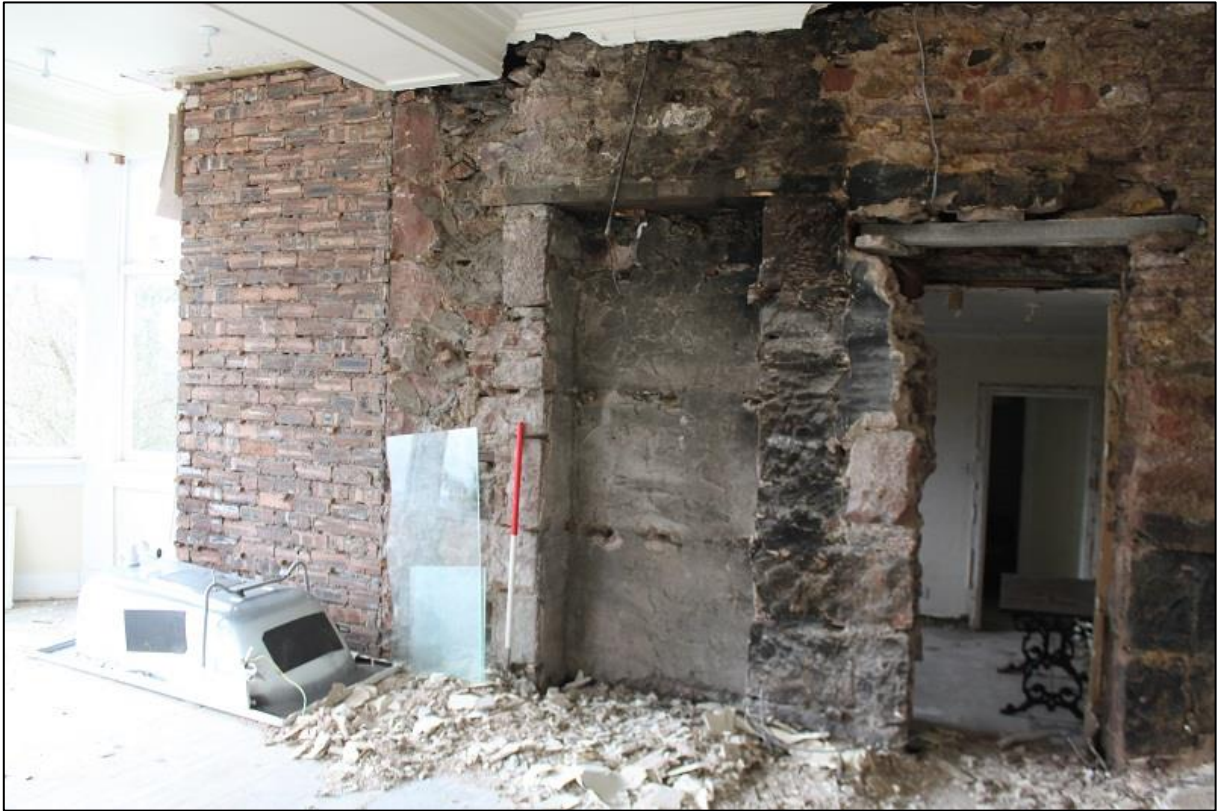
Figure 15a: SE Wing (Late 19th Century) – Retained Rear SW Wall (with Doorway and Alcove) within Room 1d (First Floor)

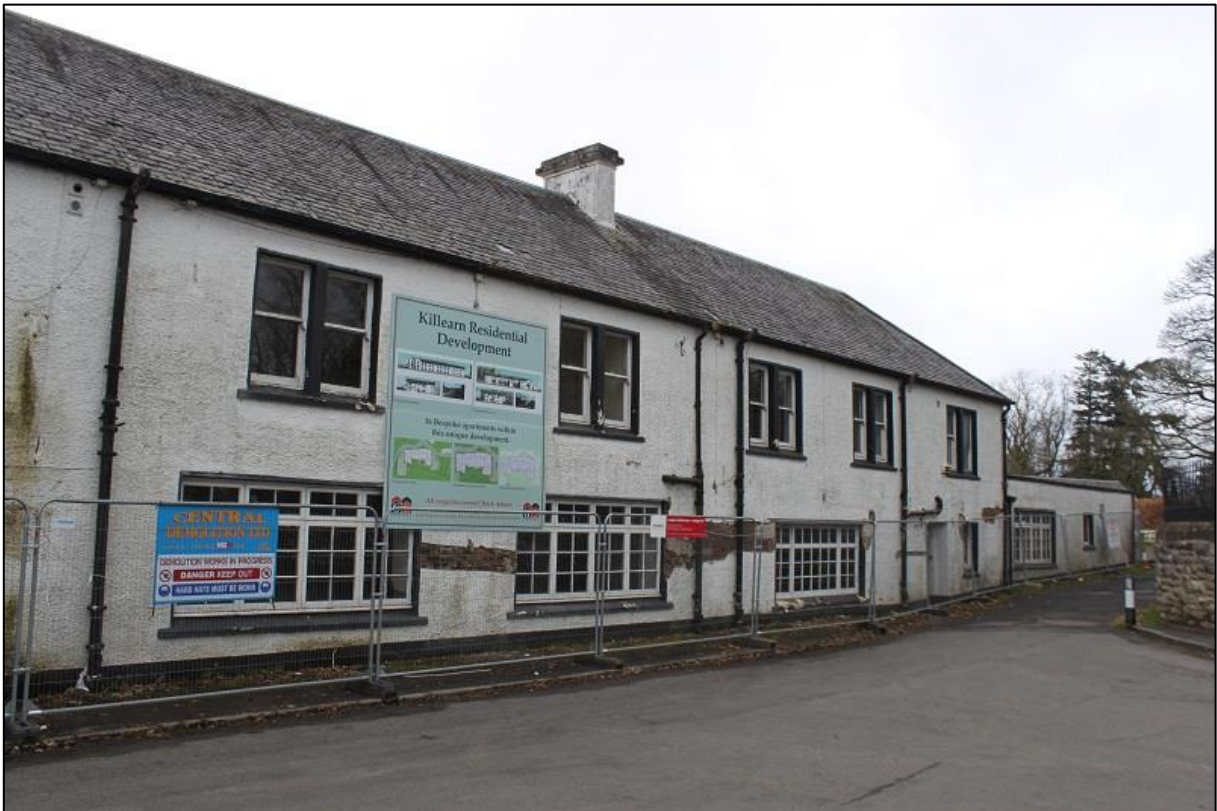
Figure 15b: *In Situ* Early Chimney Stack within rebuilt 1st Floor Section

59. The fenestration at first floor level within the central two-storey also differs from that in historic images, with the single light sash-and-case style windows replaced with larger, bipartite windows of similar style. Evidence from the ground floor confirms that these form part of a much more substantial episode of remodelling. The ceiling height has been raised in the ground floor rooms through the addition of several courses of red brick above the height of the earlier joists, and a concrete floor added, with steel beam lintels inserted over the wide openings in the rear walls of Room q. The rebuilding of the first floor has meant that the roofline between the Phase 2 and Phase 3 sections now runs at a uniform height throughout. The roof, although slated in a traditional style, has also been extended to run at a common level along much of the building, including the previously one-storey element. It is noteworthy, however, that an original chimney stack survives in situ despite the elevated roofline, and although much of the exposed masonry at ground floor level in this location (the cross-wall separating Rooms j and q) appeared to be composed of red brick (Figure 15b).

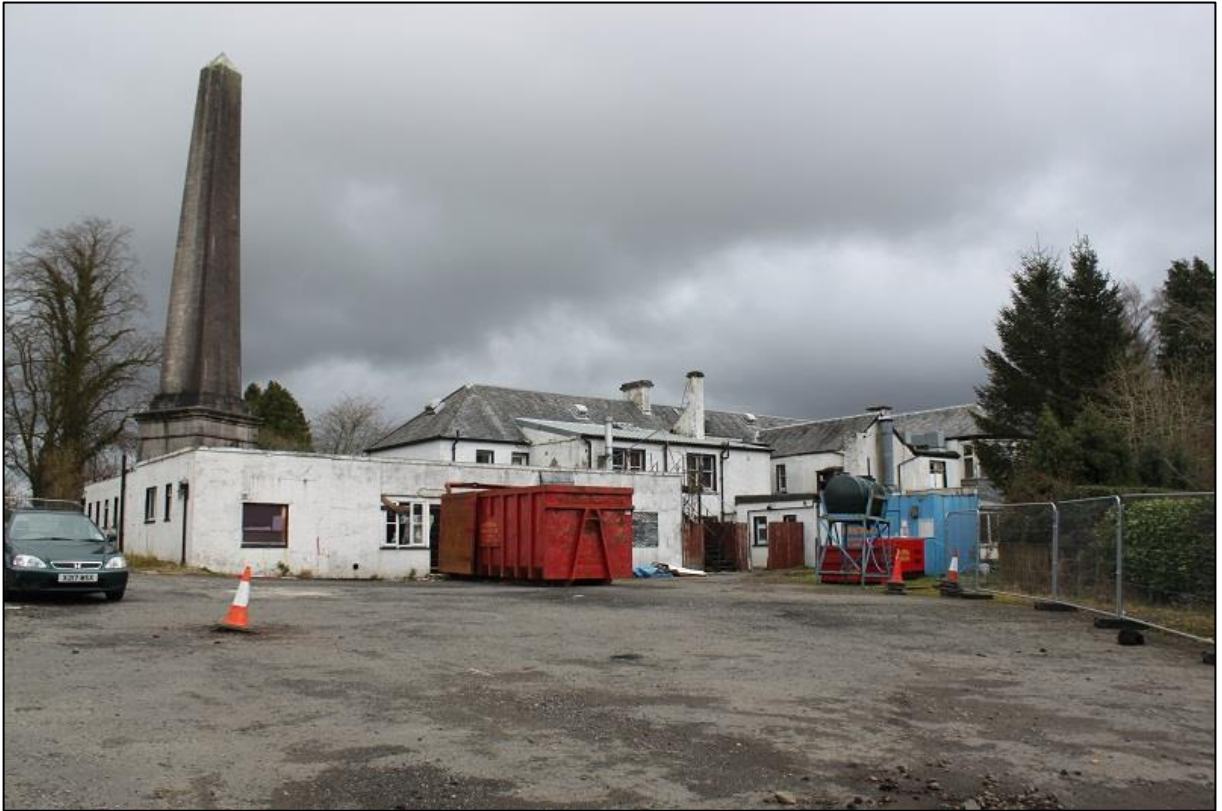
Figure 16a: View of Rear, SW, Elevation, Showing Later Extensions and Additions

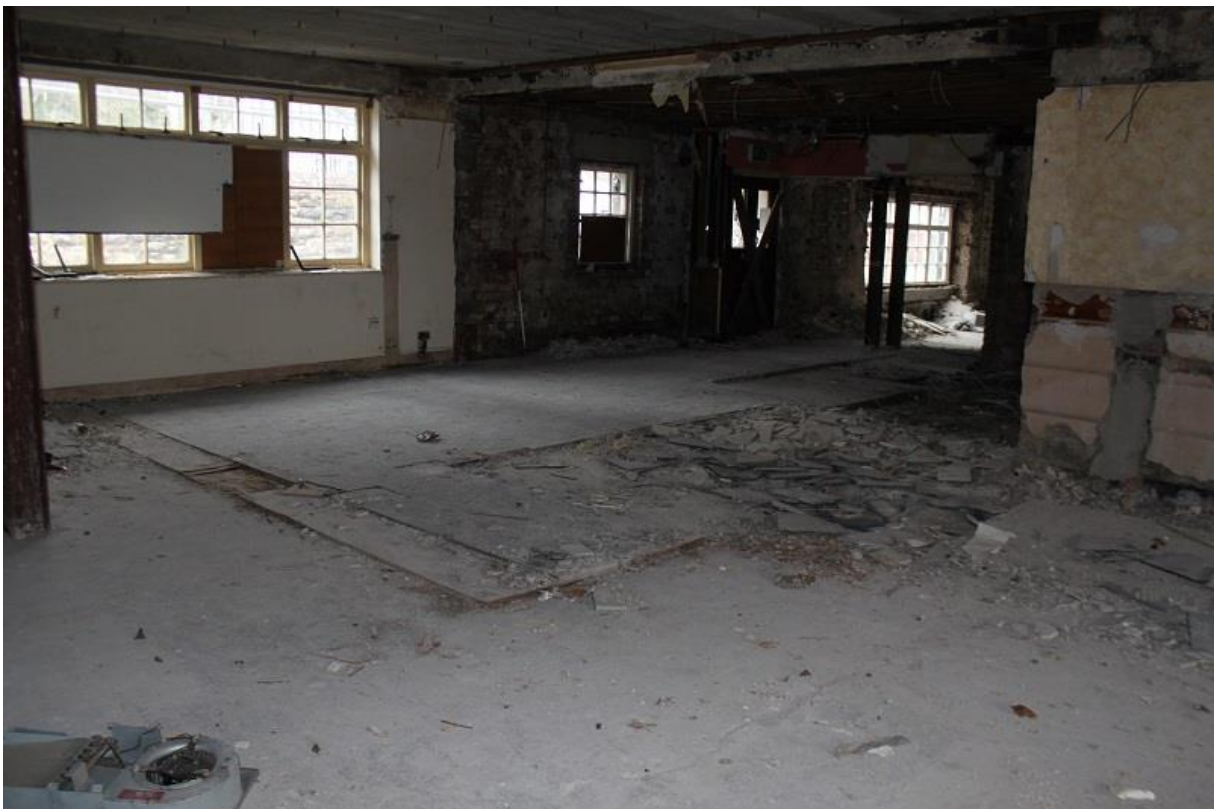
Figure 16b: Interior Room r, looking S Towards Historic Core of Building

61. Documentary evidence suggests that the addition of a large 'L'-shaped one-storey extension at the NW end of the building took place c. 1919, but Ordnance Survey mapping does not appear to show this structure until the 1960s. The addition of this space created a large lounge and performance area adjoining the NW end of the earlier building. It also incorporated some fragments of early fabric within its SE portion (Figure 16b).
